# 2031 WEST LAKE

EARLY DESIGN  
GUIDANCE

SDCI PROJECT #:3022513  
4 MAY 2016

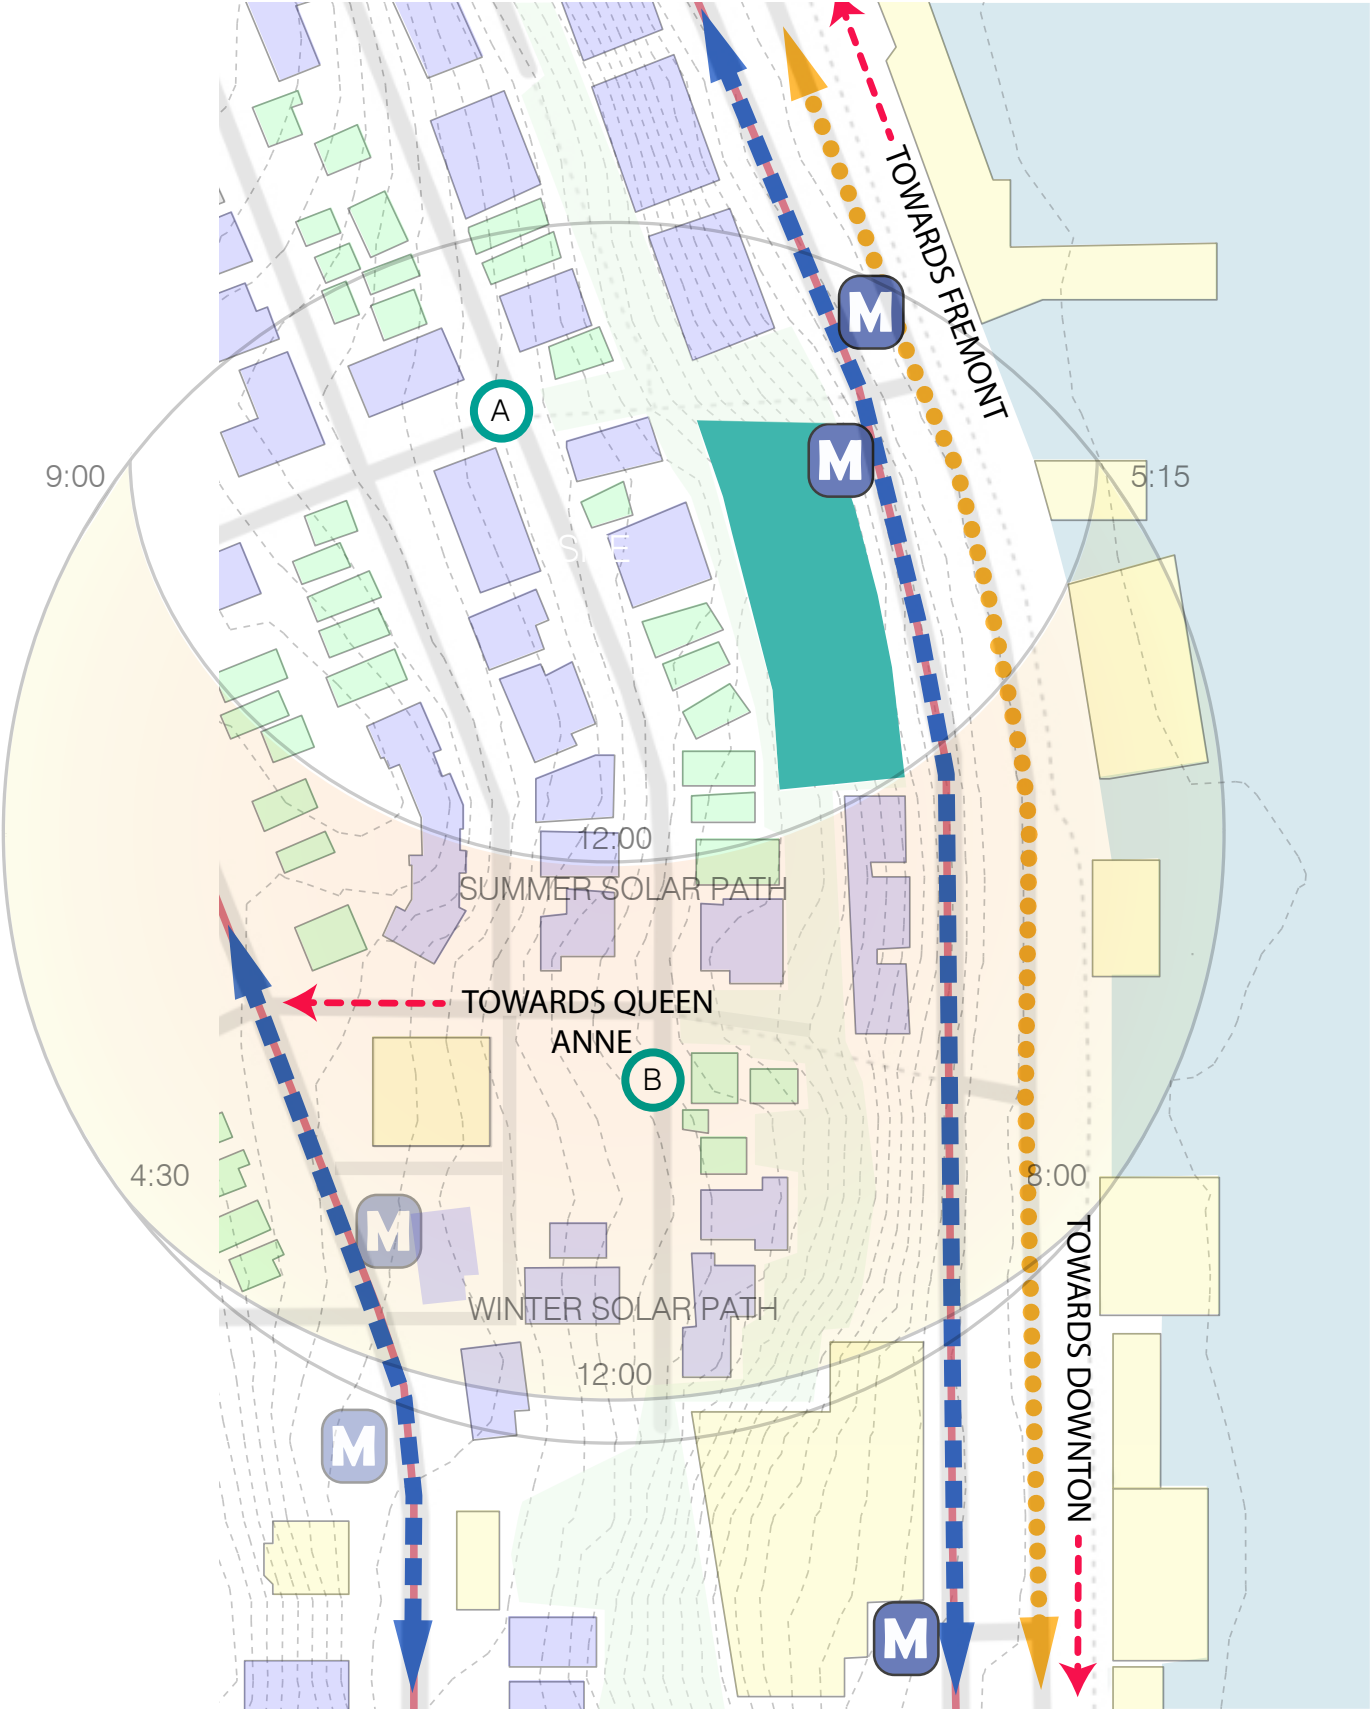
⊕ LAND USE/ TRANSPORTATION MAP

KEY: SDOT Classification

- Green Space
- Primary Arterial
- Secondary Arterial
- Bus Route
- Bus Stop
- Bike / Pedestrian Route
- Topography (2' Contours)

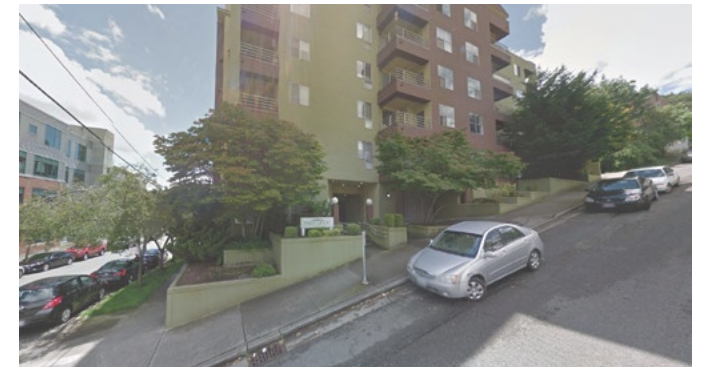
7 Slope Terrain - Multi-Family Residence

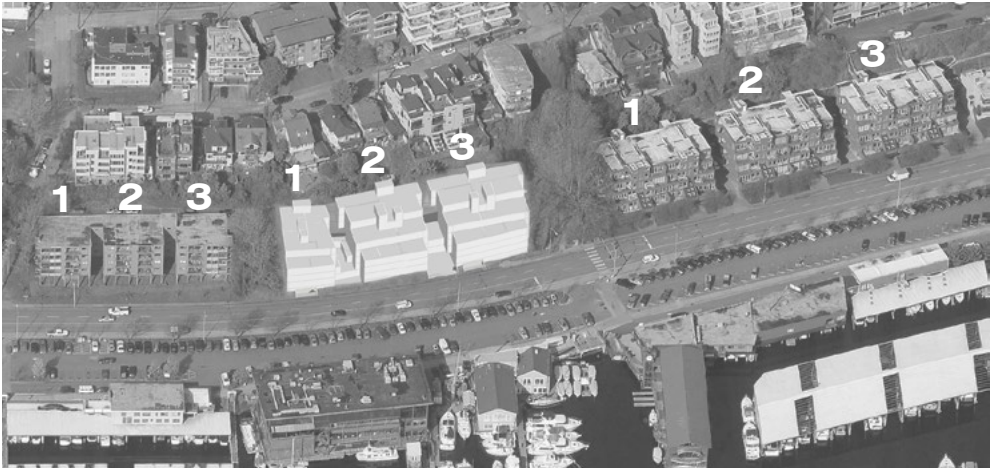
CS-2/CS-3: Massing similar to projects to North & South

Response:  
*The project is located on a steeply sloping site separated from Lake Union by Westlake Ave N. At the site's northern property line there is a pedestrian connection from Westlake Ave. N. to 8th Ave. N. At the same location there's a bus stop, stop light and crosswalk. Similarly sited multifamily projects to the North and South have very little meaningful connection to the sidewalk. We're proposing a major pedestrian entry off Westlake that would tie the project to the street, the crosswalk and the pathway. The height bulk and scale and massing break-up is similar to the projects to the north and south.*

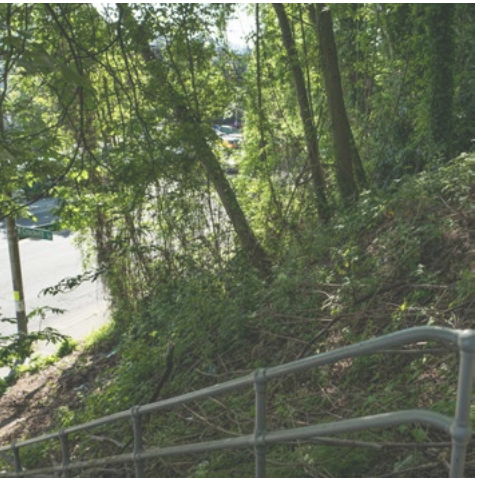
CS-1: Steep slope at NE corner of site

Response:  
*The existing site topography is a major influence on the project design. The project steps down the hill.*

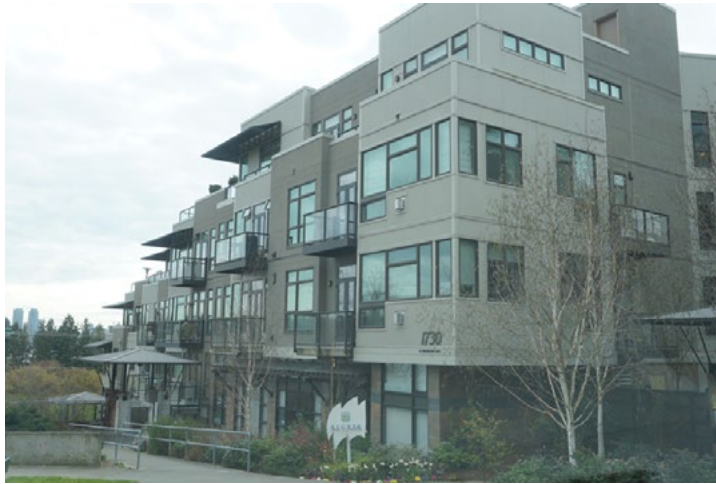
CS-1: Stepped building on a sloped site

Response:  
To the north and south of the project there are multifamily projects located on the hillside. They either step up the hill, or, are located on columns above the street. This design is broken up into three masses that break down the scale of the project. Stepping, modulation, bays, decks, and other design elements will further articulate the facades.

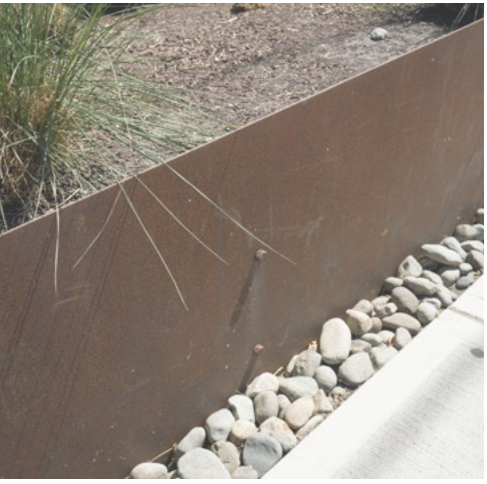
DC-2: Retaining wall at sidewalk

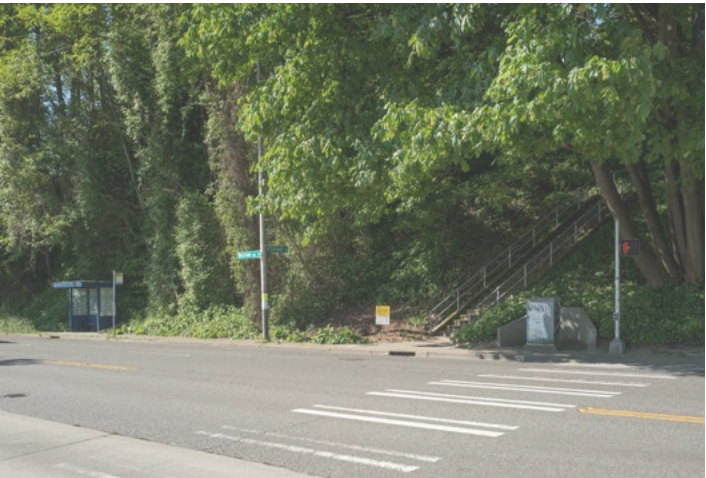
PL-4: Bus stop, Crockett St stairs, & pedestrian activated signal and crosswalk at NE corner of site

Response:  
Generally, pedestrian activity along Westlake Ave. N. to the north, all of the way to the Fremont Bridge, is very minimal. To the south, it is also minimal until Newton St. Most pedestrian activity is at the crosswalk, bus stop, and path to 8th Ave. N. adjacent to the site. Nearby multifamily projects have minimal connection to the sidewalk. Lighting, the wider main entry, and overlooking units will enhance the security and safety of the sidewalk and the pathway on Crockett.

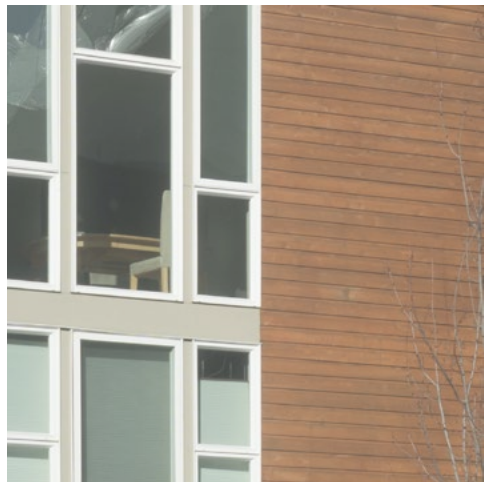
DC-4: Wood siding/vinyl window with FCP spandrel

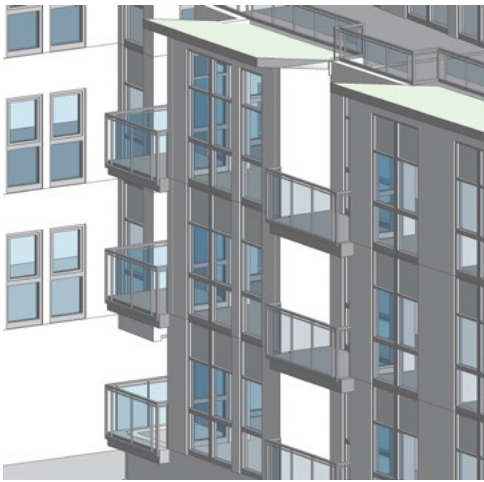
DC-4: Vinyl window with glass spandrel

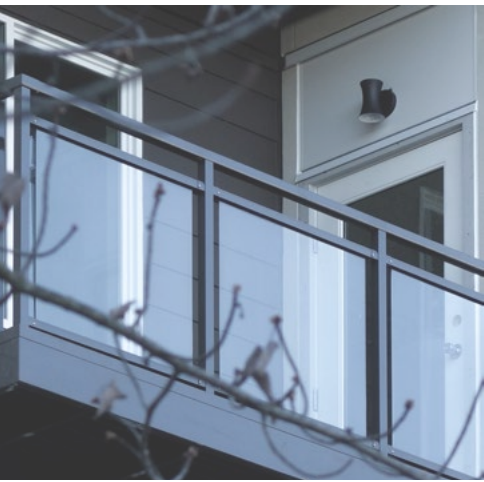
DC-4: Aluminum/glass guardrails

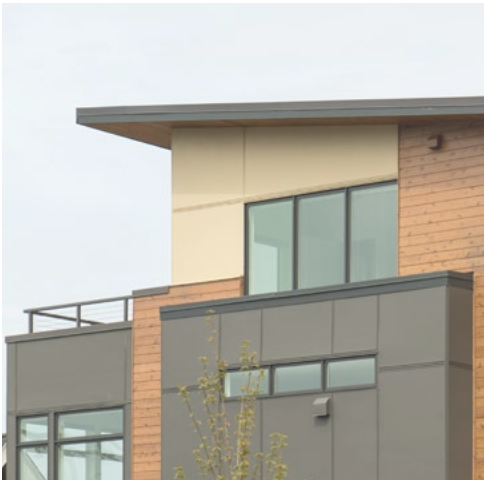
DC-4: Pitched and flat roof

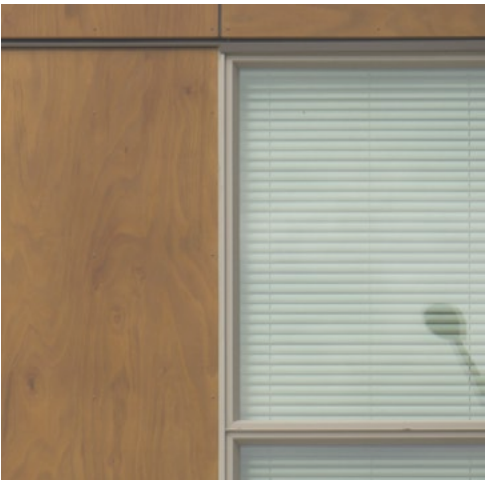
DC-4: Wood accent siding/vinyl windows

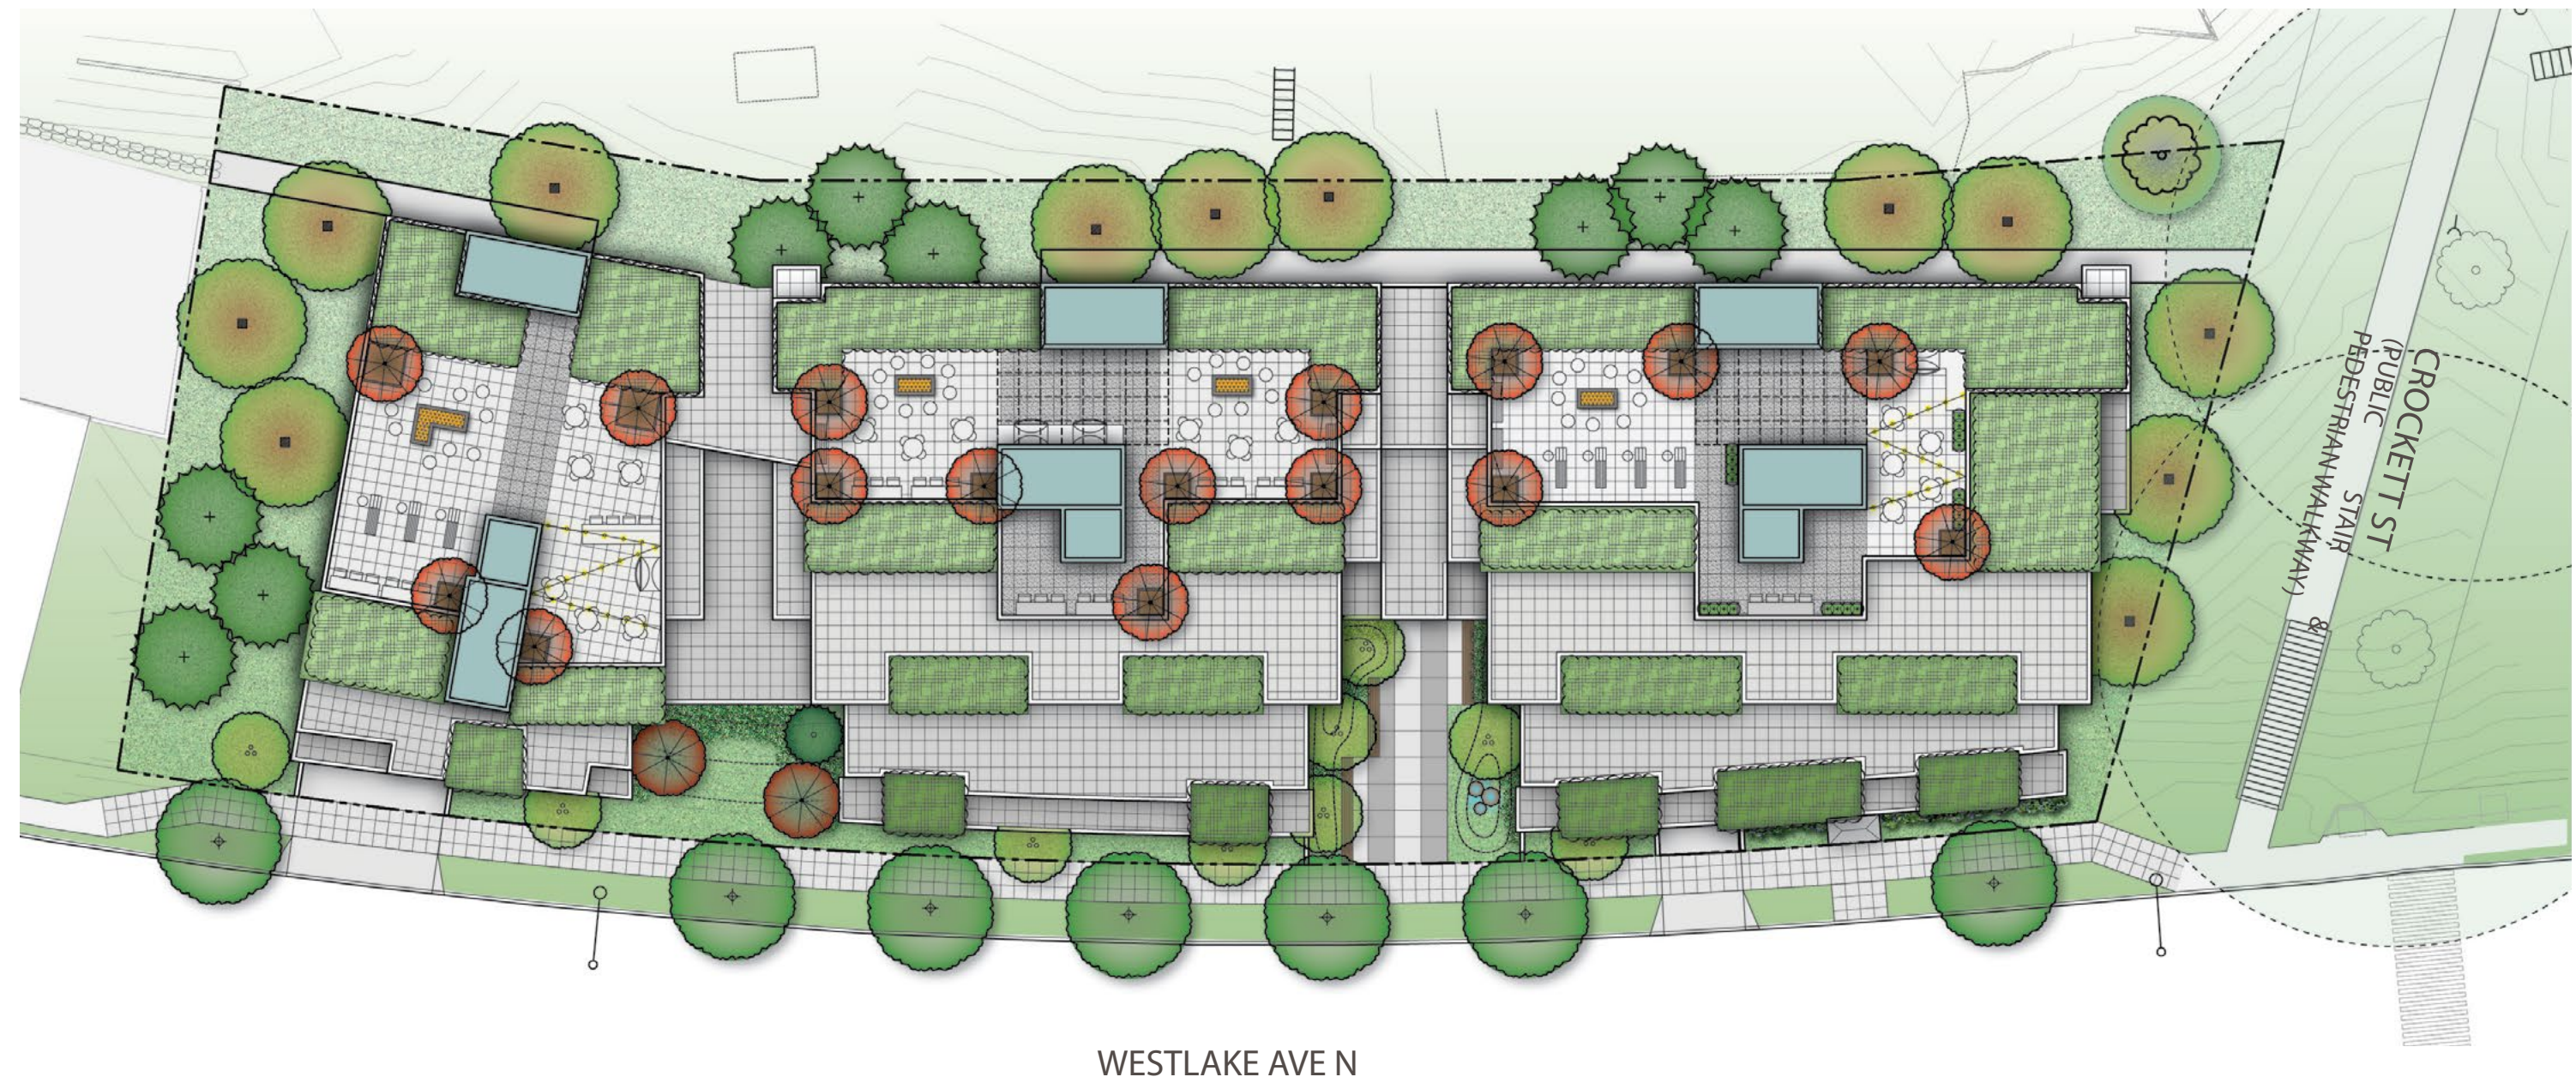
CONCEPTUAL OVERALL RENDERED LANDSCAPE PLAN

LANDSCAPE CONCEPT

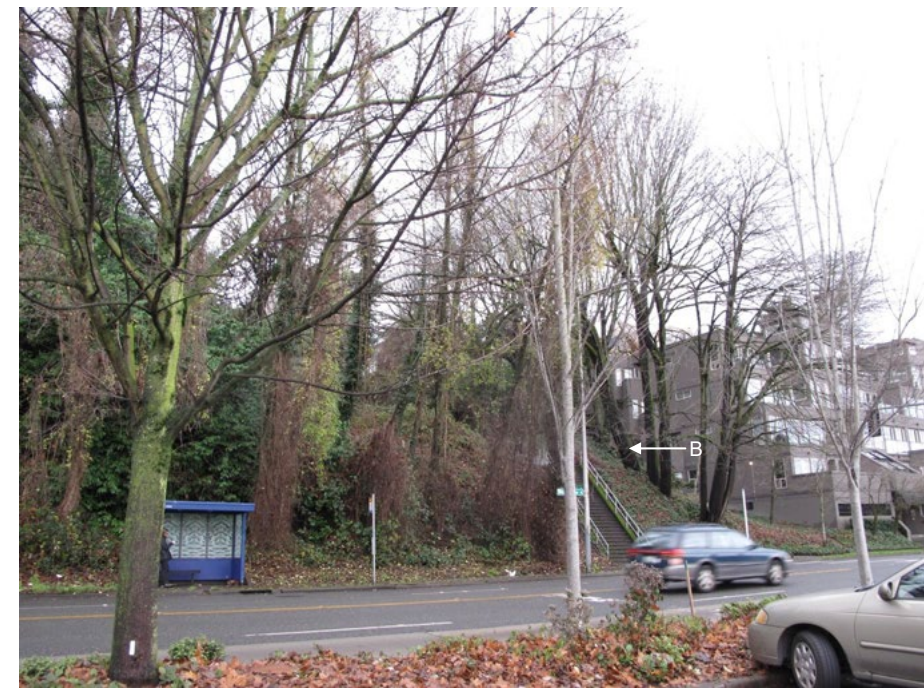
**Photo 3:** Adjacent site trees A & B located on north side of staircase to be retained. These trees should not be negatively impacted by proposed development.

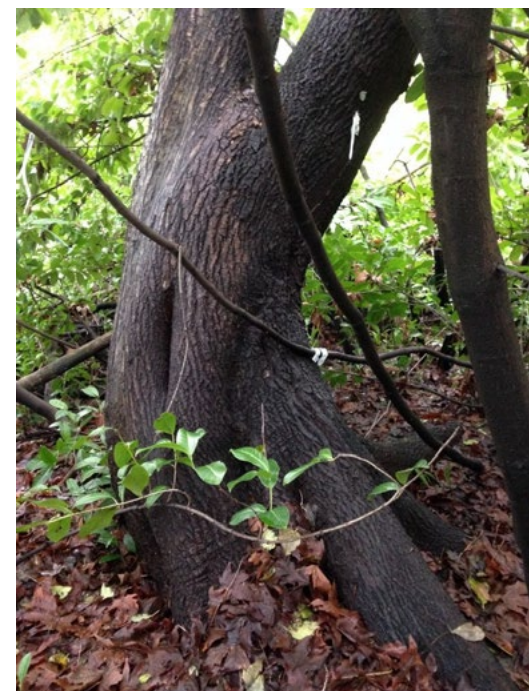
**Photo 4:** Tree 178 - Exceptional bigleaf maple tree. Potential candidate for retention.

Trees 178 and 179 were Exceptional bigleaf maple trees, measuring 31.3 and 40.8 inches DSH respectively. Both trees were in good health and fair structural condition due to co-dominant trunk form. They were located at the crest of the slope near the south end of the site. The tree bases appeared stable and we observed signs of vigorous growth.

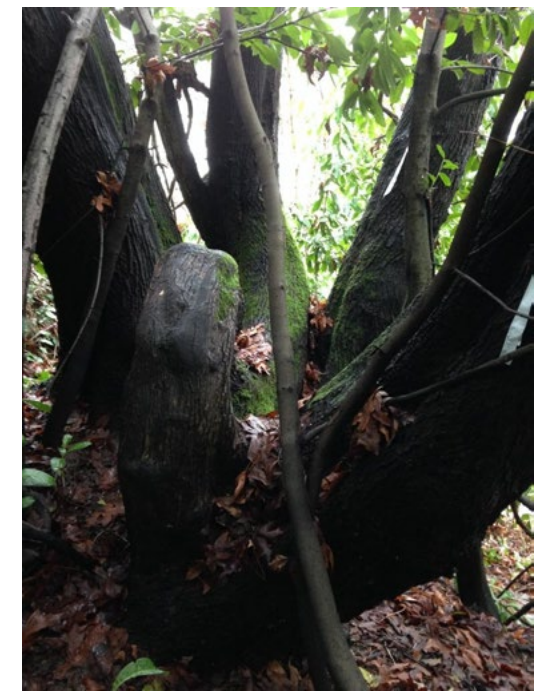
**Photo 5:** Trees 179 & 178 - potential candidates for retention.

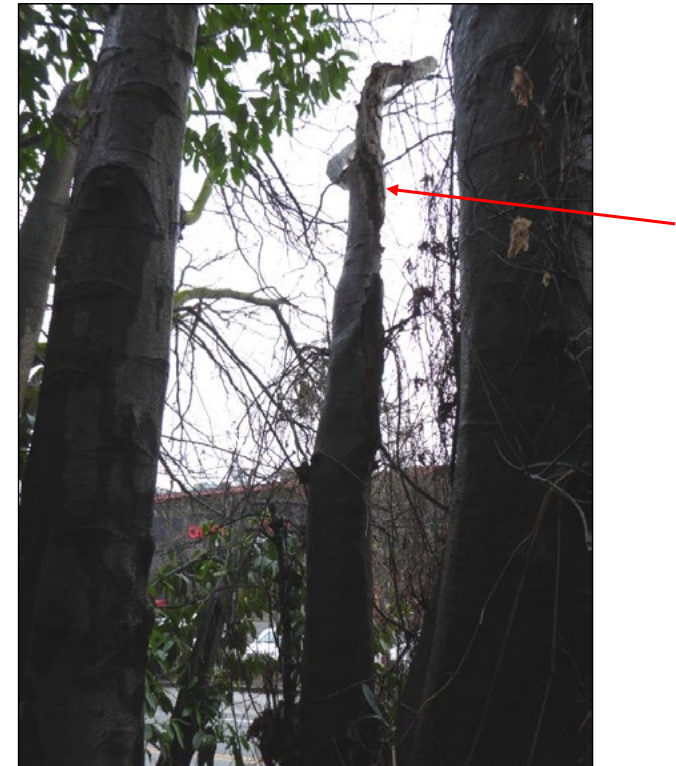
Photo 1: Red alder tree 190 looking east. Arrow points to large column of decay in trunk leaning over Westlake Ave N.

The trees that we found to be in poor structural condition within this grove were trees 183, 185, 188, and 190. Tree 190, a 28.3 inch diameter at standard height (DSH) multi-stemmed red alder (*Alnus rubra*), had large columns of decay along trunks leaning over Westlake Ave N (see [Photo 1](#)). We observed several broken branches which appeared to have fallen into Westlake Ave N. This particular species of tree is fast-growing and relatively short-lived, with brittle wood characteristics. Tree 190 appeared to be entering a stage of over-maturity, in other words, nearing the end of its life expectancy.

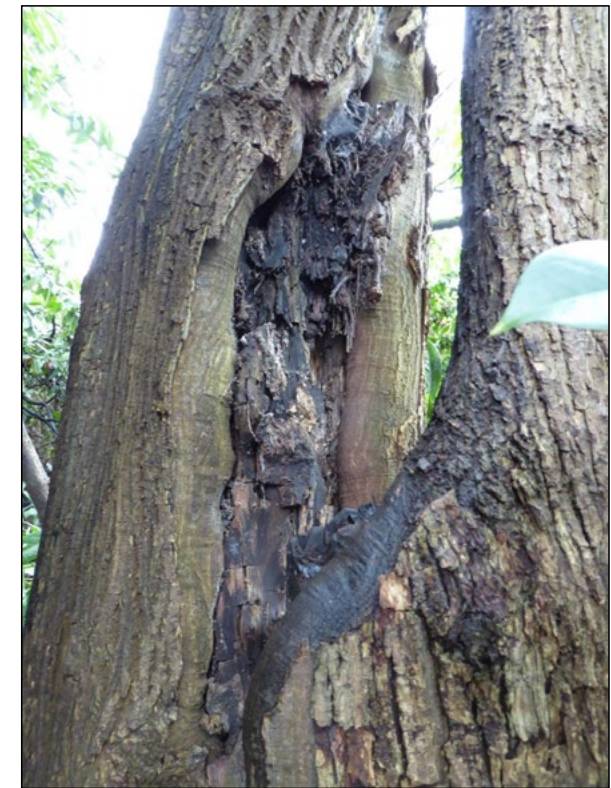
Photo 2: Decay along trunk of tree 185.

Tree 185 was a 23.1 inch DSH multi-trunk bigleaf maple tree that we found to be in fair health and poor structural condition. We observed significant trunk decay and a co-dominant union with a narrow angled attachment (see [Photo 2](#)). There was also a high volume of moderate sized diameter dead wood present throughout the canopy.

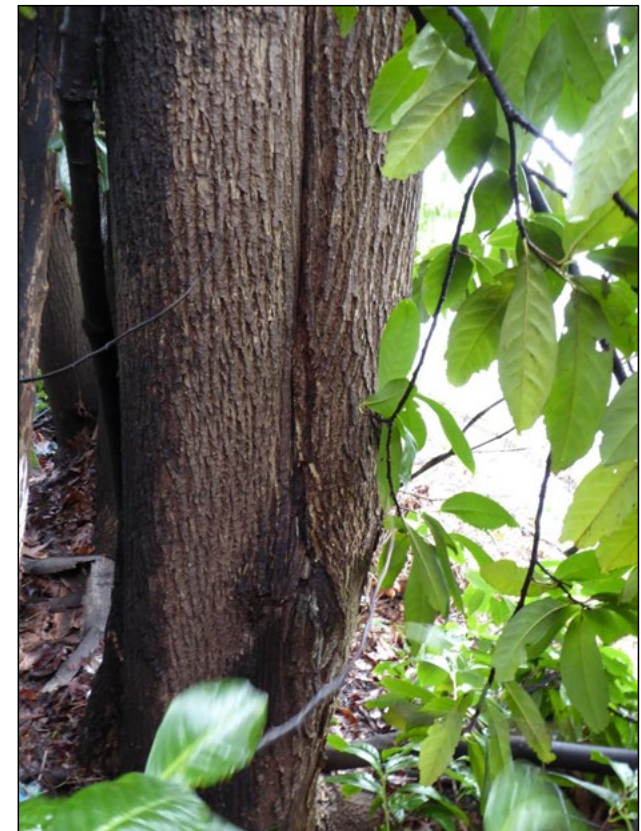
Photo 3: South side of tree 188. Note large seam of included bark and narrow angled co-dominant union.

Tree 188 was a 24.2 inch DSH bigleaf maple tree that had a co-dominant form from the base with a very narrow angled attachment and large seam of included bark. Included bark can cause structural weakness in trees due to the lack of strength in bark fibers compared to that of wood tissue. We observed that the eastern trunk targets Westlake Ave N and would likely fall into the road in the event of co-dominant failure (see [Photo 3](#)).

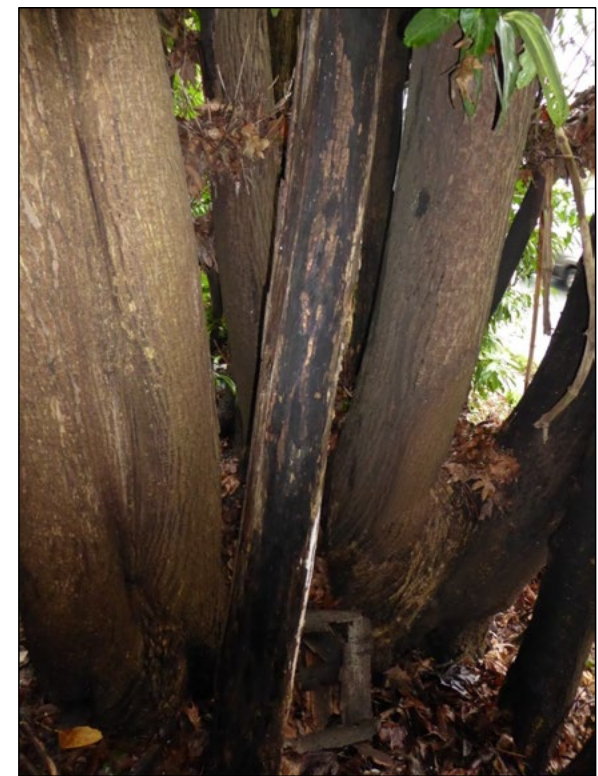
Photo 4: Base of tree 186. Note multiple trunk form.

Tree 186, a bigleaf maple tree with five co-dominant trunks, has a single-stem equivalent diameter that qualifies this tree as Exceptional by size. We found the tree to be in fair structural condition during our assessment. We observed that there was a previous co-dominant failure at about 20 feet and that the central trunk had died. The health of the tree appeared stable however it is possible that some decay exists at the base due to the co-dominant form and dead central trunk (see [Photo 4](#)). Due to these structural defects, this tree is not an ideal candidate for retention on this site. It is likely that the safe and useful life expectancy would be relatively short, especially in conjunction with adjacent development. Based on these observations as well as the risk potential to planned targets, we do not believe this tree meets the condition requirements for an Exceptional tree.
