# 2412 10TH AVENUE E.

Streamlined Design Review  
2412 Tenth Avenue E., Seattle WA 98102  
SDCI #3026149

July 21st, 2017

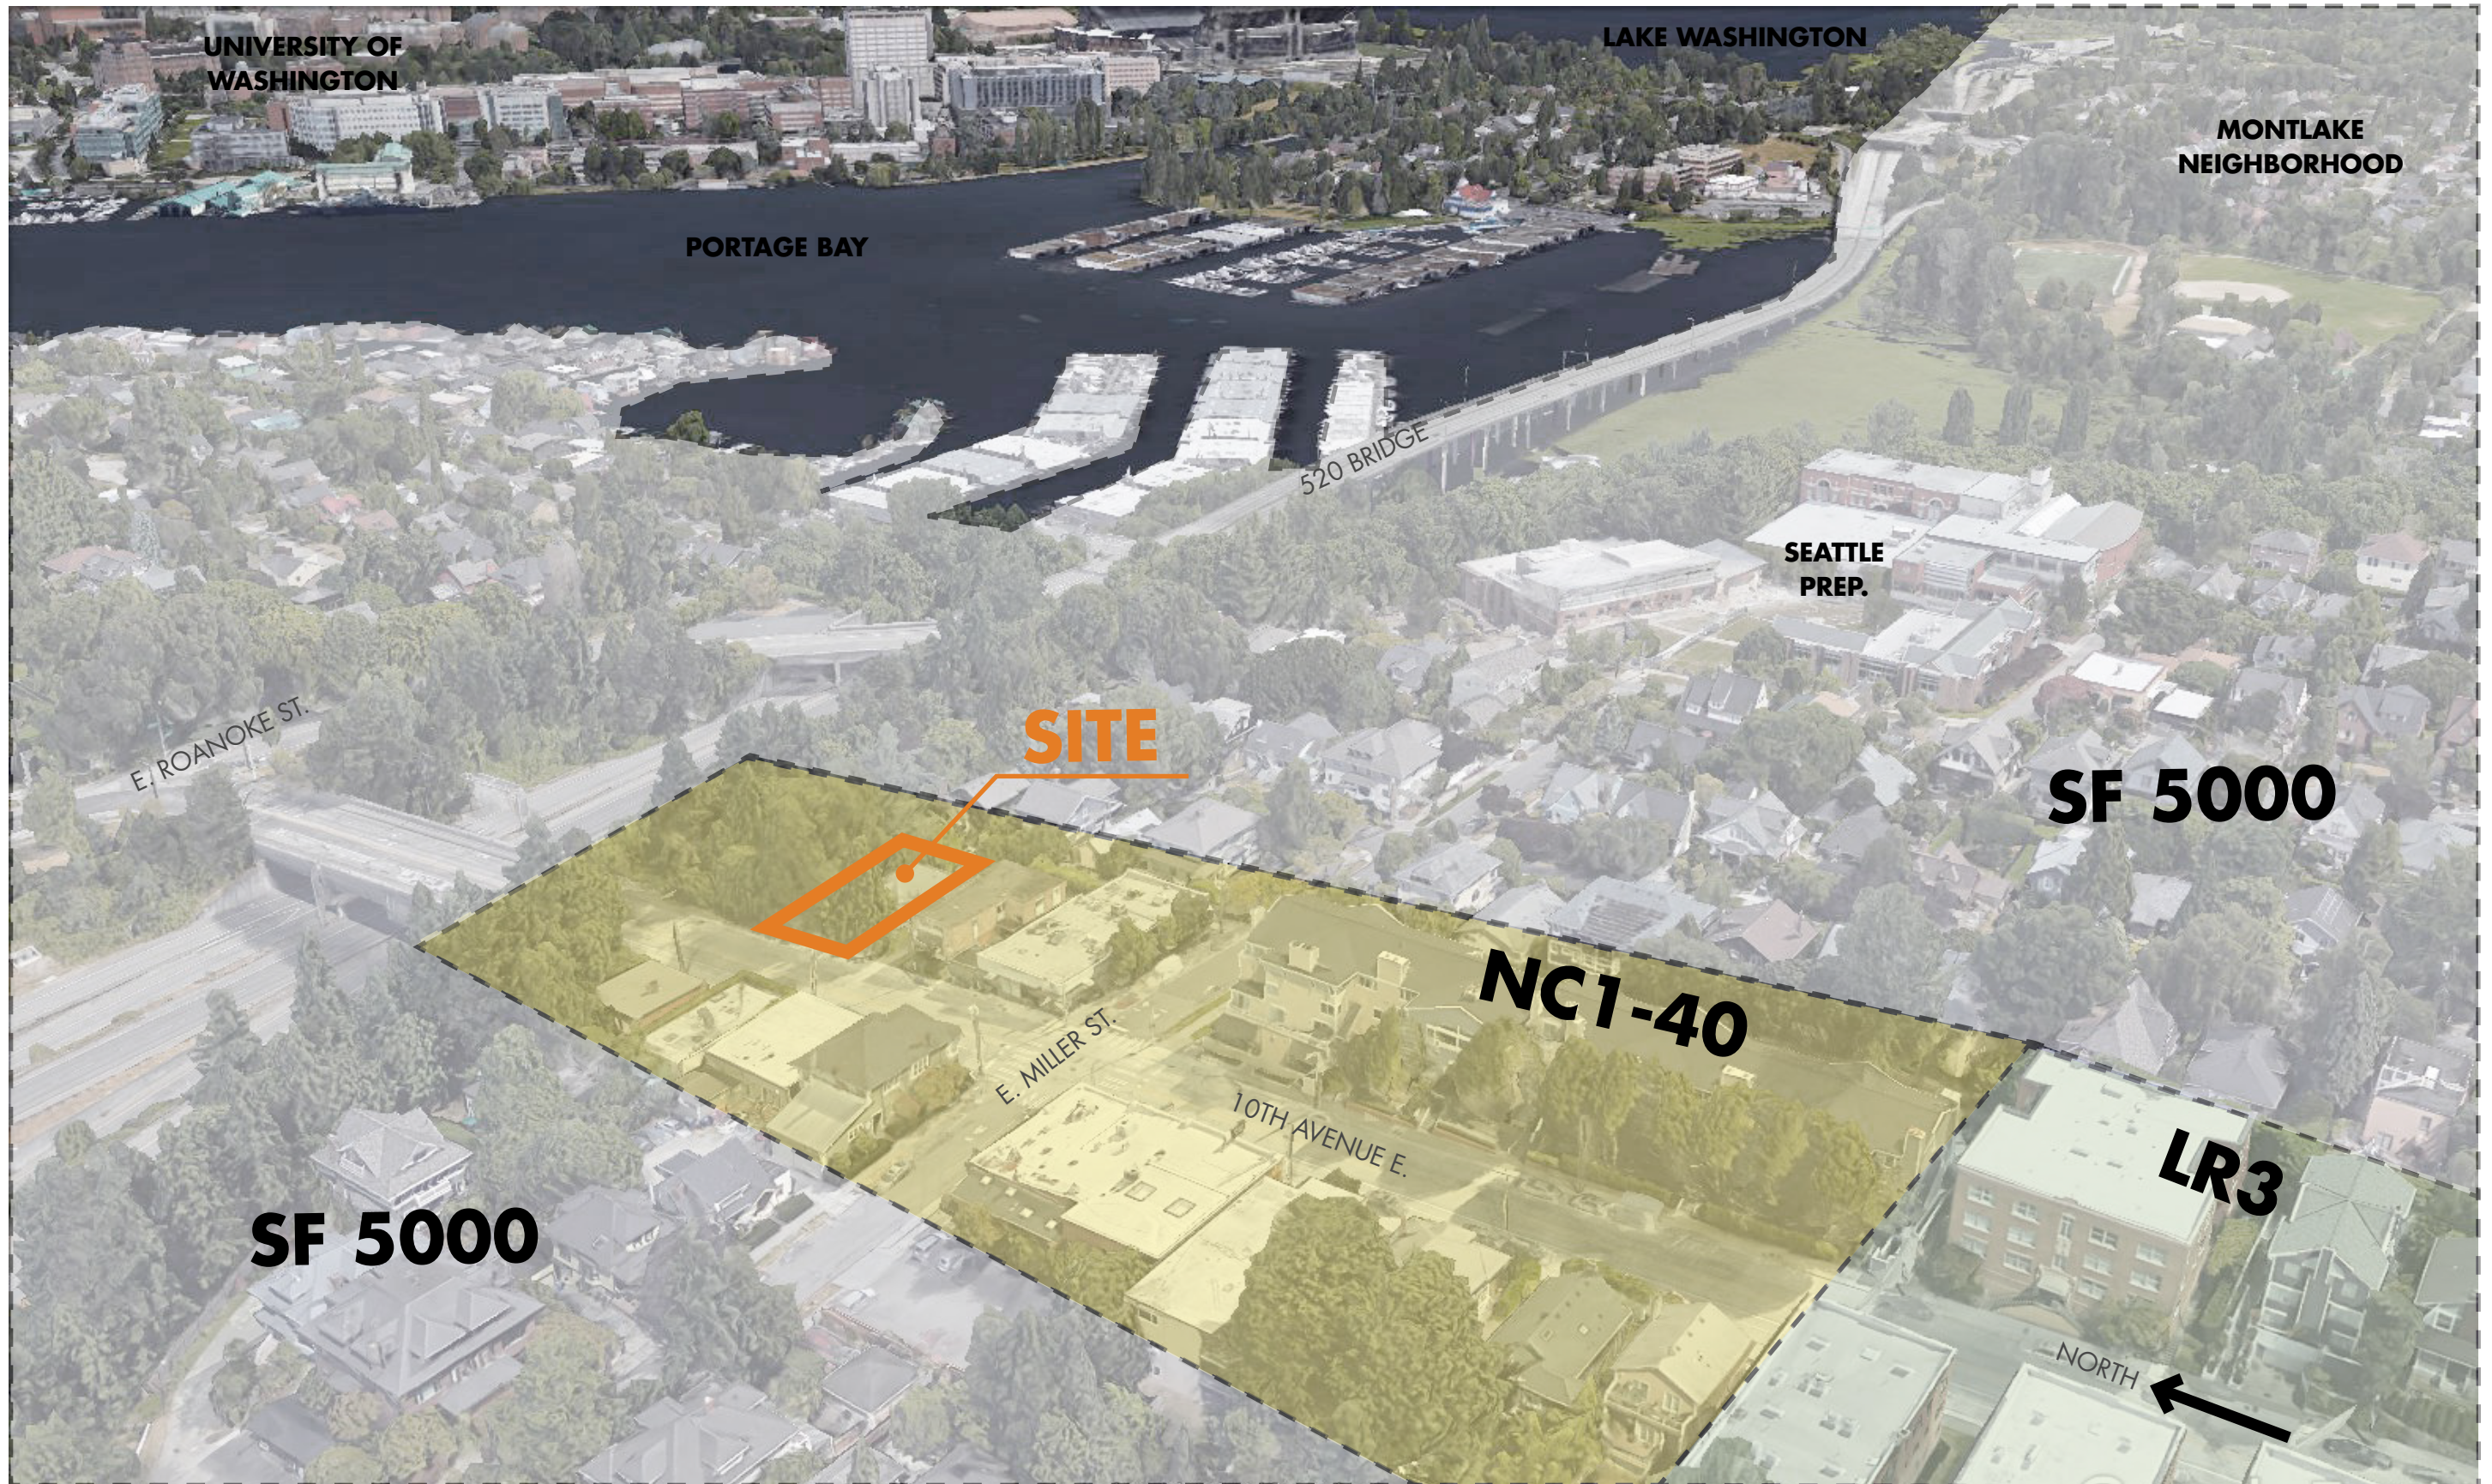
CODE REFERENCE	REQUIREMENT	PROPOSAL
23.47A.005 Street-Level Uses	Residential use on street-level facade not to exceed 20% of street-facing facade; driveways exempt from calculation	Non-Residential Livework Units = $30.58' / 34.17' = 89.5\%$ Stair up to residential egress plaza = 10.5%

23.47A.013 Floor Area Ratio	3.00 Maximum for Residential or Non-Residential Use 3.25 Maximum for Mixed Use  4,492 SF x 3 = 13,476 SF 4,492 SF x 3.25 = 14,599 SF	Total Residential Floor Area: 6,085 SF Total Non-Residential Floor Area: 2,969 SF Total Floor Area: 9,055 SF  FAR = 2.02

23.47A.012 Structure Height	Base Maximum Height Limit: 40'-0" 13'-0" Commercial Height: + 4'-0" Total Allowable Height: 44'-0"	Livework Structure Height: 44.46' above average grade Townhome Structure Height: 40.29' above average grade

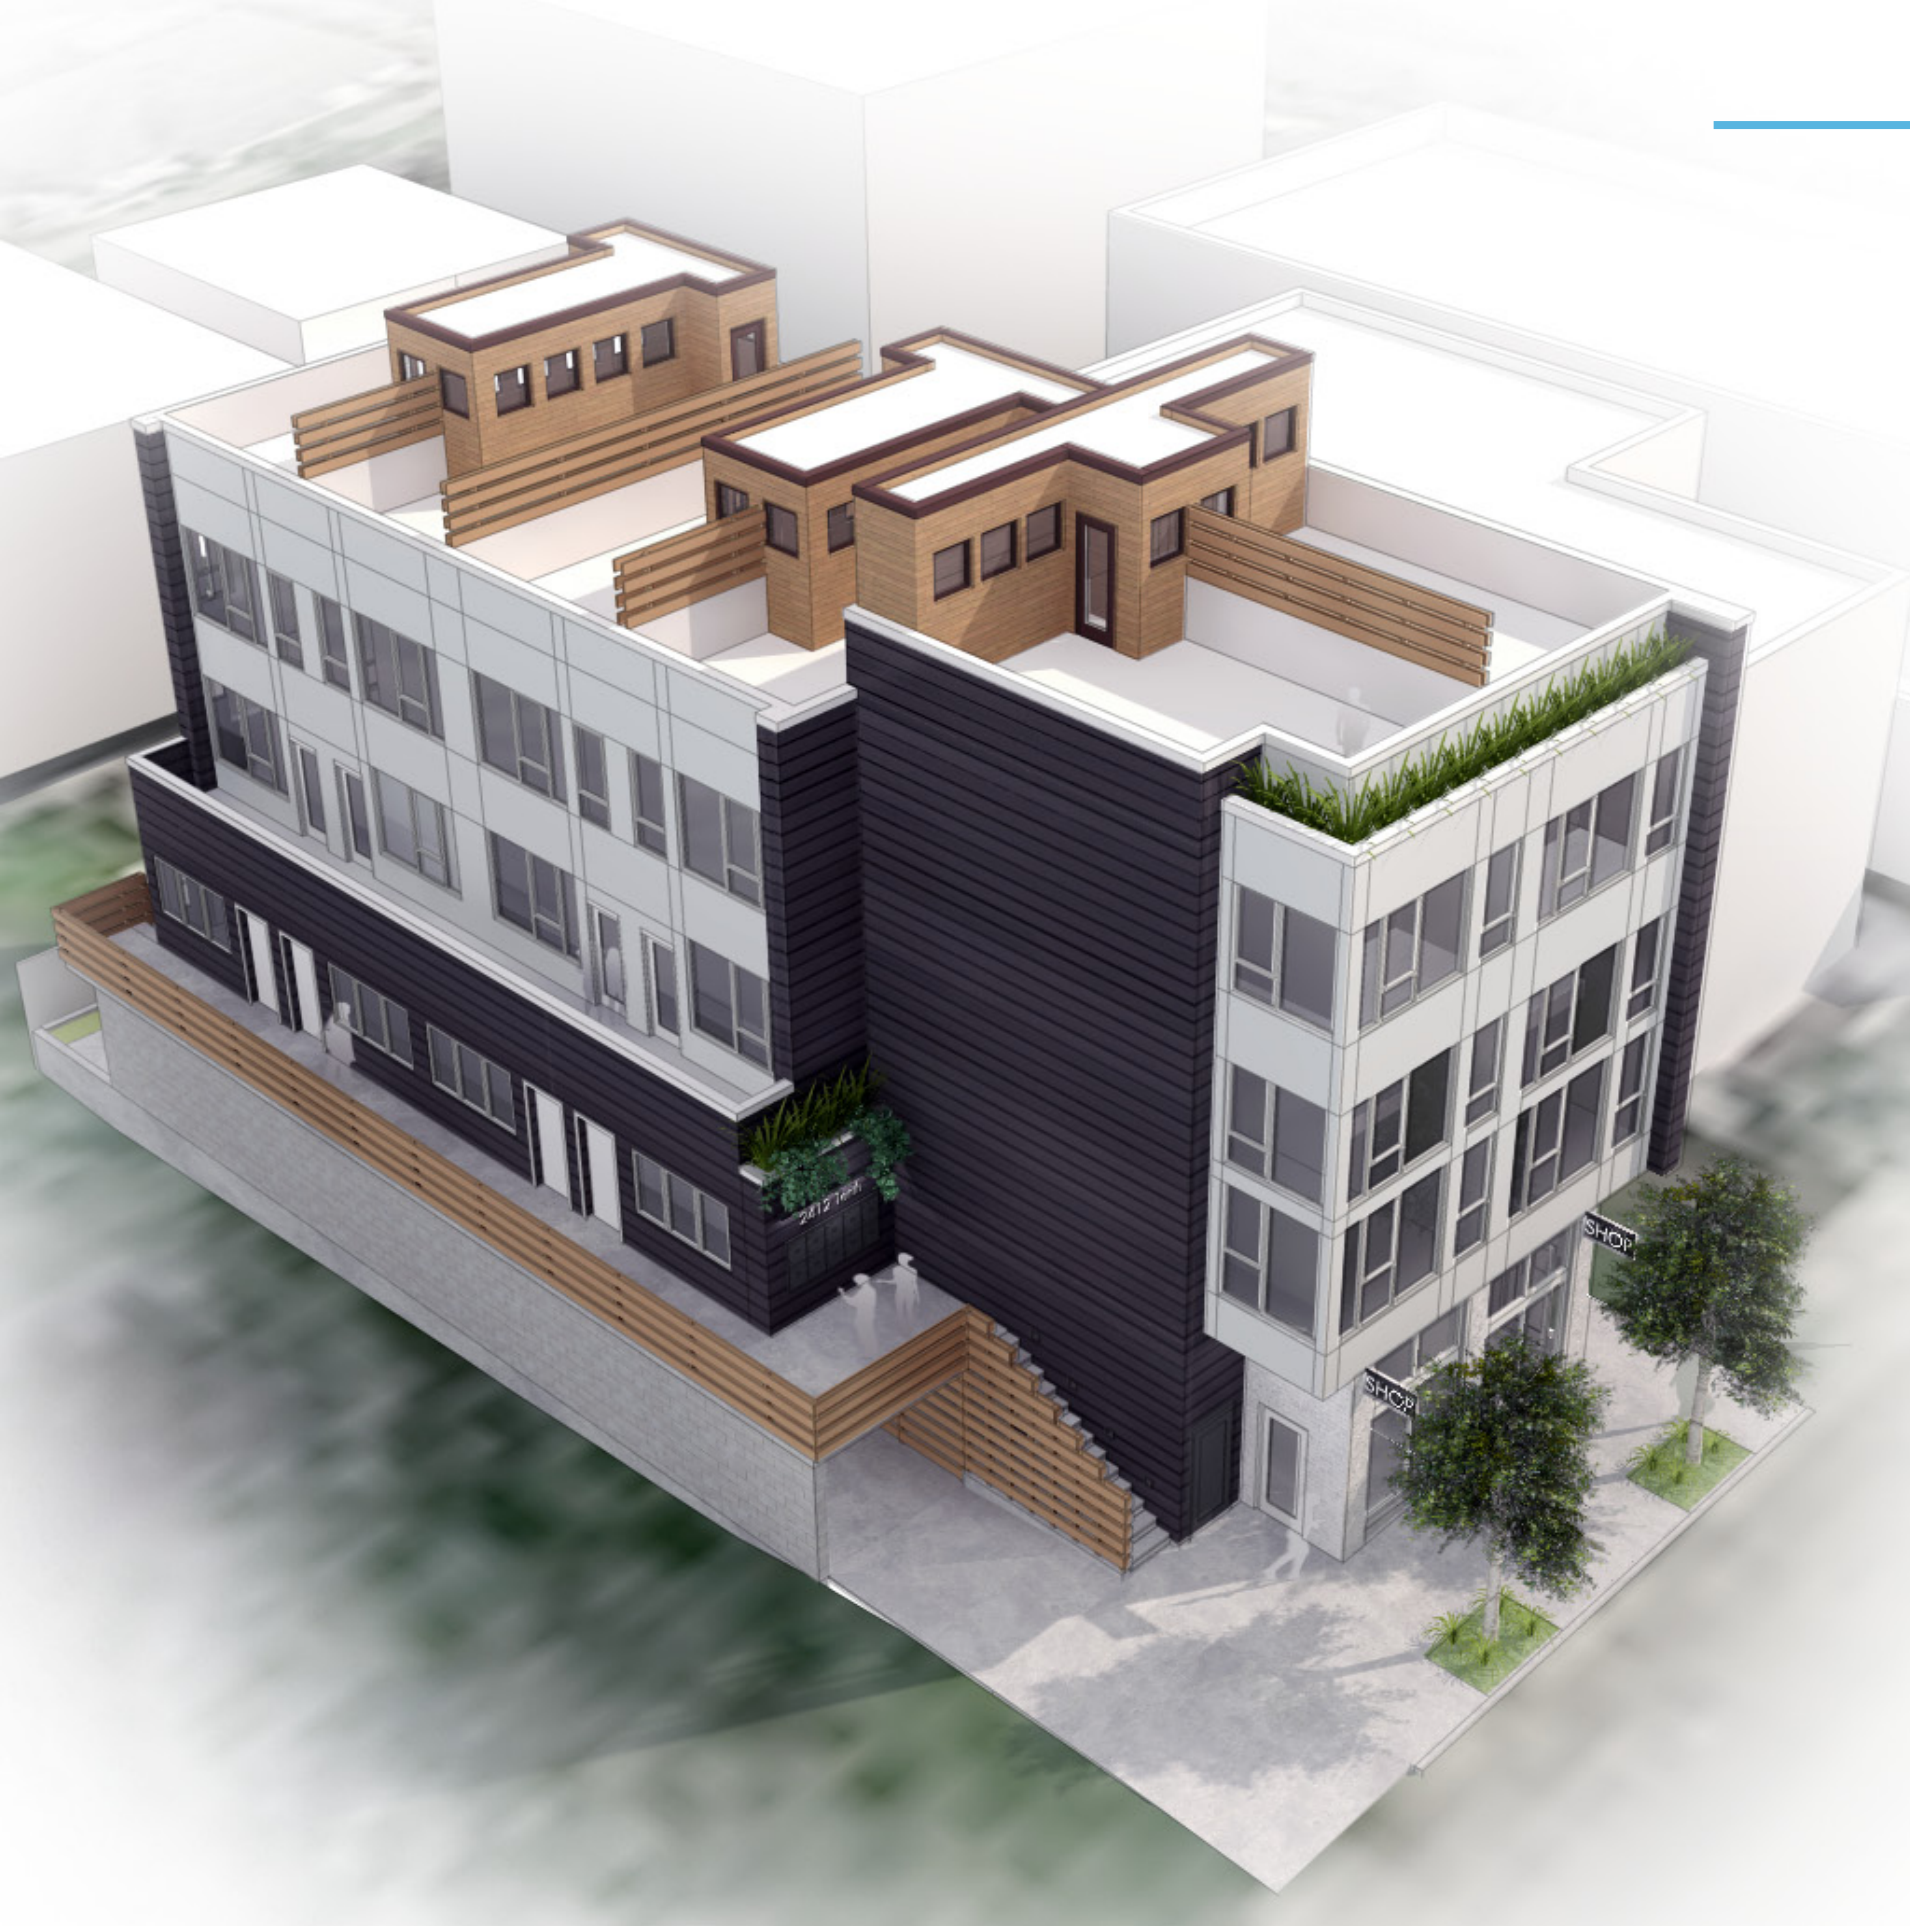
- ① **CS1 Natural Systems and Site Features**  
**CS3 Architectural Context and Character**  
The design concept includes “planted edges” that are reminiscent of the neighboring Roanoke Park Place Tavern’s ivy clad front facade.

- ② **CS3 Architectural Context and Character**  
**D2 Architectural Concept**  
The design of the stair penthouses was inspired by the Bertschi School’s award winning addition that can be seen down the street. They are also setback from the building edge and clad in a contrasting but complimentary siding material. This makes them feel more like objects on top of the building and less like a continuation of the mass.

- ③ **CS2 Relationship to Block - Corner Site**  
Because the building is adjacent to a site that is likely to never be developed it’s north side acts as a gateway to the Capitol Hill neighborhood. Windows wrapping it’s corner on this side as well as the building’s circulation being on this side provide attention to the corner.

- ④ **PL3 Street Level Interaction**  
The live-work includes two distinct entries, whose locations are made clear by a recess, lighting, and signage. The storefront along the street declares these as livework units with a true commercial program and the inset creates distinction from the residential unit above while also creating a generous public sidewalk.

- ⑤ **PL2 Walkability**  
Recessed entries with lighting soffits provide clearly defined entries and overhead weather protection. Signage with integrated lighting aids in wayfinding for the livework units.

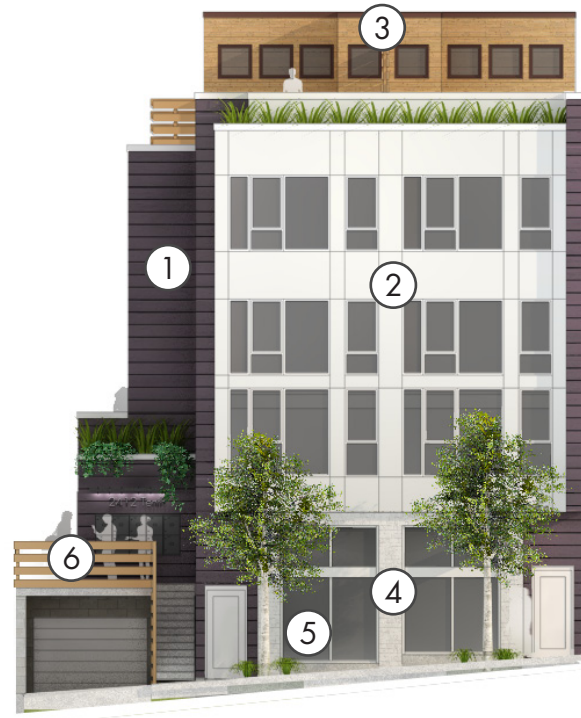
West Elevation (10th Ave. E..)

- Material Key
- ① Fiber Cement Lap Siding - Charcoal
  - ② Fiber Cement Panel Siding - White
  - ③ Fiber Cement Lap Siding - Woodtones
  - ④ Masonry Veneer
  - ⑤ Storefront
  - ⑥ Slat Screen / Railing
  - ⑦ Concrete Masonry Unit

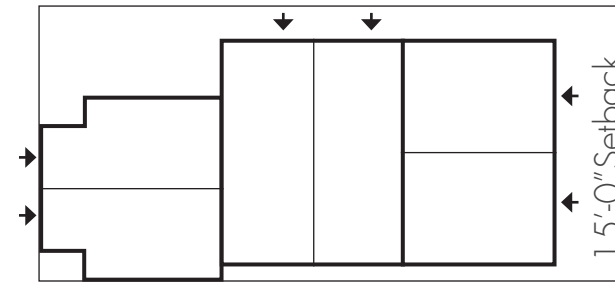
Original Design

An original design of the project included two units at the rear of the site that faced east and were entered from a large plaza with room for those units to have a patio outside of their entry. Preliminary communication with the city encouraged the design team to move to a scheme that faced these rear units north.

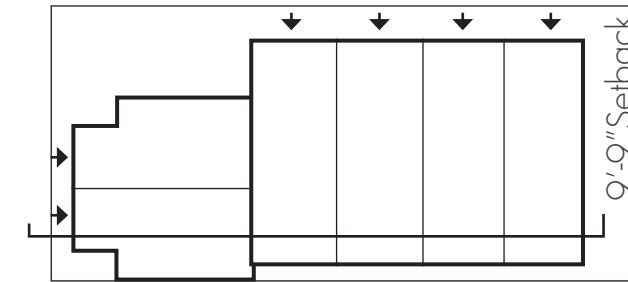
Proposed Design

- ① SDOT required 3'-0" sidewalk setback pushes building back on the site.
- ② Eastern units are turned 90 degrees to face north. In order to maintain liveability the units have a minimum workable width. This causes the units to encroach on the setback.
- ③ A corner unit, with opportunities to light and air from two sides, is lost when the units were rotated.
- ④ Premium views to the east are given up for these units that now face north.
- ⑤ The entry plaza and patio for these units was removed.

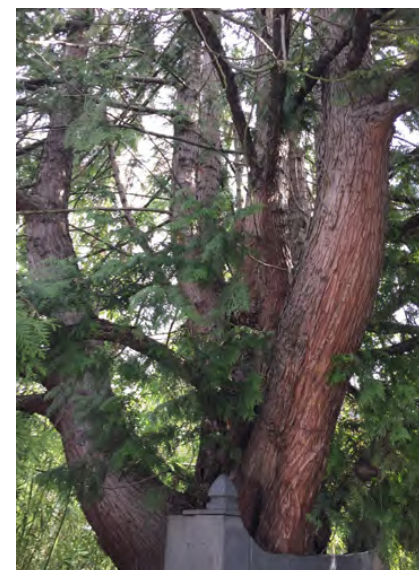
The tree has been topped more than once, the first episode resulting in the production of multiple trunks at a height of six feet and the subsequent cuts resulting in the production of many more tops just above the first cuts. As a result, this tree (which should have a single leader from the base to the top) has developed a crown that it is clustered with so many leaders and crossing limbs.

The crotches between most of the leaders are very tight, v-shaped and as a result included bark has formed at many of these connections. As the leaders increase in size, so does the included bark which puts pressure on the connections, eventually causing failure of one or more of the trunks. The largest of the new co-dominant leaders are as large as 24" in diameter and most of the co-dominant leader, both from the original cuts and the subsequent ones, are as

In addition to the tight crotches and included bark, there are a few pockets of decay at and just below the crotches. I did not take a core sample because just the presence of the decay at these locations further weakens the connections.

The tree of concern is a western red cedar measuring 44" dbh, large enough to meet the minimum size threshold to be classified as exceptional. This tree is in poor condition and presents a high risk because of its condition.
