125 STUDIOS

DPD PROJECT # 3028398
125 15TH AVE, SEATTLE, WA 98122

DEVELOPMENT OBJECTIVE

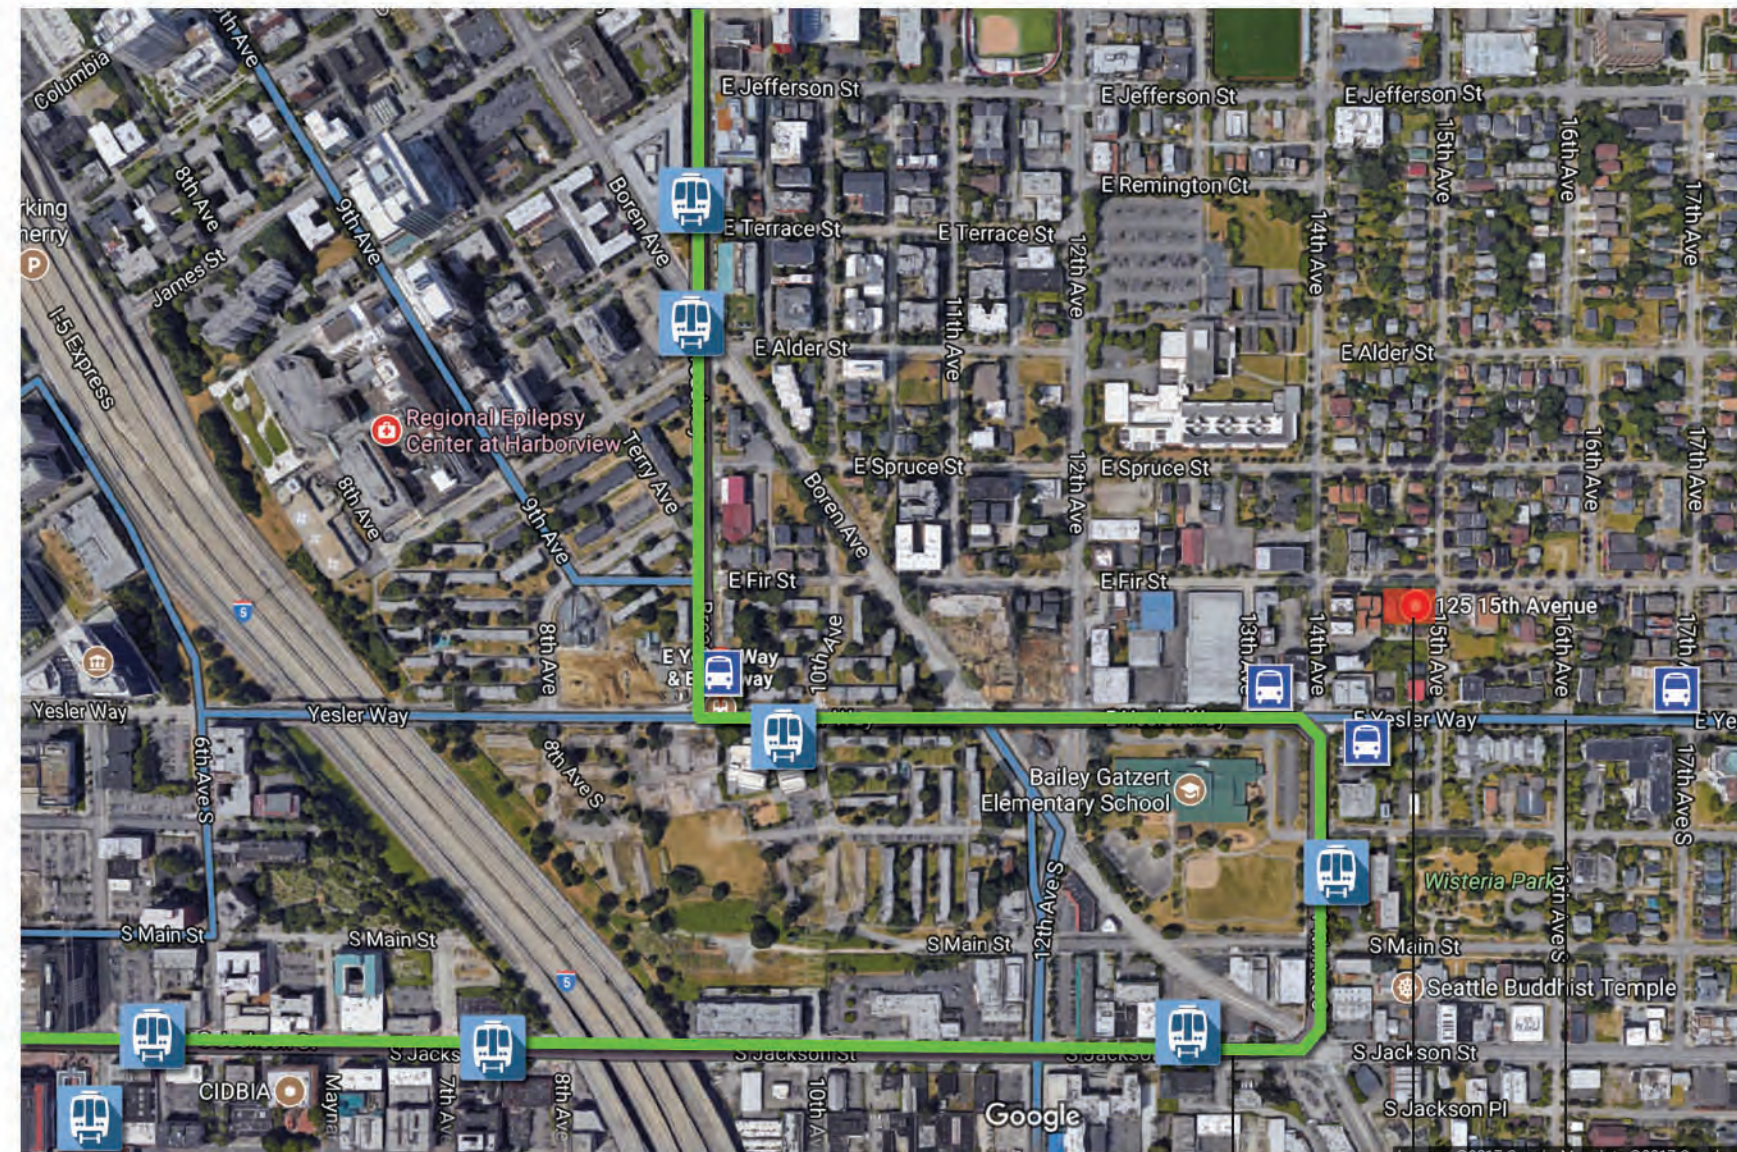
Zoning Map

The project site is zoned for 'LR3' within Residential Urban Village. NC2-40 zone is to the south-west, NC1-40 zone is at south-east.

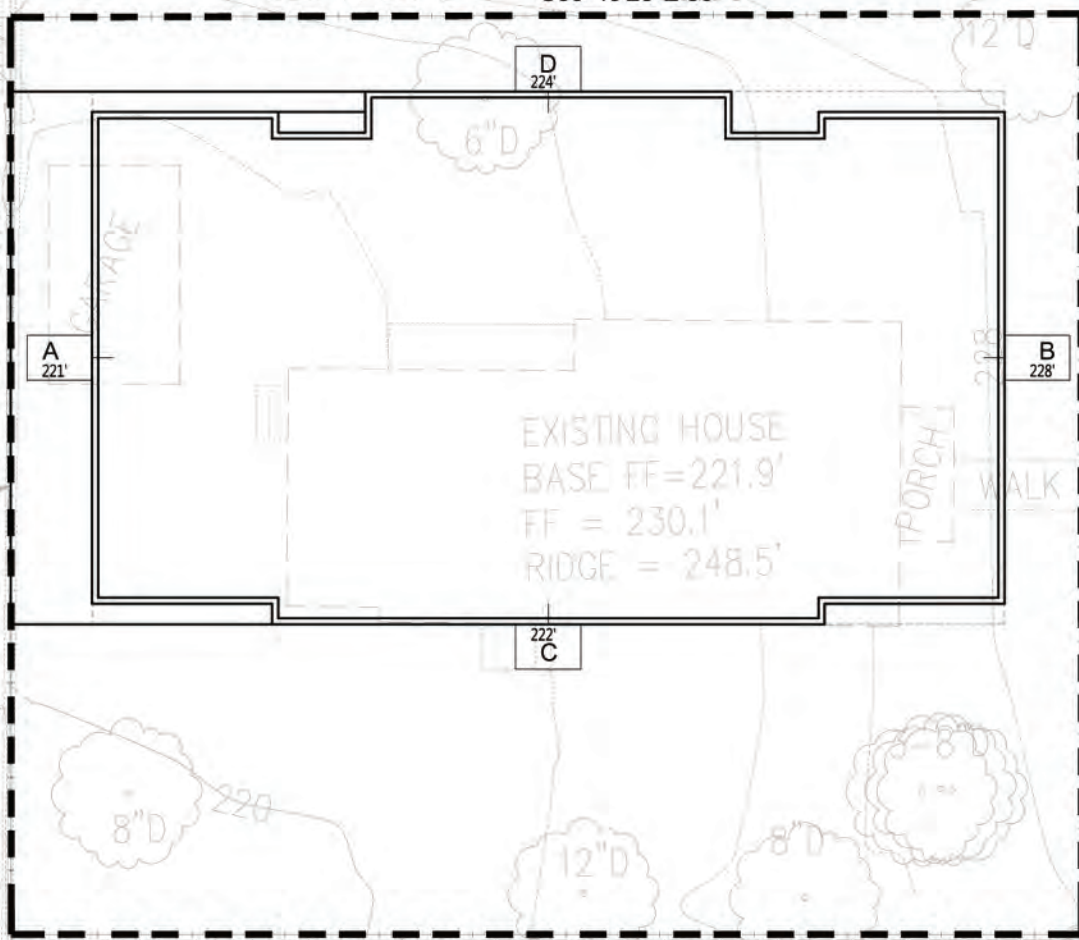
AVERAGE GRADE LEVEL CALC DIAGRAM

AVERAGE GRADE LEVEL CALC
FORMULA 2: ENCL. RECTANGLE

MARK	LENGTH (L)	ELEV. (E)	LXE
A	39'-10"	221'	8803.17
B	39'-10"	228'	9082
C	68'-2 1/2"	222'	15142.25
D	68'-2 1/2"	224'	15218.67
	228.25		48306.1

48306.1/216.08=223.56 AVG. GRADE LEVEL
 AVERAGE GRADE LEVEL: 223.56
 BASE HEIGHT LIMIT: 223.56+40=263.56
 4' BONUS FOR PARTIALLY BELOW GRADE STORY: 263.56+4=267.56
 STAIR PENTHOUSE HEIGHT: 267.56+10=277.56

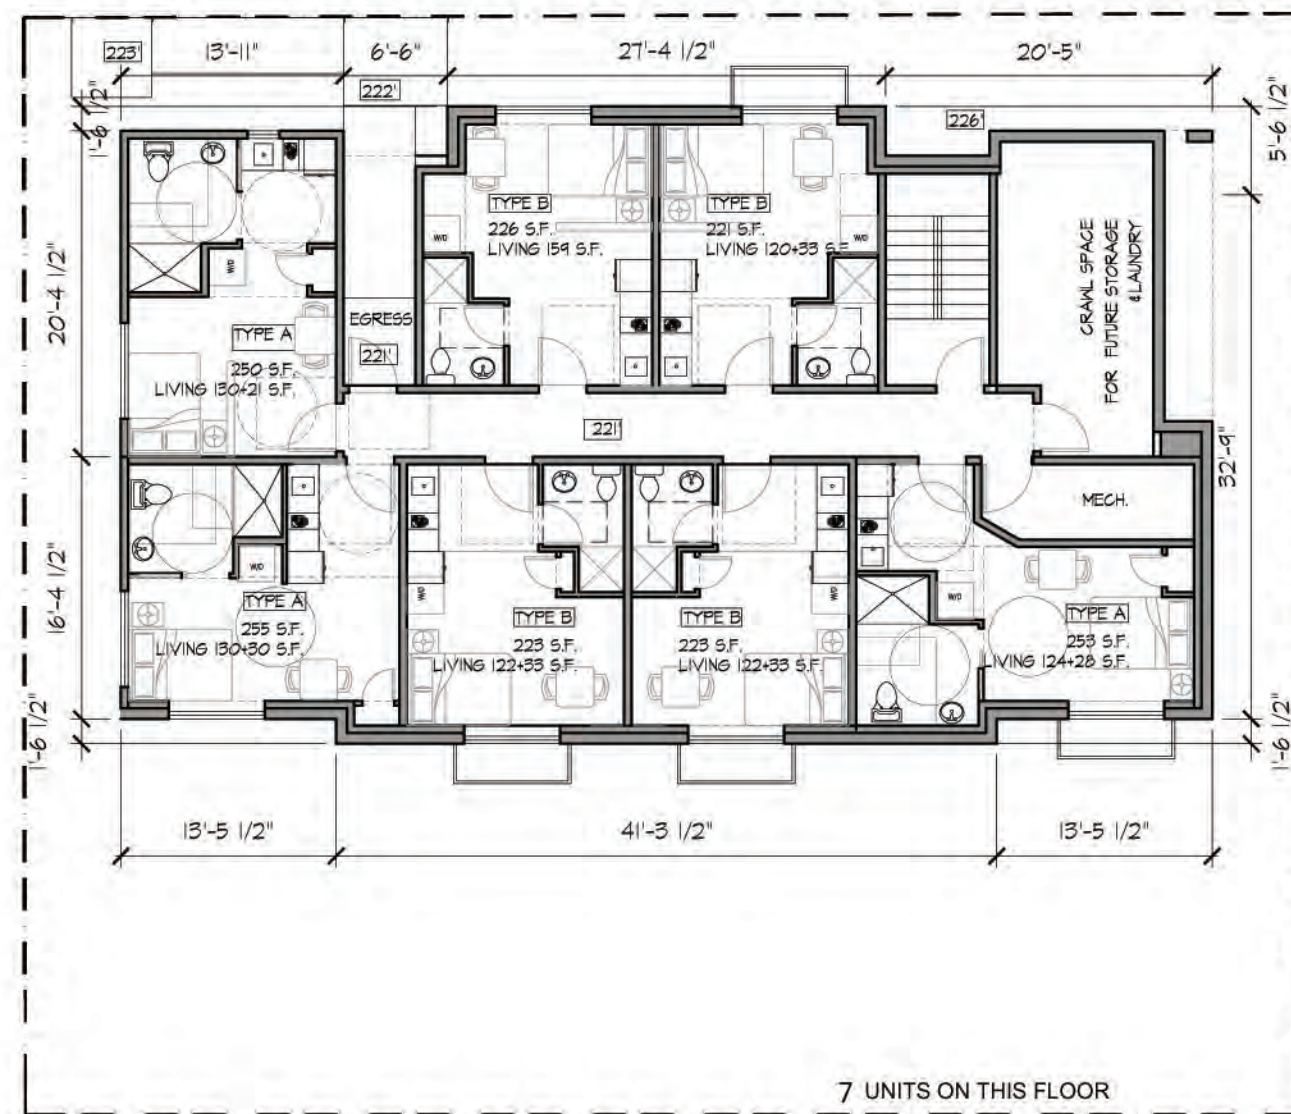
BASEMENT FLOOR PLAN

UNIT COUNT
BSMT	7 (3 TYPE A UNIT, 4 TYPE B UNIT PER 1107.5.4 ACCESSIBLE DWELLING UNITS.)
1ST	8
2ND	9
3RD	9
4TH	9
TOTAL	42

11979-1200=10,779 SF

PROPOSED GROSS FLOOR
 AREA(10,779) IS LESS
 THAN ALLOWED (10,988)

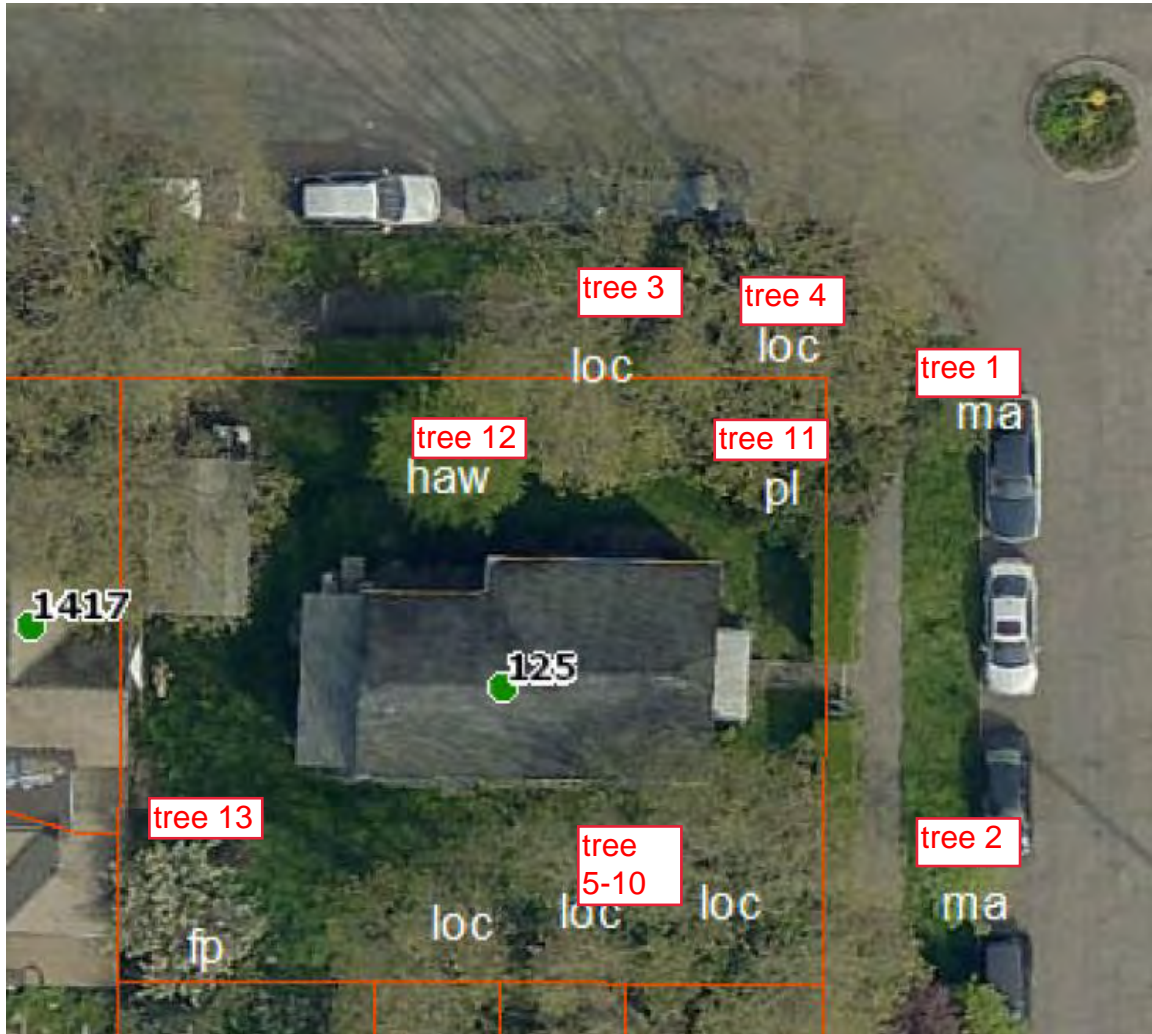
Figure 1. Aerial view of the 125 15th Avenue property showing the rough locations of the trees.

ma-Mountain Ash
loc-Black Locust
pl-Portuguese Laurel
haw-English Hawthorn
fp-Fruiting Pear

Trees 1&2 Two Mountain Ash (*Sorbus americana*) stand in the planting strip on the east side of the lot (Figure 1). They both had diameters less than 6” when measured at the standard height of 54” above grade (DSH). They are both in less than average condition with limited new growth, die back, and poor color.
