301 BELMONT

3032929 // EARLY DESIGN GUIDANCE
10 APRIL 2019
East Design Review Board

development objectives

The proposed project is a seven-story, 20,300 square feet condominium building with thirty-four dwelling units. One unit will meet the City's affordable housing incentive criteria which provides for additional GFA and building height. The project includes services, waste storage, bike parking, and five vehicle stalls at a partially below grade level. Street level uses include a corner entry, common amenity space, and four units located three to five feet above adjacent sidewalk grade. An outdoor amenity area is provided at the roof level. An exceptional Horse Chesnut tree will be preserved.

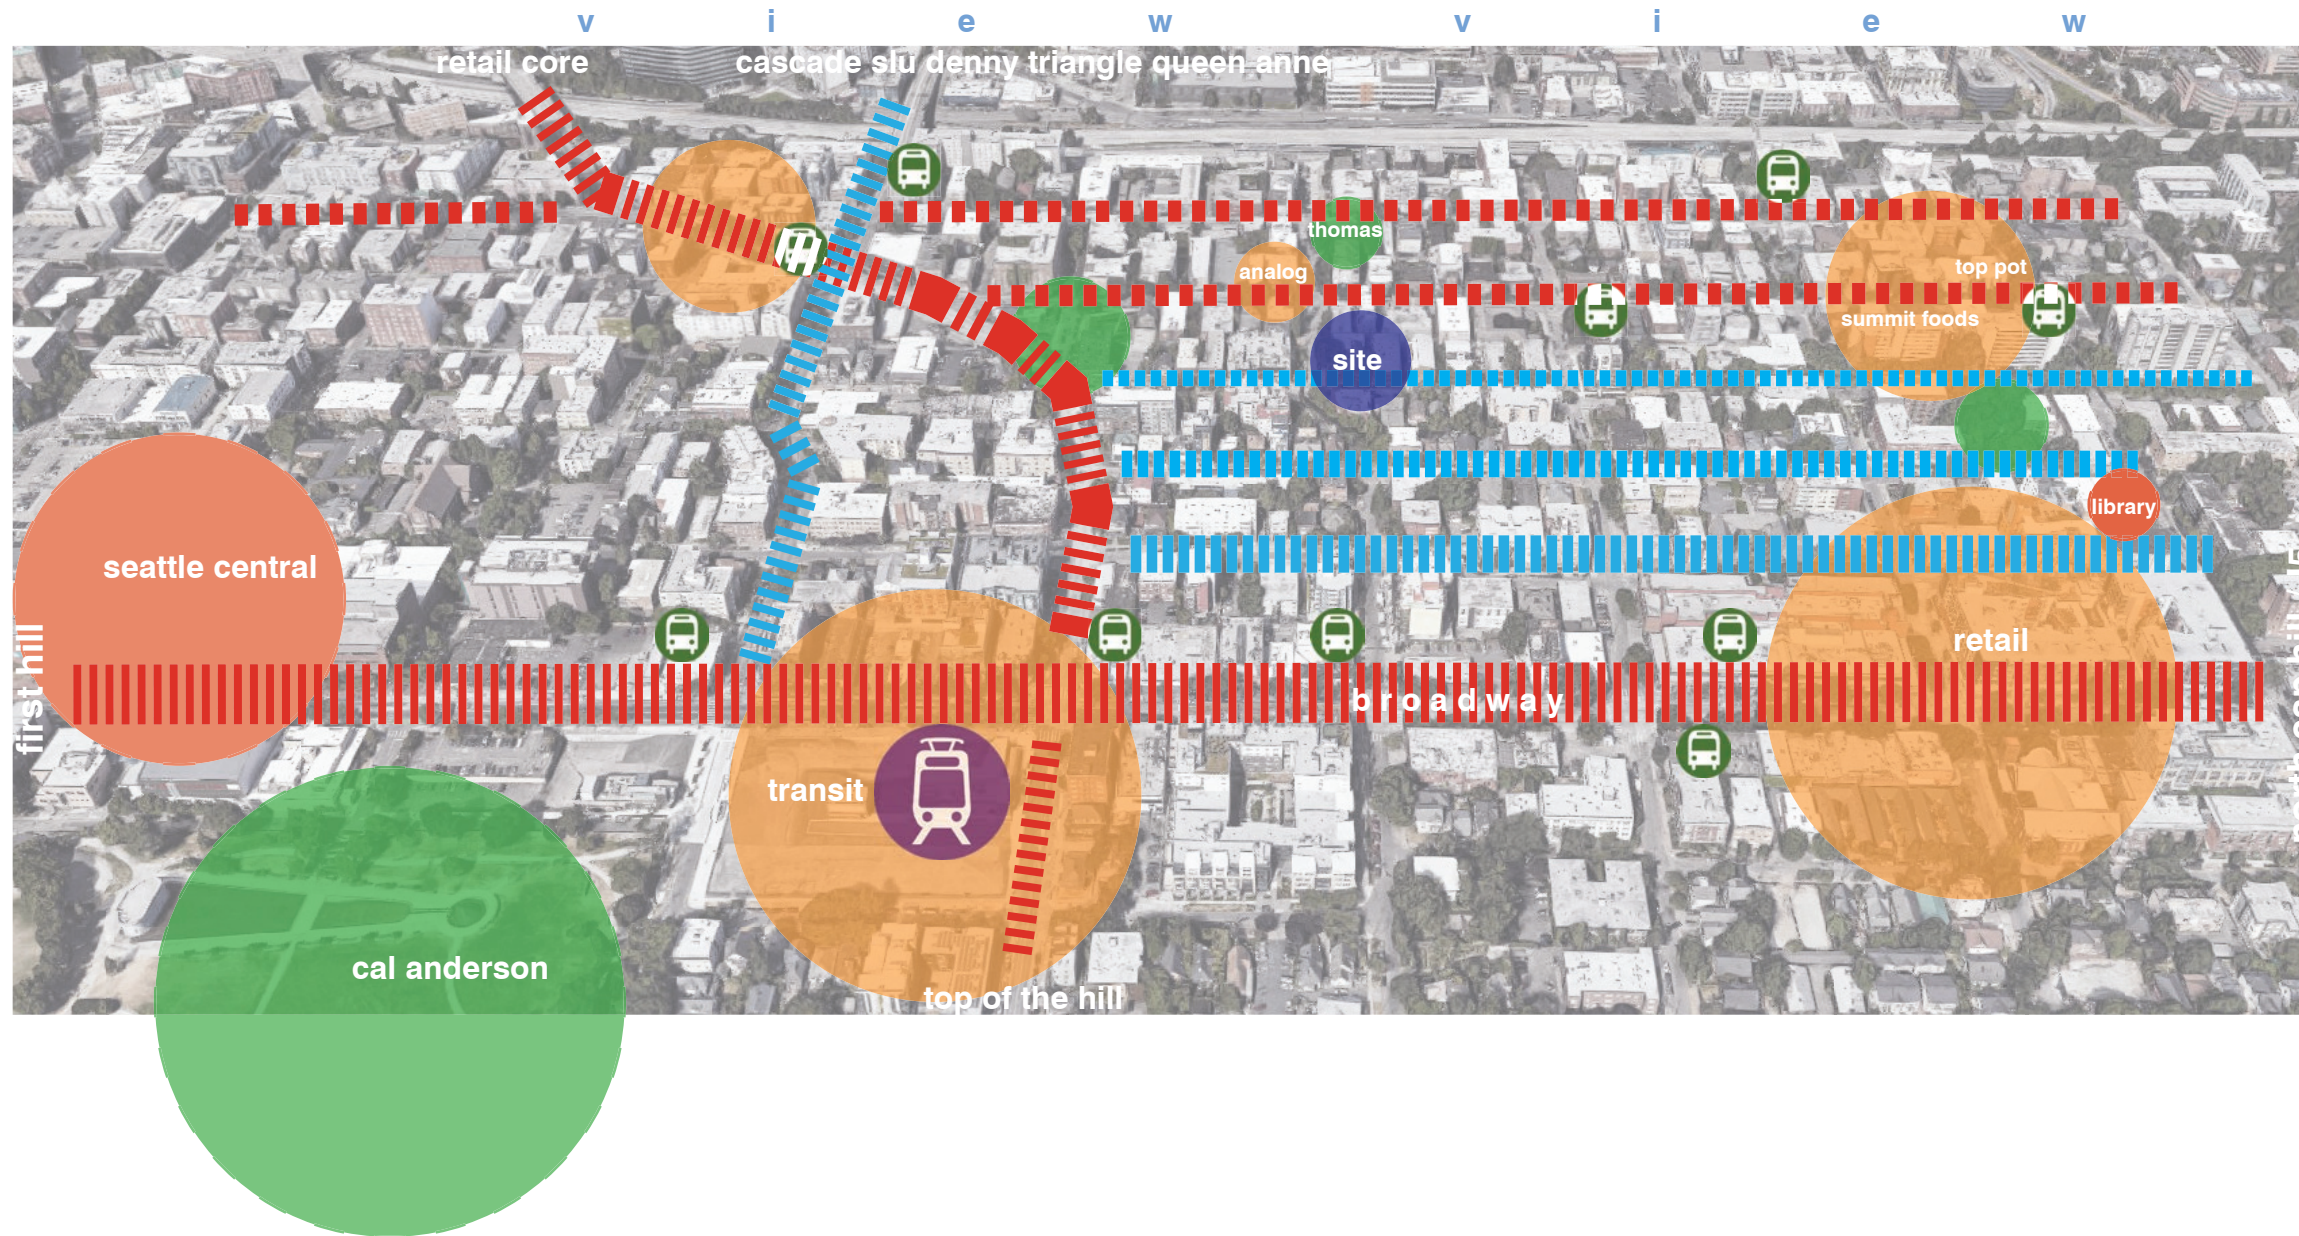
5.0 urban analysis

Situated three blocks west of Broadway and two blocks east of Bellevue, the project sits squarely within the established residential fabric of northwest Capitol Hill; a fabric of three to six story residential structures primarily constructed between 1920 and 1994. Recent development includes six and seven story residential structures that have maintained a strong urban edge through the use of departures.

The prevailing topography in the neighborhood is flat in a north/south direction and rising uphill to the east. Streets running east/west are generally sloped and any given parcel is negotiating four to eight feet of vertical rise. This leads to retaining walls or partially below grade stories fronting the street. Buildings are generally entered from the north-south running streets, unless a property only fronts an east-west street.

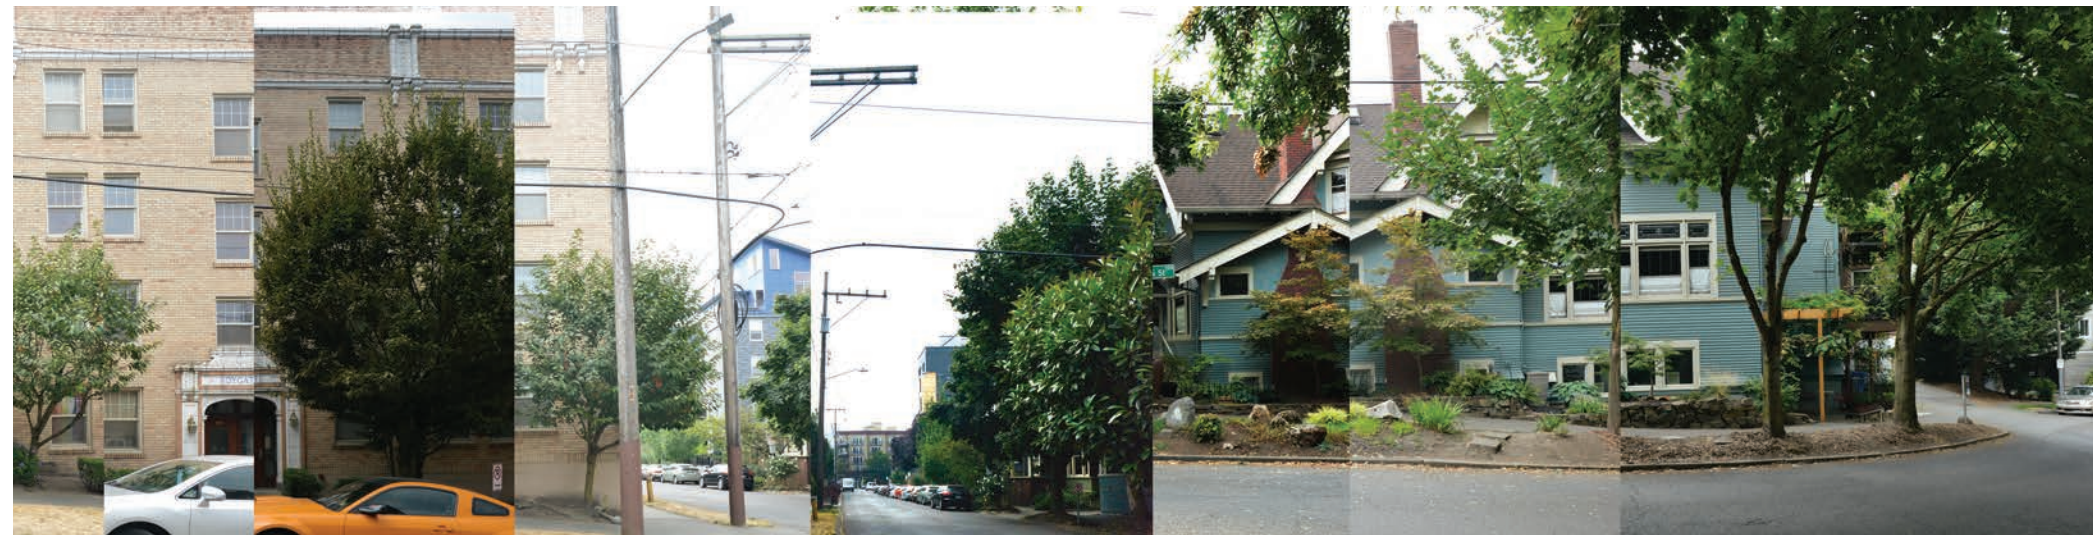
**East Thomas Street
South Side**

The range of periods, building types, and styles in the neighborhood leads to a variety of building materials and levels of quality.

Brick masonry is found across all periods; with the extent diminishing with time. Early buildings were predominantly brick. More recent buildings deploy brick primarily as an accent.

Wood is also used across the different periods of buildings in a wide range of scales and quality. Narrow profile painted vertical grain fir bevel or t&g siding has given way to lesser quality cedar that is often stained.

Metals are used in a variety of ways from stock profiles for rails and ornament to typical flashings and copings.

Panel products are most prevalent on very recent and some mid-century buildings. Stronger colors are used on these materials. Color is also used with stucco or other coatings.

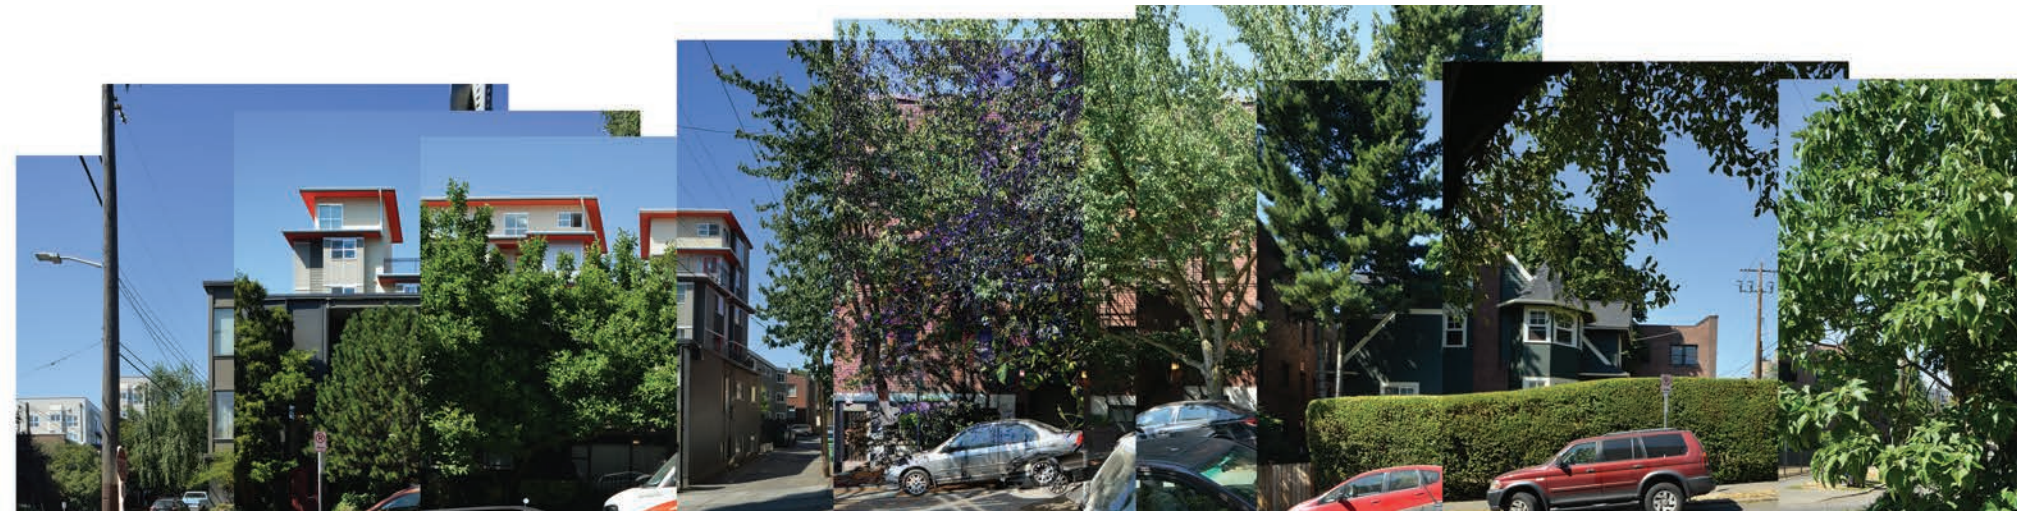
**East Thomas Street
North Side**

516th E Thomas St // condominium
1917 // 4-story red brick
punched windows

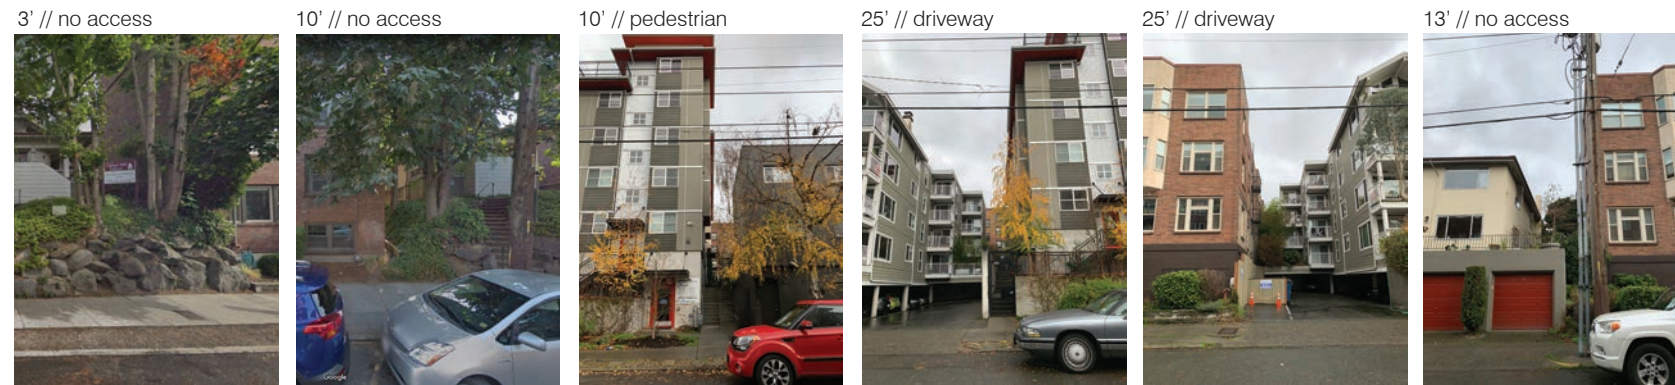
setbacks analysis

The project site is a small corner lot that does not abut an alley. Instead, both interior lot lines abut existing three-story twentieth century walk-up apartment buildings. These interior lot lines are, in effect, side lot lines. The existing seven and a half foot wide side yard to the north is currently used for street to alley through lot access via a paved pathway. The existing three foot wide side yard to the west is used for general access on the project site and is currently landscaped with minimal ground cover.

The separation between structures along interior lot lines is typically ten feet wide with exceptions that are as narrow as three feet when a building abuts a lot line and as wide as twenty-five feet when used for vehicle access and parking.

- extend the prevailing urban edge condition of the neighborhood
- equally distribute open space to both interior lot lines
- provide a greater than required side setback in order to transfer building mass from the west side of building to the south side
- expand the separation between structures and to reduce the east/west bulk of the project.

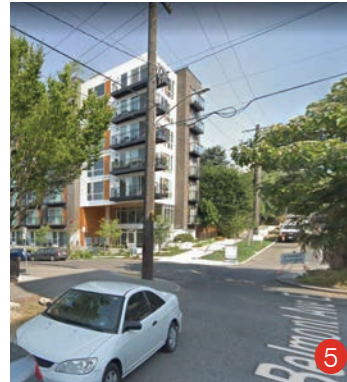
2017 // 7-story
basement datum

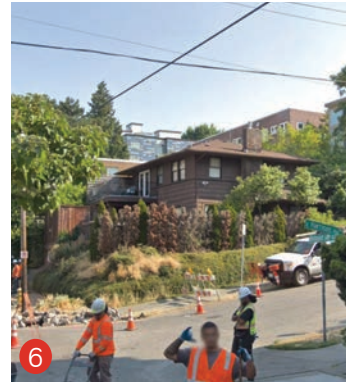
1924 // 2-story
no datum

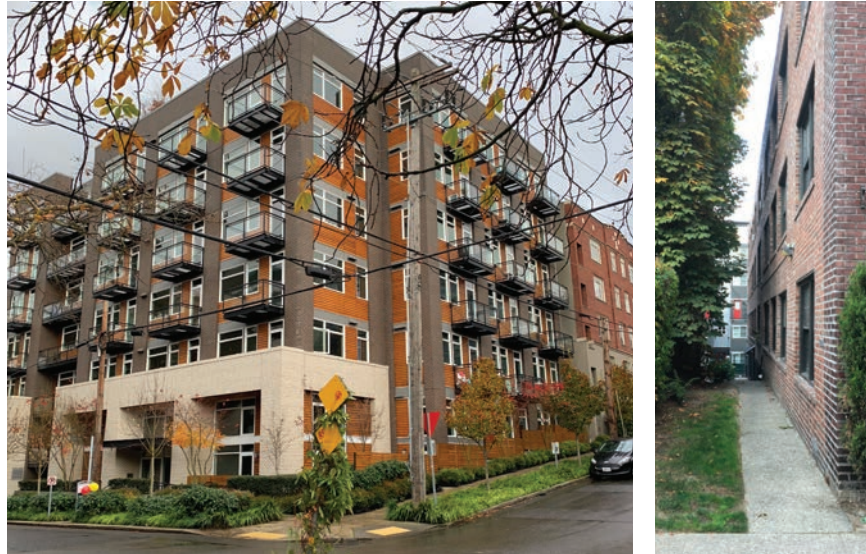
EXISTING FABRIC

The existing fabric of residential structures located at or near lot lines creates an opportunity for the project to extend this fabric across two street frontages and strengthen the cohesive pedestrian dominated neighborhood. The preservation of the exceptional tree enhances the environmental heritage of the neighborhood preserving a mature specimen and canopy on a small site.

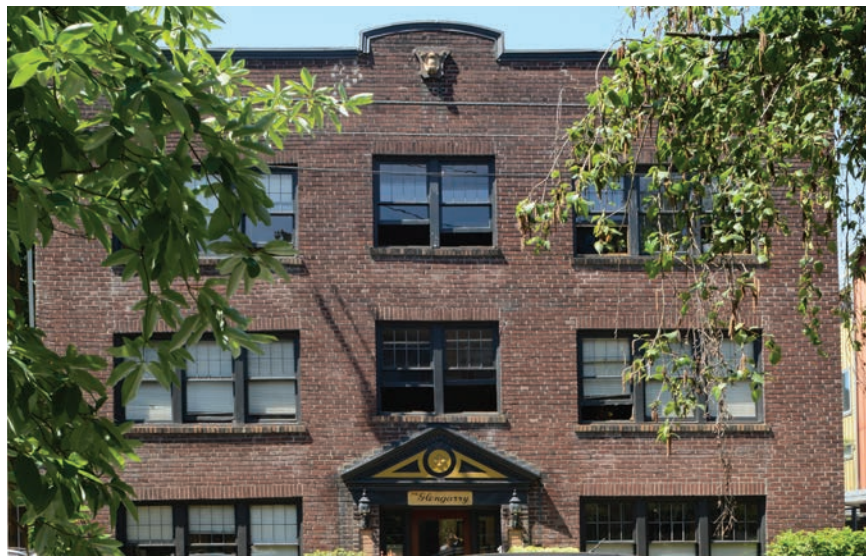
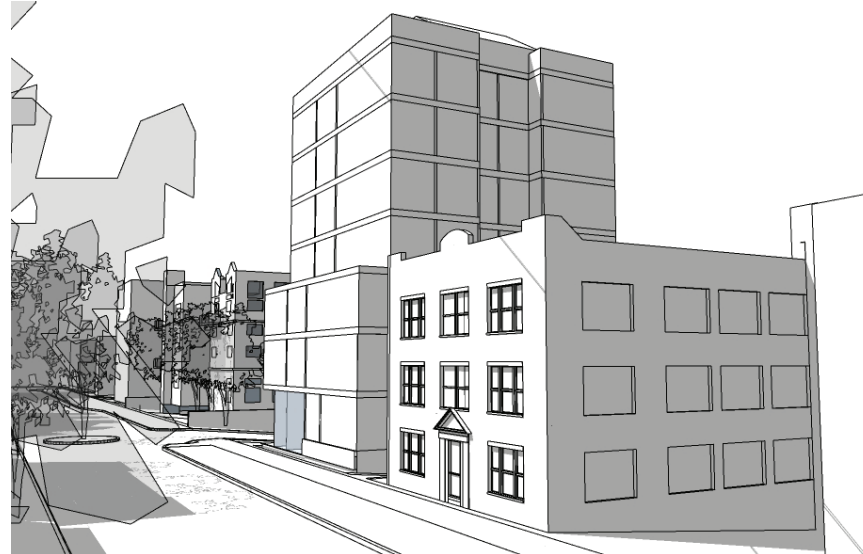
DATUMS

The overhead powerline setback along the east frontage provides an opportunity to define a strong horizontal relationship between the project and the adjacent building to the north. On the south façade, a more subtle datum can be introduced through the scale and rhythm of fenestration to allow the project to hold the street frontage while addressing the three-story scale of the building to the west. A street level datum that locates dwelling units three to five feet above sidewalk grade introduces vertical separation between the public realm and interior living space.

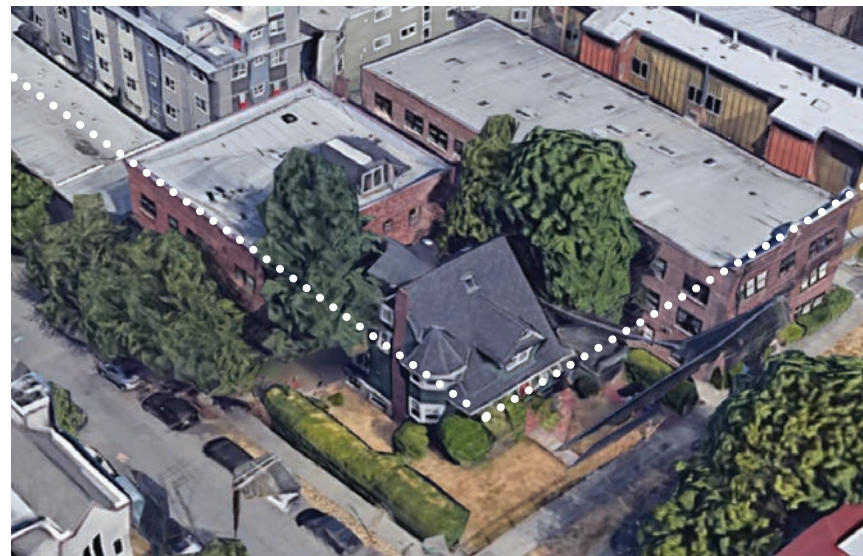
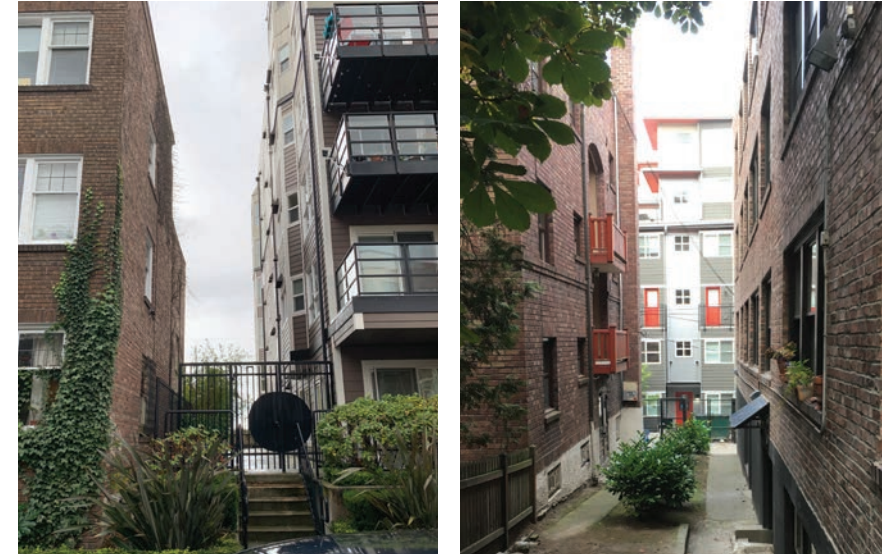
EQUITABLE OPEN SPACE

If allowed flexibility in the setback definition and requirement, the building mass can be located to match the open space volume required by code while more equitably distributing open space along the adjacent interior lot lines. This creates an expansion of the west side setback that benefits both neighboring structures and creates a dynamic architectural form. The structure to the west has two times the required setback for its full height. The widening of the west setback creates a narrower proposed massing that allows more daylight through to the north.

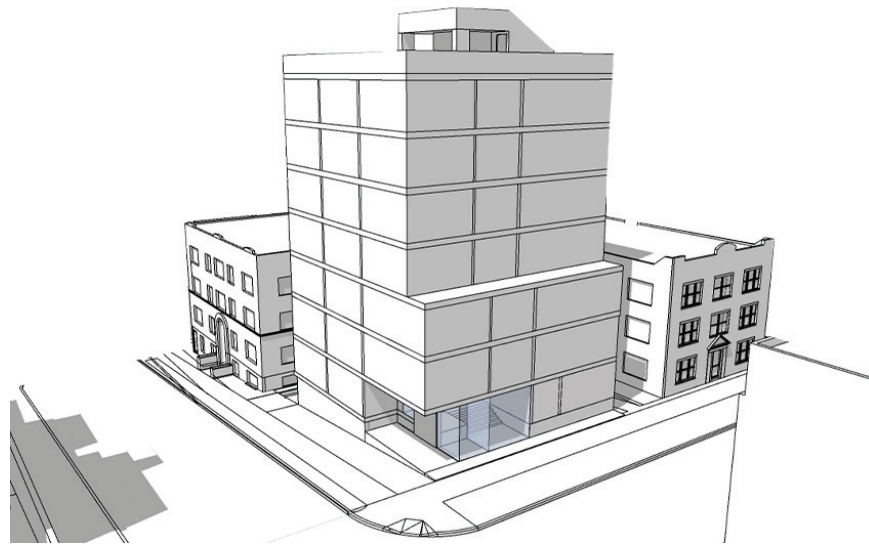
THE CORNER

Given the corner site, the project provides an opportunity to be strongly connected to the public realm on two street frontages. Vertical separation and landscaped buffers between edge of sidewalk and the street frontages creates a comfortable relationship between the public realm and private interior space.

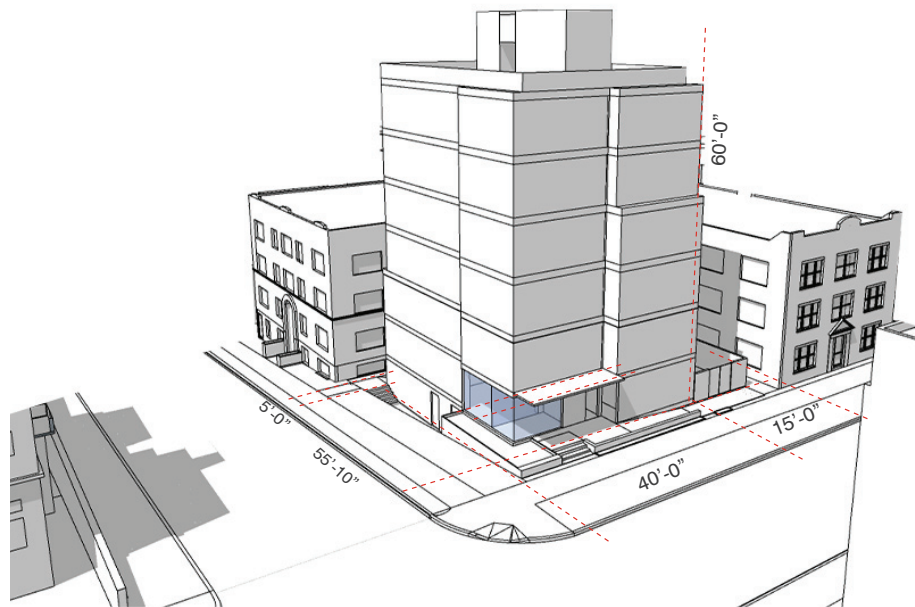
straight up // alternate A // conforming

Alternative A provides required street, side, and rear setbacks and preserves the exceptional Horse Chestnut. The preservation of the tree requires the rear setback to be located along the north lot line. If limited to six stories, a single exit stair can be used as long as certain additional life-safety provisions are provided and each floor is limited to four dwelling units. Providing a second exit stair to add an additional story results in an overall loss in dwelling units and residential area to the point the project is not feasible.

Alternative A provides required street, side, and rear setbacks and preserves the exceptional Horse Chestnut. The preservation of the tree requires the rear setback to be located along the north lot line. If limited to six stories, a single exit stair can be used as long as certain additional life-safety provisions are provided and each floor is limited to four dwelling units. Providing a second exit stair to add an additional story results in an overall loss in dwelling units and residential area to the point the project is not feasible.

The first story is located 15 inches above the Belmont sidewalk with exterior stairs and a ramp providing access to the building entry at the corner. Waste and recycling storage are enclosed in an at grade fenced area at the northwest corner of the site. A partially below grade story includes two dwelling units accessed from the western edge of the site through an area well. Building services and bike parking are also located at this level. The building mass is modulated to meet the minimum and average setbacks that are required in a midrise zone. A roof deck, limited to 150 square feet because of the single stair, is provided on the south side of the stair and elevator penthouse.

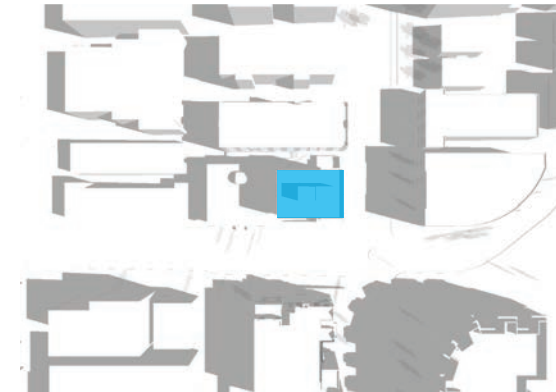
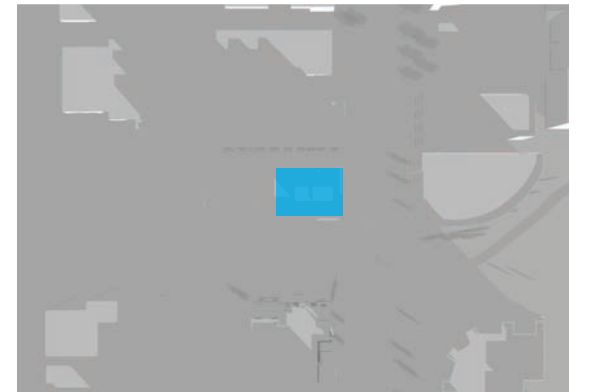
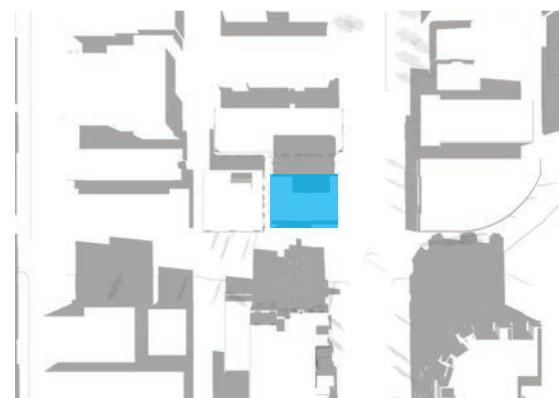
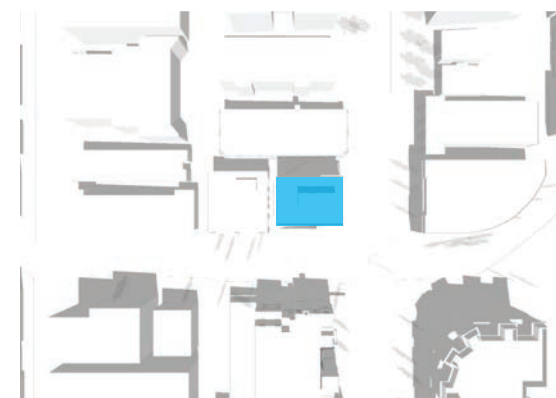
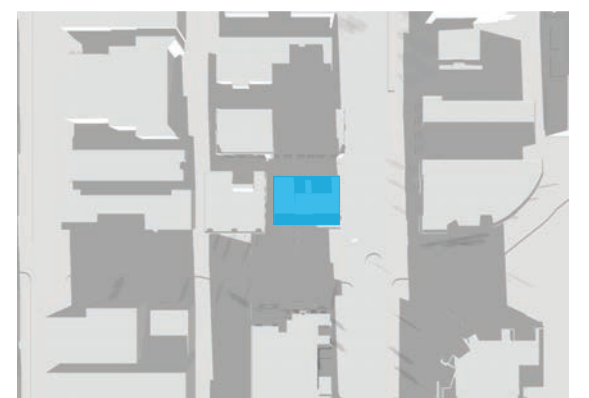
shadow study

Spring / Fall Equinox

9am

Summer Solstice

Winter Solstice

12pm

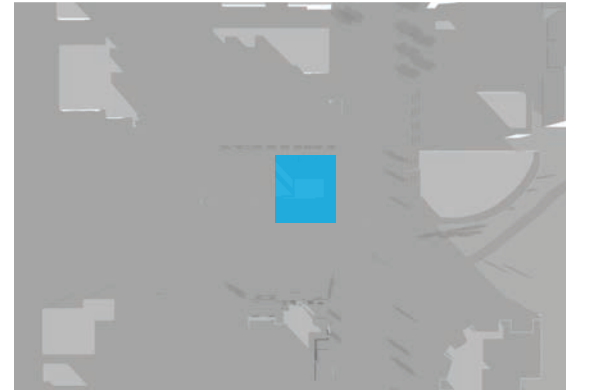
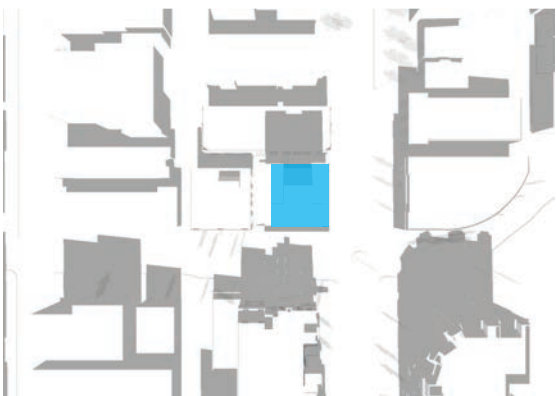
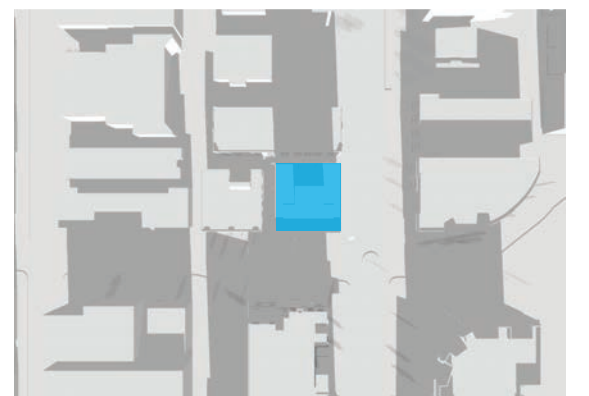
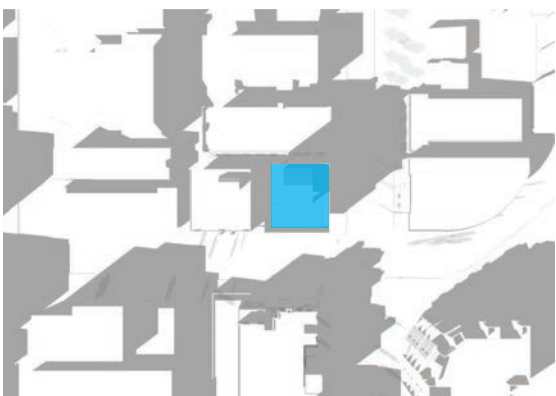
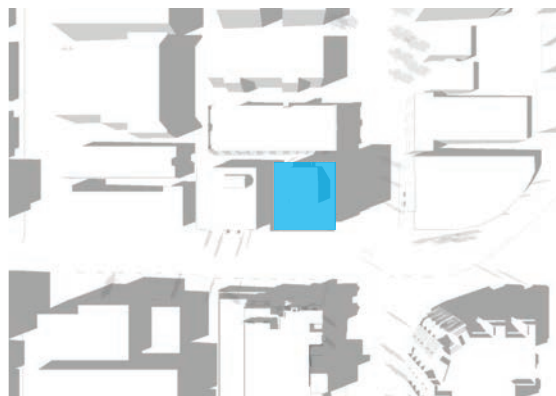
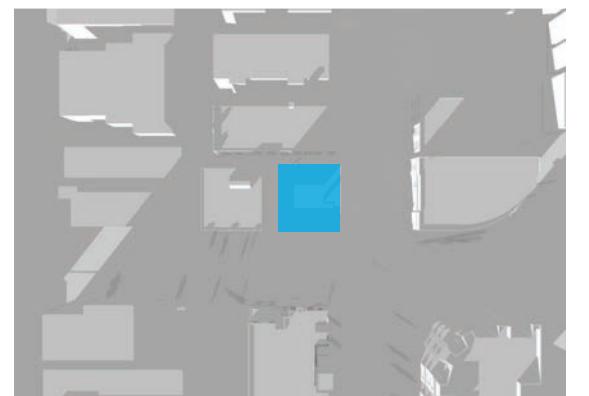
shadow study

Spring / Fall Equinox

9am

Summer Solstice

Winter Solstice

12pm

3pm

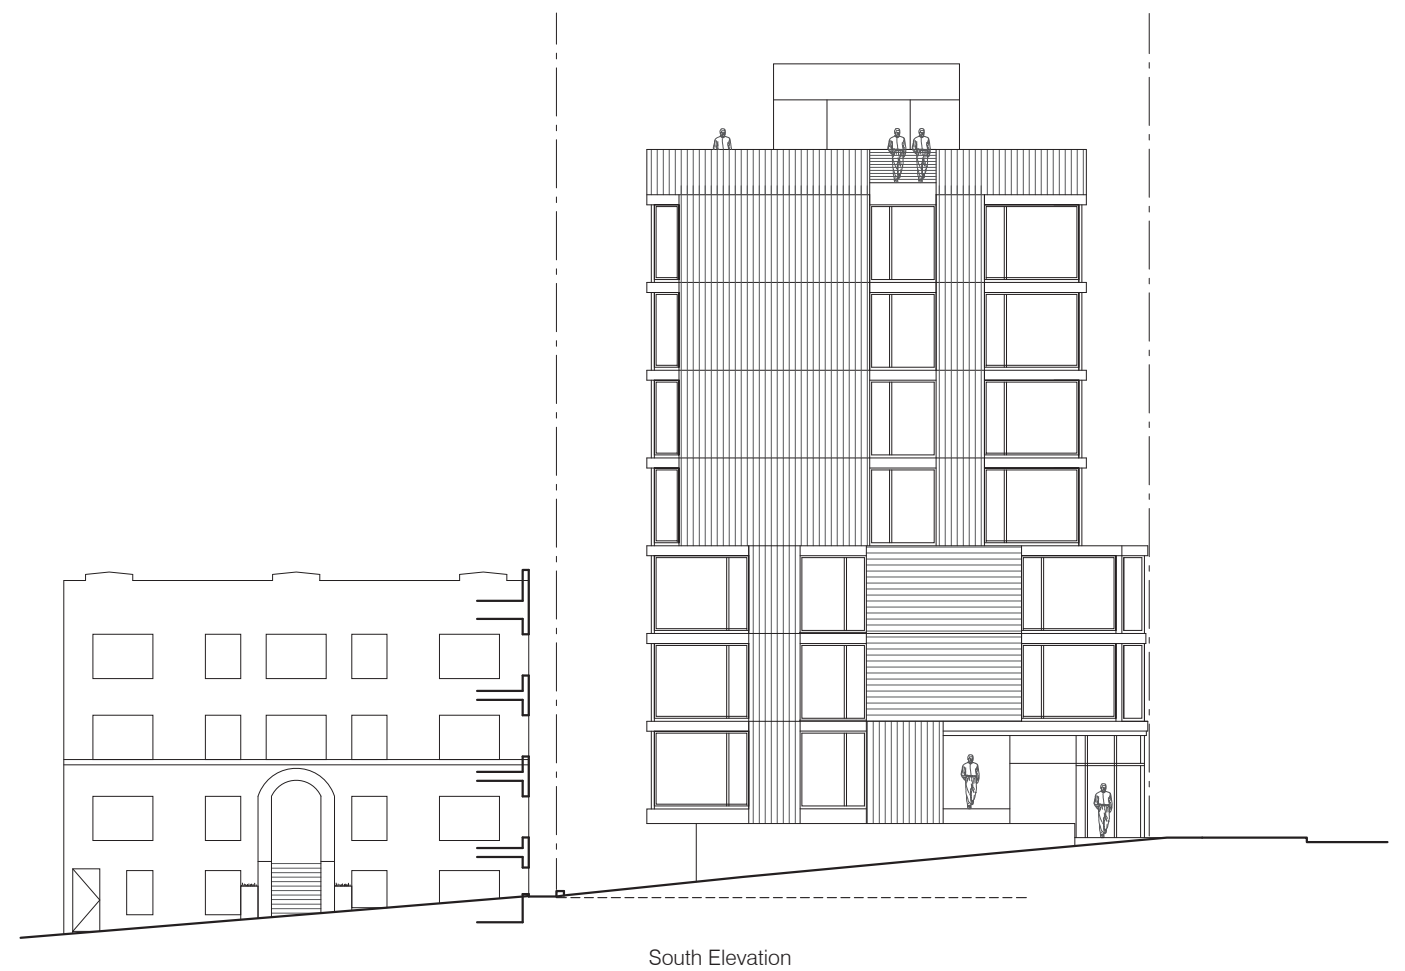
STACKED OPENINGS // Alternate 2

Stacked openings that shift at the 4th floor create a datum that responds to the scale of the adjacent buildings. In the southwest unit, primary openings front the street for the first three stories to orient the units away from the adjacent side wall. Above the third floor, the orientation shifts to the west wall and view. The façade presents an overall expression of cladding as uniform surface with vertically grouped openings.

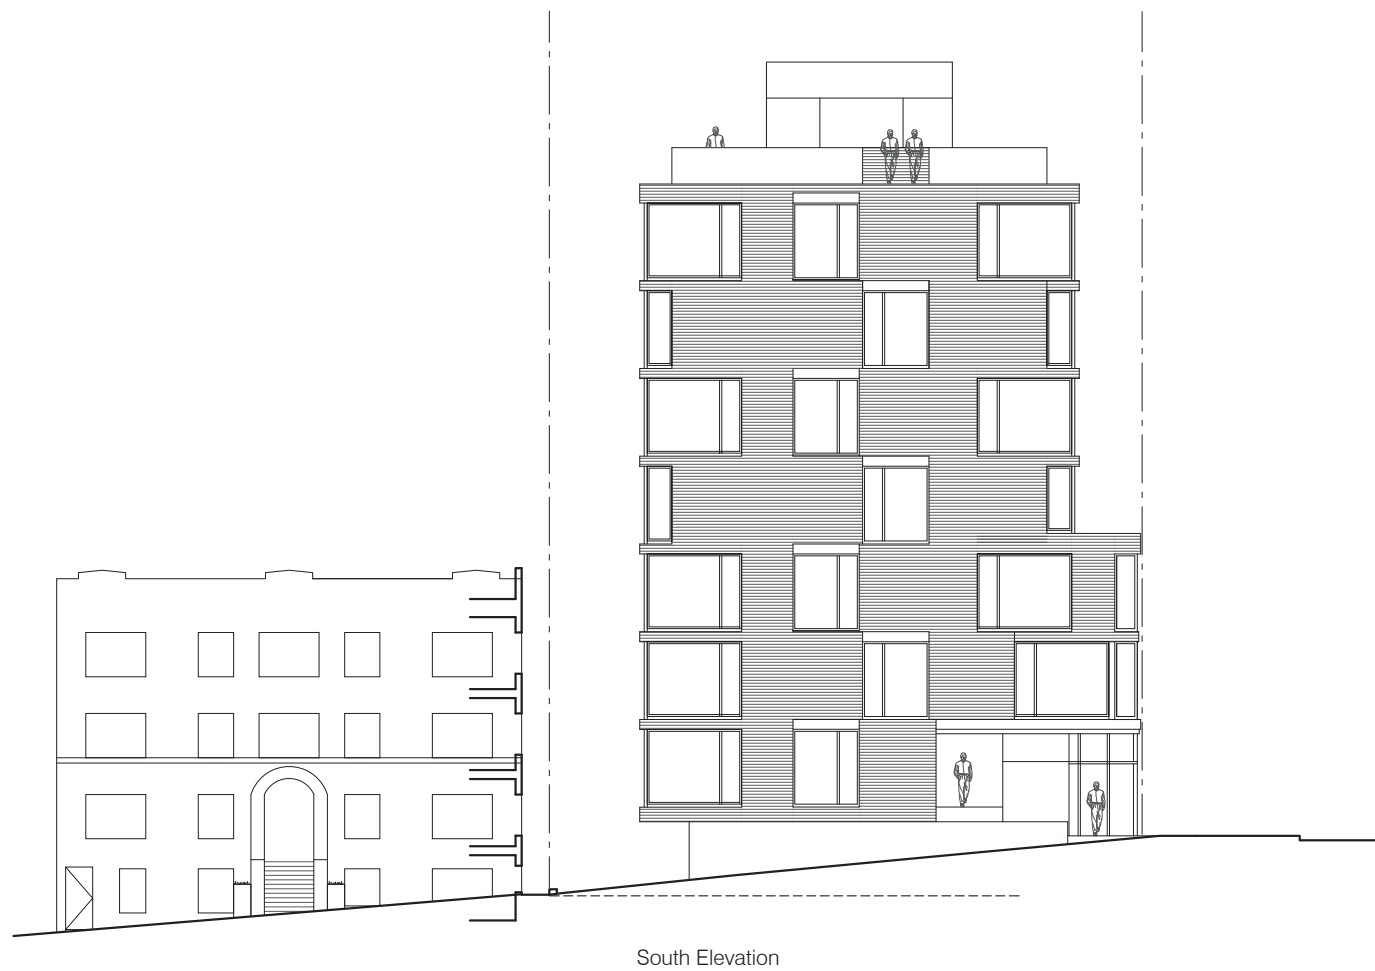
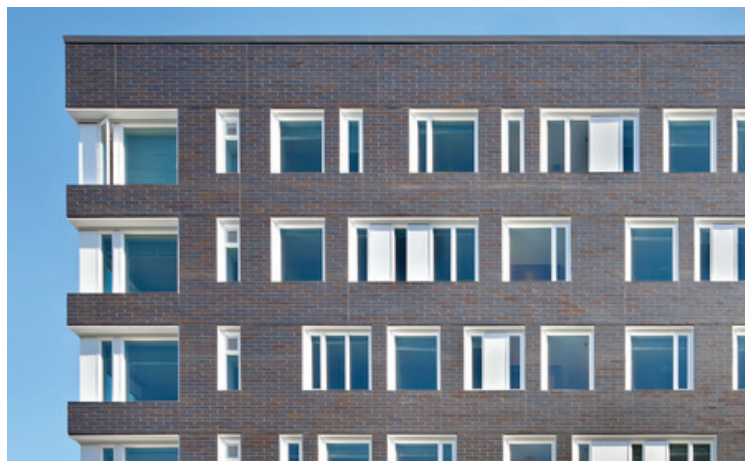
DOVETAIL ONE // Alternate 3

Windows that shift orientation on alternating floors creates a form of dovetailed variation in unit orientation. In the southwest units the first three floors are stacked and orient to the street to respect the neighboring building as well as introduce a subtle datum that responds to the scale of the neighbor. The facade presents an overall expression of clear building form, cladding as a uniform surface with punched openings.

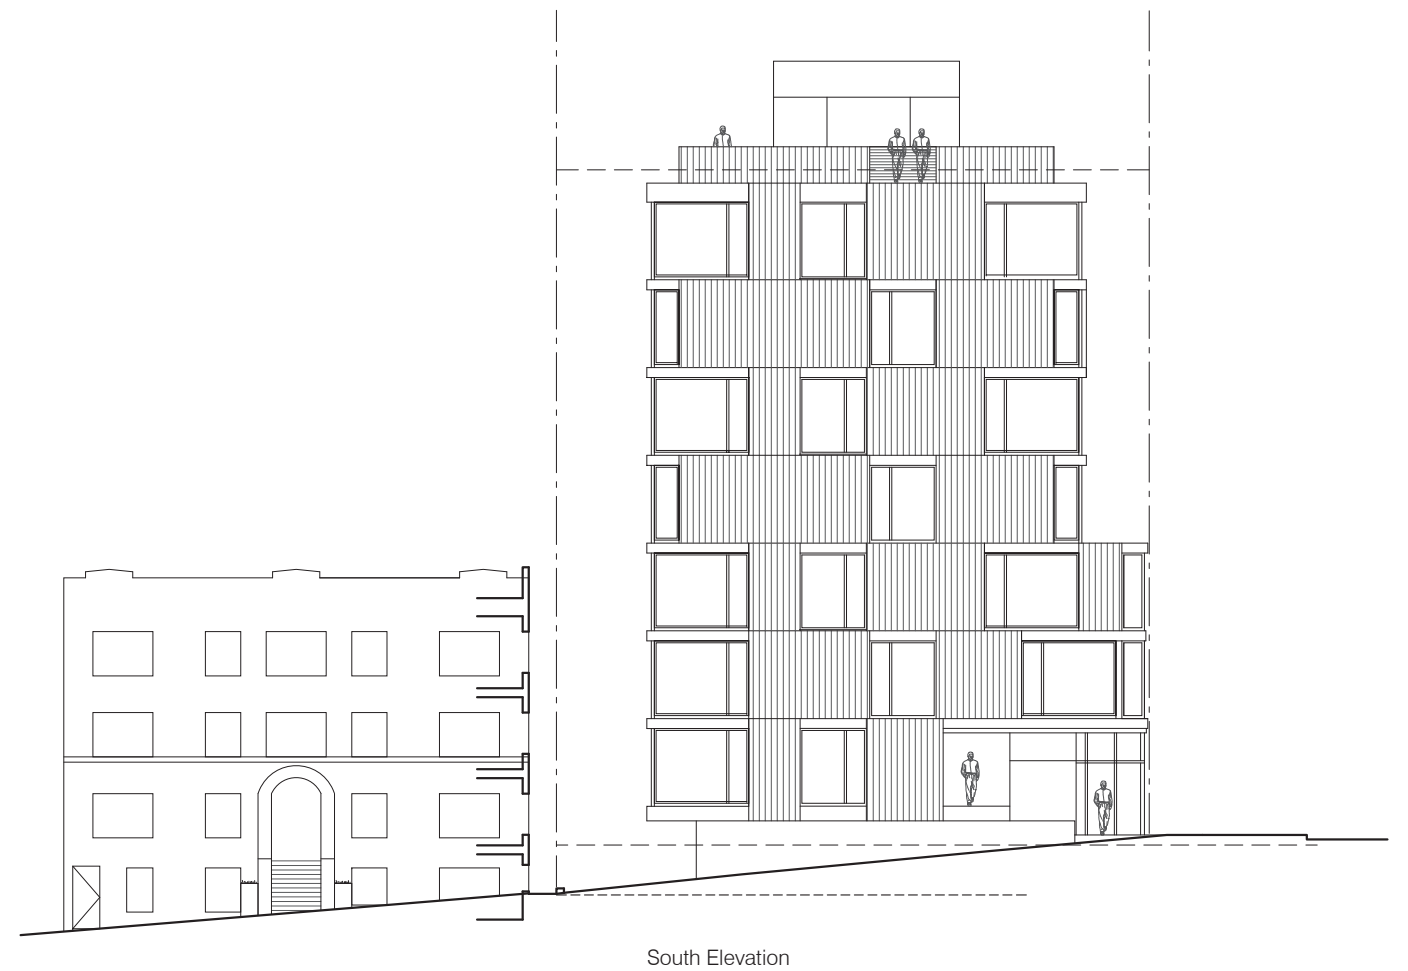
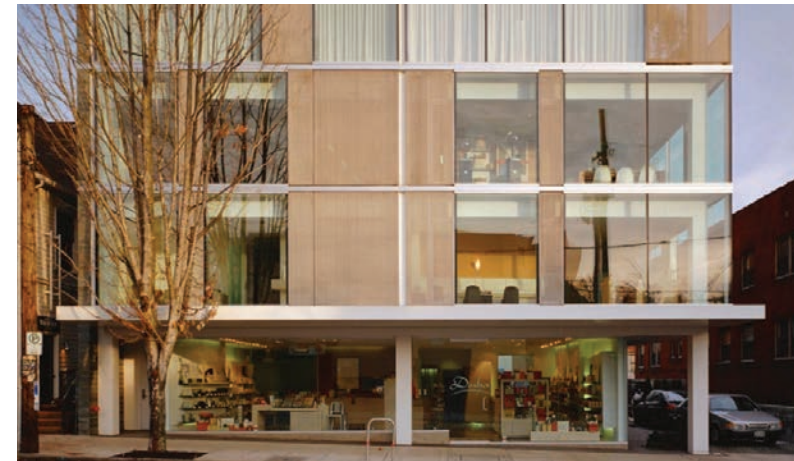
DOVETAIL TWO // Alternate 4

Windows that shift orientation on alternating floors creates a form of dovetailed variation in unit orientation. In the southwest units the first three floors are stacked and orient to the street to respect the neighboring building. This scheme introduces window groupings in the southwest unit as well as floor line expression within the window opening to add additional horizontal elements that provide a stronger definition of datums. The facade presents an overall expression of clear building form using cladding that is a hybrid of a uniform surface layered with story expression at window openings.
