PROJECT #3034147-EG 3417 Harbor Ave SW, SEATTLE, WA 98126 DESIGN RECOMMENDATION | NOVEMBER 19, 2020

project background, site information, development objectives | 3.0 PROJECT DATA

71,100 sf
58,227 sf
115 units (preferred scheme)
65 stalls (preferred scheme)
5 stories of residential with 1 partially below-grade level of parking
existing office building to be demolished

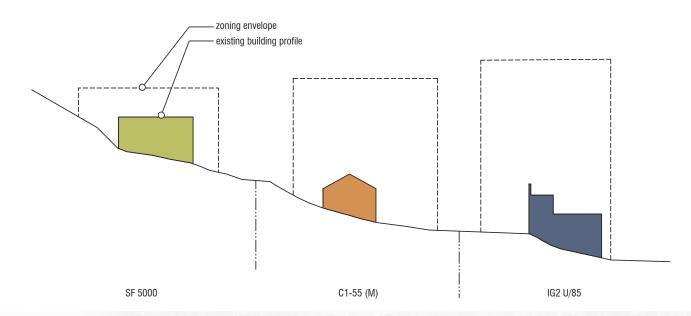
SITE ZONING

The site is located in a strip of a commercial zone (C1-55 M), bordered by an industrial zone (IG2-U/85) to the east and single-family zoning (SF5000) to the west.

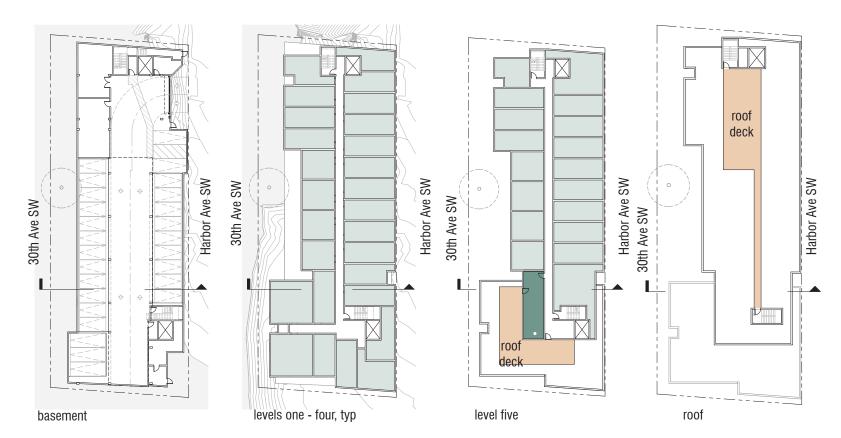
massing evolution

Following the EDG meeting, the Board recommended Scheme 3 to be explored and developed further. The Board offered specific guidance, and in conjunction with the design team's exploration, the overall massing has evolved as illustrated here. See pages 14-30 for itemized responses.

The developed scheme shifts the hierarchy of the mass in order to provide a more prominent corner condition at the southeast edge, while stepping down the mass toward the adjacent structure to the north. The building now has a main public entry at the southeast corner, a residential entry (connecting to the bike parking, mail room, and garage) at the northeast corner, and a residential pedestrian exit at the northwest corner, connecting to the ROW above.

Due to the long frontage along both Harbor Ave SW and 30th Ave SW, the mass has been broken into three sections; the north and south nodes are connected by the central bar, and the materiality is expressed accordingly. Panels are carefully detailed along the two nodes, with the patterning adjusted between the corner entry condition and the residential facing facades. Windows are recessed along these facades, with deeper metal trim provided at the corner expression. The central bar reflects the residential neighborhood, with horizontal lap siding reinforcing the horizontal bar. Secondary architectural features and materials reflect the building's place between two zones.

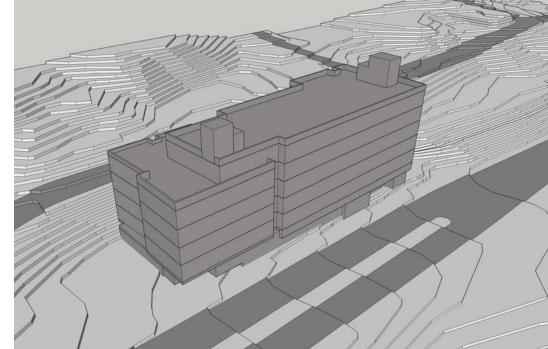
proposed massing @ EDG

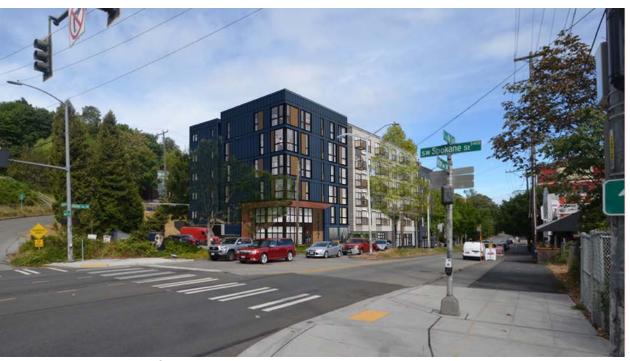
proposed massing from SE corner

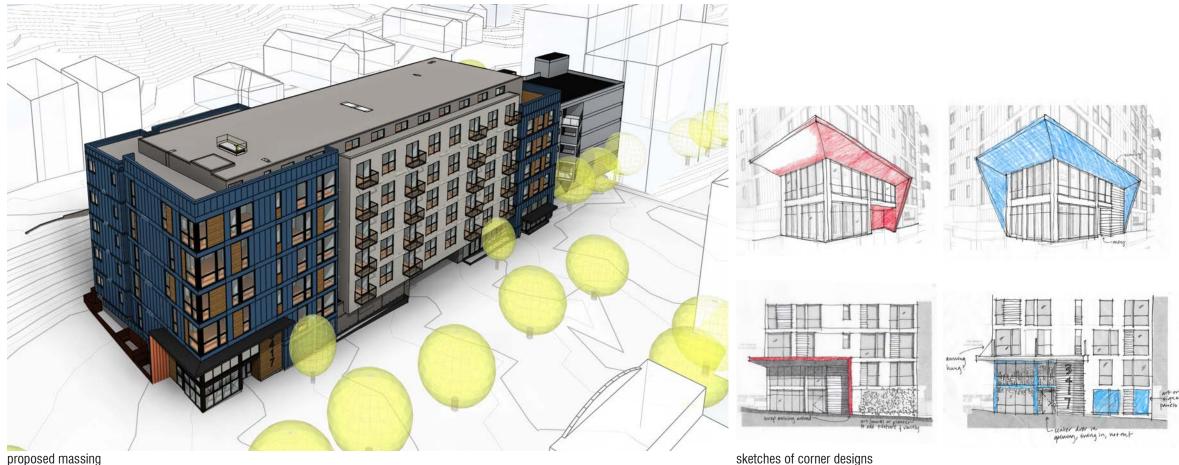
sketches of corner designs

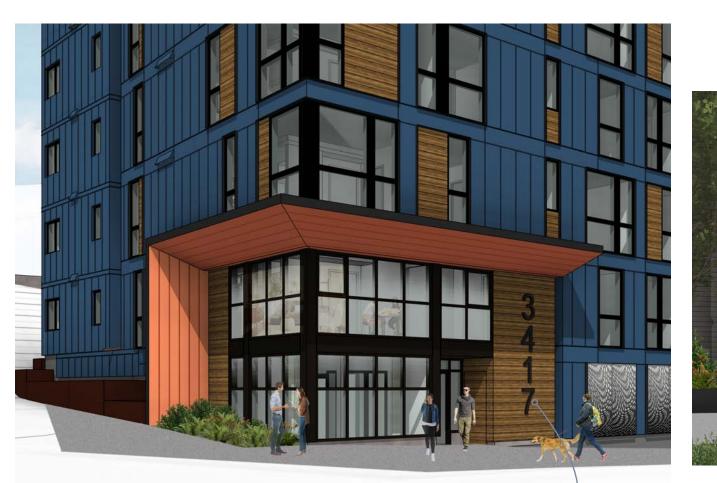
view of south lobby

address numbers & building signage, exact design to be determined

Previously, the proposal included a recessed residential entry at the southeast corner, with an exit-only condition at the northeast. The plan has been reworked in order to accommodate a primary entry at the southeast corner and secondary entry at the northeast corner. These entries relate to each other visually, but prominence is given to the southeast entry (as the corner expression) through massing and detailing. The scale, detailing, and proximity to the bus stop of the southeast entry identifies it to visitors as the main public entry, while the northeast entry has been modified and enlarged to function primarily as a resident entry.

The design as proposed at MUP included a sunken entry and a pitched awning at the southeast entry in order to provide additional height. Staff guidance suggested that this created a pinched condition rather than a grandeur entry expression and requested that we evaluate a two-story option. Following that guidance, we evaluated several options including a 1.5 story entry and 2 story entry. However, due to the small unit size above the lobby and the compact lobby itself, this resulted in an awkwardly tall lobby experience while also resulting in the loss of a unit. Focusing on the staff guidance to provide a grandeur entry expression, we have raised the awning, enlarged the lobby to align with the floor above, and treated the fenestration of the unit above in the same manner as the lobby. This design allows for a two-story expression commiserate with the scale of the building

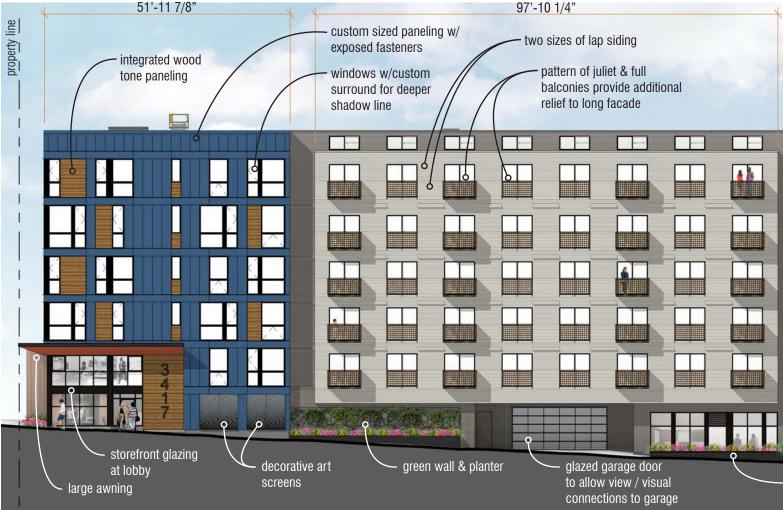
The east elevation (Harbor Ave SW) at EDG had long sections of facade, up to 126'. The revised design breaks the facade down into smaller sections and also provides additional secondary detailing to provide a smaller scale to this long facade.

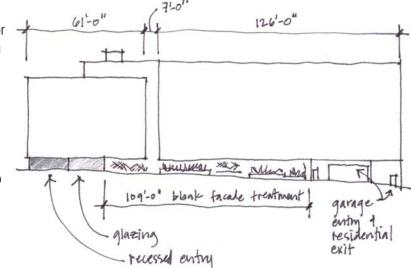
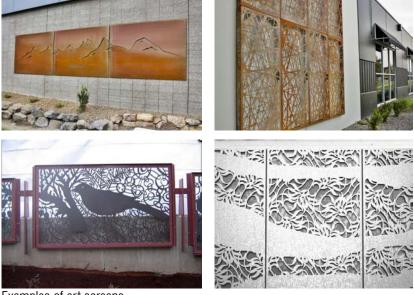
Early community feedback requested the project incorporate public art as a nod to the culture of public art in the neighborhood. This project is working with local West Seattle artists/makers to provide decorative metal art screens. which will provide visual interest along the long façade, as well as firmly connect this building to the neighborhood.

Examples of art screens

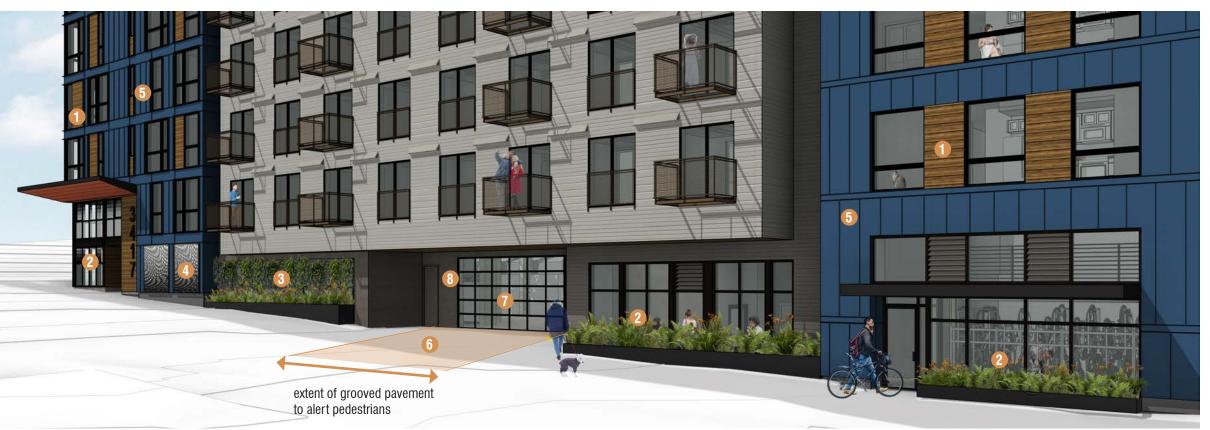
- shift drive south to enlarge south lobby
- provide bike parking facing Harbor •
- decrease in car parking facing Harbor of 13%

Harbor Ave SW garage entry

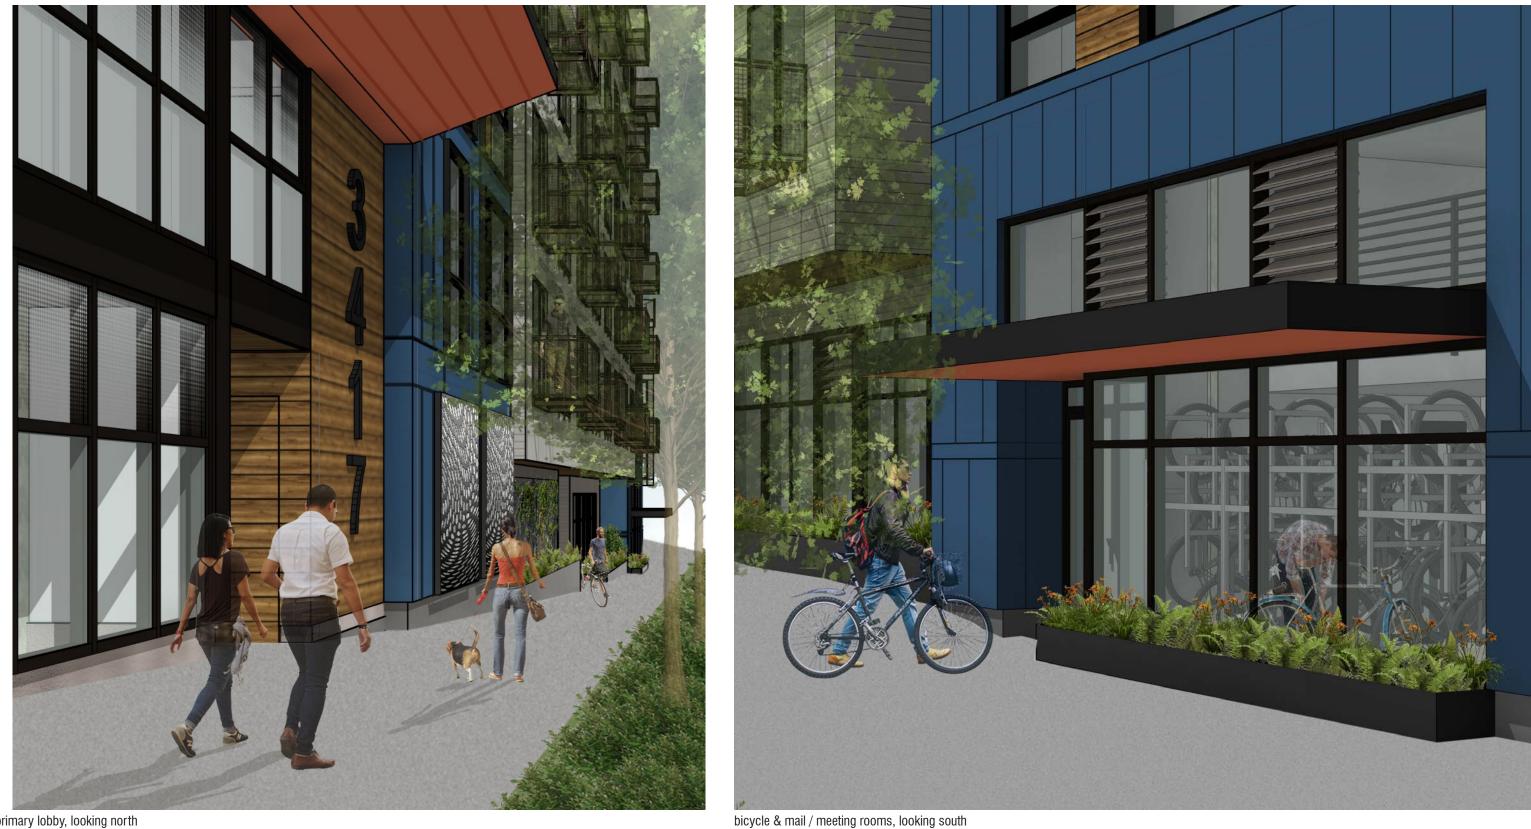
primary lobby, looking north

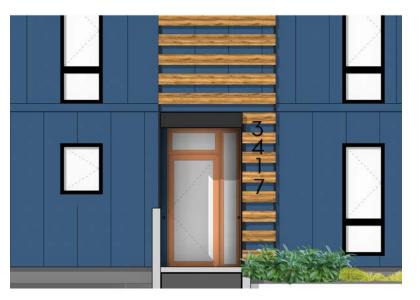
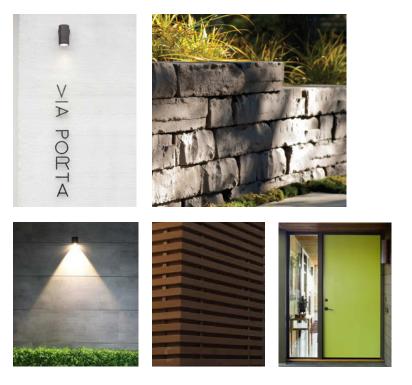
30TH AVENUE SW ENTRY

A resident-only entrance/exit has been provided facing 30th Ave SW. This allows for a neighborly pedestrian and bike connection to 30th Ave SW and SW Admiral Way beyond with a stair and runnel connection. The entrance takes its material cues from the lobby entrances on Harbor Ave SW, using wood tone accents, a metal awning, and a pop of color with coral door and windows, while still maintaining a more residential scale.

- A residential entry has been added to the northwest • node as recommended by the board. A stair and associated bike runnel have been provided in order to allow residents a neighborly, and easy access to 30th and beyond.

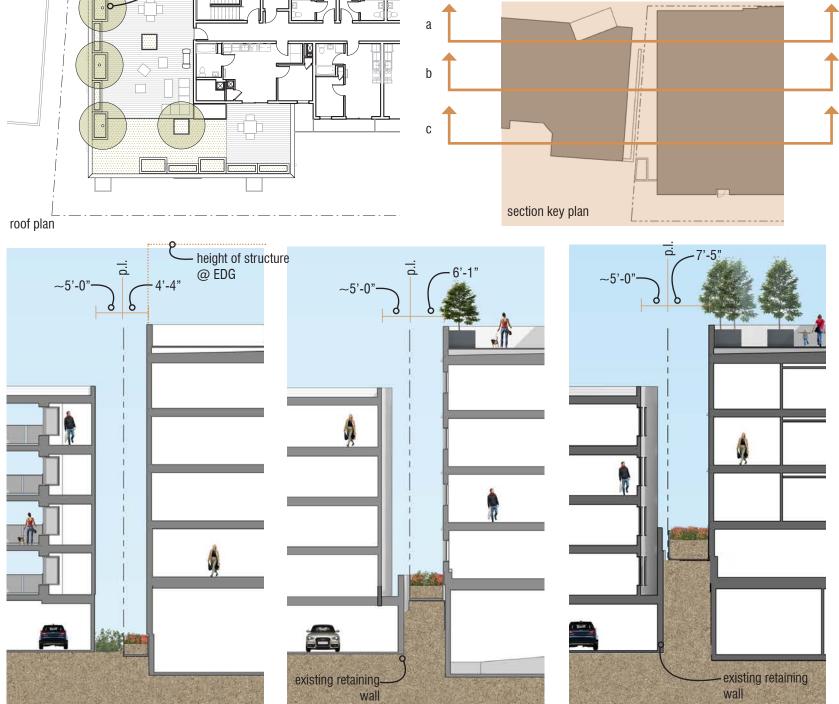
section a

section b

Per the Board's guidance, the taller more prominent corner of the building has been relocated to the south edge, allowing the building to step down adjacent to the neighboring structure. Care has been taken to reduce the impact of the new structure on the neighboring building. A variety of roof deck locations were explored, however programmatically we believe it is important to locate the roof deck connected to an indoor amenity space in order to be more usable throughout the year and various weather conditions. With the dropped massing along the north per the Board's guidance, the roof deck is located to the north as well.

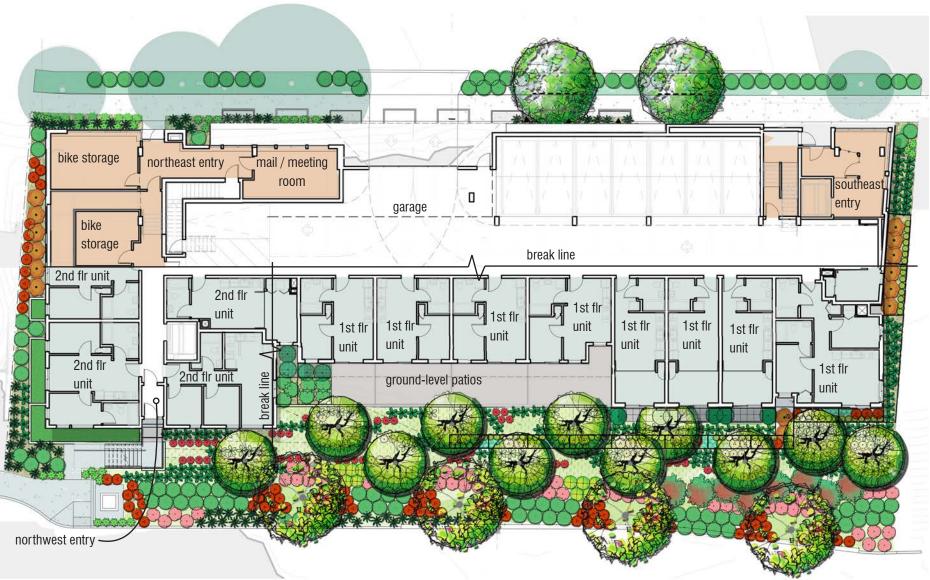
composite building & landscape plan

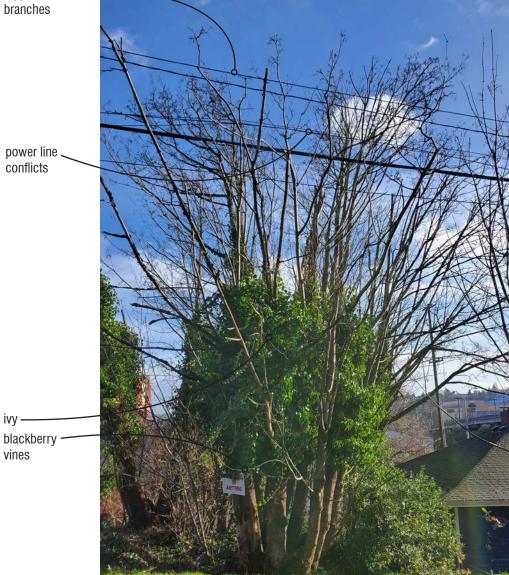
A healthy big leaf maple

The existing big leaf maple, acer macrophyllum, that is located on the west side of the site. The maple has been poorly maintained and topped many times. In addition to being topped, an overgrowth of ivy, blackberry vines, and tangled power lines have contributed to its poor condition. This poor condition has been verified by a certified arborist.

While this tree meets the threshold diameter for a tree to be considered exceptional per Director's Rule 16-2008, it does not meet the definition of an exceptional tree. The arborist's report (Hailey Mackay, ASLA of Moss Studio) indicates that there is "no evidence to suggest it has historical value, and from a type 1 evaluation it does not appear to have ecological or aesthetic value." Please see attached report dated 17 April 2020. The report designates the tree as being in poor condition. as follows:

The tree appears to have been infested with ivy and blackberry for many years, as ivy is present in the upper canopy, and the canopy is very sparse with many dead branches. It is my opinion that this tree would be unlikely to survive impacts from construction, even if a tree protection area was erected around the dripline for the duration of ivv – construction activities. This tree may even pose a potential hazard to proposed structures and people on site if the tree vines or any large limbs were to fail during or after construction. I recommend the removal of this tree, to be replaced on site by 3 native or adapted tree species at minimum 2" caliper for deciduous and broadleaf, and minimum 7' height for conifers.

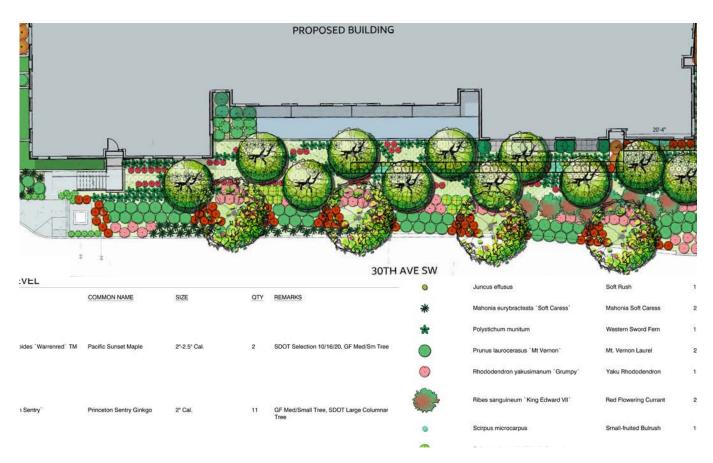
landscape plan of the 30th Ave SW courtyard

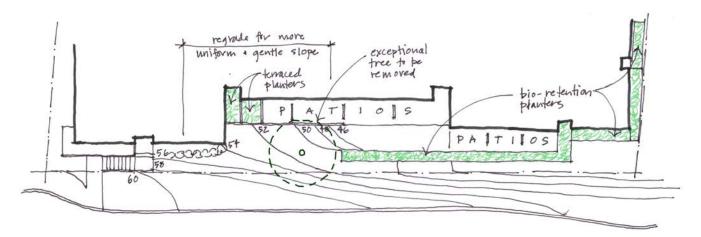
- Re-grade allows for patios at lowest level and maintains a lower perceived mass at north node, as structure is buried below grade.
- · Removing trees allows for sculptural landscape elements and new healthy trees

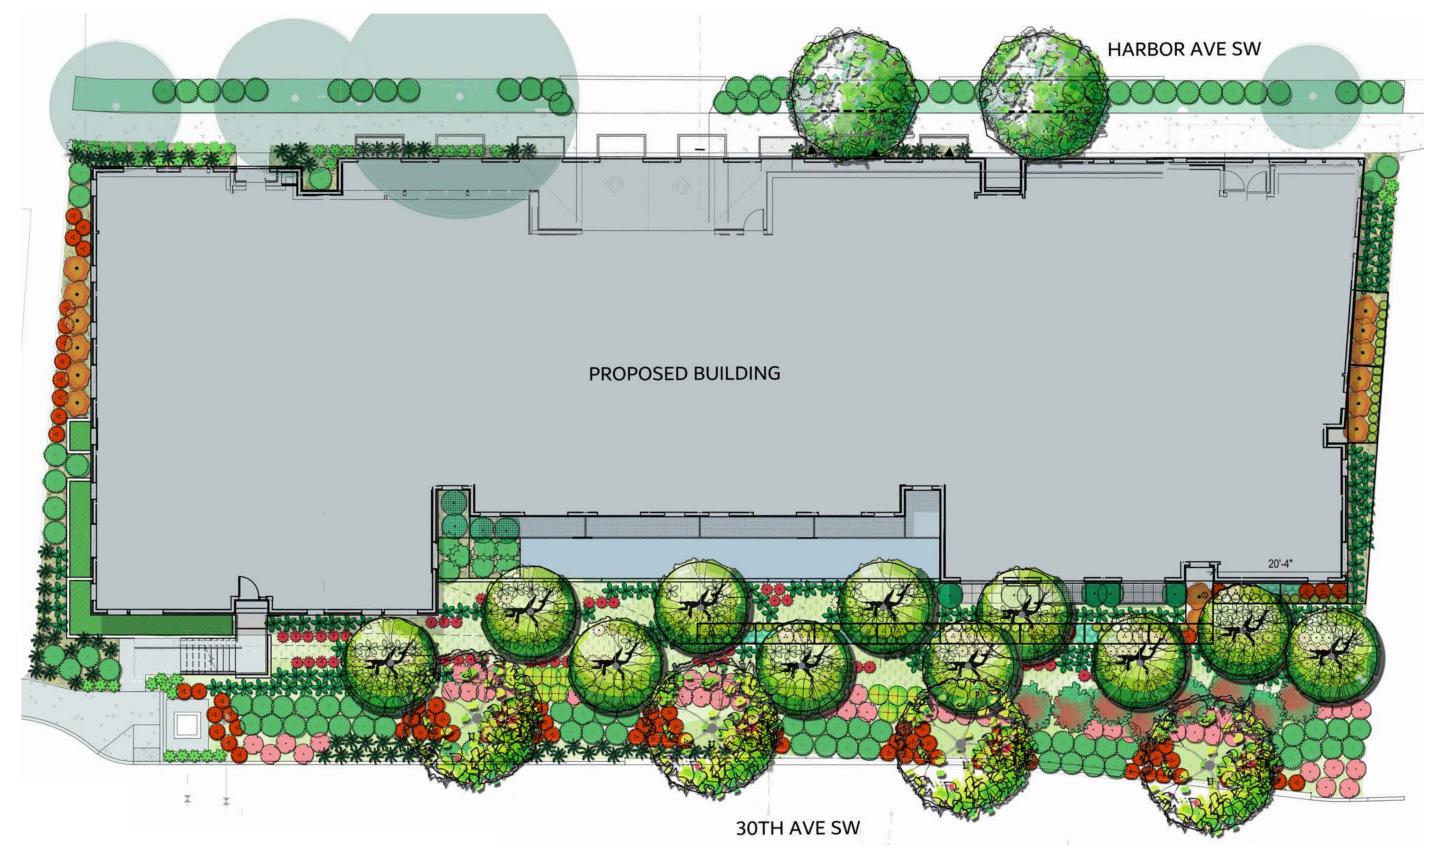
11.0 ARCHITECTURAL DESIGN | landscape - ground

The proposed landscape has been carefully selected to provide visual interest and texture throughout the seasons for both the future residents and the neighbors. The hillside will be densely planted with shrubs, grasses, and trees that decorate the slope but still allow views through for safety. The scale of the plantings was also a priority. For example, the serviceberry trees proposed at the roof deck will act as a privacy screen for the northern neighbors but at a respectful size.

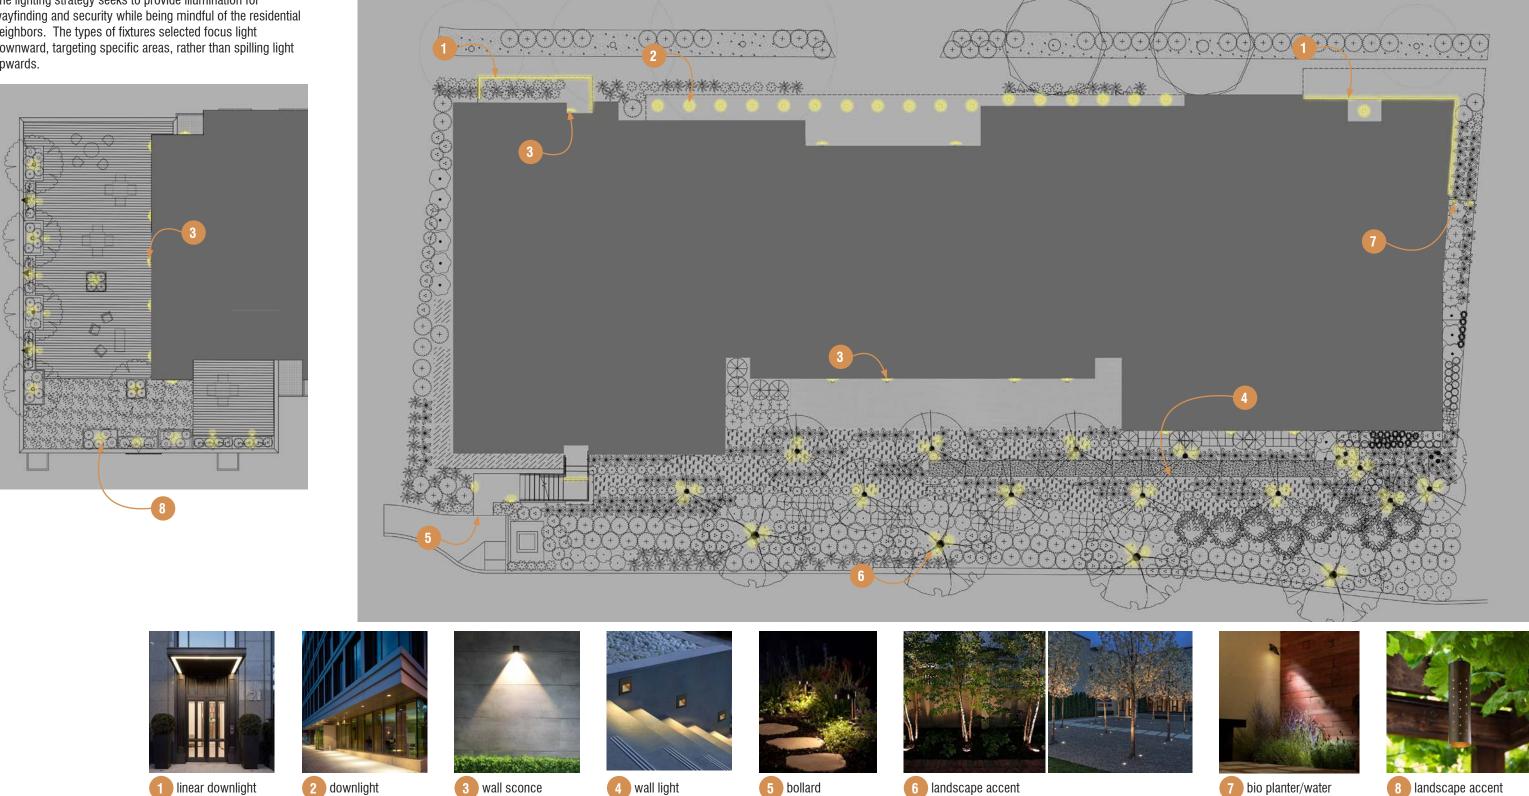
The lighting strategy seeks to provide illumination for wayfinding and security while being mindful of the residential neighbors. The types of fixtures selected focus light downward, targeting specific areas, rather than spilling light upwards.

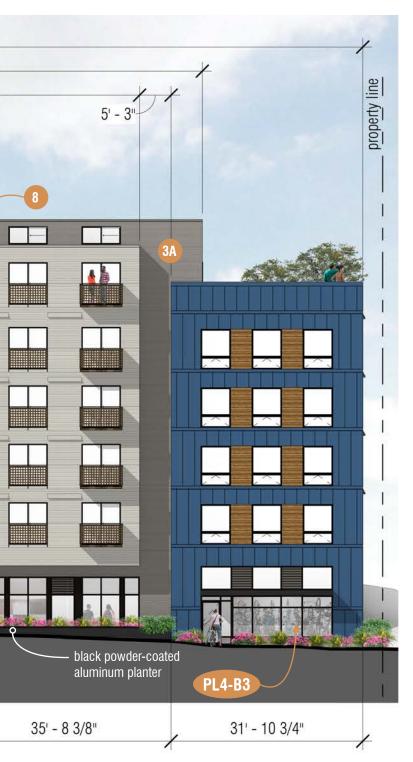
east (Harbor Ave SW) elevation

Equitone Pictura PG444, 3/8" reveal w/ exposed fasteners 2 Stonewood Panel - Cask Oak 8" plank w/ exposed fasteners 4" & 8" Cementitious Board Lap Siding w/ 1/2" integrated reveal Siding Paint A: Sherman Williams, Dovetail Siding Paint B: Sherman Williams, Dorian Gray Standard metal rail w/ wire mesh panels, powder coated Tiger Medium Bronze 38/60014 Black vinyl windows w/ extended frame Metal accent panels, black to match window assemblies Kawneer Dark Bronze 40 storefront window 8 Custom metal vent shroud Metal planks painted Benjamin

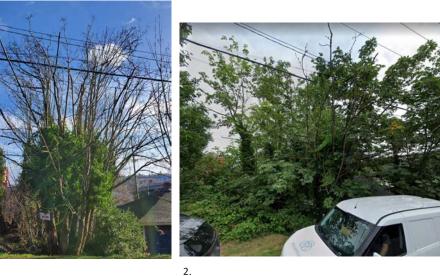
Photo 1: winter, ivy infestation in canopy

Tree #10 is a multi-trunk Bigleaf Maple that is in very poor condition. I found no evidence to suggest it has historical value, and from a type 1 evaluation it does not appear to have ecological or aesthetic value. The tree appears to have been infested with ivy and blackberry for many years, as ivy is present in the upper canopy, and the canopy is very sparse with many dead branches. It is my opinion that this tree would be unlikely to survive impacts from construction, even if a tree protection area was erected around the dripline for the duration of construction activities. This tree may even pose a potential hazard to proposed structures and people on site if the tree or any large limbs were to fail during or after construction. I recommend the removal of this tree, to be replaced on site by 3 native or adapted tree species at minimum 2" caliper for deciduous and broadleaf, and minimum 7' height for conifers.

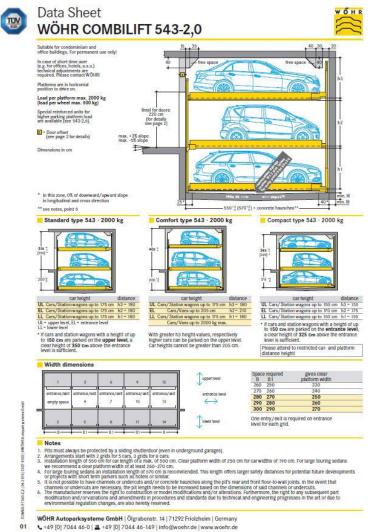
13.0 APPENDIX | parking lifts specifications - combilift

Coors According EN 14010, the Combilit 543 must be closed with shutterdoors. The door contos are integrated in the overall system. That means: a) The doors are electro-mechanically interfocked. b) The doors can only be operadwhen the selected parking place has reached the entry/ exit position. maintenance and revision are not subject of our delivery. These matters have to be observed and carried out by the customer, according to the local regulations. Door types: Manually operated sliding shutterdoors c) Any pits are closed in the entrance area. for underground garages with galvanized fence filling

above ground with powder coated metal sheets (RAL 7030)
 Alternatively, sliding shutterdoors can be supplied with electrical drive.

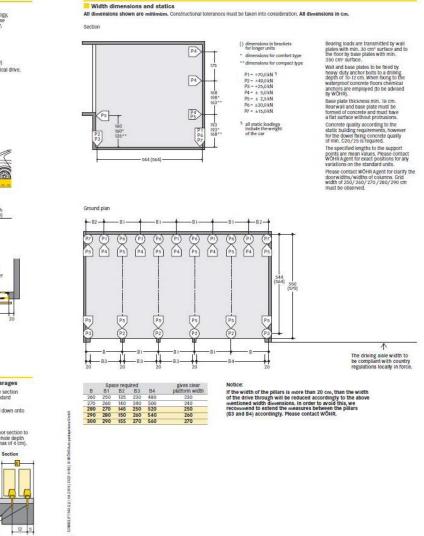
Dowel borehole depth to be approx. 9 cm Front view 1 Rollers Rollers pliant to Locking down of the rollers ess onto the base plate by means 10 tz of an adhesive anchor with an MS internal screw thread. DIN 18353, floor evenness compliant to DIN 18202 02 compliant to I table 3, line 3

Hydraulic power packs		Free spaces				
The hydraulic power pack is positione	ed within the system.	Special drawings for free spaces to accommodate air ducts or other pipes can be requested at WOHR Agent!				
Switch cabinet						
The switch cabinet is positioned with	in the system at the rearwall.	Railings				
		If walkways are arranged directly to railings have to be provided by the c	the side or behind the systems, ustomer acc, to local requirements.			
Electrical data			He during the construction phase too.			
Connections 230/ 400 V, 50 Hz, 3 phases. Power consumption max.	Grounding and potential equalisation:

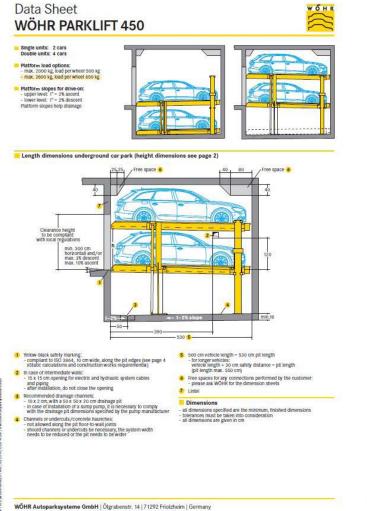
parking lifts specifications - parklift | **13.0 APPENDIX**

WÖHR PARKLIFT 450 | 03.2019 | C027-4330 Notes and directions Scope of application Conformity examination (TÜV) suitable for residential buildings, office buildings and outstreas y-suitable hotes only for ingretern users that have been instructed on how to use the system tor frequently changing users (e.g. for office, hotel and business performance of instruction of the state of CE - voluntary confi. the TÜV SÜD The parking syste - EC Machinery D Railings Noise protection solid ceiling above the parking systems with min. m² + 400 kg/m³ At differing constructional conditions additional sound absorbing measures are to be provided by the custom Basis is the German DIN 4109 "Noise protection in buildings". With the following conditions required 30 dB (Å) in rooms can be provided: noise protection package from our accessory The best results are reached by separated sole plates from the construction. insulation figure of the construction of min. Riw ~ 57 dB walls which are bordering the parking systems must be done as single wall and deflection resistant with min. m² = 300 kg/m² Increased noise protection: If increased noise protection must be provided planning ha to be confirmed on a project basis by WÖHR. Drainage Water leaks into the pit: - in the winter, up to 40 litres of snow water can possibly come with the wheel housings in just one parking process Sideways slope drainage: - only into a gutter - not possible in the remaining pit section Lengthways slope drainage: - provide according to specified construction dimensions Recommended drainage c - along the front end secti the pit Tender specification - please consider the specifications - connecting to a floor drain or drainage pit (50x 50x 20 cm) - with manual emotion Environmental safety: - coating of the pit flooring is recommended Parking Place-Profile emptying ou - installation of an oil and/or petrol separator unit between the drainage connection and the main sewerage system is recommended with manual emptying out of a drainage pit alternatively installation of a - please consi alternatively instance channel into pump or drainage channel into the sewerage system, to be performed by the customer

Temperature - system operating range: - 10" to +40" C (with unloaded platforms lowering speed is reduced if less than +5" C) - humidity: 50% at +40" C - in the event of changes to system conditions please consult with WOHR
