QA-2 EAST

530 W Barrett Street | Project# 3037571-EG

workshop AD
ROOT OF DESIGN

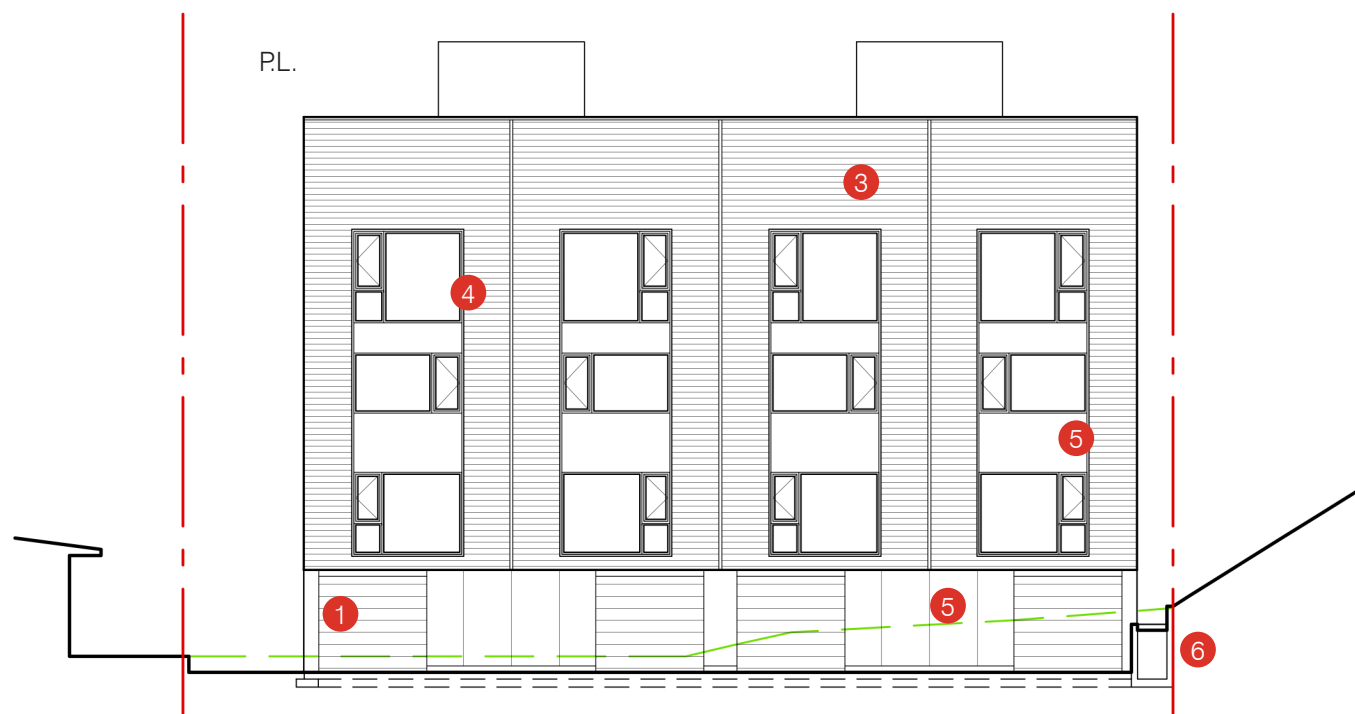
Courtyard South Elevation

- Concrete ①
- Brick ②
- Wood Siding, Stained ③
- Vinyl Windows, White ④
- Panel Siding, White ⑤
- Bio Planter ⑥
- Wood Door ⑦
- Glass Door ⑧

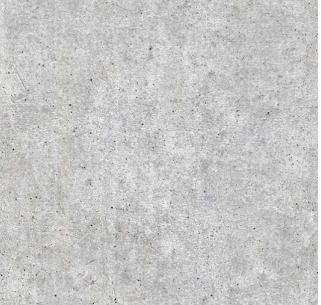
1 Concrete
Natural Finish

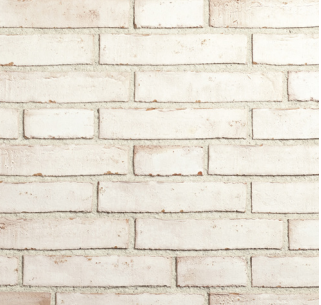
2 Brick Veneer
Mutual Materials
White

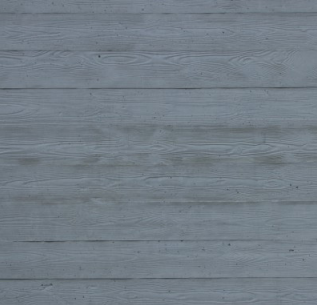
3 Wood Siding
1x4 TK T&G Cedar
Semi-Solid Stain

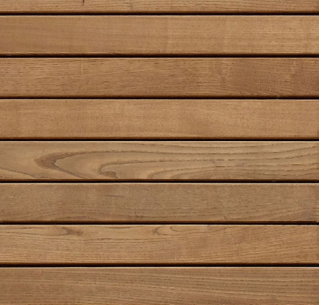
5 Wood Deck
5/4 x 6 Cedar
Clear Penetrating Sealer

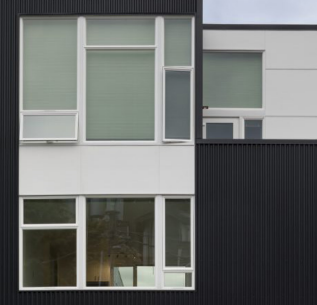
6 Windows
Vinyl
White Factory Finish

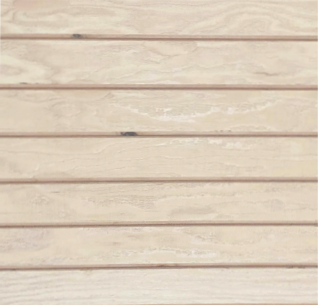
7 Wood Soffit
1x4 T&G VG Cedar
Semi-Transparent Stain

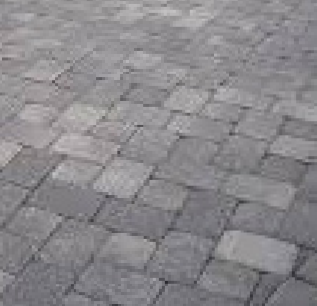
9 Permeable Pavers
8x8
Charcoal Blend

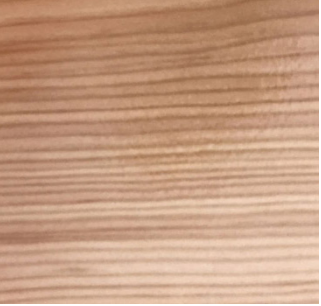
10 Wood Door
VG Fir
Clear Polyurethane

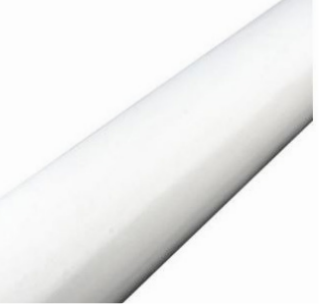
11 Exterior Railings
Metal
Powder Coat Paint // White

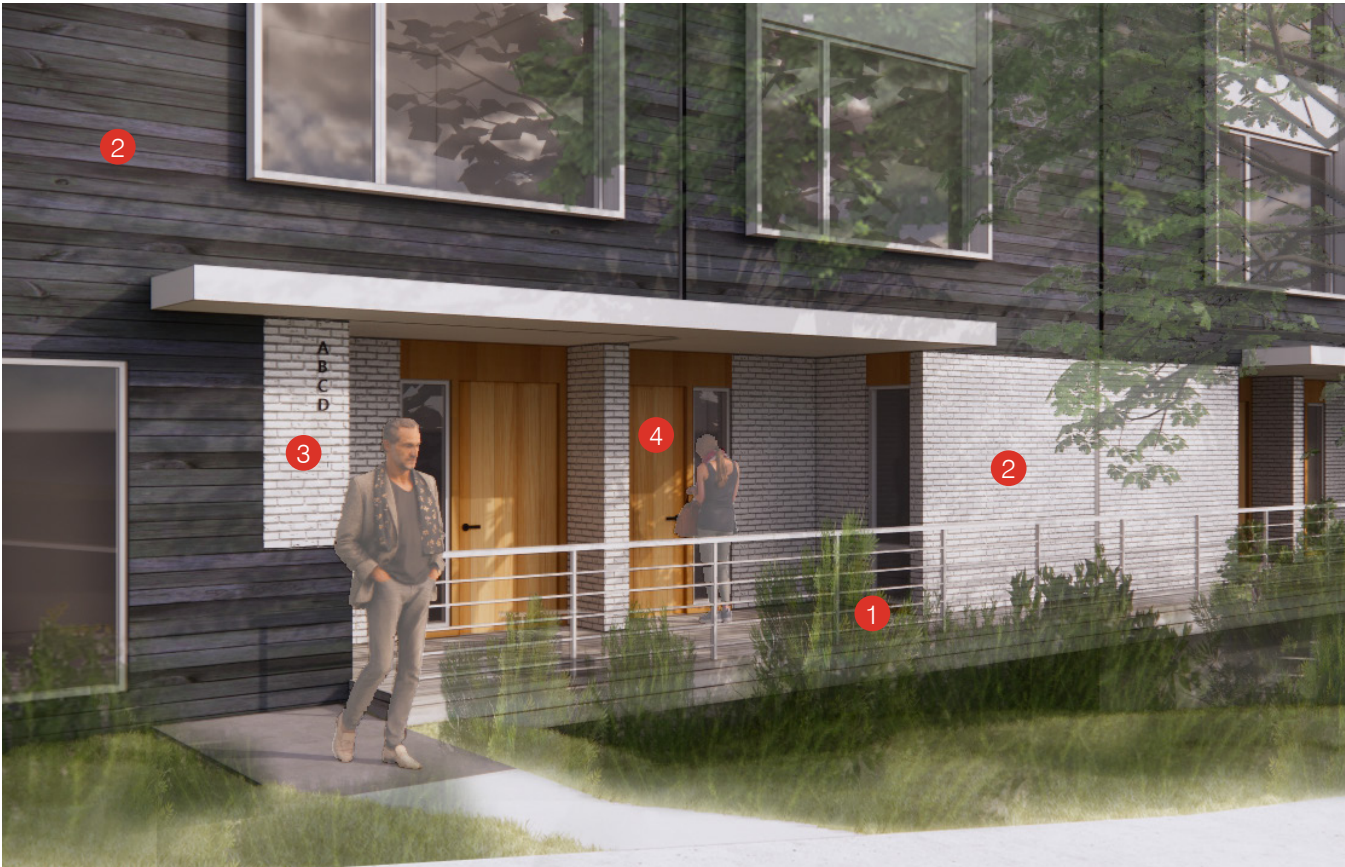
Street Units Entry

- 1 CS2.B.2 Connection to the Street
CS2.B.3 Character of Open Space
DC3.C.3 Support Natural Areas
DC4.D Trees, Landscape and Hardscape Materials
PL1.A.1 Enhancing Open Space
PL1.A.2 Adding to Public Life
PL3.A.2 Ensemble of Elements
- 2 DC4.A.1 Exterior Finish Materials
- 3 CS3.A.2 Contemporary Design
DC2.B.1 Façade Composition
DC2.C.1 Visual Depth and Interest
DC2.D.2 Texture
- 4 PL3.A.1.d Individual Entries to Ground-related Housing
DC2.D.1 Human Scale

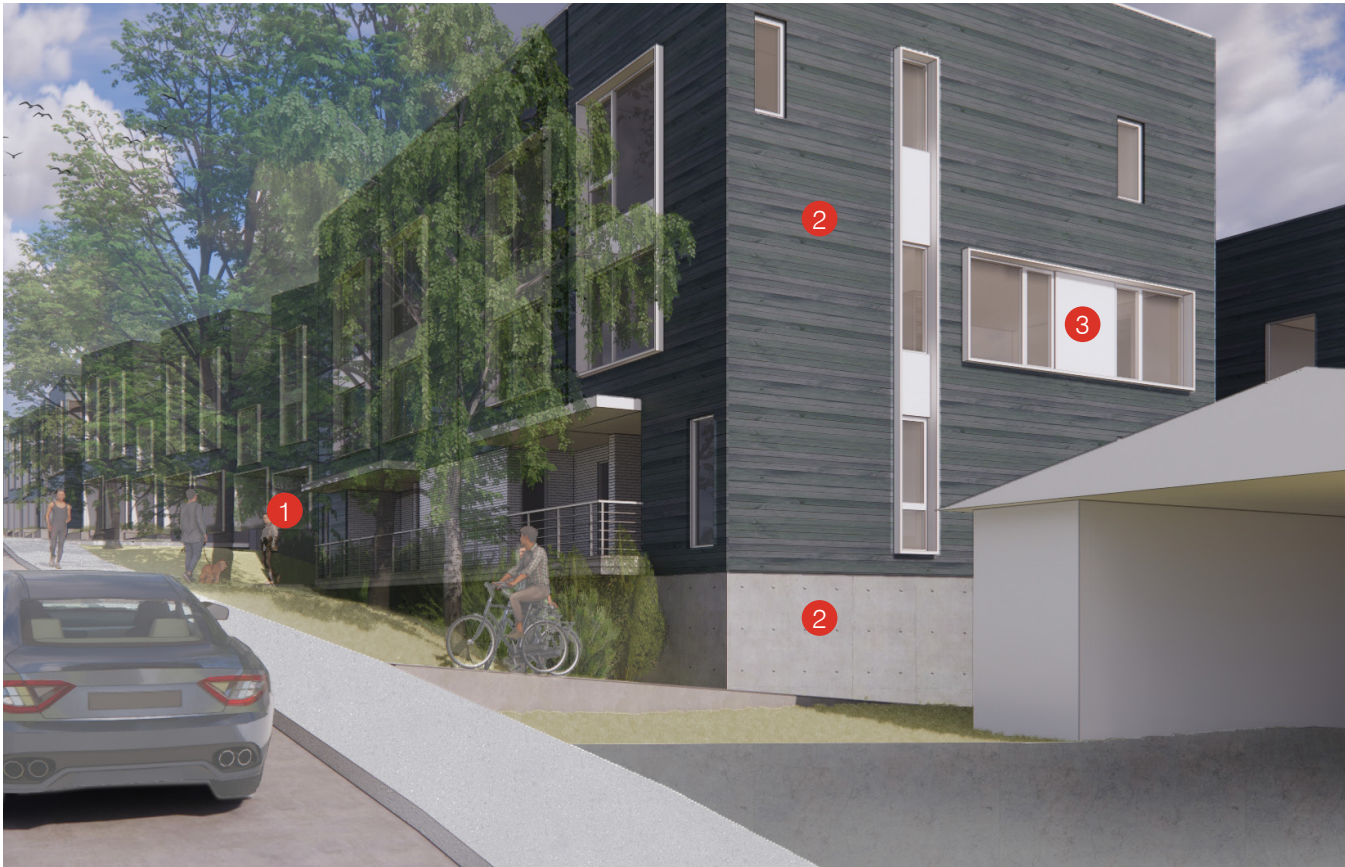
Approach From East

- CS2.B.2 Connection to the Street 1
- CS2.B.3 Character of Open Space
- DC3.C.3 Support Natural Areas
- DC4.D Trees, Landscape and Hardscape Materials
- PL1.A.1 Enhancing Open Space
- PL1.A.2 Adding to Public Life
- PL3.A.2 Ensemble of Elements
- DC4.A.1 Exterior Finish Materials 2
- CS3.A.2 Contemporary Design 3
- DC2.B.1 Façade Composition
- DC2.C.1 Visual Depth and Interest
- DC2.D.2 Texture
- PL3.A.1.d Individual Entries to Ground-related Housing 4
- DC2.D.1 Human Scale

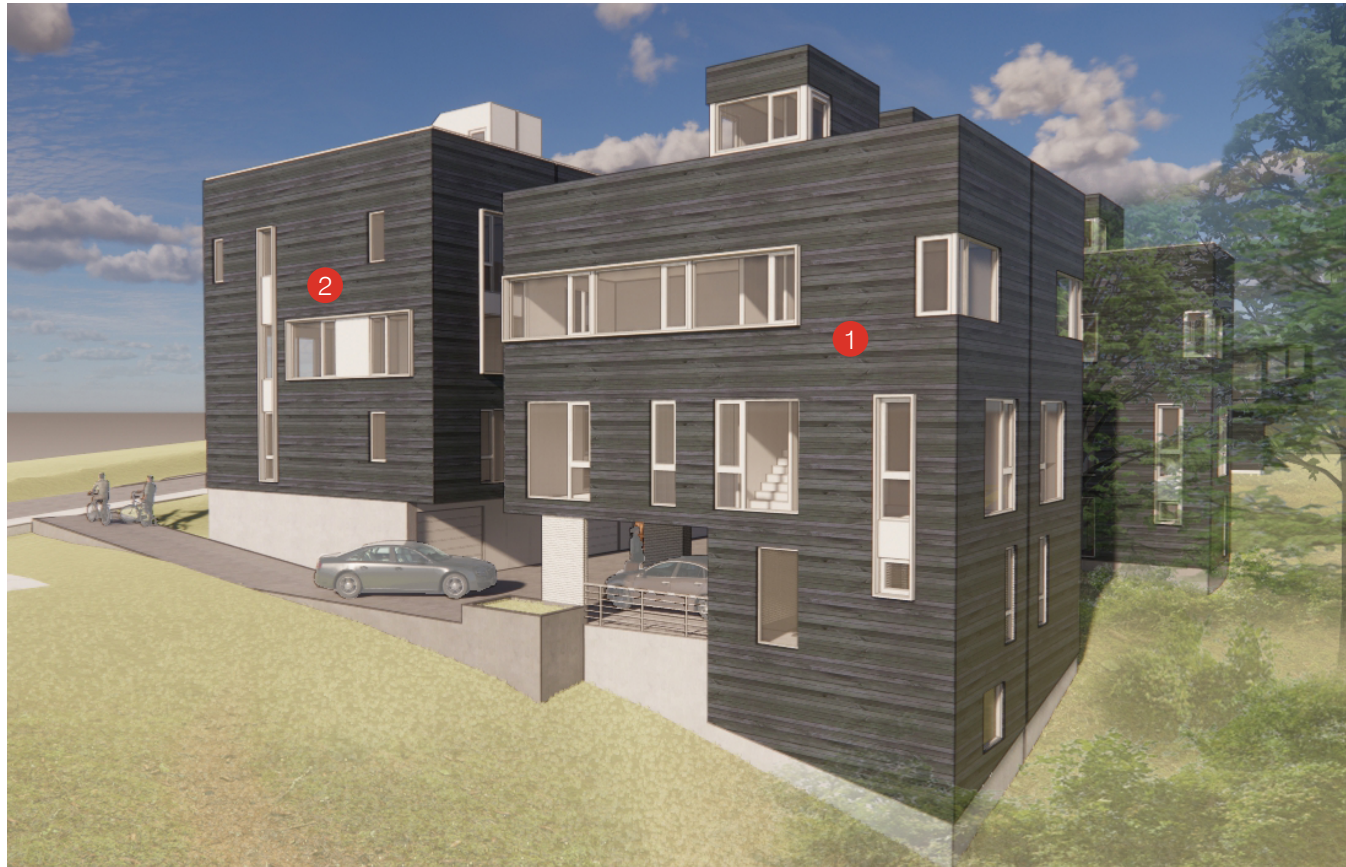
NE View

- ① DC4.A.1 Exterior Finish Materials
- ② CS3.A.2 Contemporary Design
DC2.B.1 Façade Composition
DC2.C.1 Visual Depth and Interest
DC2.D.2 Texture
- ③ PL3.A.1.d Individual Entries to Ground-related Housing
DC2.D.1 Human Scale

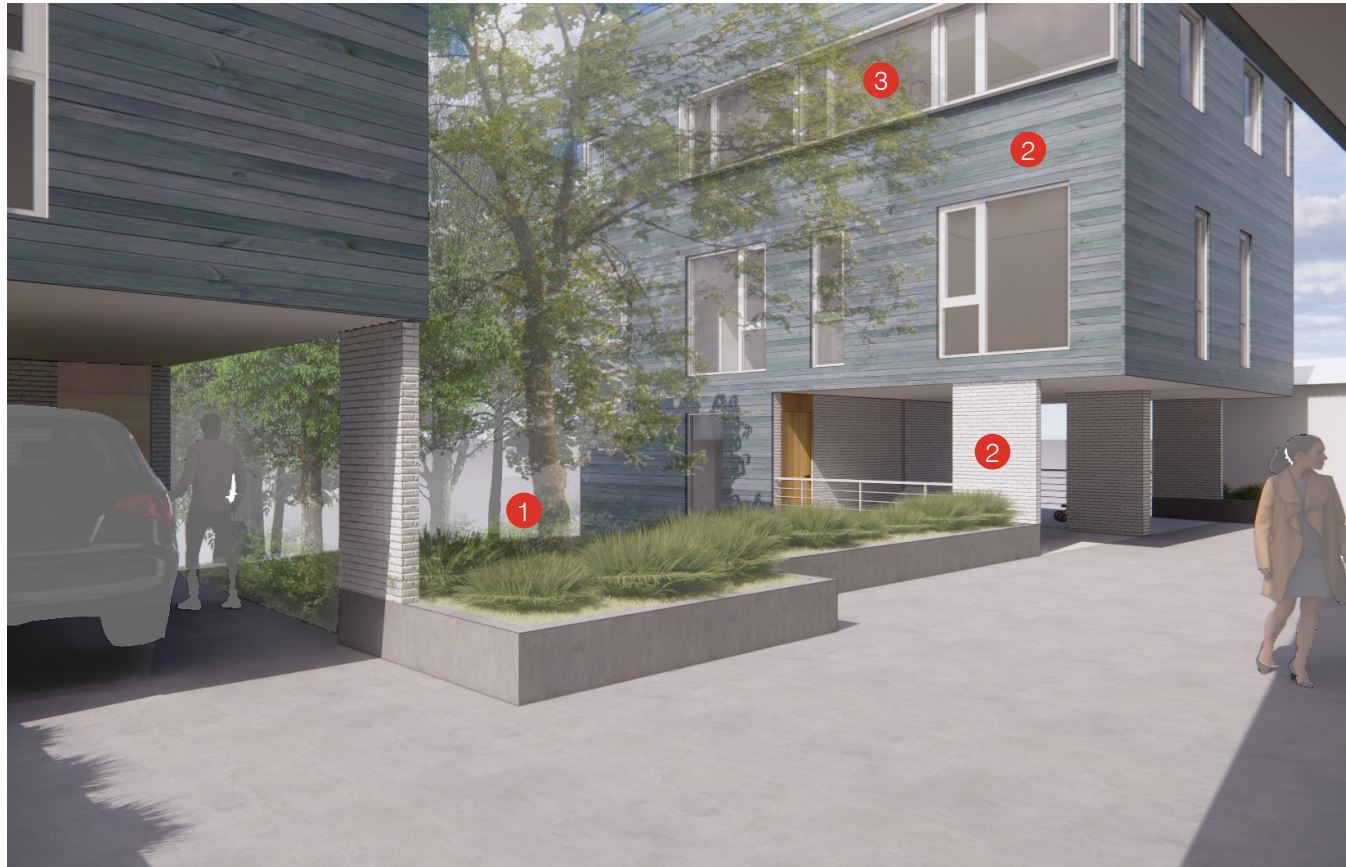
View Toward North at Auto Court

- CS2.B.3 Character of Open Space 1
- DC3.C.3 Support Natural Areas
- DC4.D Trees, Landscape and Hardscape Materials
- PL1.A.1 Enhancing Open Space
- PL1.A.2 Adding to Public Life
- PL3.A.2 Ensemble of Elements
- DC4.A.1 Exterior Finish Materials 2
- DC2.D.2 Texture
- DC2.C.1 Visual Depth and Interest 3
- PL3.A.1.d Individual Entries to Ground-related Housing 4
- DC2.D.1 Human Scale

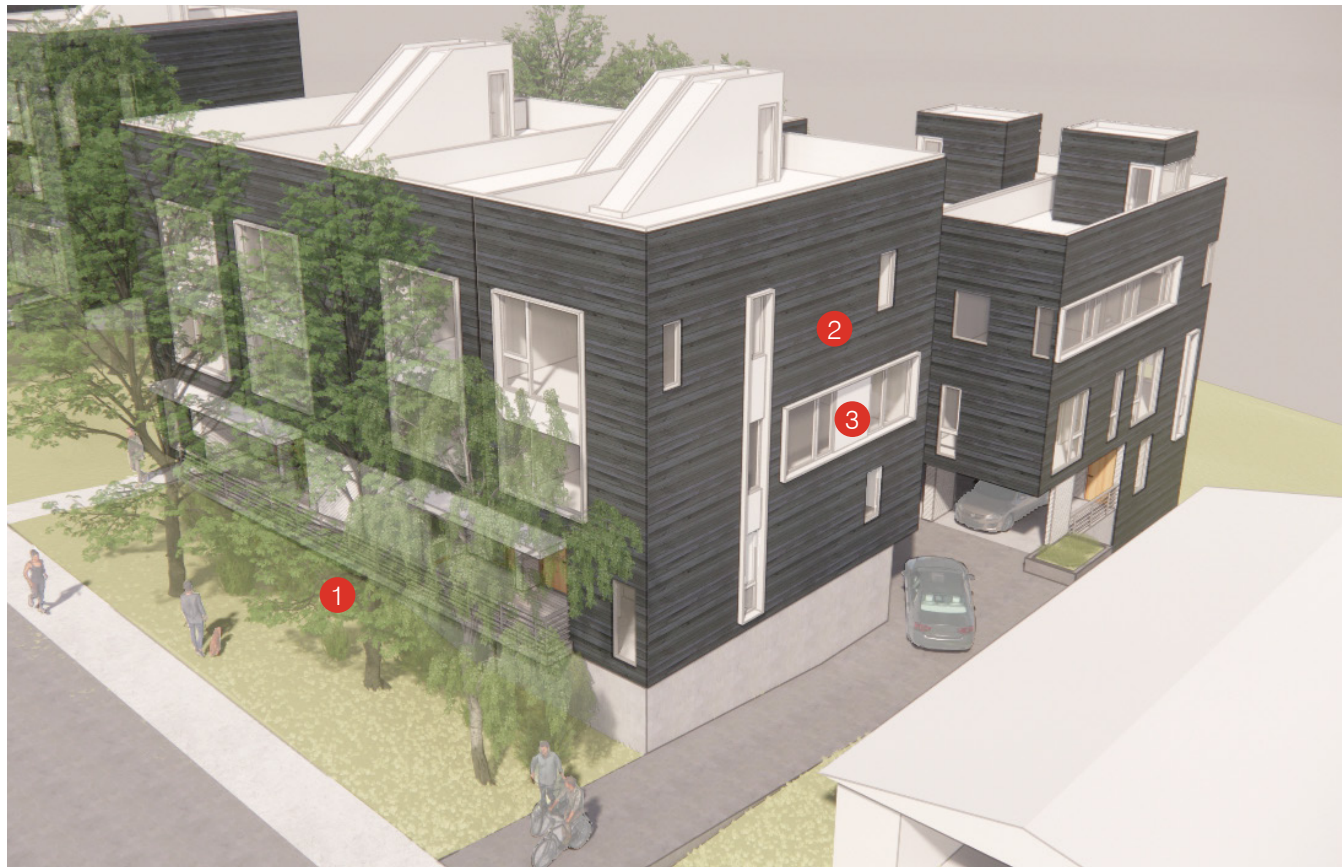
SE Bird's Eye

- 1
 CS2.B.2 Connection to the Street
 CS2.B.3 Character of Open Space
 DC3.C.3 Support Natural Areas
 DC4.D Trees, Landscape and Hardscape Materials
 PL1.A.1 Enhancing Open Space
 PL1.A.2 Adding to Public Life
 PL3.A.2 Ensemble of Elements
- 2
 DC4.A.1 Exterior Finish Materials
- 3
 CS3.A.2 Contemporary Design
 DC2.B.1 Façade Composition
 DC2.C.1 Visual Depth and Interest
 DC2.D.2 Texture

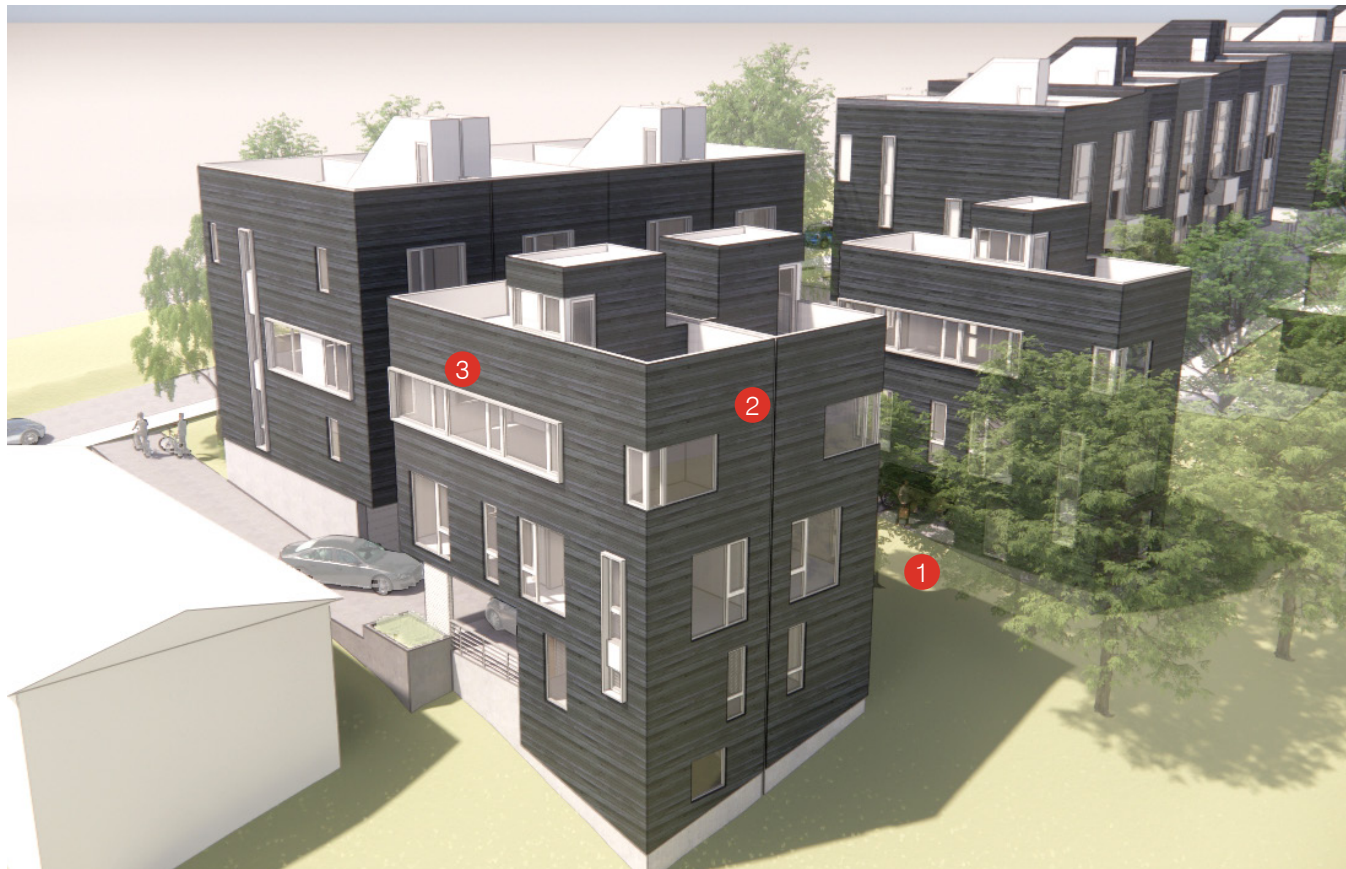
NE Bird's Eye

- CS2.B.2 Connection to the Street 1
- CS2.B.3 Character of Open Space
- DC3.C.3 Support Natural Areas
- DC4.D Trees, Landscape and Hardscape Materials
- PL1.A.1 Enhancing Open Space
- PL1.A.2 Adding to Public Life
- PL3.A.2 Ensemble of Elements
- DC4.A.1 Exterior Finish Materials 2
- CS3.A.2 Contemporary Design 3
- DC2.B.1 Façade Composition
- DC2.C.1 Visual Depth and Interest
- DC2.D.2 Texture
