DUCT EDGE PROTECTION

Reference Material Standard 7318.1

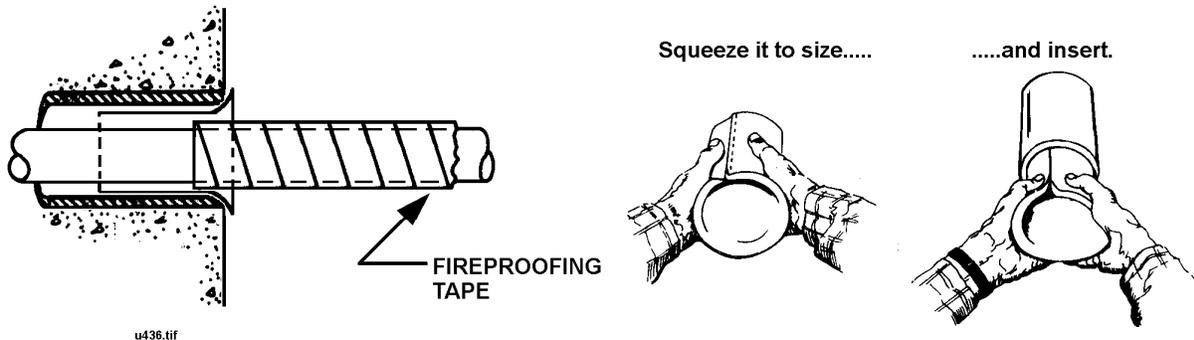
Most cable jacket failures at duct edges are the result of excessive wear due to the abrasion that takes place during expansion and contraction of the cable. This is especially true in older installations where the ducts have straight edges at cable entrance. In most of the new holes "end bells" are installed on the ducts, giving a rounded edge. However, even in these there may still be a concentrated point on the bell which will wear through the jacket or insulation.

To prevent such wear, install nylon cable protectors stocked in the following sizes:

<u>Stock No.</u>	<u>Conduit Size</u>
731800E	2" - 2-1/2"
731801E	3" - 5"
