# Morrison Hotel

Side x Side Architects  
510 Maynard Ave S  
Seattle, WA 98104

# MORRISON HOTEL REHABILITATION

PSPB MEETING  
TECHNICAL DETAILS  
11/04/26

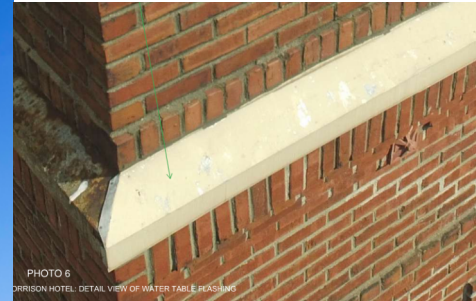
### Replacement of Sheet Metal

- Replace deteriorated sheet metal cap at upper water table

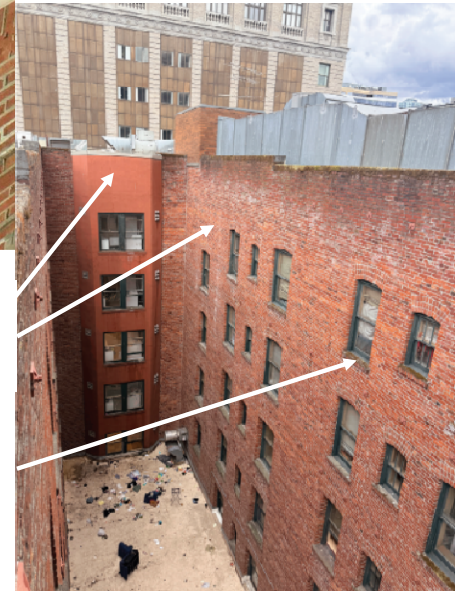
### Window Replacement

- Replace deteriorated wood windows at levels 3-7 at all elevations.

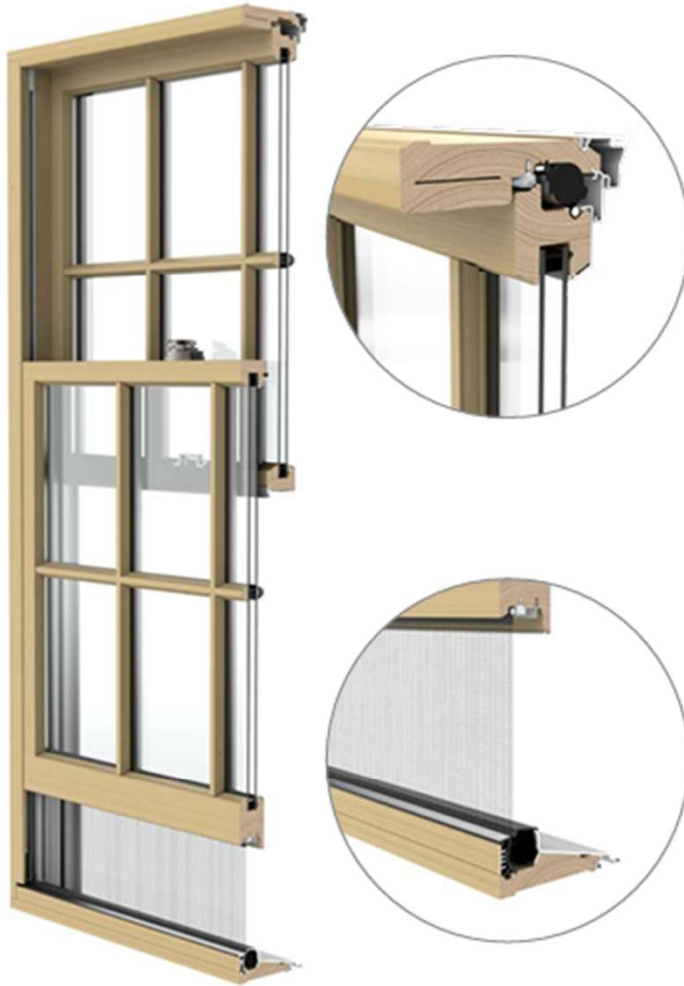
Double-Hung Interior

# Pella® Reserve™

## Traditional Wood & Clad/Wood

Exquisitely designed windows and doors with unparalleled historical detailing.

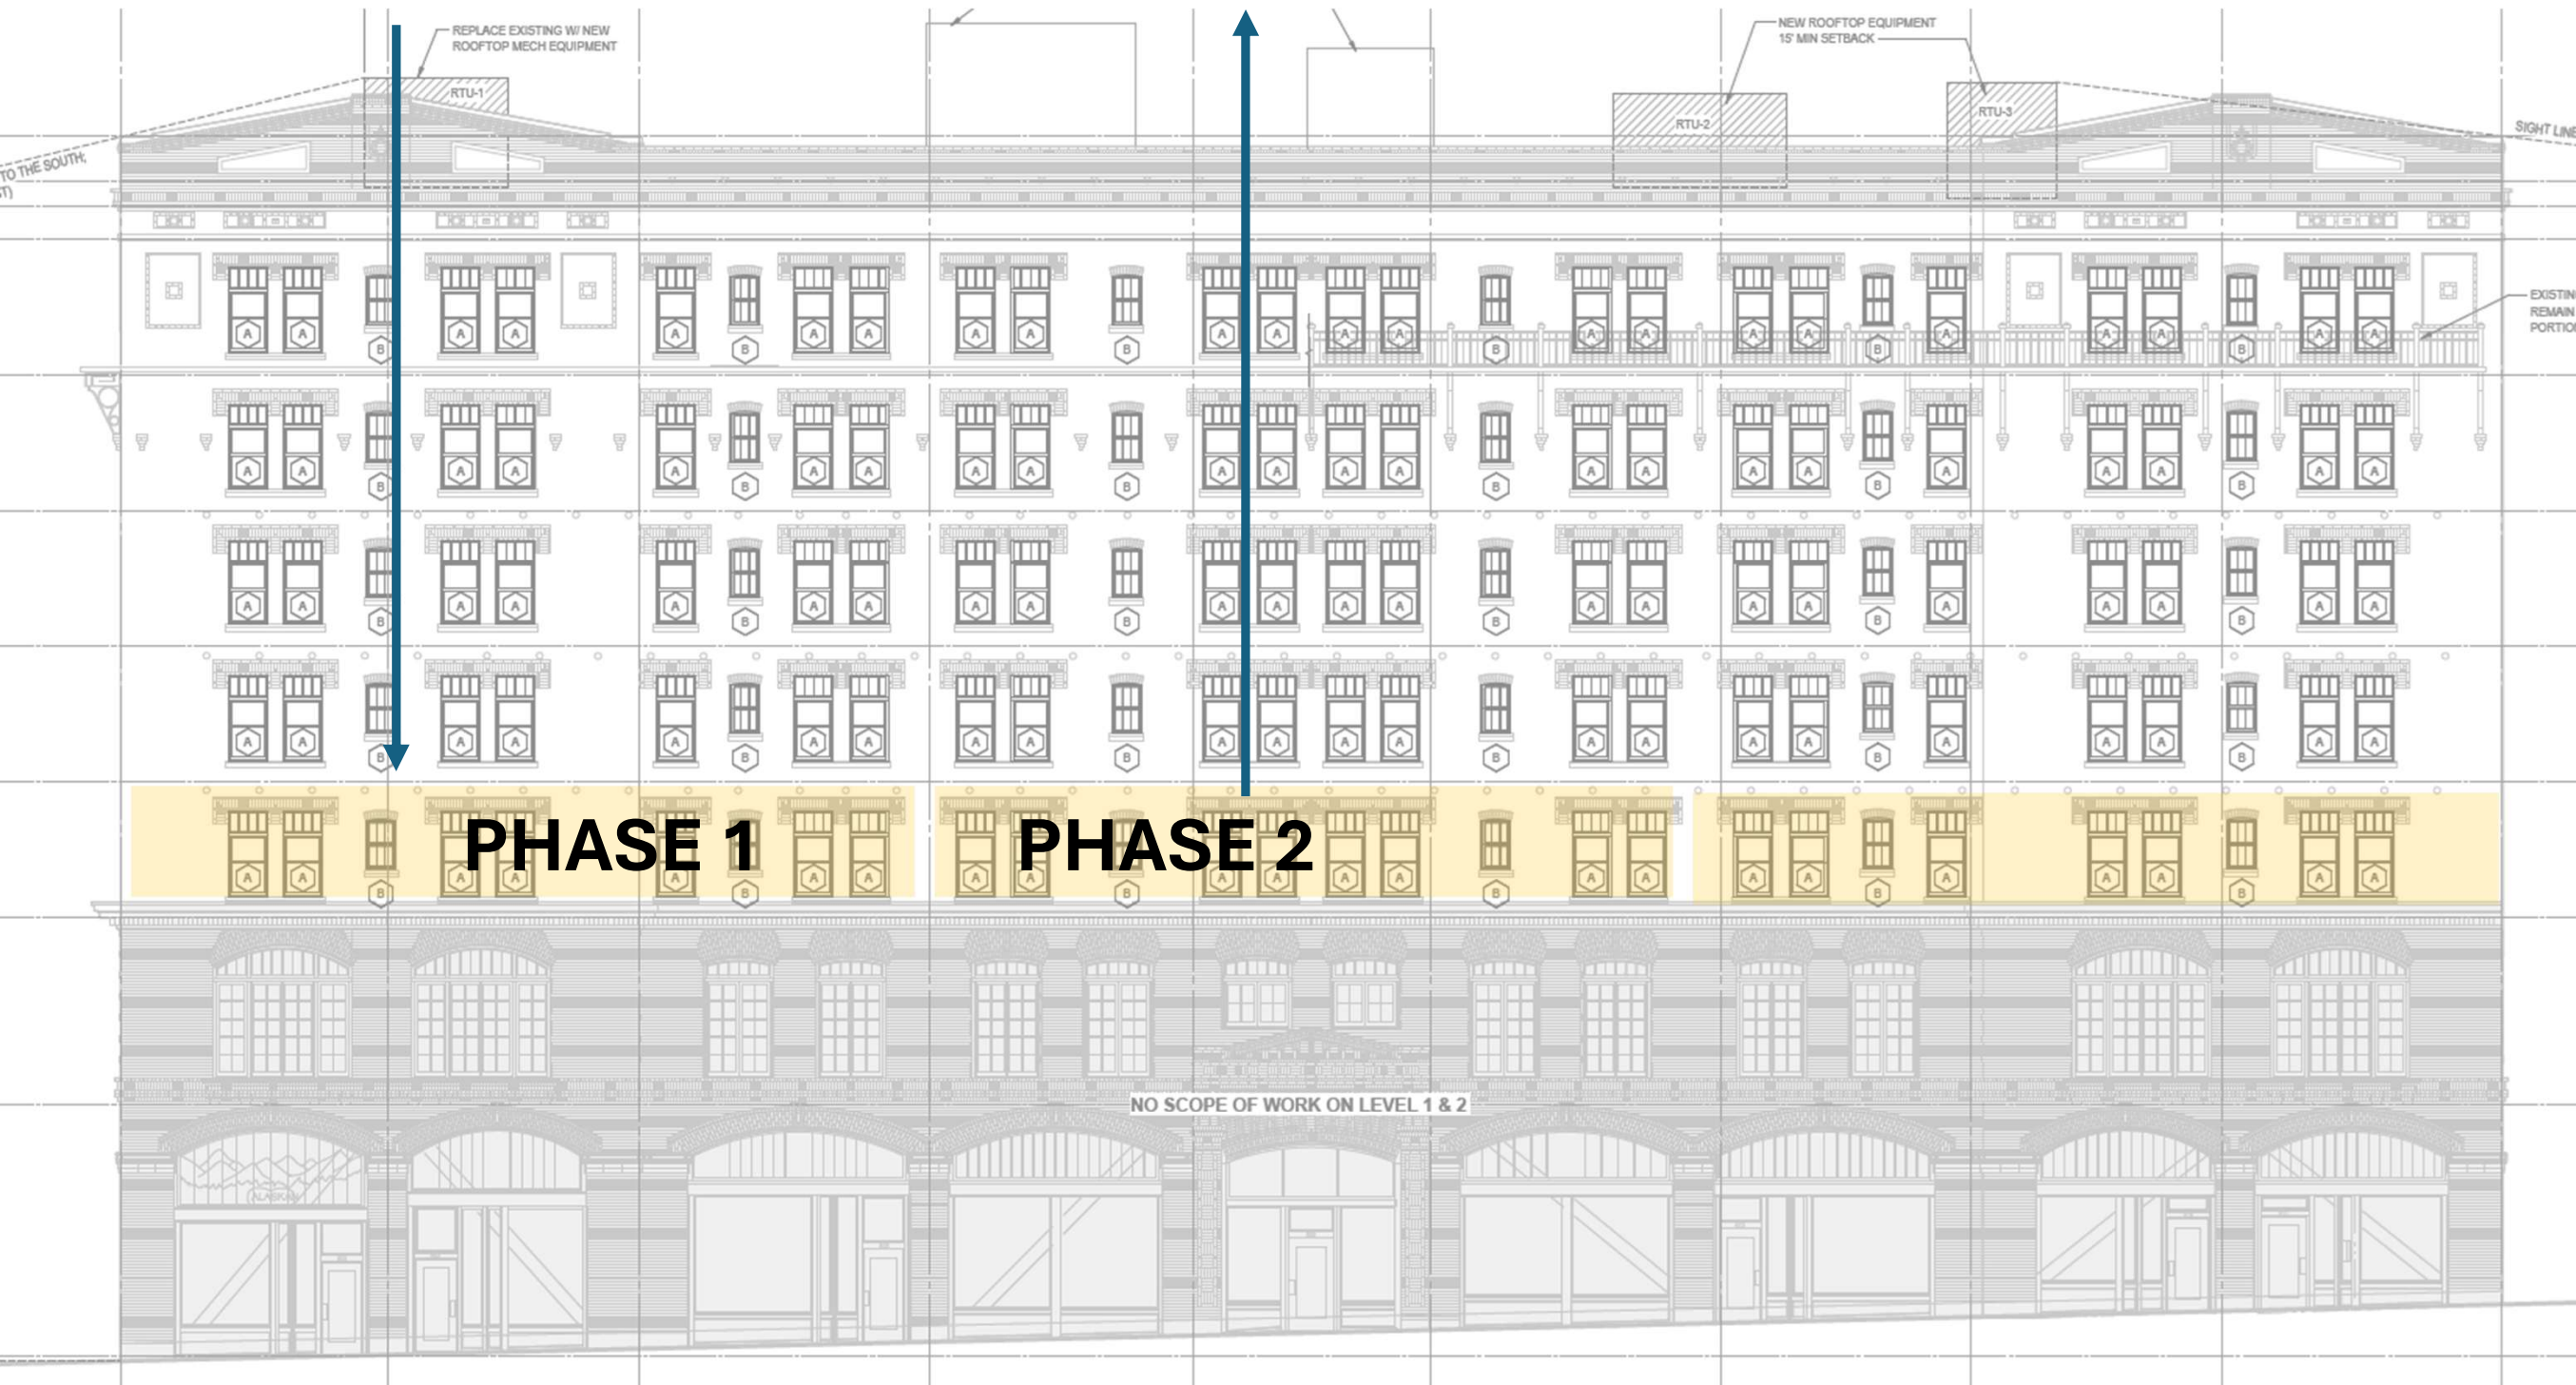
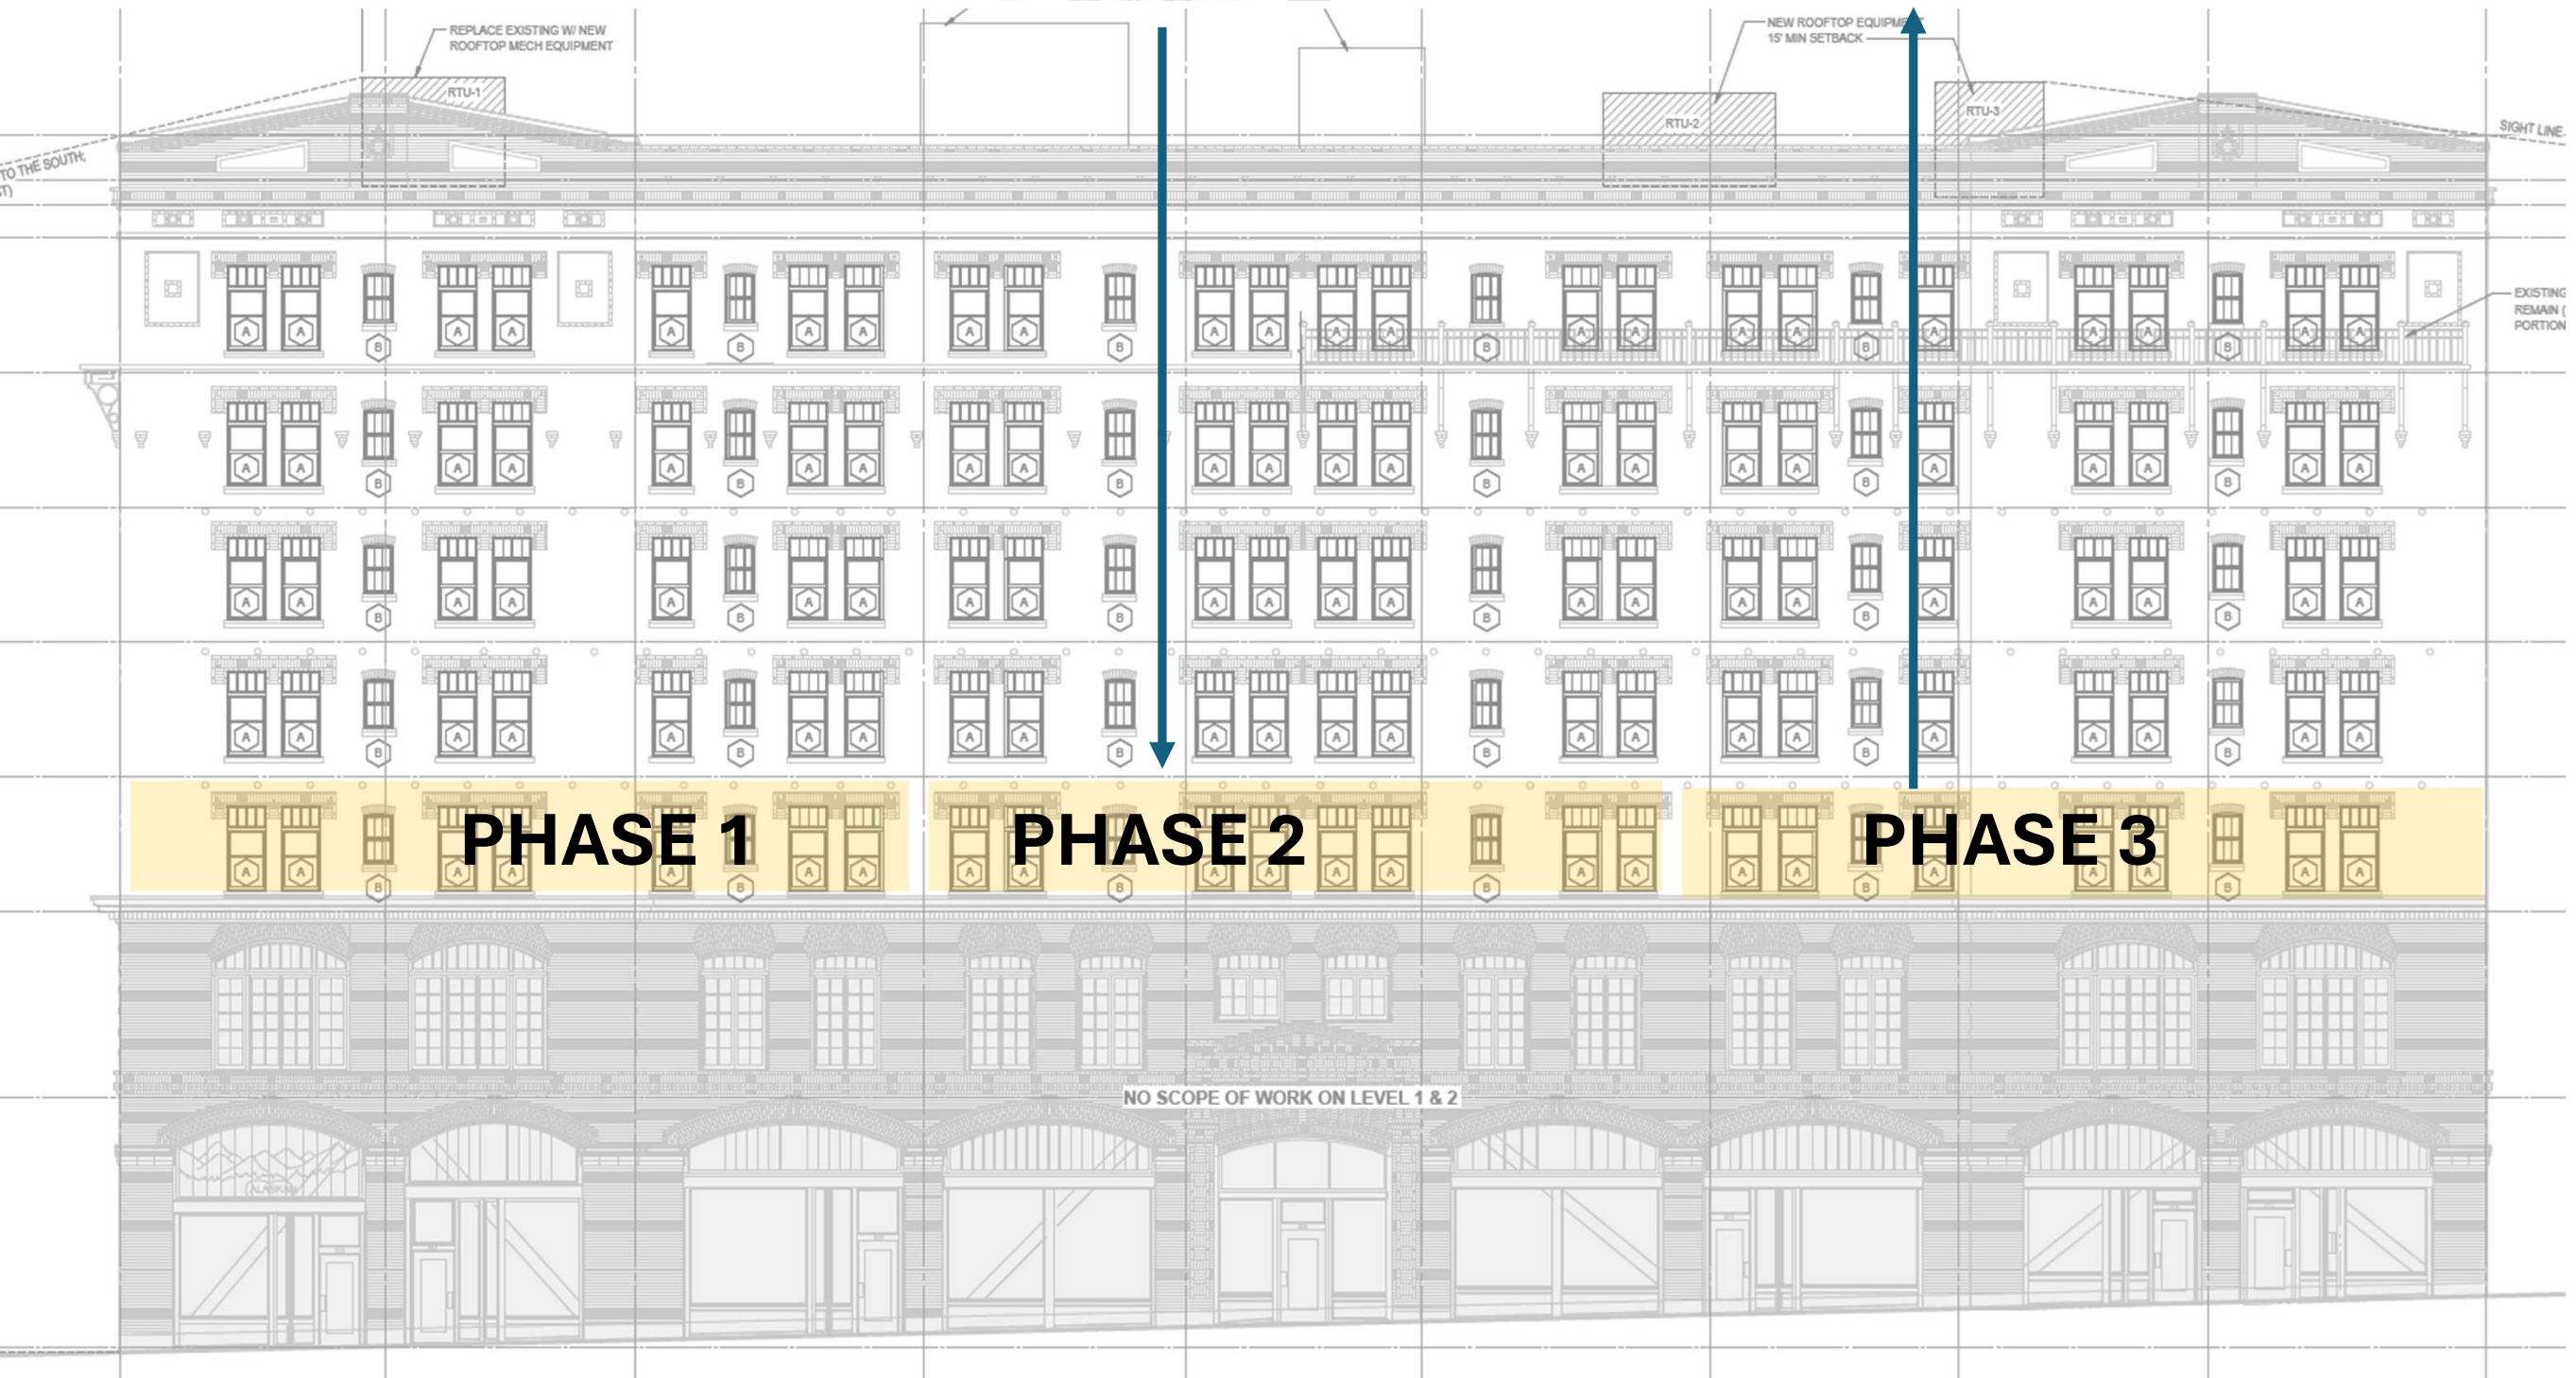
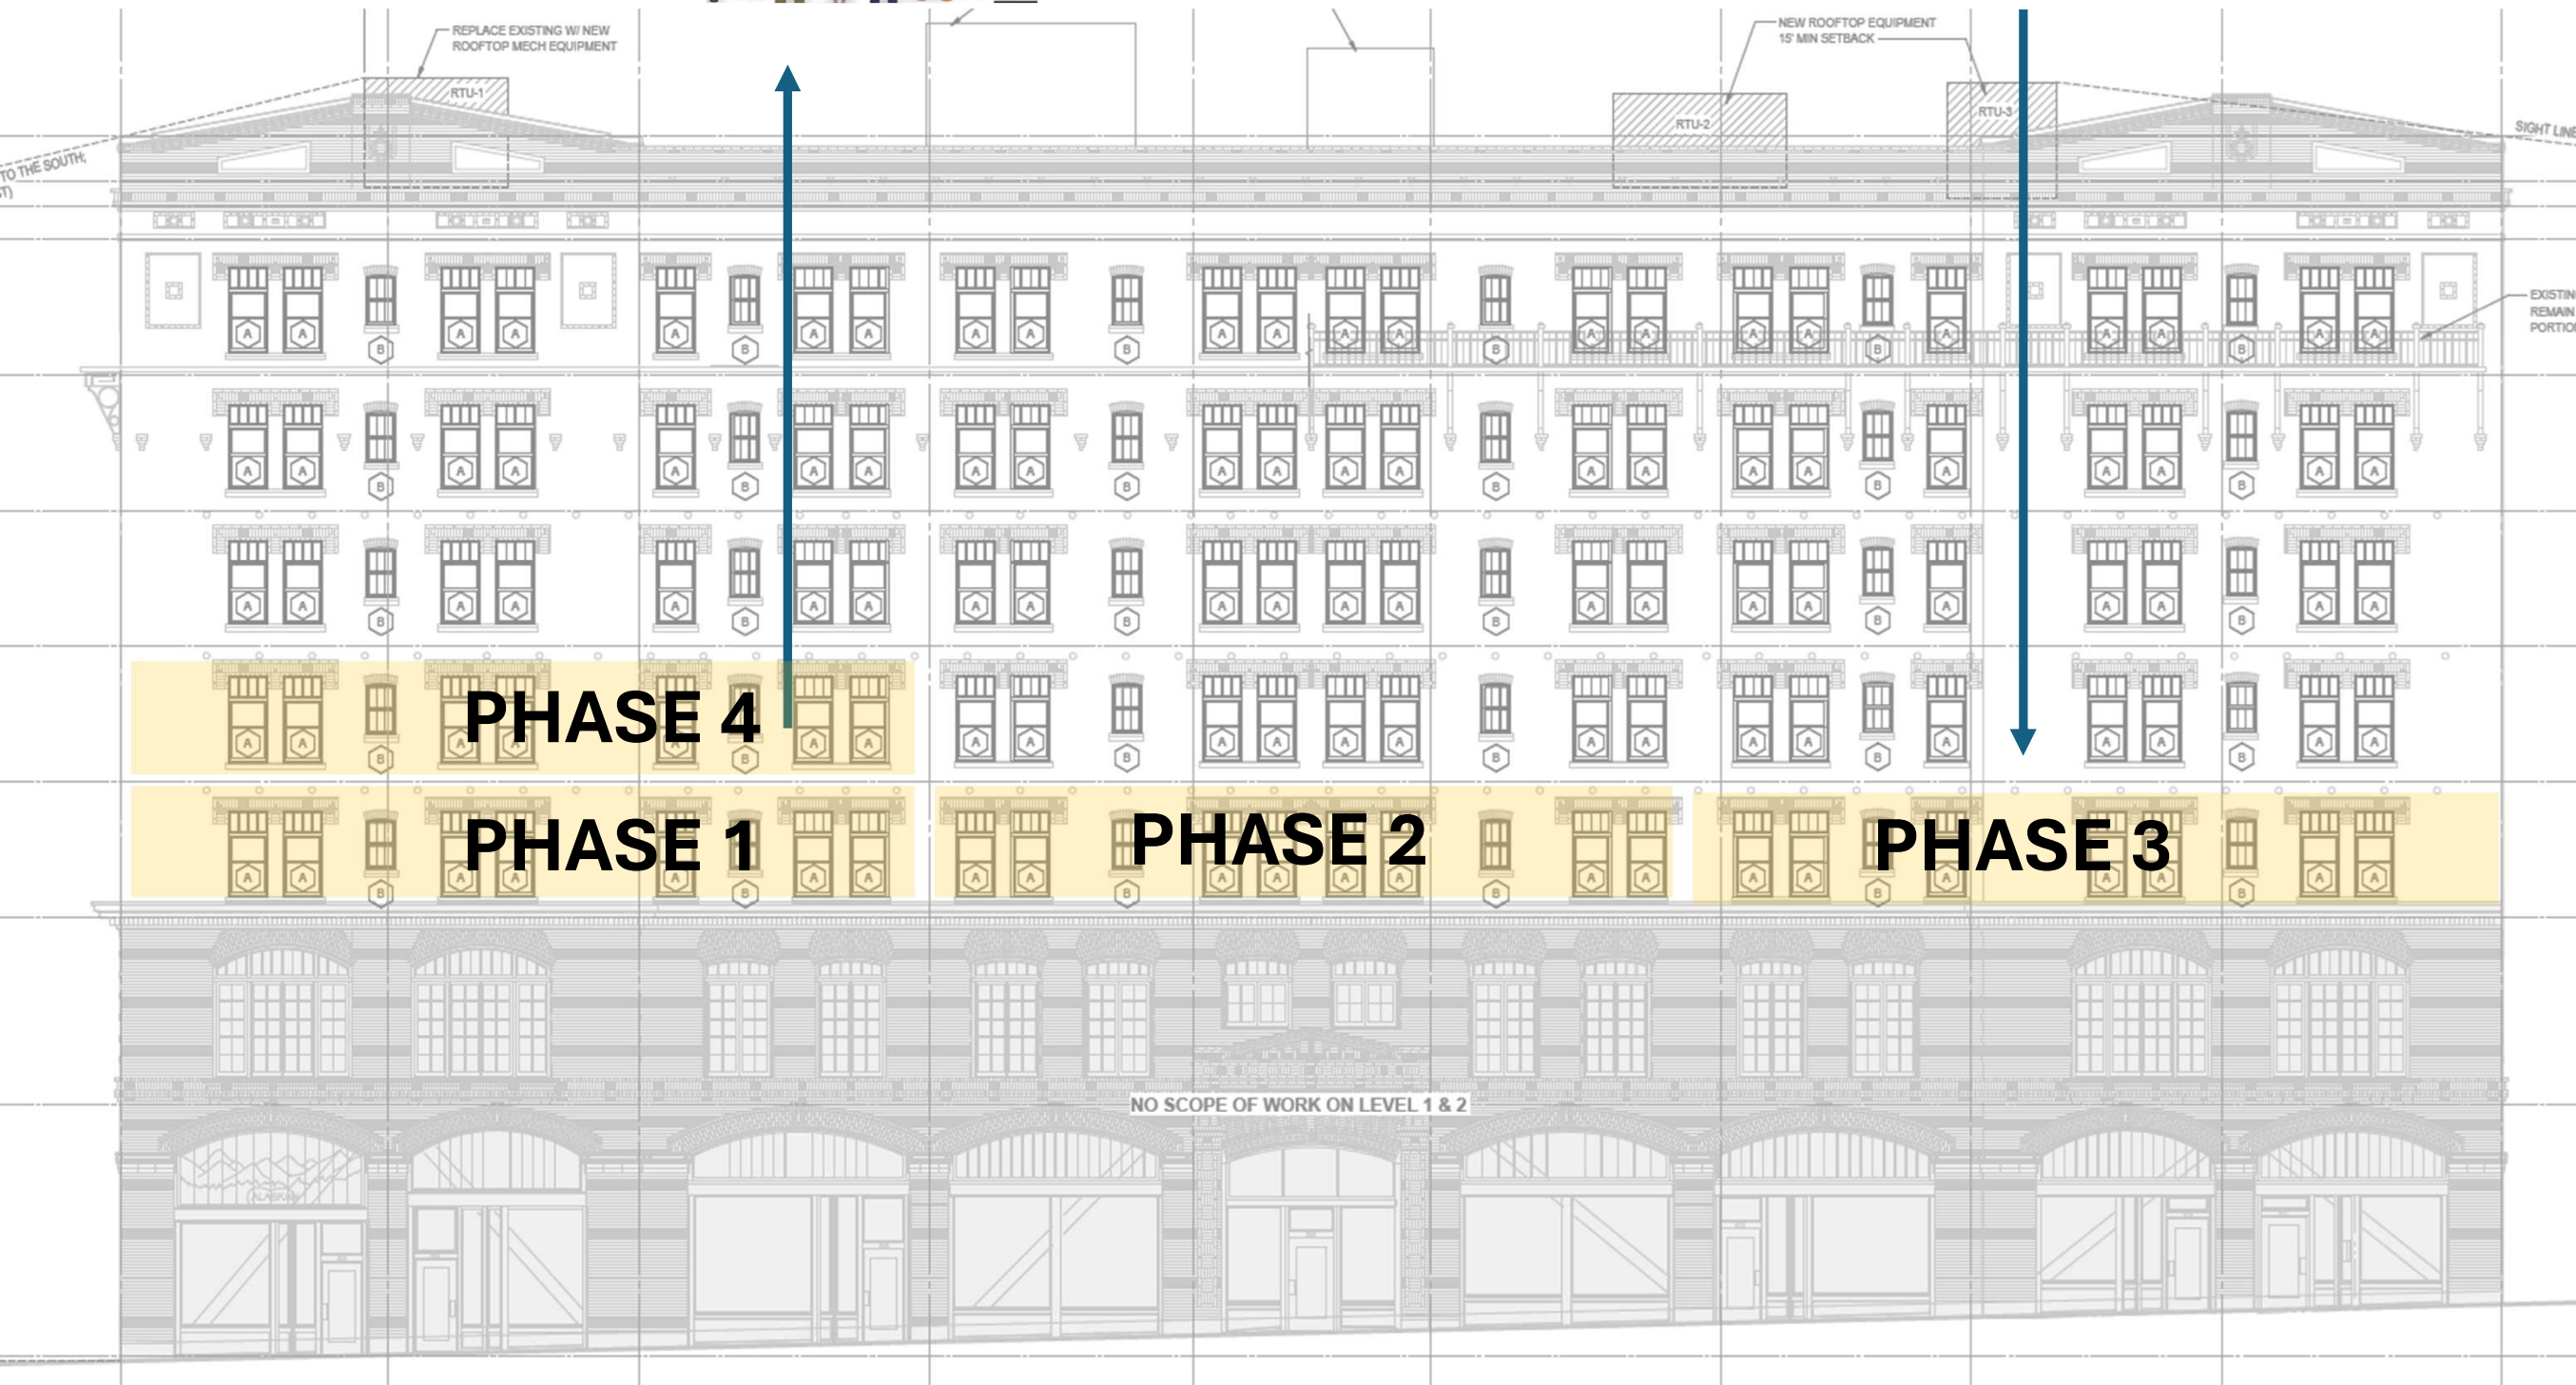
## PHASING

15 SHORT DURATION PHASES,  
1.5 MONTHS EACH,  
20 MONTHS OVERALL, TO  
AVOID DISPLACEMENT

- Built in 1908, The Morrison has not undergone a major renovation since 2002.
- Project will make critical building upgrades, improve residents' quality of life, and increase energy efficiency.
  - Maintain an important historic resource.
  - Renovations to residential floors incl. replacement of unit finishes and adding wall insulation.
  - Upgrades to mechanical and plumbing systems.
  - Gas-fired mechanical systems will be replaced with electric systems.
  - Window replacement.
  - Additional seismic improvements to remove the building from City's Unreinforced Masonry list.
  - Minimize resident displacement by employing a 20-month 15-phase construction schedule.

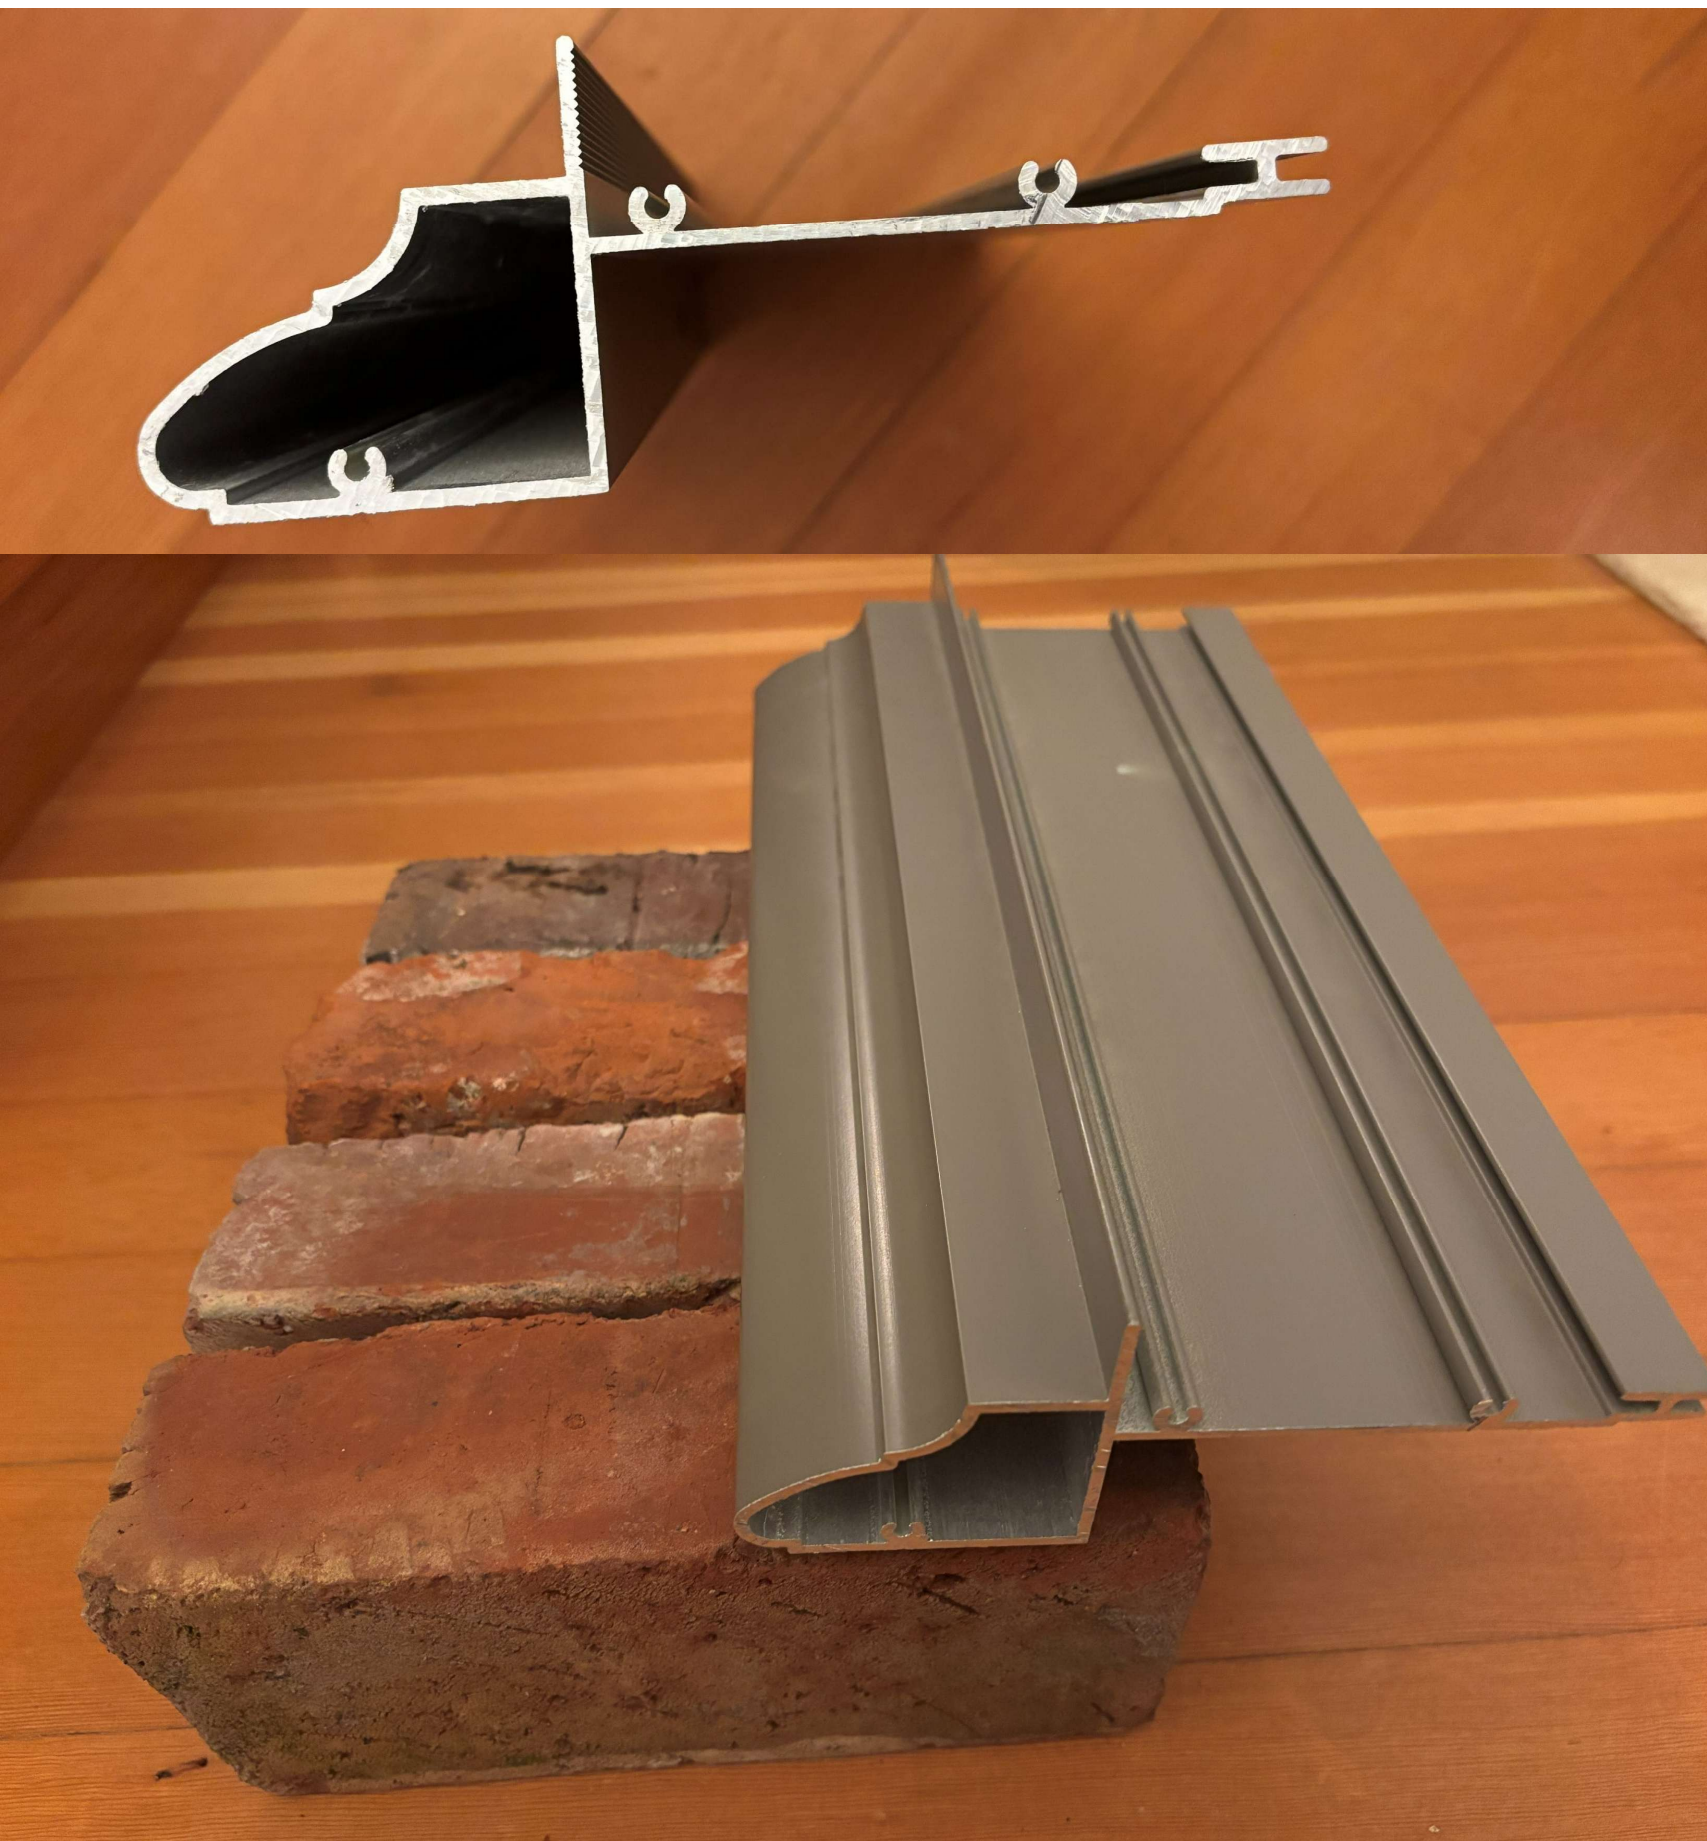
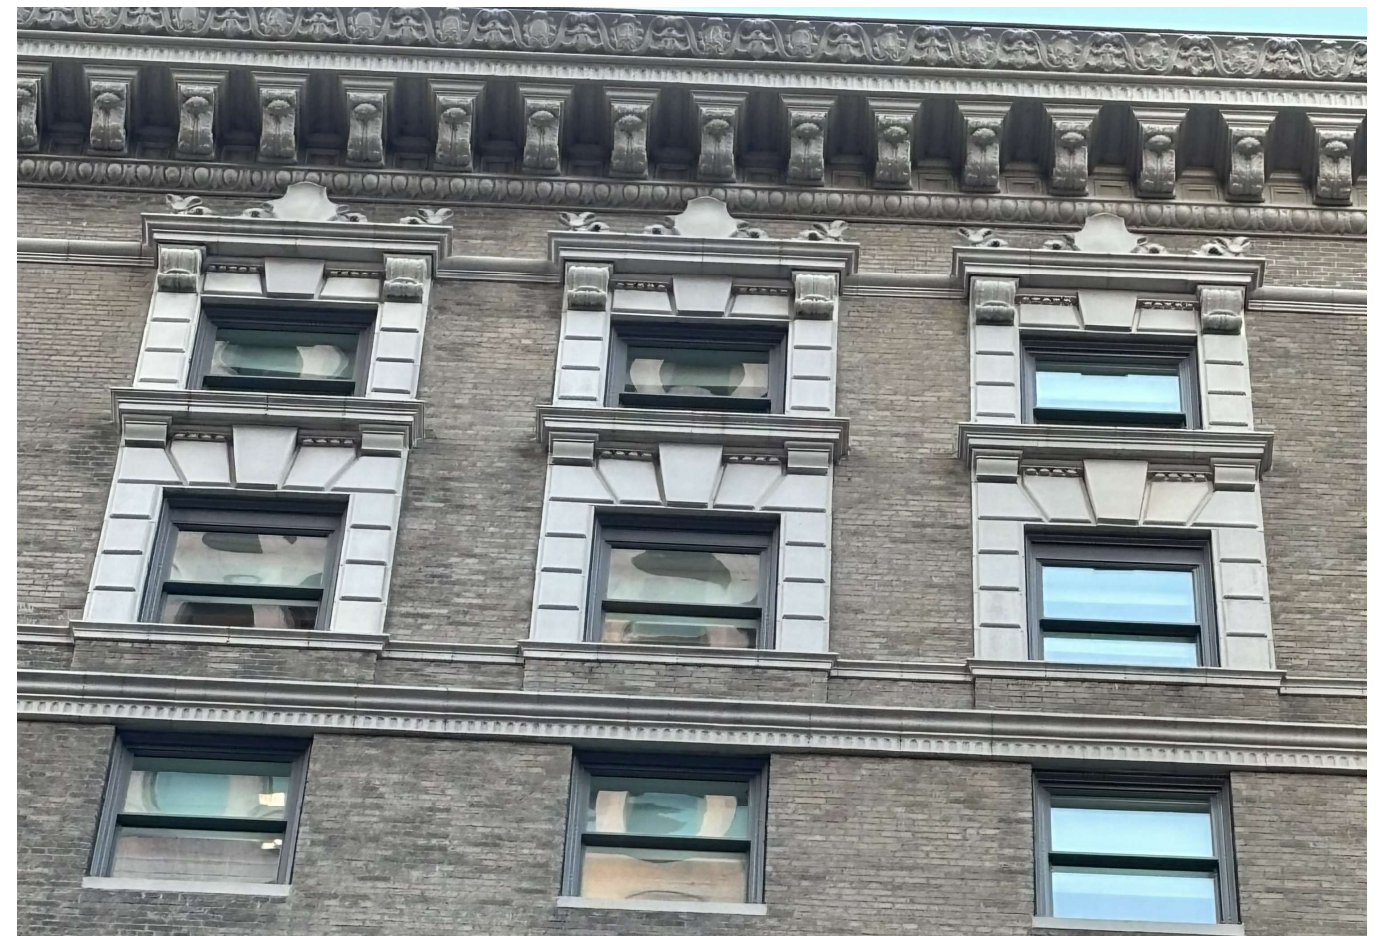
## **SUBFRAME INSTALLATION SYSTEM**

Allows for inside installation

Allows for rapid multiple phases

Safer installation- window seal to exterior is a pressure bulb vs leaning out the window to seal, or multiple phased swingstages.

INSTALL FROM INSIDE IN- NO  
SCAFFOLDING/SWING STAGE-  
AVOID EXTERIOR WINDOW SEAL  
AFTER WINDOW IS SET IN PLACE

MULTIPLE SHORT  
DURATIONS FOR  
INSTALLATION

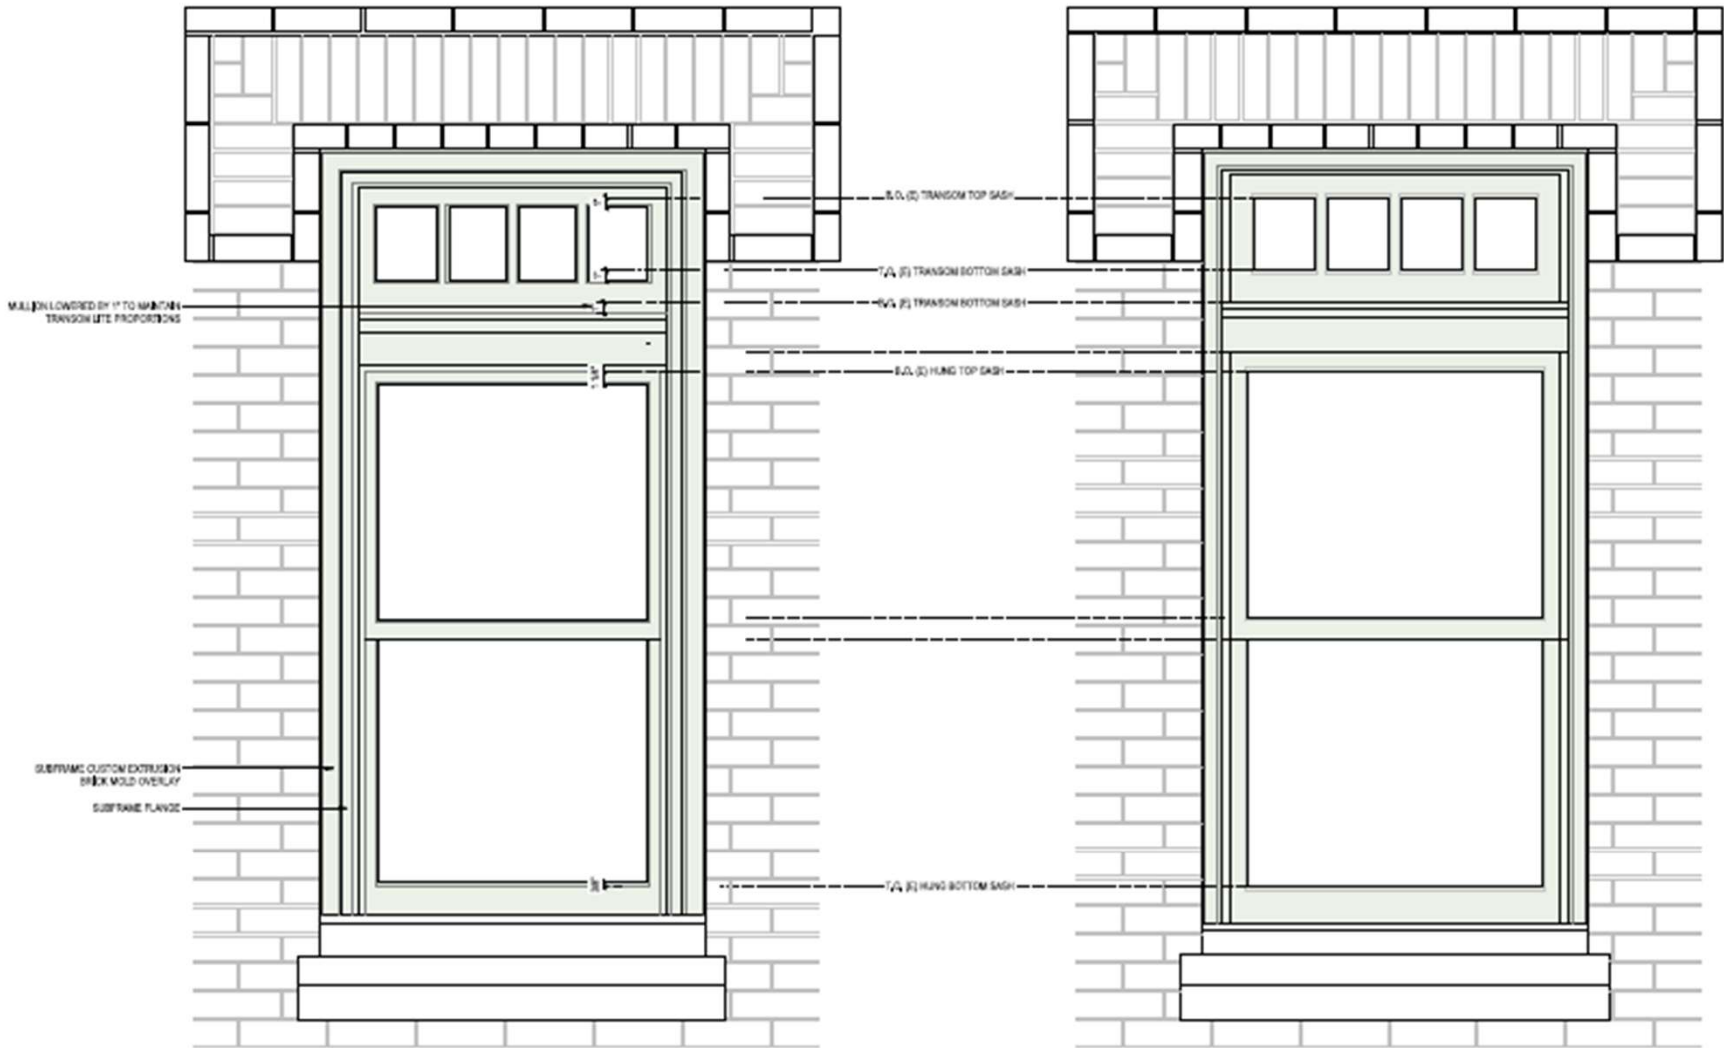
RENDERING FOR REFERENCE ONLY

2 PROPOSED WINDOW EXTERIOR ELEVATION  
SCALE: 1/8" = 1'-0"

1 EXISTING WINDOW EXTERIOR ELEVATION  
SCALE: 1/8" = 1'-0"

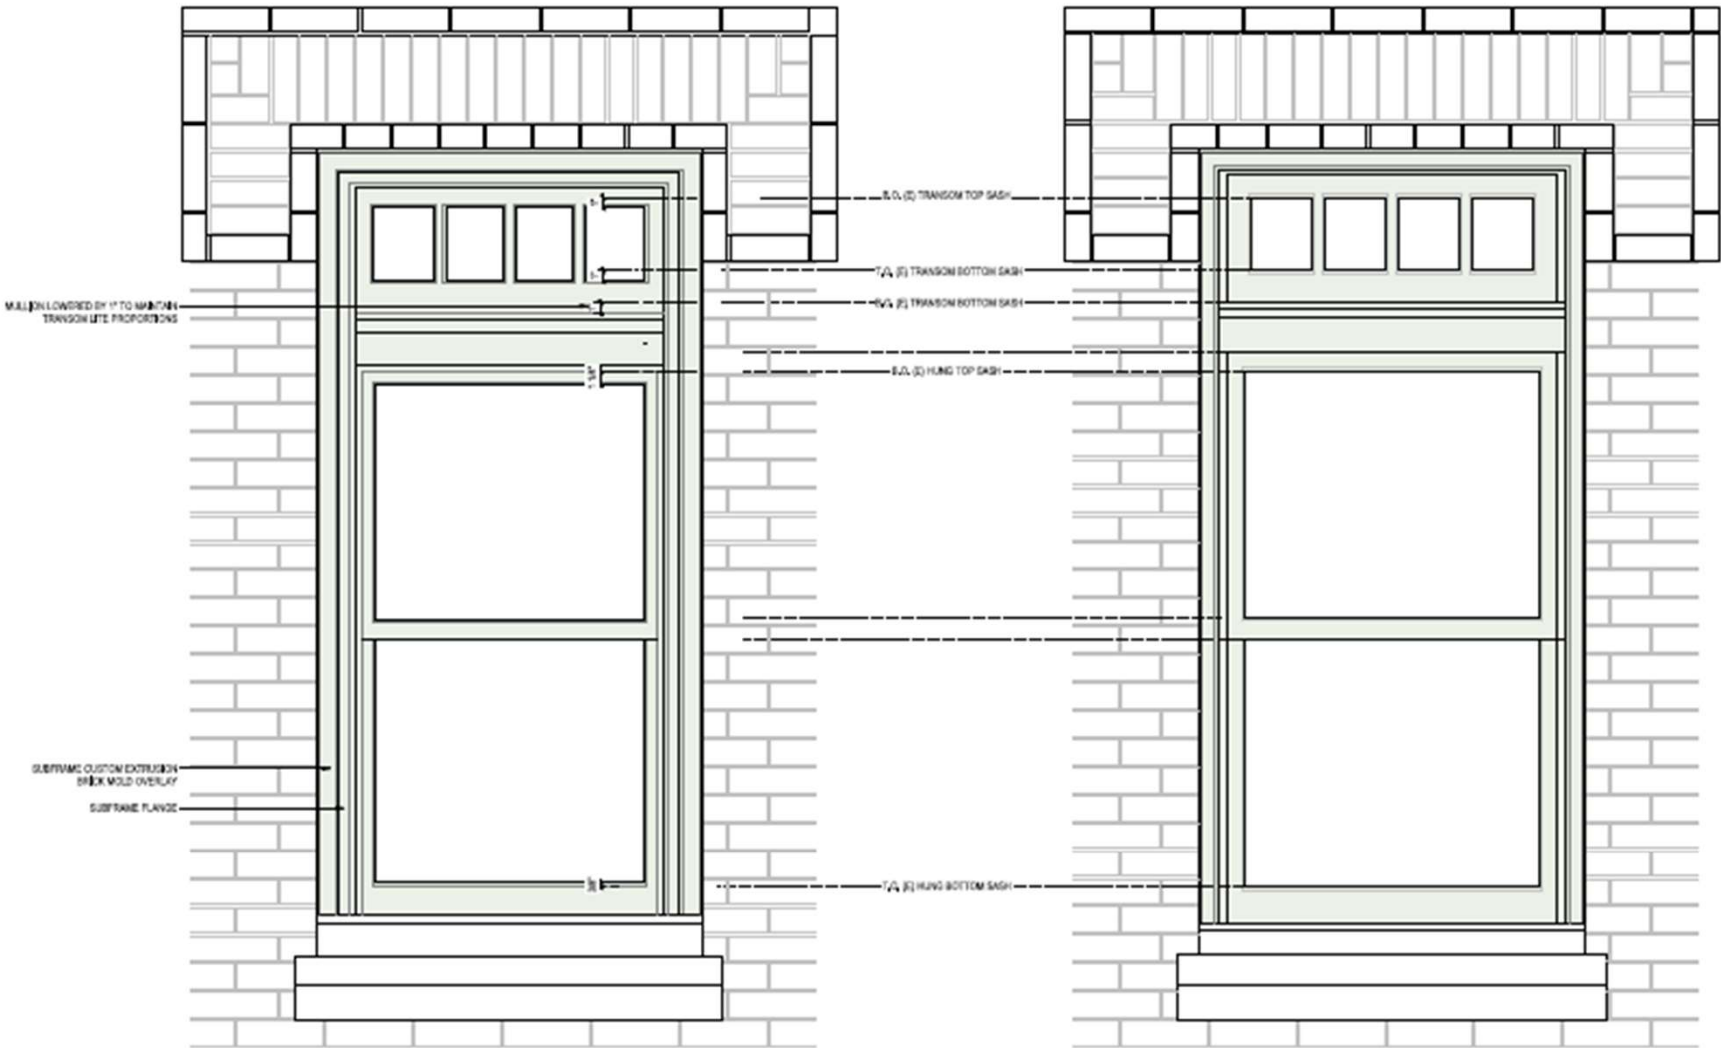
2 PROPOSED WINDOW EXTERIOR ELEVATION  
SCALE: 1/16" = 1'-0"

1 EXISTING WINDOW EXTERIOR ELEVATION  
SCALE: 1/16" = 1'-0"
