ONE YESLER BUILDING

ARCHITECTURAL REVIEW COMMITTEE
DESIGN DEVELOPMENT REVIEW
SEPTEMBER 27, 2023

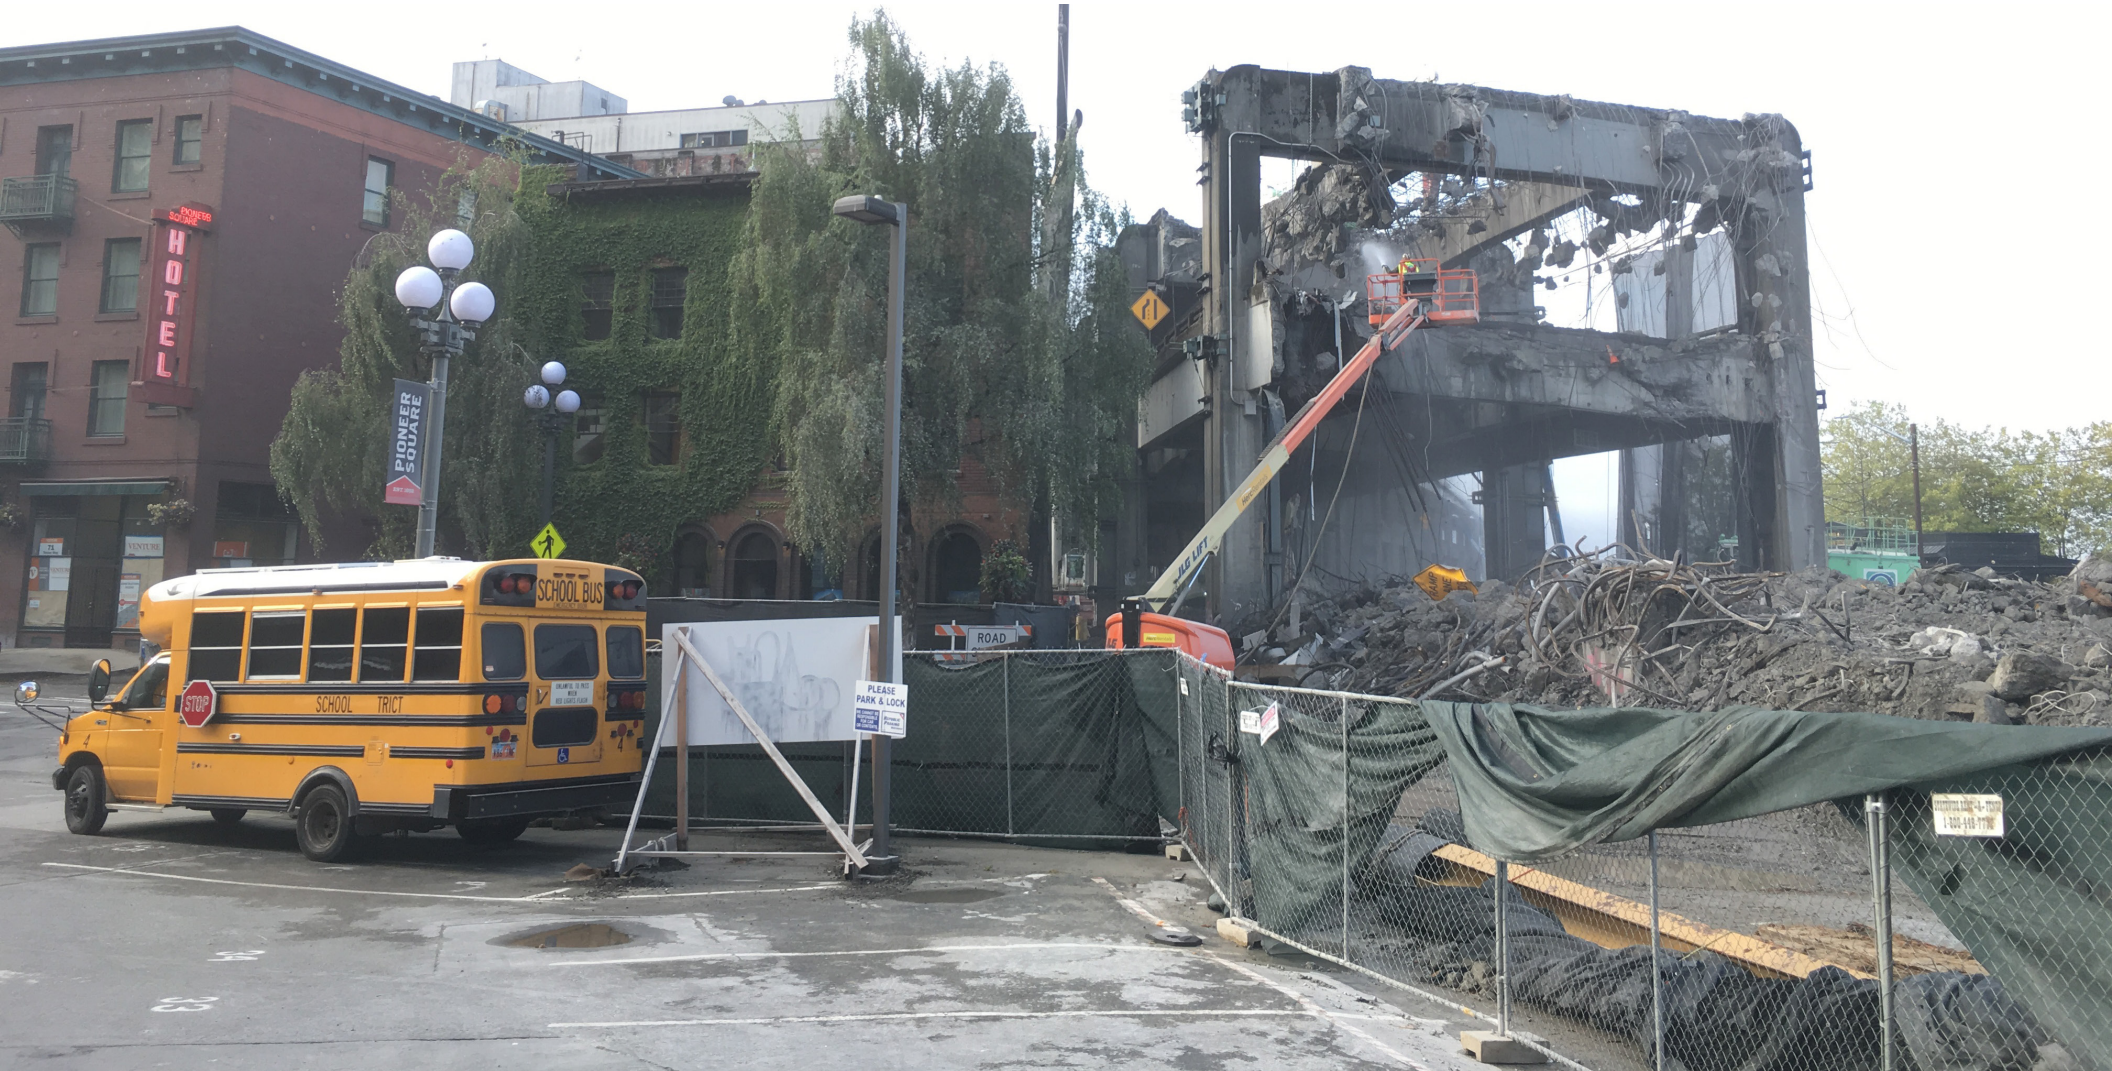
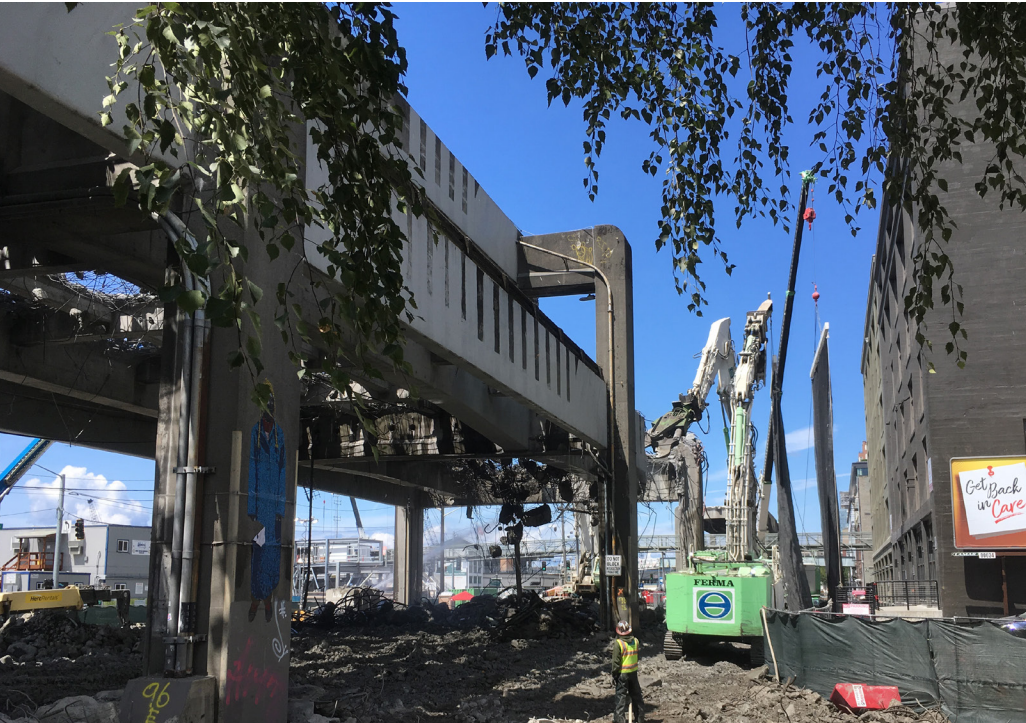
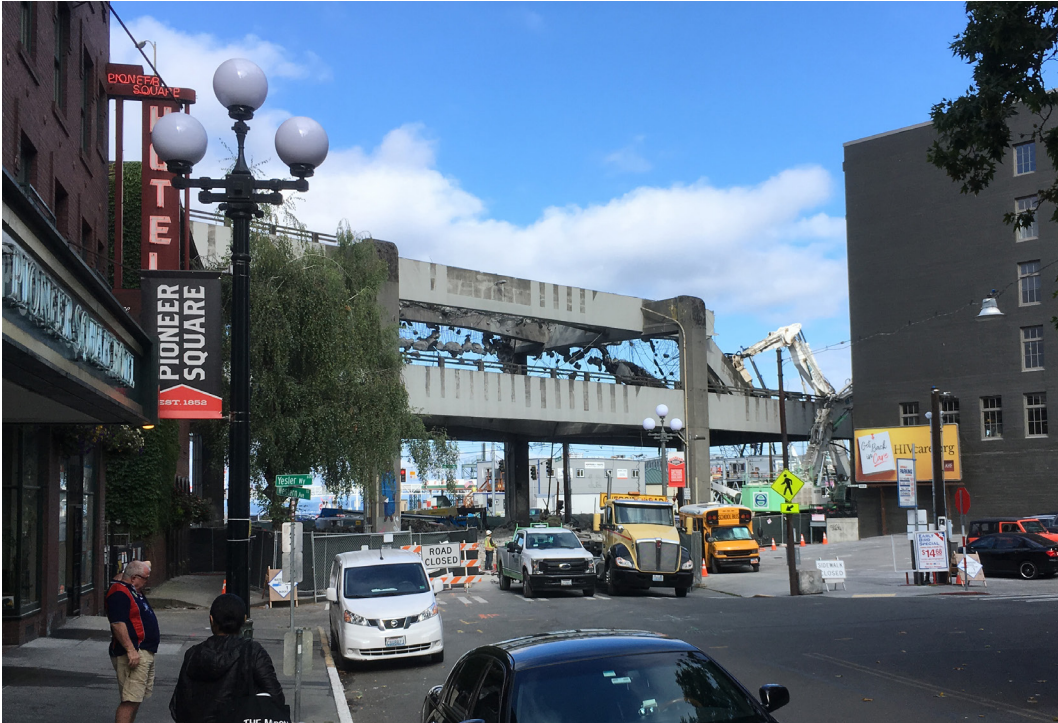
HISTORIC ONE YESLER

State Route 99 Tunnel starts construction in 2011 to replace the Alaskan Way Viaduct which starts demolition in early 2019. The tunnel bores directly underneath the One Yesler Building where Alaskan curves west along the waterfront.

The demolition finally opens up the former primary facade along Alaskan Way.

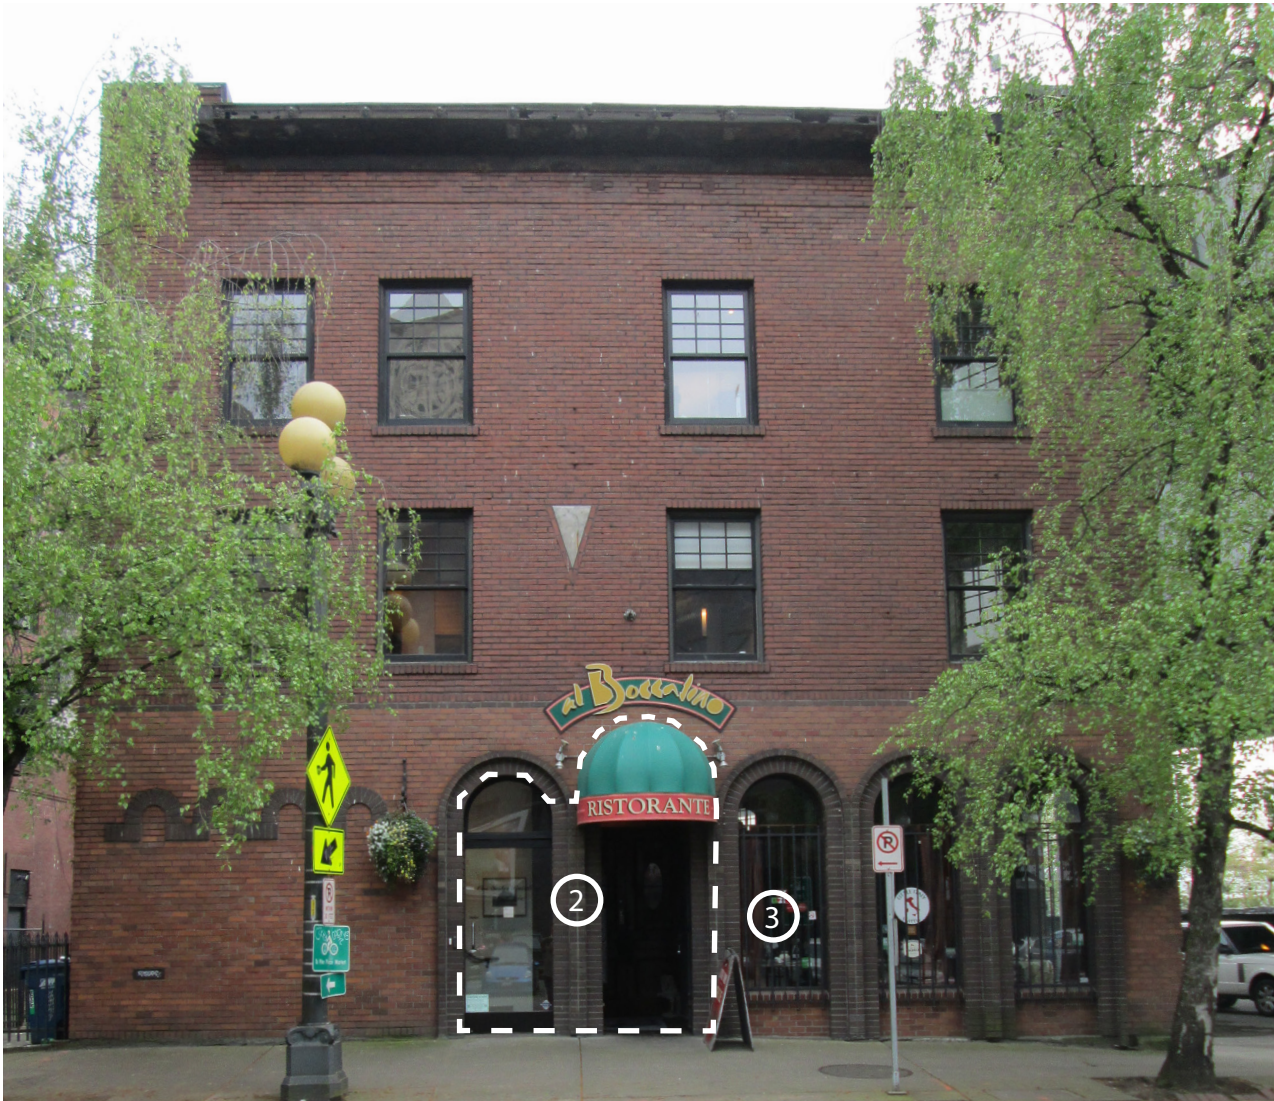
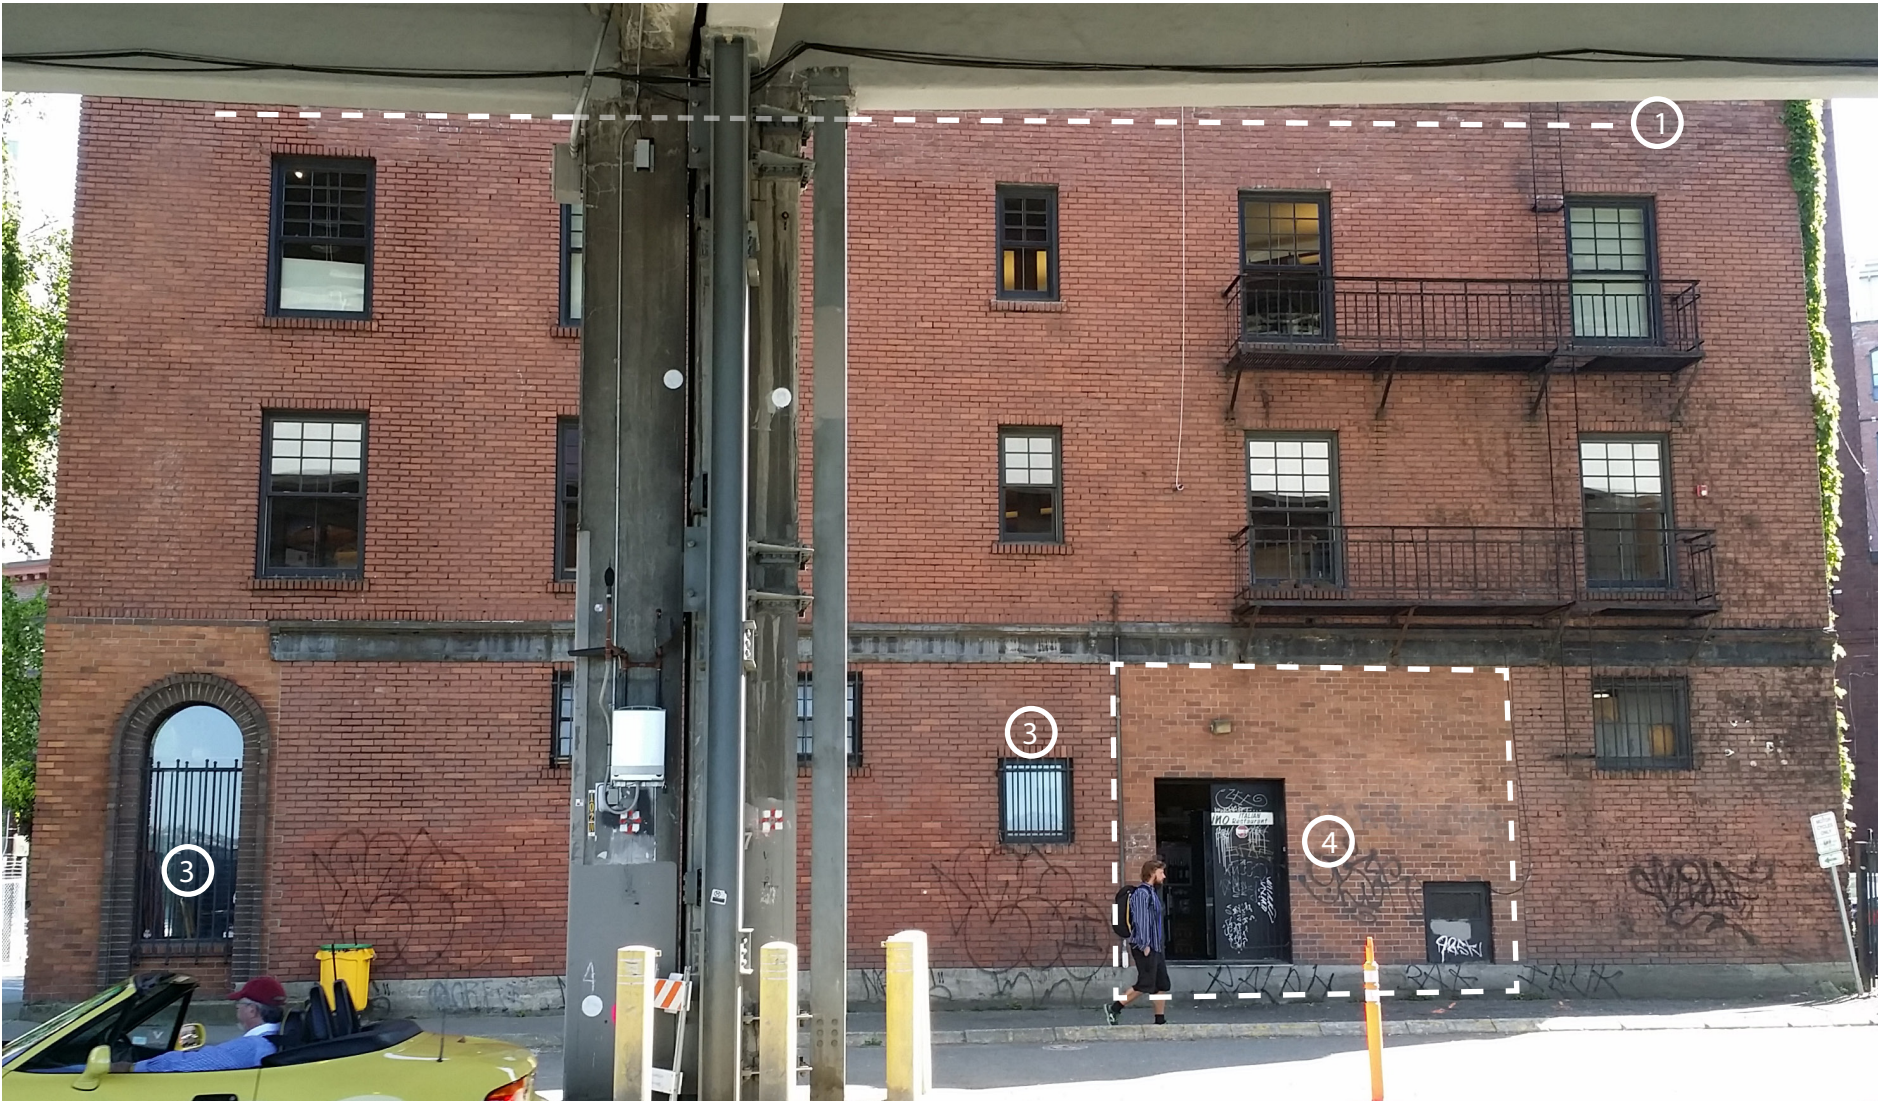
RECENT HISTORY - ONE YESLER ALTERATIONS

The 2001 Nisqually Earthquake destroyed much of the west parapet and was replaced by previous ownership.

In 2005 Brian Runberg purchased the One Yesler Building and occupied the upper levels with Runberg Architecture Group. In August of 2016, After Al Bocalino restaurant closes, the firm expands into the ground level and renovates the space.

List of Improvements from 2016 PSPB Submittal:

- 1 Replacement of west parapet replacement (2001-02)
- 2 Relocation of main entry. Canopy removed by previous tenant.
- 3 Removal of security bars at all ground level glazing
- 4 Removal on non-original (1966) brick infill and loading doors on secondary facade along Alaskan Way

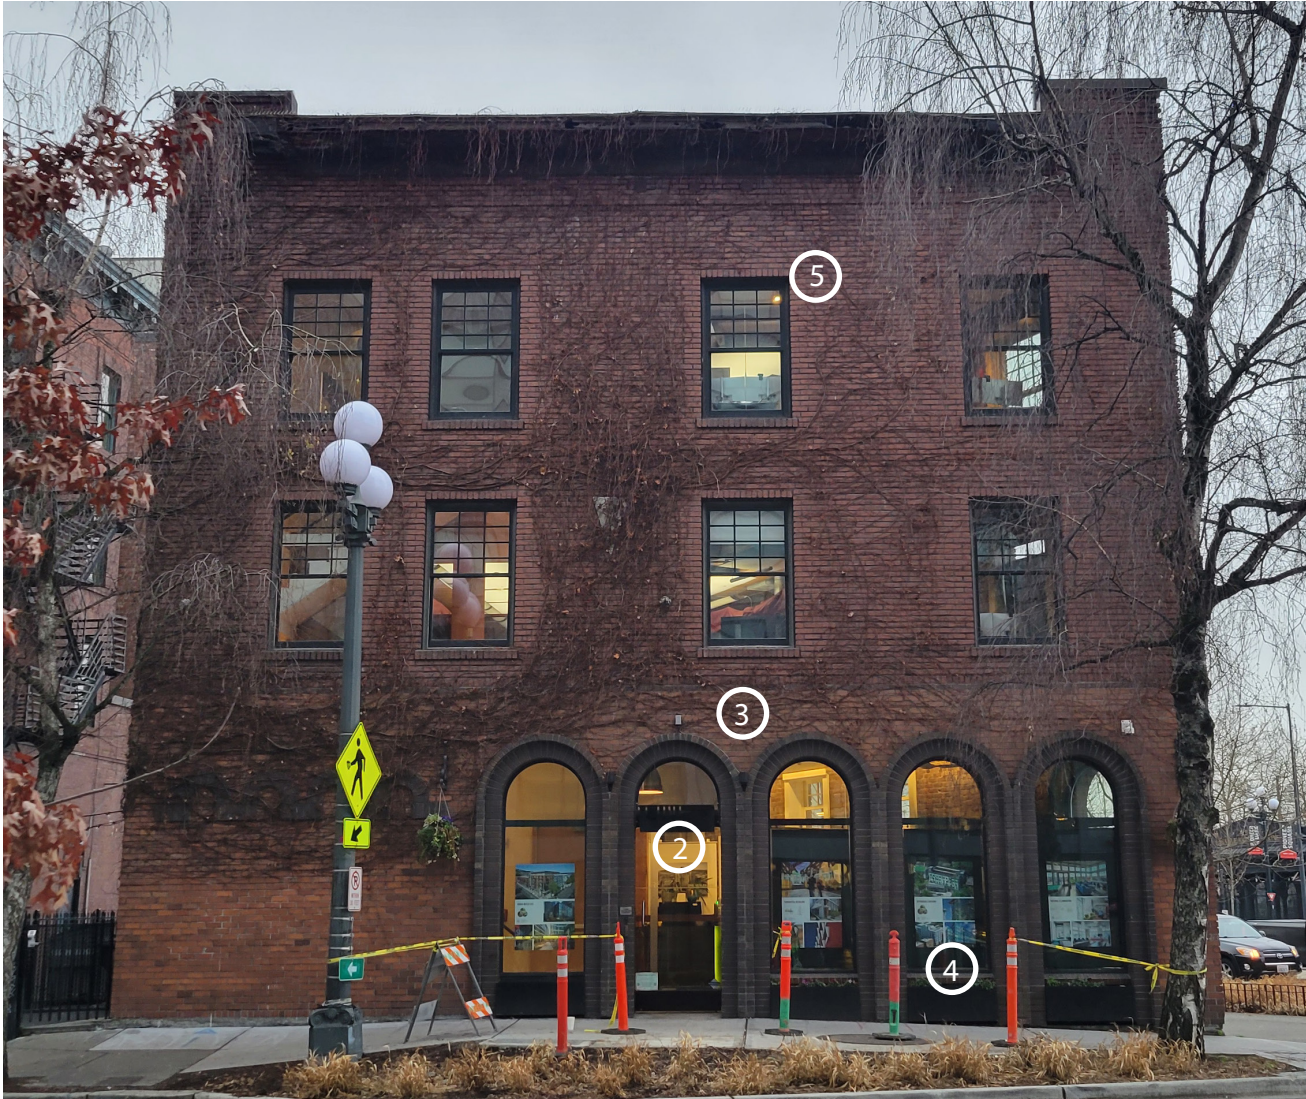
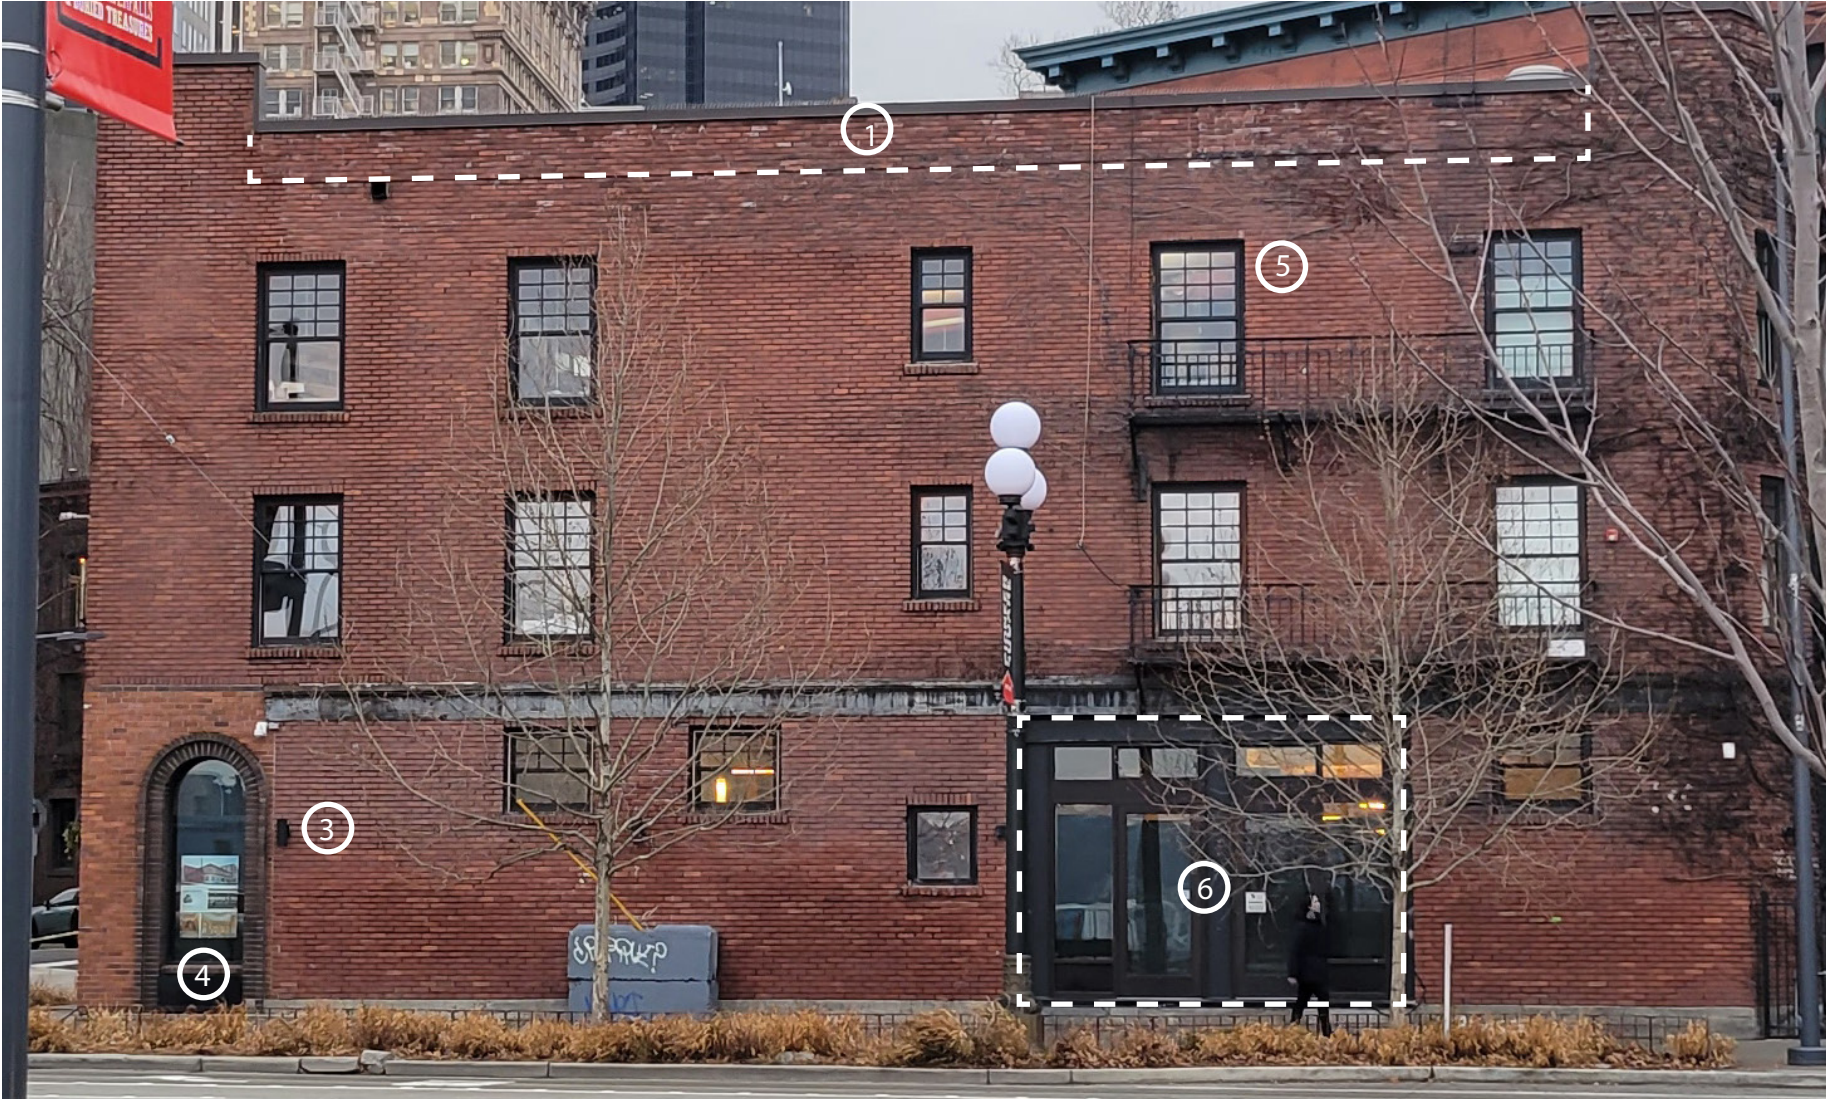
RECENT HISTORY - ONE YESLER ALTERATIONS

List of Improvements:

- 1 Replacement of west parapet replacement (2001-02)
- 2 Relocation of main entry and new canopy (2016)
- 3 New Exterior lighting (2016)
- 4 New planter boxes at arch windows (2016)
- 5 Replacement of glazing with energy efficient IGUs, to match original historic glazing design. (2016)
- 6 Removal on non-original (1966) brick infill and loading doors. Replaced with glazing similar to 1916 glazing. (2016)

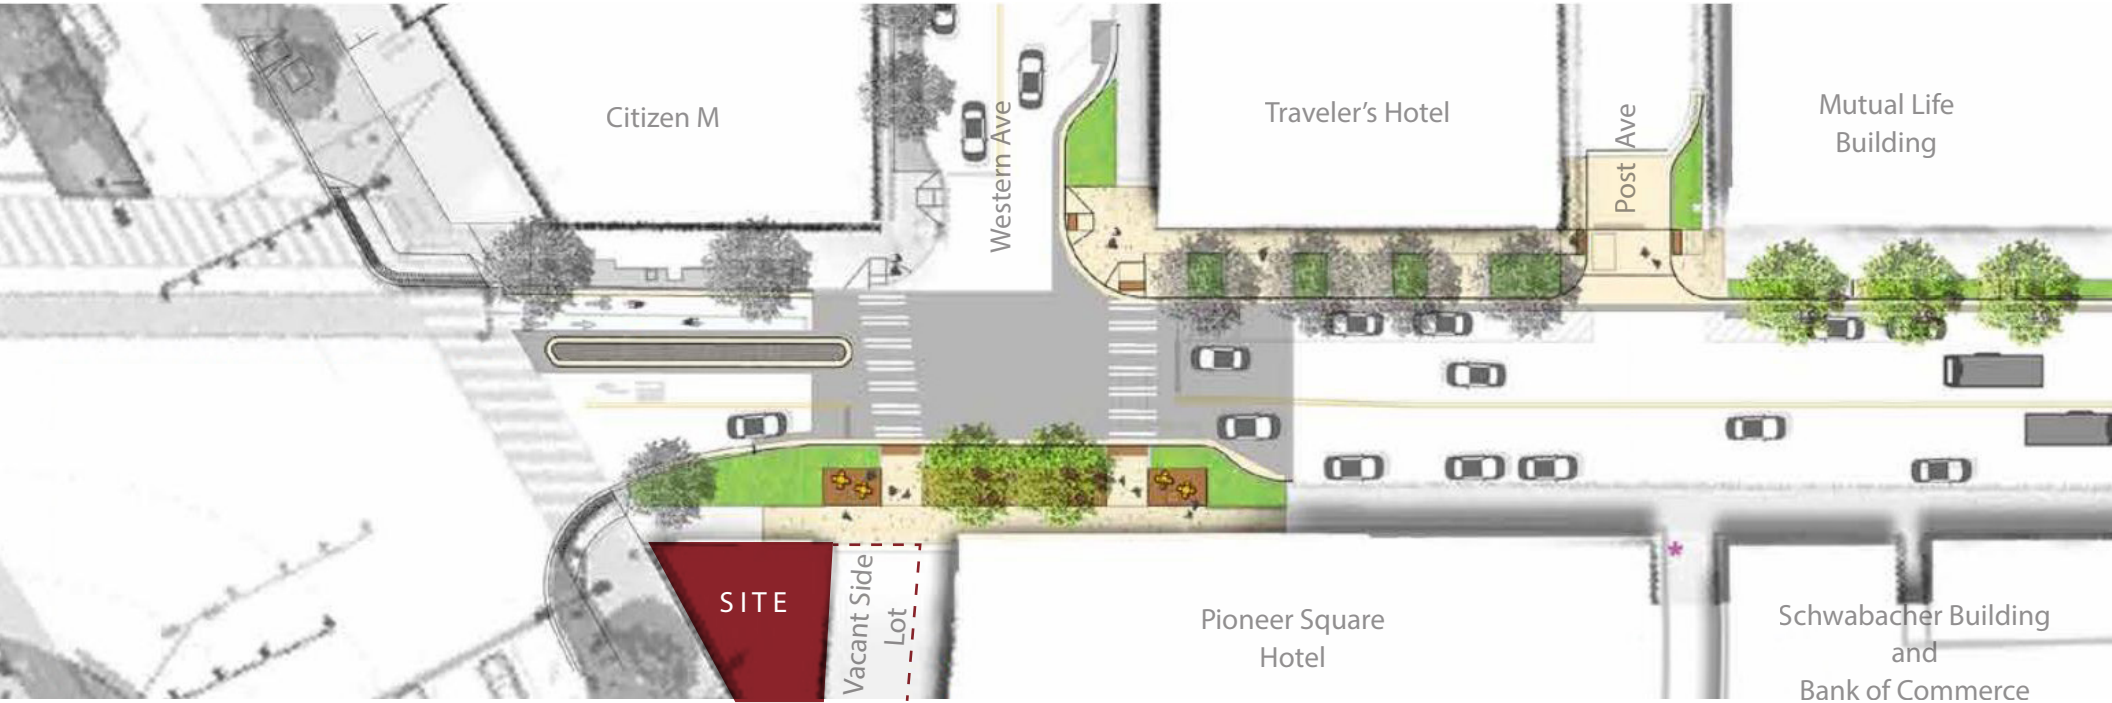
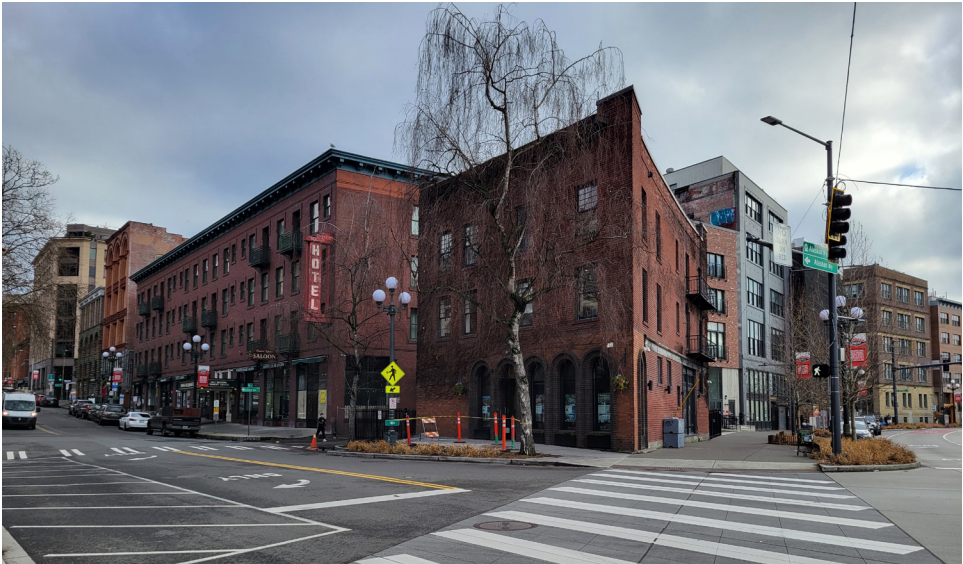
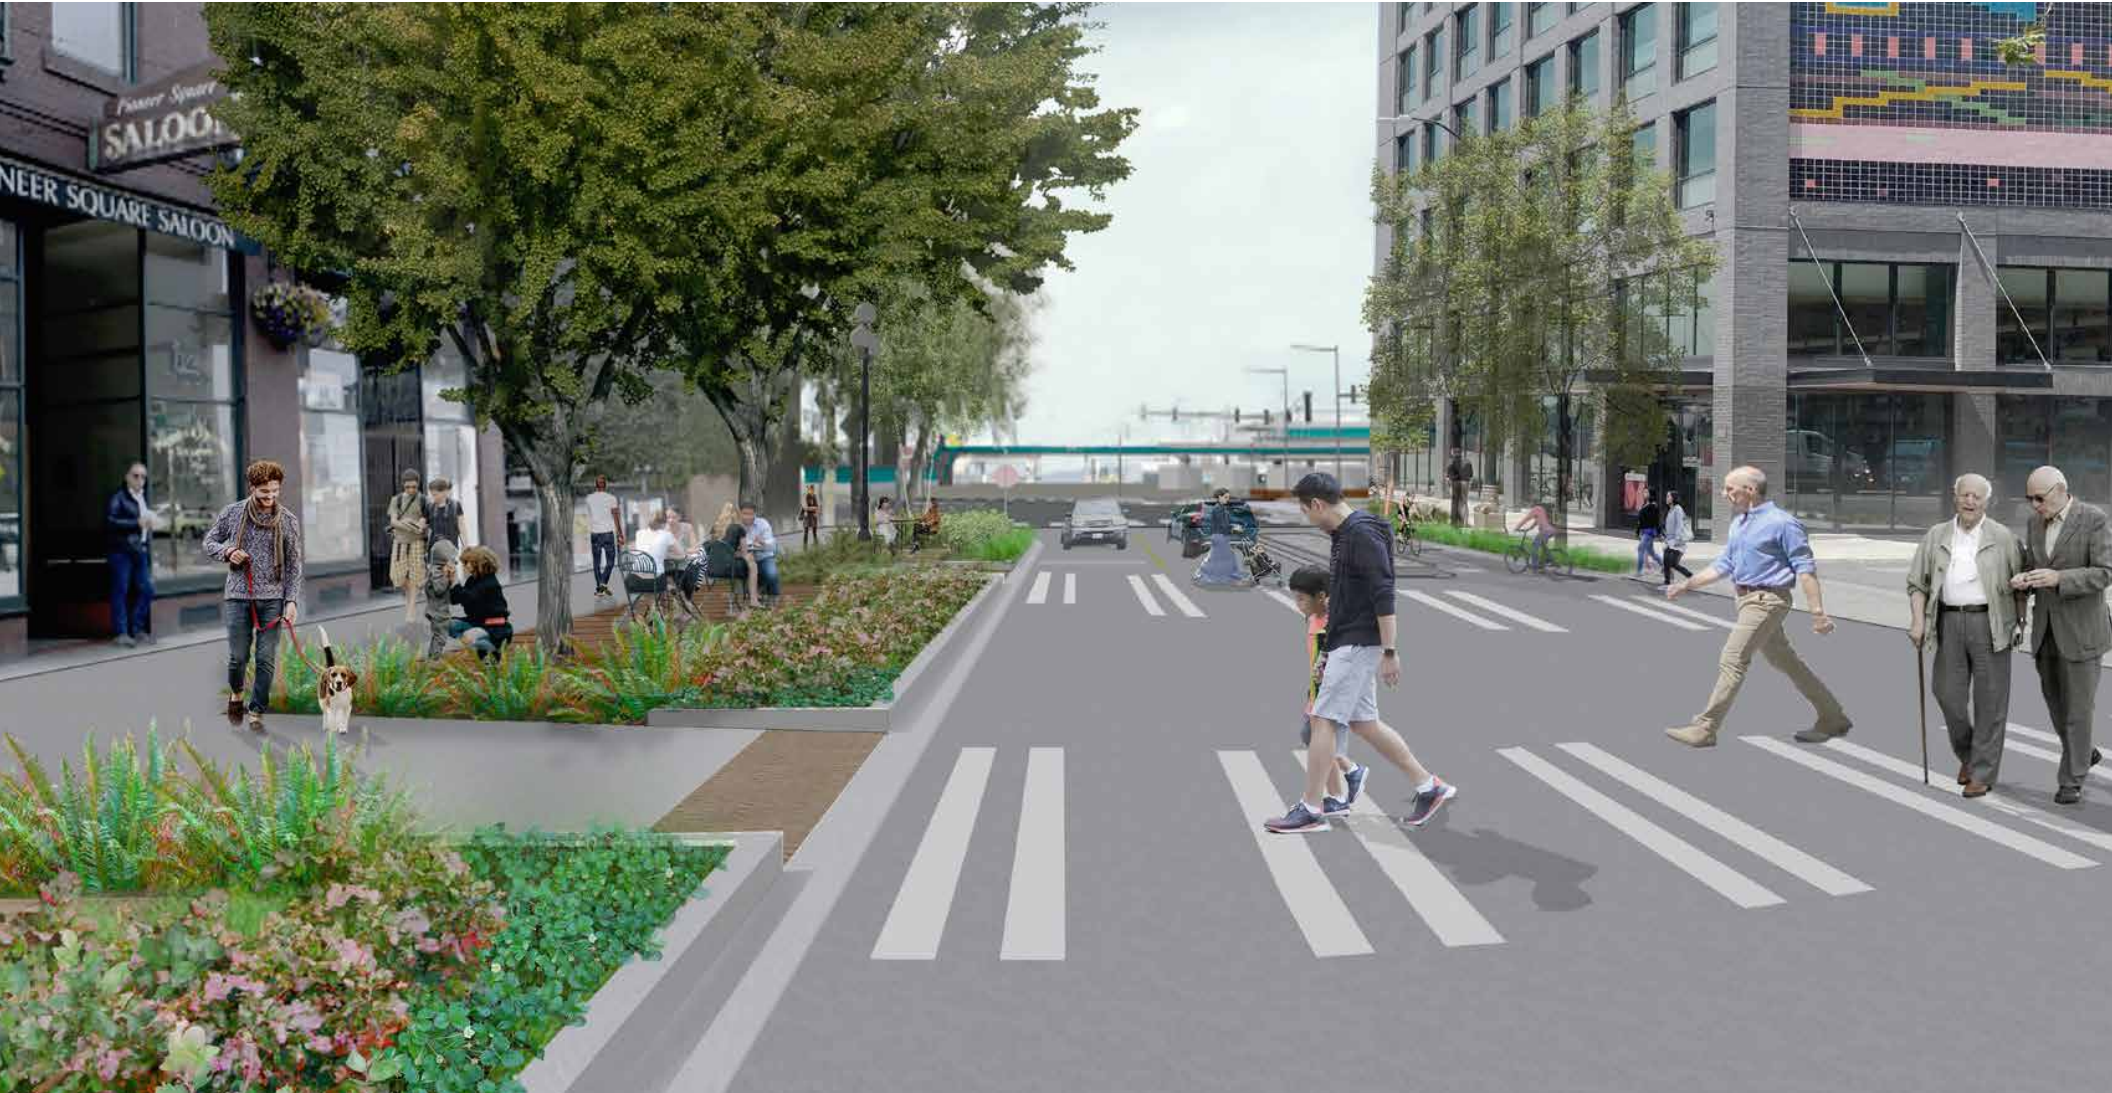
YESLER WAY PROPOSED WORK

- A new traffic island to protect cyclists between Western and Alaskan Way.
- New curb bulbs to be installed along south edge of Yesler/Western, including a new sidewalk between intersection and Pioneer Square Hotel. To include new plantings and new drainage infrastructure
- The sidewalk on the north side of Yesler between Post Avenue and Western Ave will be removed and repaved.
- New sidewalk paving restoration and plantings along the north side of Yesler Way, a target of three new street trees, with soil cells.
- A new wood decked plaza will be installed in the bulb-out at Yesler and Western.

Current Conditions

Figures and Text from Pioneer Square East-West Streets Pedestrian Improvements request for certificate of approval, June 2022

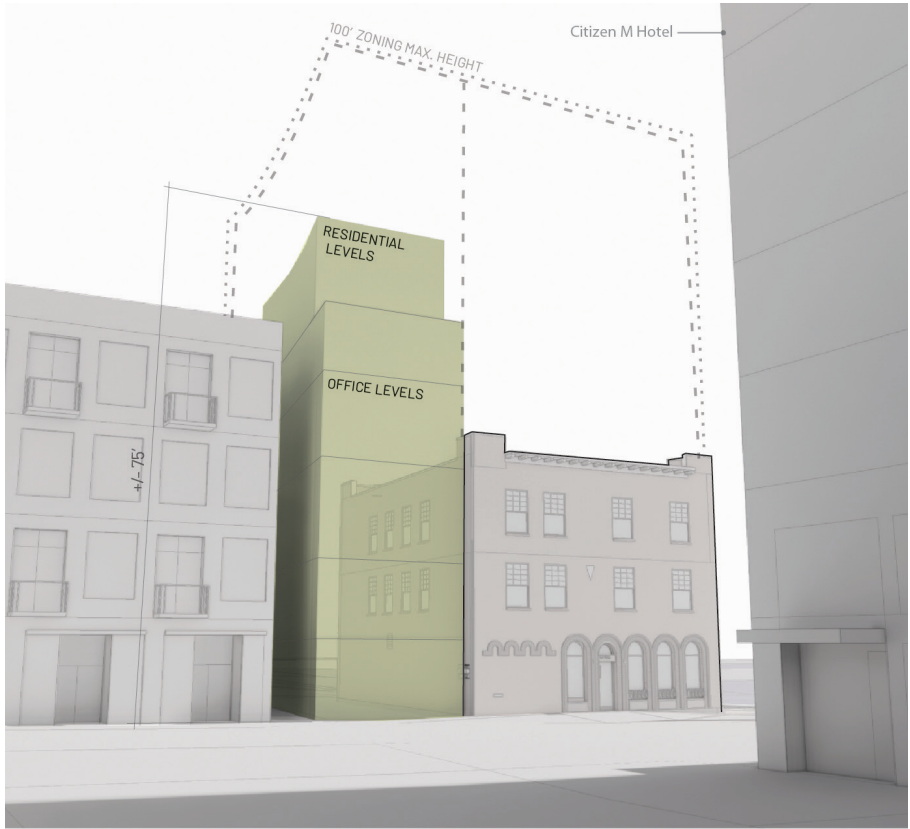
Option 3: Preferred Massing
Side Yard Infill + Scale

Existing 1 Yesler Footprint: 1,544 SF
Allowed by code, Proposed Addition Footprint: 1,517 SF
Total Lot Size: 3,061 SF

50%
Smaller FAR than Option 1: Full Site, allowed by code

1. Board member suggested a small plane change between historic structure and new infill addition.
2. Design team to abide by Preservation Brief 14, making the historic structure and new infill addition compatible but not matching.
3. Per Preservation Brief 14, use a similar palette of materials, tying into historic architectural motifs.
4. Board member took no issue with rooftop use of historic structure.
5. Penthouse, deck space, and roof extensions encouraged for giving scale to street face of the infill addition.

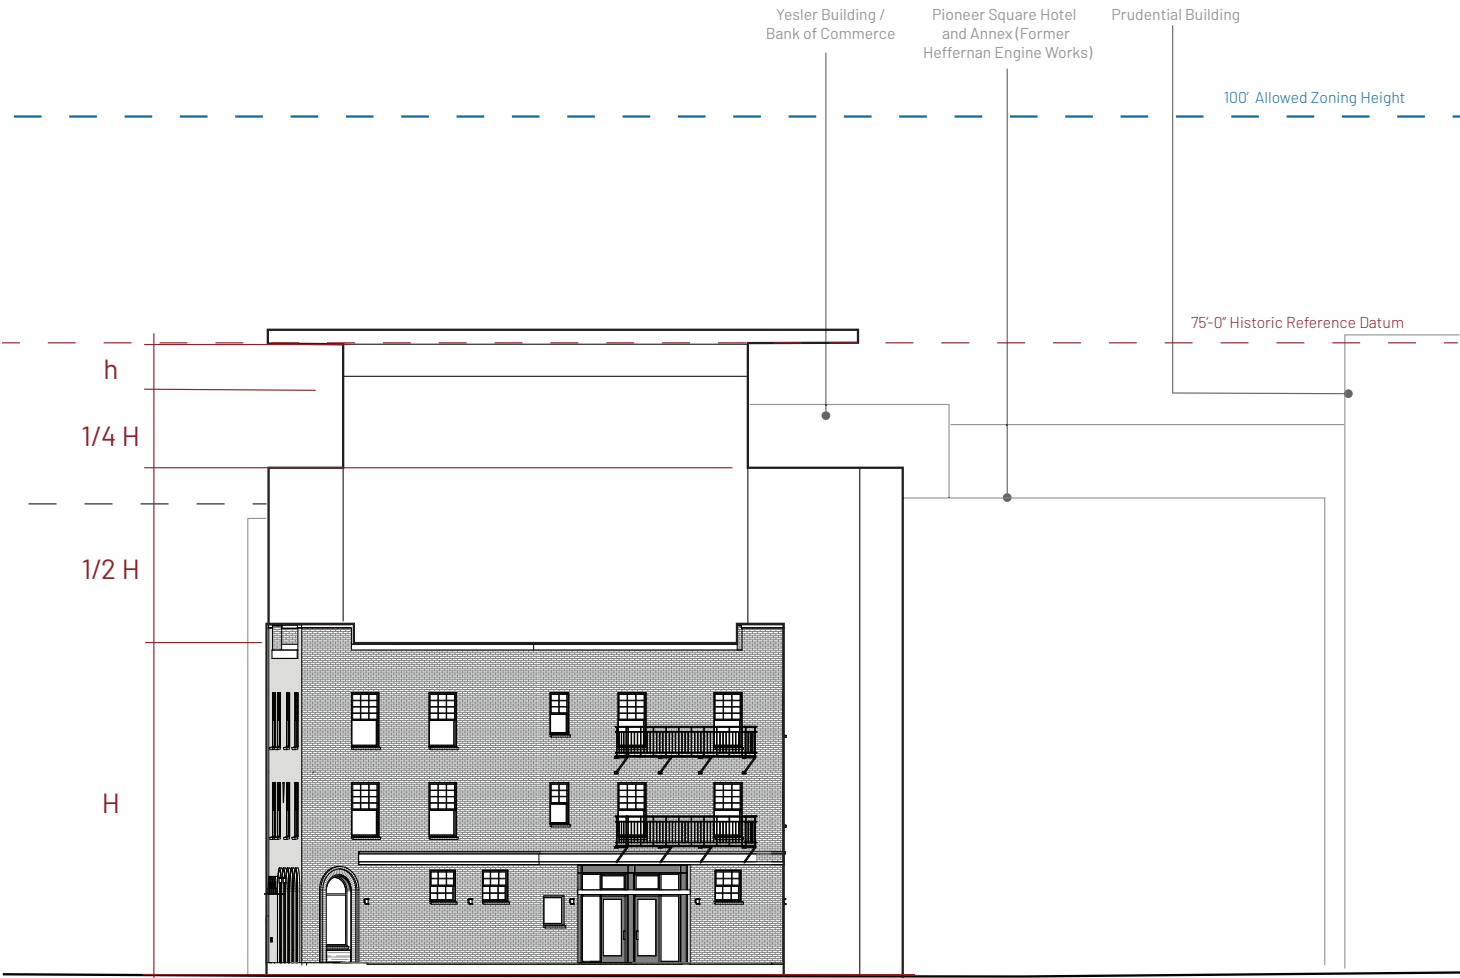
OVERALL PROPORTIONS

23.66.180B DESIGN: SCALE Exterior building facades shall be of a scale compatible with surrounding structures. Window proportions, floor height, cornice line, street elevations and other elements of the building facades shall relate to the scale of the buildings in the immediate area.

The proposed building design is derived from the original historic building height, subsequently halved again at the top to provide scale and relief.
