ONE YESLER BUILDING

ARCHITECTURAL REVIEW COMMITTEE
DESIGN DEVELOPMENT REVIEW
SEPTEMBER 27, 2023

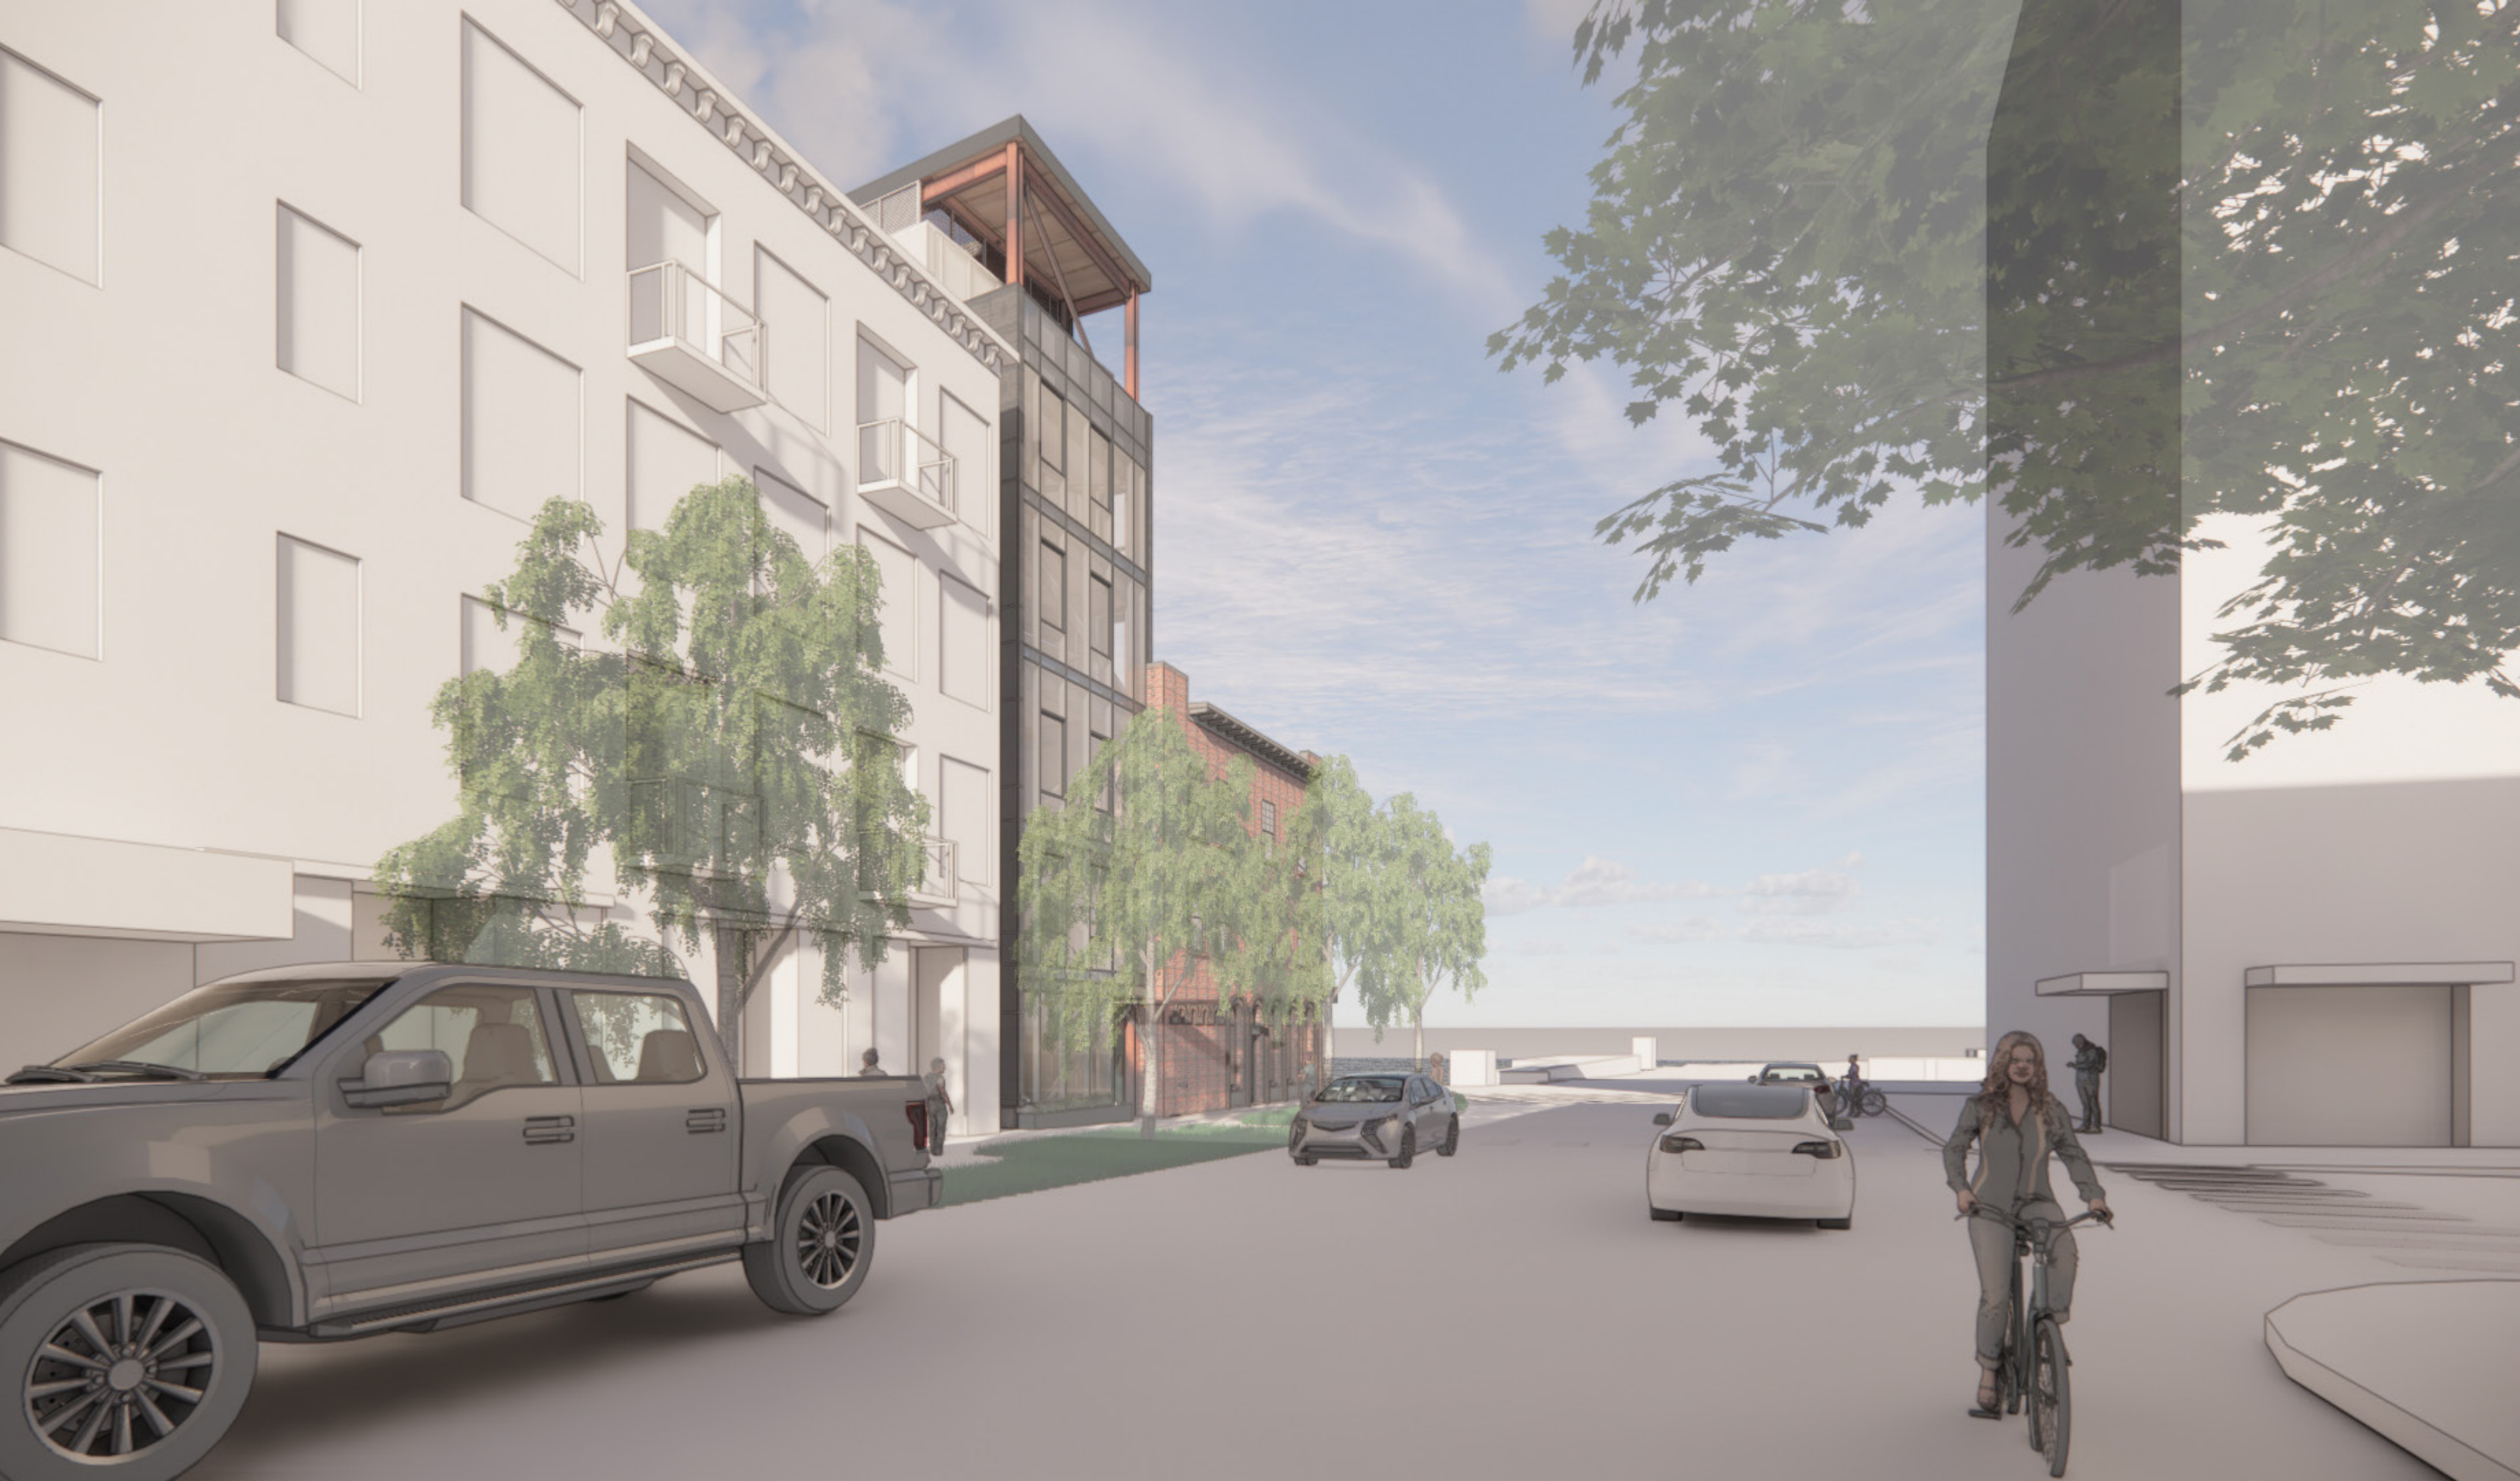
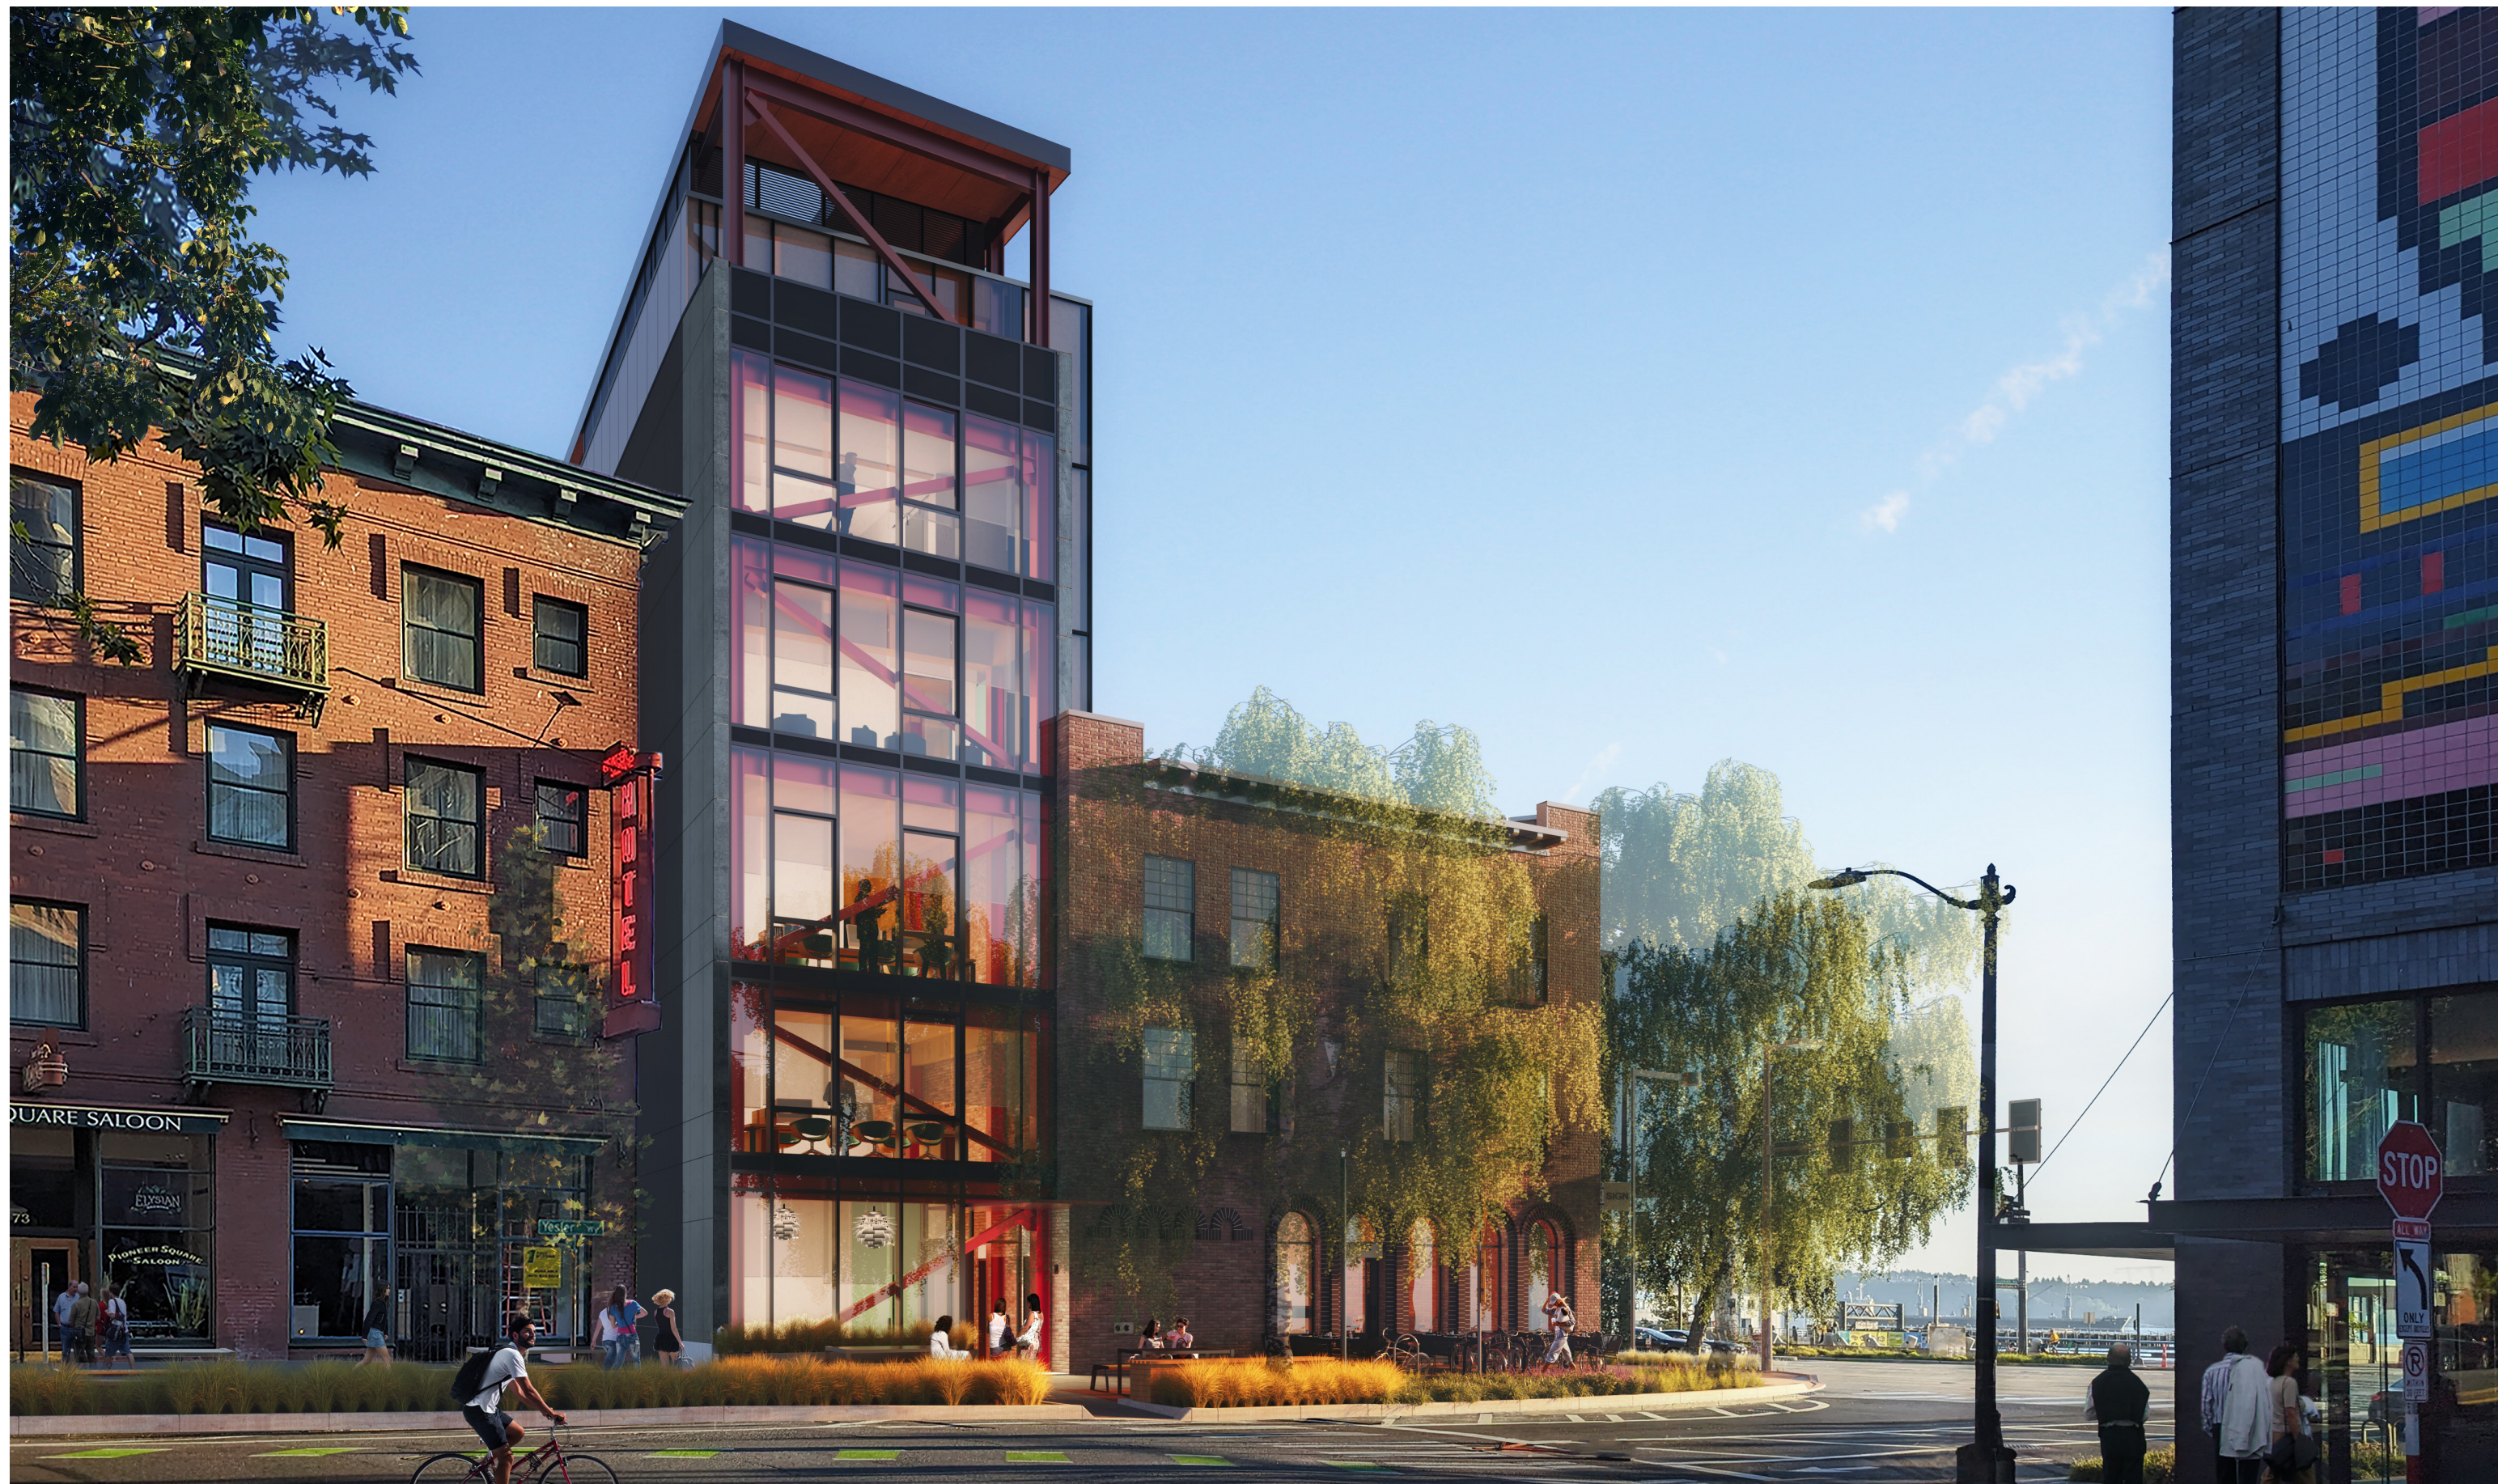
ADDITION SIGHT-LINE STUDY

Preservation Brief 14: Exterior Additions to Historic Buildings

- XII) If the site is on an adjacent vacant lot, then “reading the addition as a separate or infill building may be the best approach when designing an addition that will have the least impact on the historic building and the district”
- XIV) Visible rooftop additions should be set back “at least one full bay” from the plane of the facade to conceal the addition.

The proposed addition is situated on a vacant side lot. From the highly traveled Alaskan Way, the side lot creates a step back against the existing building that minimizes the visual appearance of the addition. Pedestrians along the interior sidewalk of Alaskan will have minimal views of the addition and pedestrians across the way, will have their views screened by landscaped trees placed by the Seattle Waterfront Project

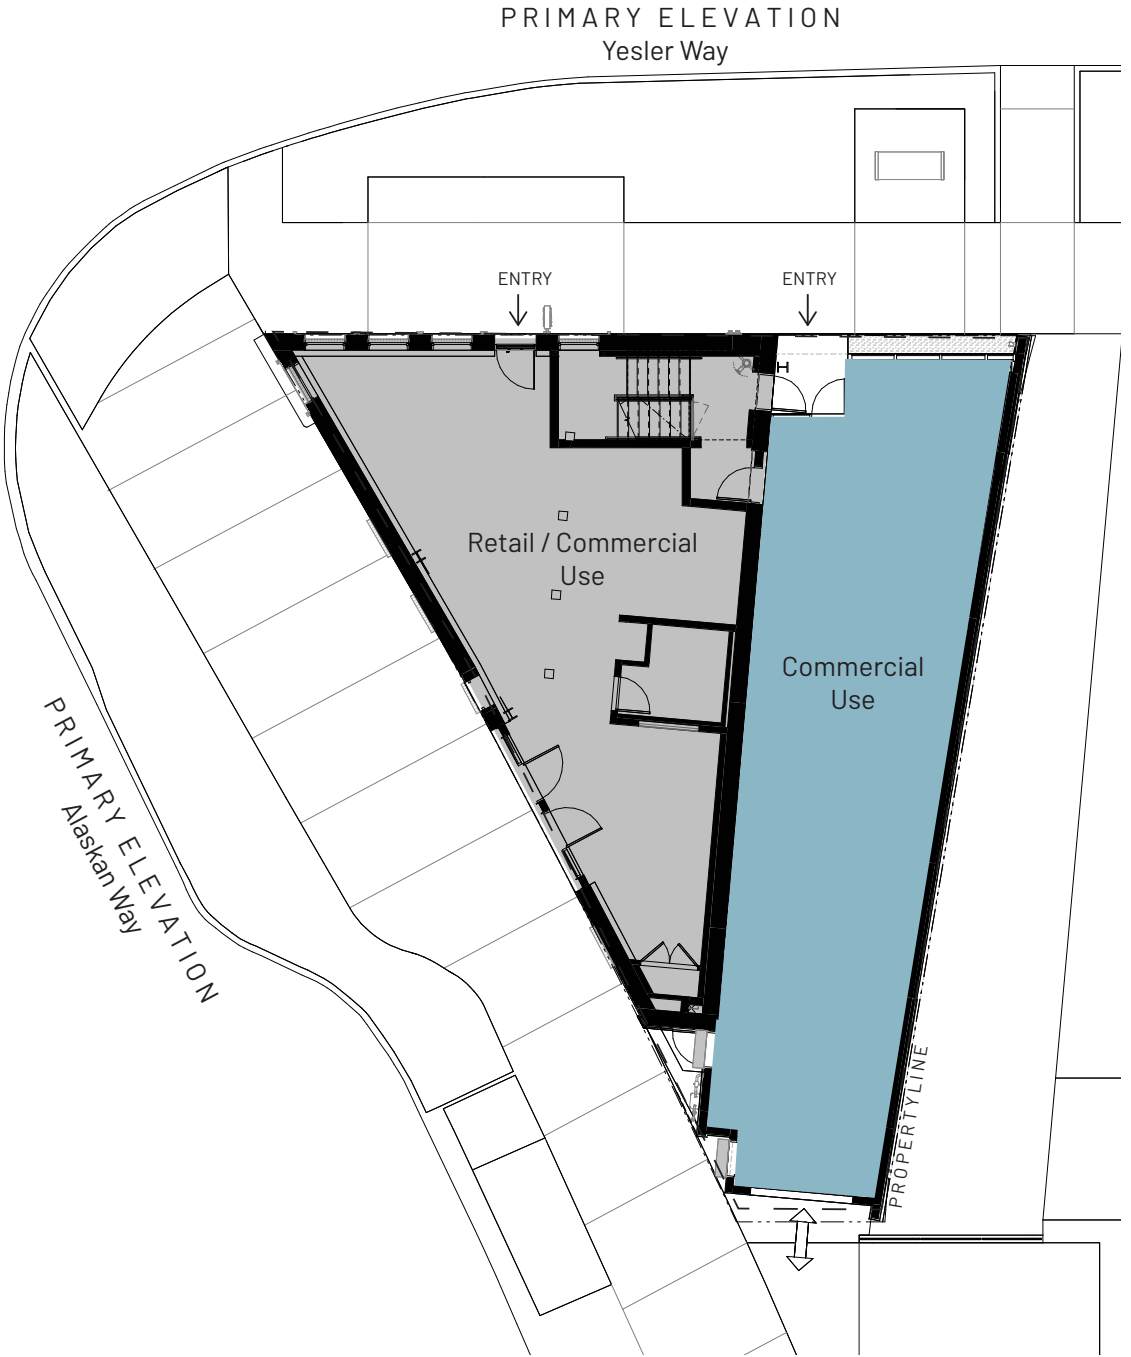
ARCHITECTURAL SITE PLAN: CURRENT USE AND PROPOSED USE

Street-level Land Use at existing building to return to Commercial Use after temporary Office Use. By Building Code, change of use is required to return to original Commercial use

- Historic Rehabilitation
- New Infill Addition

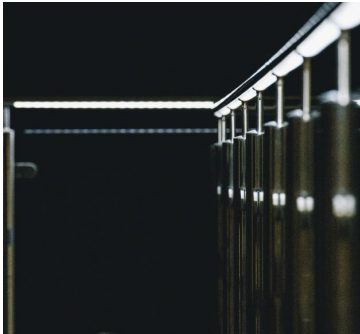
2 - New Rail Light

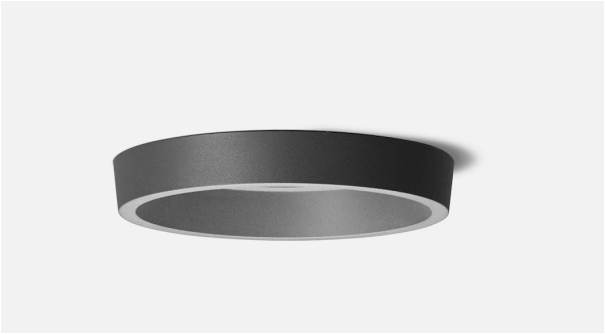
4 - New Canopy Down Light

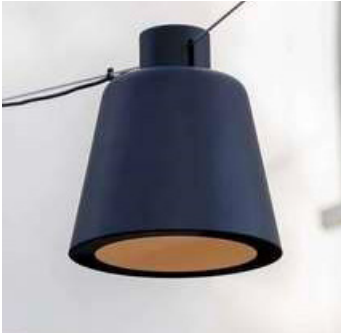
5 - New Catenairy Lights

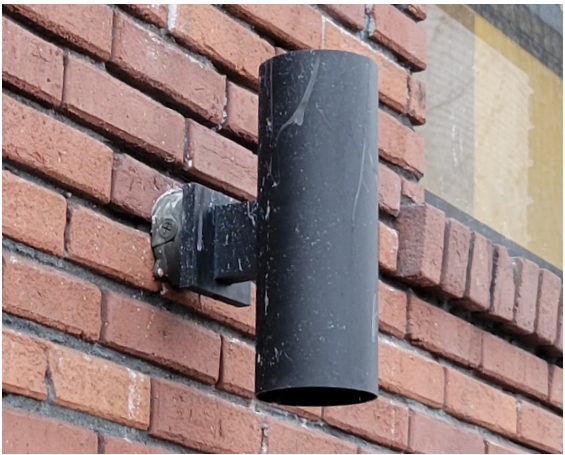
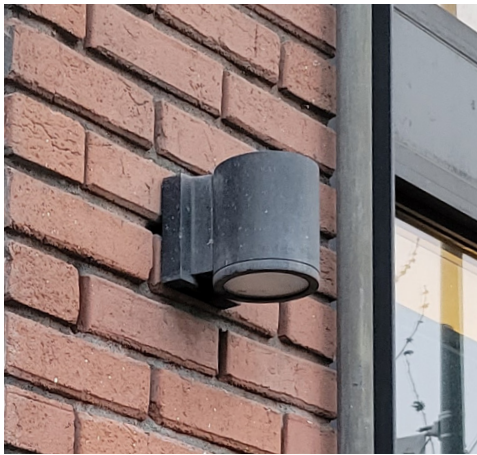
One Yesler - Existing Exterior Light Fixtures

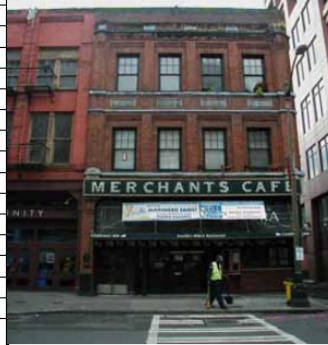
Raid/Middleton		Address 109 to 109 1/2 Yesler Way																																																																																																																																																																																																																	
729 13th Street SW - Suite 200 Everett, Washington 98204 Ph: 425 741-3800 Fax: 425 741-3900		District Downtown Zip 98104																																																																																																																																																																																																																	
Rapid Visual Screening of Seismically Hazardous Buildings		Other Identifiers No. Stories 3 Year Built 1890																																																																																																																																																																																																																	
High Seismicity Area		Inspector ADF Date 10.03.07																																																																																																																																																																																																																	
		Total Floor Area (sq. ft.) 7,500																																																																																																																																																																																																																	
		Building Name Merchants Café																																																																																																																																																																																																																	
		Use

URM Summary Sheet							
STREET ADDRESS	YEAR BUILT ¹	NO. STORY	FEMA SCORE	Gross Sq Foot Area ¹	BUILDING DEMO	EQ DAMAGE ²	COMMENTS
109-109.5 Yesler Way	1890	3	0.4	7,500	N	Y	Hazardous bldg (3/14/01, fixed by 4/01), 1998 \$430K in seismic upgrades-completed 2003
111 Yesler Way	1890	3	-0.1	5,100	N	NI	
115-117 Yesler Way	1890	3	-0.1	15,000	N	NI

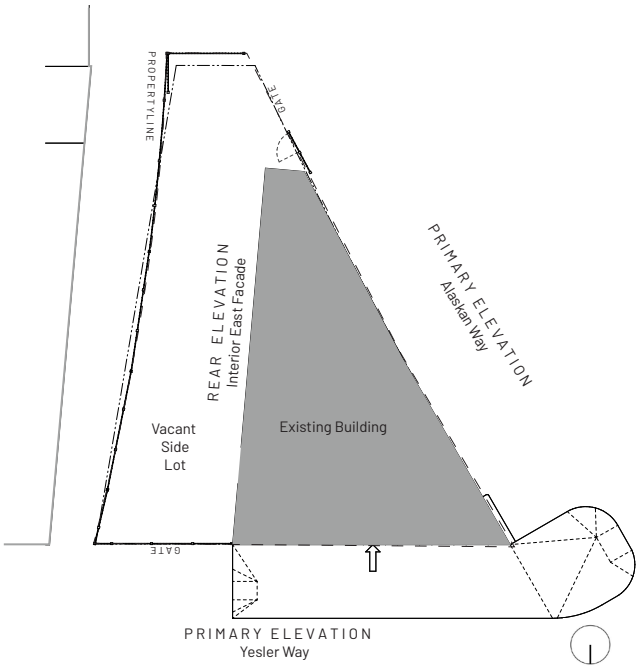
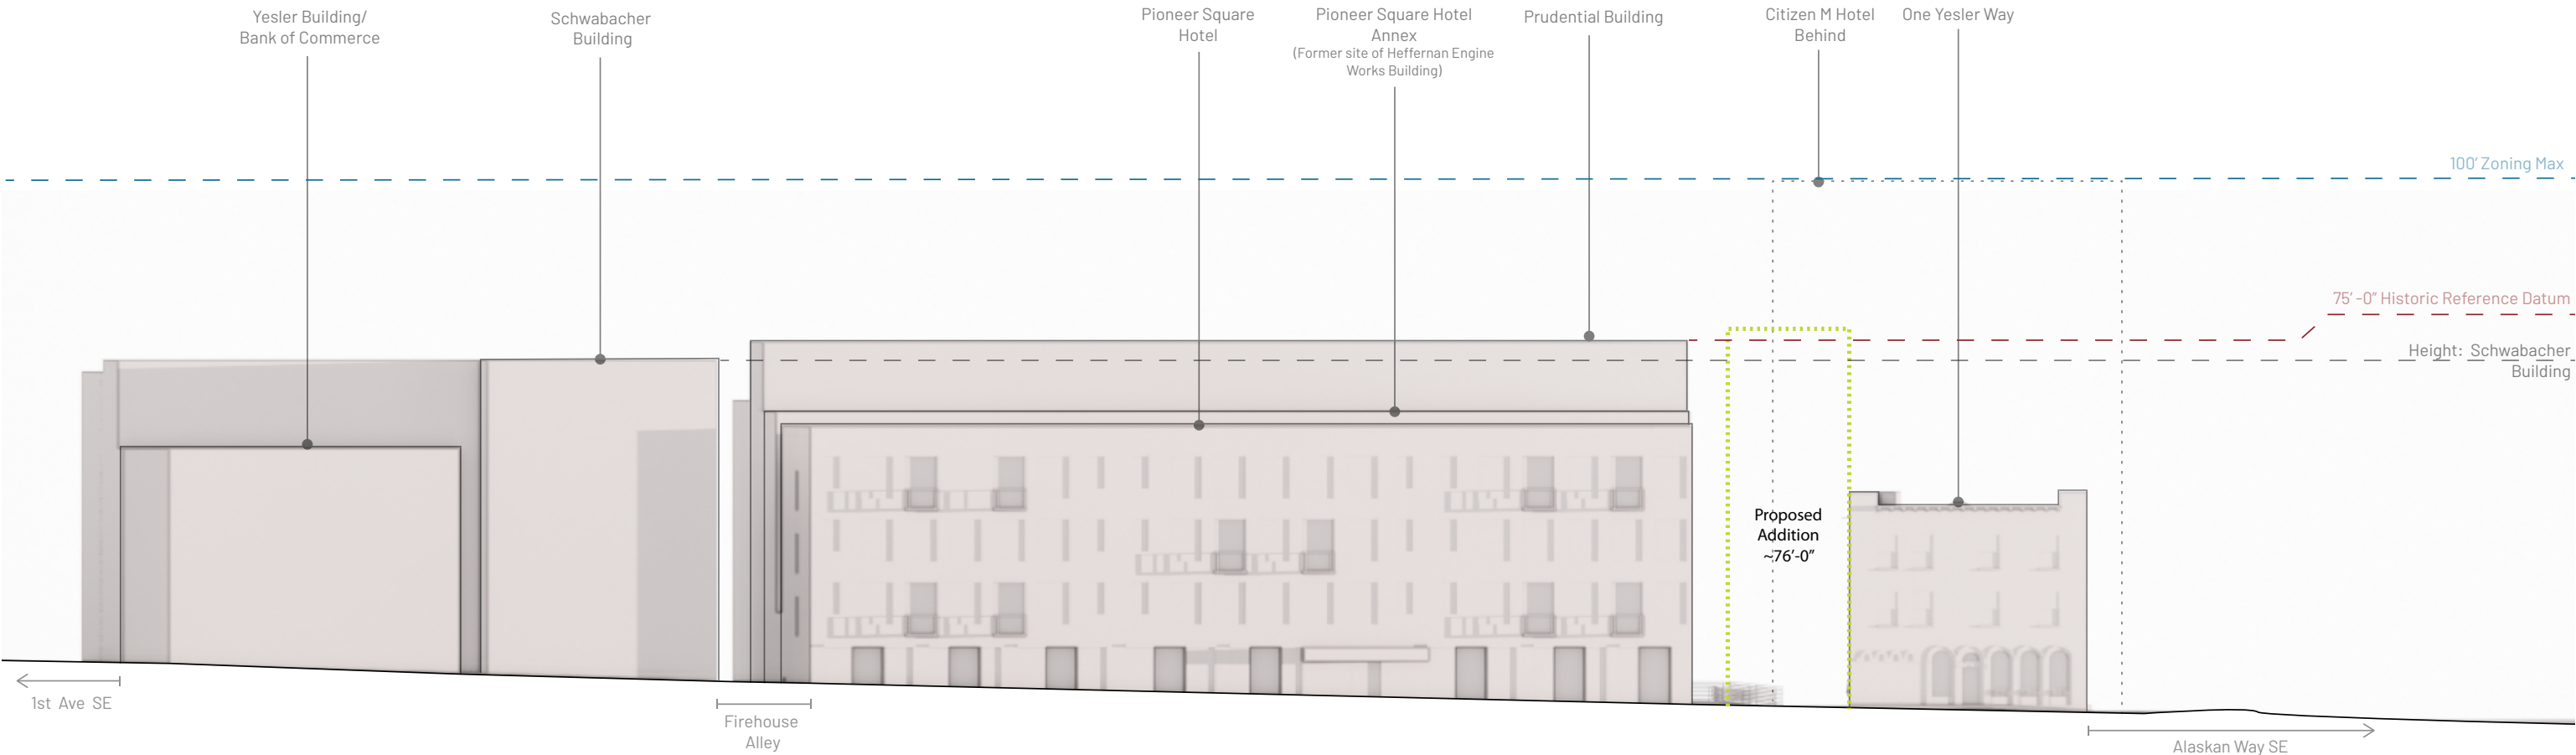
URBAN HYPHEN

- XII) If the site is on an adjacent vacant lot, then “reading the addition as a separate or infill building may be the best approach when designing an addition that will have the least impact on the historic building and the district”
- IV) New addition must be located where the “least amount of historic material and character defining features will be lost. In most cases, this will be on a secondary side or rear elevation.”
 - b) A “Hyphen” or “connector” is another means of providing a physical link
