SEATTLE PUBLIC LIBRARY UNIVERSITY BRANCH RENOVATION

LANDMARKS BRIEFING MEETING
AUGUST 11, 2023

SHKS ARCHITECTS

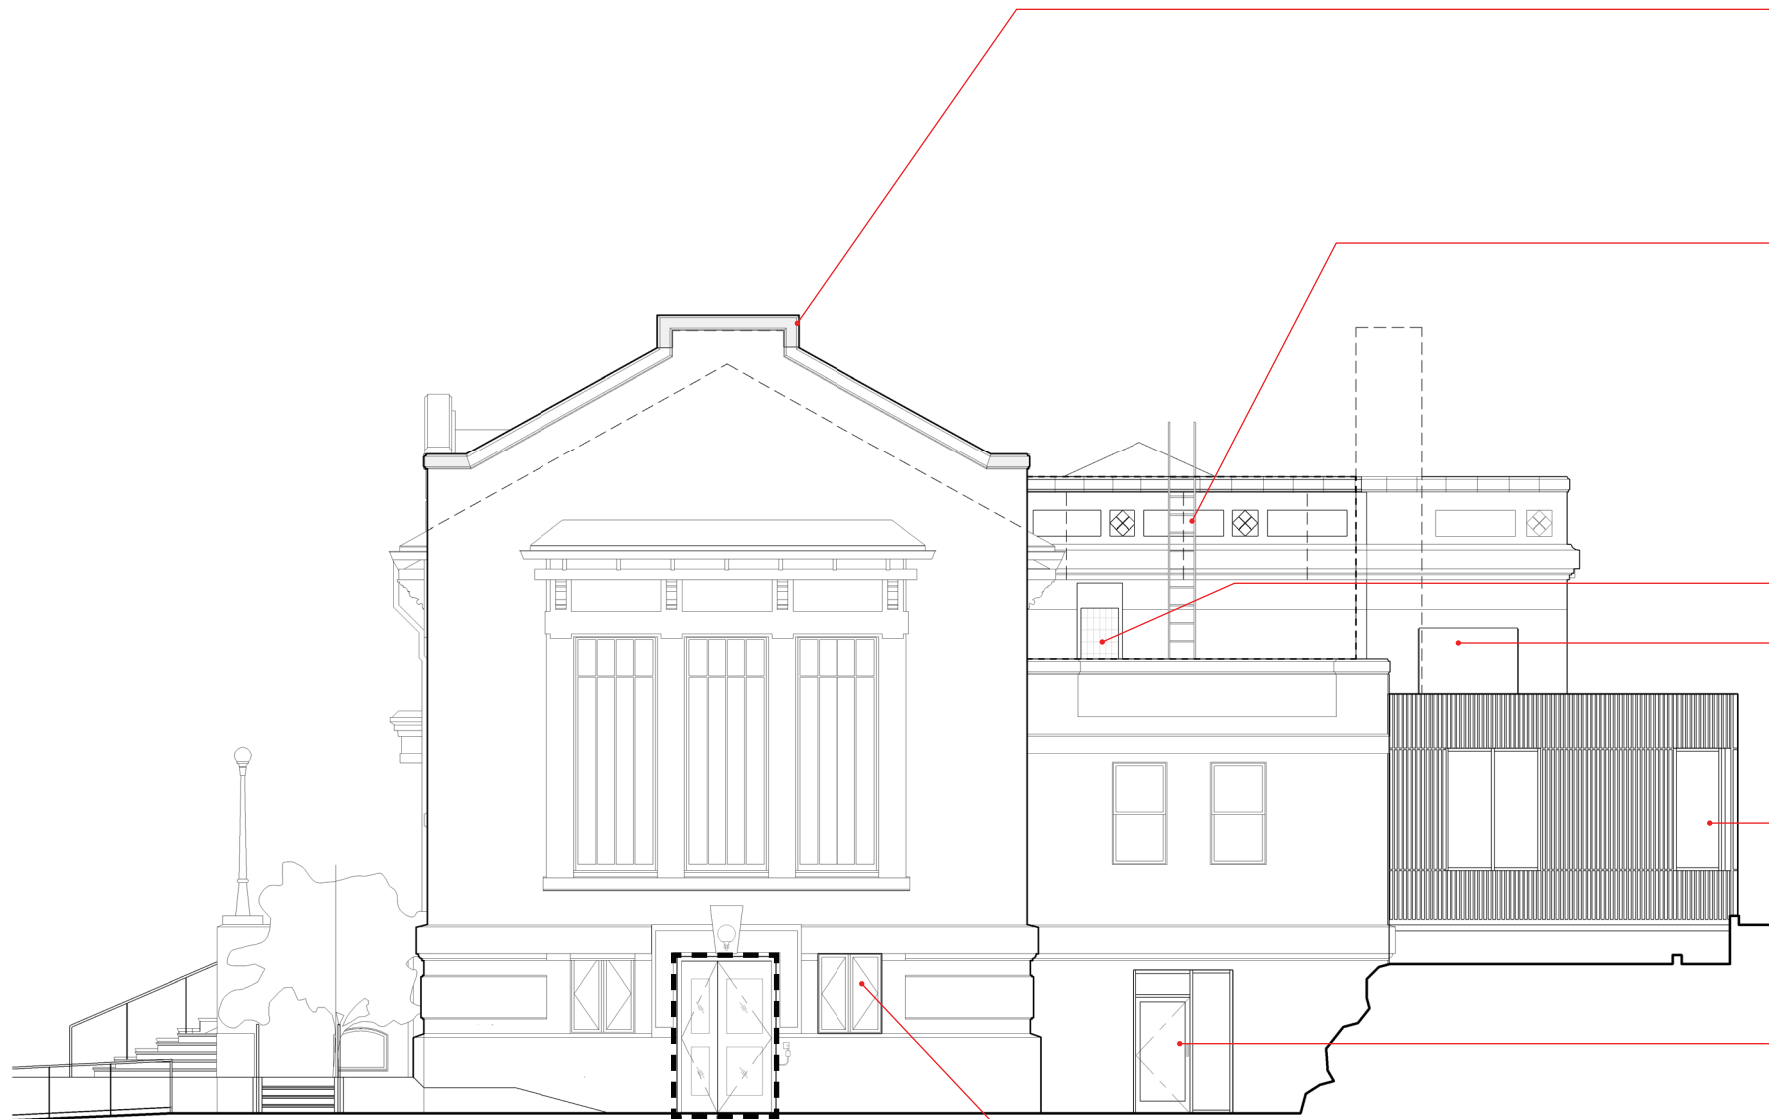
PROPOSED NORTH ELEVATION - DOOR MODIFICATION

SALVAGE AND REINSTALL
TILE ROOF PARAPET
CAPS WITH EMBEDDED
ANCHORS, TYP

INSTALL CONCRETE
SHEAR WALL; INSTALL
COMPOSITE PANELING,
STUCCO, & PAINT

ROOFTOP HVAC UNITS

SKYLIGHT OVER EXISTING
OPENING

STUDY ADDITION

ENTRY DOOR, TRANSOM,
AND SIDELITE IN EXISTING
OPENING

WINDOW - RETURN TO
1910 DESIGN INTENT

UNEQUAL LEAF DOOR
(COMMUNITY ROOM EGRESS)

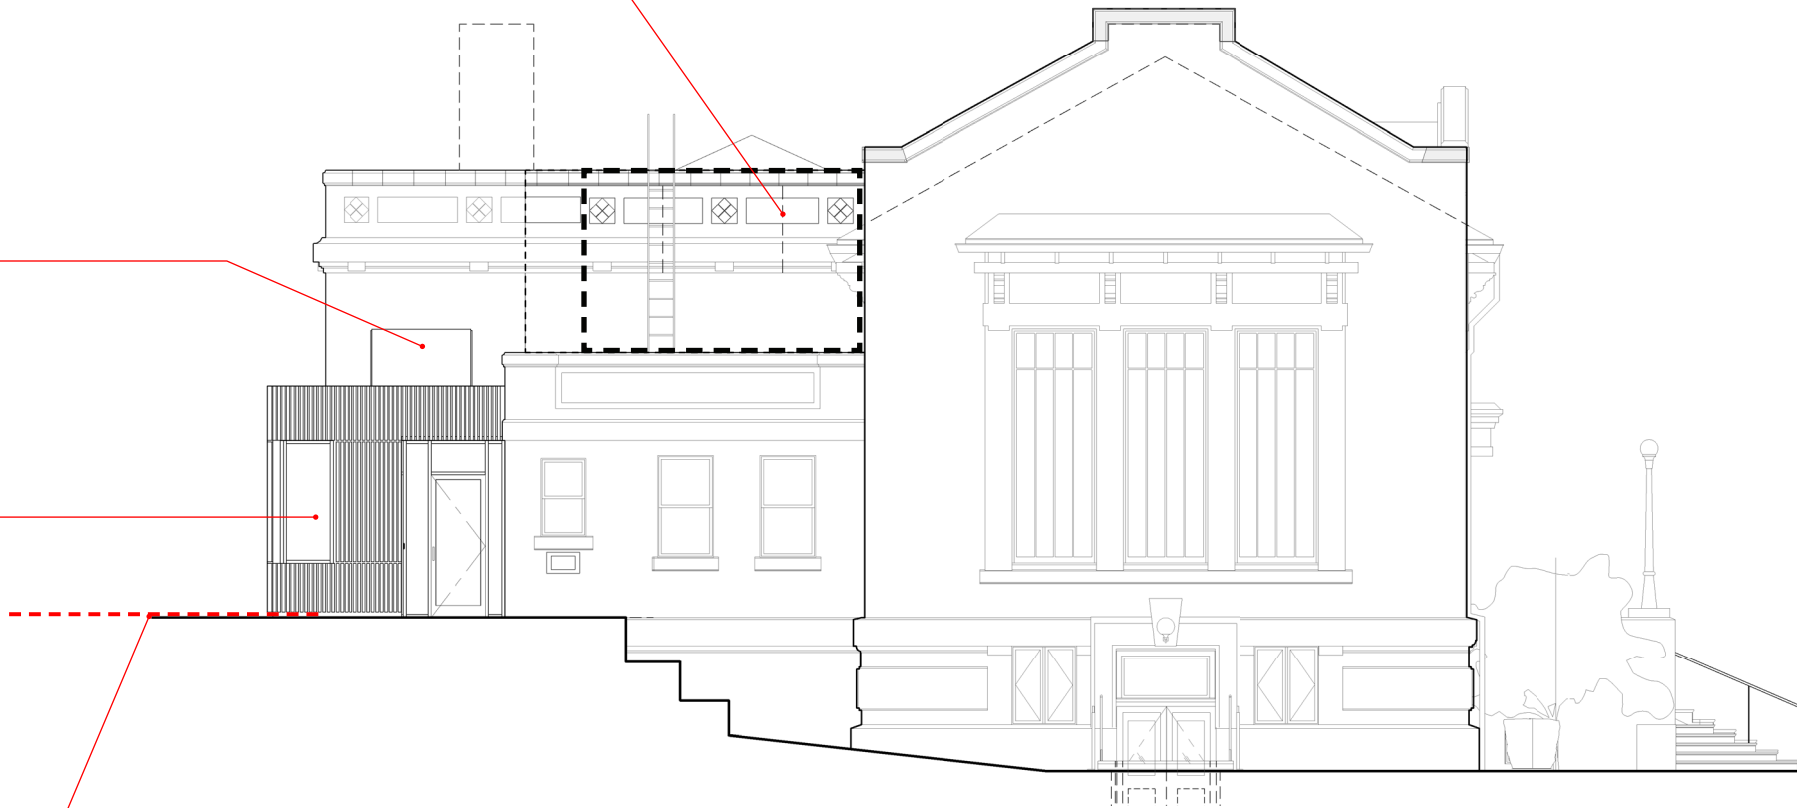
PROPOSED SOUTH ELEVATION

INSTALL CONCRETE
SHEAR WALL; INSTALL
COMPOSITE PANELING,
STUCCO & PAINT

WALL-ABUTTING
SKYLIGHT OVER
EXISTING OPENING

ACCESSIBLE ENTRY
ADDITION

RAISED PARKING
LEVEL SHOWN
DASHED

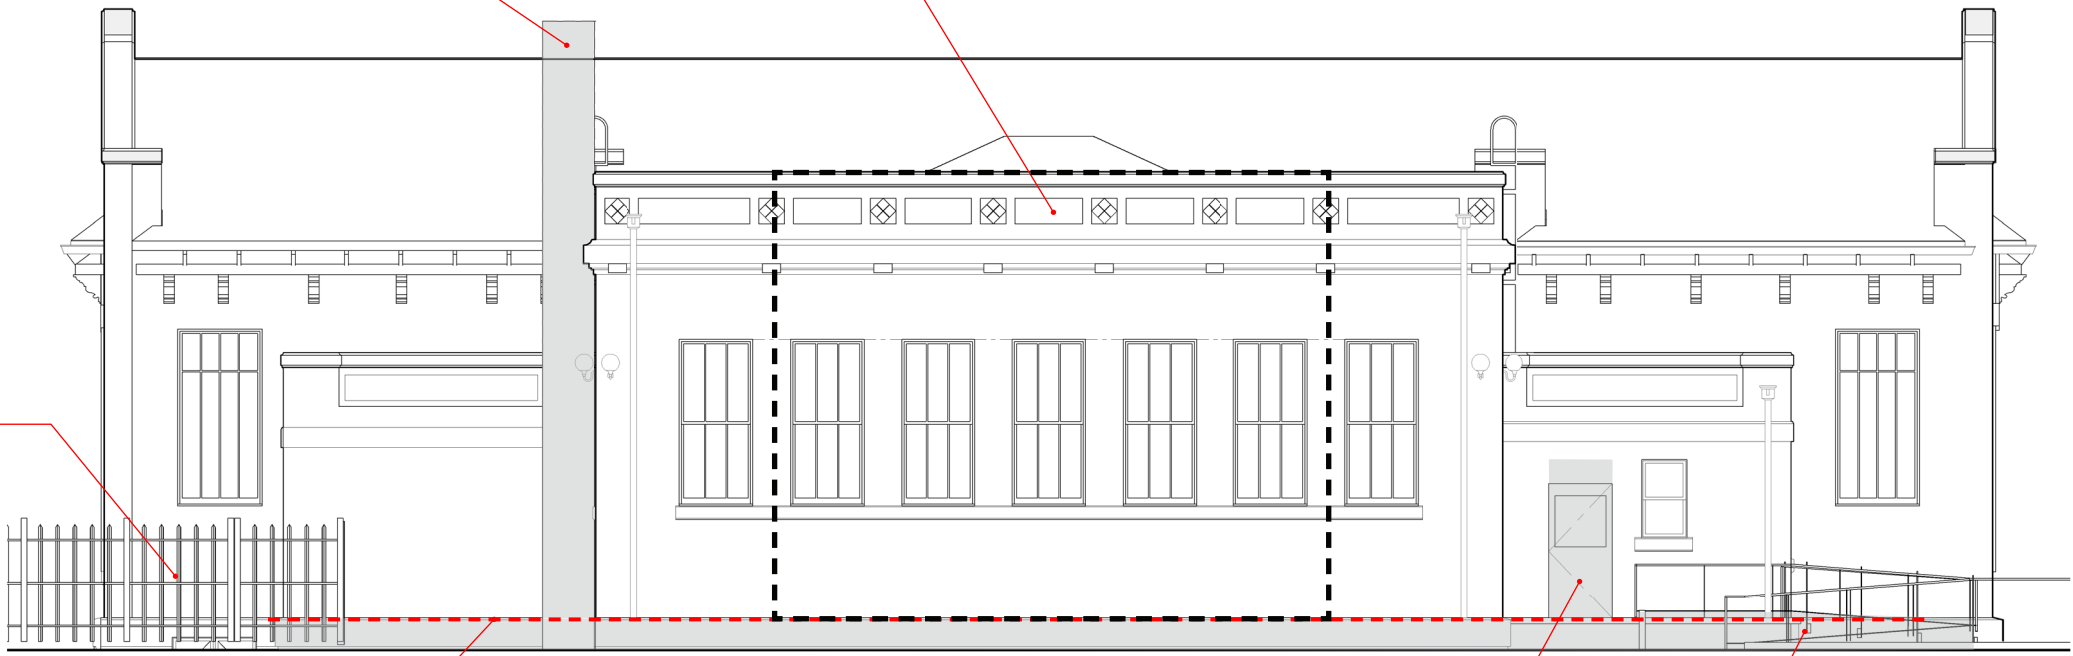
EXISTING WEST ELEVATION

DEMO EXTERIOR WALL;
INSTALL EMBEDDED
MOMENT FRAME

REMOVE CHIMNEY
(NOT ORIGINAL)

REMOVE FENCE

RAISED PARKING
LEVEL (RED DASHED)

REMOVE DOOR (NOT
ORIGINAL)

REMOVE
ACCESSIBLE RAMP

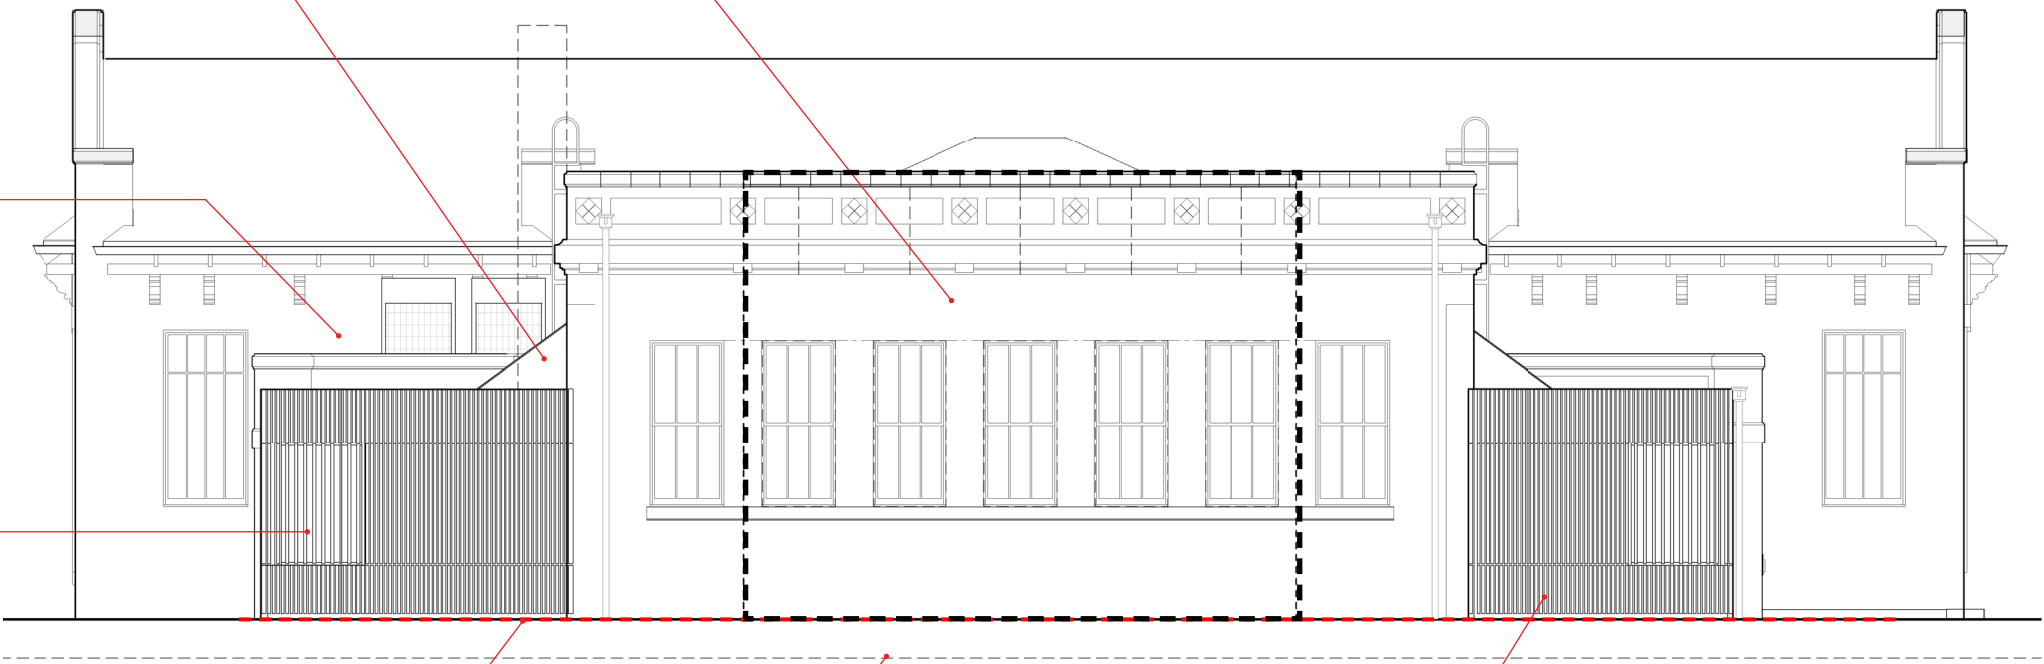
PROPOSED WEST ELEVATION

REFRAME WALL AND
PARAPET WITH
COMPOSITE PANELING,
STUCCO, & PAINT

WALL-ABUTTING
SKYLIGHT OVER
EXISTING OPENING

PREVIOUS
PARKING LEVEL
(GRAY DASHED)

ACCESSIBLE ENTRY
ADDITION

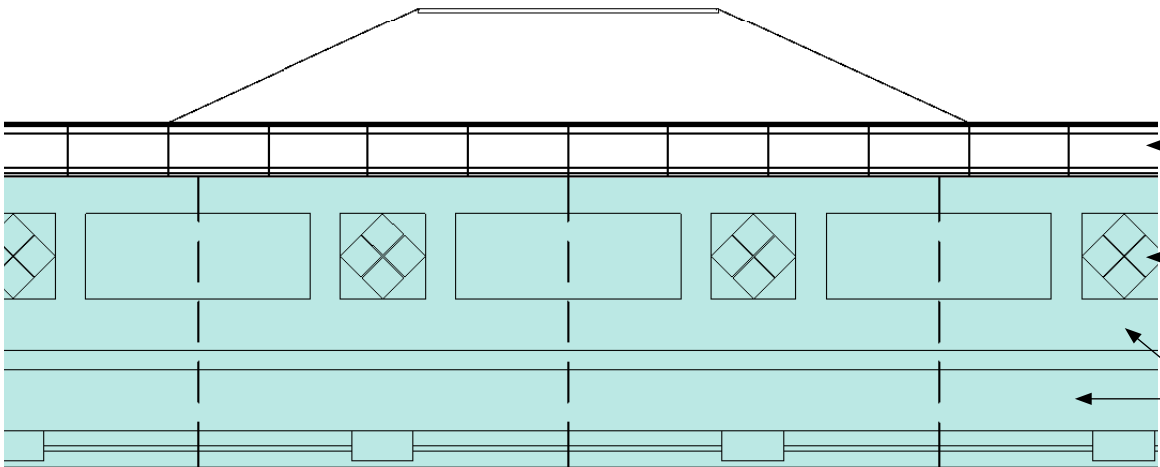
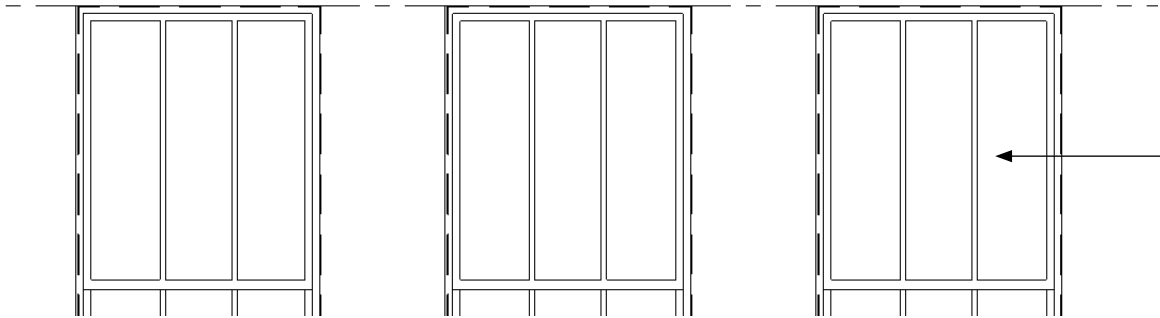
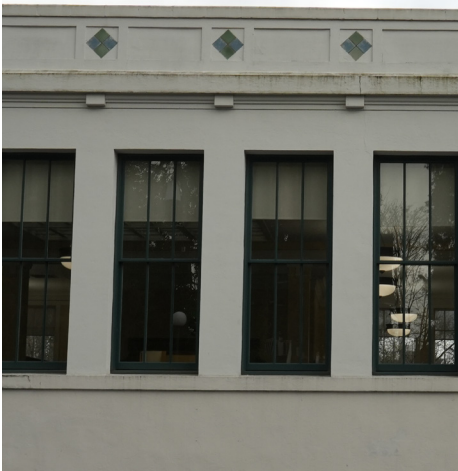
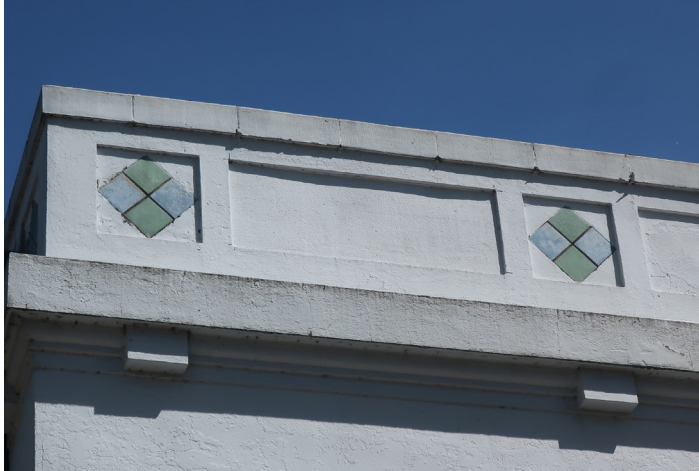
WEST ELEVATION; TILE, RELIEFS, AND BANDING

REINSTALL
TERRACOTTA
COPING CAP

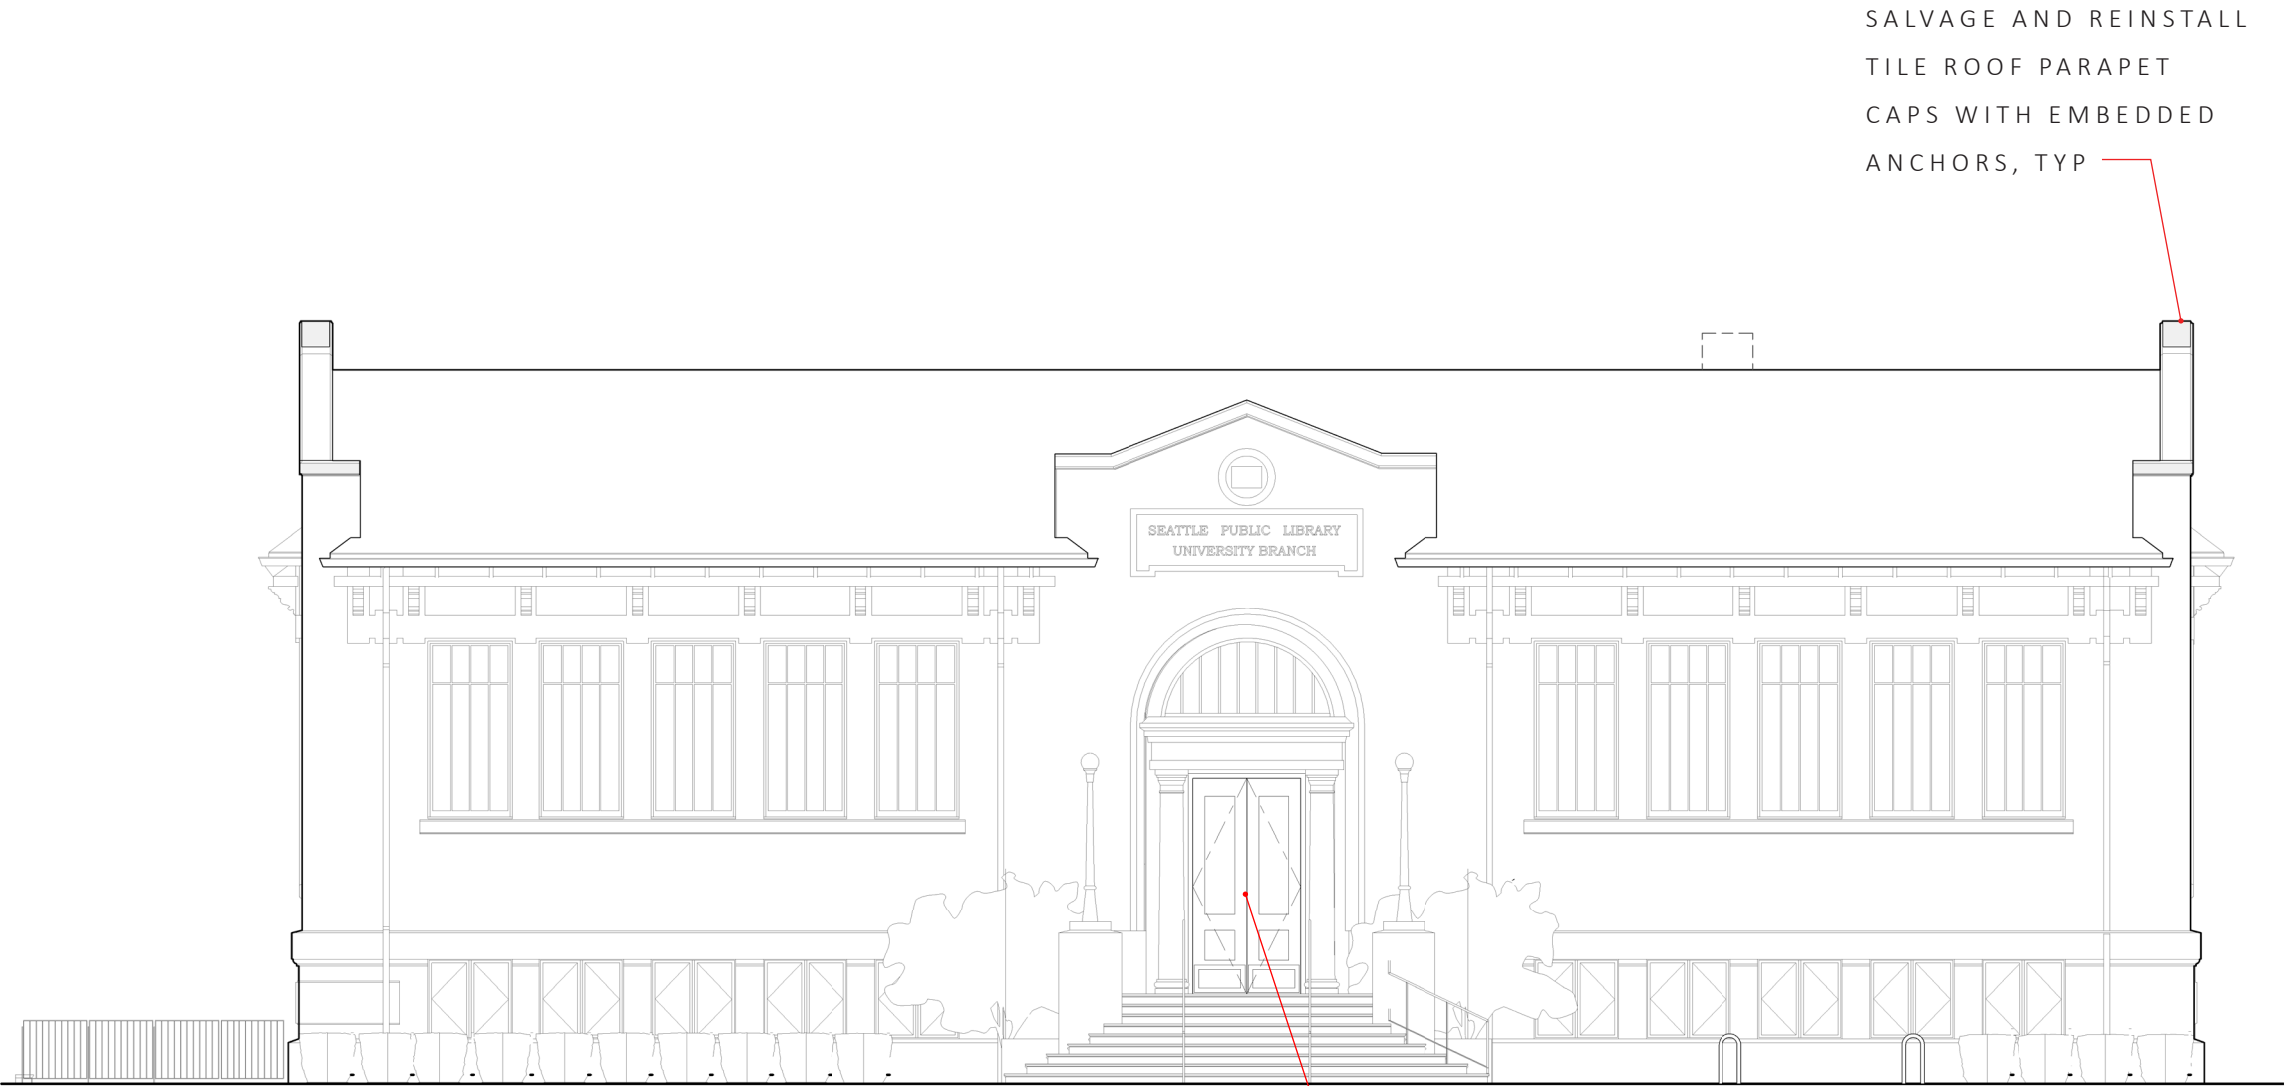
PROPOSED EAST ELEVATION

SALVAGE AND REINSTALL
TILE ROOF PARAPET
CAPS WITH EMBEDDED
ANCHORS, TYP

**DOOR - RETURN TO 1910
DESIGN INTENT**

NOTE: EQUAL LEAF DOOR DOES NOT PROVIDE
REQUIRED SINGLE-SASH MINIMUM WIDTH
FOR EGRESS; IT IS PROPOSED THAT THE
DOORS REMAIN EQUAL WIDTH TO PRESERVE
SYMMETRICAL ELEVATION

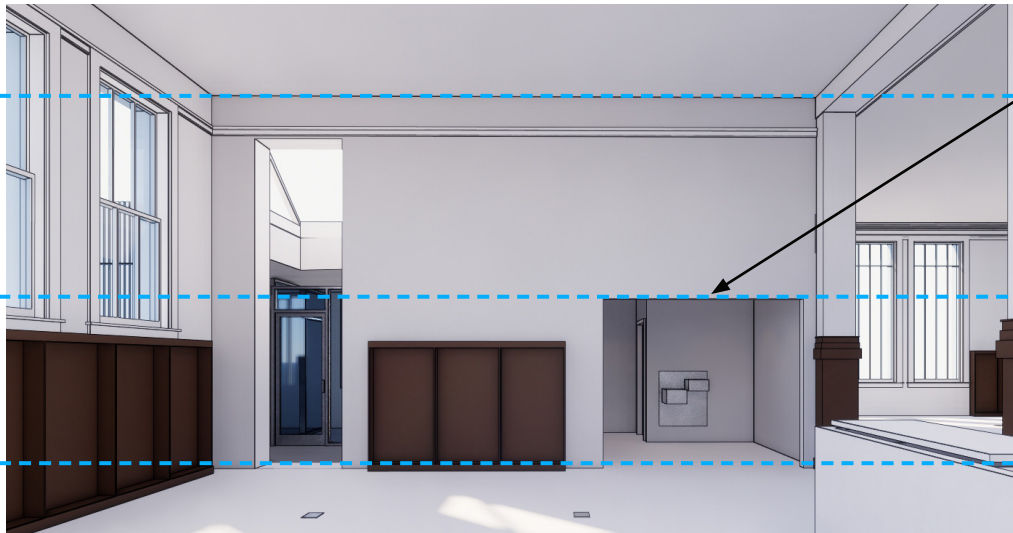
WEST WING NORTH - PROPOSED OPENING

At the April 6th Landmarks Preservation Board Meeting, SHKS proposed salvaging and reinstalling the existing wood and glass partition at the north wall of the west wing (see previous slide).

It was since found that this solution is incompatible with SPL's operational requirements of sufficient visual access and circulation clearances into this elevator lobby. Due to this and the visual impacts of the proposed elevator shaft obscuring half of the glazing, SHKS is now proposing the removal of this partition, and installing a headwall to align the opening with the mirrored south wall openings.

- **ELEV LOBBY OPENING WITH WOOD TRIM**
- HEADWALL TO MATCH MIRRORED OPENINGS/DOORS
- **STAFF WORK ROOM DOOR & ACCESSIBLE ENTRY DOOR**
- HEIGHT TO MATCH MIRRORED ELEV LOBBY HEADWALL

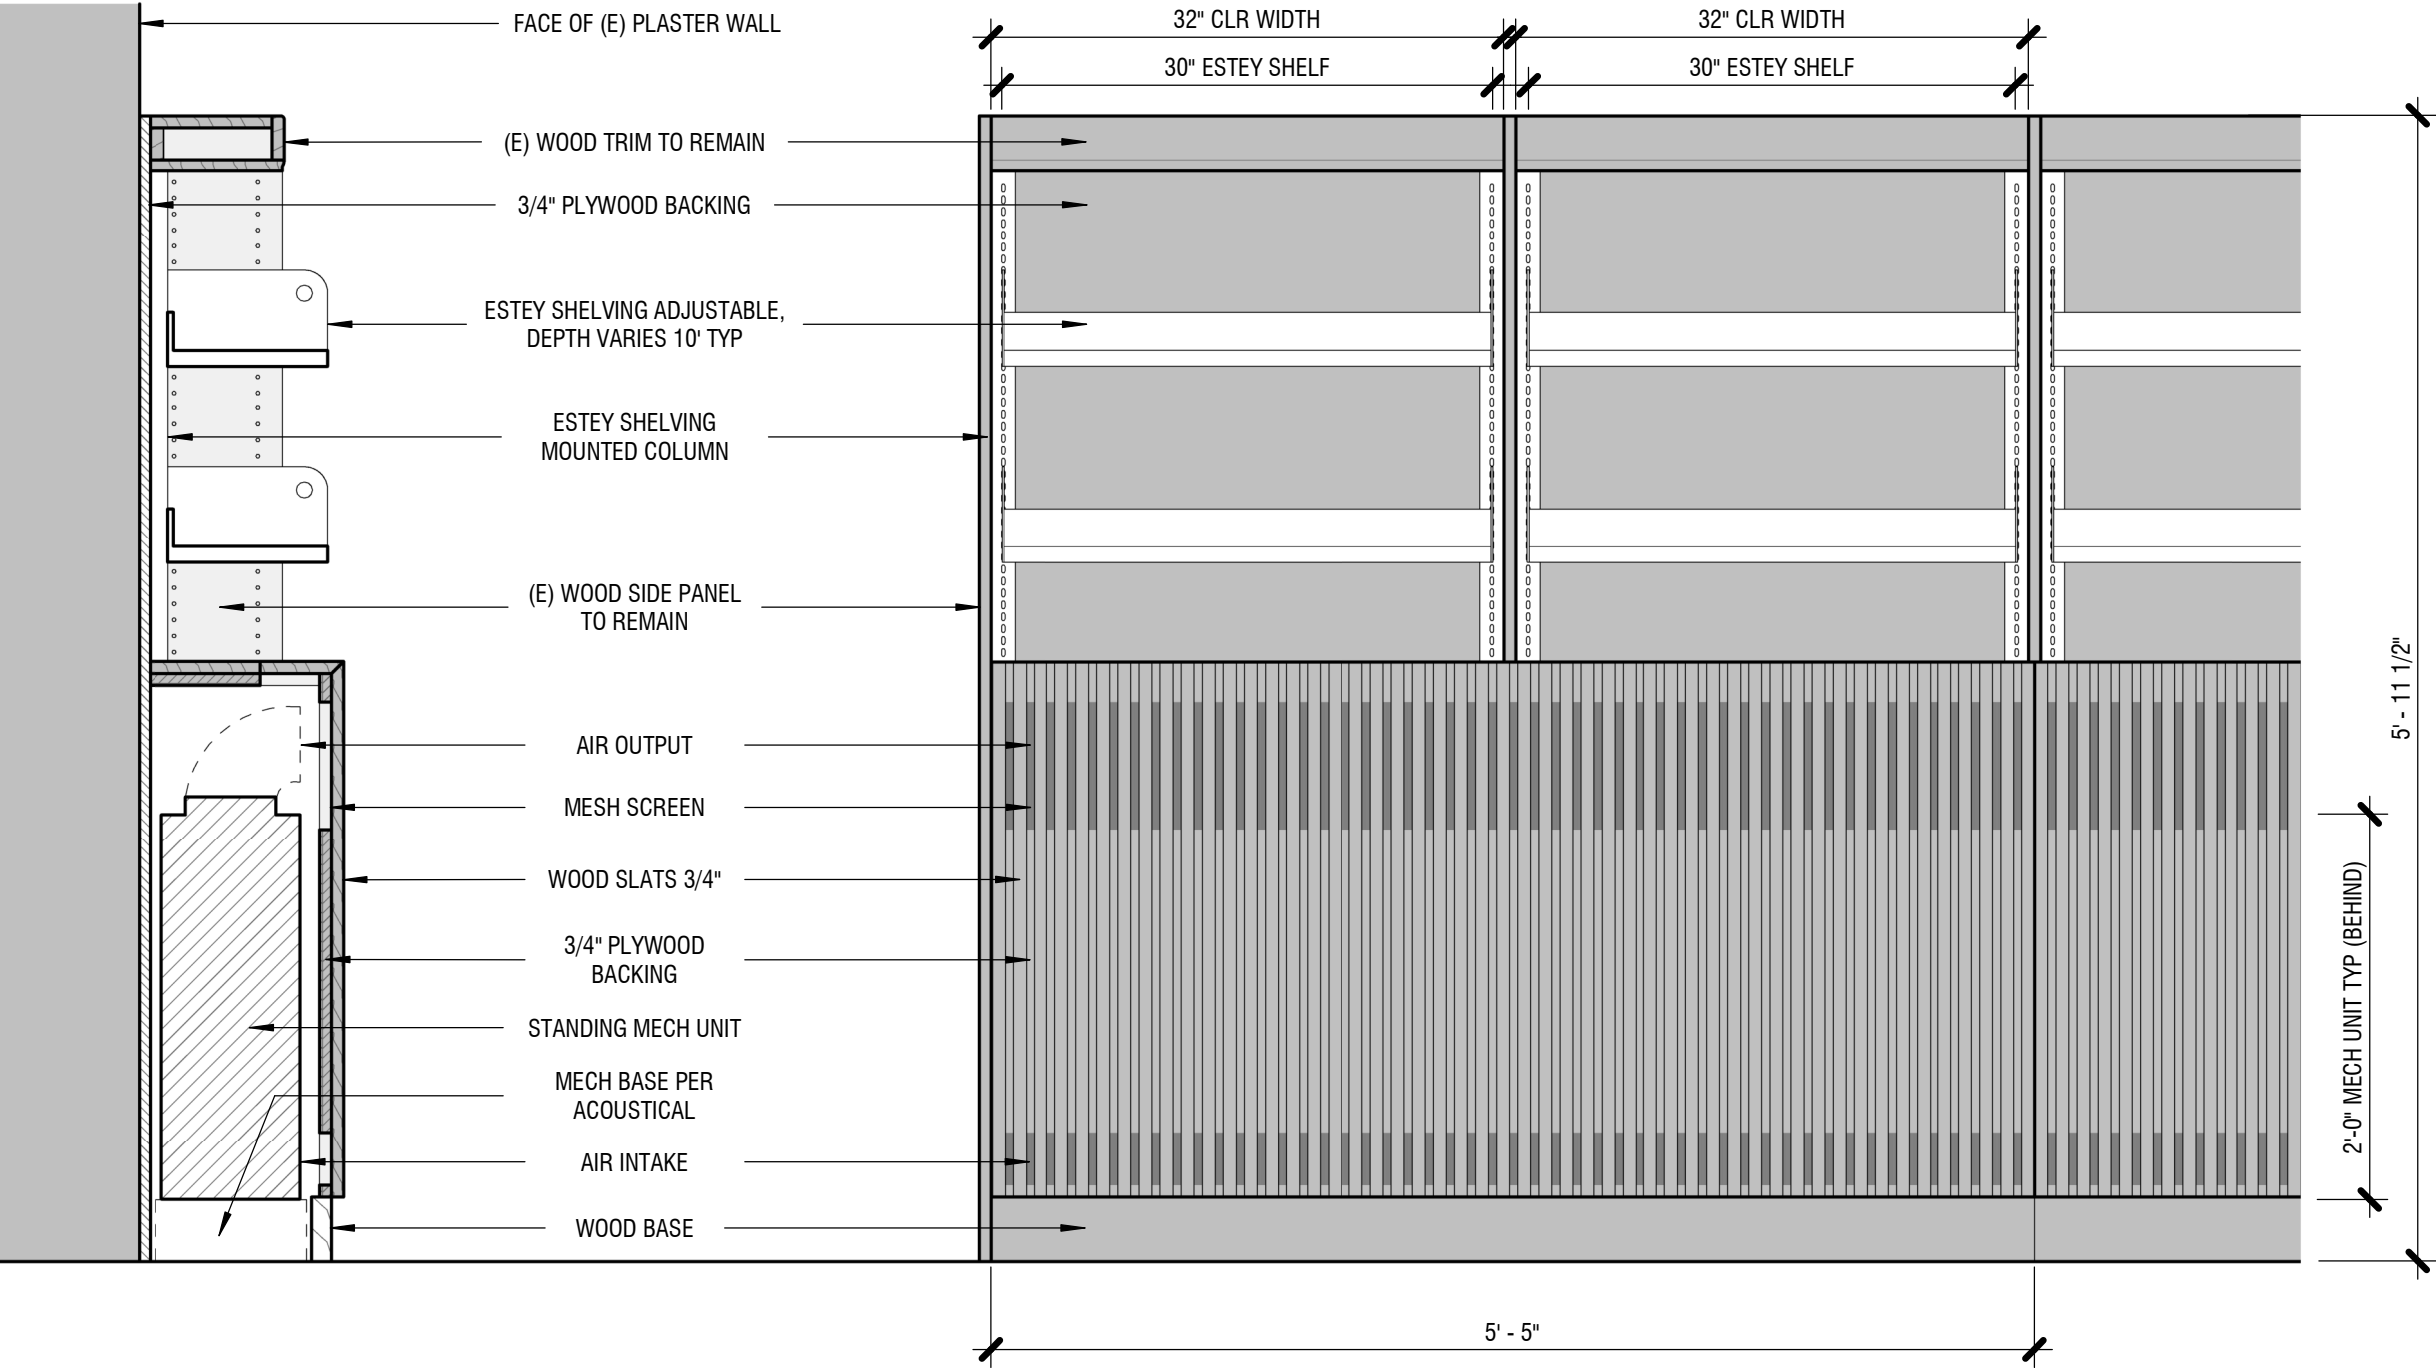
PROPOSED BOOK SHELVING SECTION WITH MECH UNIT CASEWORK - WEST READING ROOM

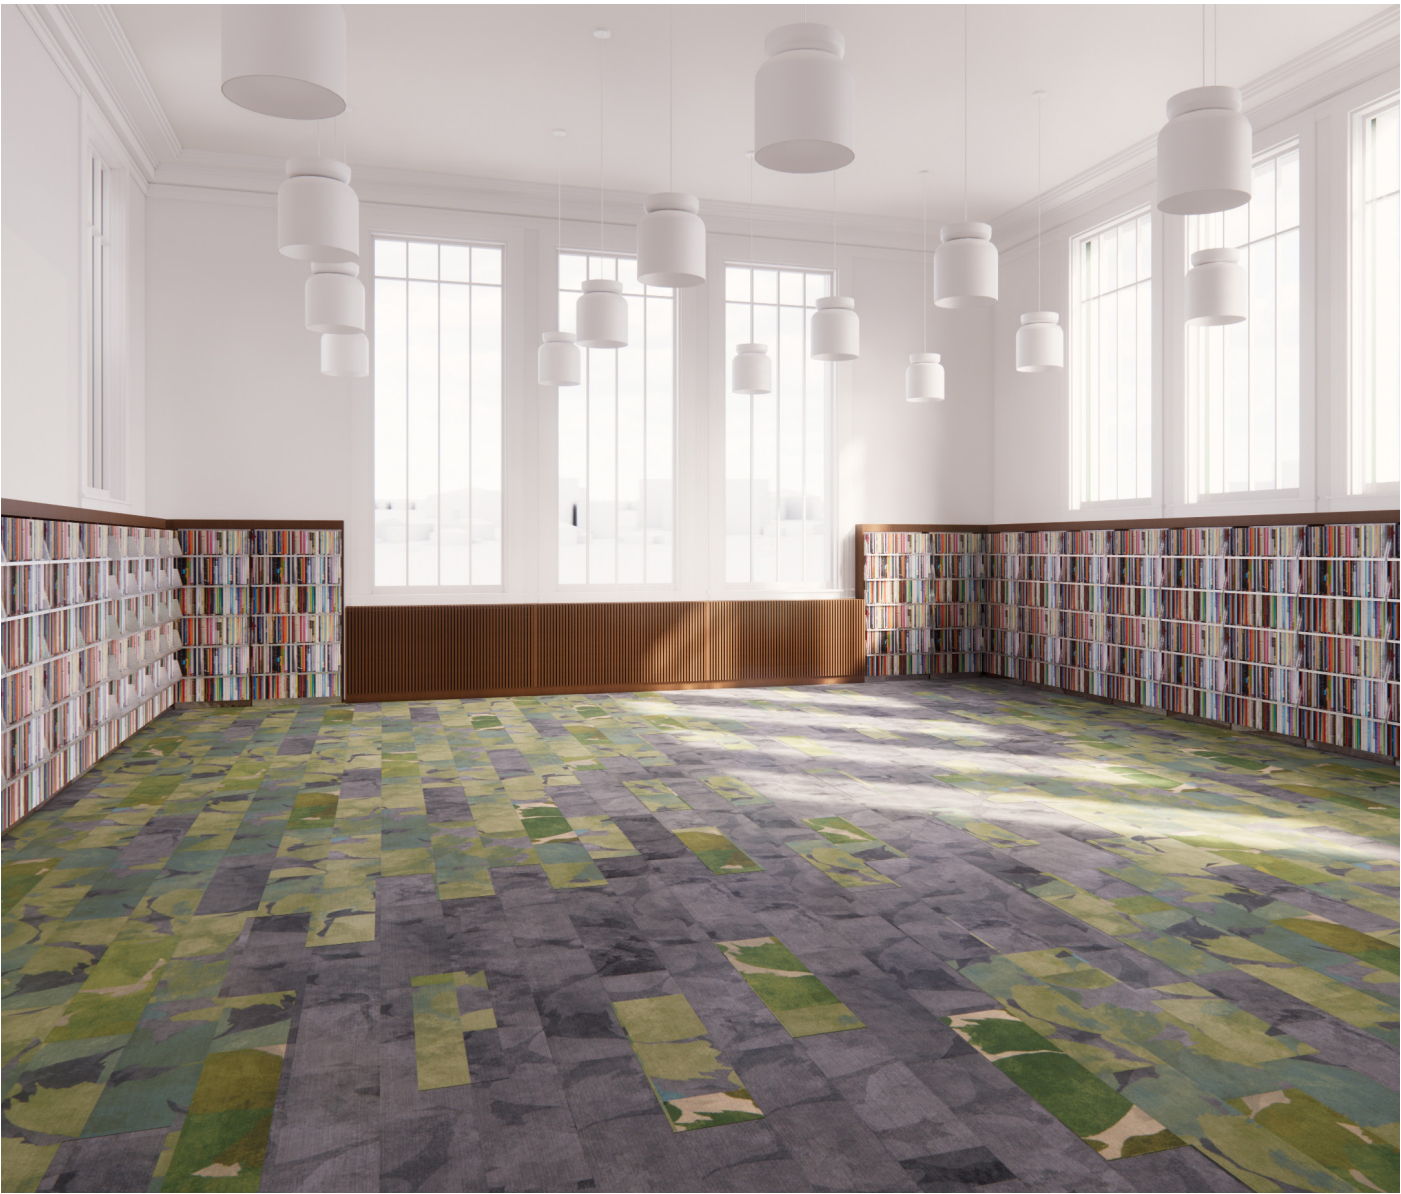
READING ROOM **(PROPOSED)**

- PAINT WALLS WHITE
- REPLACE (E) CARPET TILE; GREEN + GRAY
- INSTALL NEW WOOD FCU SURROUNDS
- INSTALL NEW PENDANT FIXTURES (PABLO DESIGN 'TOTEM')

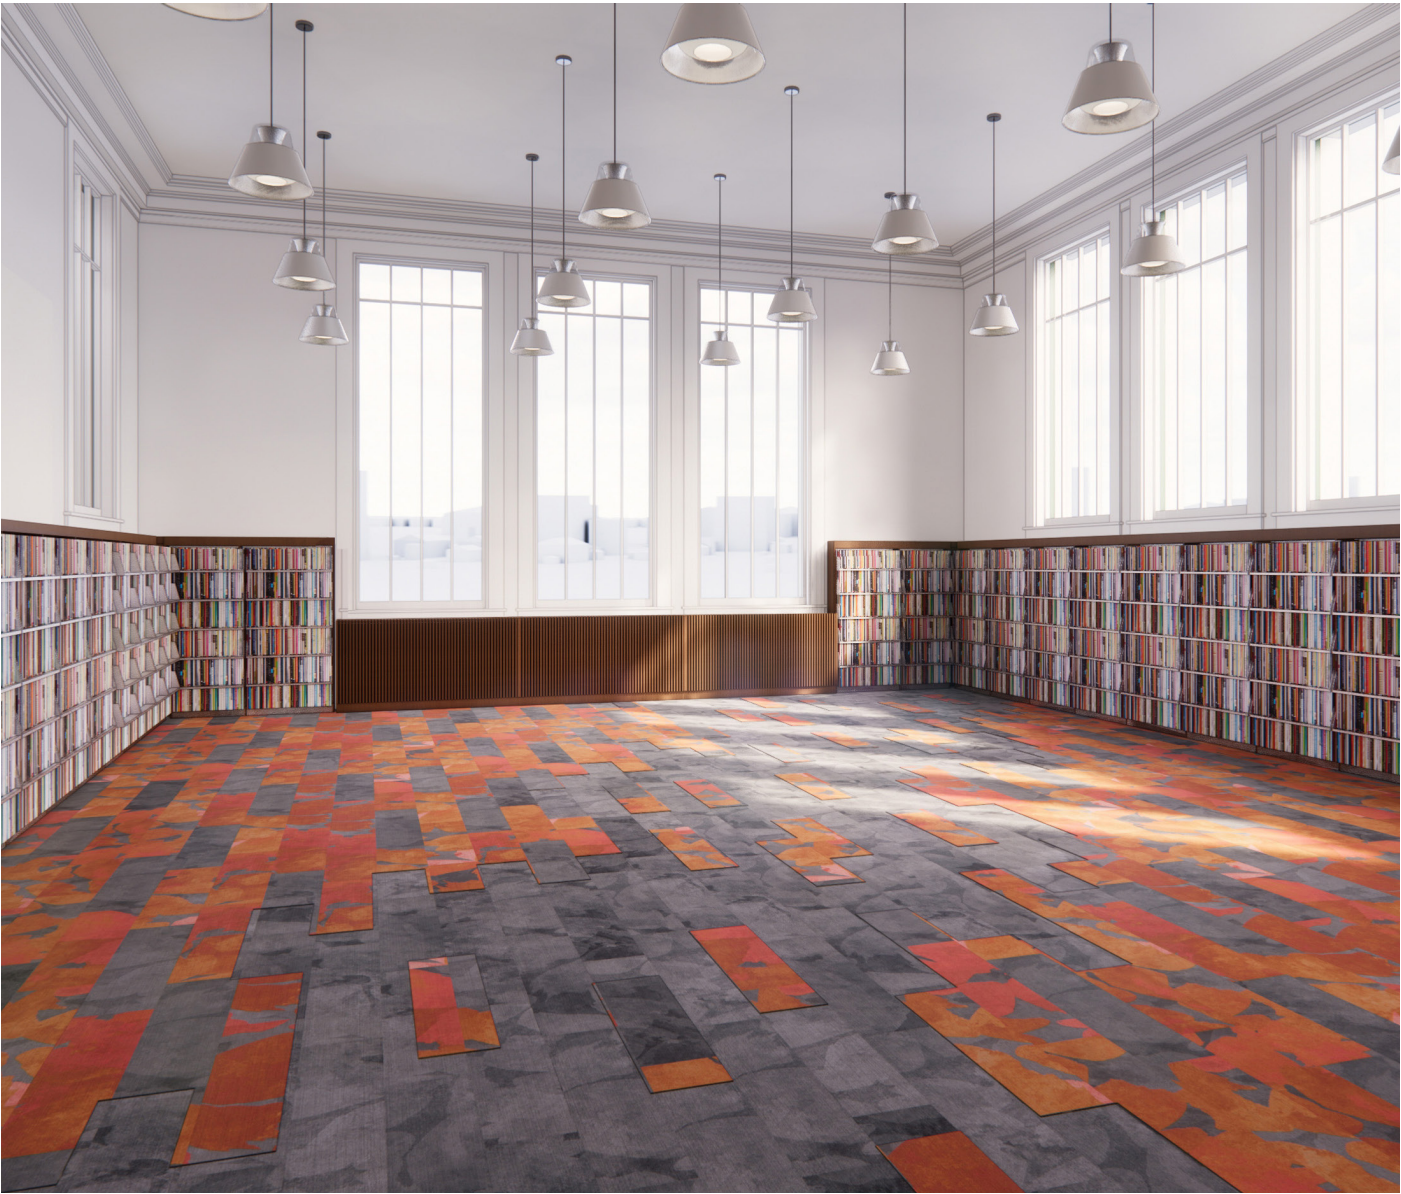
READING ROOM (ALTERNATE)

- PAINT WALLS WHITE
- REPLACE (E) CARPET TILE; ORANGE + GRAY
- INSTALL NEW WOOD FCU SURROUNDS
- INSTALL NEW PENDANT FIXTURES (EUREKA 'SKIRT')

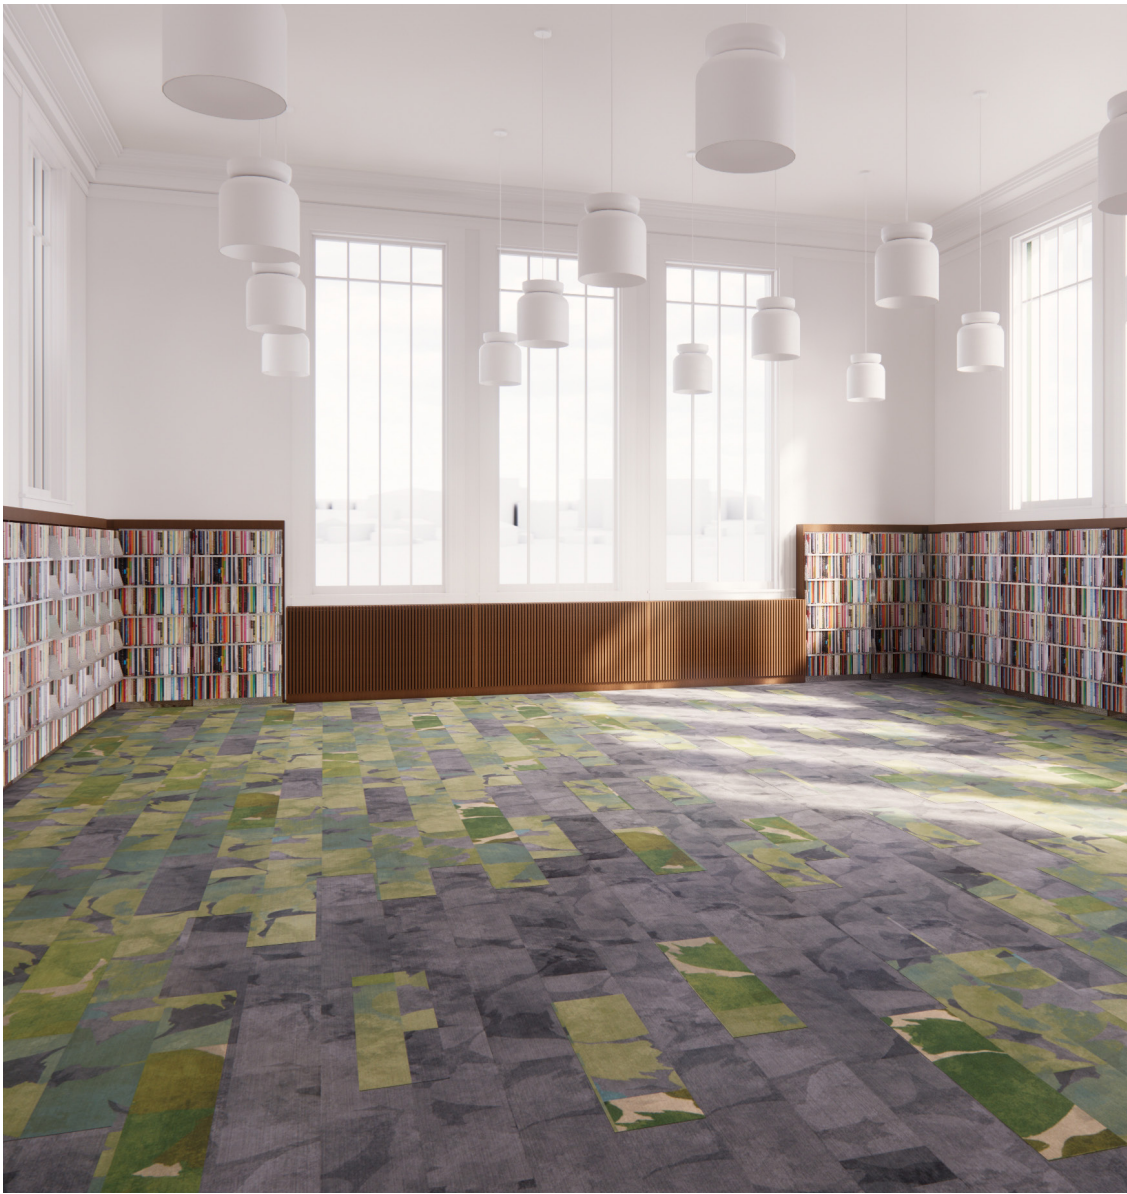
READING ROOM **(PROPOSED)**

- PAINT WALLS WHITE
- REPLACE (E) CARPET TILE; GREEN + GRAY
- INSTALL NEW WOOD FCU SURROUNDS
- INSTALL NEW PENDANT FIXTURES (PABLO DESIGN 'TOTEM')

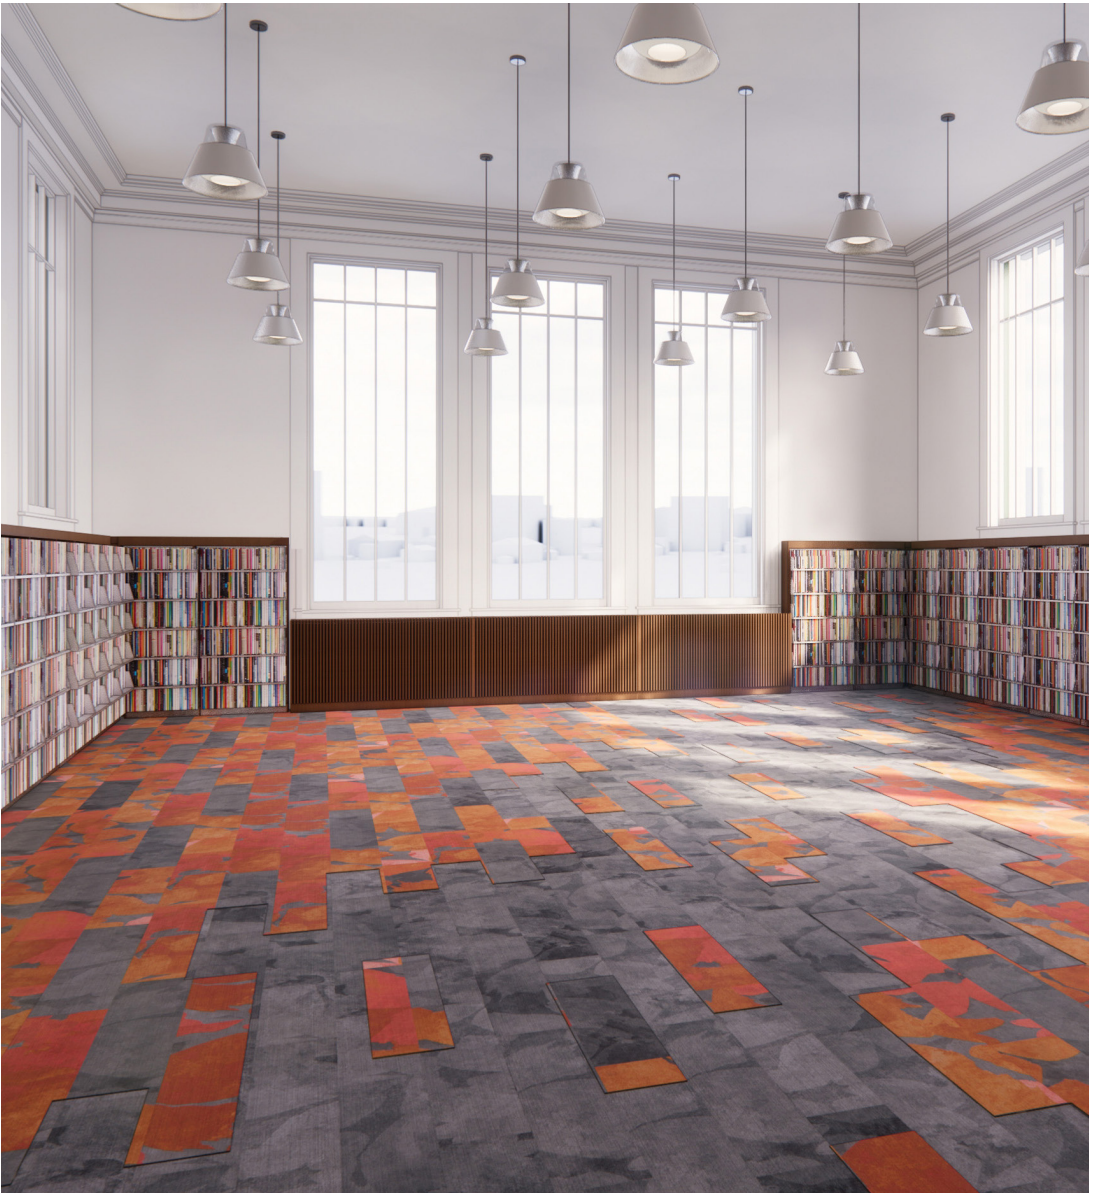
ALTERNATE READING ROOM

- PAINT WALLS WHITE
- REPLACE (E) CARPET TILE; ORANGE + GRAY
- INSTALL NEW WOOD FCU SURROUNDS
- INSTALL NEW PENDANT FIXTURES (EUREKA 'SKIRT')
