TALARIS PROJECT RECAP

SITE ENHANCEMENTS / COHESIVE WHOLE SITE LANDMARK REHABILITATION

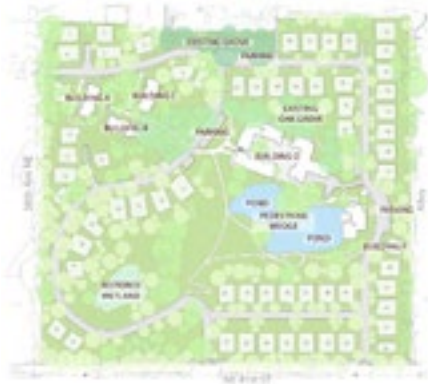
67 LOT SITE PLAN

- +Six Board/ARC briefings. Started with 67 new single-family residential lots, renovation of Buildings A/B/C/D/F and removal of Buildings E & G.
- +Board shared concerns regarding extent of impacts on the landmark buildings and landscape.
- +Applicant incorporated Board feedback and reduced site plan to 62 new SFR lots.
- +Board further shared concerns about overall site planning, general generic home design and removal of mature oak and conifer groves.

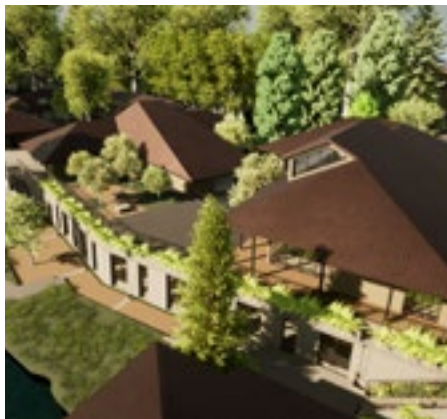
D ADDITION

- +Reviewed updated rehabilitation approach for Building D and F
- +Reviewed conceptual design of Building D-Addition
- +Updated video walk through of the overall site development plan

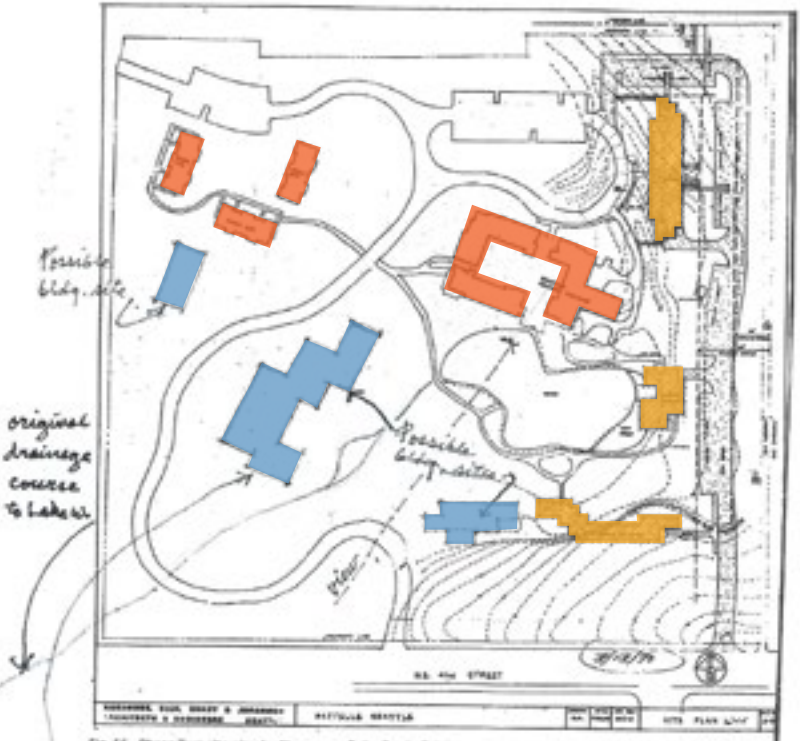
Fig. 55. Phase Two site plan by Naresmore, Bain, Brady & Johnson, 1970. Phase Two buildings indicated by shaded footprints. Source: City of Seattle Department of Planning and Development, Microfilm Library.

- + Team used NBBJ/Haag's various expansion ideas to guide site planning.
- + Expansion design maintained pond and wetlands landscape and the northern planted oak grove
- + Original design did not have view from entry road.
- + Unbuilt Wetlands Building and parking added to the SW core of the site and introduced new view from entry across to Building D
- + Despite the SW expansion not getting built, a new view from the entry view was created by removing trees.

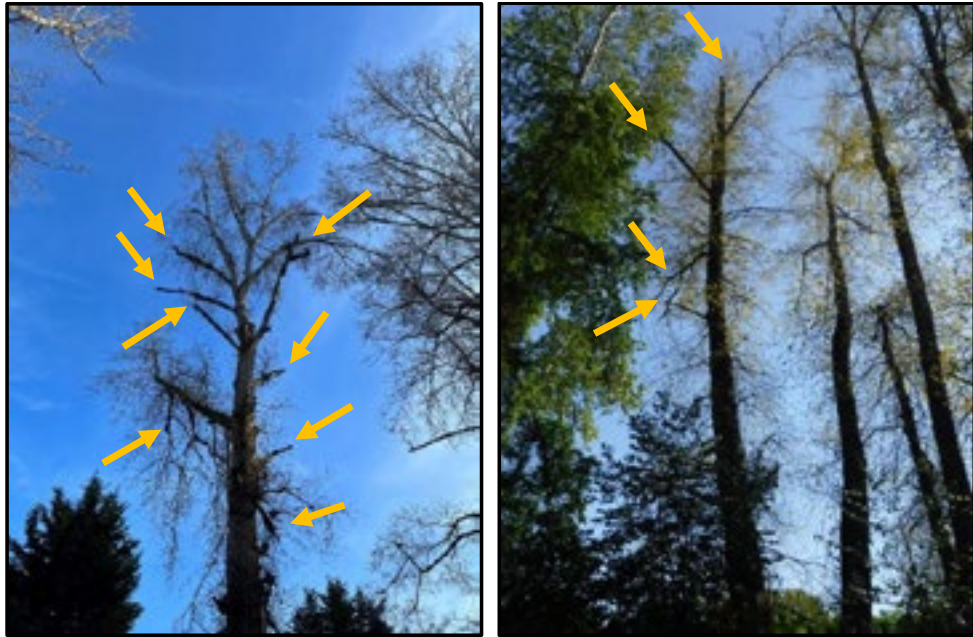
Photo 19. Black cottonwood trees in the southwest portion of the site with major canopy part failures (orange arrows).

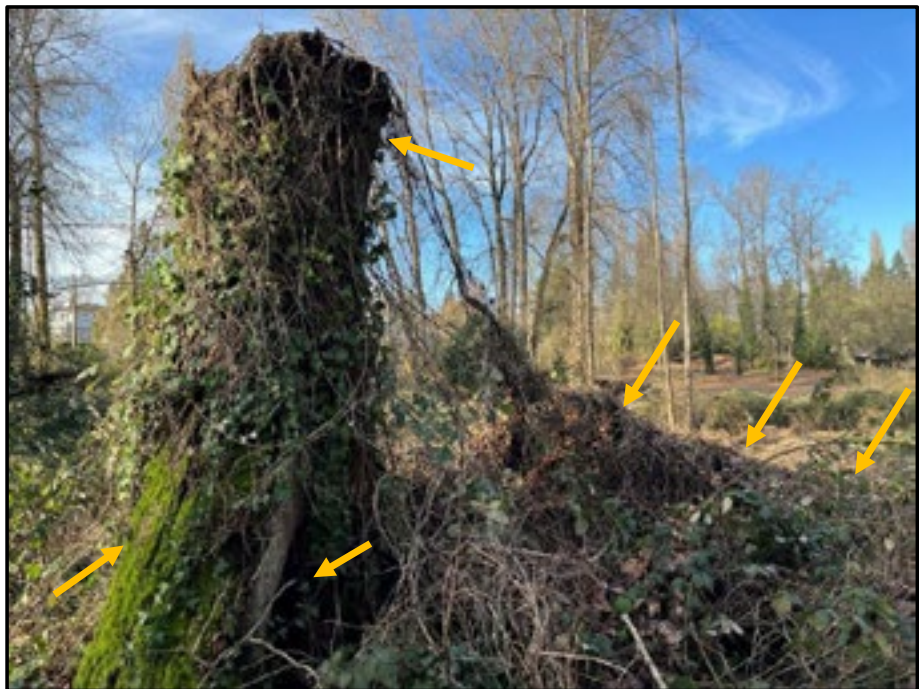
Photo 20. The stump and fallen stem (orange arrows) of 315 that failed sometime in 2021 and was discovered in January of 2022.

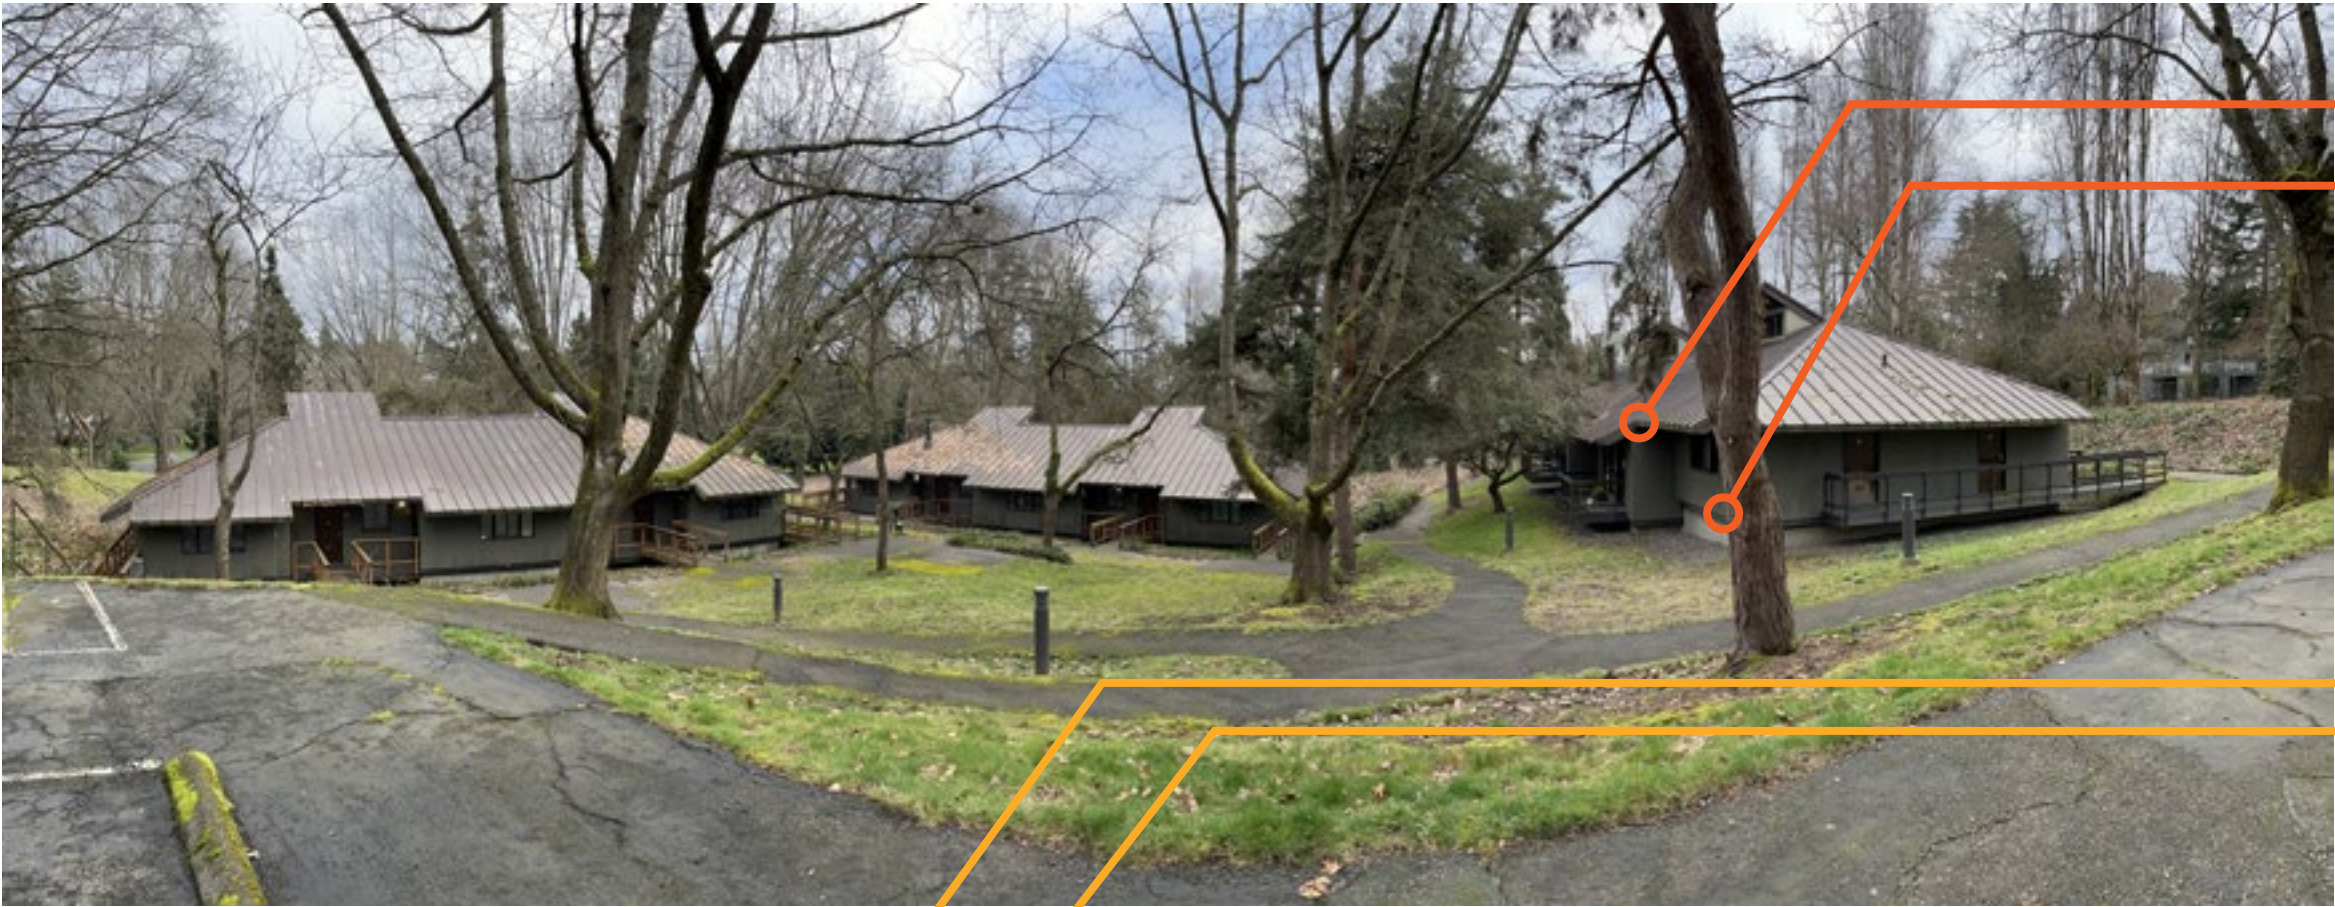
CHARACTER DEFINING FEATURES / BUILDINGS A, B, & C

- + Hipped Roof Forms with Deep Eaves
- + Batten Seam Metal Roofing Materials
- + Recessed Concrete Foundations with Articulated Belt Course
- + Painted Wood Siding
- + Aluminum Window Frames

- + Cedar Wood Board Eaves with Continuous Venting;
- + Sunken, Projecting Living Room Bays;
- + Recessed Entry Deck with Roof Overhang Broken;
- + Projecting Wood Walkways
- + Painted Wood Guardrails
- + Private Elevated Wood Decks/Rails

- + Wood Doors/Frames
- + Building Graphics
- + Metal Chimneys
- + Plumbing Roof Vent Pipes
- + Wall Mounted Light Fixtures
- + Light Bollards

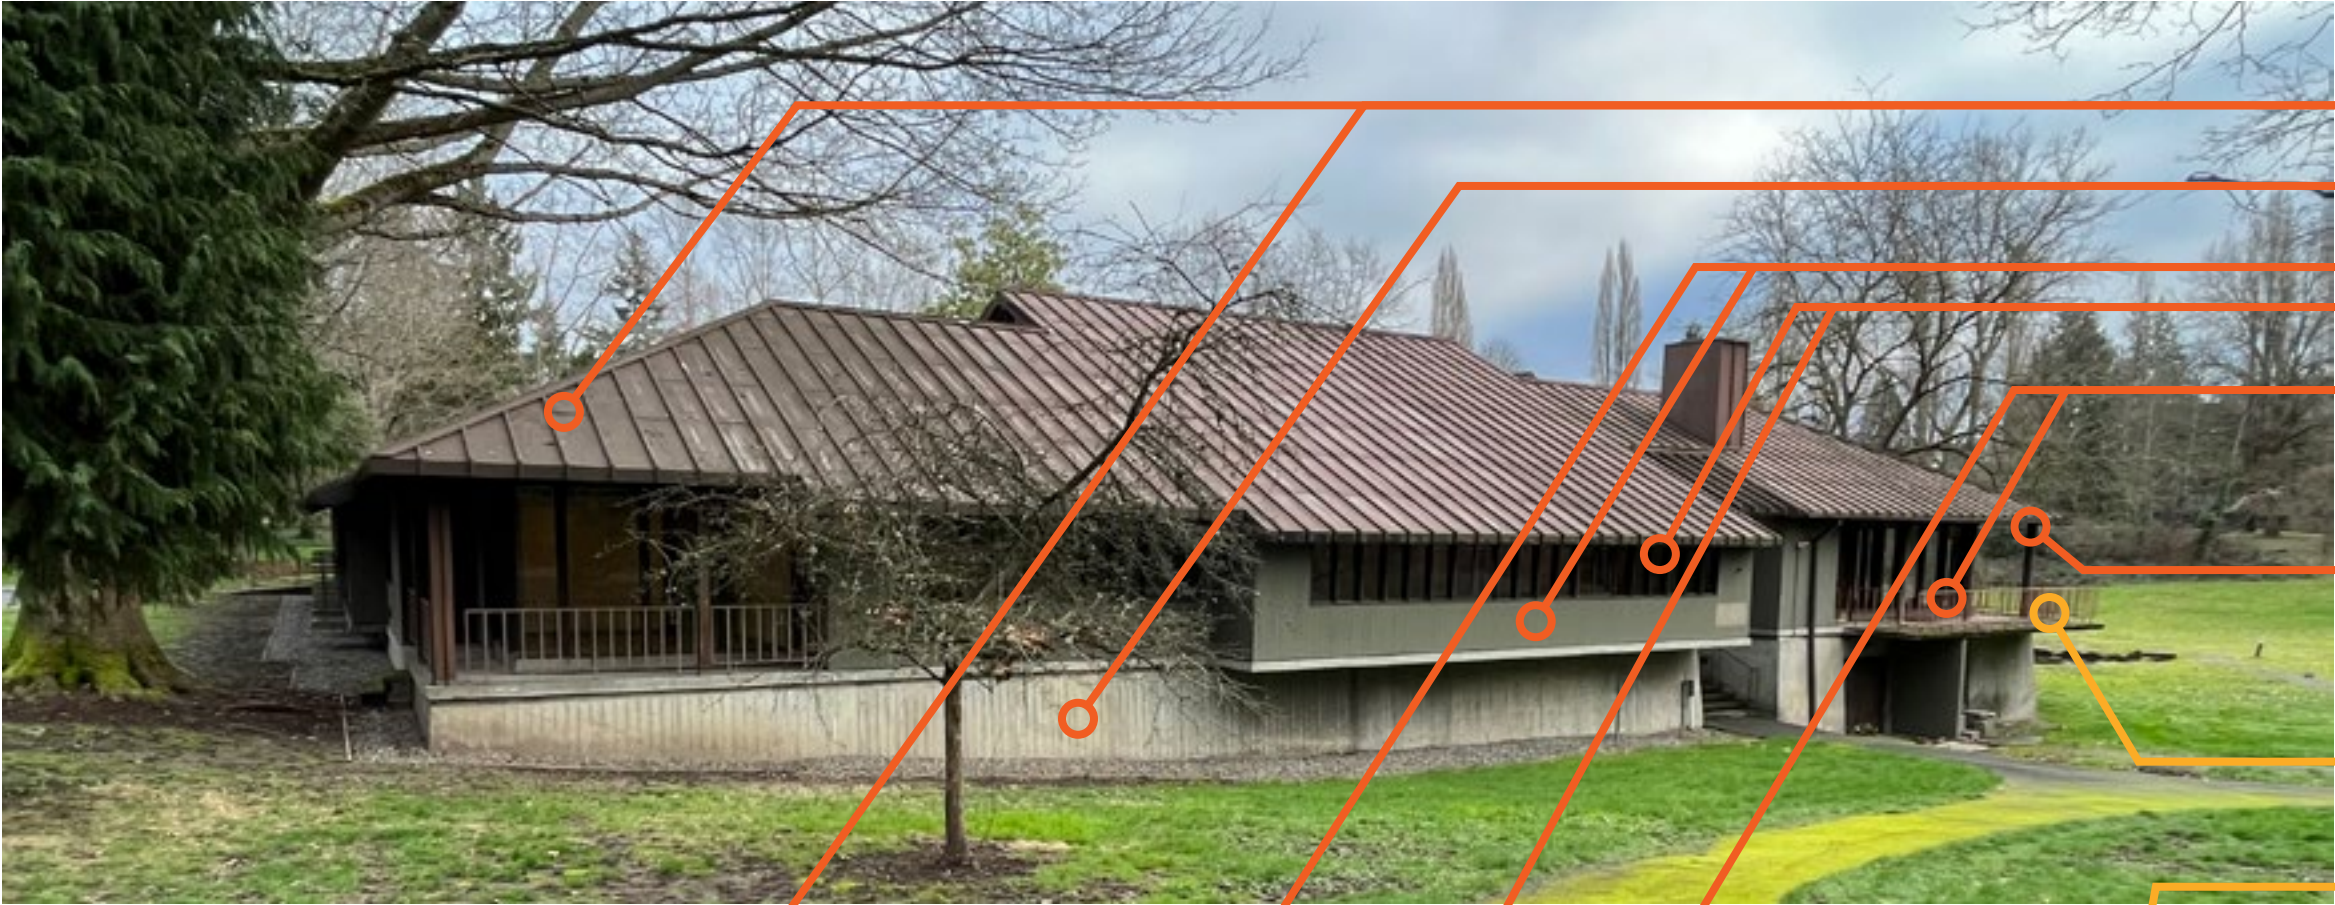
- + Hipped Roof Forms with Deep Eaves
- + Batten Seam Metal Roofing Materials
- + Battered Concrete Plinth Foundation with Articulated Belt Course
- + Painted Wood Siding
- + Aluminum Window Frames with Vertical Orientation
- + Cantilevered Concrete Balconies
- + Courtyard with Japanese Influenced Garden
- + Pond Overlook
- + Deep Cedar Wood Board Eaves with Continuous Venting

- + Painted Metal Guardrails
- + Exposed Roof Rafters Adjacent to Courtyard Entrances
- + Covered Decks with Storefront Glazing System at SW, NW, and NE Corners
- + Cast-in-place Exterior Concrete Stairs With Exposed Aggregate Finish
- + Courtyard and Building Perimeter Rain Drainage System and Concrete Paving Pattern

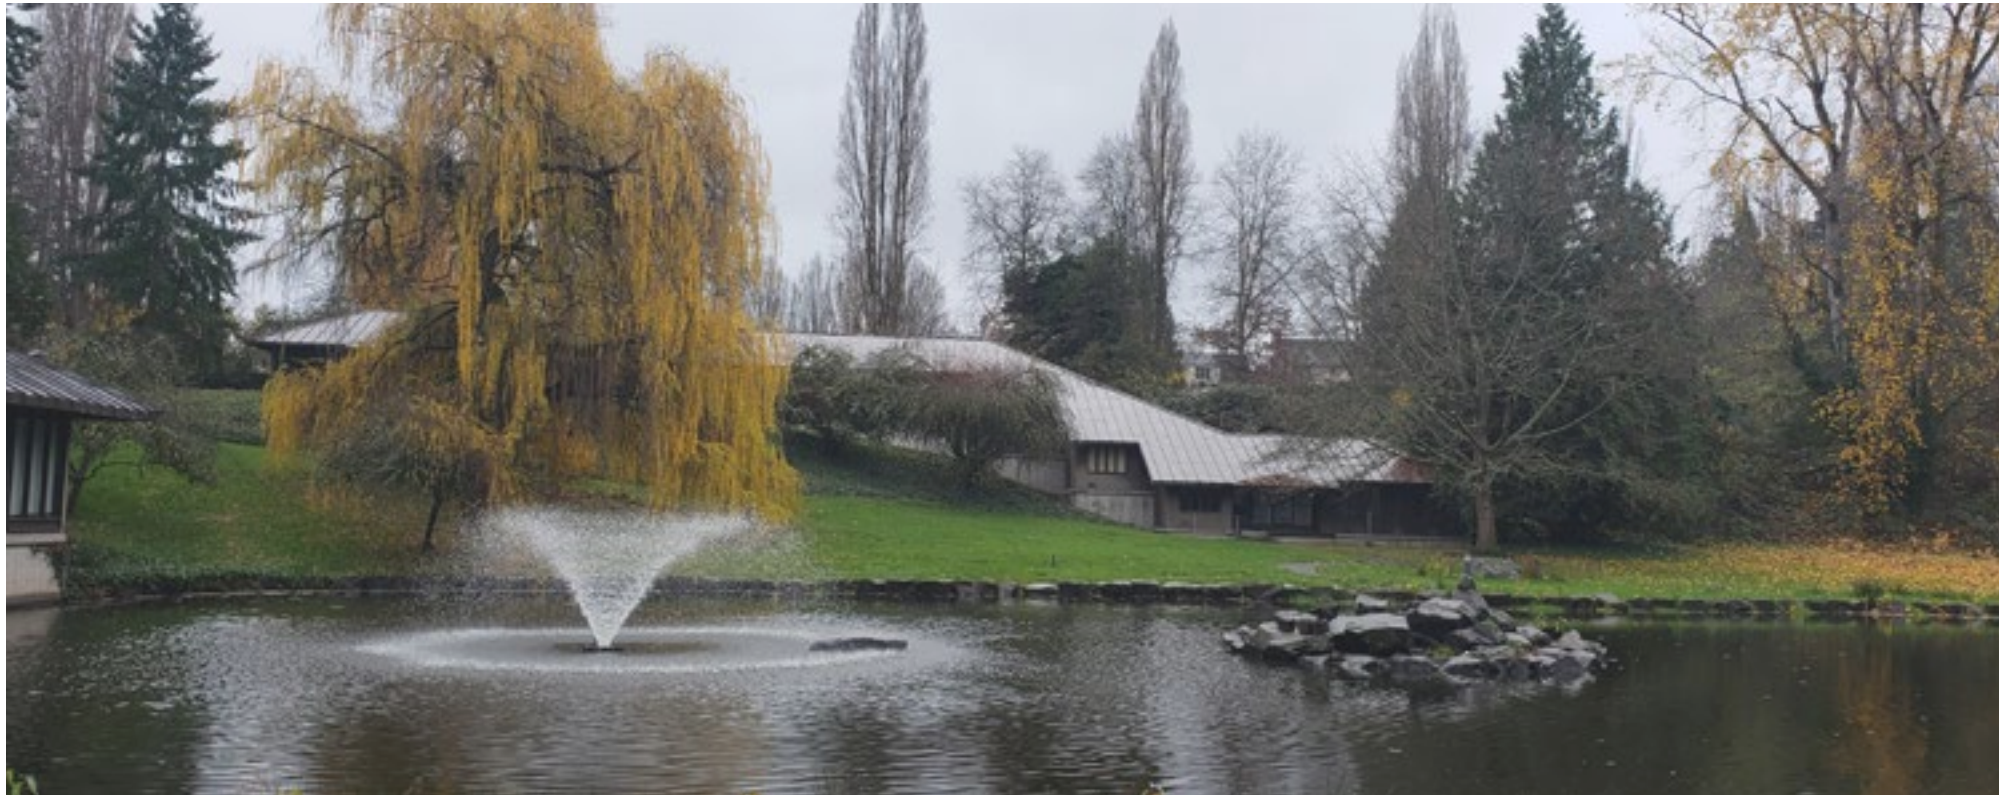
EXISTING

BALANCING WHOLE SITE LANDMARKS / DESIGN CHALLENGES WITH MAINTAINING BUILDING G

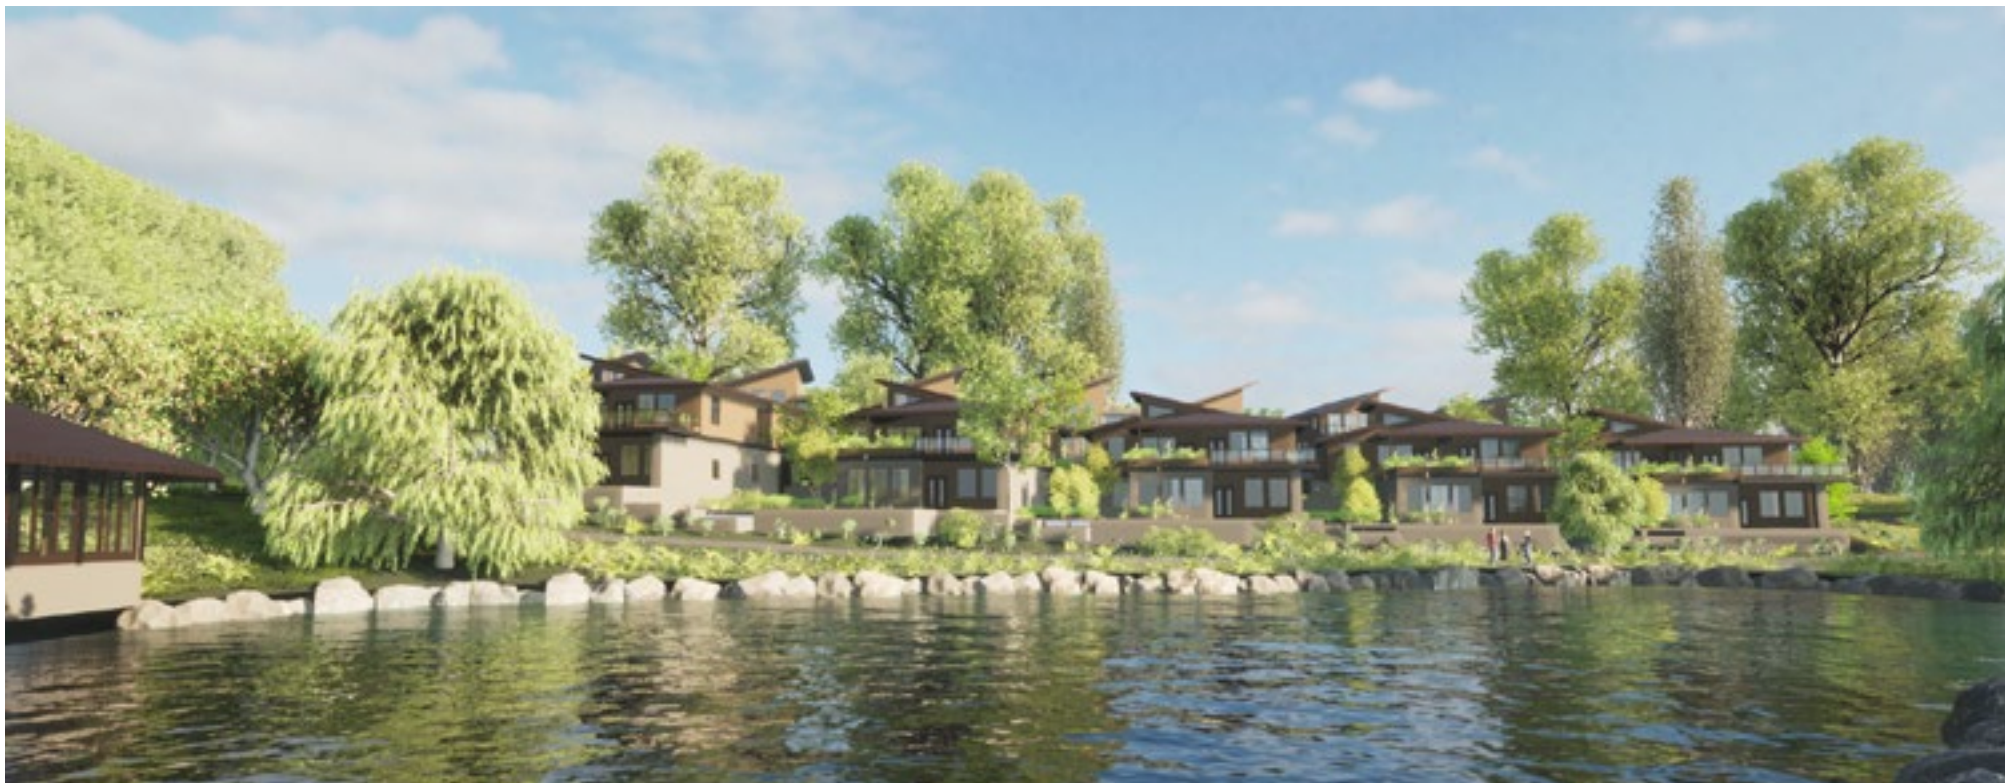
PROPOSED

Key design considerations for the replacement of Building G.

The new homes:

- + Preserve strong roof lines stepping uphill
- + Hold the edge of the center core
- + Resolve accessibility issues and provide new pathways that enhance connectivity into the heart of the campus
- + Rehabilitate and enhance the Japanese influenced garden design
- + Introduce additional landscape and water features along the revitalized south edge of the pond
- + Provide an economically viable design alternative

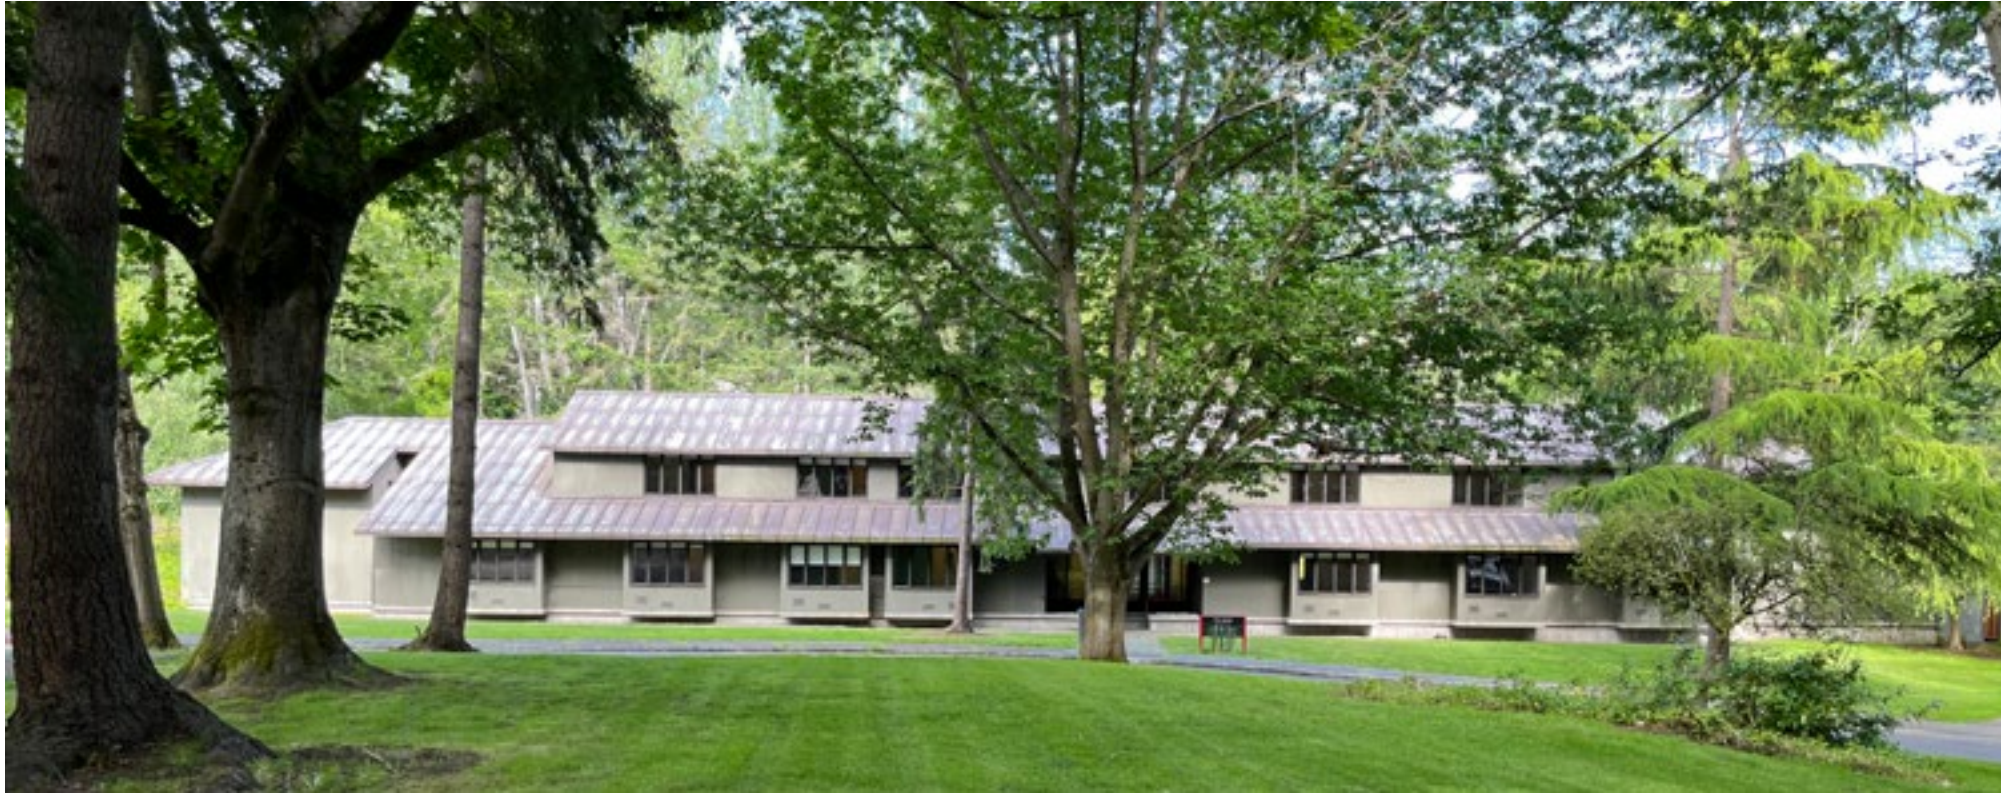
EXISTING

BALANCING WHOLE SITE LANDMARKS / REPLACEMENT OF BUILDING E

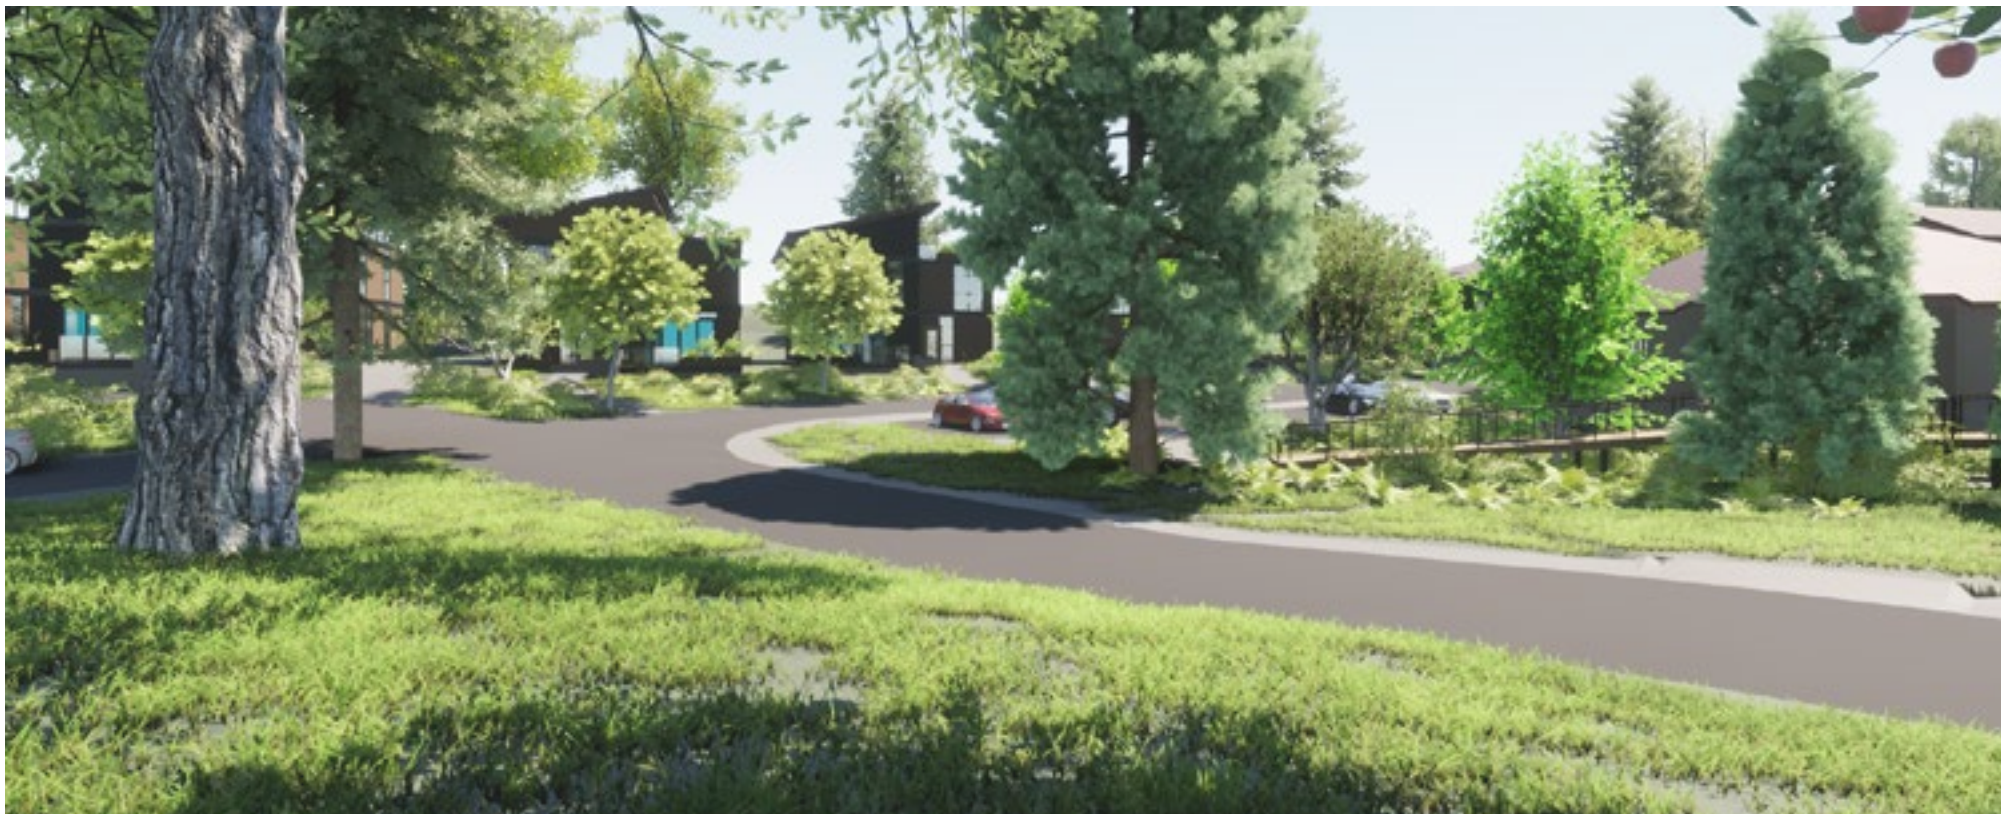
PROPOSED

Key design considerations for the replacement of Building E.

- + Creates less paved area and more landscaping in this area of the site
- + Allows Building D-Addition to connect existing historic buildings and provide new pathways and landscape at the edge of the preserved Oak Grove
- + Will celebrate storm water management of proposed development through the creation of rain gardens north of the new Building D Addition.
- + Will enhance pedestrian connectivity with an elevated boardwalk from the northern oak grove to the new D Addition elevated courtyard.
- + Provides an elevated boardwalk spanning the rain gardens to offer new views of the oak grove tree canopy.
- + Provides an economically viable design alternative.

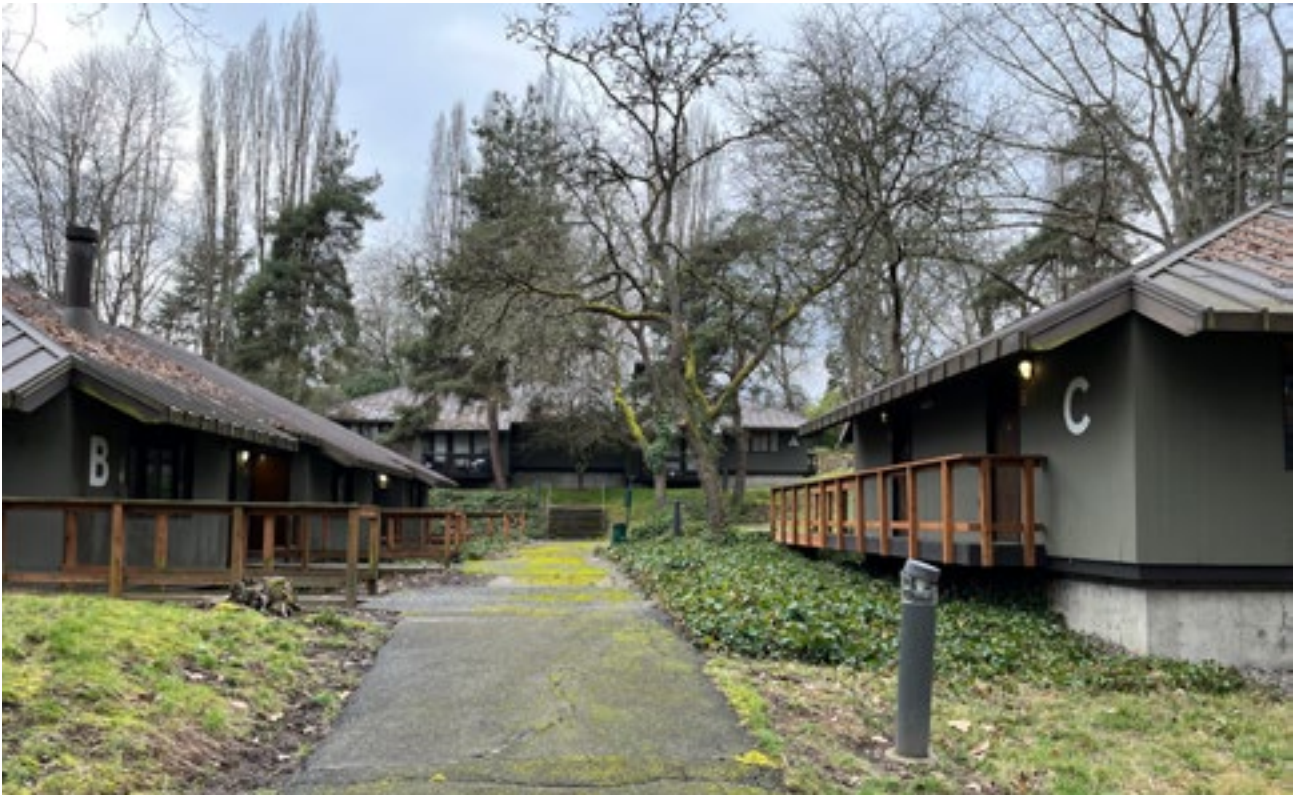
BUILDINGS A, B & C

REHABILITATION / BUILDINGS A, B, & C

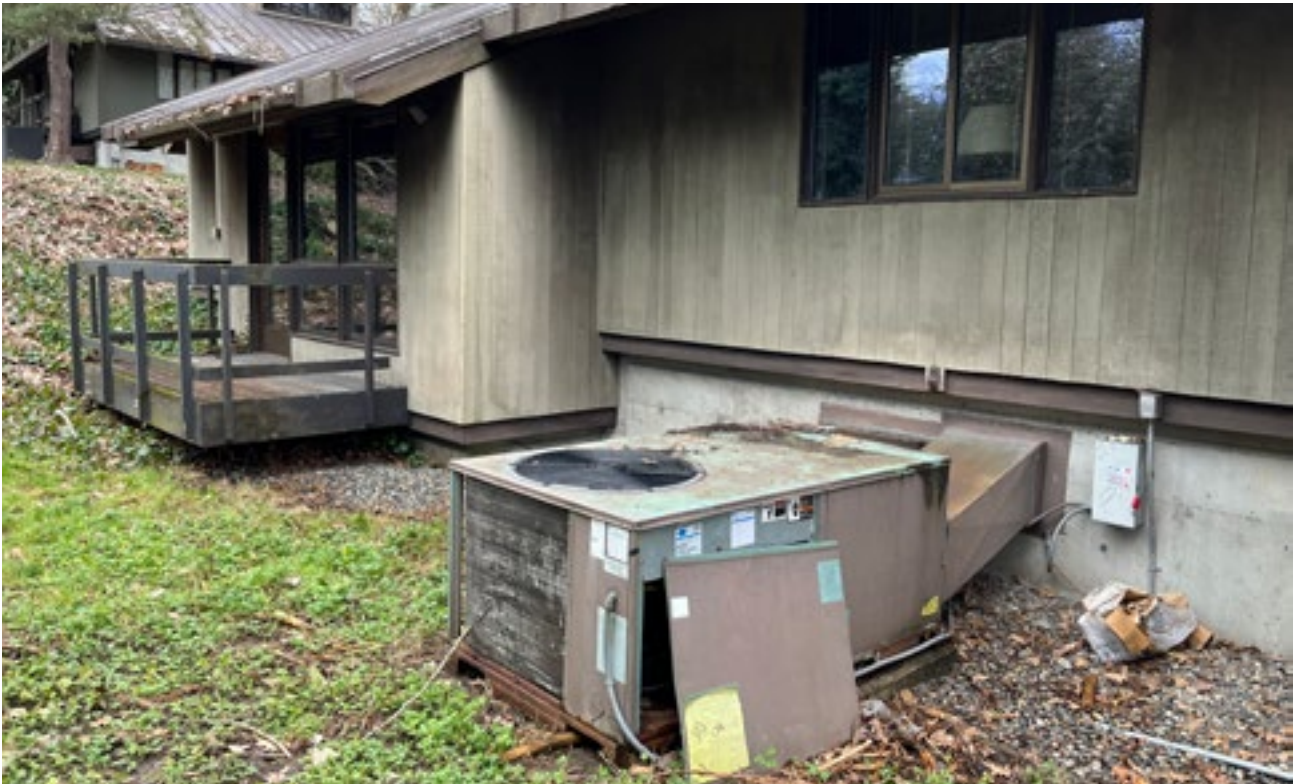
BUILDING B - EXISTING CONDITION SOUTH

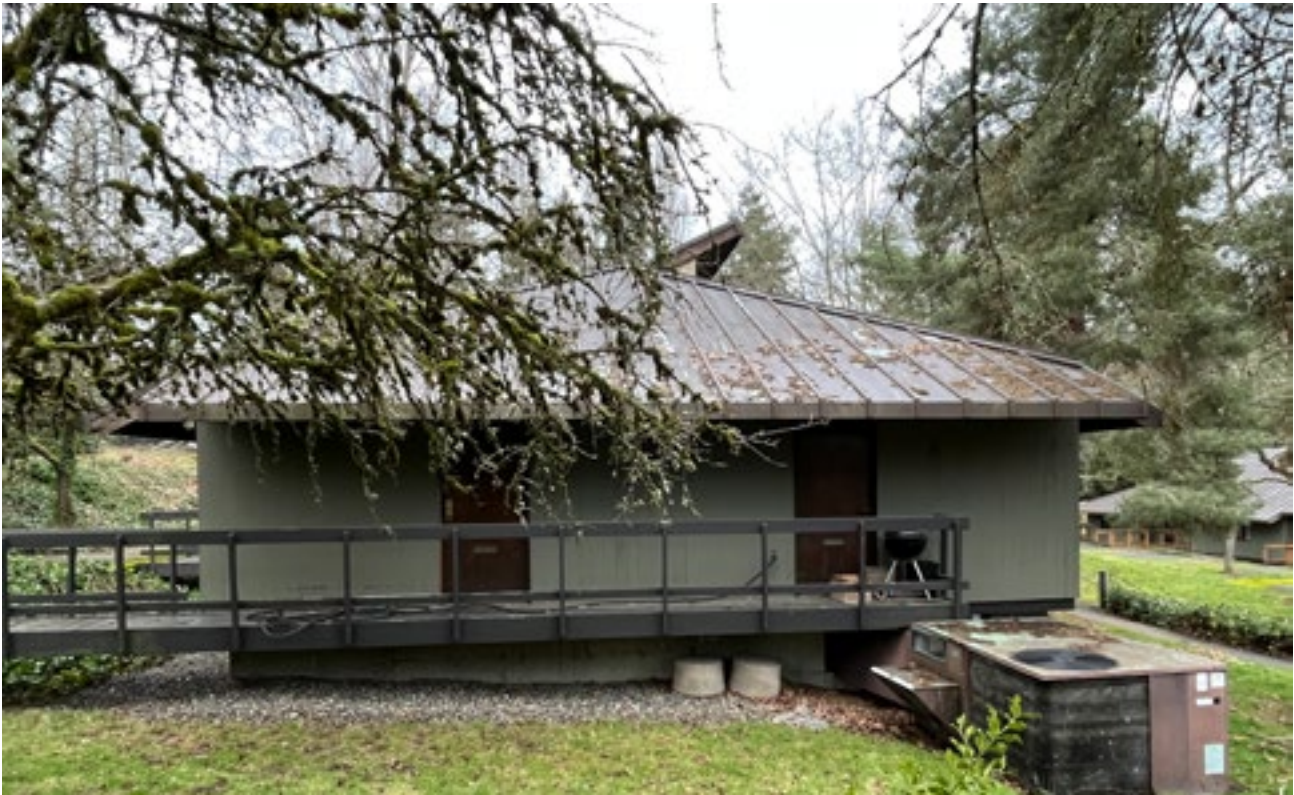
BUILDING A - EXISTING CONDITION SOUTH

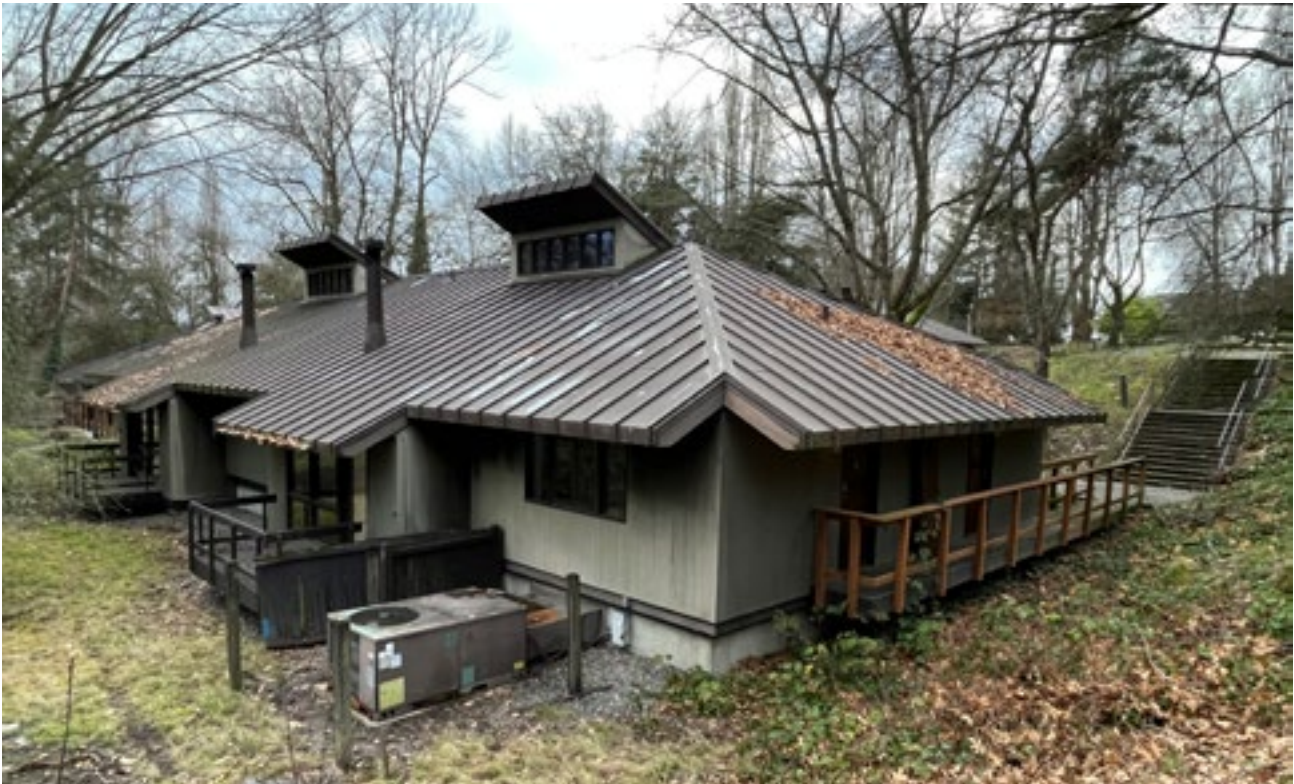
BUILDING C - EXISTING CONDITION NORTH

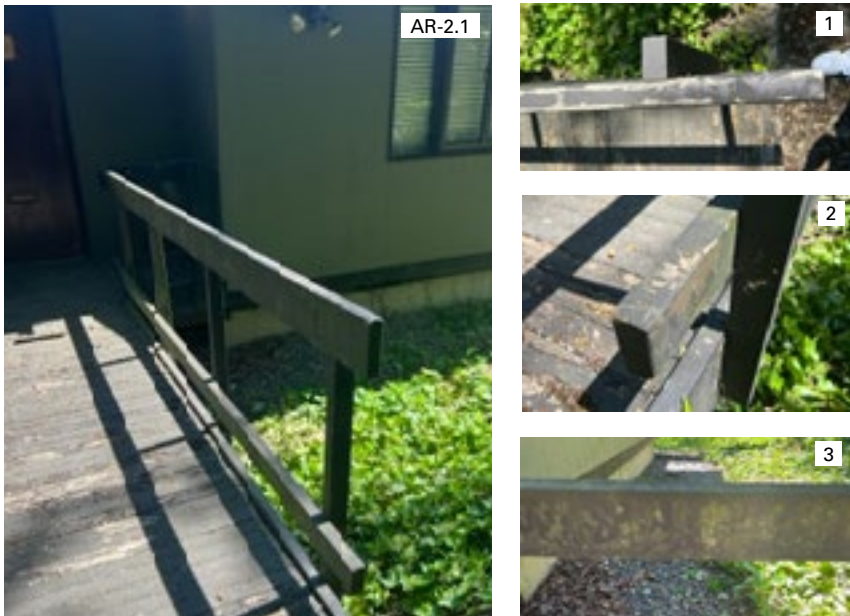
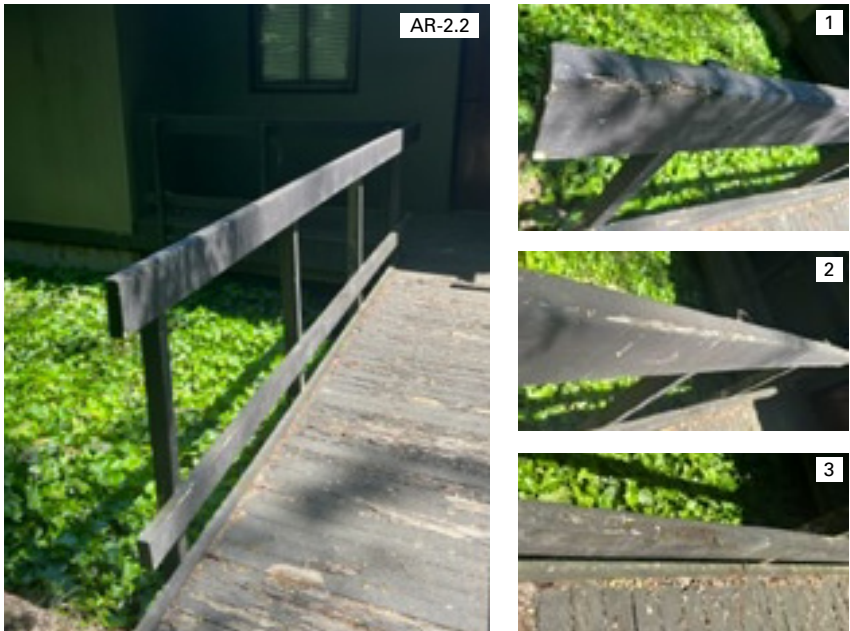
BUILDING A: EXISTING CONDITIONS - RAIL

- + PAINTED WOOD RAILING, DARK BROWN
- 1. DAMAGE AT HORIZONTAL VERTICAL RAIL
- 2. SPLIT AT HORIZONTAL RAIL
- 3. BIOLOGICAL GROWTH AT VERTICAL RAILS

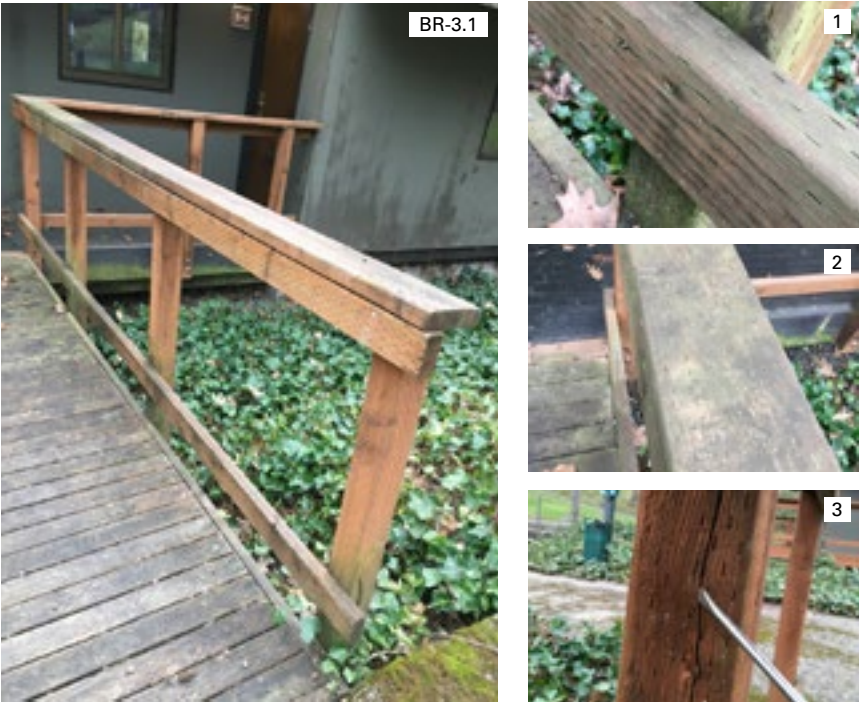
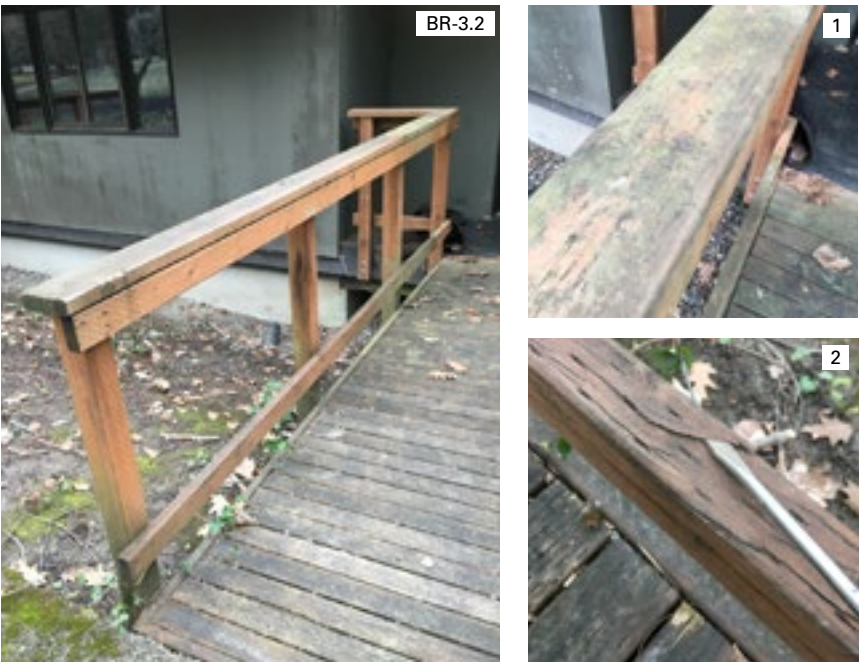
BUILDING B: EXISTING CONDITIONS - RAIL

- + PRESSURE-TREATED LUMBER RAILING, UNFINISHED
- 1. CHECKED CONDITION AT HORIZONTAL RAIL
- 2. MINOR CHECKED CONDITION AND BIOLOGICAL GROWTH ON HORIZONTAL TOP RAIL
- 3. CRACK AT VERTICAL RAIL

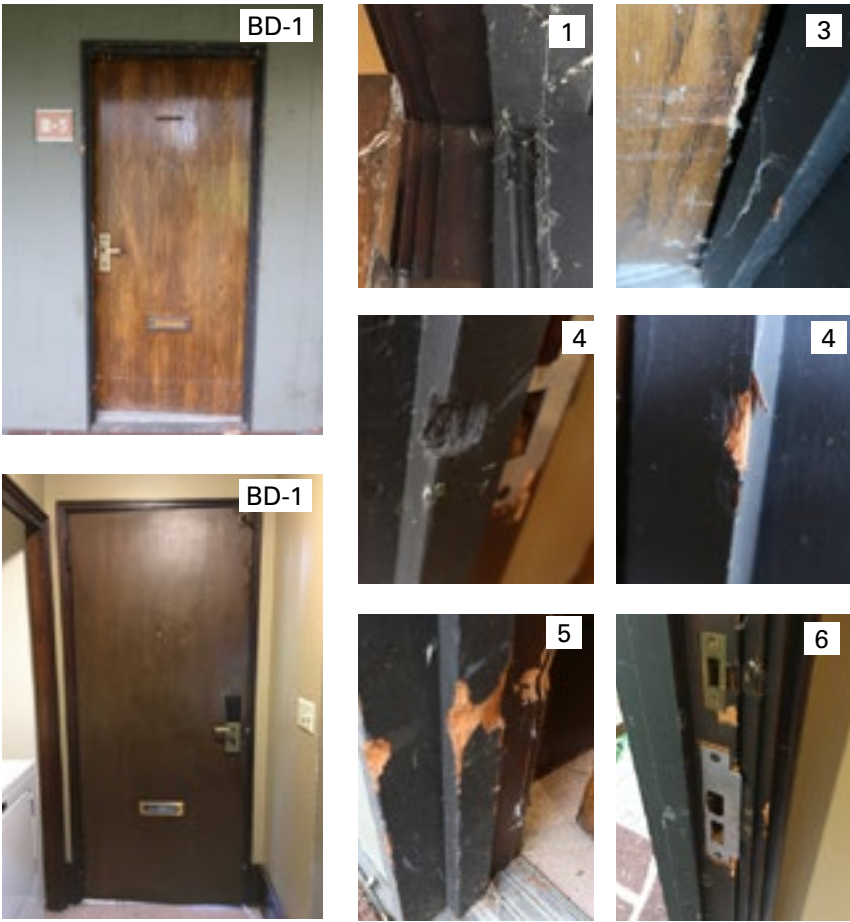
BUILDING B: EXISTING CONDITIONS - DOORS
BD-1 | TYPE A

+ STAIN AND LACQUER FLUSH WOOD DOOR

- + PAINTED WOOD FRAMES, DARK BROWN
- 1. LARGE DAMAGE AT JAMB
- 2. SCRATCHES ON DOOR SURFACE
- 3. CHIPPED EDGES AT DOOR
- 4. CHIPPED AND DAMAGED CONDITIONS AT JAMBS AND FRAMES

- + STAIN AND LACQUER WOOD TRIMS, DARK BROWN
- 5. SCRATCHES AND DAMAGE AT JAMB
- 6. CHIPPED CONDITIONS AT TRIM

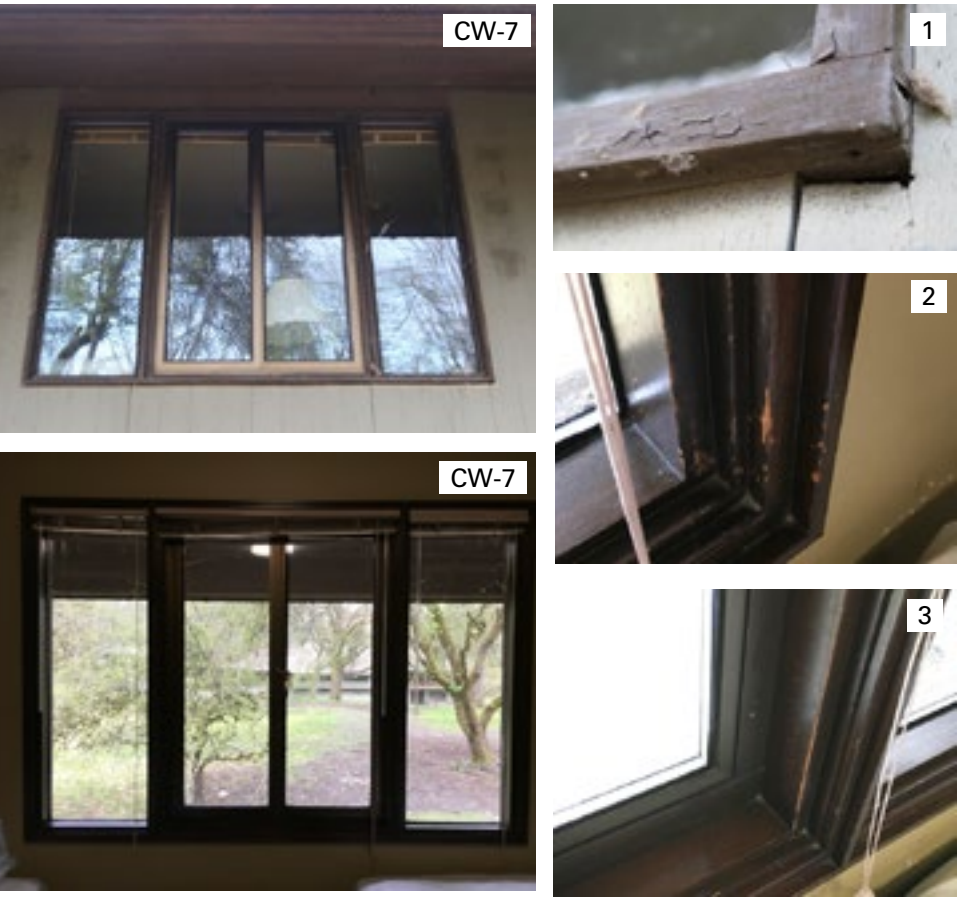
BUILDING C: EXISTING CONDITIONS - WINDOWS
CW-7 | TYPE B

- + SASHLESS WINDOW UNITS INSET IN WOOD FRAMES, FIXED
- + ALUMINUM CASEMENT WINDOW UNIT INSET IN WOOD FRAMES, MEDIUM BRONZE FINISH, OPERABLE
- + CLEAR, DOUBLE-PANED GLASS

- + PAINTED WOOD FRAMES, DARK BROWN
- 1. CHECKED CONDITION AND CHIPPED PAINT AT FRAMES

- + STAIN AND LACQUER WOOD TRIMS, DARK BROWN
- 2. CHIPPED CORNER AT TRIMS
- 3. DISCOLORATION AT TRIMS
