TALARIS PROJECT RECAP

SITE ENHANCEMENTS / COHESIVE WHOLE SITE LANDMARK REHABILITATION

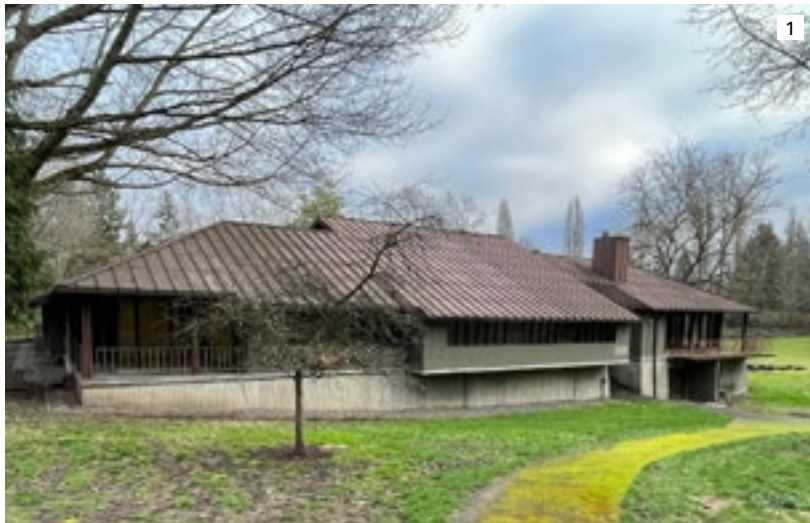
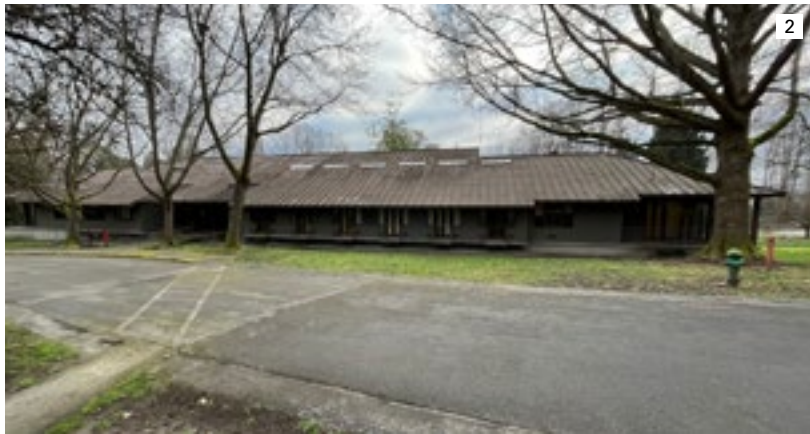
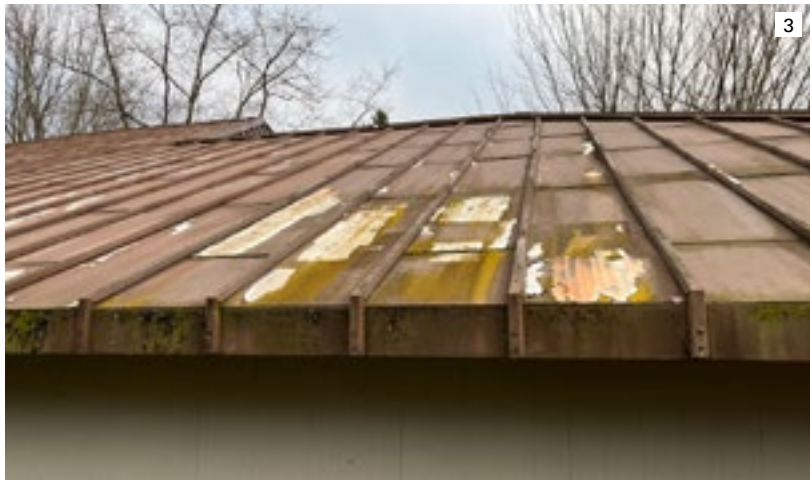
BUILDING D: EXISTING CONDITIONS - ROOF

- + METAL HIP ROOF, PAINTED RED
- 1. CHIPPED PAINT AT ROOF
- 2. PAINT DISCOLORED AT ROOF SURFACE
- 3. BIOLOGICAL GROWTH AND FLAKING PAINT AT ROOF SURFACE

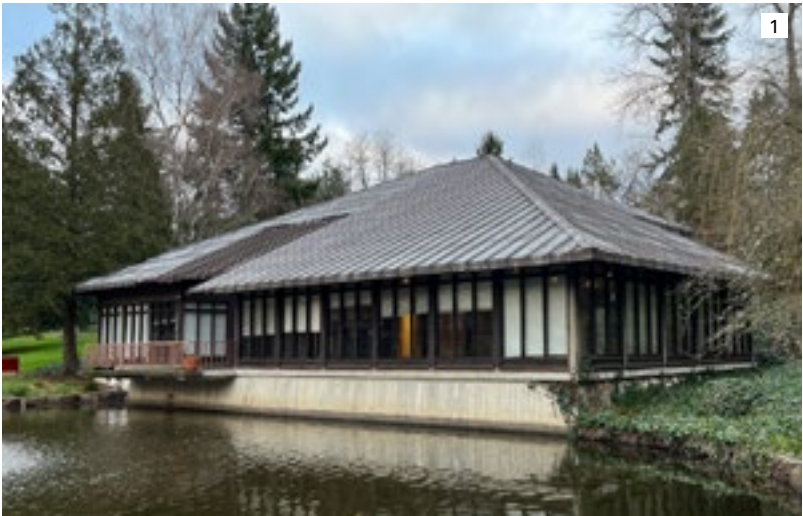
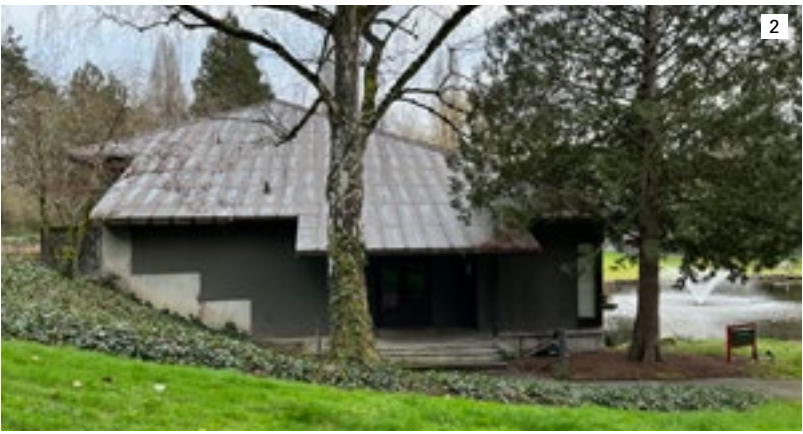
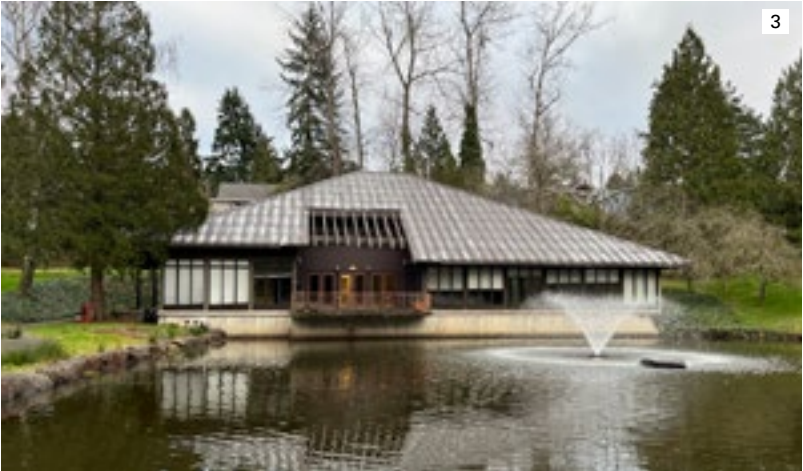
BUILDING F: EXISTING CONDITIONS - ROOF

- + METAL HIP ROOF, PAINTED RED
- 1. FAIR OVERALL CONDITION AT ROOF
- 2. CHIPPED PAINT AT ROOF SURFACE
- 3. PAINT DISCOLORED AT ROOF SURFACE
- 4. BIOLOGICAL GROWTH AND FLAKING PAINT AT ROOF SURFACE

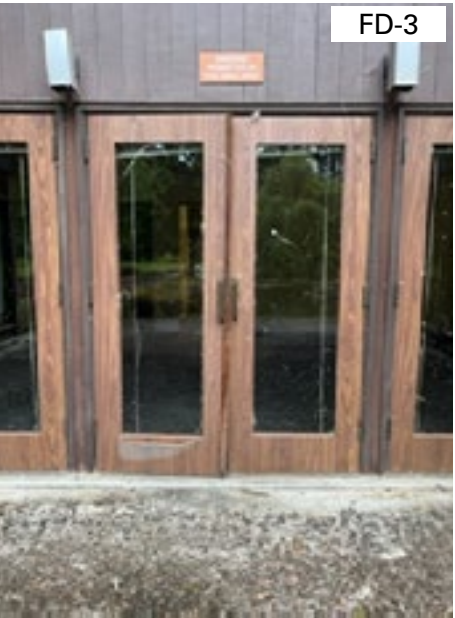
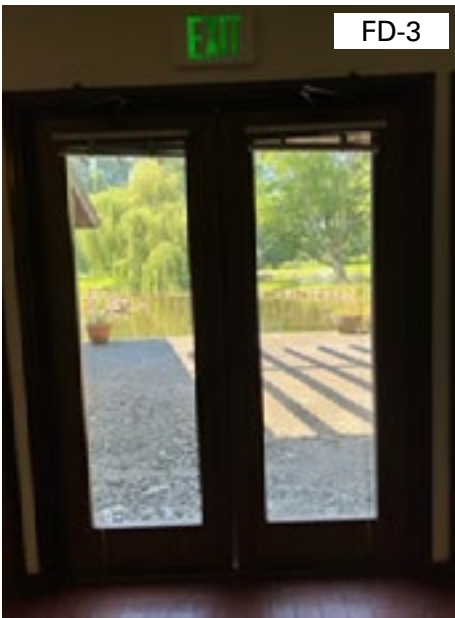
BUILDING F: EXISTING CONDITIONS - DOORS
FD-3 | TYPE 1

- + STAIN AND LACQUER STILE AND RAIL WOOD DOOR WITH FULL LIGHT GLASS, OPERABLE

- + PAINTED WOOD FRAMES, BROWN
- 1. MINOR DAMAGE AND CHIPPED CONDITION AT DOOR EDGE
- 2. FINISH DEFECT AT DOOR SURFACE

- + STAIN AND LACQUER WOOD TRIM, DARK BROWN
- 3. CHIPPED EDGE AT FRAME
- 4. CHIPPED EDGE AND SCRATCHES AT DOOR

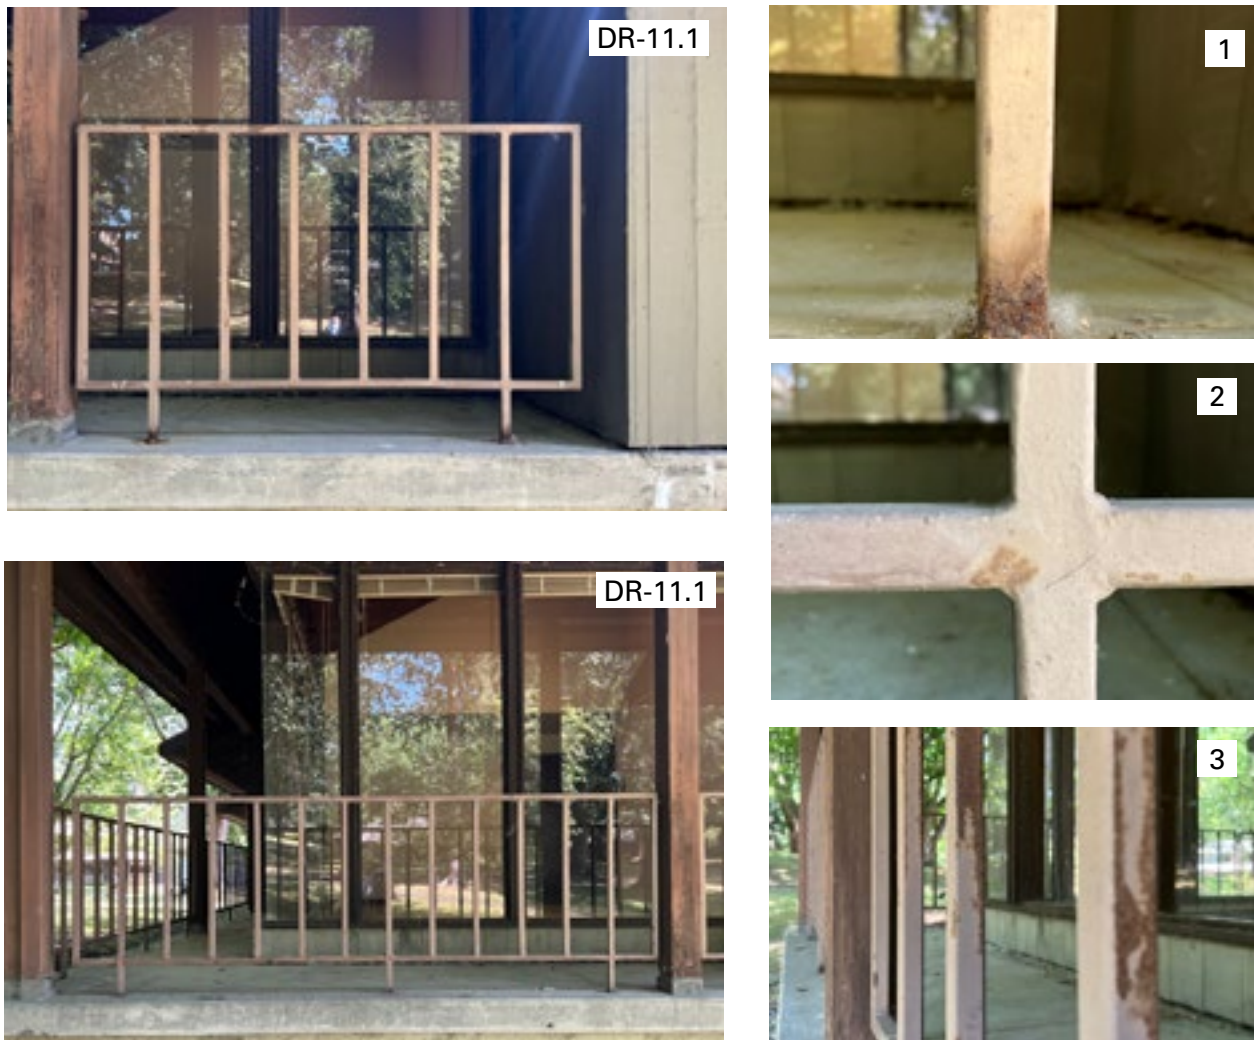
BUILDING D: EXISTING CONDITIONS - RAILINGS
DR-11.1 | TYPE B

- + HOLLOW METAL RAILING, PAINTED RED
- 1. UNEVEN FINISH AT VERTICAL AND HORIZONTAL RAILS
- 2. RUST AND FINISH DEFECT AT HORIZONTAL RAILS
- 3. BIOLOGICAL GROWTH AT VERTICAL RAILS

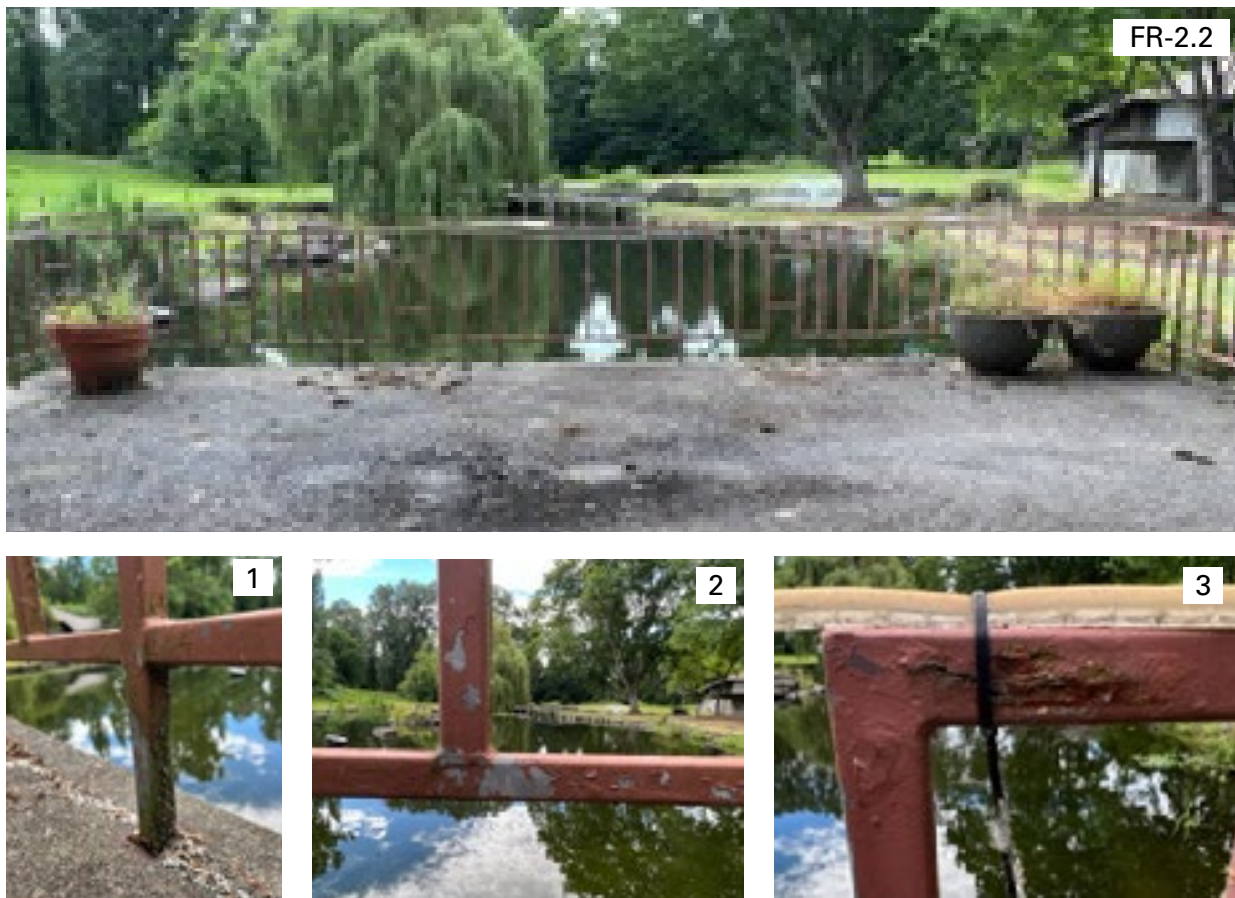
BUILDING F: EXISTING CONDITIONS - RAILINGS
FR-2.21 | TYPE B

- + HOLLOW METAL RAILING, PAINTED RED
- 1. LARGE DAMAGE AT HORIZONTAL VERTICAL RAIL
- 2. SPLIT AT HORIZONTAL RAIL
- 3. BIOLOGICAL GROWN AT VERTICAL RAILS

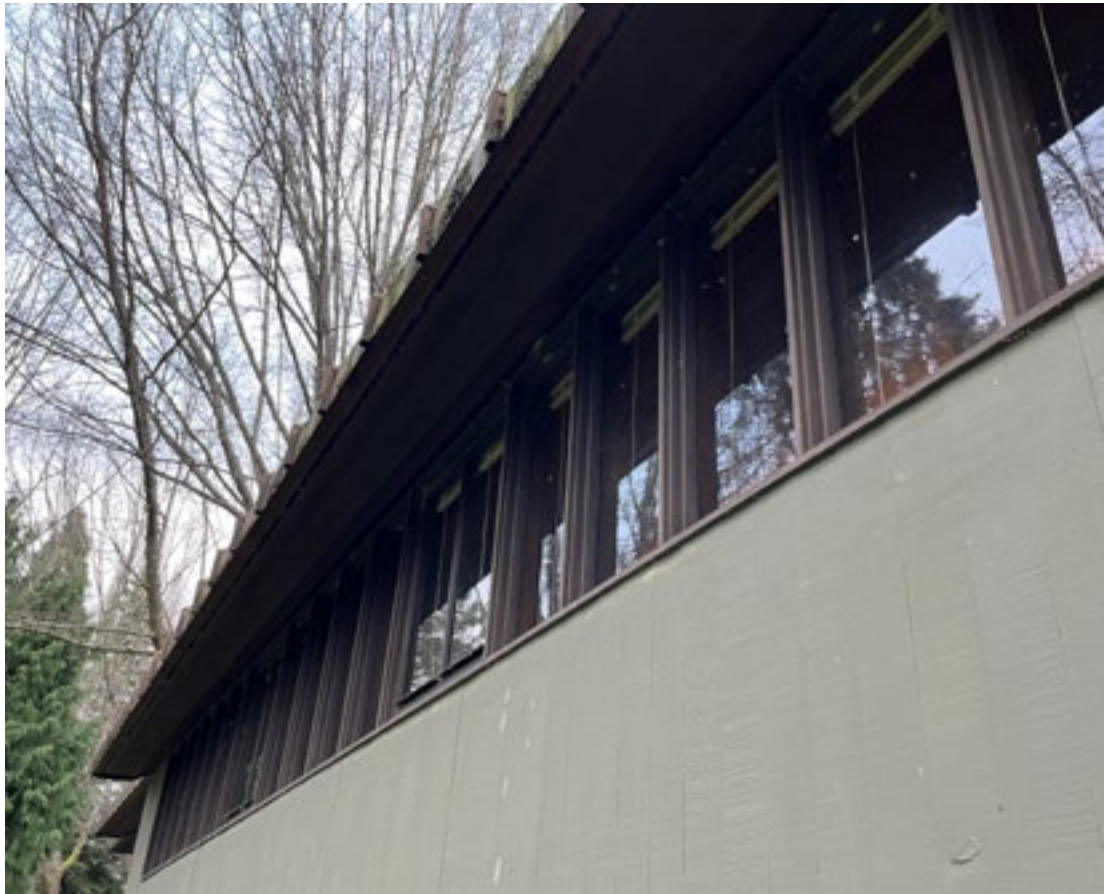
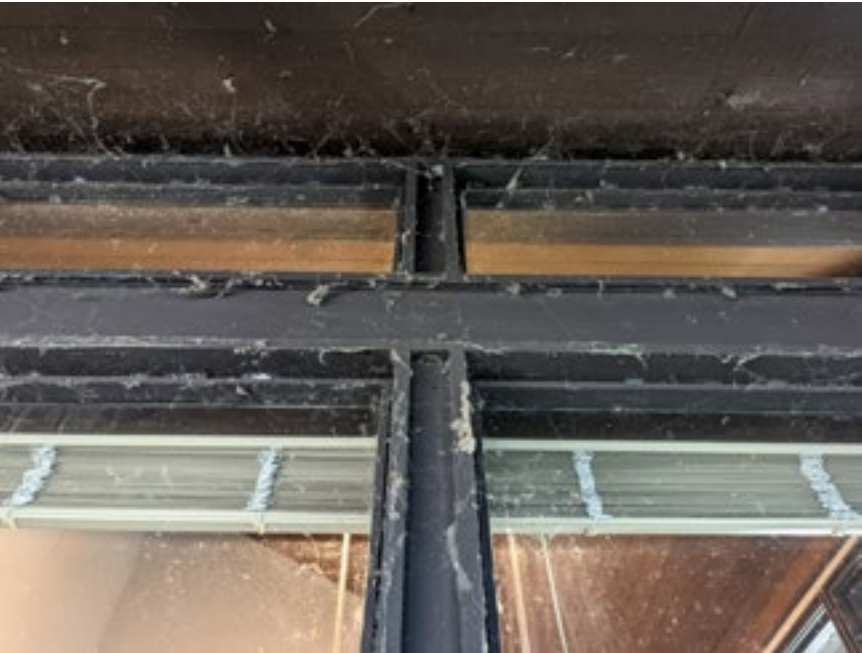
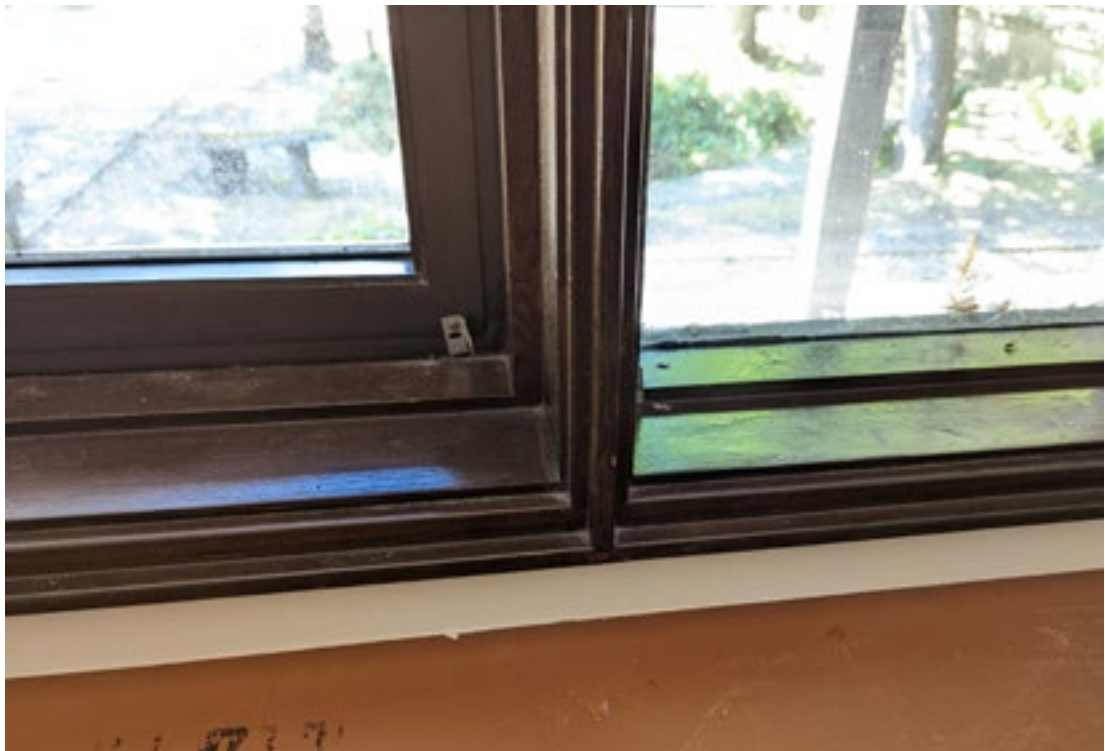
Window Restoration and New Openings Details:

New Windows: Cascadia Universal Series: thermally broken fiberglass storefront frames and operable window units

Operable Window Types: casement, awning, hopper, tilt and turn

Vertical mullions at 24"-26" O.C. to relate to historic windows.

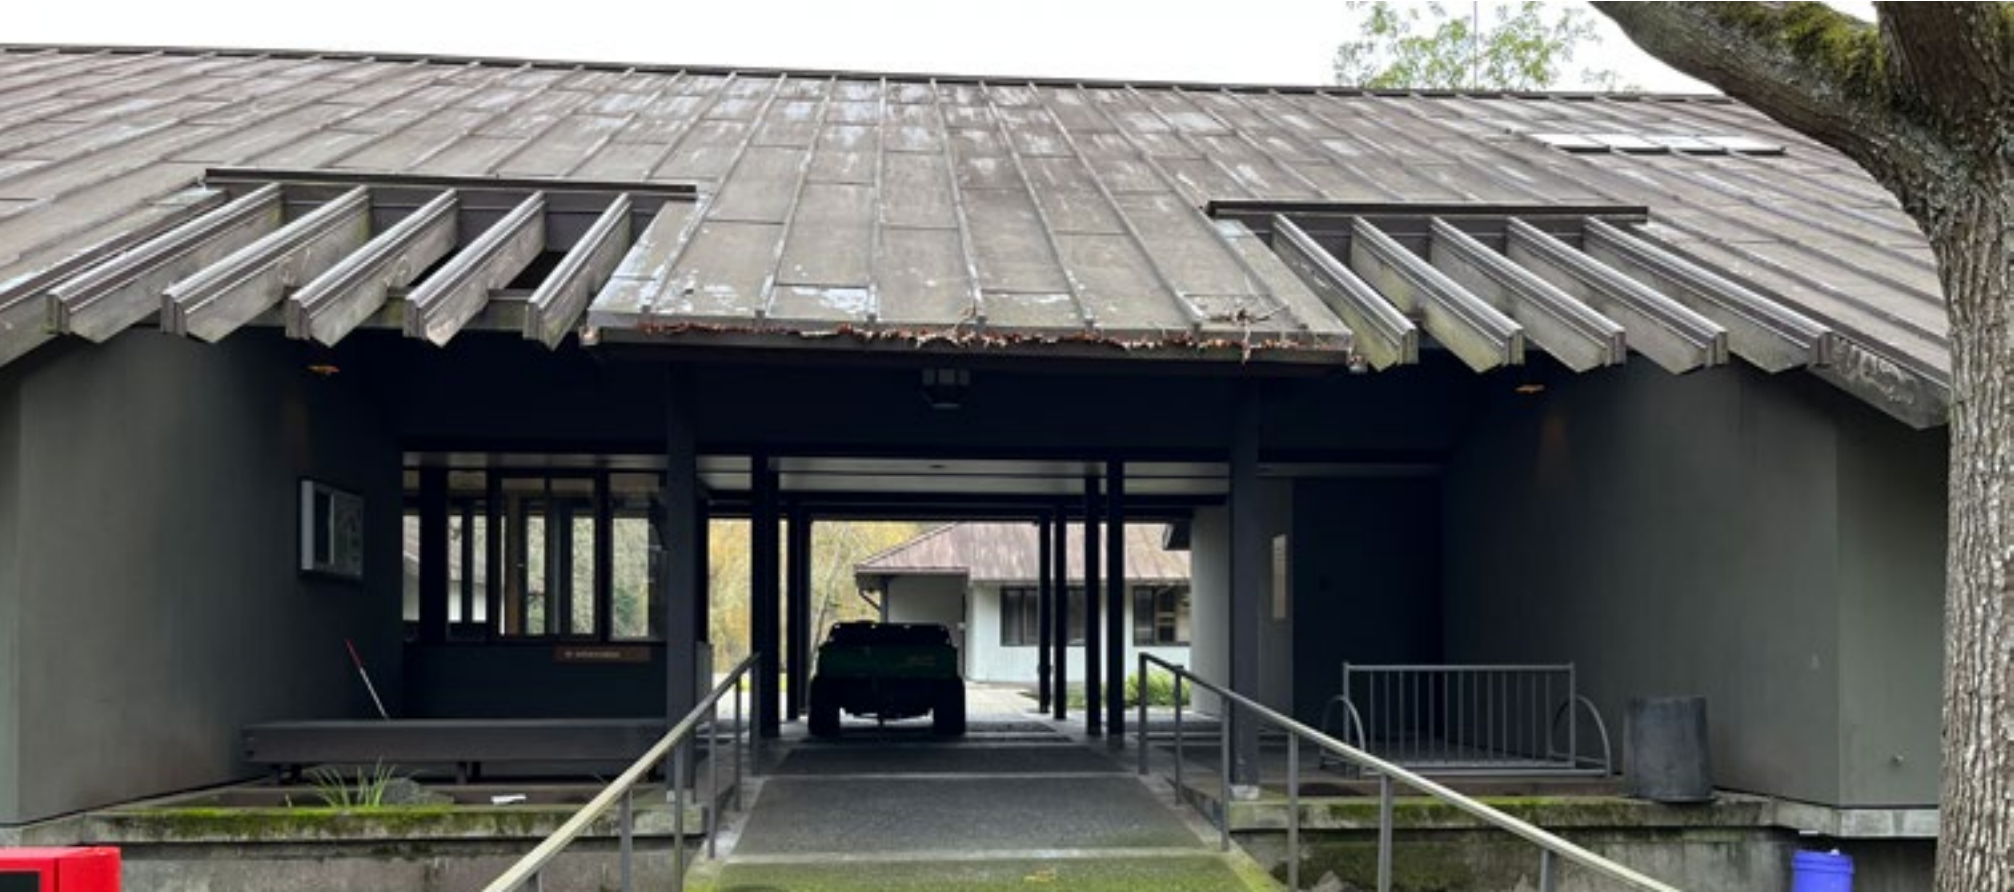
EXISTING ENTRY FROM EXTERIOR

BUILDING D / EXISTING AND PROPOSED LOBBY AT BUILDING D

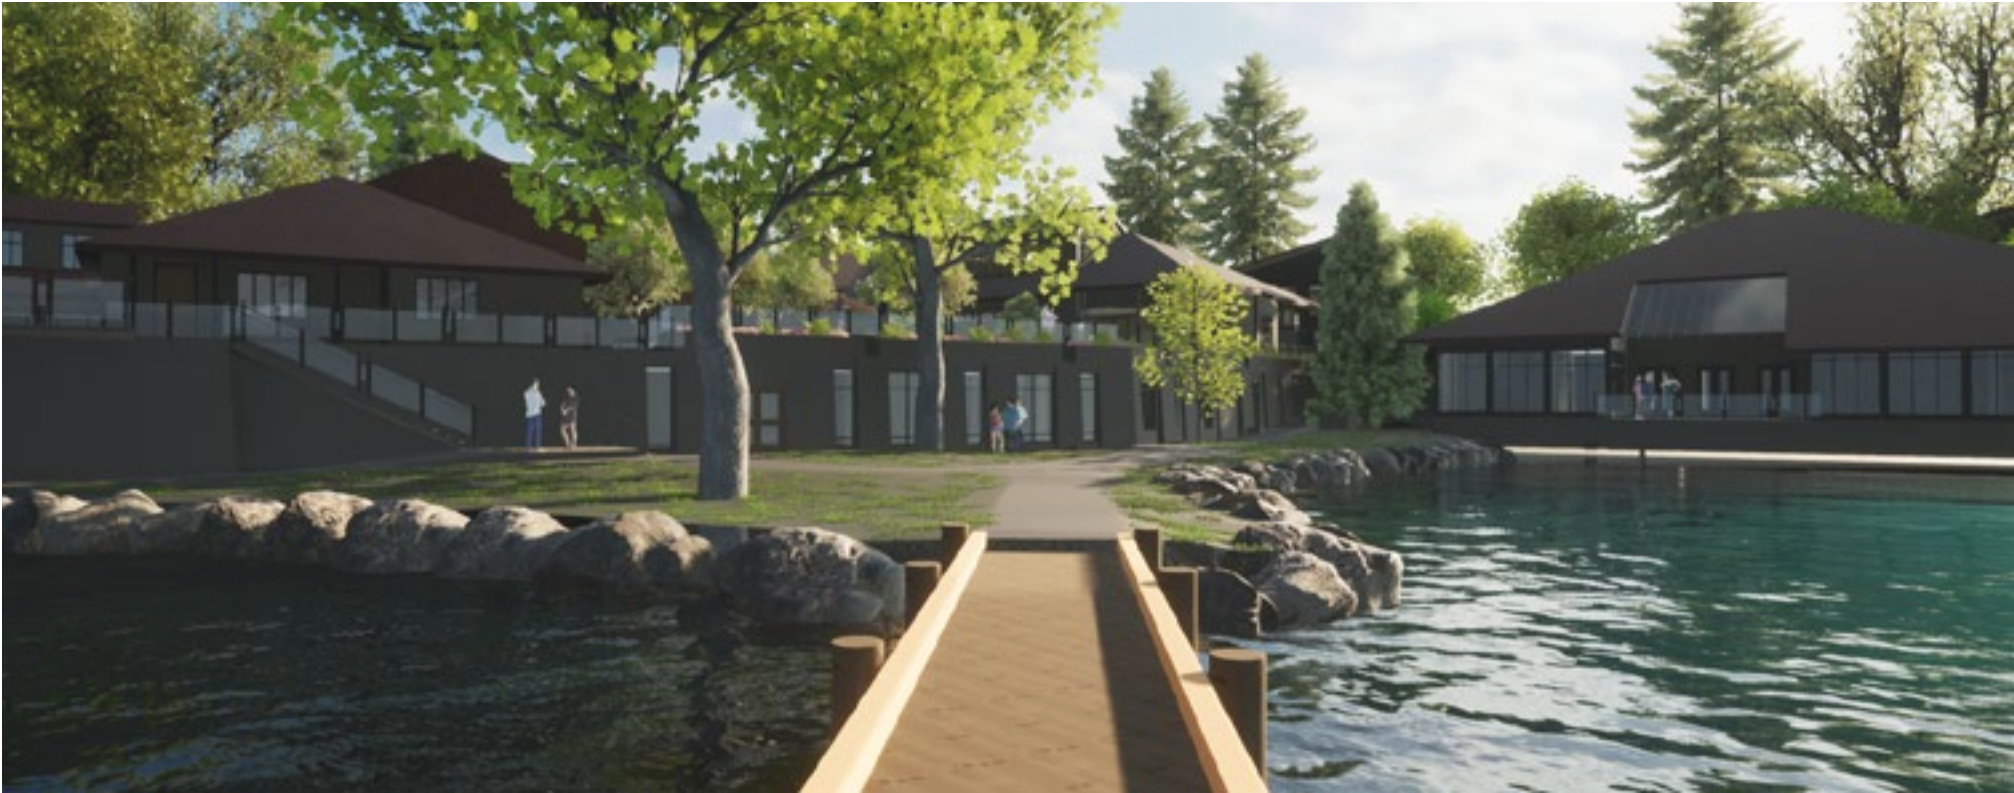
PROPOSED

Pond Bridge View:

- + Building D and F rehabilitated
- + Sensitive and appropriately scaled addition to the east side of Building D completes the northern built edge of the pond
- + Preserves the pedestrian experience
- + Revitalizes landscape adjacent to pond
- + D Addition forms and materials are consistent with historic character of buildings D and F.
- + New addition creates expanded leasable space that offsets home count reduction from Quadrant plan.
- + Provides a sensible and economically viable land use plan to ensure the site and buildings are maintained and preserved in perpetuity.

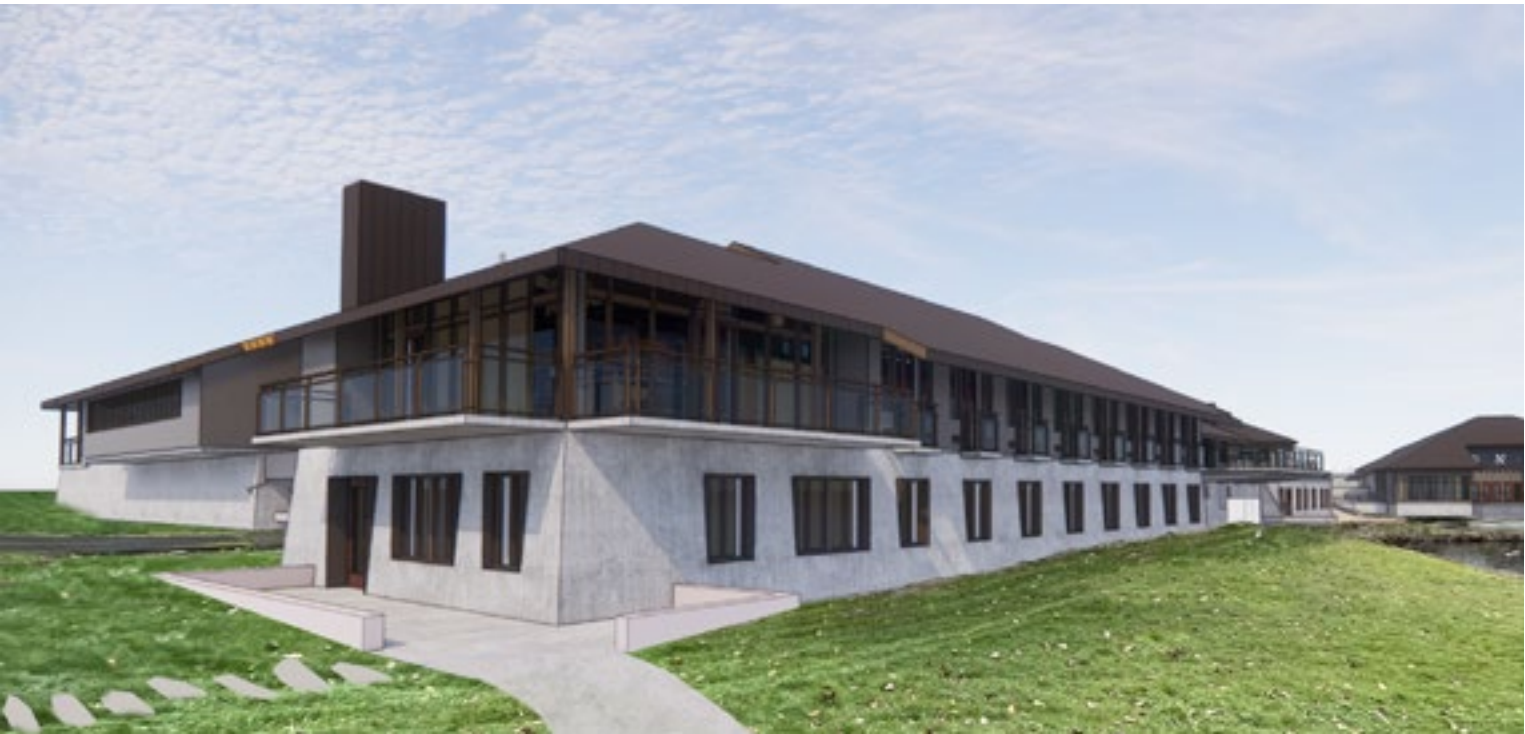
BUILDING D SOUTHWEST CORNER - UPDATED DESIGN

BUILDING D - LEVEL 0 REVISIONS FROM PREVIOUS PRESENTATIONS

- + Existing Level 0 door location maintained
- + Existing louver openings expanded to use as window openings
- + Existing mechanical louver screen wall removed
- + Two new window openings in concrete wall added at corner for daylighting occupied space
- + New openings for windows in concrete are no longer cut to floor level.
- + Window openings are punched opening with metal frames that accentuate the battered wall slope.

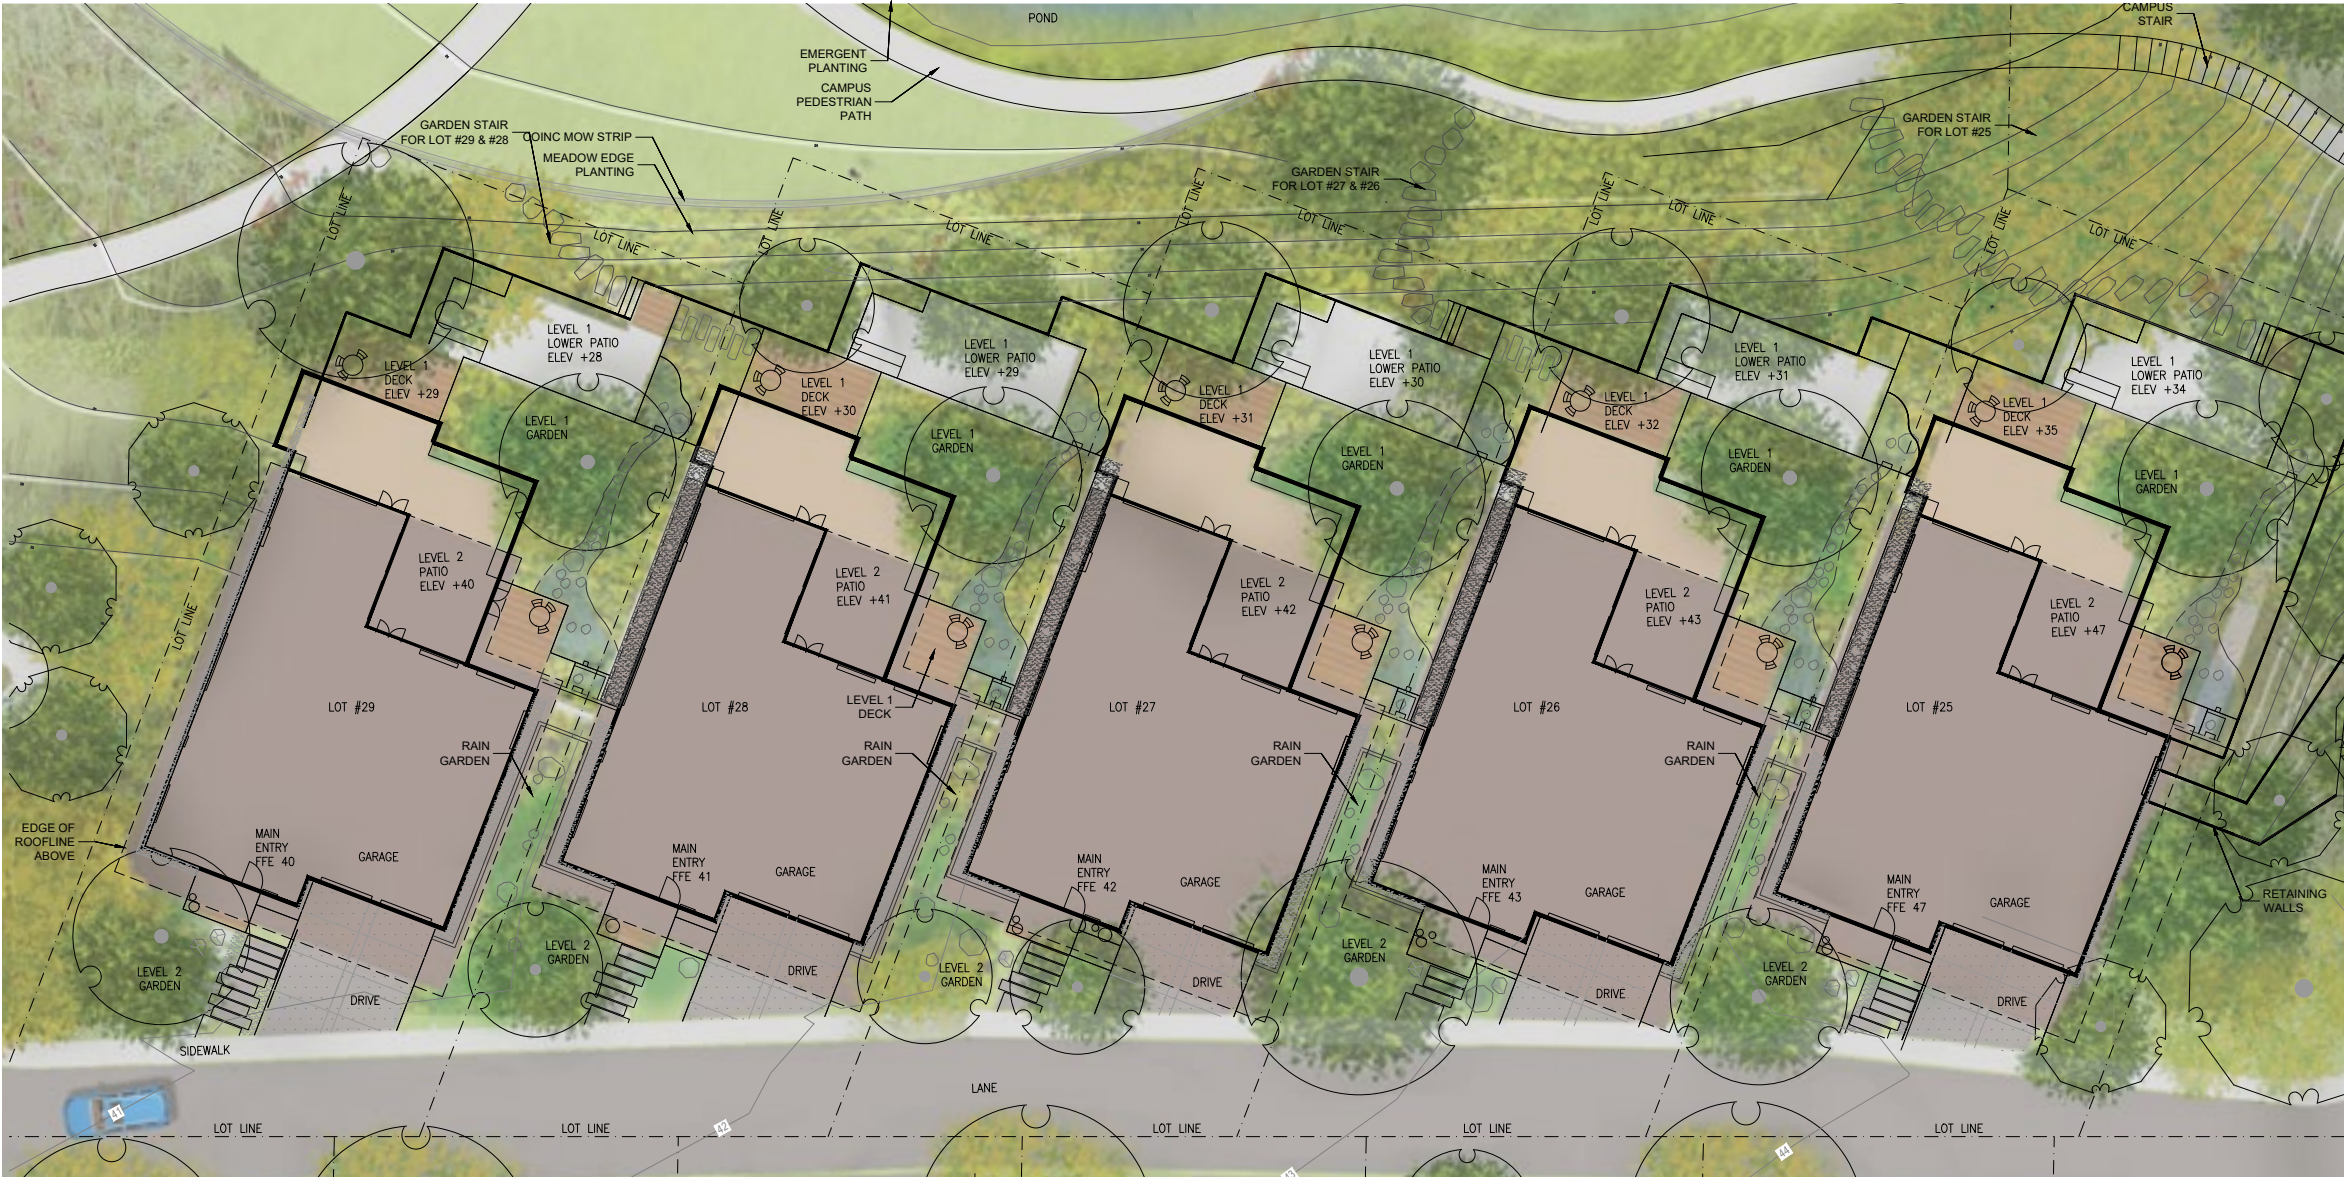
Pond Houses Landscape Plan

Pond House Design Concepts

- + Preserve strong roof lines stepping uphill
- + Softening the edge of common areas and private spaces
- + Resolve accessibility from the east loop road and provide new pathways that enhance connectivity into the heart of the campus
- + Japanese influenced Northwest garden designs
- + Reintroduce meadow along the revitalized edge of the pond
- + Increase biodiversity and wildlife habitat

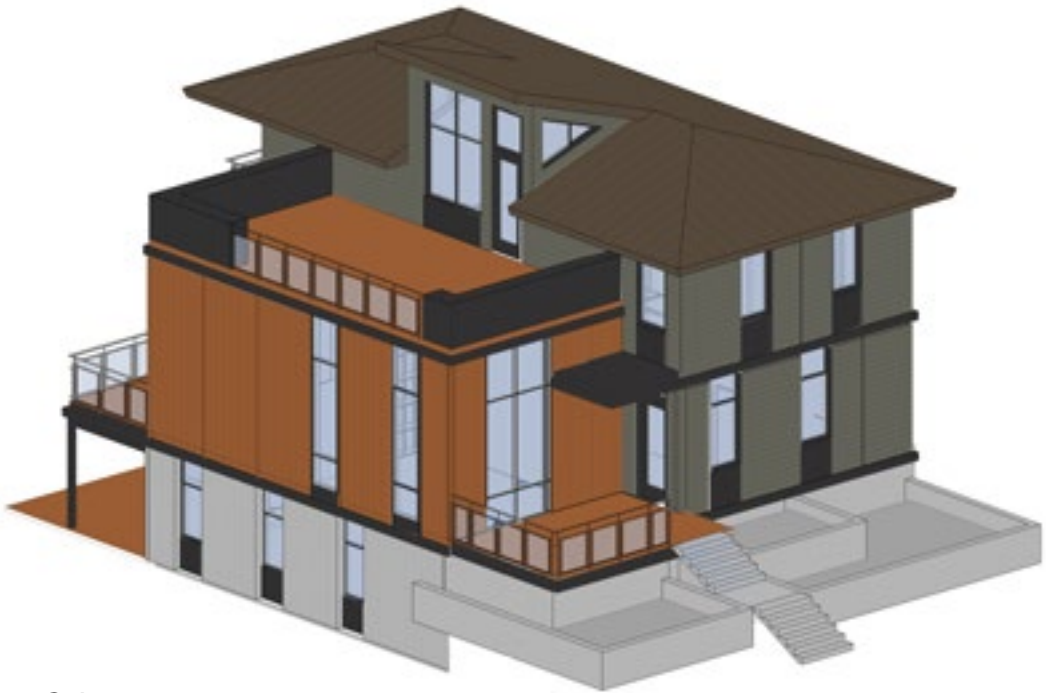
Scheme 3

- Roof Material:
Metal Sales
Weathered Copper
- Trim Color:
Sherwin Williams
Black Magic
- Facade Color:
Sherwin Williams
Cast Iron
- Trim/Accent Material:
Wood Siding
- Concrete

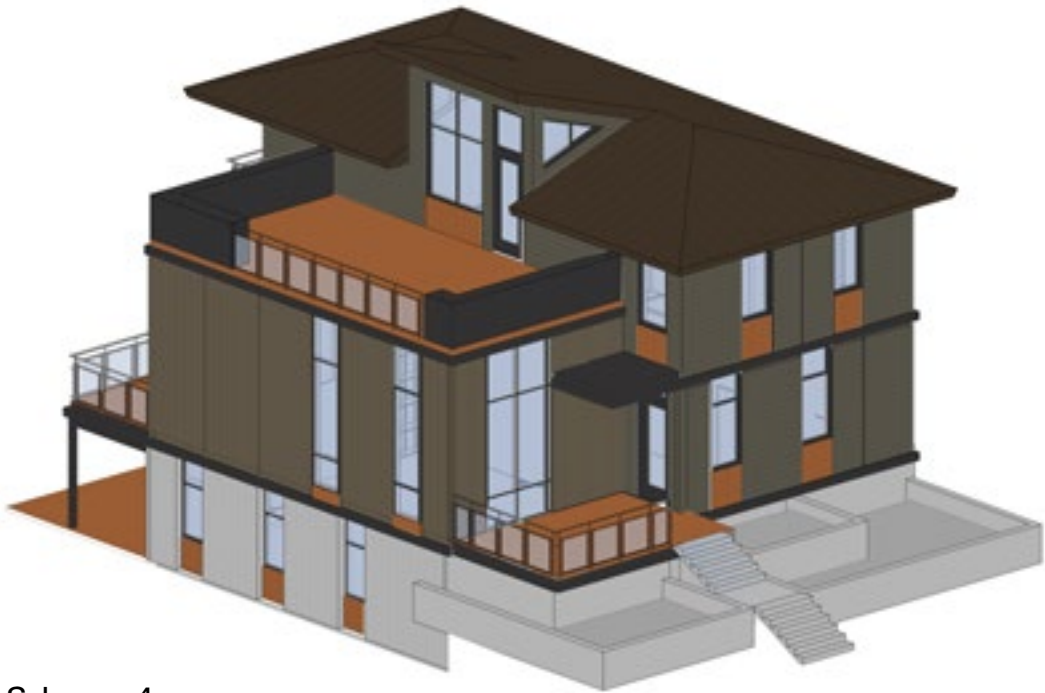
Scheme 4

- Roof Material:
Metal Sales
Dark Bronze
- Trim Color:
Sherwin Williams
Black Magic
- Facade Color:
Sherwin Williams
Roxcroft Bronze Green
- Accent Color:
Sherwin Williams
Oak Leaf Brown
- Concrete

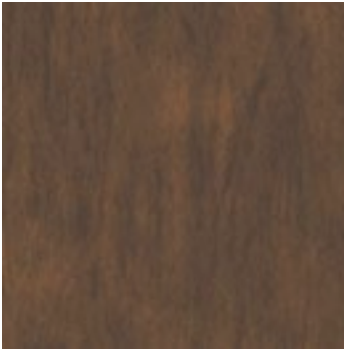
SIGNAGE POSTS AND STAIN FINISH

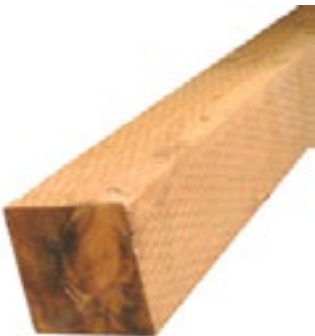
PRESSURE-TREATED LUMBER

WOOD STRUCTURE

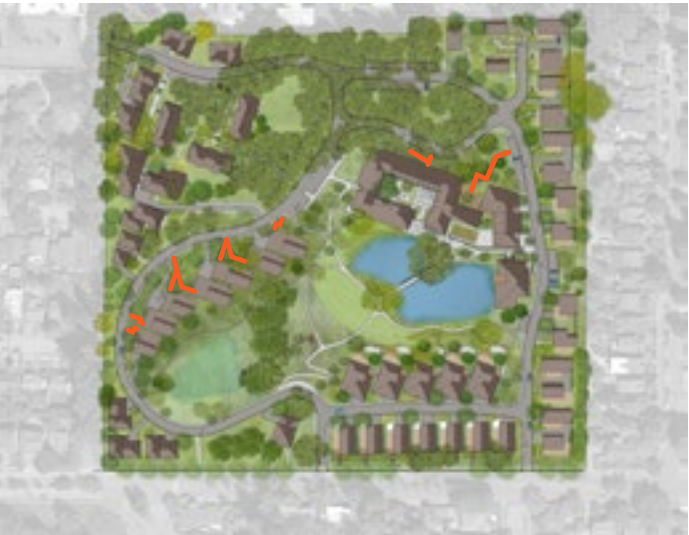
RAILING ELEVATION
AT WETLAND HOUSES

WALKING SURFACE

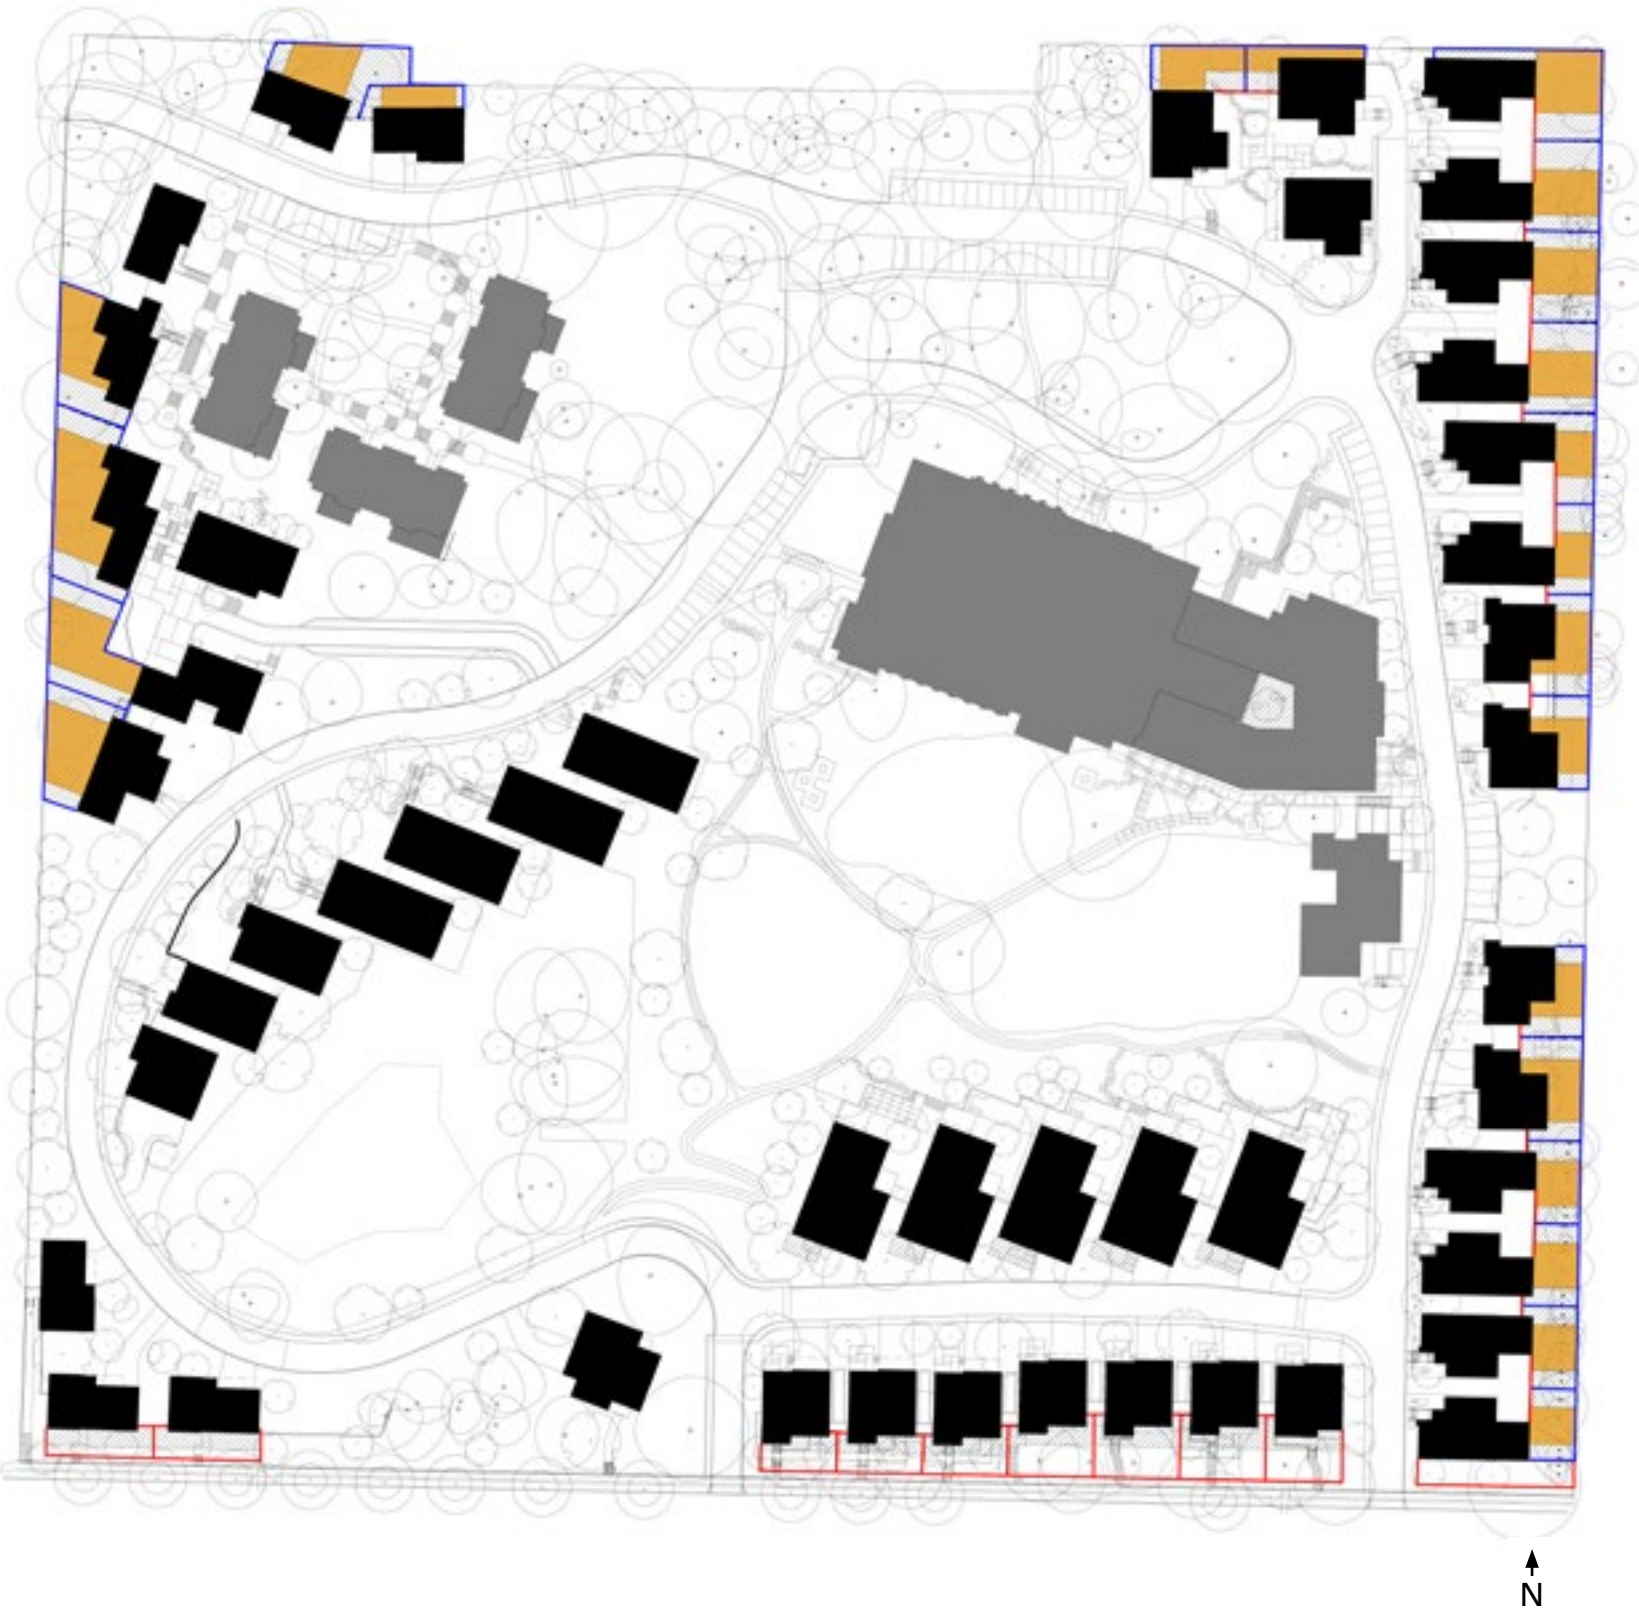
- 3' SHORT FENCE
- 6' TALL FENCE
- STRUCTURES ALLOWED IN BACKYARD BUILD ZONES
 - + MISC. STRUCTURES <9' IN HEIGHT
 - + GARDEN SHEDS
 - + ARBORS
 - + TRELLISES
 - + IN GROUND SPAS
 - + GAZEBOS
 - + COVERED PATIOS
 - + STATUARY/ART
 - + BIRDHOUSES
 - + FIRE PITS
 - + MASONRY BAR-B-QUES

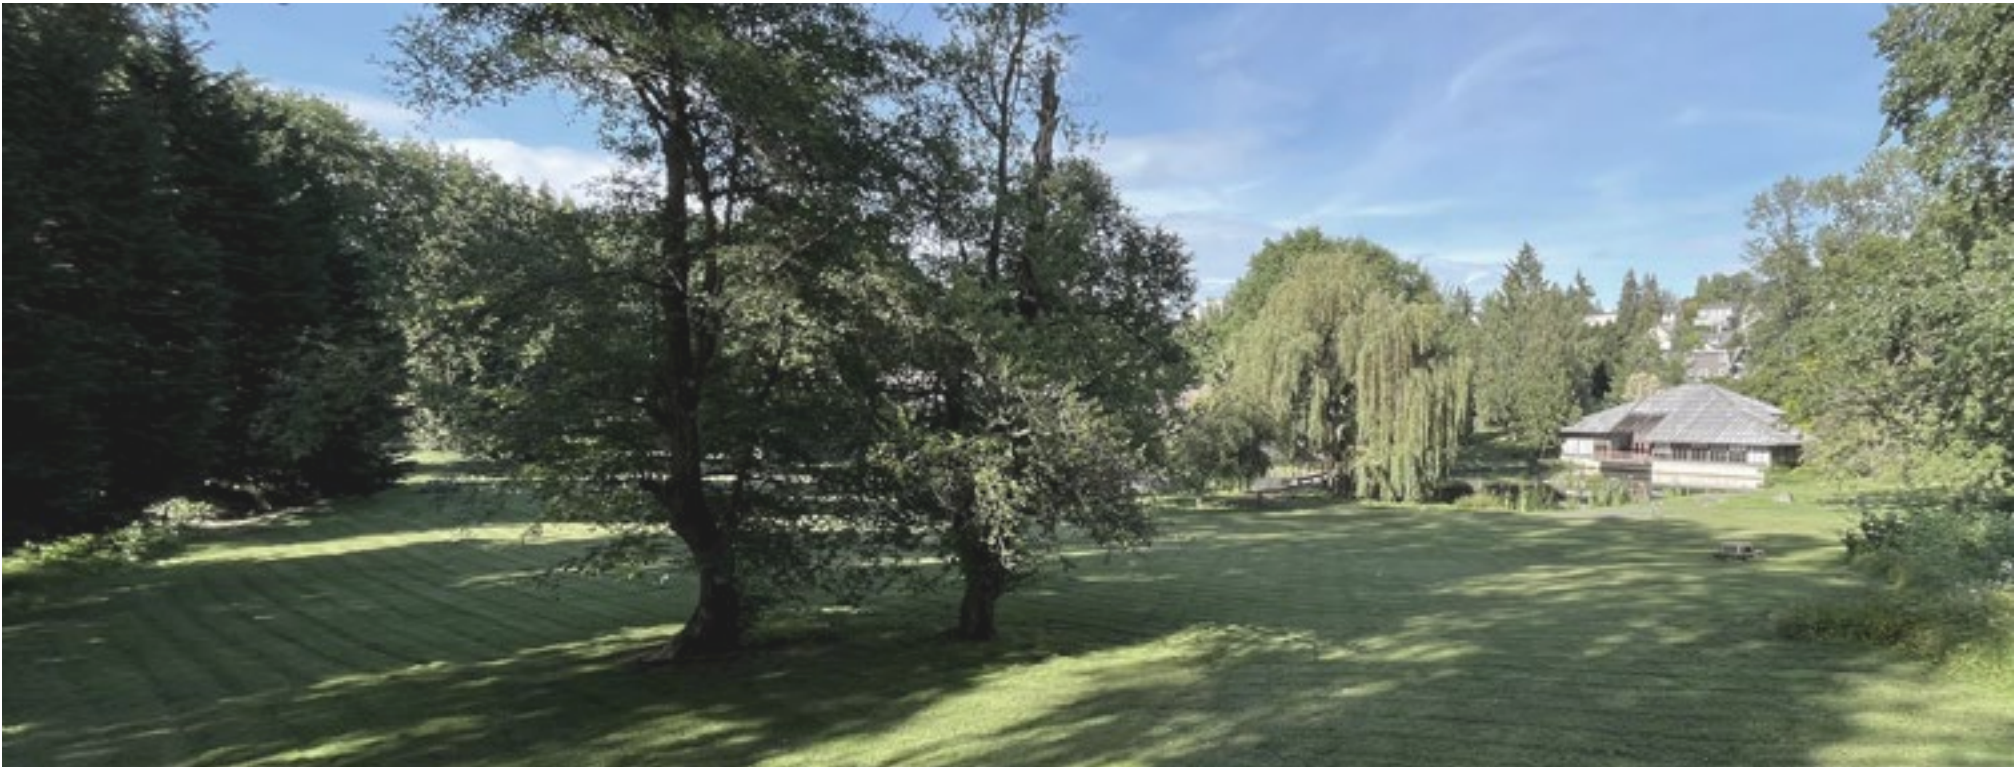
EXISTING

REHABILITATING THE HEART OF THE CAMPUS / ENTRY DRIVE & PEDESTRIAN PATH

Entry View:

- + View from entry drive experience preserved over meadow and pond to Building D and F
- + Creates open space for the public to use and walk through
- + Restores the character of the park-like setting
- + Keblis benches introduced around the site to have moments of rest and peace
- + Trees dividing the meadow and wetlands maintain privacy of adjacent homes and the public heart of the campus
