TALARIS PROJECT RECAP

SITE ENHANCEMENTS / COHESIVE WHOLE SITE LANDMARK REHABILITATION

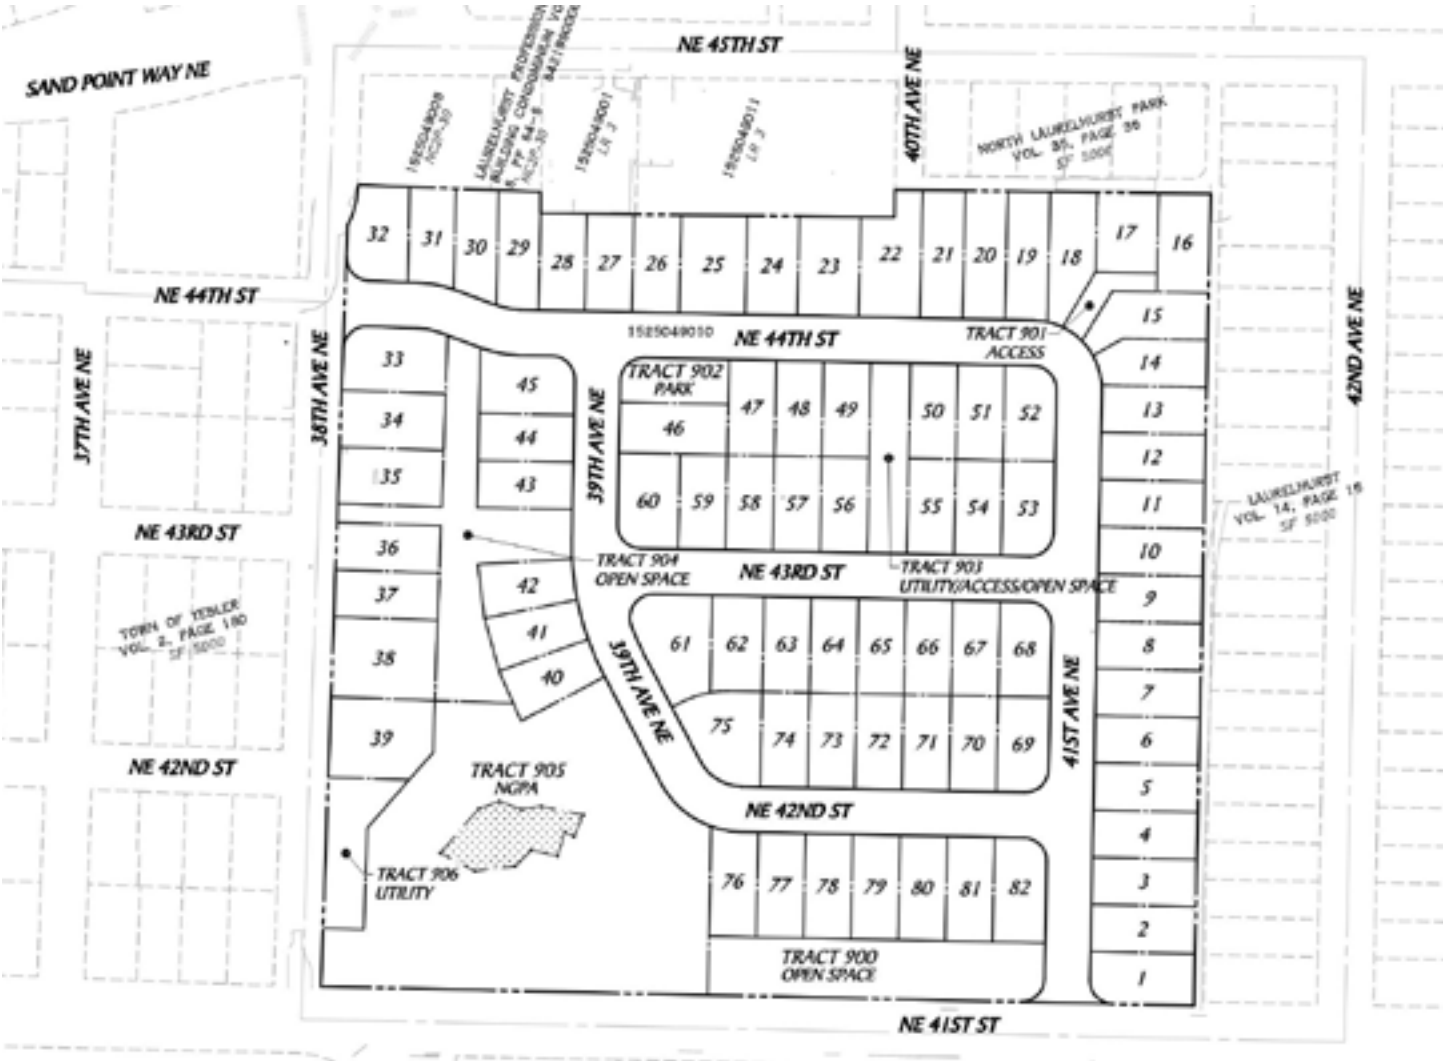
NON-LANDMARKED 82 LOT PLAT: ALL SINGLE FAMILY HOMES SF-5000

- +MAXIMUM DENSITY ALLOWED IN THE NR-3 ZONE
- +TYPICAL ROUTE TO A SALE AT PRELIMINARY PLAT APPROVAL
- +STANDARD PLATTING PROCESS REQUIRED
