SEATTLE PUBLIC LIBRARY UNIVERSITY BRANCH RENOVATION

BUILDING HISTORY + EXISTING CONDITIONS

PROPERTY CONTEXT + LANDMARK CONTROLS

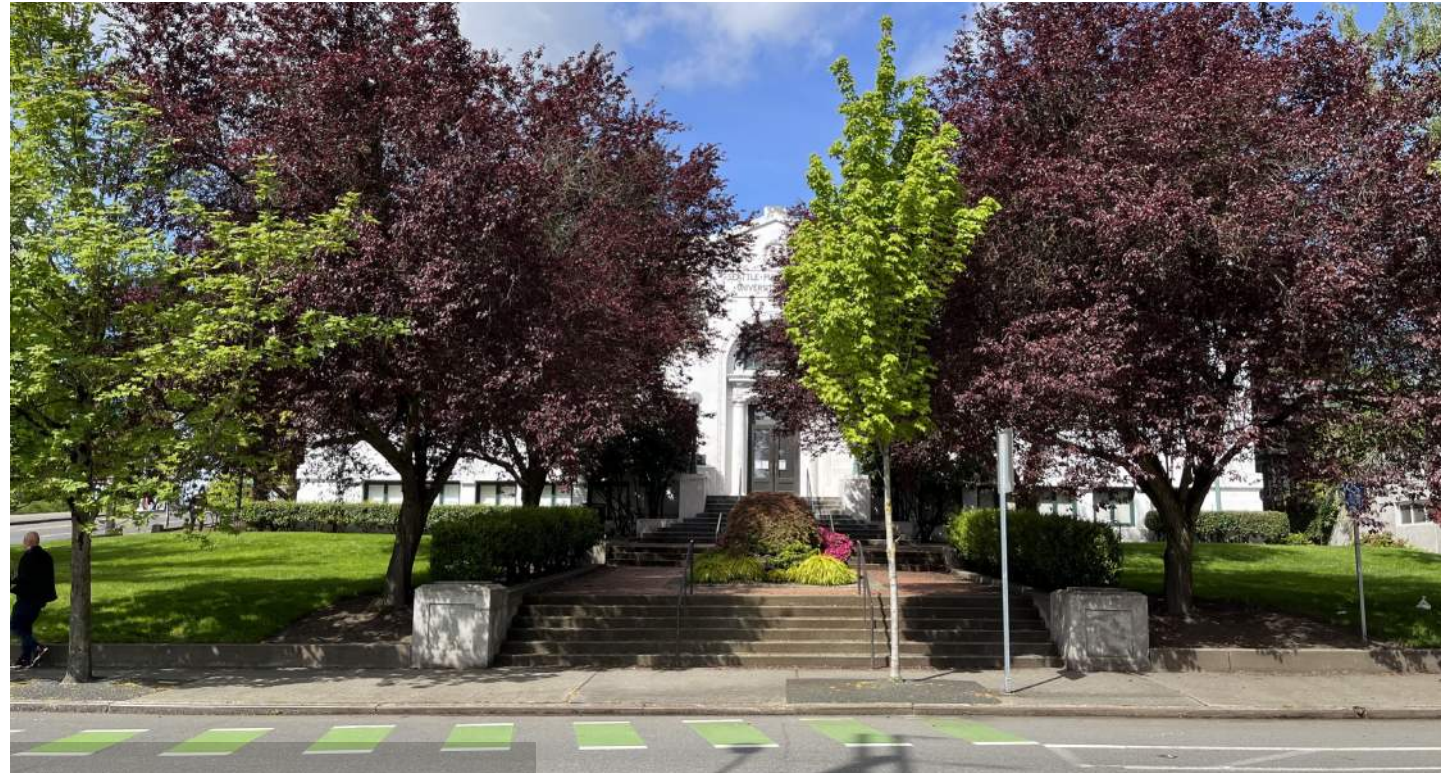
EAST ELEVATION (MAIN ENTRY)

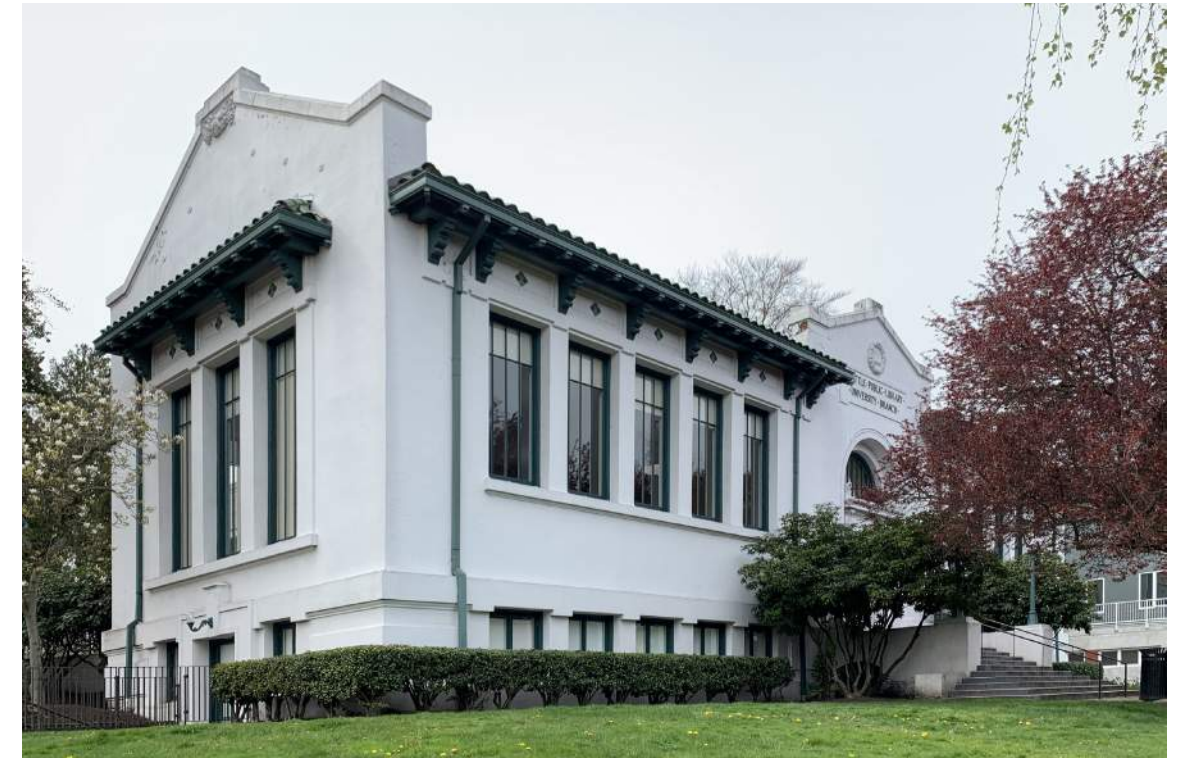
SOUTHEAST SITE + FACADE

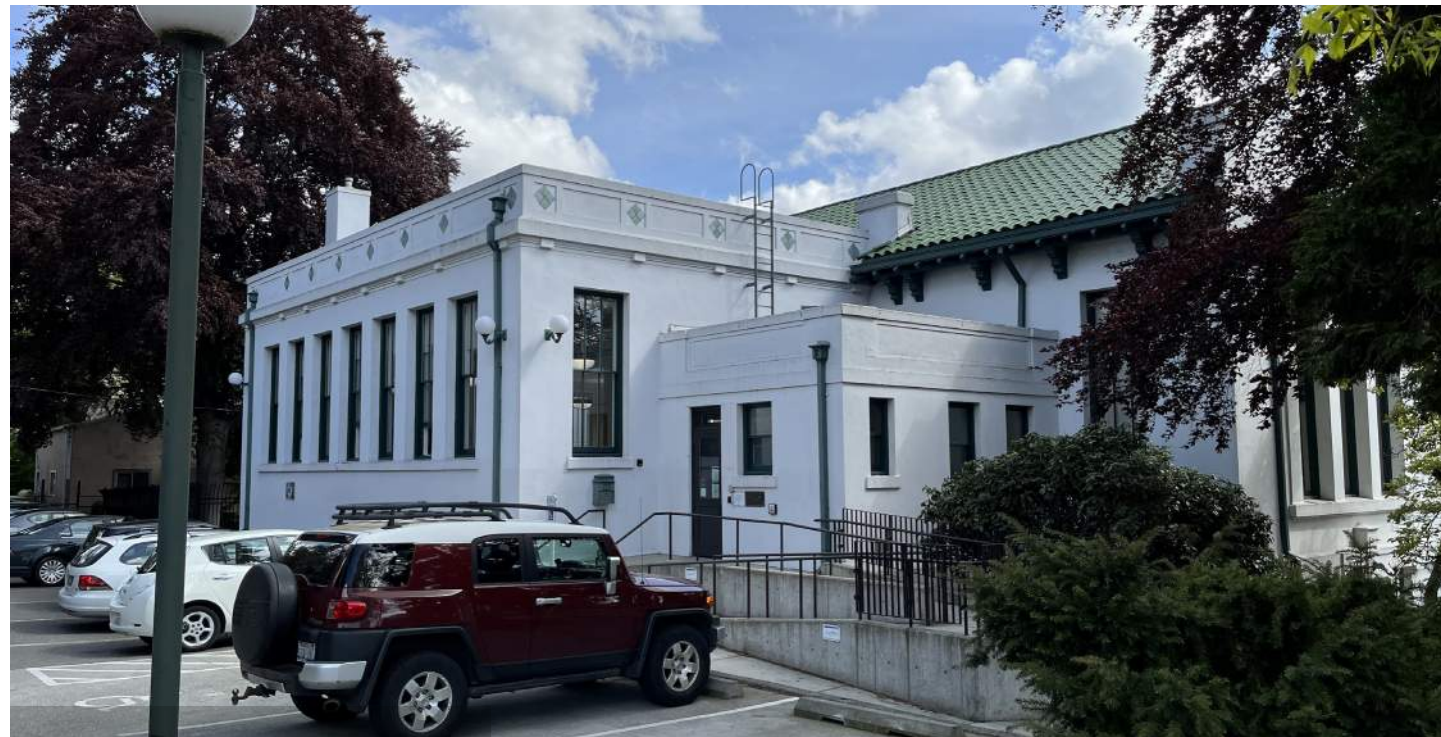
SOUTHWEST ENTRY

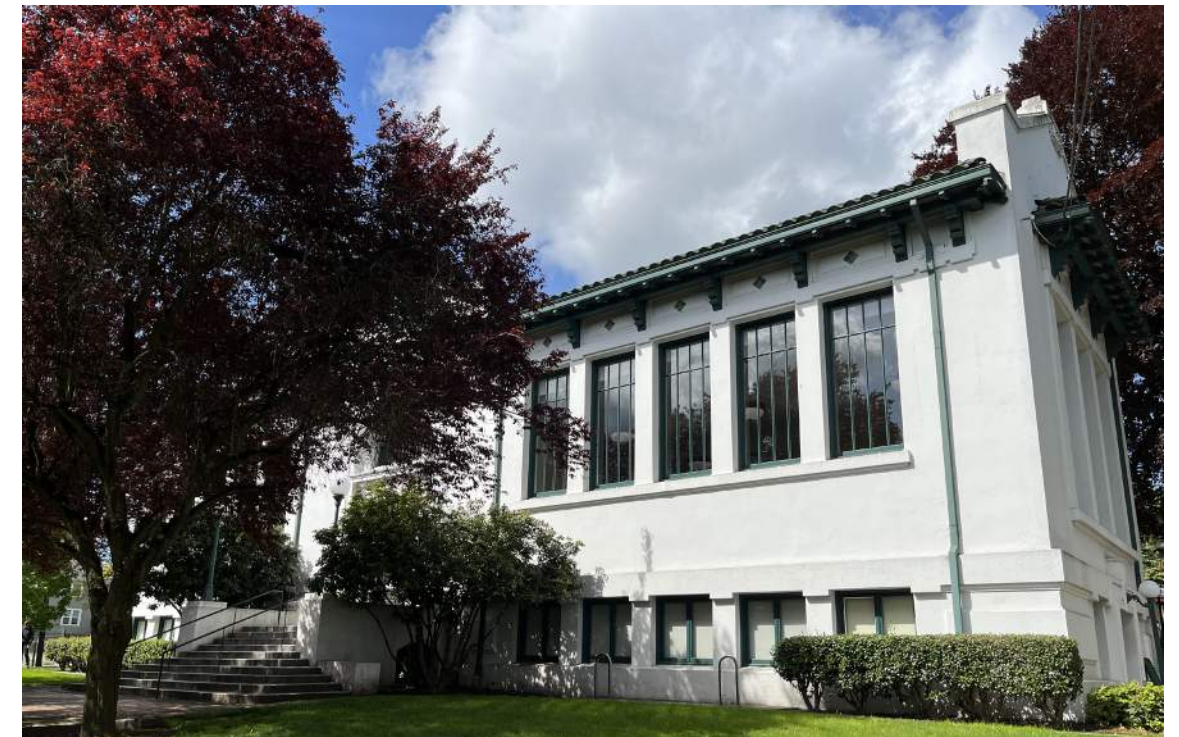
NORTHEAST SITE + FACADE

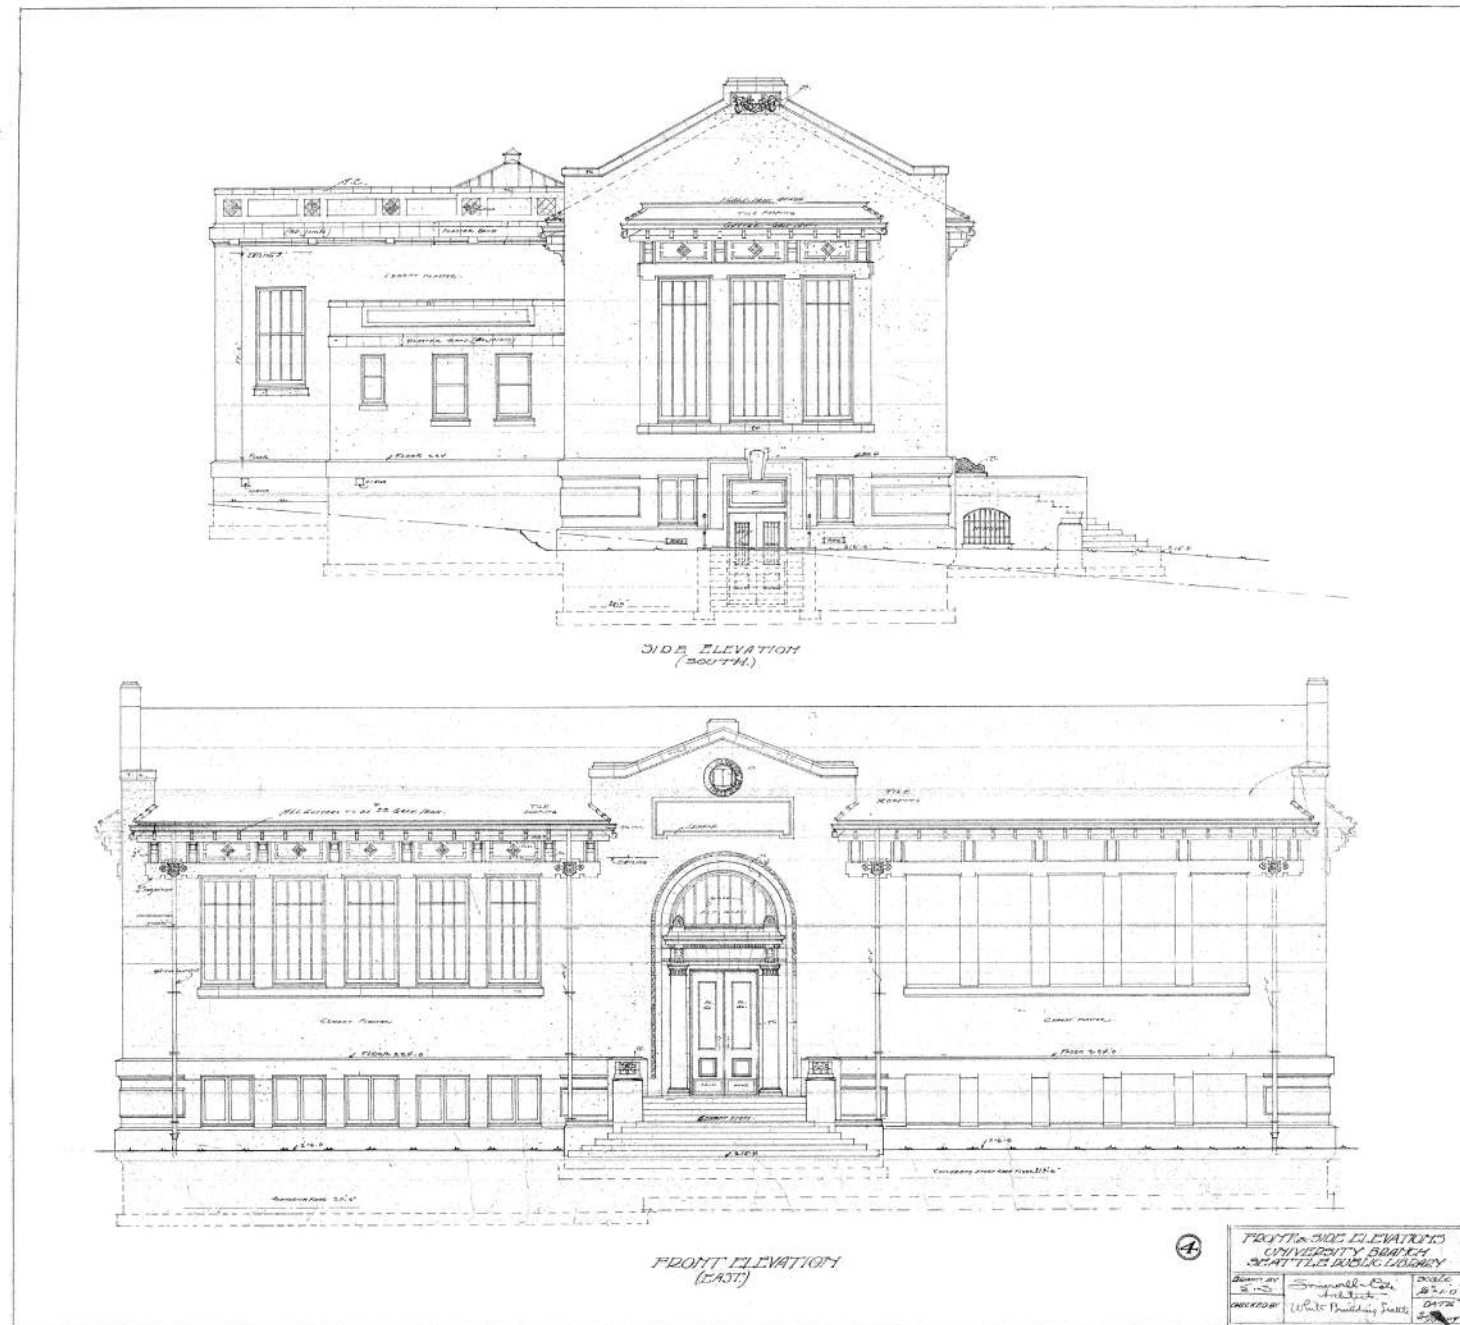
EAST AND SOUTH ELEVATIONS

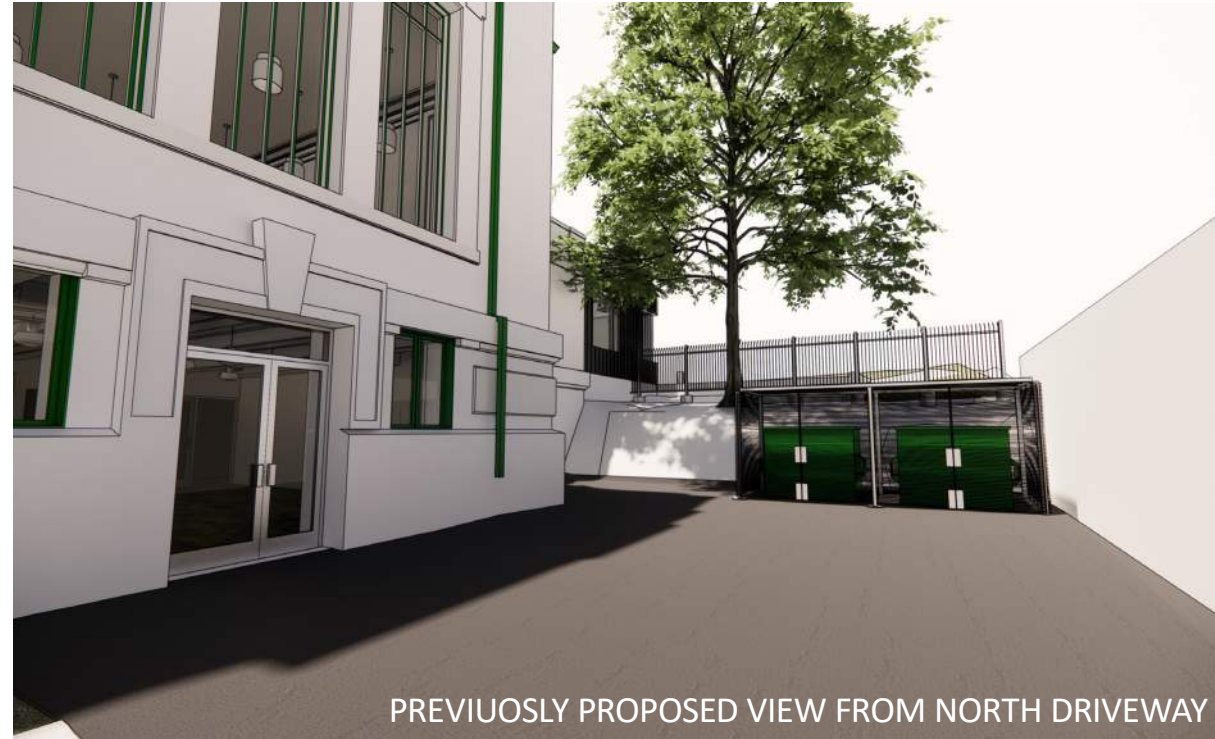
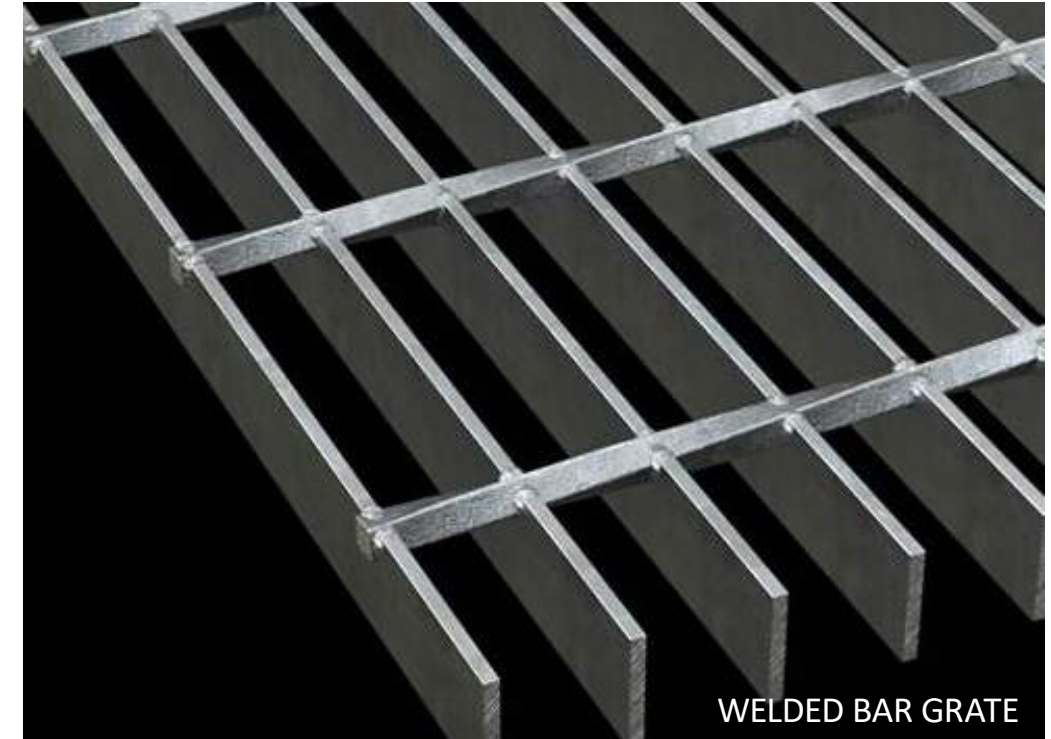
Previous Proposal:

At the April 17th briefing, SHKS proposed a **welded bar grating** assembly for durability and visibility (sides and top), painted dark (black or dark bronze) to match existing metal site elements, including the existing fence, handrails, and new steel retaining walls.

SPL requested that the assembly be modified to **obscure the dumpsters from view** from the street and building and **be located at the north property line wall**.

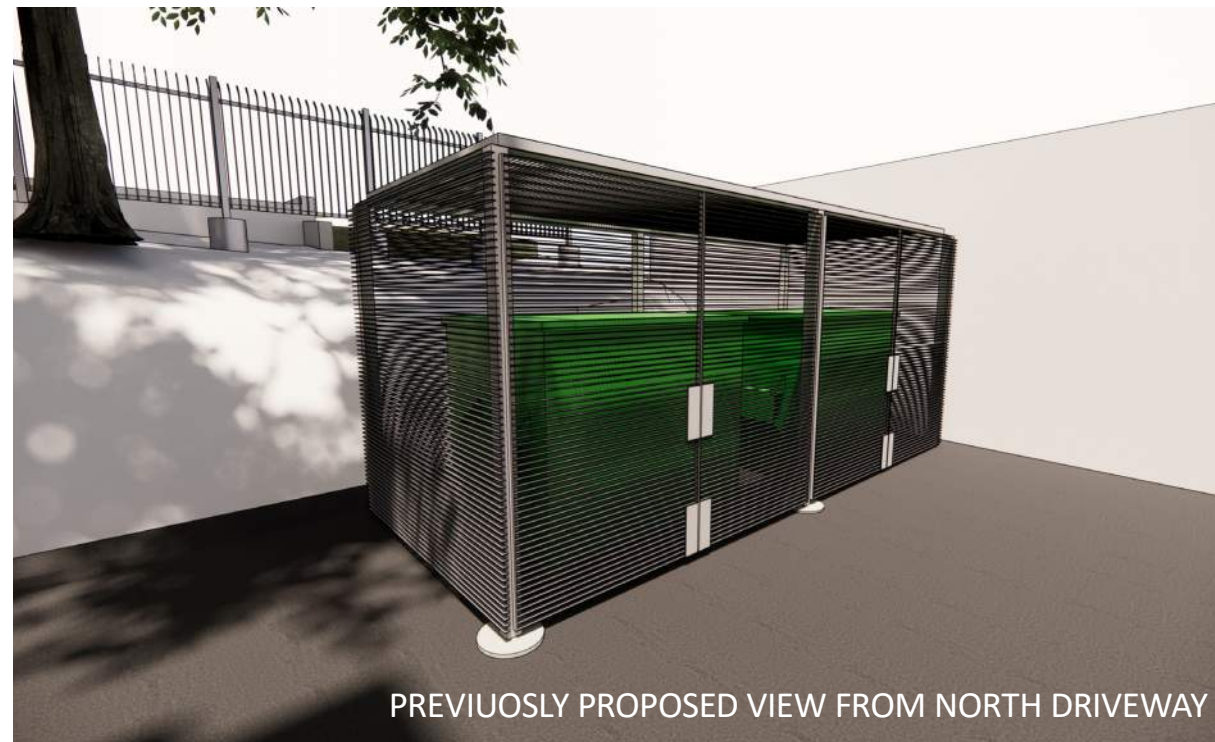
EXTERIOR TRASH ENCLOSURE

Install a painted metal enclosure, utilizing **steel plate panels** for durability and to visually obscure the dumpsters.

Paint dark (black or dark bronze) to match existing metal site elements, including the existing fence, handrails, and new steel retaining walls. Enclosure top to be welded bar grate top for security.

CURRENT PROPOSAL: STEEL PLATE ENCLOSURE W/ METAL GRATE TOP

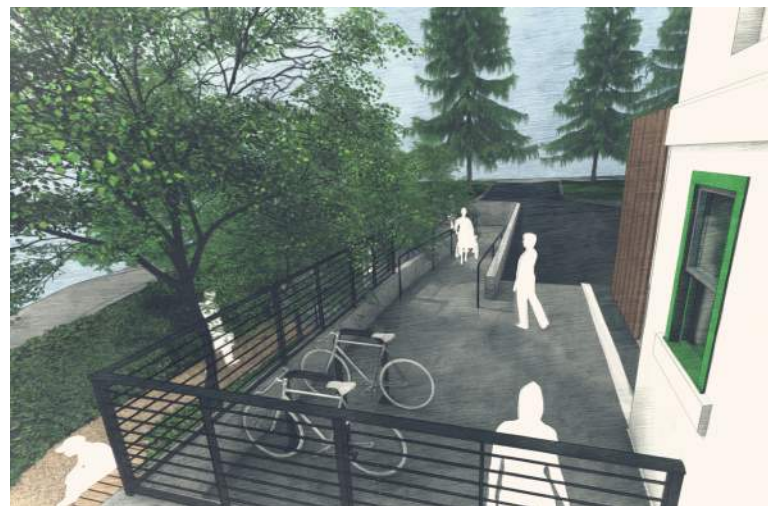
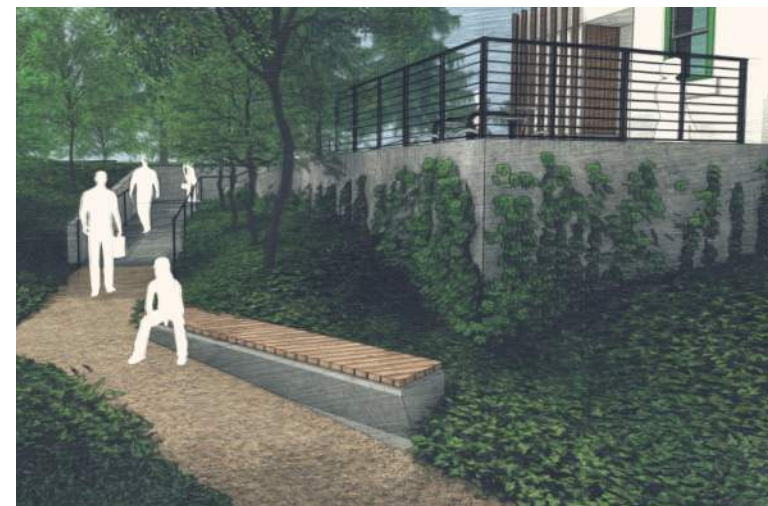
SW SITE AREA - NE 50TH ST ACCESS - DESIGN EVOLUTION

CURRENT SCHEME ADVANTAGES:

- Pathway trajectory minimizes impact on existing trees.
- Inviting and accessible sloped walk segment starting at mid-block sidewalk
- Terraced walls to reduce individual wall height and eliminate need for guardrail.
- Additional stepped walls to open up the space and make the pathway feel safer and less constrained.
- Harmonized relationship of upper plaza to architectural expansion.

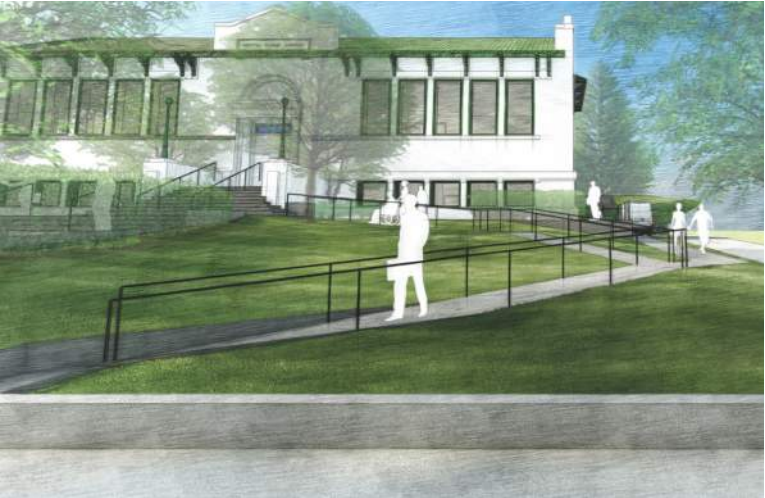
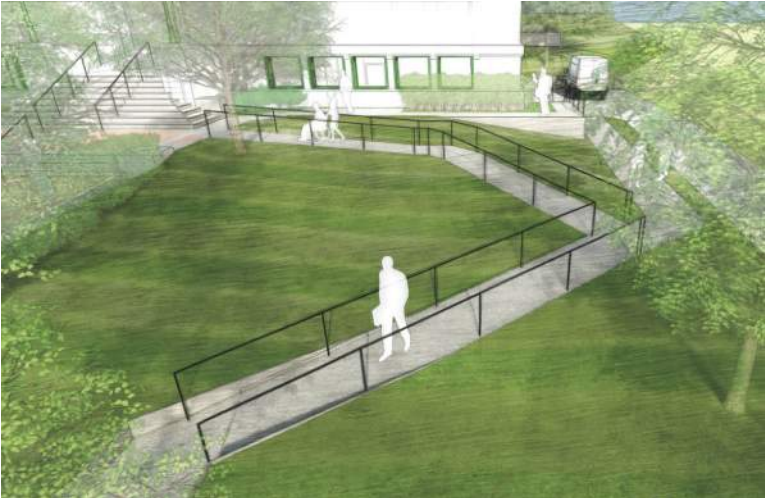
NE SITE AREA - ROOSEVELT WAY NE ACCESS - DESIGN EVOLUTION

CURRENT SCHEME ADVANTAGES:

- Pathway trajectory minimizes impact on existing trees.
- Ramp section with rails location minimizes impact on east elevation to maintain symmetry.
- Sloped walkways make up most of the grade change - gradual and easier to navigate.
- Stair relocation makes site navigation more intuitive.
- ADA access from street to both lower level entry and to south pathway ADA improvements, connecting entire site.

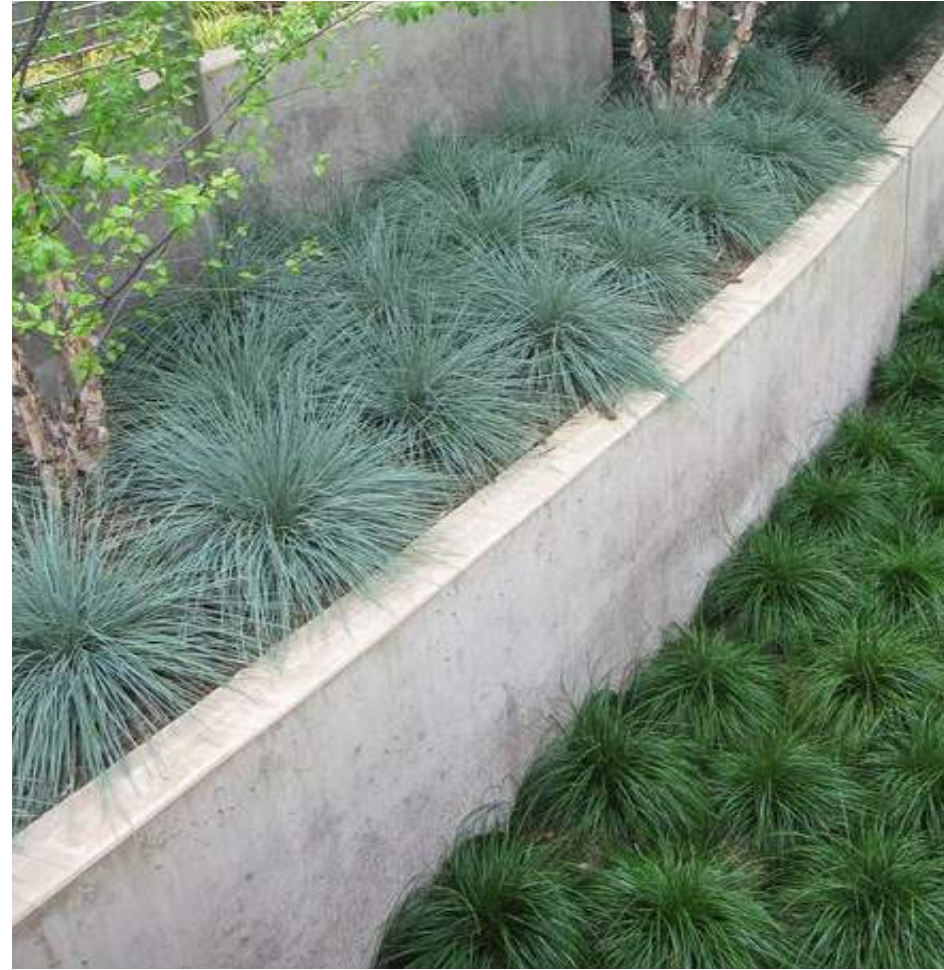
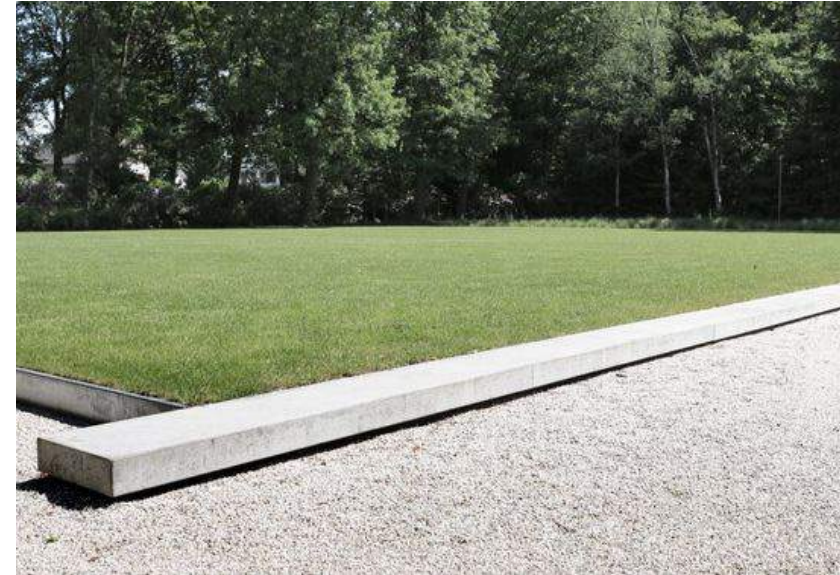
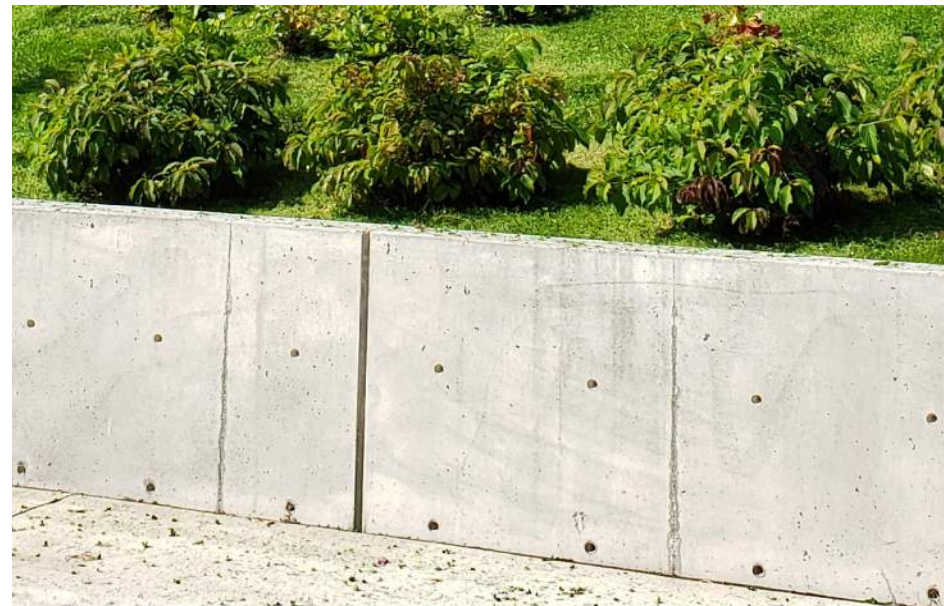
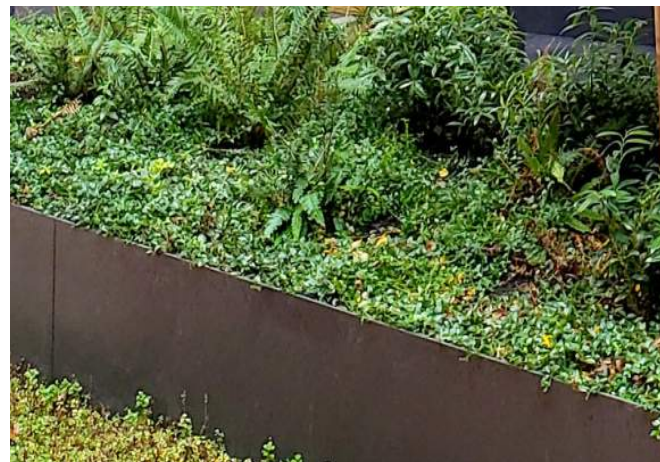
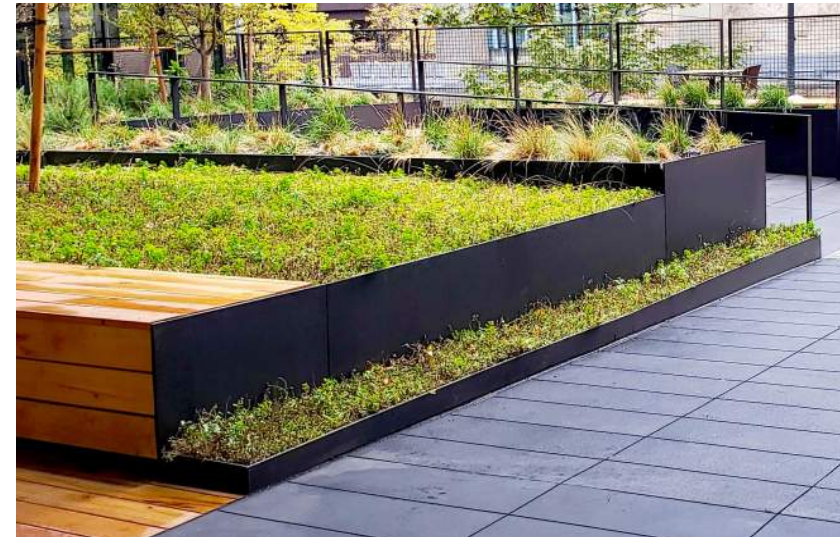
Due to the negotiation of significant grade changes throughout the site, retaining walls will be required in order to provide improved universal accessibility. Retaining walls will be designed to blend as much as possible into the site and be light in their visual impact. Planting will be used in order to minimize visual impact by screening walls where possible.

Concrete walls provide a simple, neutral, solid expression that fits with existing elements.

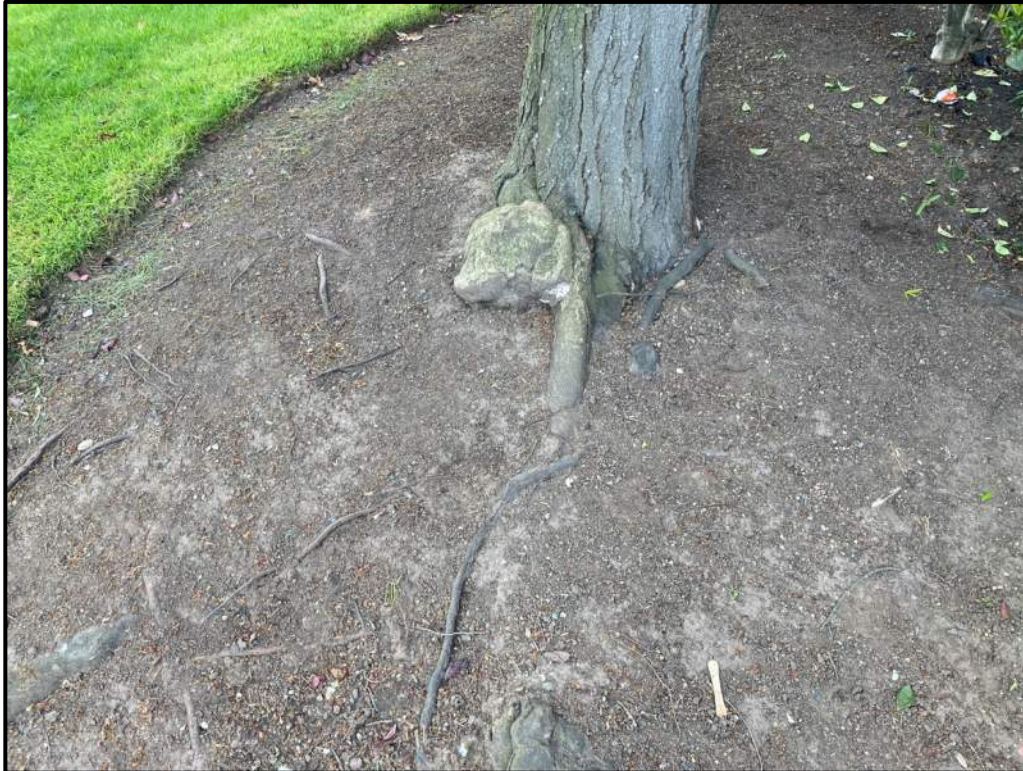
Photo 1. Exposed surface roots at the base of tree 278.

The soil across the site appears somewhat stripped and compact as a result of consistently removing organic debris from the landscape using rakes and leaf blowers. In a few instances this practice has exposed surface roots (Photo 1). The addition of woodchip mulch across the root zones of these trees would improve growing conditions.

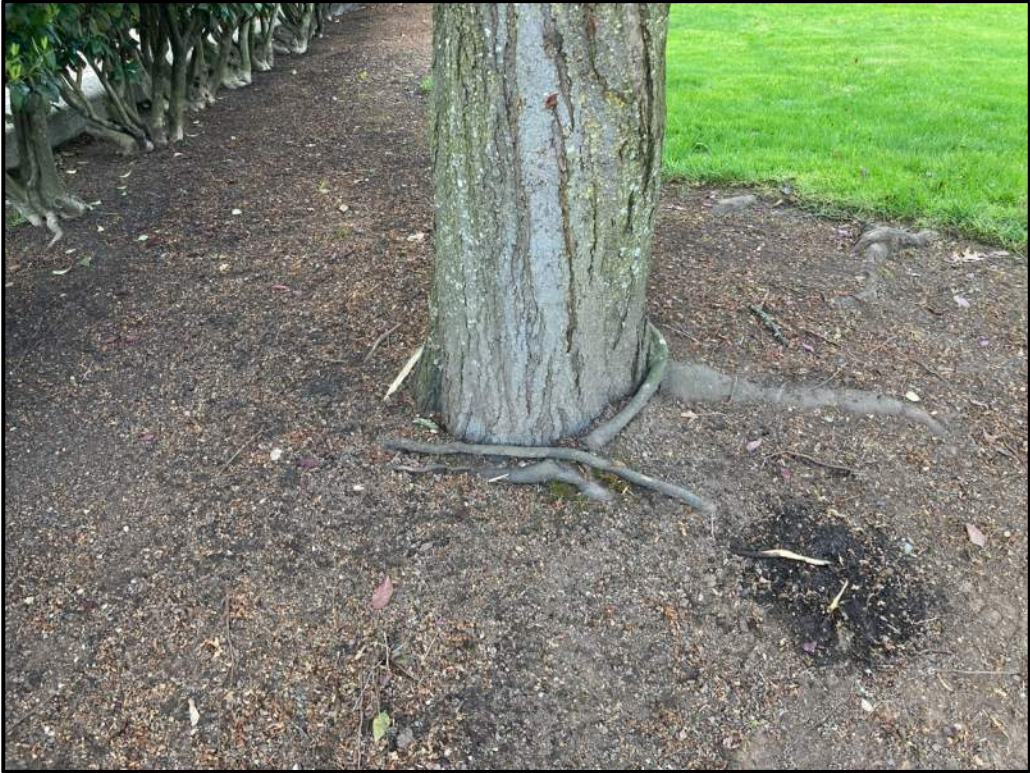
Photo 3. A prominent girdling root at the base of tree 280 (Indicated by red arrow).

Tree 280 is a flowering plum with a prominent girdling root (Photo 3). This root should be cut using a hammer and chisel to prevent future issues. If left unchecked, this root can lead to the eventual decline of the tree.

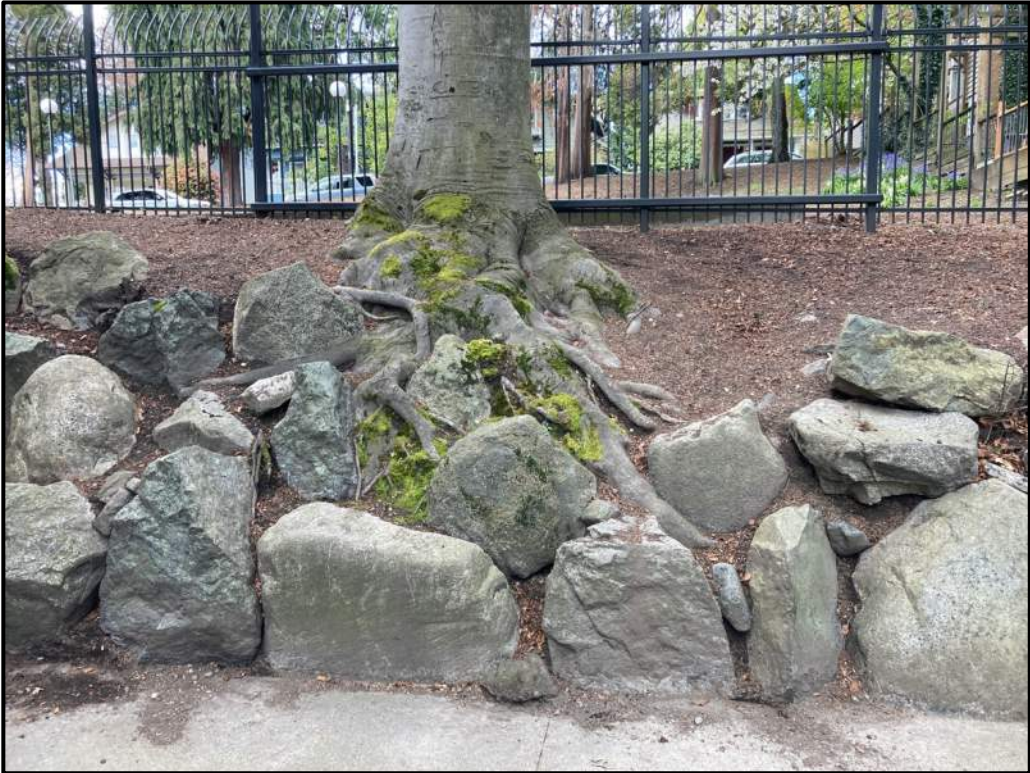
Photo 4. Roots from tree 283 that have become intertwined in the existing rockery

Tree 283 is an exceptional copper beech located on the north side of the library building. The roots of this tree are intertwined in the adjacent rockery (Photo 4). The rockery must remain in place if this tree is to be retained.
