MONTLAKE ELEMENTARY SCHOOL

SEATTLE PUBLIC SCHOOLS

**BRIEFING PACKET FOR SEATTLE LANDMARKS PRESERVATION
BOARD - ARCHITECTURAL REVIEW COMMITTEE
JANUARY 27, 2023**

Modernization of and addition to the existing landmarked Montlake Elementary School on the same site, removal of all out-buildings and a reconfiguration of the school grounds.

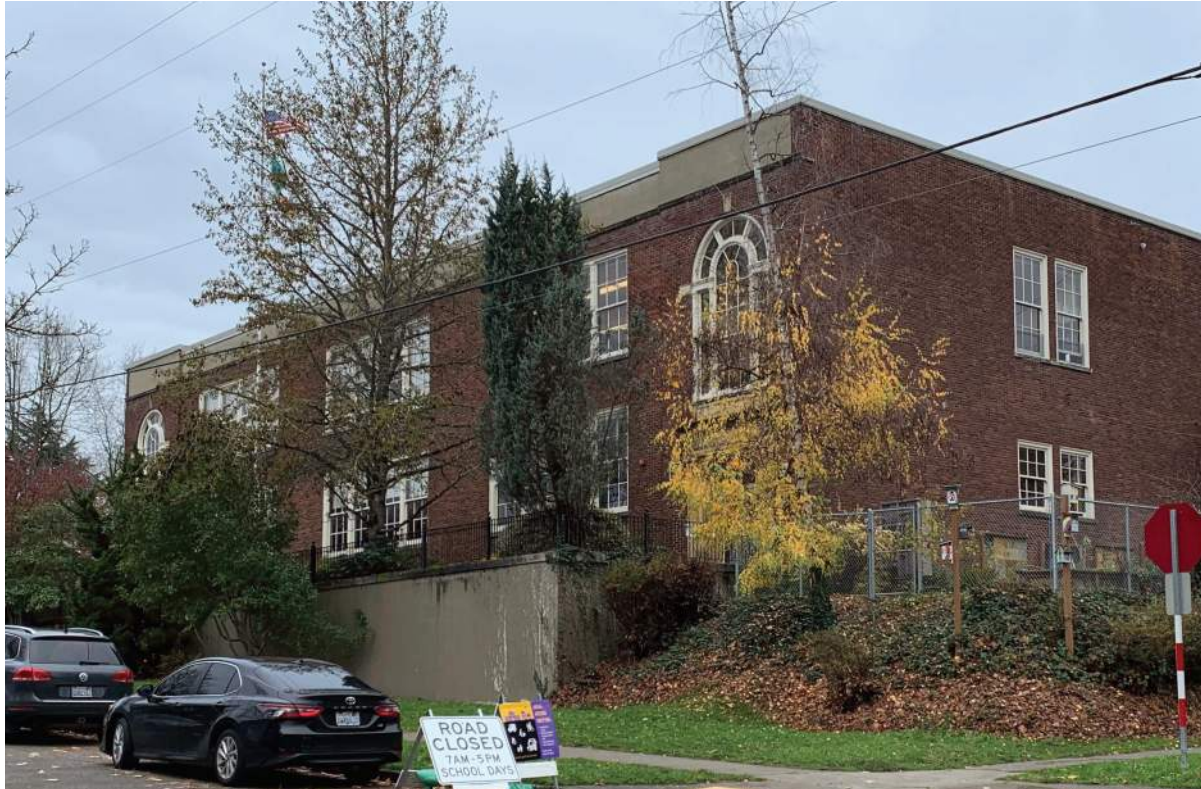
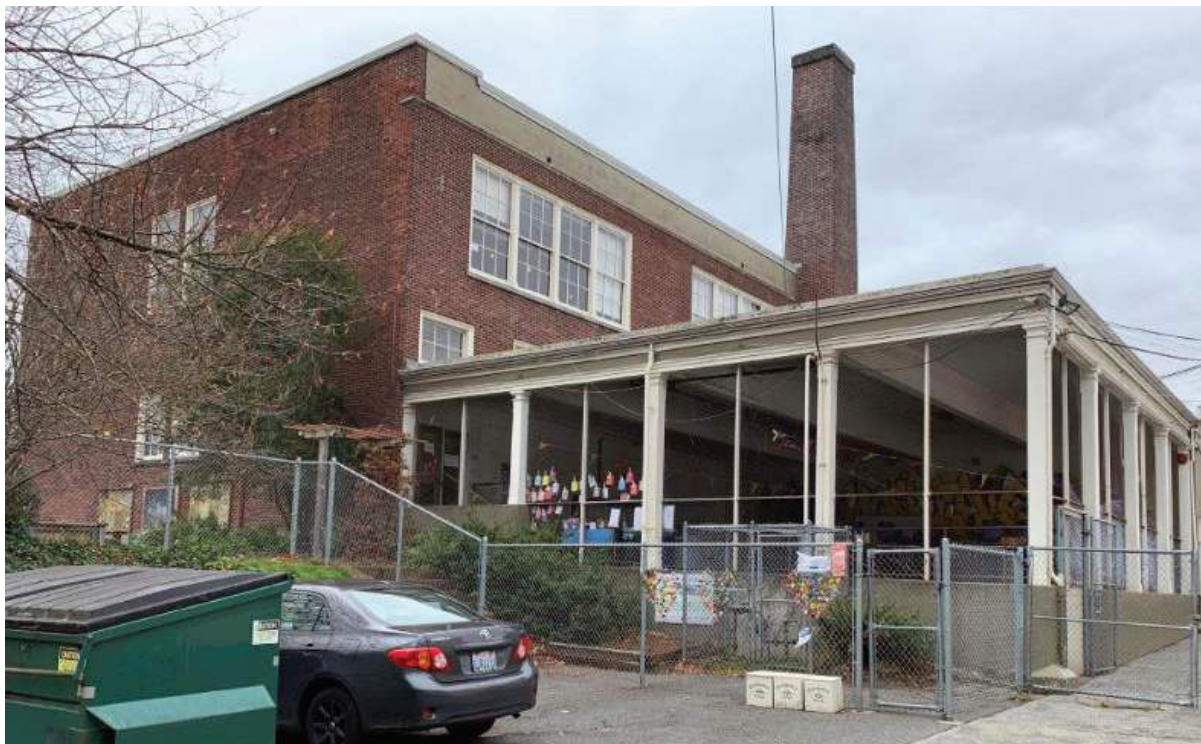
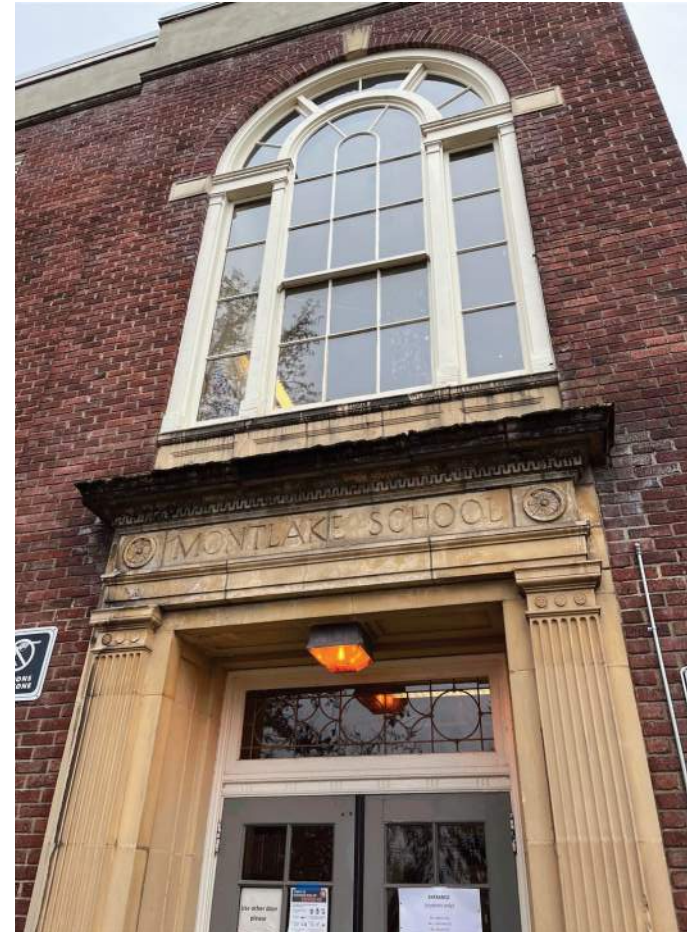
DESCRIPTION OF ARCHITECTURAL FEATURES

- Overall modest two-story, red brick building with the majority of the distinctive architectural detailing concentrated on the east facade
- Separate main entry doors (appear to have been originally separate entries for female and male students)

- Each entry door is accentuated with cast stone pilasters and an entablature with the school name carved within and flanked with rosettes
- Distinctive arched windows above each entry door that fronts the two primary interior stairwells

- North and south facades are largely devoid of ornamentation and have limited window openings
- Upper floor of the west facade has a similar window arrangement and spacing to east facade

- A wood framed single story structure is connected at the first floor of the west facade and contains a covered play area, the boiler room and the gymnasium

- An engaged chimney runs up the center of the west facade and extends about 20' above the parapet line

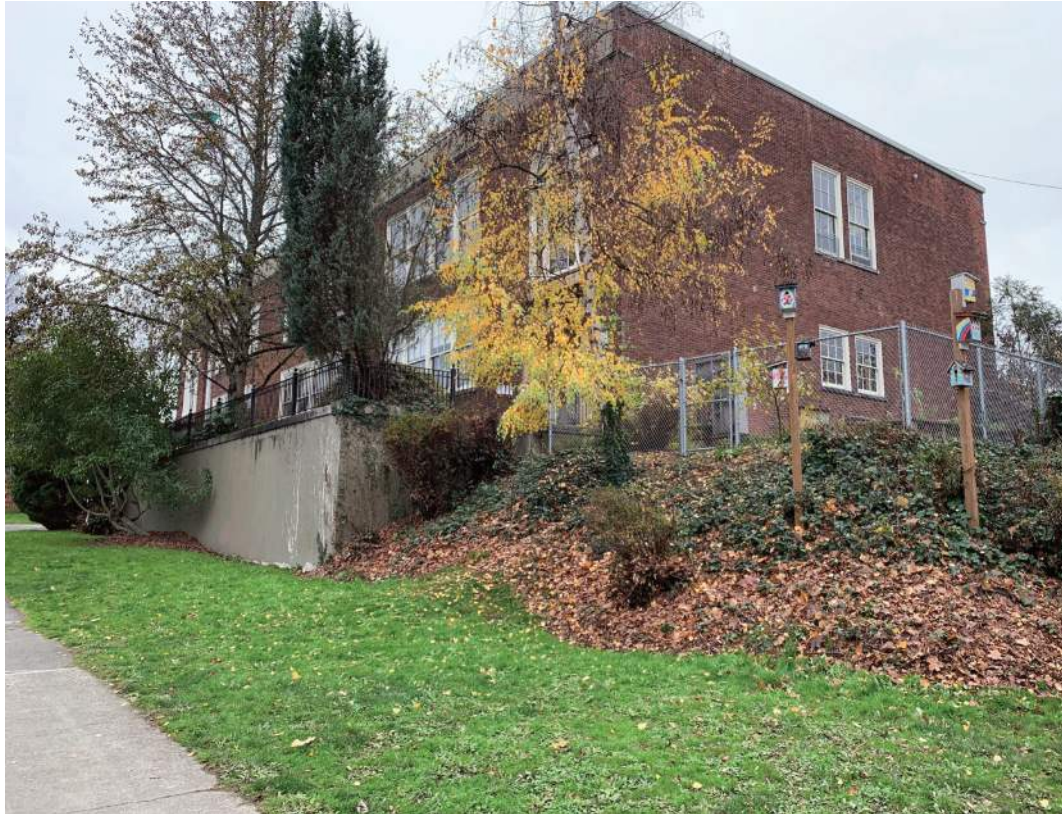
1. View of northeast corner at 22nd Ave E and E Calhoun

1. The corner of 22nd Ave E and E Calhoun is raised considerably from the adjacent sidewalk with the raised base placing the ground floor level of the school well above the sidewalk level.
2. The site slopes upwards along 22nd Ave E towards E McGraw to be more closely aligned with the building ground floor level.
3. The site continues to slope downward along E Calhoun placing the site level above the sidewalk level and creating a berm along the site edge
4. The site slopes upwards along 20th Ave E and along E McGraw. The sidewalk and site levels meet each other along E McGraw near the southwest corner of the historic building

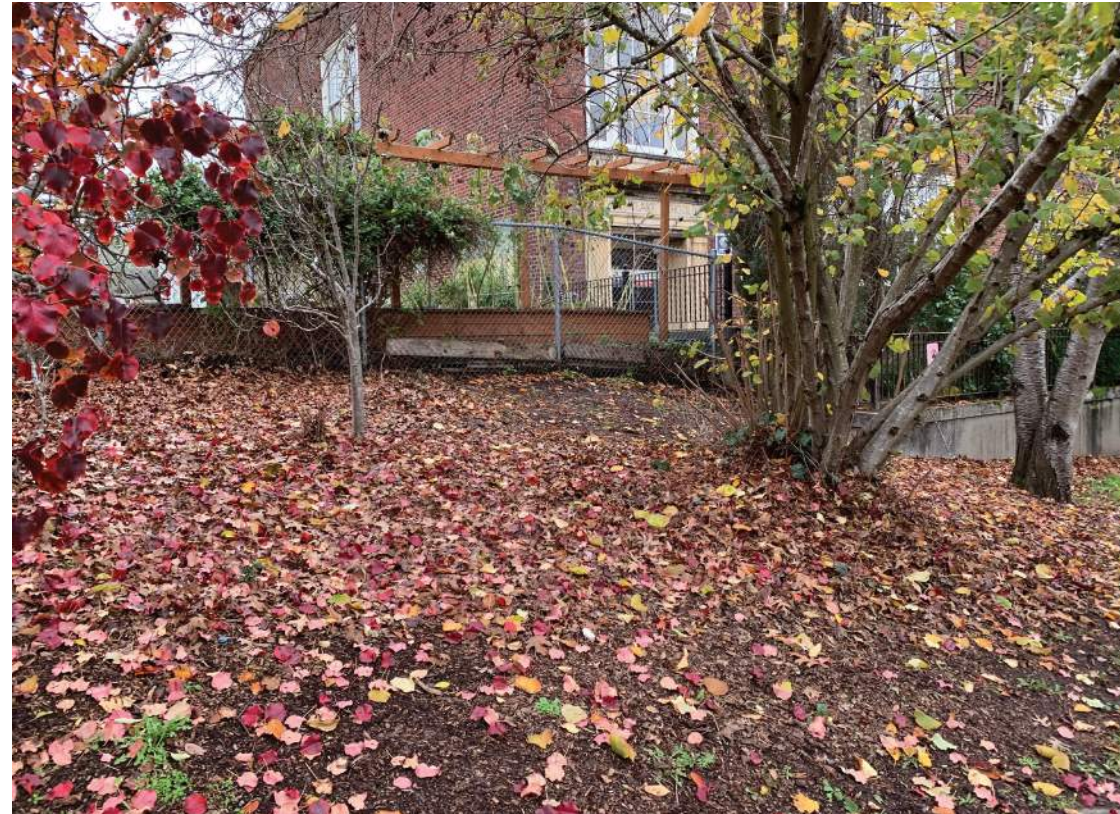
2. View of southeast corner at 22nd Ave E and E McGraw

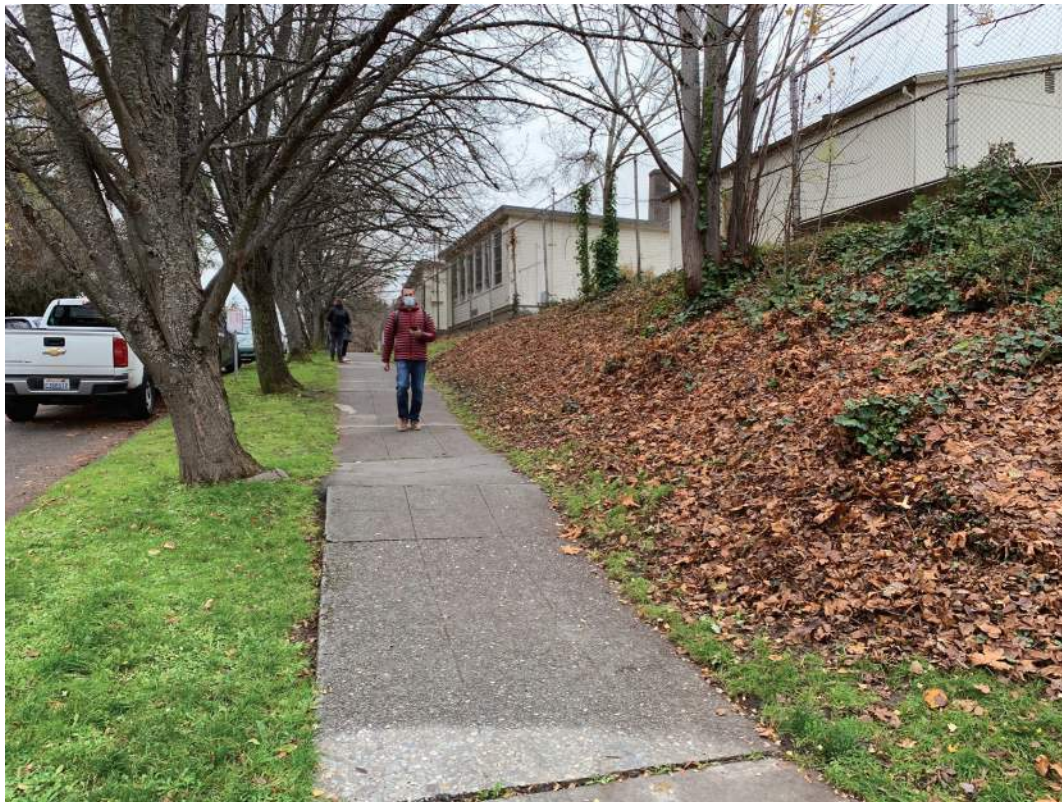
3. View of northwest corner at 20th Ave E and E Calhoun

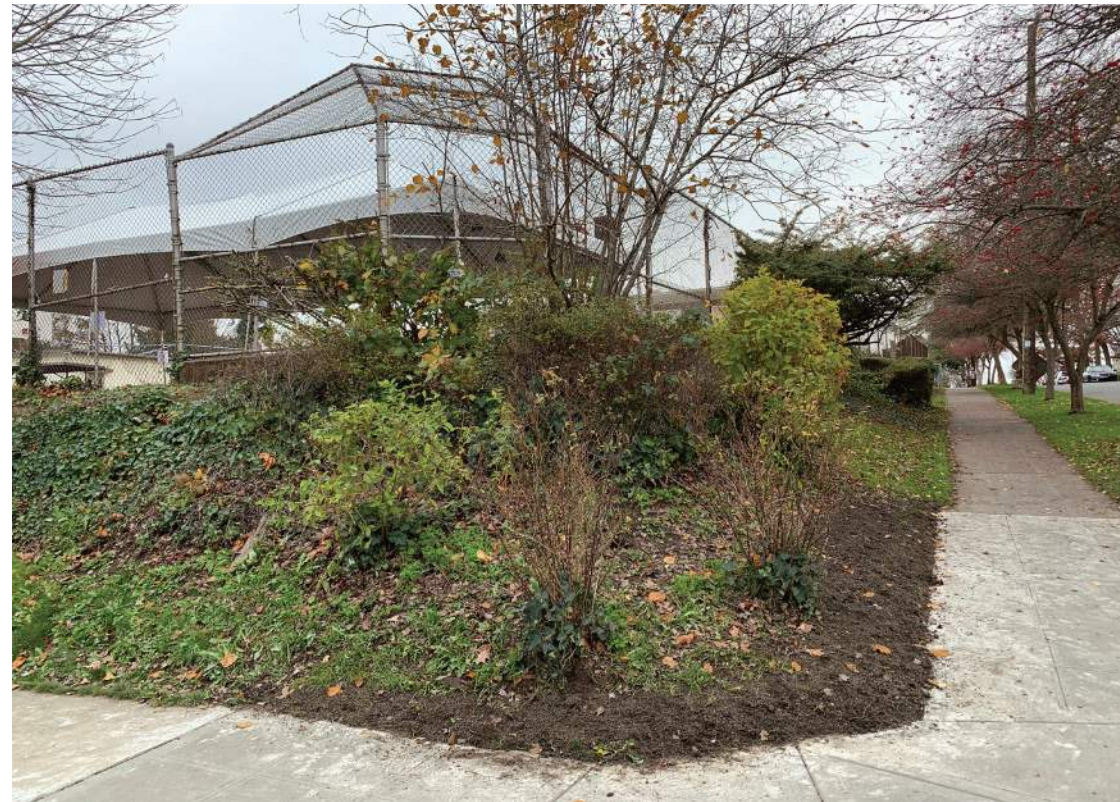
4. View of southwest corner at 20th Ave E and E McGraw

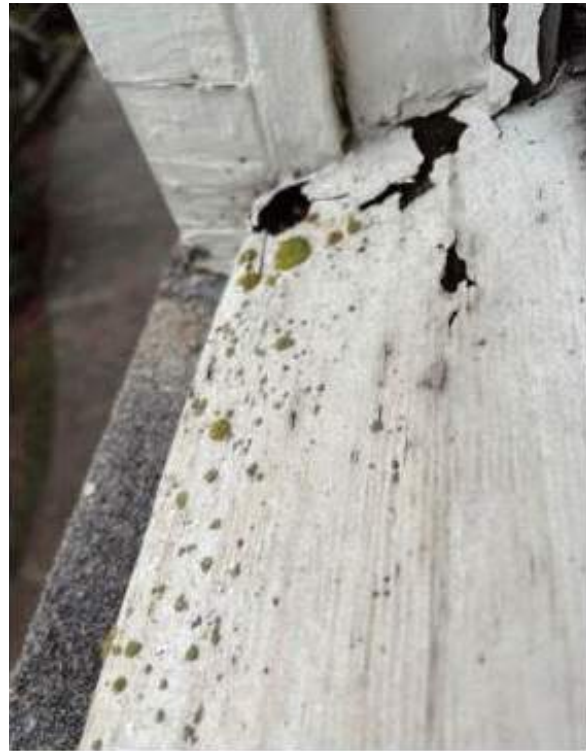
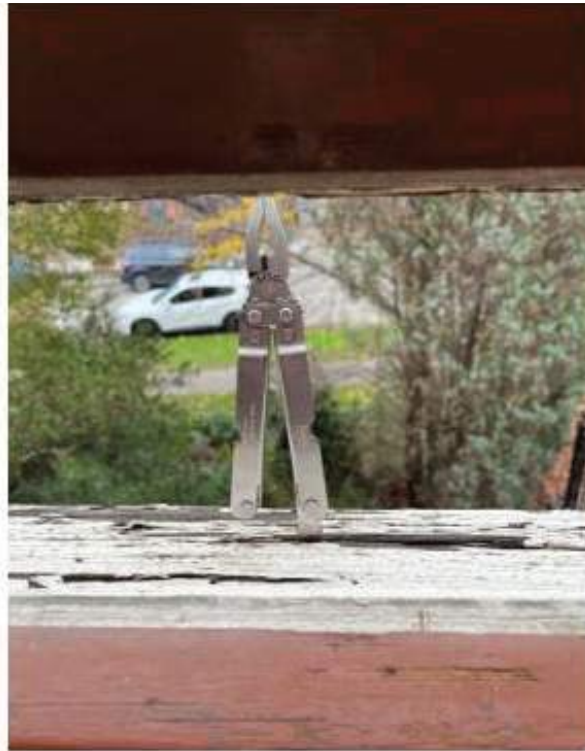
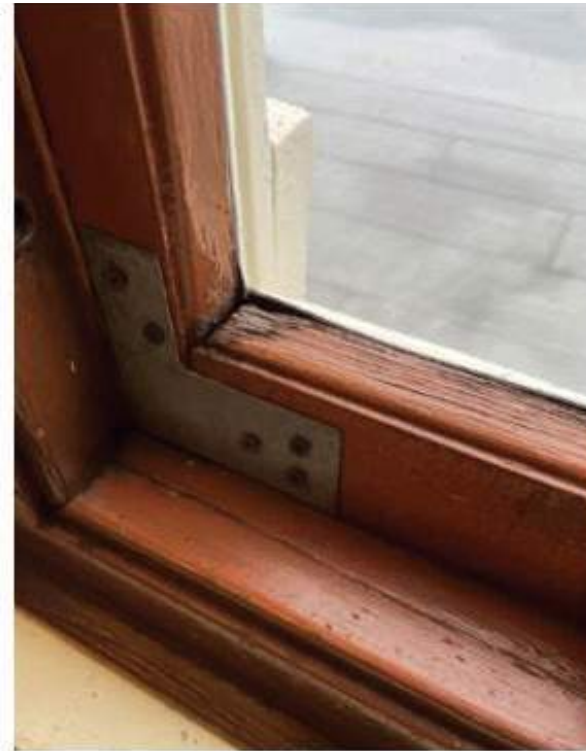
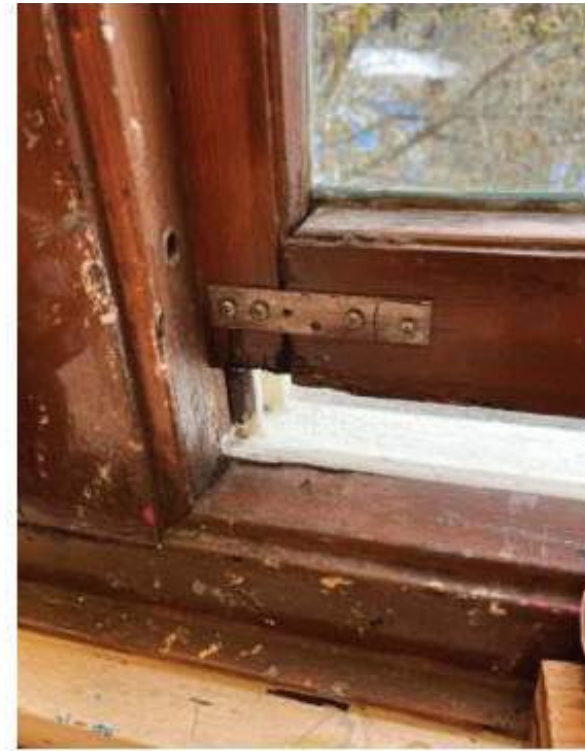
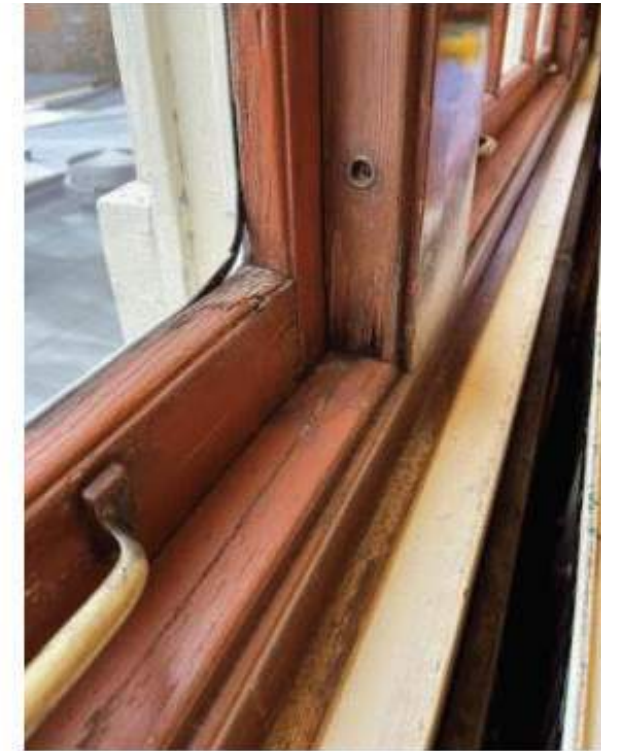
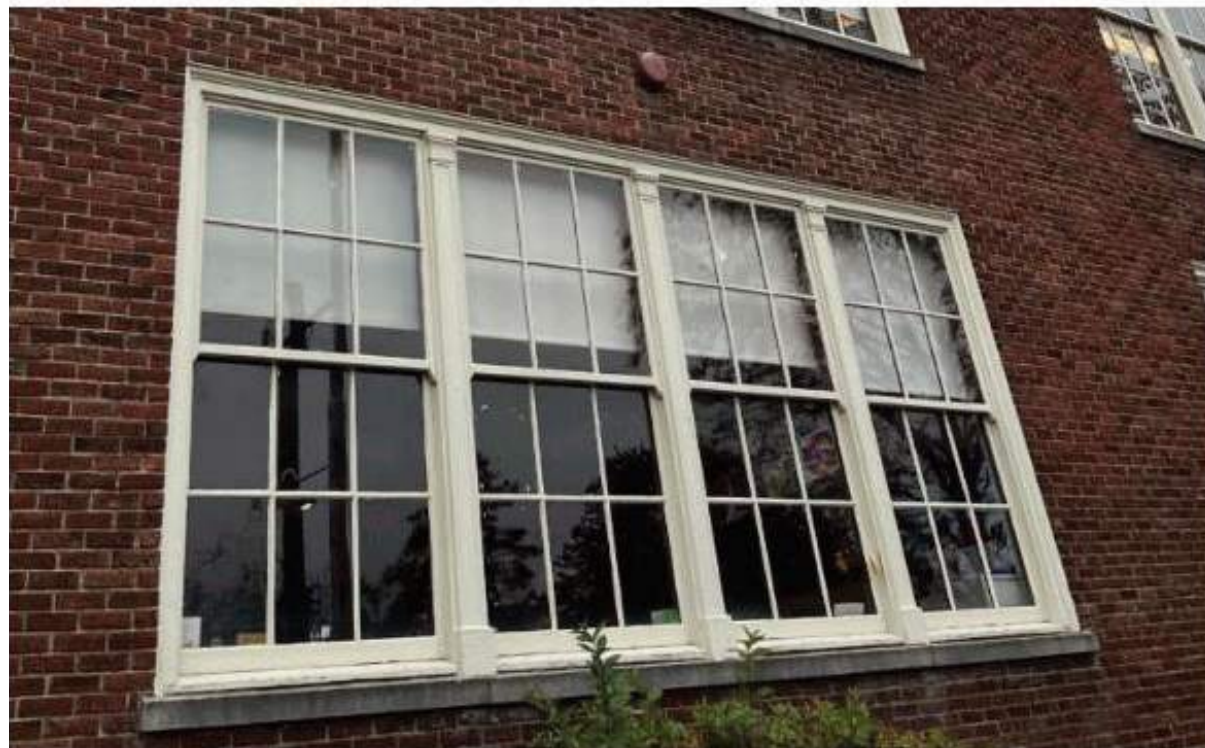
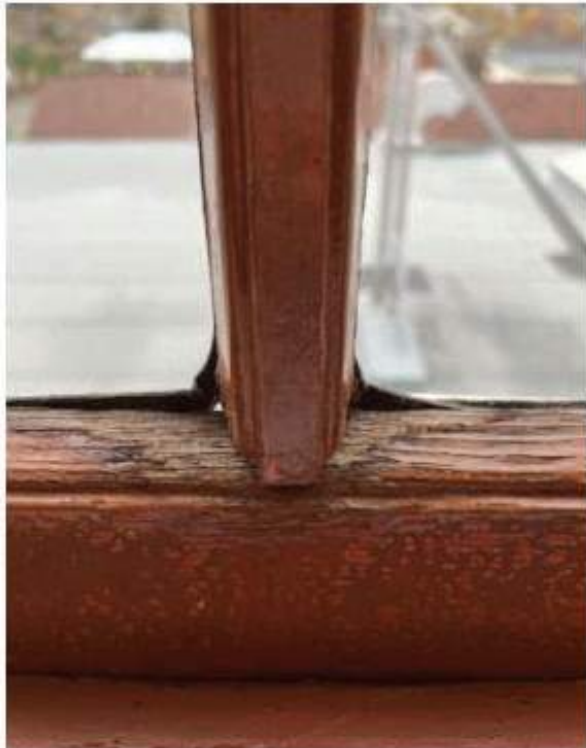
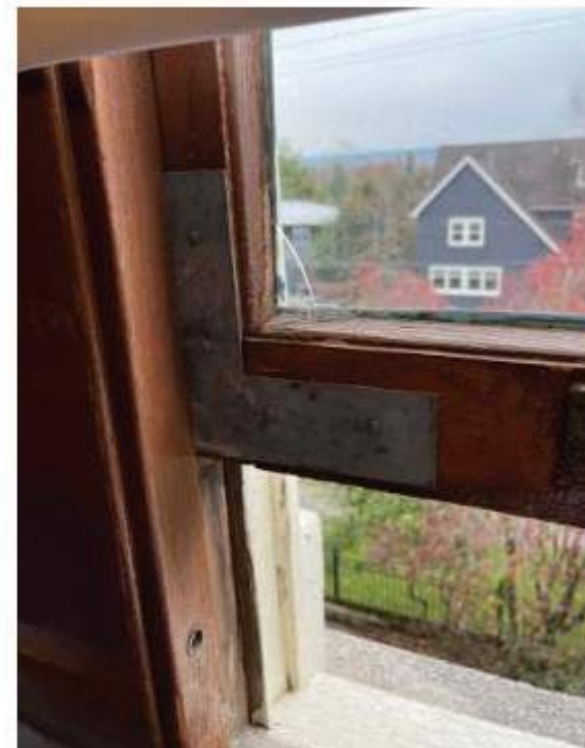
WINDOW CONDITION SURVEY

Typical deficiencies noted at windows:

- Dry rot at sills and lower jambs
- Separation at corner joints where bottom rails and stiles meet
- Failed glazing seals
- Water staining and raised grain at glass corners
- Cracking and splitting in sills

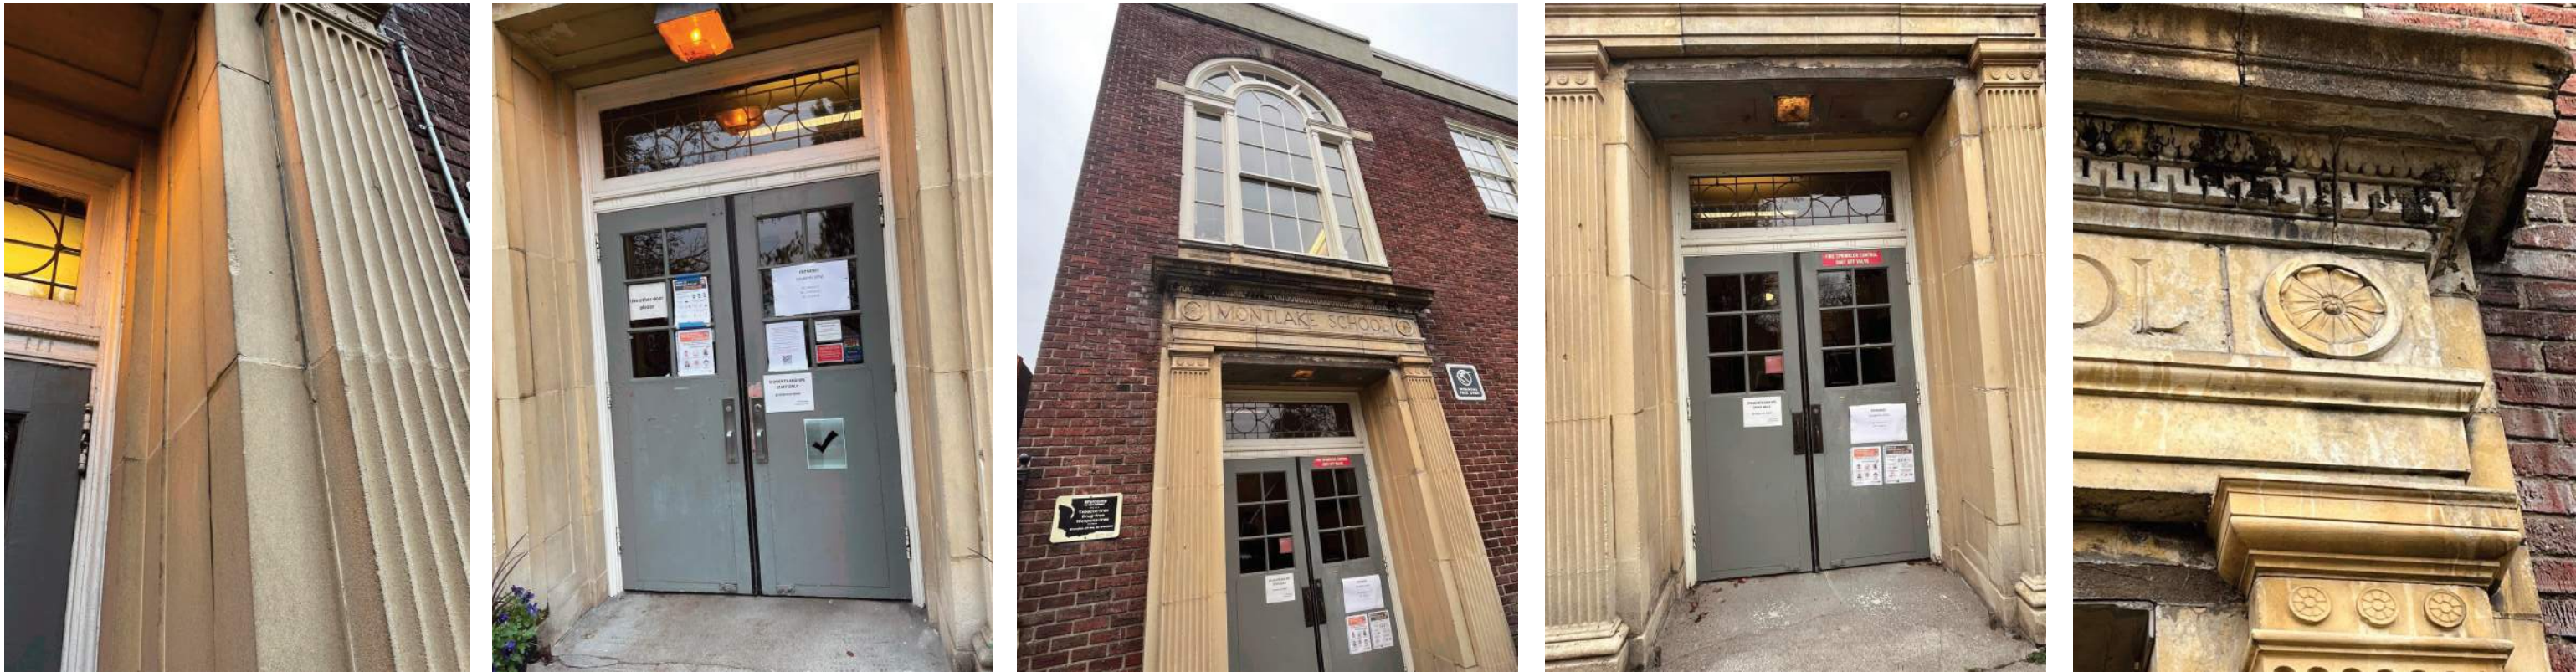
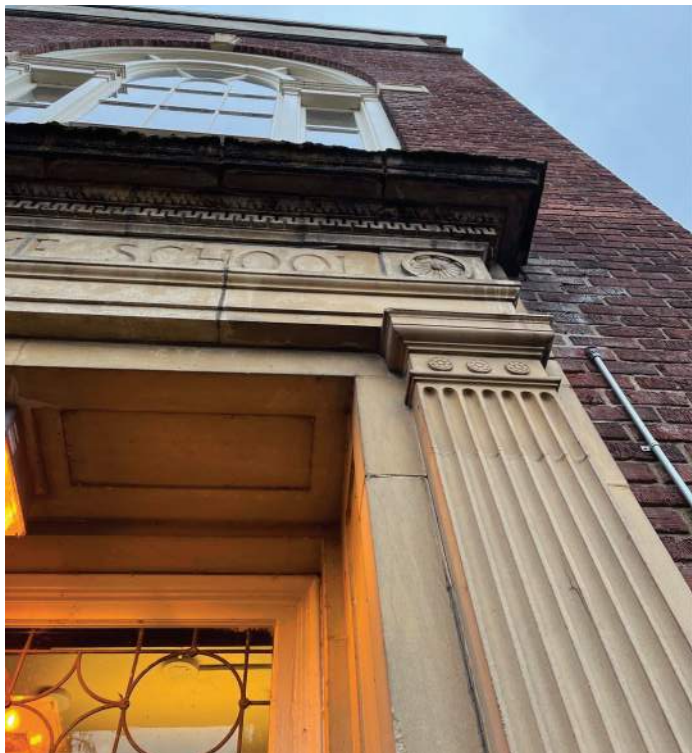
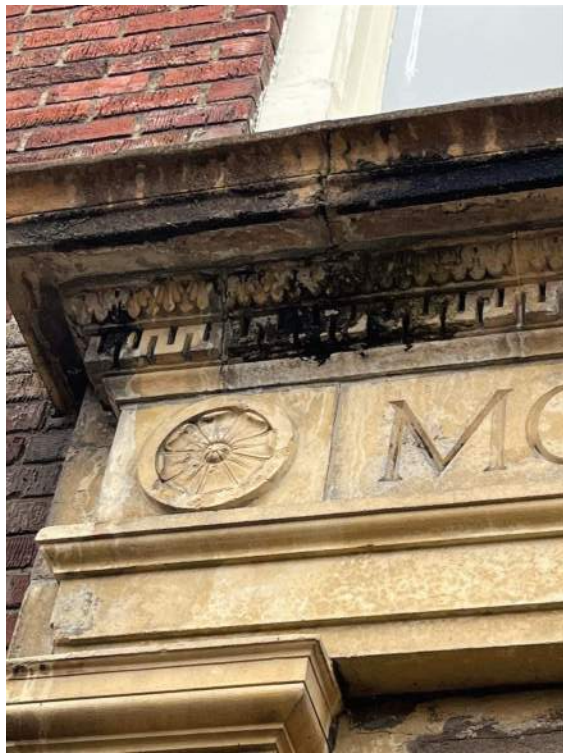
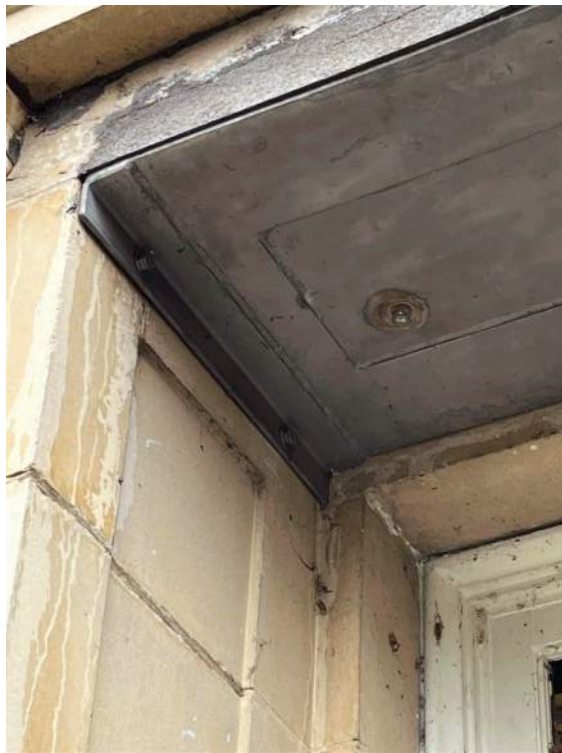
CAST STONE DOOR SURROUNDS CONDITION SURVEY

Deficiencies noted at cast stone:

- Severe discoloration at the projecting cornice above the entablature and significant water damage (cracking, spalling, staining) at the underside of those units. Water stains streaked down the adjacent vertical elements
- Water damage at the underside of the soffit panels. Soffit panels at the southeast entry have been replaced by a galvanized steel sheet (likely due to water damage)
- Vertical units at the pilasters and jambs of the surround are in fair conditions, but are in need of pointing

1. Cleaning - Warm water rinse, followed by a mild detergent wash with a nylon bristle brush and another warm water rinse.
2. Replacement - Custom cast concrete replica units at severely deteriorated units
3. Repair - Patching mortar (Cathedral Stone) to repair minor cracks and spalls
4. Cover - Recommend adding a standing seam copper cap at the top of the projecting cornice piece to assist in shedding water
5. Coating - Recommend painting all of the cast stone with a breathable coating to decrease the porosity of the cast stone and prevent further deterioration

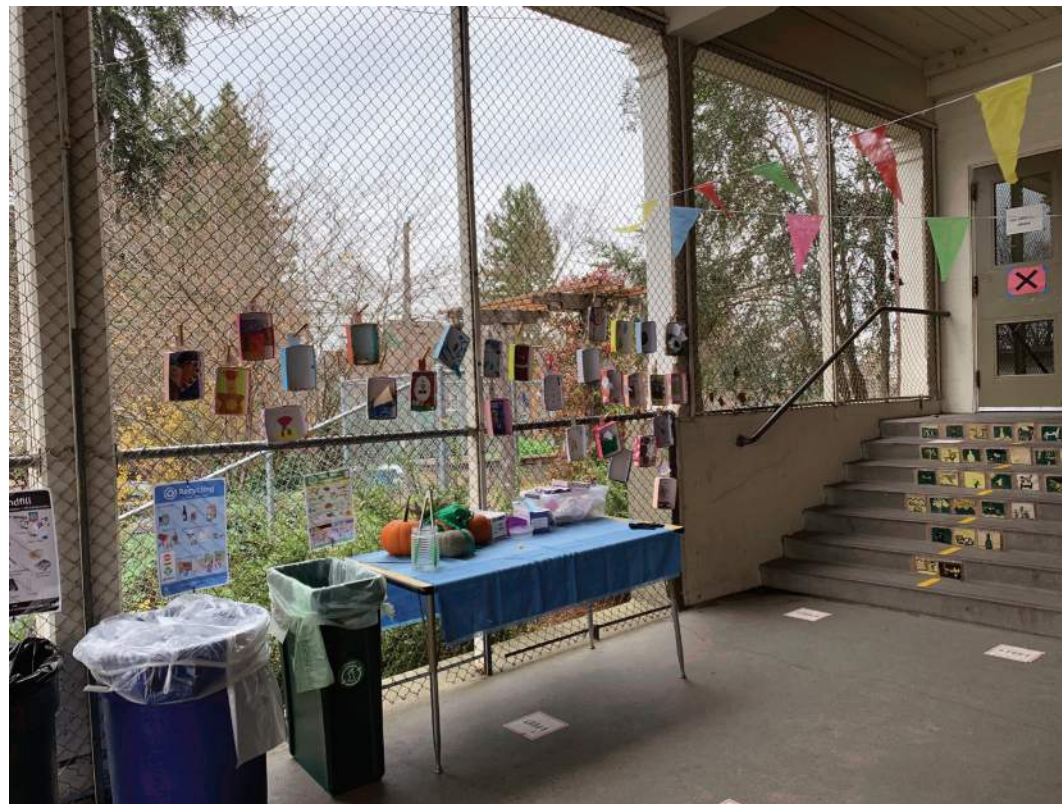
3. Interior view of covered play area from bottom of stairs to building

1. Current gymnasium is approx 1/3 of the district standard size and is only accessible to the building via stairs
2. Boiler room is undersized for current equipment needs and does not have a door to the exterior to provide safe access for maintenance staff to move supplies or equipment
3. Covered play is only accessible from the building via stairs
4. Covered play area is only accessible to the adjacent site via stairs

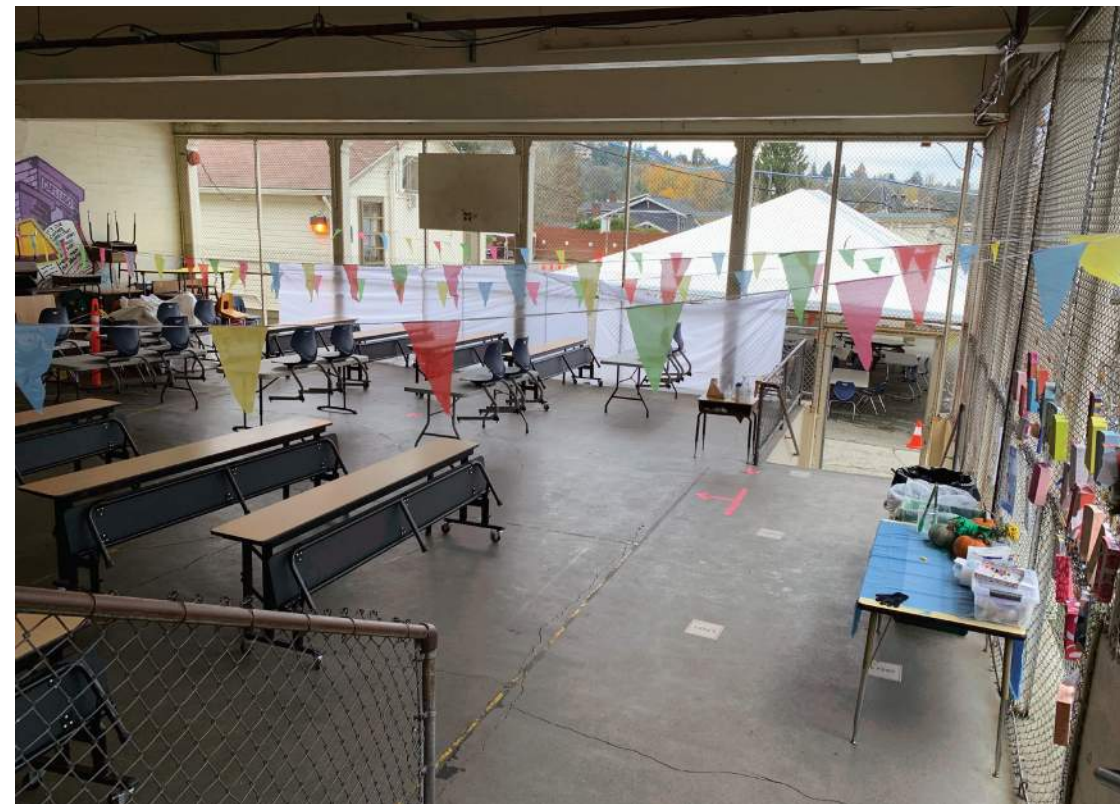
4. Interior view of covered play showing additional stairs down to site level

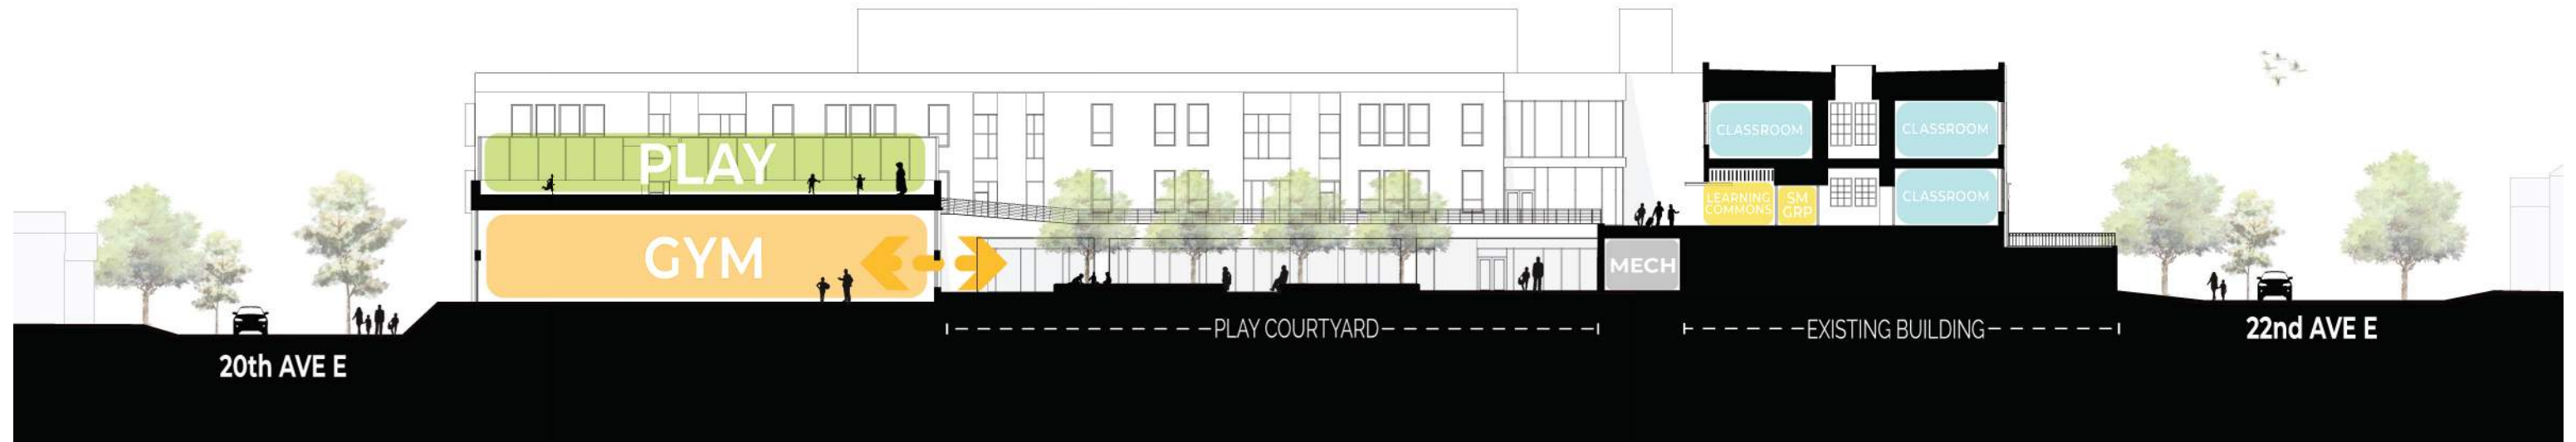
East to west site section

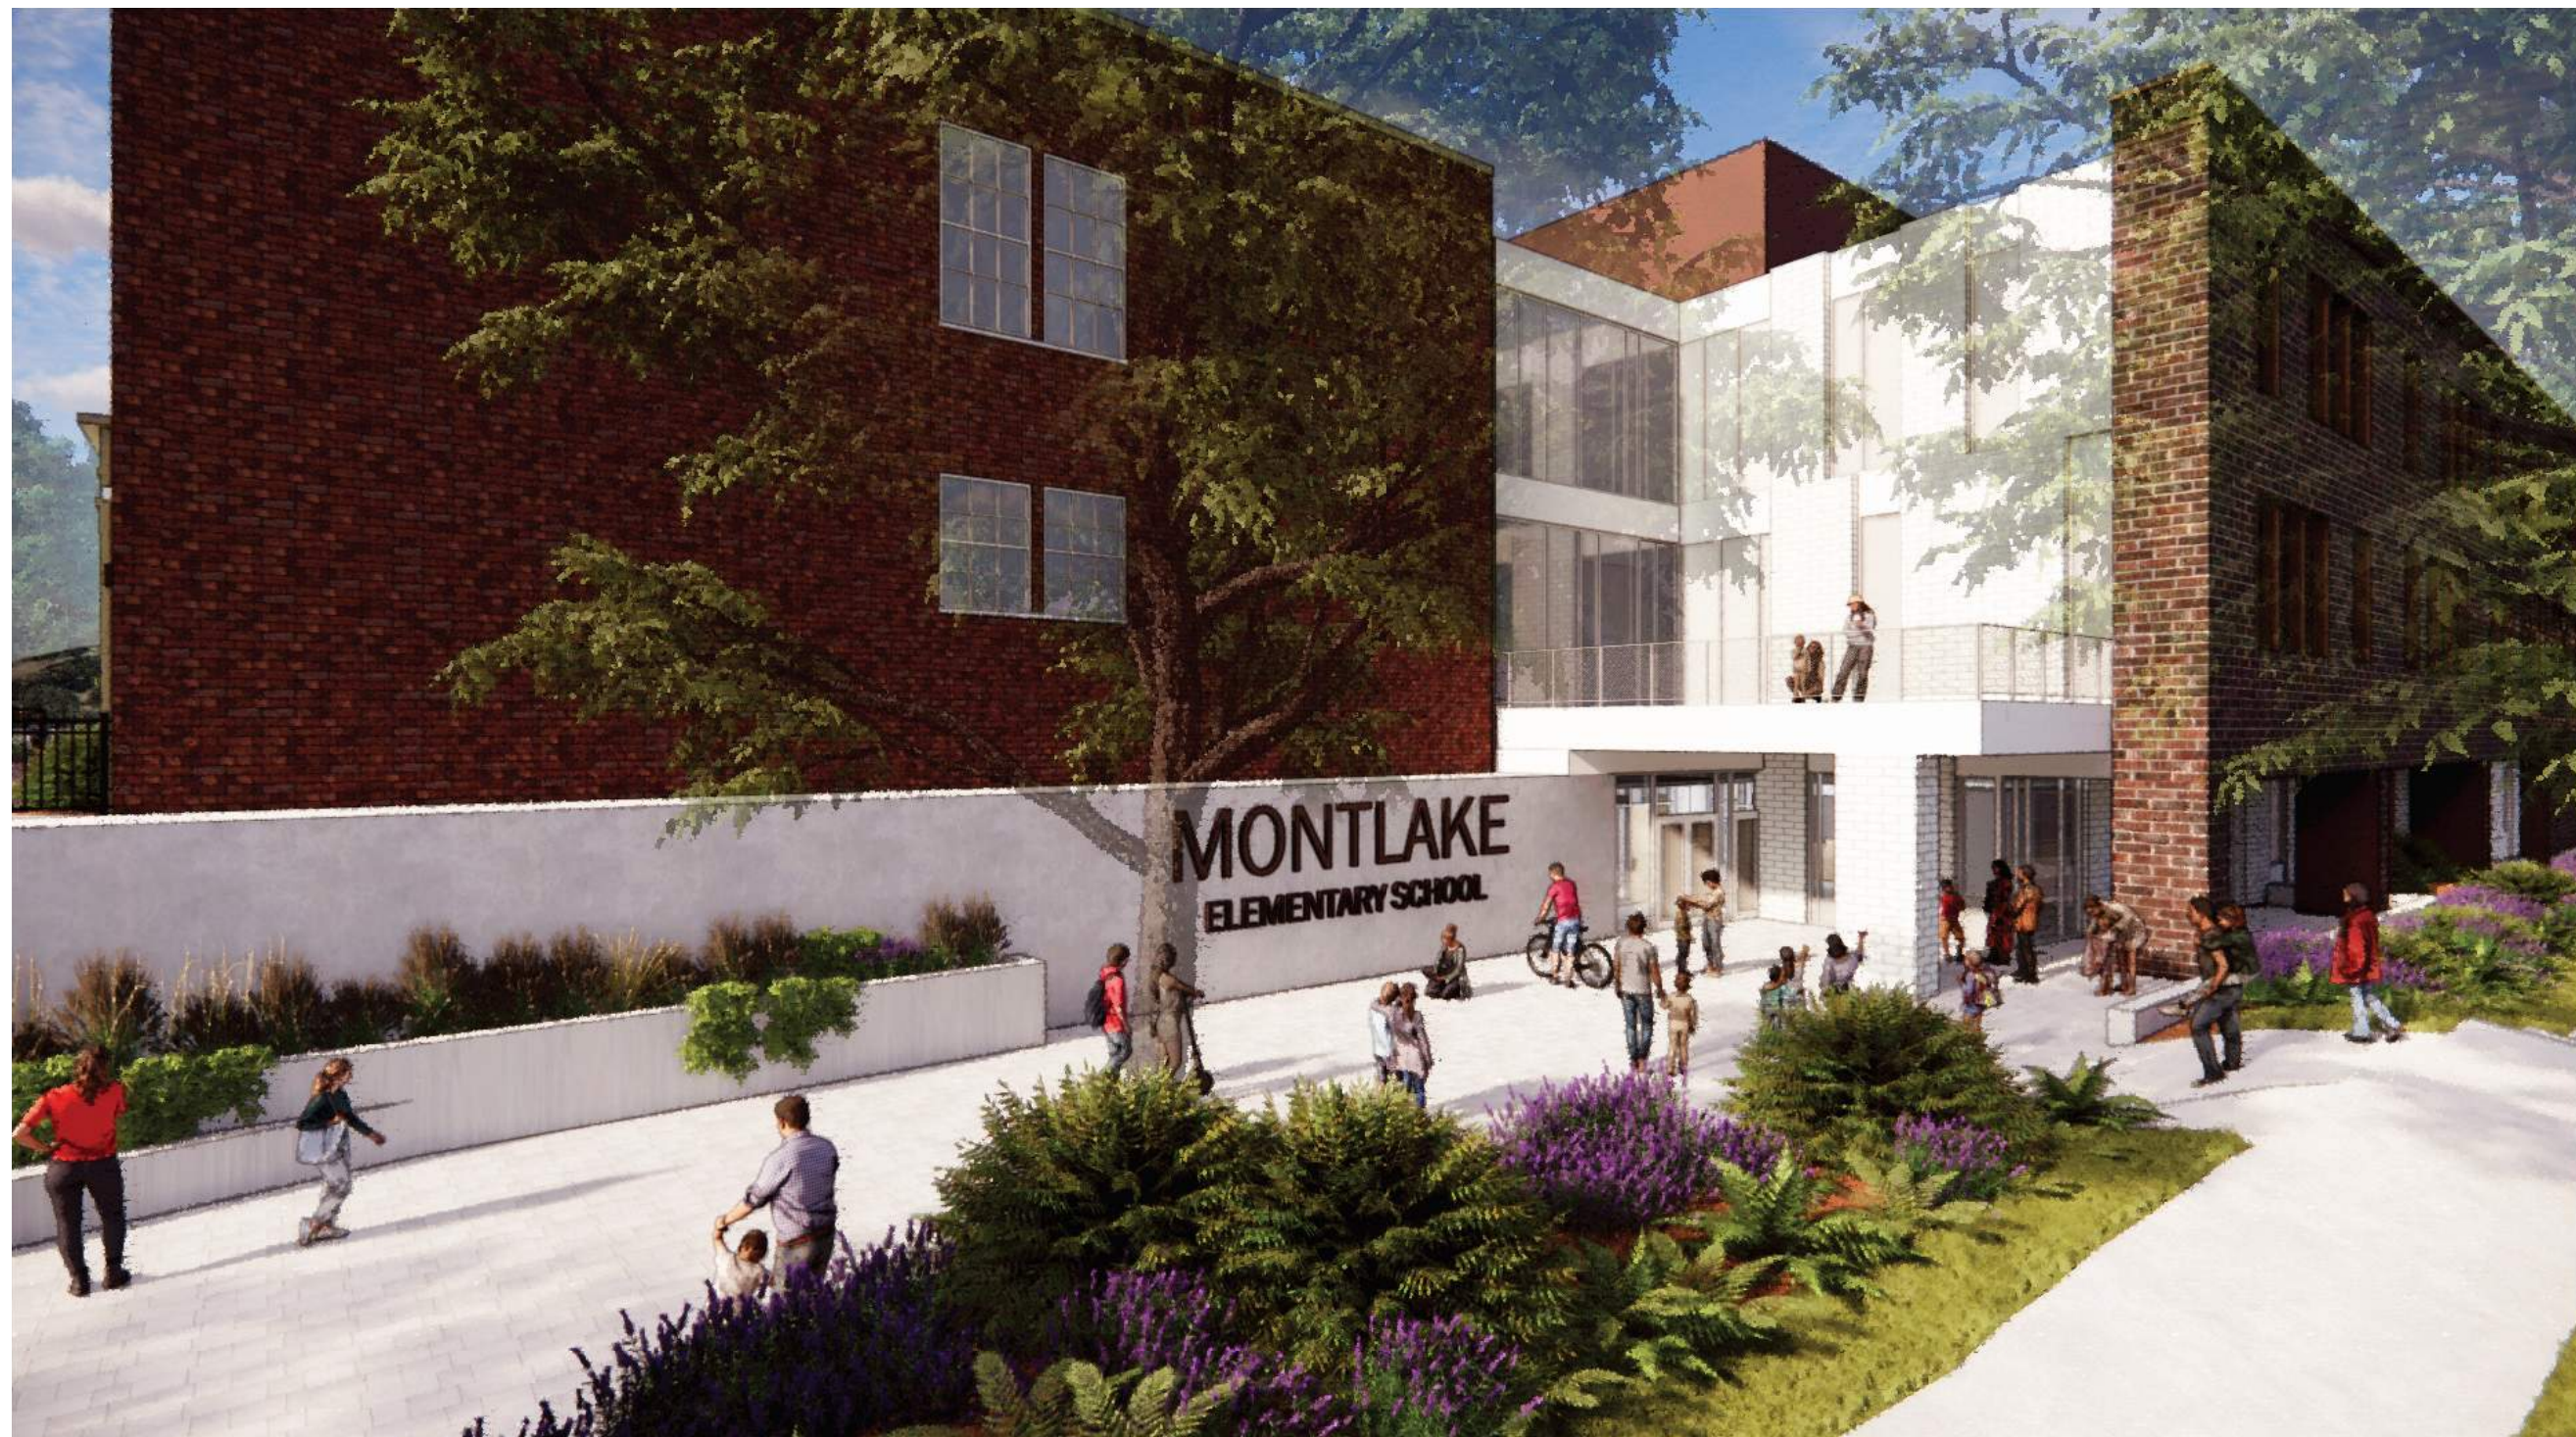
PROPOSED NE ENTRY PLAZA

Perspective view from corner of E Calhoun St and 22nd Ave S

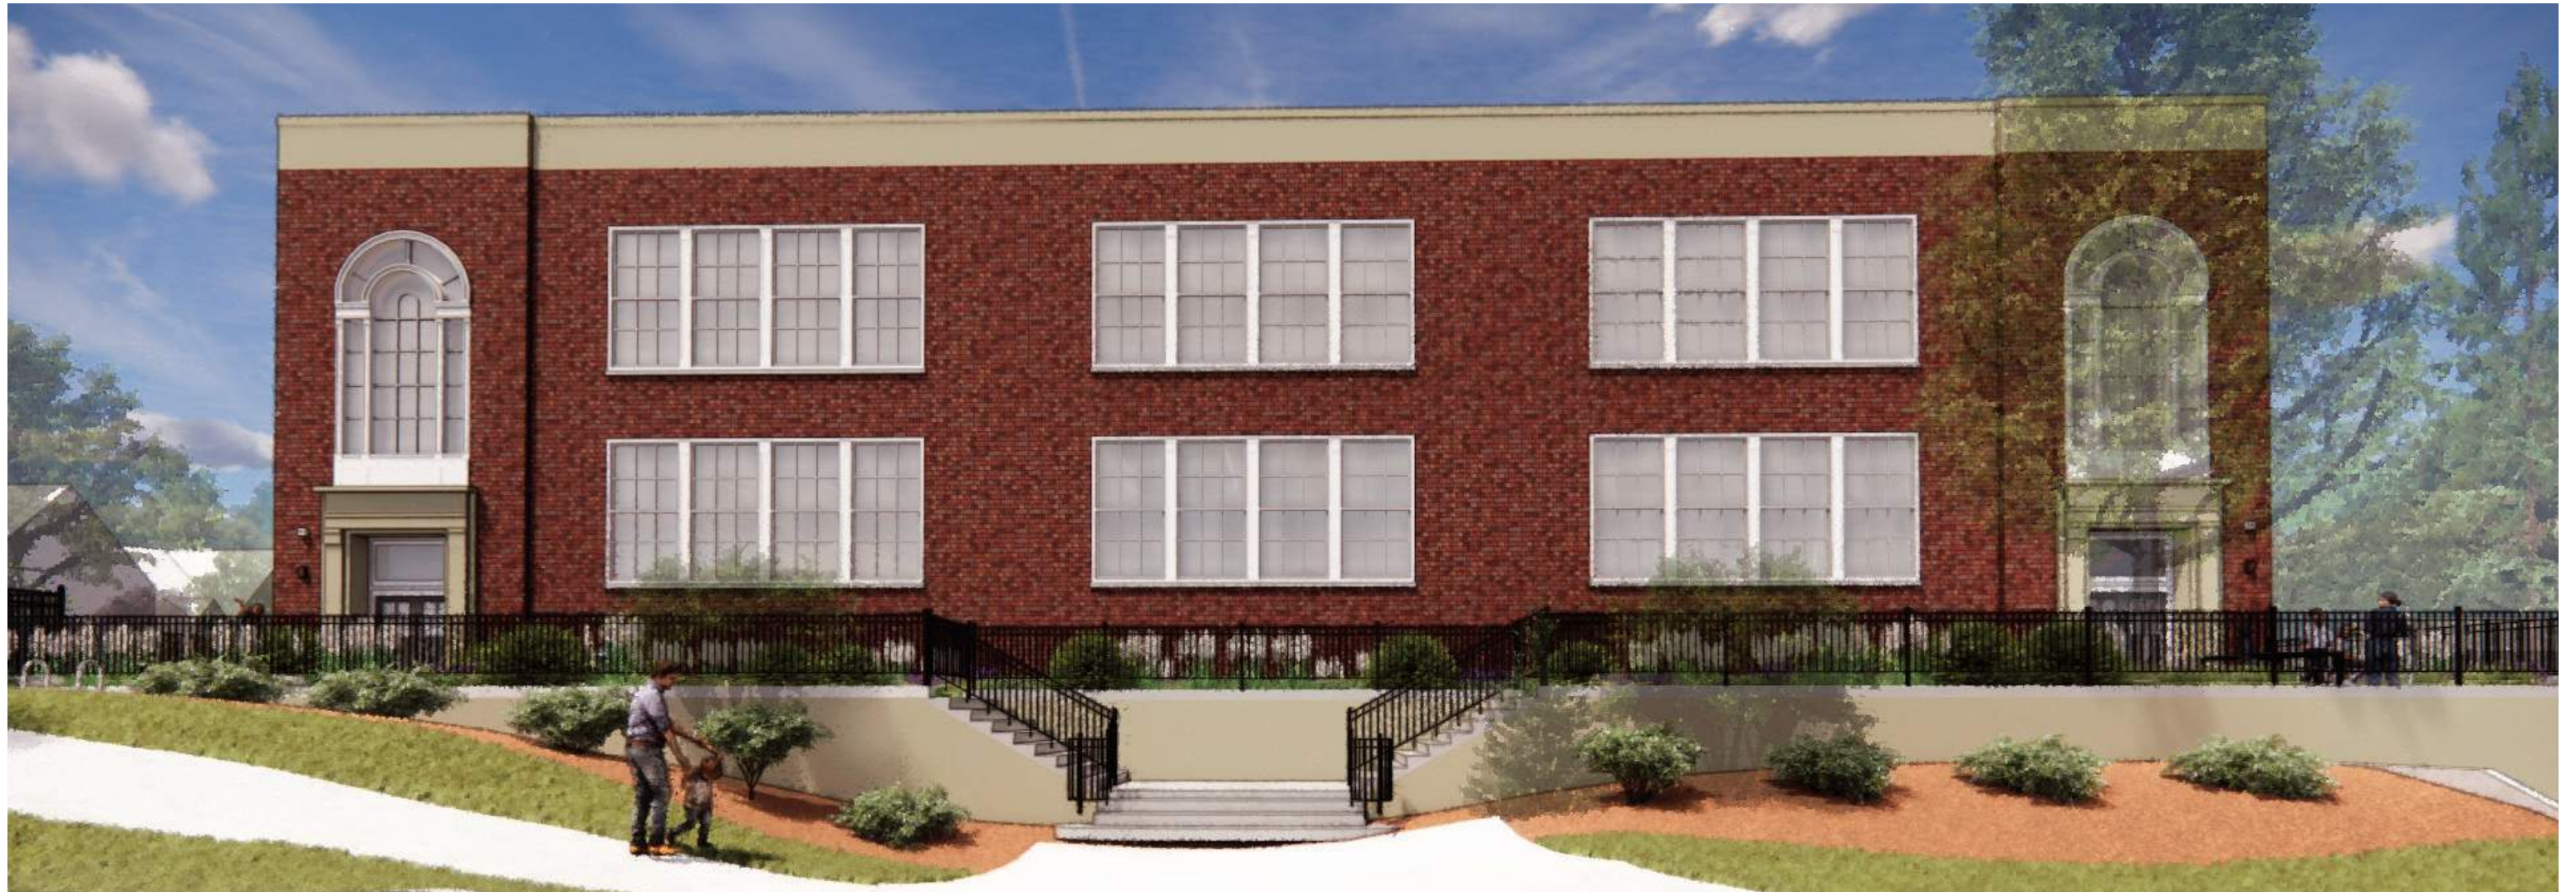
PROPOSED EAST FACADE

Perspective view from across 22nd Ave S
