MONTLAKE ELEMENTARY SCHOOL

SEATTLE PUBLIC SCHOOLS

**BRIEFING PACKET FOR SEATTLE LANDMARKS PRESERVATION
BOARD - ARCHITECTURAL REVIEW COMMITTEE
JANUARY 27, 2023**

Modernization of and addition to the existing landmarked Montlake Elementary School on the same site, removal of all out-buildings and a reconfiguration of the school grounds.

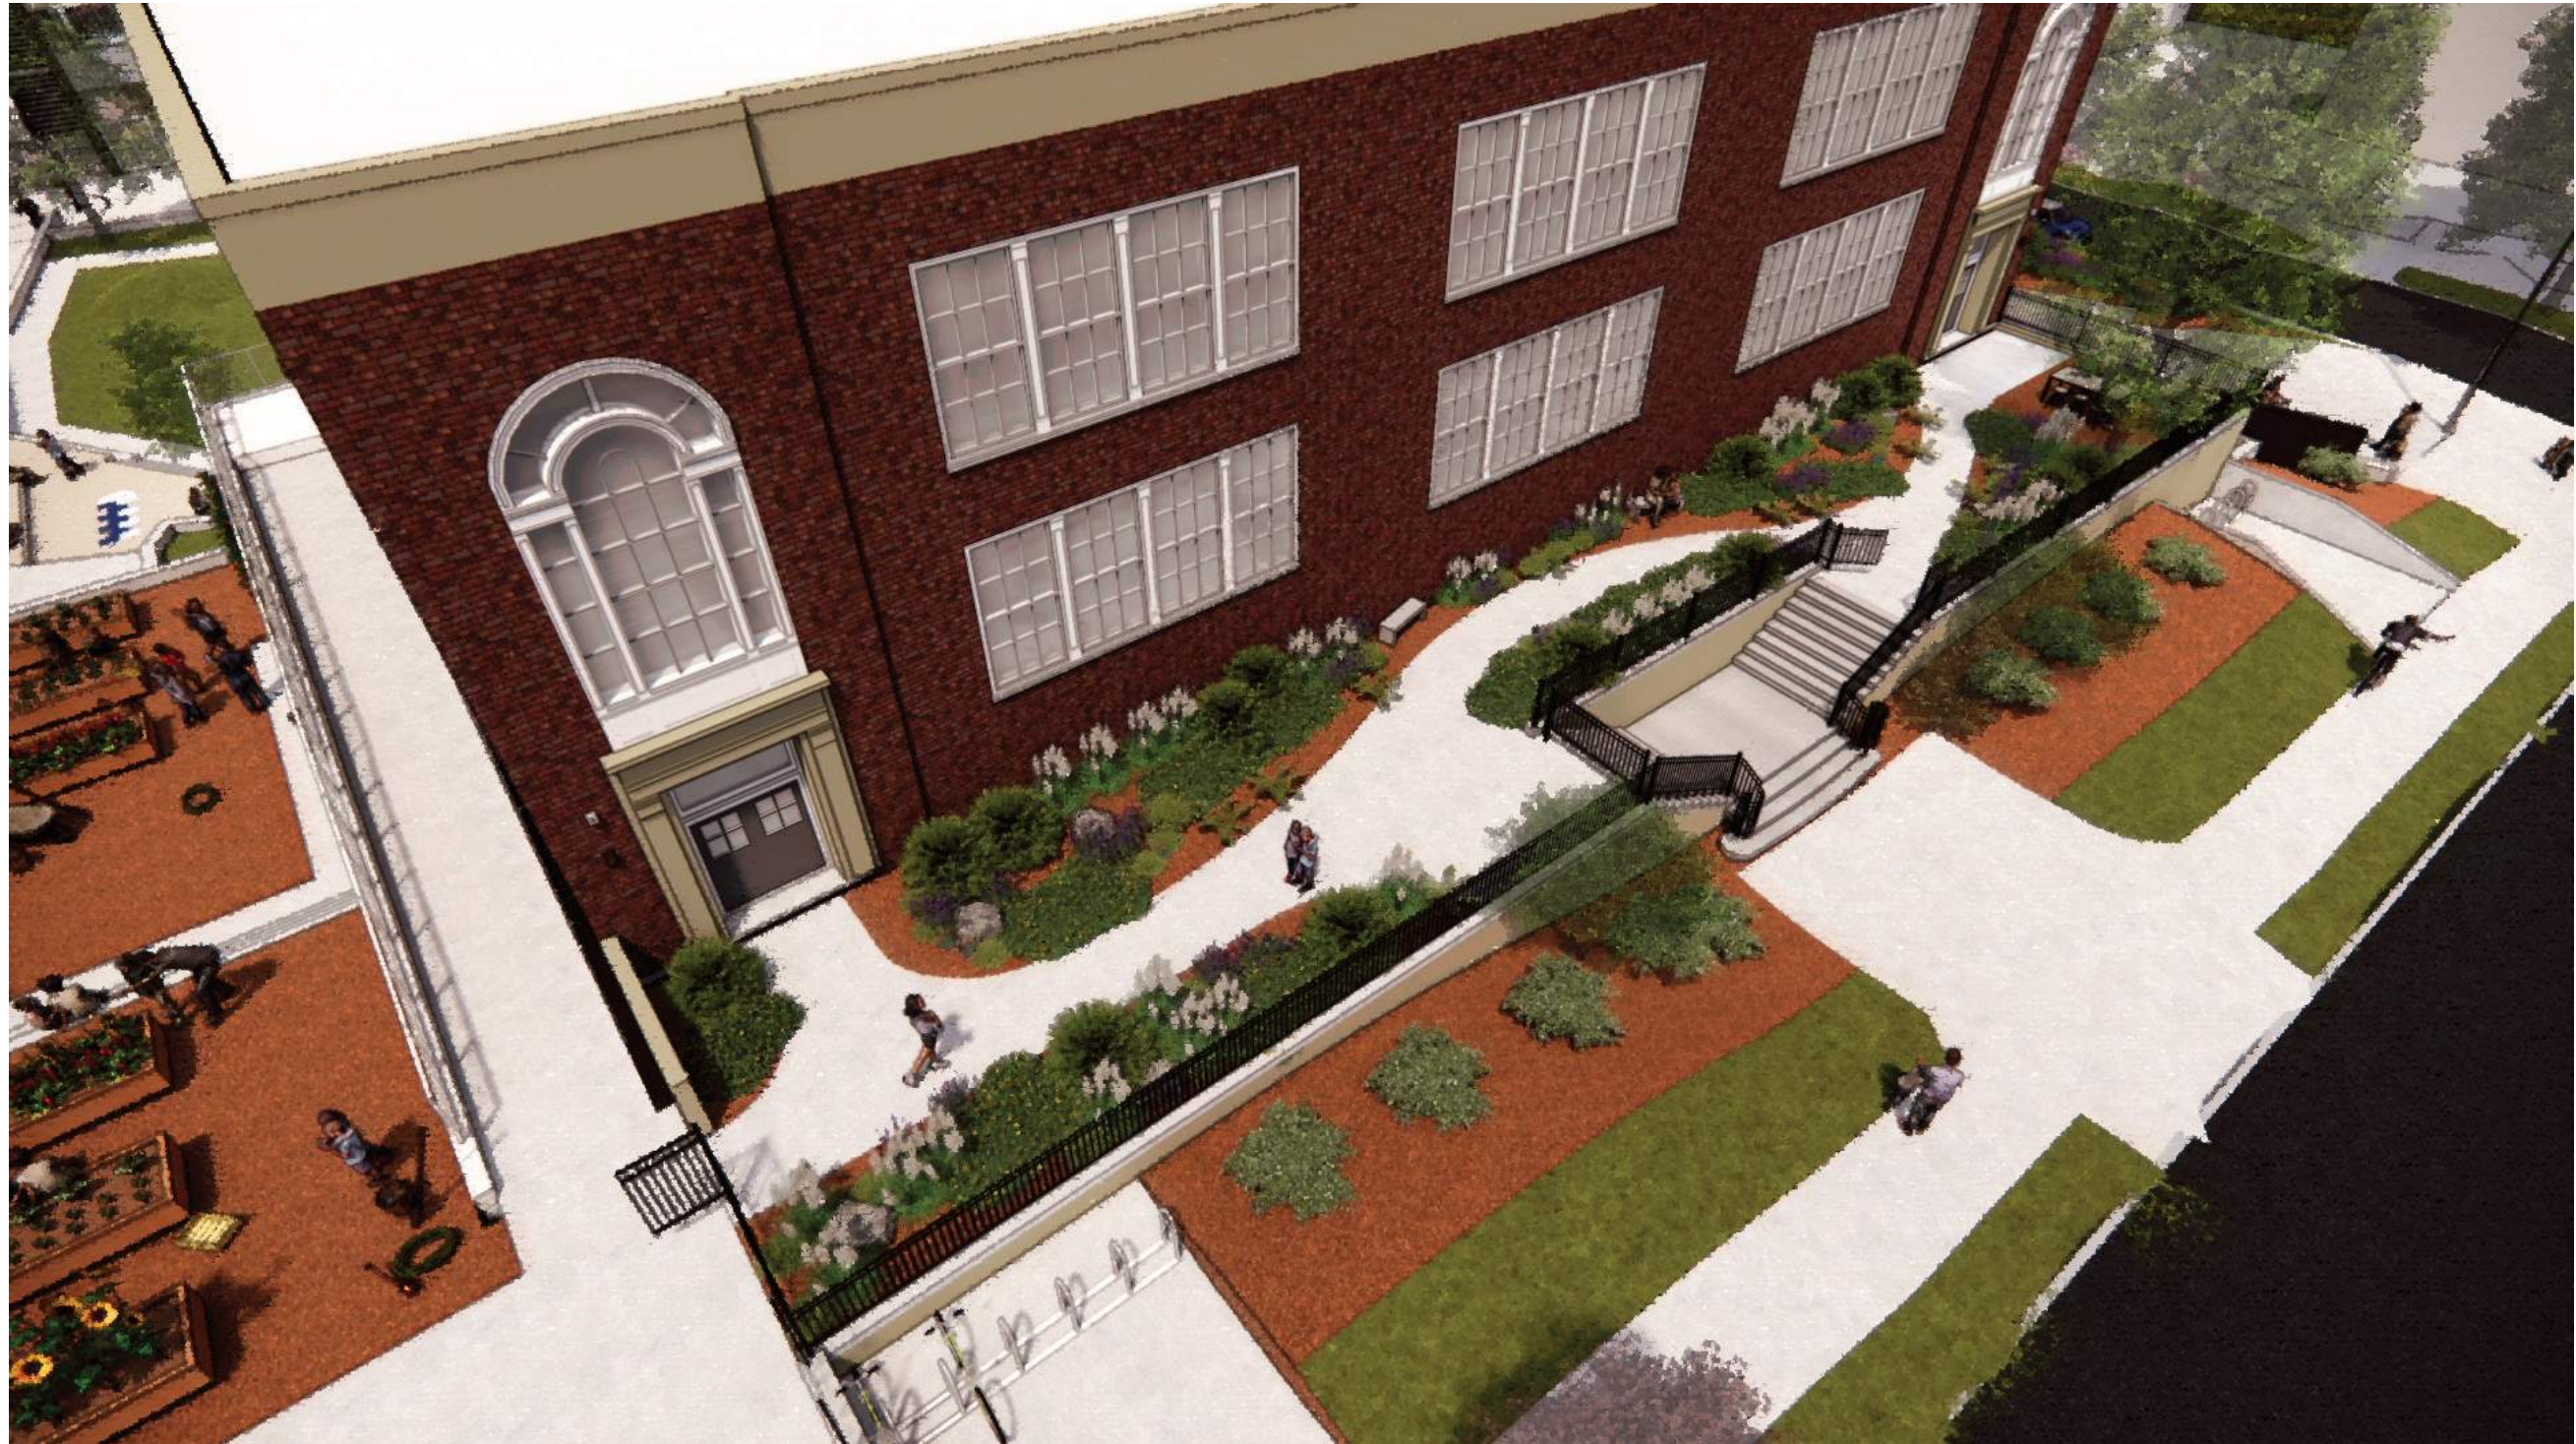
PROPOSED ENTRY FORECOURT

Aerial view from northeast corner of site

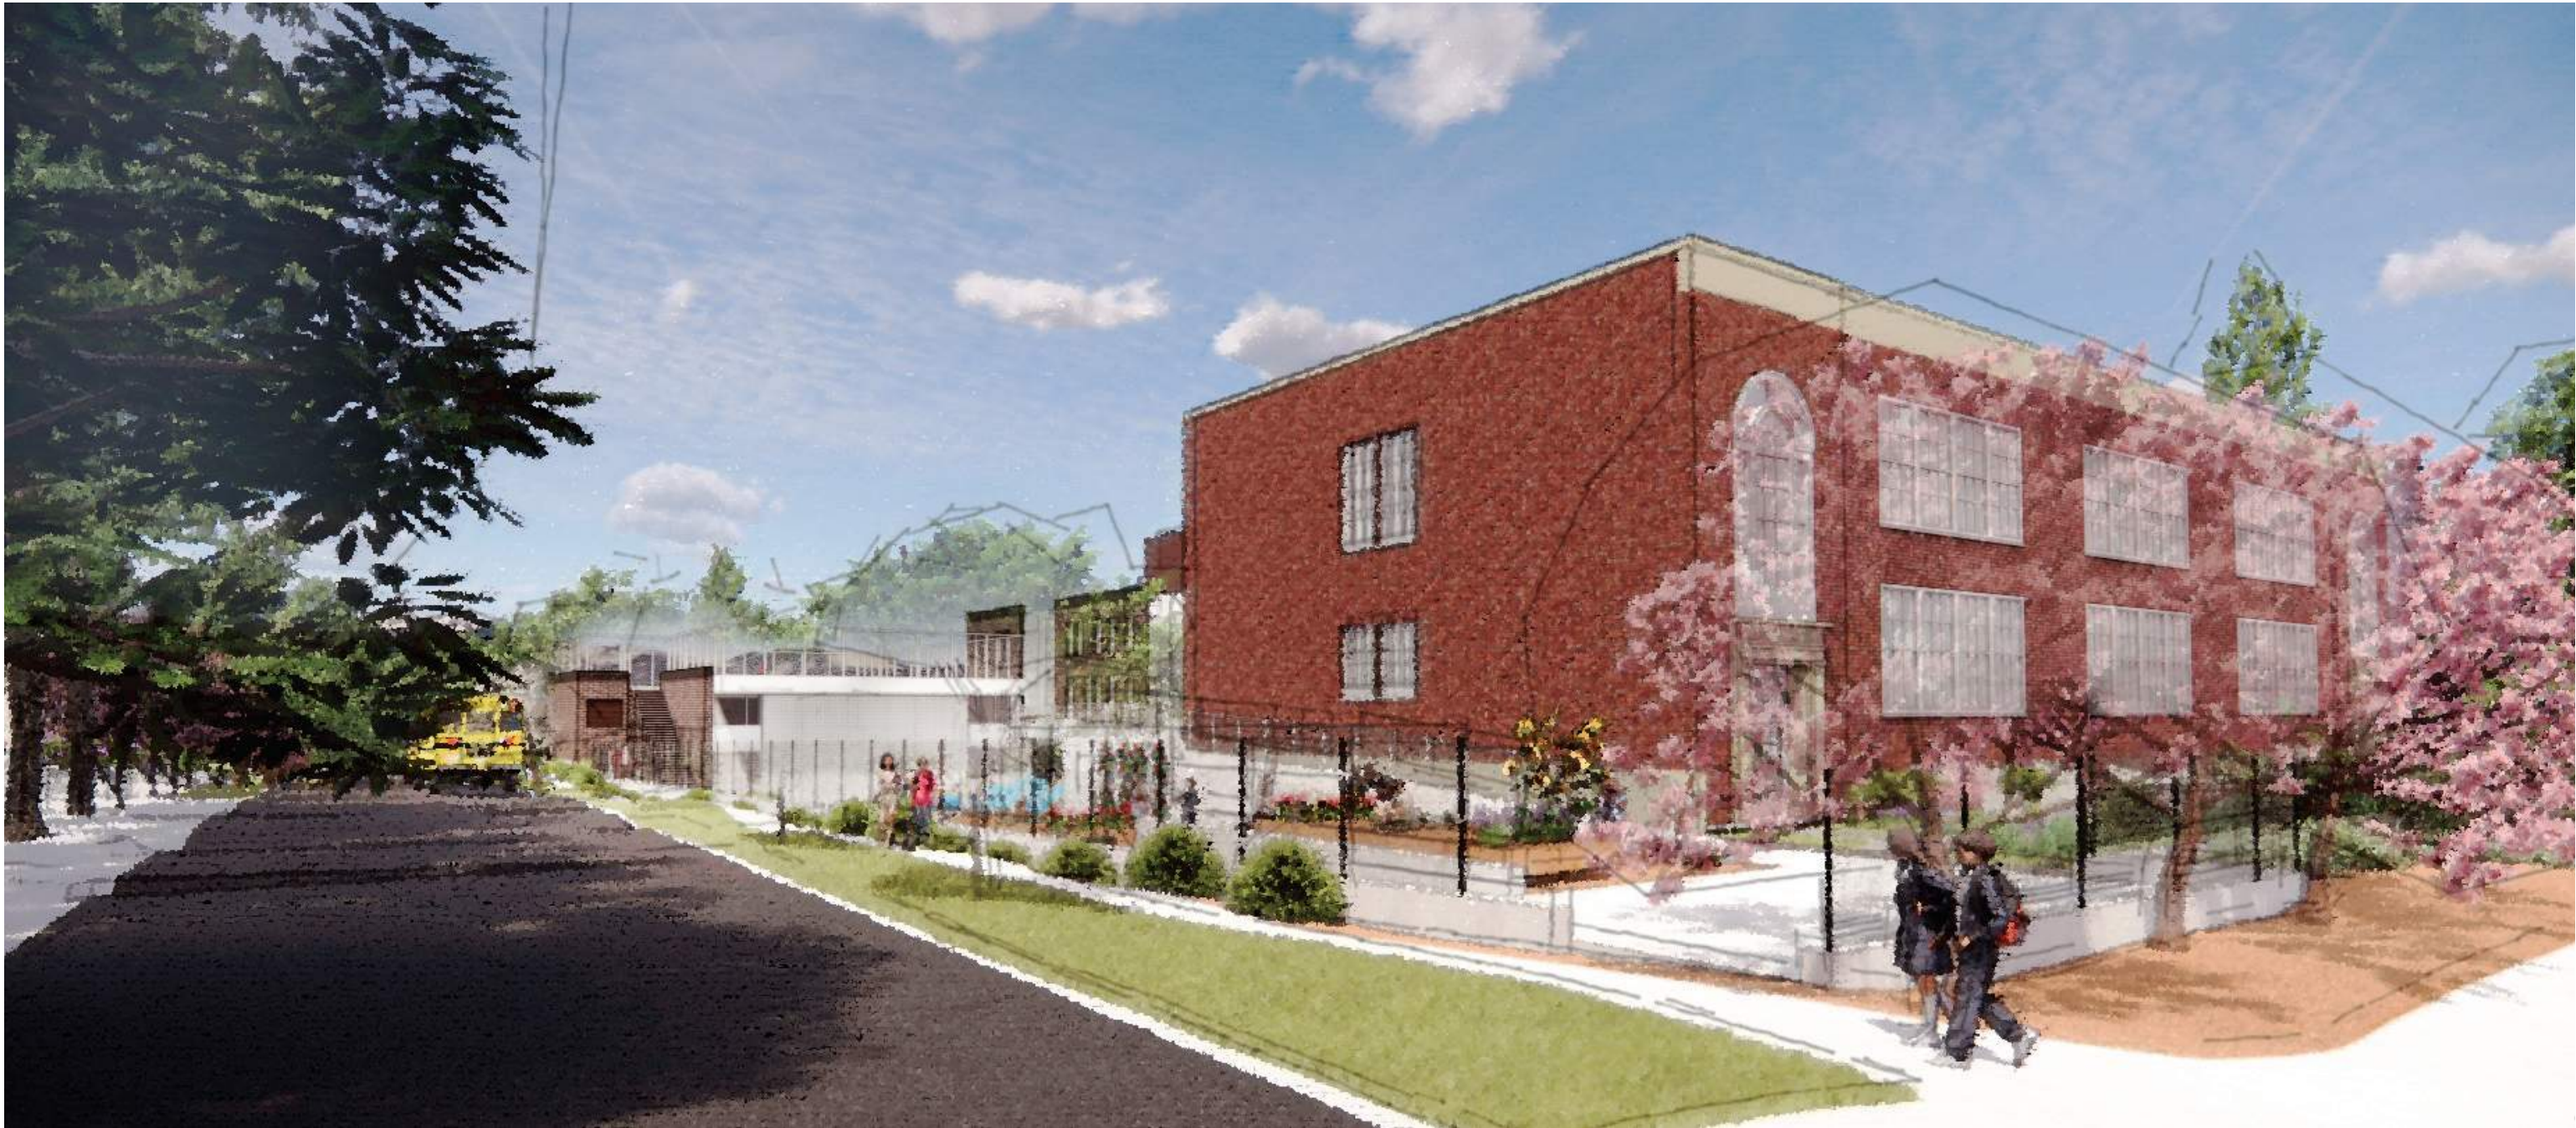
PROPOSED SOUTH AND EAST FACADES

Perspective view from corner of E McGraw St and 22nd Ave S

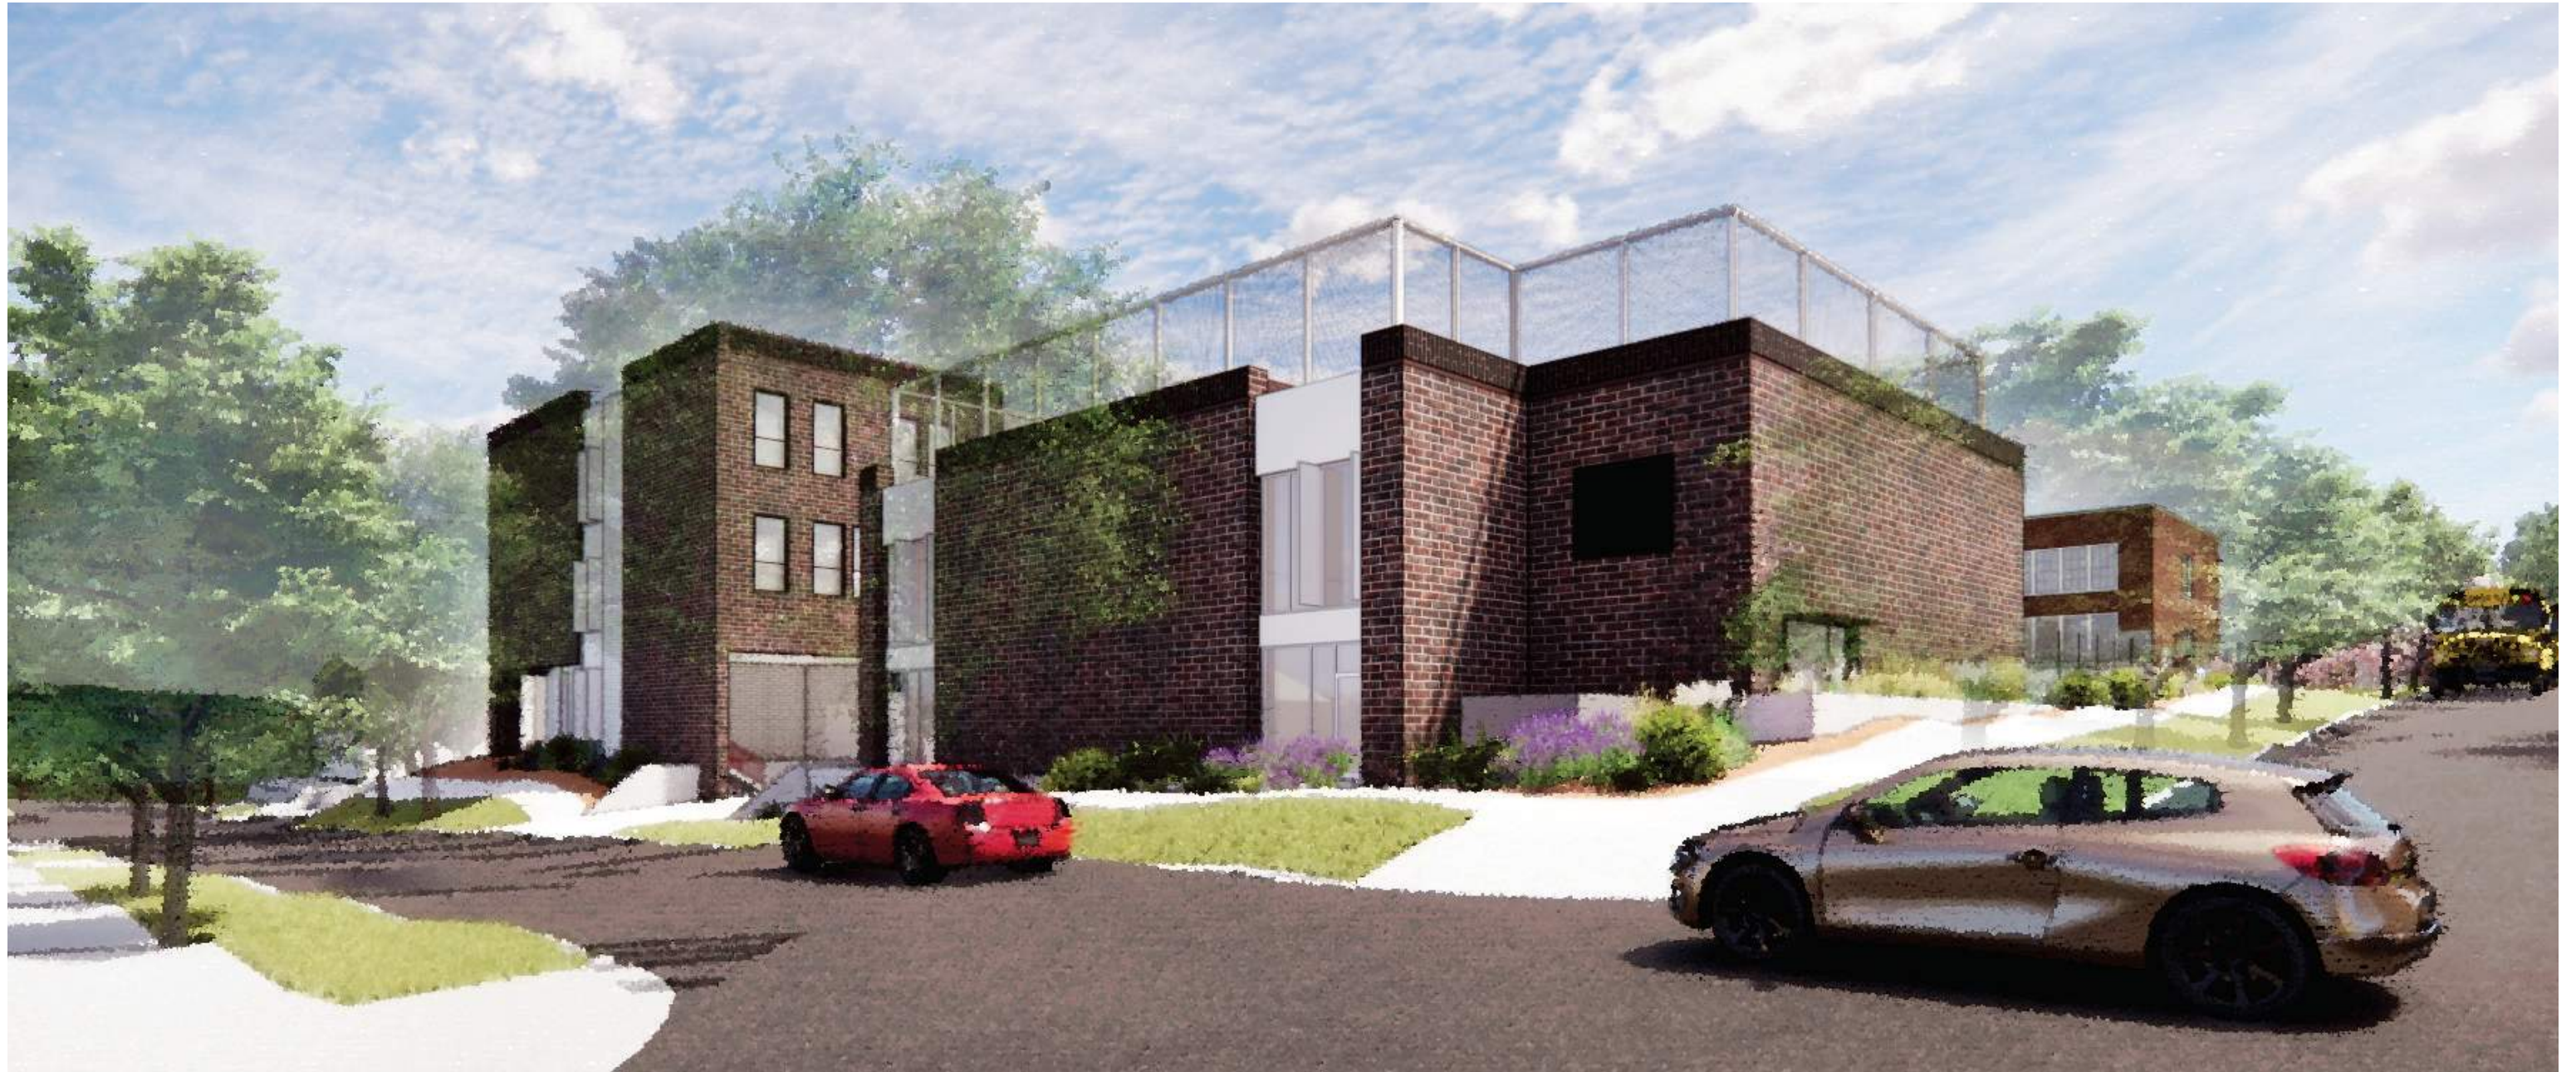
PROPOSED GYMNASIUM

Perspective view from corner of E McGraw St and 20th Ave S showing fencing for proposed rooftop play area

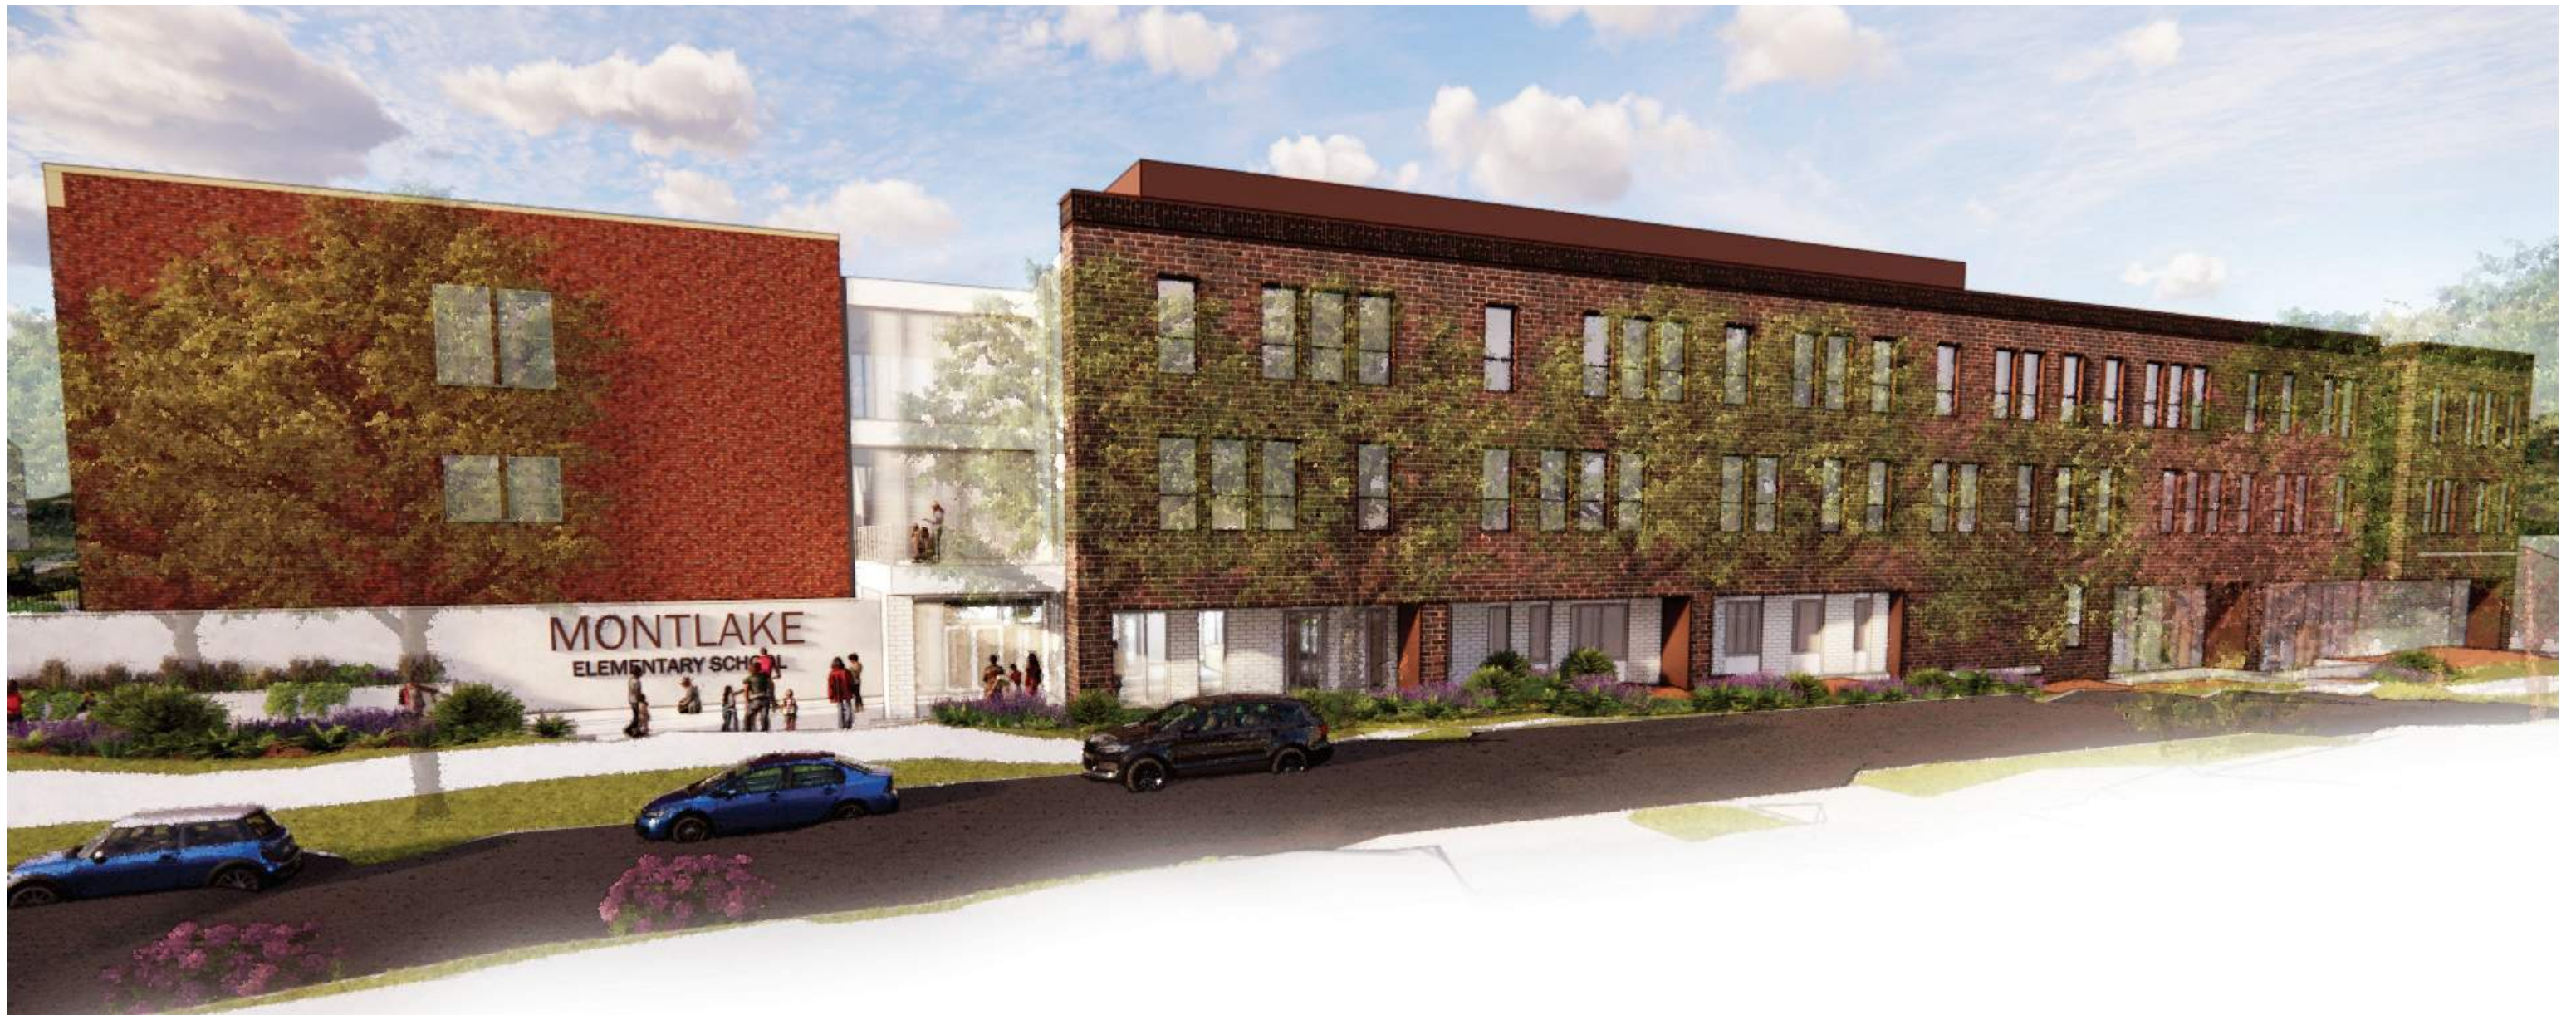
PROPOSED NORTH ELEVATION

Perspective view from across E Calhoun St and 20th Ave S showing existing historic school and addition

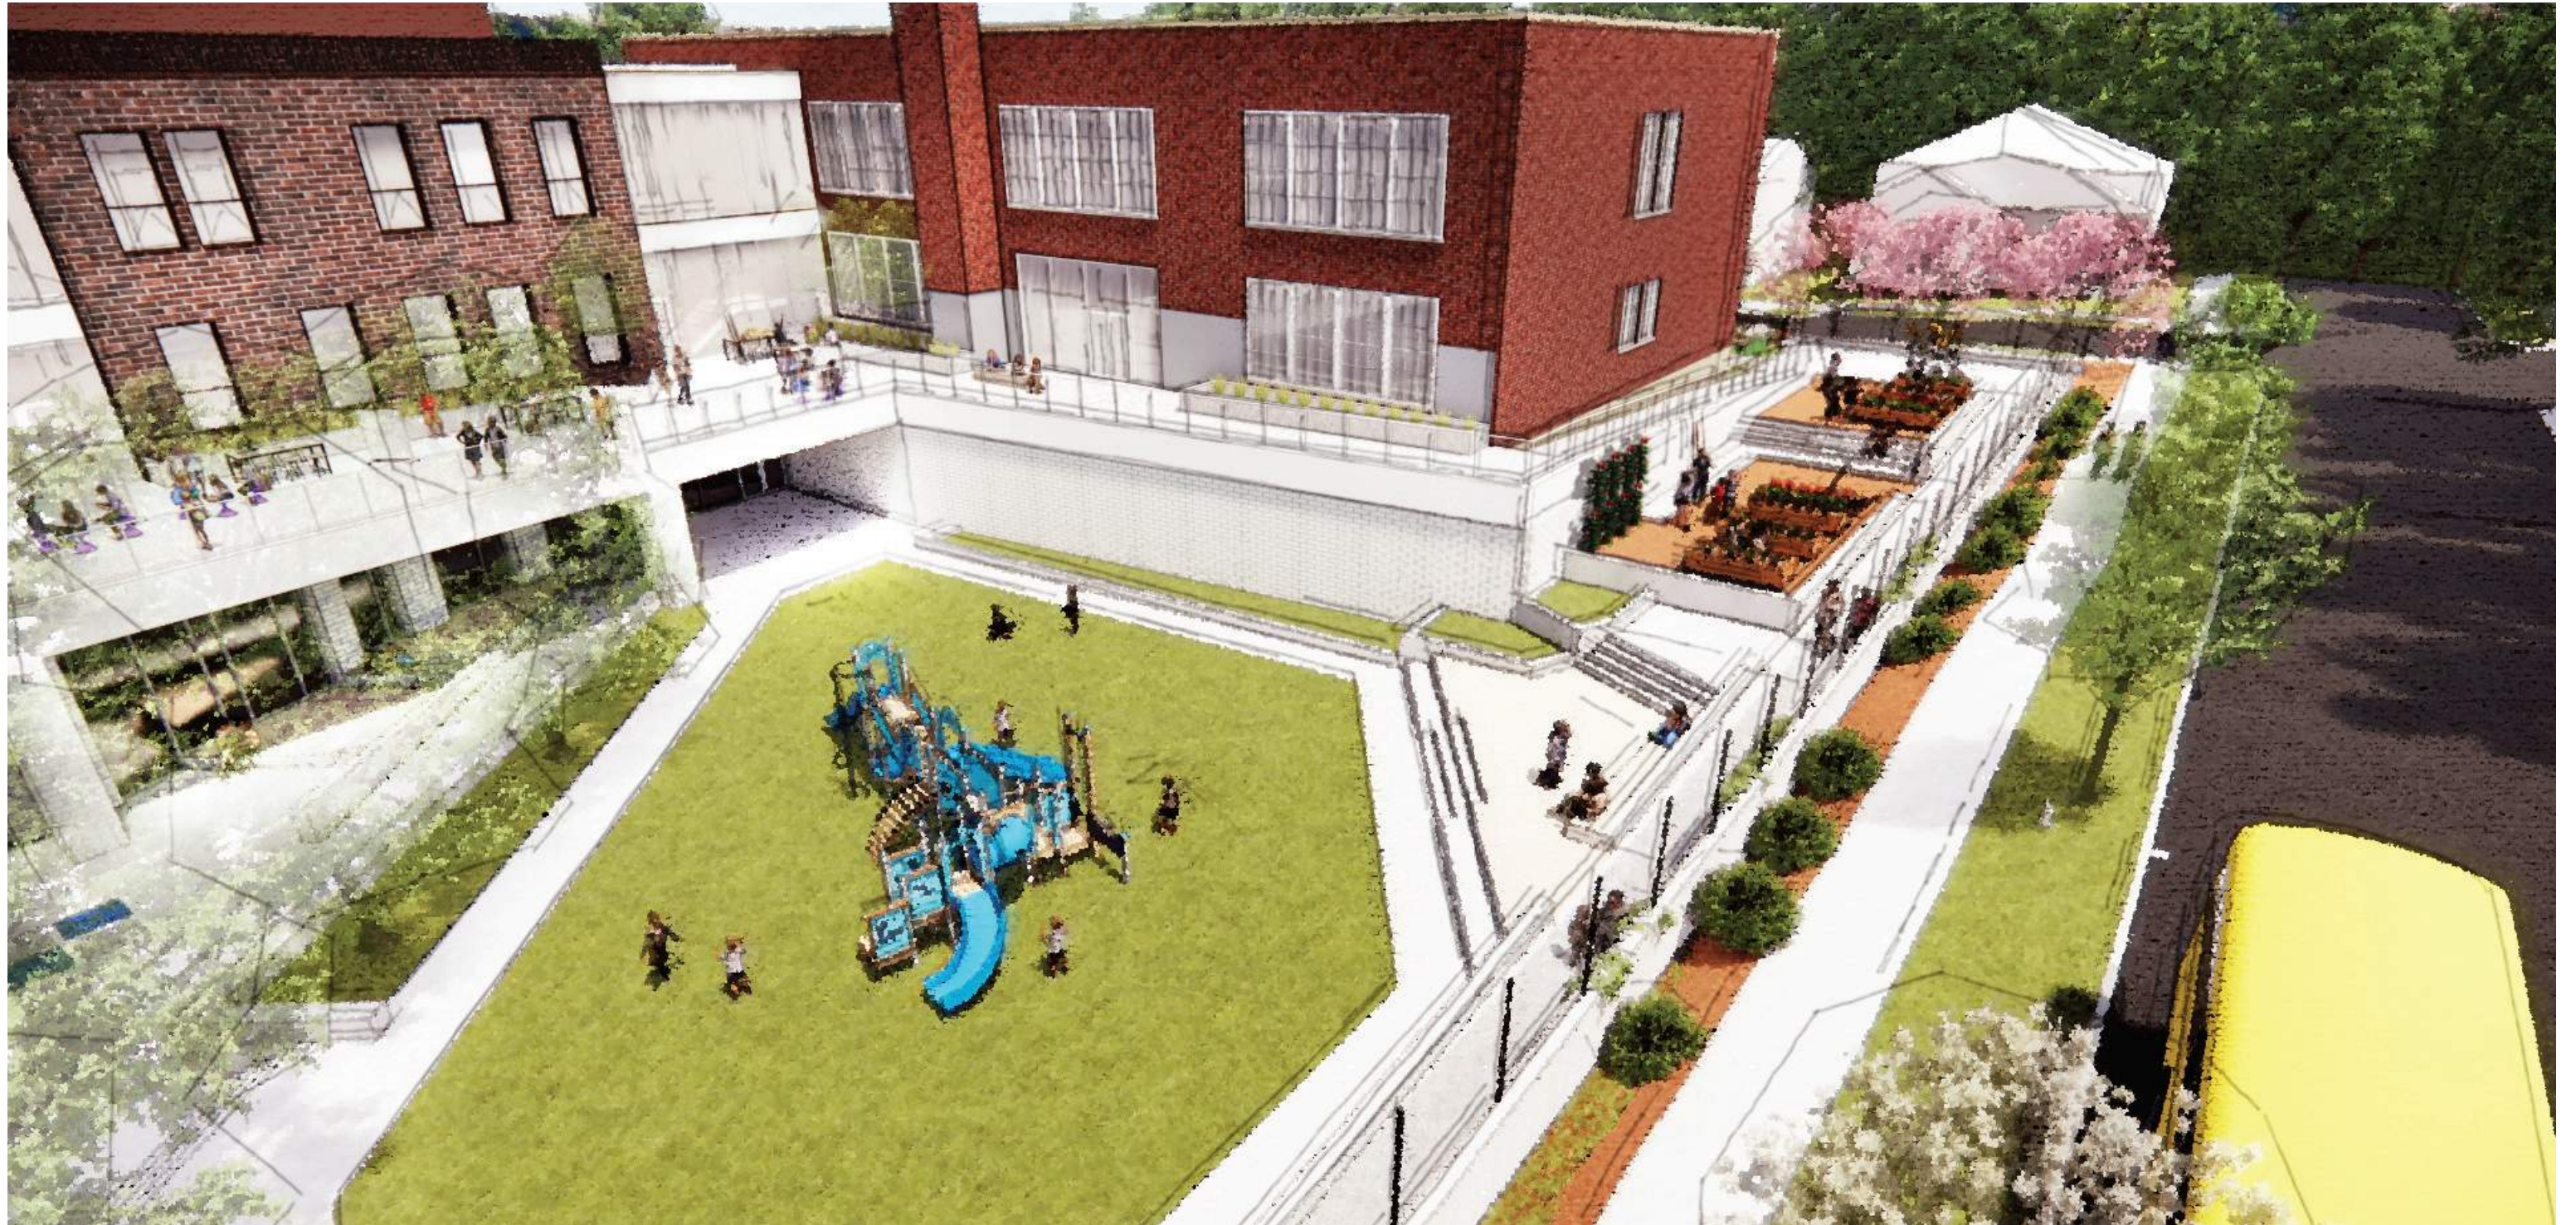
PROPOSED COURTYARD PLAY AREA

Aerial view from corner of E McGraw St looking towards 22nd Ave S

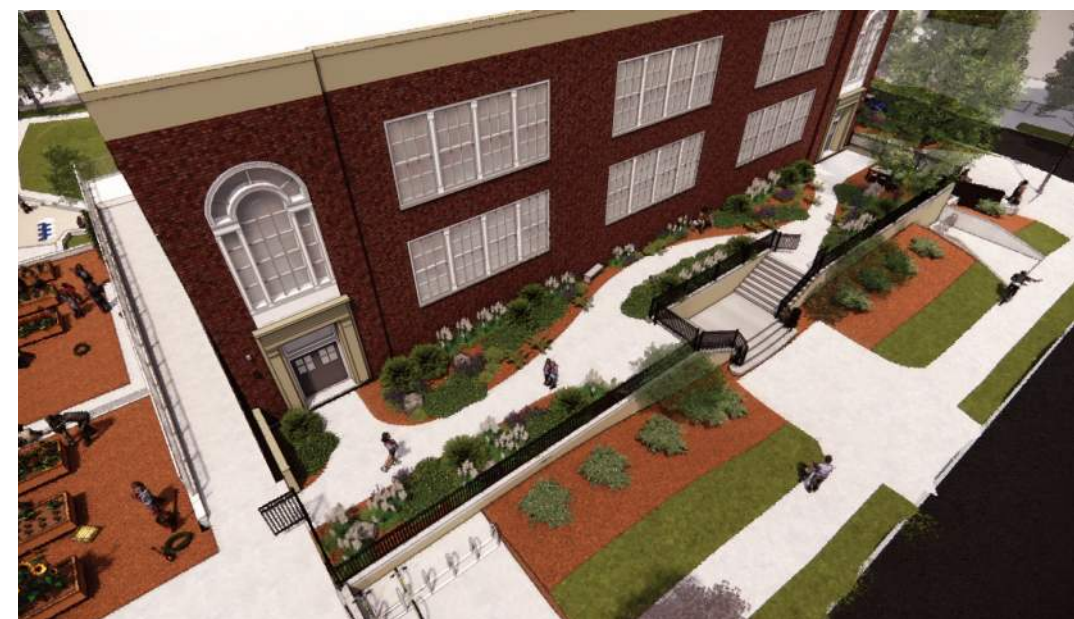
ENLARGED PROPOSED FORECOURT PLAN

Ariel view of proposed east facade entry forecourt

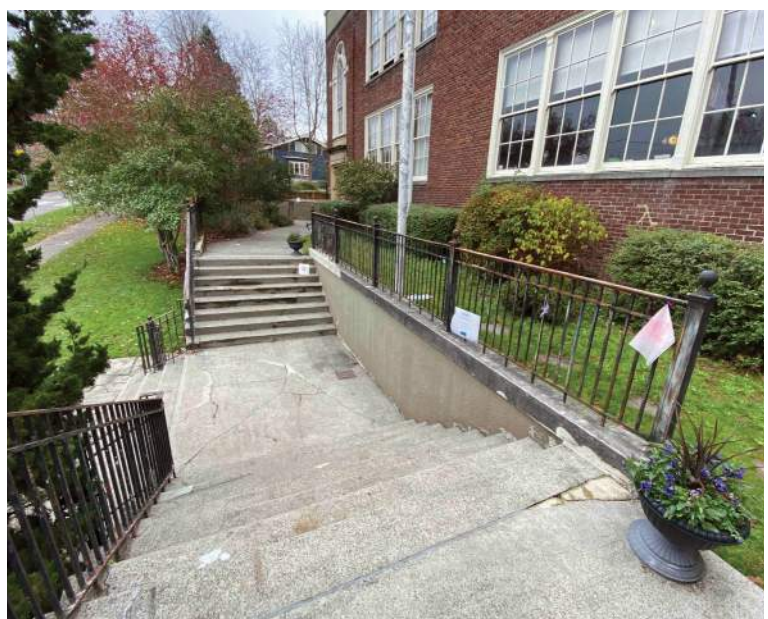
View of existing historic railing at east facade entry

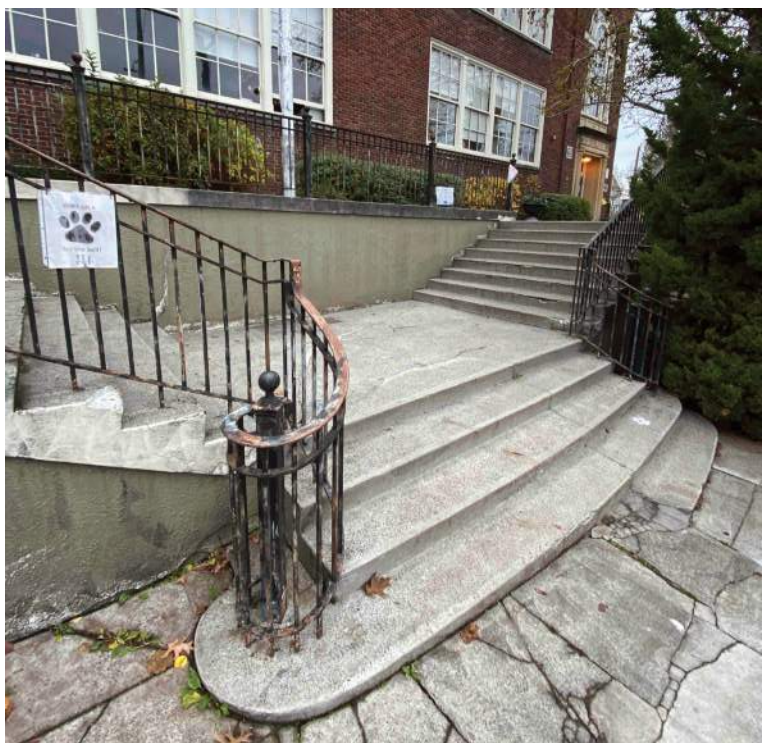
View of existing historic railing at east facade entry

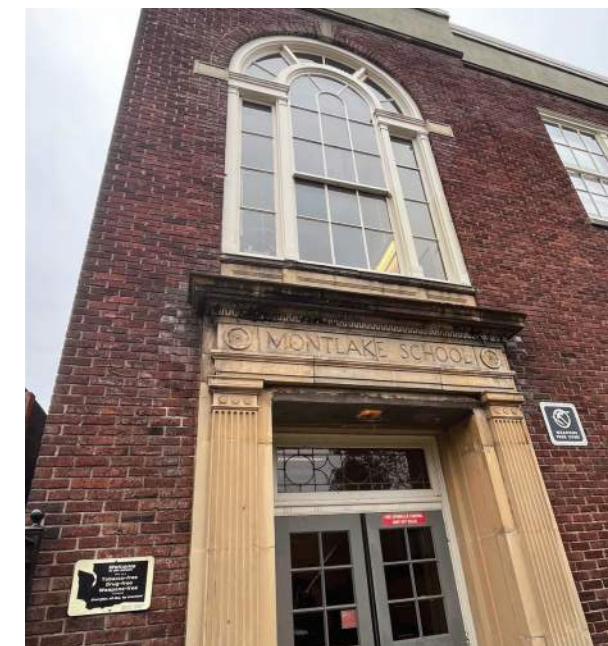
Southeast Entry Door

While the original drawings specified terra cotta, the original building was constructed using cast stone components for the ornamental pieces surrounding the main entries. Per the Landmark nomination, this was done to save cost. Because of the more porous nature of cast stone some of these pieces have not performed well. The design team is proposing the following treatments:

1. Cleaning - Warm water rinse, followed by a mild detergent wash with a nylon bristle brush and another warm water rinse.
2. Replacement - Custom cast concrete replica units at severely deteriorated units
3. Repair - Patching mortar (Cathedral Stone) to repair minor cracks and spalls
4. Cover - Recommend adding a standing seam copper cap at the top of the projecting cornice piece to assist in shedding water
5. Coating - Recommend painting all of the cast stone with a breathable coating to decrease the porosity of the cast stone and prevent further deterioration

- Severe discoloration at the projecting cornice above the entablature and significant water damage (cracking, spalling, staining) at the underside of those units. Water stains streaked down the adjacent vertical elements
- Water damage at the underside of the soffit panels. Soffit panels at the southeast entry have been replaced by a galvanized steel sheet (likely due to water damage)
- Vertical units at the pilasters and jambs of the surround are in fair conditions, but are in need of pointing

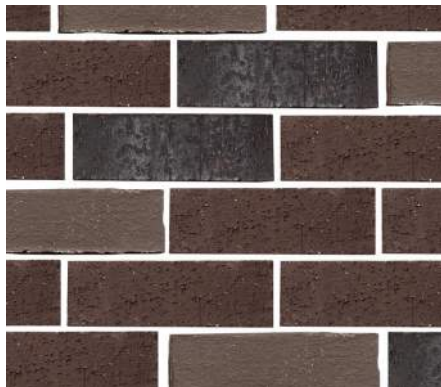
1C. Brick
Custom Brick Blend

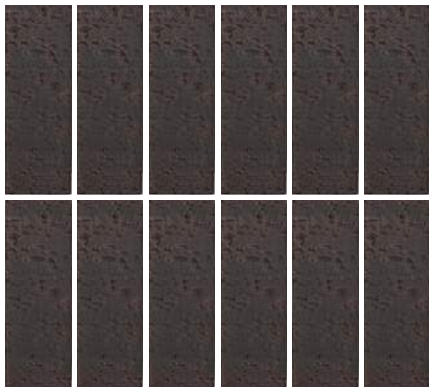
1D. Brick
Coal Creek

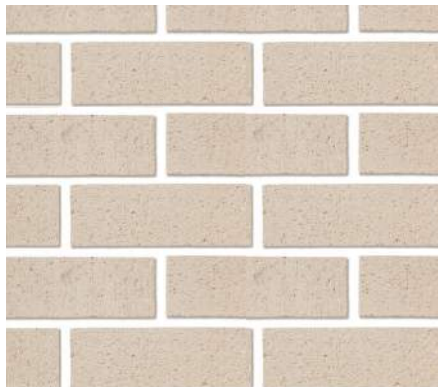
1E. Brick
Limestone in Smooth Texture

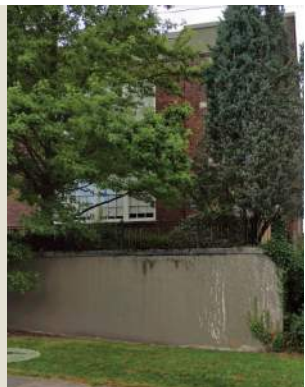
7A. Aluminum Frames
Medium Bronze Windows

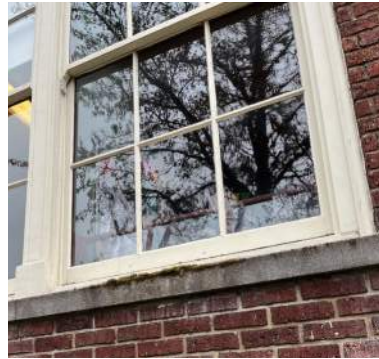
8A. Historic Windows
Color Match Existing

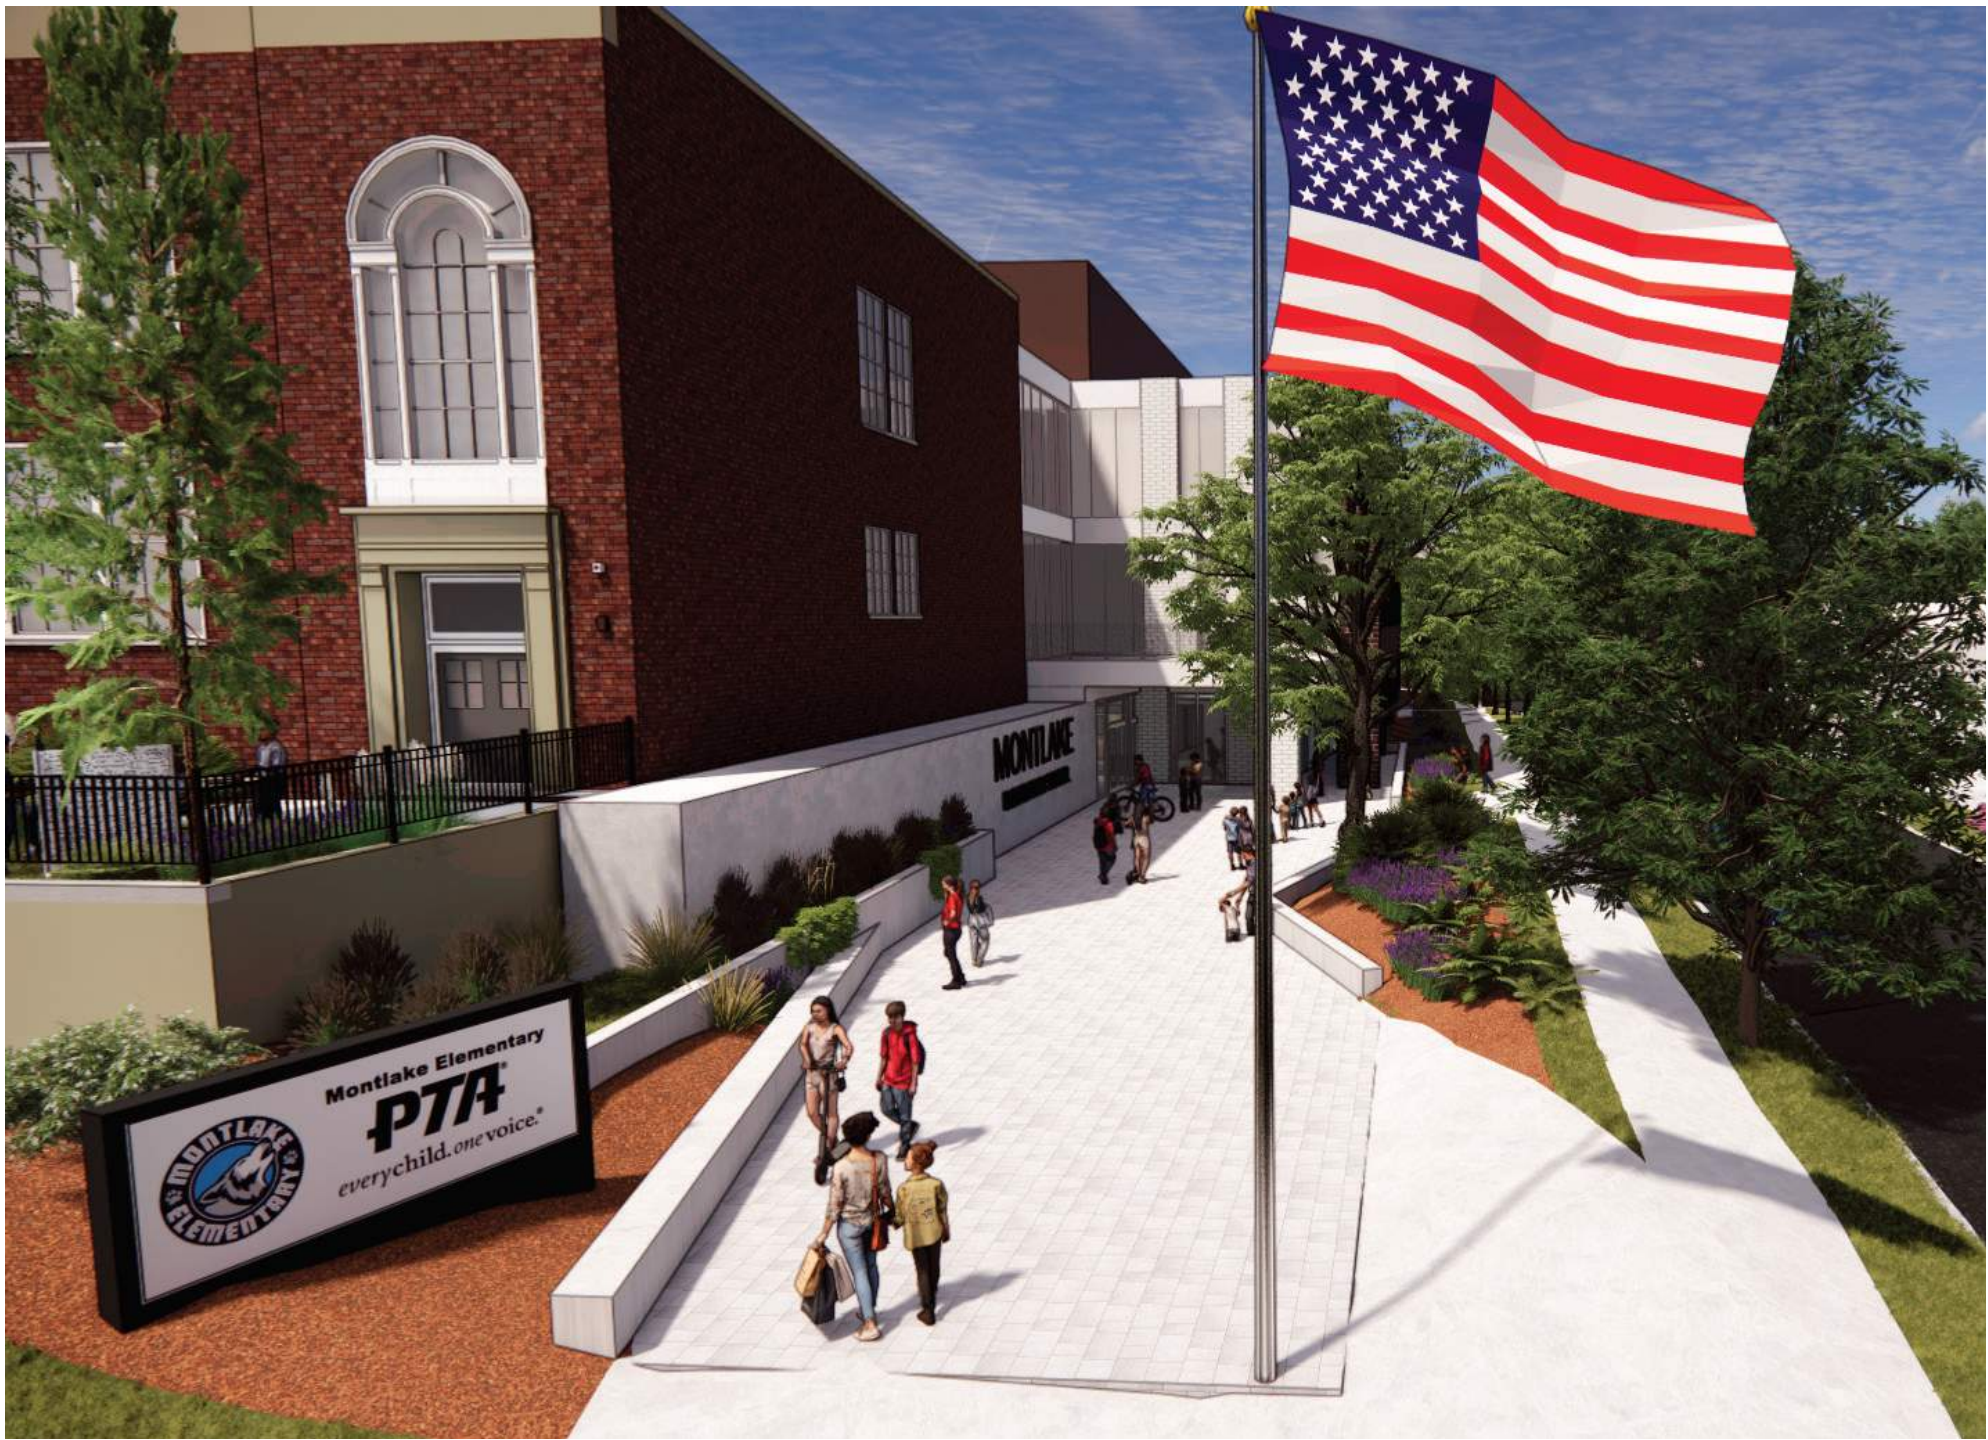
PROPOSED ELECTRONIC SIGN LOCATION

ELECTRONIC READER BOARD SIGN:

Seattle Public Schools is currently seeking a departure to include a digital reader board sign outside of the school. The intent of this sign is to inform the school and larger community of events and notices. The sign would be programmable and the displayed information would change, but it is not intended to display rapid changing or flashing animations or to operate in the late evening hours. The digital format would allow messages to be displayed in multiple languages to increase equity in school communications.

Proposed Electronic Reader Board Location (View from the 22nd and E Calhoun St.
