**Attachment 2**  
Geotechnical Engineering Report

HWA Project No. 2014-177-21

Subject: **FINAL GEOTECHNICAL ENGINEERING REPORT  
Cheasty Greenspace Mountain Bike Trail  
City of Seattle Parks and Recreation  
Seattle, Washington**

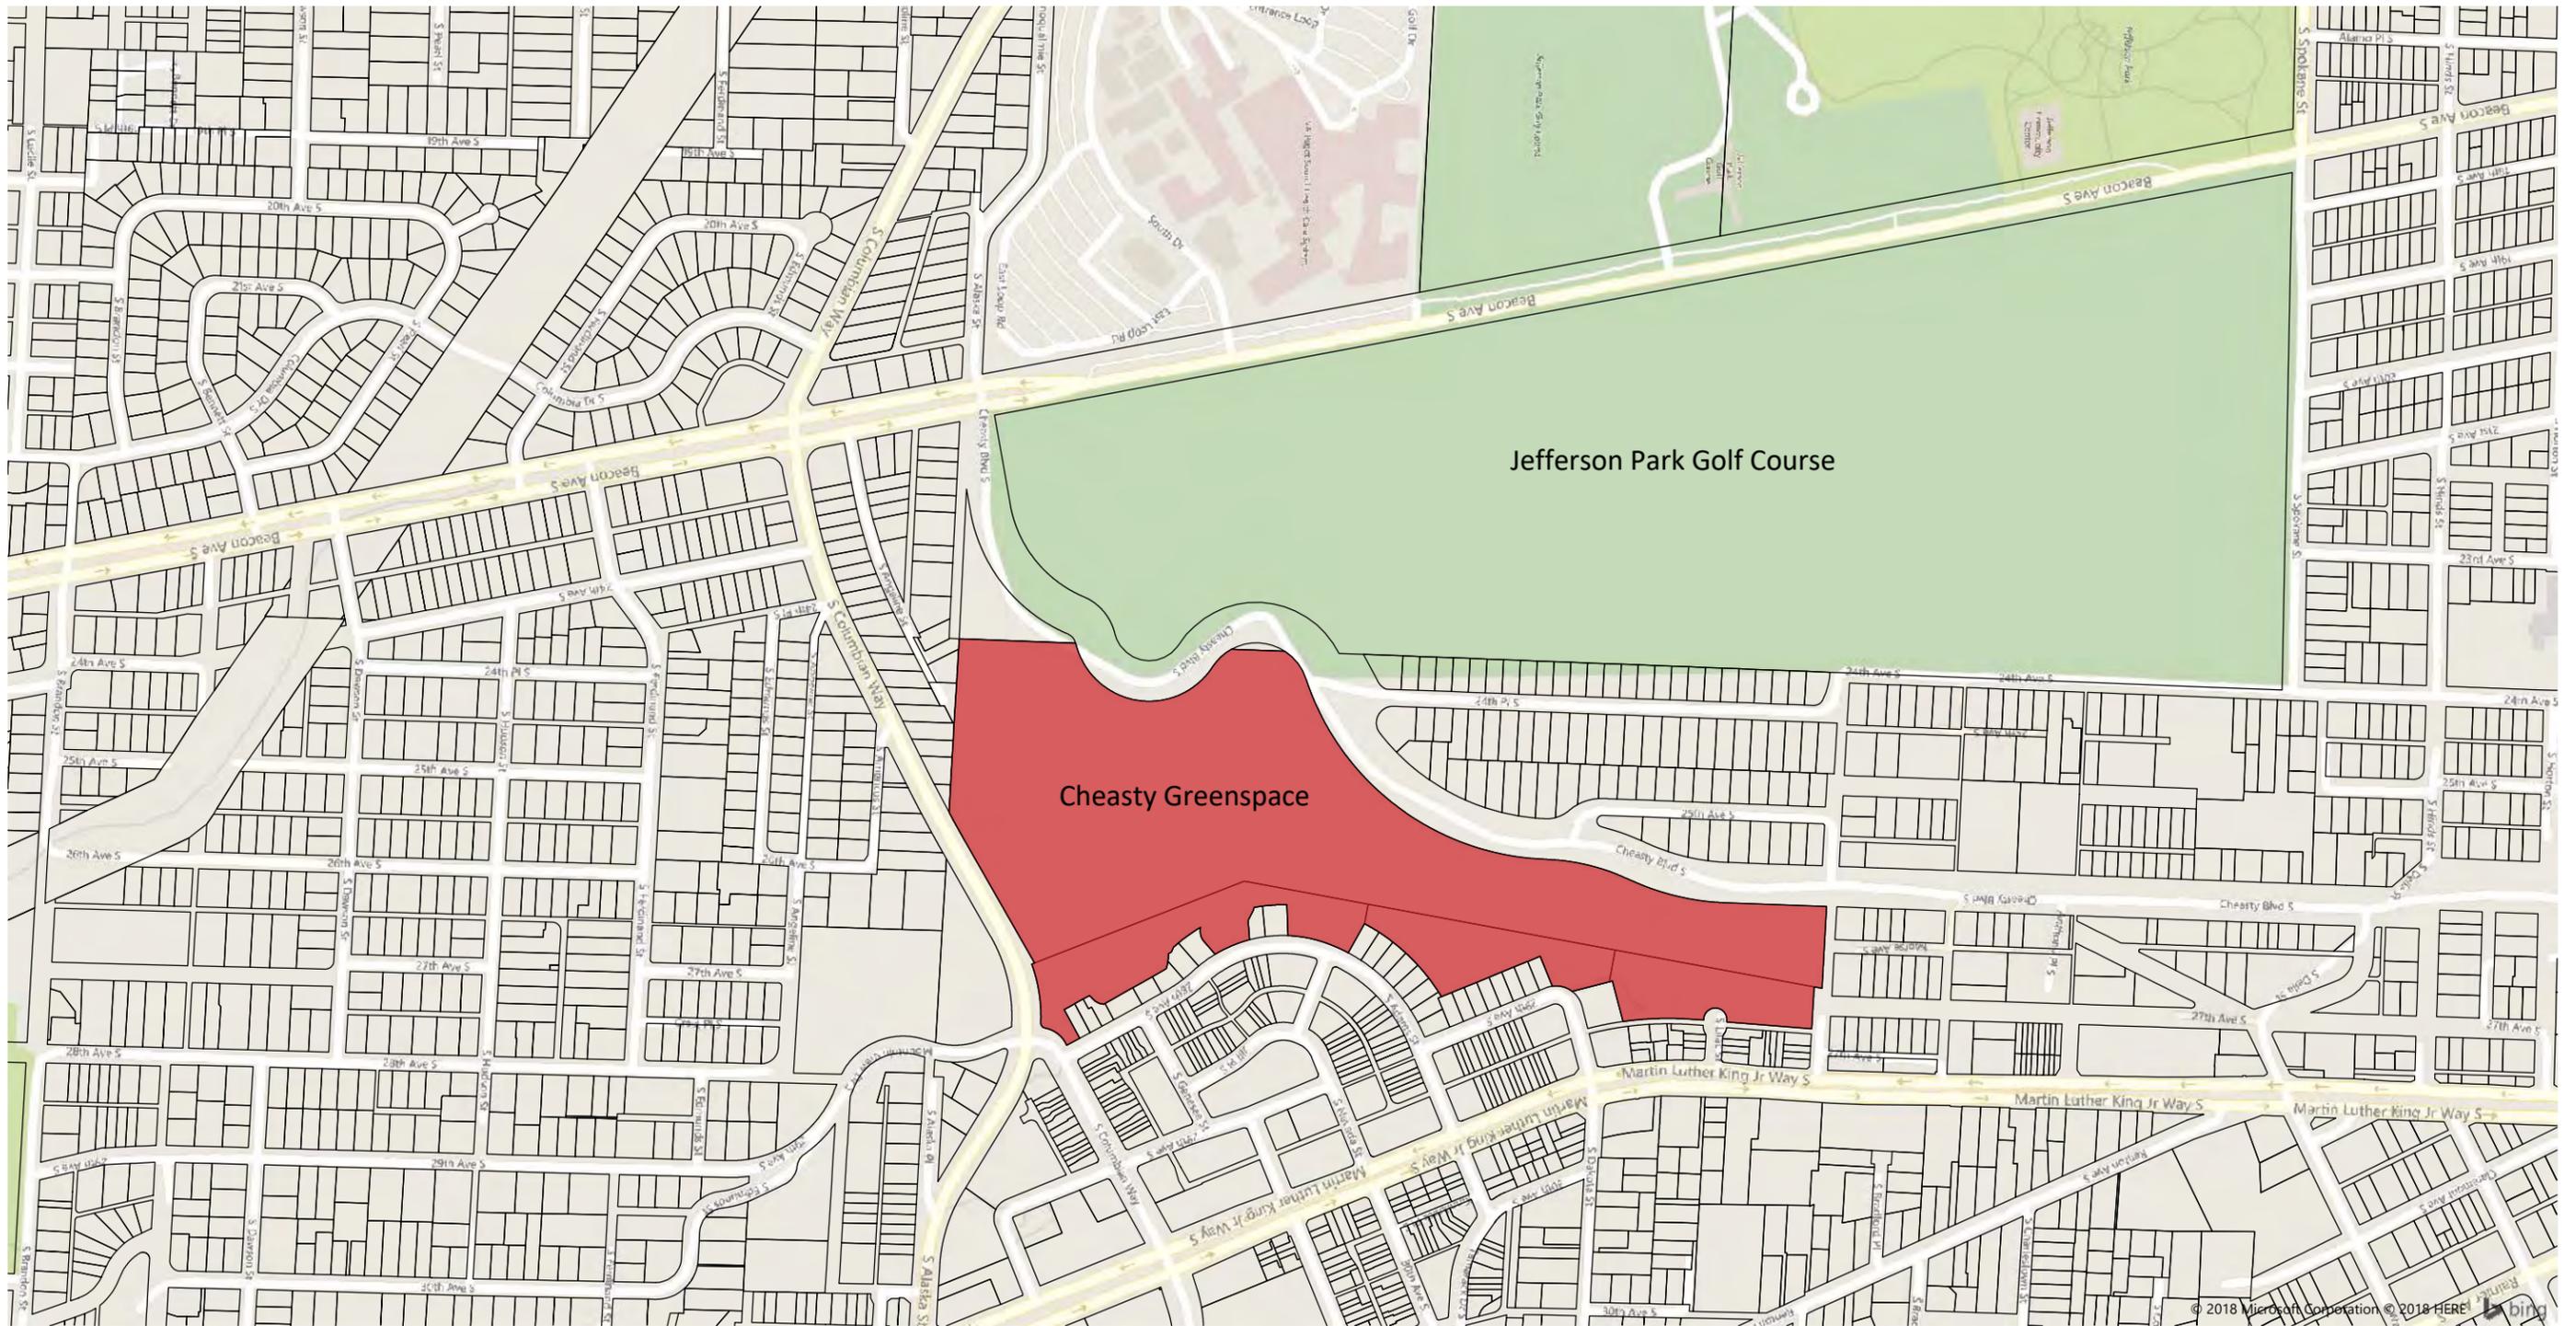
FIGURE #  
**1**  
PROJECT #  
**2014-177-21**

Cheasty Greenspace  
Mountain Bike Trail  
Seattle, Washington

Figure 1	Site Plan
Figures 2A, 2B	Site and Exploration Plan

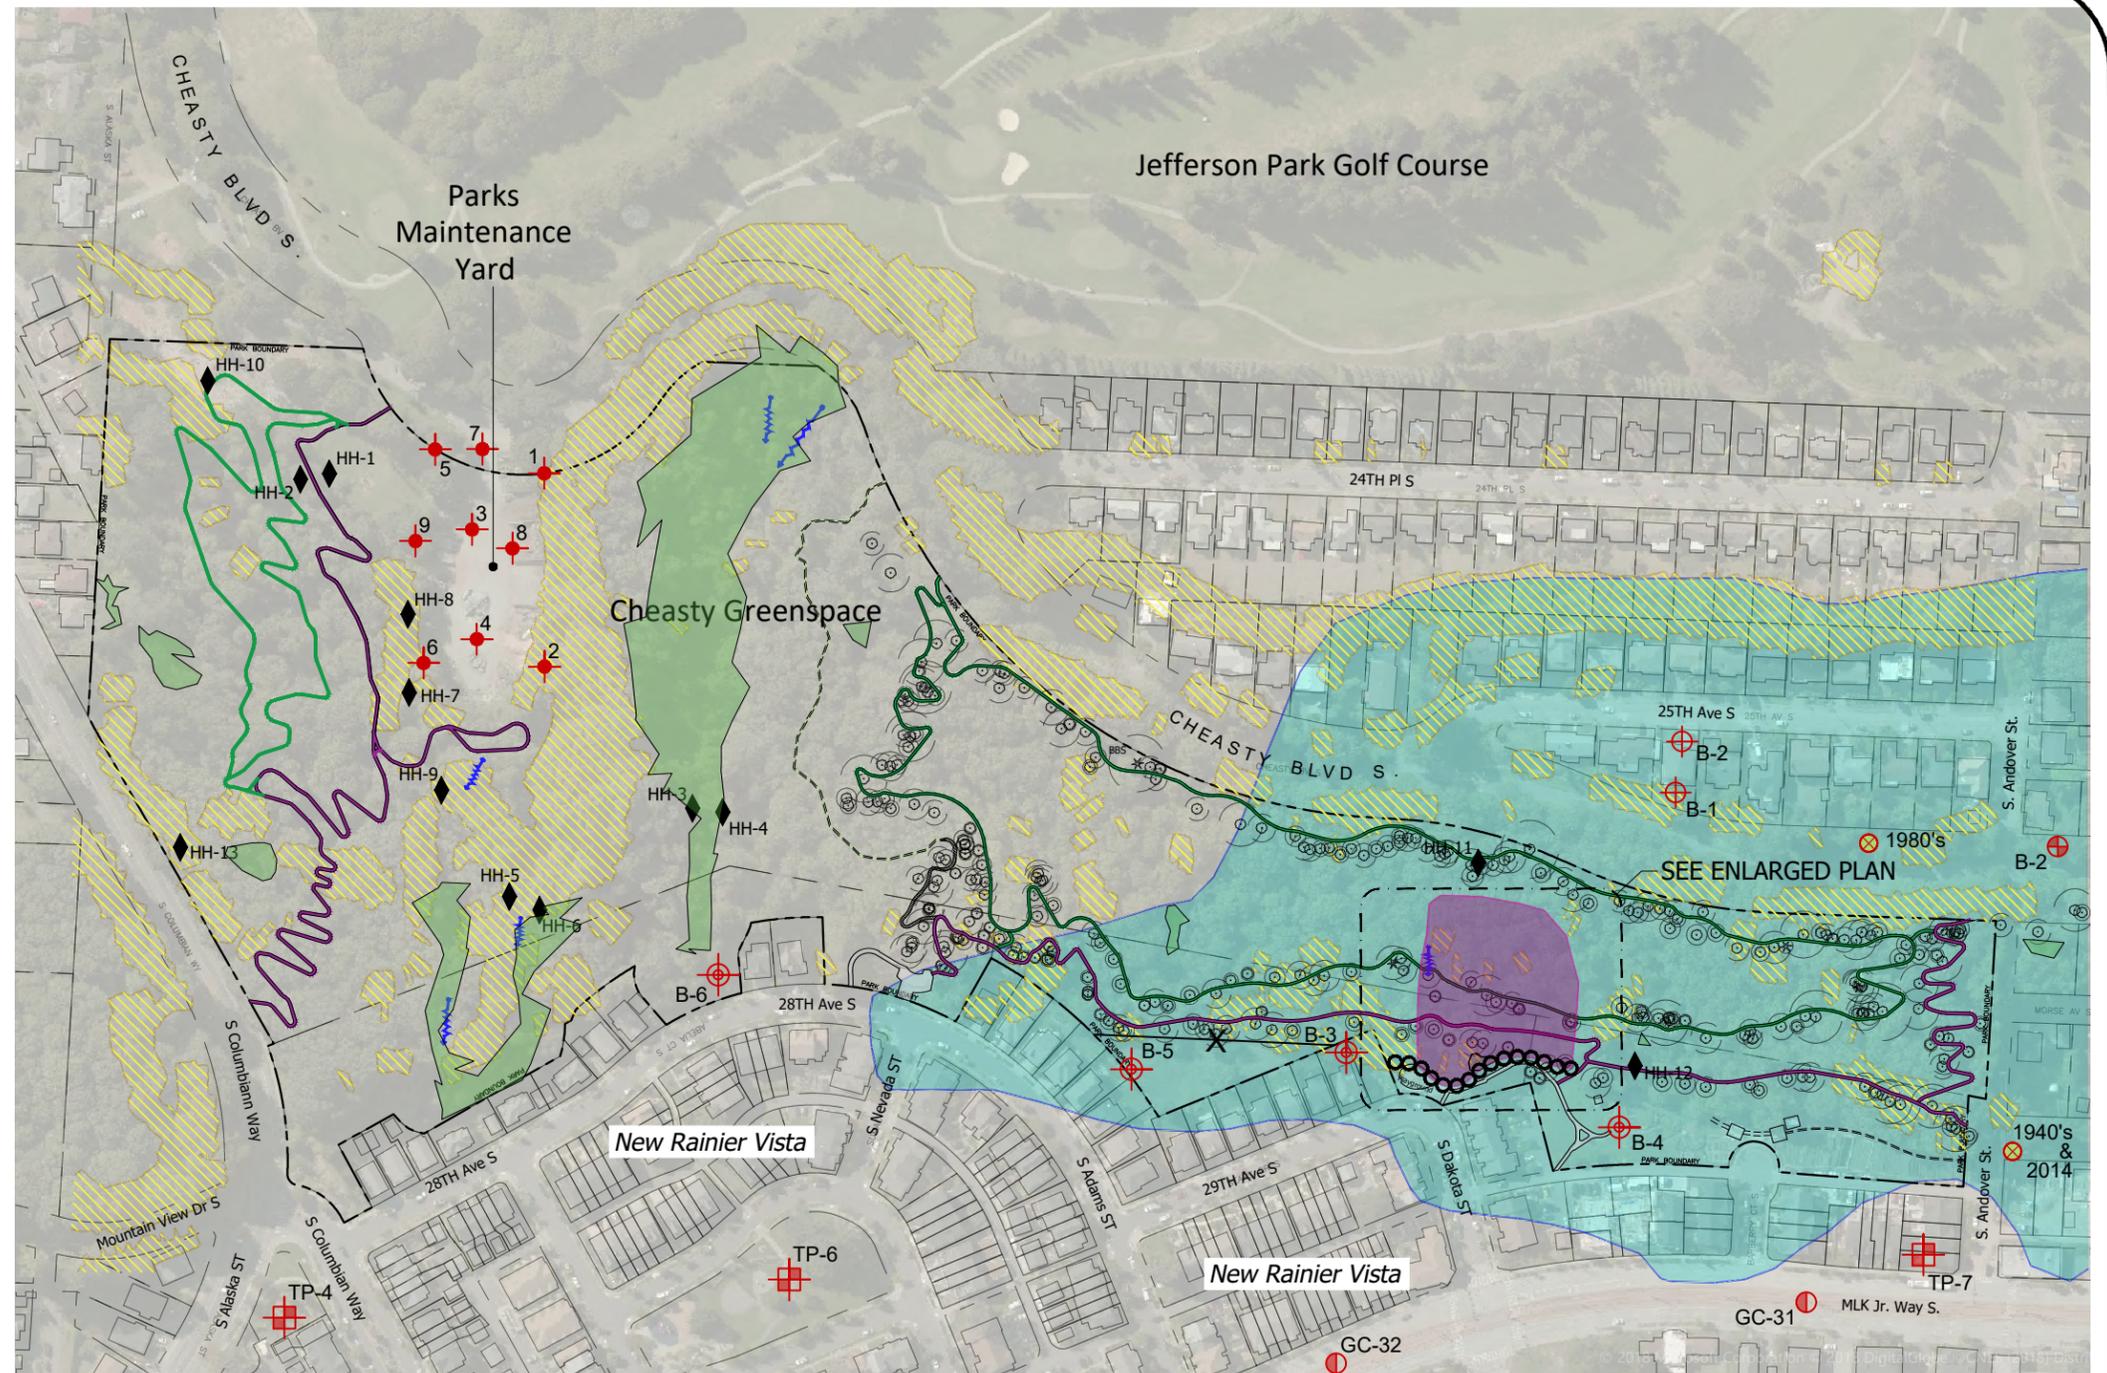
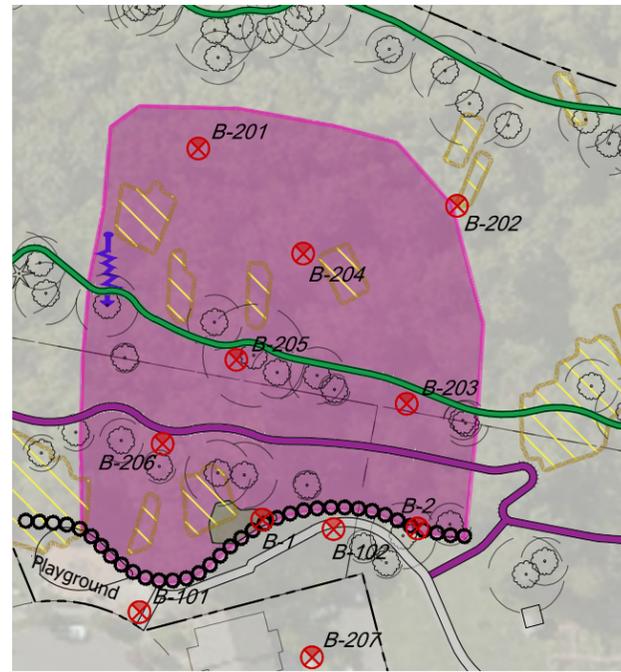
DRAWN BY BFM	FIGURE # <b>2A</b>
CHECK BY BT	PROJECT #
DATE: 12.27.2022	2014-177-21

**ENLARGED PLAN**  
Scale: 1" = 100'-0"

**CHEASTY GREENSPACE MOUNTAIN BIKE TRAIL**  
Scale: 1" = 250'-0"

**SITE AND  
EXPLORATION  
PLAN**

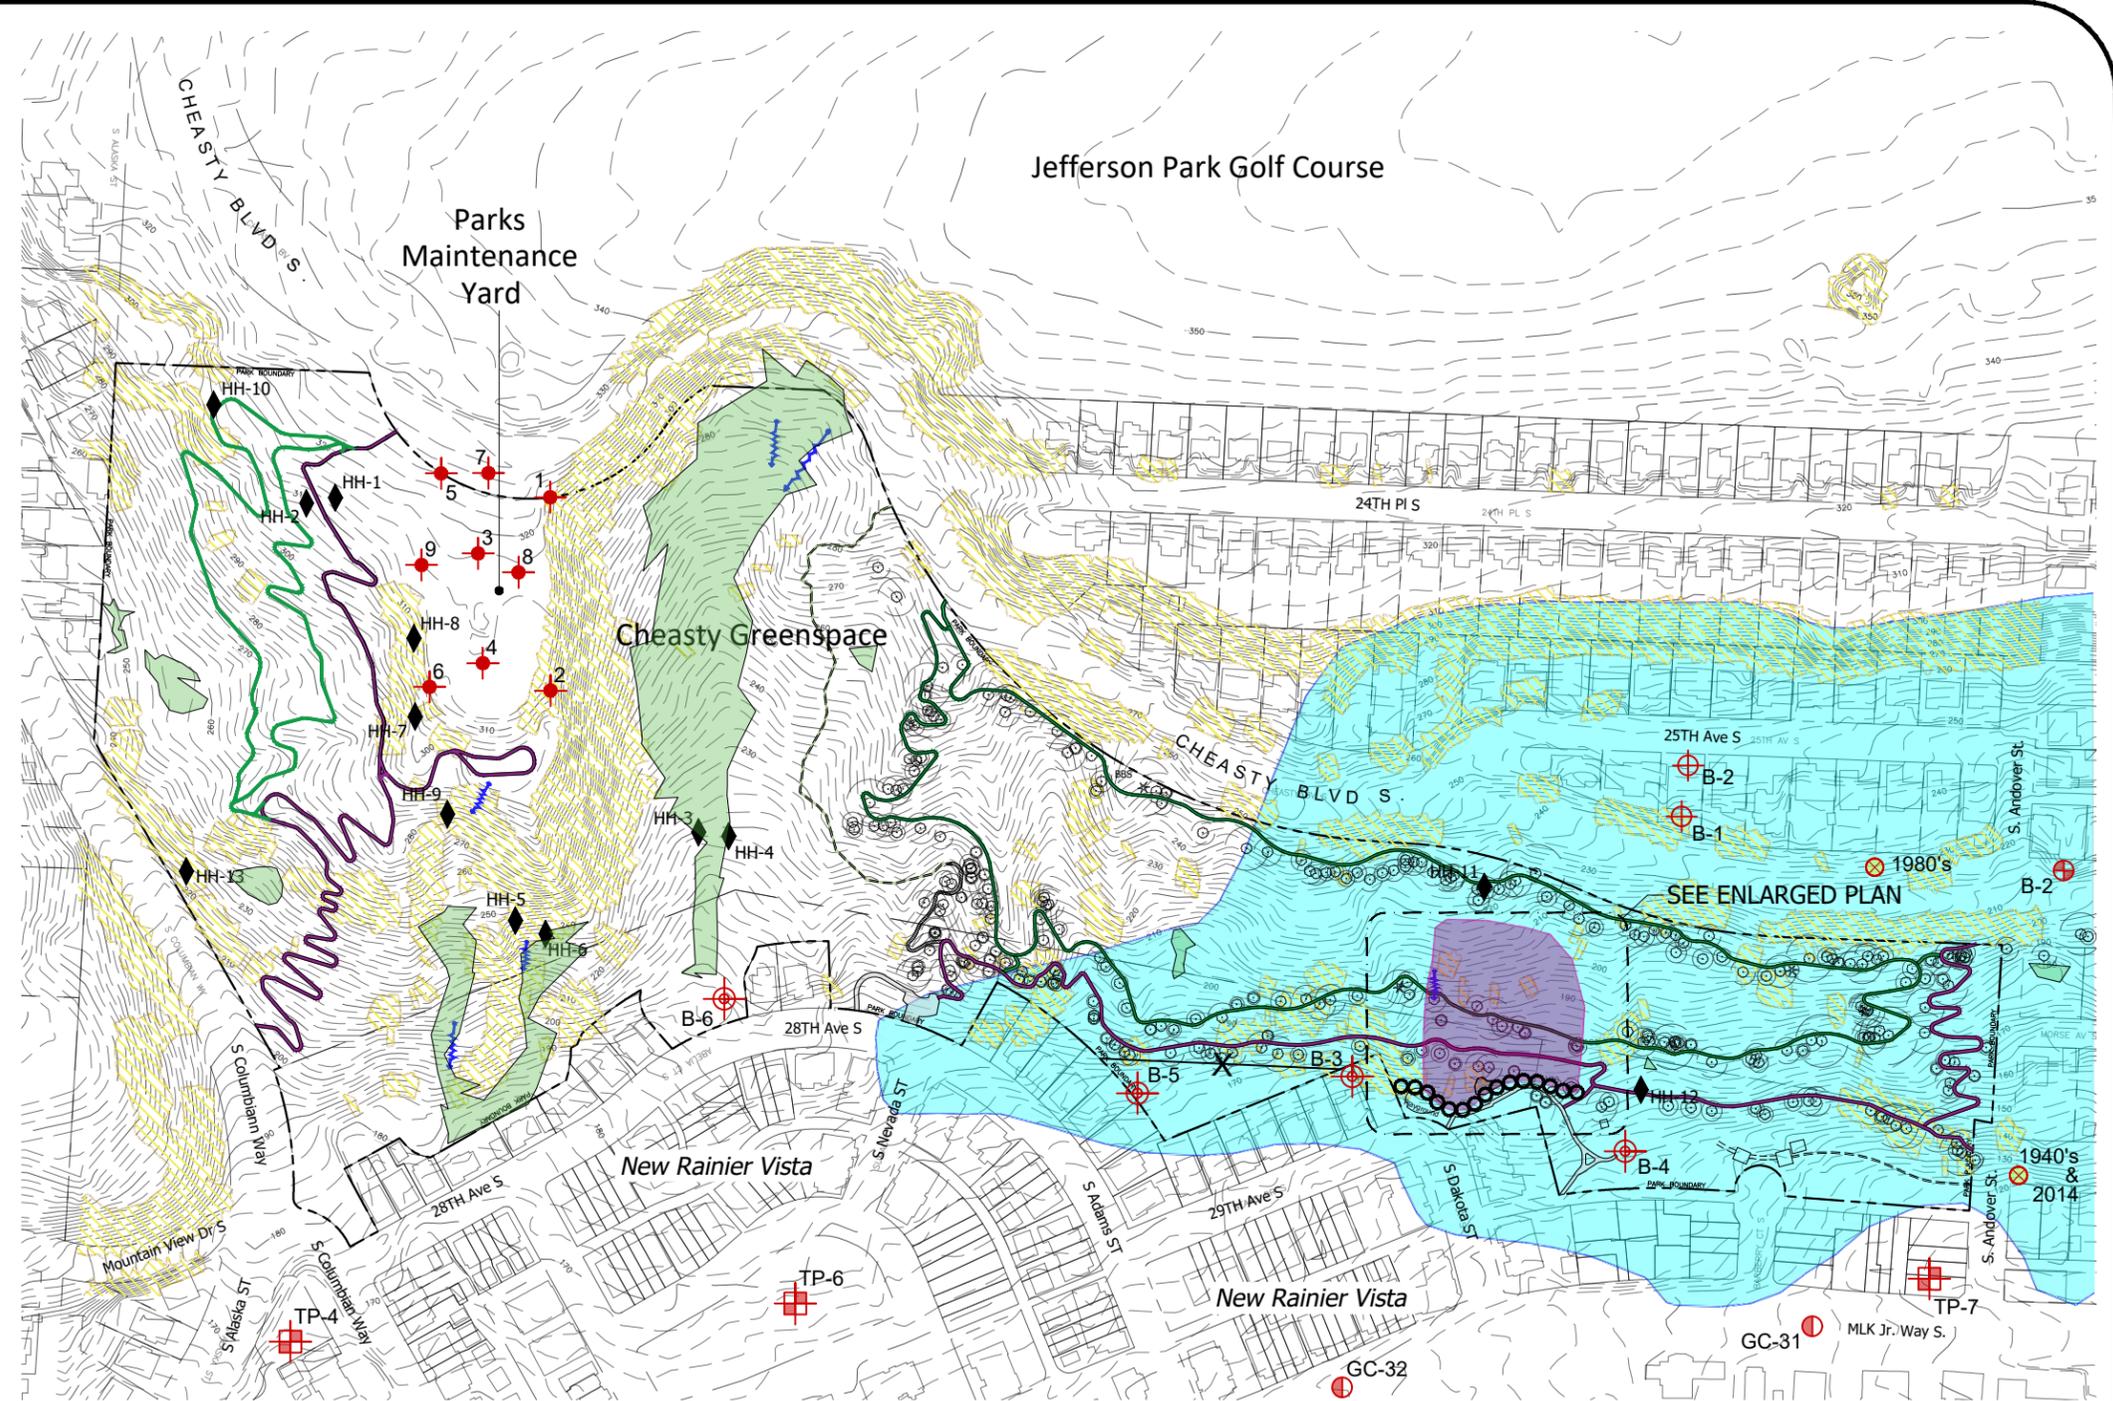
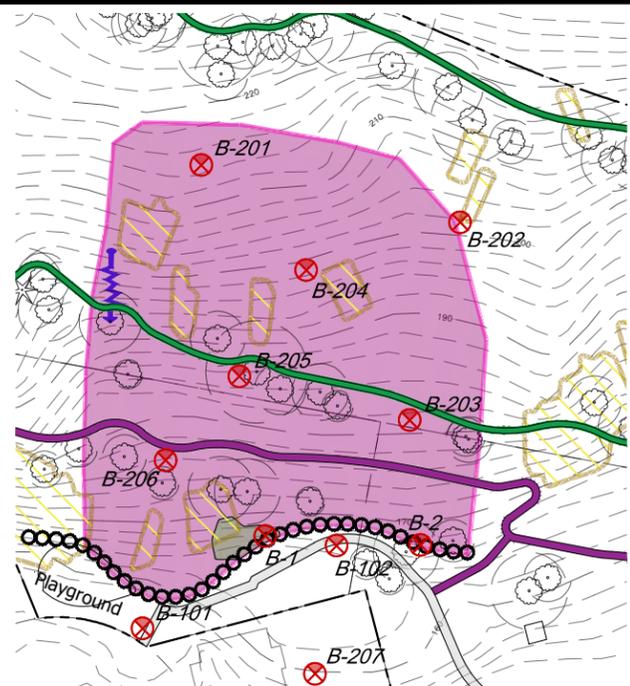
**ENLARGED PLAN**  
Scale: 1" = 100'-0"

- HH-13 HANDHOLE DESIGNATION AND APPROXIMATE LOCATION (HWA 2015, 2018)
- B-207 BOREHOLE DESIGNATION AND APPROXIMATE LOCATION (ECI, 2003-2004)
- B-2 BOREHOLE DESIGNATION AND APPROXIMATE LOCATION (LSI ADAPT, 2001)
- GC-32 BOREHOLE DESIGNATION AND APPROXIMATE LOCATION (GOLDER, 2001)
- B-6 BOREHOLE DESIGNATION AND APPROXIMATE LOCATION (ECI, 2000)
- TP-7 TEST PITS DESIGNATION AND APPROXIMATE LOCATION (ECI, 2000)
- B-2 BOREHOLE DESIGNATION AND APPROXIMATE LOCATION (HARTCROWSER, 1986)
- 9 BOREHOLE DESIGNATION AND APPROXIMATE LOCATION (SEATTLE ENG. DEPT., 1973)

**CHEASTY GREENSPACE MOUNTAIN BIKE TRAIL**  
Scale: 1" = 250'-0"

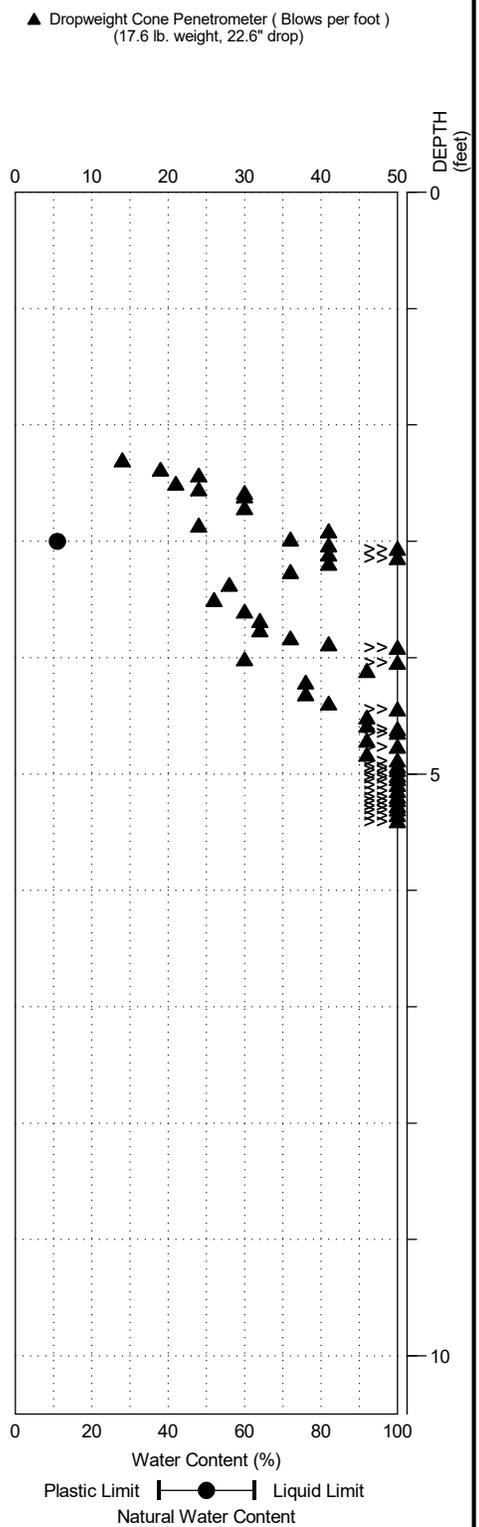
DEPTH (feet)	SYMBOL	USCS SOIL CLASS	DESCRIPTION	SAMPLE TYPE	SAMPLE NUMBER	PEN. RESISTANCE (blows/6 inches)	OTHER TESTS	GROUNDWATER
0		SM	Medium dense, dark brown, silty, fine SAND, moist, with rootlets and scattered fine to coarse gravel. <b>(TOPSOIL)</b>		S-1			
		SM	Medium dense to dense, olive brown, silty, gravelly, fine to medium SAND, moist to wet. <b>(COLLUVIUM)</b>		S-2		GS	
5					S-3

Handhole terminated at 5.3 feet below ground surface (bgs) due to refusal on gravel.  
 No ground water seepage encountered.  
 No caving.

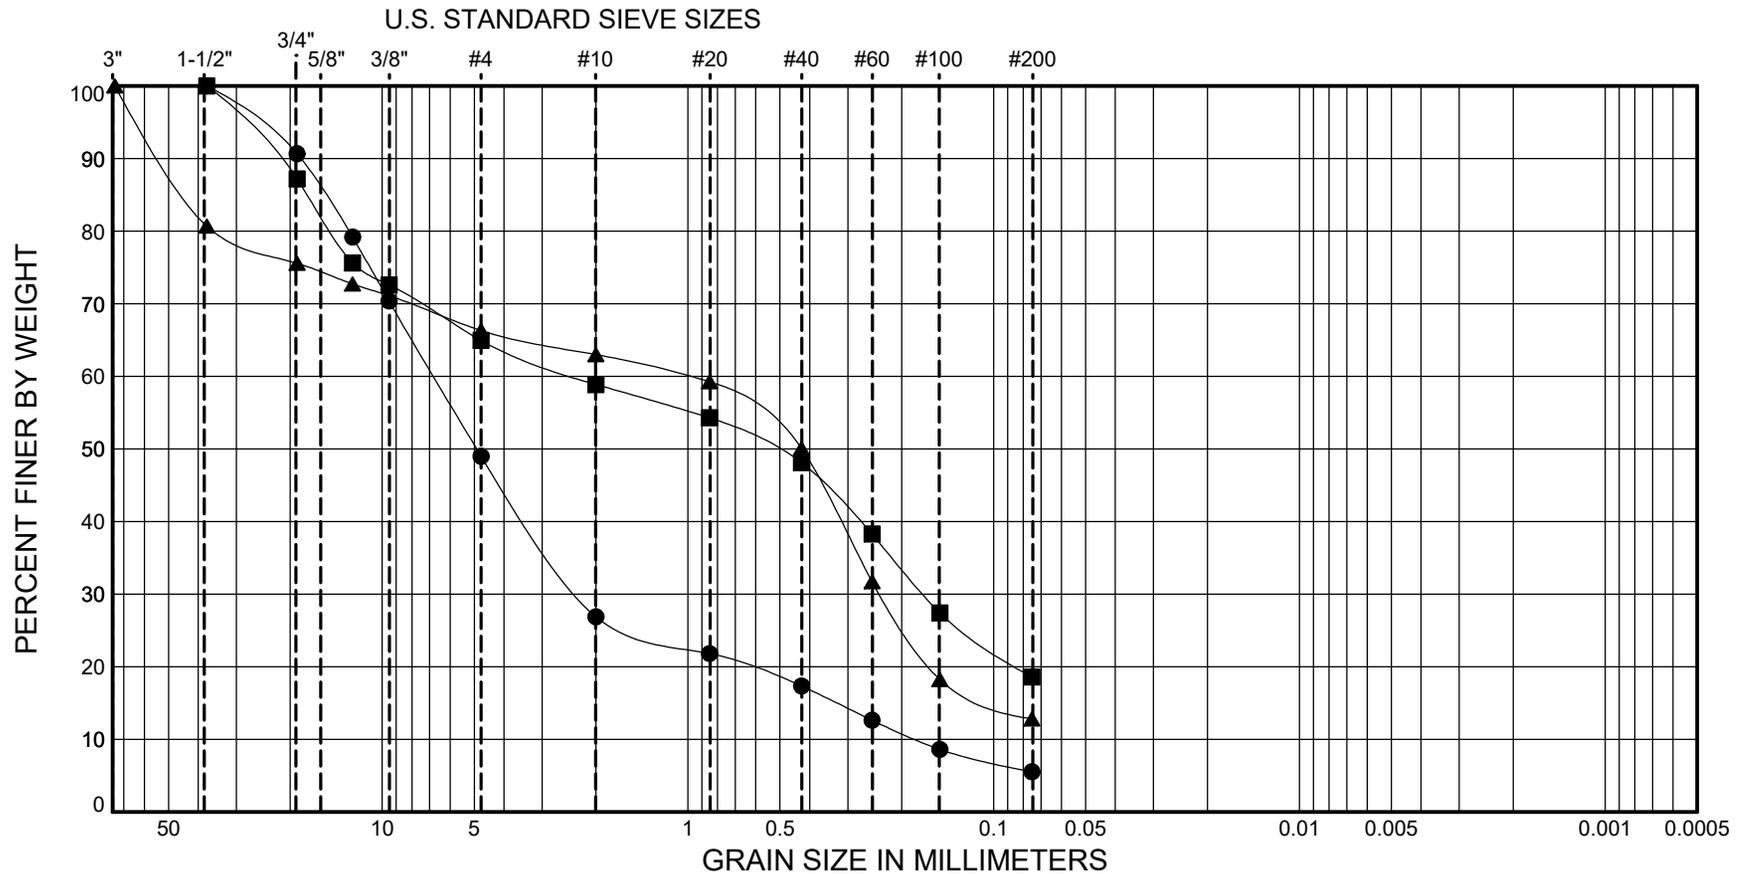
SYMBOL	SAMPLE		DEPTH ( ft. )	CLASSIFICATION OF SOIL- ASTM D2487 Group Symbol and Name	% MC	LL	PL	PI	Gravel %	Sand %	Fines %
●	HH- 8	S-1	0.5 - 1.0	(GP-GM) Very dark brown, poorly graded GRAVEL with silt and sand	9				51.0	43.5	5.5
■	HH-10	S-1	1.0 - 1.5	(SM) Yellowish-brown, silty SAND with gravel	11				35.1	46.3	18.6
▲	HH-12	S-2	3.0 - 3.5	(SM) Olive-brown, silty SAND with gravel	11				33.7	53.5	12.8

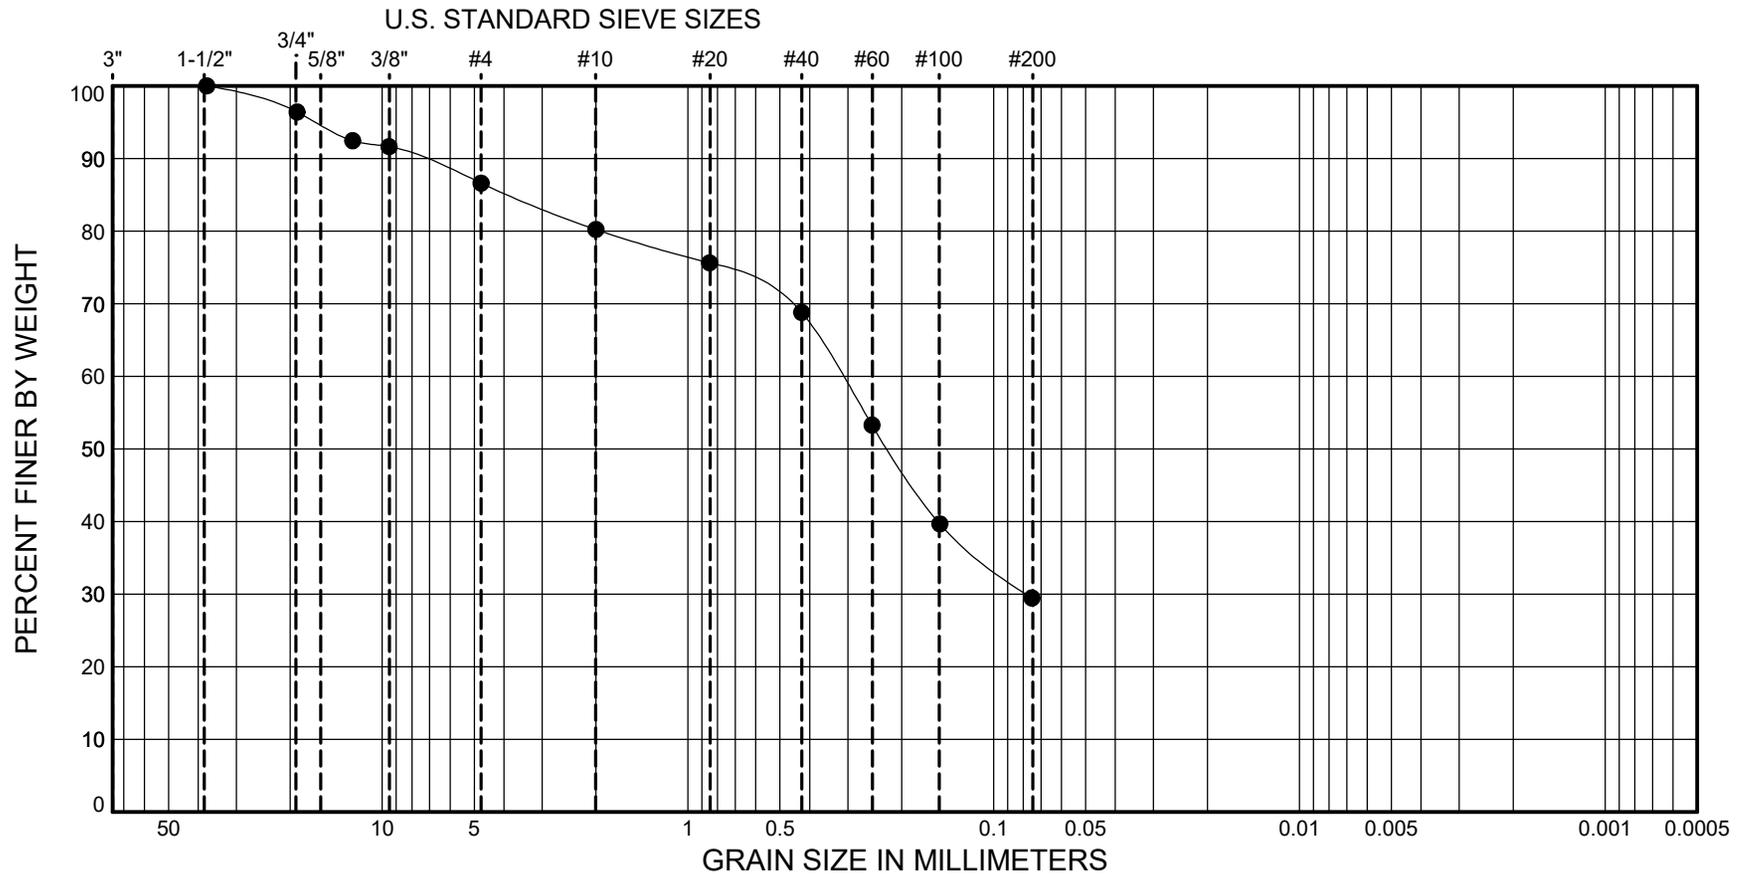
PARTICLE-SIZE ANALYSIS  
OF SOILS  
METHOD ASTM D6913

SYMBOL	SAMPLE	DEPTH ( ft.)	CLASSIFICATION OF SOIL- ASTM D2487 Group Symbol and Name	% MC	LL	PL	PI	Gravel %	Sand %	Fines %
●	HH-13 S-1	1.0 - 1.5	(SM) Dark yellowish-brown, silty SAND	13				13.4	57.1	29.5

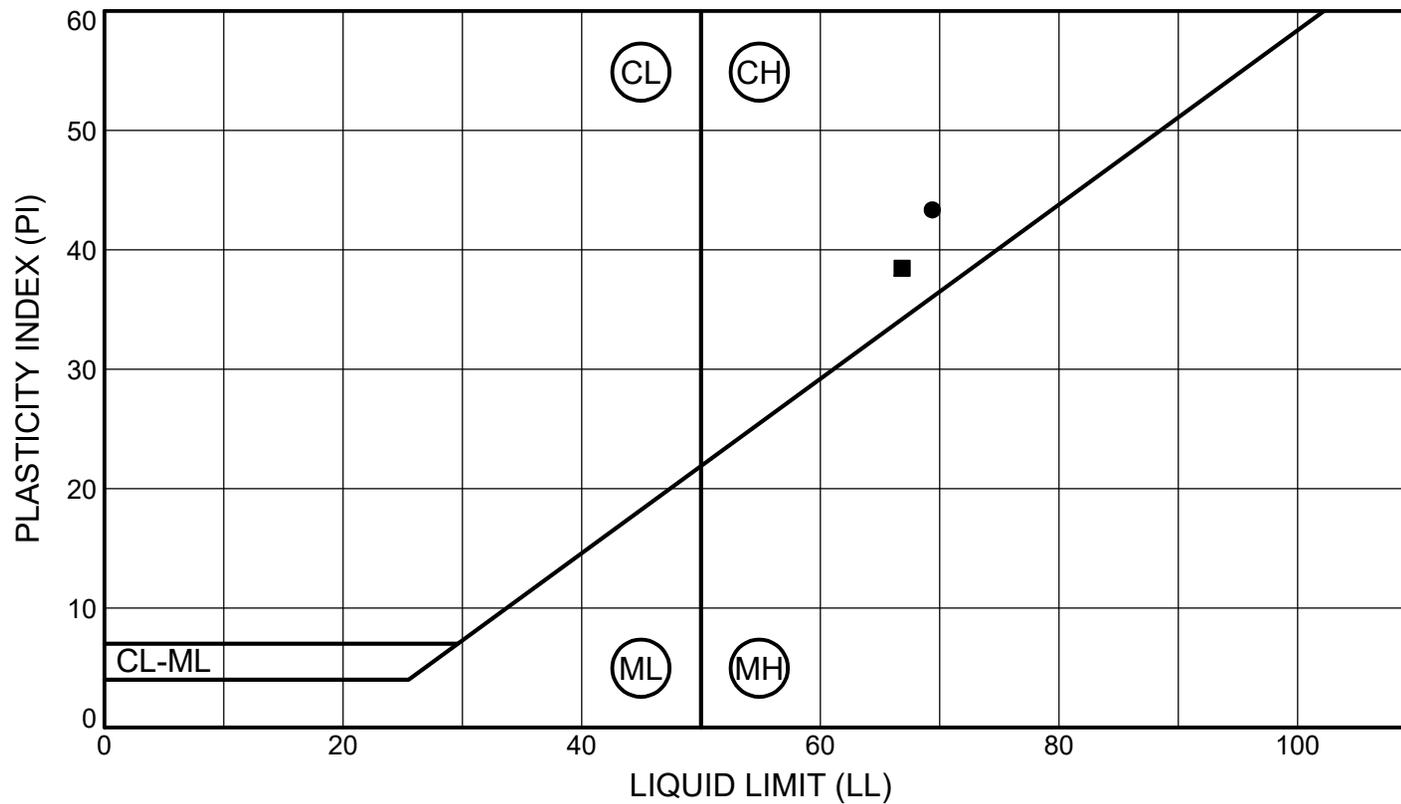
SYMBOL	SAMPLE		DEPTH (ft)	CLASSIFICATION	% MC	LL	PL	PI	% Fines
●	HH-7	S-1	1.0 - 1.5	(CH) Gray, fat CLAY	34	69	26	43	
■	HH-11	S-3	3.0 - 3.5	(CH) Yellowish-brown, fat CLAY with sand	55	67	28	39

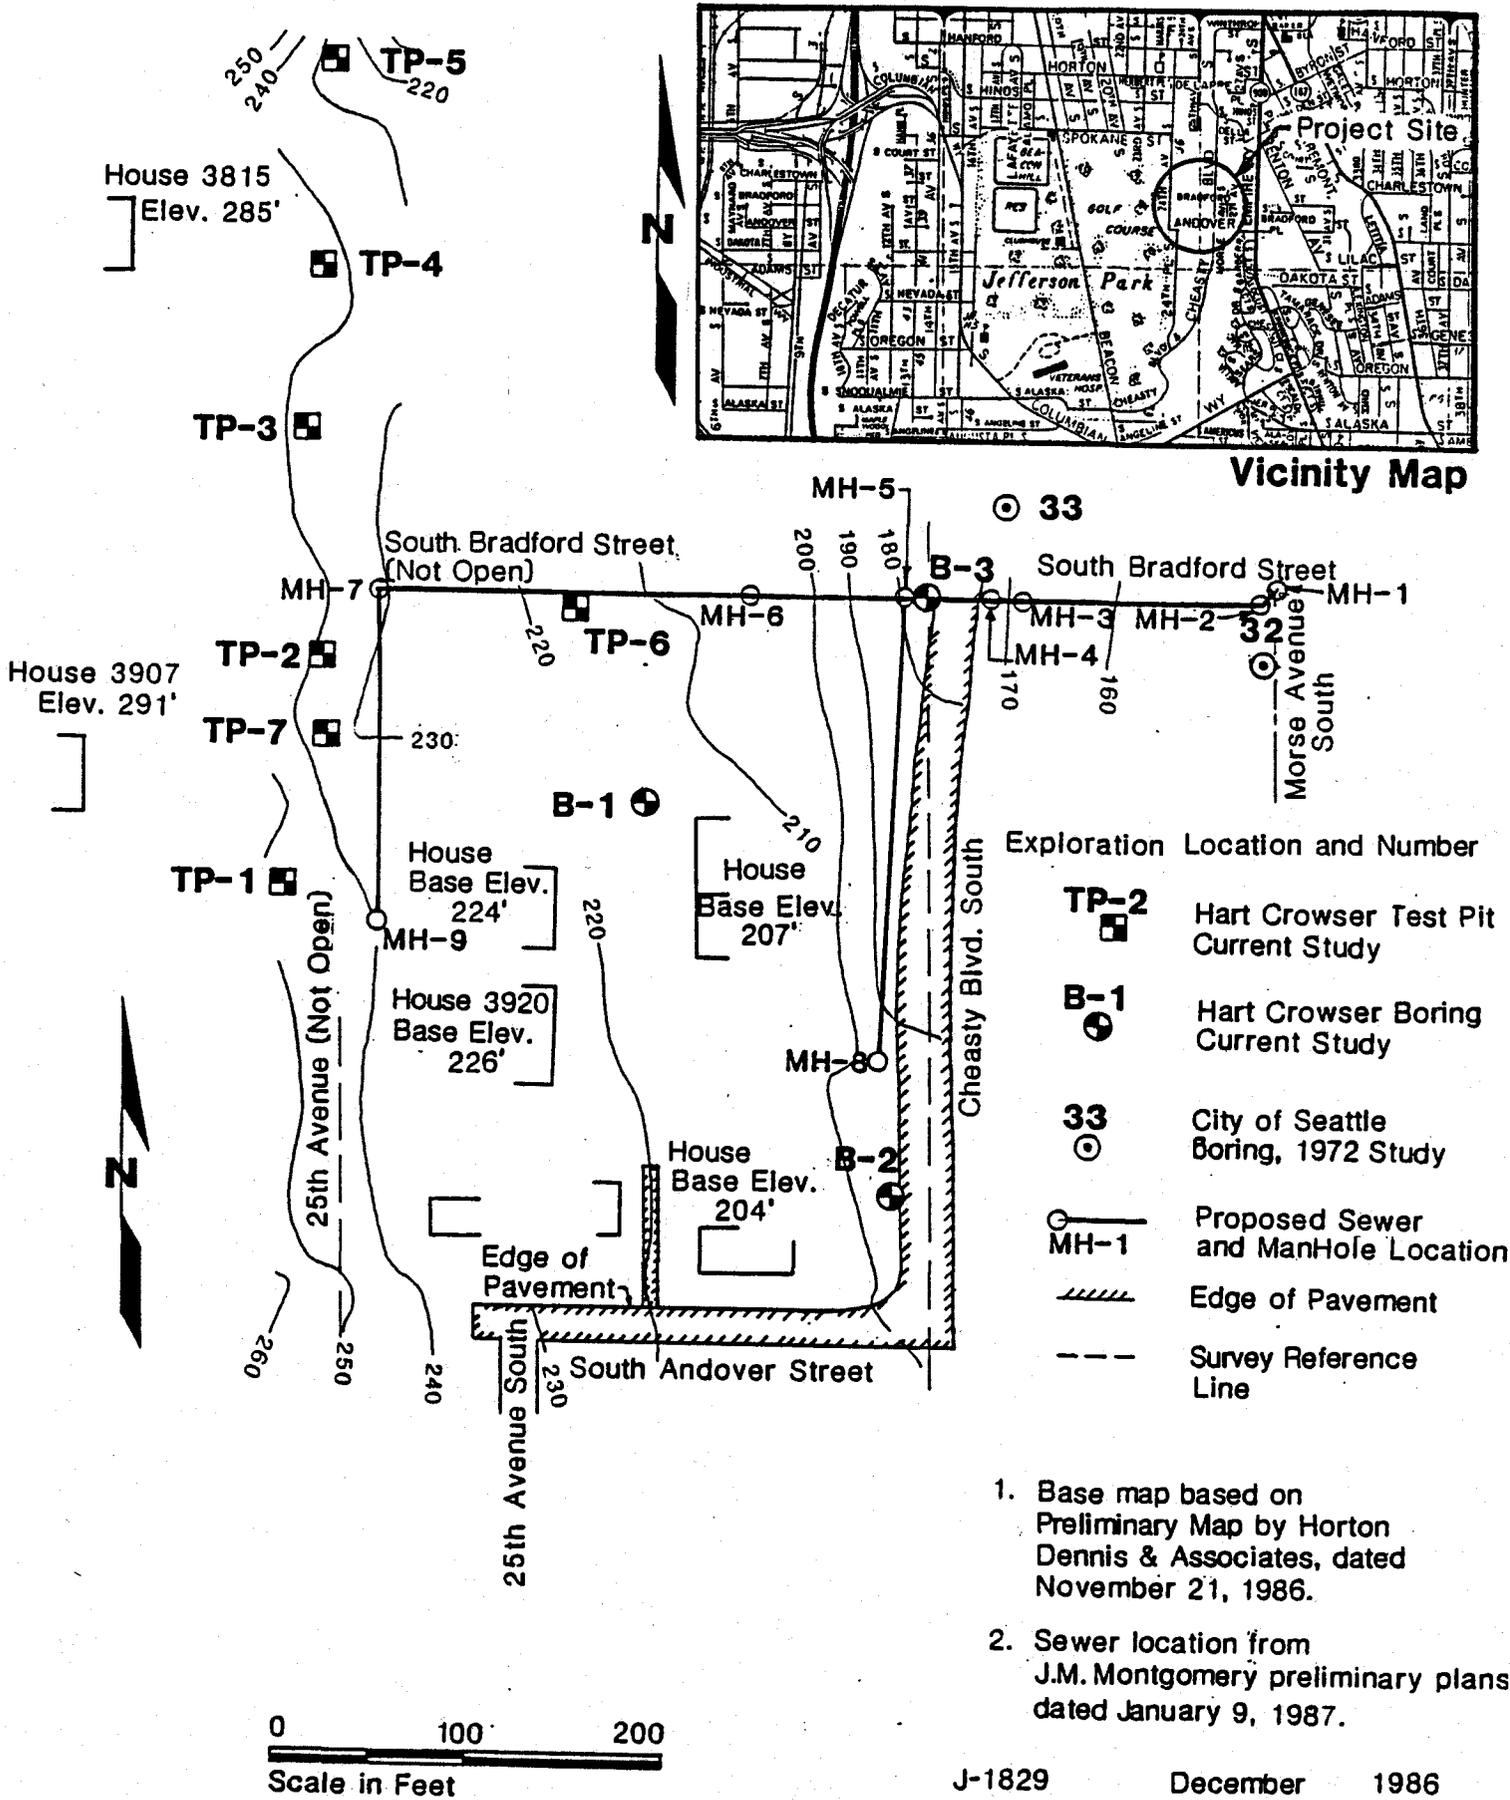
# Site and Exploration Plan

Symbol	Exploration Location and Number	Description
□	TP-2	Hart Crowser Test Pit Current Study
●	B-1	Hart Crowser Boring Current Study
⊙	33	City of Seattle Boring, 1972 Study
○	MH-1	Proposed Sewer and ManHole Location
▨		Edge of Pavement
- - -		Survey Reference Line

1. Base map based on Preliminary Map by Horton Dennis & Associates, dated November 21, 1986.
2. Sewer location from J.M. Montgomery preliminary plans dated January 9, 1987.

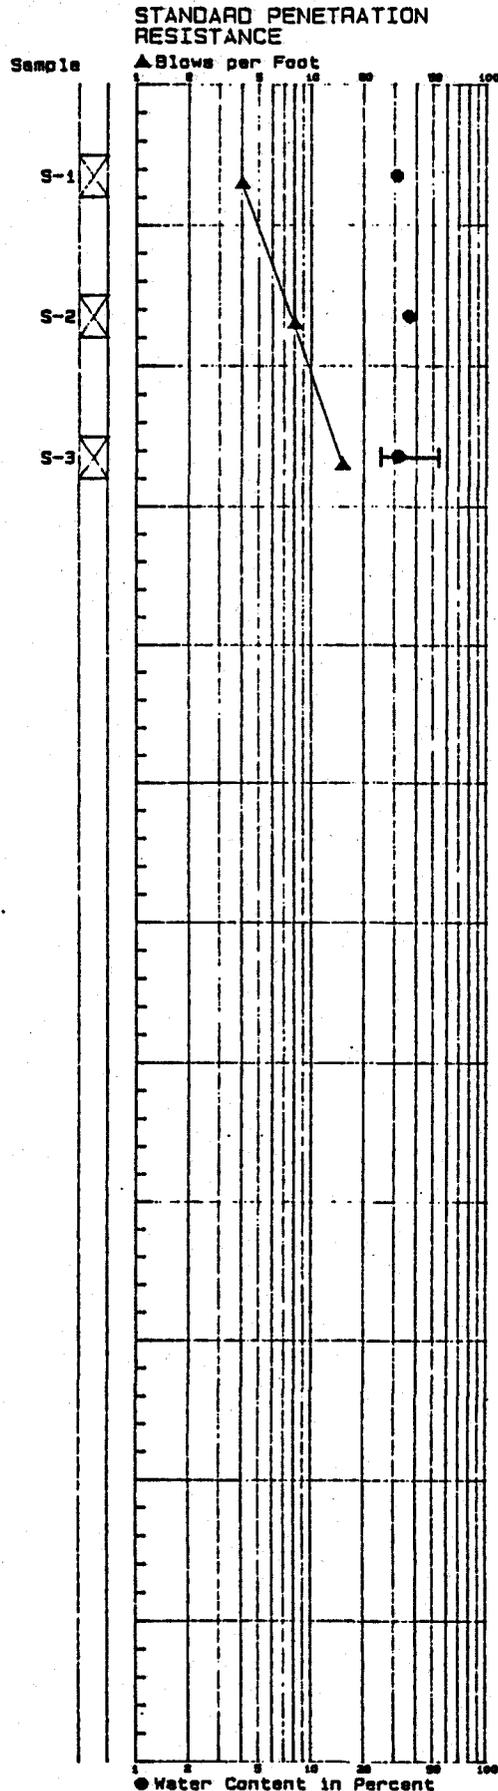
(Loose), moist, brown, sandy SILT with organics. (TOPSOIL)

Stiff, wet, blue-gray, silty CLAY.

Bottom of Boring at 14.0 Feet.  
Completed 11/4/86.

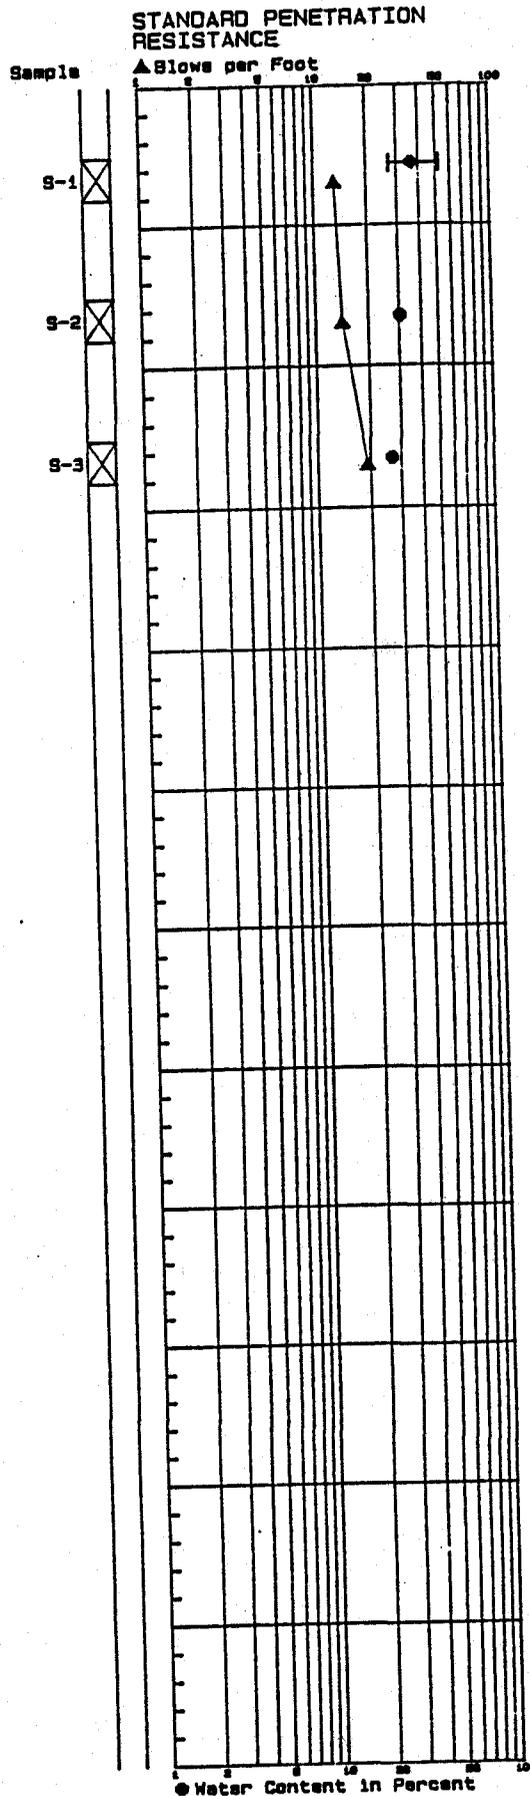
(Loose), wet, brown, sandy SILT with organics. (TOPSOIL)

Stiff, moist to wet, brown, silty CLAY.

Stiff to very stiff, wet, blue-gray, silty CLAY.

Bottom of Boring at 14.0 Feet.  
Completed 11/4/86.

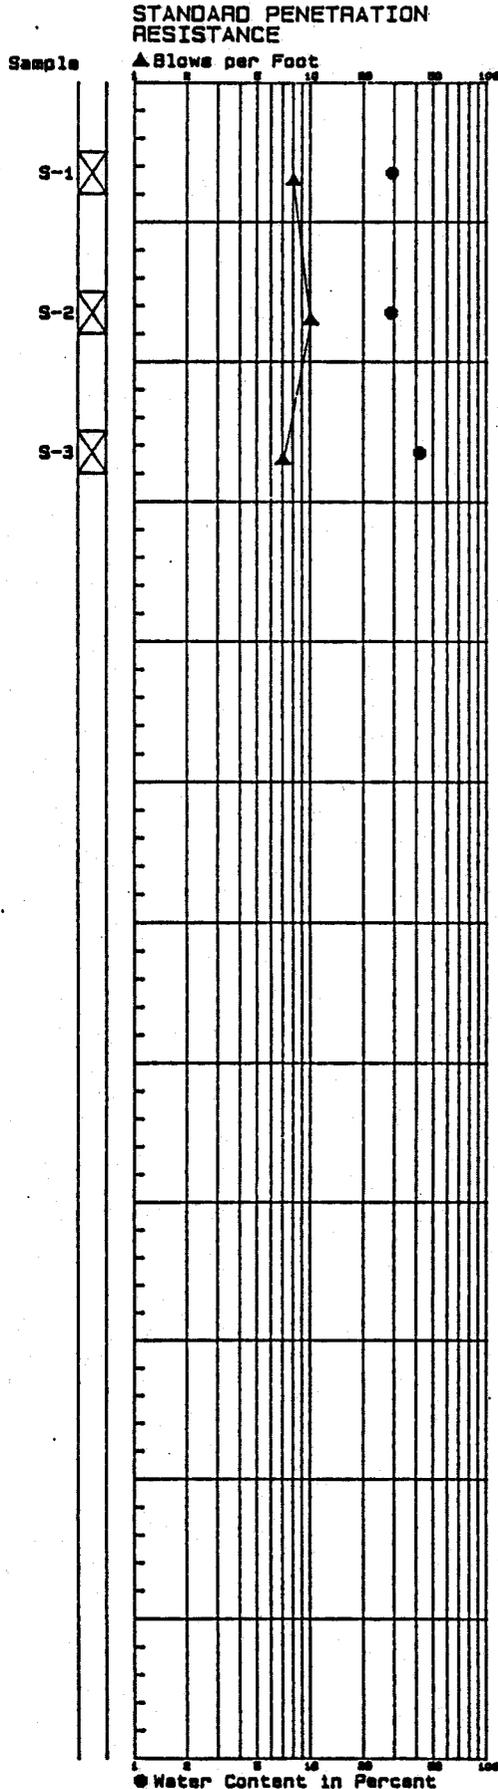
(Loose), wet, brown, sandy SILT with organics. (TOPSOIL)

Medium stiff, wet, brown, silty CLAY.

Bottom of Boring 14.0 Feet.  
Completed 11/4/86.
