**Attachment 2**  
Geotechnical Engineering Report

HWA Project No. 2014-177-21

Subject: **FINAL GEOTECHNICAL ENGINEERING REPORT  
Cheasty Greenspace Mountain Bike Trail  
City of Seattle Parks and Recreation  
Seattle, Washington**

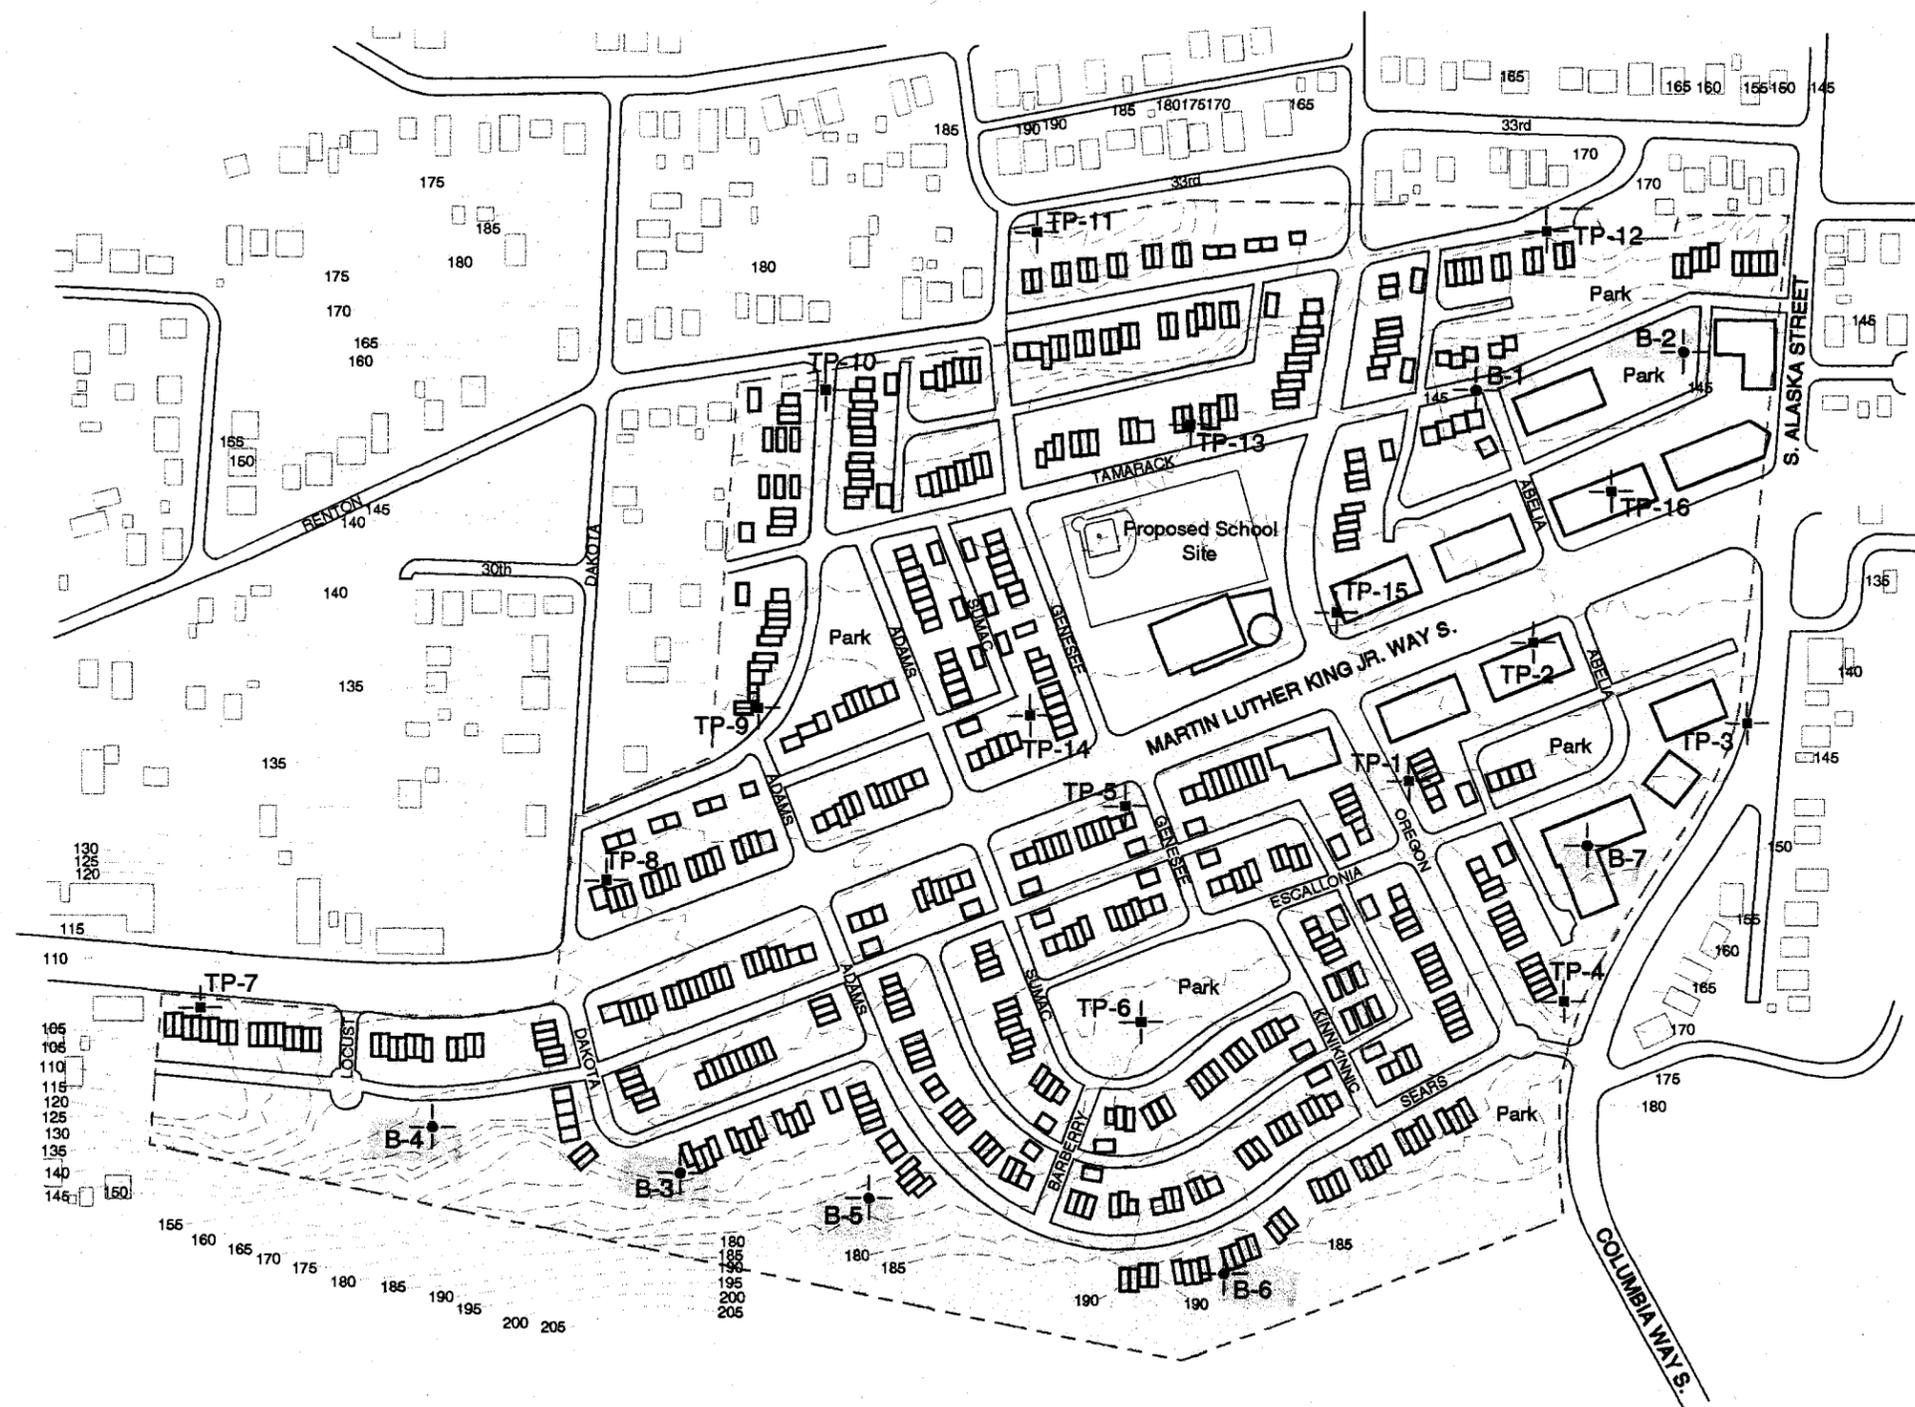
**LEGEND**

- B-1— Approximate Location of ECI Boring, Proj. No. E-9334, Sept. 2000
- TP-1— Approximate Location of ECI Test Pit, Proj. No. E-9334, Sept. 2000
-

Since the groundwater levels did not have time to stabilize, slotted three-quarter inch standpipes were installed in Borings B-4, B-5 and B-6 along the toe of the slope on the west side of the site. A reading, taken eight days after the completion of the borings, is also shown on the boring logs.

Slight groundwater seepage was encountered in our test pits TP-2 and TP-3 at eight and nine feet below existing grade and are shown on the test pit logs.

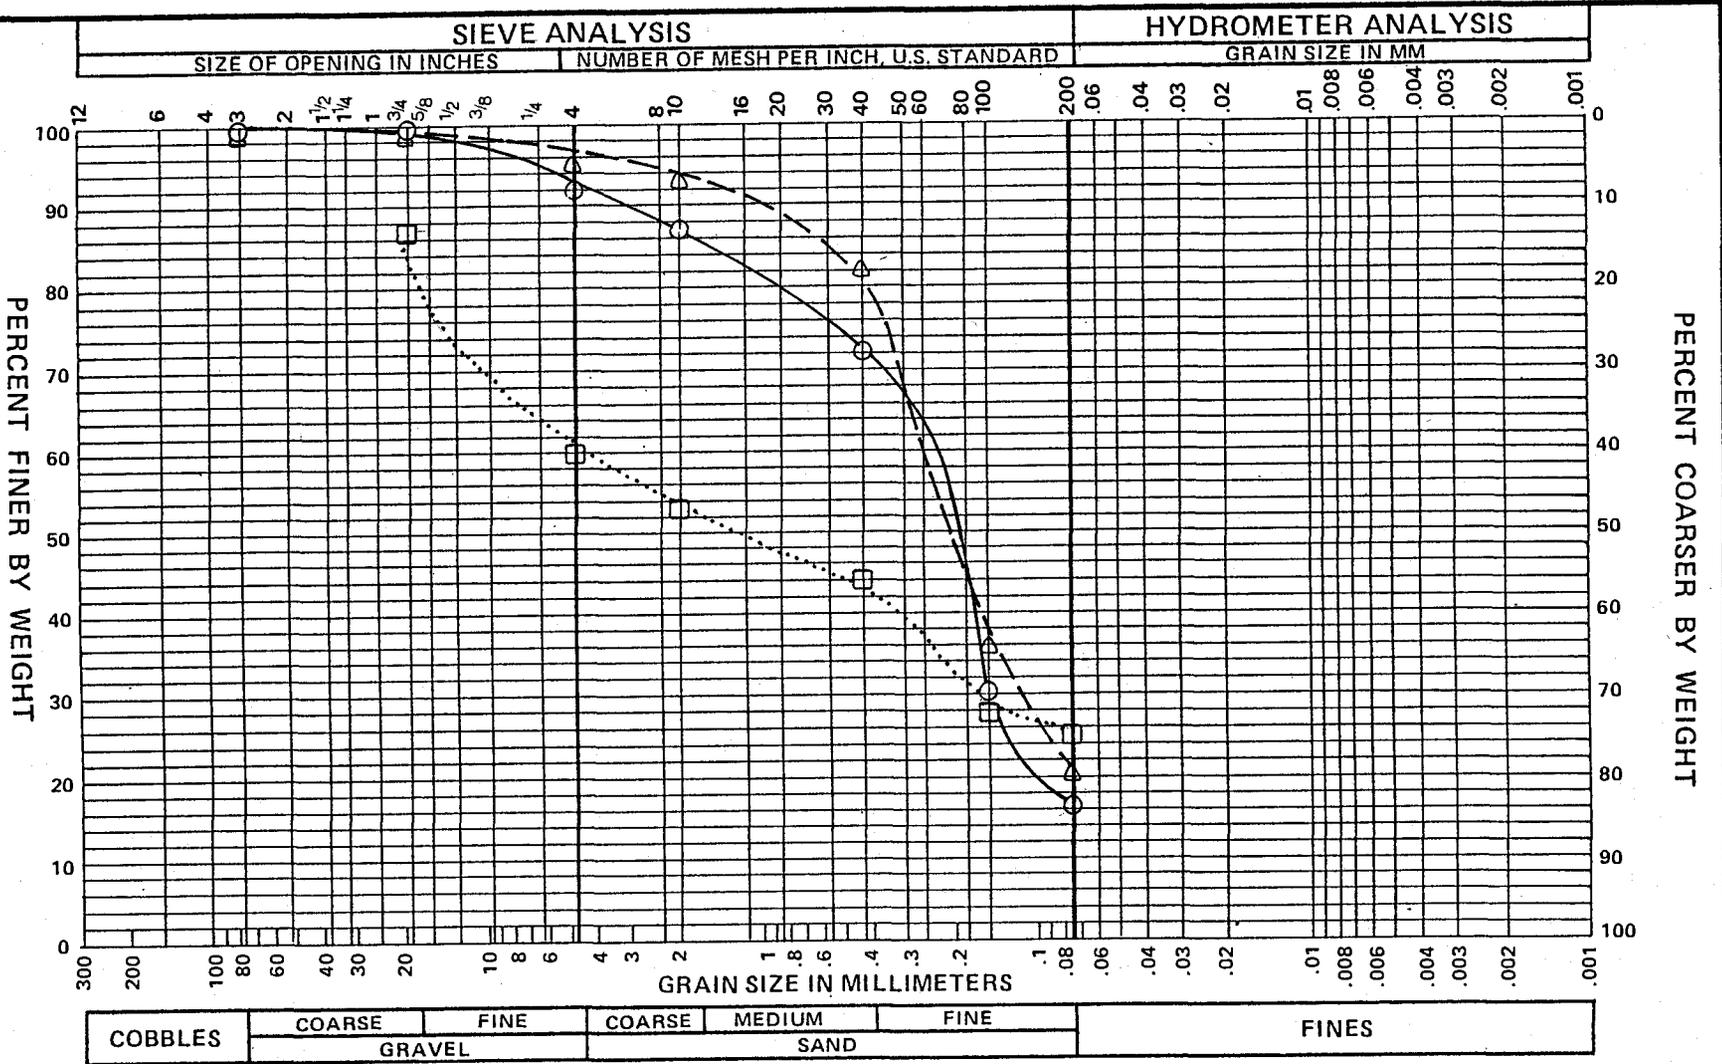
**GRAIN SIZE ANALYSES**  
 Rainier Vista  
 Seattle, Washington

KEY	Boring or Test Pit No.	DEPTH (ft.)	USCS	DESCRIPTION	Moisture Content (%)	LL	PL
○ ———	B-6	10	SM	Gray silty SAND	14.4	---	---
△ - - - -	B-7	7.5	SM	Gray silty SAND	16.3	---	---
□ ······	TP-4	3	SM	Brown silty SAND with gravel	14.6	---	---

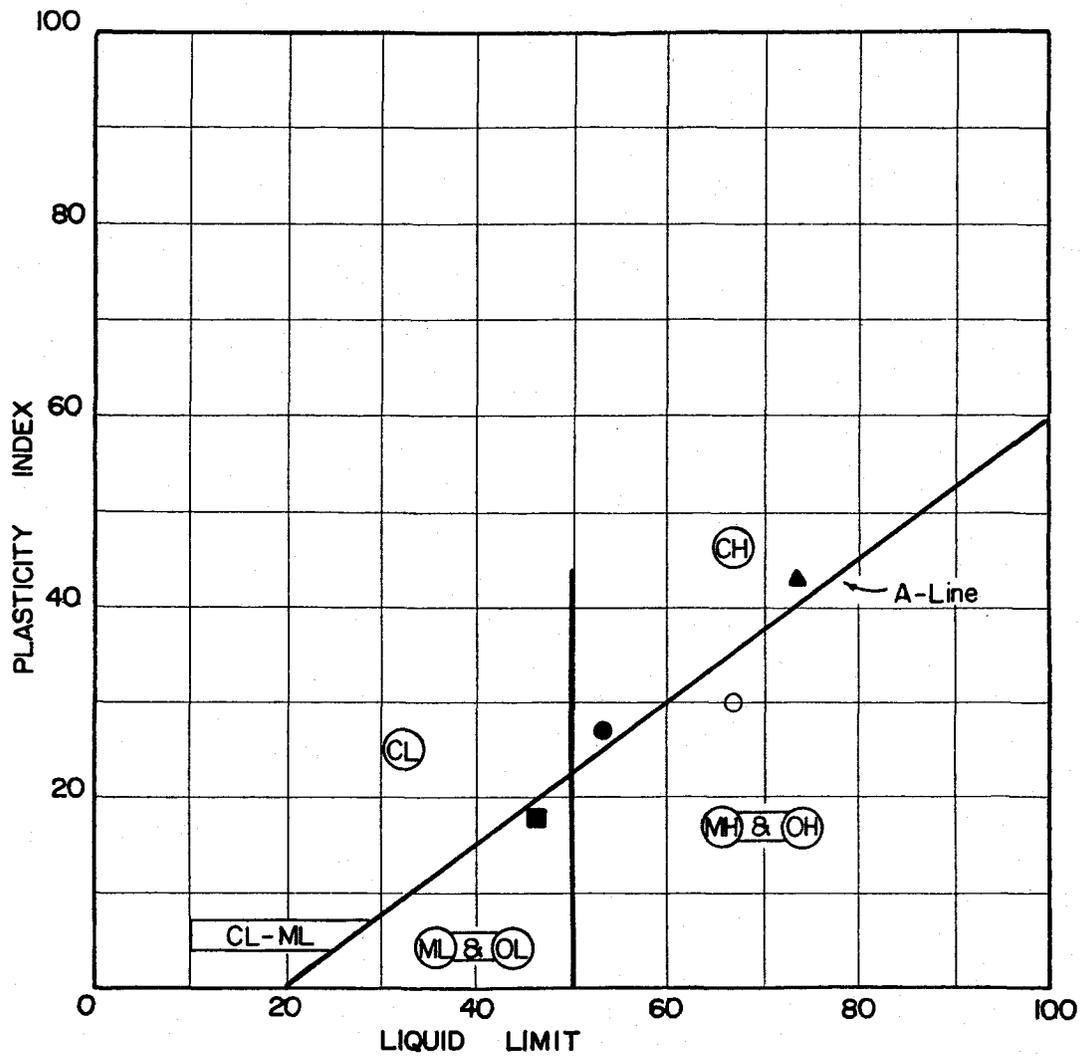
Key	Boring/ Test Pit	Depth (ft)	Soil Classification	USCS	L.L.	P.L.	P.I.	Natural Water Content
●	B-1	15	Brown fat CLAY	CH	52.9	25.1	27.8	22.8
▲	B-3	5	Brown fat CLAY	CH	73.8	32.5	41.3	40.8
■	B-4	12.5	Gray SILT	ML	47.6	29	18.6	32.5
○	B-5	5	Gray SILT	MH	67.8	27.8	30	29.9

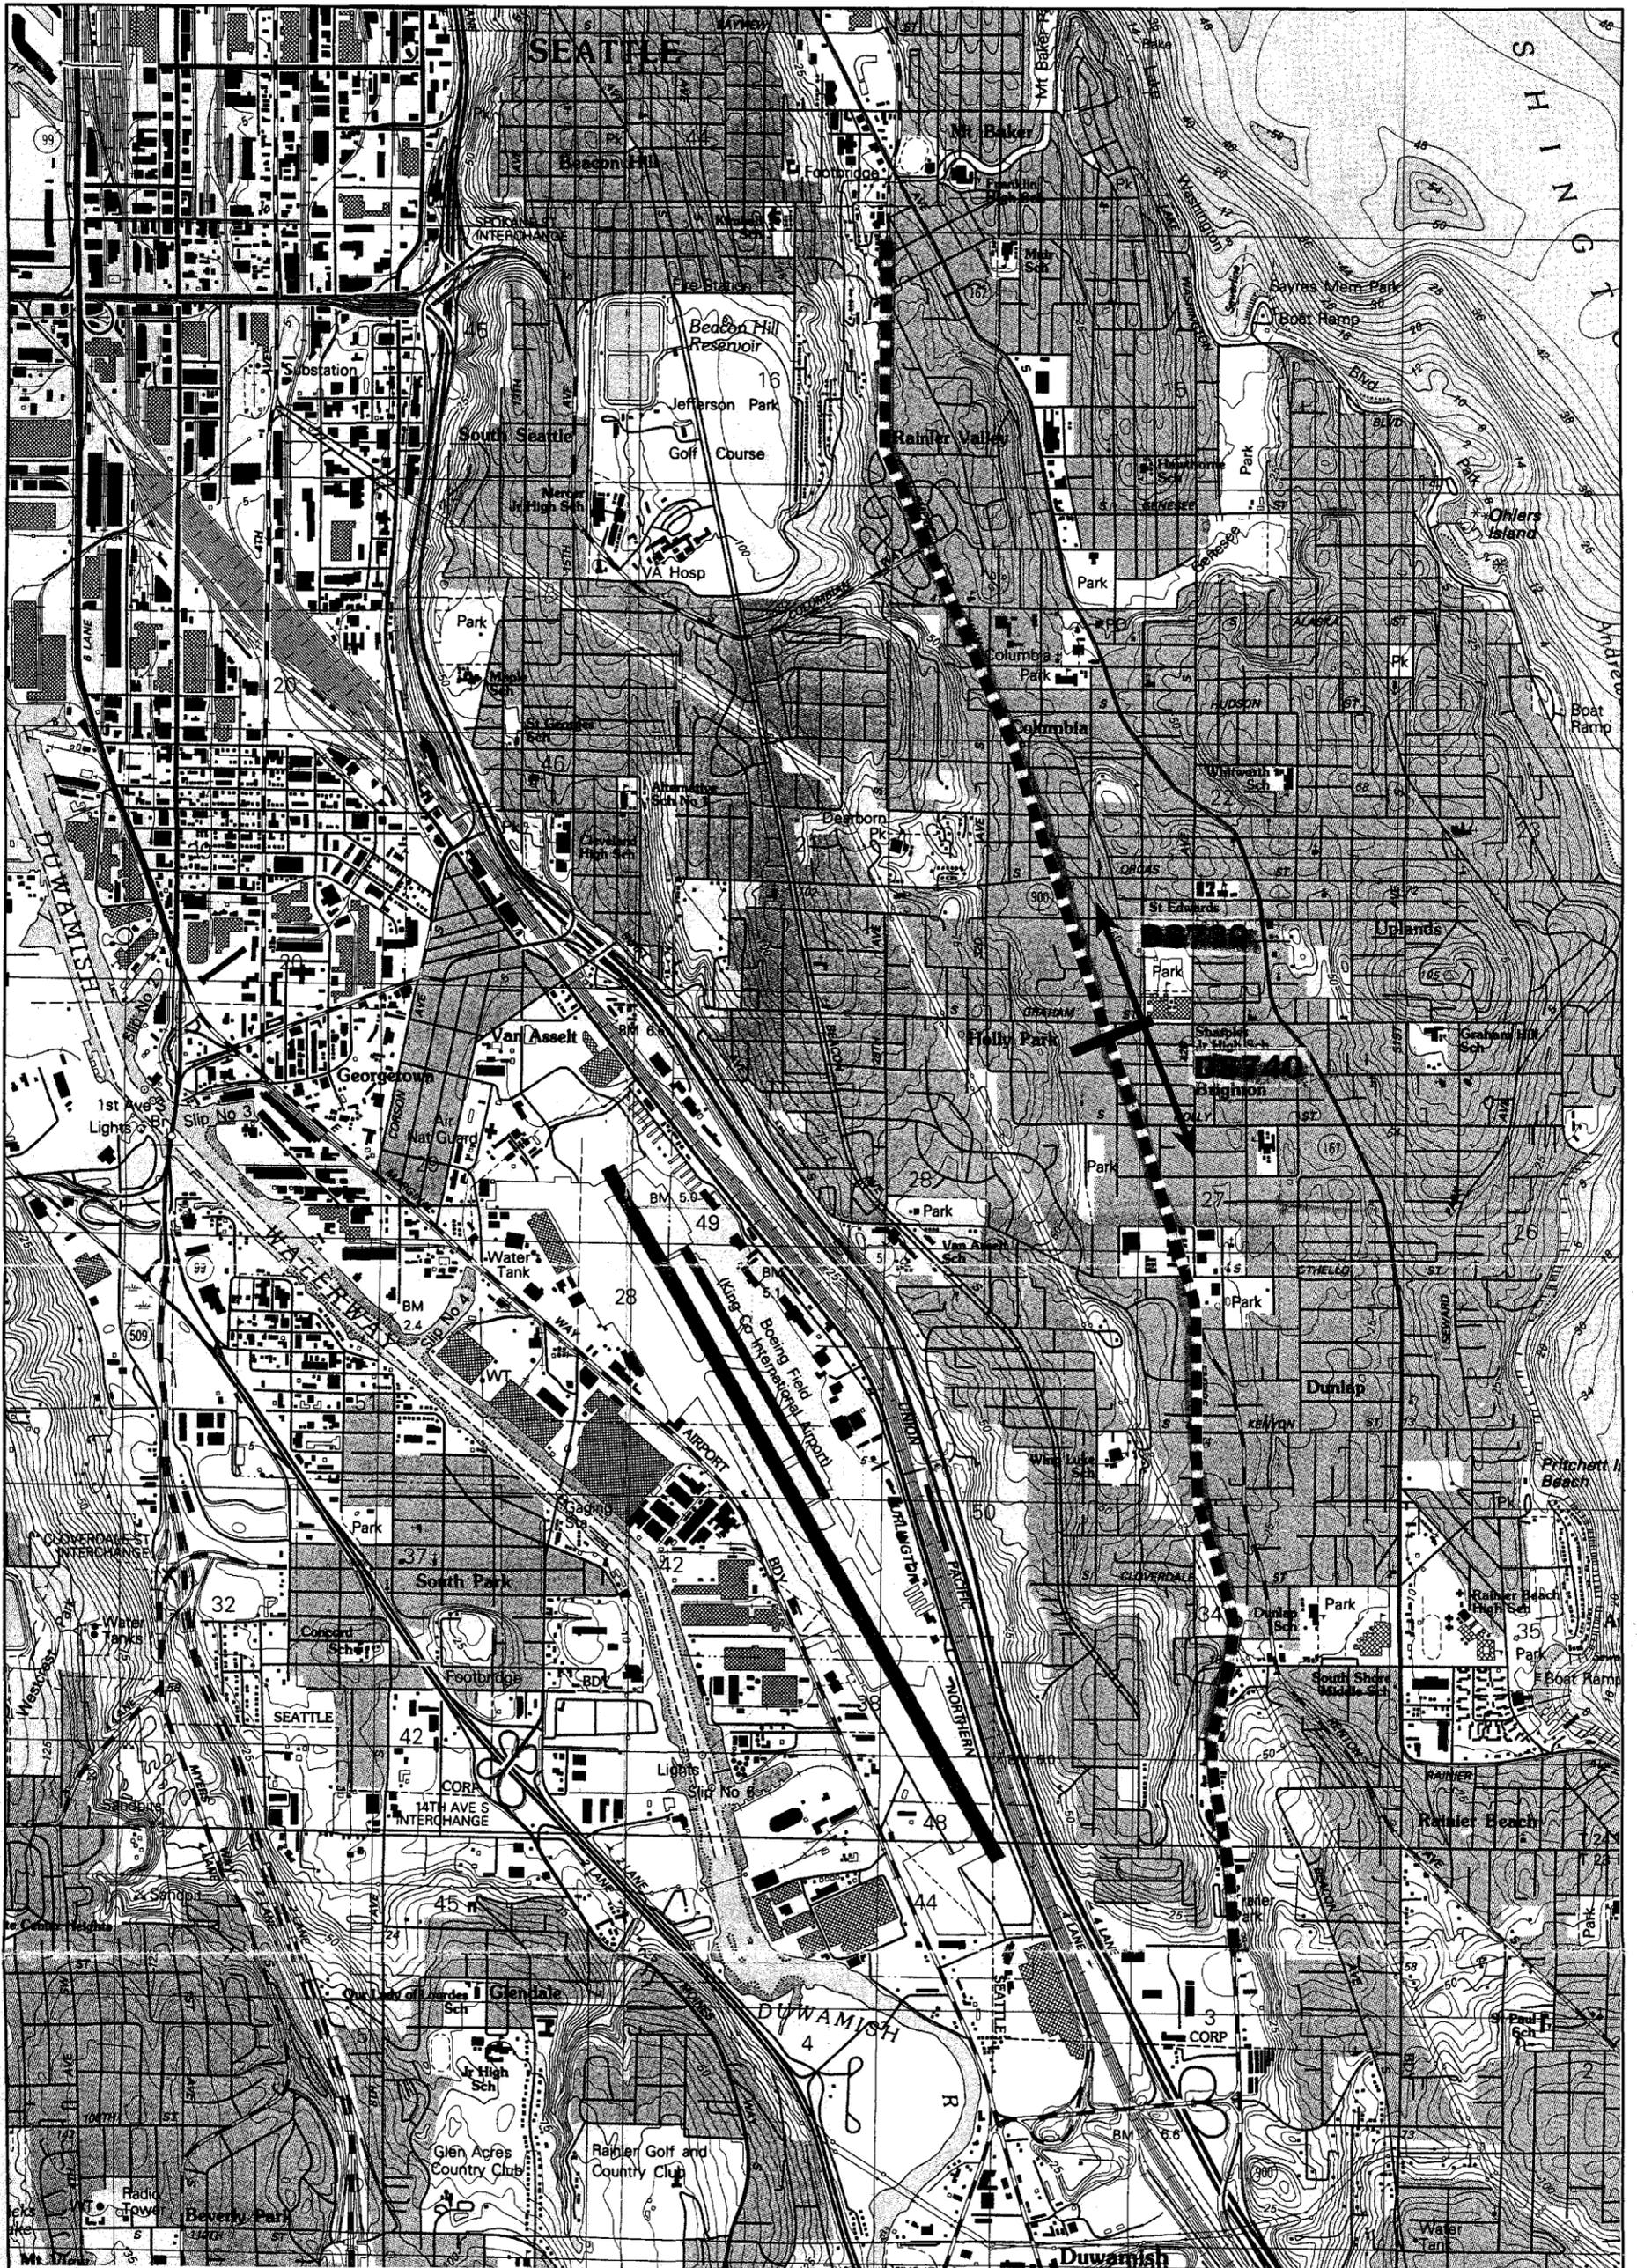
FIGURE 1  
 SEGMENTS 730 & 740 PROJECT LOCATION  
 SOUND TRANSIT SEGMENT 3WA

Ref: Seattle South  
 1:25,000  
 Topographic - Bathymetric map.  
 USGS (1983)

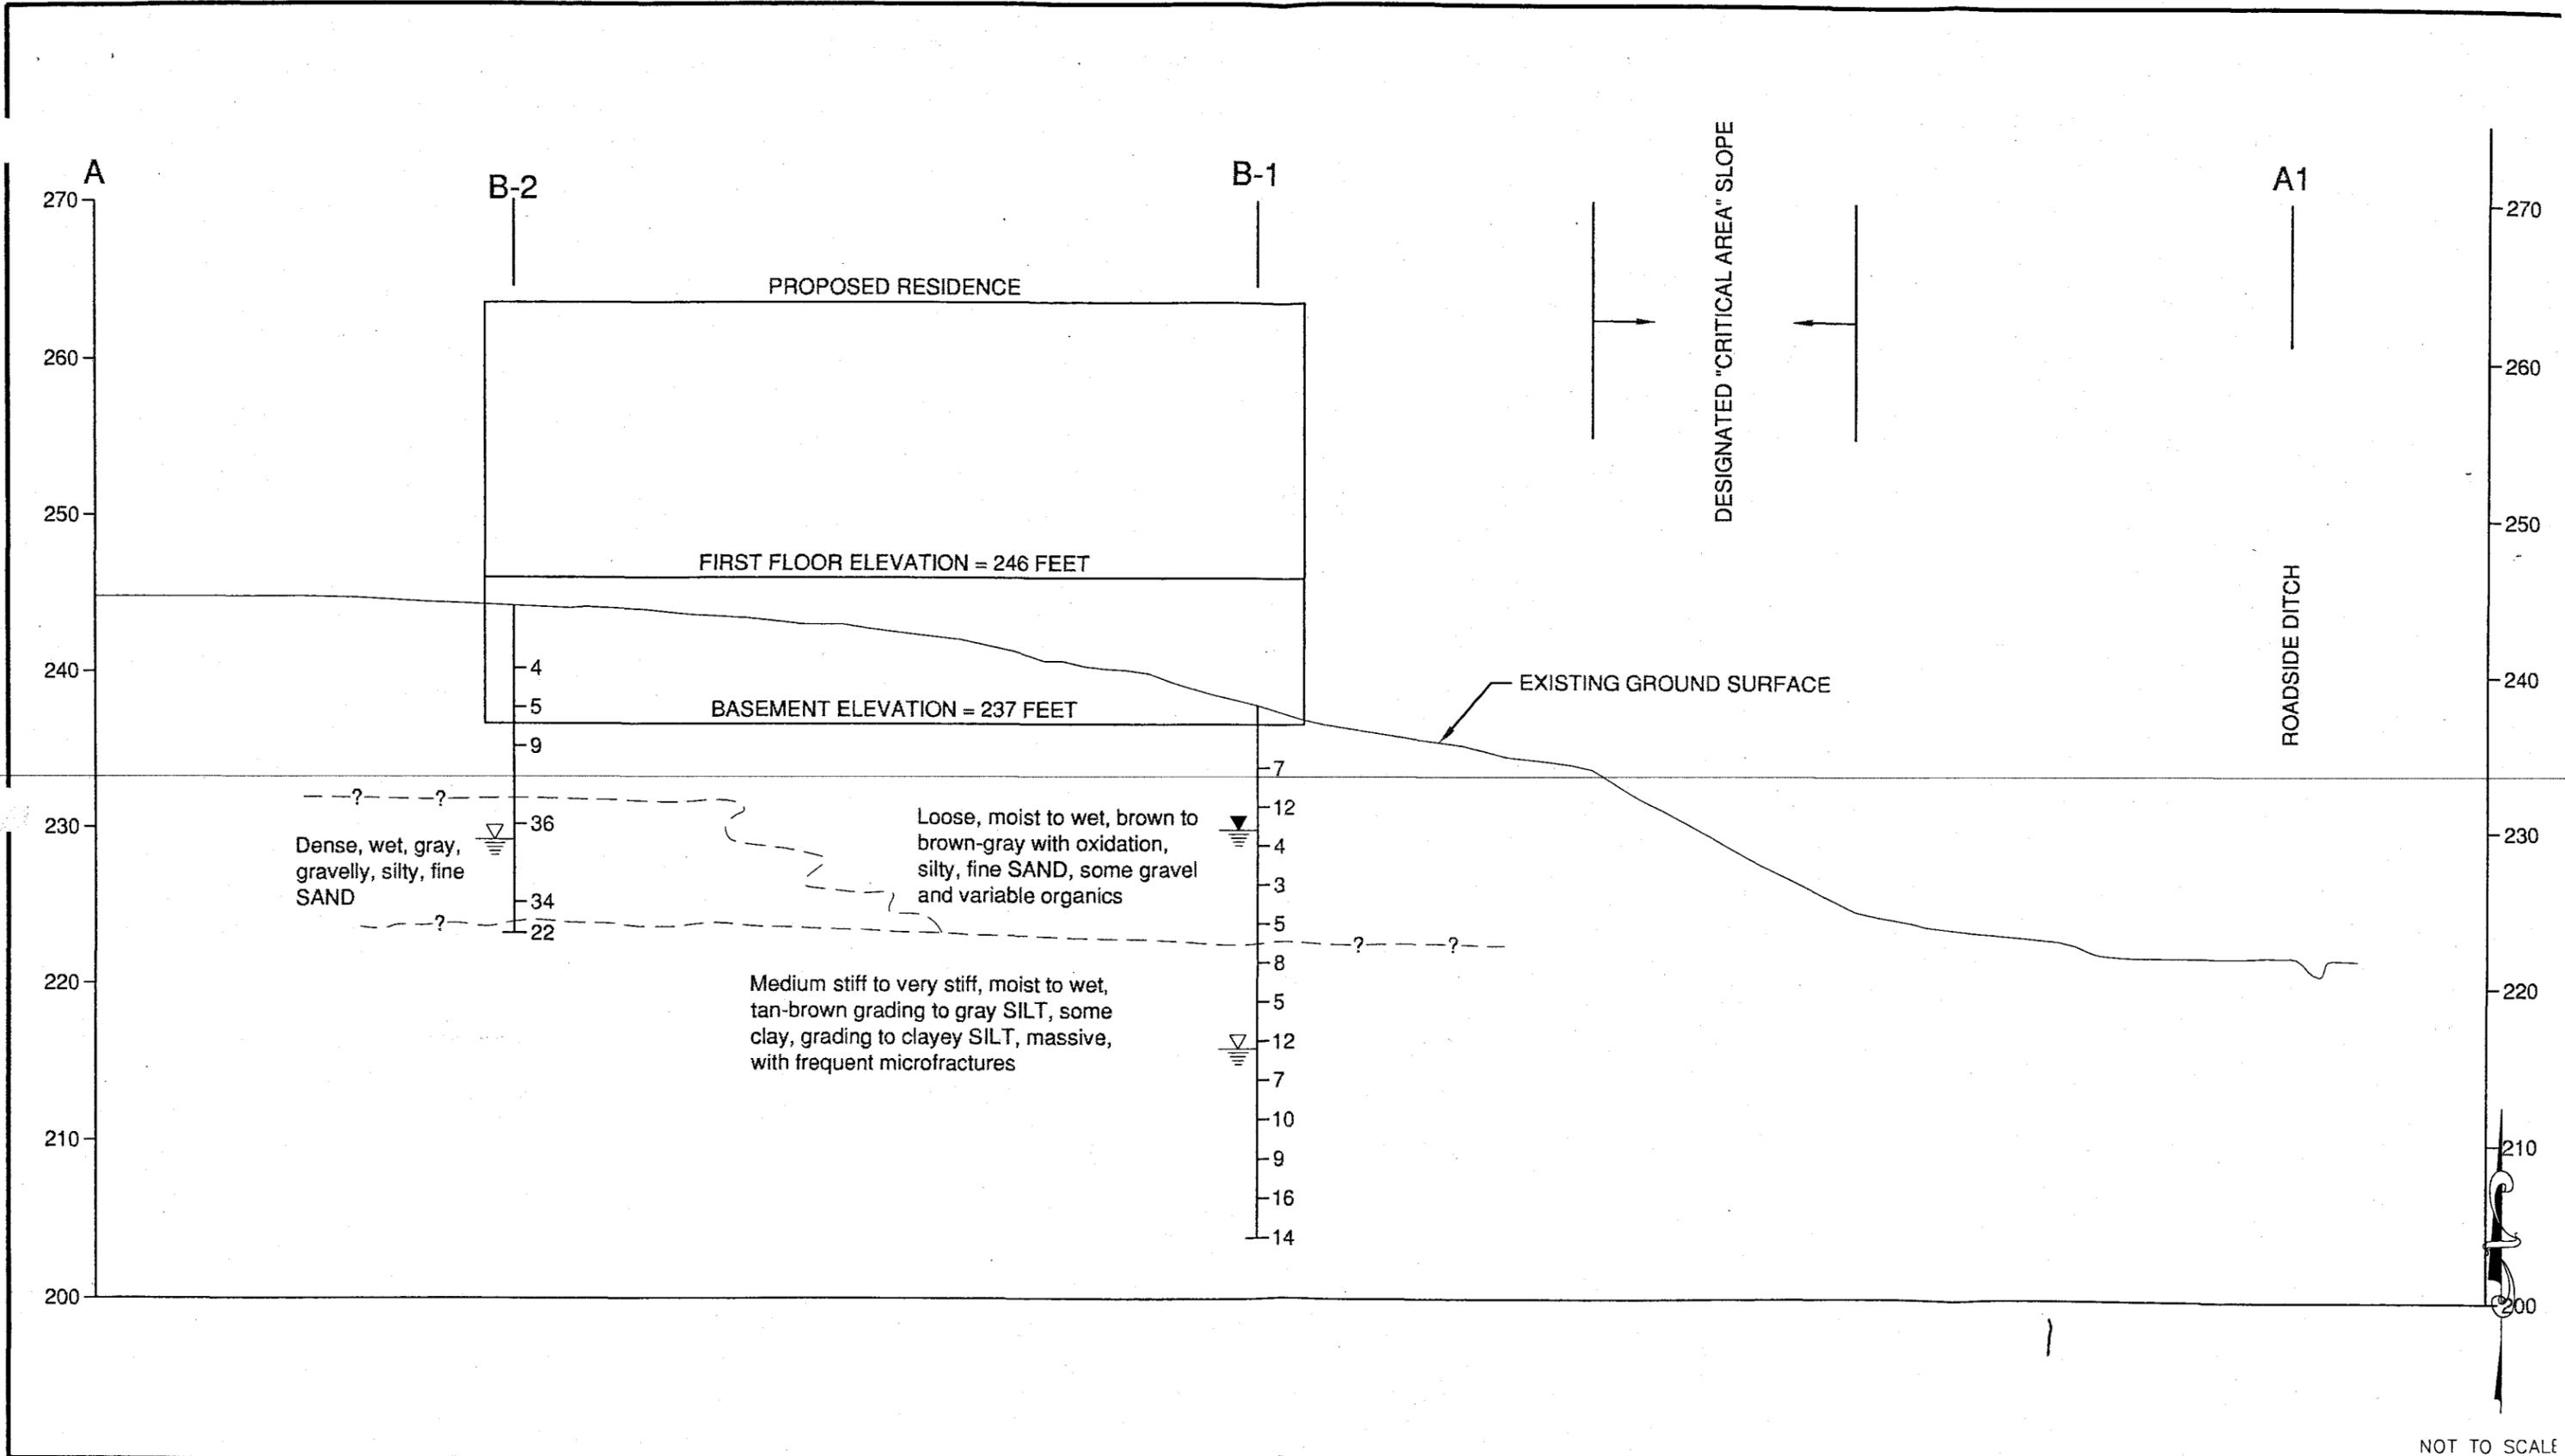
**FIGURE 3 - Geological Cross Section**

**Project :** Eng Residence  
**Location :** 4042 25th Avenue South  
 Seattle, Washington  
**Client :** Tandem Development, Corporation  
**Date :** 04/10/01 **Job # :** S-WA-01-6172

ADAPT's subsequently completed a subsurface assessment of the property, which included advancing two test borings on the property to depths of up to 34 feet below ground surface. Borings B-1 and B-2 disclosed loose, moist to wet, brown to dark brown silty fine sand with some gravel and organic that extended to about 9 feet (B-2) to 14 feet (B-1) bgs. The 10-11½ foot sample from B-1 showed wet black organic and brick fragments, suggesting that it may be man-placed fill. The near surface silty sands in boring B-2 may also be, in part, man-placed fill. These fill or possible fill soils were underlain in boring B-1 by damp to wet, medium stiff to very stiff, brown-tan grading to gray, silt to clayey silt that extended to the full depth explored (up to 34 feet bgs). The upper loose sands in boring B-2 were underlain by wet dense gray gravelly, silty fine sand that extended to a depth of about 18 feet bgs. These soils were underlain by very stiff or hard dark gray silt that extended the full depth explored (up to 21½ feet bgs). The lower silty or clayey silt unit in boring B-1 was massive in nature, and exhibited variable micro-fracturing throughout, but not obviously disturbed and we did not observe obvious zones of failure, such as slickensides.
