# SEATTLE PUBLIC LIBRARY UNIVERSITY BRANCH RENOVATION

# BUILDING HISTORY, EXISTING CONDITIONS, & PRINCIPLES

## BUILDING SUMMARY

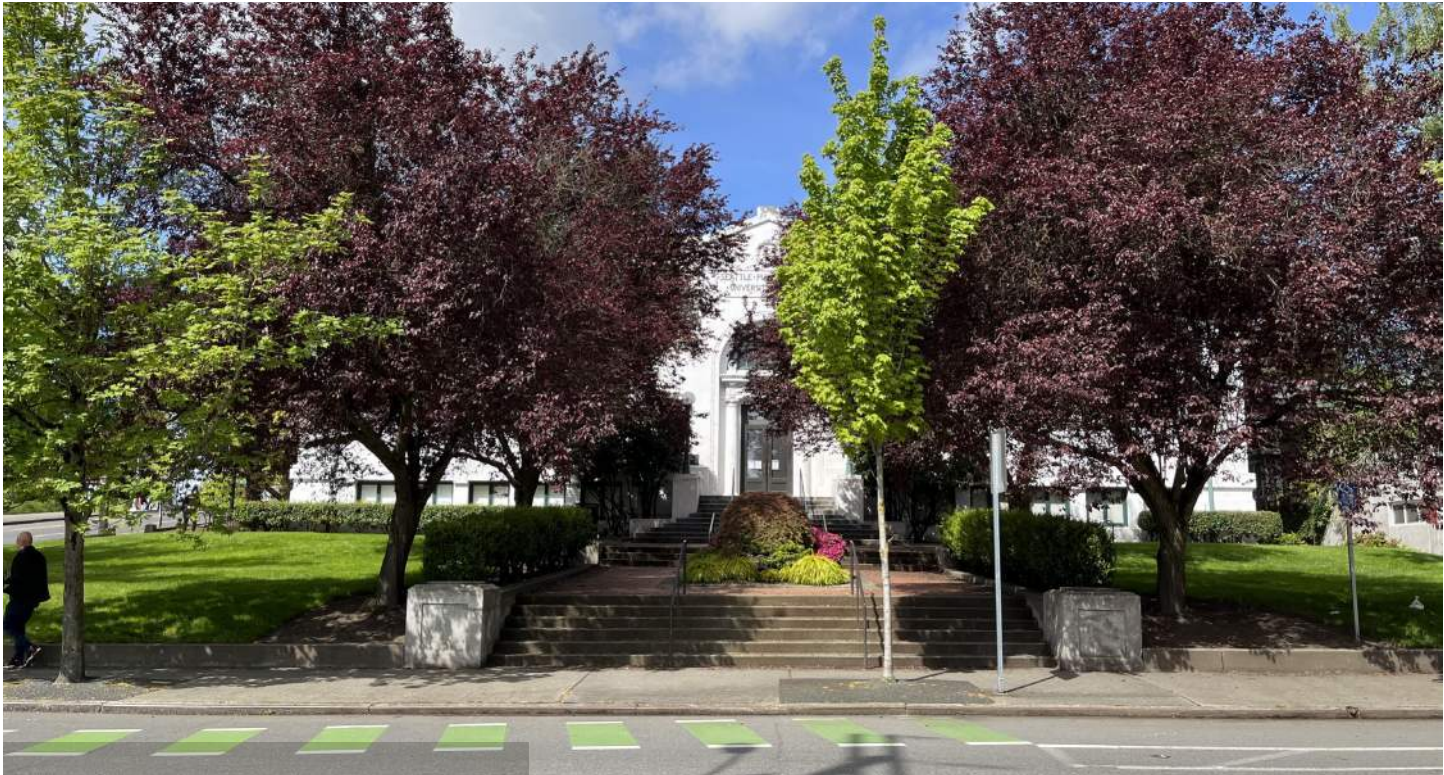
EAST ELEVATION (MAIN ENTRY)

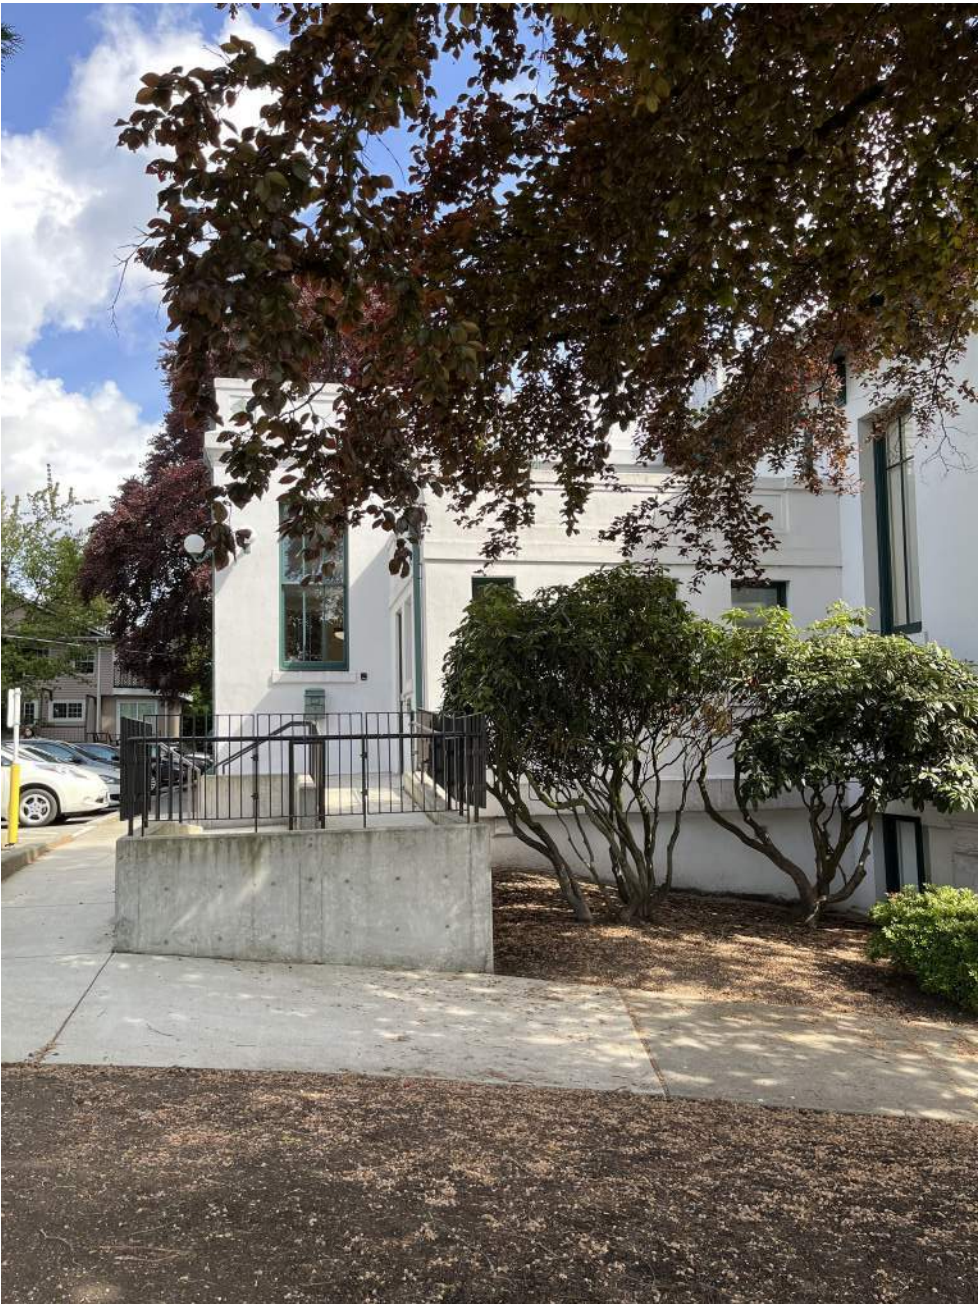
SOUTHWEST ADA RAMP

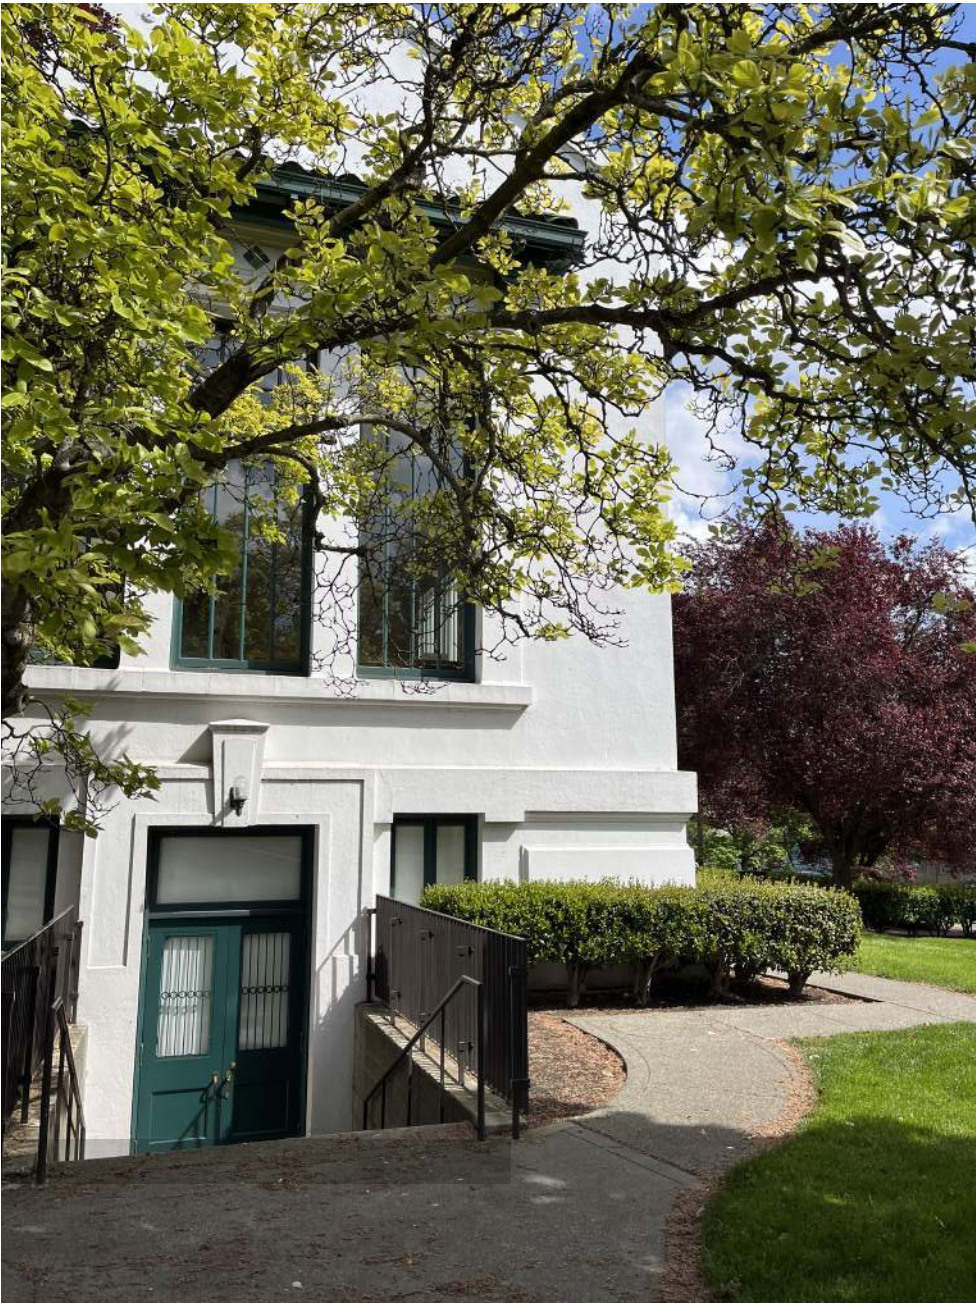
SOUTH ELEVATION (LOWER LEVEL ENTRY)

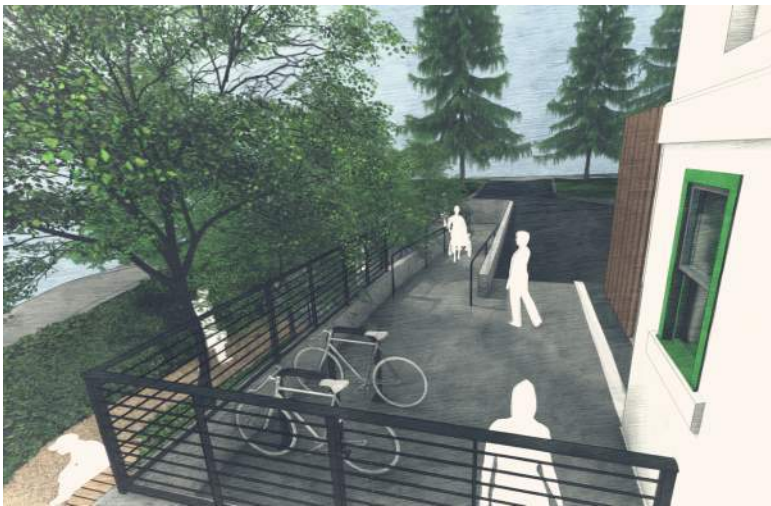
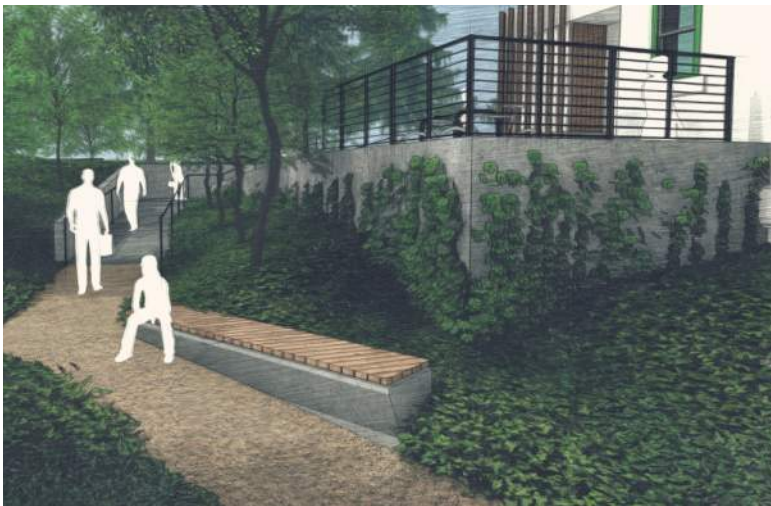
SW SITE AREA - NE 50TH ST ACCESS - DESIGN EVOLUTION

CURRENT SCHEME ADVANTAGES:

- Pathway trajectory minimizes impact on existing trees.
- Inviting and accessible sloped walk segment starting at mid-block sidewalk
- Terraced walls to reduce individual wall height and eliminate need for guardrail.
- Additional stepped walls to open up the space and make the pathway feel safer and less constrained.
- Harmonized relationship of upper plaza to architectural expansion.

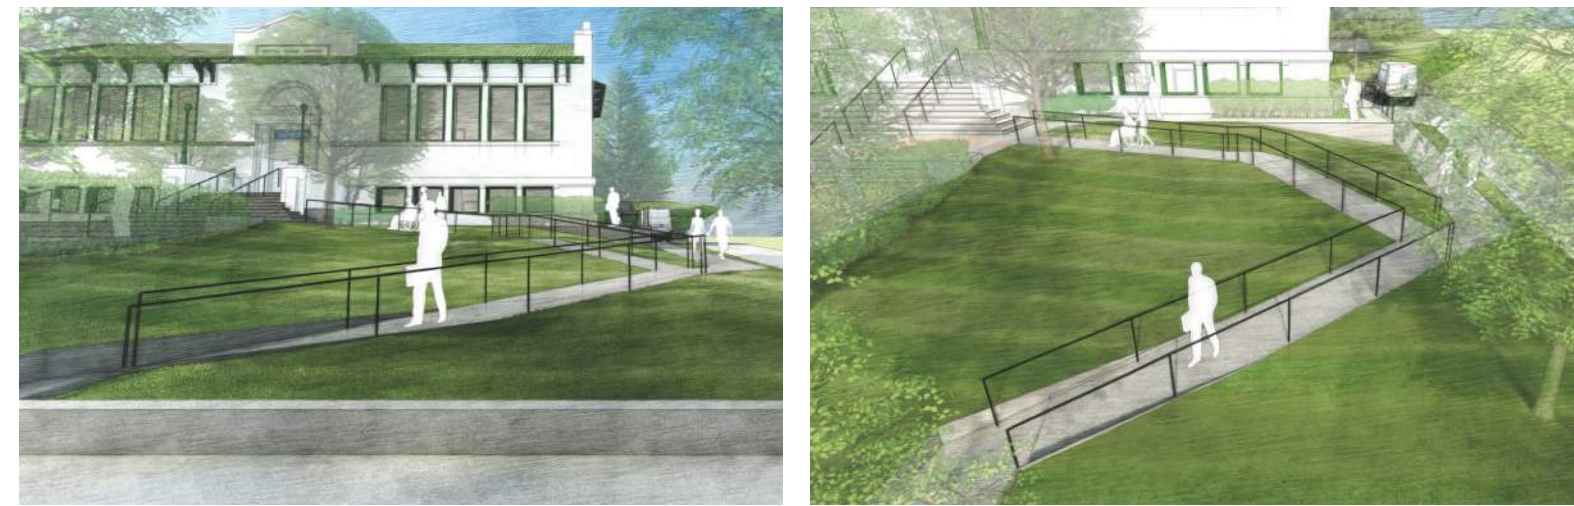
NE SITE AREA - ROOSEVELT WAY NE ACCESS - DESIGN EVOLUTION

CURRENT SCHEME ADVANTAGES:

- Pathway trajectory minimizes impact on existing trees.
- Ramp section with rails location minimizes impact on east elevation to maintain symmetry.
- Sloped walkways make up most of the grade change - gradual and easier to navigate.
- Stair relocation makes site navigation more intuitive.
- ADA access from street to both lower level entry and to south pathway ADA improvements, connecting entire site.

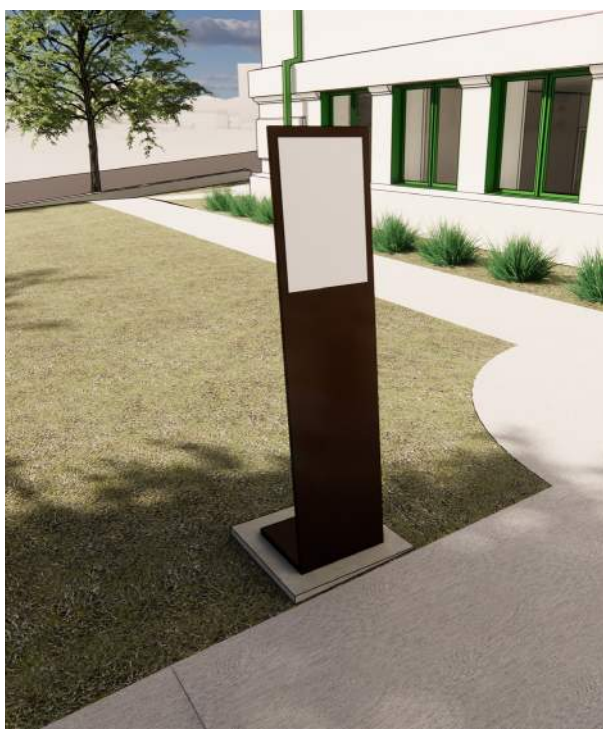
Proposed sign rendering

ACCESSIBLE PATH SITE SIGNAGE

Site Plan A1.0 of the construction drawings indicate a number accessible path signage elements throughout the site.

The proposed signage element is constructed from 1/2" bent steel plate set on a concrete footing. The proposed finish is a dark bronze high performance metal coating to match all other exterior metal fabrications.

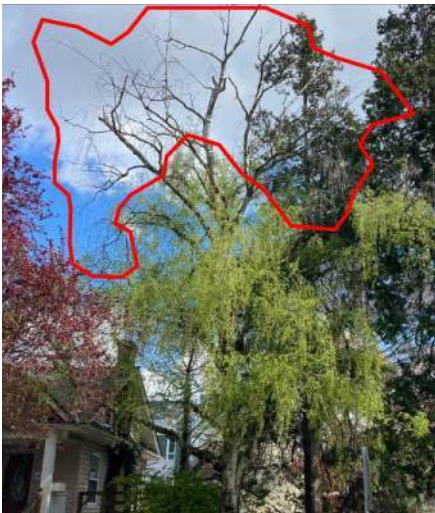
**Tree #267** (white birch) at northwest corner of the site is also **proposed to be removed**; the arborist report indicates it to be in poor condition and **unlikely to recover from birch borer disease.**

Tree 276 (northwest), significant dieback

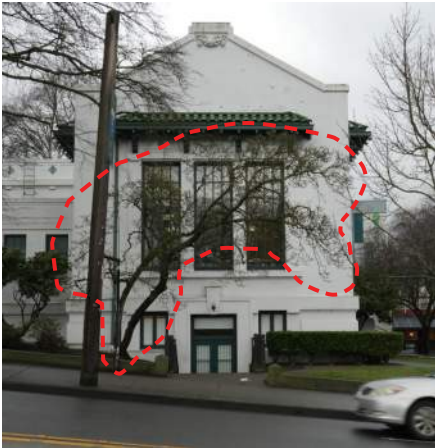
**South & West Tree removal:**  
**Tree 276** (magnolia) at the south walkway is proposed to be removed as indicated in the arborist report; while it was indicated as in good health condition, **its critical root zone conflicts with the proposed concrete accessible path. It is proposed to be replaced with a Karpick Red Maple.**

Tree 267 (south)

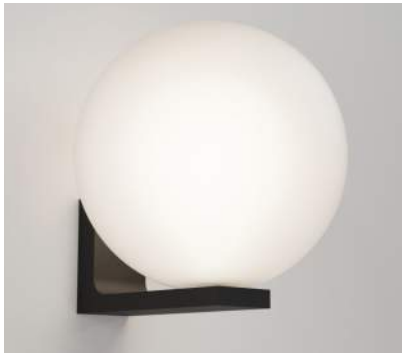
Mnfr: DeltaLight  
Model: Oono W L  
Size: 8"Dia & 12"Dia  
Finish: Black, white diffuser  
Notes: Replaces existing sconces  
N/S lower entry & west elev

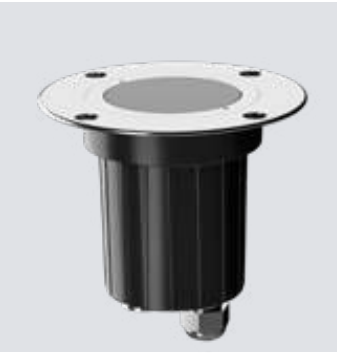
Mnfr: Interlux  
Model: Suelo series  
Size: 4.7"Dia x 6.1"D  
Color: Standard (stainless)  
Notes: In-ground uplights

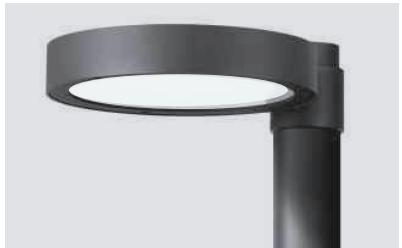
Mnfr: Bega  
Model: 99407 Series  
Size: 18" x 24" x 2.25" (14' pole)  
Finish: Black  
Notes: West parking lot

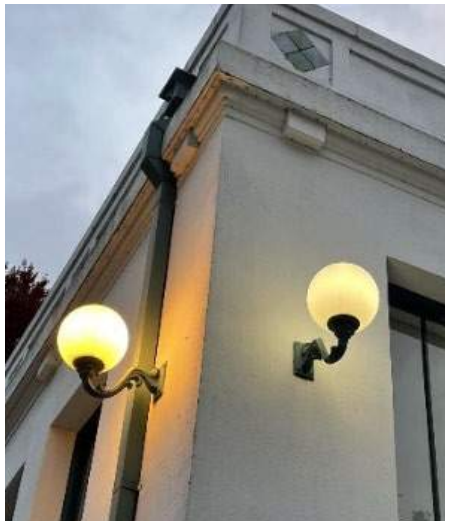
Existing sconces, circa 1954  
(proposed to be removed)

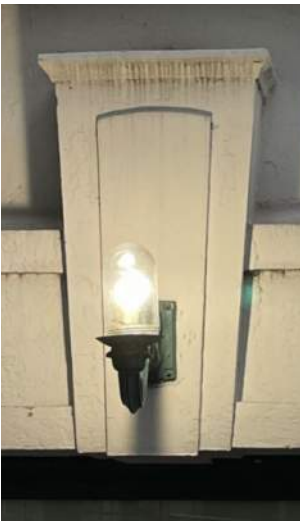
Existing sconce, circa 1989  
(proposed to be removed)

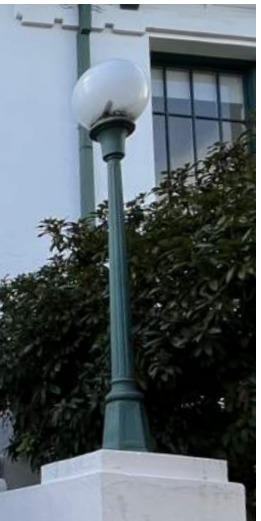
Existing pole  
(proposed to be restored)

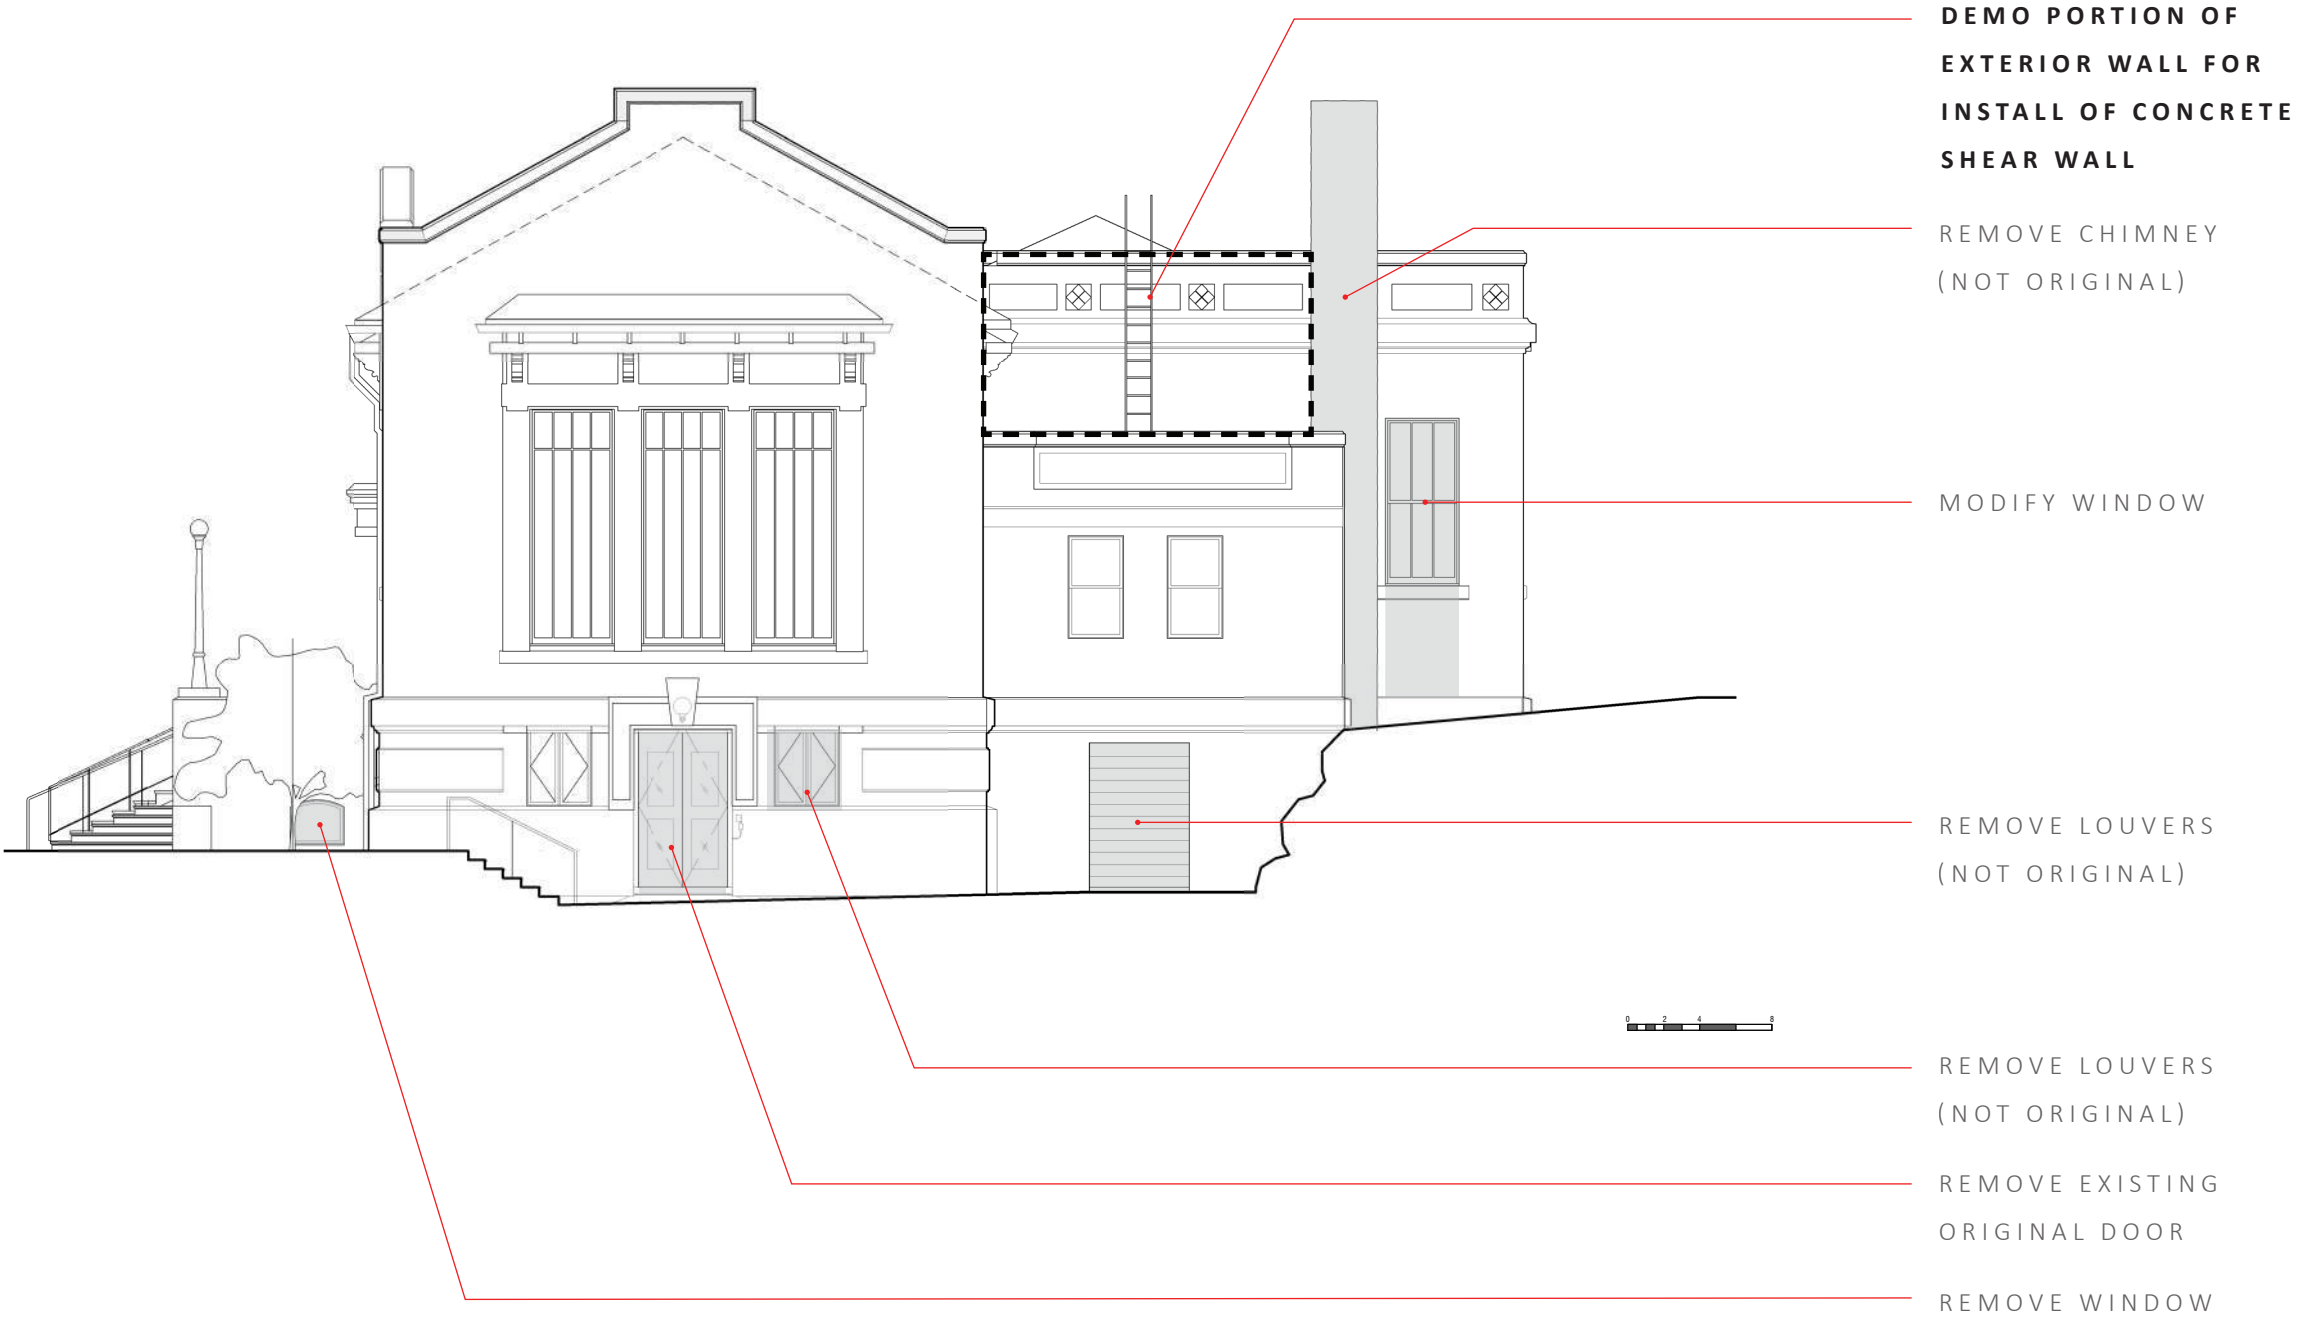
EXISTING NORTH ELEVATION

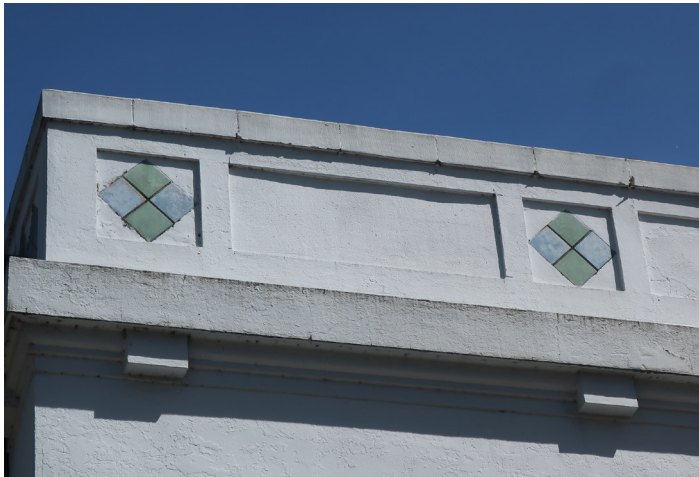
WEST ELEVATION; TILE, RELIEFS, AND BANDING

TYPICAL BANDING; PAINT OVER CEMENTITIOUS BLOCK

REINSTALL  
TERRACOTTA  
COPING CAP  
REINSTALL TILES

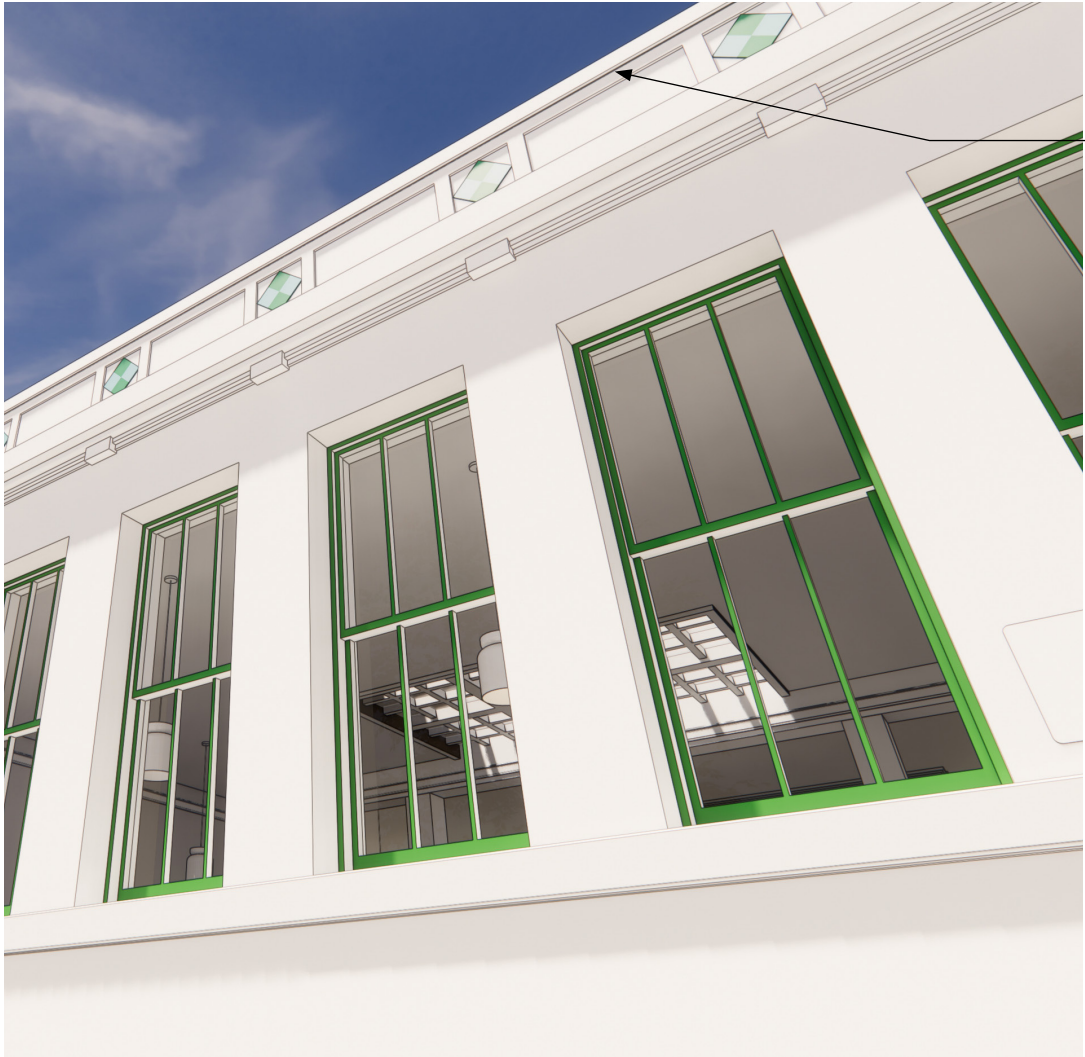
VIEW FROM PARKING

## THROUGH-WALL COPING FLASHING

THROUGH-WALL  
FLASHING,  
(1/2" DRIP EDGE,  
BEAD-BLASTED  
STAINLESS STEEL)

The existing coping caps are covered with liquid flashing from previous roofing and repair projects. A majority of west-wing coping caps are be salvaged and reinstalled as part of the proposed wall rebuilds; the project is an advantageous time to install through-wall flashing to protect the wall assembly.

Salvage and reinstall the existing original terracotta coping caps with **anchor bolts and through wall flashing (west wing parapet only)**. Exposed exterior drip edge to be 1/2" bead blasted stainless steel.

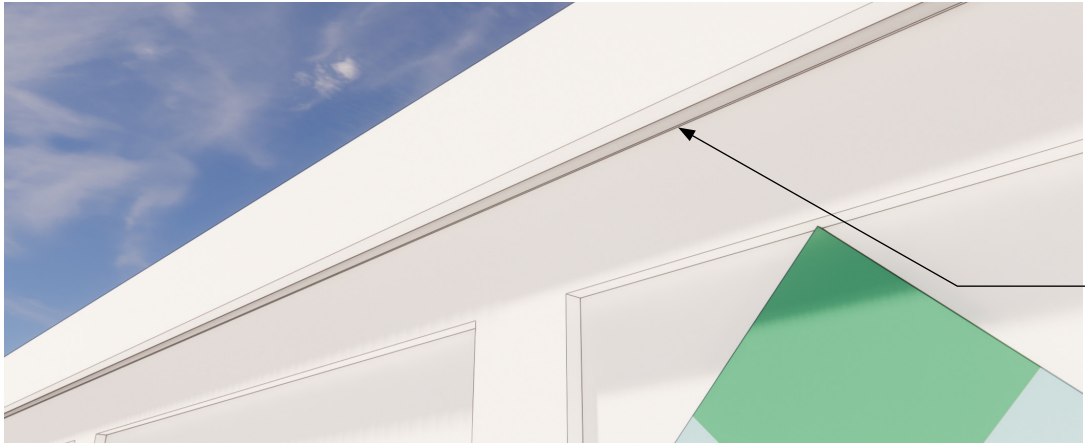
CLOSE-UP OF COPING FLASHING

THROUGH-WALL  
FLASHING

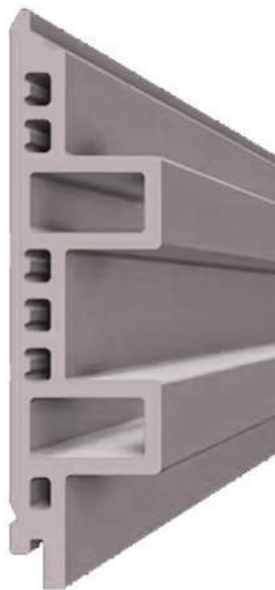
### Horizontal

A horizontally oriented profile tests the hypothesis of vertical grain. Horizontal layouts contrast with the vertical grain of the existing building windows and mullions.

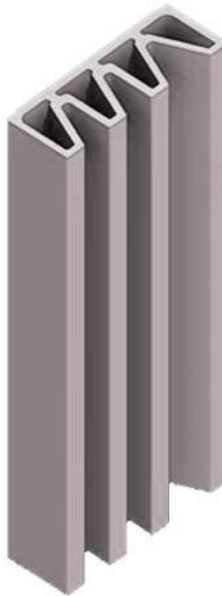
### Custom Verticals

A variegated custom profile carries the same benefits of a more regular vertical while introducing variation to the rhythm, reflecting the natural variation of the existing stucco. This is consistent with an approach of complementary yet differentiated cladding building elements.

**\*Proposed**

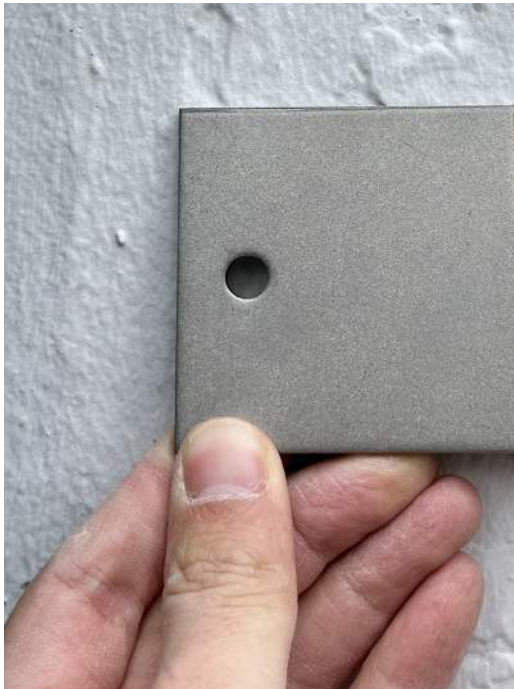
### BEAD BLASTED STAINLESS

**LOCATION:** ALL EXTERIOR EXPOSED FLASHINGS

PUGET SOUND COATINGS  
#3 - 80 GRIT /GLASS BEAD

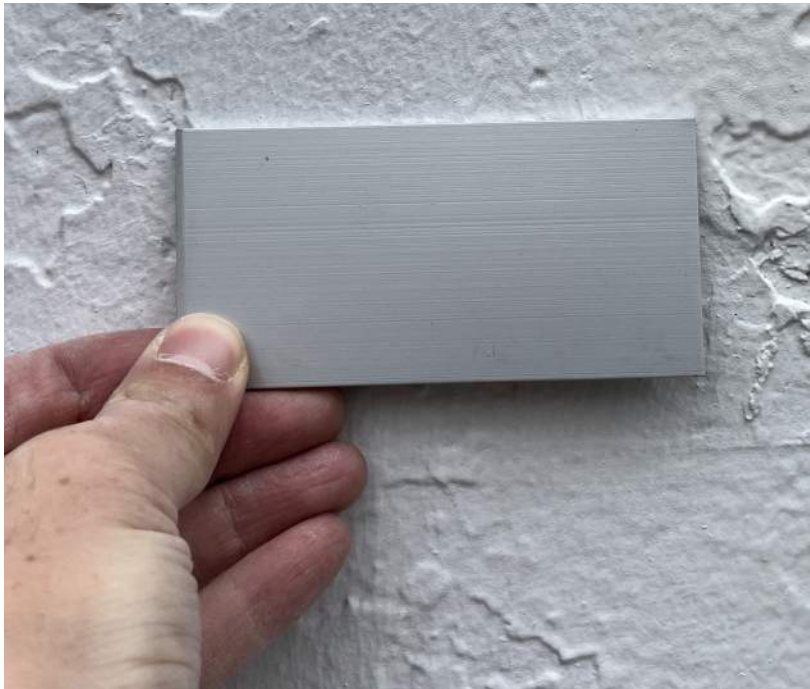
### CLEAR ANODIZED ALUMINUM OPENINGS

**LOCATION:** INTERIOR & EXTERIOR ALUMINUM FRAMED OPENINGS

KAWNEER FINISH #14 (CLEAR)  
AA-M10C21A41

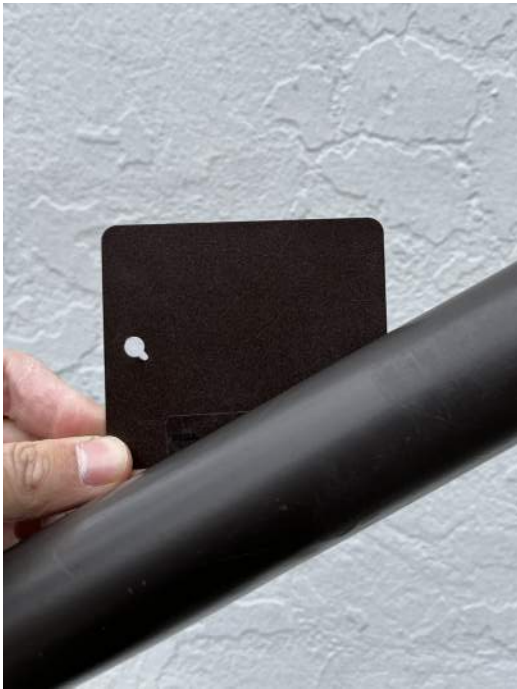
### HIGH PERFORMANCE COATING

**LOCATION:** ALL EXTERIOR METAL FABRICATIONS

TNEMEC 86BR "DARK BRONZE  
(SHOP APPLIED).

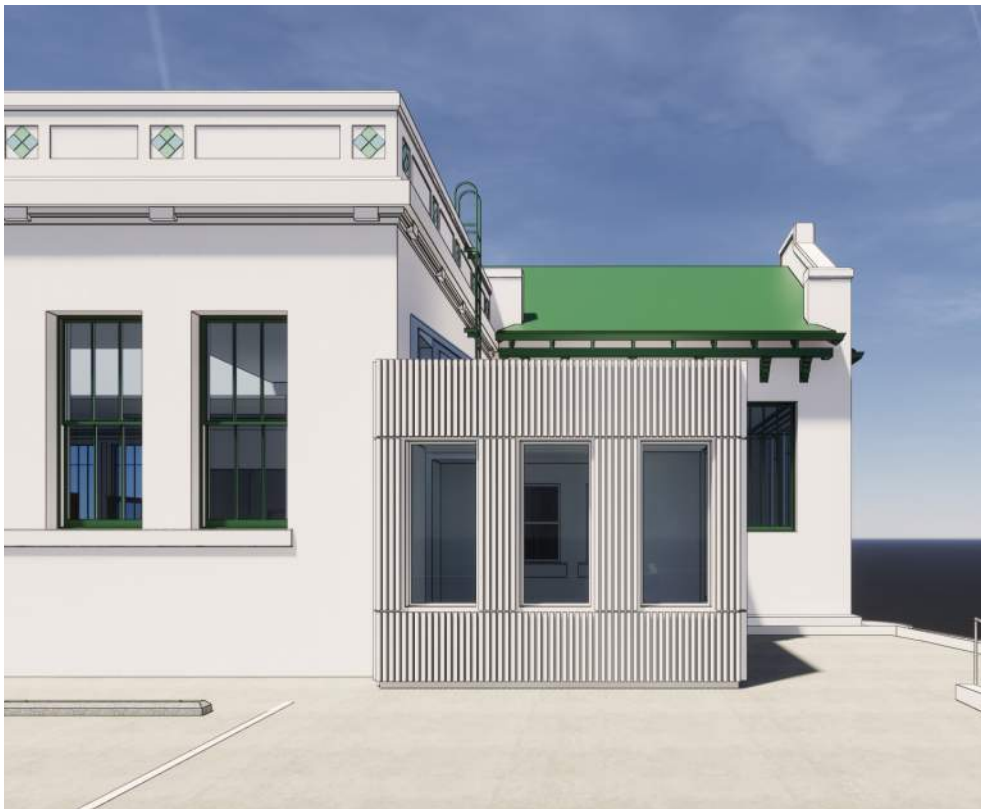
VERTICAL OPENINGS

Purely punched openings—especially vertical—imitate the existing windows. By contrast A carved corner window responds to and differentiates itself from the original building's in a method compatible with monolithic buildings (contemporary examples shown at right).

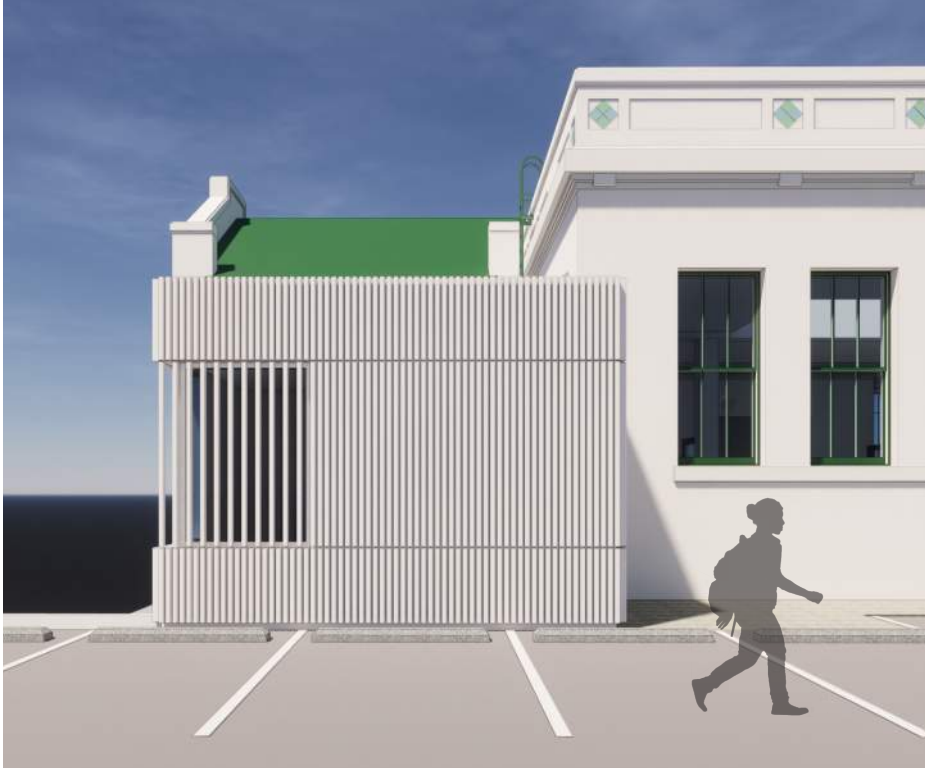
WEST ELEVATION

Outdoors units for the new HVAC system are proposed to be located on the north service bay roof. The elevator overrun aligns with the parapet. These elements will not be visible from the parking lot, though the outdoor units will be visible from the higher elevation of 9th Avenue.

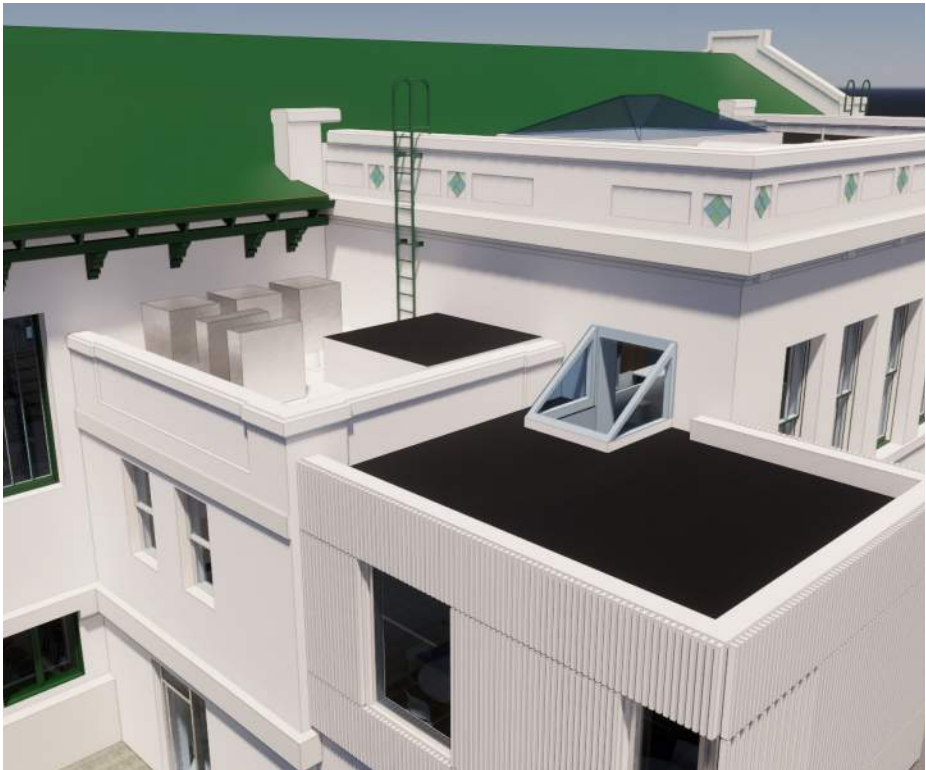
ROOFTOP ELEMENTS

A solar panel array is proposed to be located on the west wing roof. The incidence angle will be set such that the panels will be fully concealed by the parapet when viewed from 9th Avenue.

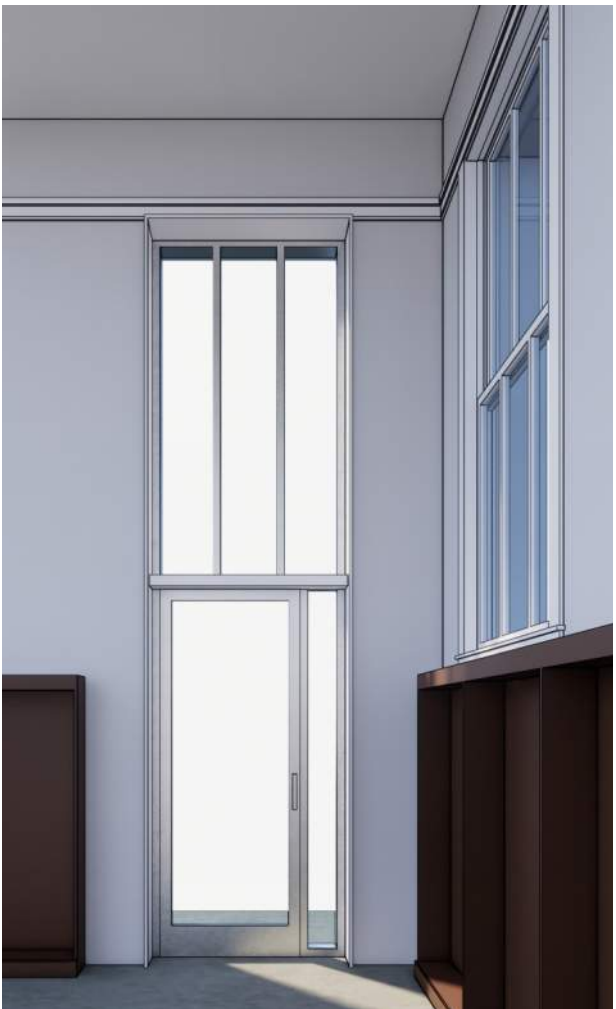
## 2: Window Removal w/Sticking

- Vertically flush opening
- Mimics original tripartite glazing
- Accessible door framing misaligned with sticking above

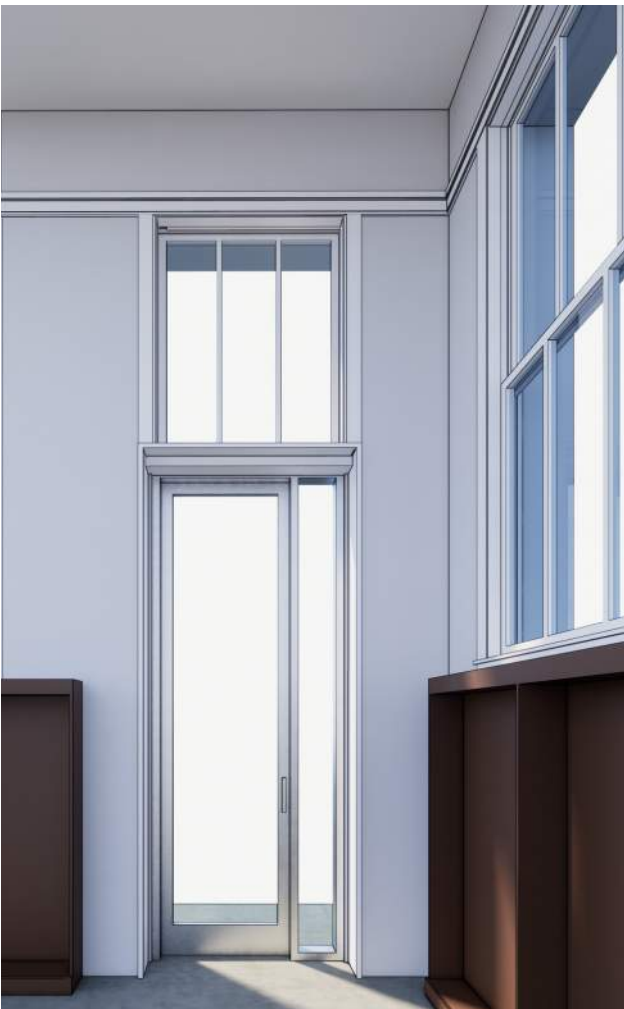
## 3: Retain Upper Sash

- Retains portion of original window
- Transom or tall door required to bridge gap
- Lintel delineates old & new openings

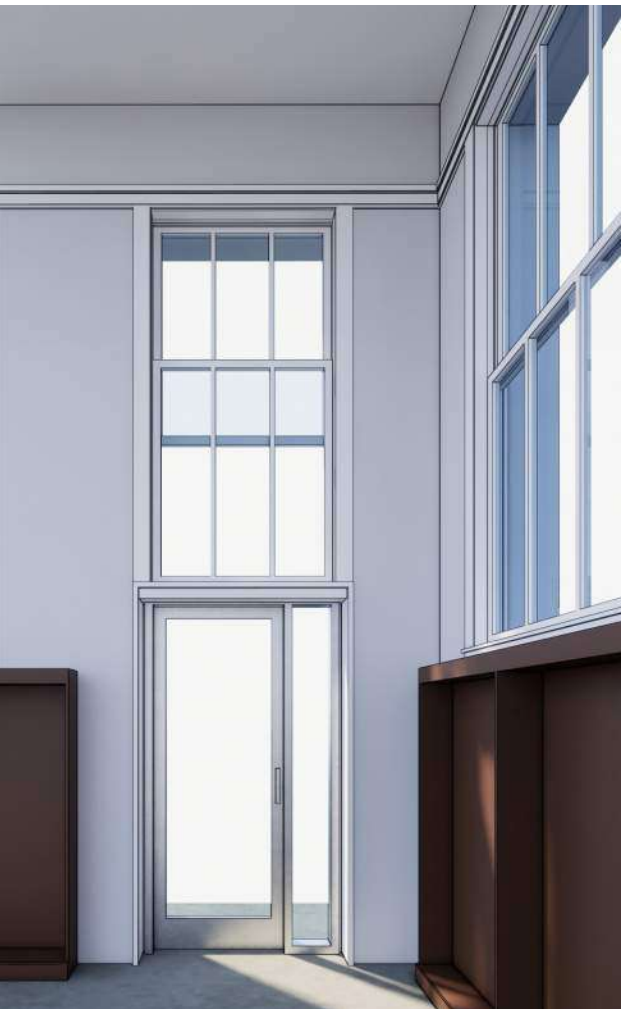
## 4: Retain Upper & Lower Sash

- Maximizes retainage of material
- Reflects original window operation
- Lintel delineates old & new openings

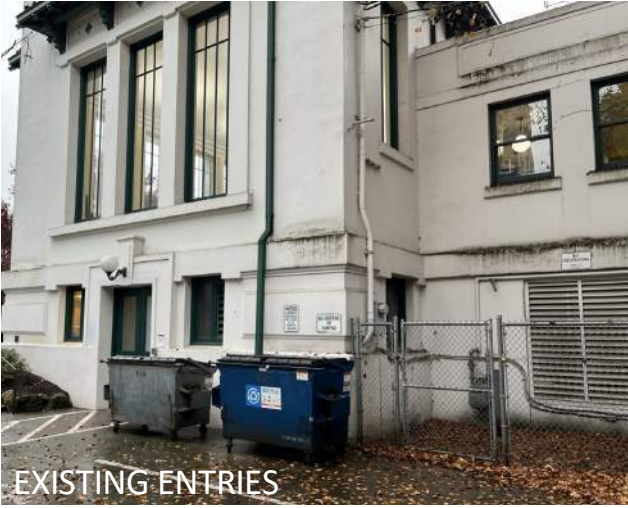
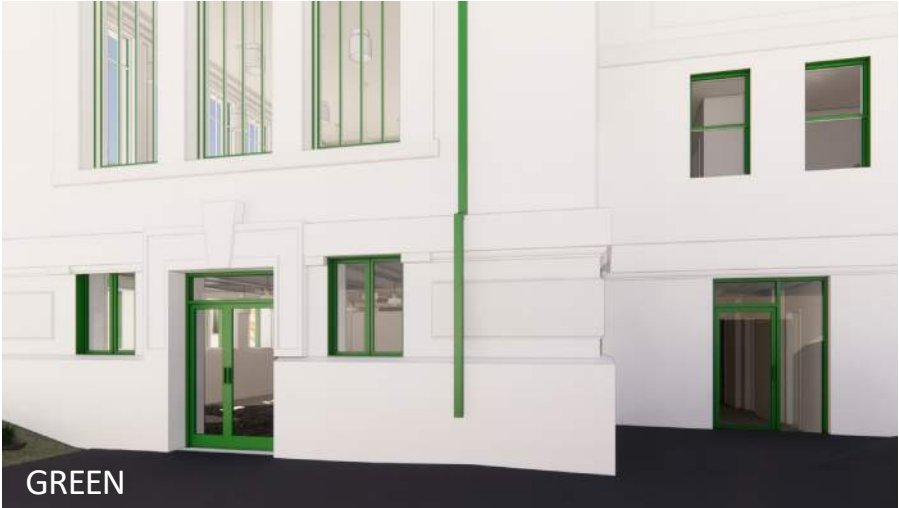
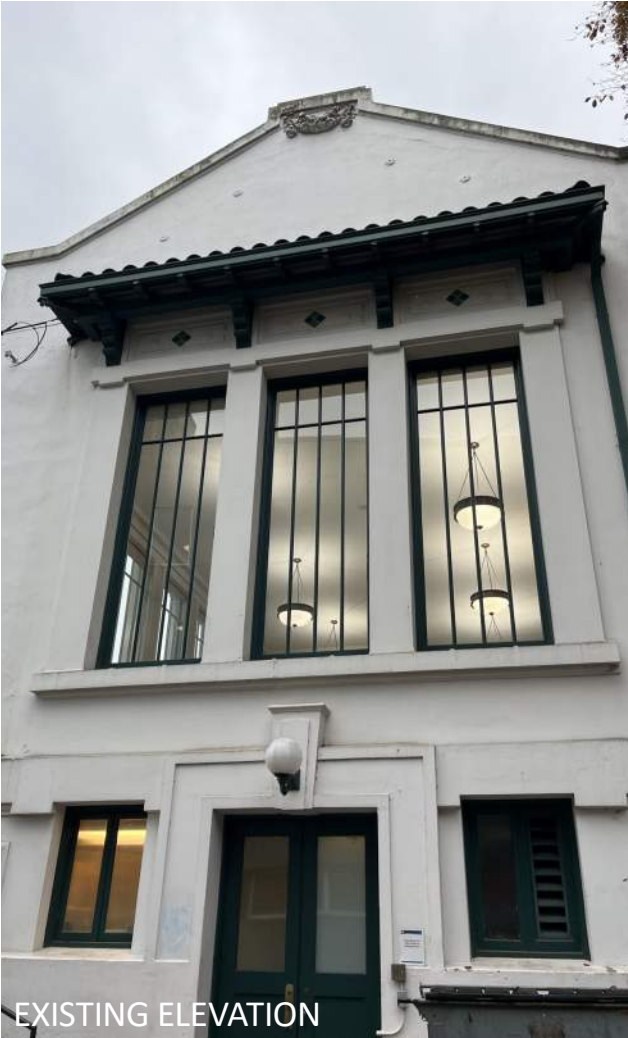
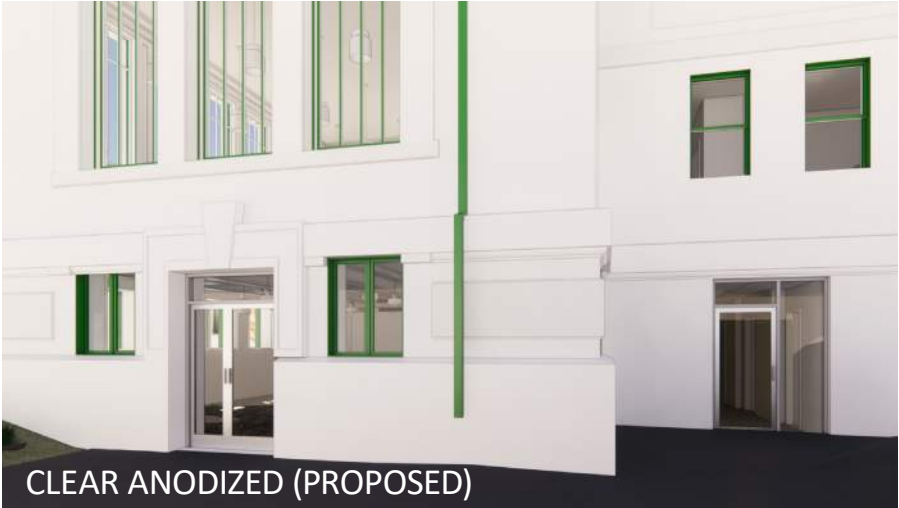
## FLOOR PLANS AND OPENINGS - LOWER LEVEL

### North Elevation Openings:

Relocation of the lower level meeting room requires modification or replacement of the existing original double door to meet egress requirements (min. (1) 3' wide leaf).

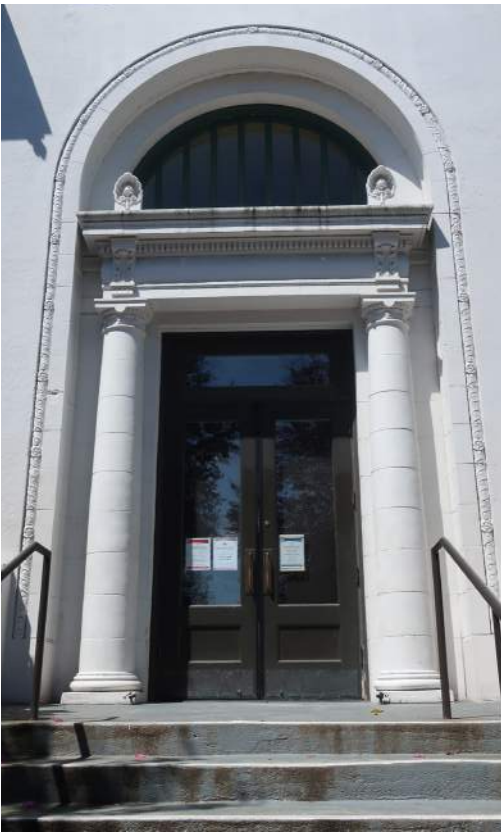
EAST DOOR EXTERIOR

The existing configuration of the east entry door, stair, and lower level access door have a number of conditions that are not code compliant for the proposed main & lower level egress plan:

- The symmetrical main east entry door leafs do not meet the minimum 32” clear width for egress (30-3/4”).
- The existing door to the lower level does not swing in the direction of travel for lower level egress.
- The position of the existing door to the lower level does not permit 12” extension for lower level egress stair handrail.
- The existing landing stair handrails do not meet the minimum 12” extension beyond end of stair.
- An additional handrail is required to prevent original door from protruding into defined main level egress path.

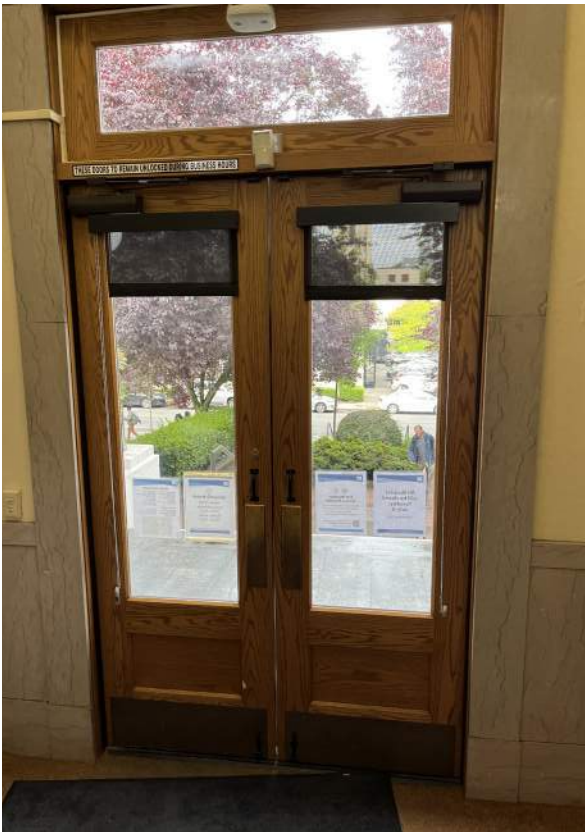
EAST DOOR INTERIOR

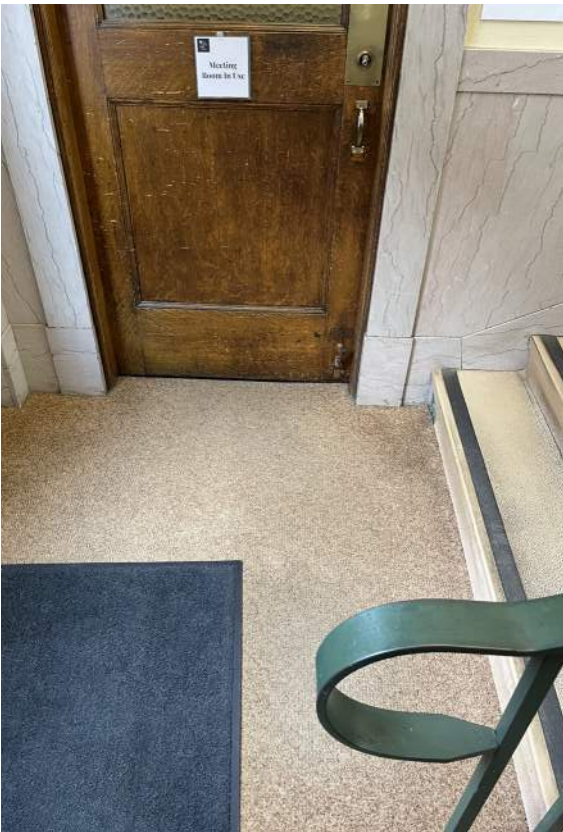
LOWER LEVEL DOOR, STAIR, & RAIL
