# SEATTLE PUBLIC LIBRARY UNIVERSITY BRANCH RENOVATION

# BUILDING HISTORY, EXISTING CONDITIONS, & PRINCIPLES

## BUILDING SUMMARY

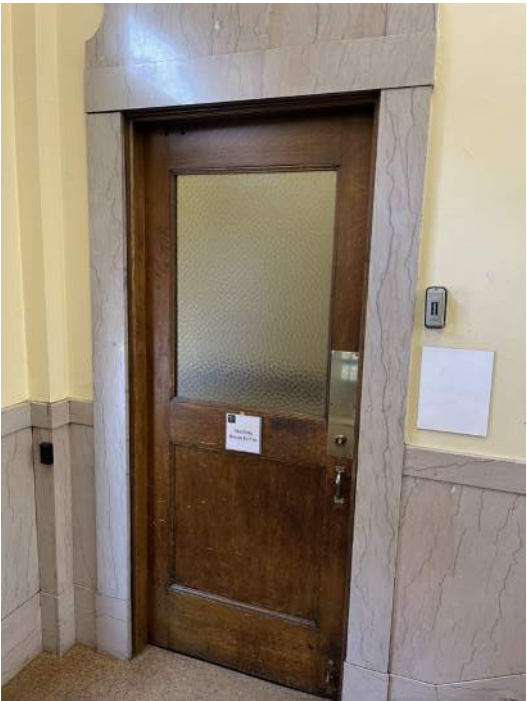
LOWER LEVEL DOOR

- Retain the existing east entry door width to preserve east facade symmetry & detailing.
- Install new landing stair handrails; extend to the maximum extent feasible without obstructing lower level egress (10.5”)
- Preserve the existing location of the lower level door; reverse swing and inset door as required to not obstruct main level egress path.
- Install new wood handrail at lower level stair. Extend handrail to the maximum extent feasible (7-1/2”).

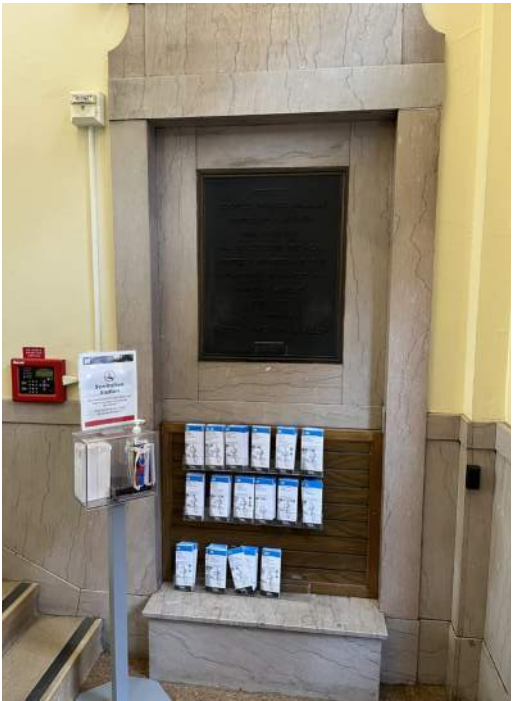
MIRRORED INSET

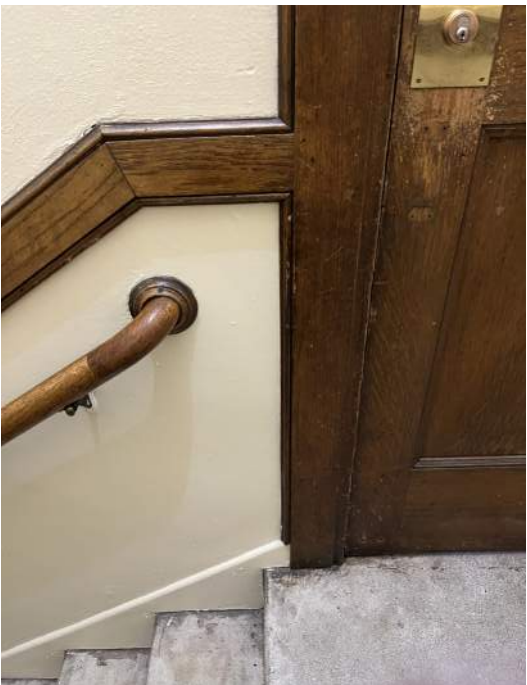
EXISTING HANDRAIL  
(LOWER LEVEL SIDE)

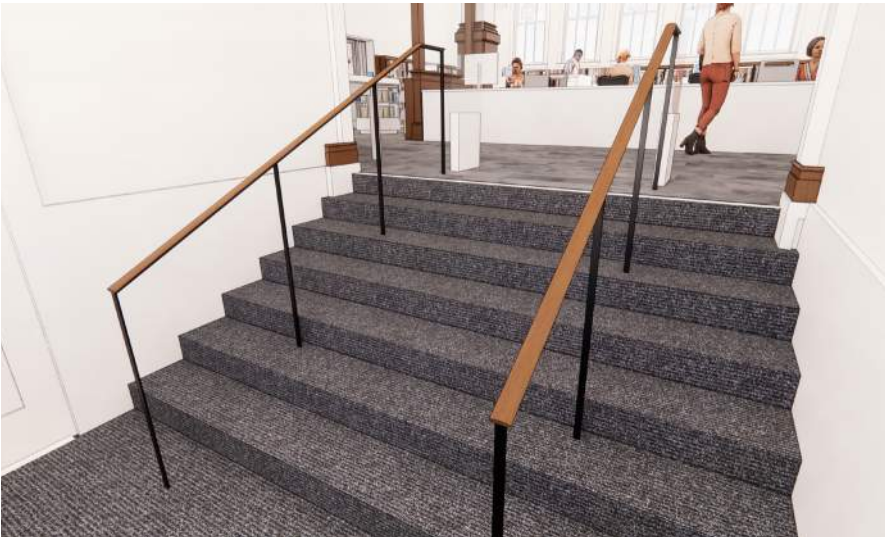
ENTRY W/ PROPOSED (2) HANDRAILS AND WALK-OFF MAT

Remove the existing non-original metal rail and install (2) elliptical profile wood handrails on metal balusters (profile indicated in drawings). The proposed profile, differentiated from the original wood handrail to the lower level, prioritizes comfort and grip, provision of pushable surface, and reference to the existing metal rail.

Remove existing resilient flooring from landing and stairs and install continuous walk-off mat as required (10'-0" minimum extension from door) to meet LEED interior air quality credit requirements.

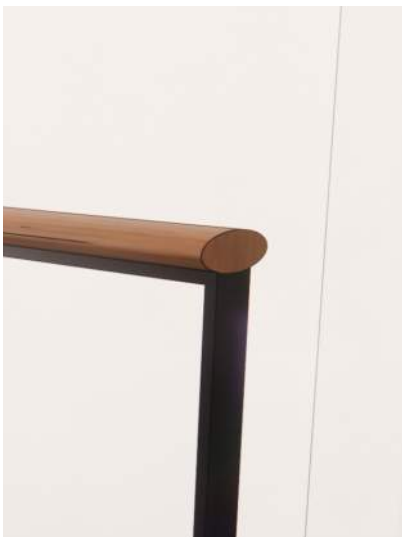
PROPOSED WOOD HANDRAIL PROFILE

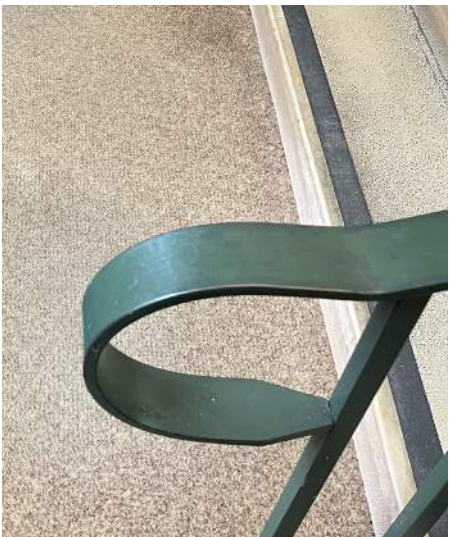
EXISTING NON-ORIGINAL METAL RAIL

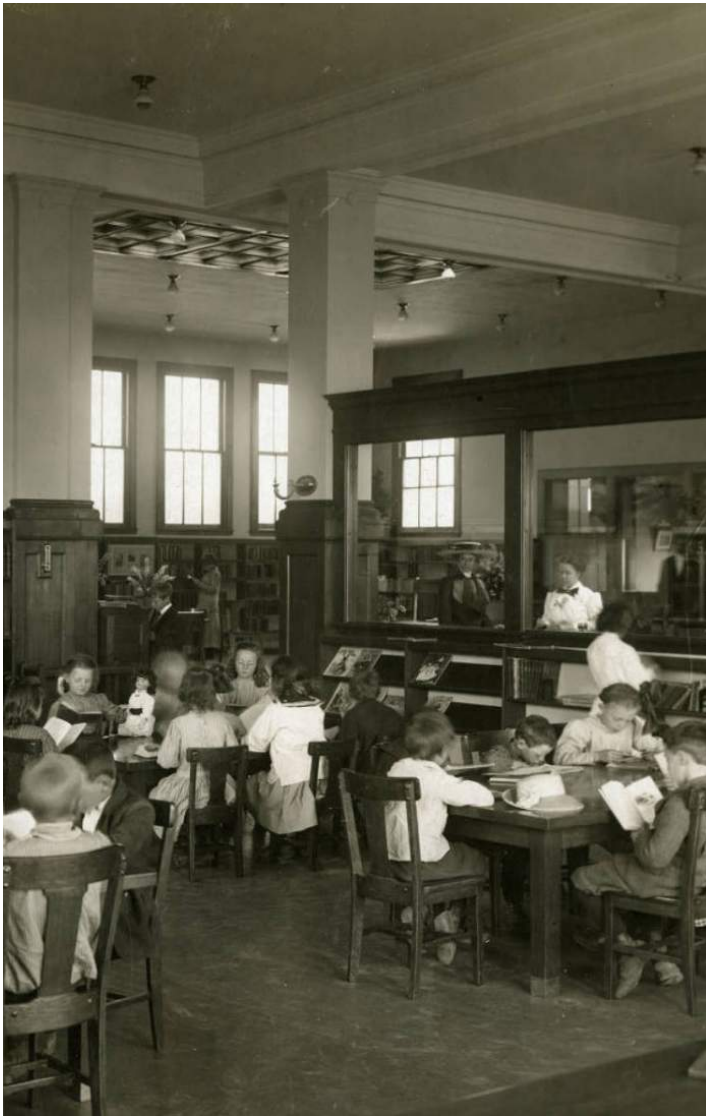
GLK HISTORIC LIGHTING

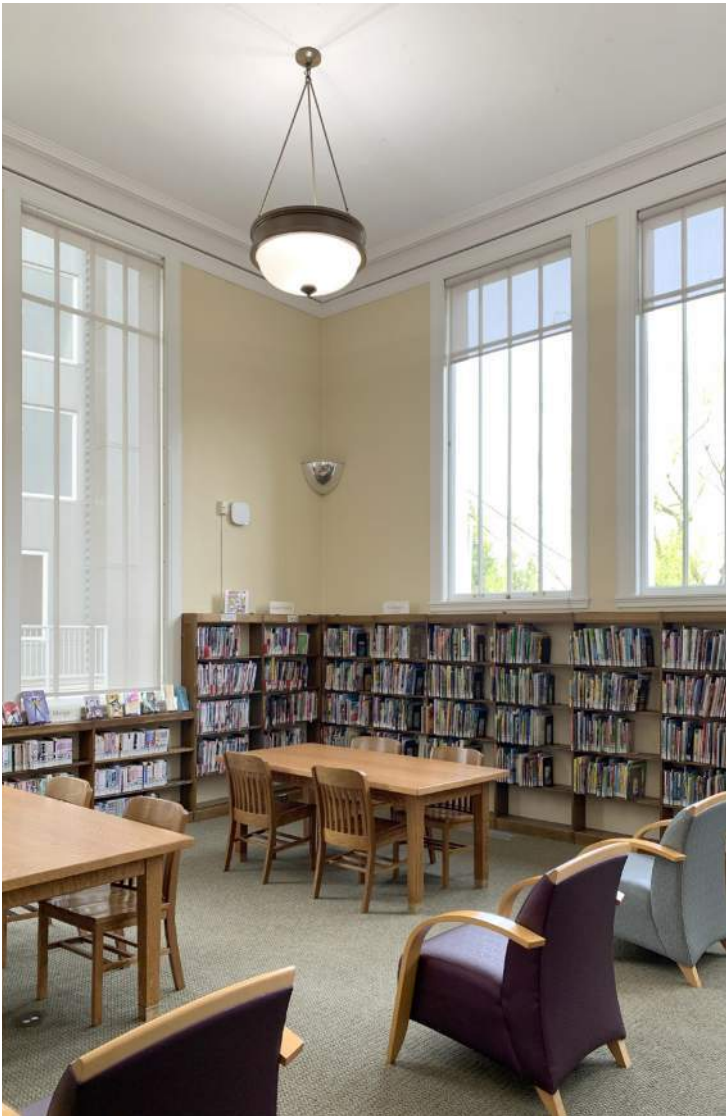
EXISTING UNI LIGHTING

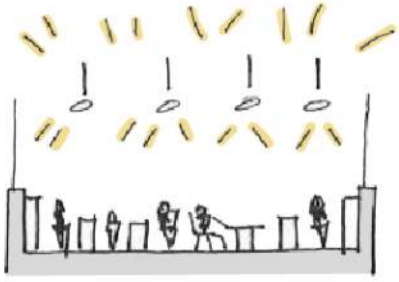
PROPOSED "FIELD OF LIGHT"

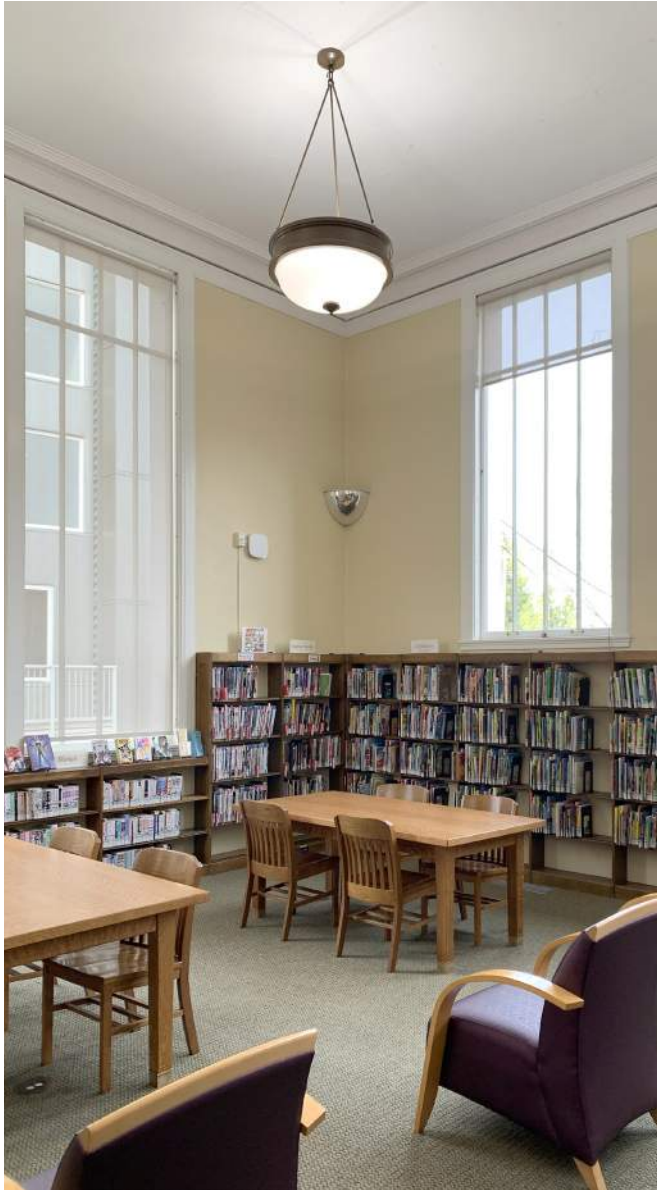
EXISTING READING ROOM

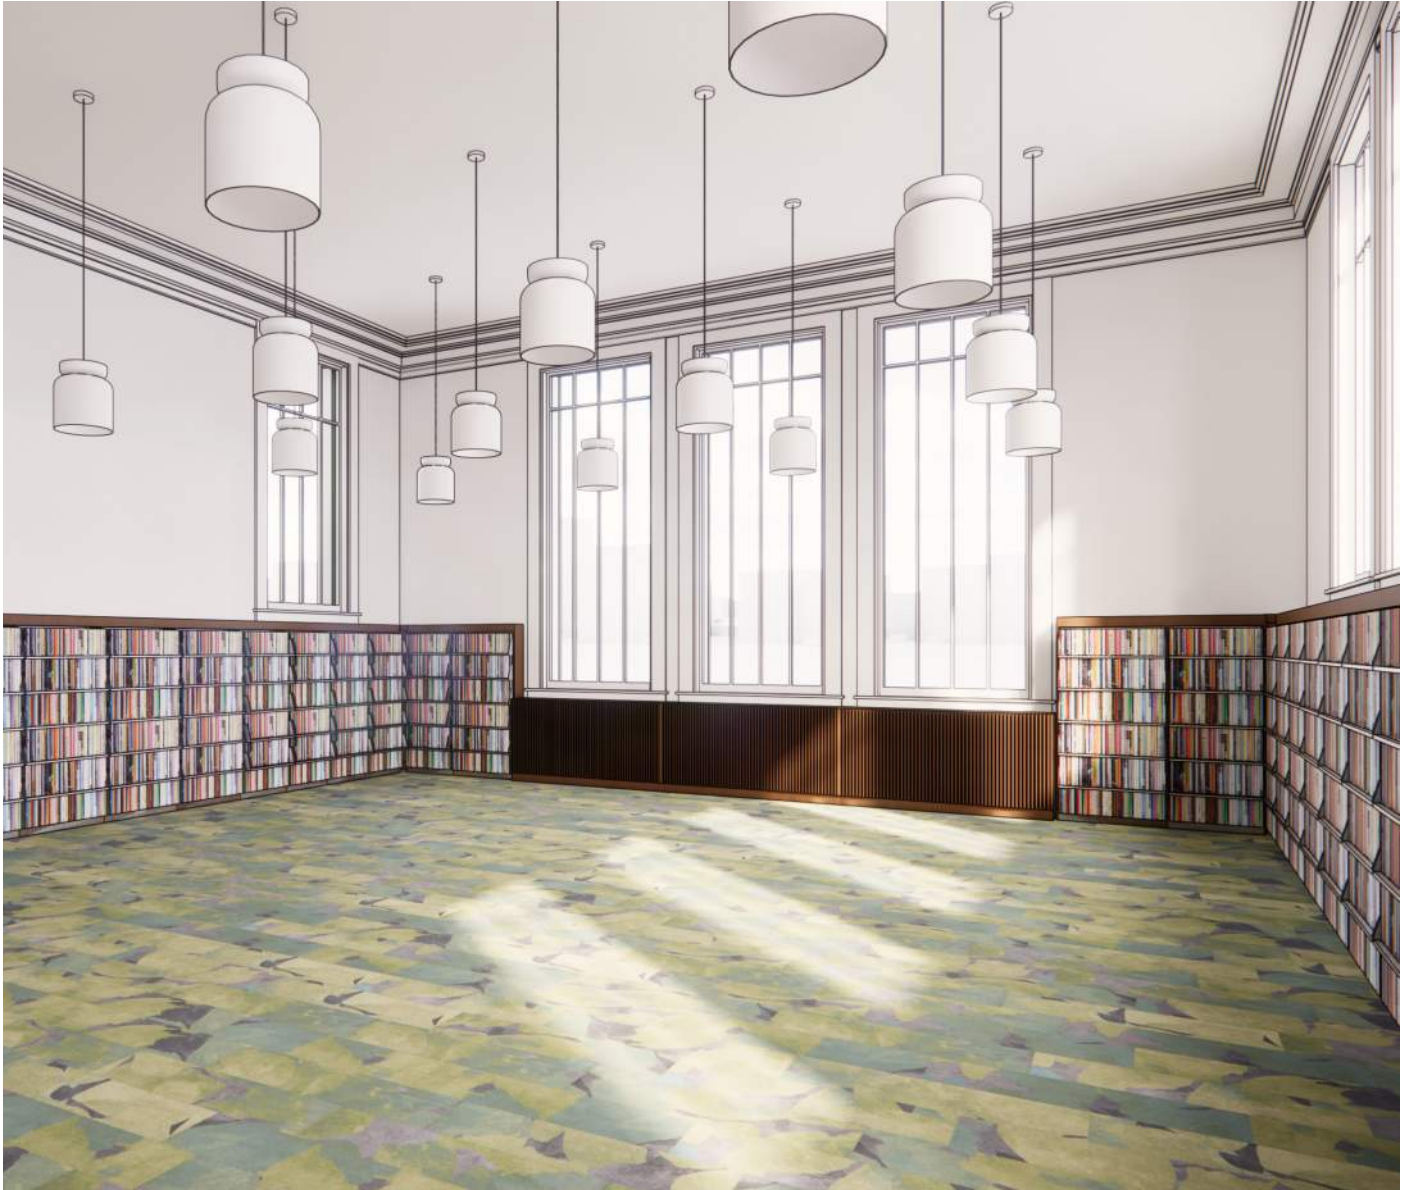
PROPOSED READING ROOM (FCU CABINET, CARPET, LIGHTING)

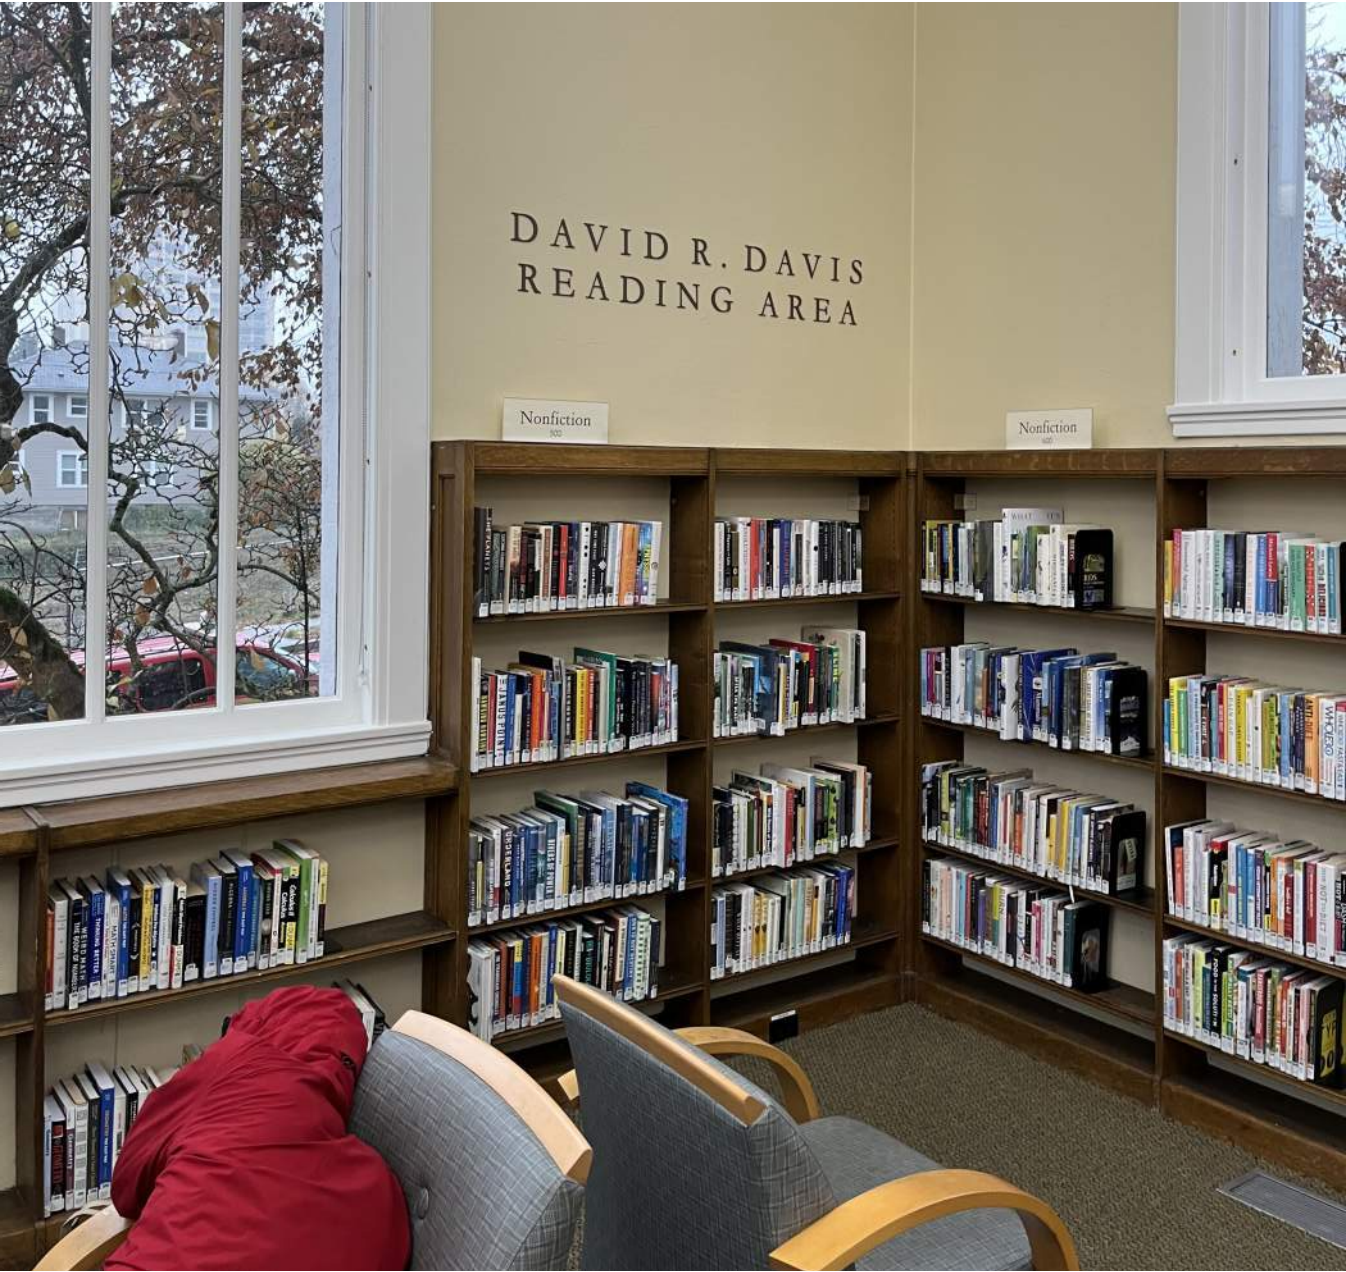
EXISTING SHELVING SECTION (SOUTH READING)

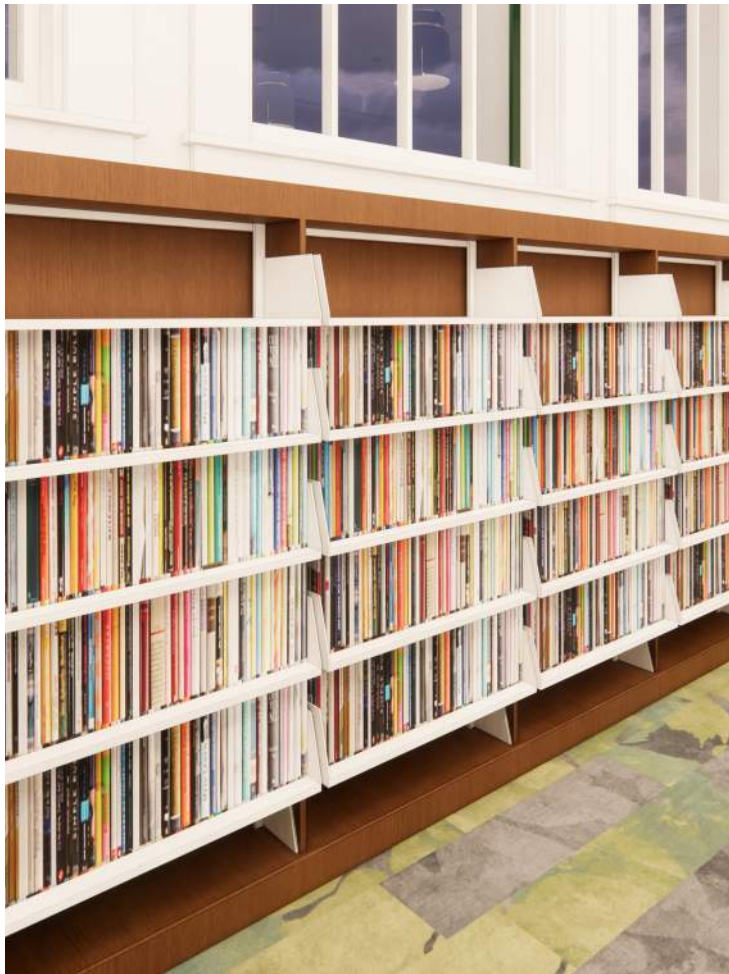
**PROPOSED:** STAINED PLYWOOD BACKING + WHITE SHELVES

Install white metal shelving on veneer plywood backing, stained to match the existing casework verticals and trim. The stained veneer plywood backing refers to and retains the tactile quality of the original wood shelves, and the white shelving is clearly differentiated from original material.

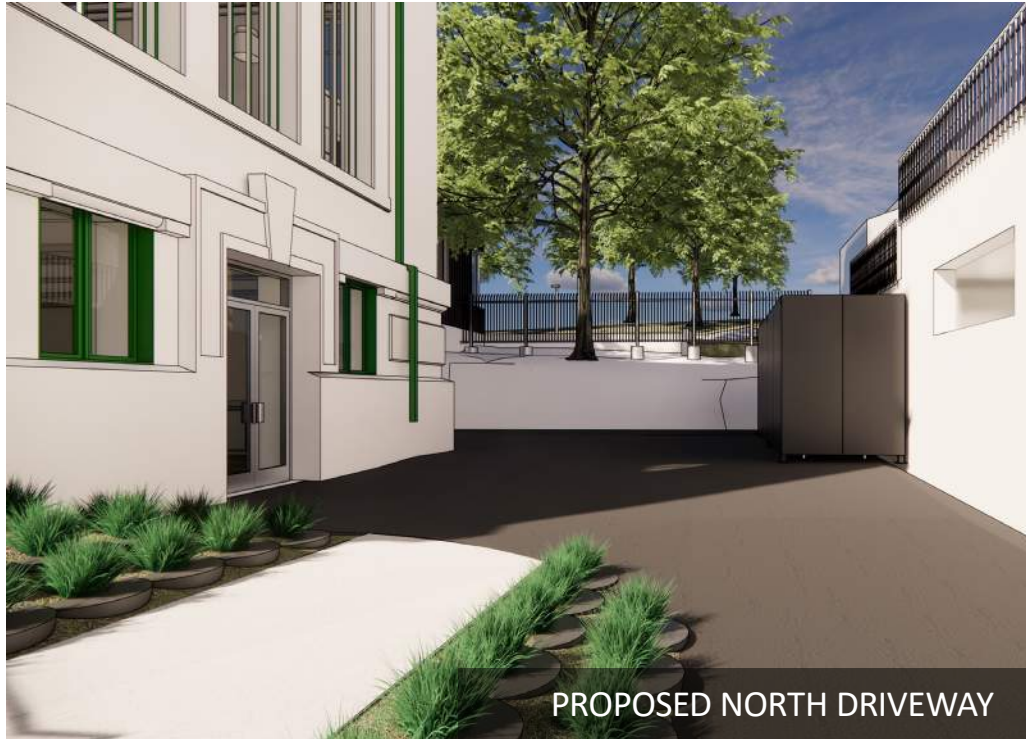
PROPOSED NORTH DRIVEWAY

**Current Proposal:**  
Install a painted metal enclosure, utilizing **steel plate panels** for durability and to visually obscure the dumpsters.

**Paint dark (black or dark bronze) to match existing metal site elements,** including the existing fence, handrails, and new steel retaining walls. Enclosure top to be welded bar grate top for security.

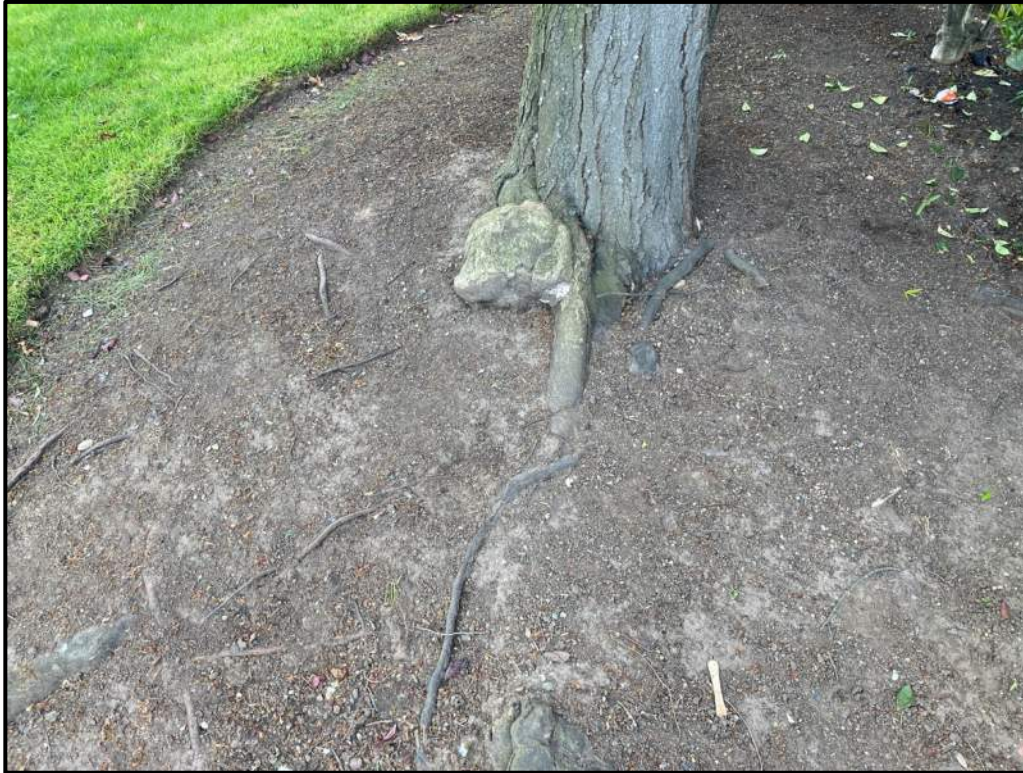
Photo 1. Exposed surface roots at the base of tree 278.

The soil across the site appears somewhat stripped and compact as a result of consistently removing organic debris from the landscape using rakes and leaf blowers. In a few instances this practice has exposed surface roots (Photo 1). The addition of woodchip mulch across the root zones of these trees would improve growing conditions.

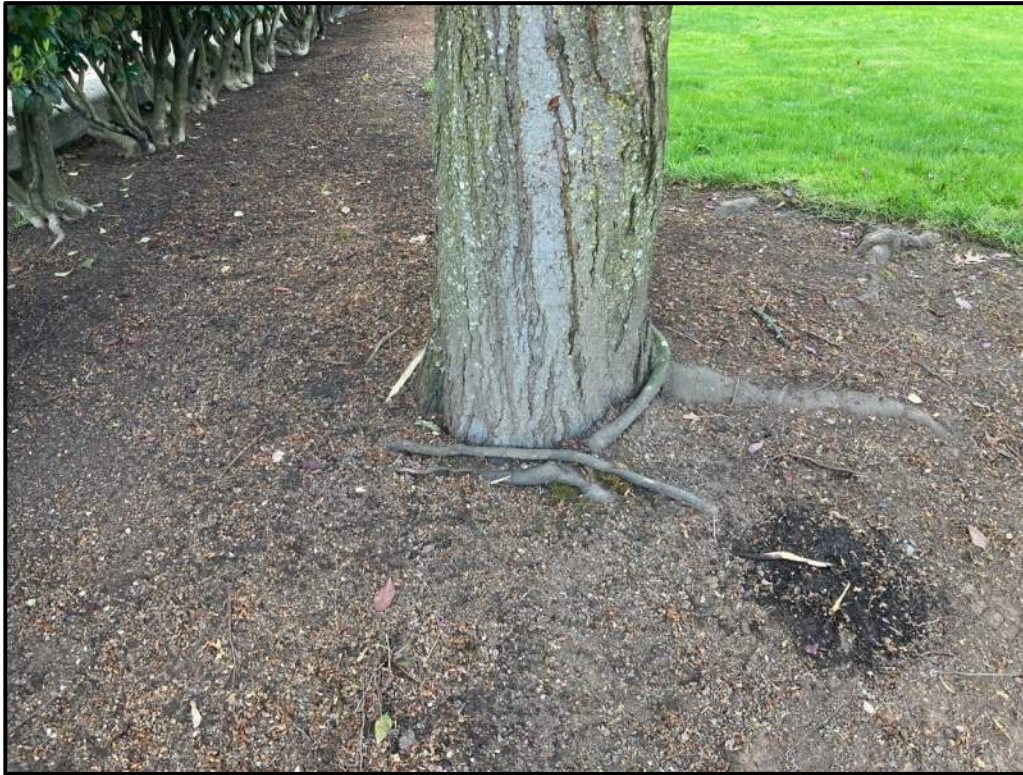
Photo 3. A prominent girdling root at the base of tree 280 (Indicated by red arrow).

Tree 280 is a flowering plum with a prominent girdling root (Photo 3). This root should be cut using a hammer and chisel to prevent future issues. If left unchecked, this root can lead to the eventual decline of the tree.

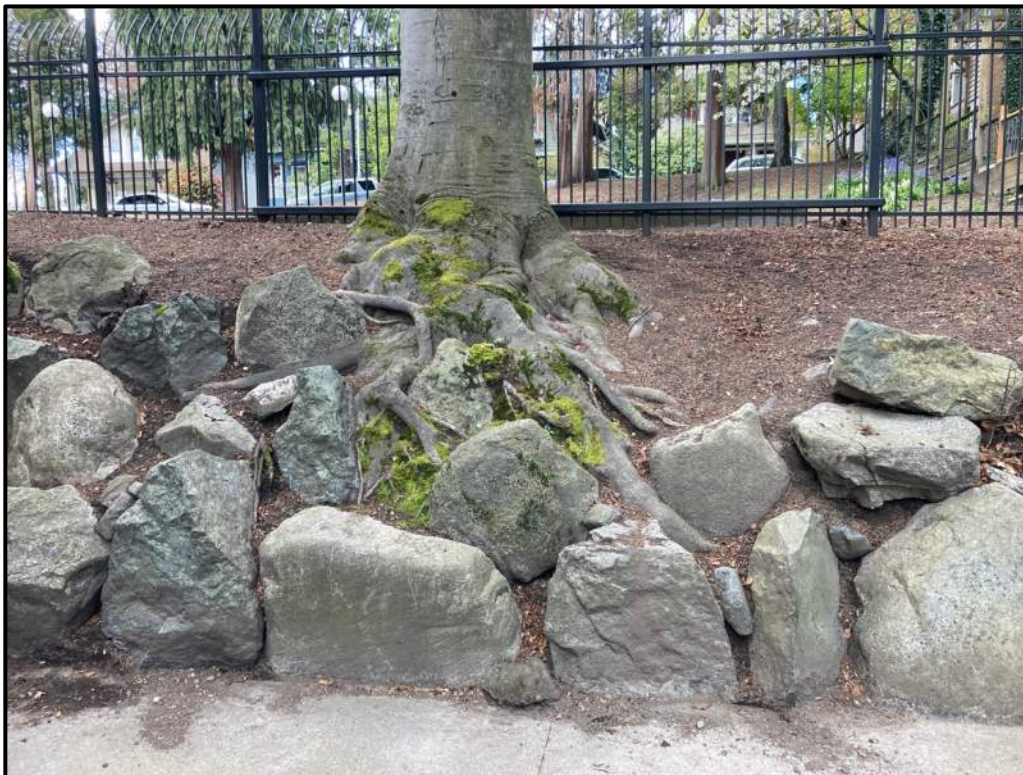
Photo 4. Roots from tree 283 that have become intertwined in the existing rockery

Tree 283 is an exceptional copper beech located on the north side of the library building. The roots of this tree are intertwined in the adjacent rockery (Photo 4). The rockery must remain in place if this tree is to be retained.
