Lake Union Steam Plant Garage Addition

SEATTLE, WASHINGTON
LANDMARK REVIEW | JUNE 2020

Project Description

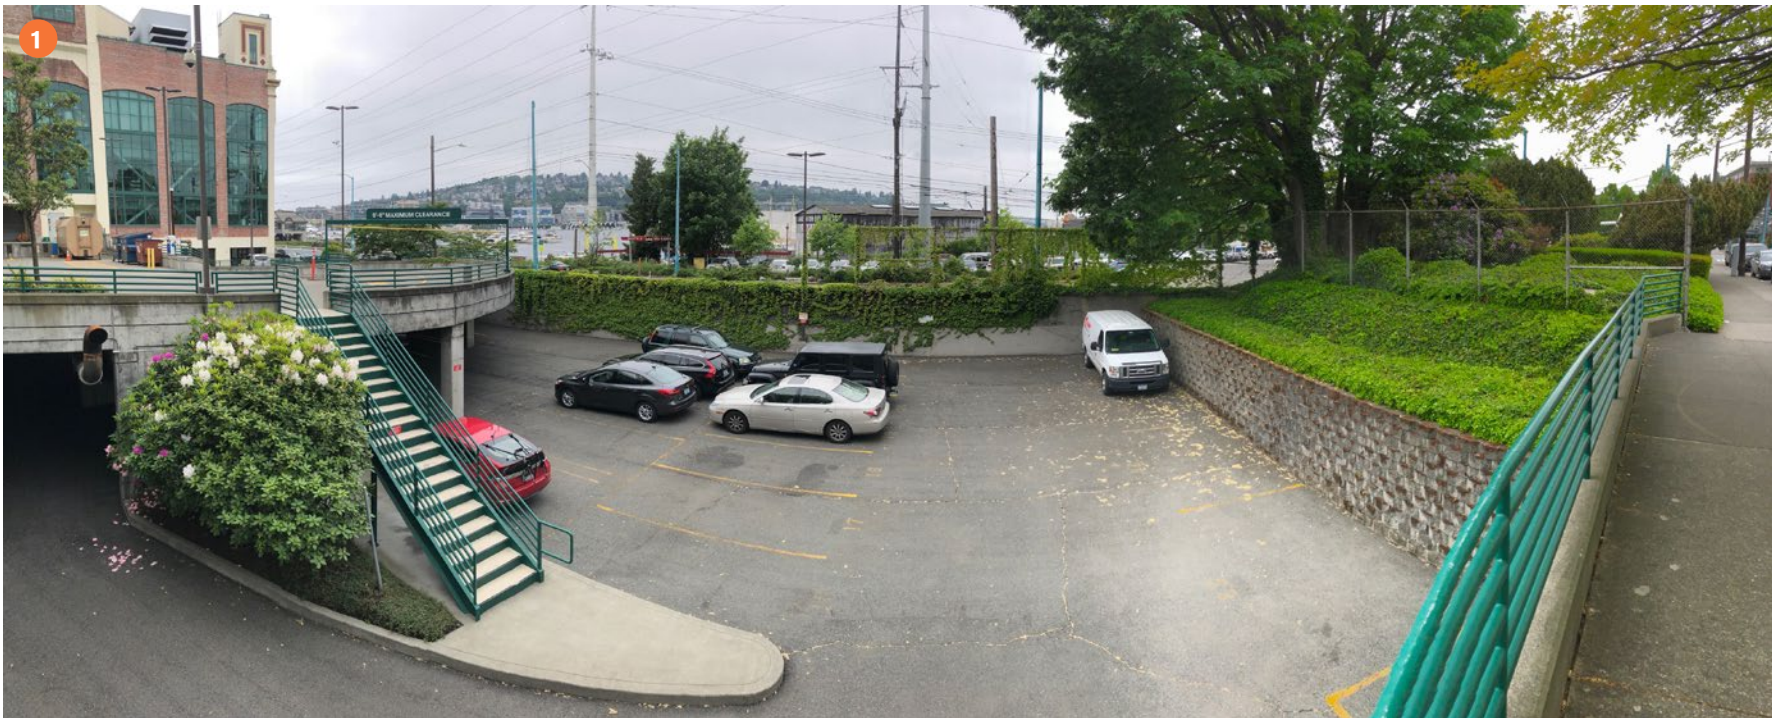
Existing submerged surface parking lot, looking west towards Lake Union.

The proposed project is for the site immediately north of the Lake Union Steam Plant. At that location currently there is a submerged surface parking lot (31 stalls), above which there are 2 garage entry/exit ramps and service area with loading dock. The ramps serve the existing 2-level garage beneath the building from a curb cut off Eastlake Avenue. These items were created as a part of the 1993 renovation of the building and would be replaced with this project. [See pages 6-8 for photos].

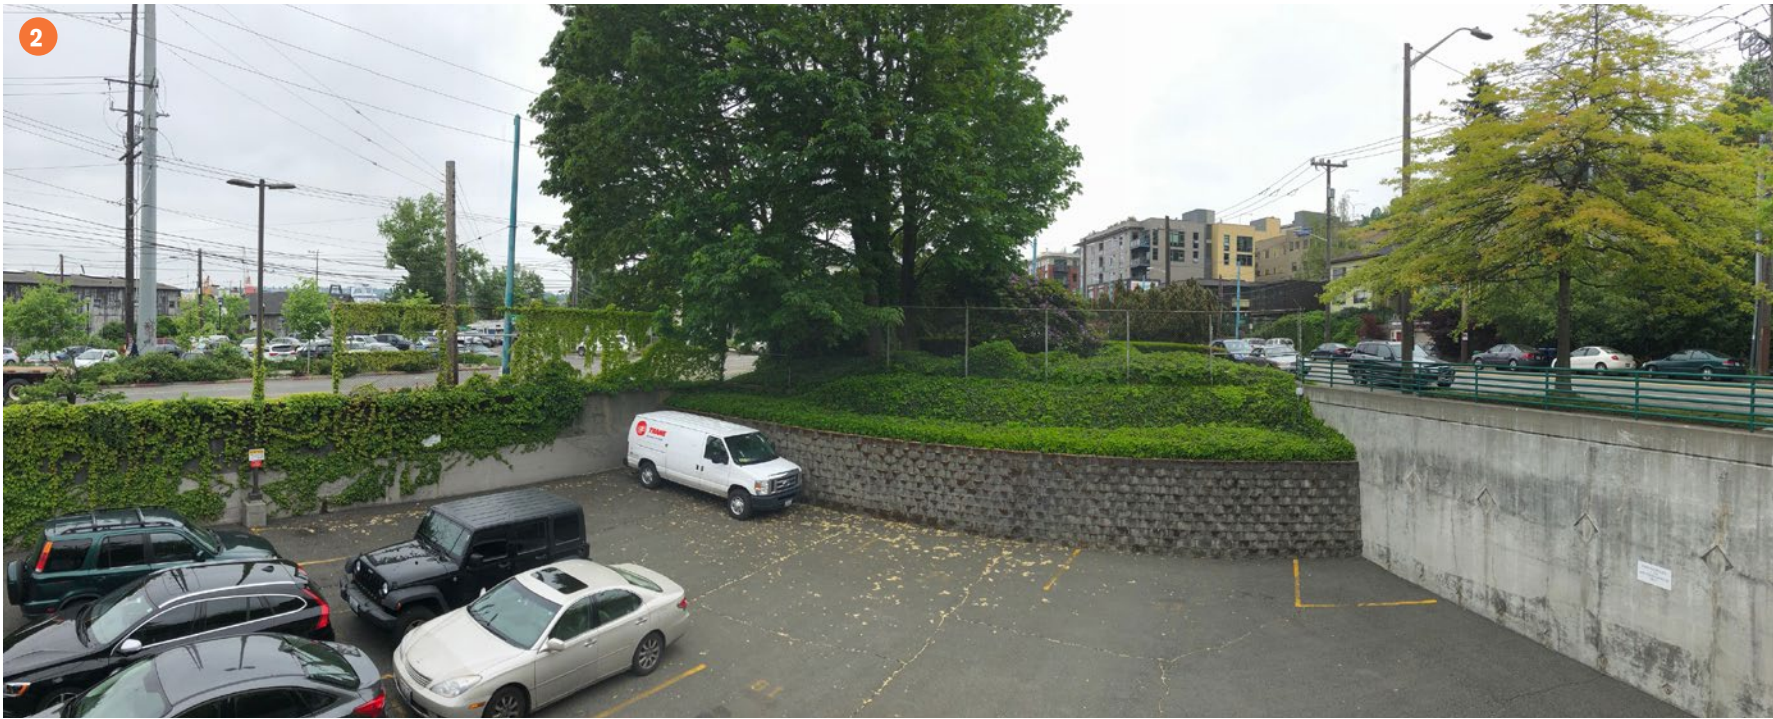
Existing submerged surface parking lot, looking north.

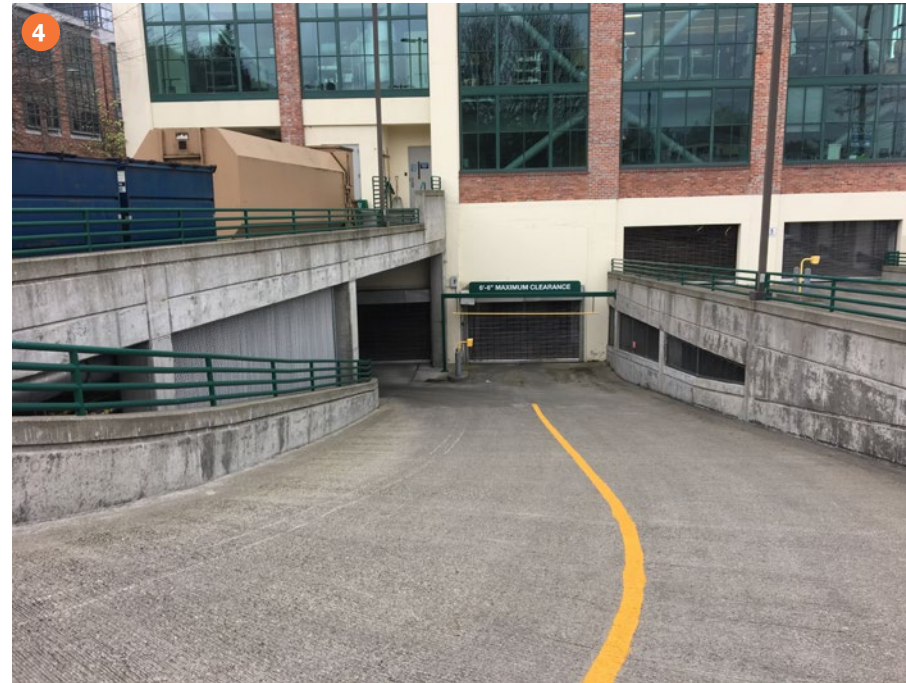
Lower level garage ramp.

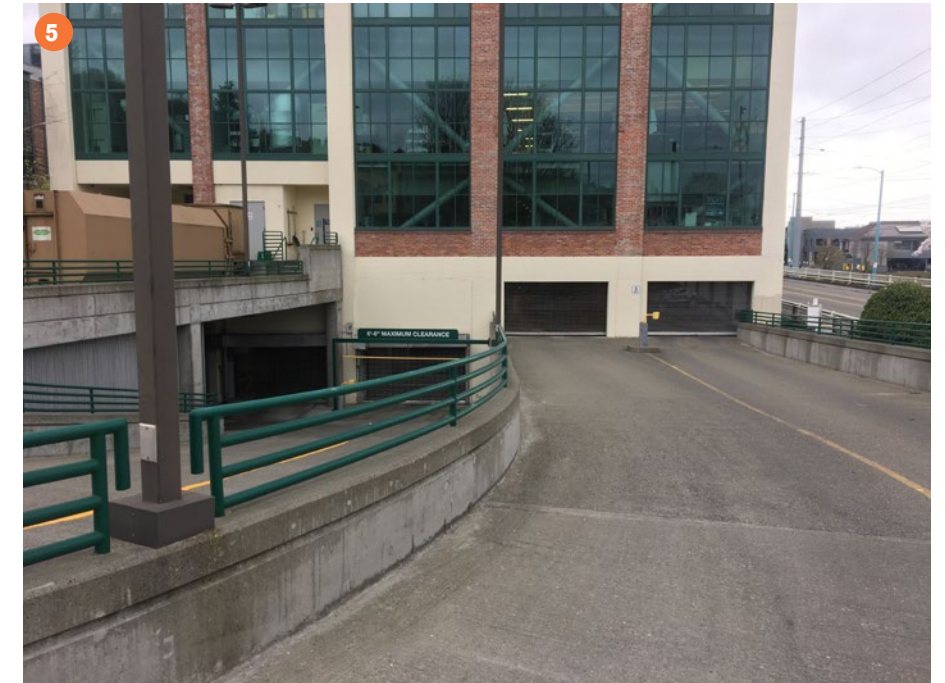
Upper level garage ramp.

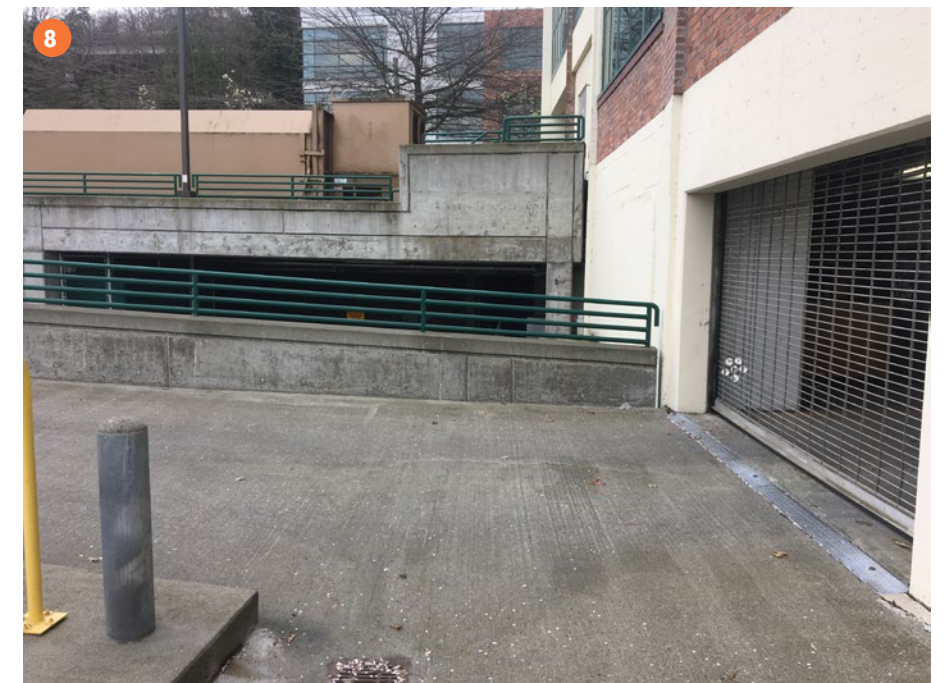
Upper level garage ramp with loading dock & compactor beyond.

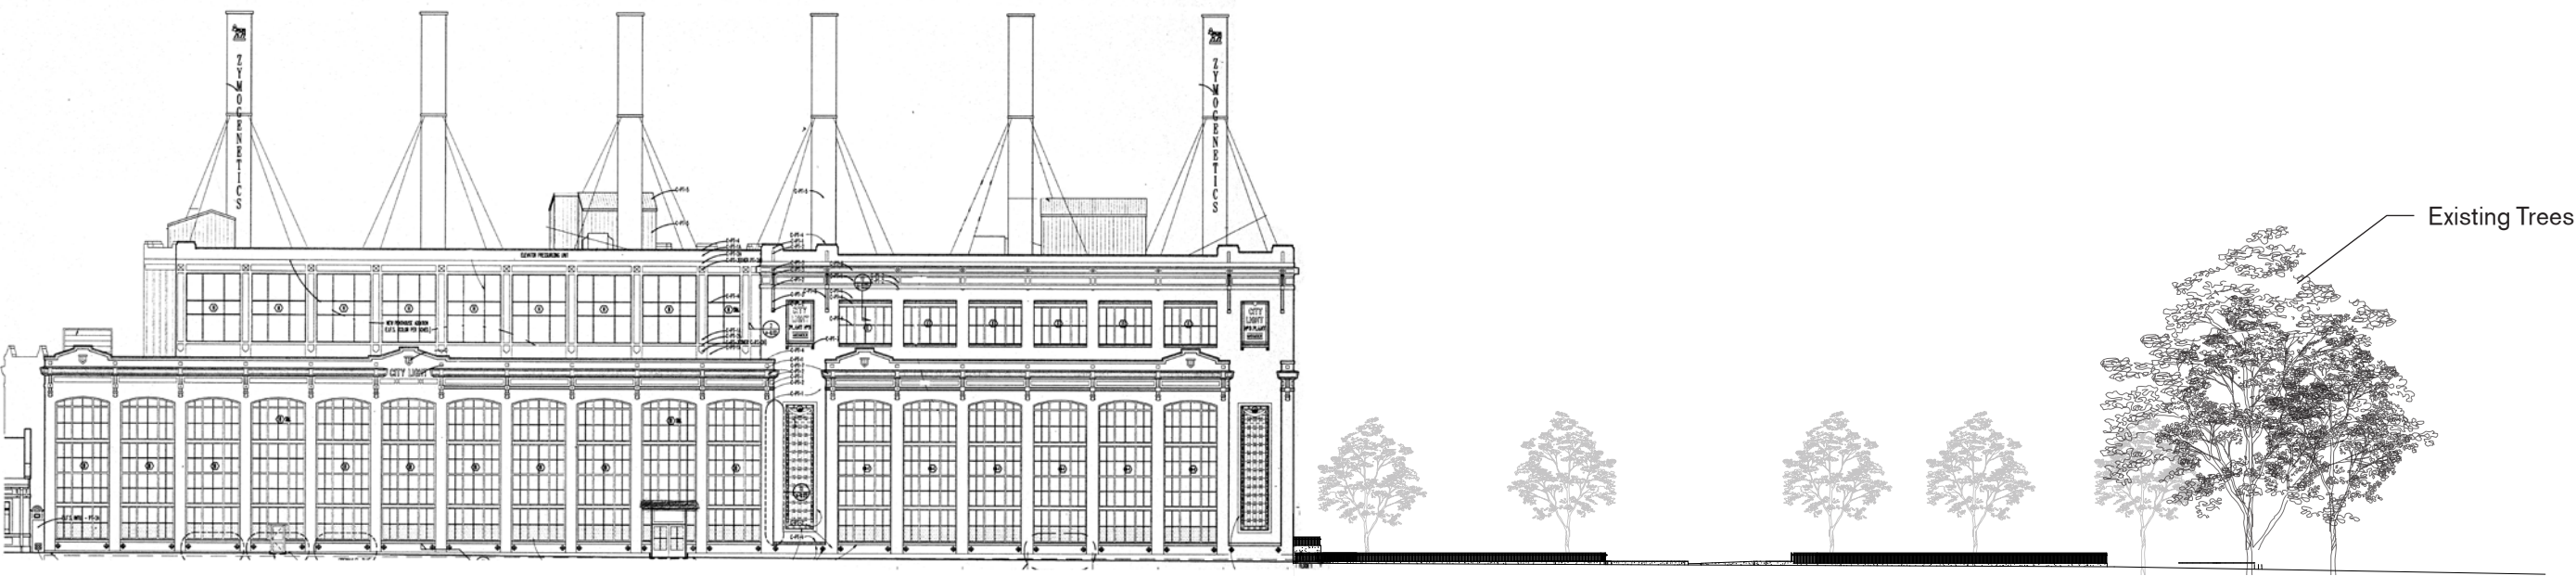
EAST ELEVATION

Existing Design

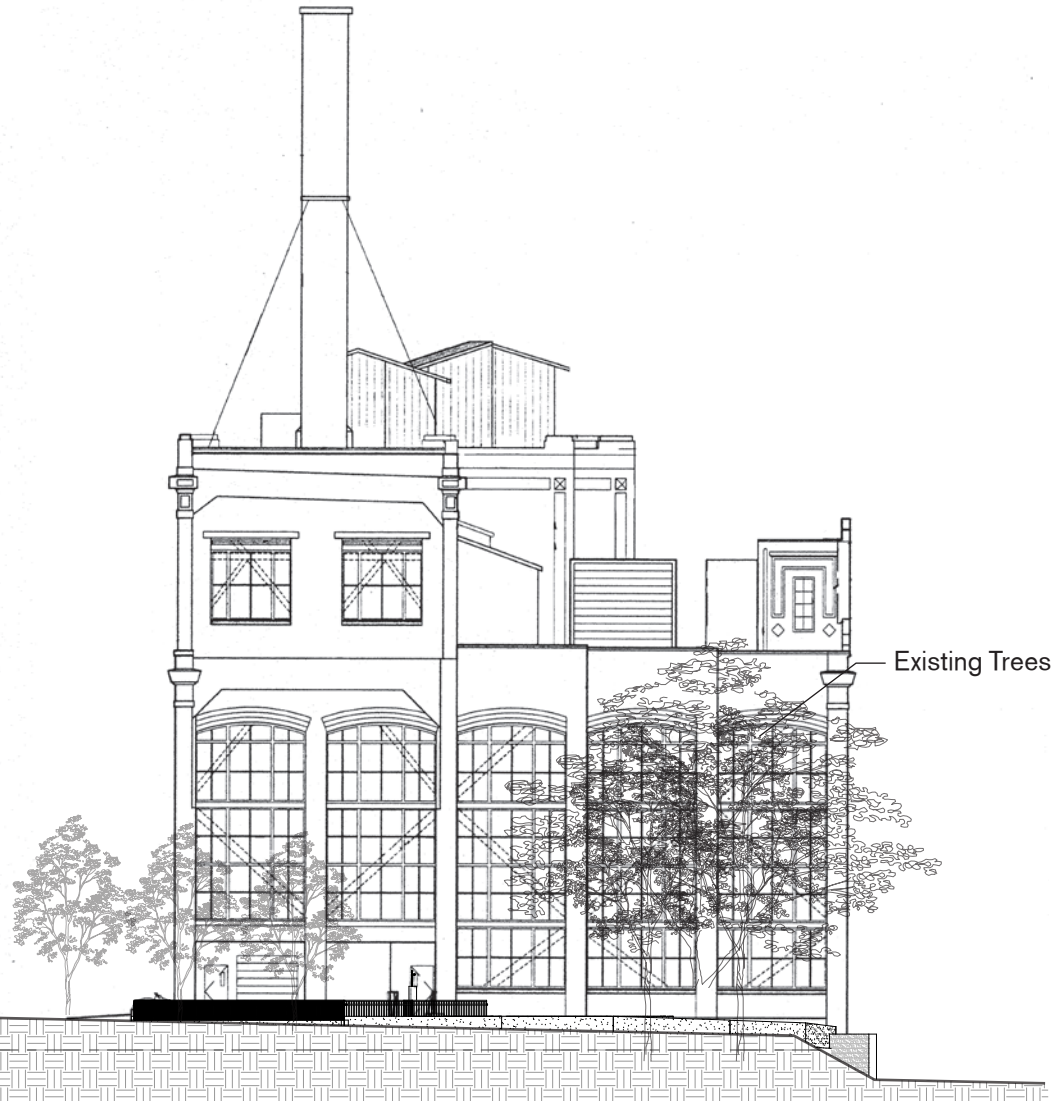
NORTH ELEVATION

Existing Design

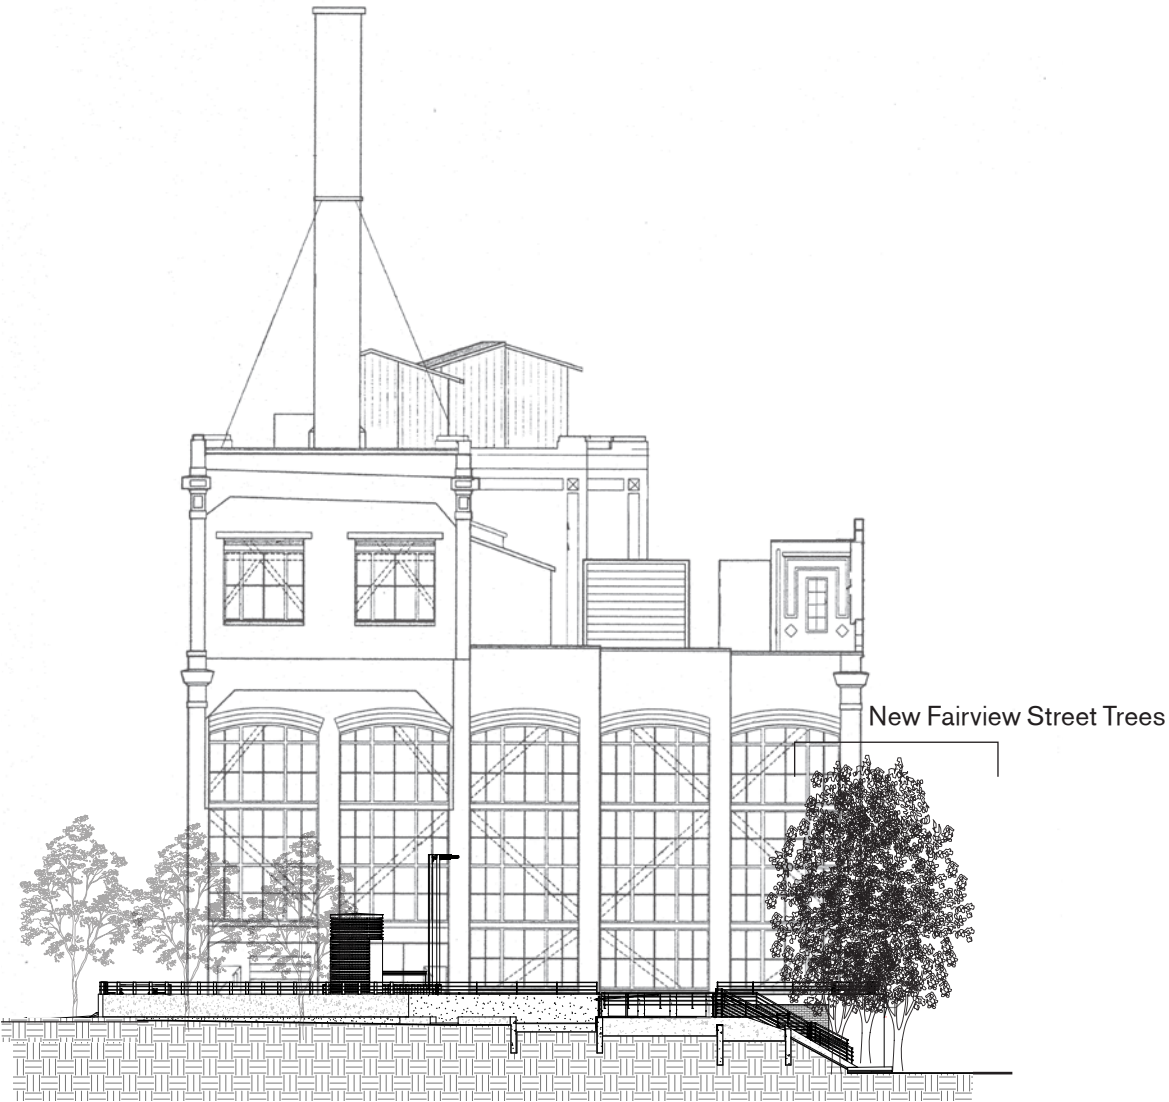
NORTH ELEVATION

Proposed Design

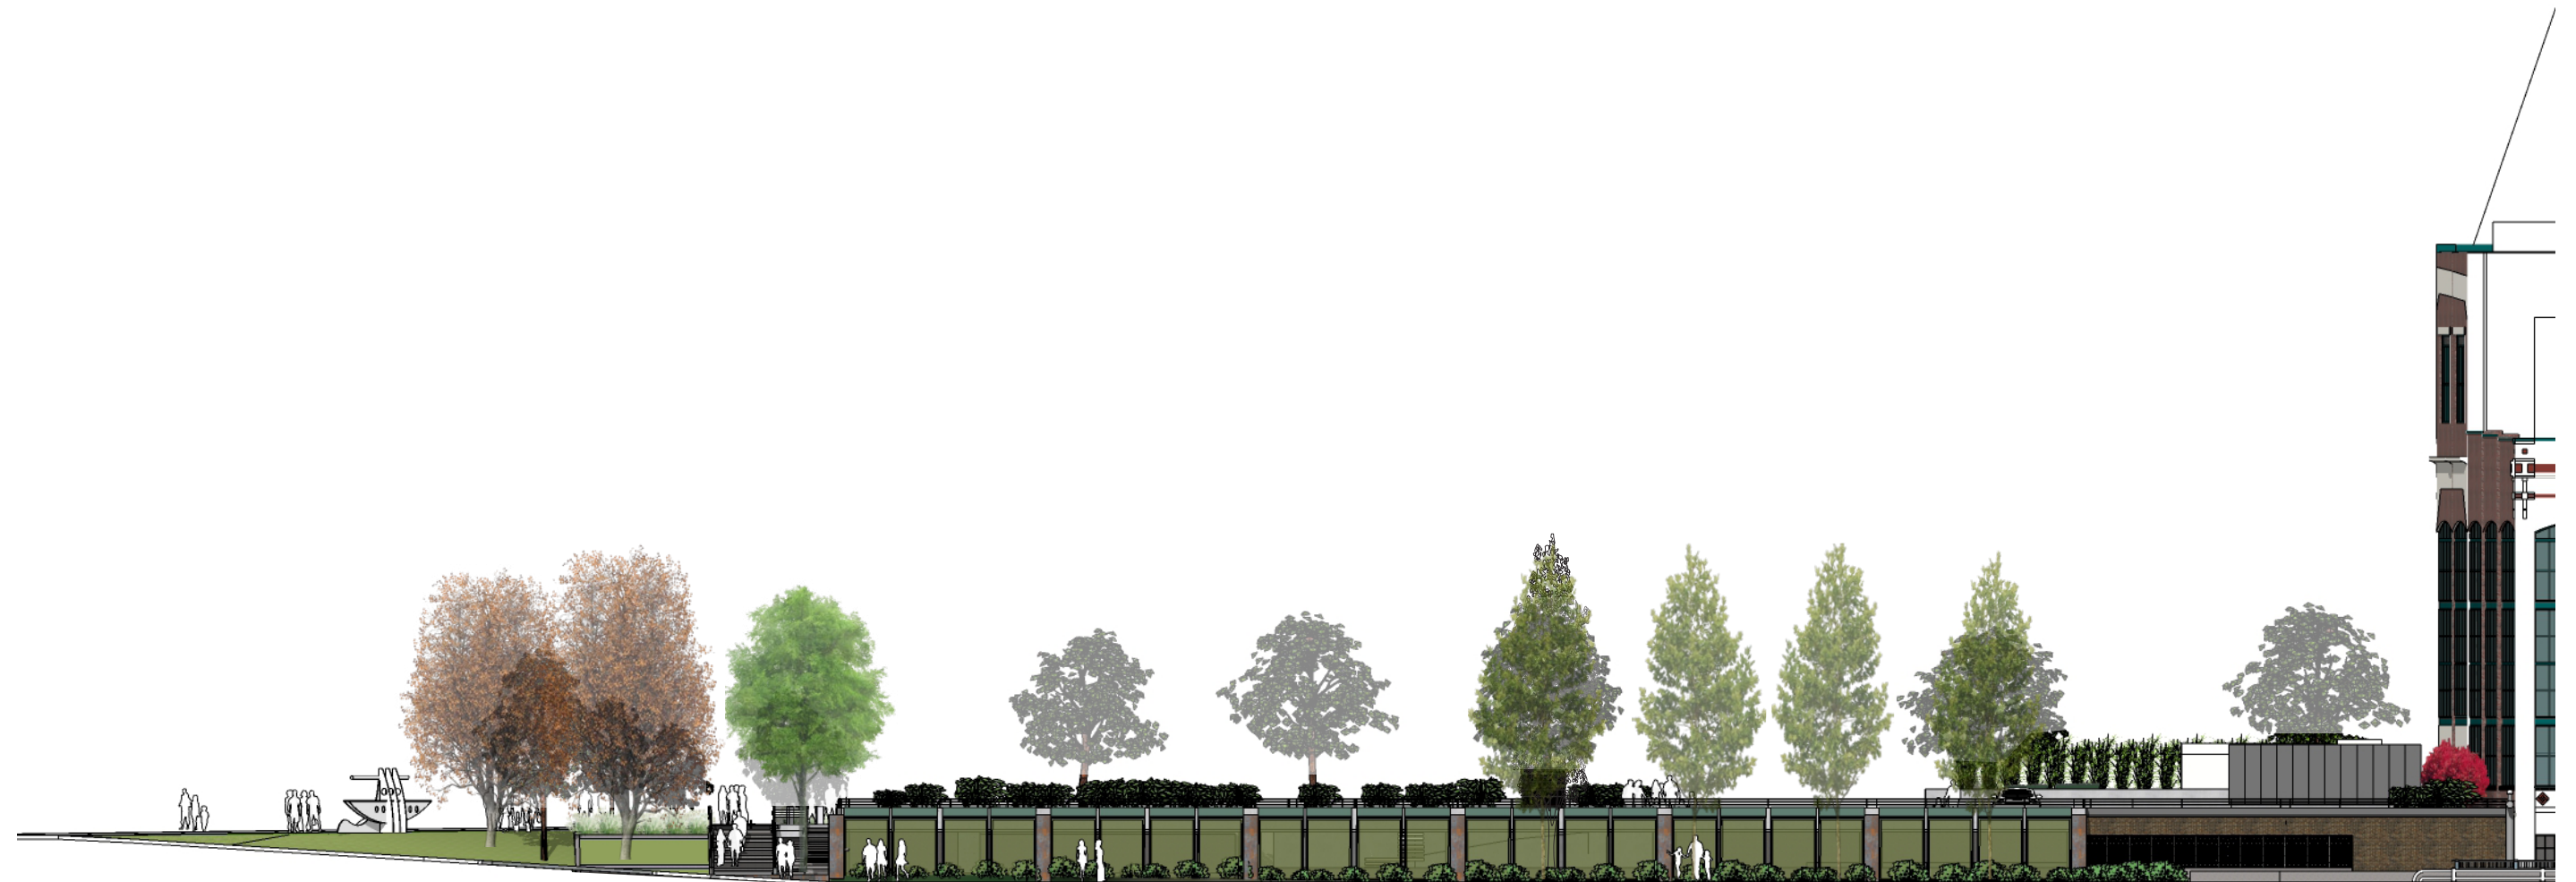
Full West Elevation

Not to scale

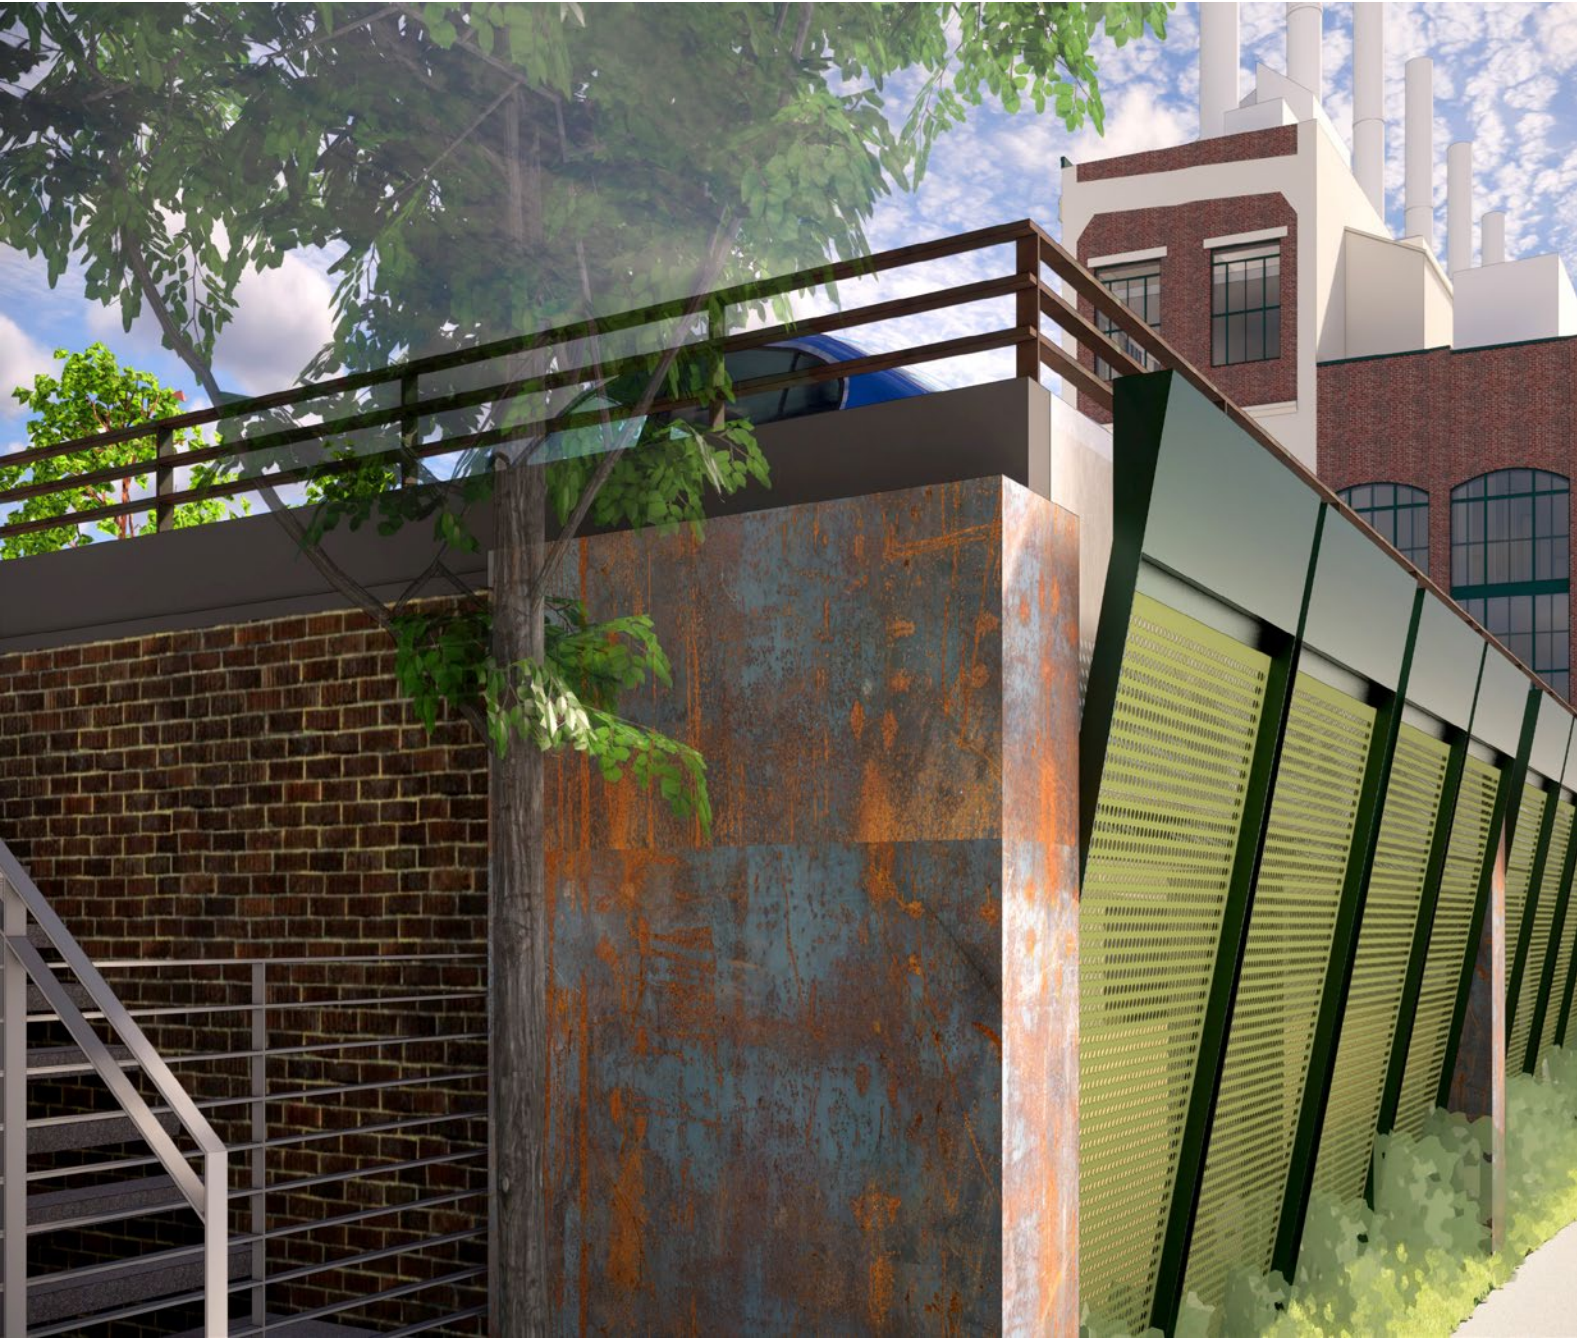
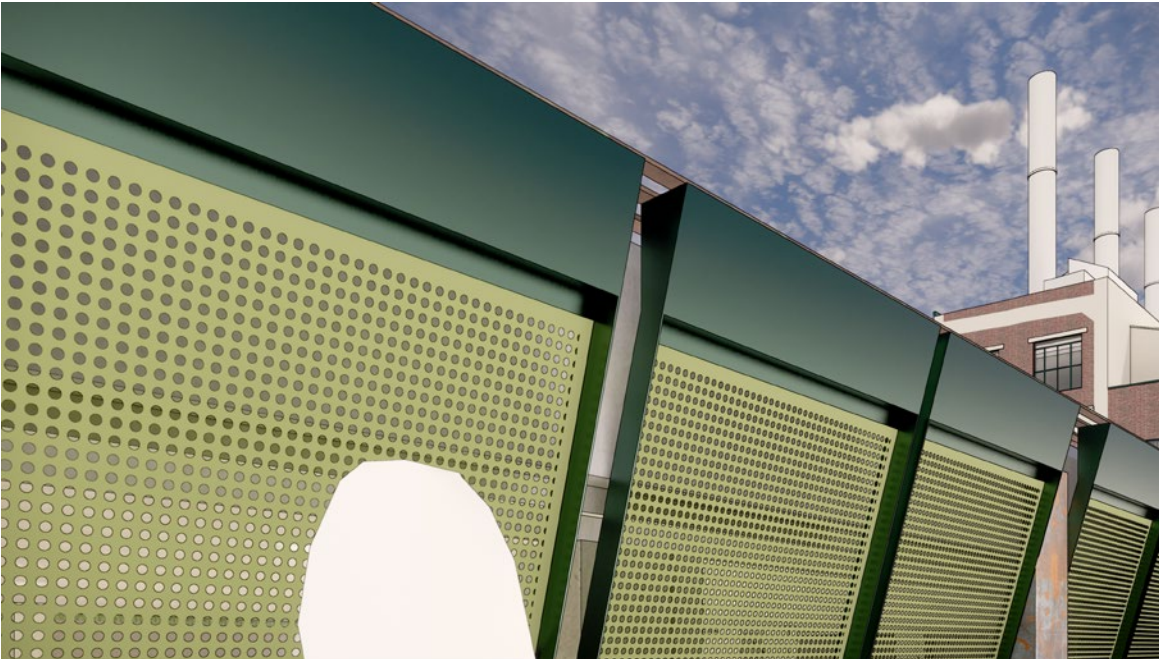
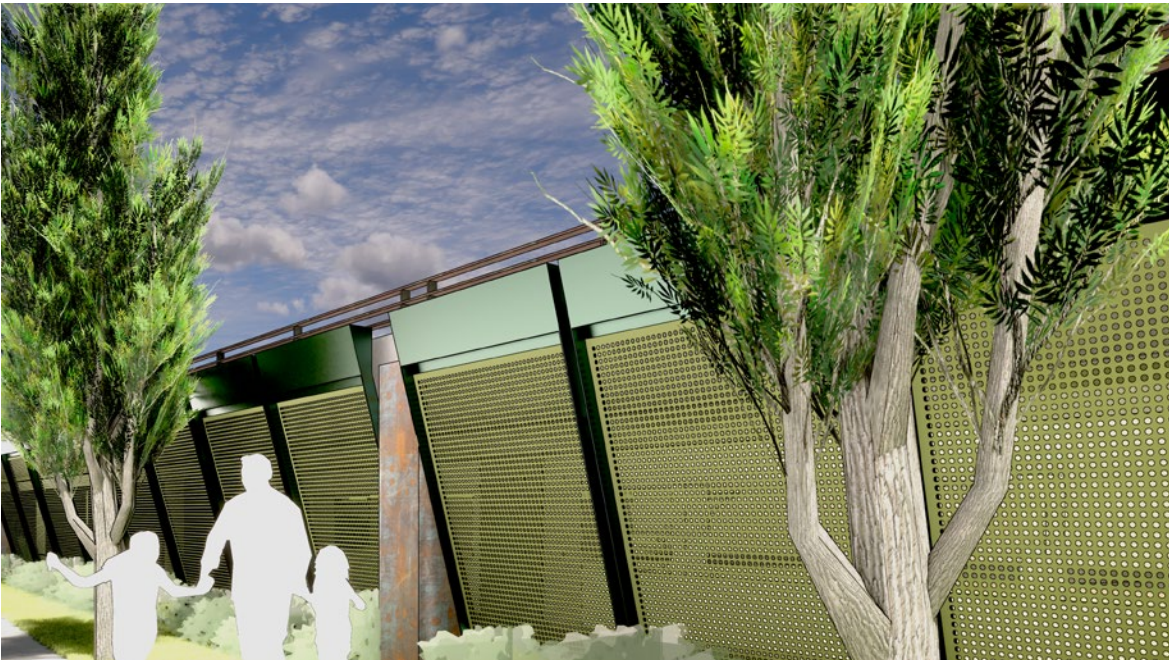
Views of Roof Parking from Fairview sidewalk

Sidewalk context/views

*View from eye-level/ approx 5'8" above sidewalk

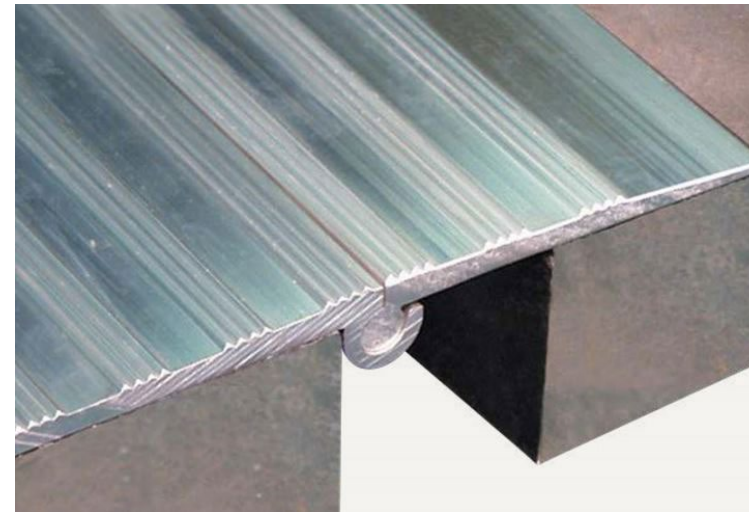
Expansion Joint Hinged System Details

Material: 6063-T6 Aluminum
 Finish: Mill
 Movement: Thermal- Horizontal and Vertical
 Mounting: Surface
 Joint Size: 2 inches to 6 inches

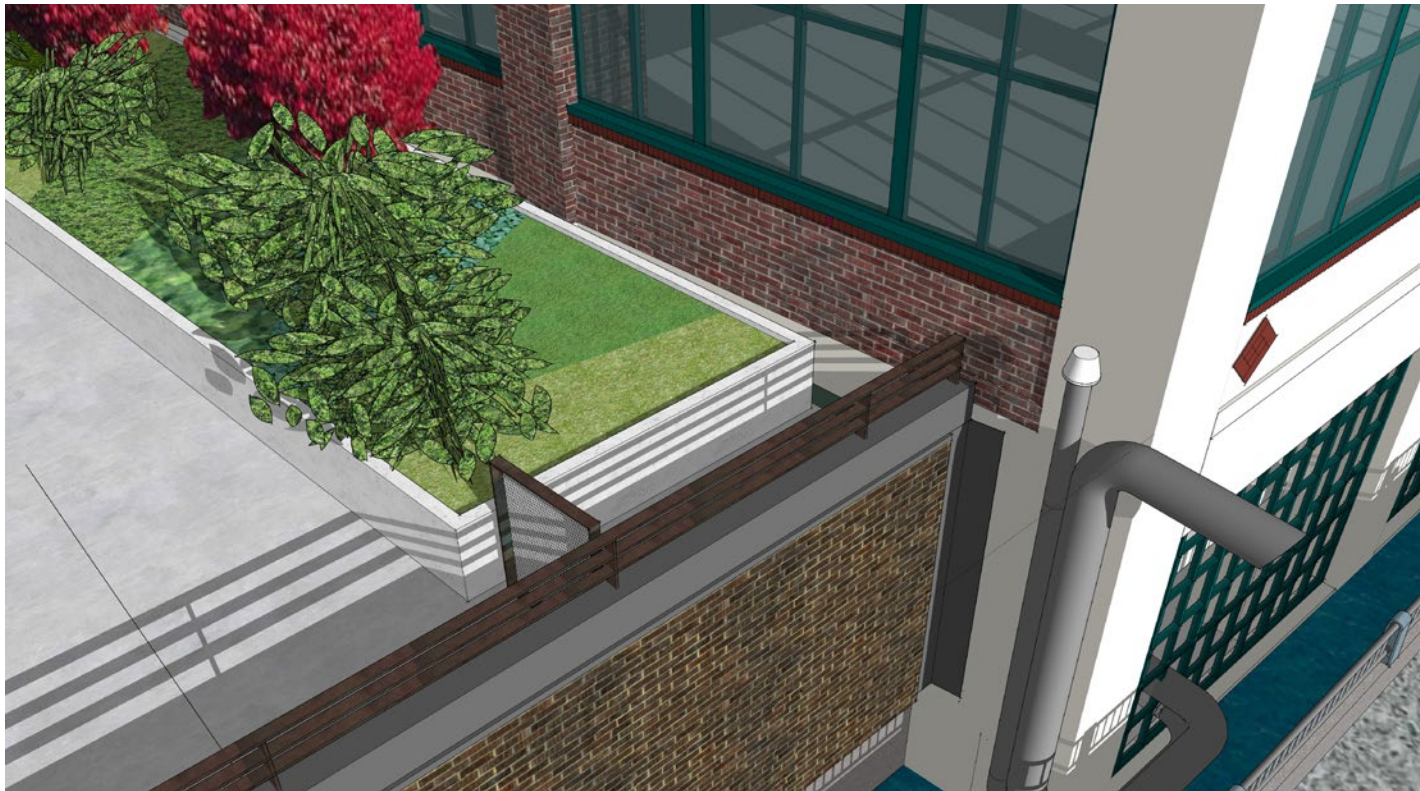
New garage at existing North West corner

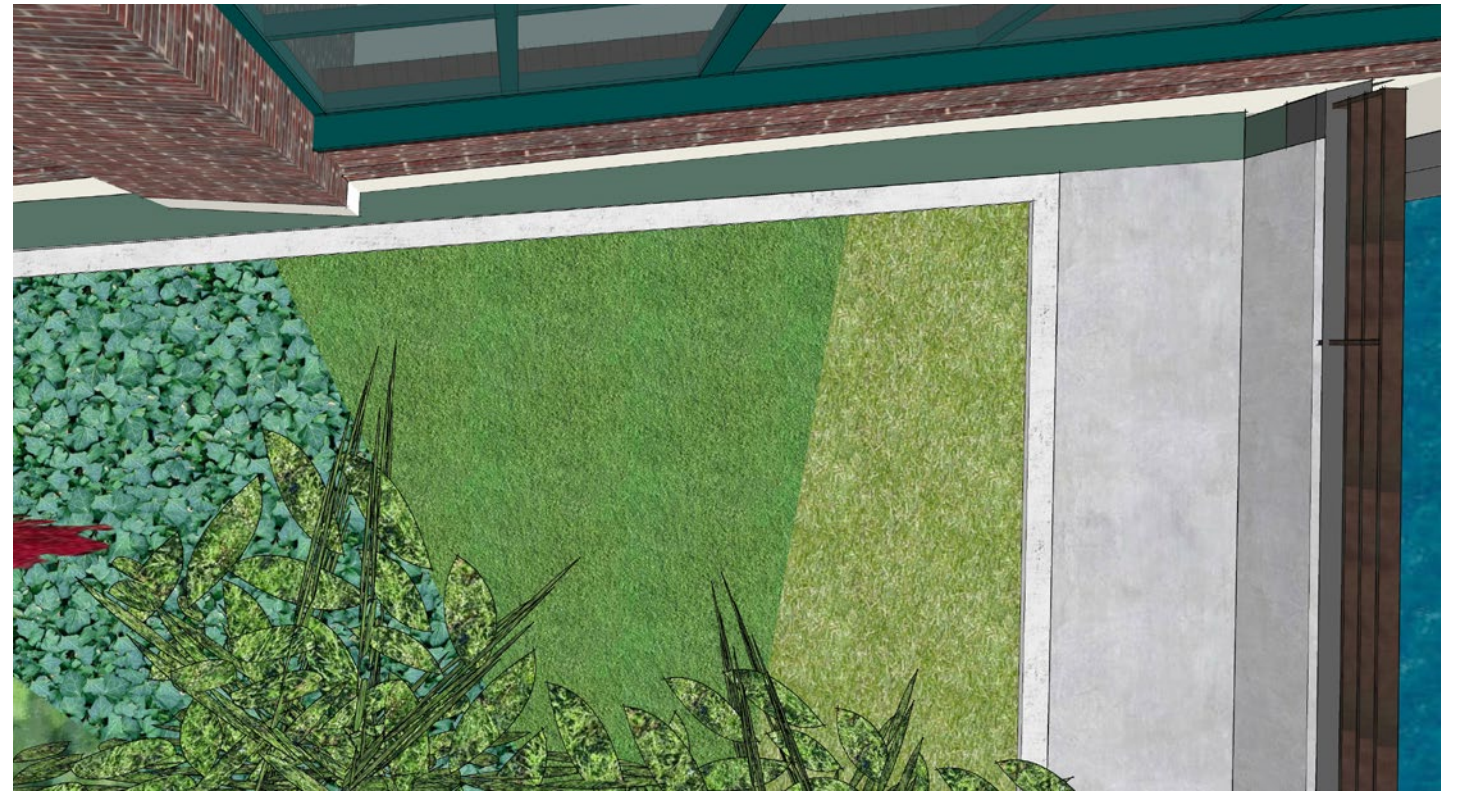
North planter separation against existing building.

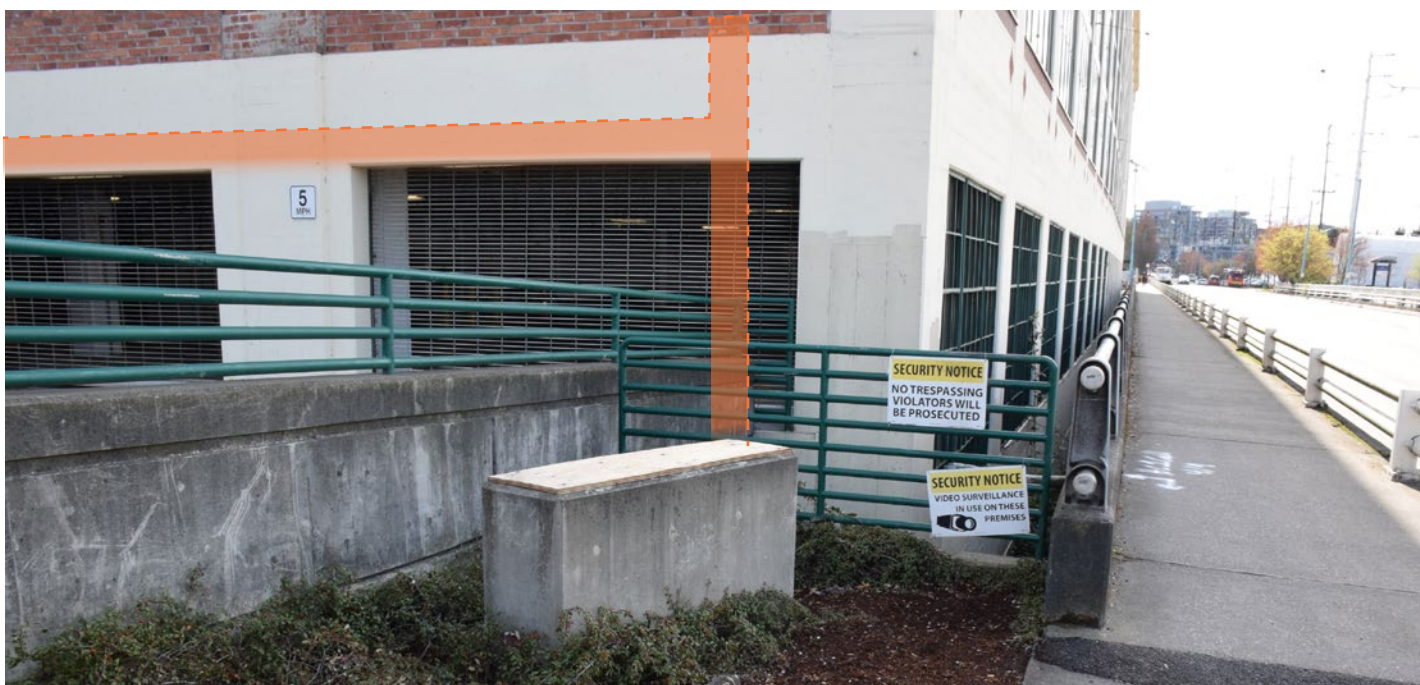
Approximate location of new garage West Facade

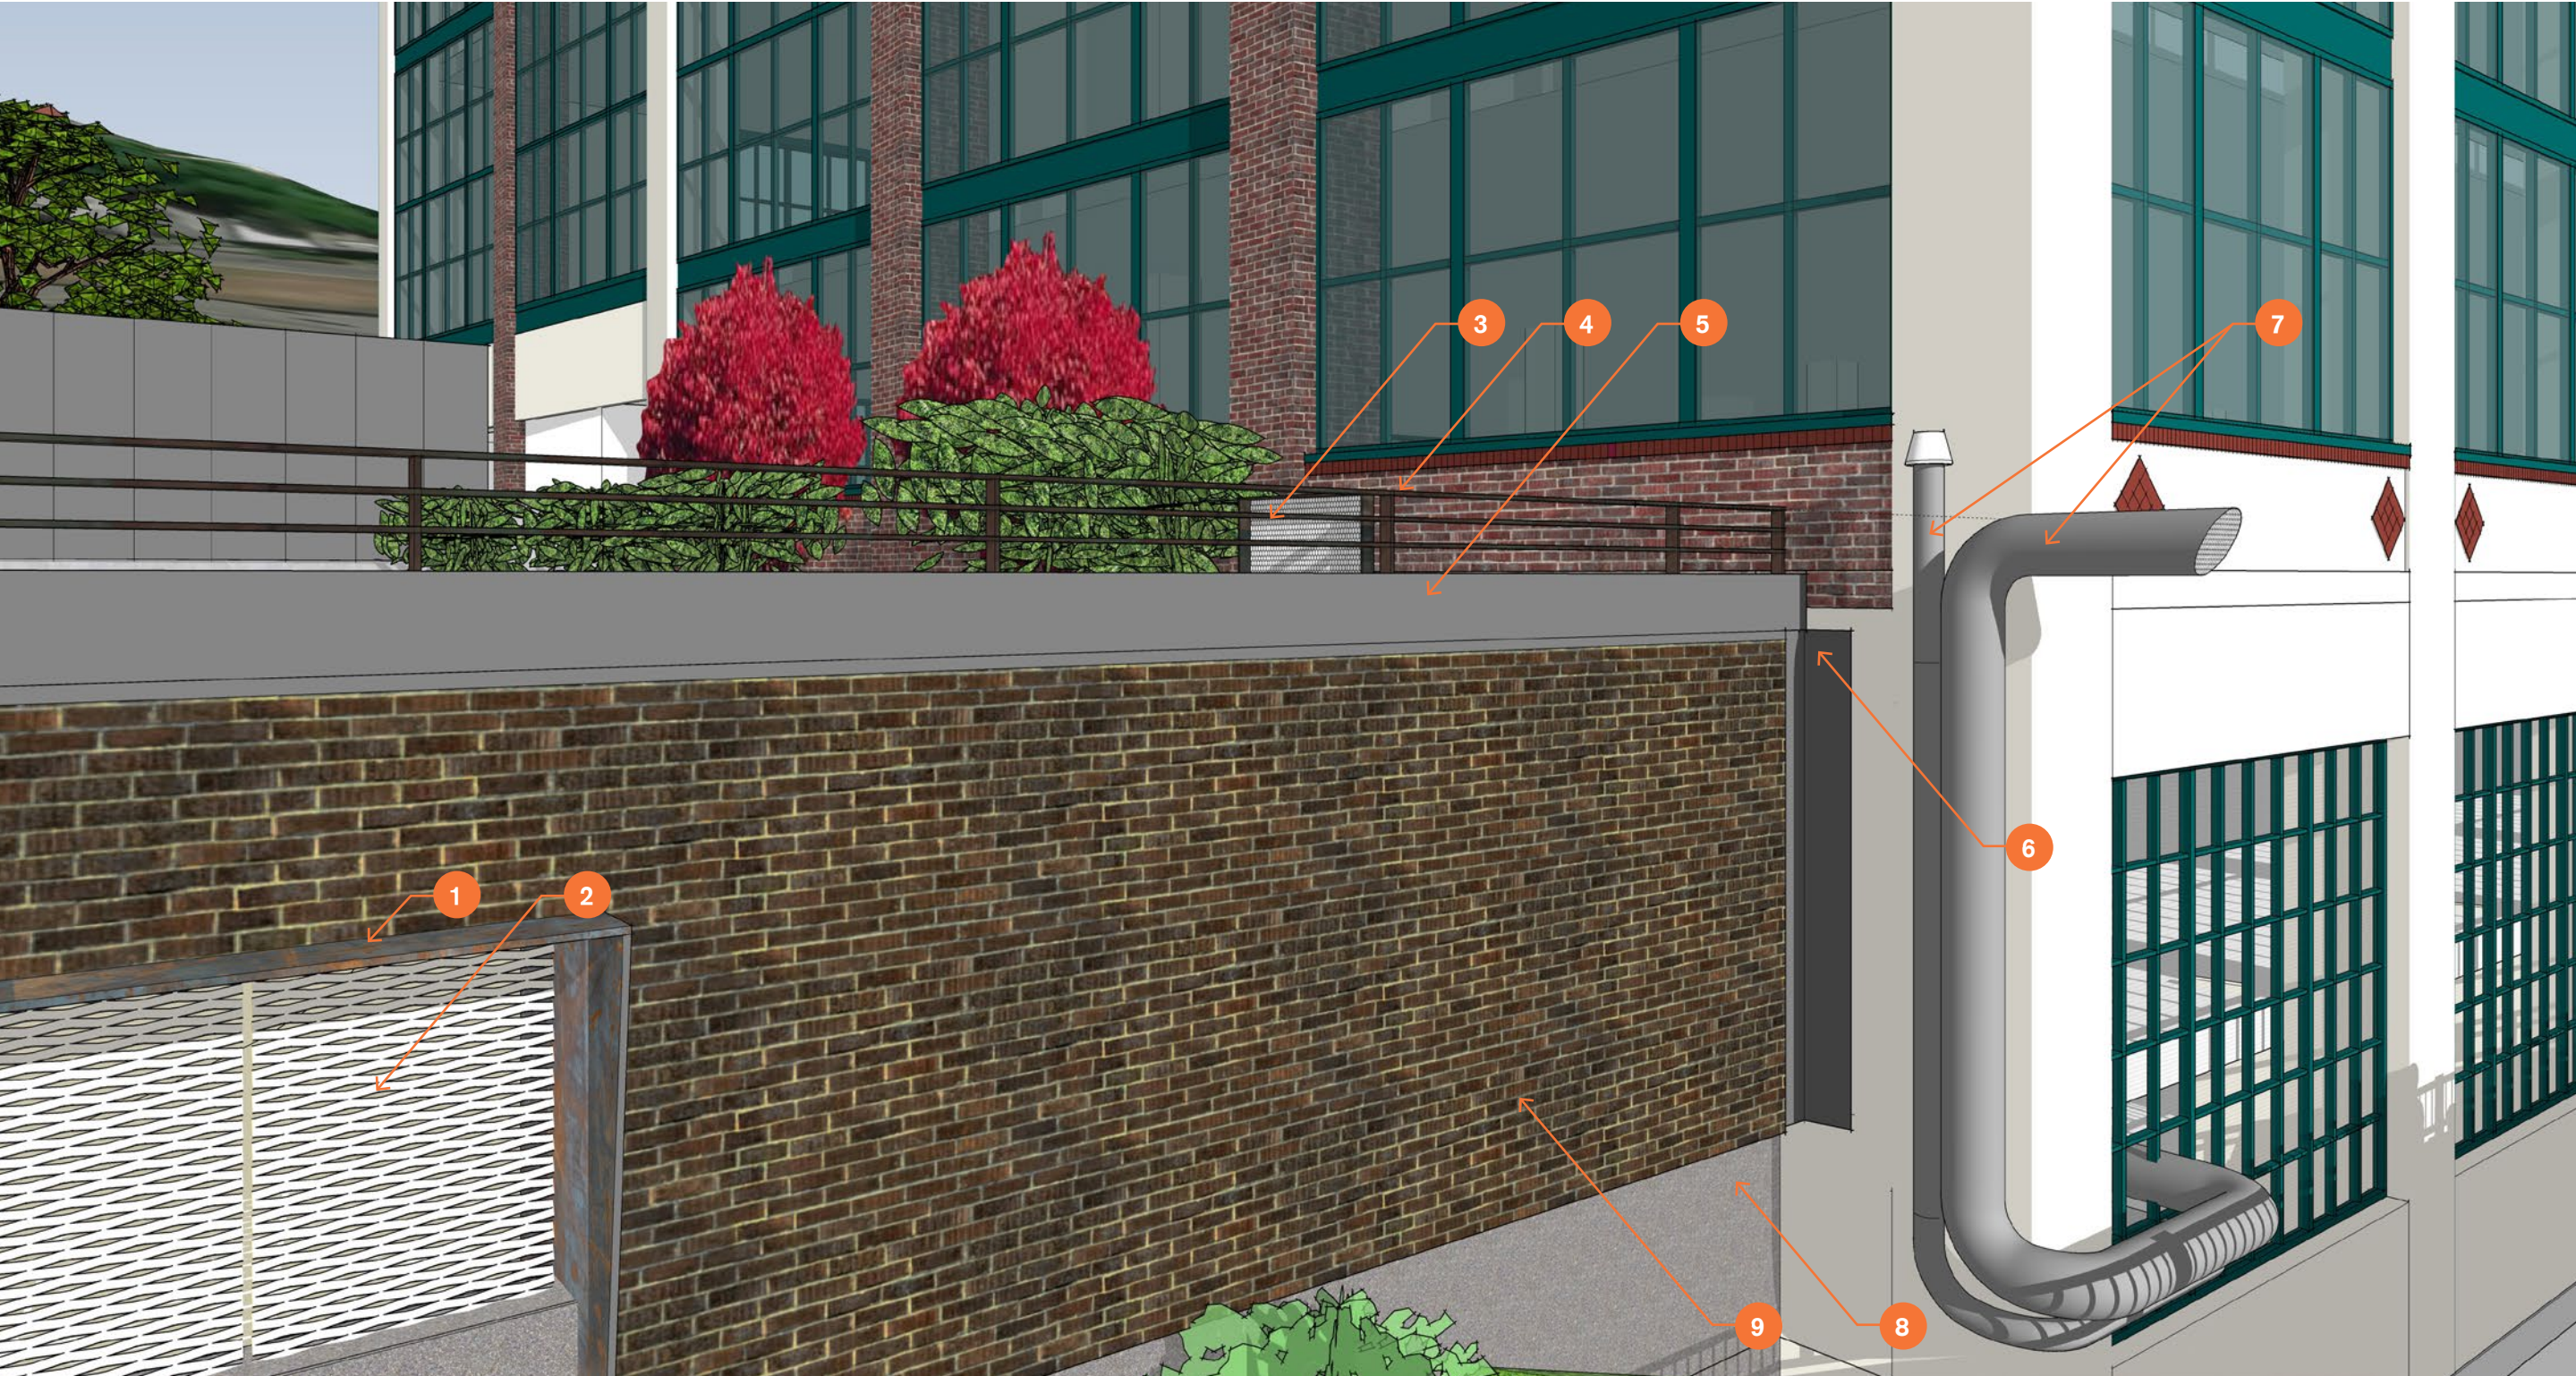
1/4" steel plate brow at masonry opening
- 2

Expanded metal security screen (type 2), powder coat paint finish
- 3

Steel maintenance gate beyond (adjacent to planter)
- 4

Metal rail to code
- 5

Metal flasshing/ Cap
- 6

16ga steel plate enclosure at existing opening edge
- 7

Generator exhaust vent (per approved 6/19 Landmark submission)
- 8

Concrete foundation wall
- 9

Brick veneer masonry
