Lake Union Steam Plant Garage Addition

SEATTLE, WASHINGTON
LANDMARK REVIEW | JUNE 2020

Project Description

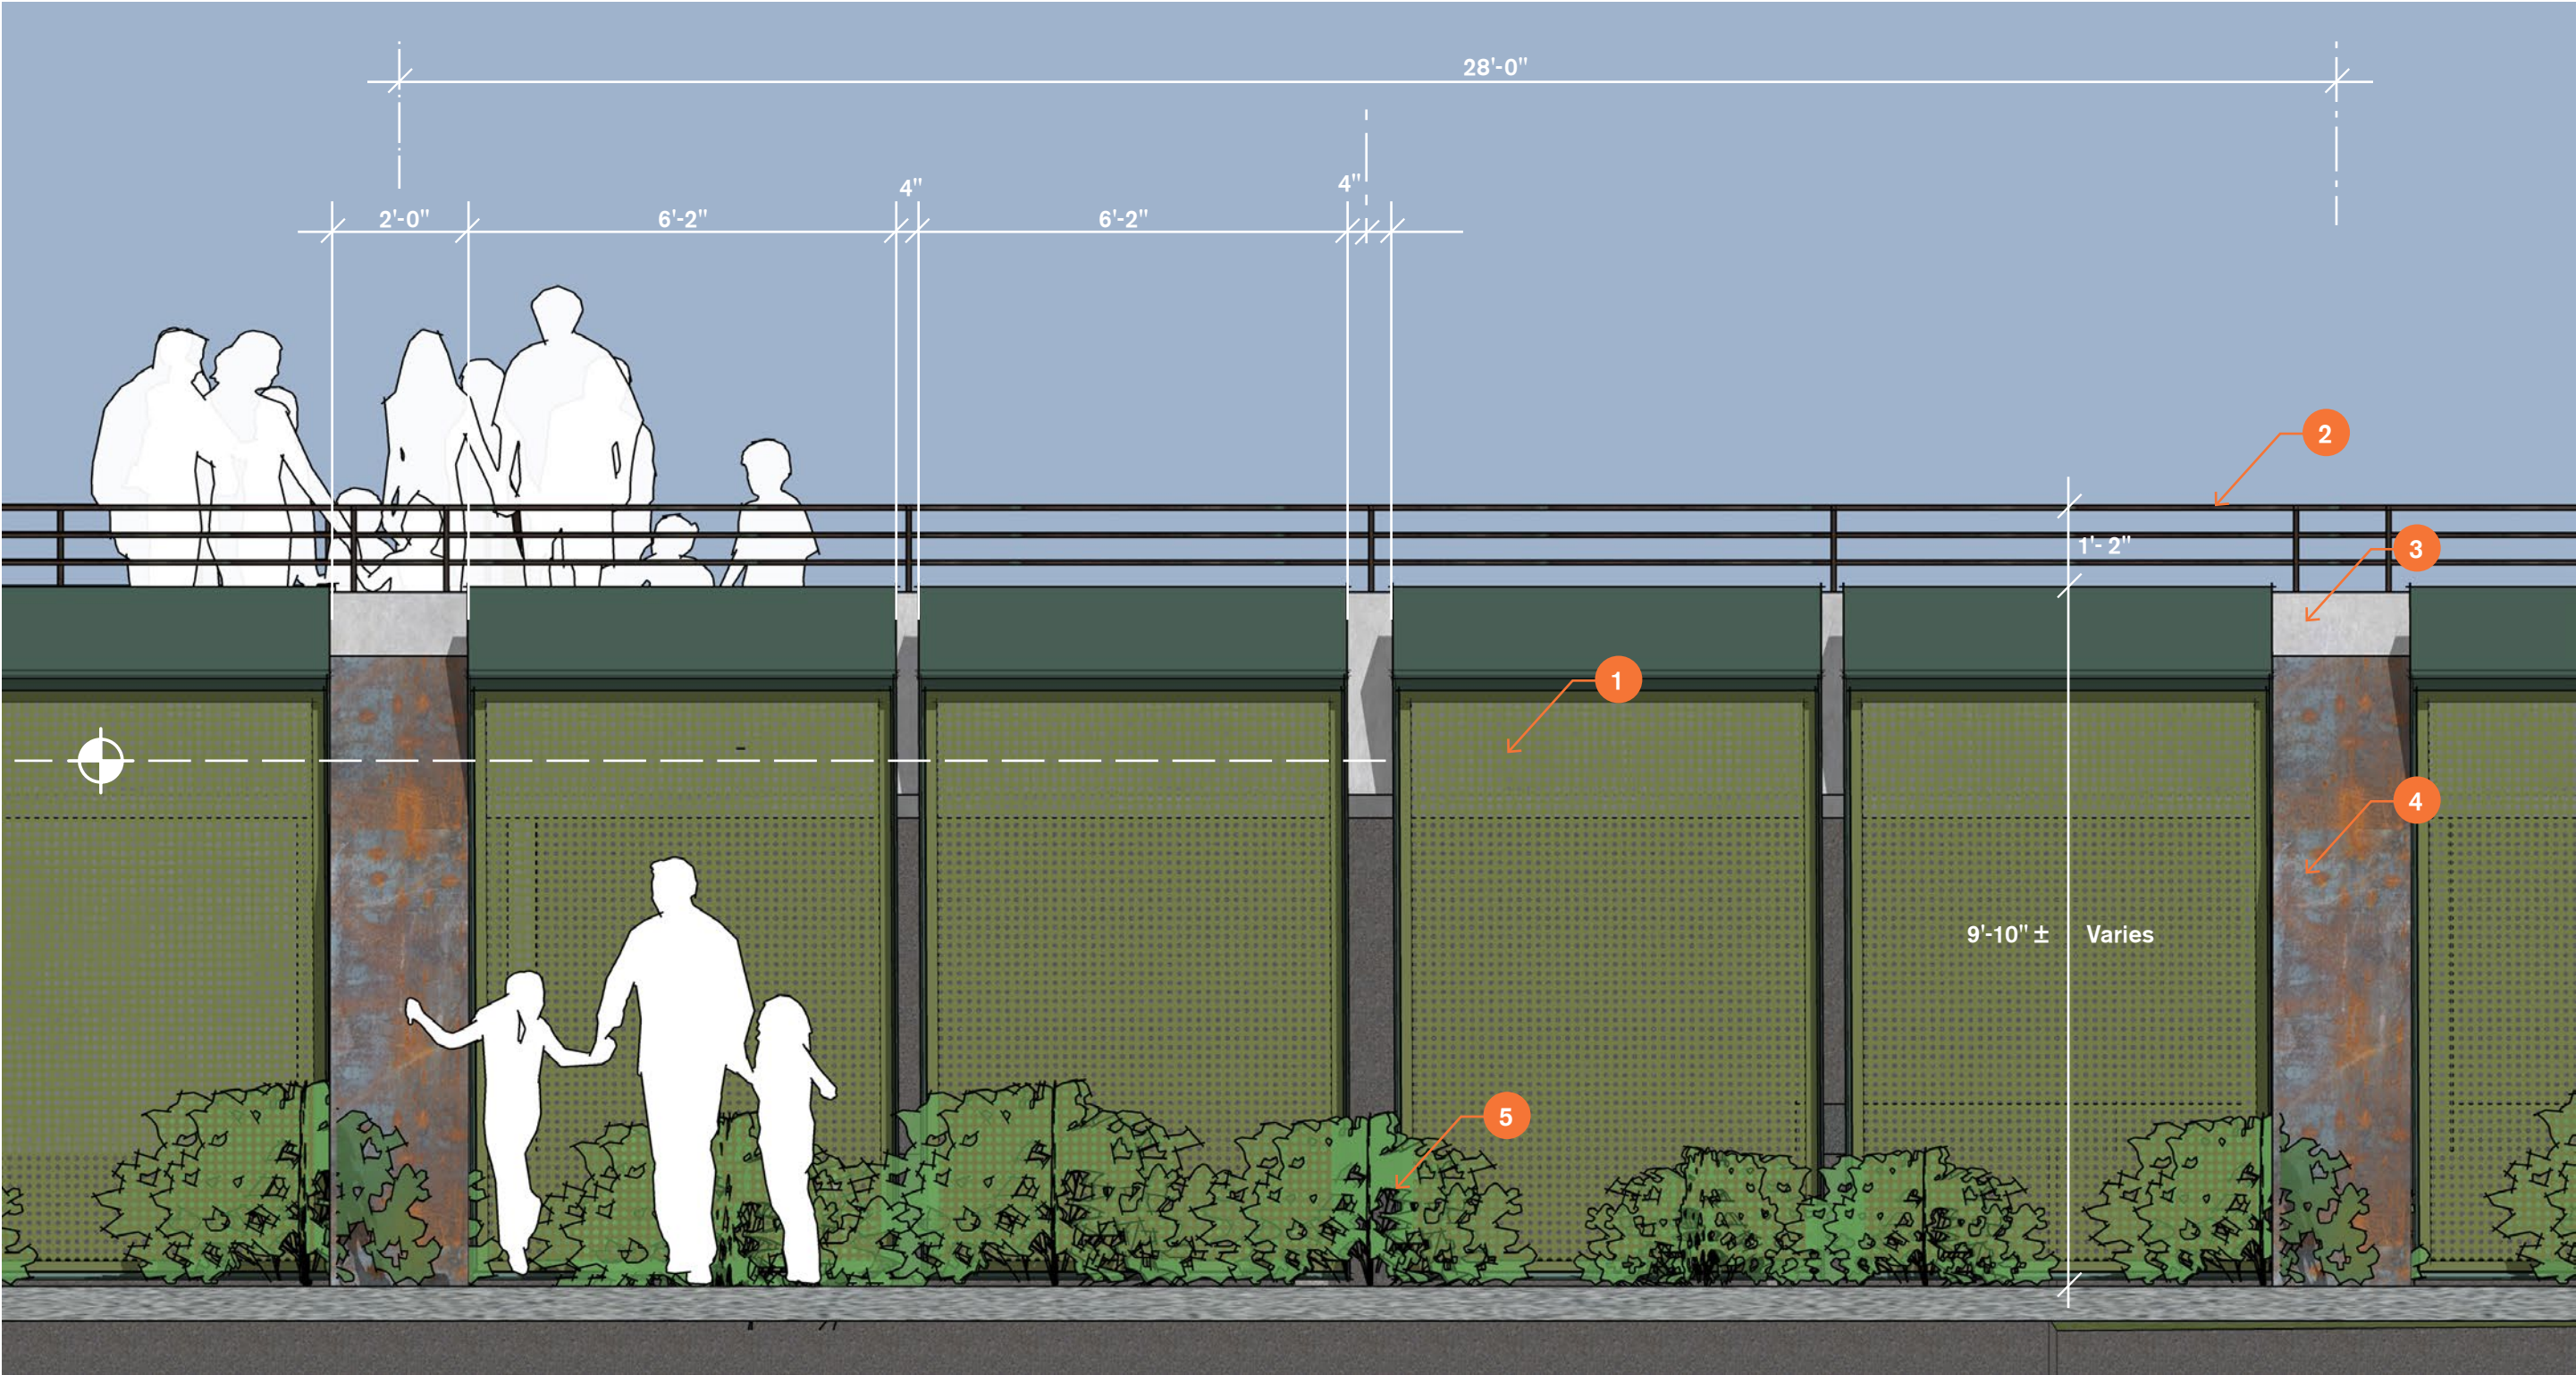
Mini-matrix pattern 16ga perforated steel panel in steel angle frame. Powder coat paint finish
- 2

Metal rail to code
- 3

Concrete vehicle restraining upturn wall beyond
- 4

Metal panel pilaster
- 5

New landscape planting from sidewalk edge to base of garage

Detail at typical bay.

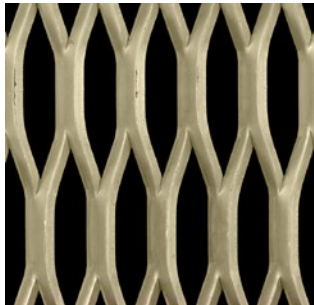
4 Expanded aluminum
security panel,
P3 paint

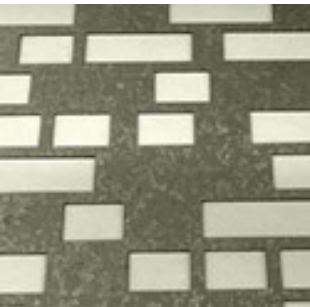
5 Perforated metal
panel, P2 paint

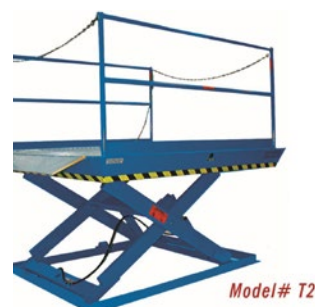
9 Dock lift

- 1 Face of existing concrete orthogonal pier beyond
- 2 New 5,000lb capacity Recessed Dock Lift (shown dashed in maximum open position). Mfr: Advance Lifts Model # T2-50608
- 3 Existing Building to remain -- no changes
- 4 2" hinged expansion joint
- 5 Saw-cut 1993 slab
- 6 New concrete wall at west side of planter beyond
- 7 New 12" concrete slab (Garage roof) sloped at x/1'
- 8 Removed 1993 concrete slab and loading dock

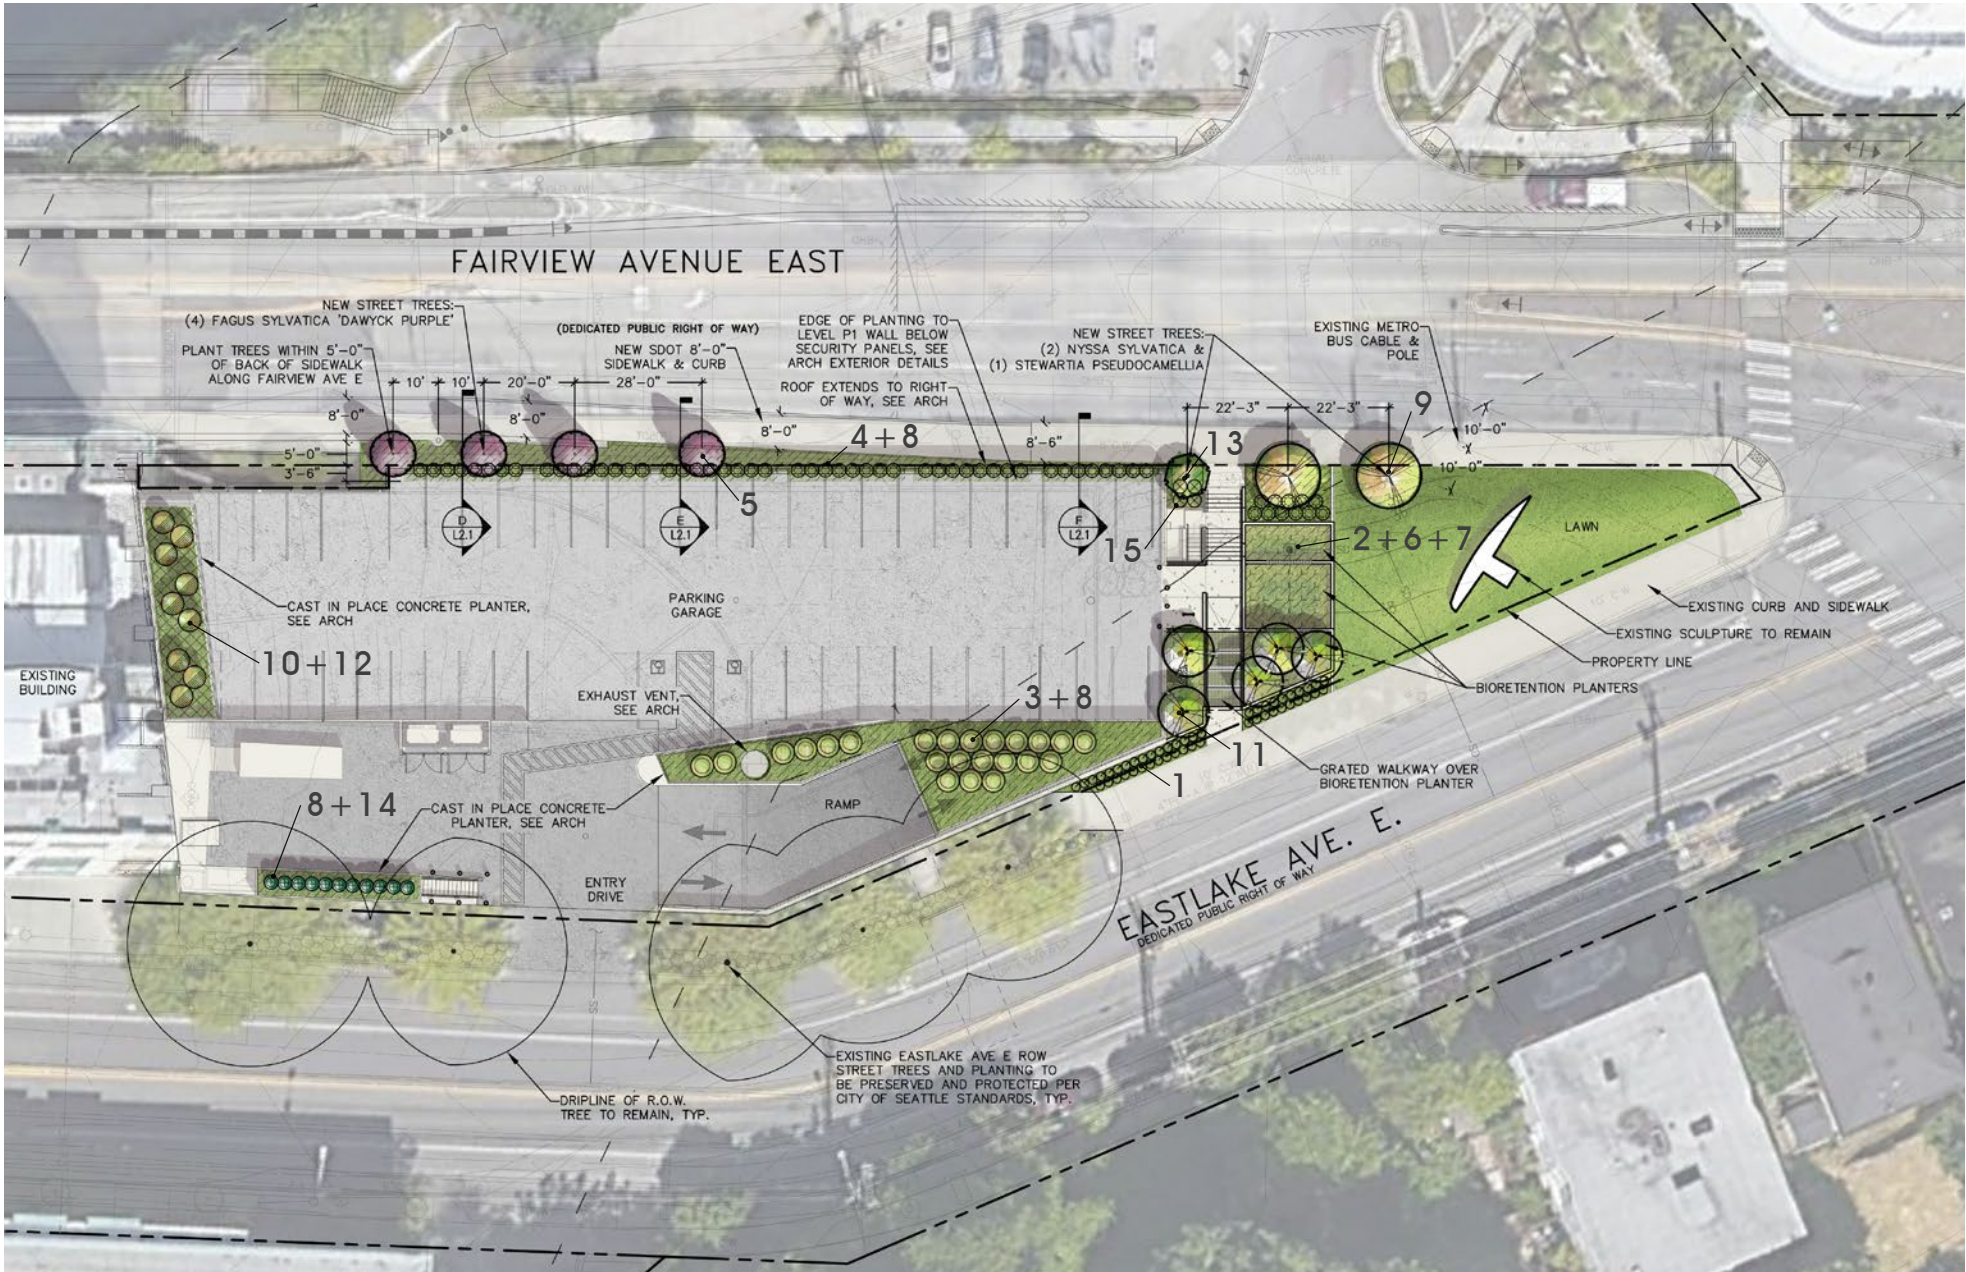
SITE LANDSCAPE

TREE REPLACEMENT SUMMARY

TOTAL TREE CANOPY REMOVED: 2,620 SF

TREE REPLACEMENT CANOPY PROVIDED ON-SITE: 2,826 SF	
4	EUROPEAN BEECH X 113 SF CANOPY =452 SF
2	SOUR GUM X 314 SF CANOPY =628 SF
5	CASCARA X 314 SF CANOPY =1,570 SF
1	JAPANESE STEWARTIA X 176 SF CANOPY =176 SF

SYM	QTY	DESCRIPTION
	4	FAGUS SYLVATICA 'DAWYCK PURPLE' (EUROPEAN BEECH) *12' DIAMETER MATURE CANOPY (113 SF)
	2	NYSSA SYLVATICA 'BLACK TUPELO' (SOUR GUM) *20' DIAMETER MATURE CANOPY (314 SF)
	5	RHAMNUS PURSHIANA (CASCARA) *20' DIAMETER MATURE CANOPY (314 SF)
	1	STEWARTIA PSEUDOCAMELLIA (JAPANESE STEWARTIA) *15' DIAMETER MATURE CANOPY (176 SF)

TREE ID	SCIENTIFIC NAME	COMMON NAME	DBH (inches)	RETAIN	REMOVE
1083	Acer macrophyllum	Bigleaf Maple	30.2		X
1084	Acer macrophyllum	Bigleaf Maple	31.9		X
1085	Acer macrophyllum	Bigleaf Maple	44.0		X

The tree replacement summary and exceptional tree list is based on the arborist report prepared by Tree Solutions Inc, dated 05.09.2019

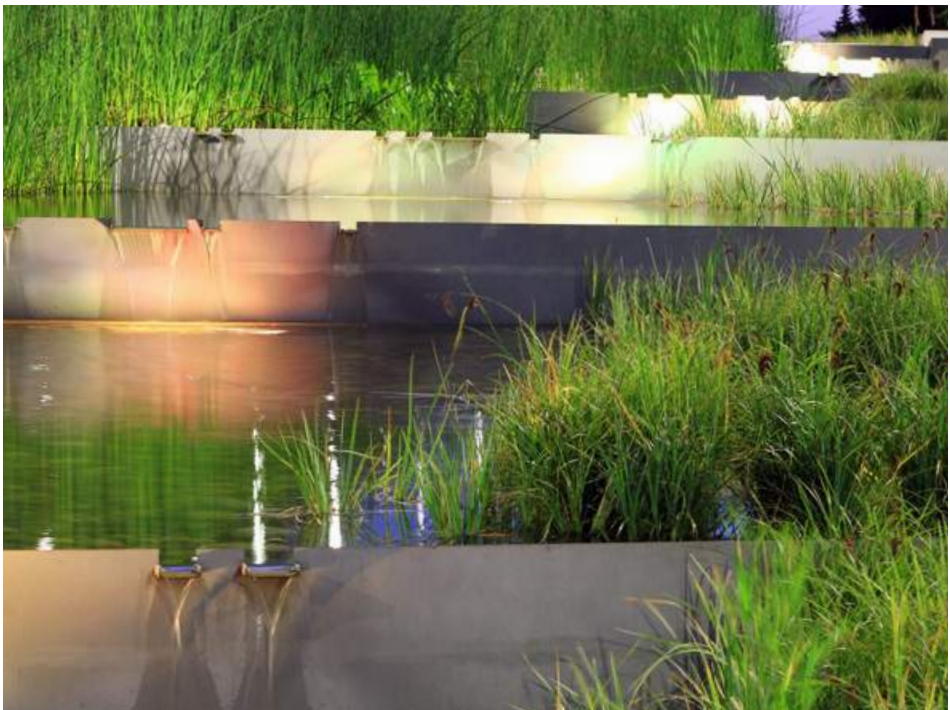
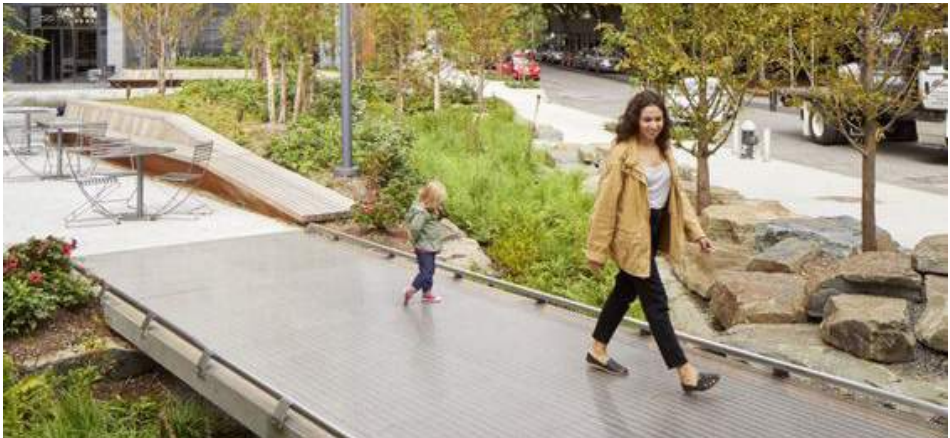
Concept Sketch

The pedestrian experience at the corner of Eastlake Ave E and Fairview Ave N is enhanced by bioretention planters. The terraced planters detain stormwater from the new parking garage and flow into one another via functional weirs. A grated walkway extends over the first planter in the series of three, providing access to the parking garage and concrete stairs down to Fairview Ave N.

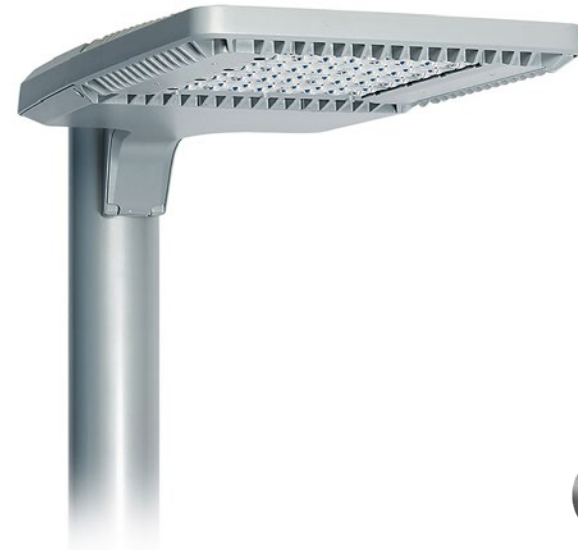
EcoForm small LED area luminaire

Site & Area Poles: 4" Straight Square Steel with White Paint Finish

Finish: Bronze

Location: Roof Parking

Type: P5

Manufacturer: Lightolier/SIGNIFY

Color: 4000K

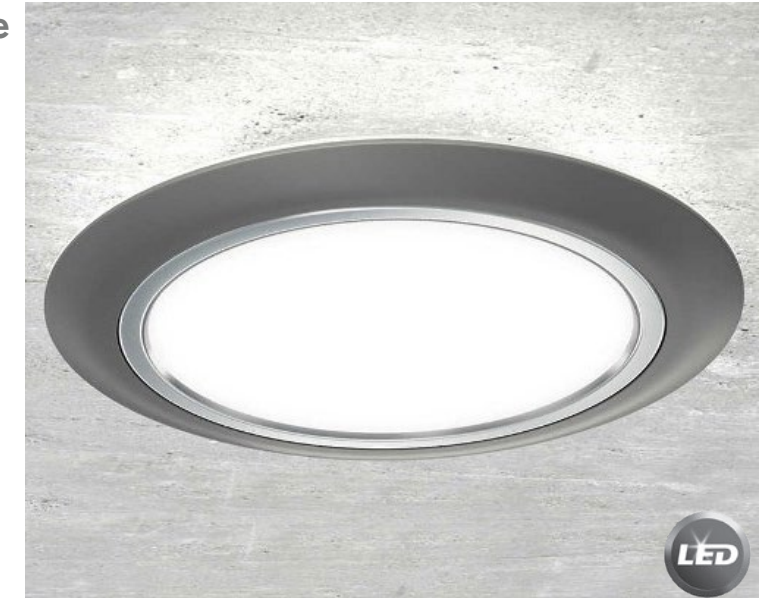
SoftView LED parking garage luminaire

Finish: White

Location: Level P2, Level P1

Types: P5, P1, P1A, P5A

Manufacturer: Gardco/SIGNIFY

Color: 4000K
