301 BELMONT

3032784-LU

Design Review Recommendation

12 November 2020

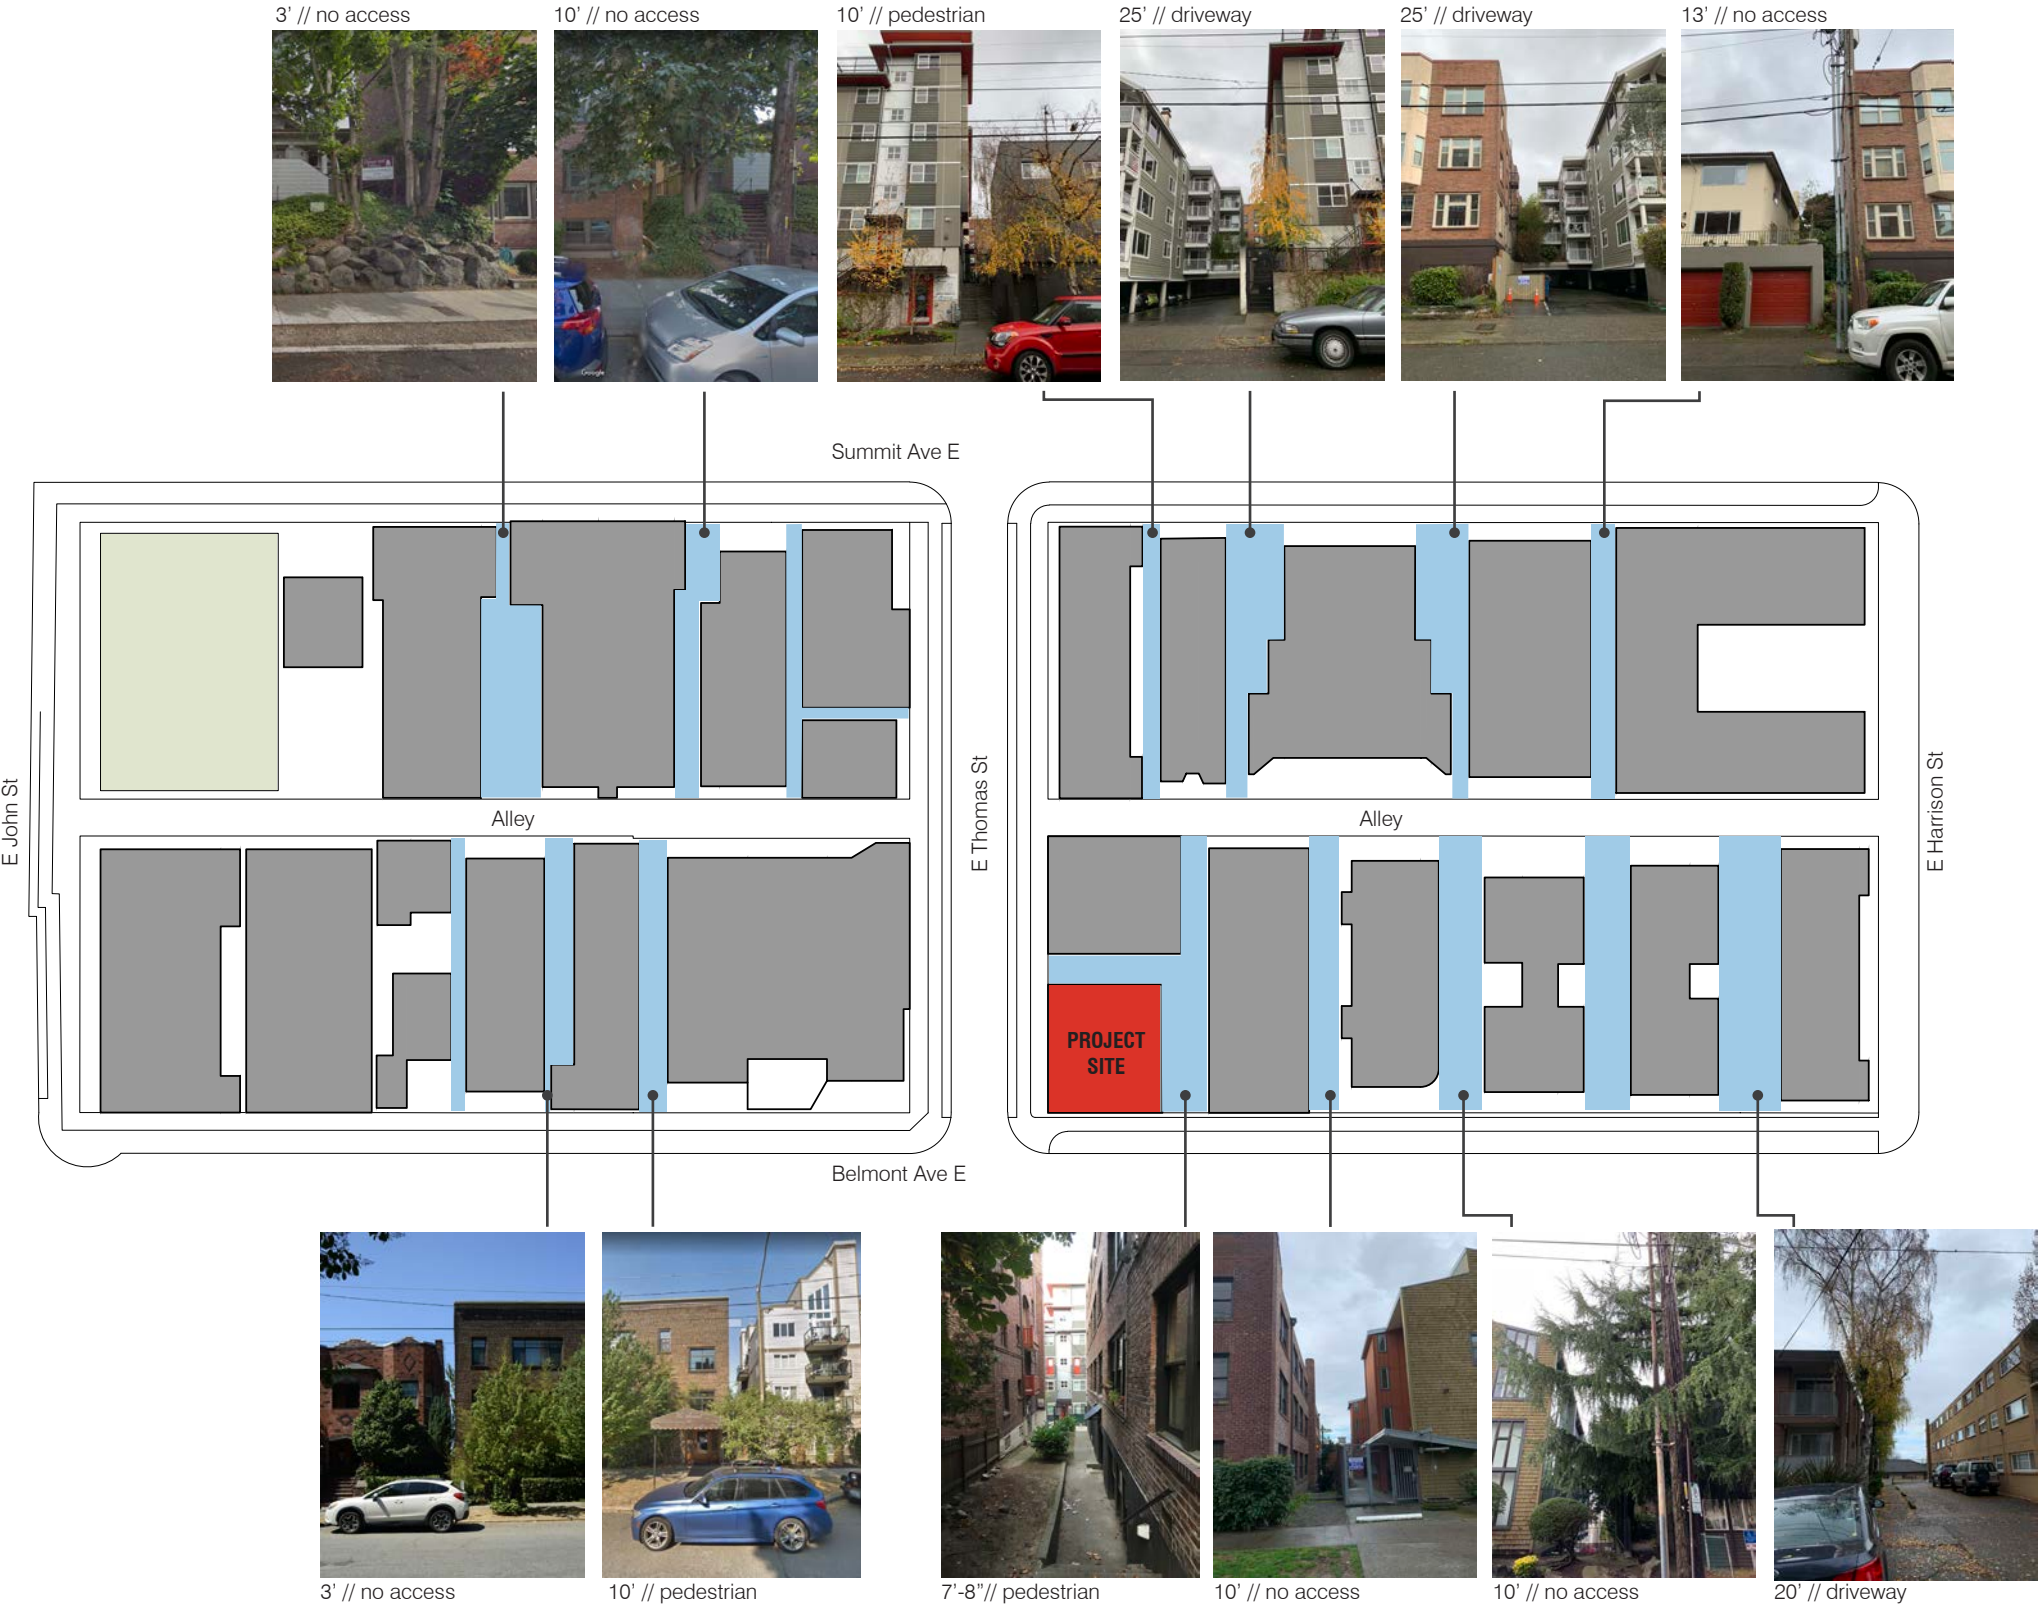
setbacks analysis

The project site is a small corner lot that does not abut an alley. Instead, both interior lot lines abut existing three-story twentieth century walk-up apartment buildings. These interior lot lines are, in effect, side lot lines. The existing seven and a half foot wide side yard to the north is currently used for street to alley through lot access via a paved pathway. The existing three foot wide side yard to the west is used for general access on the project site and is currently landscaped with minimal ground cover.

The separation between structures along interior lot lines is typically ten feet wide with exceptions that are as narrow as three feet when a building abuts a lot line and as wide as twenty-five feet when used for vehicle access and parking.

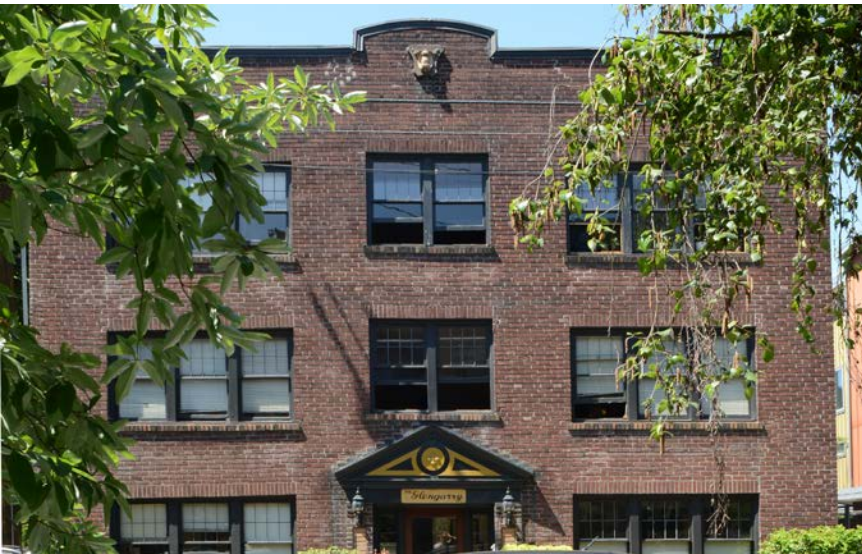
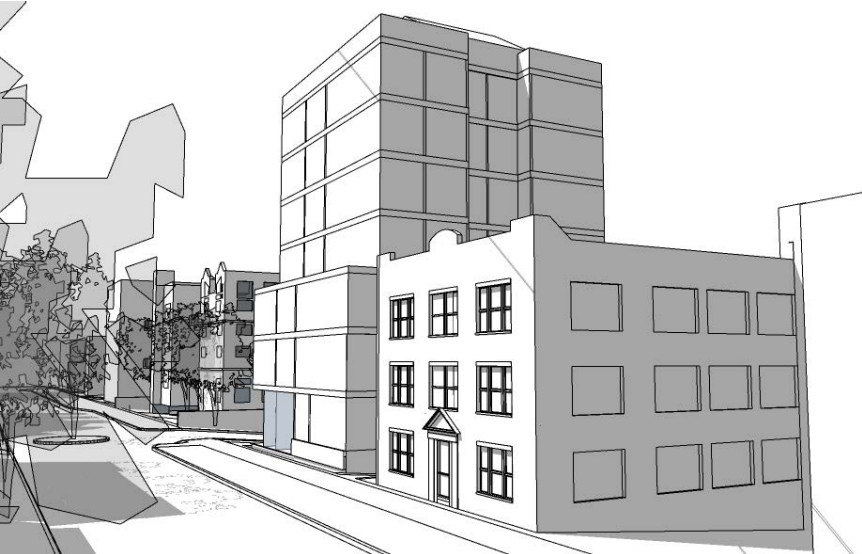
DATUMS

The overhead powerline setback along the east frontage provides an opportunity to define a strong horizontal relationship between the project and the adjacent building to the north. On the south façade, a more subtle datum can be introduced through the scale and rhythm of fenestration to allow the project to hold the street frontage while addressing the three-story scale of the building to the west. A street level datum that locates dwelling units three to five feet above sidewalk grade introduces vertical separation between the public realm and interior living space.

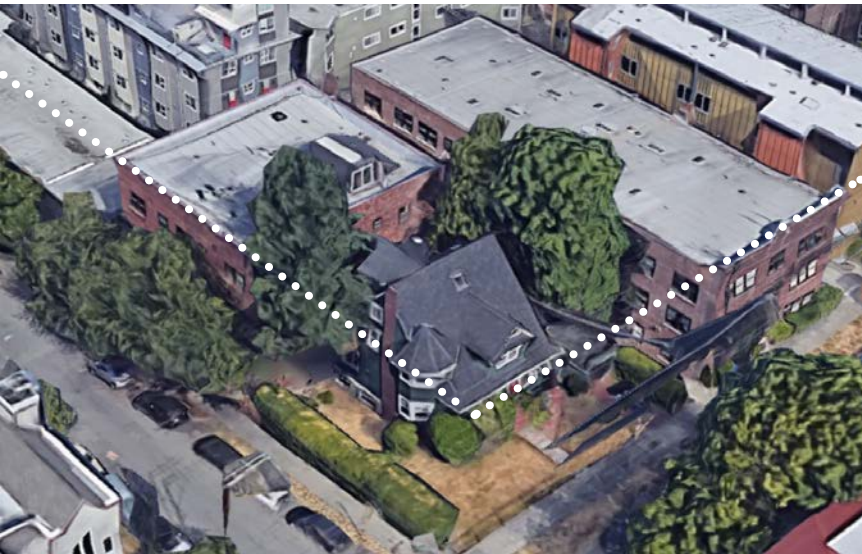
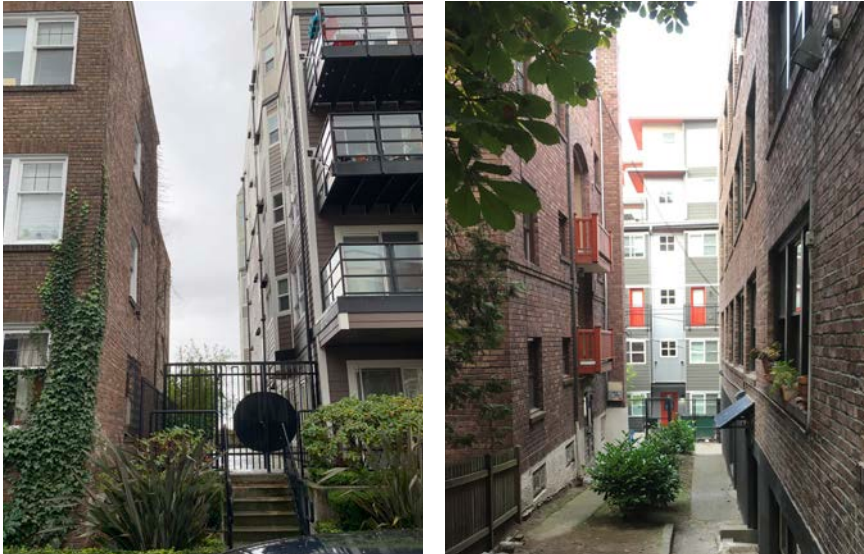
EQUITABLE OPEN SPACE

If allowed flexibility in the setback definition and requirement, the building mass can be located to match the open space volume required by code while more equitably distributing open space along the adjacent interior lot lines. This creates an expansion of the west side setback that benefits both neighboring structures and creates a dynamic architectural form. The structure to the west has two times the required setback for its full height. The widening of the west setback creates a narrower proposed massing that allows more daylight through to the north.

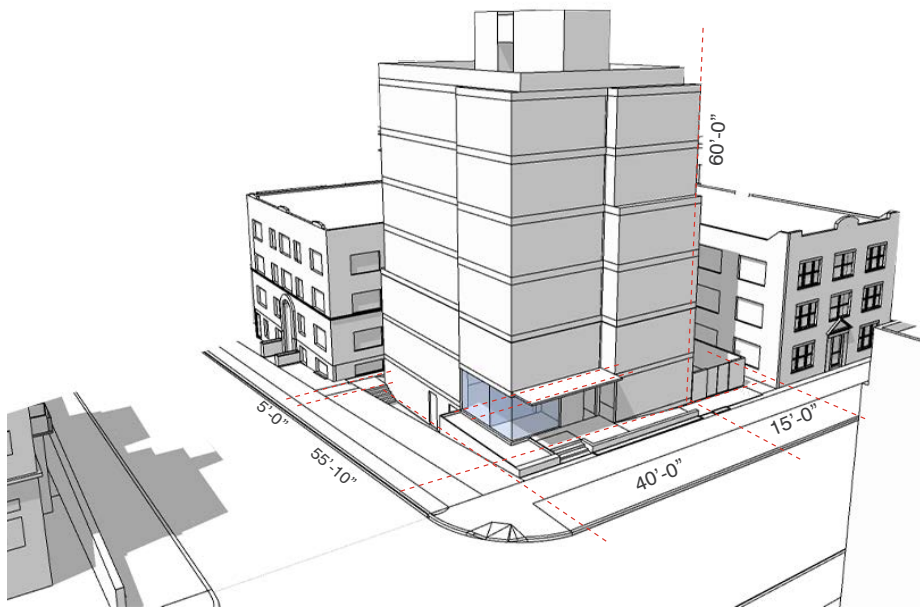
straight up // alternate A // conforming

Alternative A provides required street, side, and rear setbacks and preserves the exceptional Horse Chestnut. The preservation of the tree requires the rear setback to be located along the north lot line. If limited to six stories, a single exit stair can be used as long as certain additional life-safety provisions are provided and each floor is limited to four dwelling units. Providing a second exit stair to add an additional story results in an overall loss in dwelling units and residential area to the point the project is not feasible.

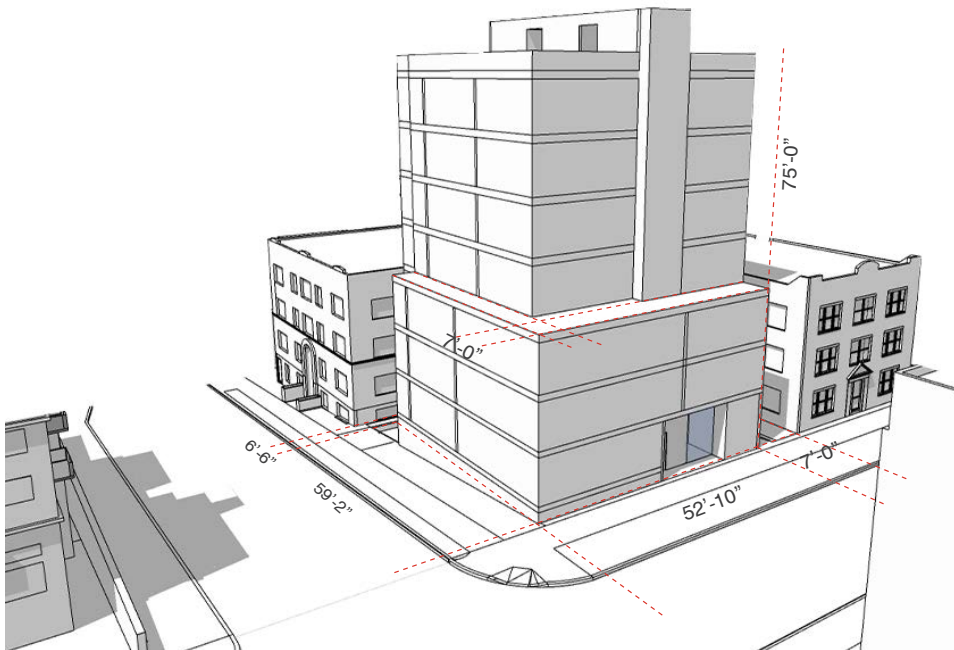
stepped tower // alternate B

Alternative B preserves the exceptional Horse Chestnut and requires departures for street and rear setbacks. The rear setback (north lot line) is treated like a side setback and meets the requirements for minimum and average side setbacks. Up to the third story, the project provides limited street setbacks to reinforce the strong urban edge of the block. Above the third story, the south facade is setback to meet the required street setback and the east facade is setback to meet the required overhead power and street setback.

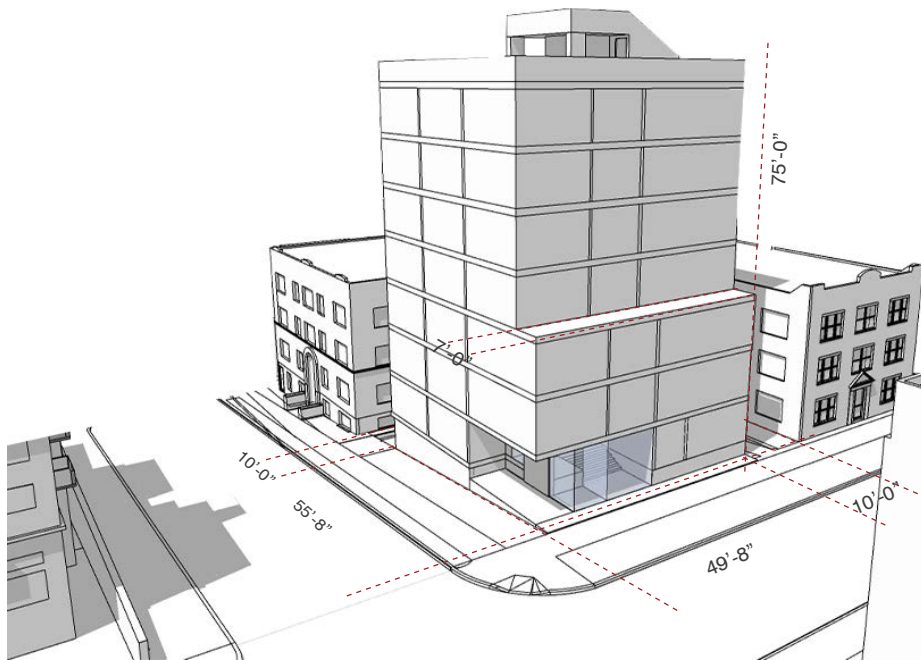
corner up // alternate C // preferred

Alternative C preserves the exceptional Horse Chestnut and requires departures for street and rear setbacks. The rear setback (north lot line) is treated like a side setback and exceeds the requirements for minimum and average side setbacks. Up to the third story, the project provides limited street setbacks to reinforce the strong urban edge of the block. Above the third story, the south facade maintains no street setback and the east facade is setback to meet the required overhead power and street setback.

a. The Board favored the proposed massing of alternate C, the applicant's preferred option, to move forward to a recommendation meeting with changes as recommended by the Board. The Board noted the datum lines and fenestration patterns of the preferred alternative were done well and responded appropriately to neighboring building context. To further illustrate how the building fits well into the existing context of the neighborhood the Board requested renderings in the recommendation packet showing how adjacent properties will view the proposed building. (CS2.D.5, CS2 Capitol Hill – III, CS3.A.2)

a. While the Board supported the applicant’s preferred massing option, alternate C, the Board observed the entry sequence from the sidewalk to the lobby had too many layers. The Board noted these layers acted as a barrier and recommended the entry sequence should be reworked to provide a better connection between the lobby and sidewalk. (CS2 Capitol Hill – II.i, PL2 Capitol Hill – I, PL3.A, PL4.A)

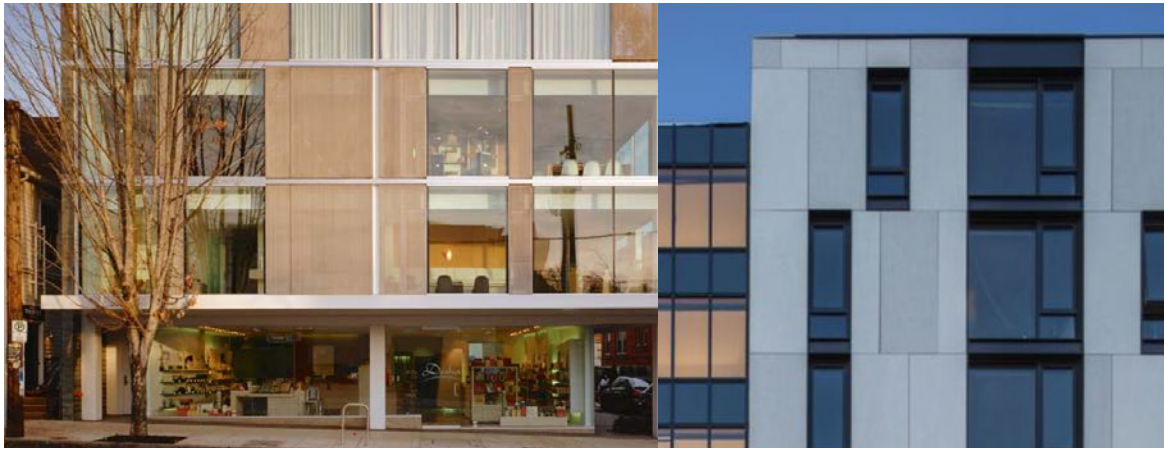
DOVETAIL TWO // Alternate 4

Windows that shift orientation on alternating floors creates a form of dovetailed variation in unit orientation. In the southwest units the first three floors are stacked and orient to the street to respect the neighboring building. This scheme introduces window groupings in the southwest unit as well as floor line expression within the window opening to add additional horizontal elements that provide a stronger definition of datums. The facade presents an overall expression of clear building form using cladding that is a hybrid of a uniform surface layered with story expression at window openings.

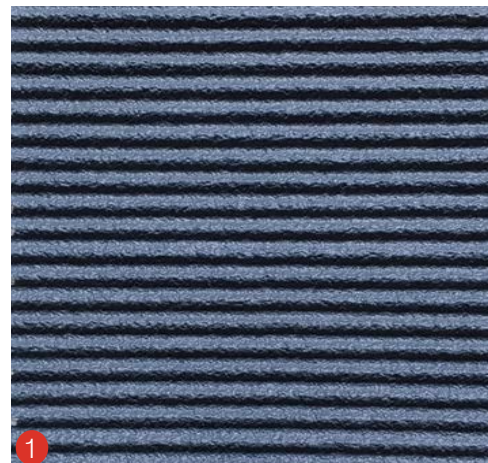
typ facades: Ceraclad zen garden
color: Midnight Blue

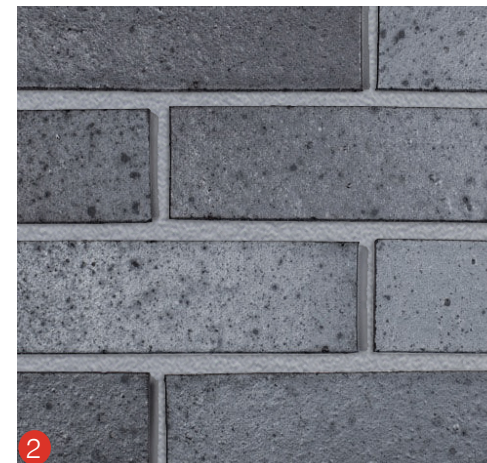
ground level street edge: manganese
ironspot modular brick
size: Modular 2-1/4" x 7-5/8"
finish: smooth

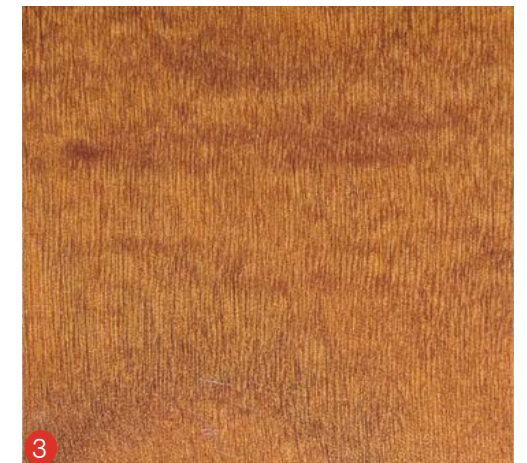
entry accent wall & entry soffit: Prodema
Prodex wood veneer composite
color: Rustix

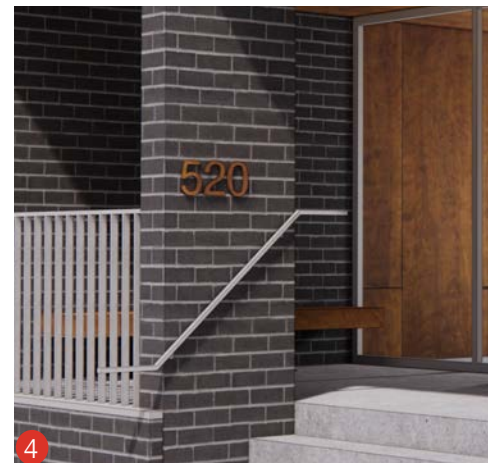
white painted steel handrail and panel at
entry

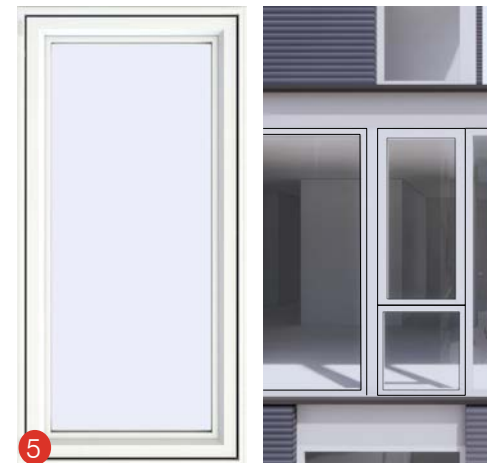
white vinyl windows & doors
spandrel white

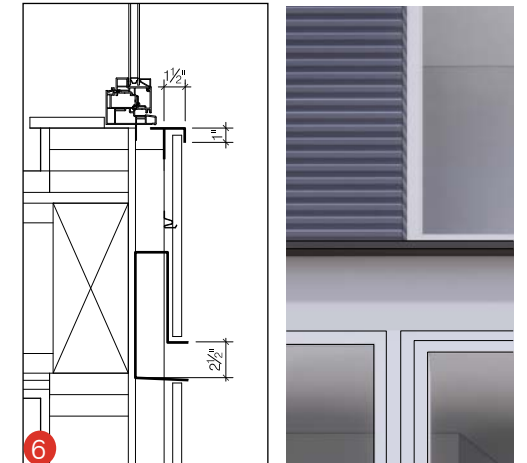
charcoal metal flashing

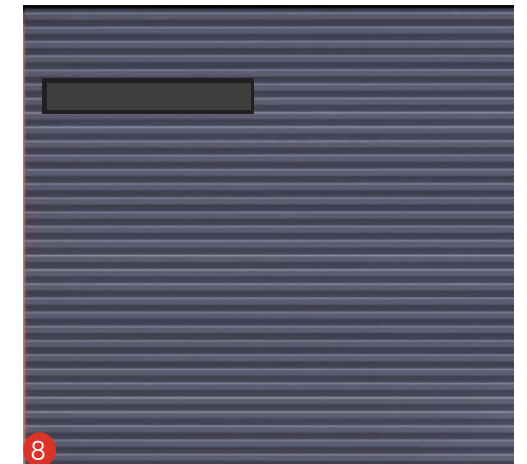
3" tall charcoal metal slot vent - widths vary

Exhaust venting will be narrow slot vents integrated into the ceramic composite panels. They will be a dark metal and present a tertiary level façade accent.

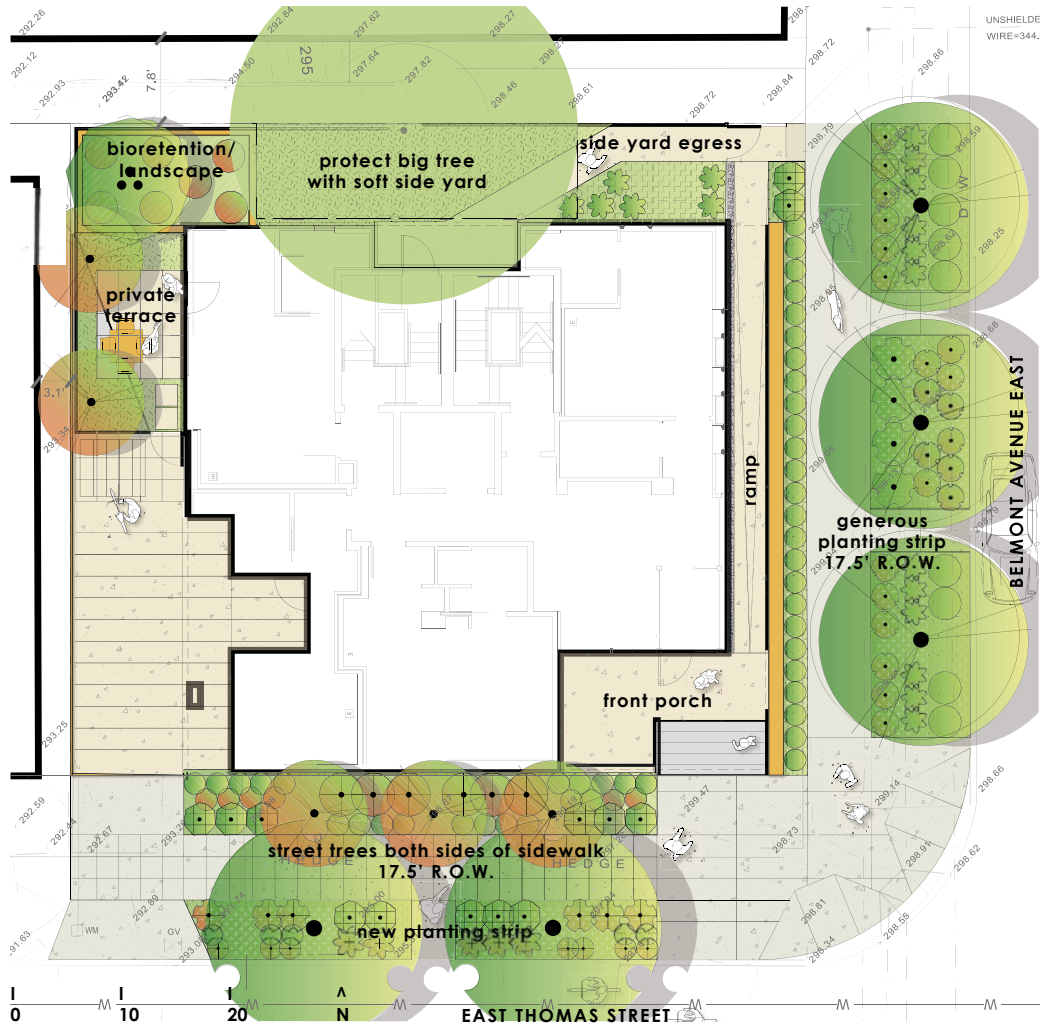
site plan

By eliminating vehicle parking, providing a short term loading space, and relocating the trash room to the southwest corner of the building, on site staging is not required. SPU will be able to wheel dumpsters directly out of the trash room to the street.

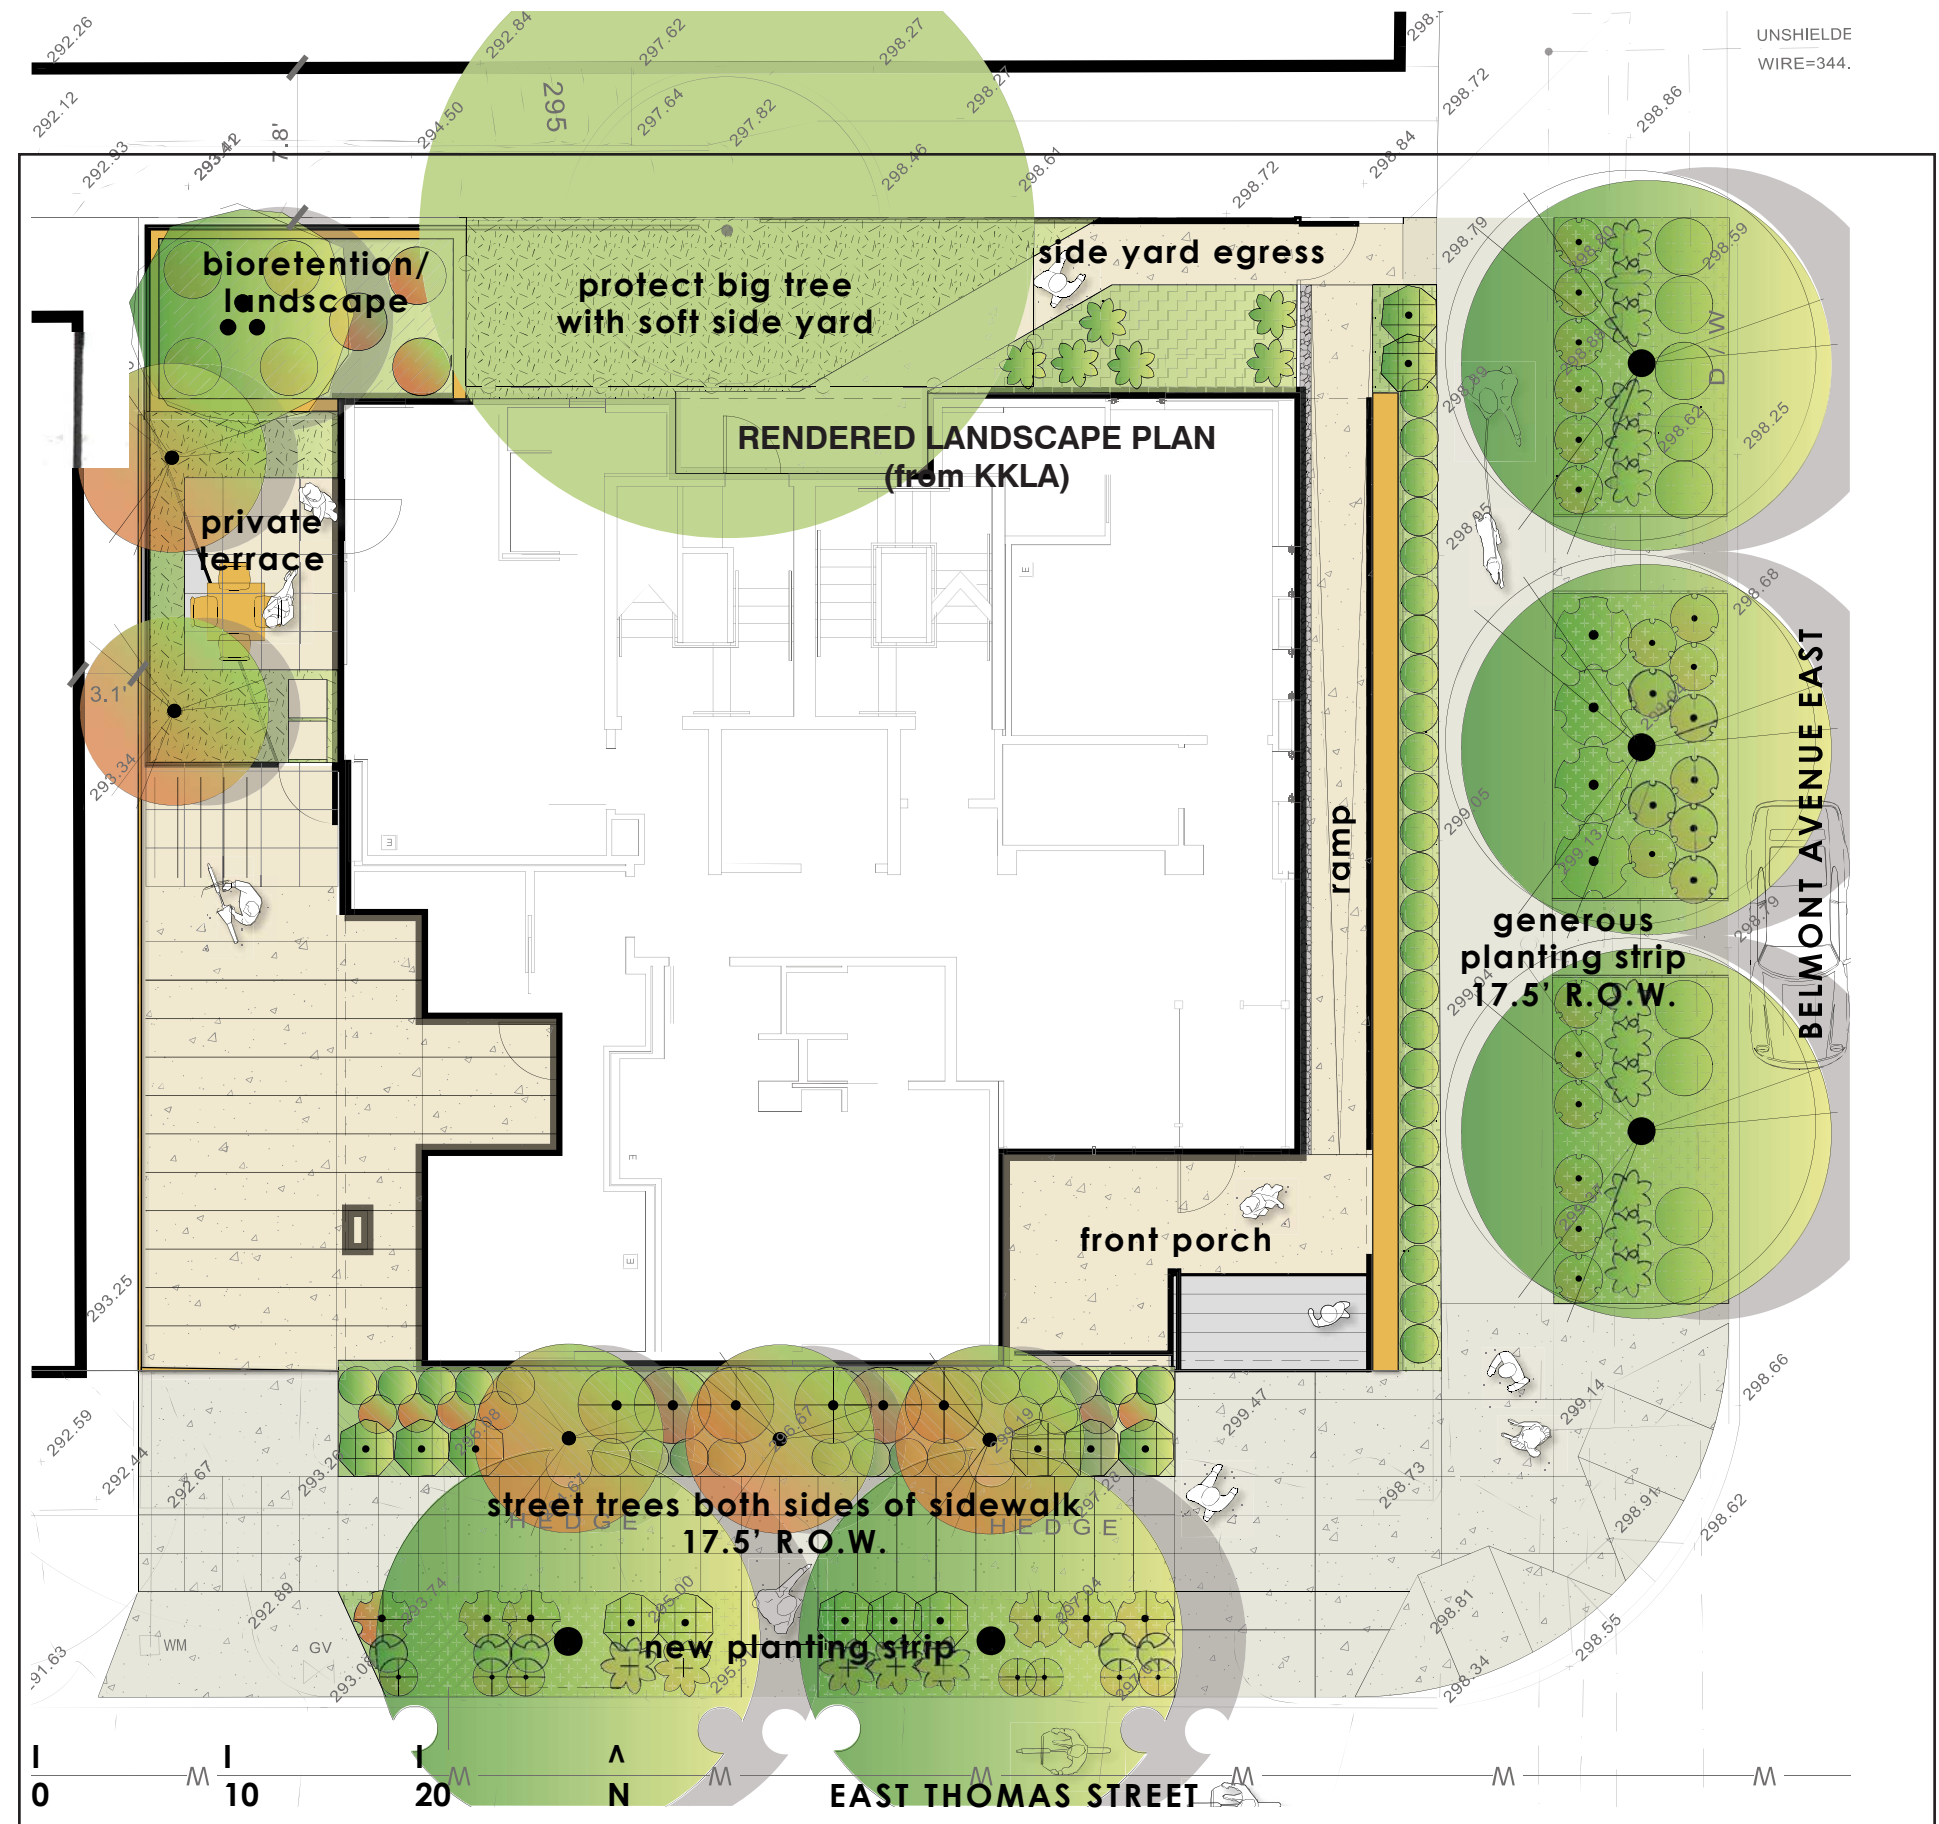
landscape -planting schedule

Flowering plants are incorporated in the landscape plan to attract pollinators. Pollinator plants include Coneflower, Sedum, Serviceberry, Spiraea and Vine Maple.

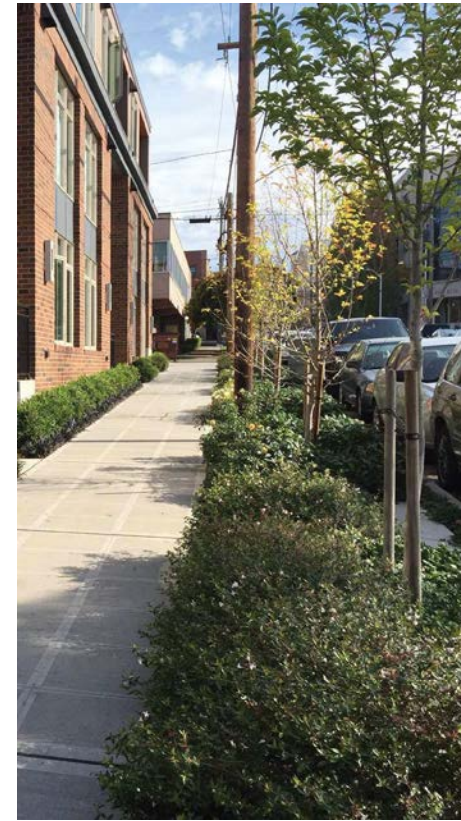
generous planting strip

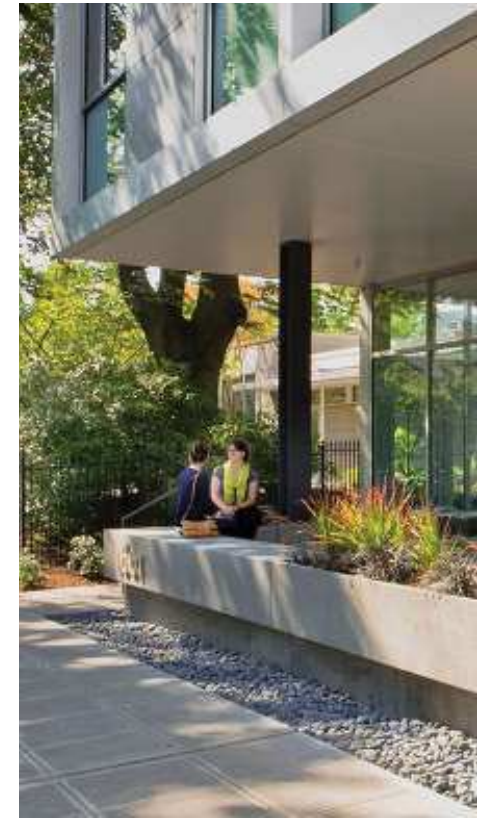
streetside ramp

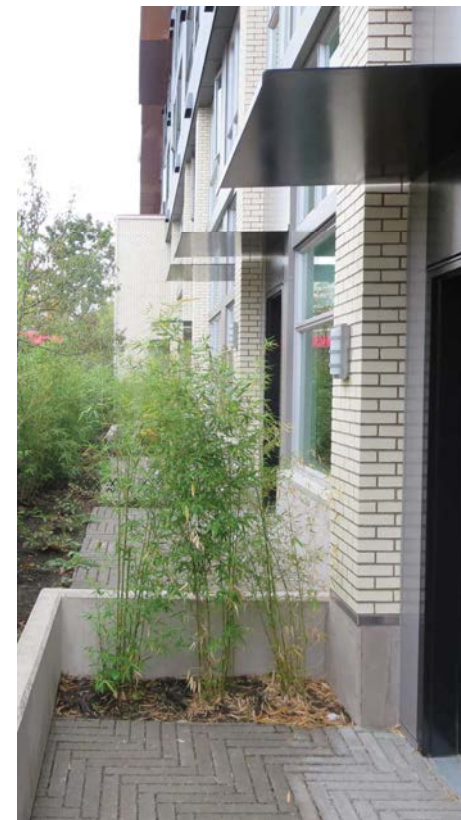
private side terrace

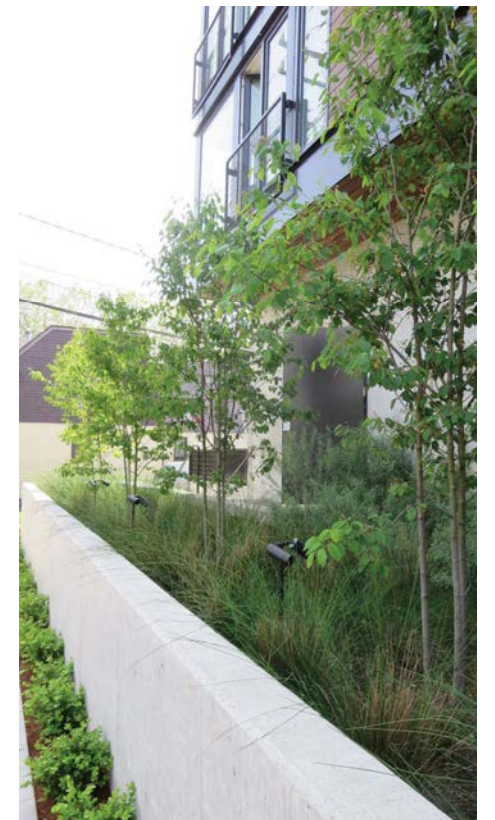
bioretention landscape

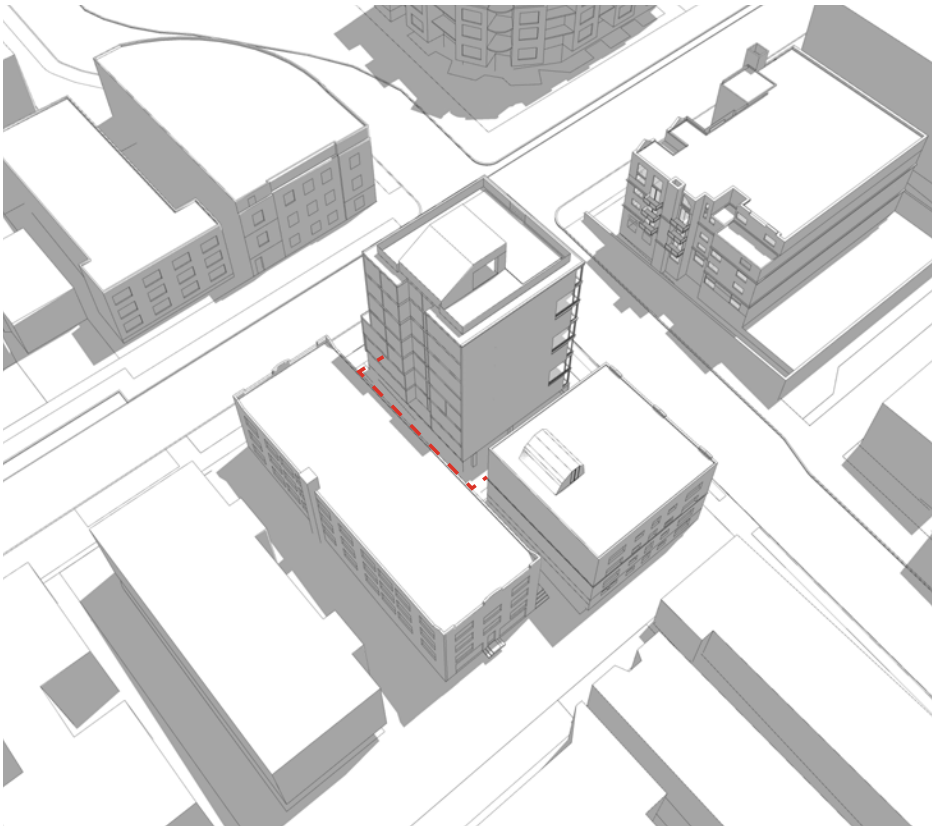
Autumn Solstice
12pm

Summer Solstice
12pm

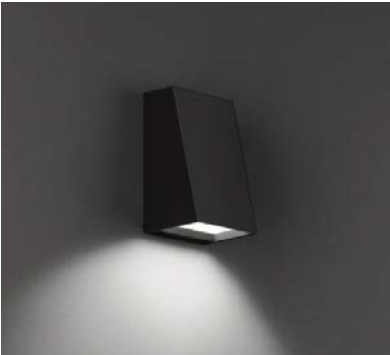
A - downlight wall mounted

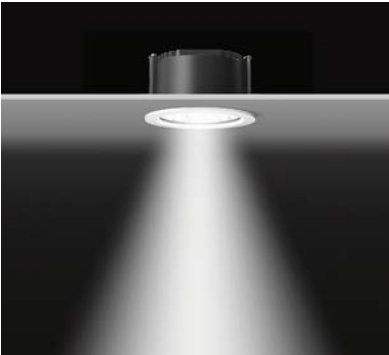
B - recessed downlight

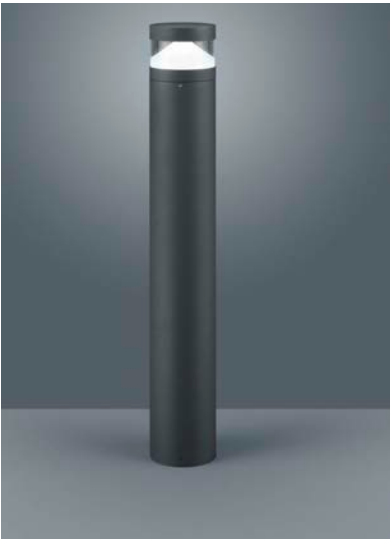
C- bollard

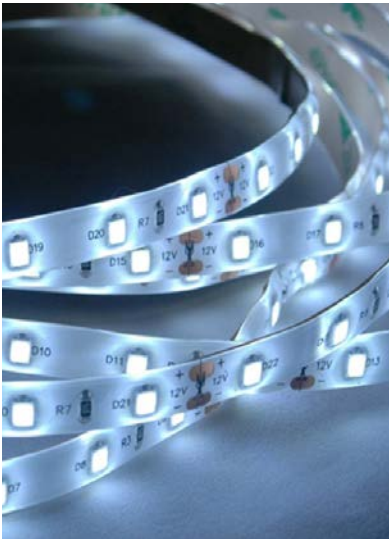
D - recessed LINEAR led cove

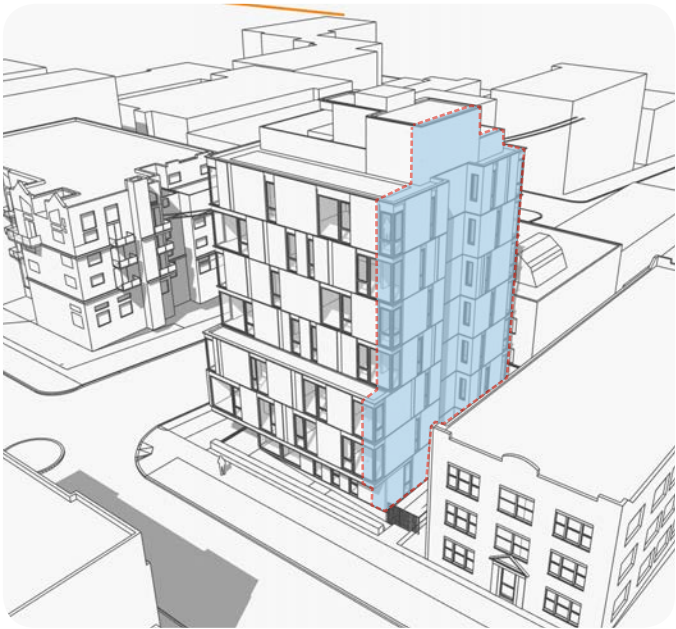
diagram // region of departure

Allows the massing of the building to be arranged on a very small corner lot in a manner that is more contextually responsive.

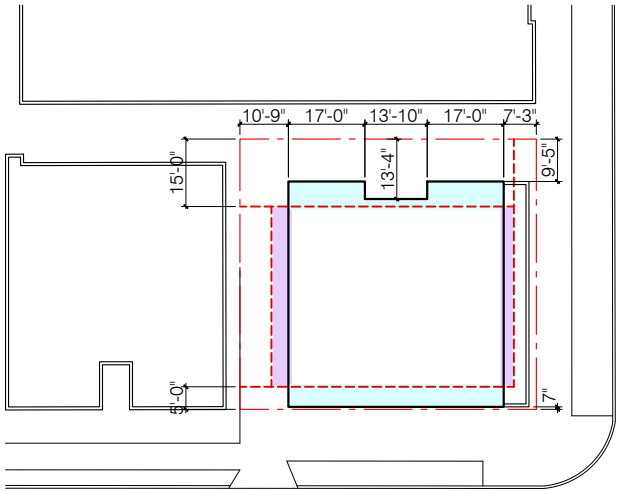
additional GFA // level 4 to 7

Additional GFA	411 sf
Unused GFA	236 sf
Total per story	175 sf

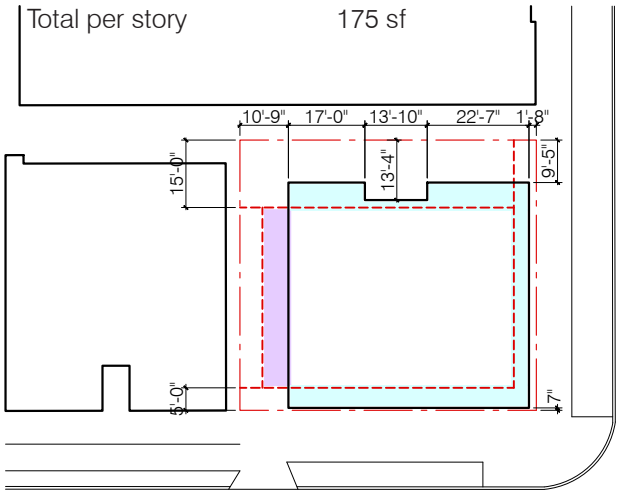
additional GFA // level 2 to 3

Additional GFA	599 sf
Unused GFA	226 sf
Total per story	373 sf

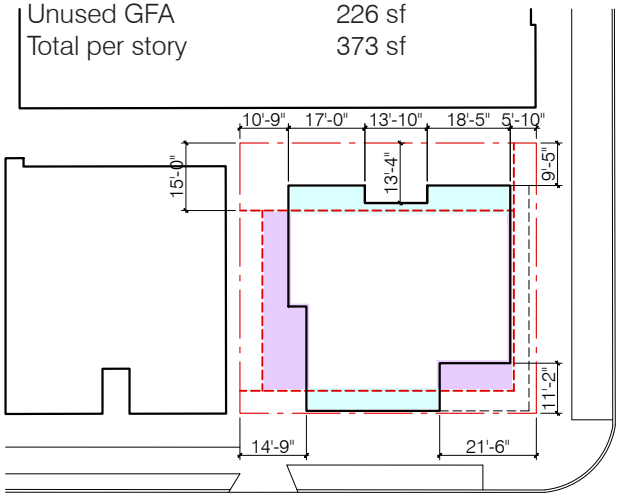
additional GFA // ground level

Additional GFA	338 sf
Unused GFA	428 sf
Total	(90) sf

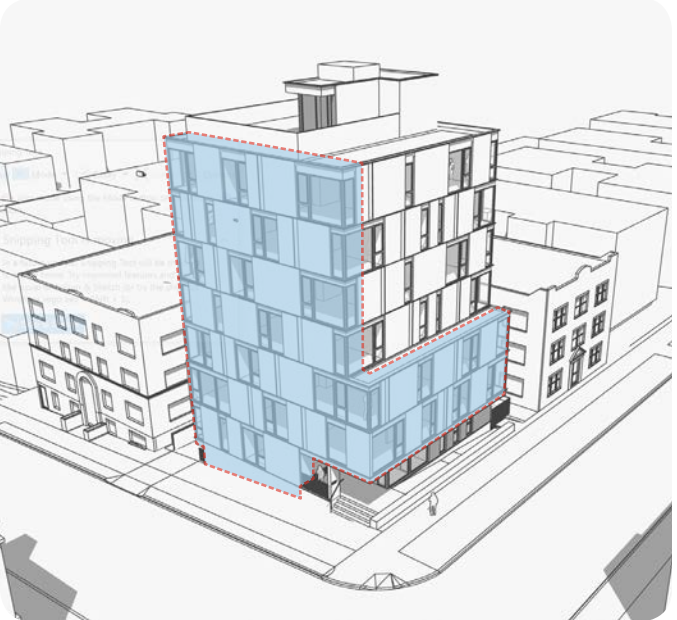
diagram // region of departure

- To locate the south facade of the structure 7" from the lot line and the east facade of the structure, at levels two and three, 1'-8" from the lot line in order to,
- extend the prevailing urban edge condition of the neighborhood.
 - equally distribute open space to both interior lot lines
 - provide a greater than required side setback in order to transfer building mass from the west side of building to the south side
 - expand the separation between structures and to reduce the east/west bulk of the project.

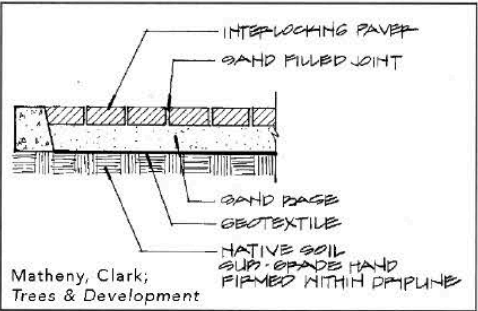
FIGURE 8.4 Brick or interlocking pavers on sand often are recommended as pervious paving. Use of geotextile under the sand and hand-firmed subgrade can minimize root impacts.

Walkway: In the areas where any walkway crosses inside a dripline, roots shall be exposed with air excavation – monitored by a certified arborist on site – following completion of all other construction. After review by the project arborist, the walkway shall be constructed with minimal impact to the existing roots. If the roots are found to be minimal, they shall be cut clean at the edge of the walkway location, covered with soil or arborist chips, and kept moist. If extensive roots are found, the walkways shall be constructed on top of existing grade with no root disturbance. Three to four inches of topsoil or compost may be applied to meet grade of the walkway edge, but kept away from the trunk. See detail.⁸

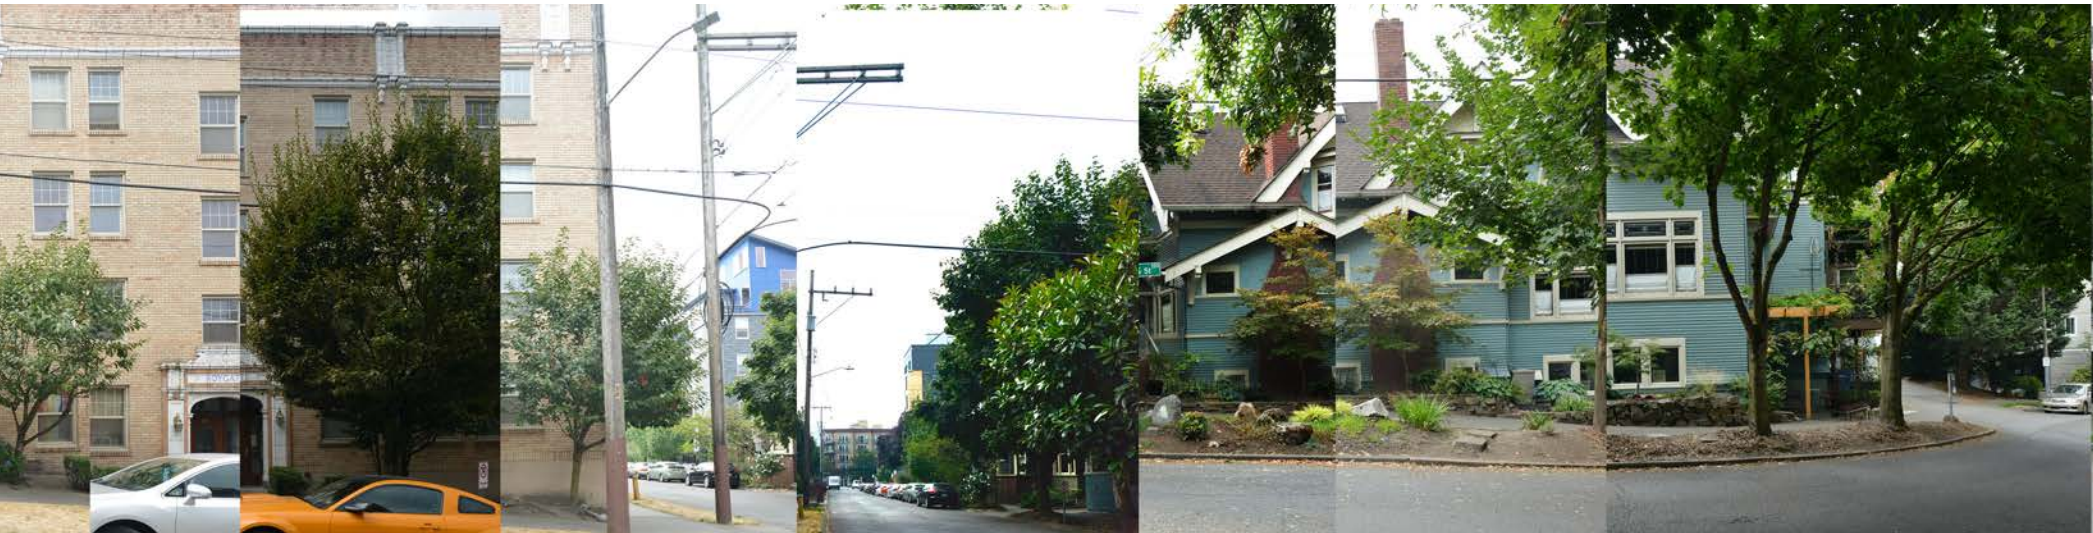
East Thomas Street
South Side

Brick masonry is found across all periods; with the extent diminishing with time. Early buildings were predominantly brick. More recent buildings deploy brick primarily as an accent.

Wood is also used across the different periods of buildings in a wide range of scales and quality. Narrow profile painted vertical grain fir bevel or t&g siding has given way to lesser quality cedar that is often stained.
