301 BELMONT

3032784-LU

Design Review Recommendation

12 November 2020

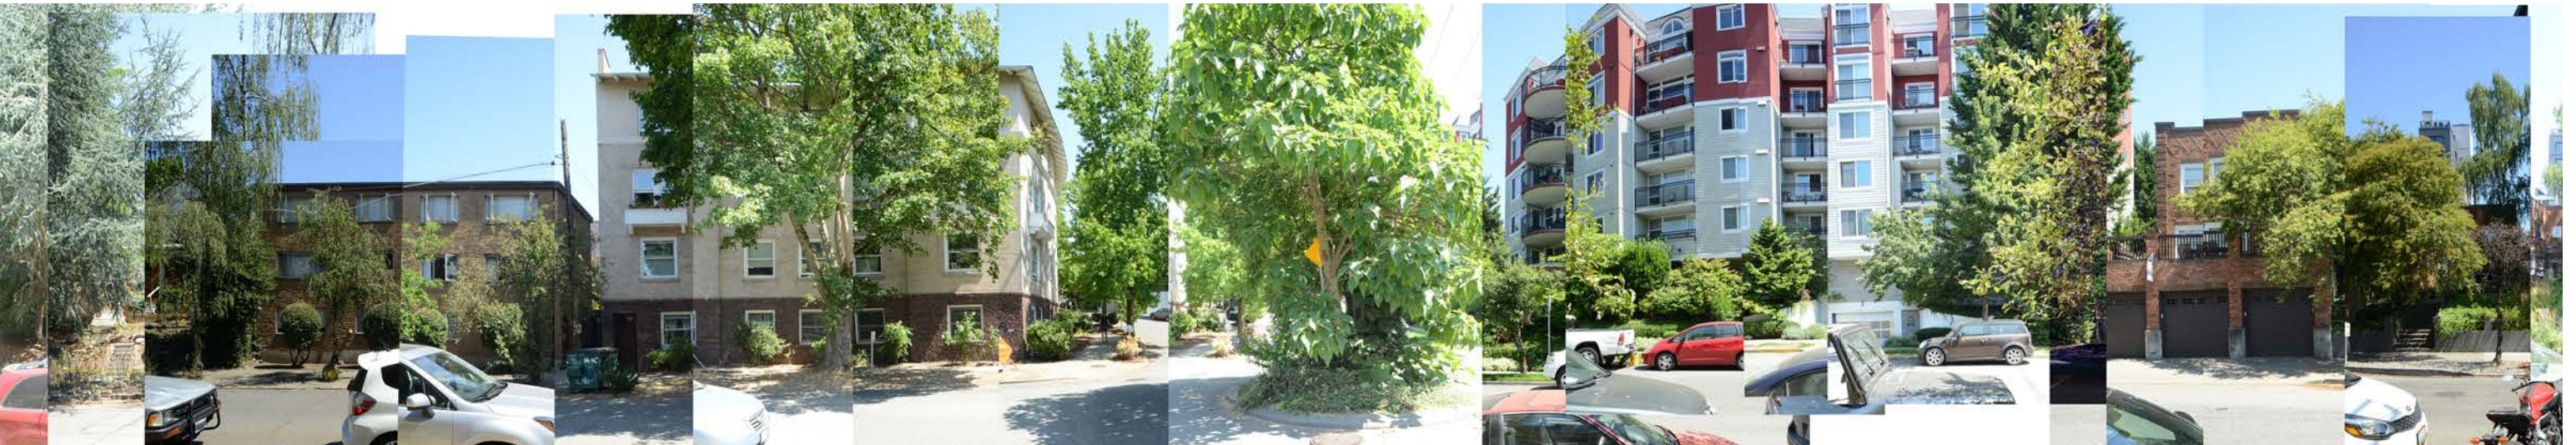
Across from site

Sand Remo // condominium
1906 // 4-story wood frame
punched windows

232 Belmont Ave // condominium
1994 // 6-story wood frame
punched window // balconies
