# ROY

**635 13th Avenue East**

SDCI numbers 3034042-EG // 6710766-CN

**Streamlined Design Review Submittal**

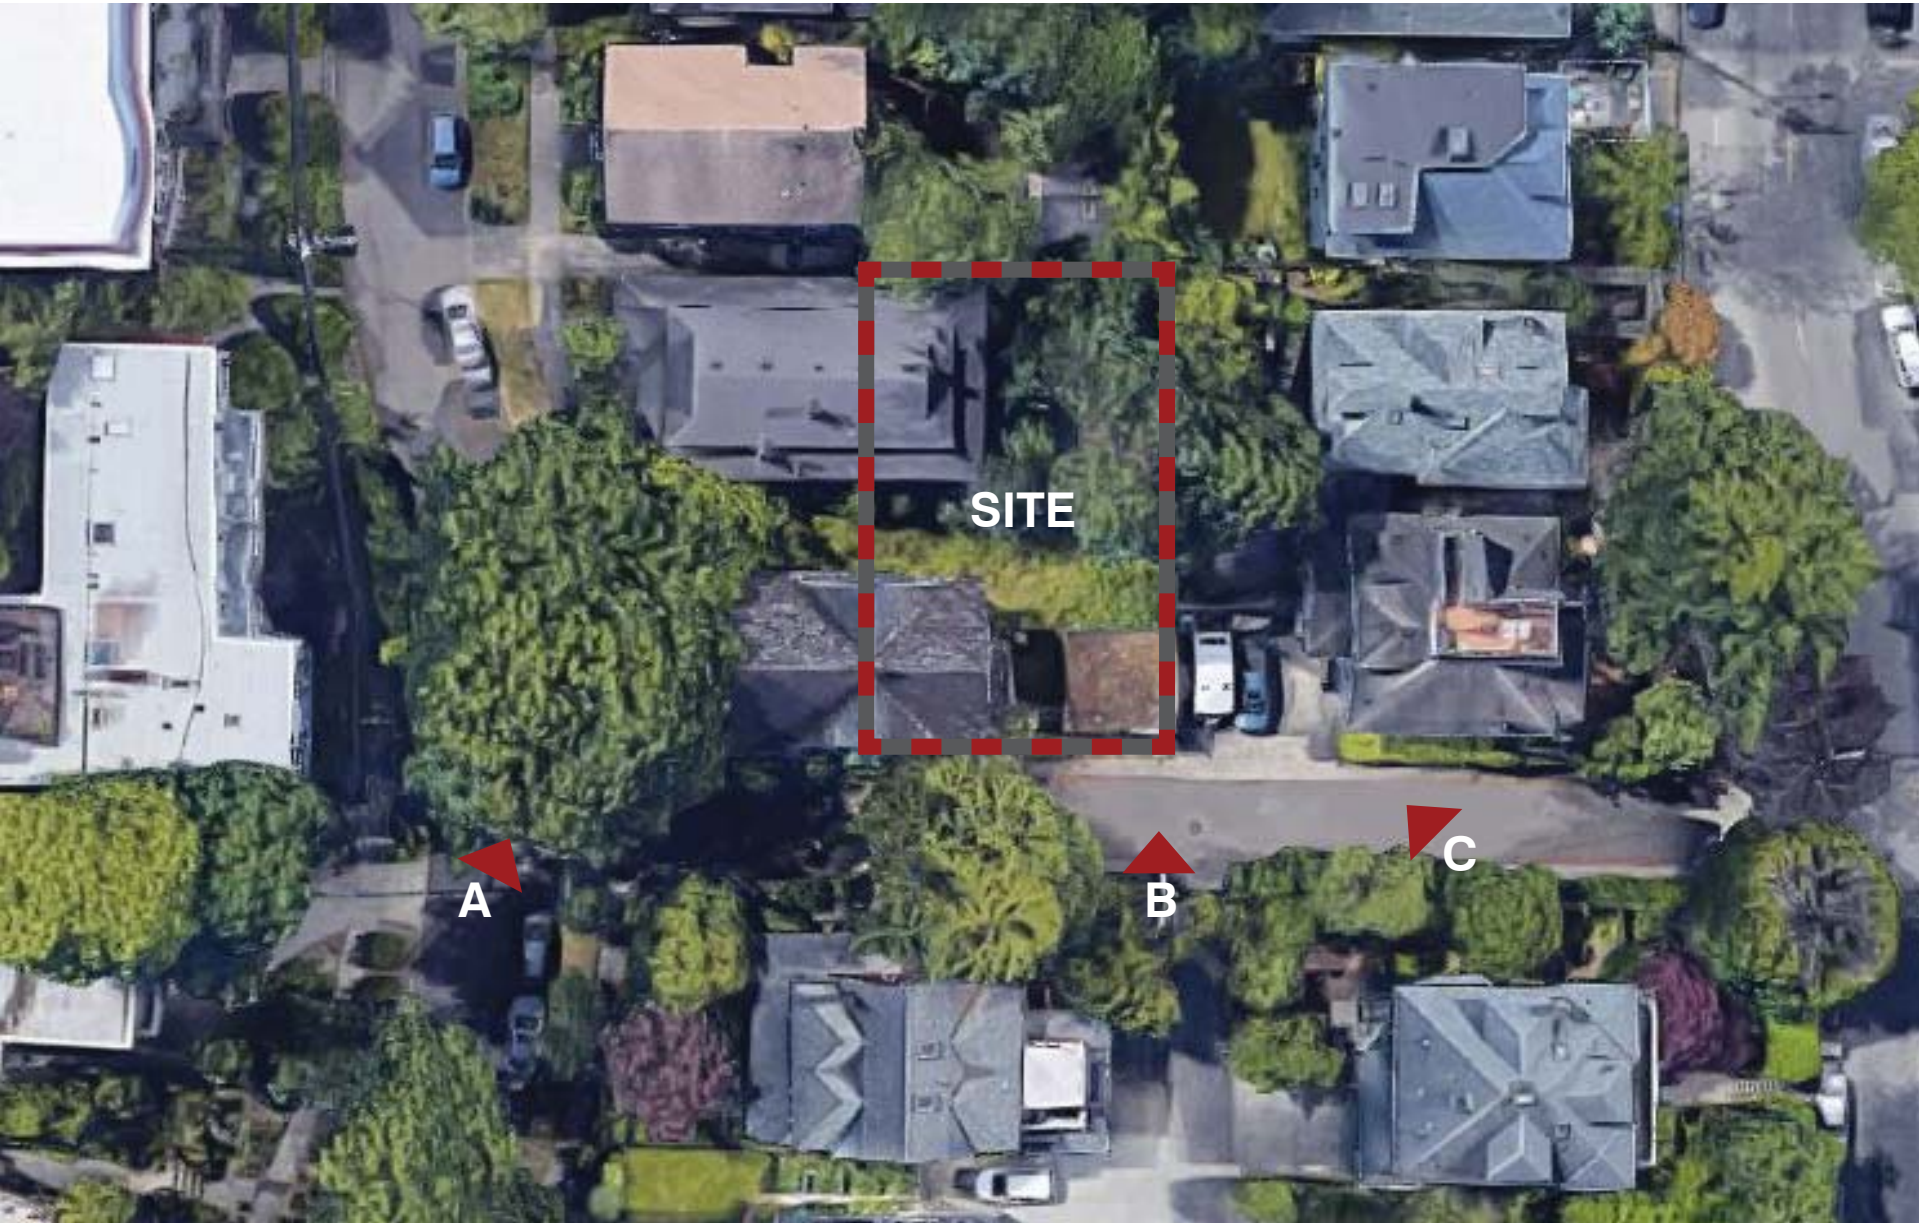
urban analysis

East Roy is a very narrow street with no on street parking and extends just three blocks between 13th Avenue East and 11th Avenue East where it terminates at the Lowell Elementary playground. The south side sidewalk is very narrow at 3.5 feet and is adjacent to the curb edge. Structures or retaining walls are located at the property line and create a strong street edge. The north side of Roy is defined by tall hedges and landscape that separates single-family homes and private yards from the streetscape. These homes present side facades with limited visual or physical connections to Roy.

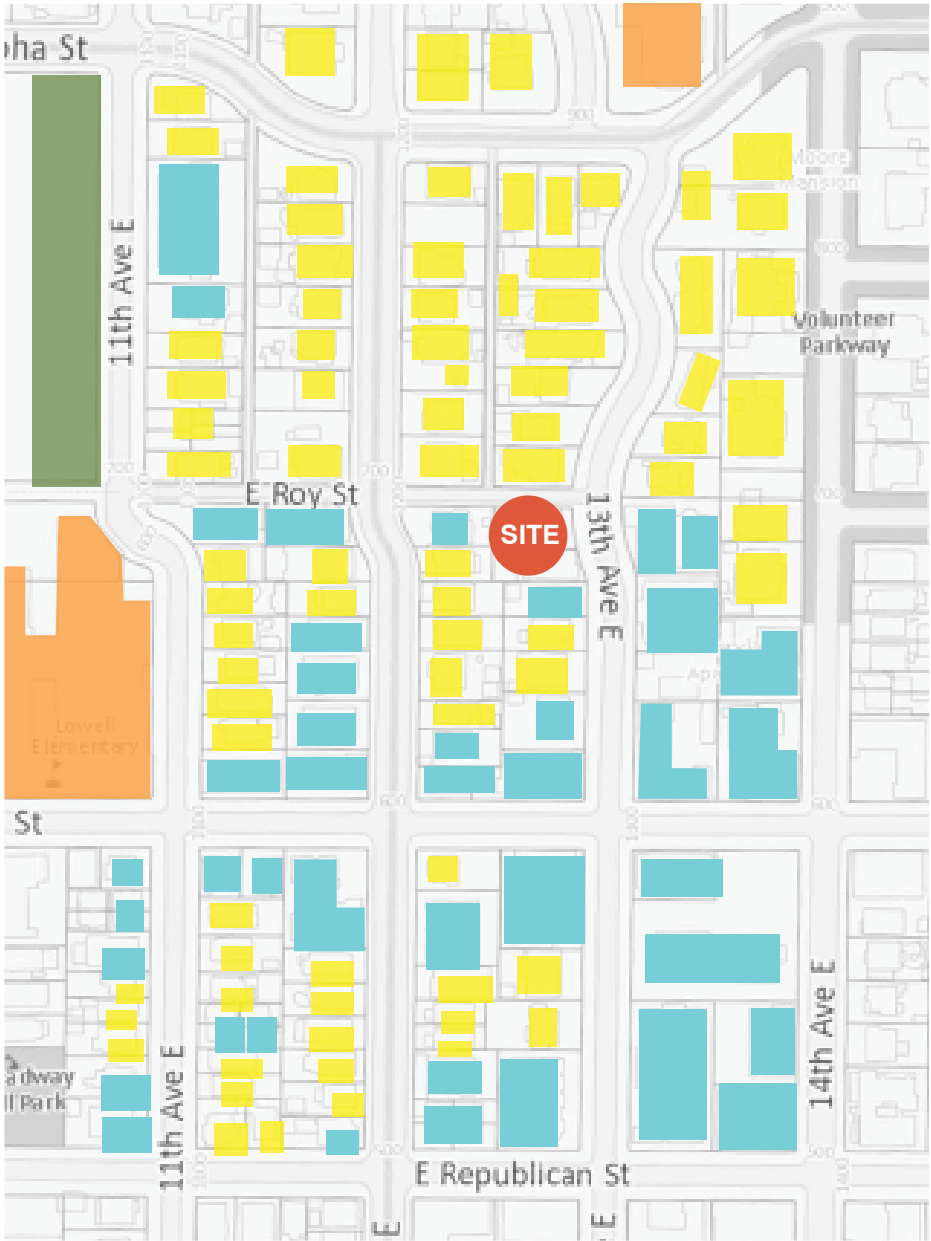
use diagram

- single family
- multifamily
- school / church

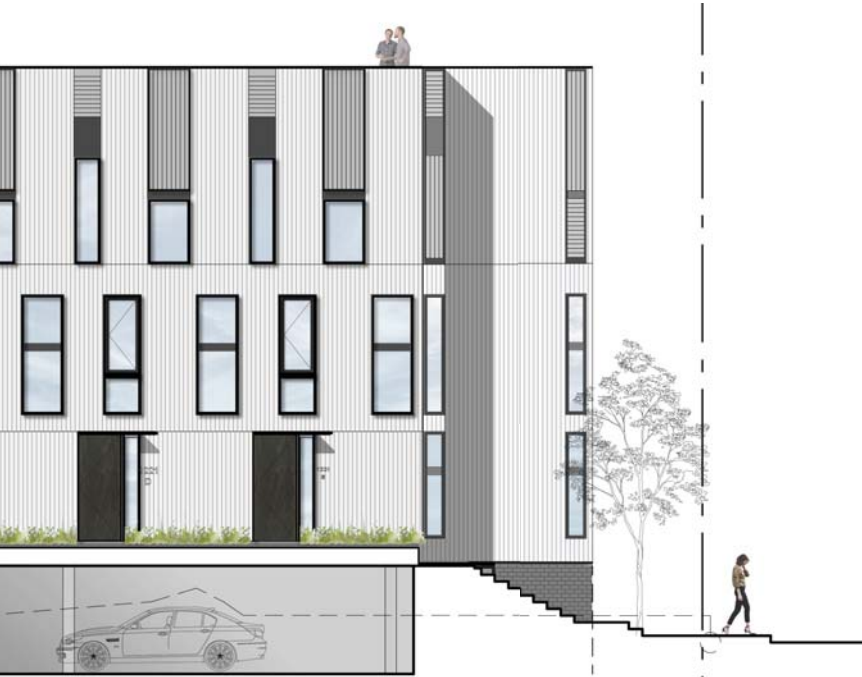
TOPOGRAPHY AND ORIENTATION

The sloping topography of the site provides an opportunity to locate parking within a structure that is below finished grade. A central open space that connects the street to the townhome units occupies the space above the garage. This open space is a community-making space. The parking access can then be provided on the downhill side of the site, away from the street corner intersection and the active space of the central pedestrian stairway and site circulation.

- CS1-C Topography: Elevation Changes
- CS2-A Location in the City and Neighborhood: Sense of Place
- DC1-B Vehicular Access and Circulation: Access Location and Design
- DC1-C Parking and Service Uses: Below-Grade Parking | Visual Impacts
- DC1-2 Capitol Hill: Visual Impacts and Parking and Service Uses

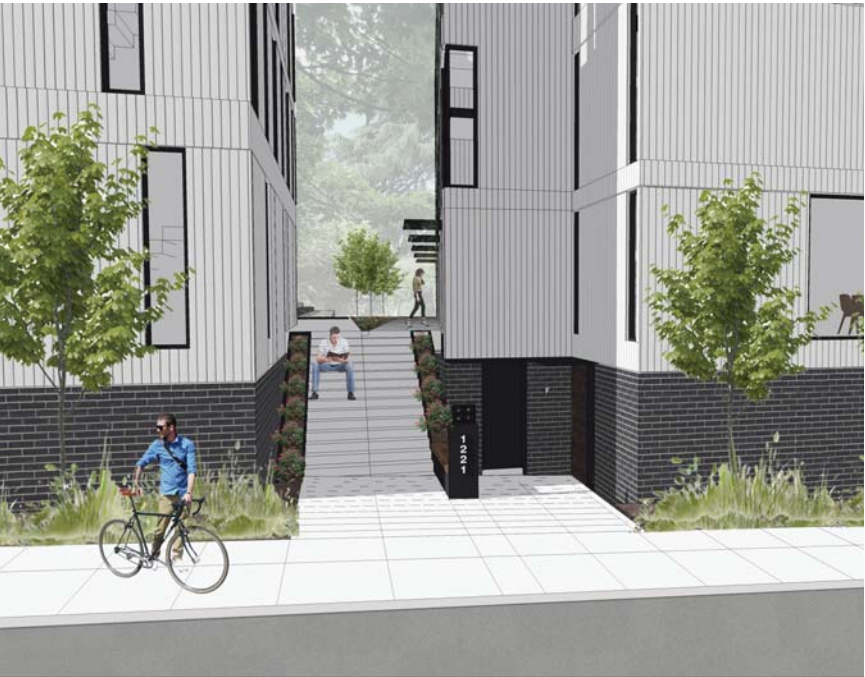
THE PUBLIC REALM AND PEDESTRIAN ACCESS

A central stairway into the south facing open space creates the opportunity for a direct connection between each unit and the public realm. All units share equally in this connection. A wide stairway and other site elements provides an opportunity to linger at the transition to the public realm.

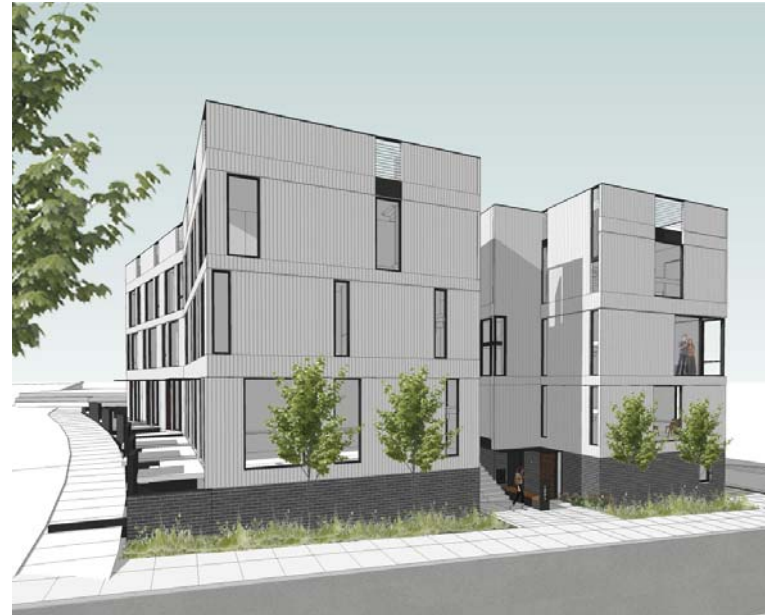
## scale

with a brick building base and upper stories with legible townhome differentiation and subtle story expressions.

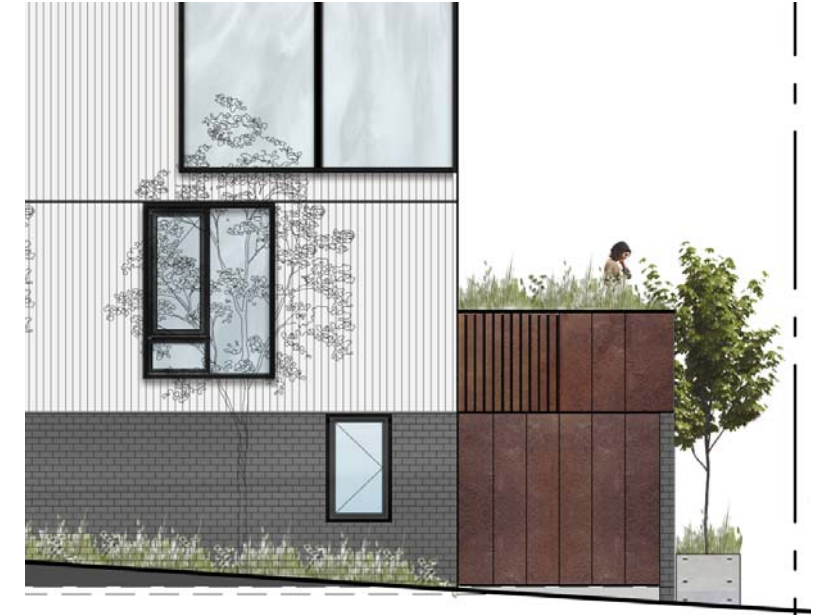
## texture

using brick, wood, metal, and landscaping that is contextually responsive.

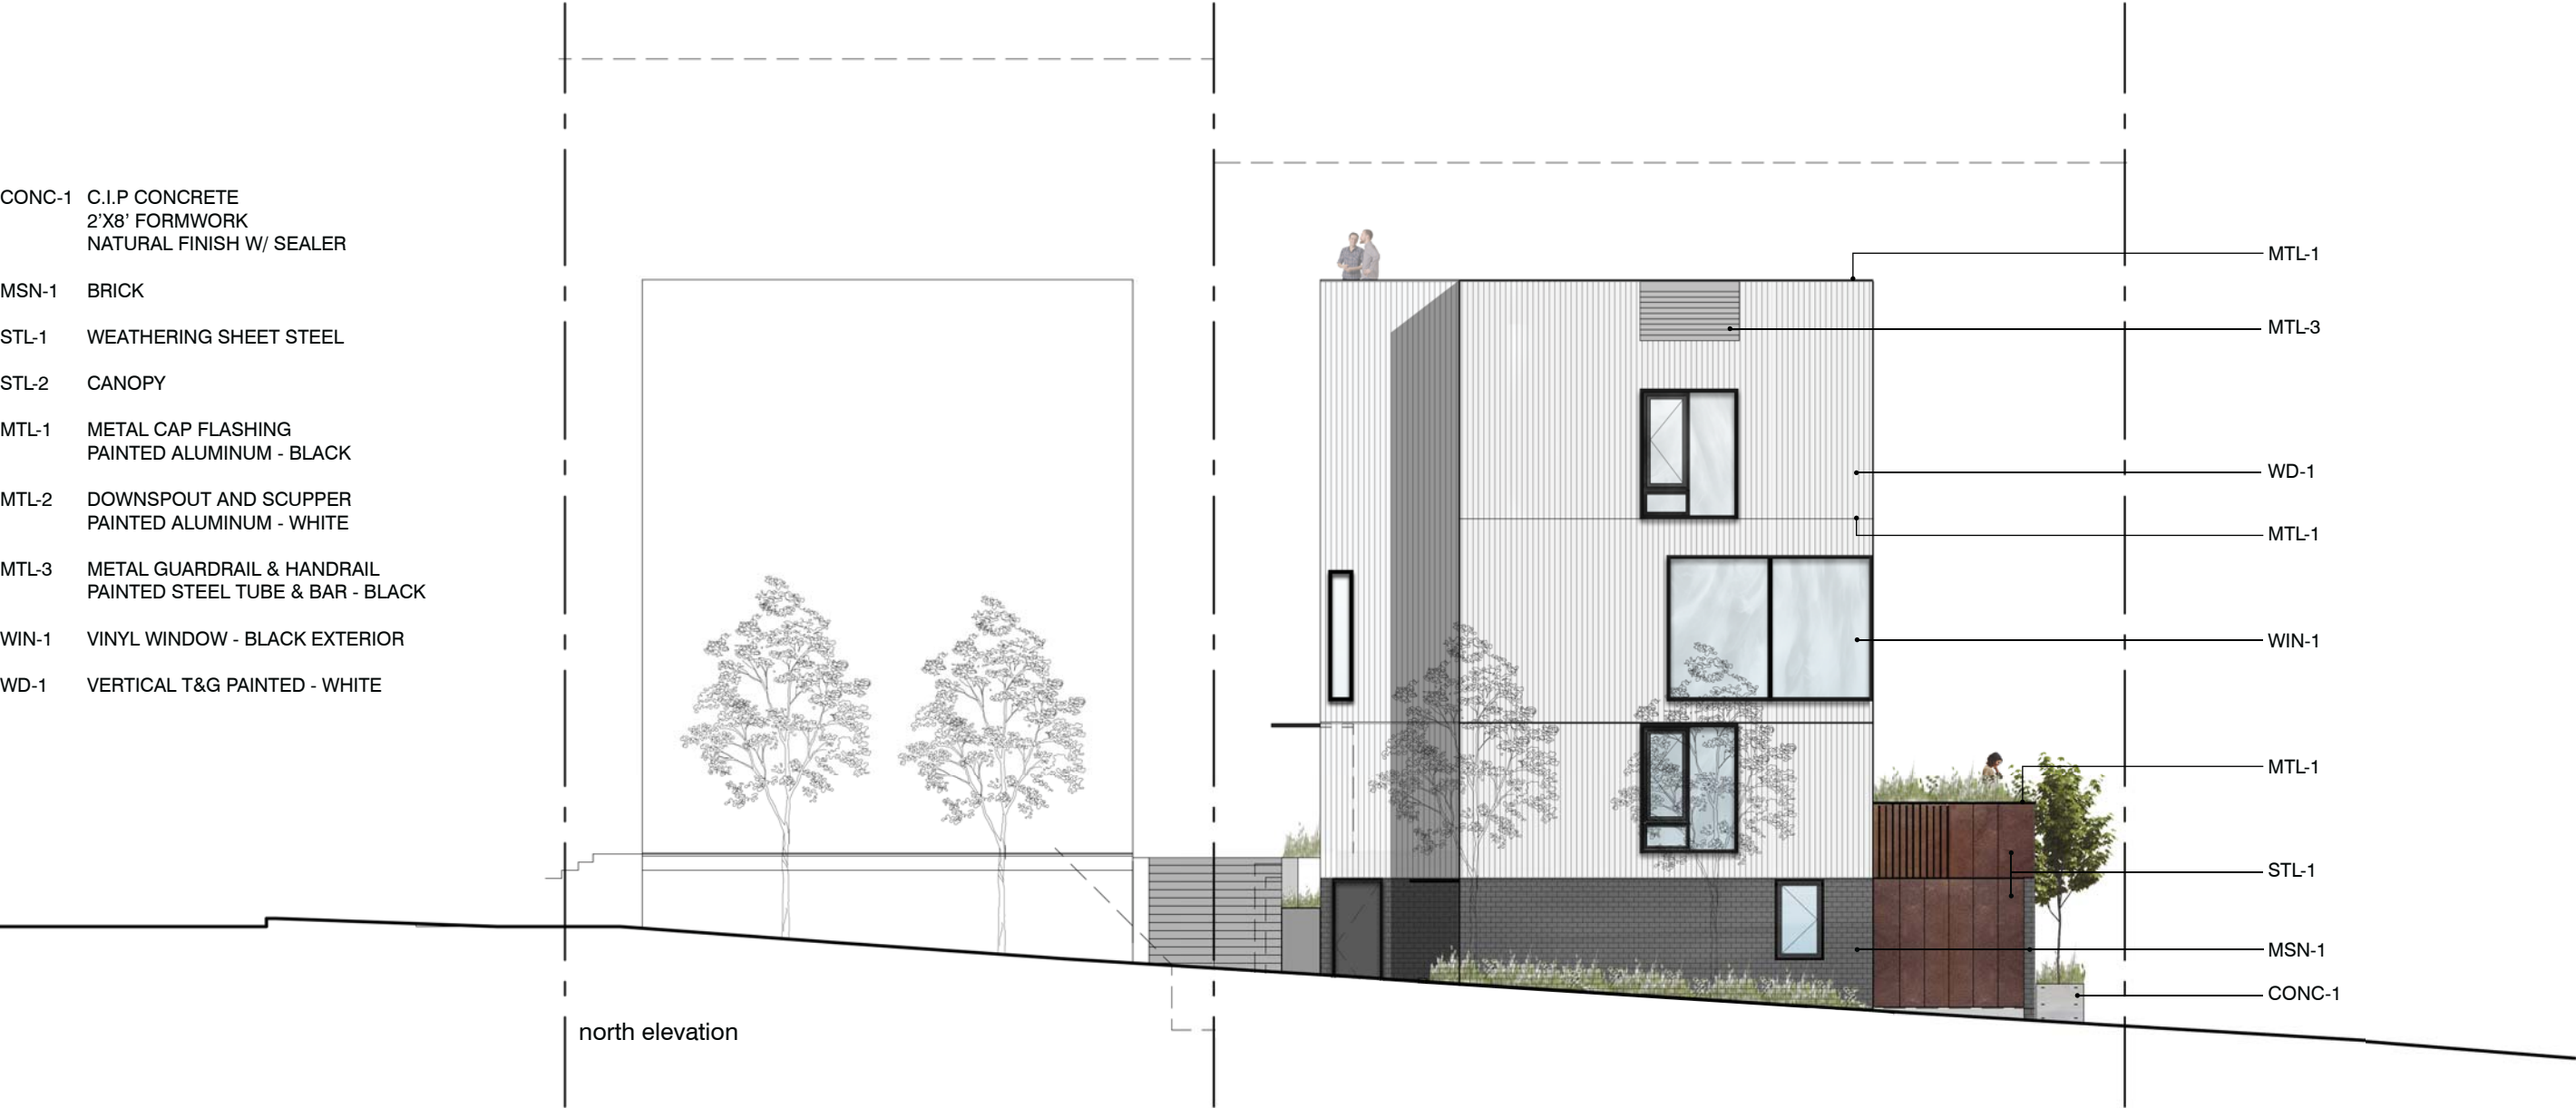
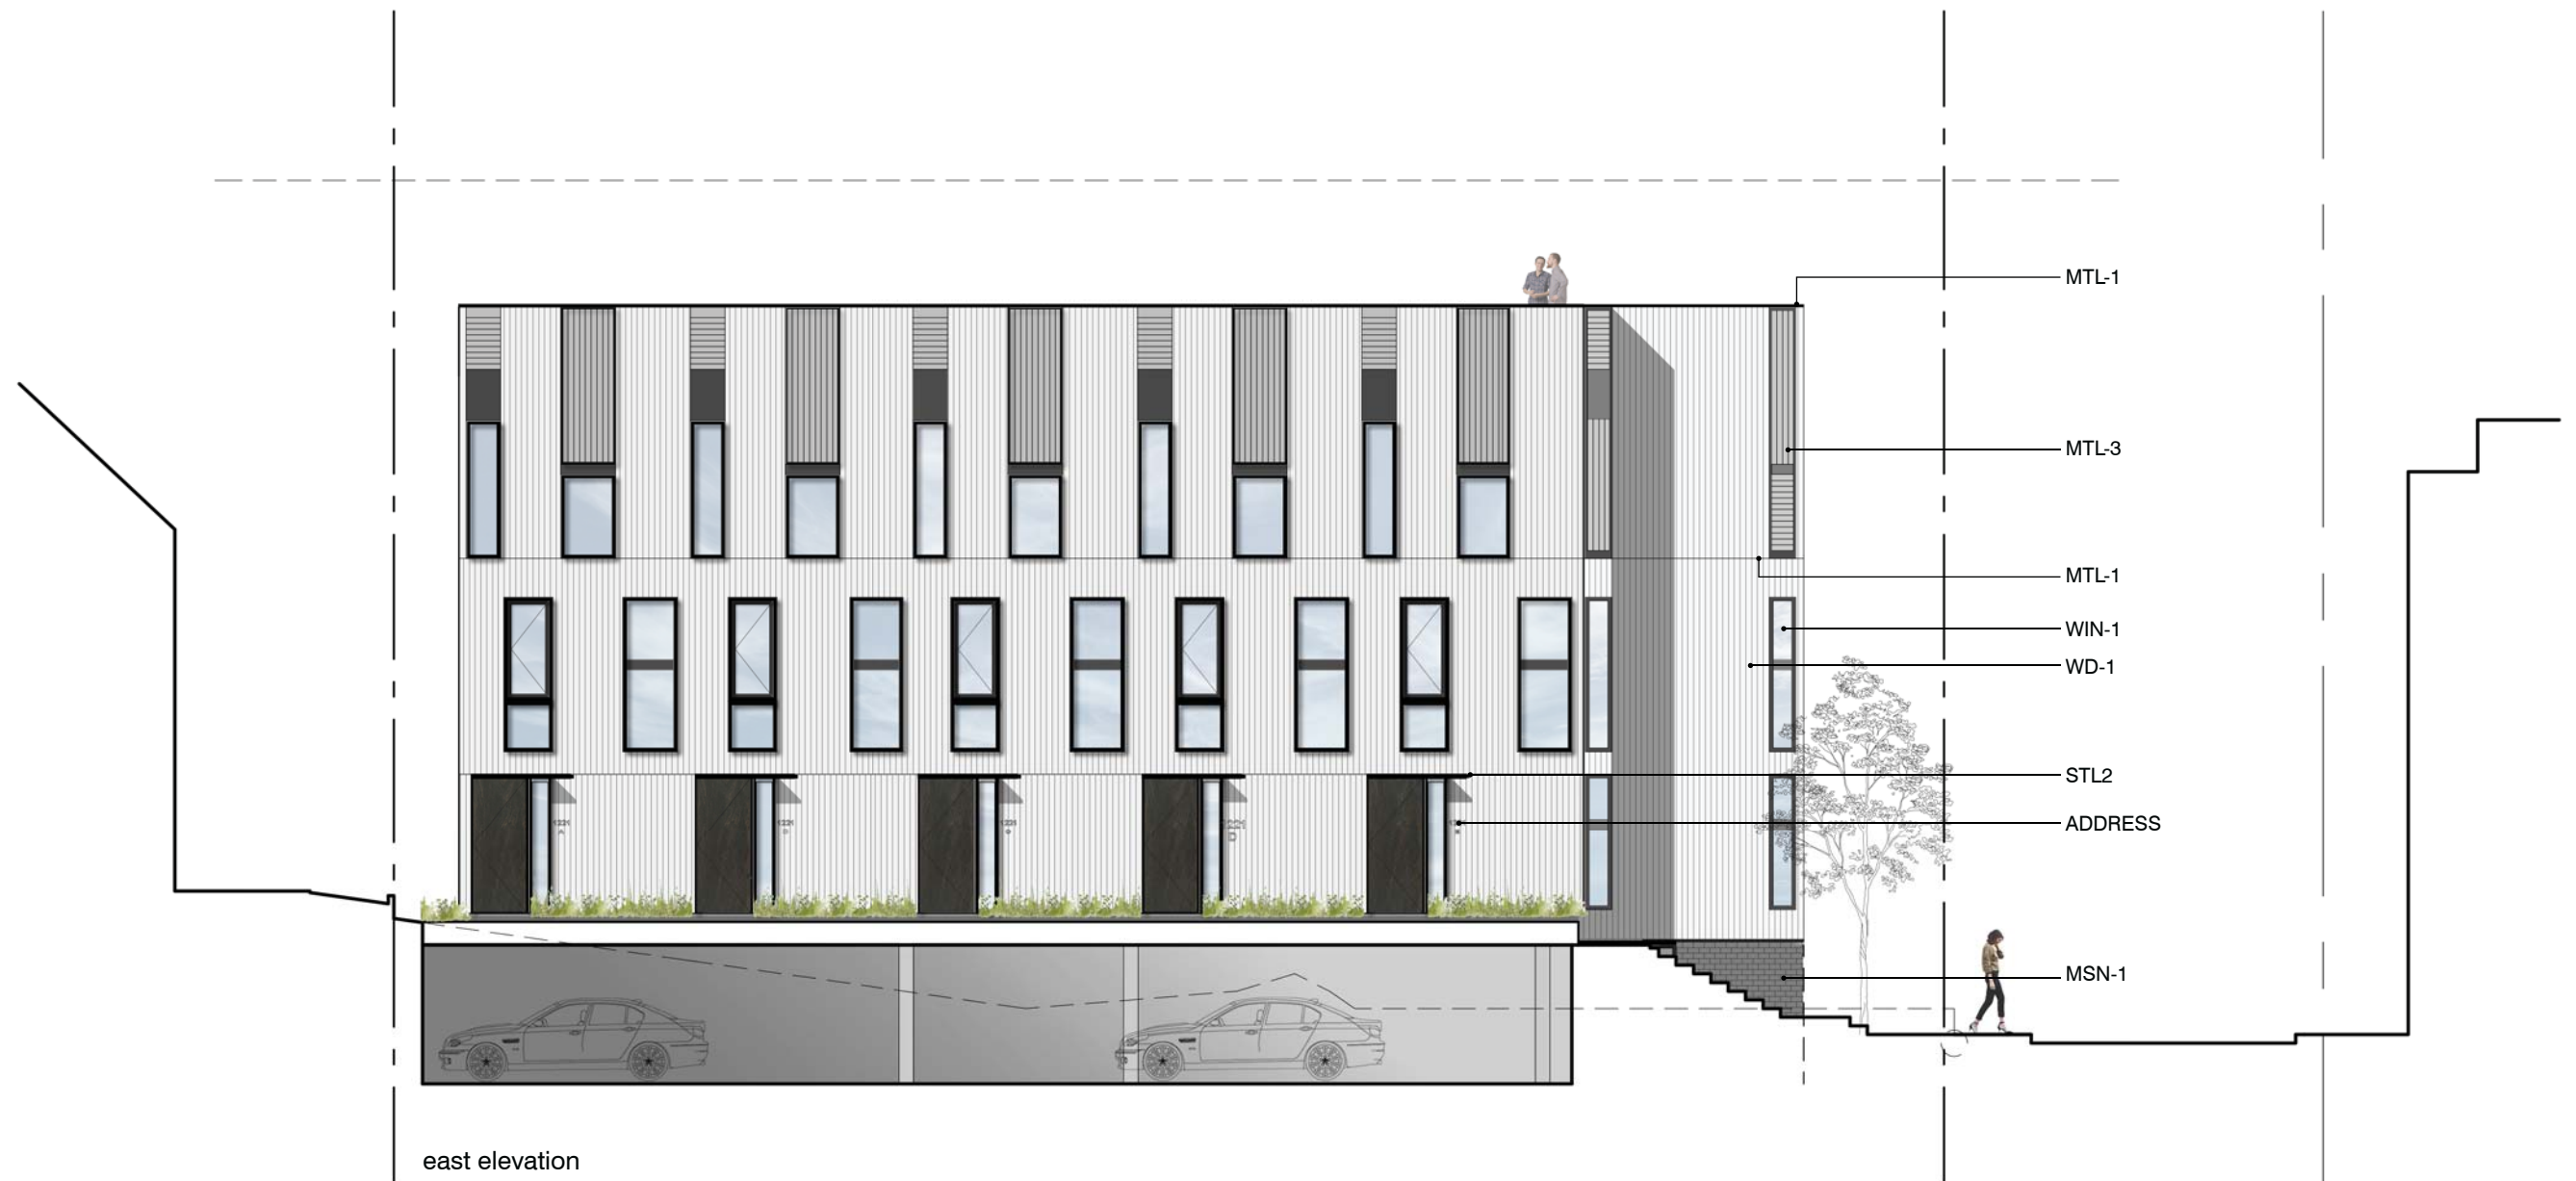
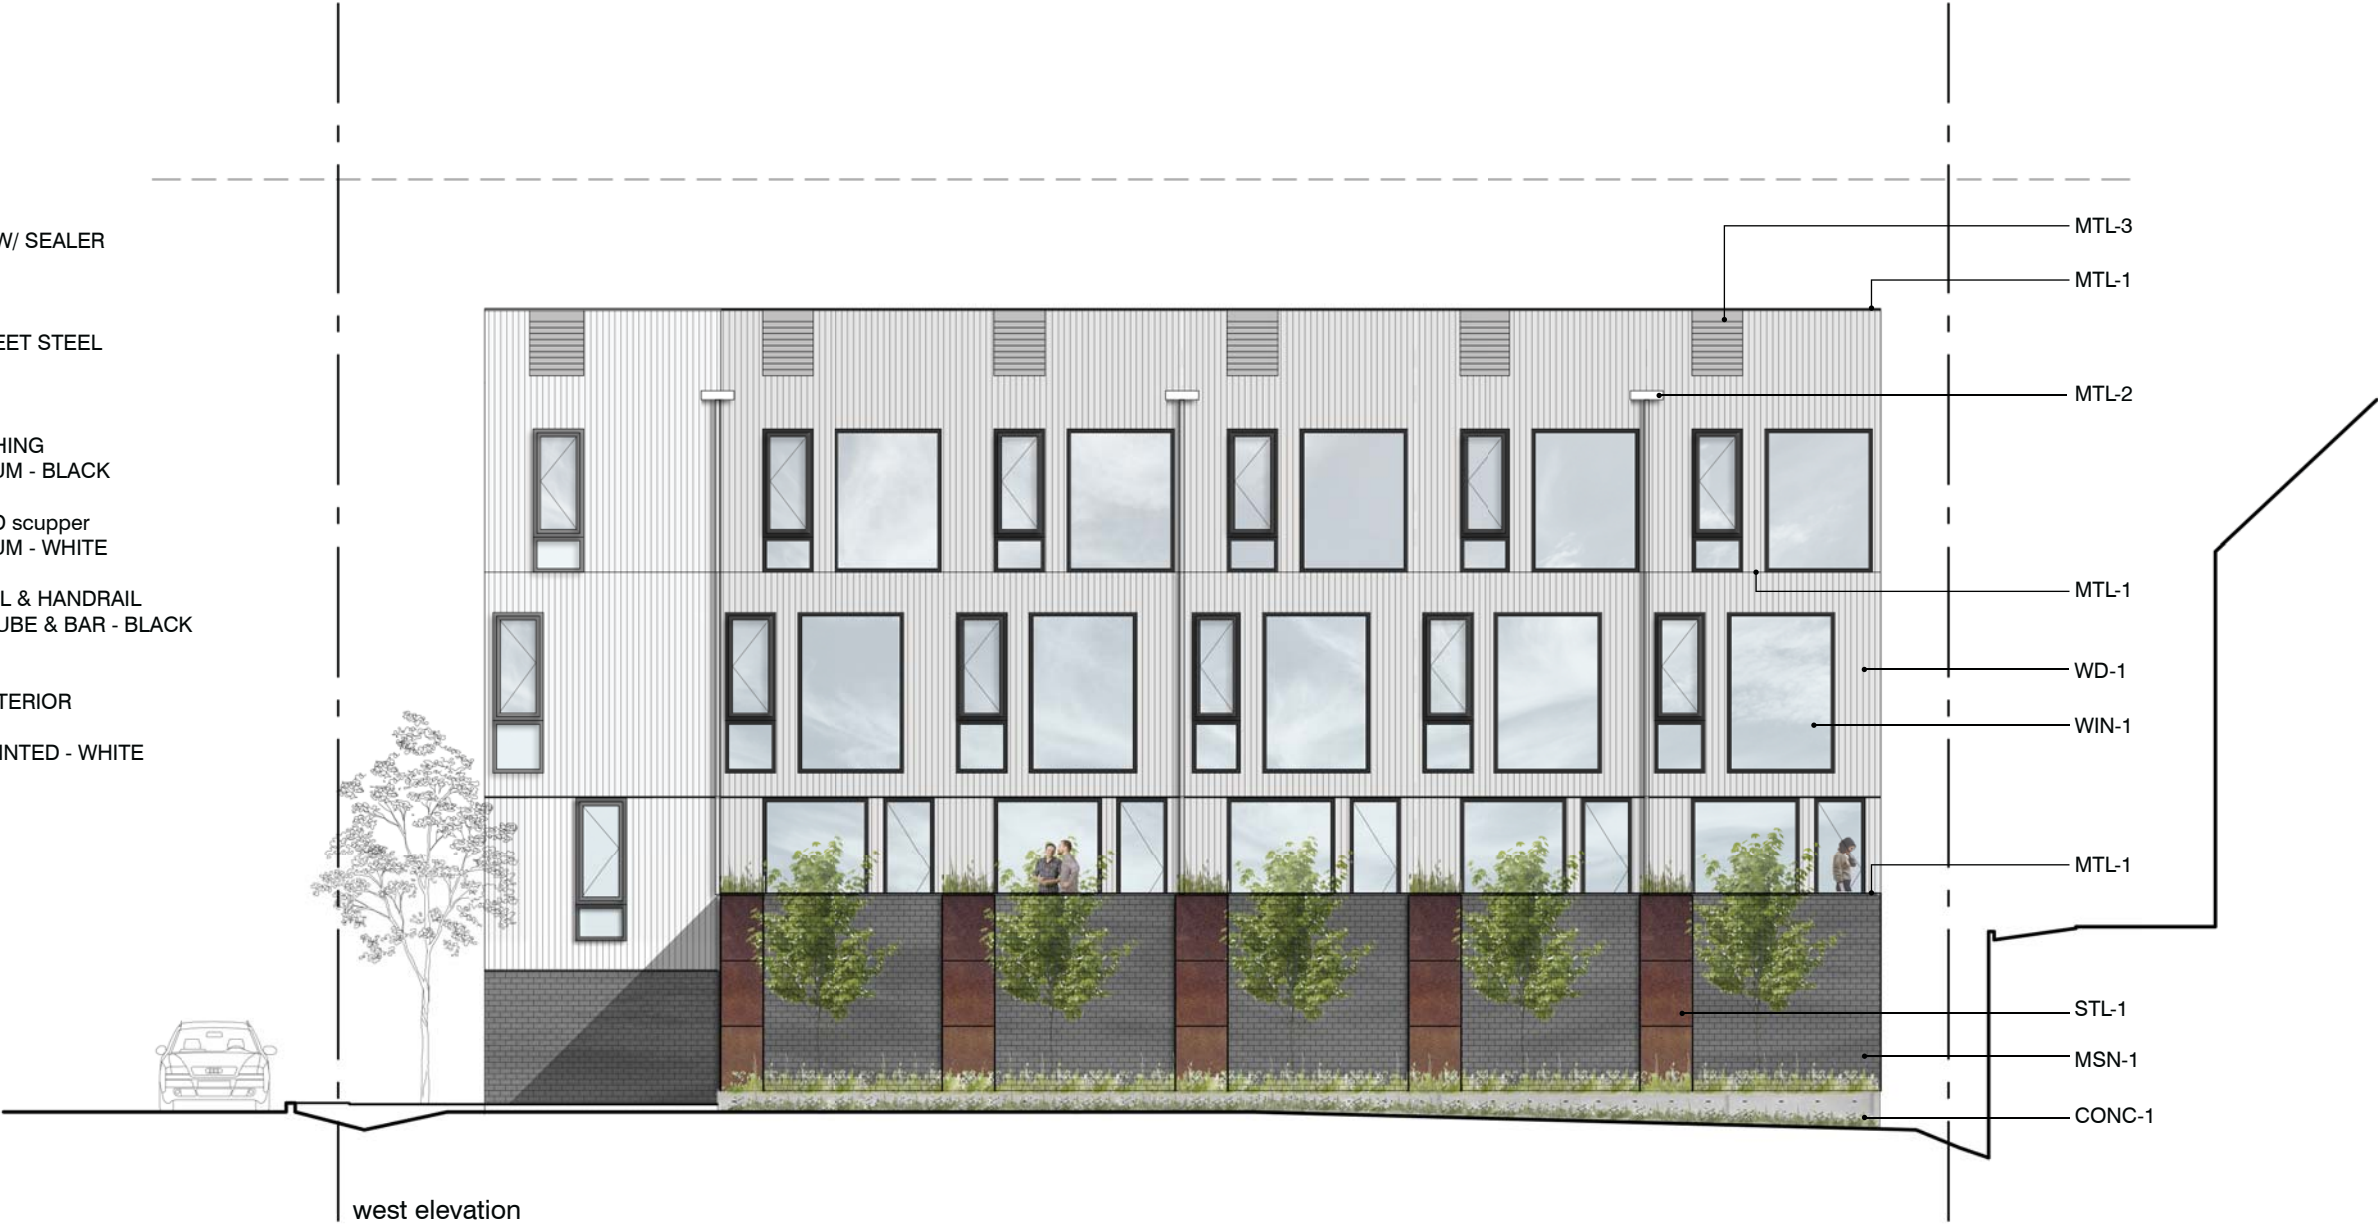
exterior elevations

- CONC-1 C.I.P CONCRETE  
2'X8' FORMWORK  
NATURAL FINISH W/ SEALER
- MSN-1 BRICK
- STL-1 WEATHERING SHEET STEEL
- STL-2 CANOPY
- MTL-1 METAL CAP FLASHING  
PAINTED ALUMINUM - BLACK
- MTL-2 DOWNSPOUT AND scupper  
PAINTED ALUMINUM - WHITE
- MTL-3 METAL GUARDRAIL & HANDRAIL  
PAINTED STEEL TUBE & BAR - BLACK
- WIN-1 TYPICAL WINDOW  
VINYL - BLACK EXTERIOR
- WD-1 VERTICAL T&G PAINTED - WHITE

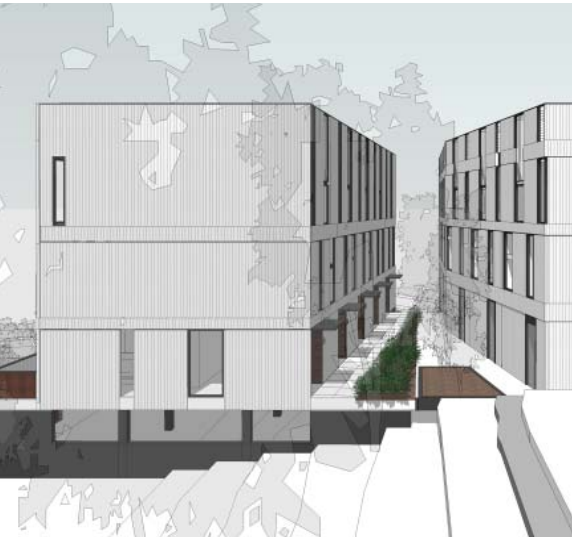
1) SMC 23.45.518 rear setback requirement

To allow a rear yard setback reduction to 3'-9" in order to provide wider side yard setbacks on both the east and west sides of the residential portion of the project.

Although the adjacent project to the east is not part of this proposal the proposed setback reduction allows for continuity in the relationship to the adjacent lot line with a 6'-6" setback at the northeast corner and 13'-11" at the southeast corner.

The structure width has been minimized to 32'-2" wide. The west side yard has been increased to 9'-8" at the southwest corner, 14'-9" at the northwest corner and 16'-7" at the maximum inflection point which provides substantially less building mass along the adjacent neighbor's side lot line.

The reduced rear yard allows an expansion of the side yards in order to situate the living spaces a greater distance from adjacent lots. The proposed adjustment is a superior solution to a code conforming condition.

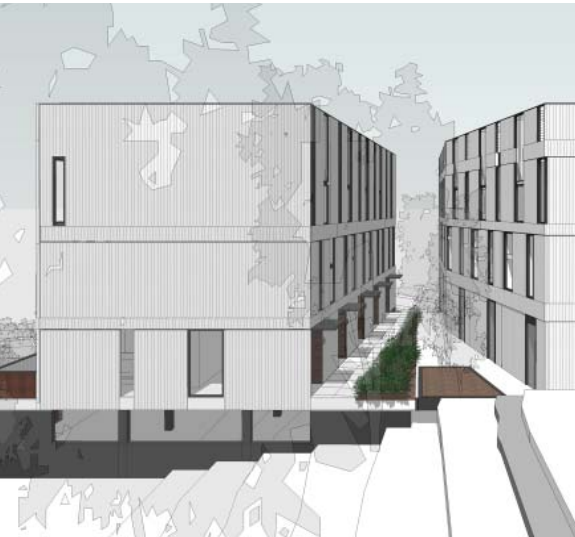
3) SMC 23.45.527.B. Maximum façade length in LR zone

The maximum combined length of all portions of facades within 15 feet of a lot line that is neither a rear lot line nor a street or alley lot line shall not exceed 65 percent of the length of that lot line.  
East lot line = 89.90' x 65% = 58.37' maximum façade length

To allow a 7% increase in the façade length to 67.35'.

The inflection angle of the east wall is determined by two project goals:

- 1. To create a central landscaped open space that is shared with the neighboring rowhouse development to the east.
- 2. To respect the neighboring property to the west with additional building setback that creates functional landscaped outdoor space for each unit.

This east wall is an “interior” side wall to the broader development across the open space. The adjacent rowhouse structure also inflects its west wall at a complimentary angle to maximize south exposure of the shared courtyard space. The proposed adjustment is a superior solution to a code conforming condition.

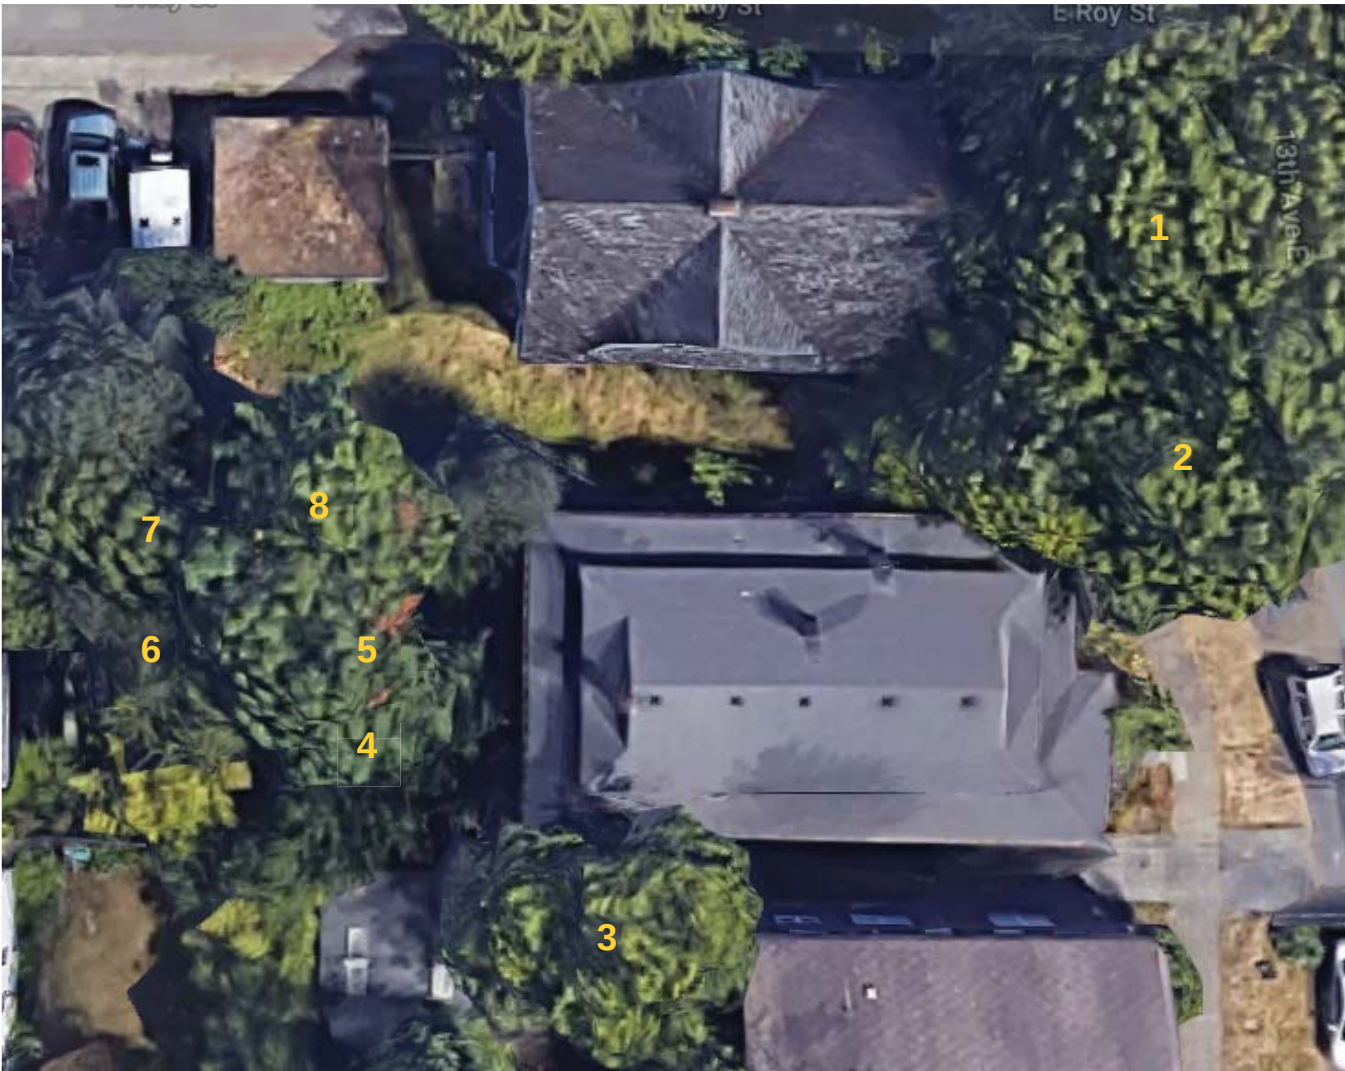
Attachment 2: Aerial photo of site – Google satellite maps

- Number – as shown on the aerial photo attached.
- Species – both common and Latin names.
- DBH – stem diameter measured in inches, 4.5 feet from the ground.
- Dripline – average branch extension from the trunk measured as radius in feet.
- Category – significant or exceptional, as defined by Seattle Tip 242 and Director’s rule 16-2008.
- Ratings – from 1 to 3 (where 1 indicates no visible defects, in structure or health; 2 indicates minor problems that may require action; 3 indicates significant problems or defects and tree removal is recommended.).

| Tree # | Species | DBH | Dripline | Health | Structure | Category | Notes |
| 1 | Norway maple<br>Acer platanoides | 31 in. | 28 ft. | 1 | 2 | Significant to<br>Exceptional* | Large water sprouts in response to past pruning, signs of decay, street tree (TRE-43784) |
| 2 | Norway maple<br>Acer platanoides | 31 in. | 28 ft. | 1 | 2 | Significant to<br>Exceptional* | Asymmetrical canopy, signs of decay, street tree (TRE-43883) |
| 3 | Elm<br>Ulmus spp. | 14.5 in. | 11 ft. | 1 | 2 | Significant | Asymmetrical canopy, very close to house |
| 4 | Western red cedar<br>Thuja plicata | 6.5 in. | 8 ft. | 1 | 2 | Significant | Growing out of whiskey barrel |
| 5 | Western red cedar<br>Thuja plicata | 9 in. | 11 ft. | 1 | 1 | Significant | |
| 6 | Black locust<br>Robinia pseudoacacia | 22.5 in. | 4 ft. | 3 | 3 | Significant | Dead/dieing, advanced signs of decay, poorly pruned, included bark |
| 7 | Horse chestnut<br>Aesculus hippocastanum | 22 in. ** | 15 ft. | 1 | 3 | Significant | 17 in., 14.5 in., large wound from past pruning, signs of trunk girdling |
| 8 | Big leaf maple<br>Acer macrophyllum | 25 in. | 24 ft. | 2 | 2 | Significant | Large wound from past pruning, low live crown ratio |
