# **2011 Restoration Planting Project Plan**

## & As-Built Report

Written by Wendy Sammarco Seattle Public Utilities, Watershed Services Division

The 2011 Restoration Planting Project Plan is a summary of 2011 planting related projects, prescriptions, and accomplishments occurring in the Cedar River Municipal Watershed

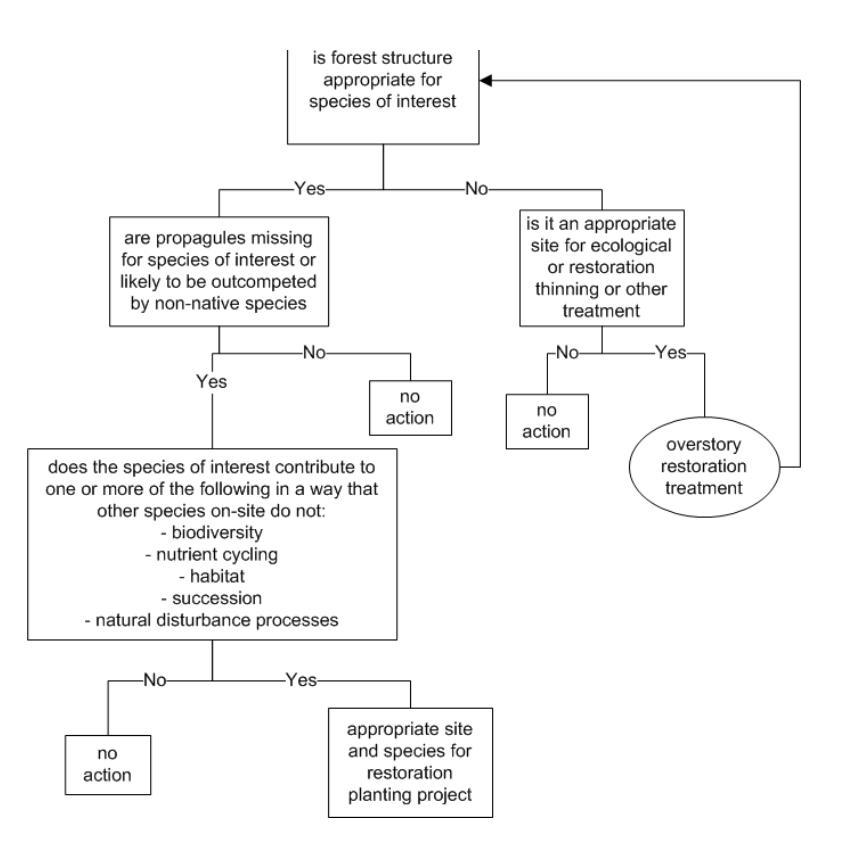
Figure 1: Decision tree for upland planting species and site selection.

We created decision tree for selecting appropriate sites and species for upland planting (Figure 1). It emphasizes that planting should only occur where appropriate structure exists and propagules are absent, and planting should utilize species that contribute to ecosystem processes in a way not already addressed by on-site species. (Upland Restoration Planting Plan, 2004)

- Continue evaluating restoration planting as a compliment to road decommissioning, utilizing the restoration planting flow chart as a decision making tool. The road decommissioning program cost commitment is complete in 2021.

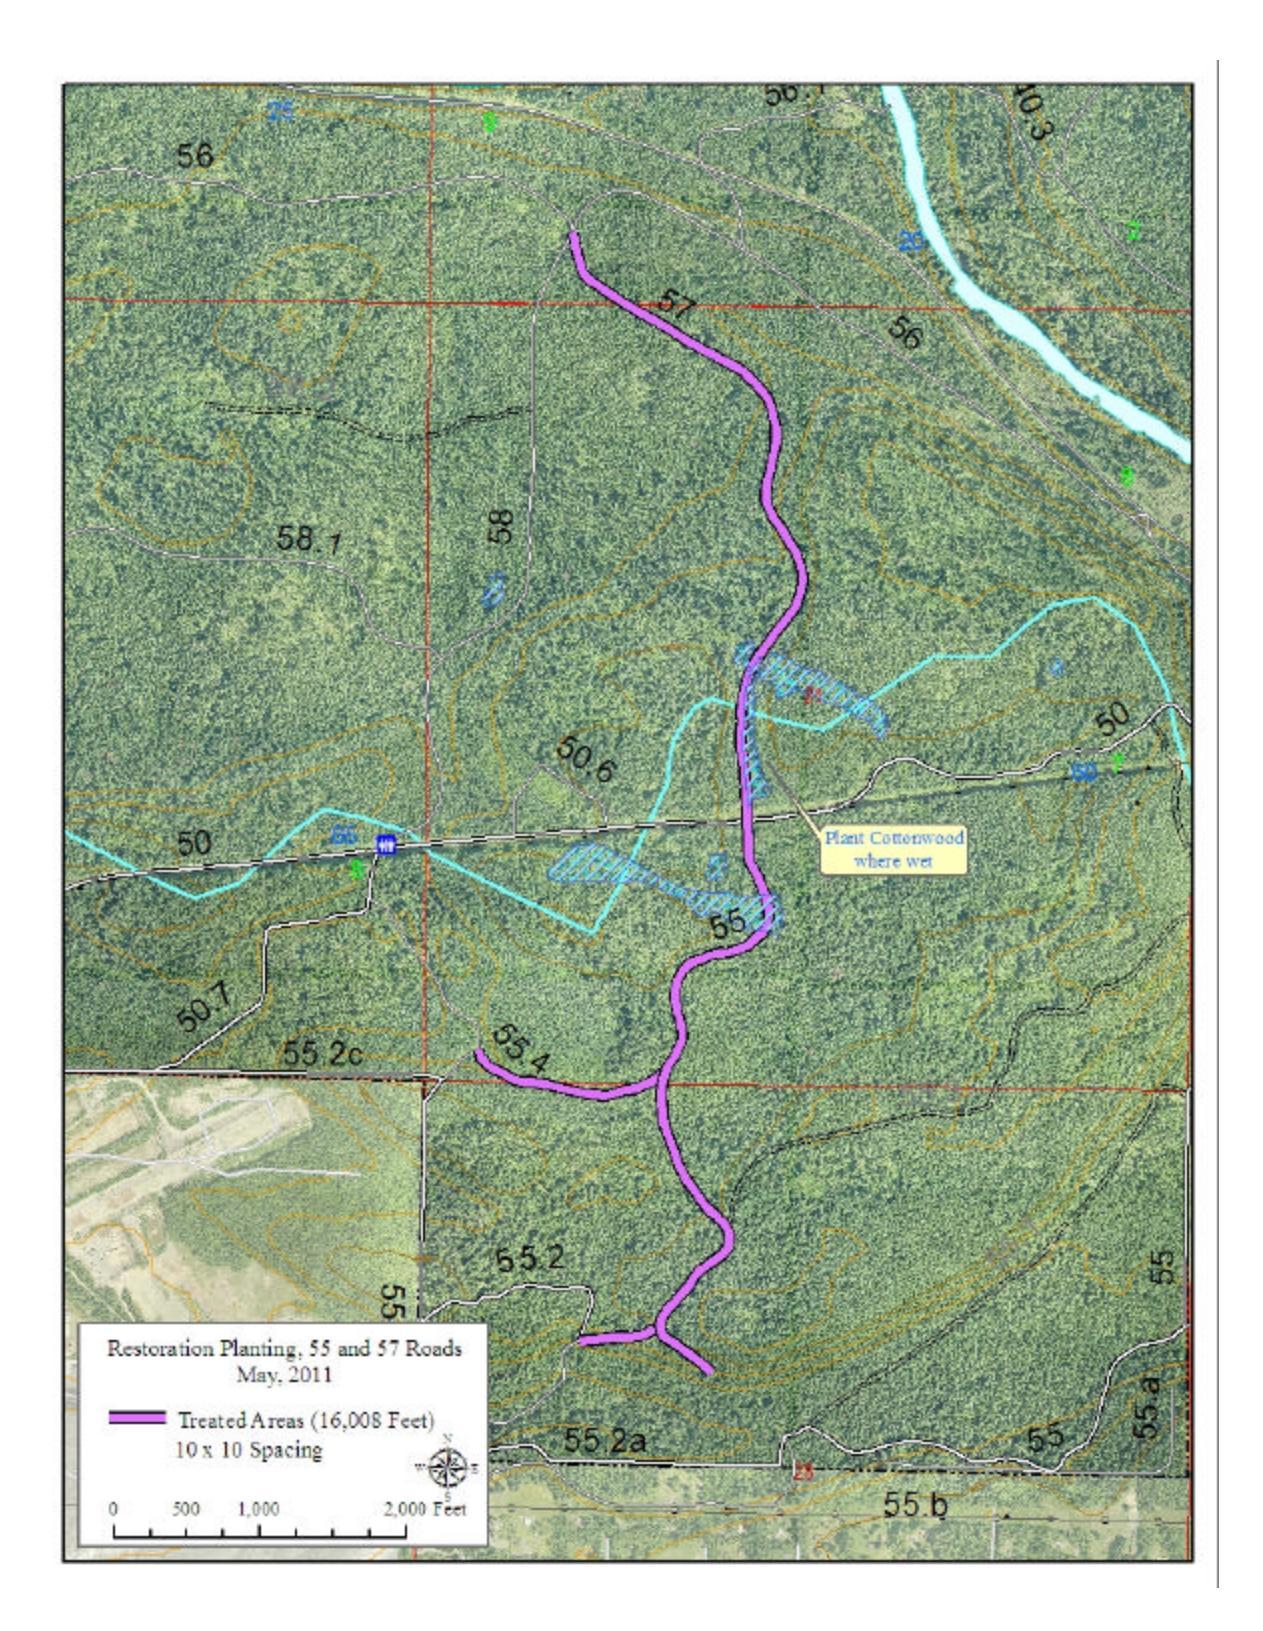
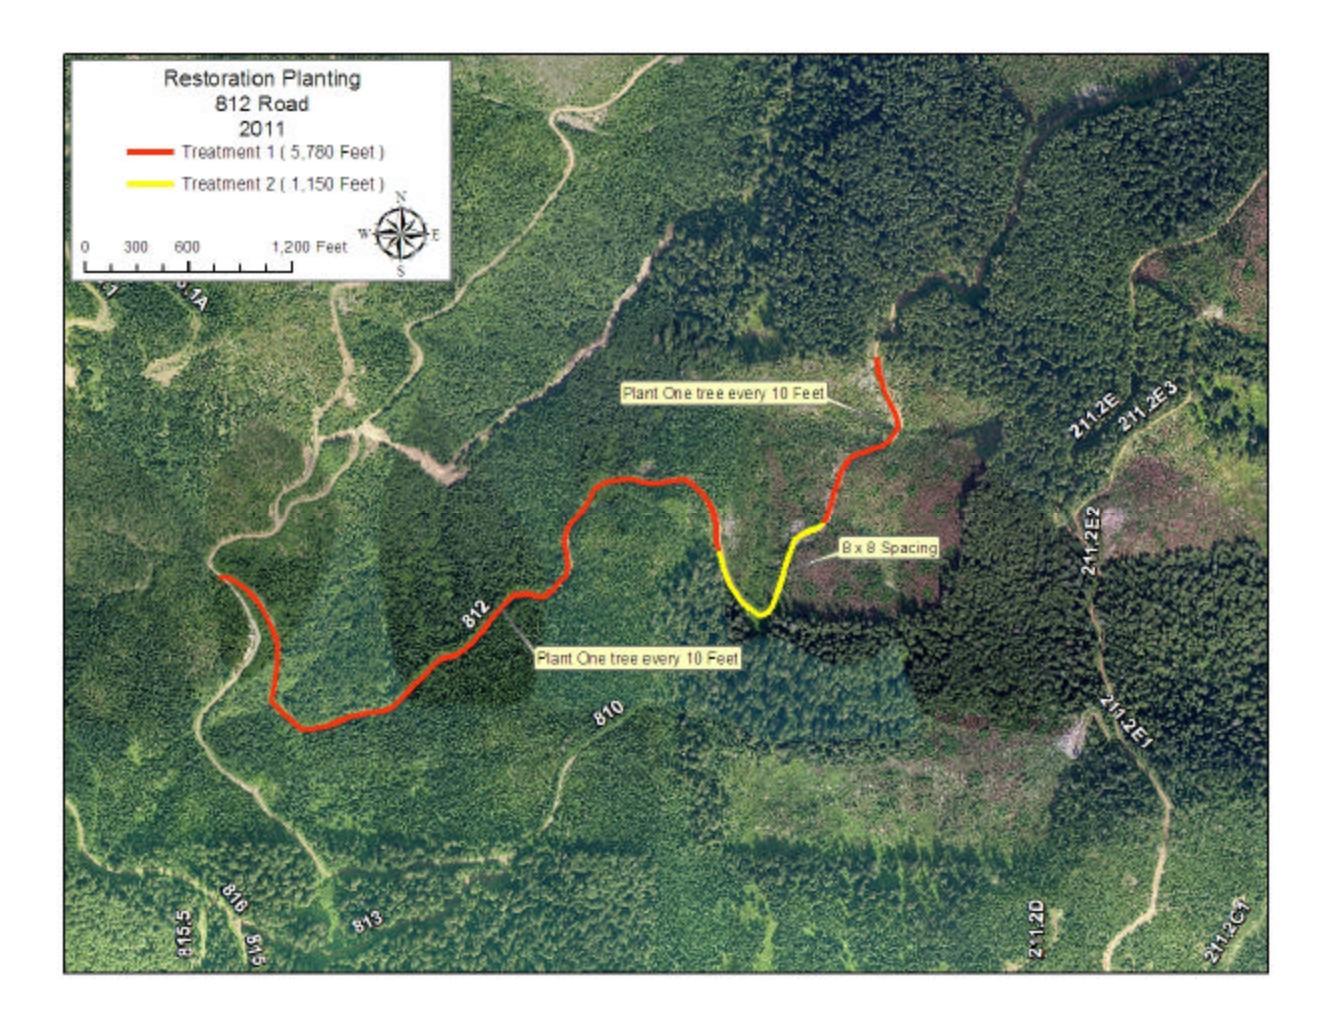
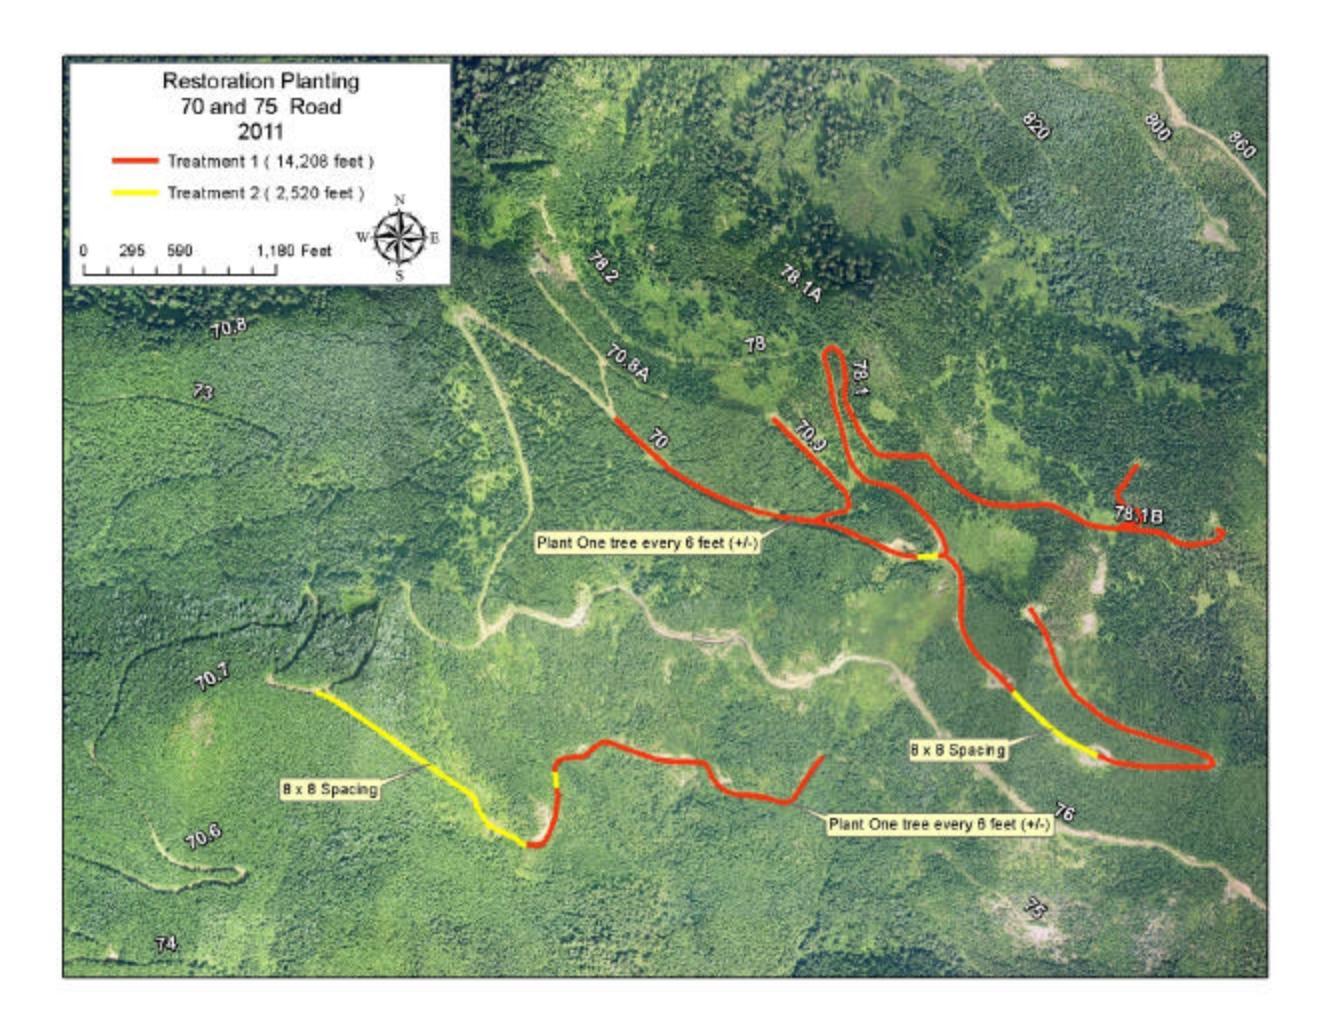
#### Appendix 1: 2011 Unit Maps

Information about site conditions and justifications for the particular planting prescriptions follow. Maps of these planting units are included in Appendix A.
