Landmark NOMINATION Application

Name: Donahoe Building / Bergman Luggage

Donahoe Building / Bergman Luggage
Seattle Landmark Nomination

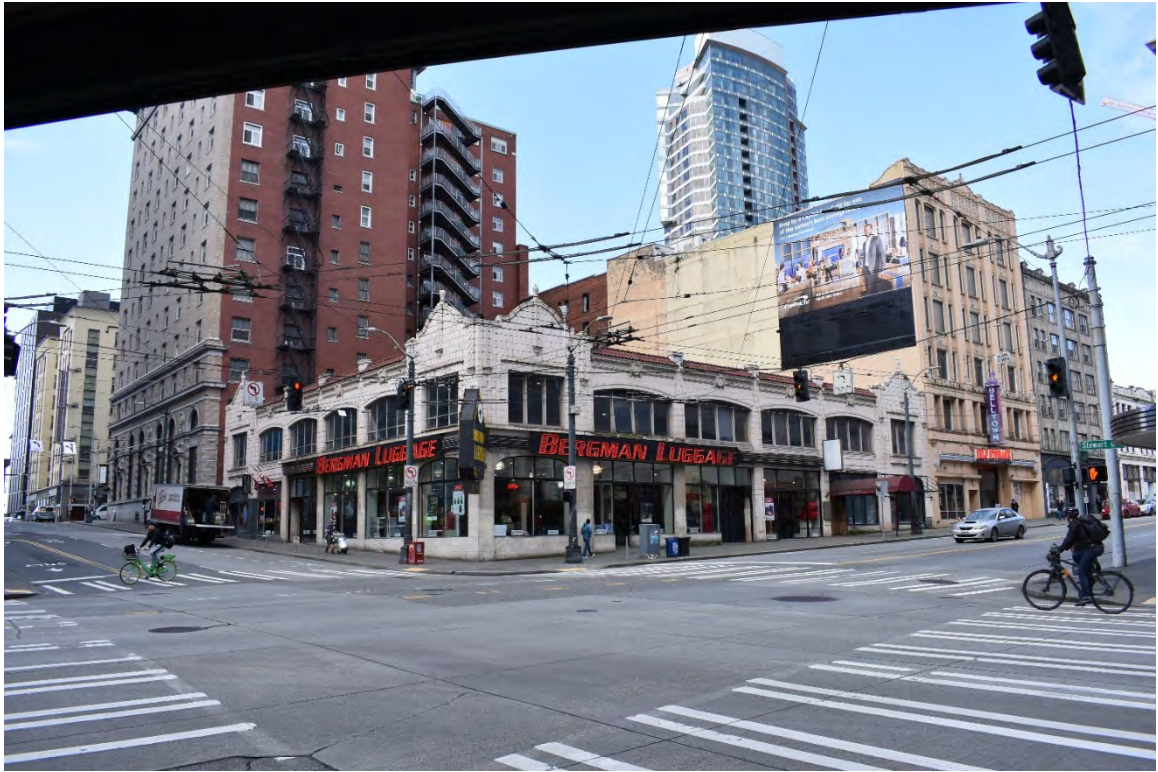
Fig. 7 – South and east elevation

The building is a two-story unreinforced masonry building on a concrete foundation with terra cotta cladding on the two primary street elevations (south facing Stewart Street, and east facing 3rd Avenue), and red common brick on the alley or west elevation. Interior supports are heavy timber post and beam. The flat, nail-laminated timber built-up roof is hidden from the street by an elaborate terra cotta parapet on the street elevations, and a low parapet on the alley side with a sheet metal parapet cap (as a result of the 2001 Nisqually earthquake, the alley parapet was damaged and later patched; the terra cotta parapet was undamaged but strengthened with anchors). The subject building has no basement.

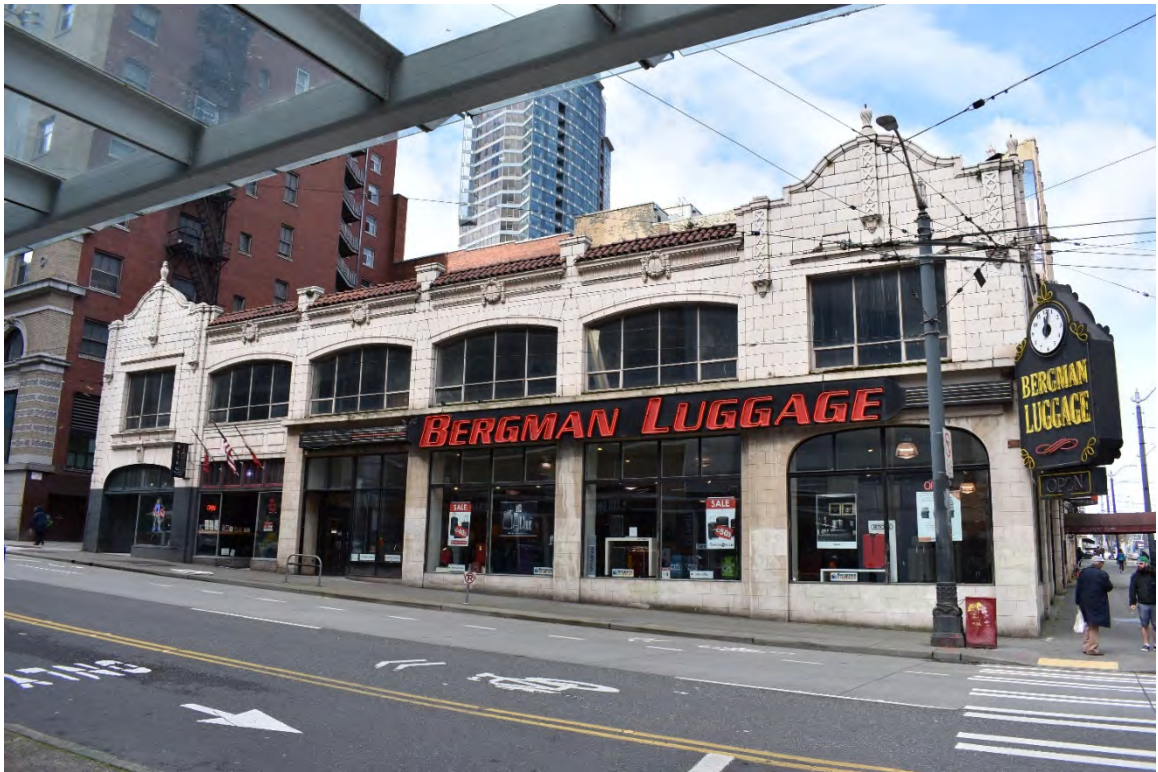
Fig. 8 – South elevation (Stewart Street)

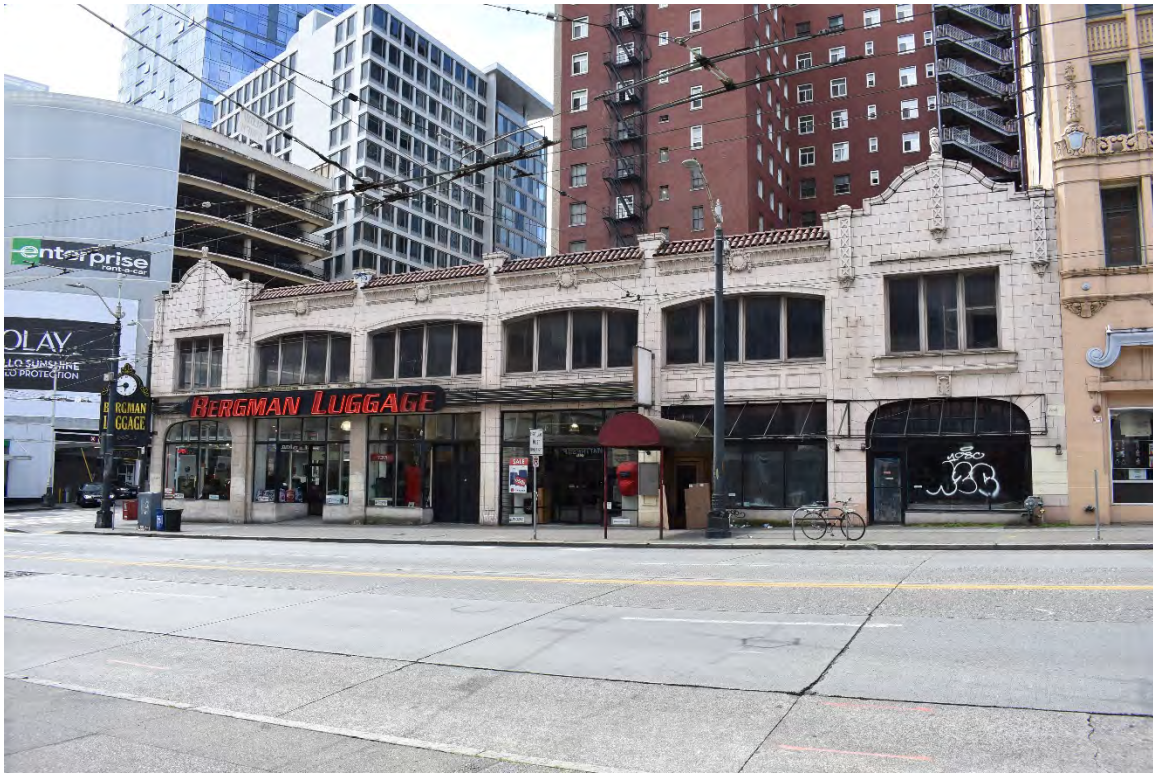
Fig. 9 – East elevation (3rd Avenue)

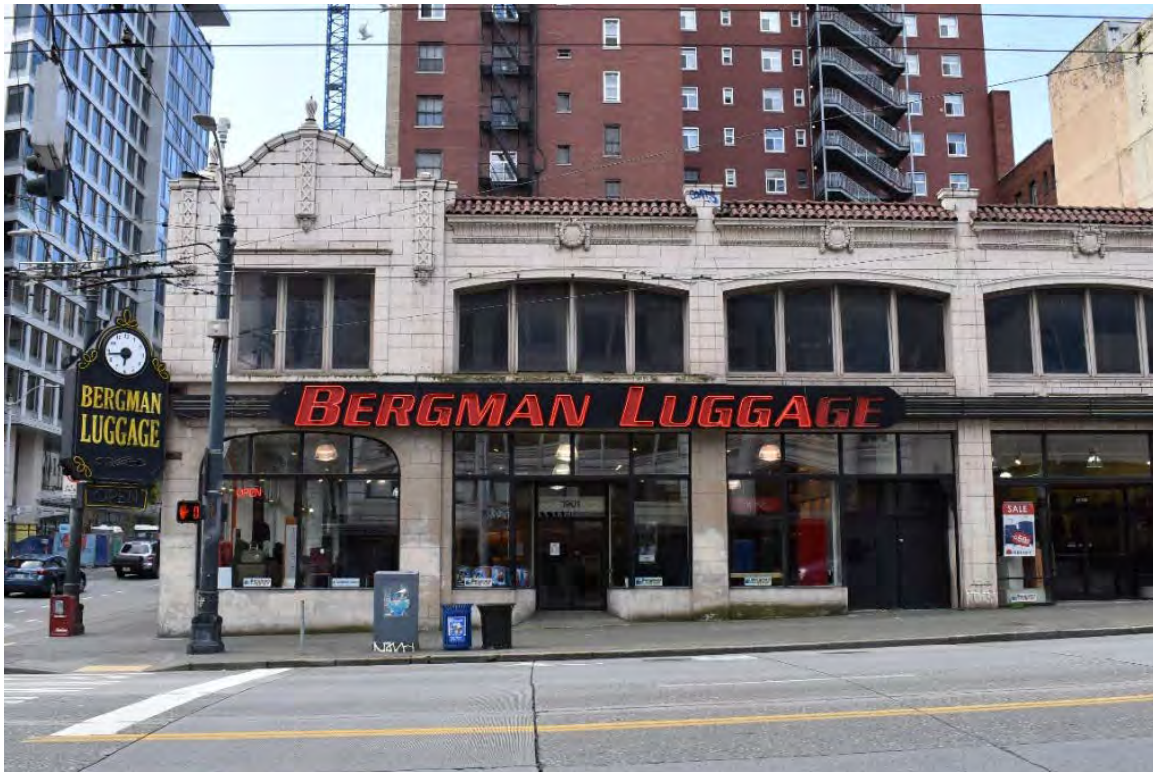
Fig. 10 – East elevation (3rd Avenue), south part

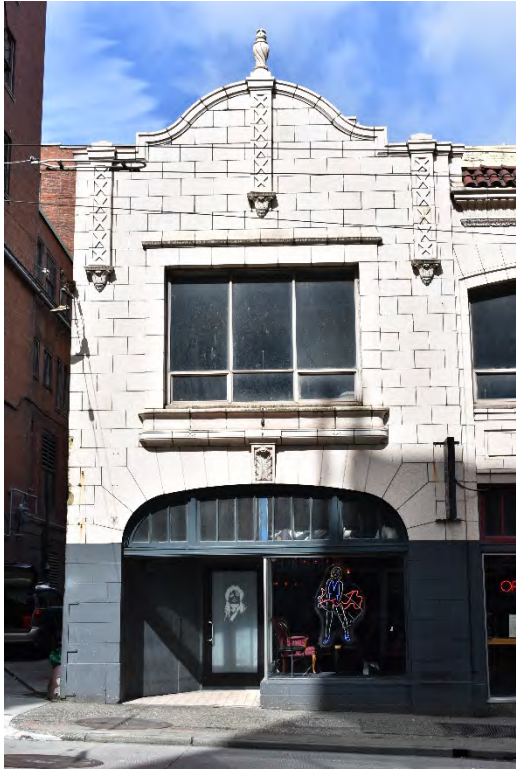
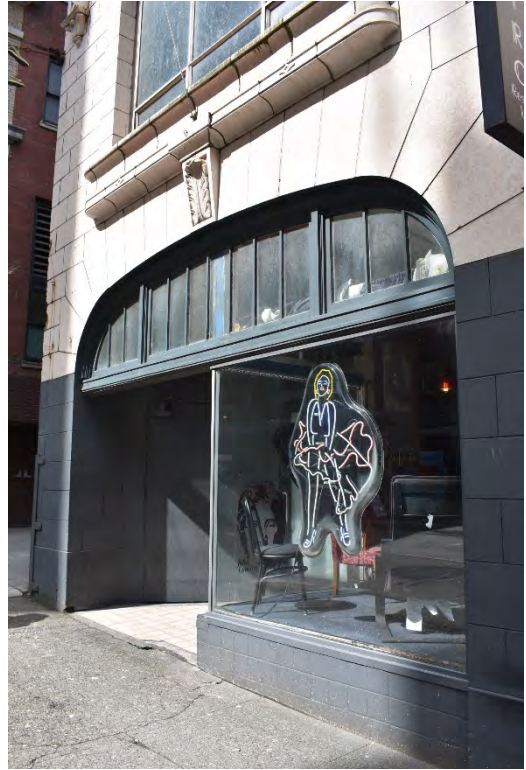
Fig. 11 – South elevation, detail of first bay

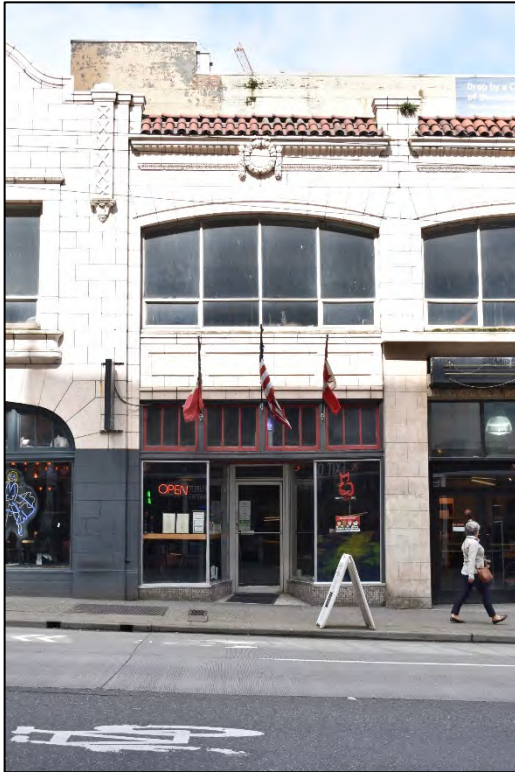
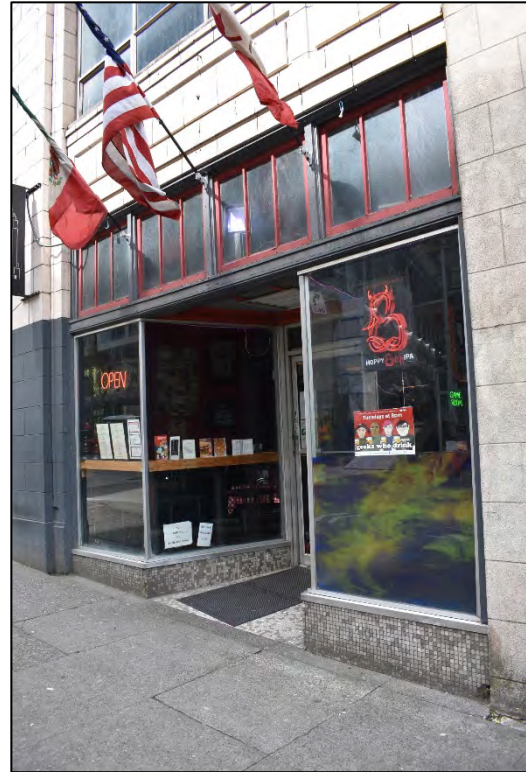
Fig. 12 – South elevation, detail of second bay

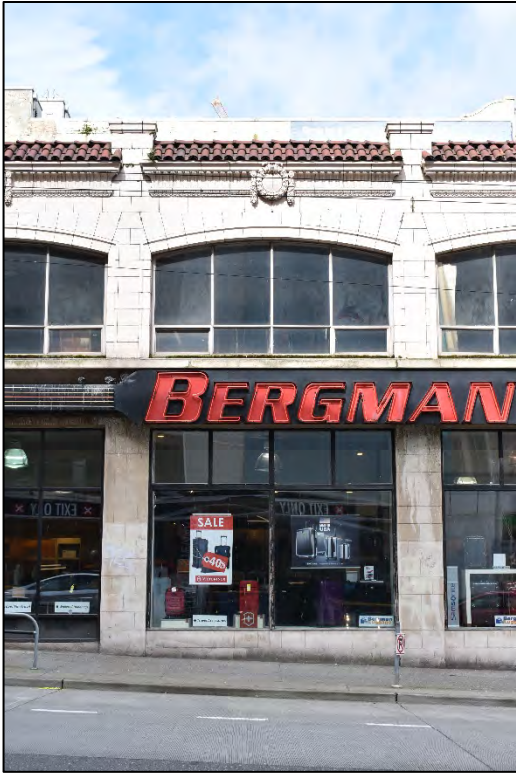
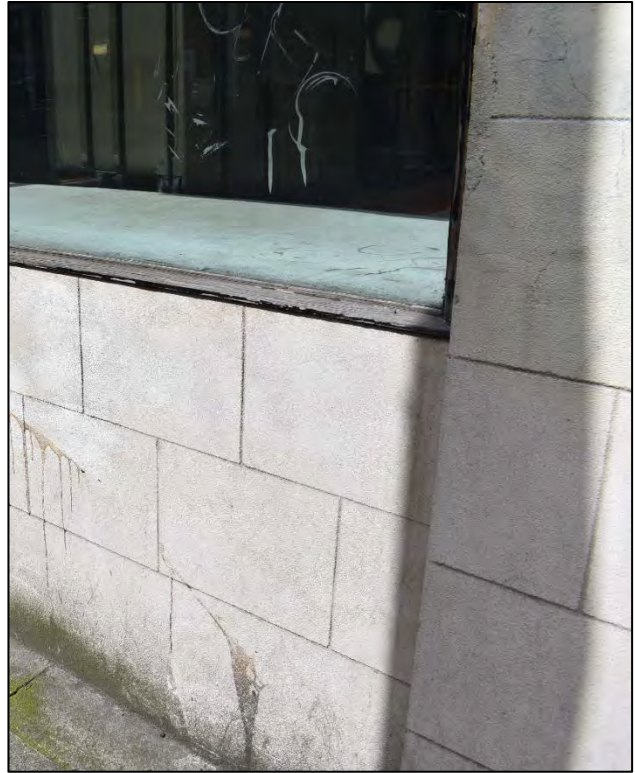
Fig. 13 – South elevation, detail of third bay, with c.1980s stucco finish at lower part

- All storefronts at the first floor are non-original, although original first floor wood transoms remain at bays 1-2 along Stewart Street, and at bay 6 on 3rd Avenue. (Since 1937)
- Original terra cotta cladding was removed from the first floor level of bays 3-6 on the Stewart Street elevation, and bays 1-2 on 3rd Avenue elevation, and replaced in 1959-1961 with a red granite Modern-style façade to serve as a People’s National Bank branch. Around 1989, the present owner removed that Modern façade, and replaced it with the current painted stucco finish, scored to appear as masonry.
- Collapse of roof at two locations, and subsequent repairs (c. late 1980s).
- Roof parapet at alley collapsed and removed after Nisqually earthquake. (c.2001)
- No significant interiors remain; all have been altered to suit tenants over time.

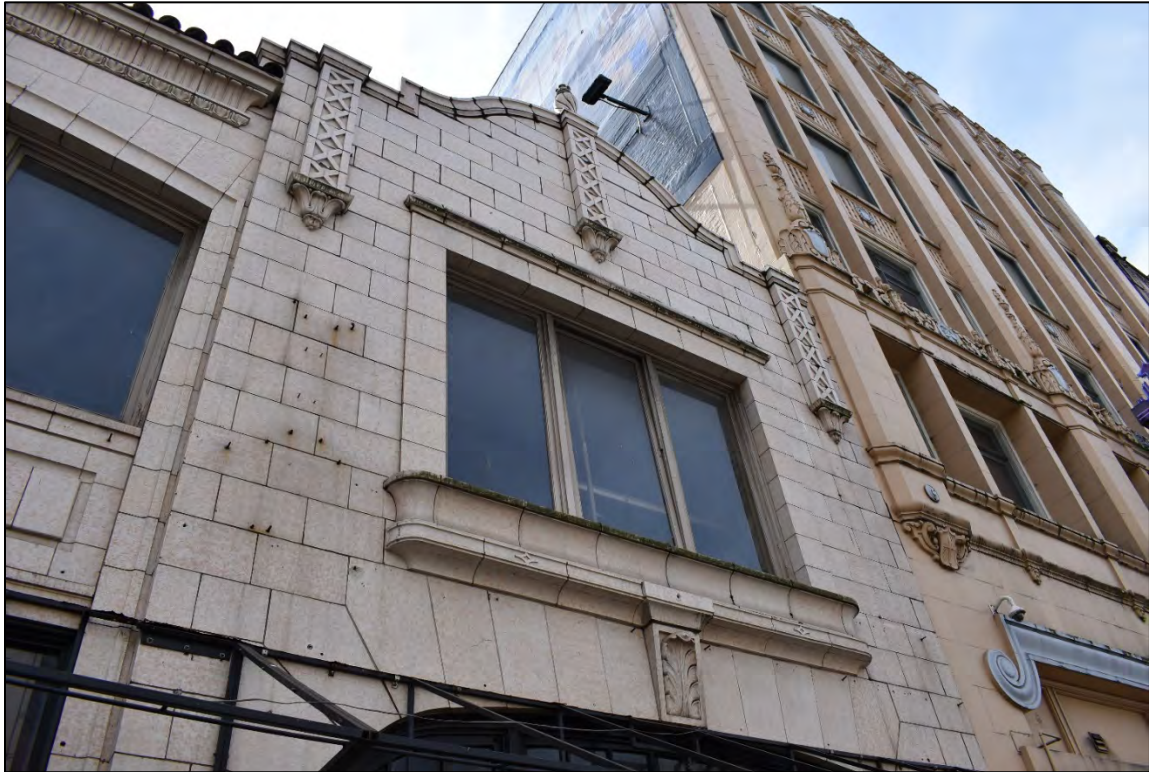
Fig. 14 – East elevation, detail of sixth bay, upper part.
Window dates to between 1923 and 1937, likely installed during 1924 alterations.

Additionally, in 1921—as evidenced by original architectural drawings and the 1921 and 1923 Seattle Times images—all of the upper floor windows, and the first three bays of windows at the first floor on the south elevation, were multi-light. By 1937 (probably as part of the 1924 alterations), these windows were replaced with single-pane windows.

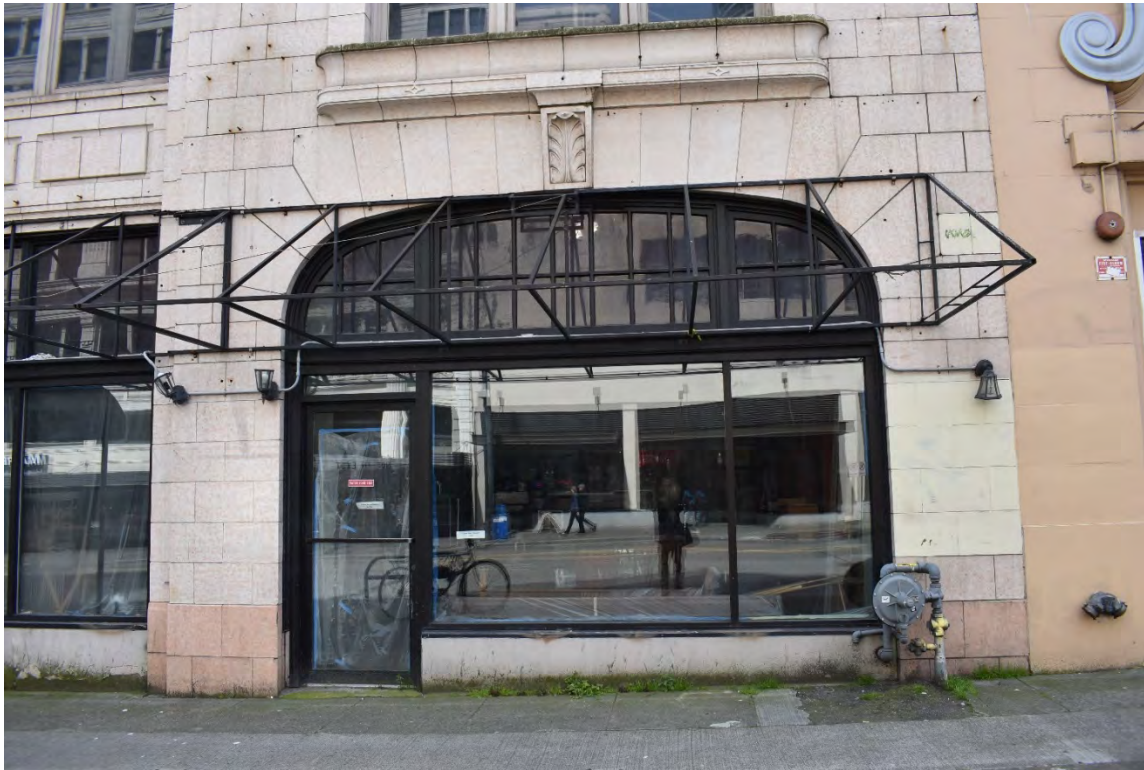
Fig. 15 – East elevation, detail of sixth bay, lower part

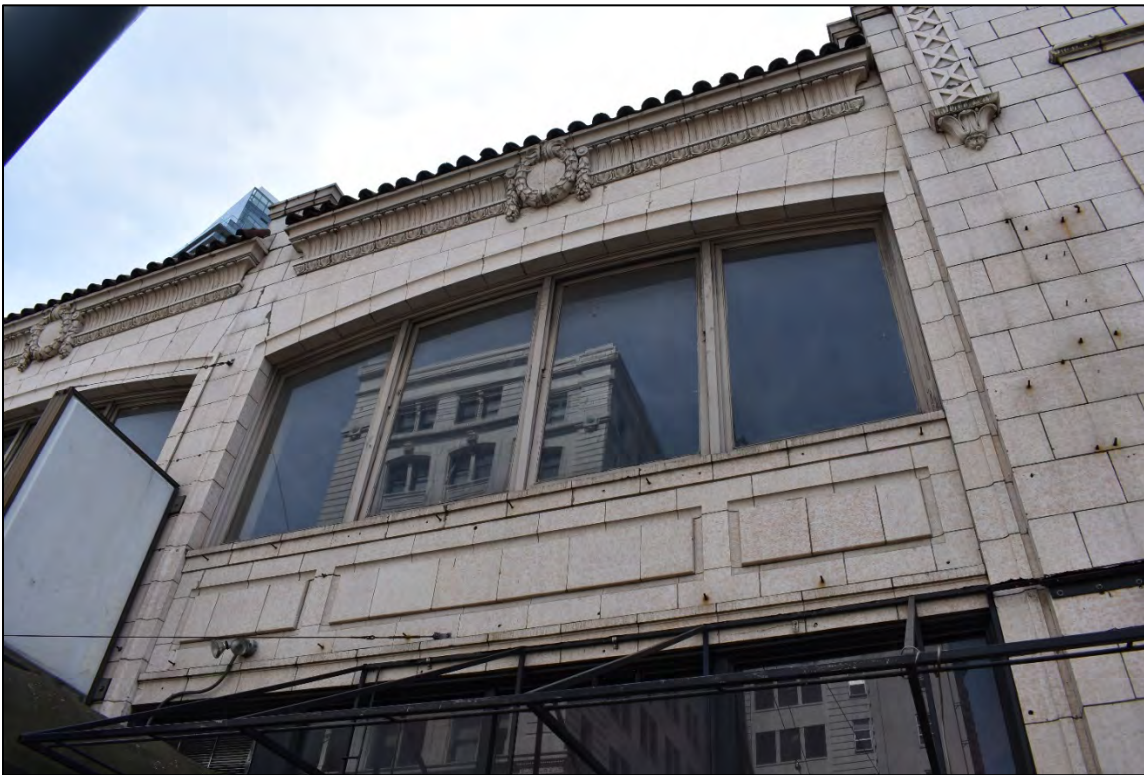
**Fig. 16 – East elevation, detail of sixth bay, upper part.
Window dates to between 1923 and 1937, likely installed during 1924 alterations.**

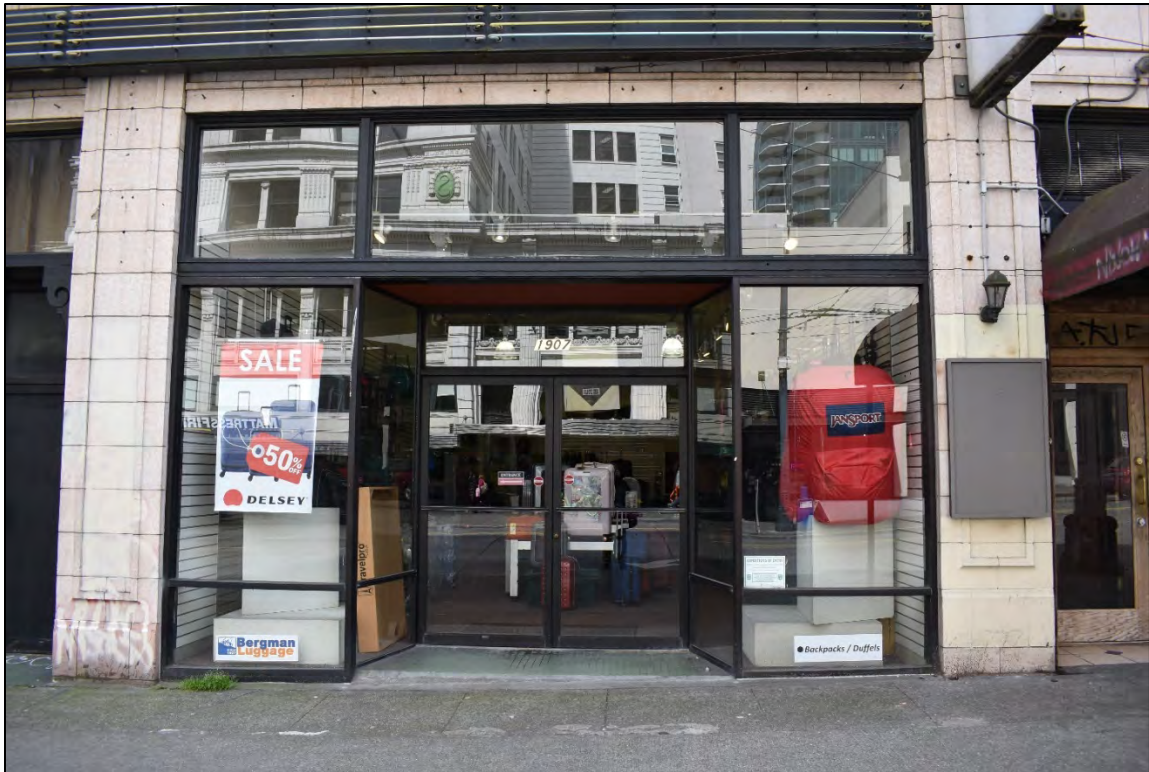
Fig. 17 – East elevation, detail of fifth bay, lower part, showing non-original storefront, typical

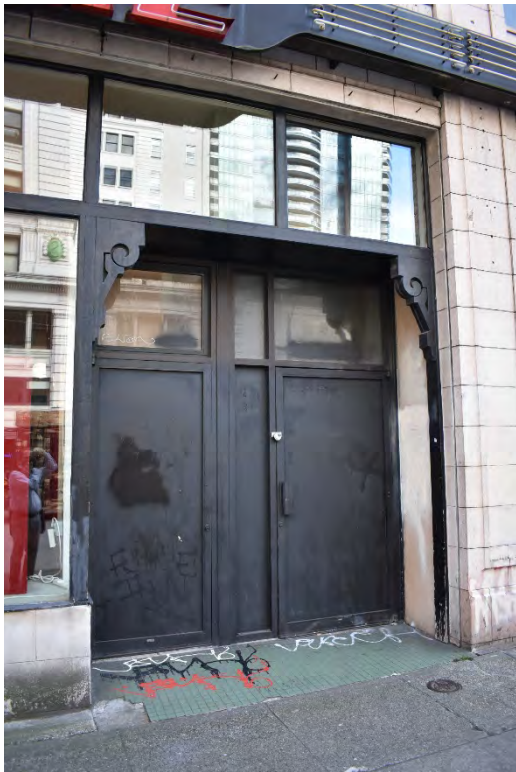
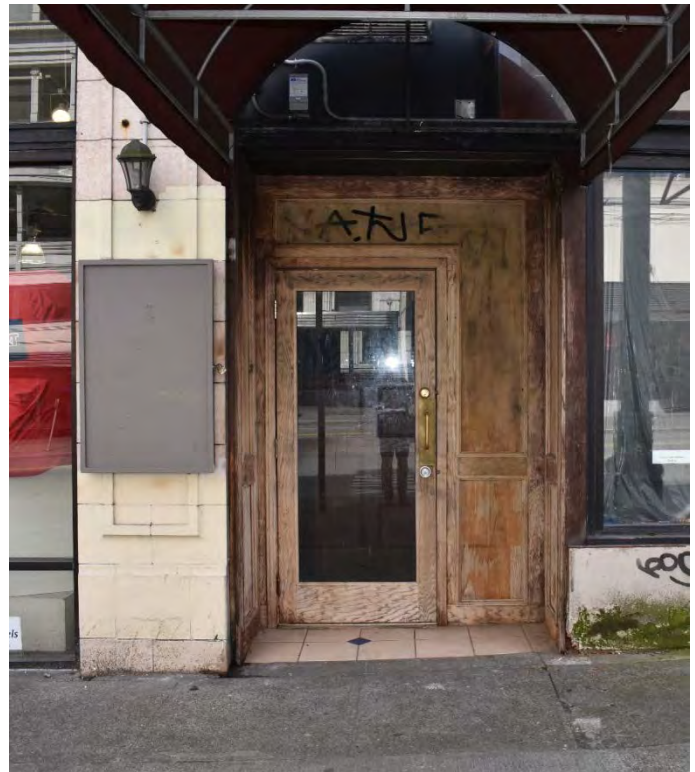
Fig. 18 – East elevation, detail of third and fifth bays, lower part, showing non-original doors with decorative features

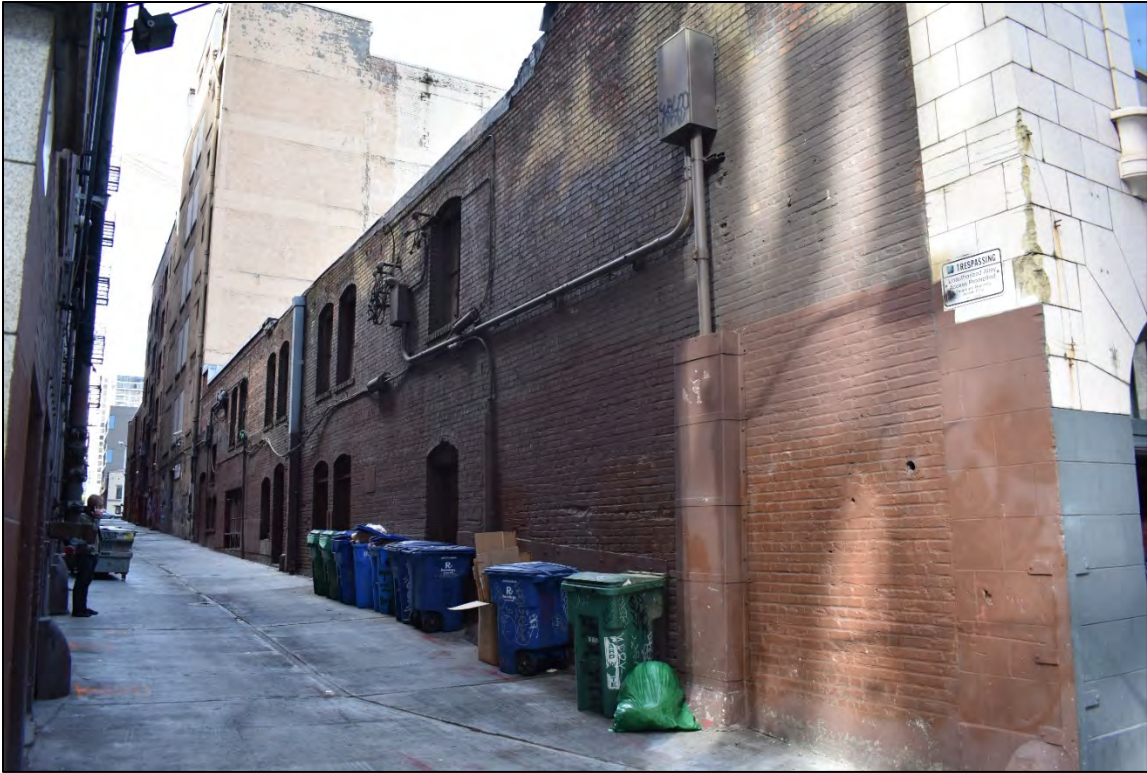
Fig. 19 – West elevation (alley), view north

The alley or west elevation is utilitarian, and features brick arch windows at both floors, many with original metal sash and fretted translucent glass. According to the original 1921 architectural drawings, the first or northernmost bay of the alley was originally a garage opening to a ramp leading to the upper floor. However, this condition was removed in the 1924 alterations, when it was replaced with a freight elevator.

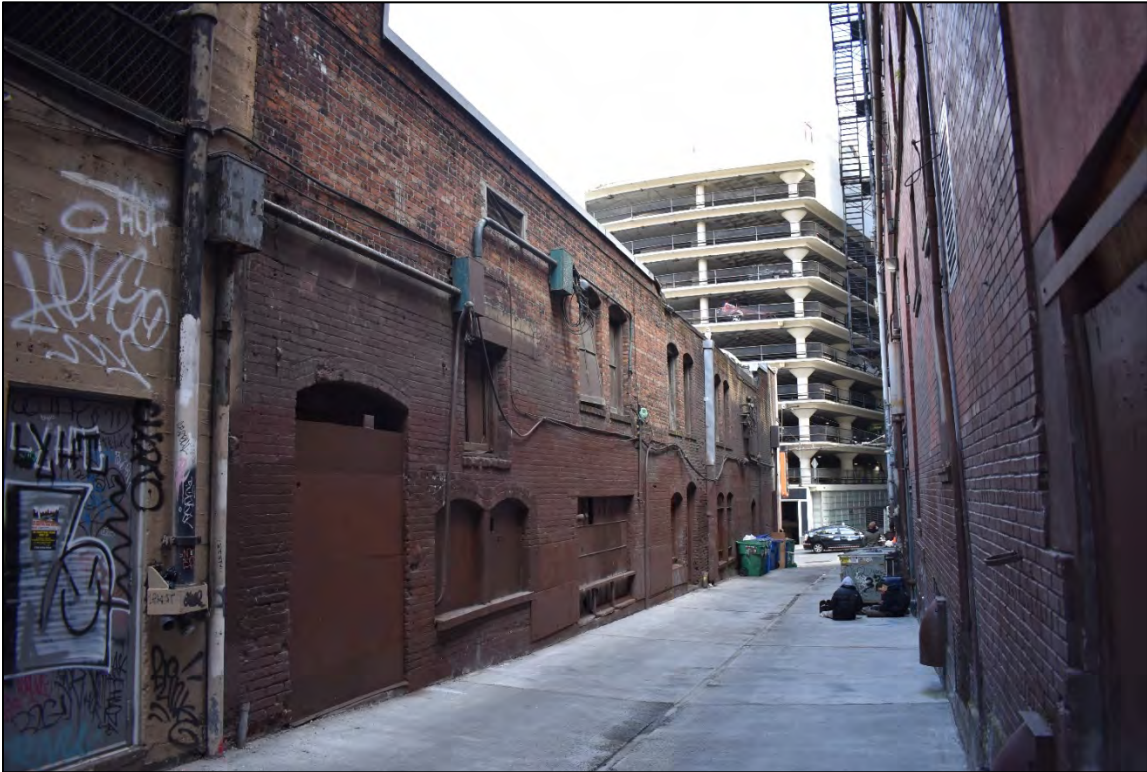
Fig. 20 – West elevation (alley), view south

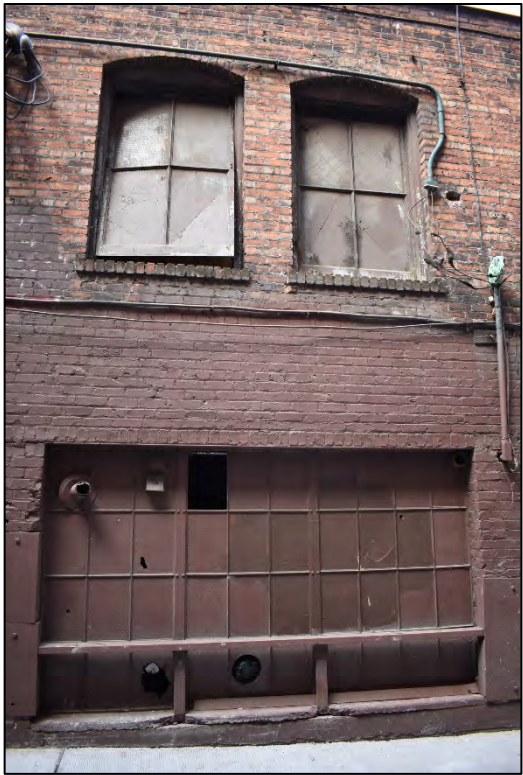
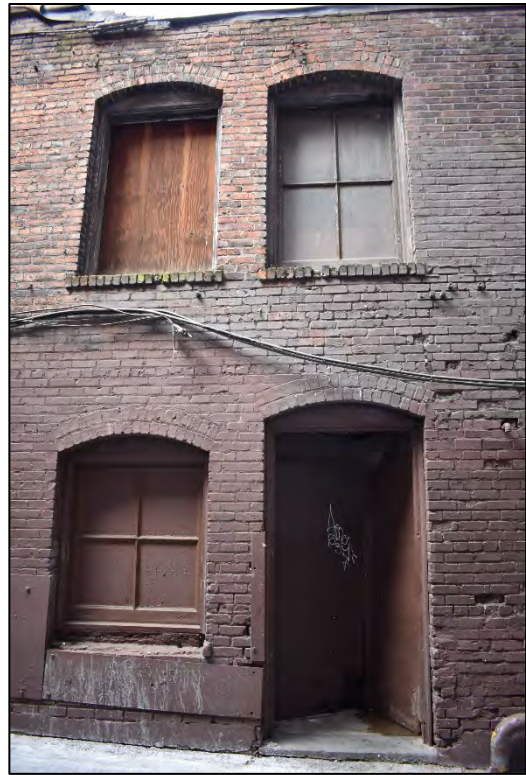
Fig. 21 – West elevation (alley), detail of windows and openings

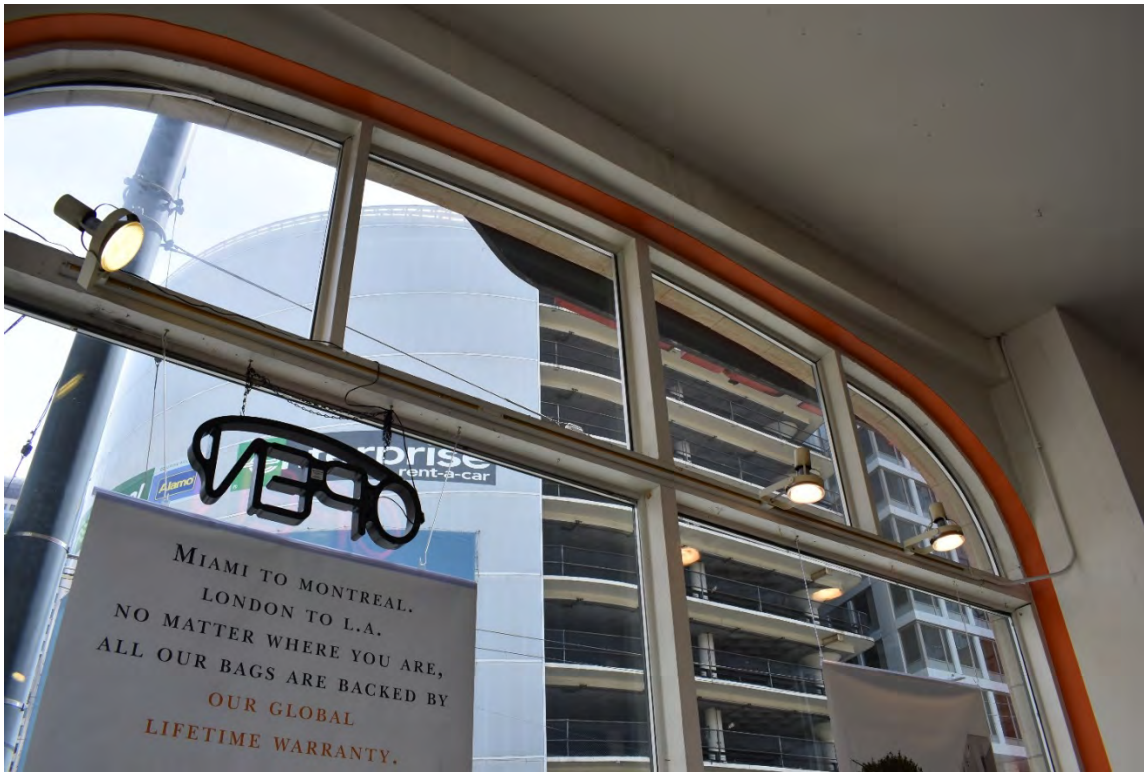
Fig. 26 – Interior, first floor, luggage store at corner of Stewart & 3rd, detail of window

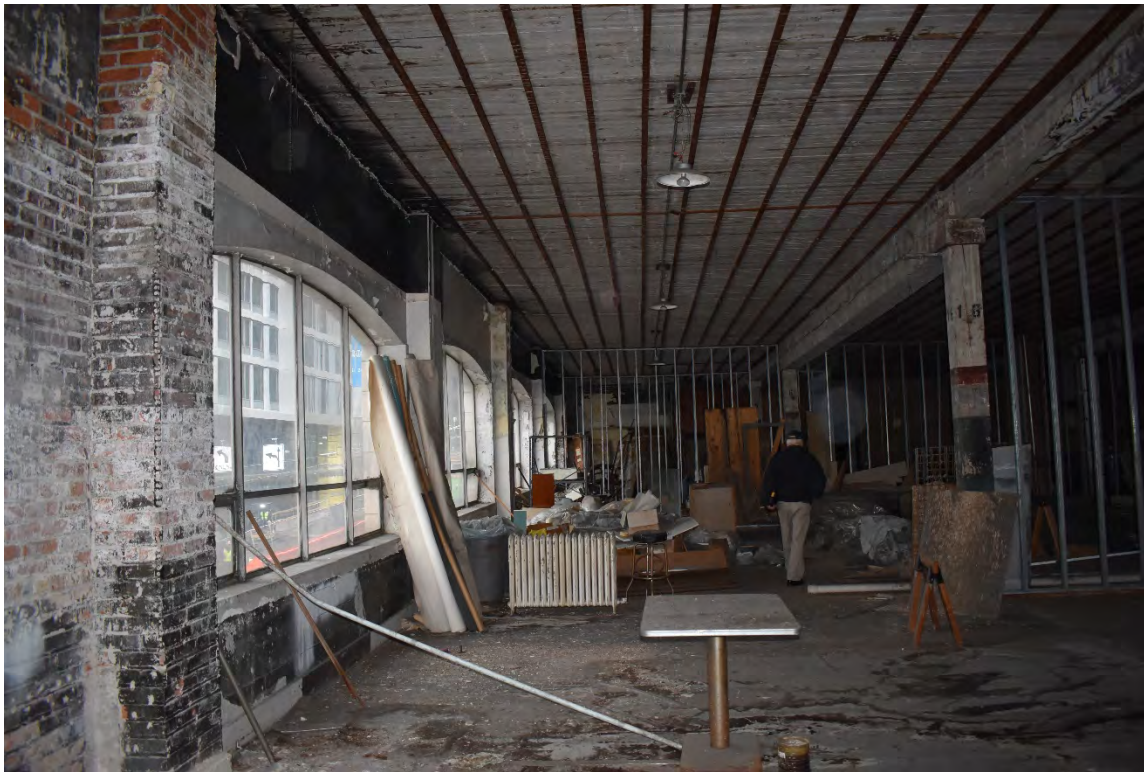
Fig. 30 – Interior, second floor, showing south elevation windows (Stewart Street)

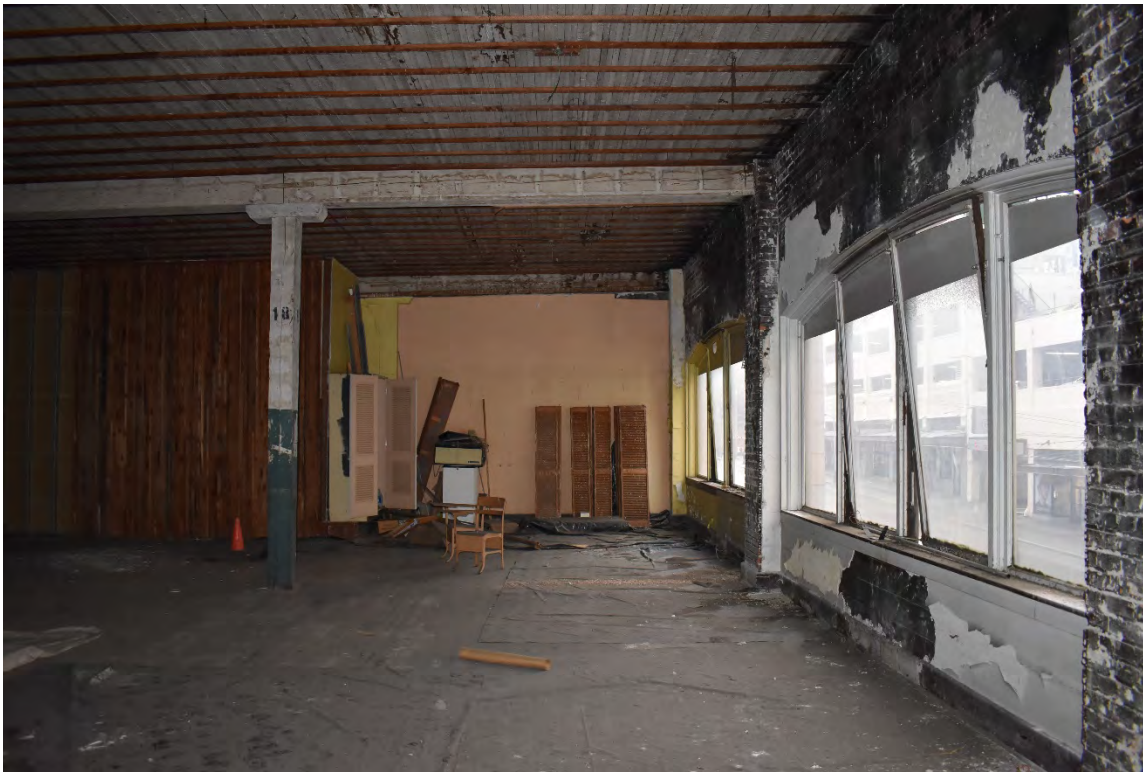
Fig. 32 – Interior, second floor, showing east elevation windows (3rd Avenue)

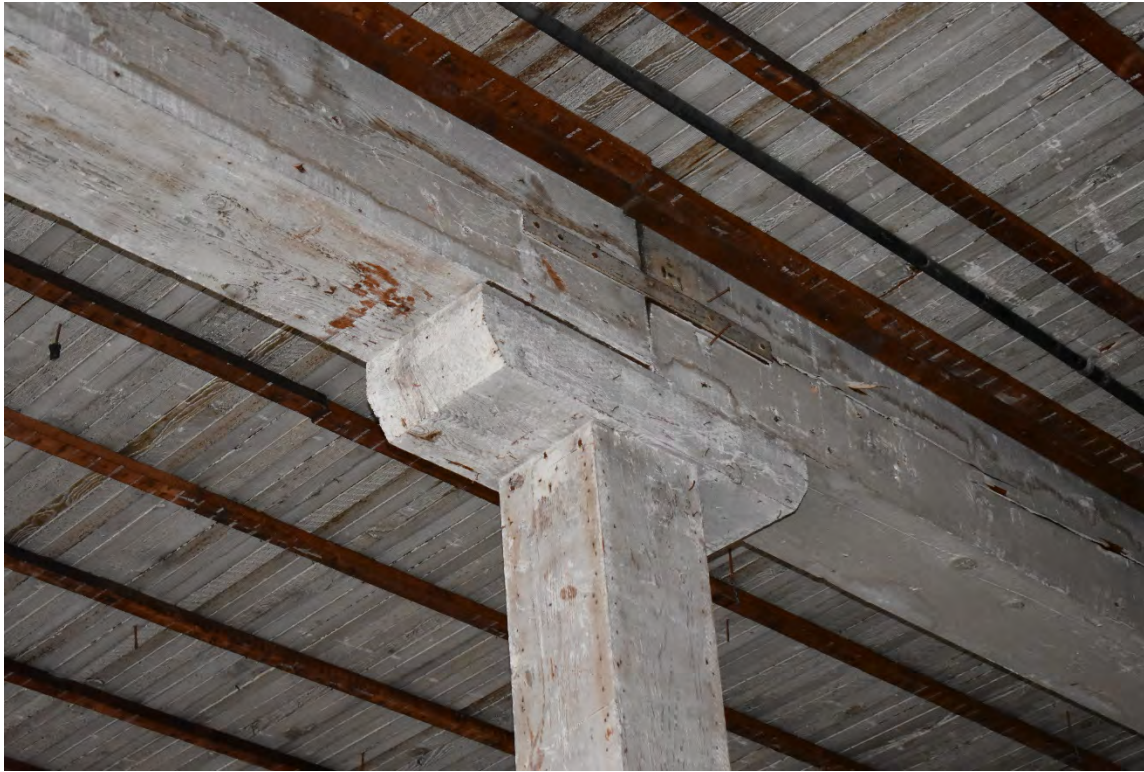
Fig. 33 – Interior, second floor, detail of post and beam

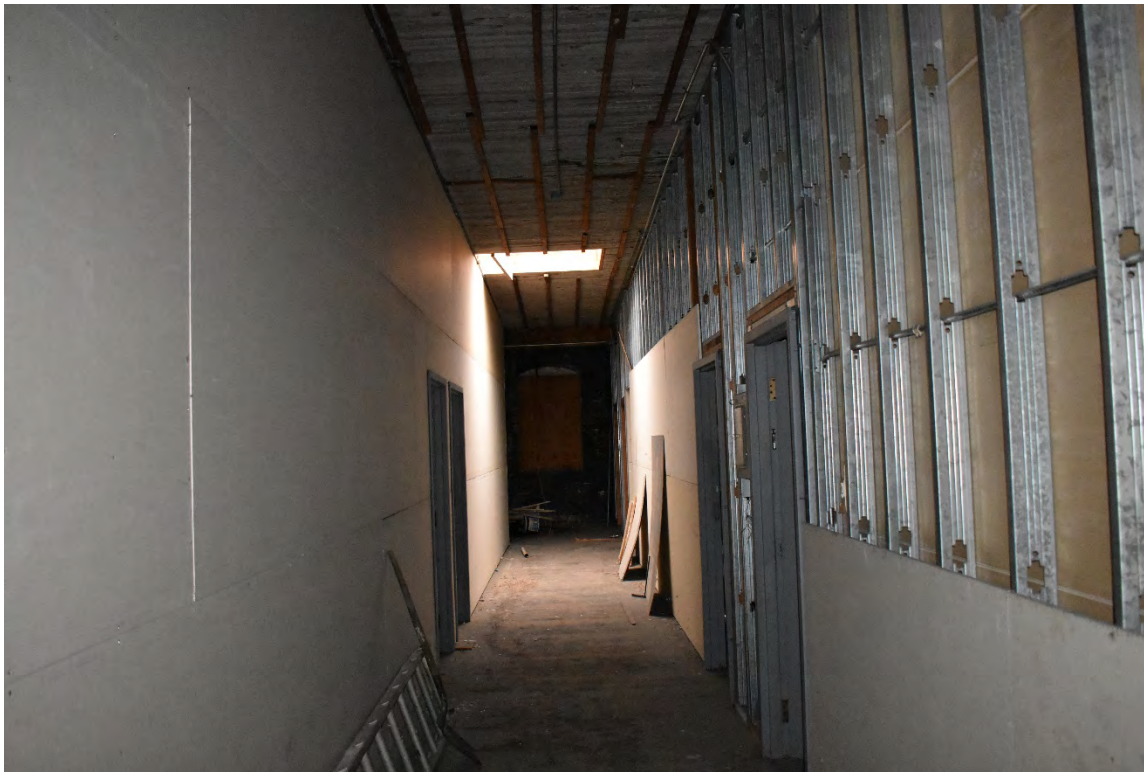
Fig. 34 – Interior, second floor, typical corridor with skylight

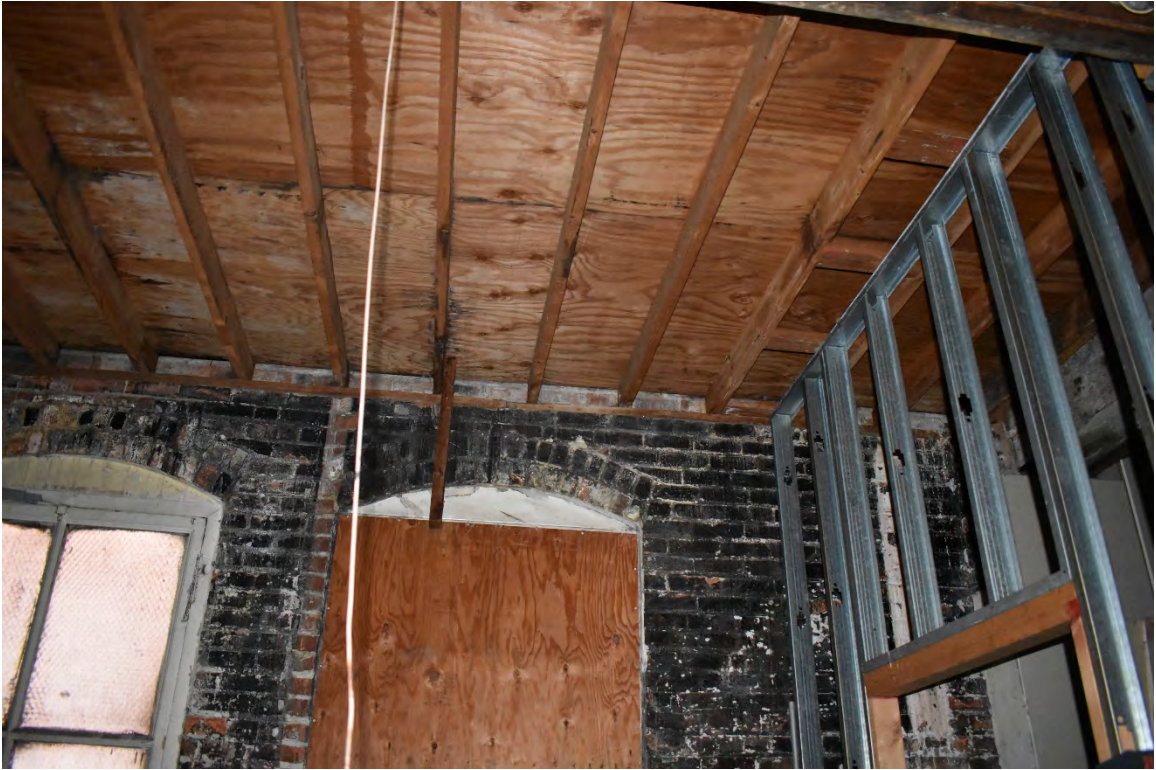
Fig. 35 – Interior, second floor, alley side showing repair at location where roof collapsed.

The second floor interior space is in very poor condition and has not been leased for decades. It is stabilized but not in an occupiable state, following past roof repairs and partially-completed interior partition walls.

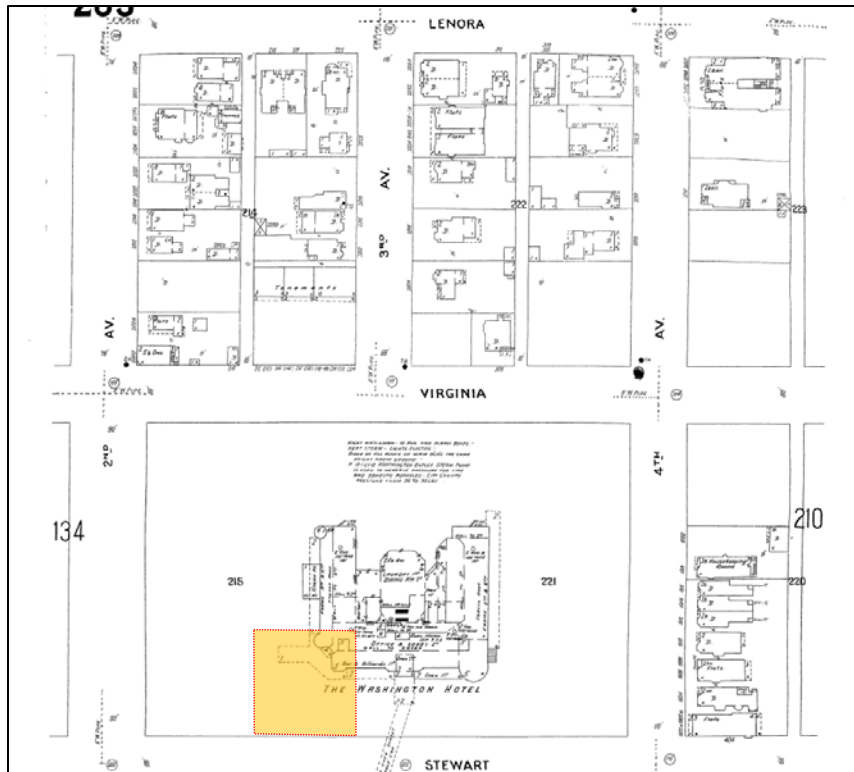
Fig. 42 – 1905 Sanborn Fire Insurance map showing Denny/Washington Hotel; approximate subject site indicated by shaded box. North is up.

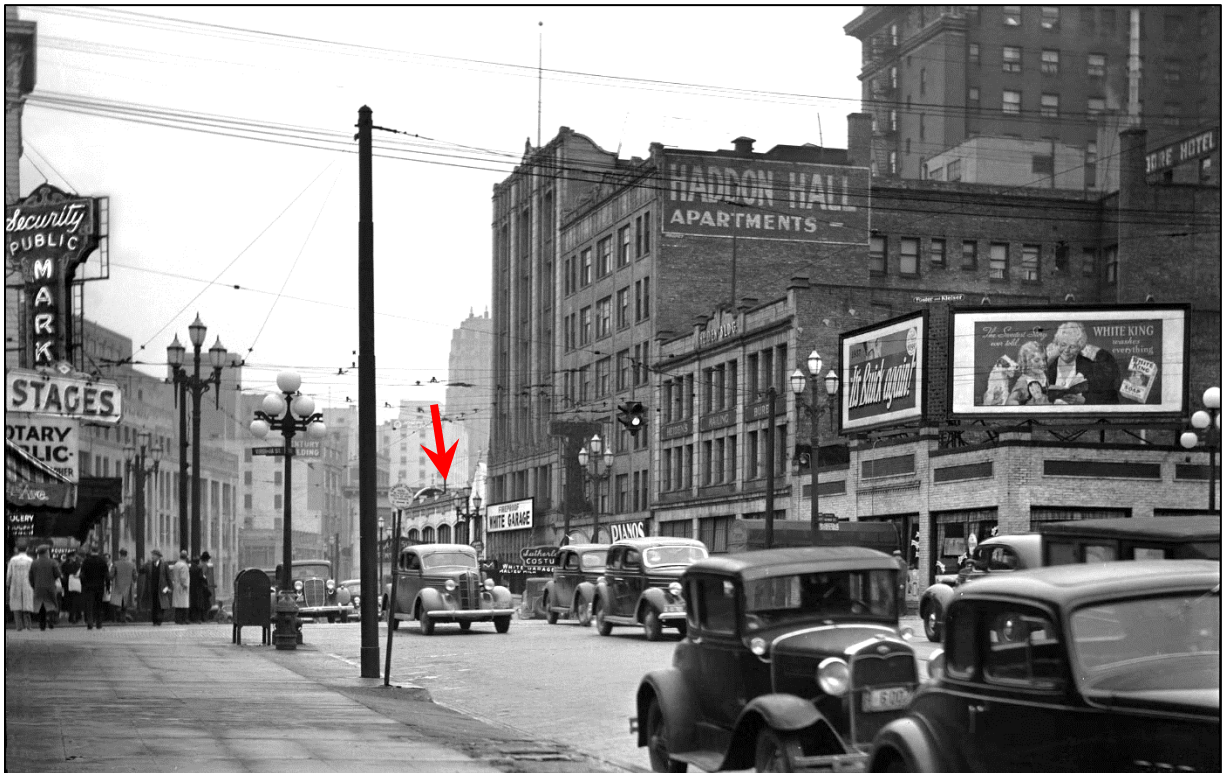
Fig. 46 – “Seattle’s coming retail and apartment-house district,” by B. Dudley Stewart and artist W. E. Sproat. Subject site is an empty lot surrounded by tall buildings in 1917.

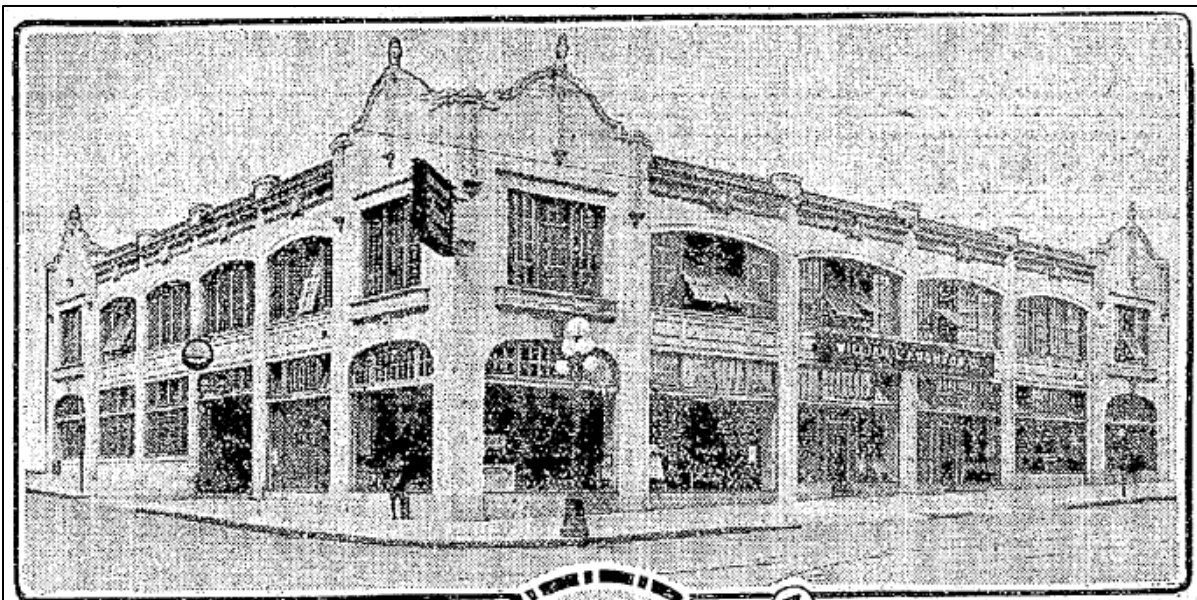
Fig. 51 – 1921 image, when the Alfred G. Ayerst Ford Dealership was the original tenant.
This is the earliest image of the building found. (Seattle Times, October 23, 1921)
