Landmark NOMINATION Application

Name: Donahoe Building / Bergman Luggage

Donahoe Building / Bergman Luggage
Seattle Landmark Nomination

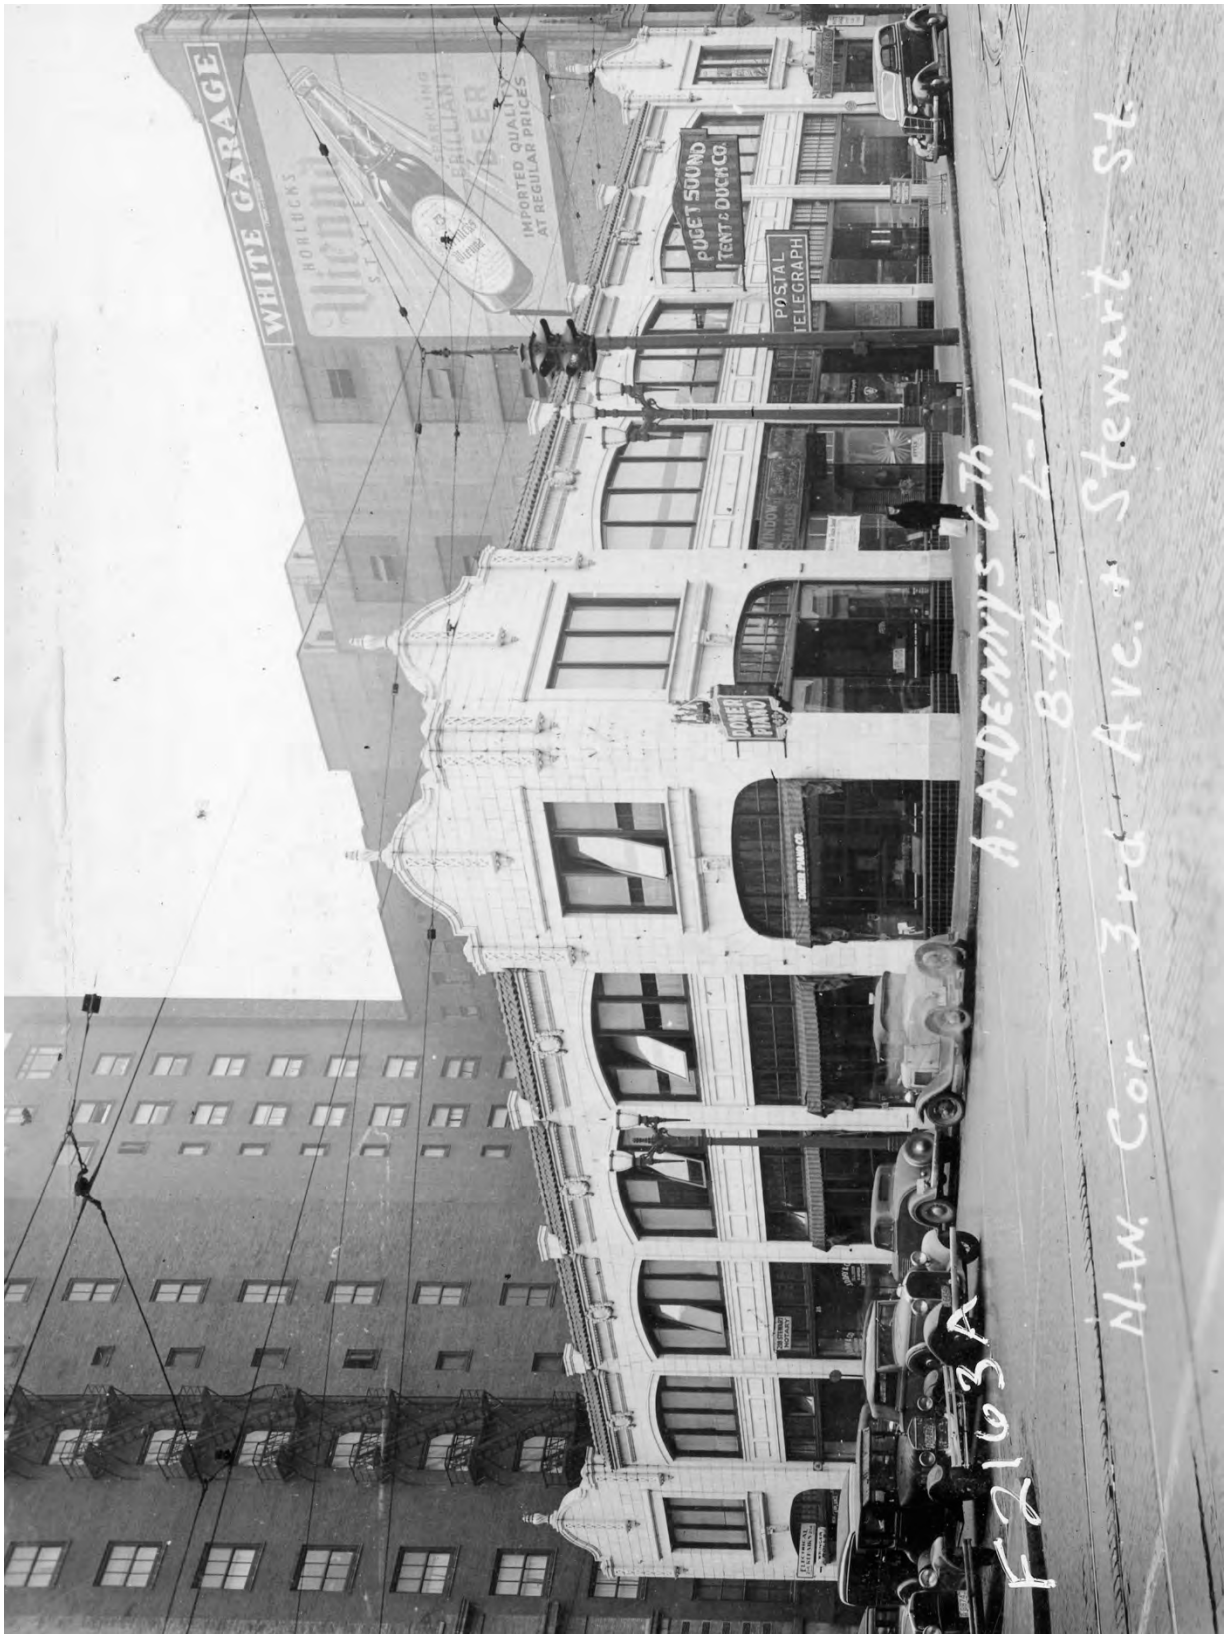
Fig. 52 – 1923 image, after Ayerst was bought out by the William L. Hughson Ford agency.
(Seattle Times, October 23, 1921)

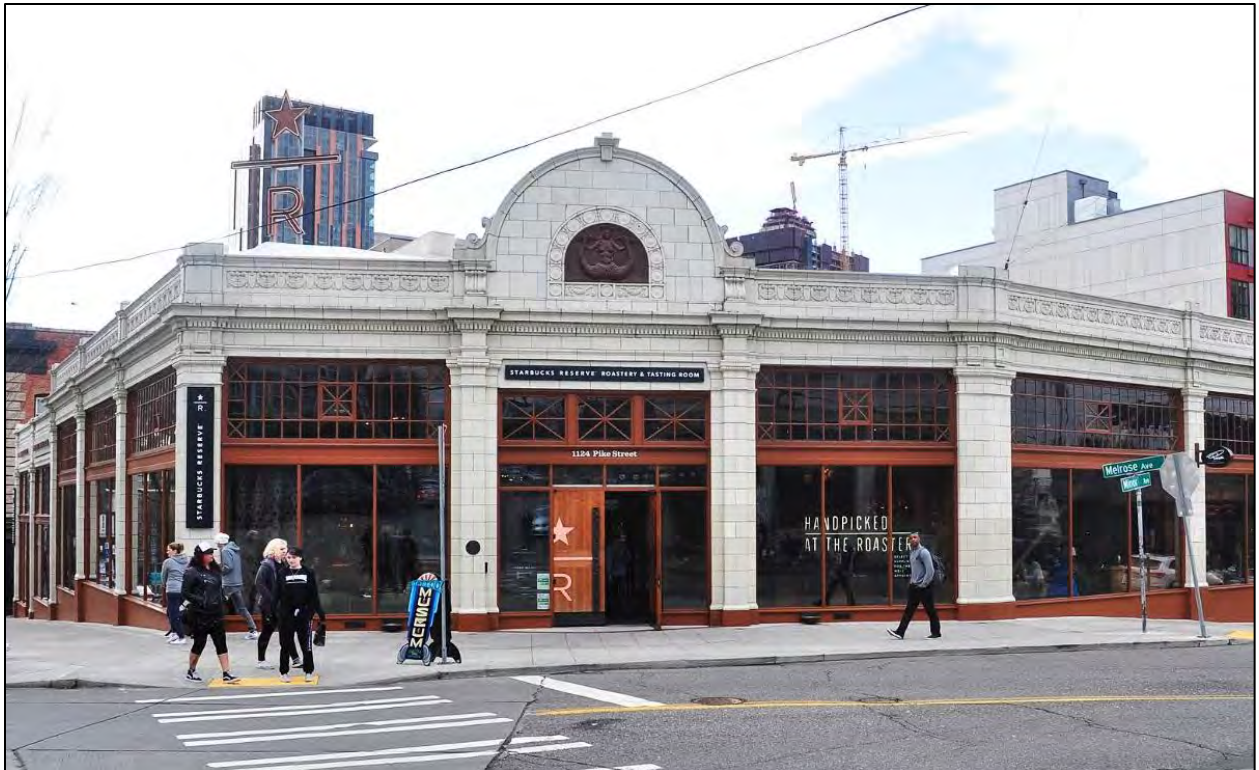
Fig. 55 – Comparable buildings: White Motor Company (Julian Everett, 1918) at 11th Avenue & Pine Street. Automobile dealership showrooms were frequently ornate and located in prominent locations. This building is clad in terra cotta. (PSRA)

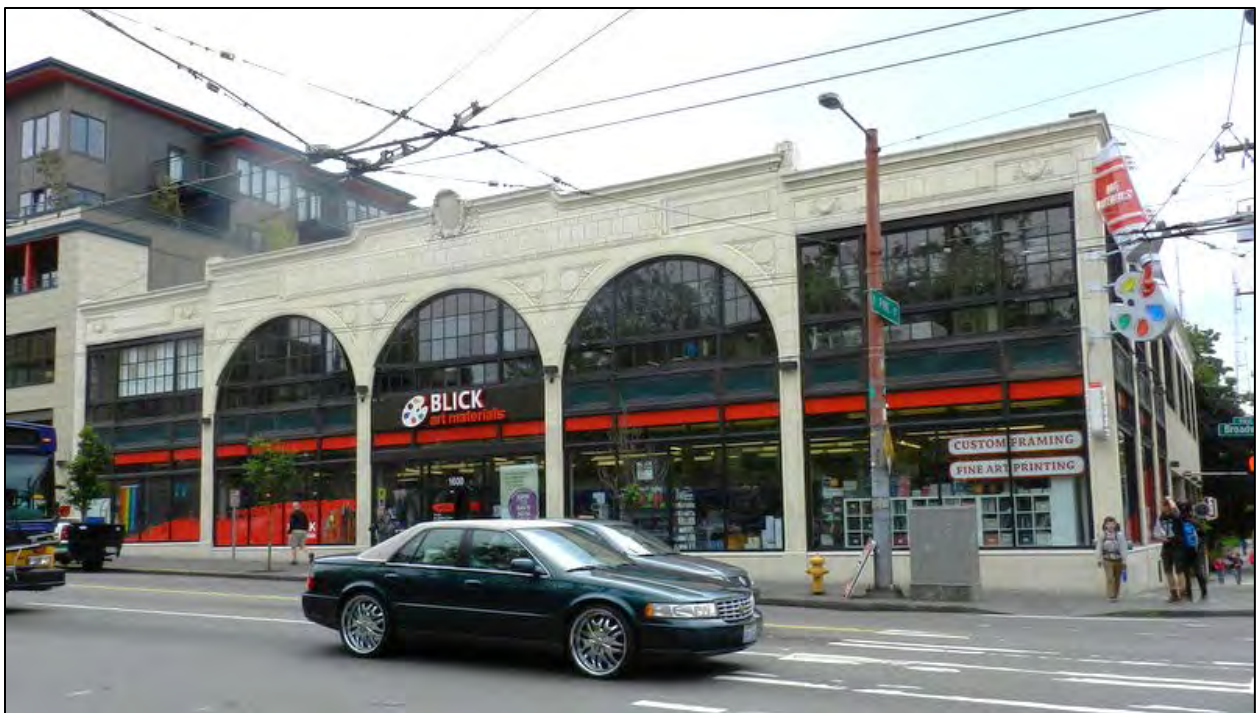
Fig. 56 – Comparable buildings: Packard Automobile dealership (Louis Svarz, 1920) at Pike & Melrose. This building is clad in terra cotta. (Joe Mabel)

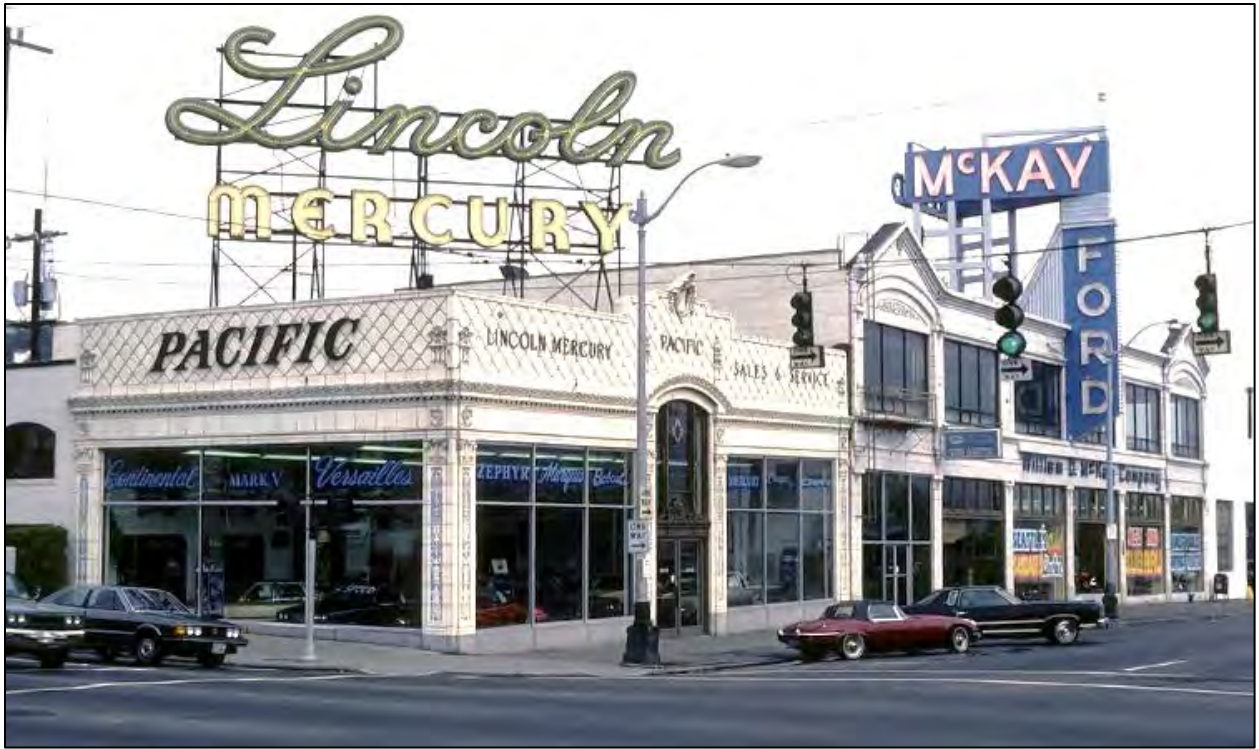
Fig. 57 – Comparable buildings: Boone & Co. Pontiac dealership (1925, altered) at Pine & Broadway. This building is clad in terra cotta. (DON)

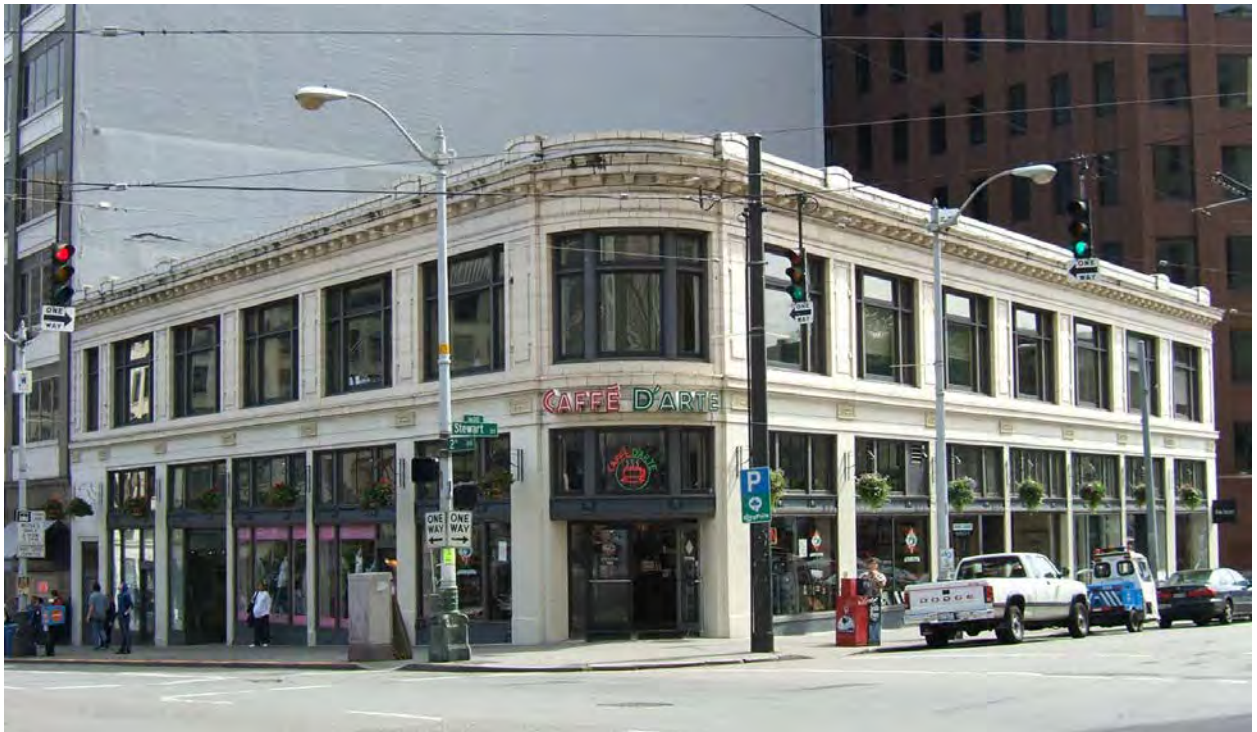
Fig. 58 – Comparable buildings: Pacific Ford McKay dealership (Harlan Thomas, 1922-25, altered) at Mercer & Westlake, view in 1970. These buildings are clad in terra cotta. (SDOT)

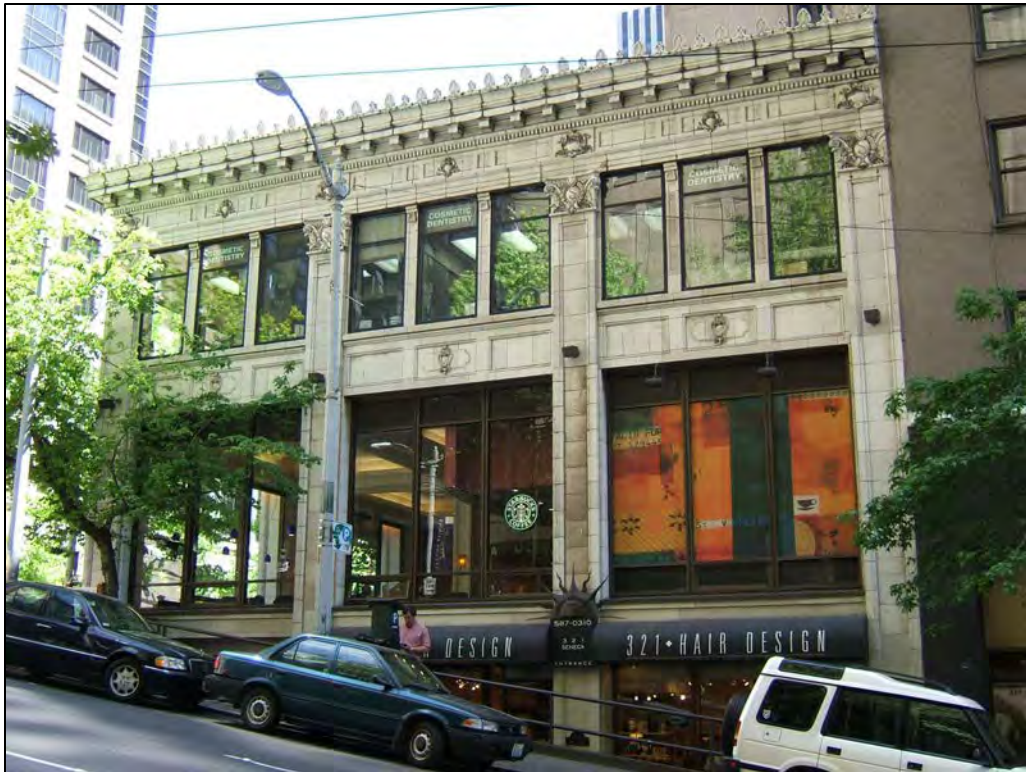
Fig. 59 – Comparable buildings: Ames Building (Charles Bebb, 1914, demolished), this terra cotta clad store-and-office building was located at 2nd Avenue & Stewart Street, one block from the subject site. (DON)

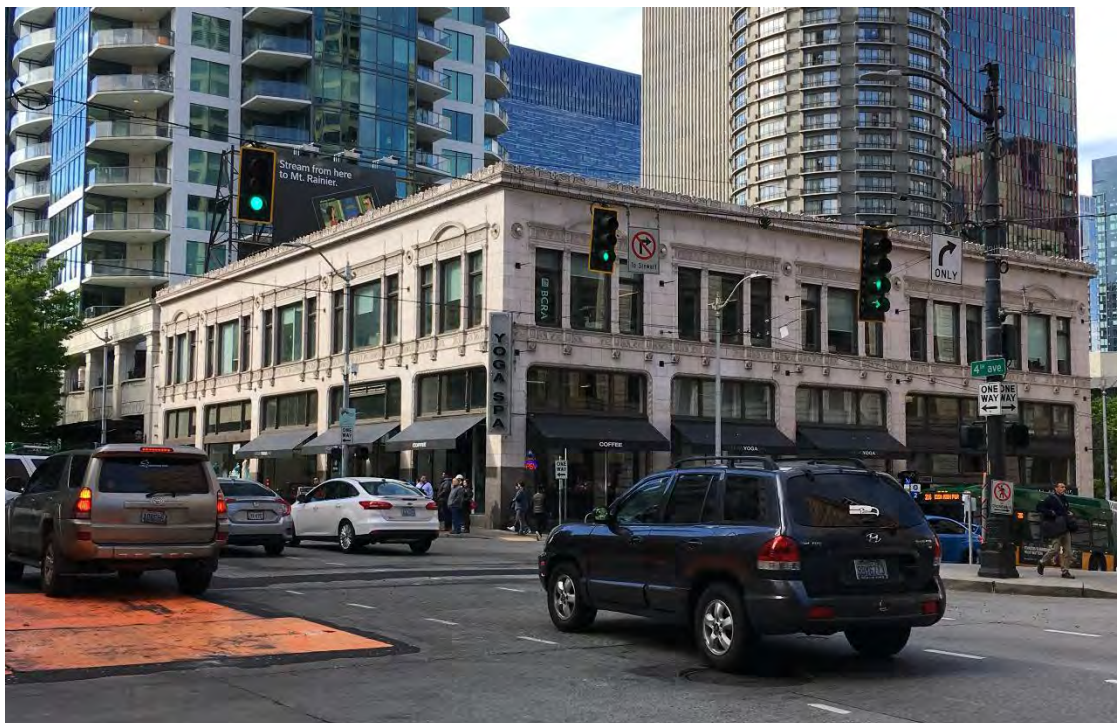
Fig. 60 – Comparable buildings: 1119 4th Avenue (1922)
 This terra cotta building was originally constructed as a store-and-office building. (DON)

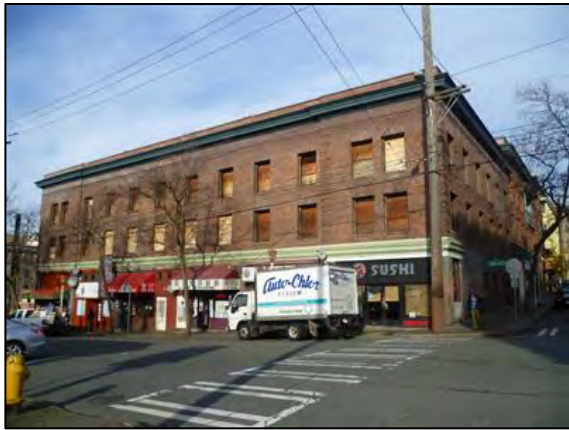
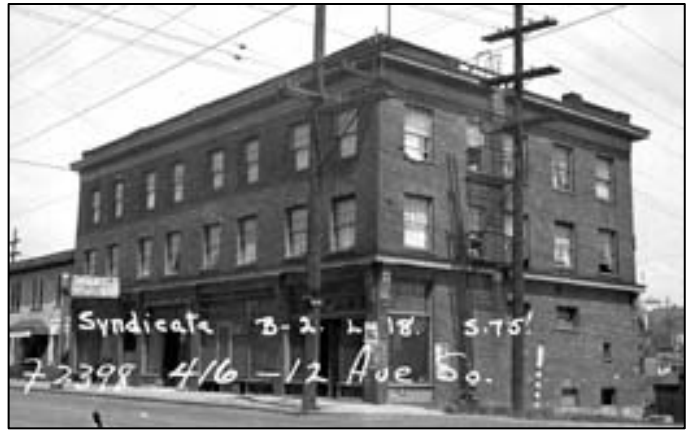
Fig. 61 – Comparable buildings: Tyee Building (1925),
 a terra cotta clad store-and-office building at 4th Avenue & Stewart Street, one block from the subject site. (DON)

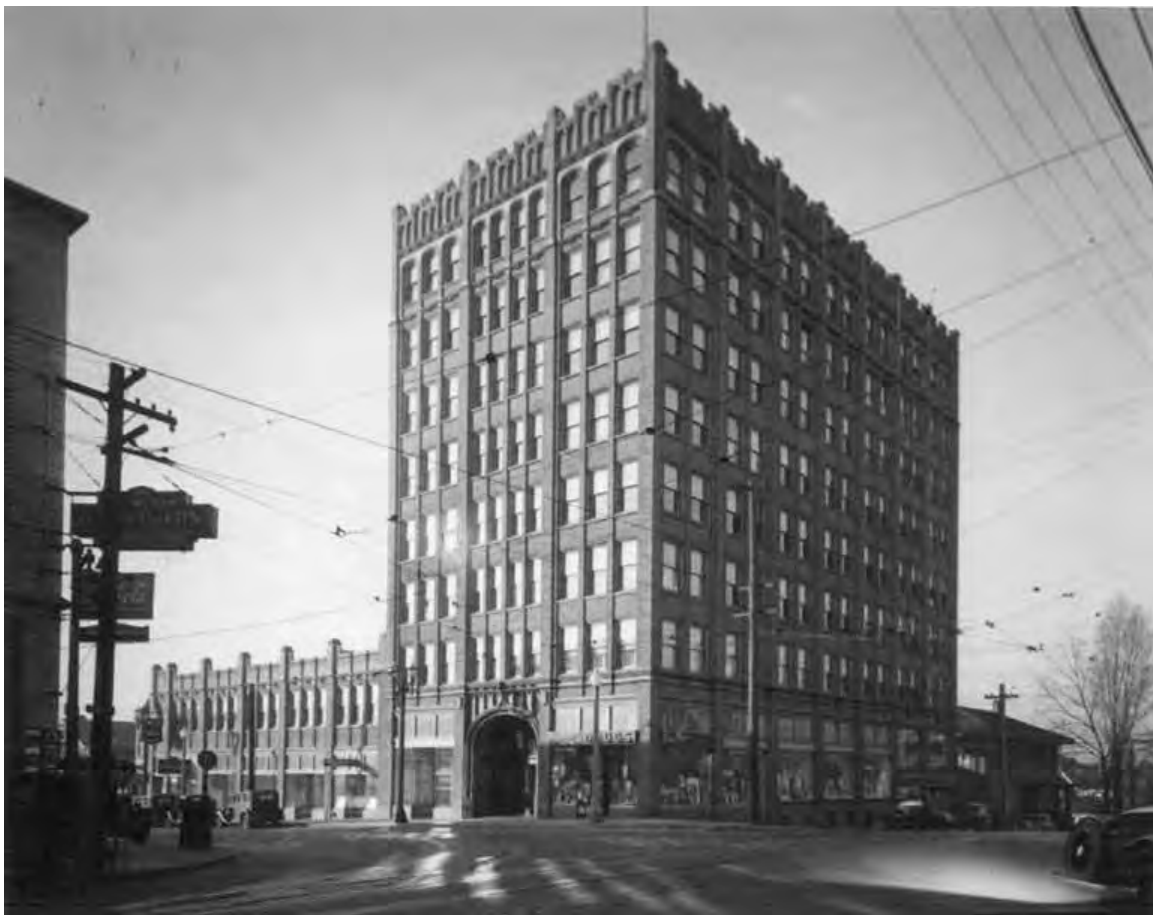
**Fig. 71 – Charles L. Haynes: Broadway Market (1928, altered). (PSRA)
The building was designed in the Spanish Eclectic style, like the subject building.**

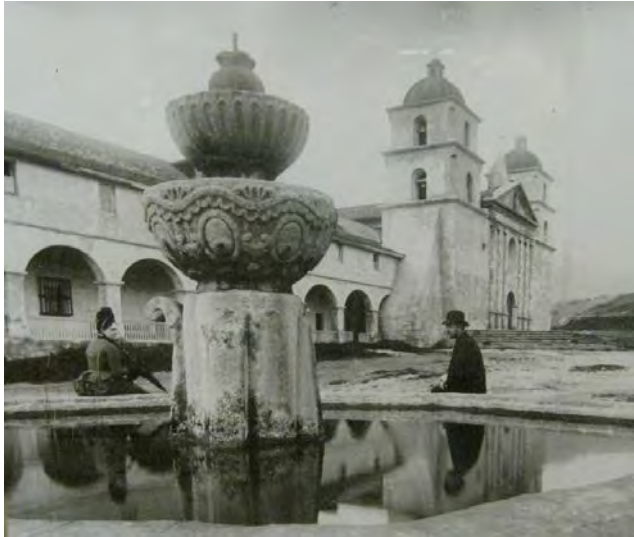
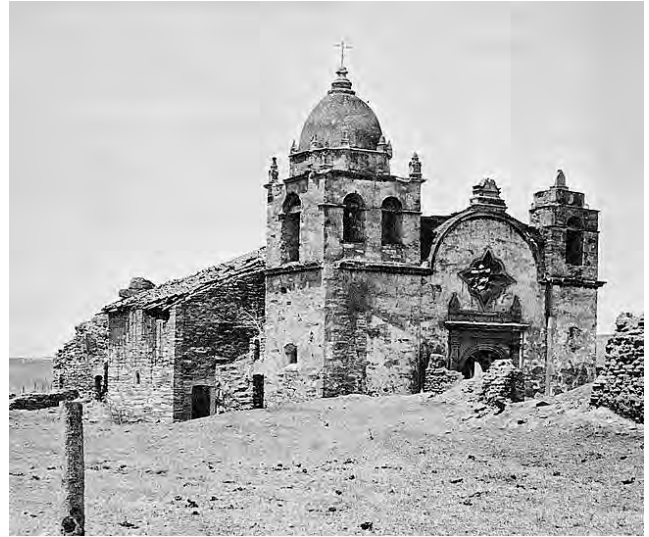
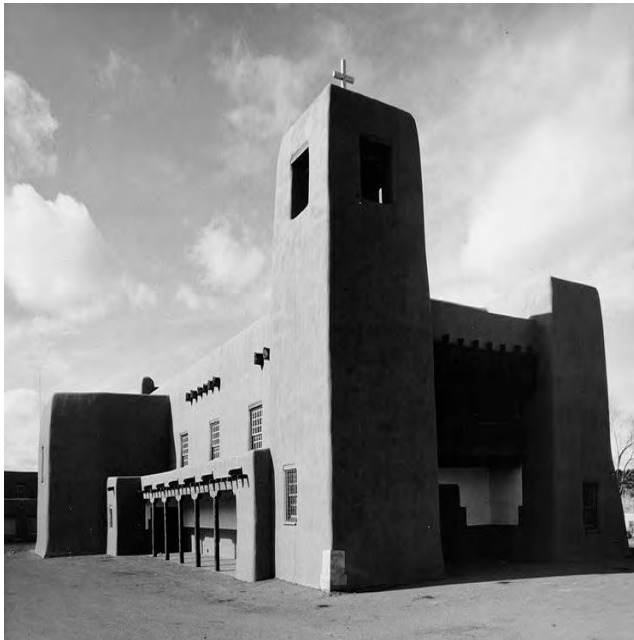
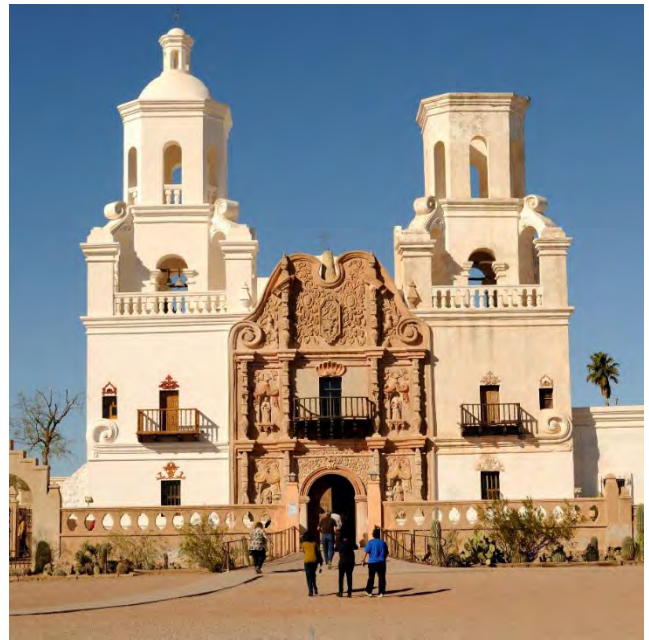
Fig. 73 – (Four images above) Spanish Colonial missions; buildings such as these provided inspiration to the Mission Revival, Spanish Colonial Revival, and related styles in the late 19th and early 20th centuries.

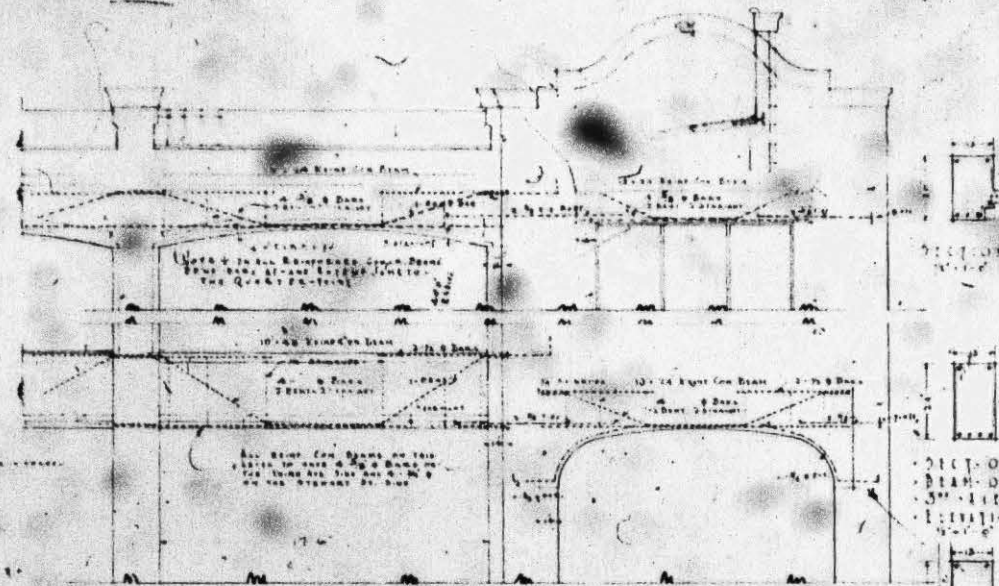
DETAIL ELEV. SHOWING REIN. COL. BEAMS
ON STREET ELEVATIONS OF BLDG.
Scale 1/4" = 1'-0"

SECTION OF
COLUMN
SECTION OF
COLUMN
SECTION OF
COLUMN

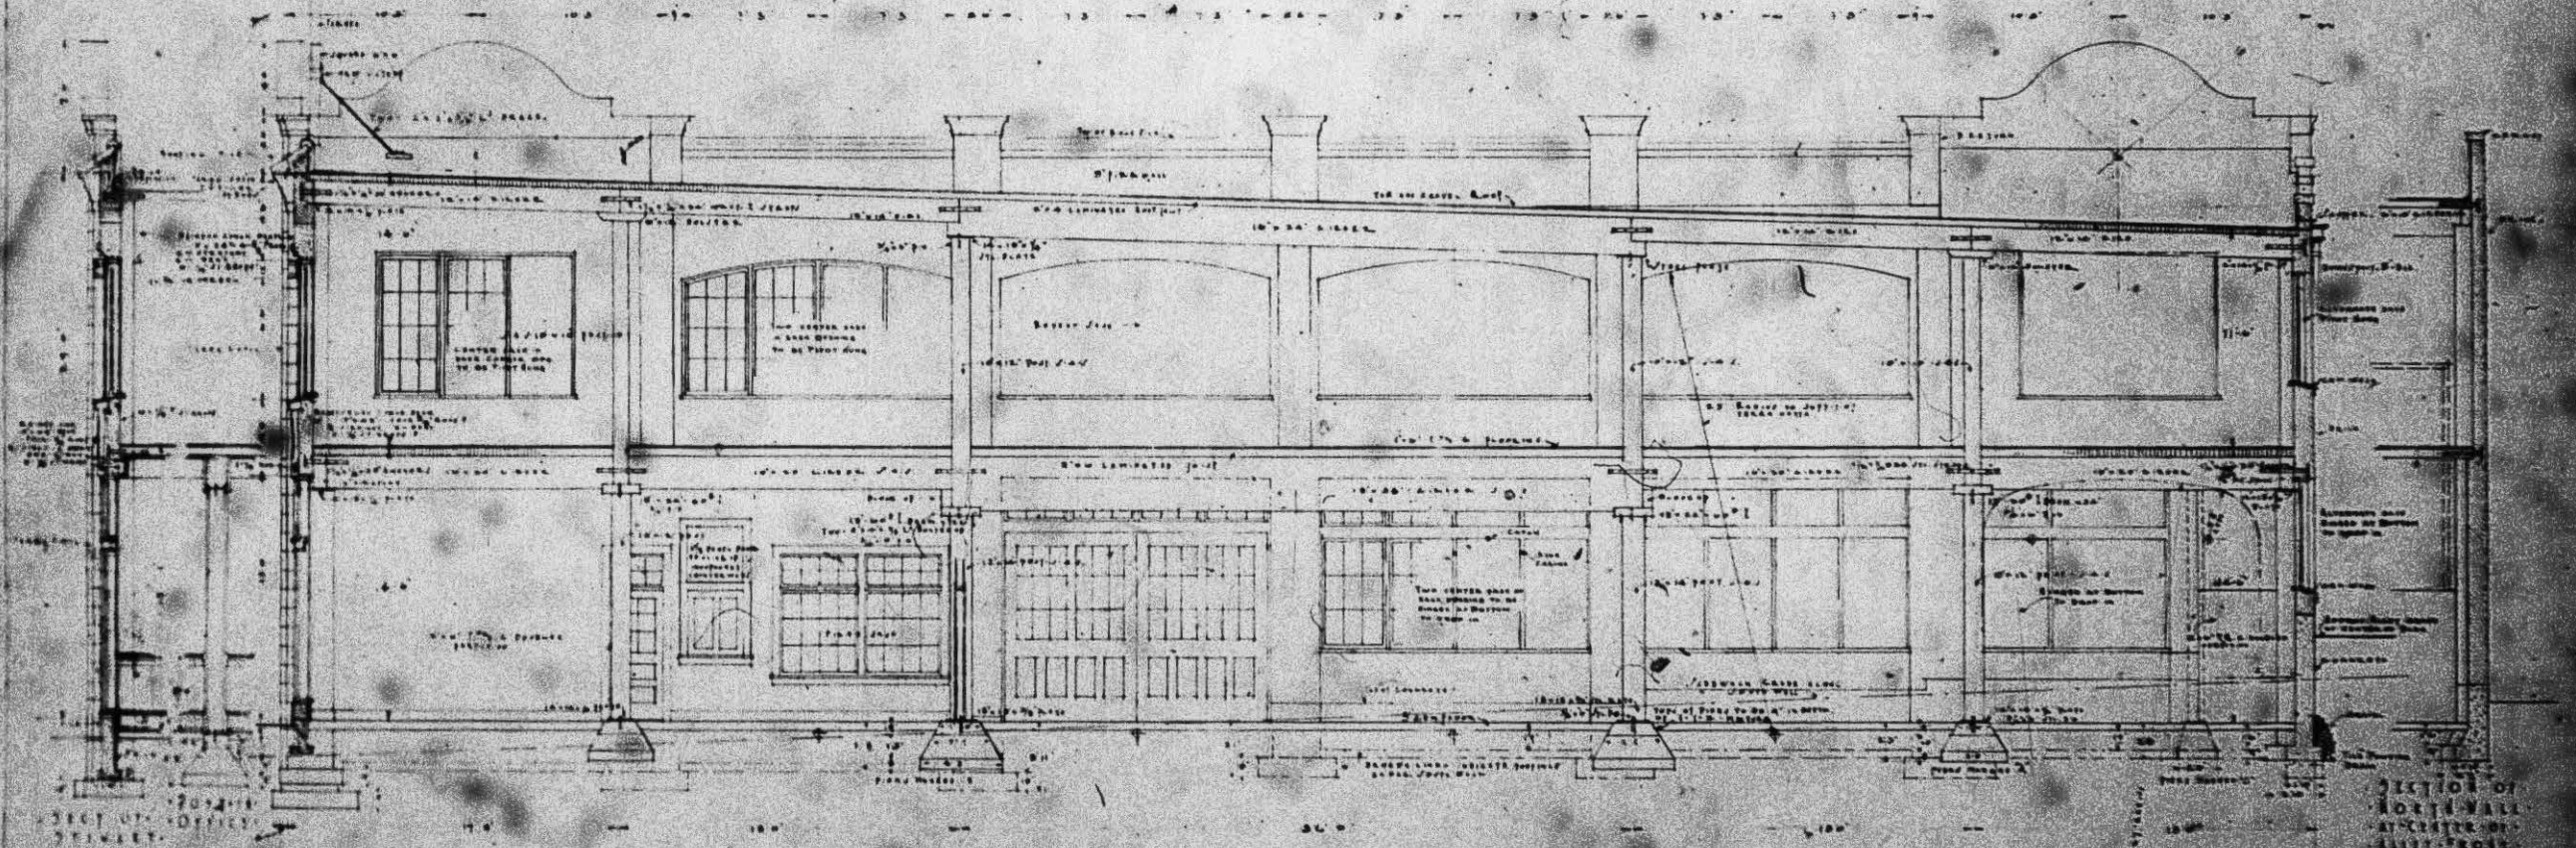
108' 0"
 LONGITUDINAL SECTION THROUGH BUILDING
 SCALE 1/4" = 1'-0"

SECTION OF OFFICE
 STREET
 WALL
 STREET

SECTION OF
 NORTH WALL
 AT CENTER OF
 BUILDING FROM
 GARAGE BUILDING FOR
 ANA-M. DONOHUE TRUST
 AT N.W. COR. OF TRAIL ST.
 AND STEWART ST.
 CHAS. HARRIS ARCHT. STATION
 510 - 11 FIFTH ST. N.

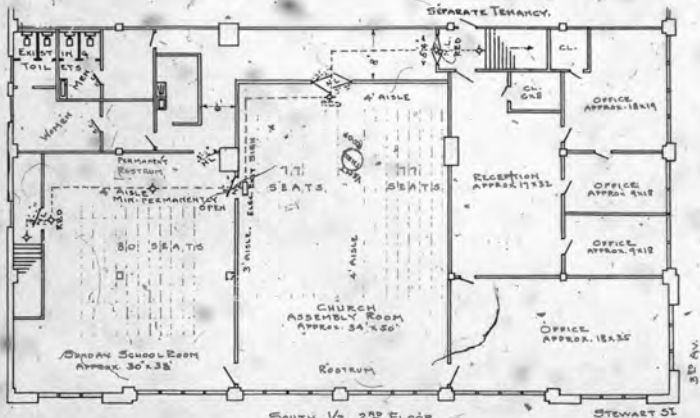
SOUTH 1/2 2ND FLOOR
 BLDG. 1901-11 3RD AV. FOR UNITY SOCIETY OF THE N.W.
 SCALE 1/8" = 1 FT. JULY 16, 1935
