Landmark NOMINATION Application

El Monterey

El Monterey Condominium

El Monterey Condominium - 4204 11th Avenue NE Seattle Landmark Nomination

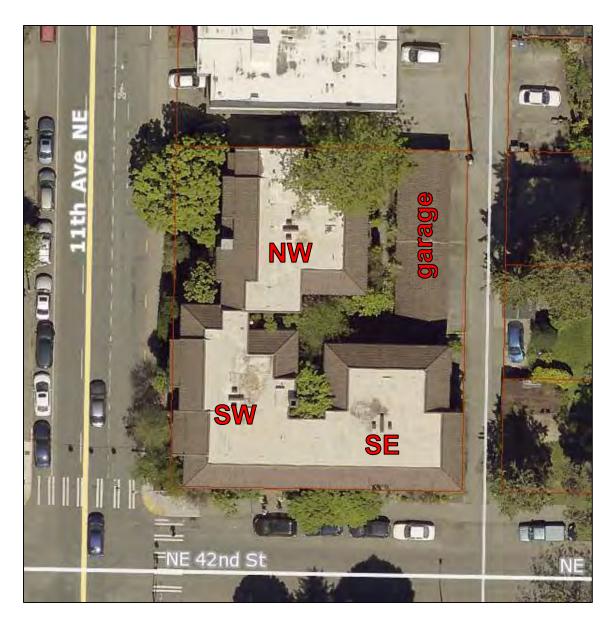
Fig. 3 – Orientation key, showing NW, SW, and SE building masses. North is up.

Although connected on the exterior, each of the three building masses are not connected on the interior and function separately. Each is accessed from point entries on the street, accessing a front main stairway, typically serving two units per floor. Each also has a separate rear stairway, accessible from each unit, accessing the rear courtyard. The separate, freestanding garage is noted at the northeast corner. Faint red lines indicate tax parcel boundaries. (KCTA)

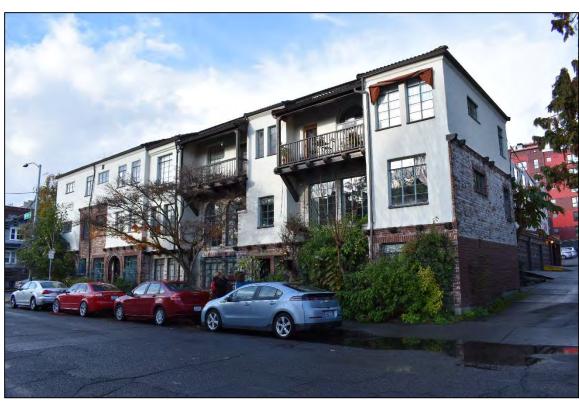
Fig. 7 – View northwest towards site from NE 42nd Street, showing south and east elevations.

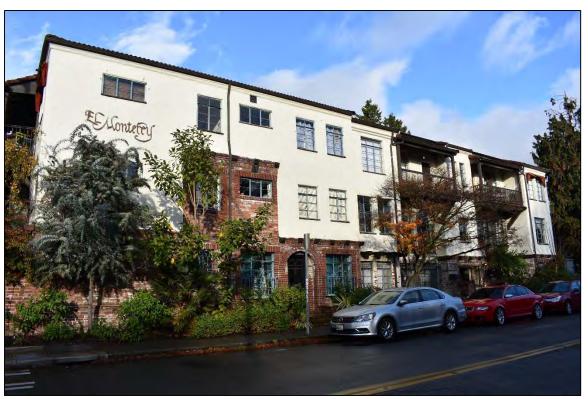
Fig. 8 – South elevation from NE 42nd Street.

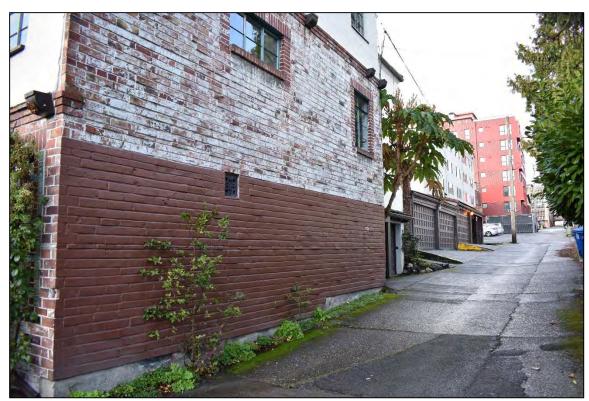
Fig. 9 – East elevation, lower part, from alley. Garage building visible at left in distance.

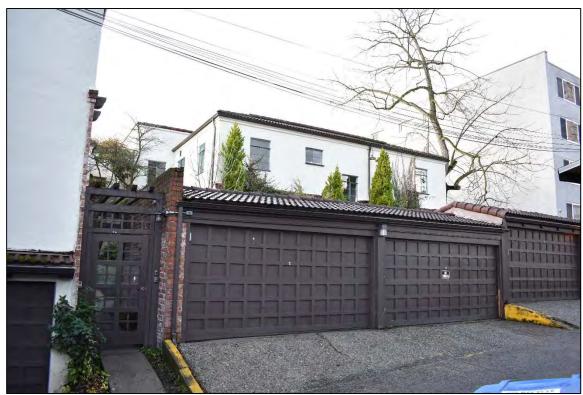
Fig. 10 – East elevation of garage from alley.

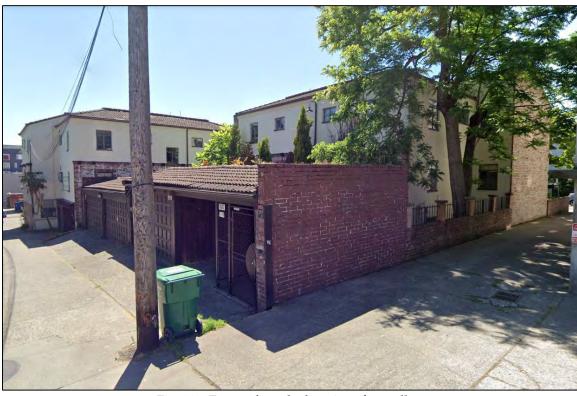
Fig. 11 – East and north elevations from alley. (Google Streetview, 2019)

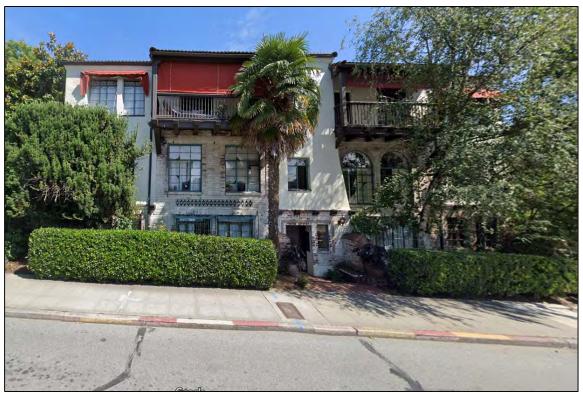
Fig. 12 – West elevation, south part, from 11th Avenue NE. (Google Streetview, 2019)

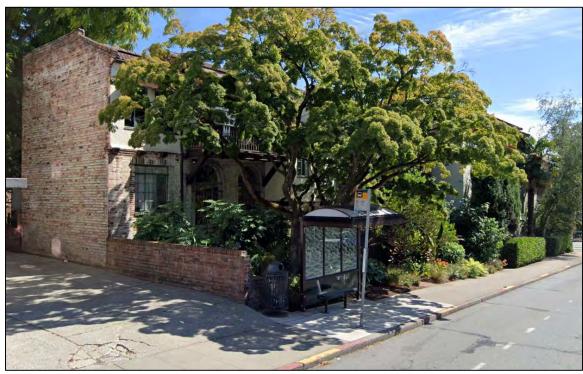
Fig. 13 – North and west elevations from 11th Avenue NE. (Google Streetview, 2019)

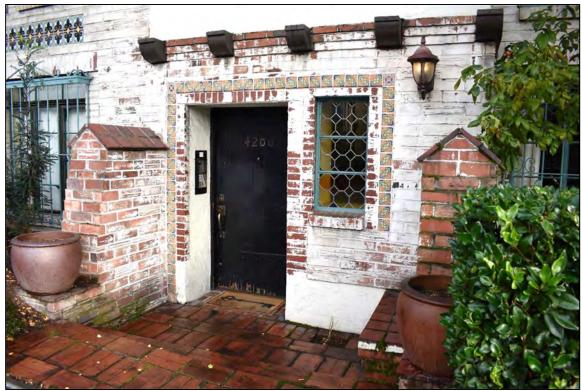
Fig. 16 - South elevation, main entry to southwest units; note glazed tile surround.

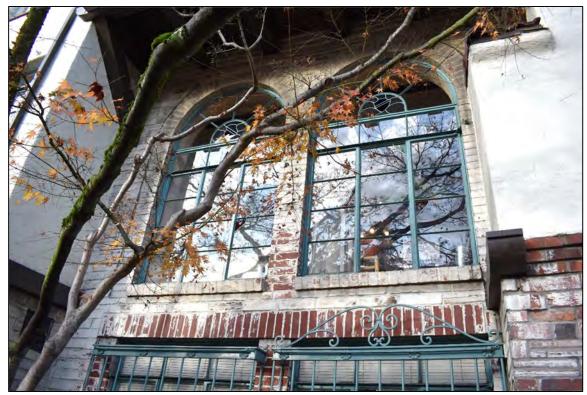
Fig. 18 - West elevation, detail of arched double window, metal window screens, masonry, stucco.

Windows throughout the building appear to be the original steel sash, typically casements or fixed. Lites are uniformly sized and organized into regular grids, occasionally including small amounts of stained glass. A repeating window type (usually lighting bedrooms) has eight vertically-oriented lites arranged in a 2×4 grid, with the upper two fixed and the lower three on one side functioning as a casement. A larger window at living rooms features a 3×5 grid, with the upper three lites fixed and the outer lower four lites operating as two casements. A variation of this larger living room window features a round-arched transom with a stained glass shield motif, above the fixed upper three lites. A smaller window, typically located at kitchens or bathrooms, is a horizontally-oriented 3×2 window, with the outer two lites functioning as casements. Windows are often arranged in pairs on the facades. Window sills at brick locations feature brick sills; at stucco locations, sills are slate or cast stone. At each of the three main building entries, there is a small three-lite window with clear and colored glass divided by lead cames in an octagon-and-diamond pattern.

Other notable building features are in keeping with the Spanish Eclectic style, including carved, projecting floor beams visible on street-facing facades; decorative wrought-iron window grilles at the first floor; and custom exterior light fixtures and door hardware at entries. A prominent feature are the six heavy timber projecting bracketed balconies at the third floor on both street elevations, which support red tile shed roofs. Their current railings appear to be replacements of the balustrades visible in the 1937 tax assessor photos, although then as now, balustrades vary across the building, with shaped or simple pickets.

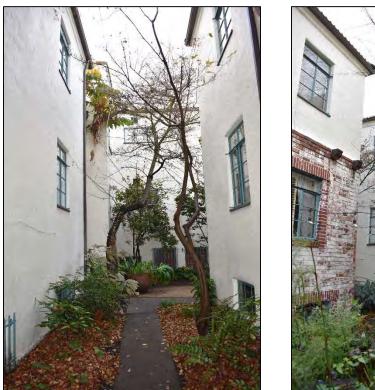
Fig. 19 - (Two photos) Courtyard elevations; view west and south.

The courtyard-facing building facades are two and a half stories in height, due to the grade; first floor windows at the rear of most units appear as basement windows, low on the exterior wall. The courtyard facades are simpler than the street-facing primary facades, but feature the same basic elements found on the primary facades--textured stucco and brick cladding; and similar windows, although lacking arches or stained glass. The south courtyard wall (north facade of the southeast building mass) has carved floor beam ends, and has a small red tile pent roof porchlet over a doorway accessing a rear stairwell; adjacent to that door is an arbor-covered walk and wooden gate accessing the alley. There is a non-original steel pipe with wood pads which braces a brick vent stack against an opposite courtyard wall, between the southeast and southwest building masses; the date of its installation is unknown.

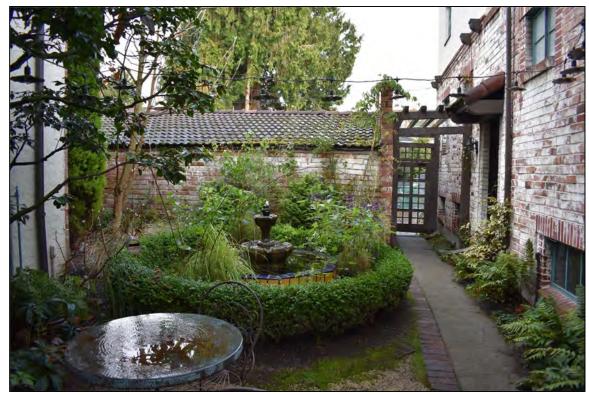
Fig. 20 - Courtyard, view east over fountain towards roof of garage.

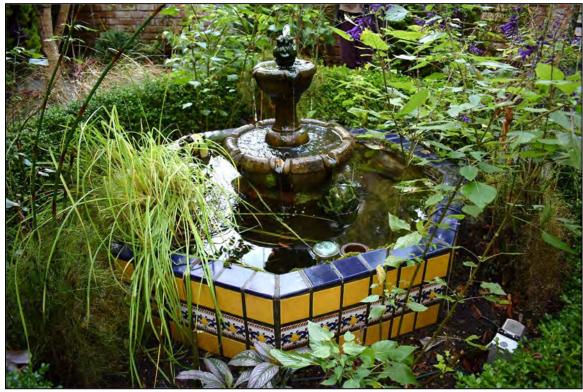
Fig. 21 – Courtyard, detail of fountain.

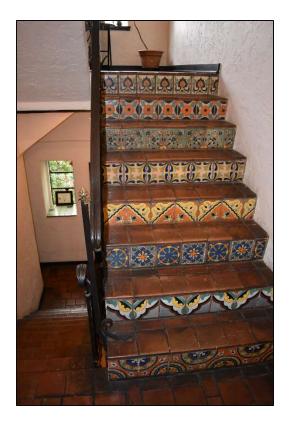
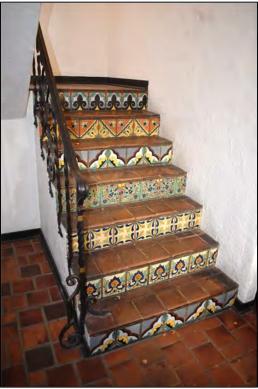
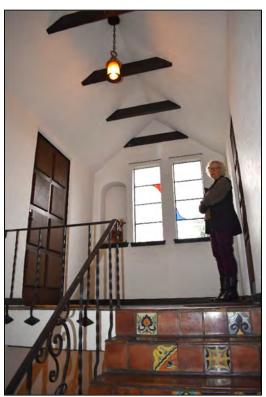
Fig. 22 – (Four photos) Interior, main stairwells (typical), showing variety of decorative glazed tile. Photo at lower right shows third floor landing at southwest building mass; visible are exposed beams, wall niche, leaded stained glass. There are two unit doors at each landing.

found on the building exterior. Stairs have ornate, wrought iron balustrades, and are lit with custom light fixtures. Stairwells have textured stucco walls and red quarry tile floors, and windows at landings. Each landing serves two unit entries.

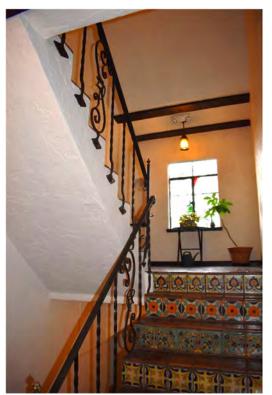
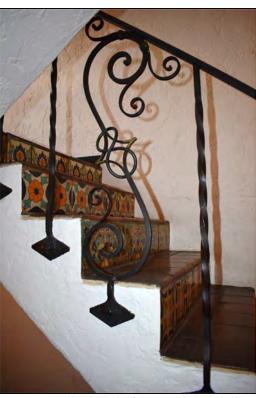
Fig. 23 - (Two photos) Interior, typical conditions at main stairwells; detail of wrought iron balustrade.

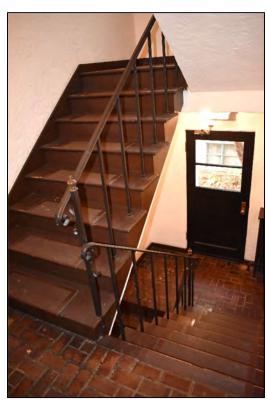
Fig. 24 – Interior, typical rear stairwell; risers lack glazed tile and handrail is simpler.

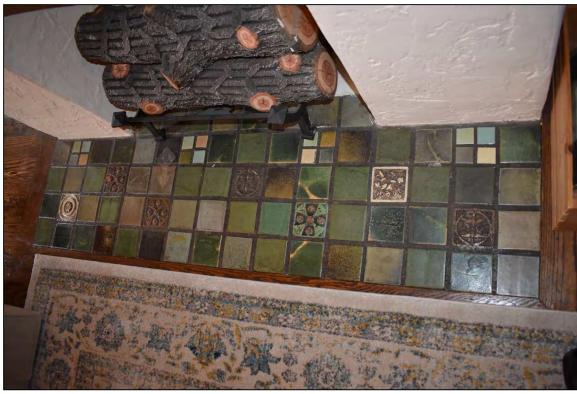
Fig. 30 – Interior, Unit 7 tile hearth.

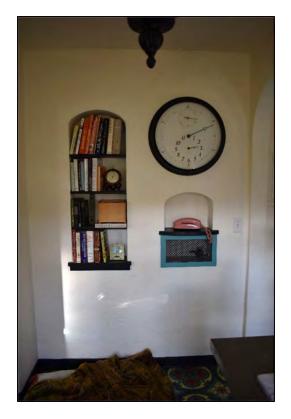
Fig. 35 – (Four photos) Interior, typical unit details. All include wall niches, built-in cabinets, hand-adzed ceiling beams, period light fixtures and door hardware.

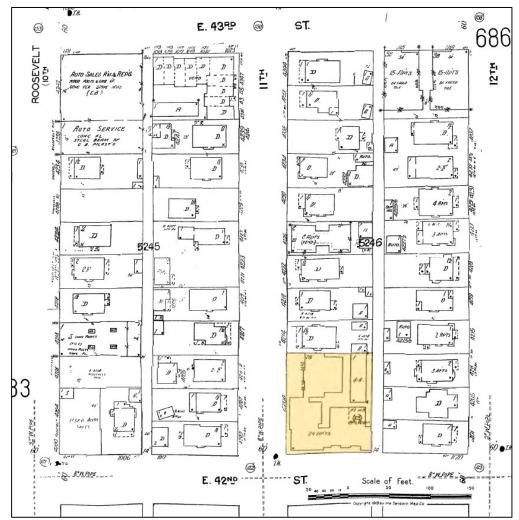
Fig. 49 - 1951 Sanborn map of the block; subject parcel indicated by shading.

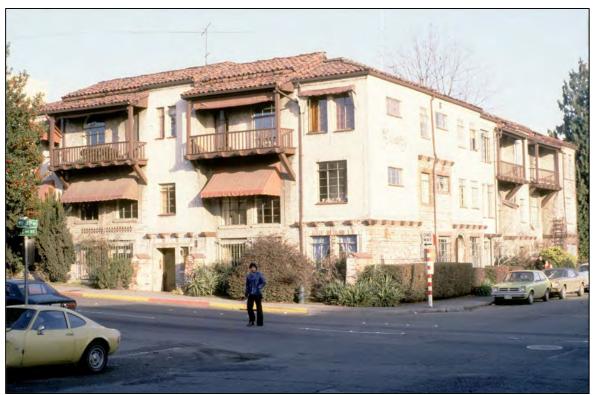
Fig. 54 – 1975 photo of the subject building, west and south elevations. (SMA #180226)

- Replacement of roof tiles occurred at some time after 1975, as evidenced by photos of that year. Close inspection of the photo suggests that the original red barrel-shaped tiles were a larger diameter than those in place presently, and may have had a wider variety of colors or hues.
- Addition of "El Monterey" metal sign at the third floor of the south facade (likely added in the early 1970s, and certainly by 1975 as evidenced by photos).
- Some unit interiors have been updated over time (such as bathrooms, kitchens, flooring, fixtures or hardware), but typically in a sympathetic manner in keeping with existing historic features.
- Garage: Removal of northernmost pair of garage doors and installation of chain link fencing for use as a garbage bin storage area.

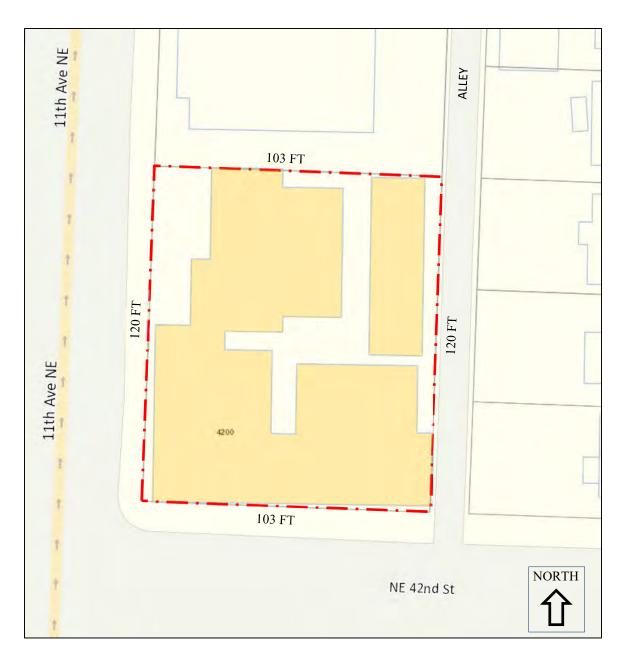
SITE PLAN

Site plan sketch of the El Monterey Condominium property, 4204 11th Avenue NE, Seattle WA 98105. Red dotted line indicates parcel boundary, with dimensions noted. Approximate building footprint indicated by shading. (SDCI GIS maps, 2020, with annotations)
