Landmark Nomination
The Singerman Residence / Gaslight Inn
1727 15th Avenue, Seattle

BOLA Architecture + Planning
Seattle

July 15, 2015

Landmark NOMINATION Application

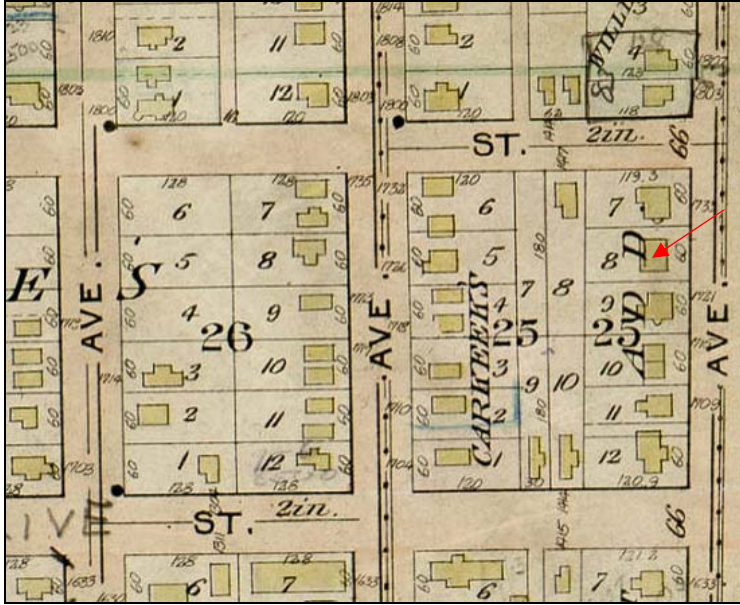
Figure 1. Left, an excerpt the 1905 Baist map, showing wood-frame dwellings on the block, lot lines, and street rights of way. North is oriented up. (Baist Real Estate Atlas, Plate 4, from the digital collections of the Seattle Public Library). The subject property, identified by a red arrow, is on Lot 8.

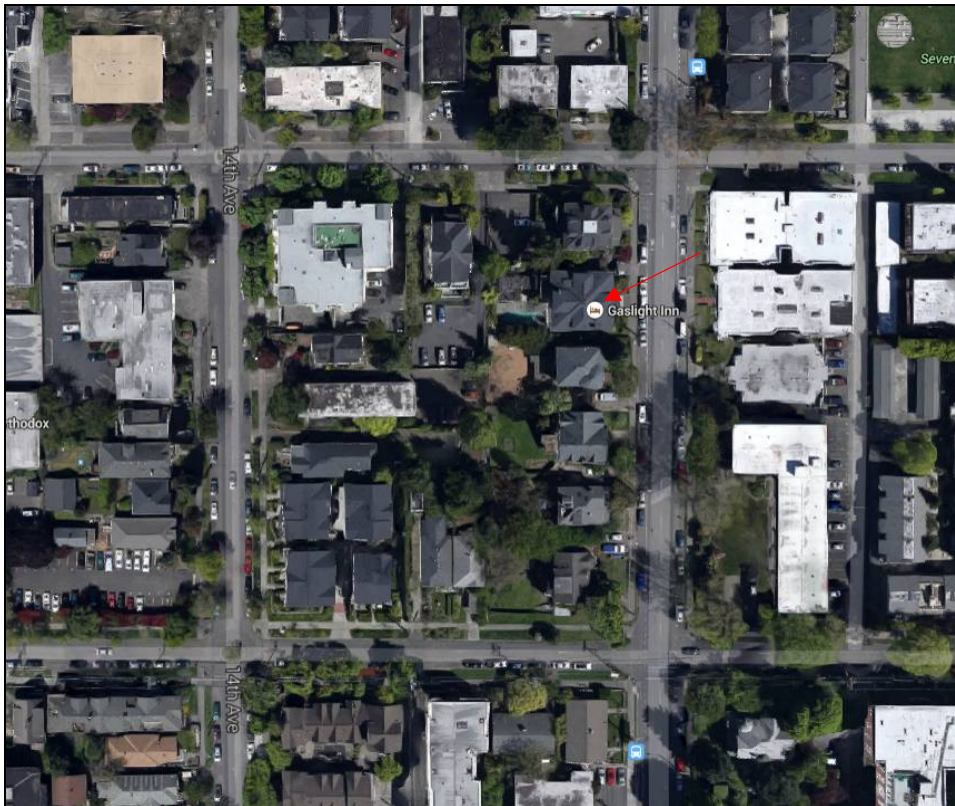
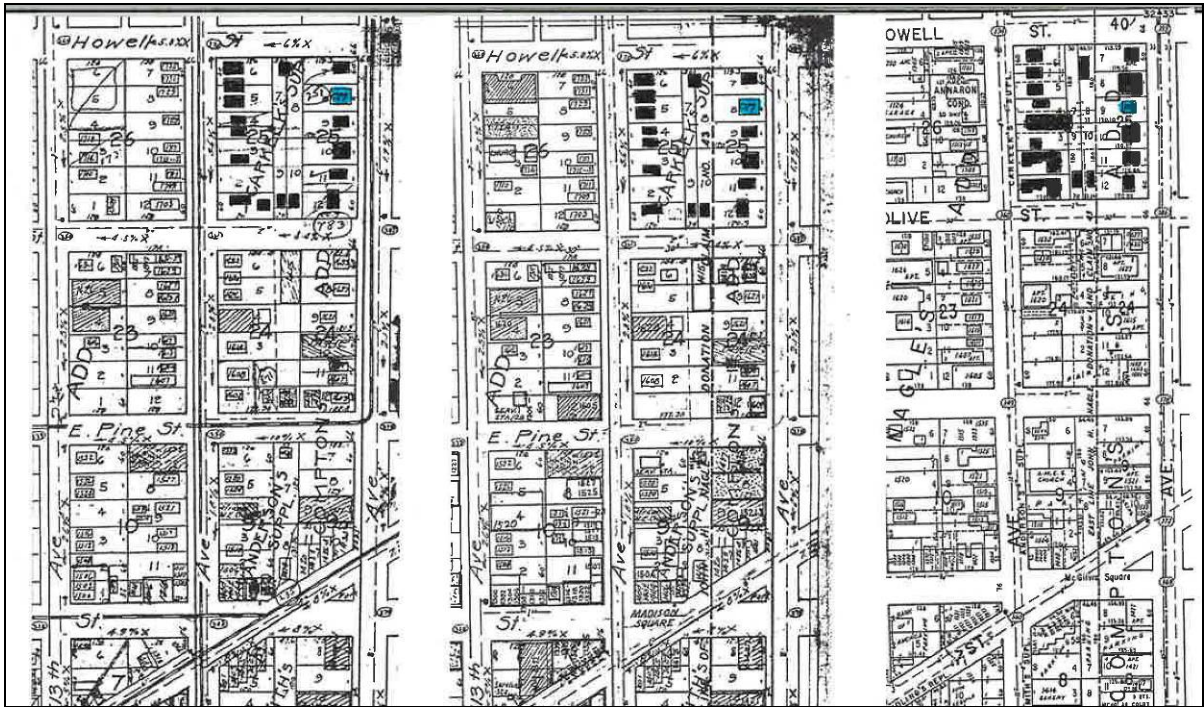
Figure 2. Below, a contemporary aerial view of the neighborhood. North is oriented up. The building is identified by a red arrow (Google Maps, 2015). Historic Baist and Kroll maps indicates that early 20th century buildings on the east and middle south and west portions of the block remain, while there new construction of apartment buildings is on the west side of the block. Across 15th Avenue (to the right) there are older apartment buildings, indicated by their white roofs.

Figure 3. Above, a figure-ground analysis of the subject property (in blue) and other houses on the block, most of which predate the earliest map, along with recent construction of larger apartments. Map dates are 1912 – 1920 (left), 1940 – 1960 (middle), and 2000 (right).

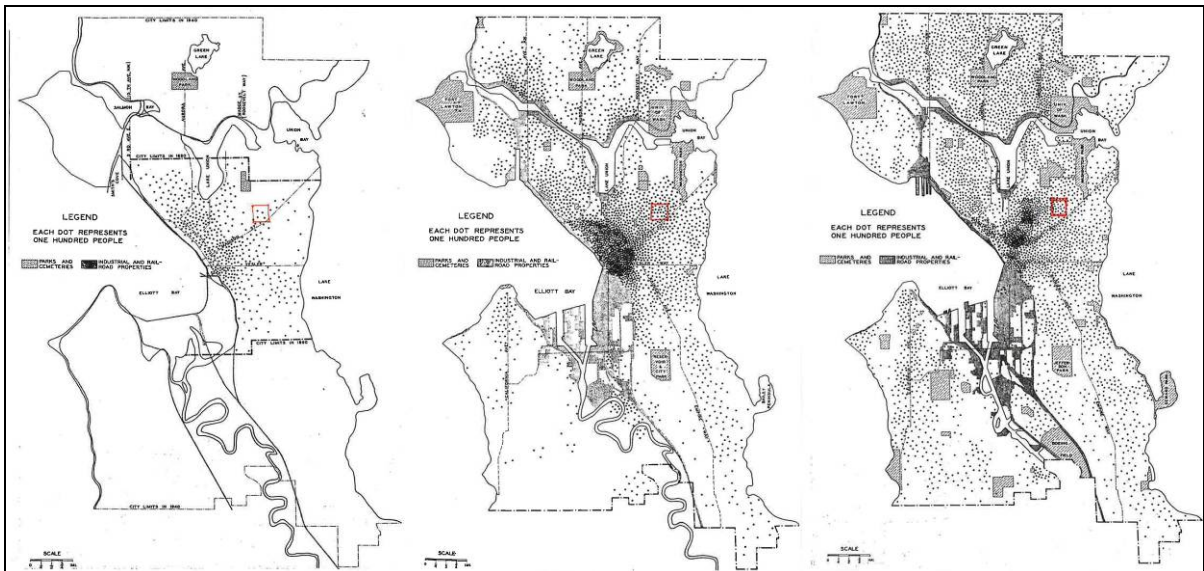
Figure 4. Below, a composite view of Seattle's population density in 1890 (left), 1910 (middle), and 1940 (right). The approximate census tract containing the subject property is outlined in red on each map (Schmid, p. 56-58).

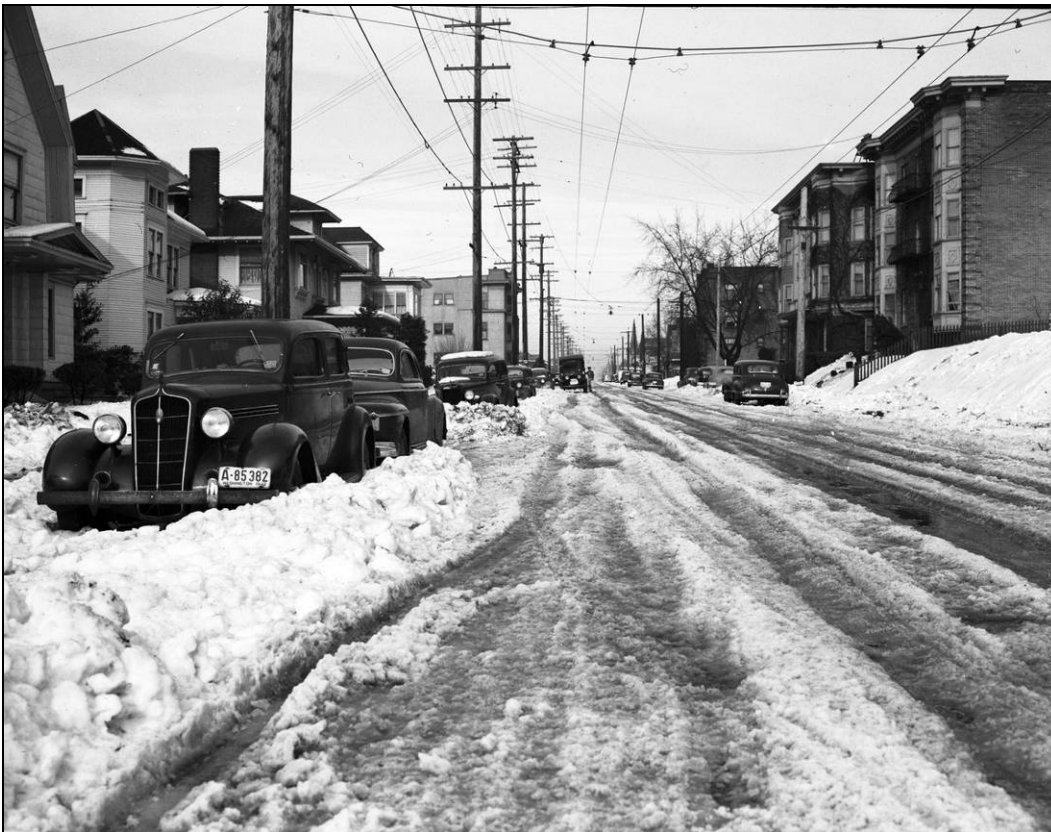
Figure 10. Below, a view looking north on 15th Avenue E from E Olive Street on January 26, 1943. The Singerman residence is partially visible on the left in mid-frame, distinguished by its tall brick chimney (SMA 40083).

The neighborhood's close proximity to early transportation included the cable cars that ran along Madison Street by 1900, and the streetcars with routes along Broadway, 15th and 19th Avenues (**Figures 8 - 10**), and the presence of churches and retail shops, undoubtedly enhanced its appeal to residents, including tenants of the original Singerman residence after its conversion to a boarding house in ca. 1918. Nearby, a major employer, St. Luke's Hospital, was constructed on the west side of 16th Avenue E at John Street in 1919-1920 by its owner, Dr. John W. Wilkins and his wife, Alice. (St. Luke's Hospital became one of Group Health Cooperative's earliest medical facilities in 1947 after Group Health acquired the property and added a 30-bed wing to the hospital.)

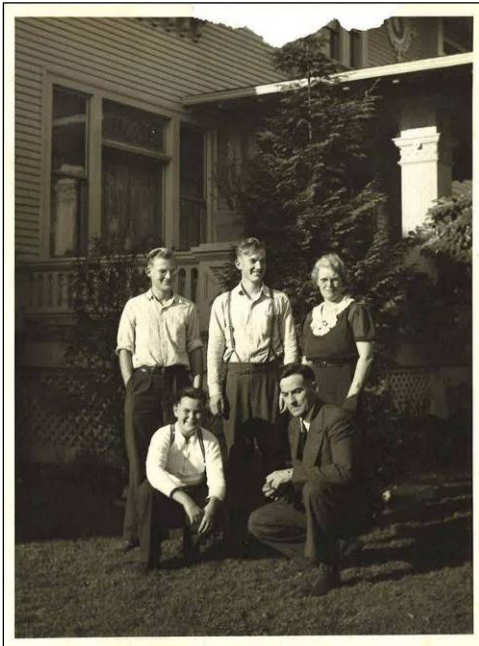
Figure 20. Above, the Christensen family in front of 1727 15th Avenue (Dwight is on the lower right). A note on the back of the photo indicates it dates from the 1940s. At that time, the front porch decking extended to match the full width of the house, while the porch roof was centered as it is presently.

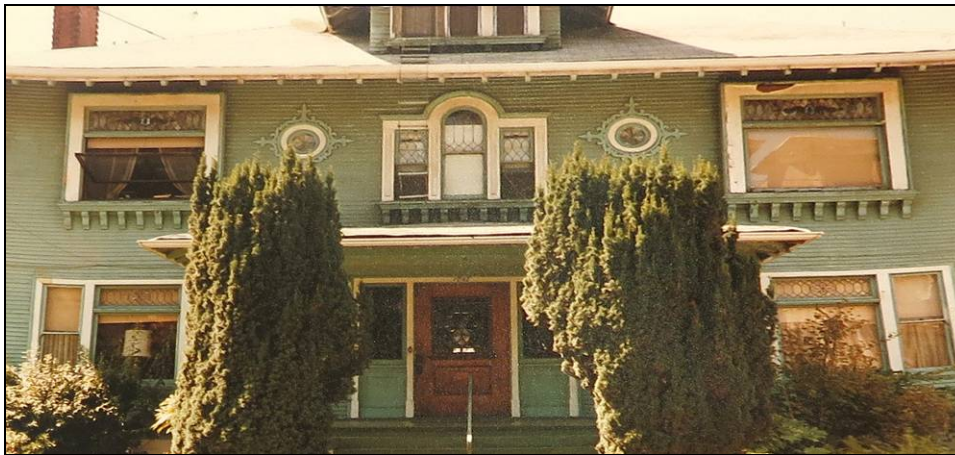
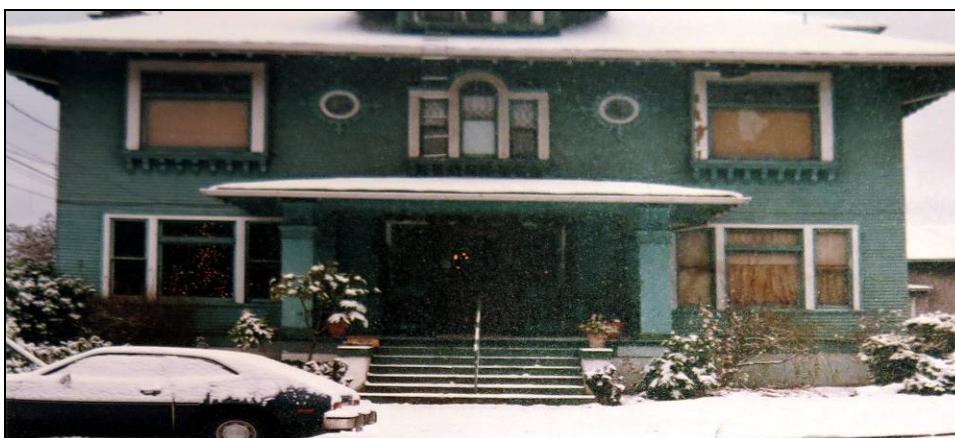
Figures 21 & 22. Below and bottom, part of the primary east facade of the subject property. Both images date from ca. 1980 (photos courtesy of Stephen Bennett, owner).

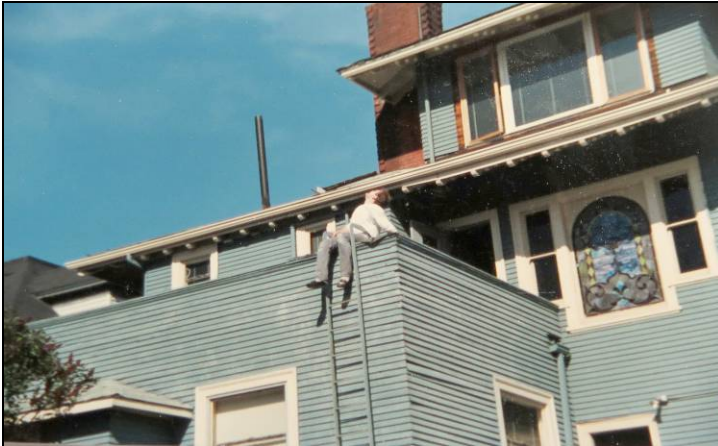
Figure 23. Top left, a ca. 1980 view of part of the west facade and ca. 1950 kitchen addition. The stained glass window is not original to the house.

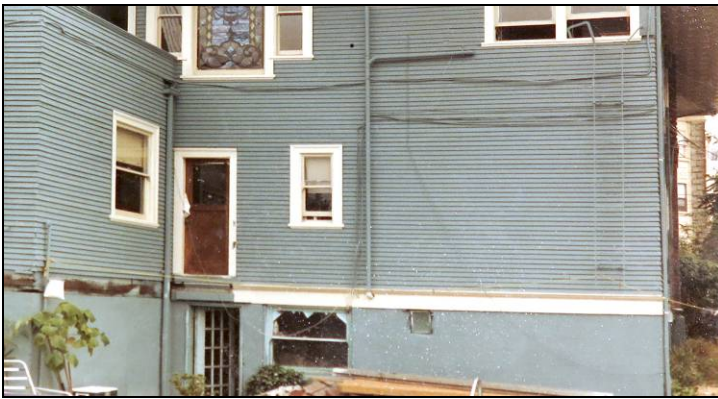
Figures 24 – 26. Lower through bottom left, ca. 1980 views of the southern portion of the west facade before (lower), during (below), and after (bottom) back balcony addition.

Figure 27. Directly below, another ca. 1990 view of the completed balcony and new swimming pool.

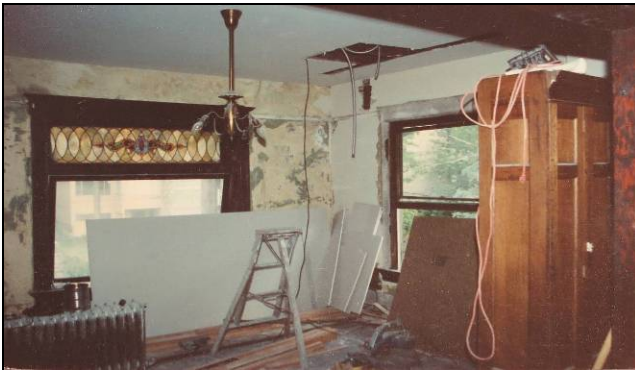
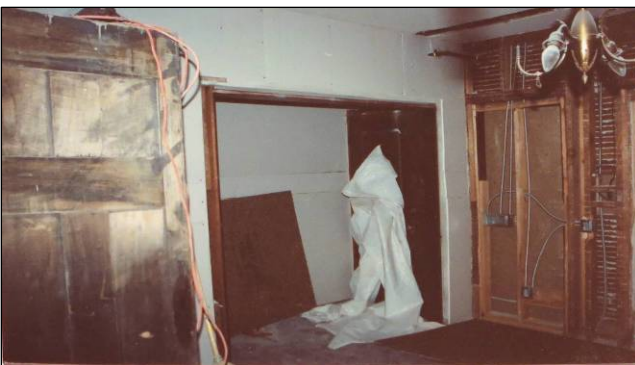
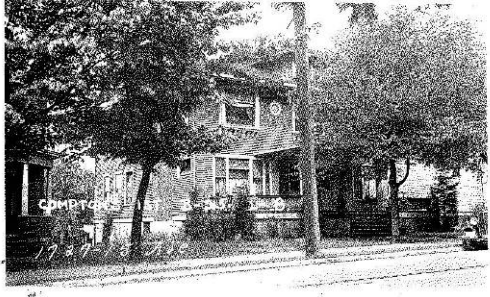
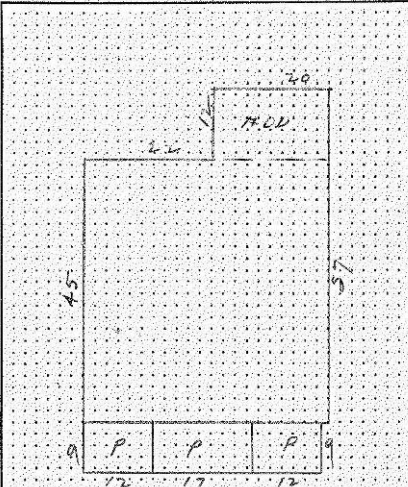
Property Tax Record Cards

Figure 32. Below, the County Assessor's property record card dating from 1937 (Puget Sound Regional Archives).

8. BUILDING Rooming House	TILE WORK None	PORCHES 3 One-Story
2 Sty & Attic	Attic 4 Ceiled Stairway	9. CORNER JOINTS Mitred
1/2 Rooms	Interior Walls 12 Plaster 4 1/2 Plaster Ad. Stair 11 Kalamazoo	10. FIRST FLOOR JOIST SIZE 2 x 8 AND 20 INCH CENTERS BRIDGED Yes
6 1st Flr.	Floors 4 Fir 4 Cove	11. FIRST FLOOR JOIST SUPPORT COLUMN OR POST SIZE 6 x 6
12 2nd "	Fire Place 1 Brick	12. CLASS OR GRADE NO. 3 SHAPE NO.
13 3rd "	Interior Trim 12 Fir	13. BUILDING FINISHED OR UNFINISHED Finished
14 4th "	Plumbing 10 Fixtures 2 Tub-Legs 2 Toilets 8 Basins 1 H.W. Tank 1 Lndry Tray 4 Averages 1 Kitchen Sink	14. DEPRECIATION: CONDITION 100 OBSLSE. % ECON. SUIT. % TOTAL % DATE BUILT 1910 REMODELED No EFFECTIVE AGE 30 YEARS FUTURE LIFE 10 YEARS
15 5th "	Basement Full Concrete 7' Conc. Fir. Drain 1 R. Sew. 3	LAND INFORMATION 1. SIZE x TOPOGRAPHY Level GRADE On FEET 2. STREET ROAD Graded SURFACE Paved ALLEY No 3. SIDEWALK Conc. SEWERAGE Sewer WELL ELECT. PUMP 4. LANDSCAPING Lawn, Shrubs COND. Fair 5. TREND Static VALUE OF LAND 6. USE OF DISTRICT Residential VIEW None 7. RESIDENTIAL Medium-Old ZONED

16 6th "	Foundation Conc. Fch. P & B. ROOF Shingle 16 to 18	REMARKS
17 7th "	Exterior Walls Cedar Siding

18 8th "		MAIN BUILDING DIMENSION SQ. FT. AREA 42 x 45 1890 Add. 12 x 20 240 Pch. 9 x 17 153 Pch. 9 x 12 108 Pch. 9 x 12 108
19 9th "		IMPROVEMENT VALUE MAIN BUILDING \$ 1780 OTHER BUILDINGS \$ 100 TOTAL \$ 1880 ASSESSED VALUE 50% \$ 940 DATE 7/19/37
20 10th "		OTHER BUILDINGS GARAGE BRICK Wood Exp 1 16x80 480 \$ 144
21 11th "		FLOOR PLAN

The three story building is wood-framed and contains a total of 7,708 gross square feet, according to King County records. The owner's data indicates a different total area of 6,860: 1,890 square feet each at the 42' by 45' basement and second floor levels, 2,130 square feet at the main floor, and 950 square feet in the attic space. The building is constructed with typical wood framing, and 8"-wide concrete foundation and basement walls. Portions of the wall, with the concrete scored to appear as block, is visible along the sides and back of the building due to the sloped site. The wood framing indicated in the 1937 property record card included 8x10 main support columns and floor joists of 2x12 on 16" centers.

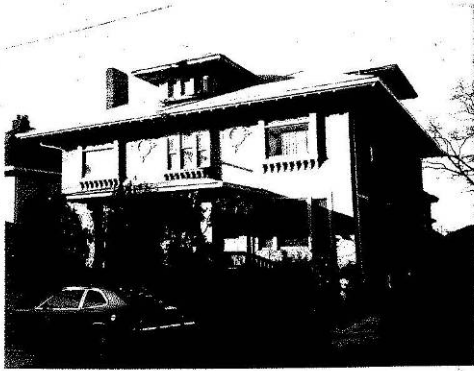
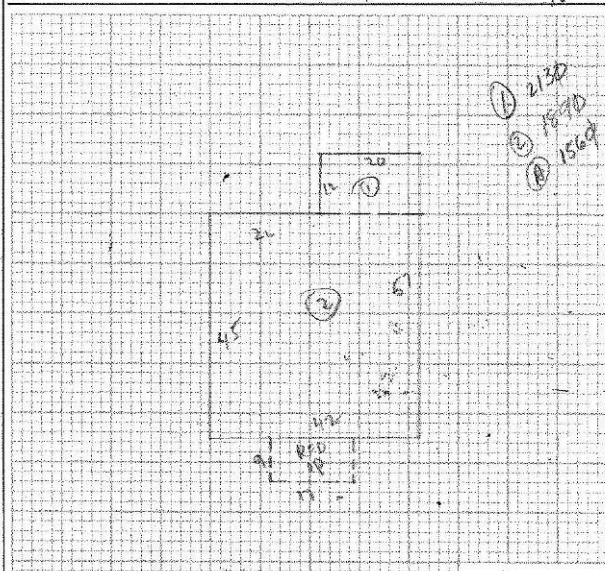
11 **PLAT OF BUILDING** Scale 1 CM = 10'

Figure 33. Below, a later County Assessor's property record card from ca. 1986 (Puget Sound Regional Archives).

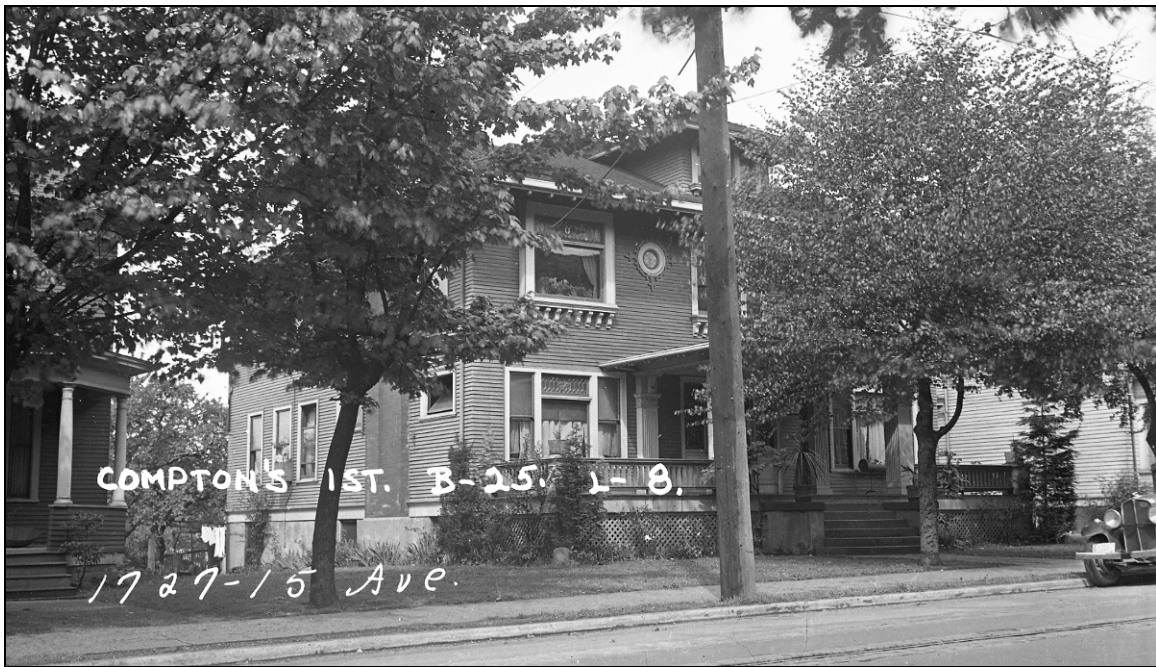
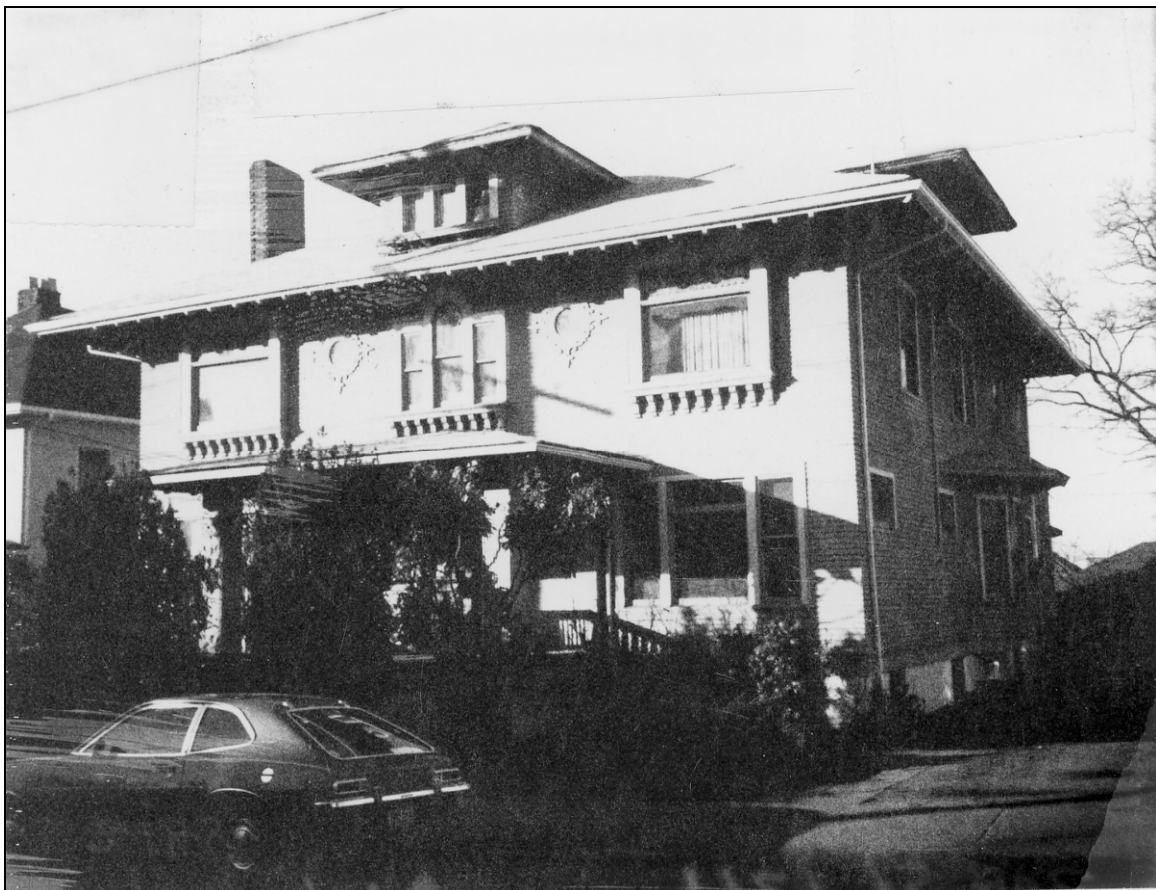
Figures 34 & 35. Assessor's property record card photos of the building in 1937 (above), and 1980 when it was a 10-unit apartment house (below).

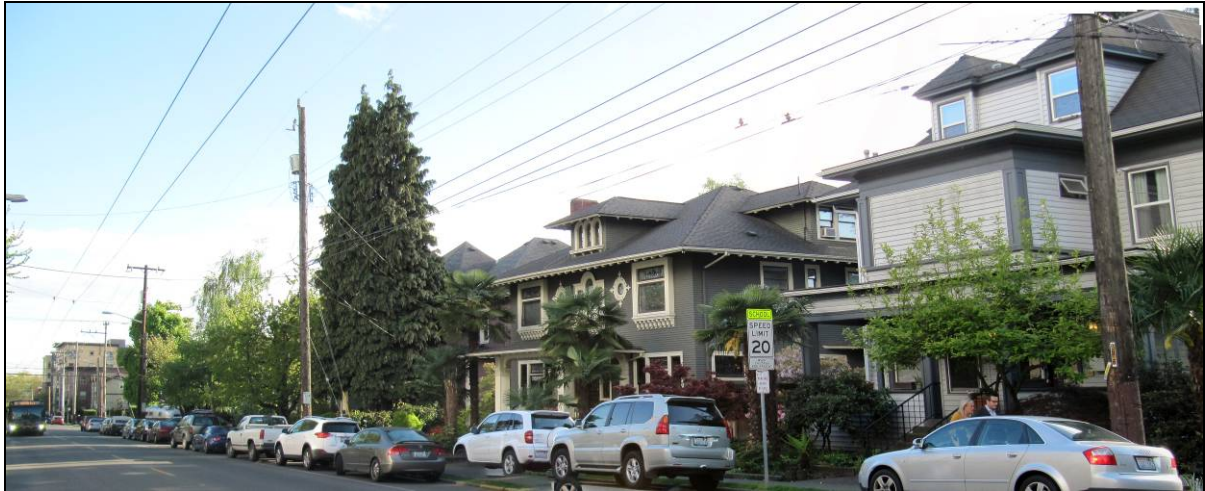
Figure 36. Above, looking southwest on 15th Avenue from E Howell Street at the property and the neighboring dwelling to the north of it.

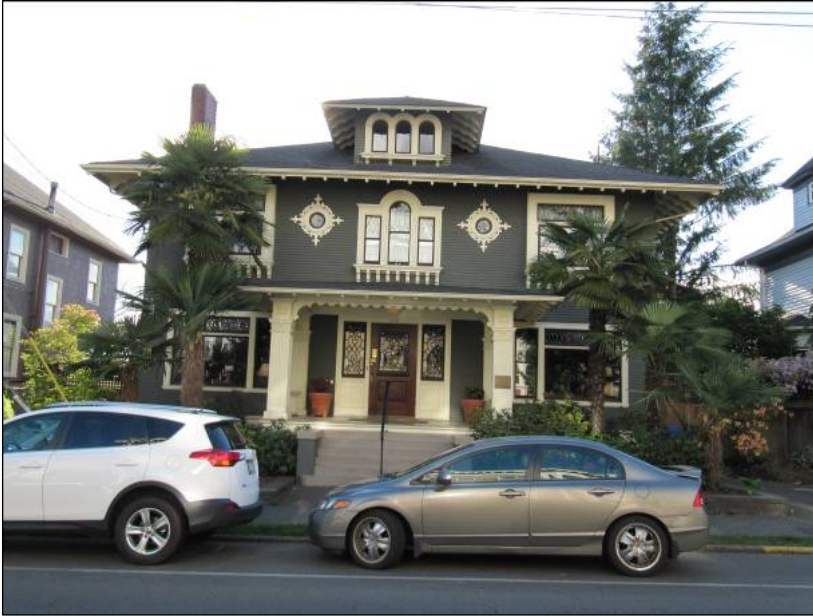
Figure 41. Above, looking west at the primary east facade.

The main entry consists of a centered 48"-wide and 92"-tall white oak door, 4" thick, fitted with 32"-wide glazed reight panels on each side, set within a stained fir frame. The front facade features leaded and beveled glass windows in the main front rooms, and in the entry door and reights. Above, at the second floor, the symmetrical facade composition include large, square-shaped windows with leaded glass transoms in the outer wall areas, and a central Palladian window, with a tall arched head central unit and lower rectangular side windows (Figure 49). These upper floor windows are treated with deep wood frames, all supported by individual rows of small decorative brackets. Between these there are two small circular windows with "spider web" divided lights of cream-colored stained glass, each set within a wide, ornate decorative surround. The colored glass within these windows came from the Kokomo Opalescent Glass Company, a manufacturer in Indiana. The attic window assembly, of three narrow arched head window units, is situated within a separate roof dormer. It is aligned with the main entry and second floor Palladian window. Despite this strict symmetrical composition, the scale of the front facade is mediated by the siding and the exuberant decorative details.

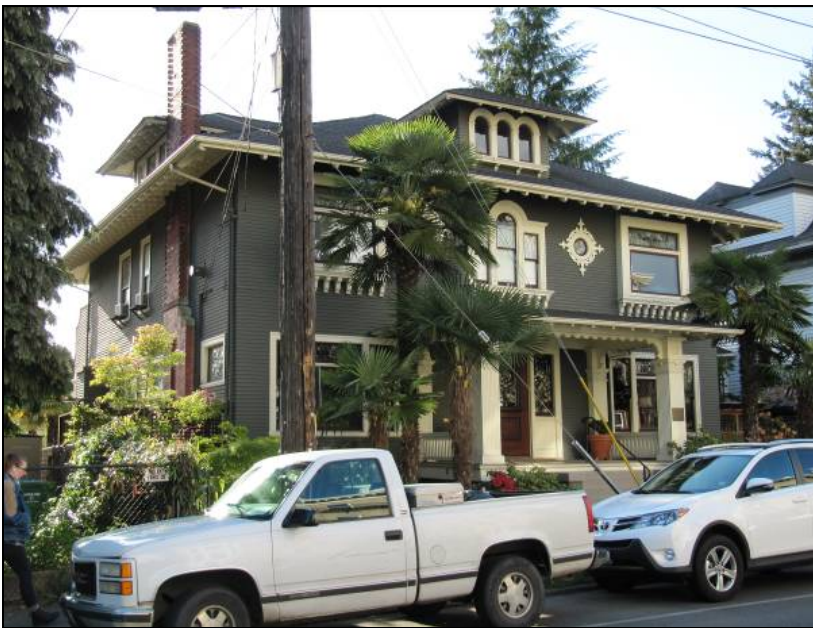
Figure 42. Below, looking northwest at the east and south facades.

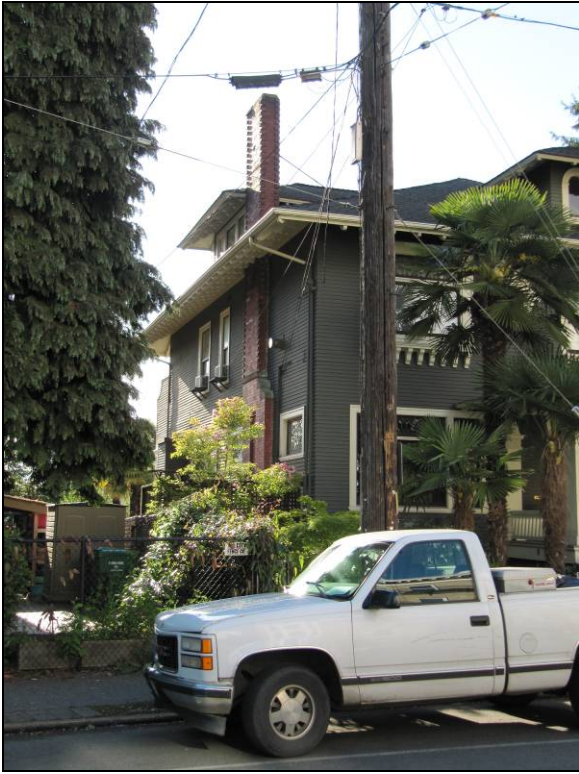
Figure 43. Above left, looking west at the south facade and a portion of the primary east facade.

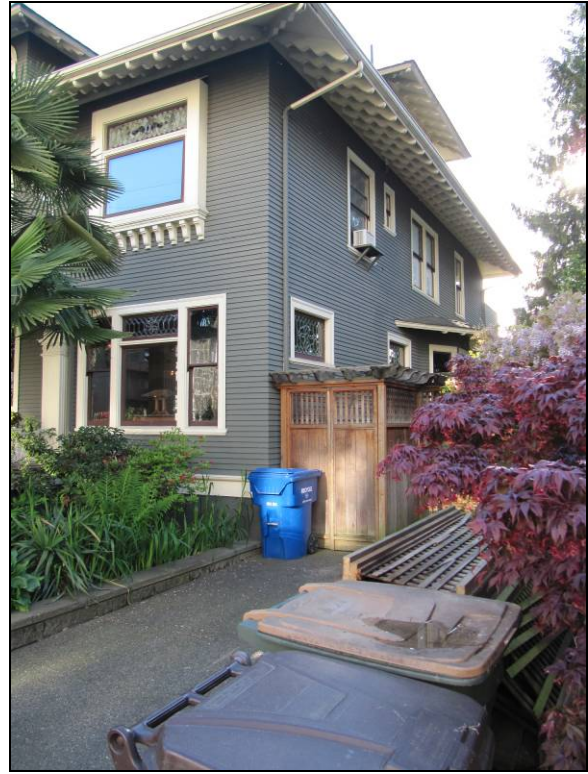
Figure 44. Above right, looking southwest at the driveway, north facade and a portion of the primary east facade.

The original driveway was located along the north side of the house. The present driveway, set within a 17.8'-wide north side yard setback, terminates at a wood fence and trellis placed slightly back from the building's front facade (Figures 44 & 52). A drawing from August 1983 indicates that the driveway extended into the 43' back yard on the west where there was an 18'-deep by 30'-wide garage behind the house. The garage, which apparently dated from the early 20th century, was in poor condition in 1983, according to a Buyer's Inspection report (Foster), and it was removed in ca. 1983. At that time, a 12' by 33' heated pool, small pool equipment shed, and timber trellis were inserted into the back yard. In addition, a 5'-deep deck and stairs leading from the building's main floor to the back yard grade was built.

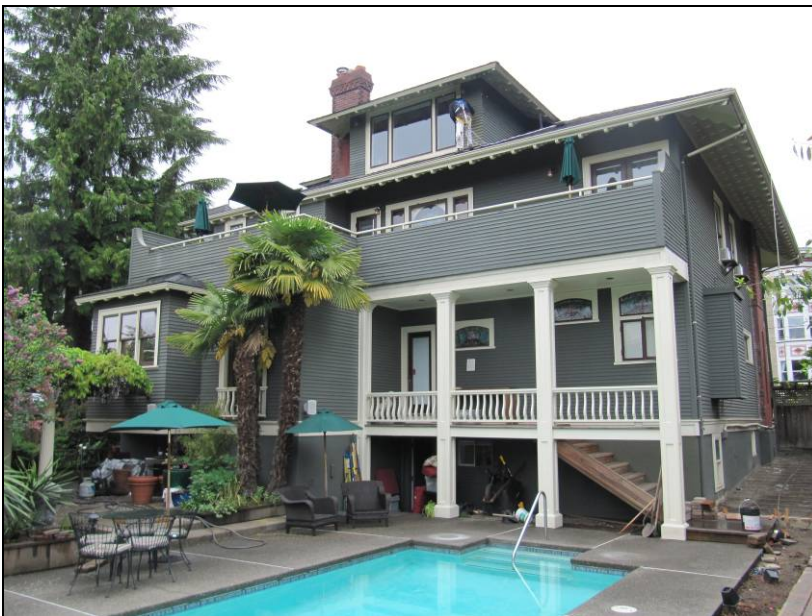
Figure 45. Below, looking east at the back (west) facade.

The back yard is solidly fenced and contains mature palm trees, planted in a bed along the west side, and other trees and flowers in large pots. The plants, trellis work, and varied level concrete aggregate paving create a lush landscape setting for the swimming pool. The front yard landscaping provides a rich appearance with evergreen foundation plantings along with Japanese maples and palm trees. These plant beds, and those along the south side of the house, have been replanted periodically since the mid-1980s (Figure 45).

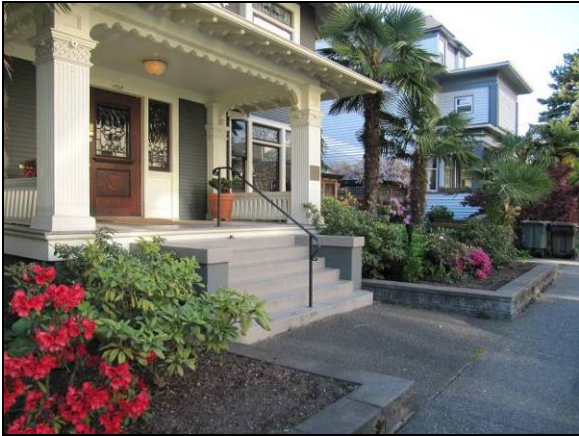
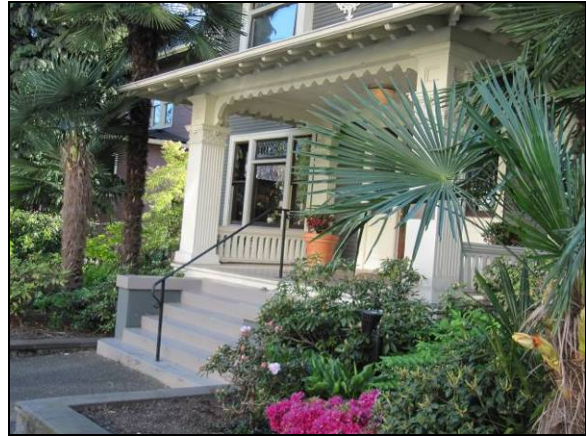
Figures 46 & 47. Top left and right, views of the front entry porch on the primary east facade. Looking northwest (left) and southwest (right).

The main entry porch is centered on the primary east facade. It originally featured T& G cedar decking that extended the full width of the building, while its hipped roof was provided only over the center third. Due to maintenance issues, the porch floor area was reduced sometime in the 1970s, and it presently fits below the low, nearly flat hipped roof. Two square, fluted porch columns, with decorative capitals and trim, rise from concrete cheek blocks on the sides of the front steps to support the porch roof, along with the deep outriggers (rafter tails). (Fluted pilasters on either side of the doors align with the porch columns.) The decorative outriggers, which feature a curved ends and lower edges, are typical (Figures 48 – 51).

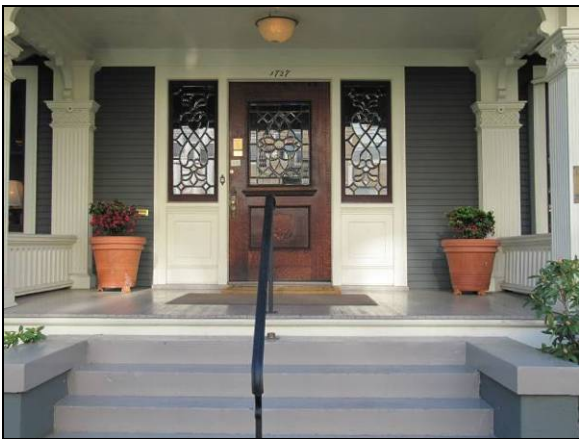
Figure 48. Middle left, looking west at the front porch and entry on the east facade.

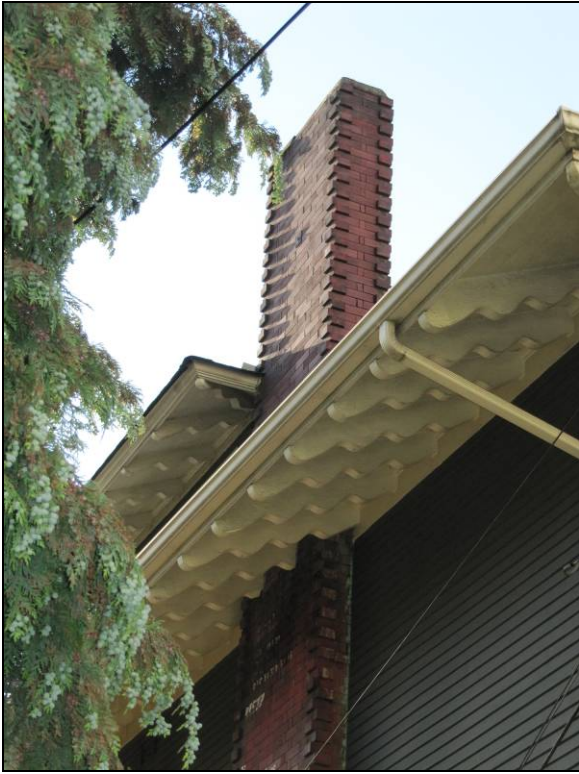
Figure 51. Above left, the chimney and roof rafter tails supporting the overhang on the south facade.

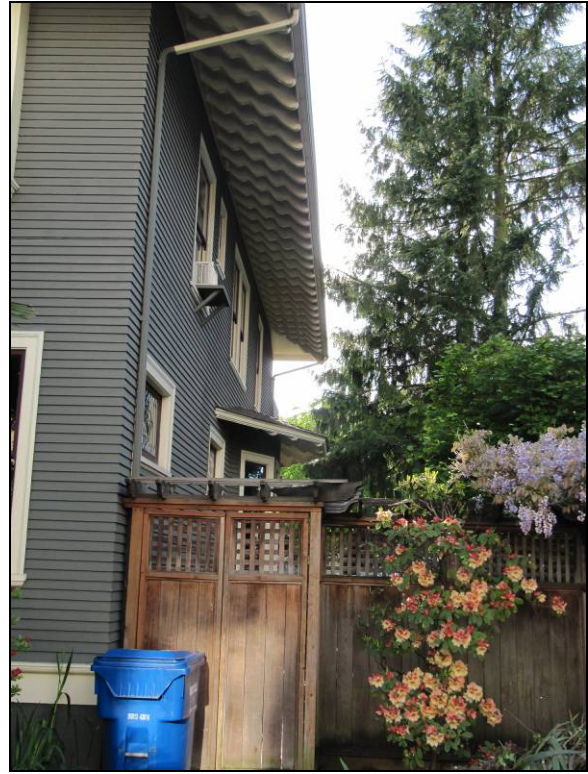
Figure 52. Above right, looking west at the gate leading to the north side yard, and similar roof details. Note the narrow siding pattern and corner treatment without corner boards.

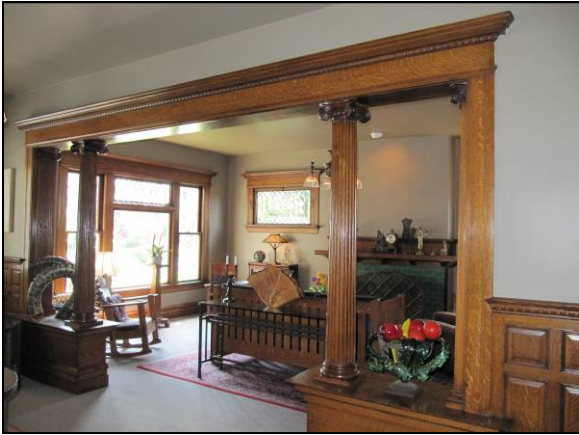
Figure 53. Top left, a view of the living room from the entryway.

The floor plan of the house is a center hall type, a layout that dates from Colonial times (and before that back to the Palladian villas of the 16th century Veneto). This plan provided a spacious semi-public entry and allowed for discrete rooms to be closed to one another for both privacy and heat conservation. The plan of the Singerman Residence featured large rooms for socializing at the first floor. Proportionally, it is divided into three spaces, each nearly equal in width. The first floor includes an approximate 13'-wide entry hall, which led to a parlor/living room on the south through a wide opening announced by oak columns, and a similar sized ballroom on the north through pairs of pocket doors. Behind these sides opposite rooms, there was a smaller library on the south and a dining room on the north, with the kitchen and maid's quarters beyond. The center hall also led to a 5'-wide, open stair to the second floor (Figures 53, 54, and 56).

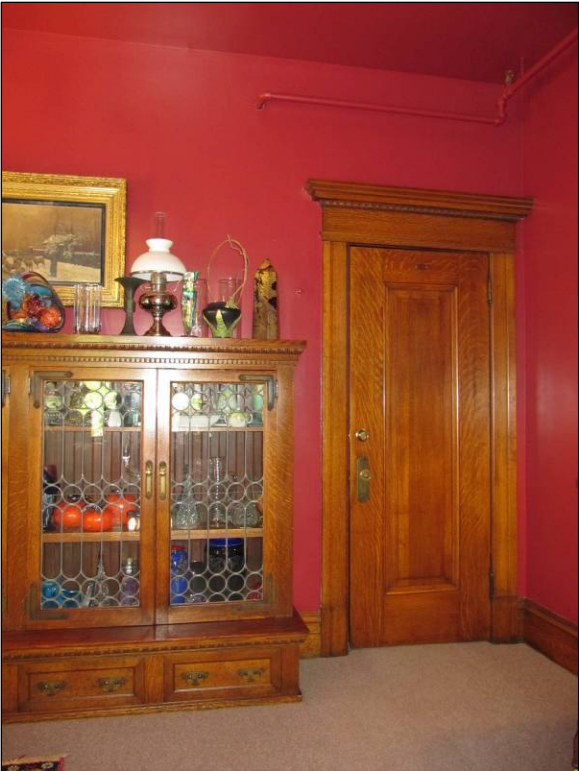
Figure 55. Lower left, built-in cabinetry detail in the library.

The house contains a fine stained oak built-in bookcase in the library, with leaded glass doors and lower storage drawers, while the dining room retains the original built-in china cabinet, which is fitted also with leaded glass doors and lower storage drawers (Figures 55). The wide, switch-back stair that connects the first and second floor levels has deep landing featuring a built-in white oak storage bench (Figures 57 – 61). The landing is illuminated by daylight through a large, non-original stained glass window. Both this stair and a second, more narrow one from the second floor to the attic level, retain original stained wood paneling (and beadboard wainscoting in the servant's stair), oak trim, molding, and balustrades.

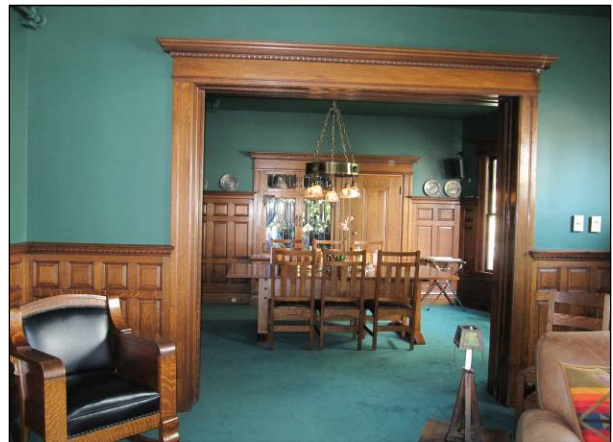
Figure 56. Lower right, a view of the dining room from the ballroom.

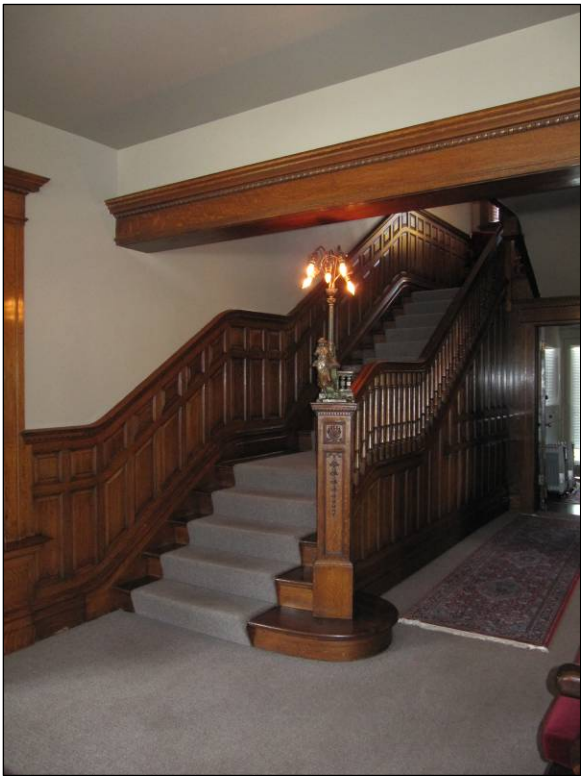
Figure 57. Top left, the main stair from the entryway.

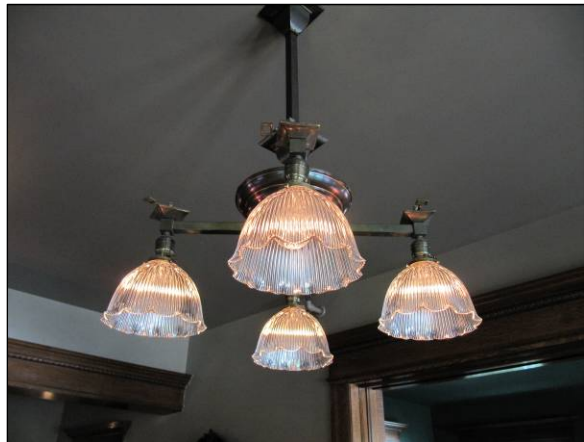
Figure 58. Top right, original gas and electric light fixture.

The main stairs' lowest steps flare out and extend in a curve terminating at an oak newel post. This post rises to hold a cast bronze light fixture, which is one of the most unique features of the house. It depicts a maiden with a basket of roses and shower of lights overhead, while monks' faces are depicted in other cast bronze fixtures. Several original dual-fueled (gas- and electrical-lamped) bronze light fixtures are also suspended from ceilings at the first floor, and in the second floor hall (Figure 58). These light fixtures gave rise to the name of the guesthouse.

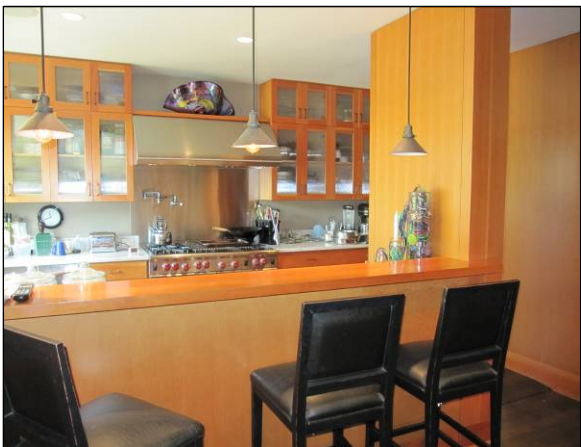
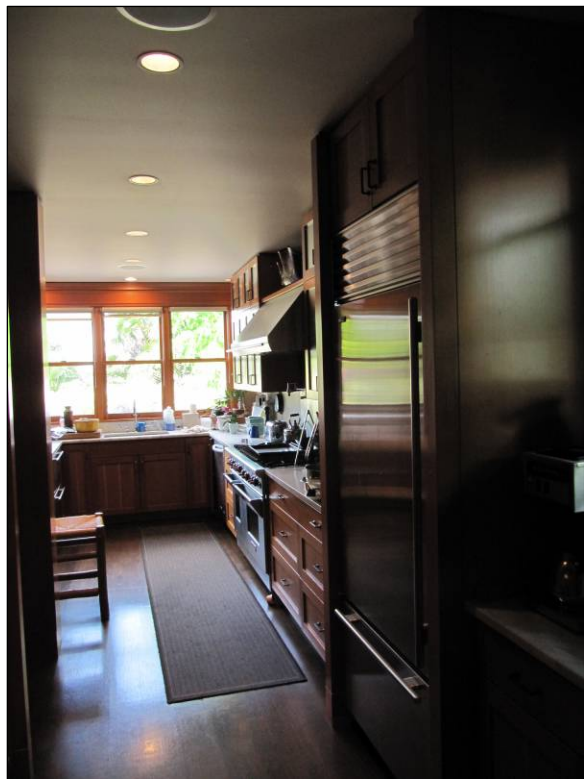
Figures 59 & 60. Below right and left, the kitchen. Left, looking north, and right, looking west from the dining room.

First floor rooms along the west side include a non-original kitchen, and a former servant's room and bath, which have been remodeled (Figures 59 & 60). The guestroom, the smallest one in the inn, features ornate, non-original finishes such as deep cove molding and ceramic floor tiles, and the kitchen and adjoining informal dining and lounge spaces feature solid cherry cabinetry. In these areas, the

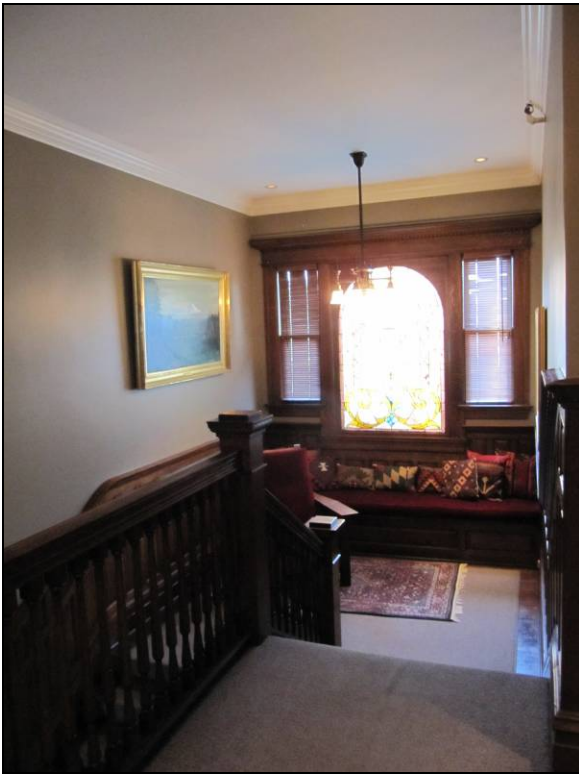
Figure 61. Above left, stair landing and non-original stained glass.

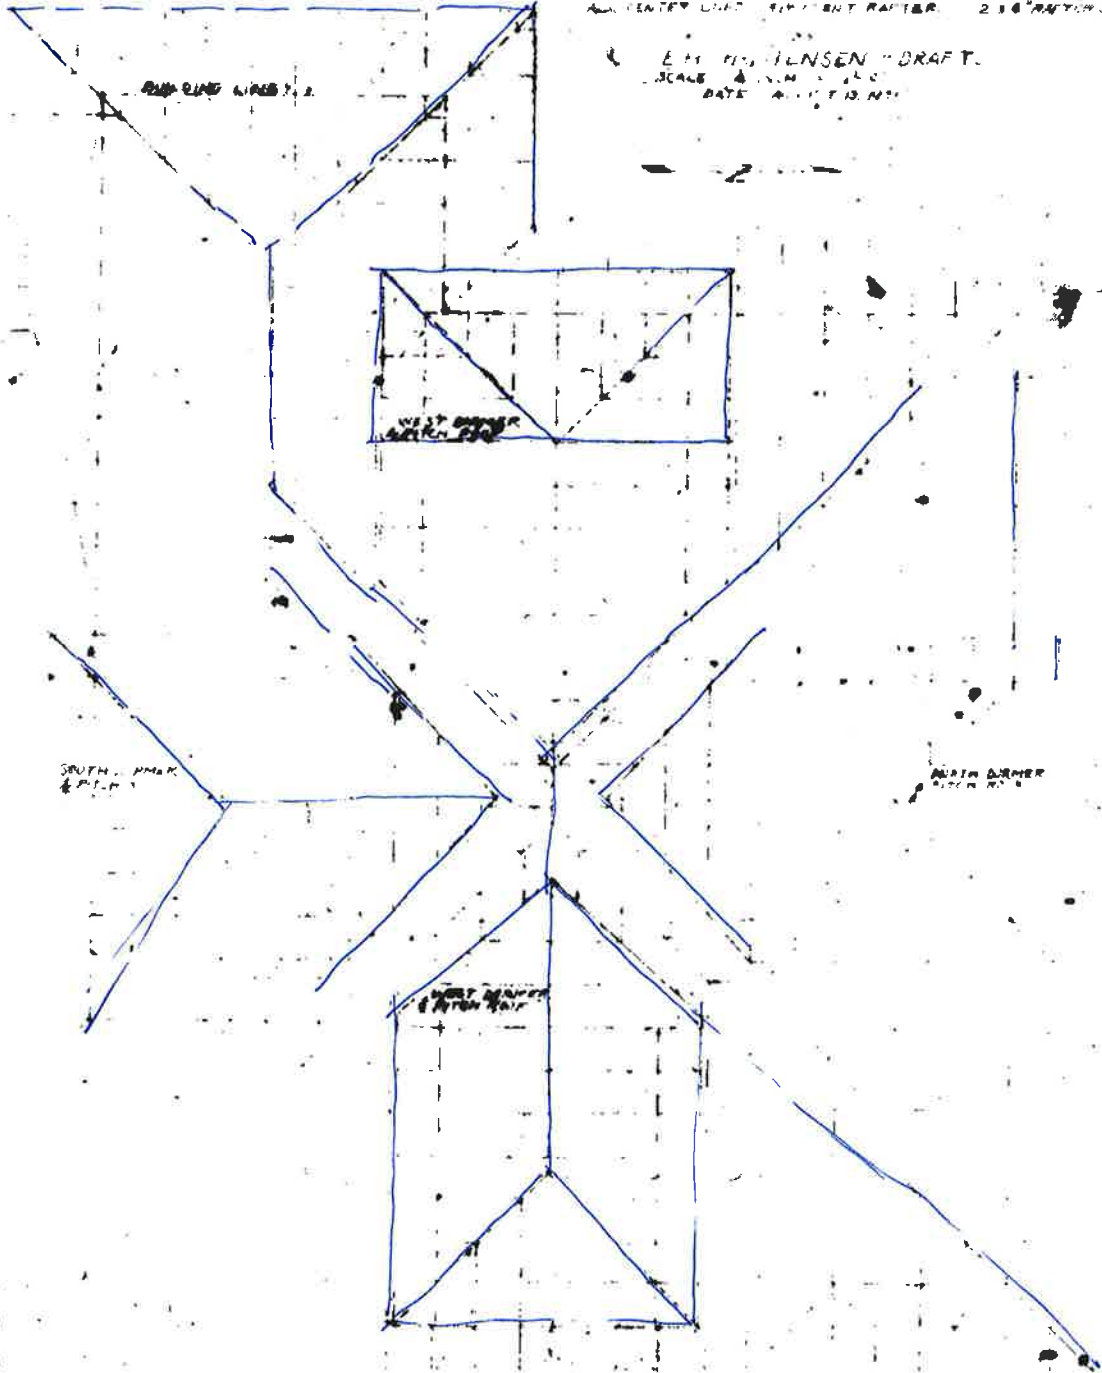
SOUTH VIEW OF ADDITION to
E. H. CHRISTENSEN, DRAFT (ca 1931)

RAFTERS 2x4 CENTER TO CENTER
ALL CENTER LINE RIFTS 2x4 RAFTERS

E. H. HENSEN DRAFT.
SCALE 1/4" = 1'-0"
DATE AUG. 12, 1931

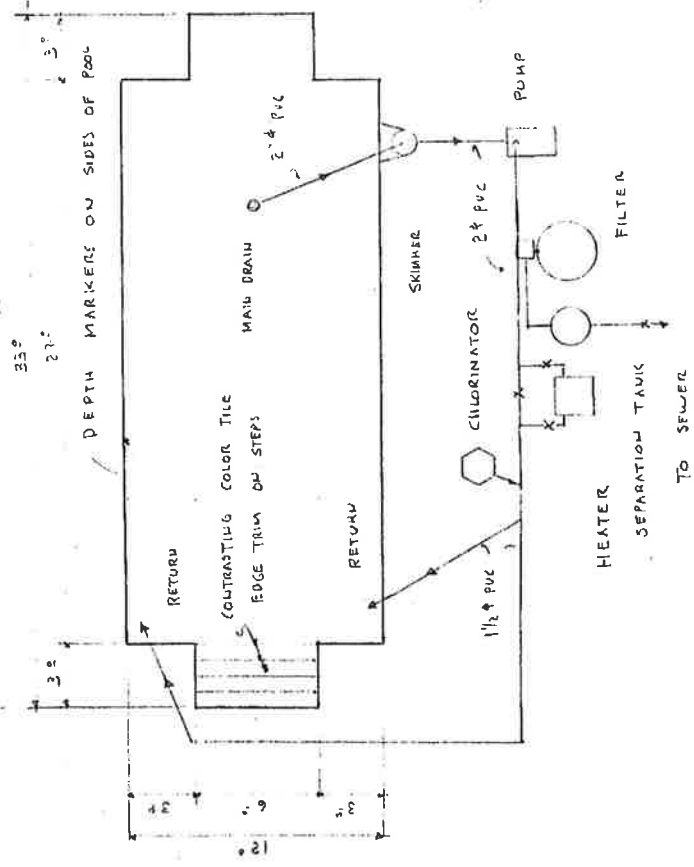
POOL PLAN & DIAGRAMMATIC PIPING
1/4" = 1'-0"

POOL DATA
 VOLUME: 360 @ 3.5'x6' FT = 4" AVE = 1440 CU FT. = 10,800 GAL
 TURNOVER RATE: 10,800 @ 60 GPM = 3 HR
