Landmark Nomination
The Singerman Residence / Gaslight Inn
1727 15th Avenue, Seattle

BOLA Architecture + Planning
Seattle

July 15, 2015

Landmark NOMINATION Application

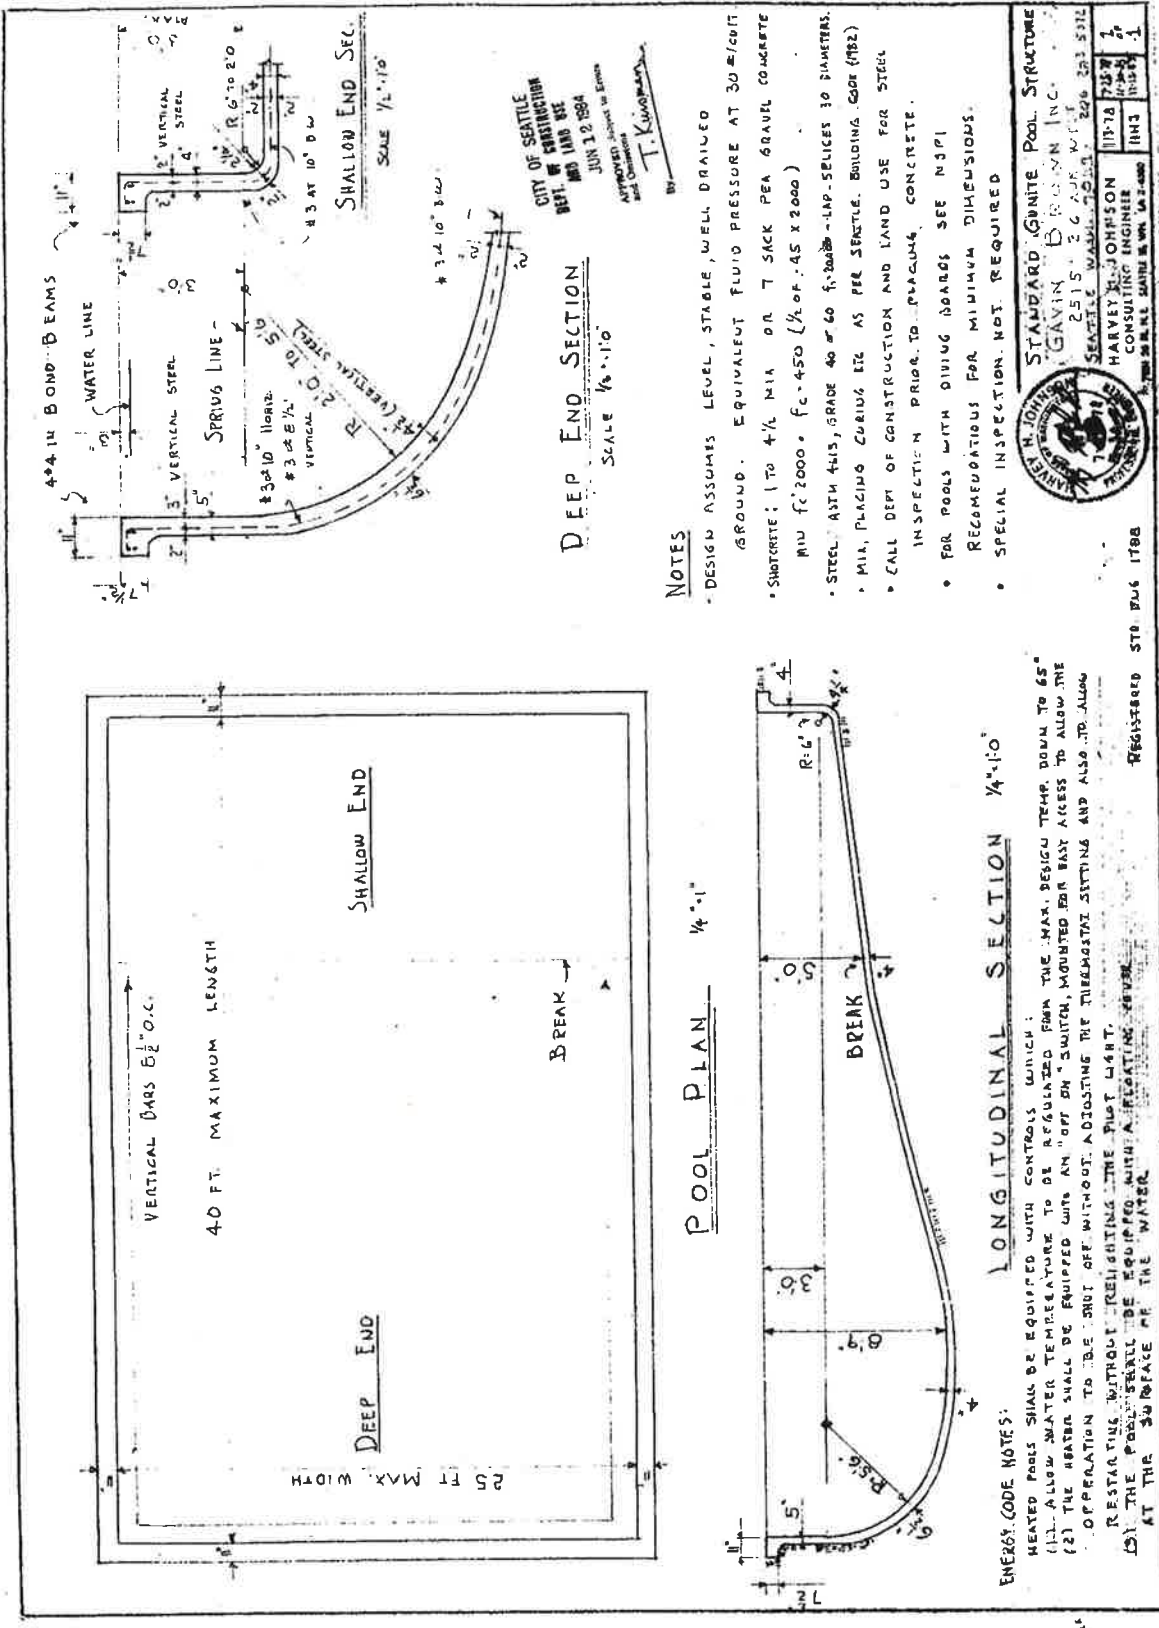
- DESIGN ASSUMES LEVEL, STABLE, WELL DRAINED GROUND. EQUIVALENT FLUID PRESSURE AT 30#/SQ FT
- STEEL: 1 TO 4/8 MIA OR 7 SACK PER GRAVEL CONCRETE MIN $f_c = 2000$, $f_y = 450$ (1/2 OF .45 X 2000)
- STEEL: ASTM A413, GRADE 40 #60 LAPS - LAP SPICES 30 DIAMETERS.
- MIA, PLACING CURBS ETC AS PER SCHEDULE. BUILDING CODE (1982)
- CALL DEPT OF CONSTRUCTION AND LAND USE FOR STEEL INSPECTION PRIOR TO PLACING CONCRETE.
- FOR POOLS WITH DIVING BOARDS SEE MSPI RECOMMENDATIONS FOR MINIMUM DIMENSIONS.
- SPECIAL INSPECTION NOT REQUIRED.
