**Name:** La Quinta Apartments

**Street and Number:** 1710 E Denny Way, Seattle, WA 98122

**Submitted by:** Katie Pratt and Spencer Howard, Northwest Vernacular  
on behalf of Historic Seattle

# La Quinta

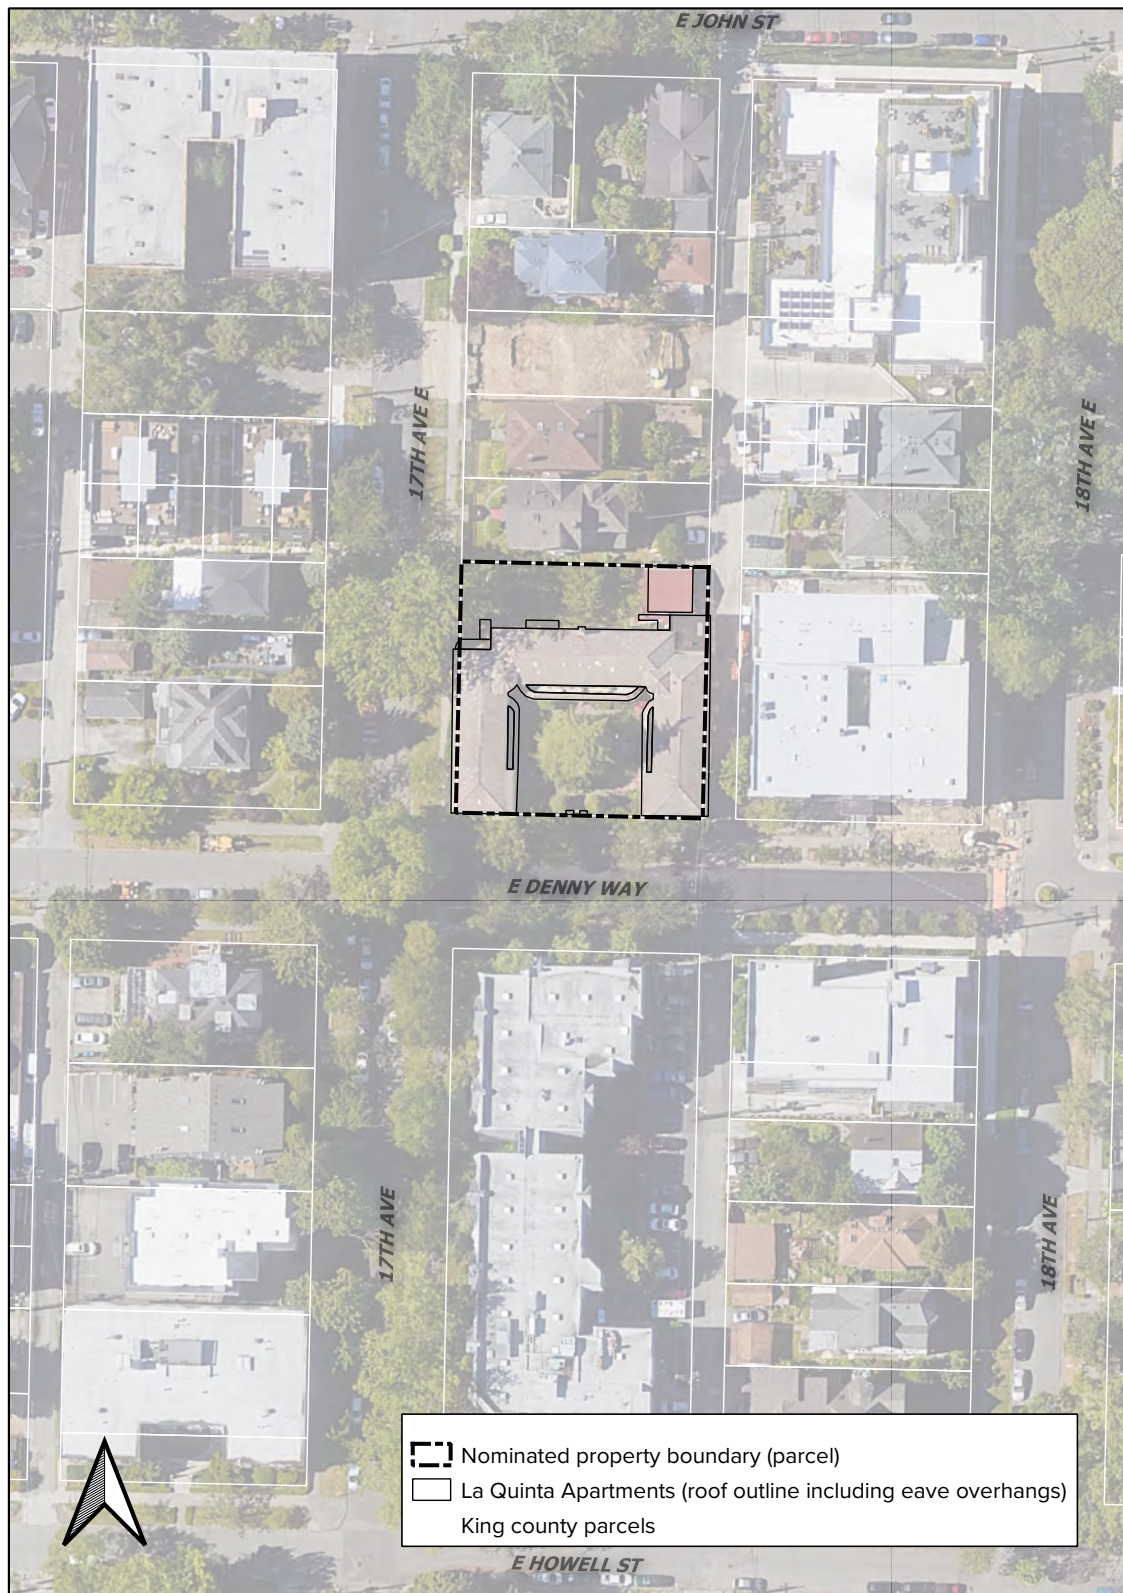
**Figure 1.** Nominated property map

The nomination boundary with the building footprint shown.

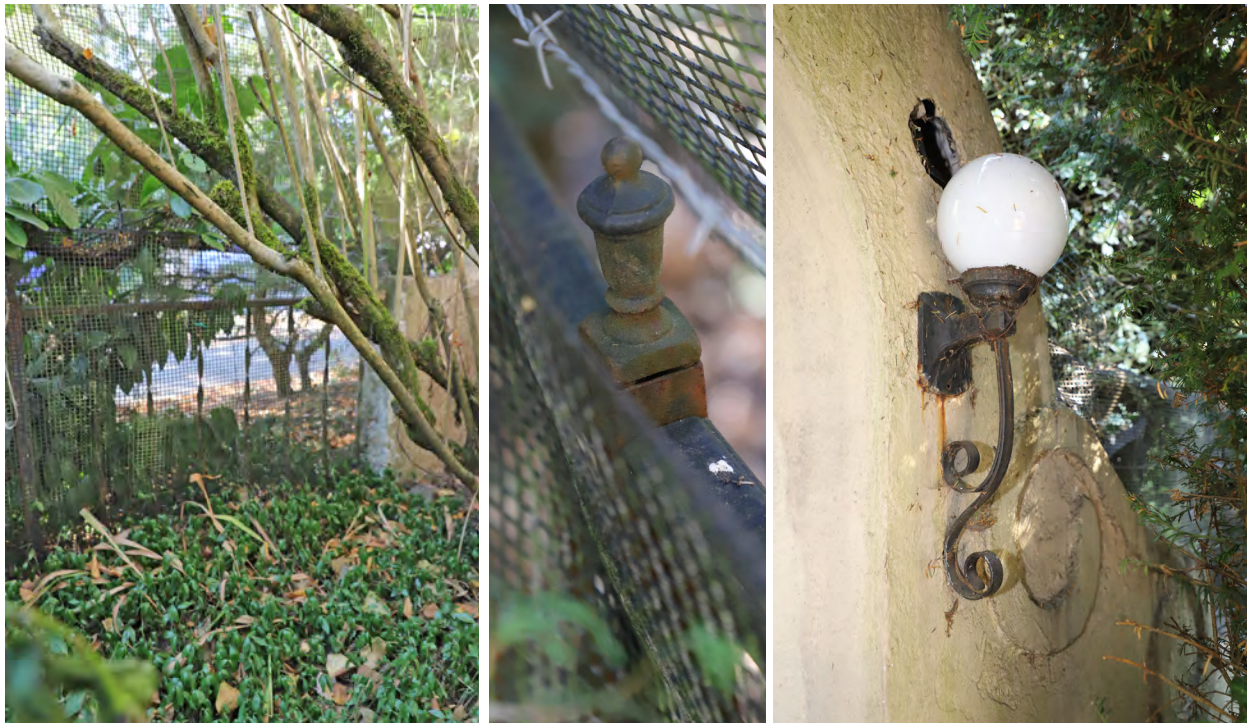
**Figure 9.** Courtyard, fence along the south edge (above left and middle), and lighting at the arched gate (above right).

Site furnishings include the stucco clad hollow clay tile entrance gate. The round arched gate has sloped shoulders with a raised scroll pattern at the shoulders. Original metal gate sections remain at the interior side of the gate with an added metal gate and associated call box set within the arched opening. Decorative iron scroll type light fixtures with replacement globes flank the entrance on the exterior side of the gate. Added lighting is mounted to the top of the gate. Extending from the gate shoulders are short stucco clad walls. Corresponding short walls occur at the opposite building corners with a low metal fence with decorative finials extending between the walls. Added wire fencing installed to contain a former resident's cat(s) extends above the low fence. The larger northeast and northwest stoops each have low metal railings with scroll buttresses along their outer edge. These railings match the low metal fence. A picnic table and several small tables and associated chairs are distributed throughout the courtyard for tenant use.

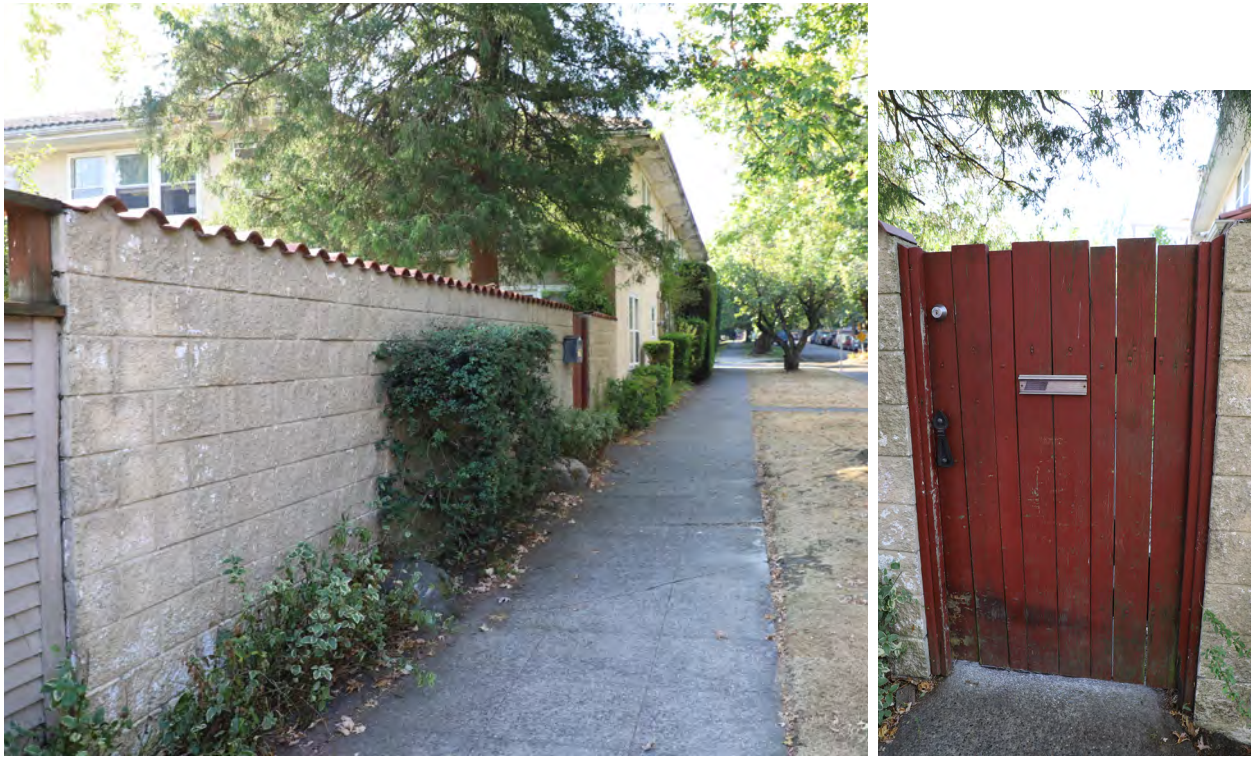
**Figure 14.** Backyard, west wall.  
Concrete block wall looking south (above left) and gate (above right).

length of the north facade. Planting areas occur along the foundation of the building, extending out from the northwest corner of the building, and at the east end adjacent the detached garage (built 1950). A concrete block wall (built ca. 1950 and not evident in a 1937 aerial) encloses the west edge with the attached and detached garages enclosing the east end. The north side opens to the yards of the adjacent houses (114 and 116-118 17th Avenue E) on separate parcels and built ca. 1926 and 1905, respectively. The topography of the back yard has a slight slope down to the north edge of the property line. **(Figures 11-14)**

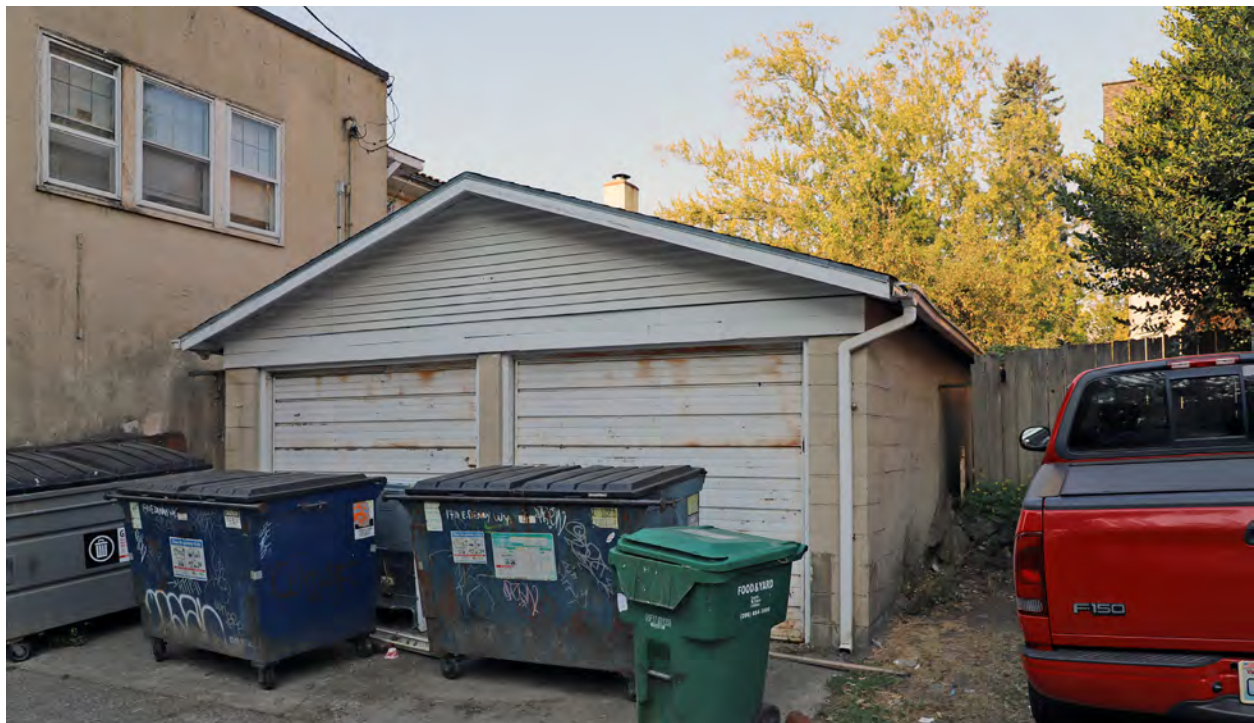
**Figure 23.** 1950 detached garage, northeast corner.

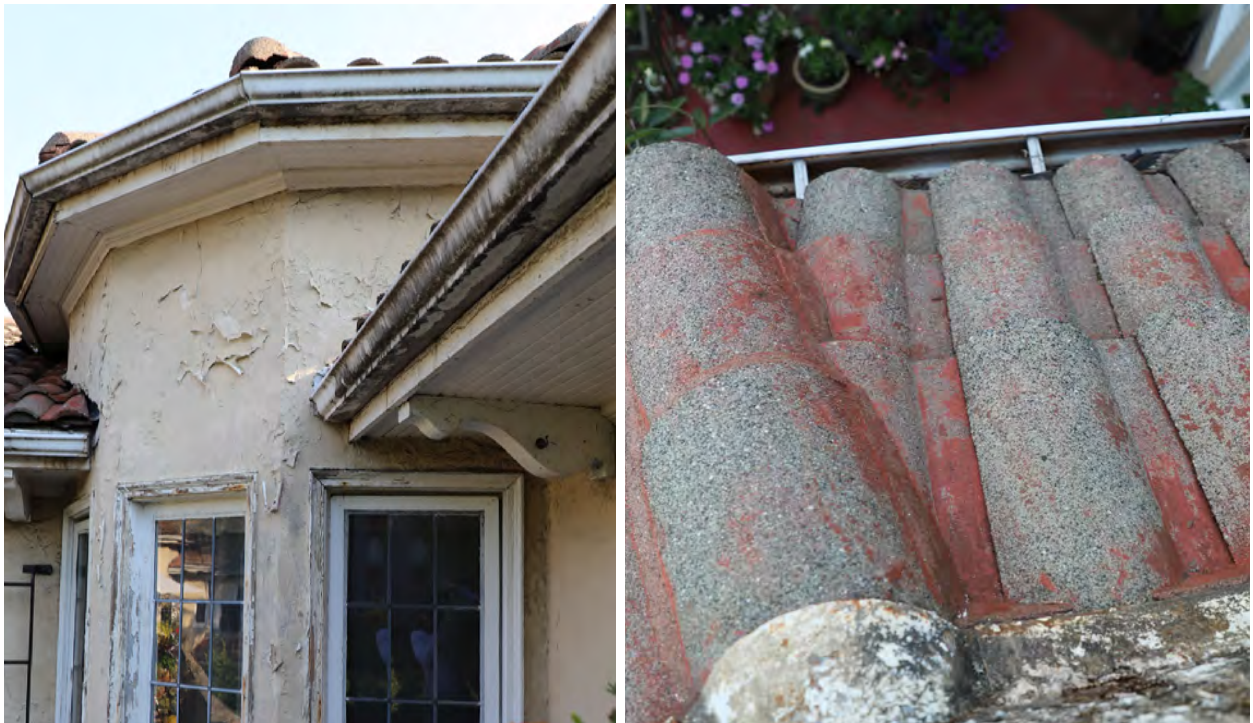
**Figure 37.** Roof details.  
Tower and boxed eaves (above left) and concrete tiles painted red with flat valleys (above right).

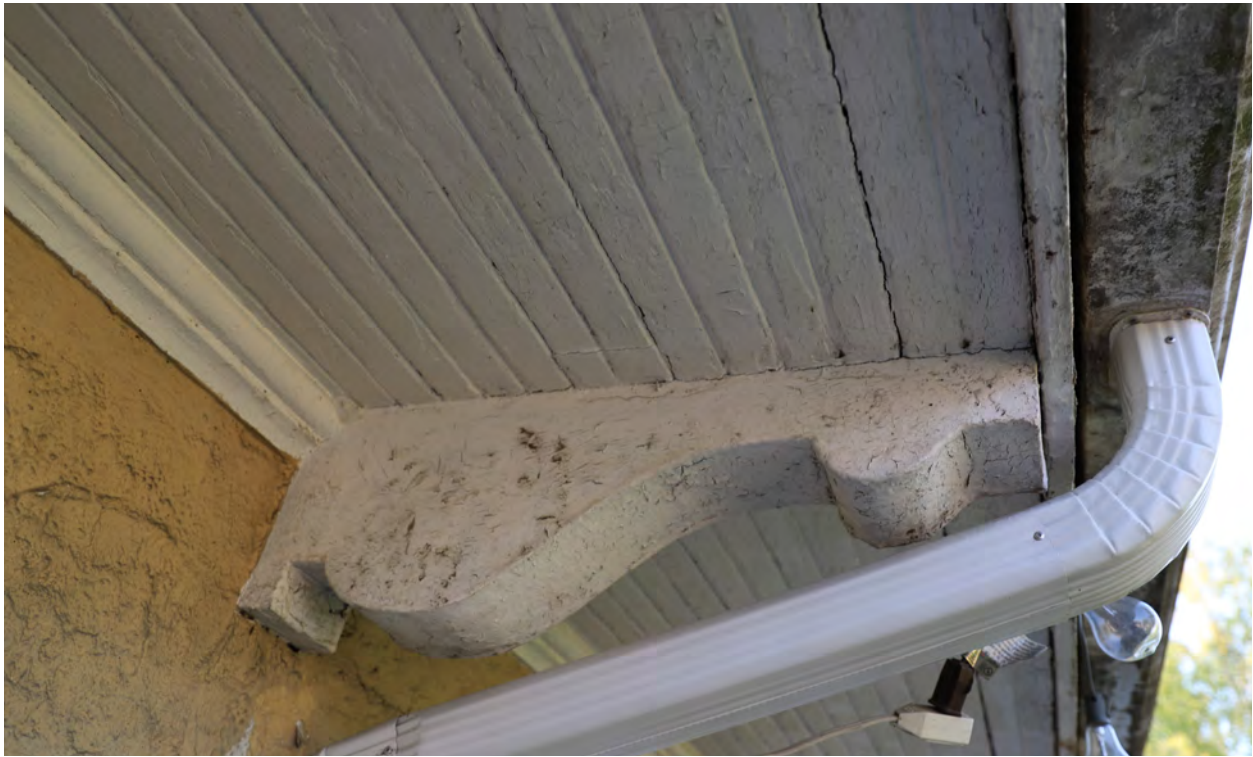
**Figure 38.** Roof, bracket and soffit detail.

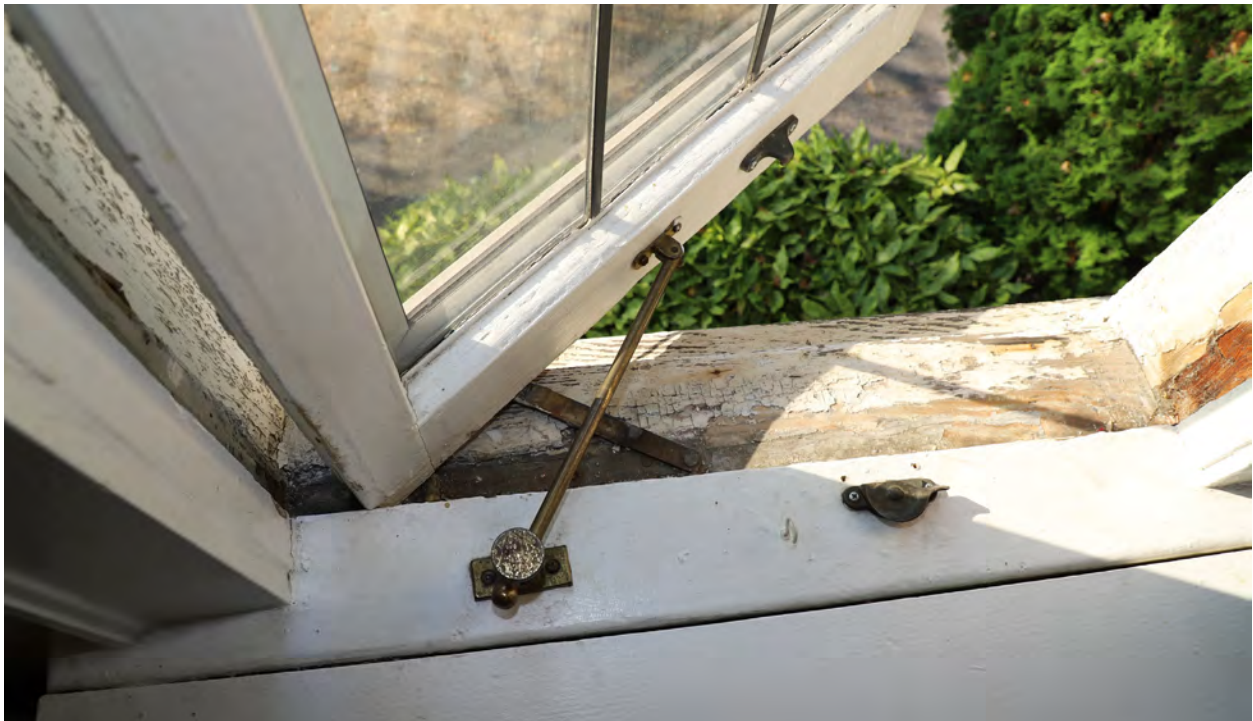
**Figure 39.** Window, sash stay and lock detail.

Windows facing 17th Avenue E, the alley, and back yard generally correspond with dining rooms and kitchens on the first story and bathrooms and bedrooms on the second story. The original brass sash locks are located on the meeting rails, with sash lifts on the bottom rail. Sash weights are set in pockets and connected with cotton cords (or compatible replacement material) passing over sash pulleys. **(Figures 15-23)**

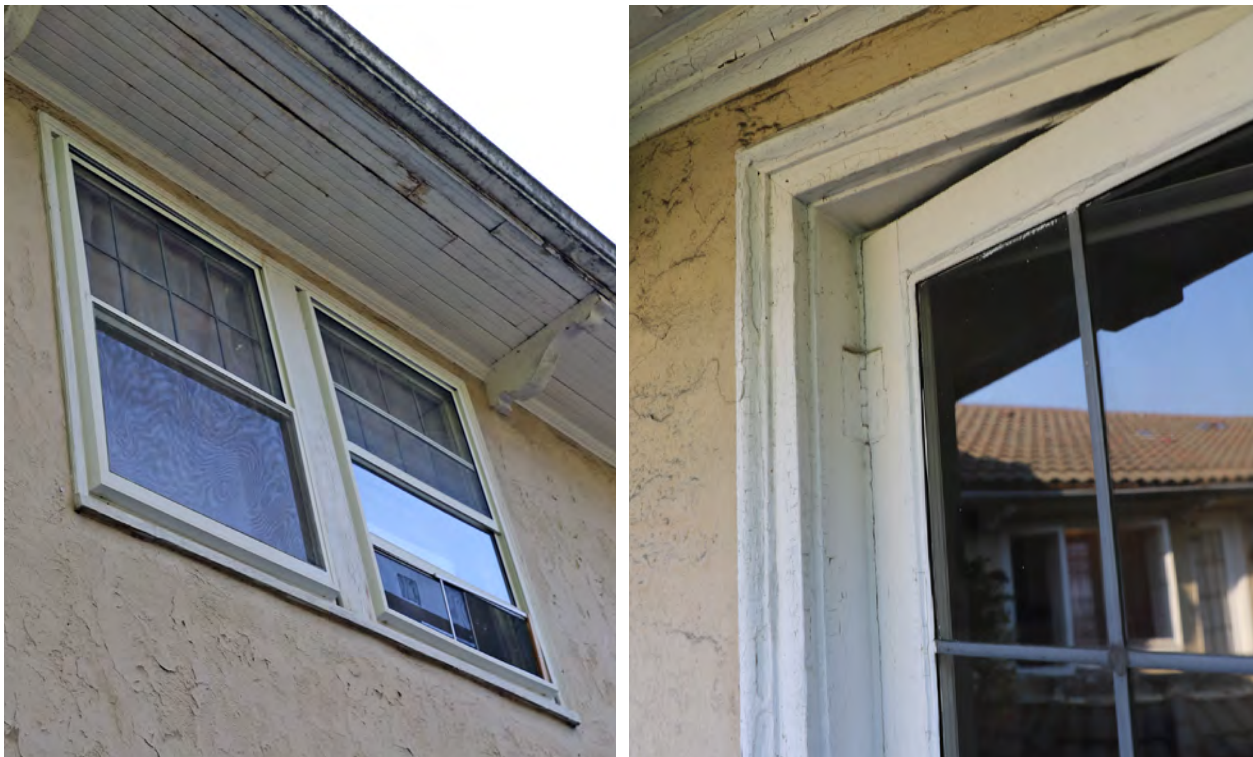
**Figure 40.** Window details.  
Exterior vinyl storm sash, (above left) and unit 3 balcony level sash detail (above right).

- Eave reconfiguration along the alley to accommodate placement of the power pole adjacent the building.
- Windows: installation of vinyl storm sash; and replacement of some basement window glass panes with vents.
- Fence, installation of wire above the original fence.
- Tree, replacement of the original monkey puzzle tree with the existing tree.
- Light fixtures: installation of the wall bracket fixtures on the west facade; selective replacement and removal of light fixtures within units.
- Exterior doors: replacement of some exterior doors with flush panel units.

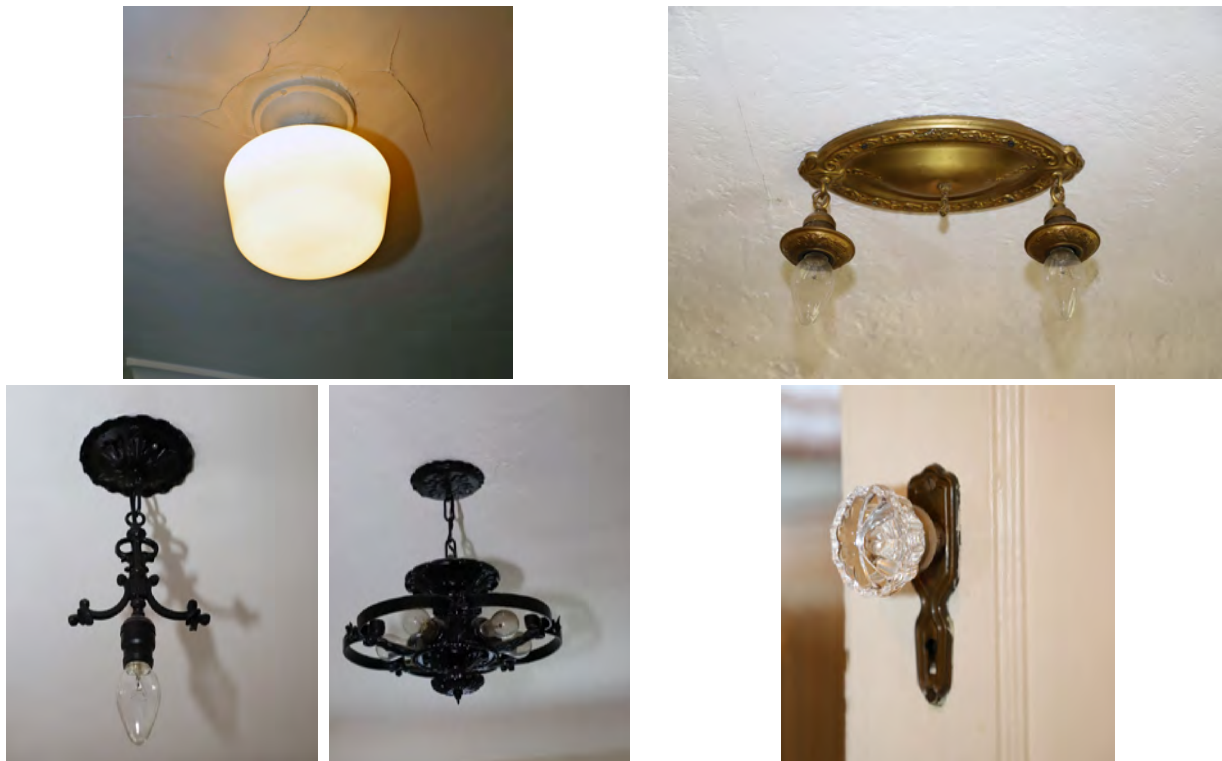
**Figure 59.** Original light fixtures and hardware within unit 3, with a ca. 1980s replacement globe shown on the upper left fixture.

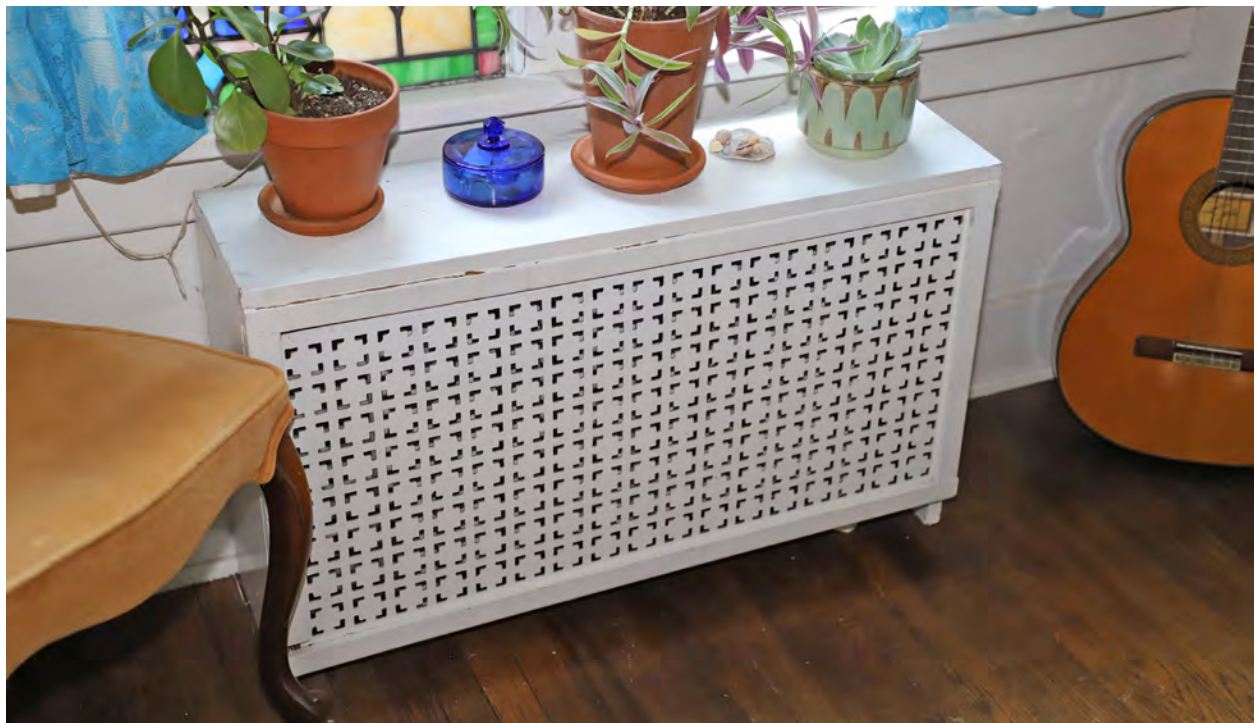
**Figure 60.** Radiator cabinet, typical of other units.

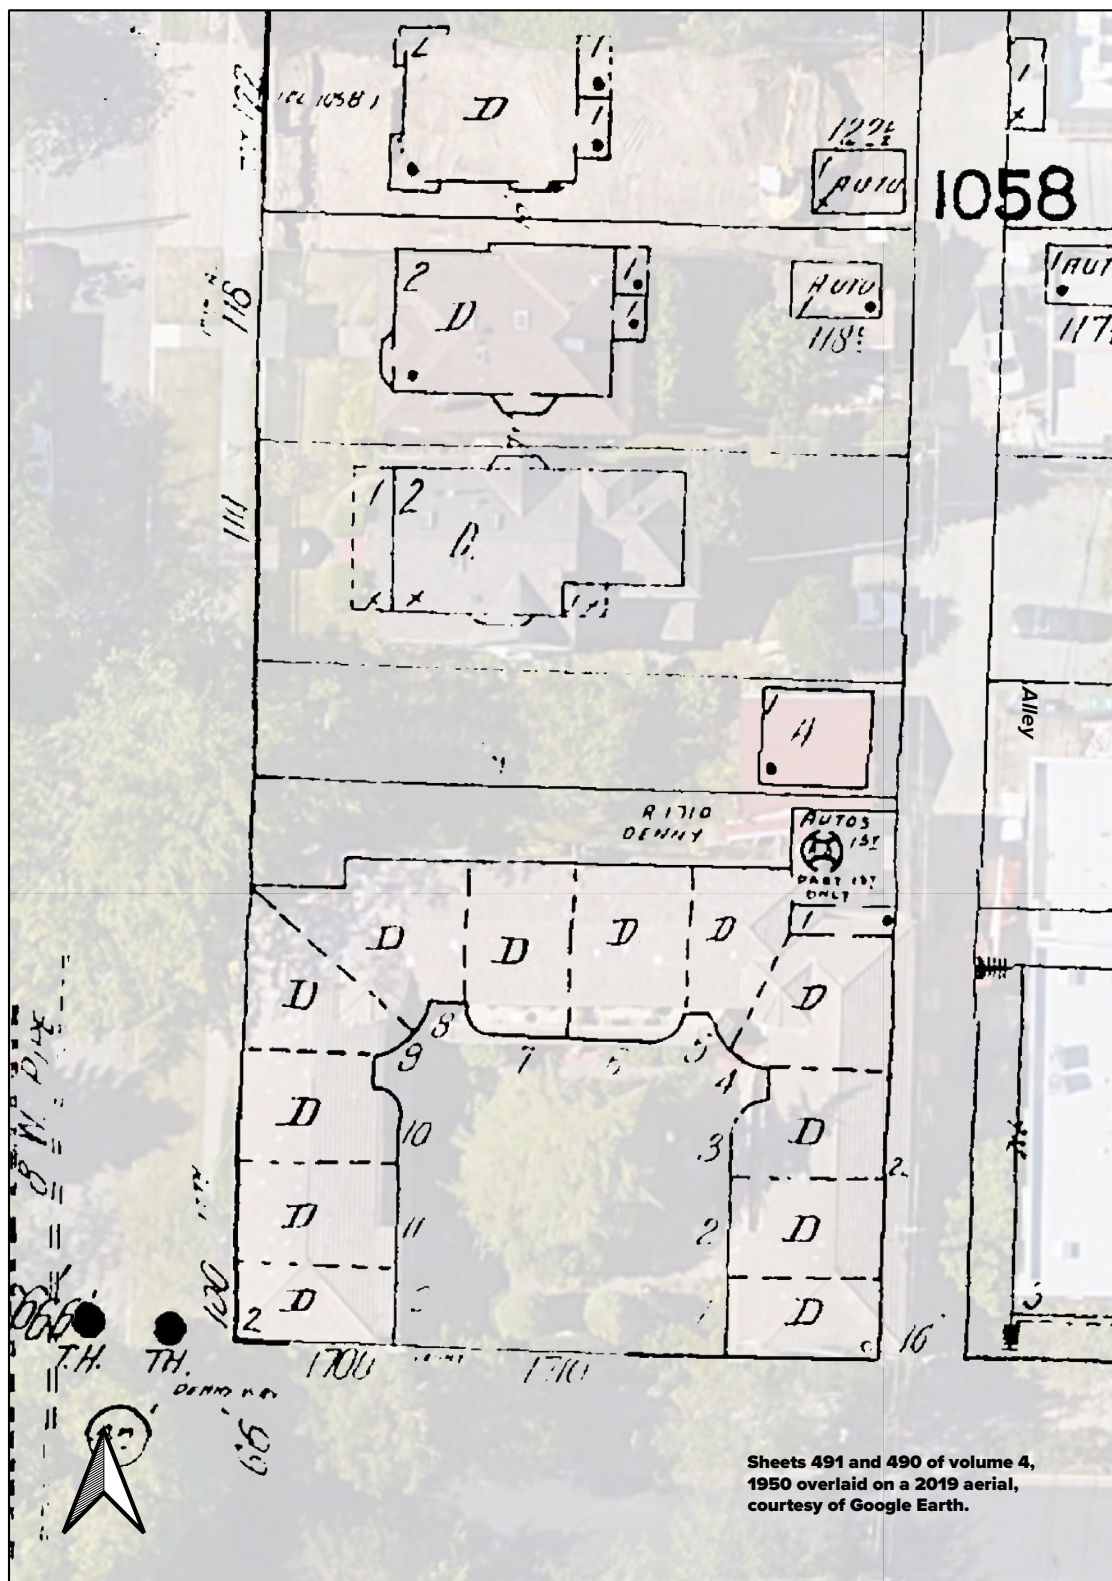
Figure 102. Sanborn Map.

1950 Sanborn map overlaid on a 2019 aerial.

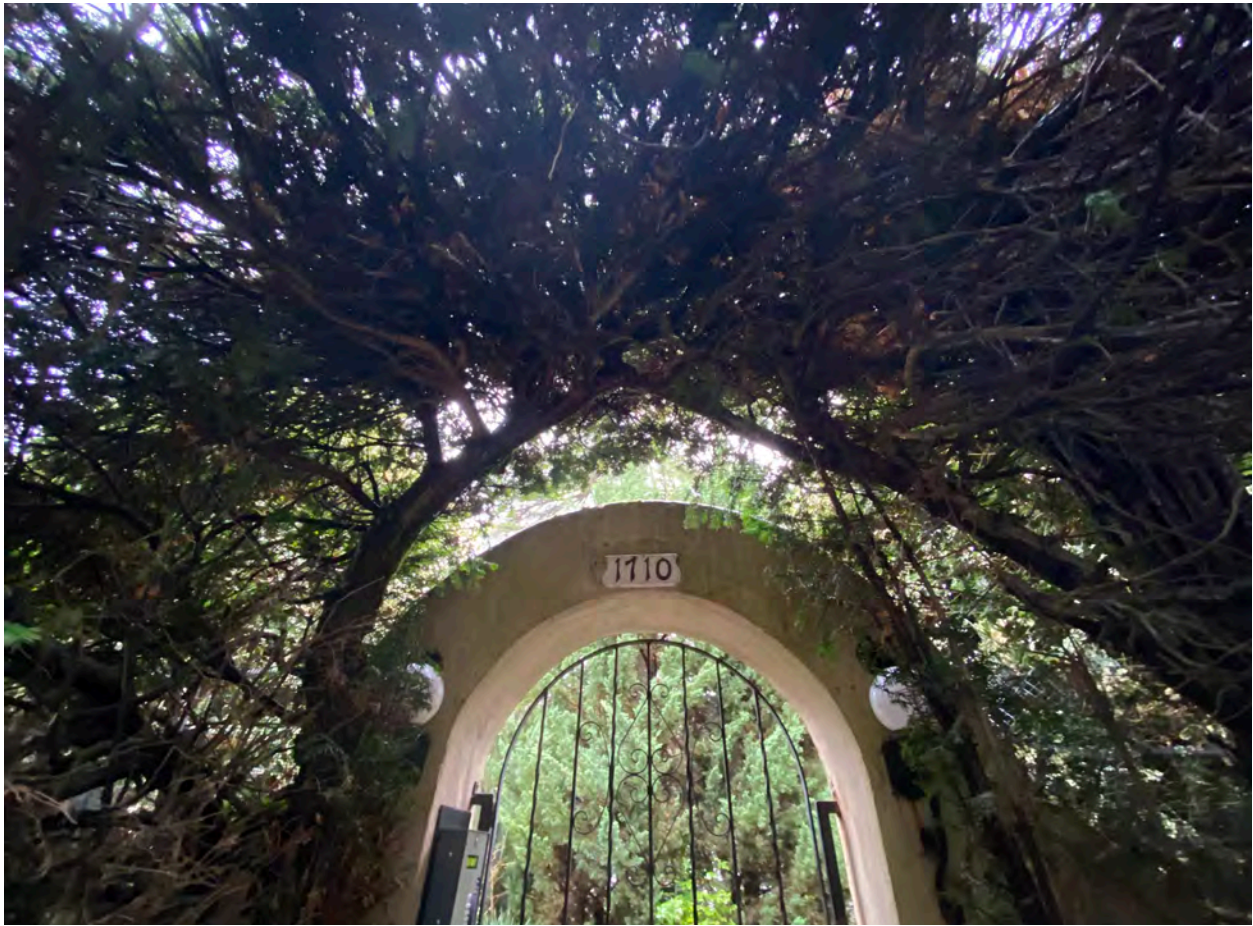
**Figure 157.** View of the Yews at the front gate, trained to grow together in an arch over the entrance.

- Courtyard: open space, lawn, central specimen tree design (currently this is the Deodar Cedar that replaced the Monkey Puzzle Tree), stucco clad main gate and light fixtures, Yews at the main gate, Holly trees adjacent main gate, metal fence, planting beds, and concrete walkways.
- Backyard: open space, lawn, pear trees, concrete walkway, and planting beds.
- Perimeter: Japanese Aucuba, Yews, Bald Cypress.
