MAGNUSON PARK

<p>CLEAN COMPREHENSIVE LONG-TERM ENVIRONMENTAL ACTION NAVY</p>	<p>CTO 0104 NAVSTA PS, Seattle Seattle, Washington EBS</p>
	<p>Figure 6-1 Environmental Risk Classifications, NAVSTA PS, Seattle</p>

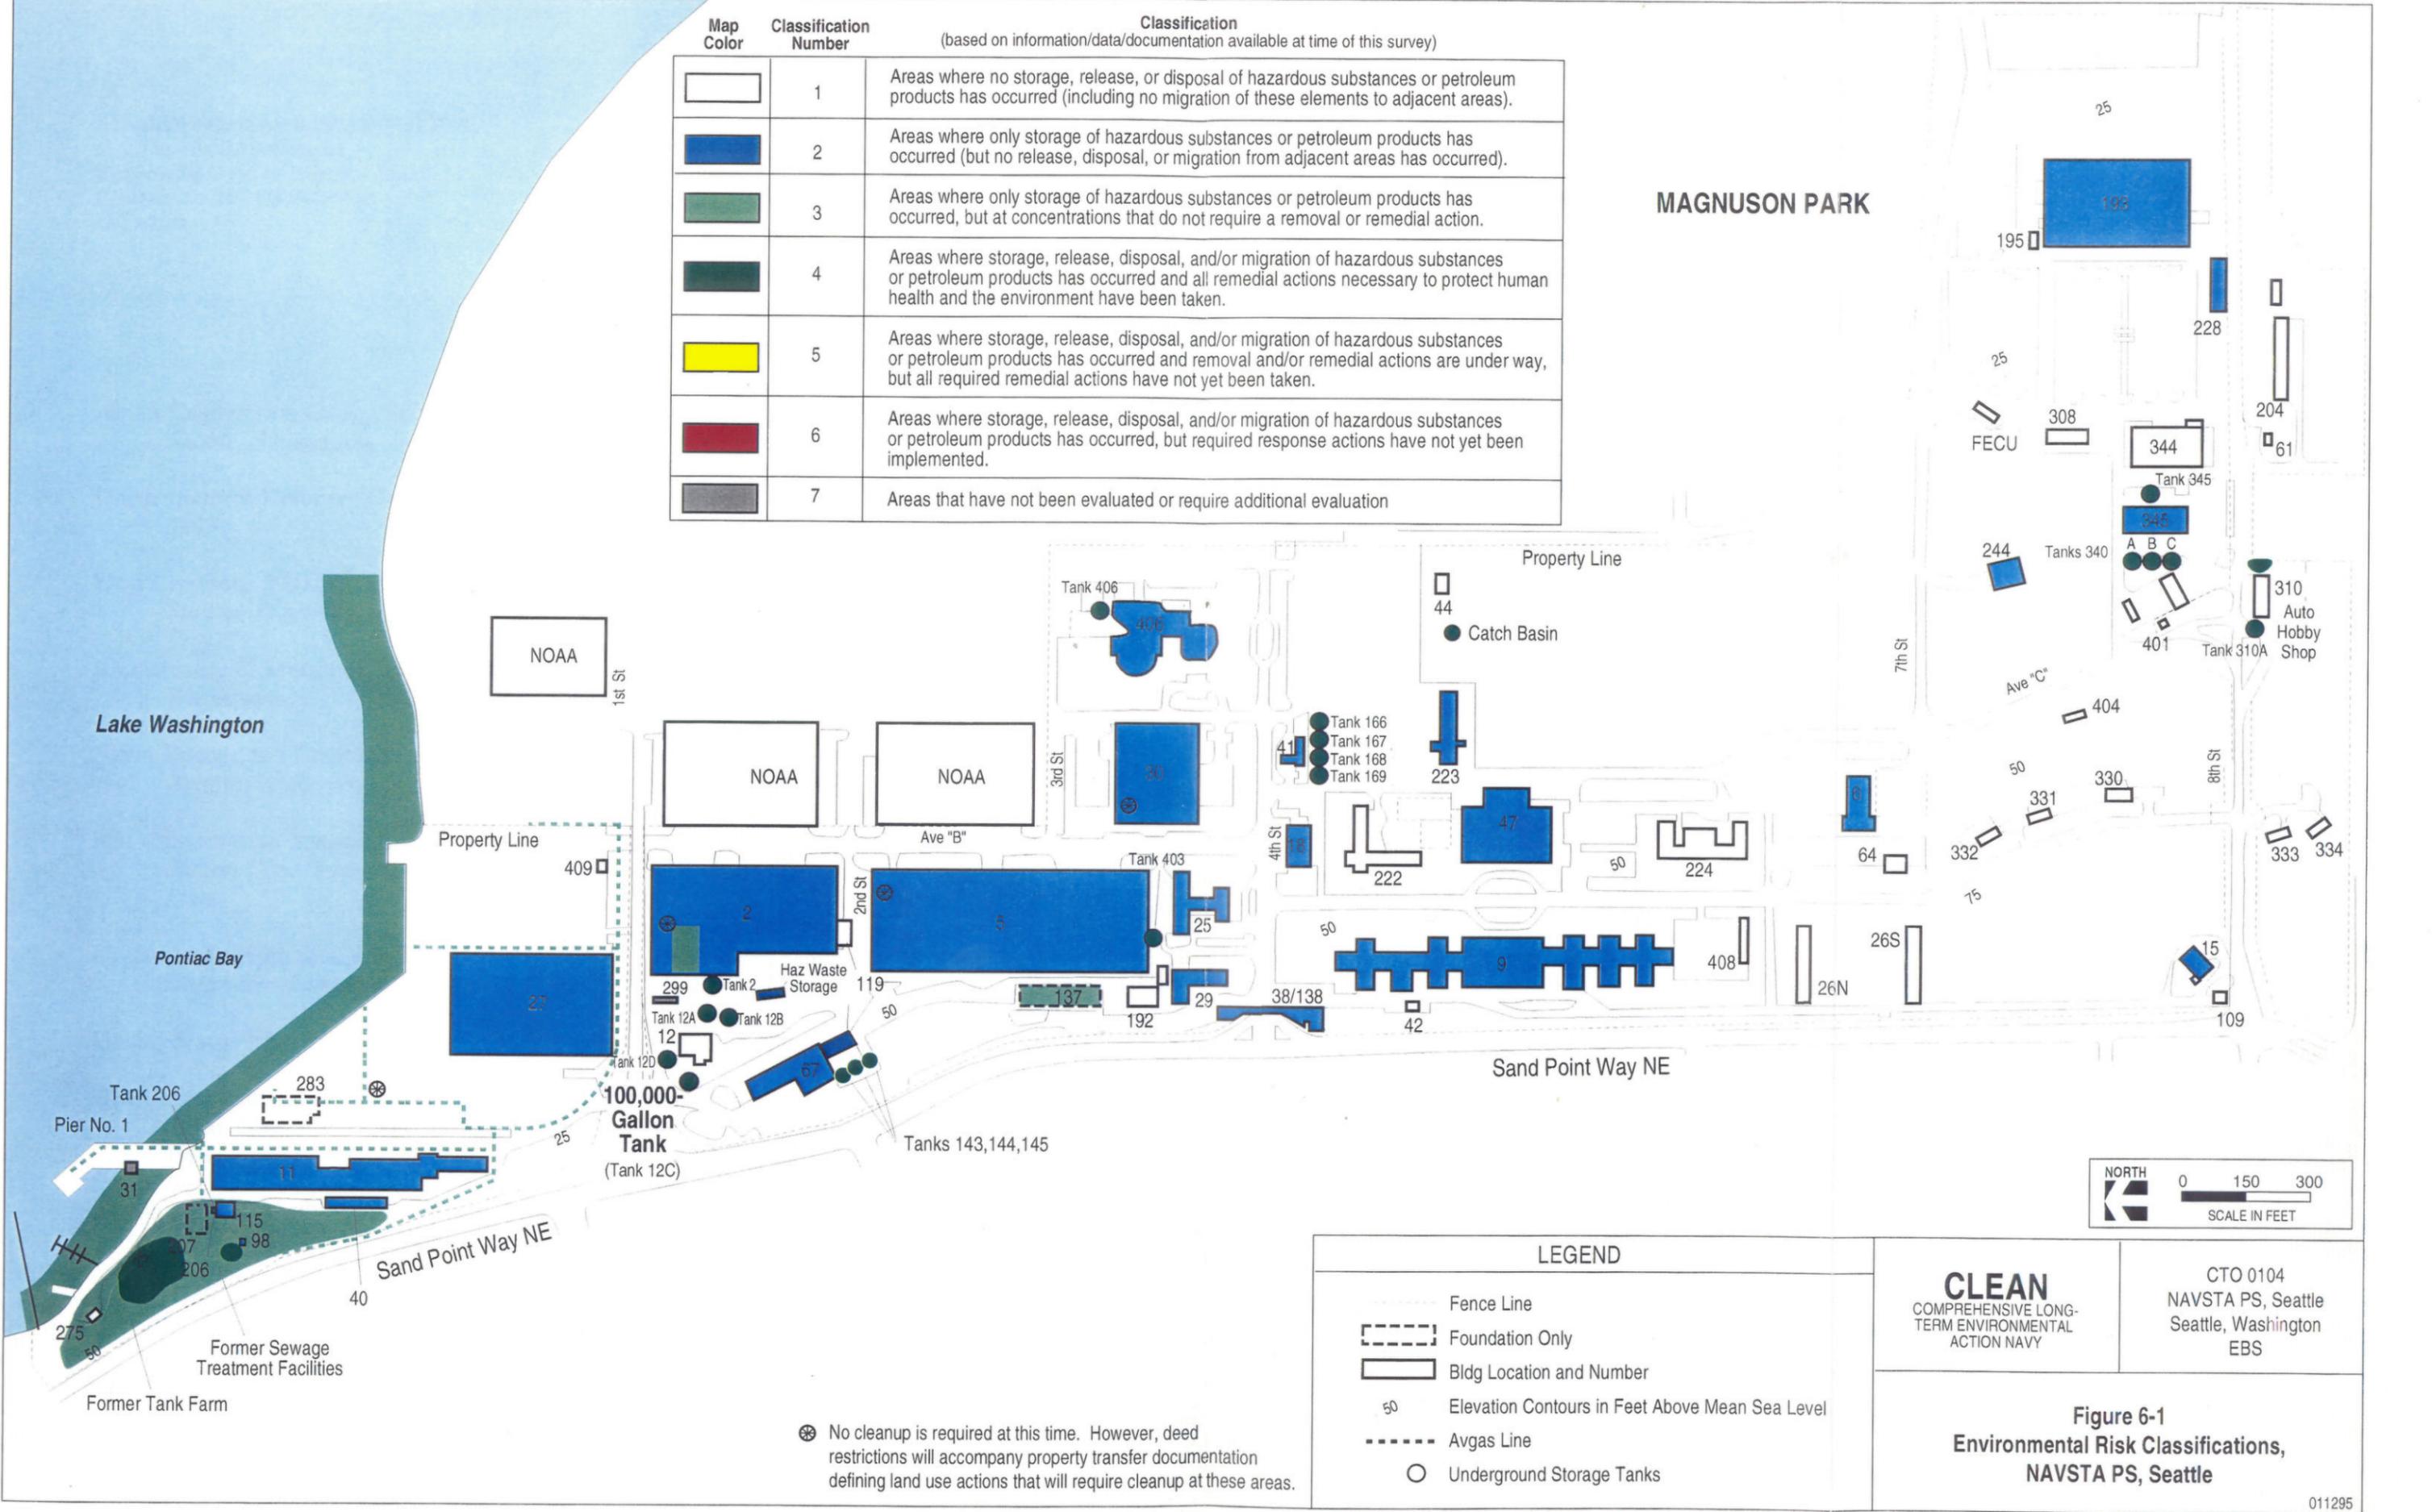
⊗ No cleanup is required at this time. However, deed restrictions will accompany property transfer documentation defining land use actions that will require cleanup at these areas.
