Protecting Seattle's Waterways

# Wastewater Collection System: 2014 Annual Report

March 27, 2015

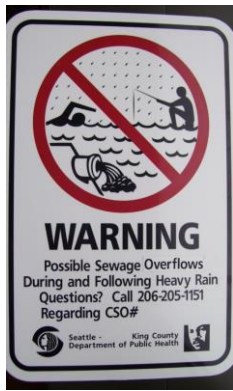
Figure 3-2. Example of Outfall Signage

SPU, together with Seattle King County Public Health, maintains a sewage overflow notification and posting program for Seattle’s CSO outfalls. Signs at each outfall identify the outfall and warn of possible sewage overflows. The signs include the phone number for the CSO Hotline, staffed and managed by Seattle King County Public Health. Seattle King County Public Health also provides a website with detailed information about CSOs, potential public health hazards, and precautions the public may take to protect themselves. If sewage overflows occur due to side sewer breaks or illicit connections or discharges, SPU posts additional warning signs at impacted waterways until the problem is resolved.

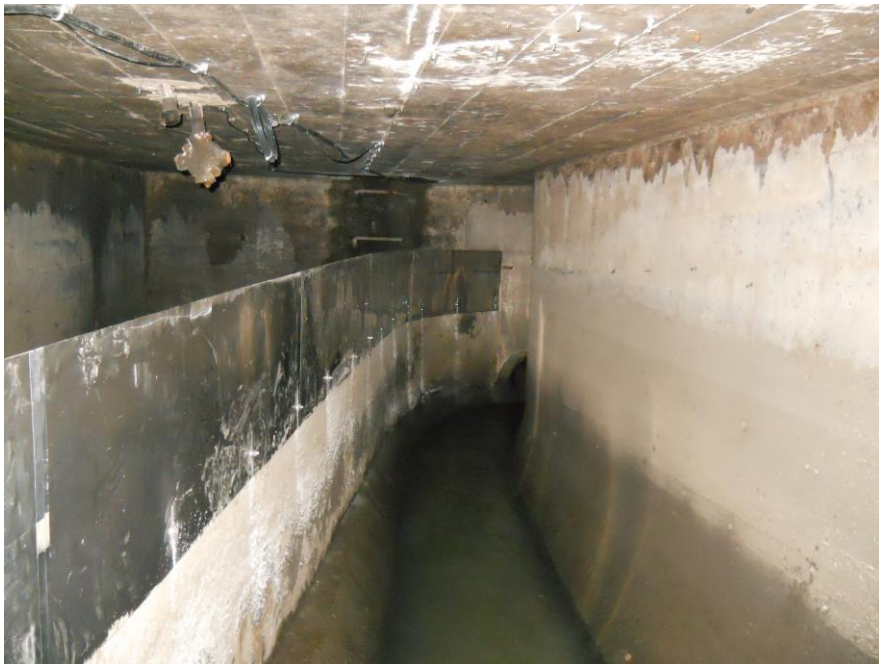
**Figure 4-2. Retrofit Improvements At Overflow Structure 47C**

The retrofit for Basin 47 consisted of raising the overflow weir in Overflow Structure 47C to maximize storage as well as improve access to the overflow structure. Figure 4-2 below shows the new raised weir.

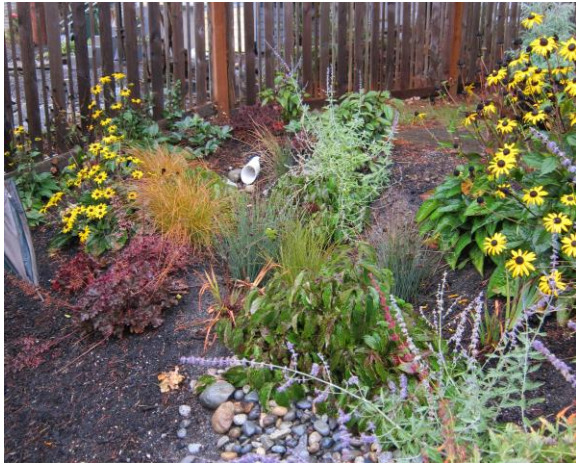
**Figure 4-7. Raingarden (left) and Cistern (right)**

Upon completion, installations are inspected by a RainWise inspector and homeowners apply for rebates. RainWise rebates for rain gardens are currently three dollars and fifty cents per square foot of roof area controlled. Rebates for cisterns equal 64% or more of the rain garden rate, depending on the size of the cistern and contributing area. The average 2014 installation now controls the runoff from over 1,300 square feet of roof area. Typical RainWise installations are shown in Figure 4-7.

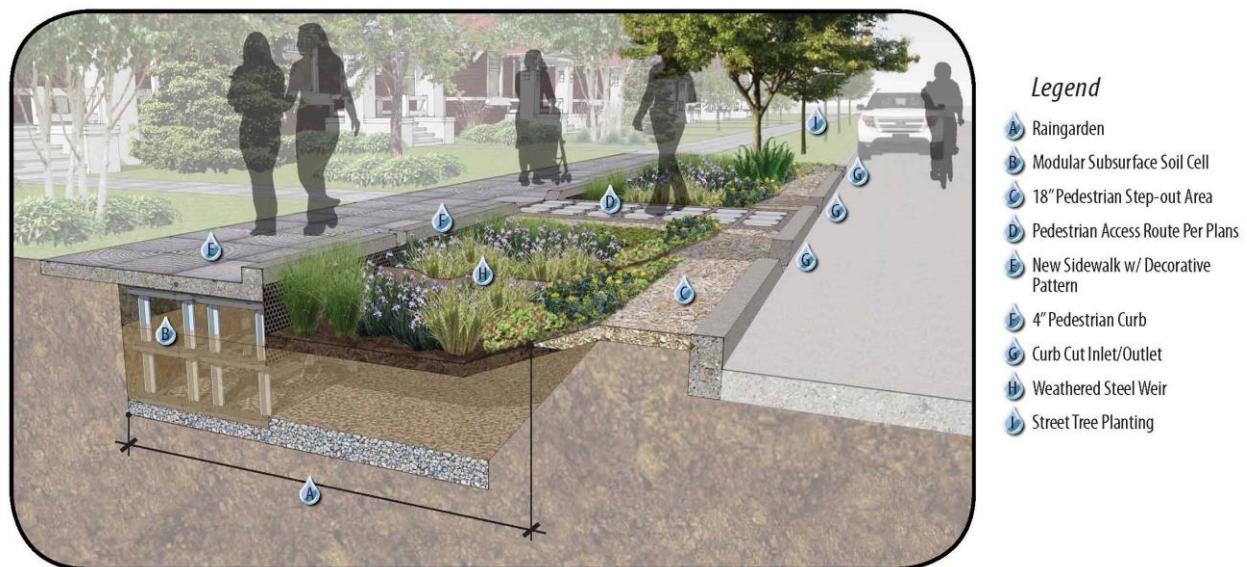
**Figure 4-8. Ballard NDS 2015 Proposed Modular Soil Cells**

- SPU shared the 30 percent design with the community and received feedback on preferences for plant palettes.
- Cost estimates showed that the original concrete vertical wall design was too expensive, so the project team developed a new concept using modular soil cells (see Figure 4-8), which reduced costs and reduced the number of raingarden cells required along each block.
- The 60 percent design was completed at the end of 2014.

\* Illustration represents approximately 3 years growth following installation.

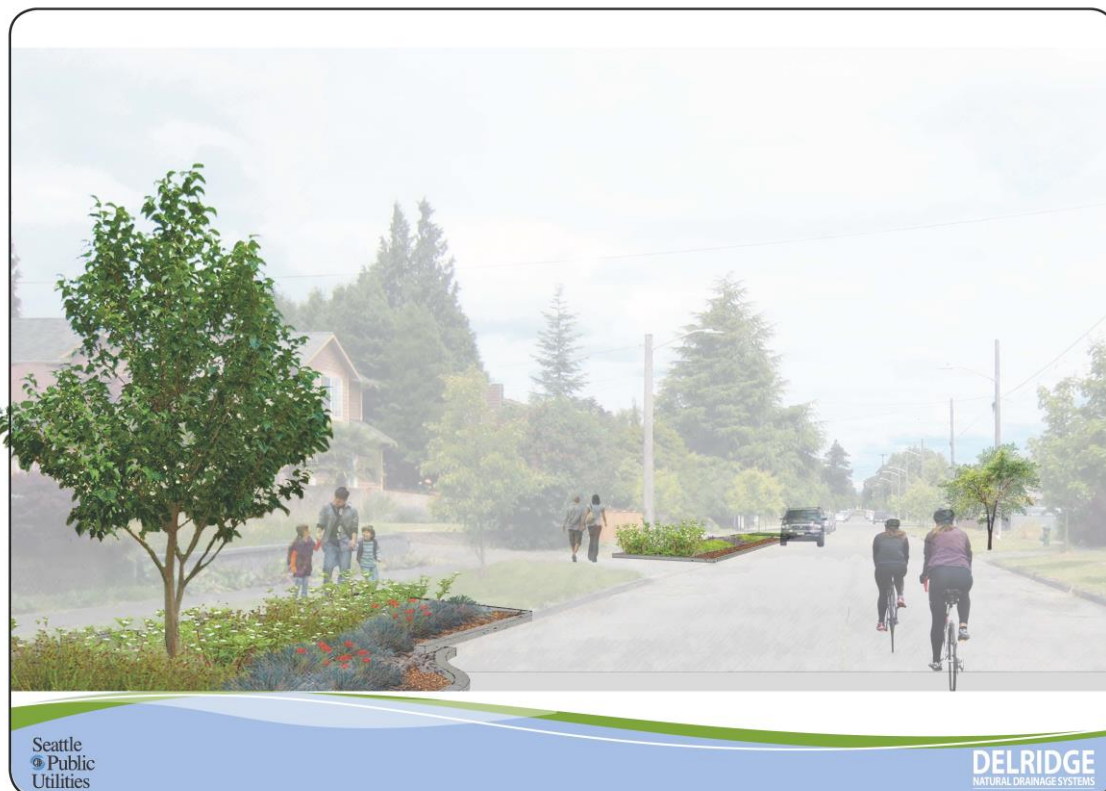
Figure 4-9. Delridge NDS 2015 Conceptual Drawing

The refined design for Delridge NDS includes raingardens connected with underdrains that convey cleaned waters to medium-depth infiltration wells (30-40' deep). These drilled drains are similar to underground injection control (UIC) wells, and provide infiltration to the advance outwash layer below glacial till. The current design coordinates siting of individual raingarden cells within existing landscape strips to minimize conflicts with utilities, driveways and trees, while maximizing the possible control of surface water within these catchment areas. Design will be completed in the second quarter of 2015, and construction is slated to begin in 2015 and extend into 2016.

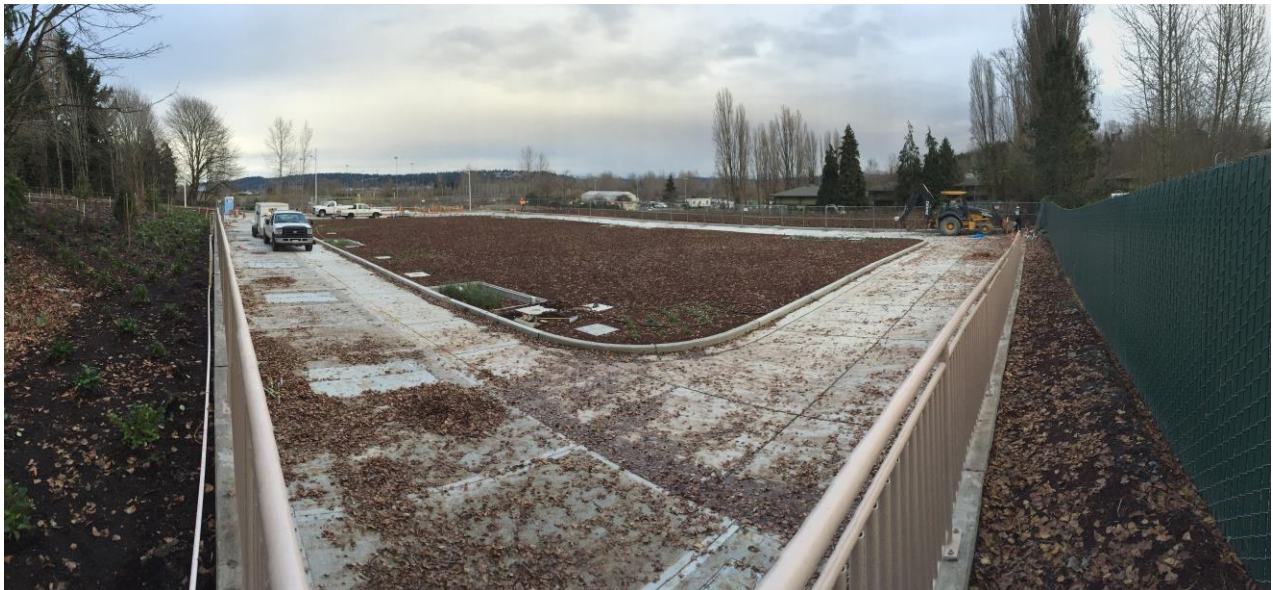
Figure 4-10. Windermere CSO Reduction Project Construction, February 2015

In 2013, SPU constructed the floor slab, walls and columns for the new storage tank and installed 1,400 feet of conveyance pipe in Sand Point Way. In 2014, SPU constructed the roof and then backfilled the storage tank; installed the remaining 700 feet of conveyance pipe in NE 65<sup>th</sup> St; installed the mechanical, electrical, and instrumentation equipment in the tank and the facility vault; and completed system and operational testing. Final commissioning of the Windermere system (including Windermere CSO 22 and 22A) is scheduled to be complete in Spring 2015.

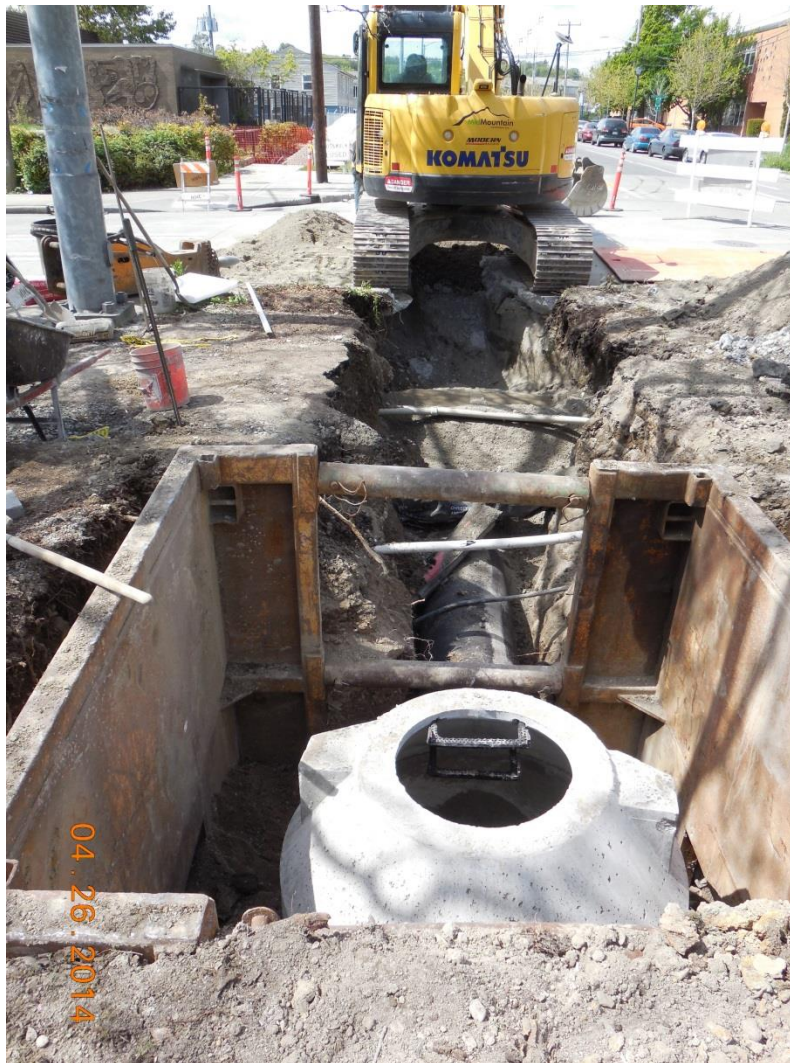
Figure 4-13. 52<sup>nd</sup> Ave S Conveyance Project Construction, April 2014

In 2014, SPU awarded the construction contract, installed the new piping and structures, restored disturbed surfaces, and put the new pipeline into service. Final construction completion will occur in 2015 as the contractor completes work with the associated Mapes Creek Restoration project. In addition, SPU will create record of construction drawings and begin post construction monitoring

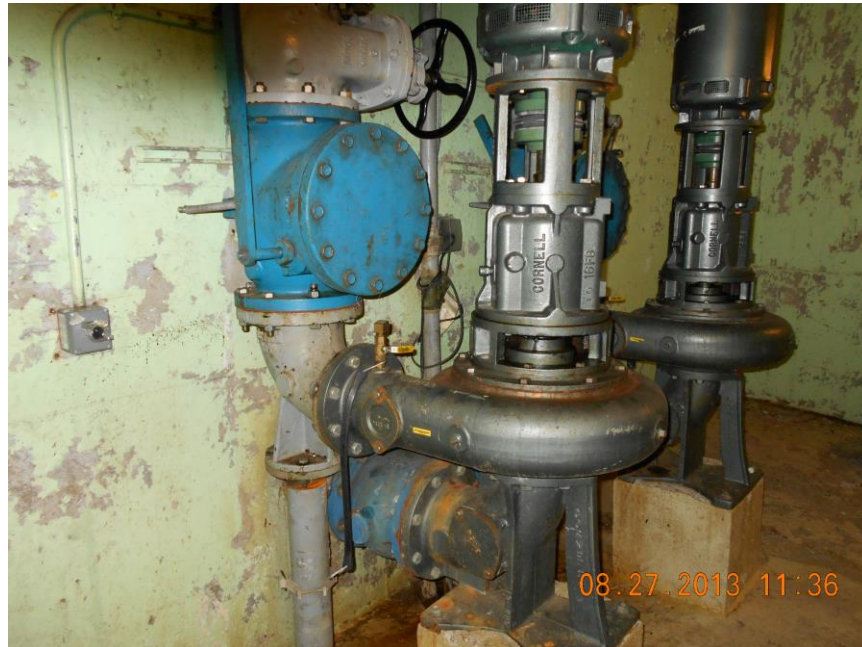
Figure 4-14. Pump Station 9 Rehabilitation Project

The Pump Station 9 Rehabilitation Project will reduce the number and volume of combined sewage overflows from Outfall 46 in the South Henderson area. SPU is replacing the existing pumps with two higher capacity pumps. SPU submitted the final design drawings and the construction quality assurance plan to Ecology for review in 2014. All required construction permits have been obtained and the contract has been awarded. SPU expects to complete construction in the third quarter of 2015.

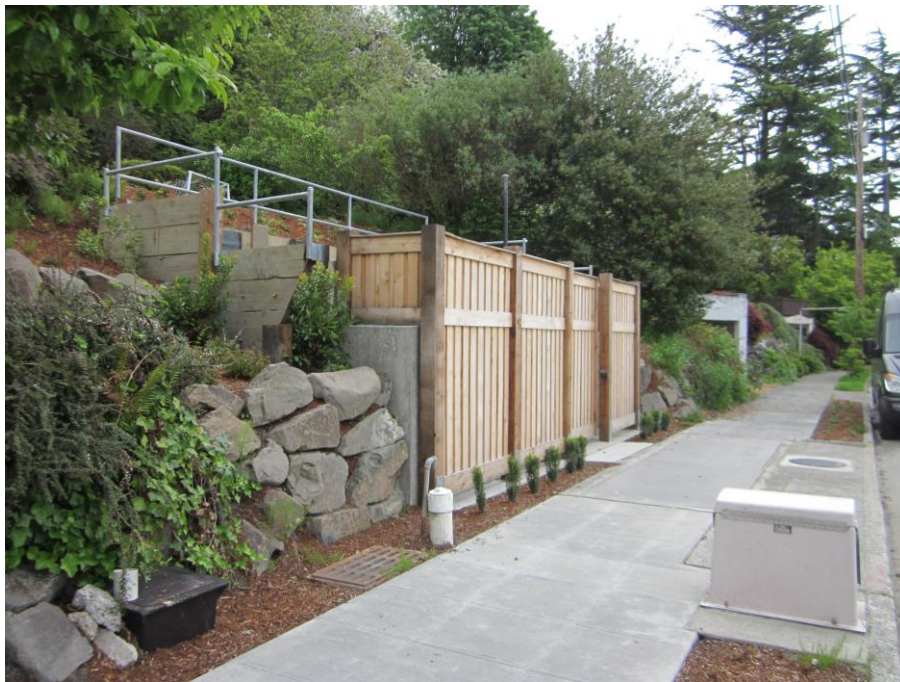
Figure 4-15. Pump Station 39 Backup Generator

In 2010, SPU installed emergency plugs at all wastewater pump stations without permanent generators. From 2011 through 2013, SPU installed permanent generators at nine additional pump stations having peak daily flows over 1 MGD, short wet well storage times (less than 1 hour during peak flow), and a history of crews needing to respond to power outages. Permanent generators were installed at five locations in 2011 (Pump Stations 7, 25, 43, 49, and 59), an additional three locations in 2012 (Pump Stations 62, 63, and 77), and one final location in 2013 (Pump Station 39). SPU completed the landscaping work at Pump Station 39 in April 2014.

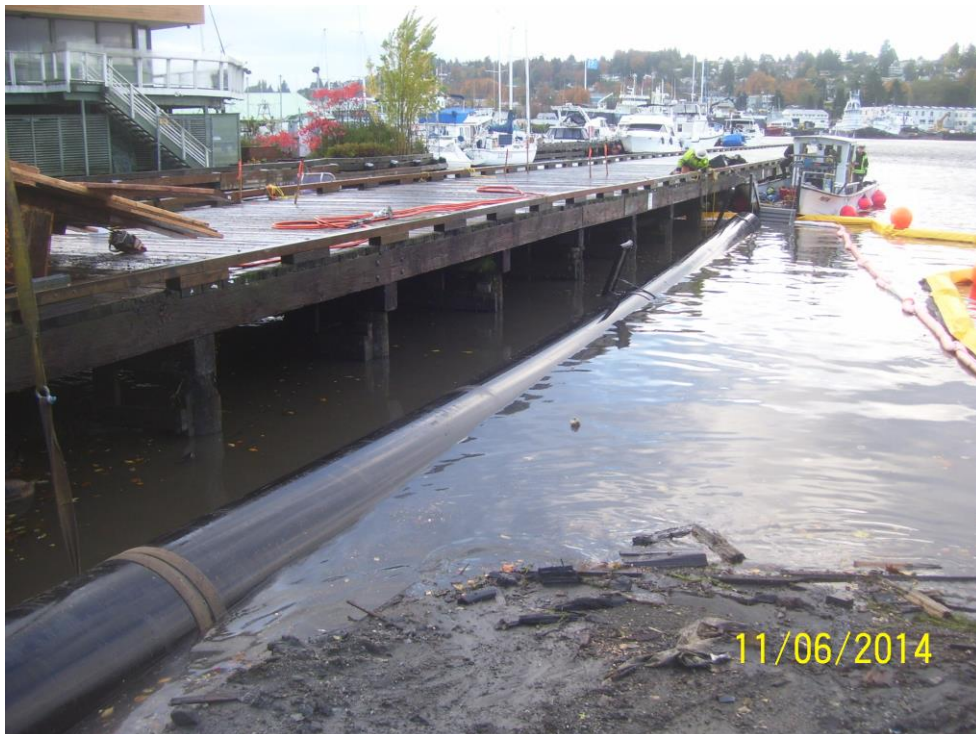
Figure 4-16. Outfall 150 Rehabilitation Project

Outfall 150 had deteriorated under an existing pedestrian pier. The Outfall 150 rehabilitation project replaced the existing maintenance hole just upstream of the shoreline and installed a replacement outfall comprised of approximately 50 feet of 30-inch diameter epoxy-coated ductile iron pipe and approximately 110 feet of 30-inch diameter high-density polyethylene (HDPE) outfall pipe. The work was completed in December 2014. As mitigation, SPU is required to install flap gates on two nearby storm drainage outfalls: Outfalls 181 and 183. The mitigation work is expected to be completed by Fall 2015.
