## Cultural Resources Assessment

Title of Report: Elliott Bay Seawall Project Cultural Resources Assessment

Date of Report: January 2013

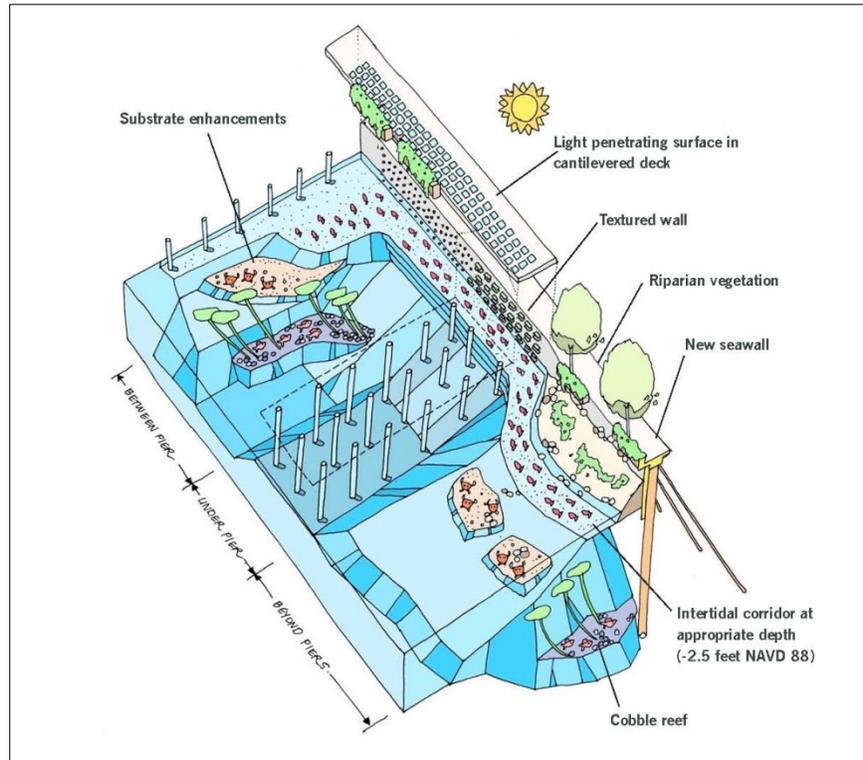
Figure 1-3. Conceptual Rendering of Proposed Habitat Improvements

Rebuilding the seawall would provide the opportunity to improve adjacent aquatic habitat. Habitat improvement measures would be implemented as part of each build alternative. These measures would be designed to restore a functional intertidal migration corridor along the seawall for juvenile salmonids, and would also improve ecosystem productivity to enhance the marine nearshore food web. Figure 1-3 shows a conceptual rendering of the proposed habitat improvements.

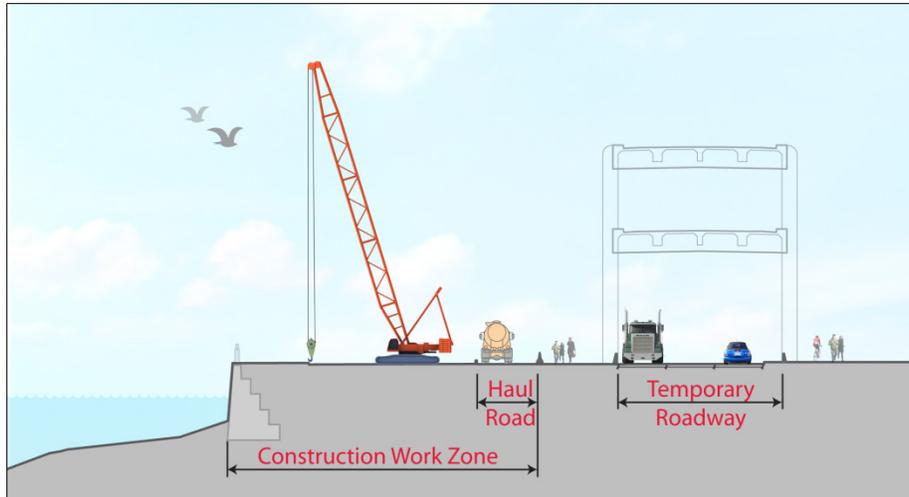
*Figure 1-4. Construction Work Zone and Temporary Roadways*

To accommodate construction activities during replacement of the seawall, the existing Alaskan Way roadway would be relocated beneath the Alaskan Way Viaduct. Three lanes of traffic would be maintained underneath the viaduct throughout construction. The resulting space along the waterfront would be used as a work zone during construction of the Central Seawall (Figure 1-4). During North Seawall construction, this dedicated construction work zone would not be available, and the temporary roadway would be accommodated in the available right-of-way.

The construction work zone would extend from the western edge of the existing multi-use path on Alaskan Way to the water. Existing street trees would be removed to provide additional space within this area and would either be replaced as riparian plantings with the EBSP or replaced during future waterfront improvement projects. The existing streetcar tracks that run along Alaskan Way would also be removed during construction.

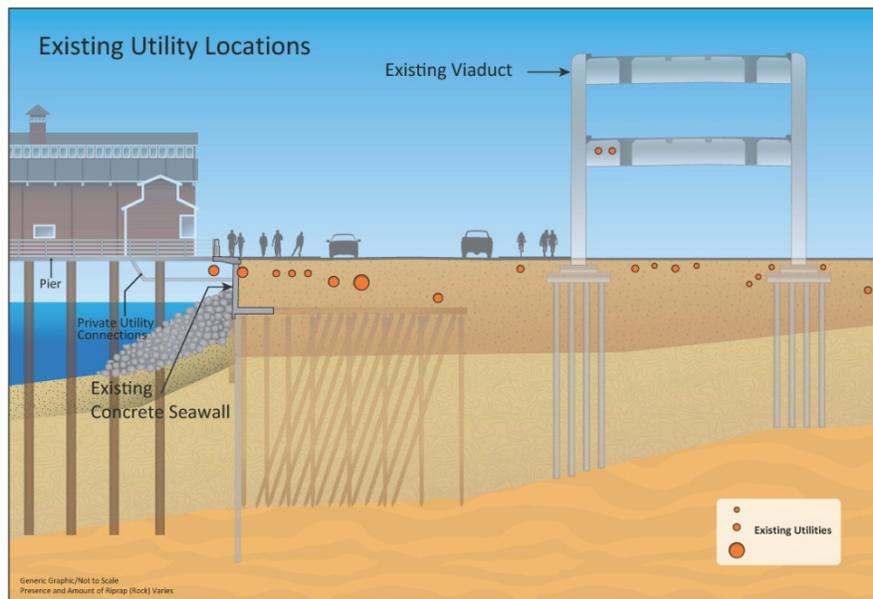
Figure 1-5. Representative Cross-Section Showing Typical Existing Utility Locations within Project Limits

The project area contains a large number of utilities, including water, sanitary sewer, combined sewer, stormwater, electrical transmission and distribution, steam, gas, fire alarm, and numerous telecommunication systems. These utilities range from major transmission lines serving portions of Seattle and the region to individual connections serving adjacent properties. As shown in Figure 1-5, some of these utilities are directly beneath the Alaskan Way roadway and sidewalk and above the relieving platform of the existing seawall, while others extend through the seawall to the piers.

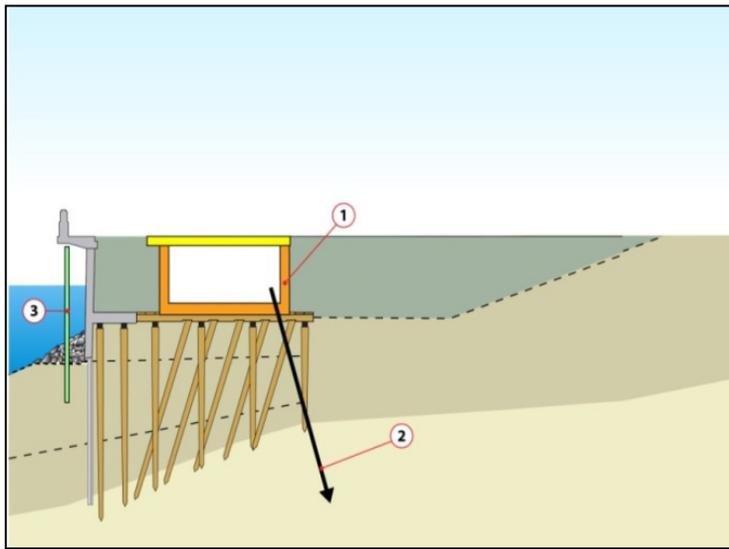
#### Alternative A, Stage 1

Figure 1-6. Alternative A, Stage 1

The anticipated construction activities and probable sequence for Alternative A, using jet grouting for the structural improvements, are depicted in a series of figures below. The figures describe four primary stages of work that would occur along the waterfront. The activities within each zone would vary depending on the type of existing seawall present. Figures 1-6 through 1-9 are representative of the expected Alternative A construction sequence, and depict the Type A seawall, which is the most common wall type. (Type A seawall is a sheet-pile supported, reinforced, concrete face panel, which is tied back to a buried timber relieving platform supported by vertical and battered timber piles.) For Alternative A, it was assumed that the area above the existing relieving platform would be excavated before jet grouting began.

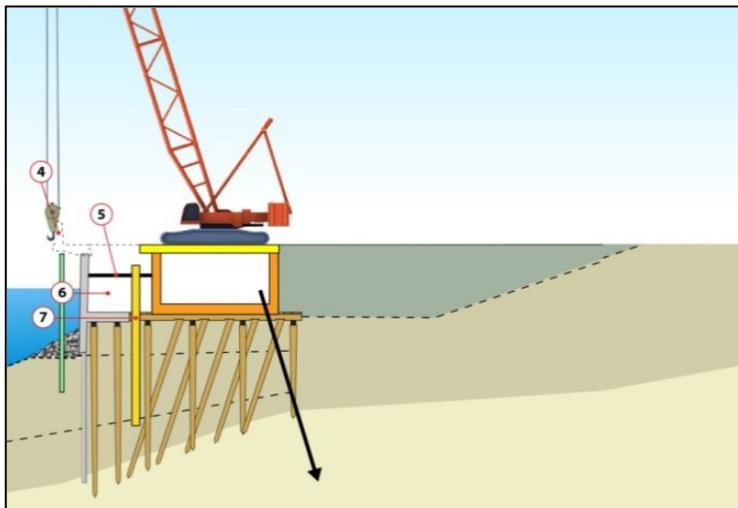
#### Alternative A, Stage 2

Figure 1-7. Alternative A, Stage 2

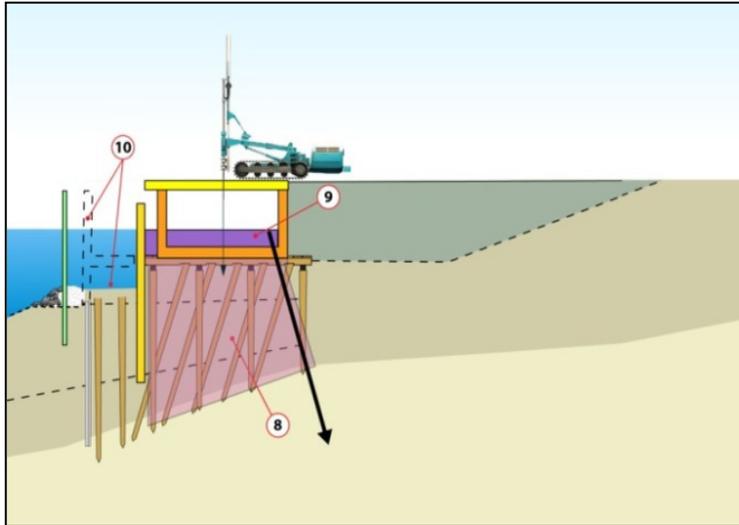
**Alternative A, Stage 3**

Figure 1-8. Alternative A, Stage 3

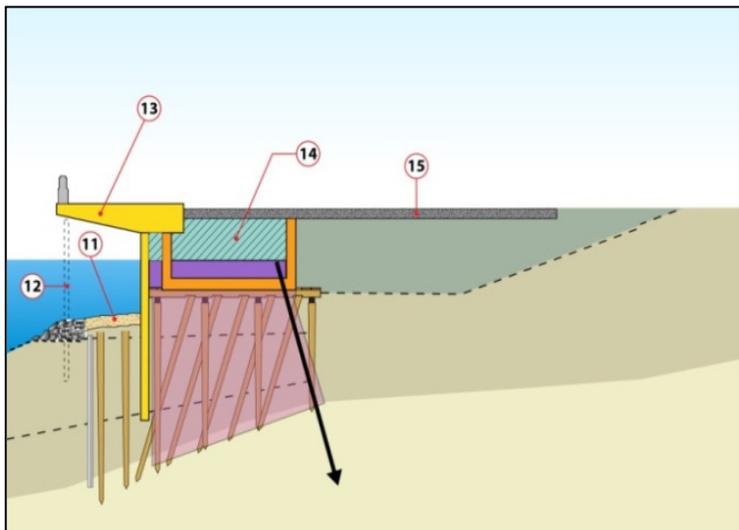
**Alternative A, Stage 4**

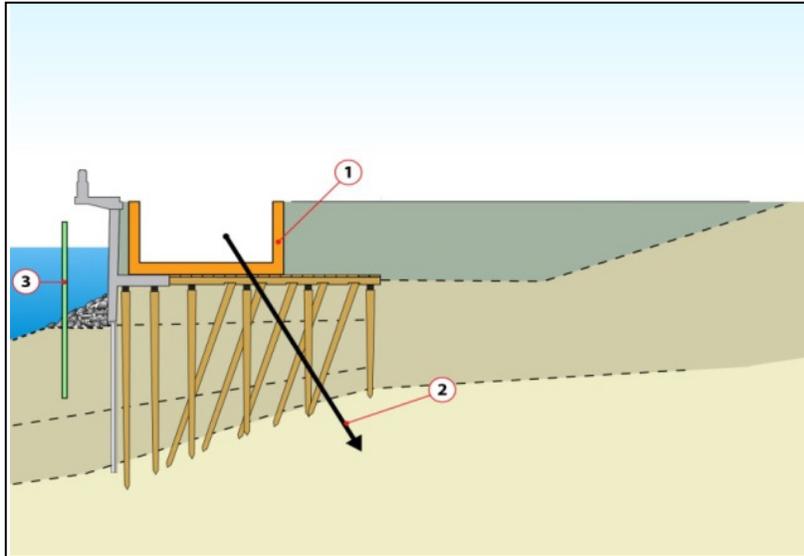
**Alternative B, Stage 1**

Figure 1-10. Alternative B, Stage 1

Construction of Alternative B would begin in the Central Seawall in Zone 4, move southward to Zone 3, and then progress to Zones 2 and 1. Central Seawall construction would be followed by North Seawall construction in Zones 6 and 5. The anticipated construction stages for Alternative B (assuming a Type A existing seawall) are shown in Figures 1-10 through 1-13.

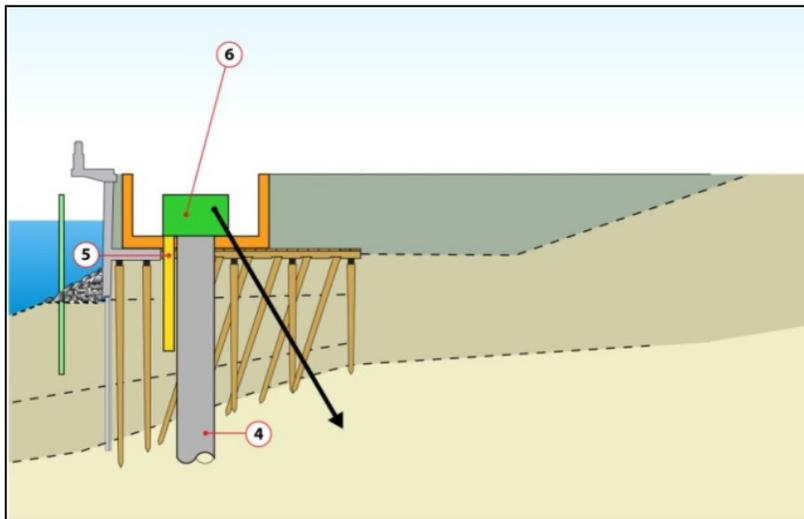
**Alternative B, Stage 2**

Figure 1-11. Alternative B, Stage 2

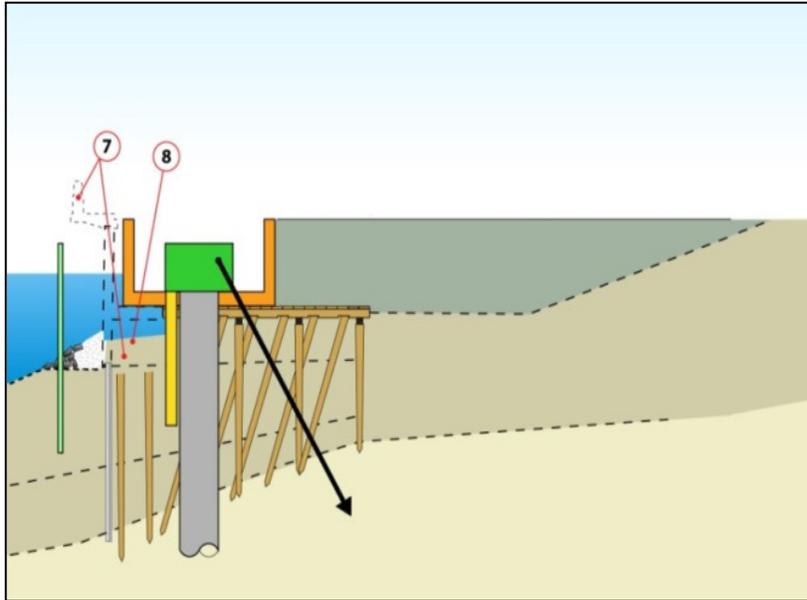
**Alternative B, Stage 3**

Figure 1-12. Alternative B, Stage 3

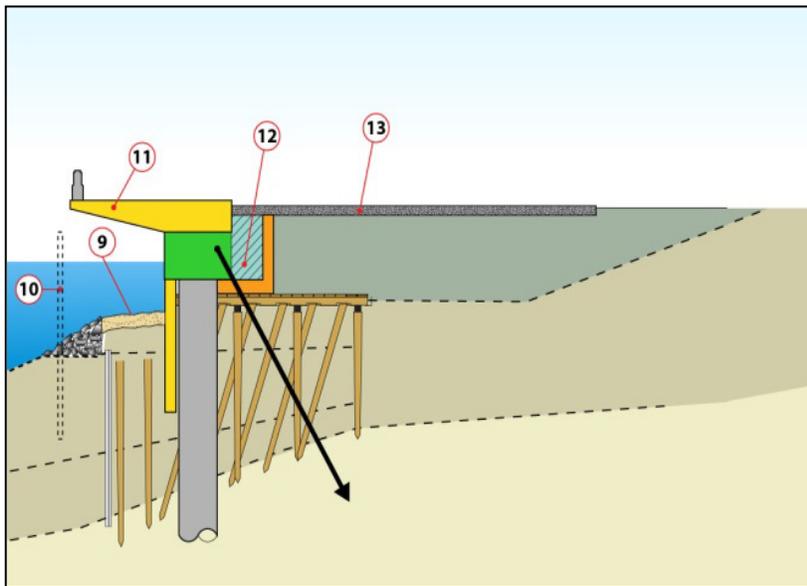
**Alternative B, Stage 4**

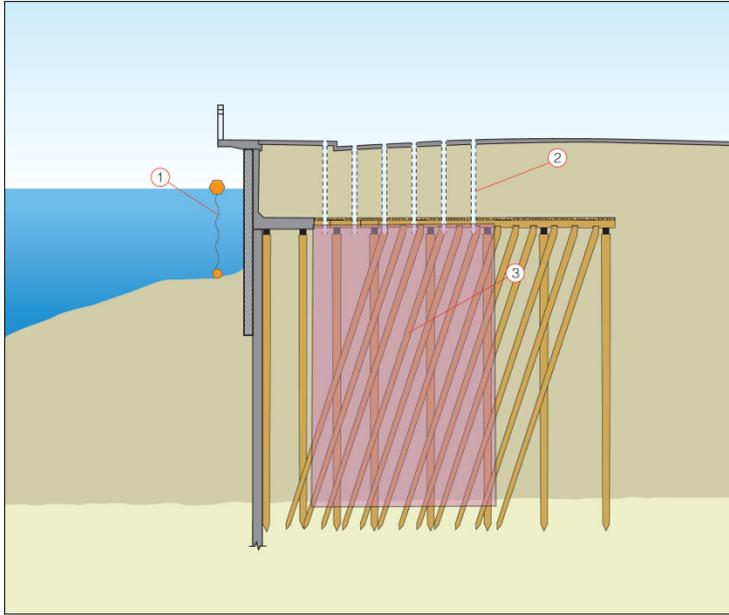
**Alternative C, Stage 1**

Figure 1-14. Alternative C, Stage 1

The anticipated construction activities and probable sequence for Alternative C, using soil improvement, are depicted below. The figures describe four primary stages of work that would occur along the waterfront. The activities within each zone would vary depending on the type of existing seawall present. Figures 1-14 through 1-17 are representative of the expected Alternative C construction sequence, and depict the Type A seawall, which is the most common wall type.

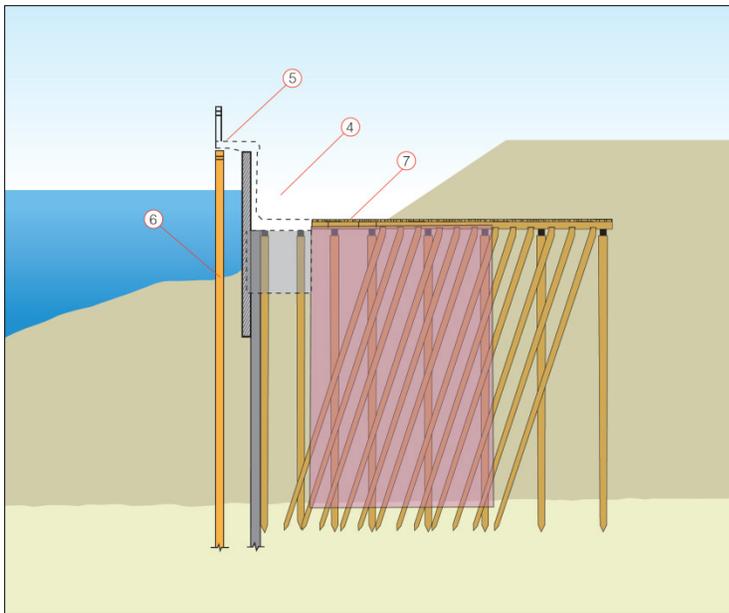
Figure 1-15. Alternative C, Stage 2

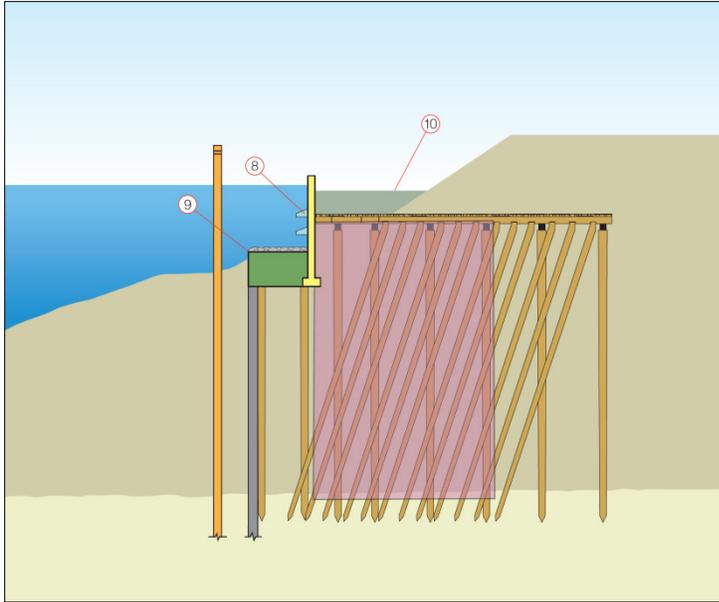
**Alternative C, Stage 3**

Figure 1-16. Alternative C, Stage 3

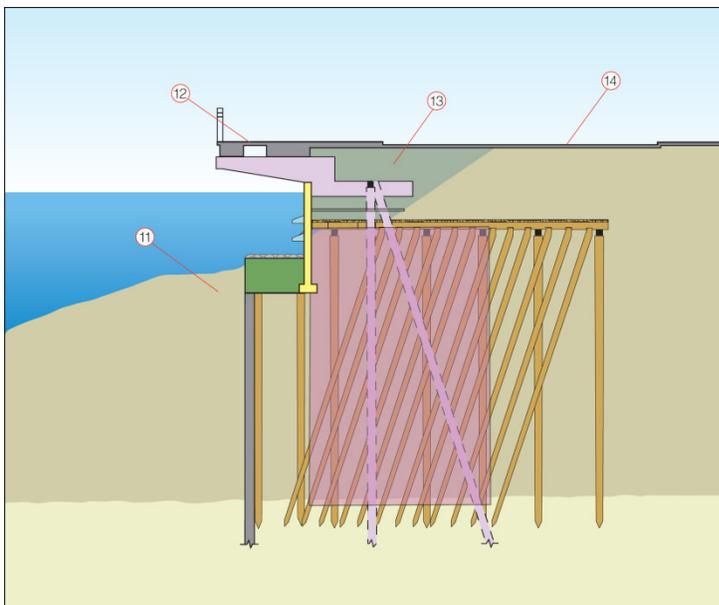
**Alternative C, Stage 4**

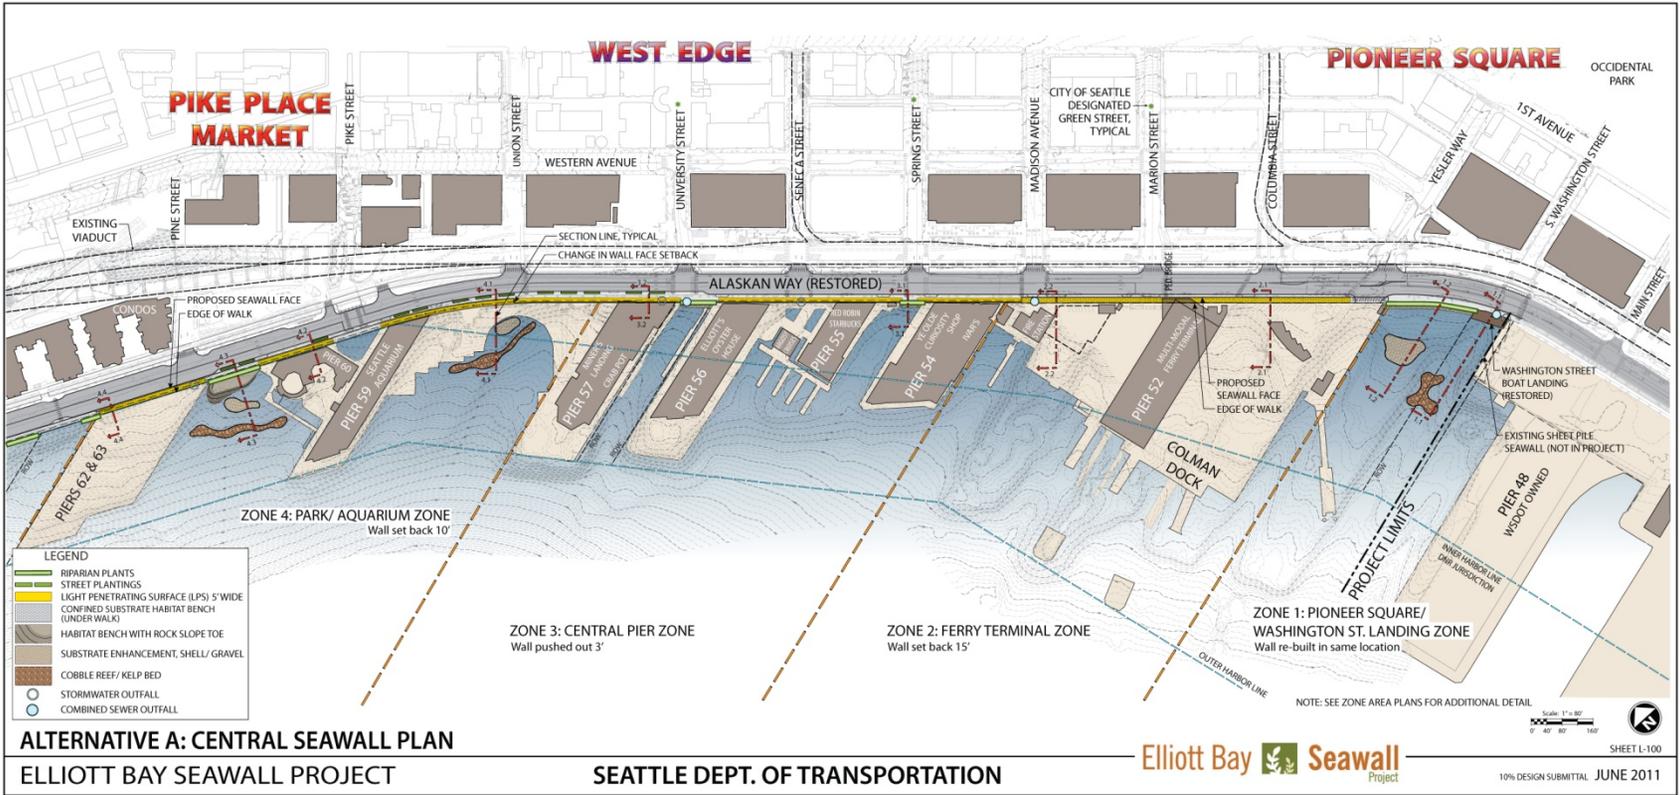
Figure 1-18. Alternative A: Central Seawall Plan

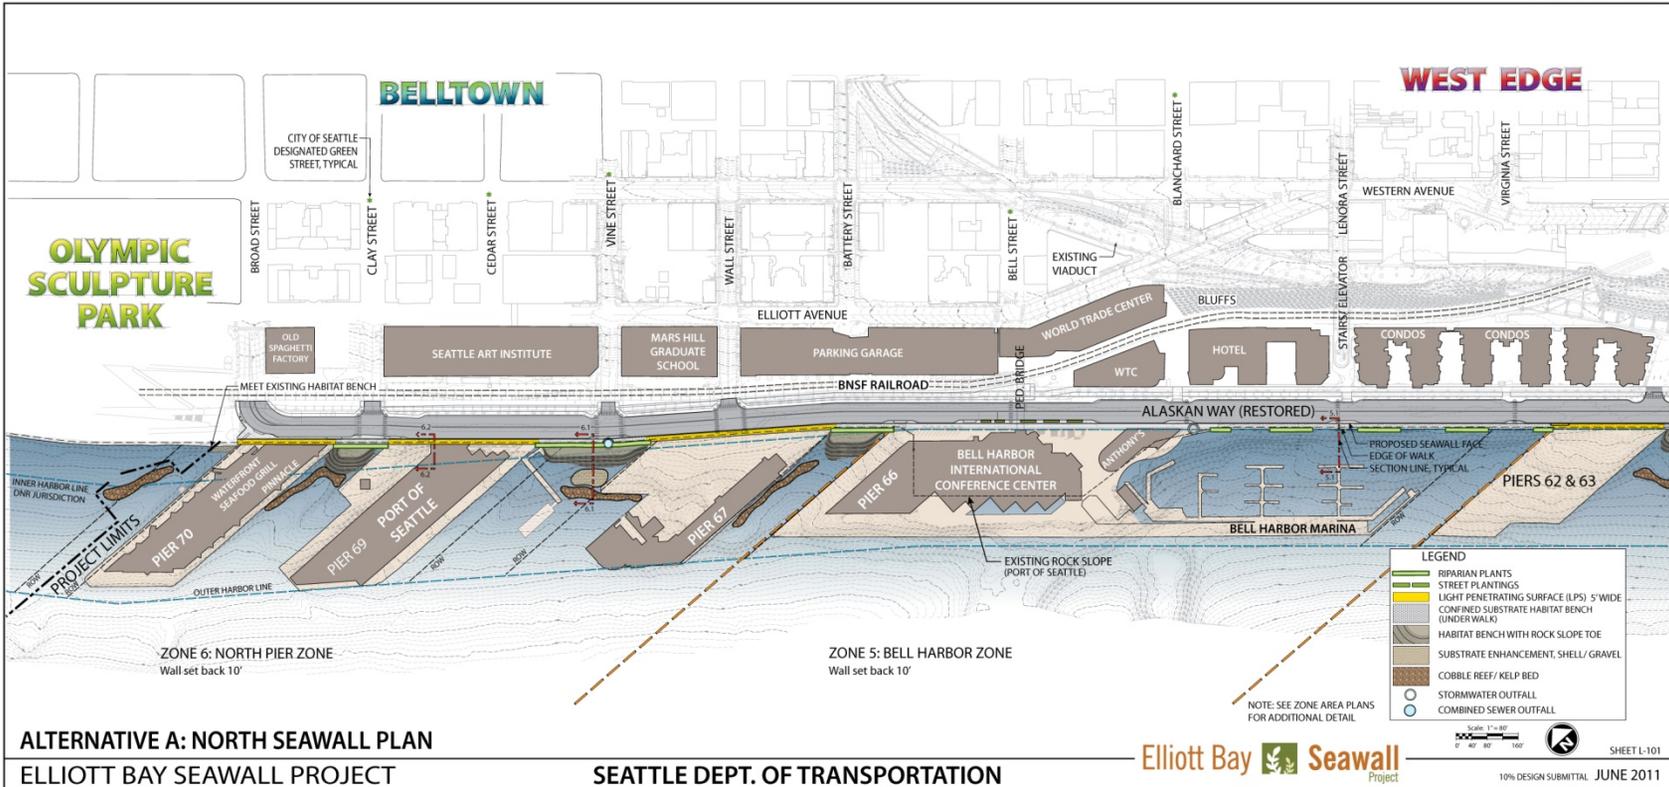
Figure 1-19. Alternative A: North Seawall Plan

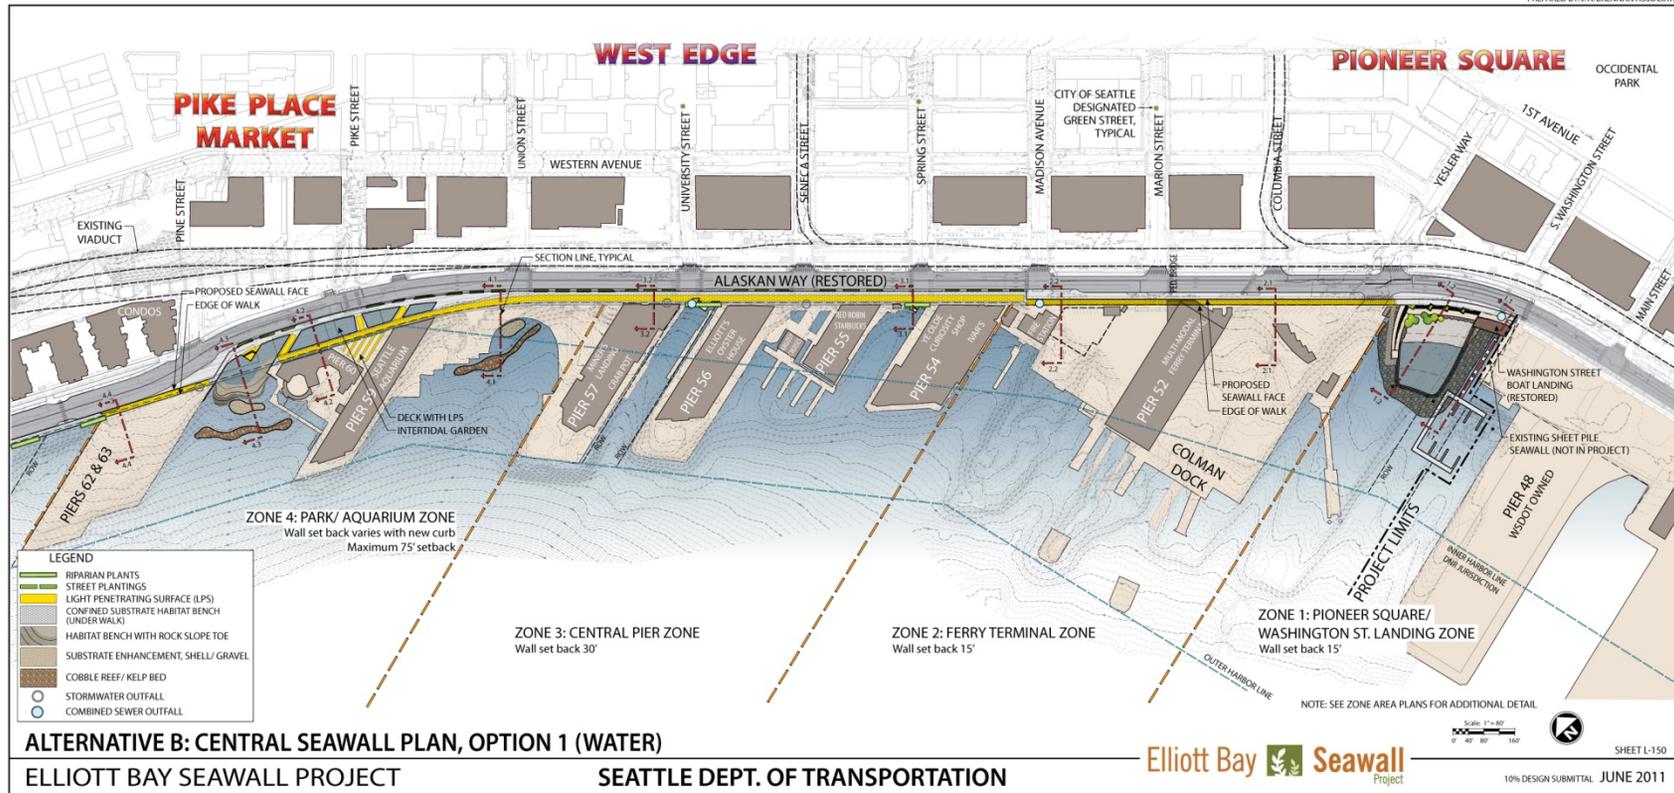
Figure 1-20. Alternative B: Central Seawall Plan, Option 1

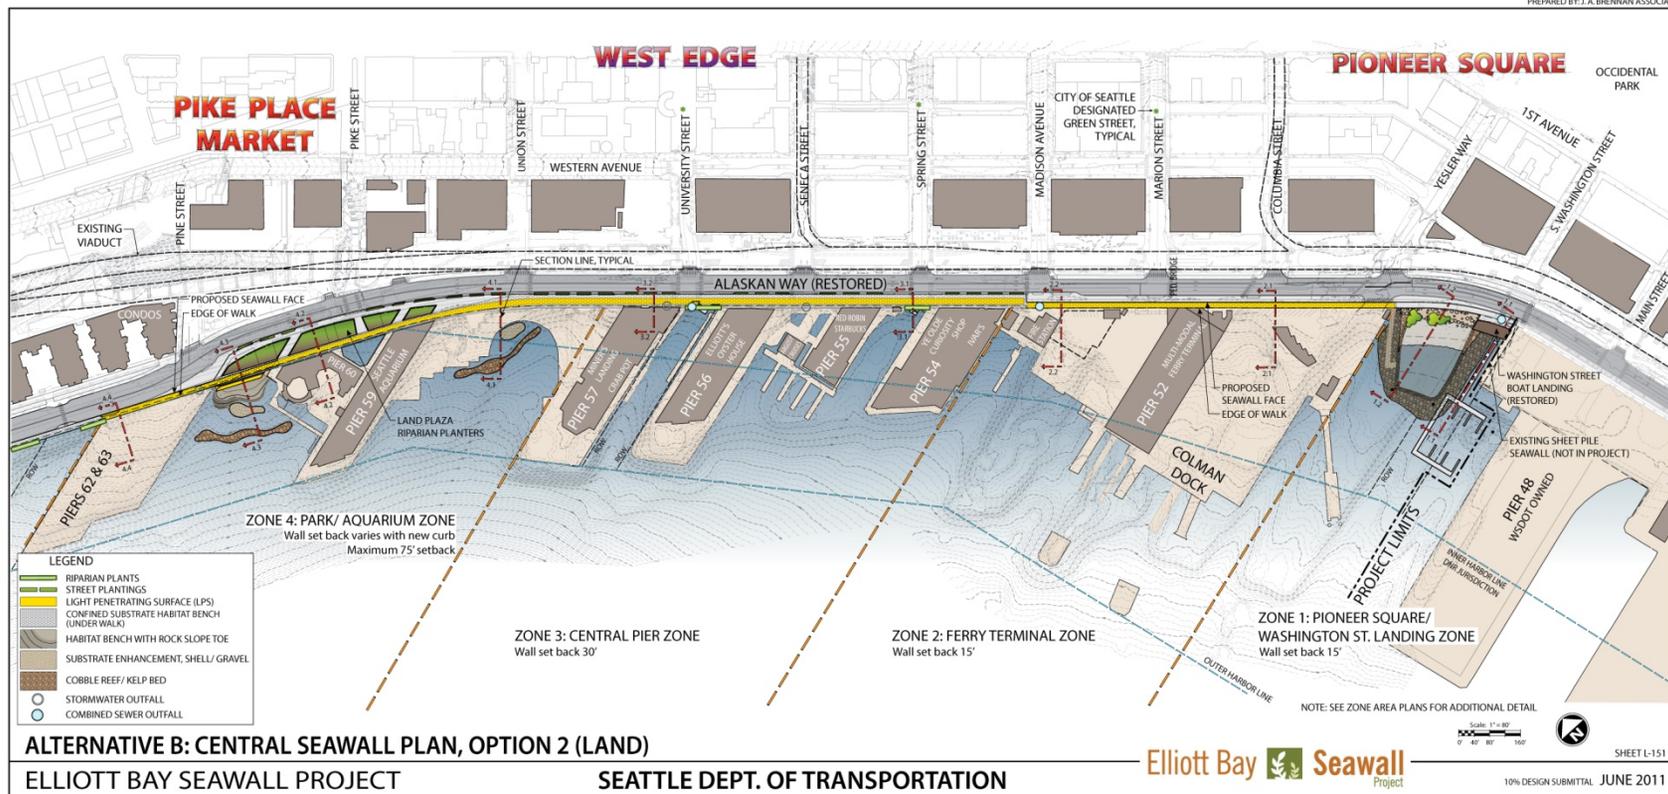
Figure 1-21. Alternative B: Central Seawall Plan, Option 2

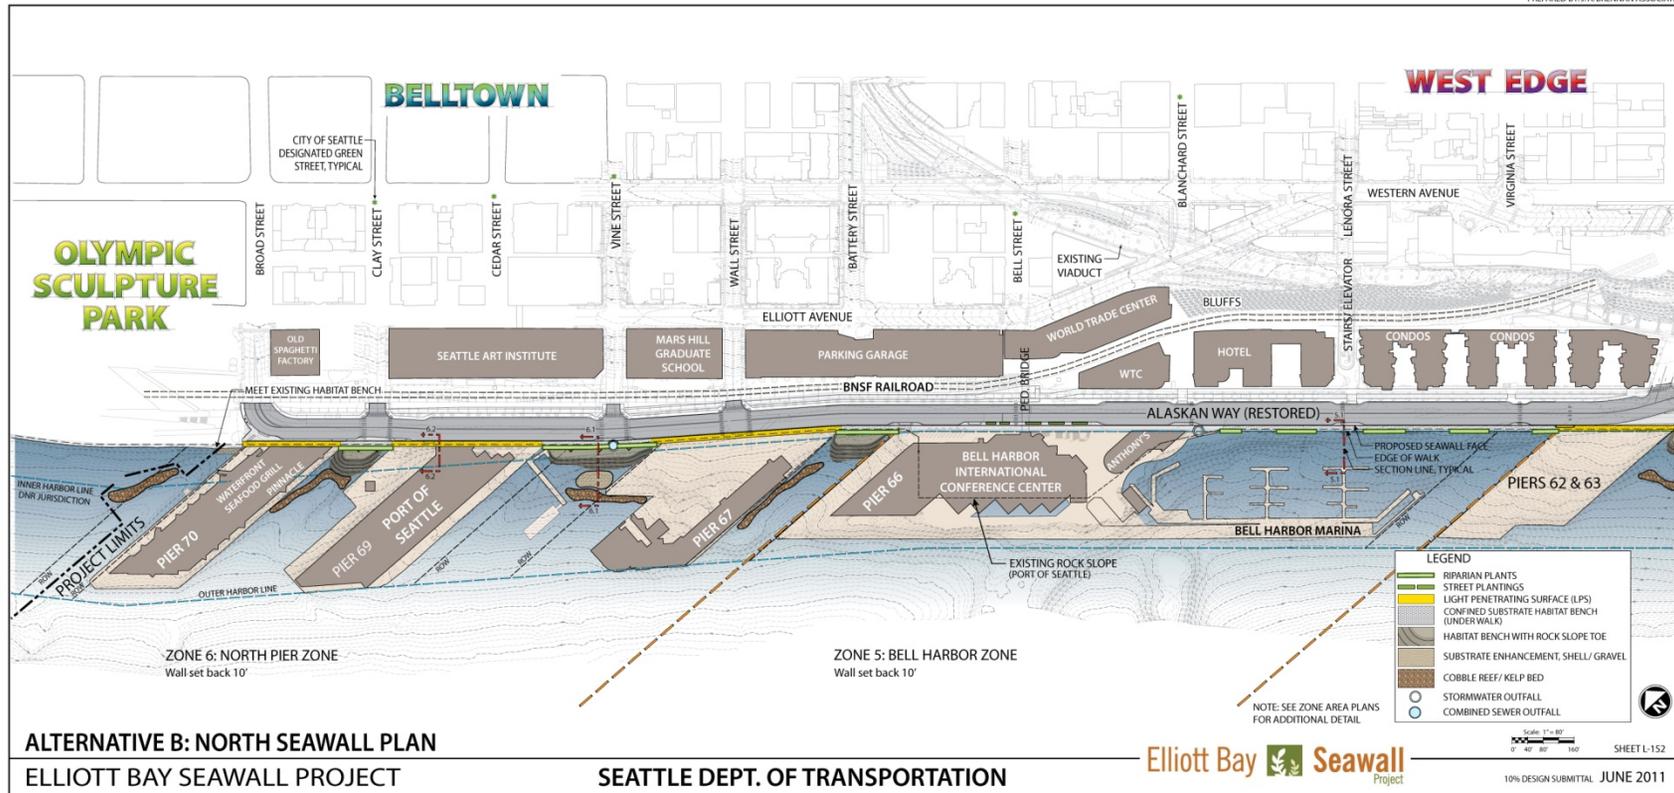
Figure 1-22. Alternative B: North Seawall Plan

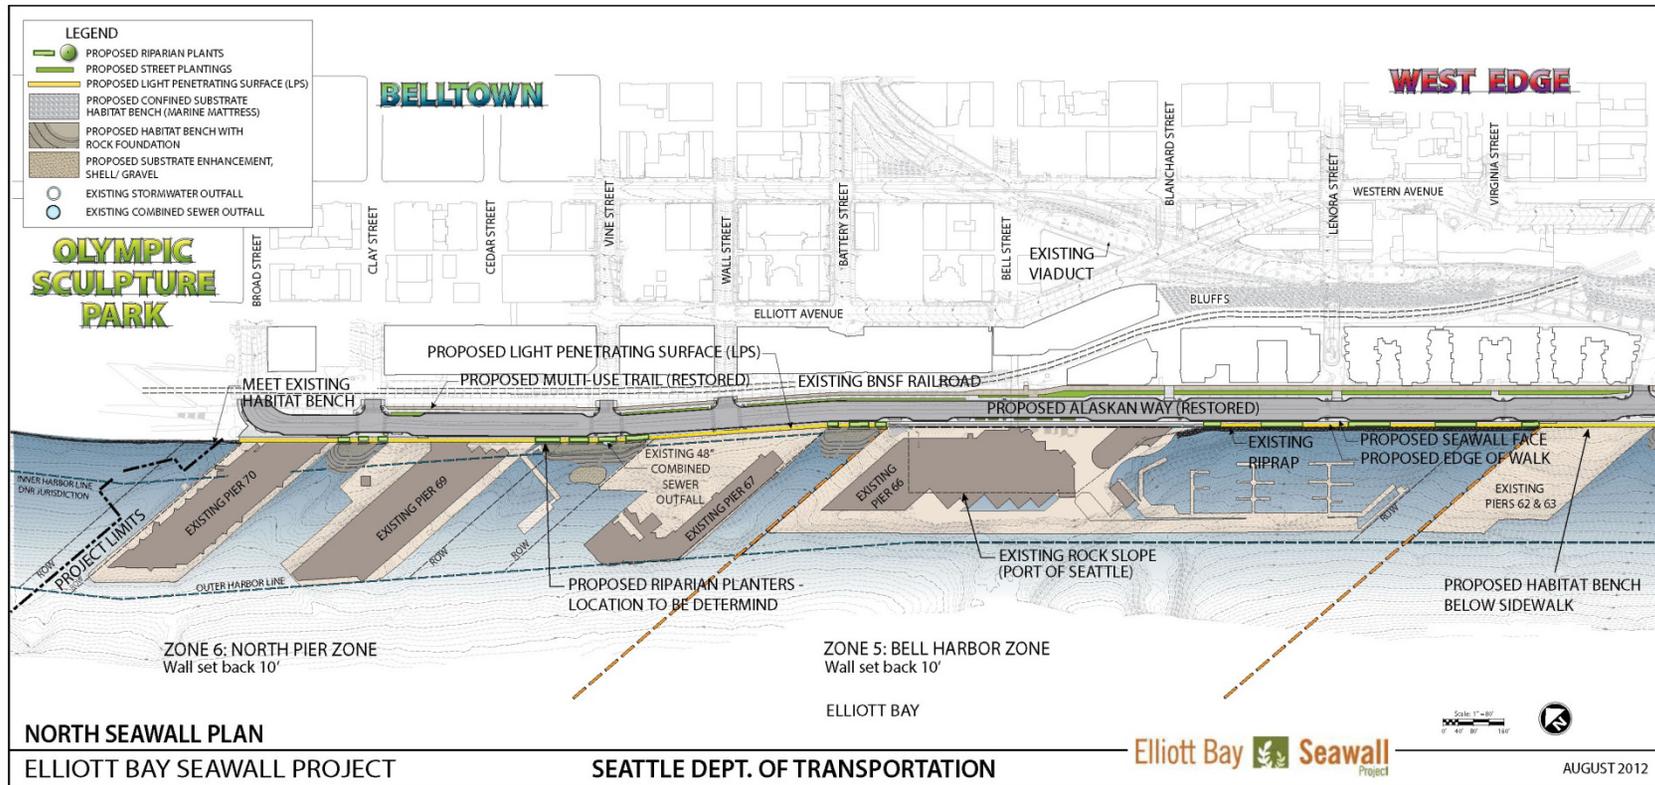
Figure 1-24. Alternative C: North Seawall Plan

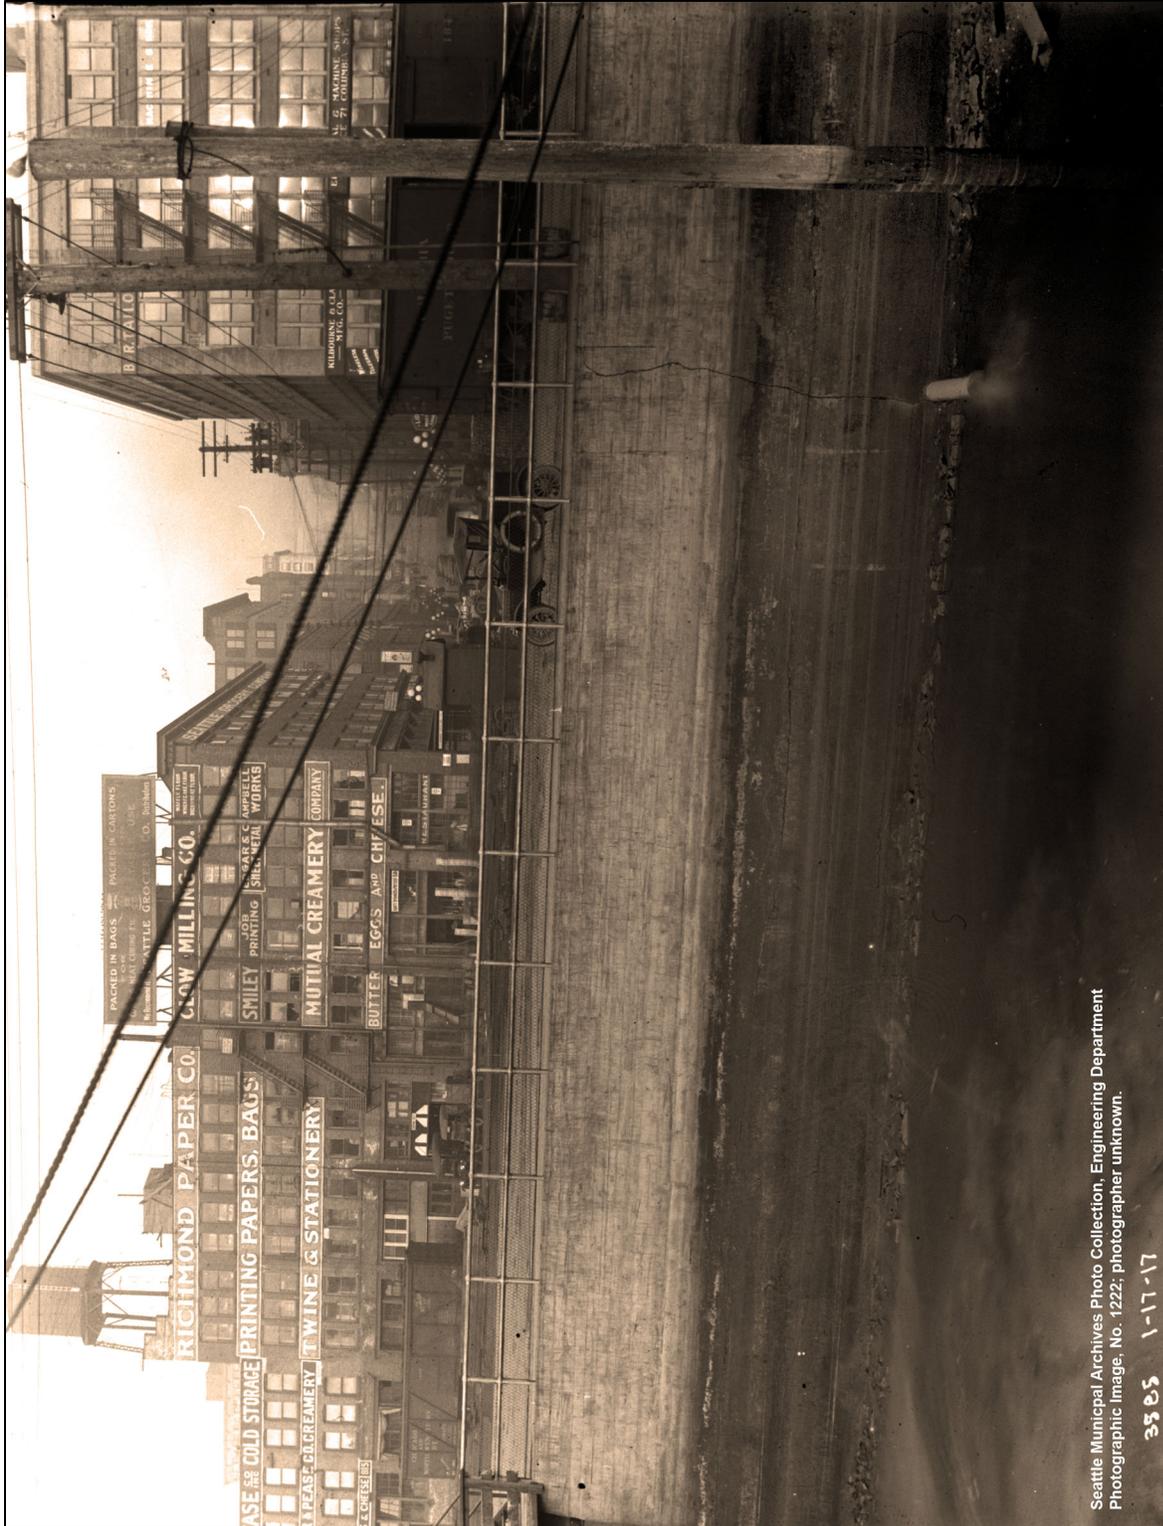
Figure 4-5. The early seawall at the foot of Columbia Street, January 1917.

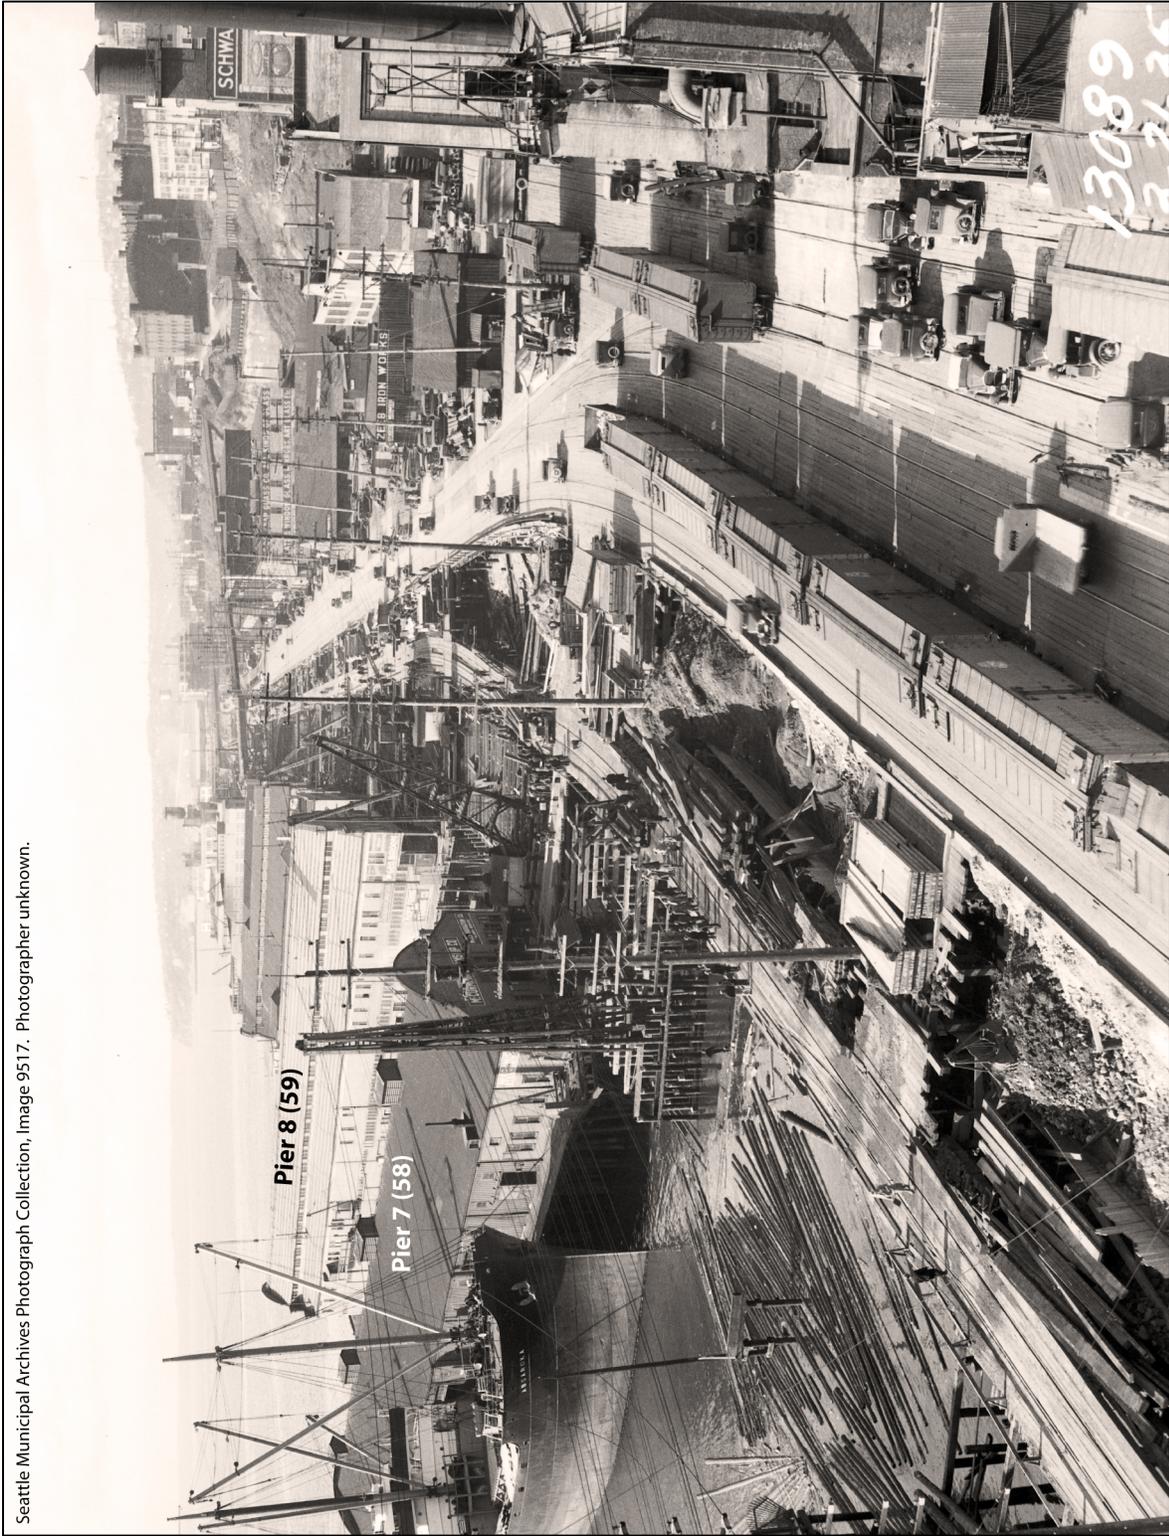
Figure 4-6. View north along Railroad Avenue from University Street showing the construction of the seawall, March 21, 1935.

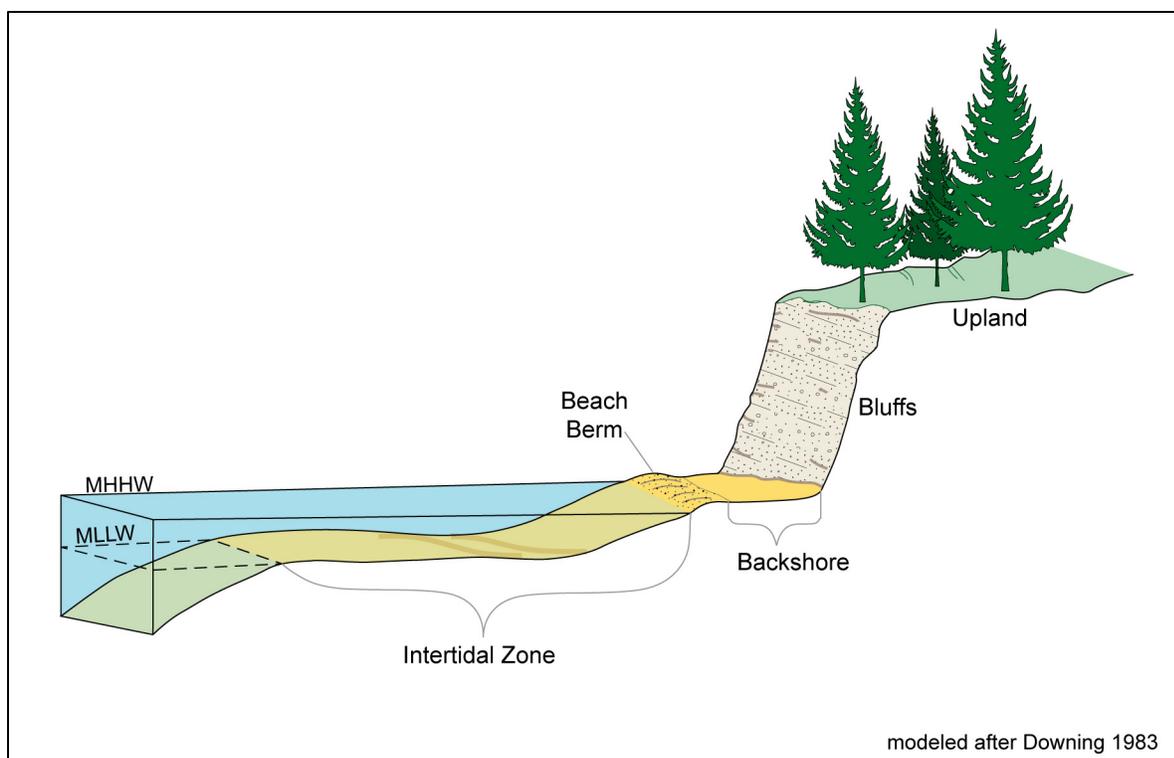
Figure 4-13. Schematic of the precontact shoreline showing bluff, beach berm, backshore, and intertidal depositional environments.

Beach backshore deposits have relatively low potential for harboring significant precontact resources. There is limited potential for isolated lost tools and discarded items to be found associated with backshore deposits. There is also some potential for remains associated with temporary camping, resource procurement, and processing along the backshore where ephemeral streams draining the uplands have carved ravines and formed small alluvial fans. The small fans could have raised portions of the backshore out of the intertidal zone, making them preferred camping locations. Preservation potential is higher on the beach backshore than on the beach berm. Sediment commonly accumulates along the protected backshore, but backshores are subject to erosion during winter storms and high water events.

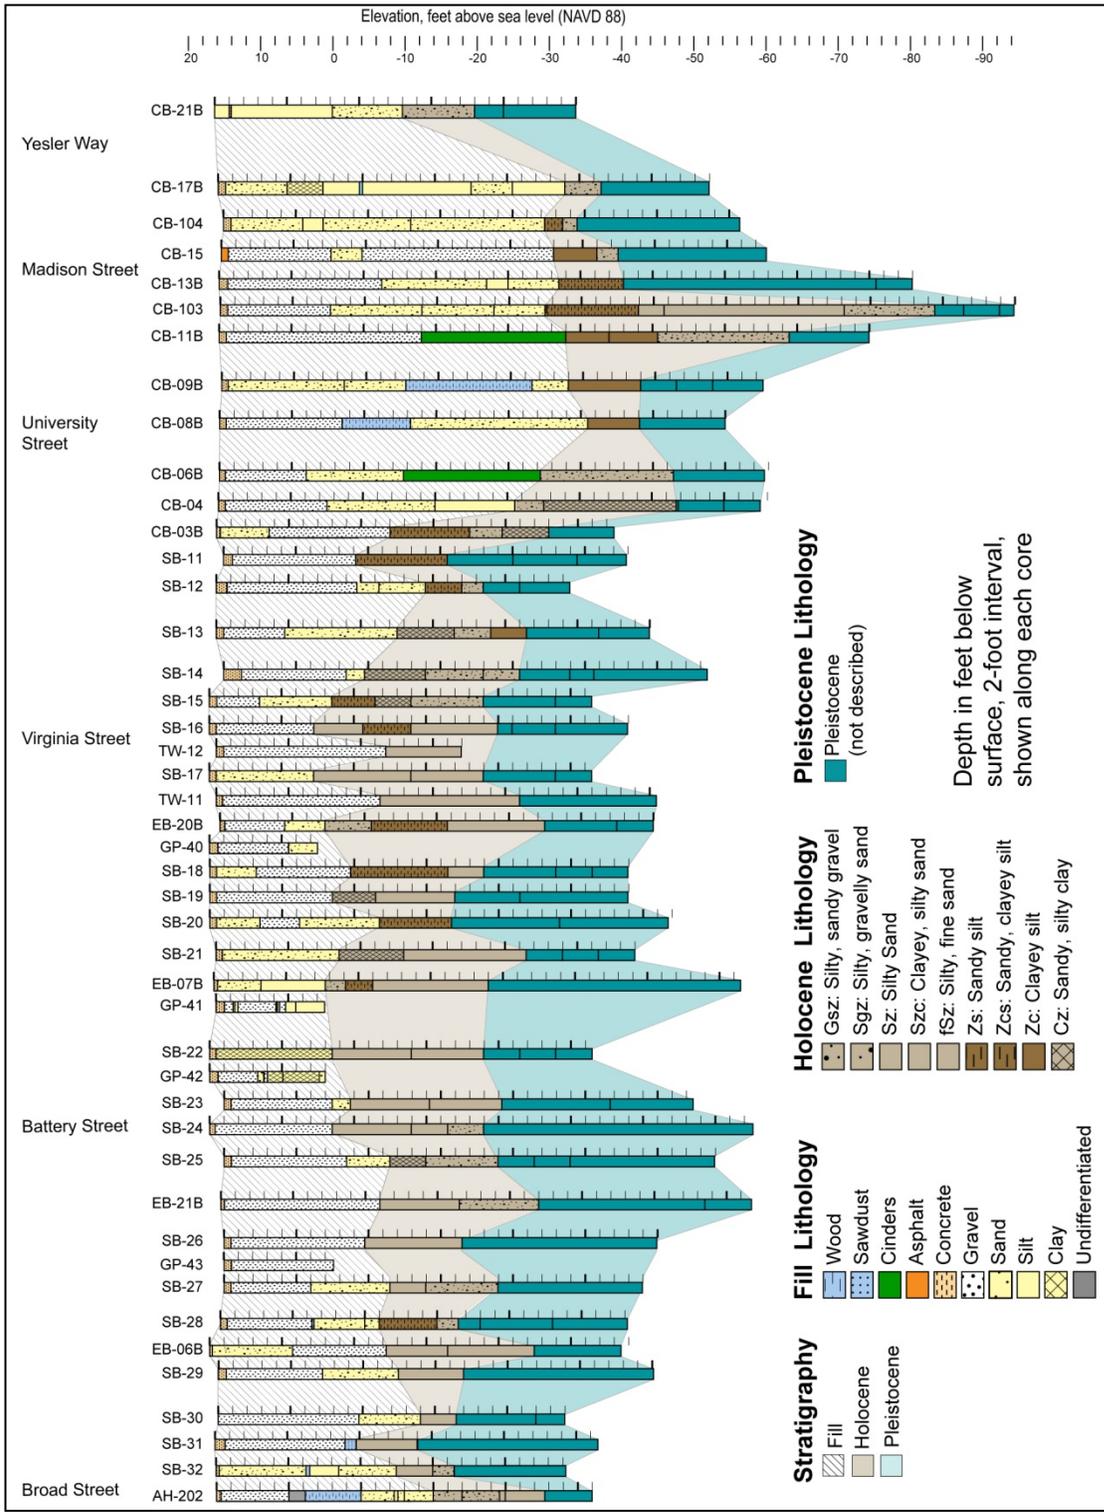
Figure 5-17. Cross-Section showing the Stratigraphy and Lithology of Previously Drilled Cores in the APE.

Fill is at the surface in all 45 borings, between an average of 0 and about 30 fbs. The fill is mainly composed of Concrete capping layers of Sand and Gravel, but layers of Clay, Cinders, Wood, and Sawdust are also recorded as depositional units within the fill. The fill is deepest south of University
