## Cultural Resources Assessment

Title of Report: Elliott Bay Seawall Project Cultural Resources Assessment

Date of Report: January 2013

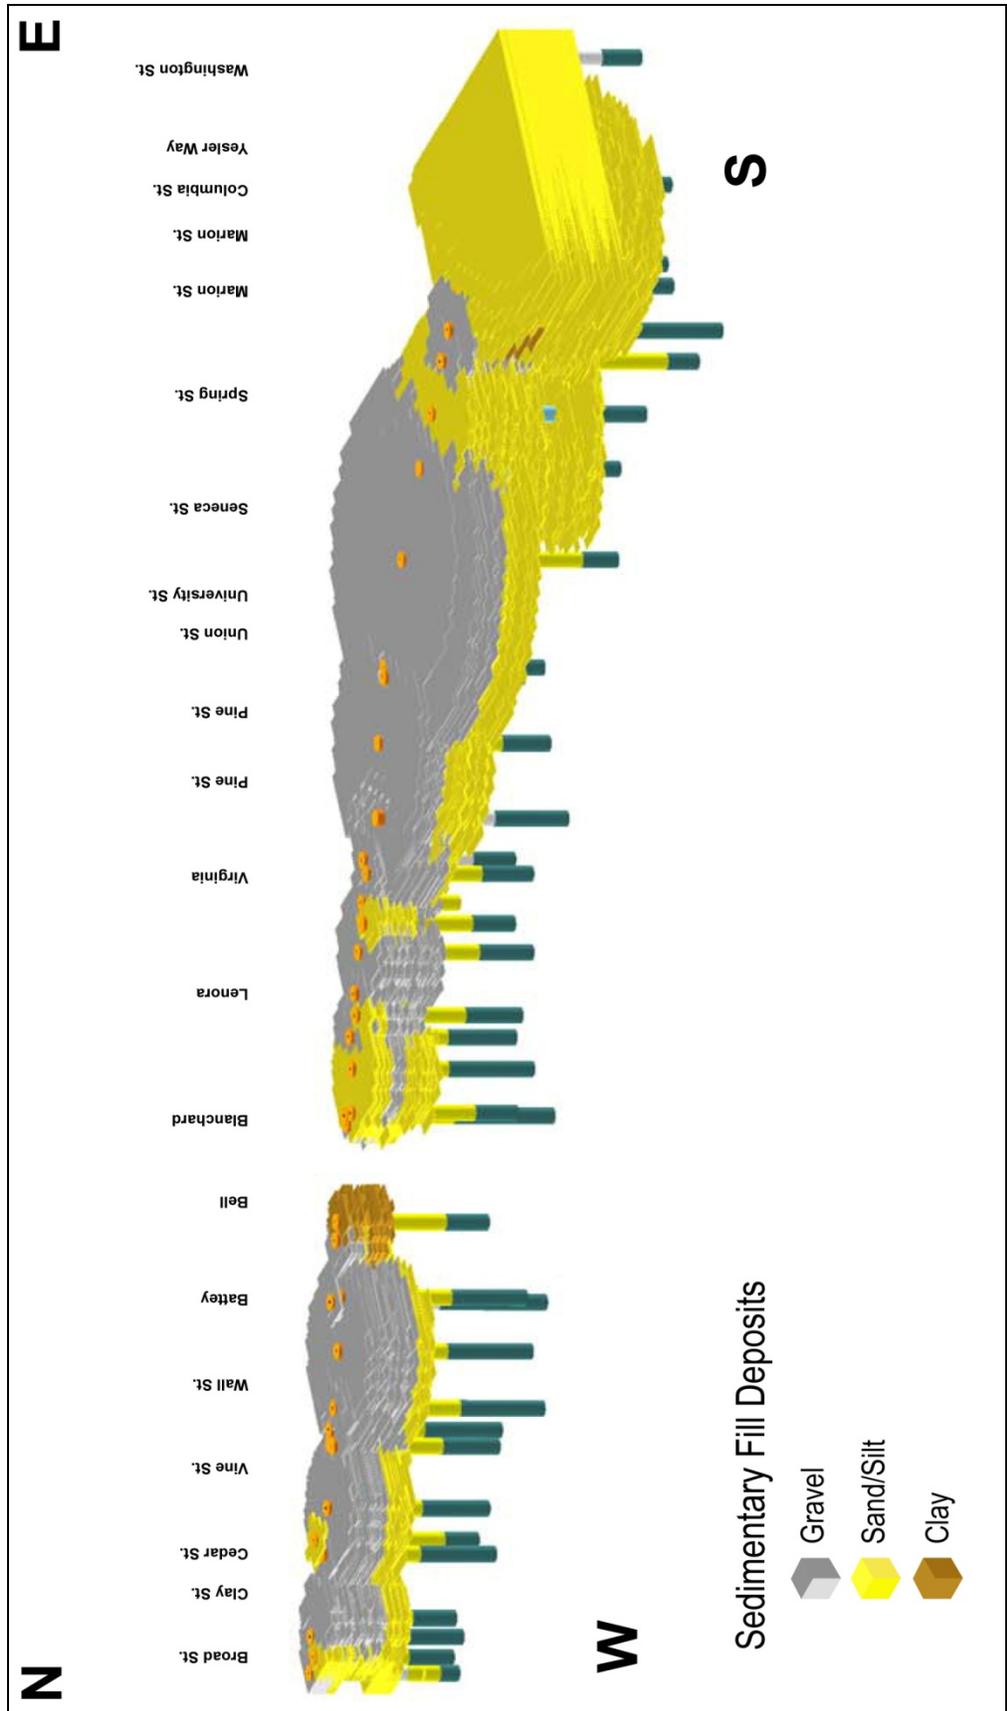
Figure 5-18. Three-dimensional model of the sedimentary fill deposits in the APE, showing Sand dominating the fill in the southern APE, while gravels overlying sand is to the north; based on existing geotechnical data.

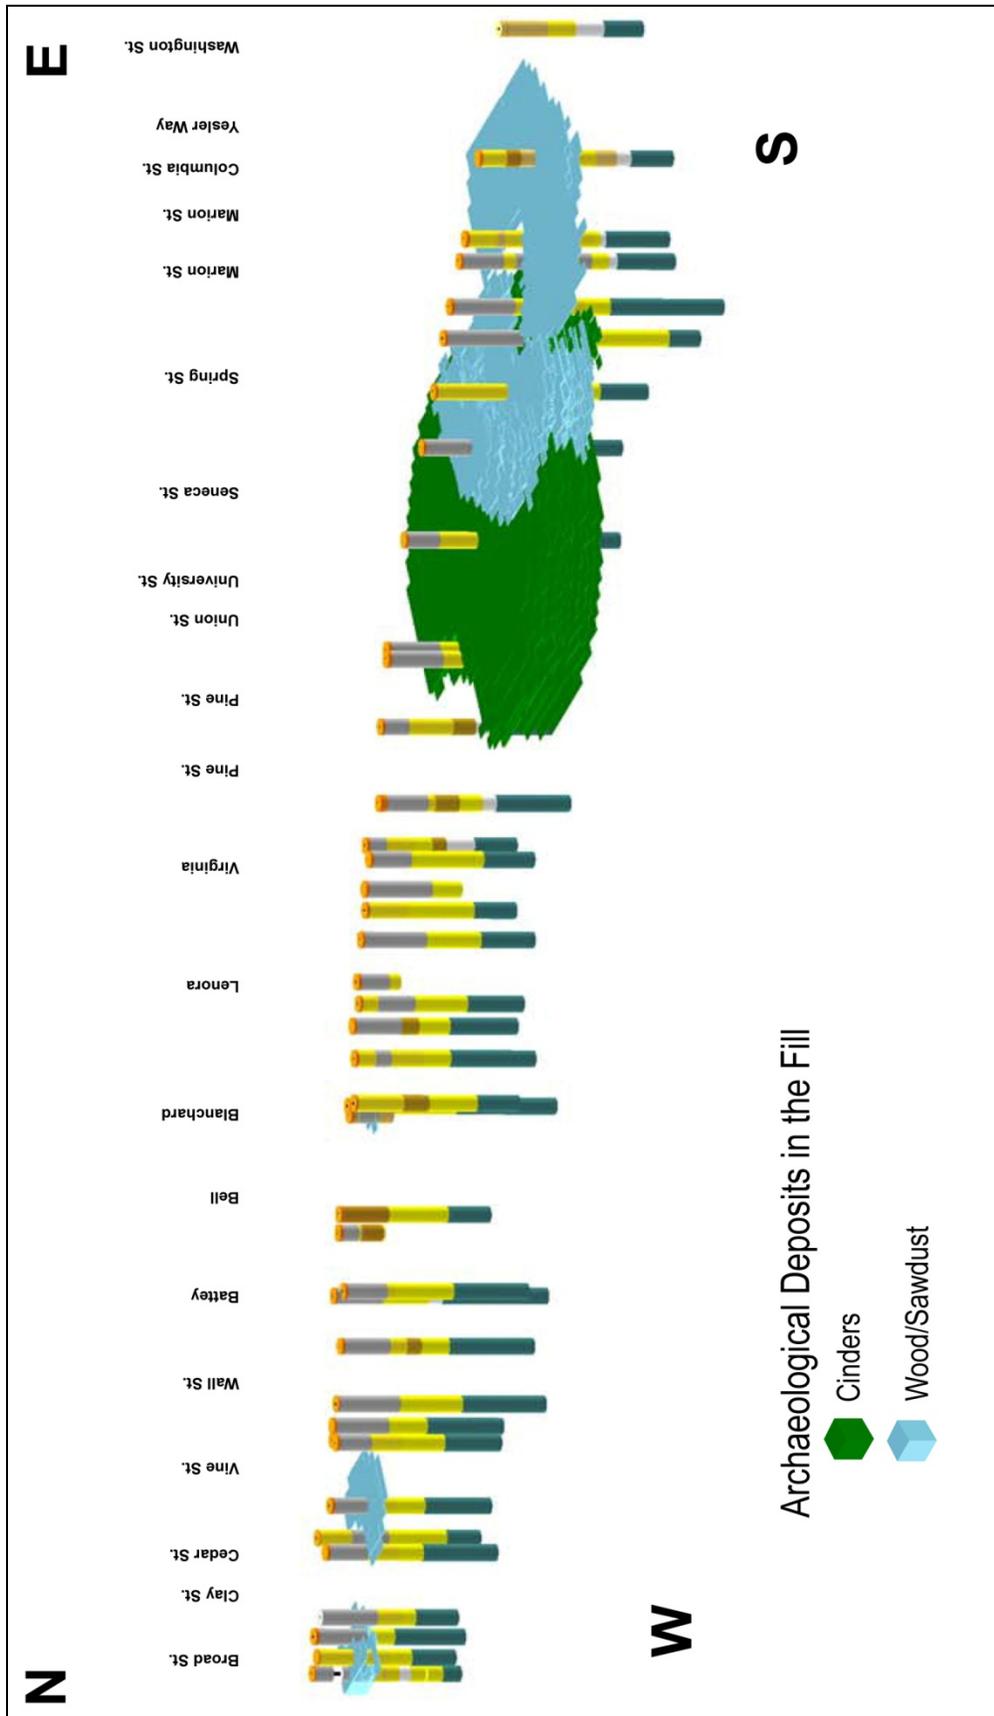
Figure 5-19. Archaeological deposits within the fill, showing thick Wood and Cinders layers in the southern APE; based on existing geotechnical data.

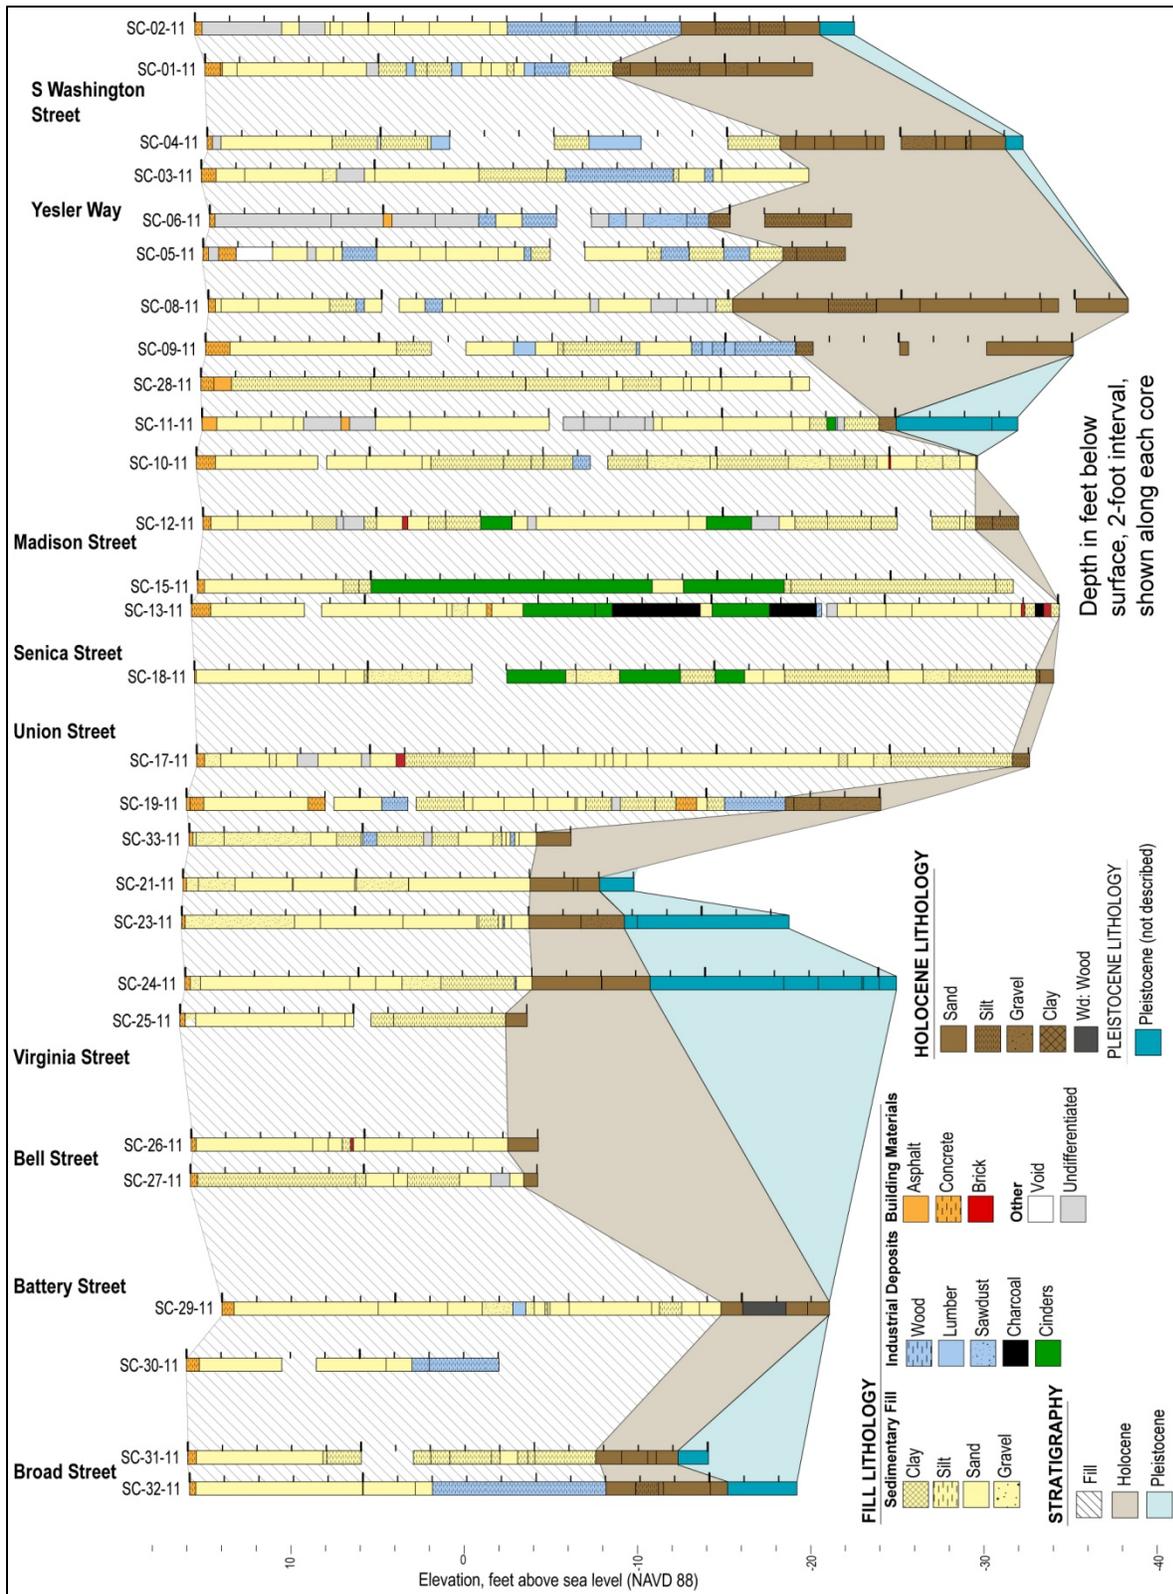
Figure 5-22. Cross-section of the stratigraphy and lithology observed in the EBSP sonicores from south to north along the APE.

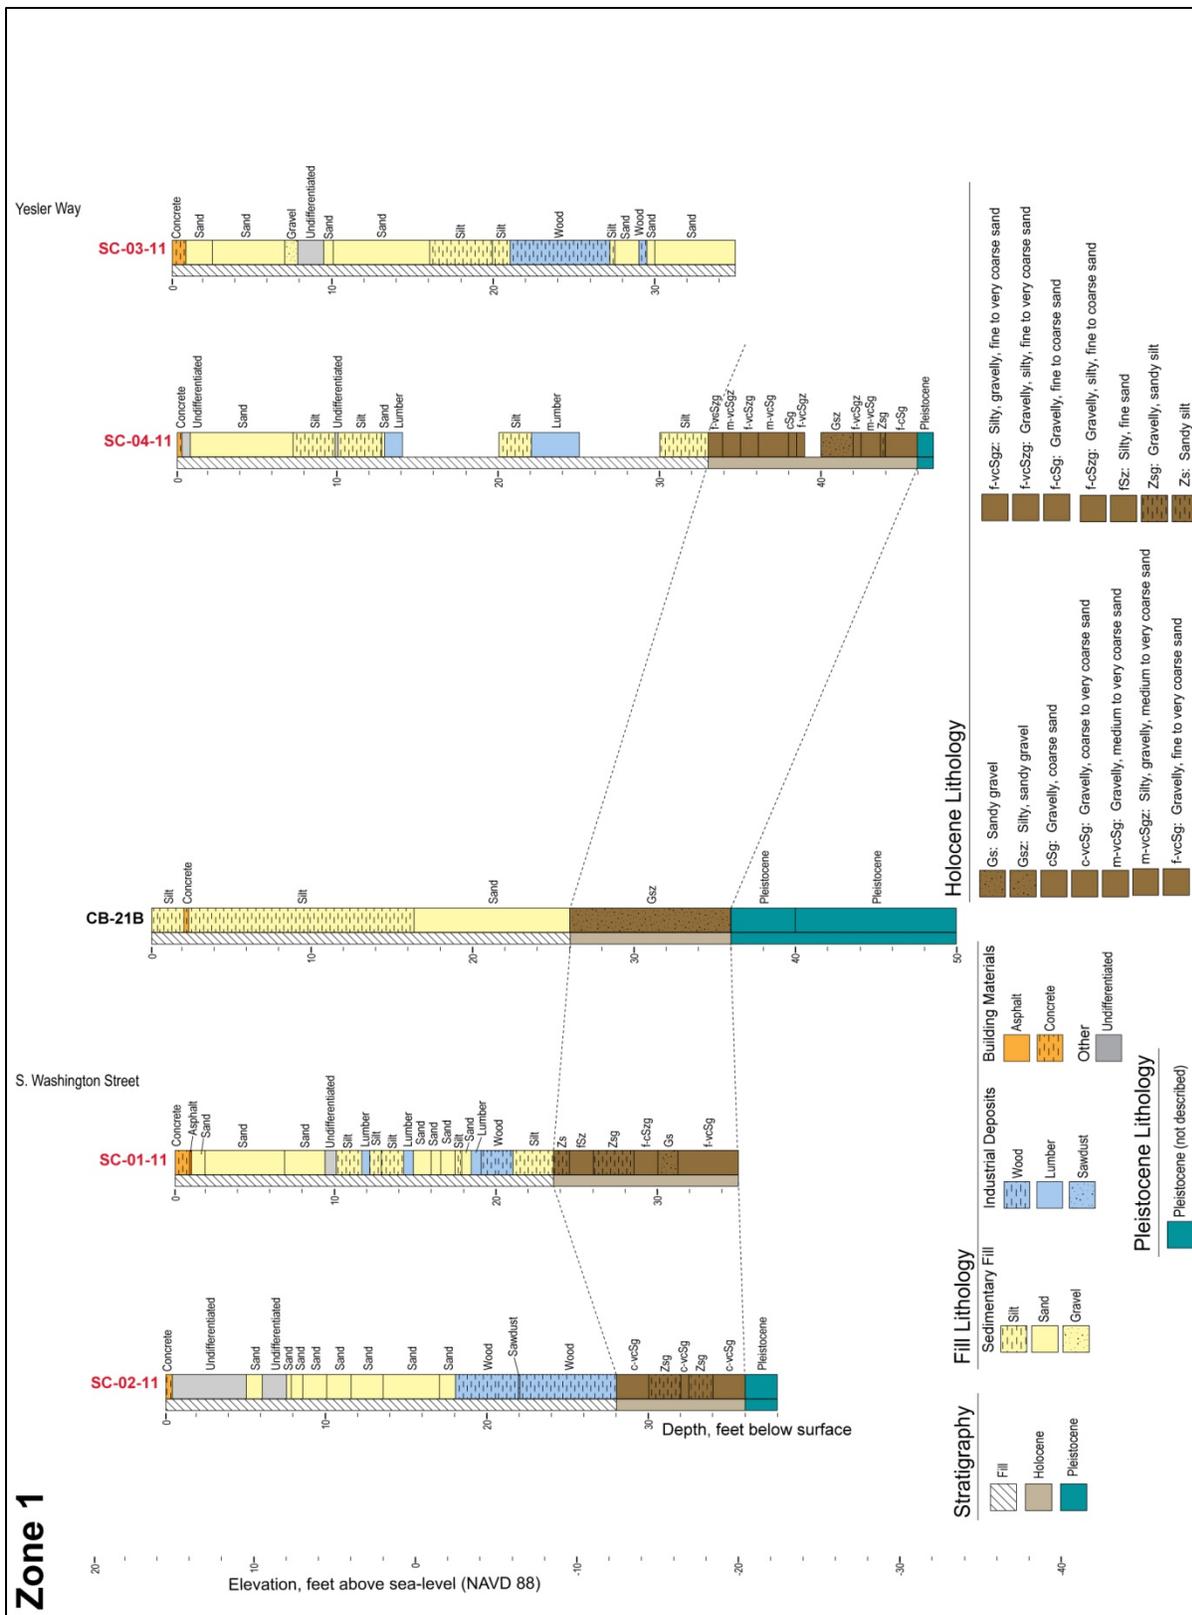
Figure 5-23. Zone 1 cross section compiled from existing geotechnical borelogs and sonicores drilled for the EBSP.

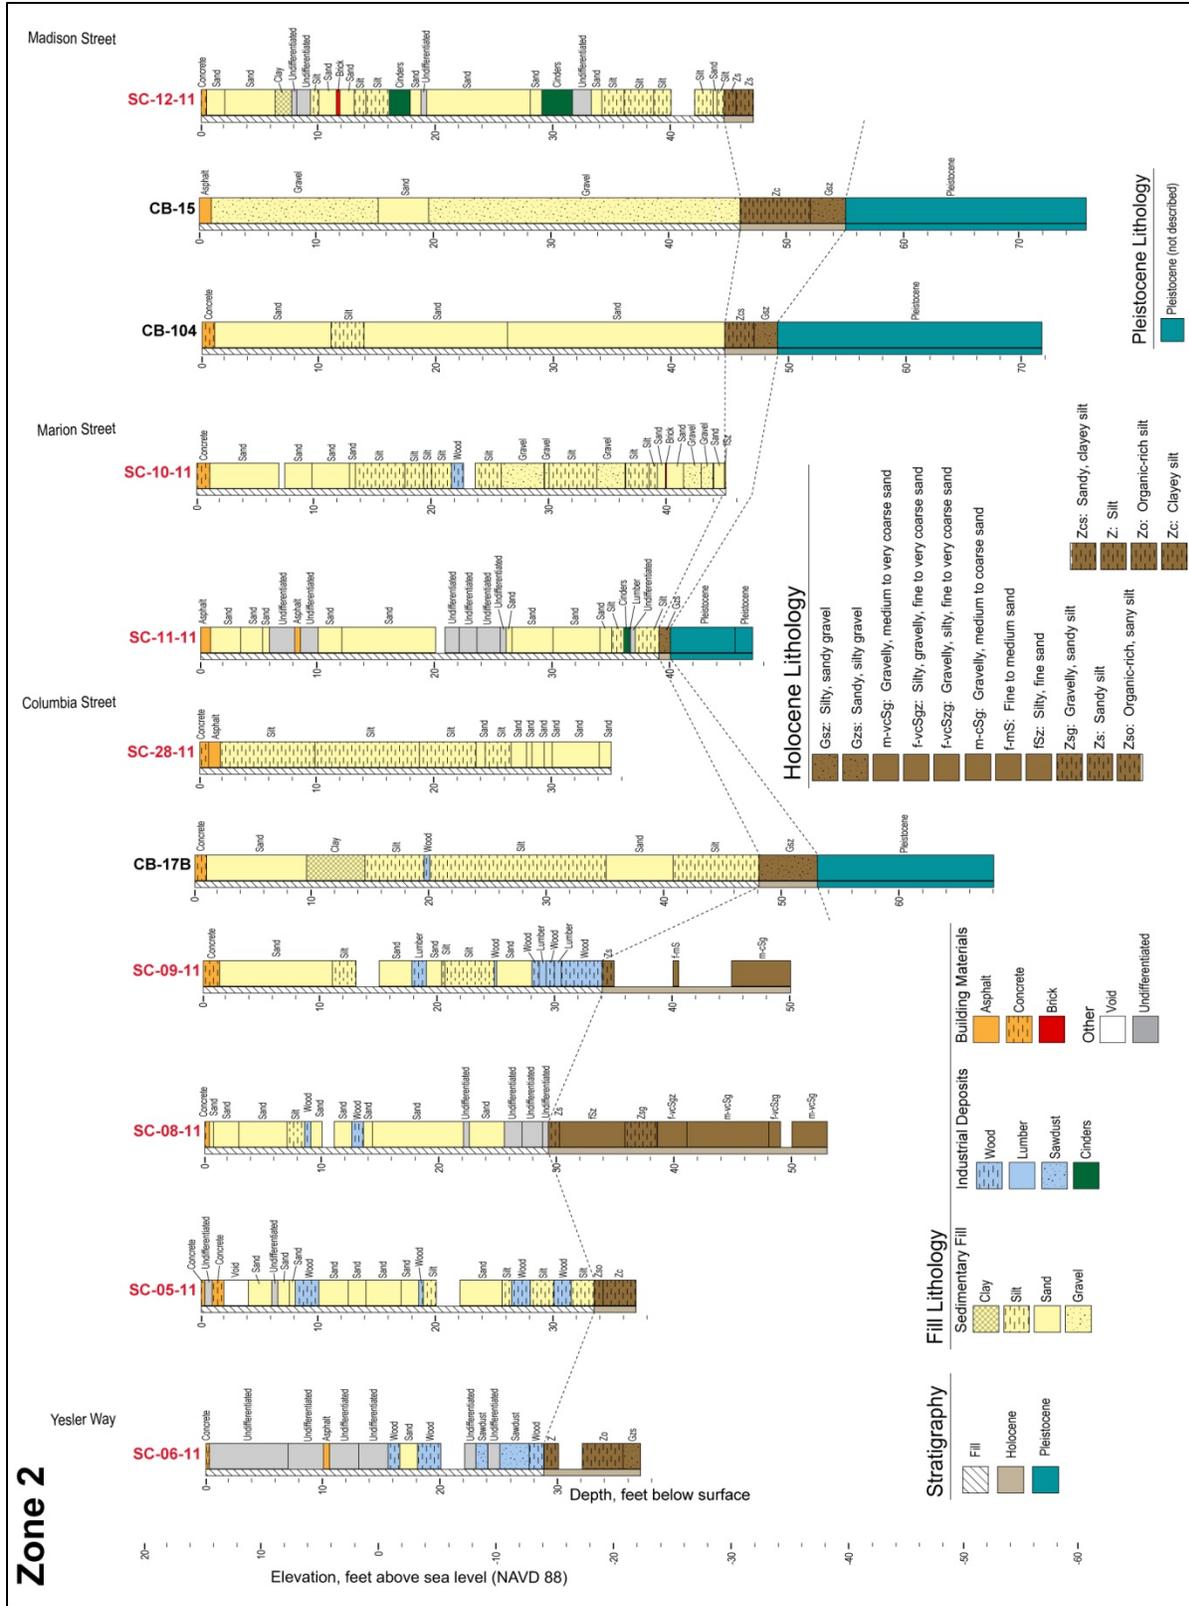
Figure 5-24. Cross section of Zone 2 compiled from existing geotechnical borelogs and sonicores drilled for the EBSP.

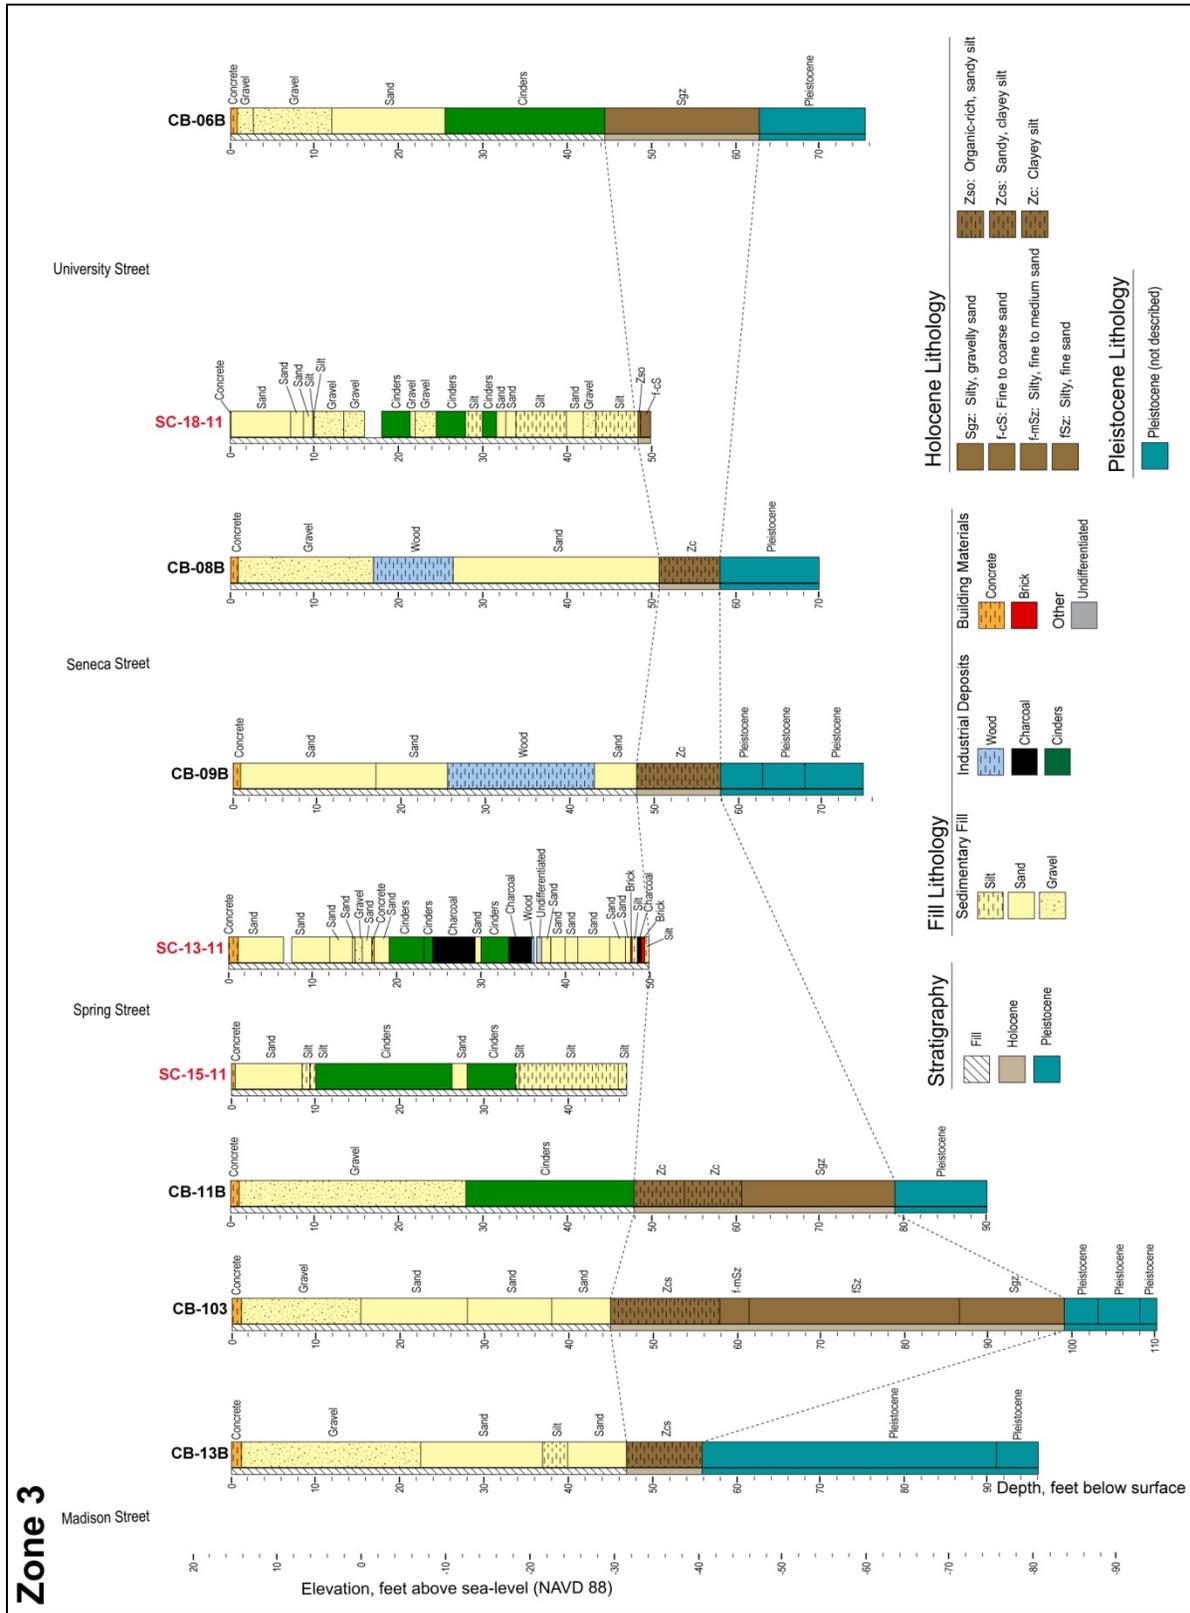
Figure 5-25. Cross section of Zone 2 compiled from existing geotechnical borelogs and sonicores drilled for the EBSP.

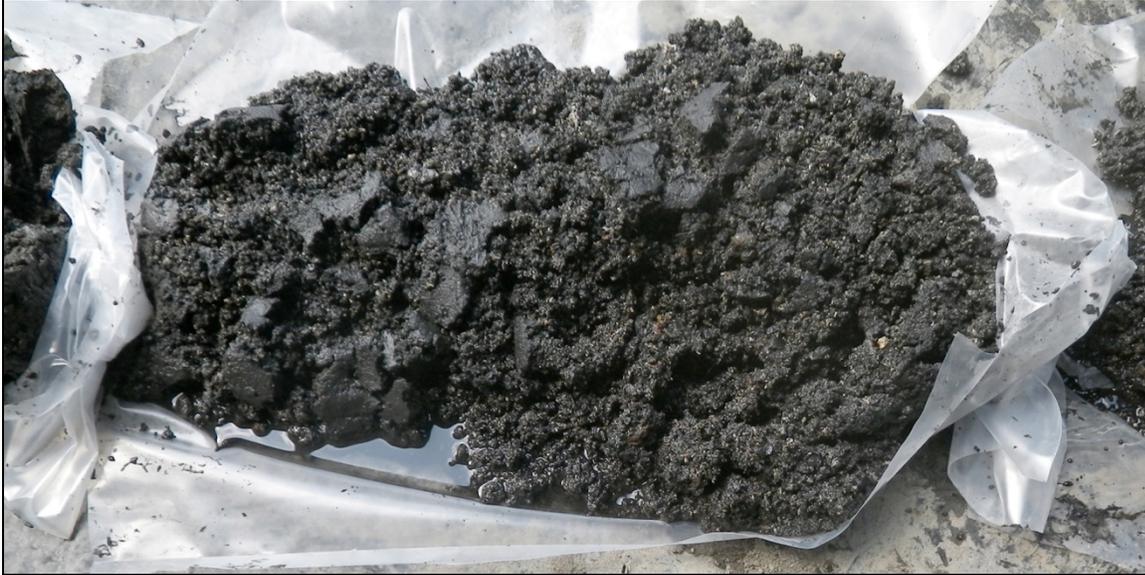
Figure 5-26. Cinders unit in the historic fill from between [REDACTED].

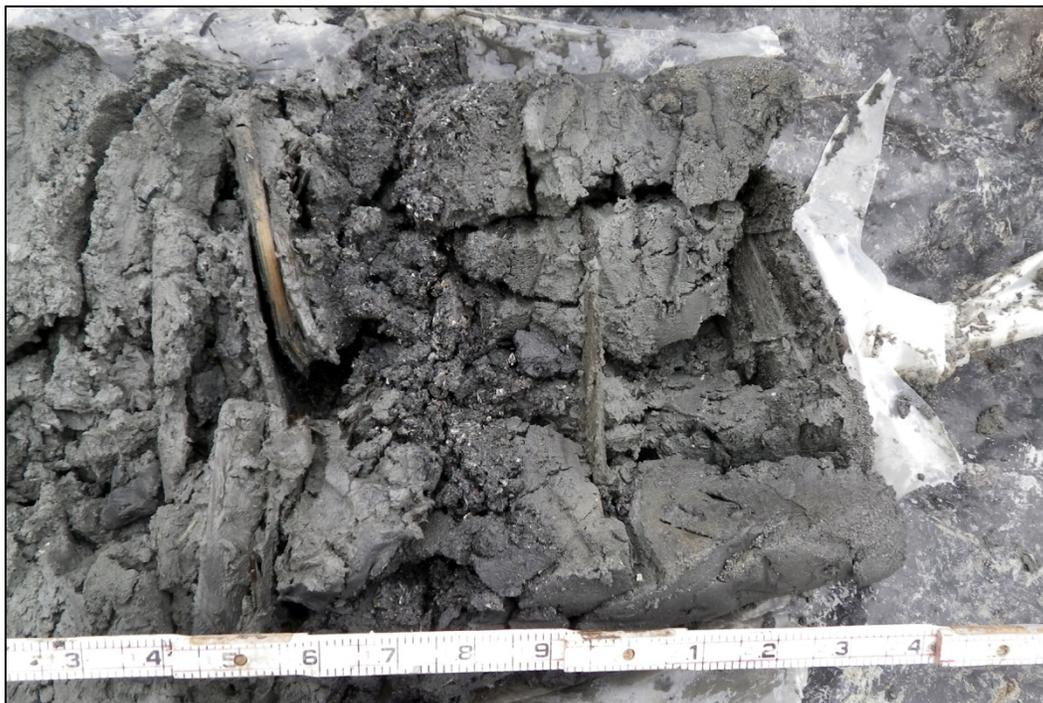
Figure 5-27. Thin bed of sand with woody debris and shell fragments in [REDACTED].

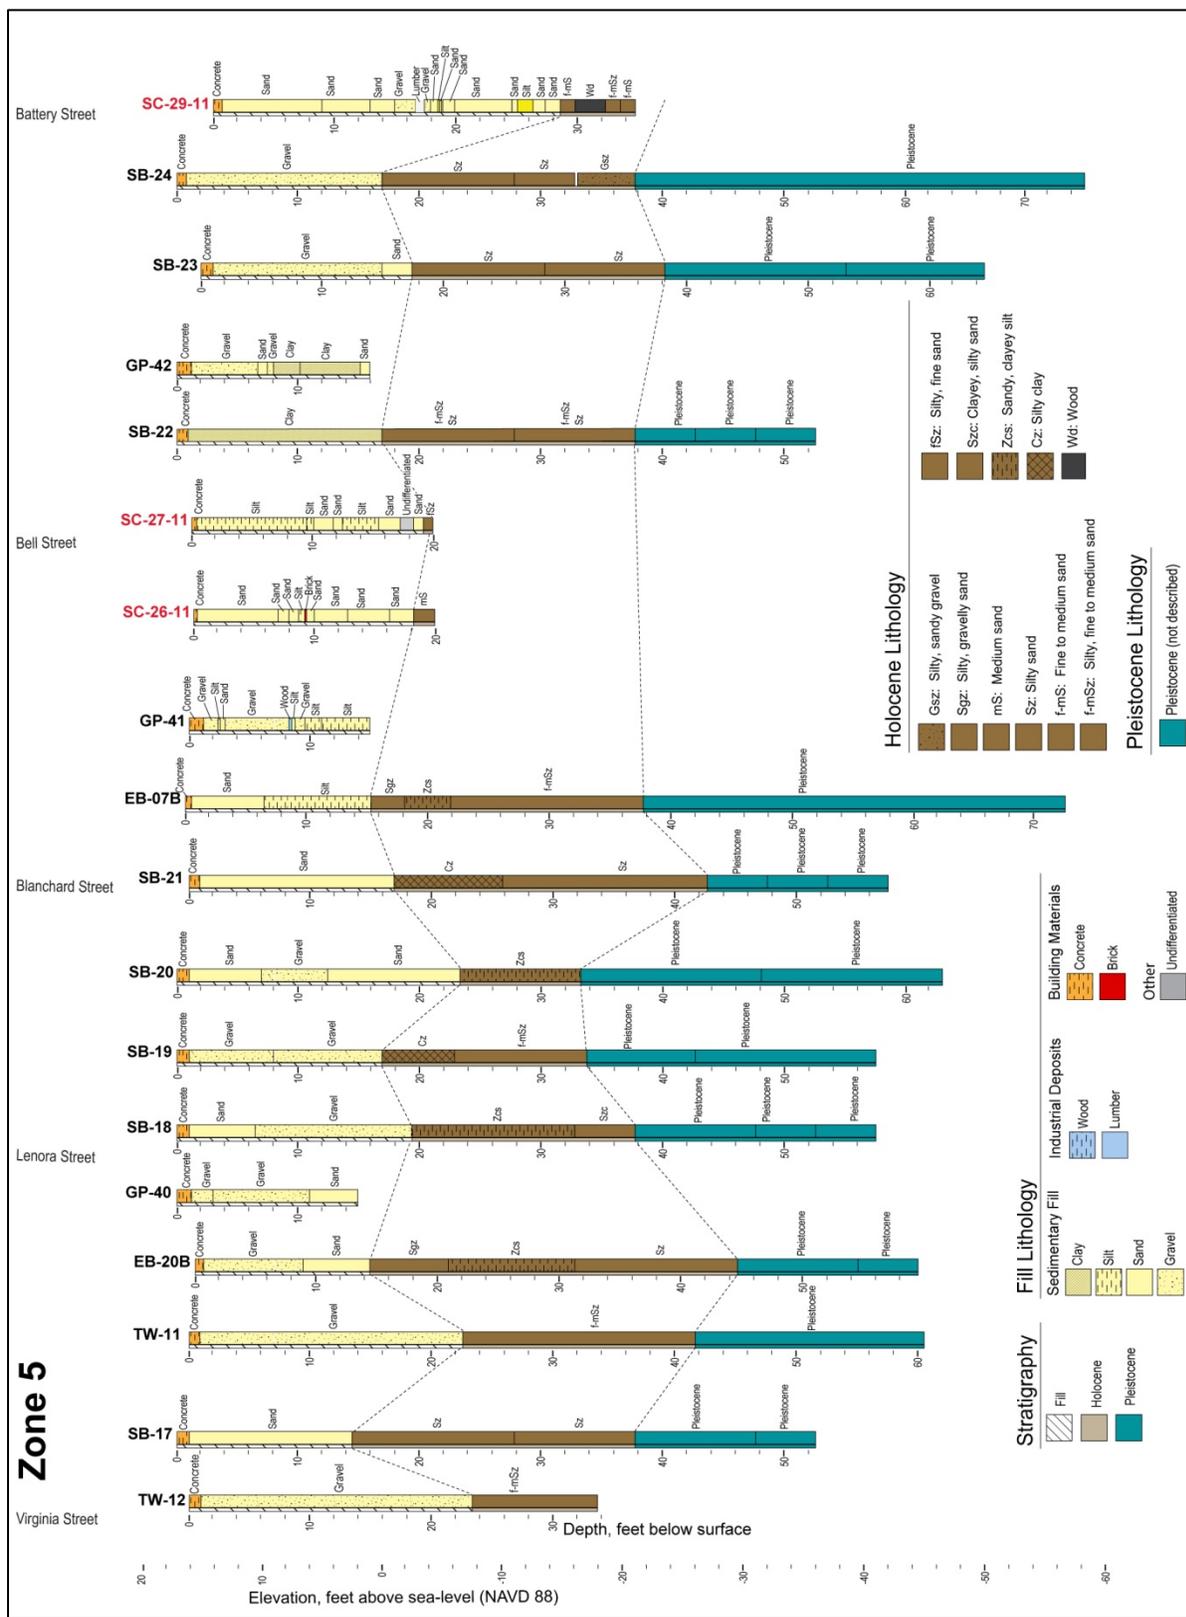
Figure 5-29. Cross section of Zone 5 compiled from existing geotechnical borelogs and sonicores drilled for the EBSP.

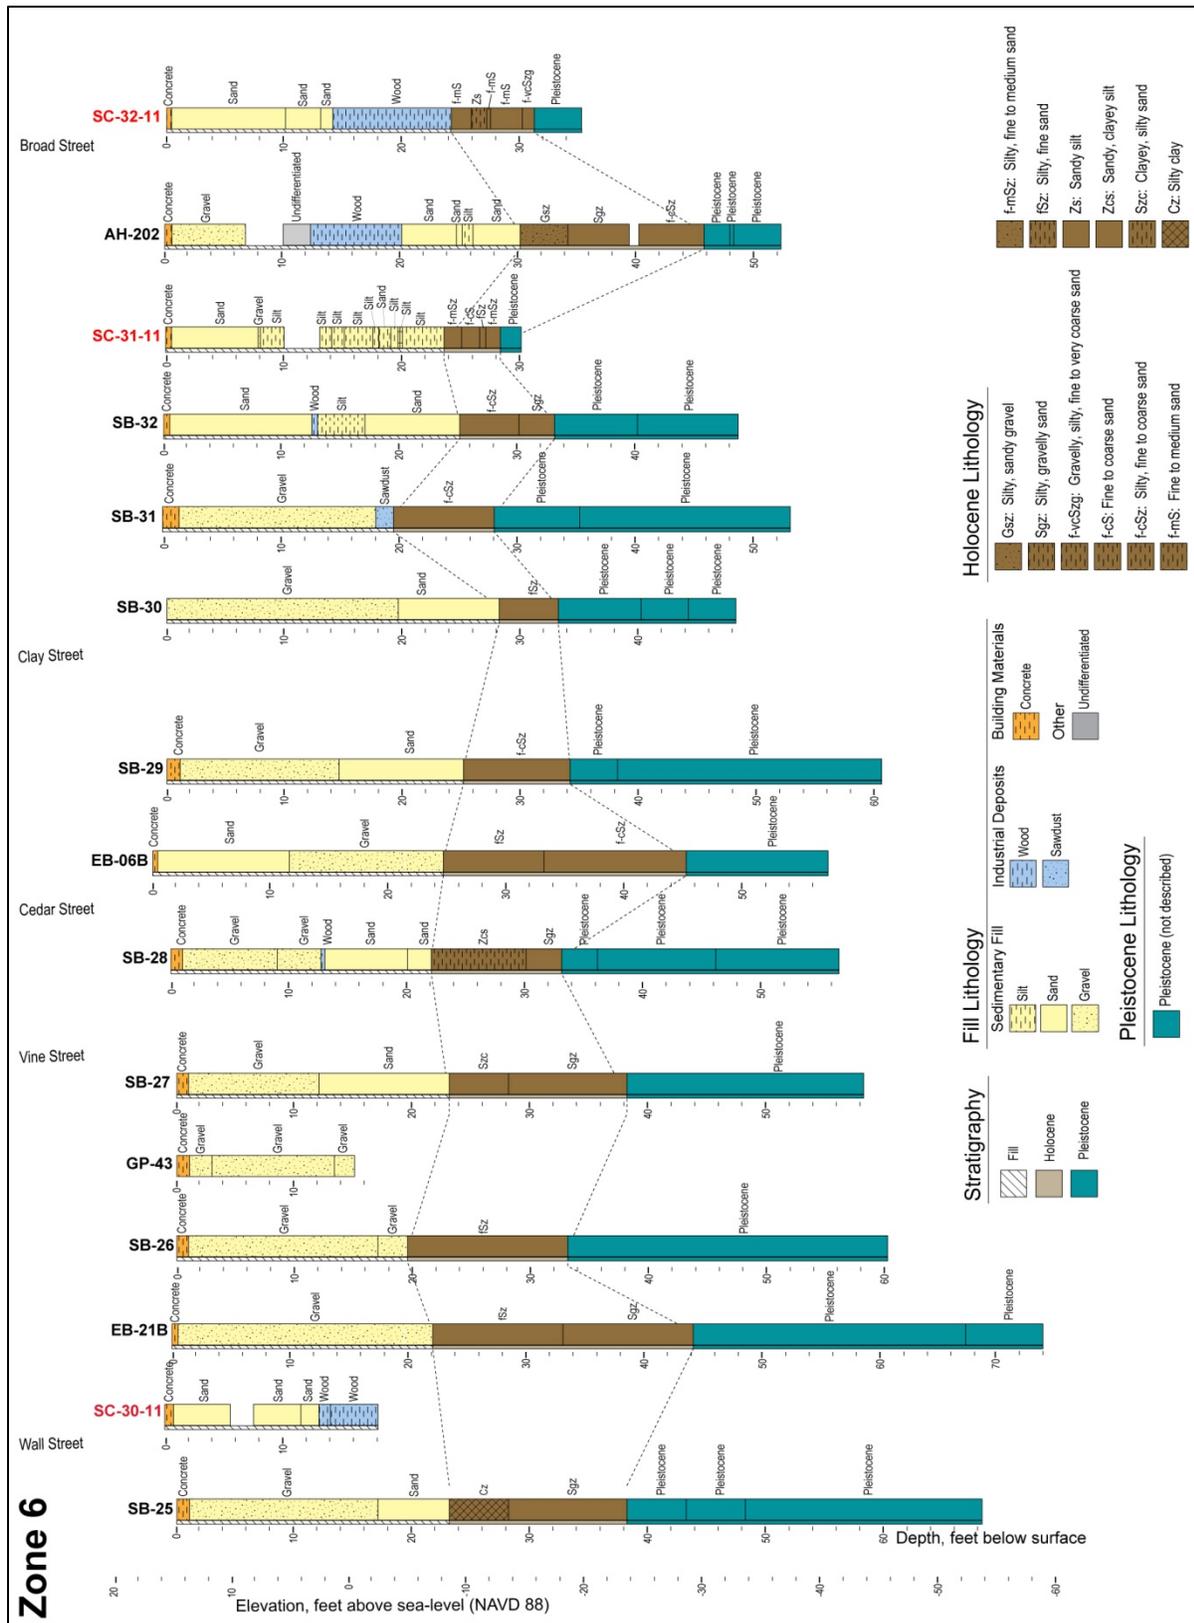
Figure 5-30. Cross section of Zone 6 compiled from existing geotechnical borelogs and sonicores drilled for the EBSP.

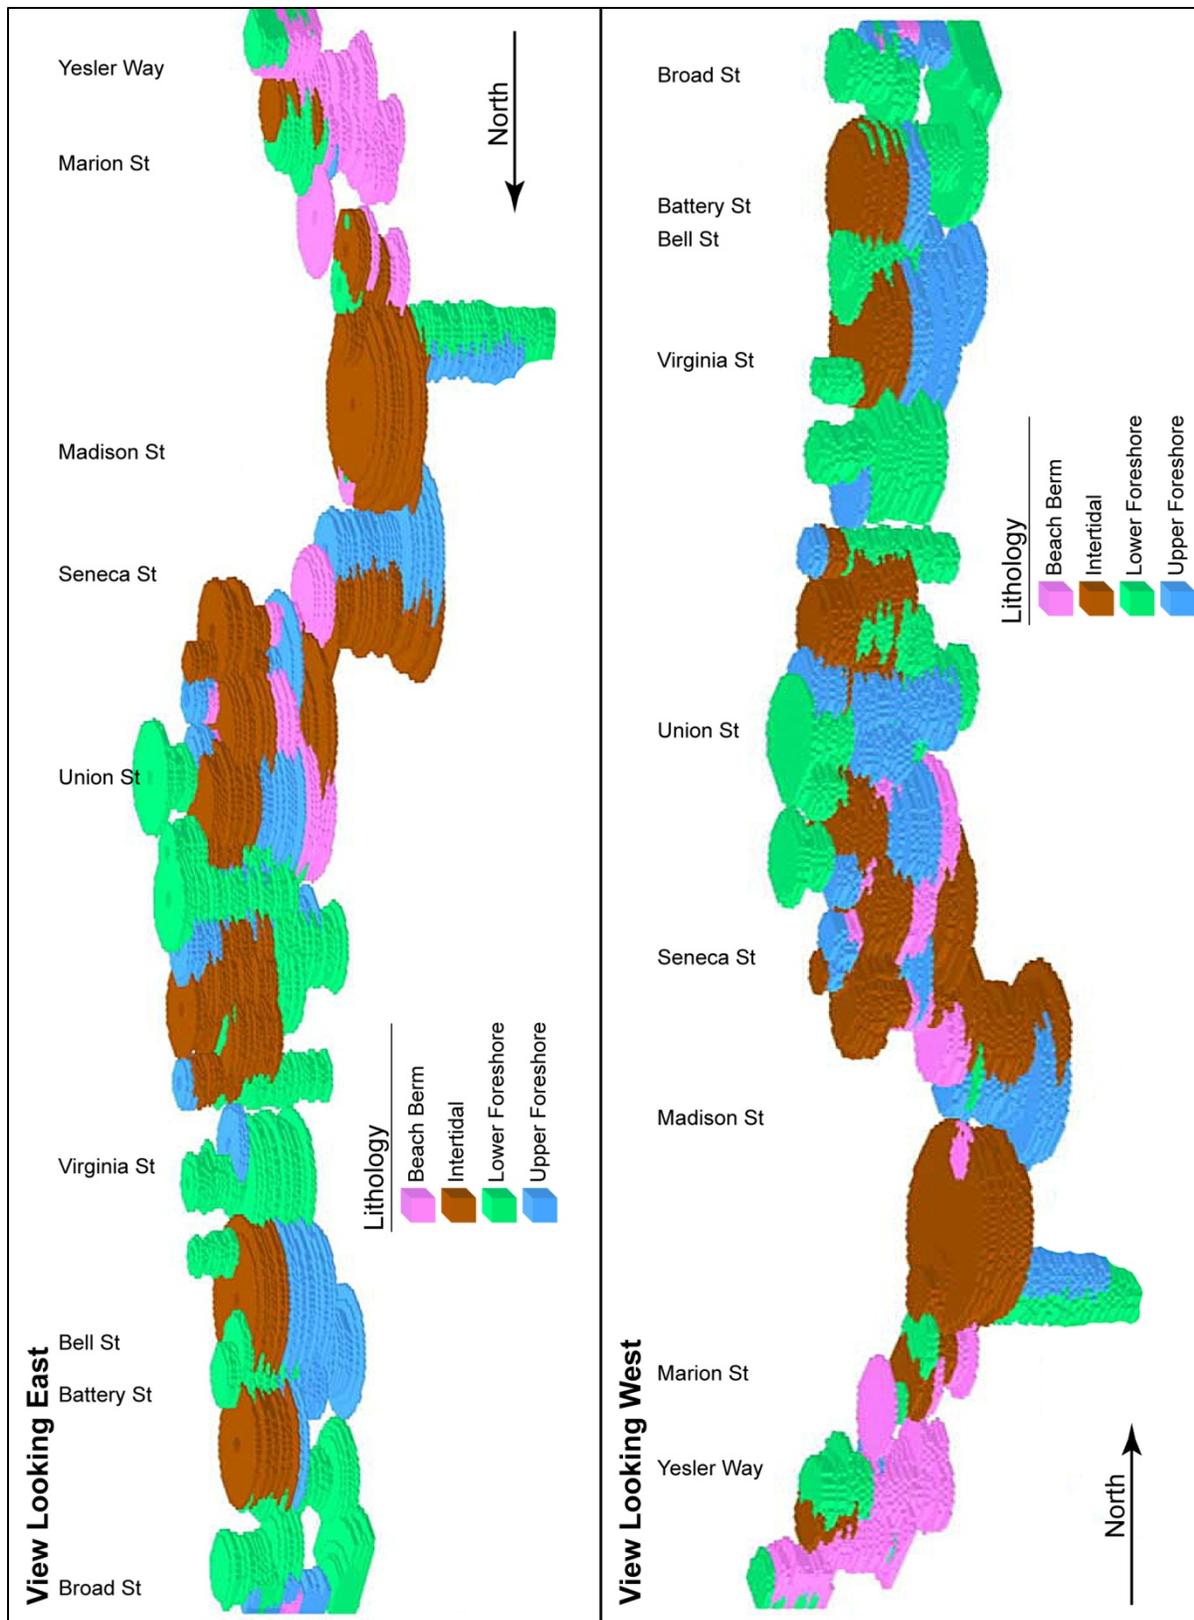
Figure 5-31. Three-dimensional model of the Holocene sub-environments.

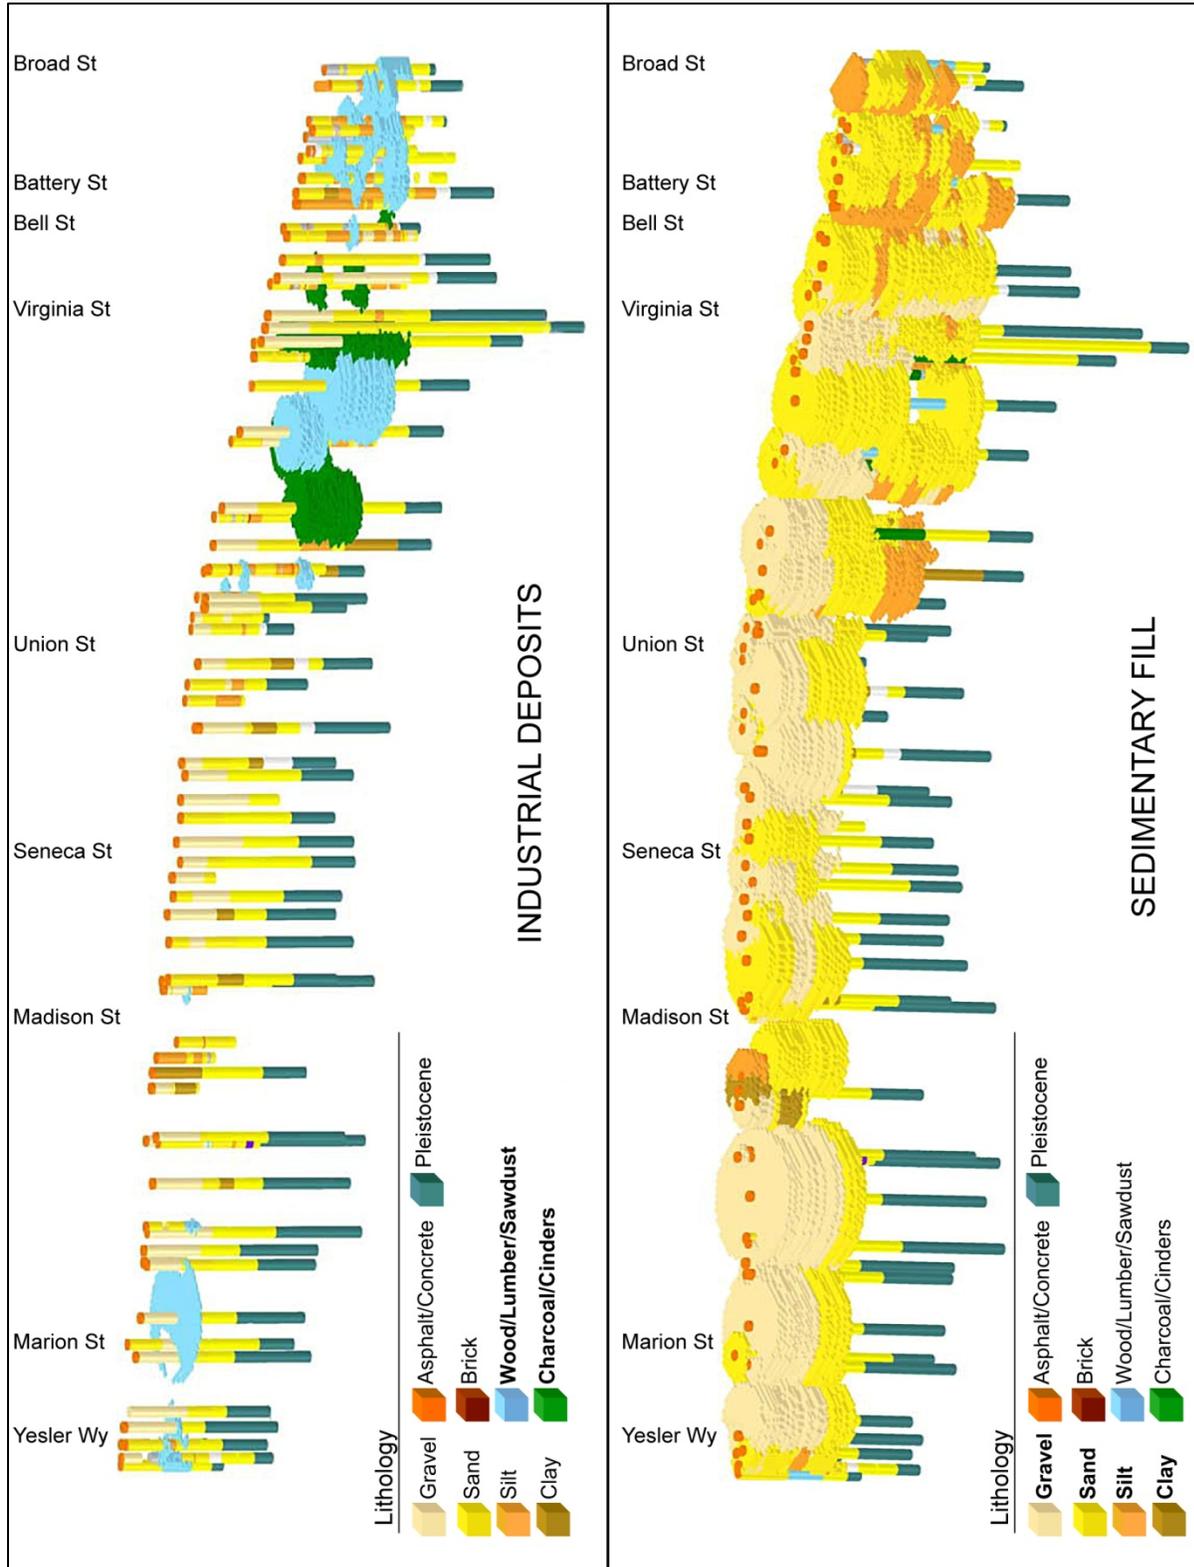
Figure 5-32. Three-dimensional model of the Industrial Deposits and Sedimentary Fill recorded along the seawall.
