Ballard Roadside Raingardens, Phase 1 – Lessons Learned

Shanti Colwell¹, Tracy Tackett²

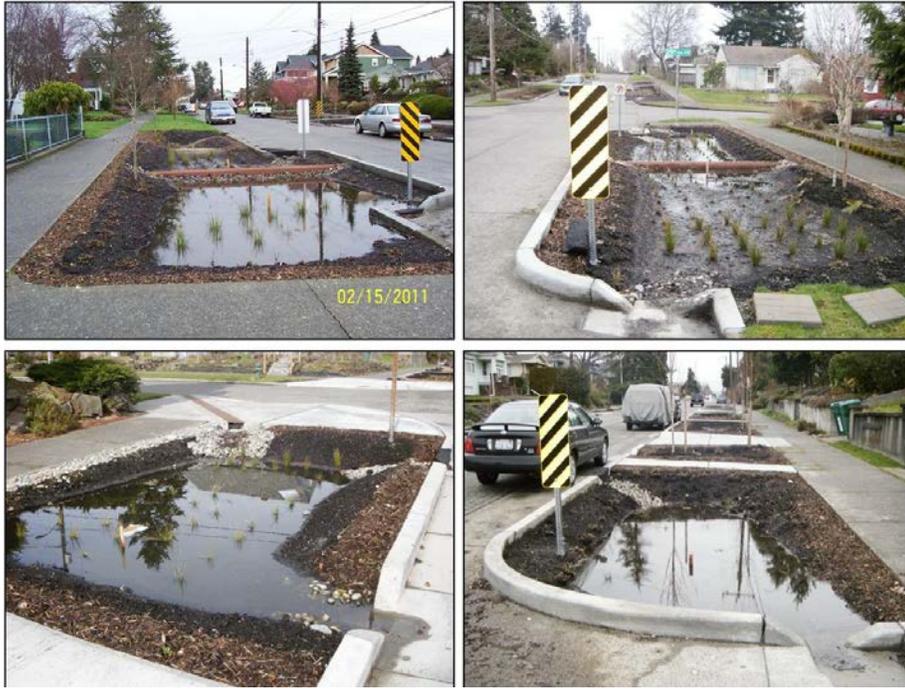
Figure G illustrates some of the non-functioning cells and the community concerns, such as long-term ponded water, the large black and yellow striped object marker signs, the parking restrictions, cell depth, and general aesthetics.

Figure G - Examples of Nonperforming Cells and Community Concerns

Based on the outcome of the Task Force meetings, the raingardens on 29th Ave NW and NW 77th St. will be completely removed, with the curb replaced back to its original location. Most of the raingardens on 31st Ave NW, along the east and west side of 28th Ave NW between NW 71st St and NW 72nd St, and along the east side of 28th Ave NW between NW 65th St and NW 67th St were retrofitted to be more shallow and remove any visible ponding, with several being completely removed.

The cells that were retrofitted to be more shallow have varying levels of infiltration due to the native soils conditions, but generally do not provide anything close to the intended performance and are classified as low performing or low infiltrating raingardens. Along the west side of 28th Ave NW, many of the raingardens are being redesigned as a detention system with an orifice-controlled underdrain. This design will capture the stormwater in the cell and temporarily store it in the bioretention soil (there is no surface ponding) while it waits to be slowly metered out to the combined sewer system by moving through the soil into the underdrain fitted with an orifice, which controls the rate of flow. A detention system helps with reducing CSOs by only allowing a little of the stormwater into the system when it is at capacity. Raingardens along 30st Ave NW work as designed and do not have any long term ponded water issues or community concerns, so no additional work or redesign is required.
