Protecting Seattle's Waterways

Wastewater Collection System: 2014 Annual Report

March 27, 2015

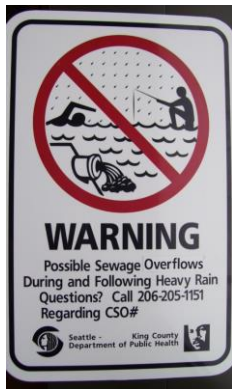
Figure 3-2. Example of Outfall Signage

SPU, together with Seattle King County Public Health, maintains a sewage overflow notification and posting program for Seattle's CSO outfalls. Signs at each outfall identify the outfall and warn of possible sewage overflows. The signs include the phone number for the CSO Hotline, staffed and managed by Seattle King County Public Health. Seattle King County Public Health also provides a website with detailed information about CSOs, potential public health hazards, and precautions the public may take to protect themselves. If sewage overflows occur due to side sewer breaks or illicit connections or discharges, SPU posts additional warning signs at impacted waterways until the problem is resolved.

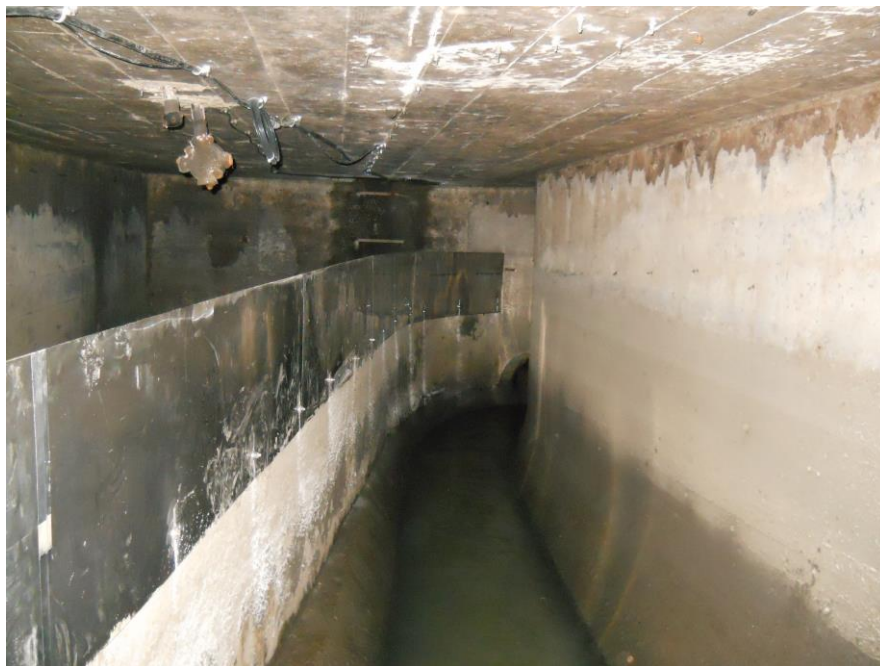
Figure 4-2. Retrofit Improvements At Overflow Structure 47C

The retrofit for Basin 47 consisted of raising the overflow weir in Overflow Structure 47C to maximize storage as well as improve access to the overflow structure. Figure 4-2 below shows the new raised weir.

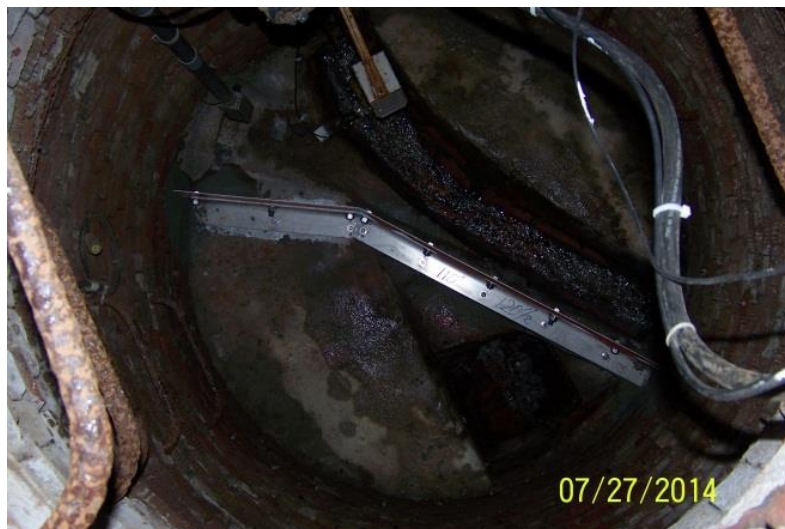
Figure 4-5. Outfall 29 Raised Weir Installation

Figures 4-5 and 4-6 show some of the constructed improvements that are a part of the Phase 1 Leschi Retrofits. The only remaining improvement of Phase 1 is replacement of two existing pumps at Pump Station 2. This will be completed by the end of the first quarter of 2015.

- Raised the overflow weirs at CSO Outfalls 34, 30, and 29 by 1 foot,
- Sealed Overflow Structure 32B and removed CSO Outfall 26 from service, and
- Removed the HydroBrakes at Overflow Structure 32B and Outfall 33.

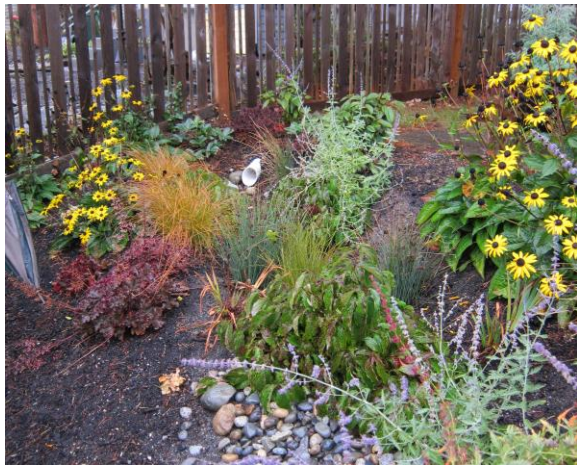
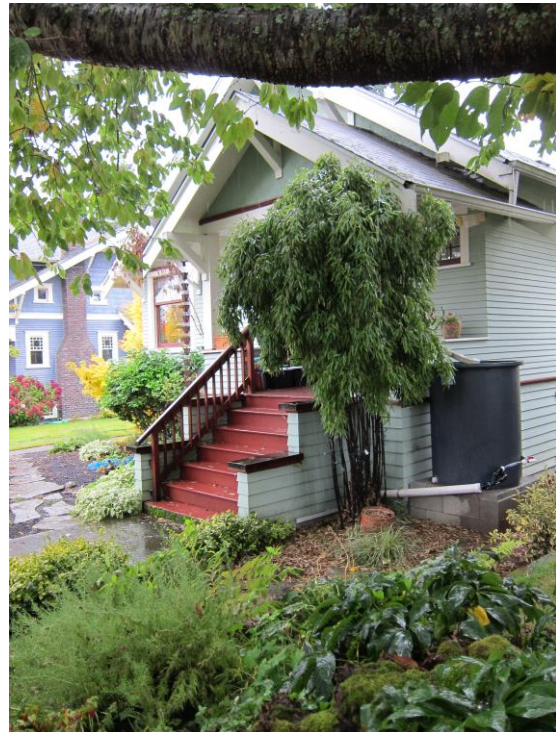
Figure 4-7. Raingarden (left) and Cistern (right)

Upon completion, installations are inspected by a RainWise inspector and homeowners apply for rebates. RainWise rebates for rain gardens are currently three dollars and fifty cents per square foot of roof area controlled. Rebates for cisterns equal 64% or more of the rain garden rate, depending on the size of the cistern and contributing area. The average 2014 installation now controls the runoff from over 1,300 square feet of roof area. Typical RainWise installations are shown in Figure 4-7.

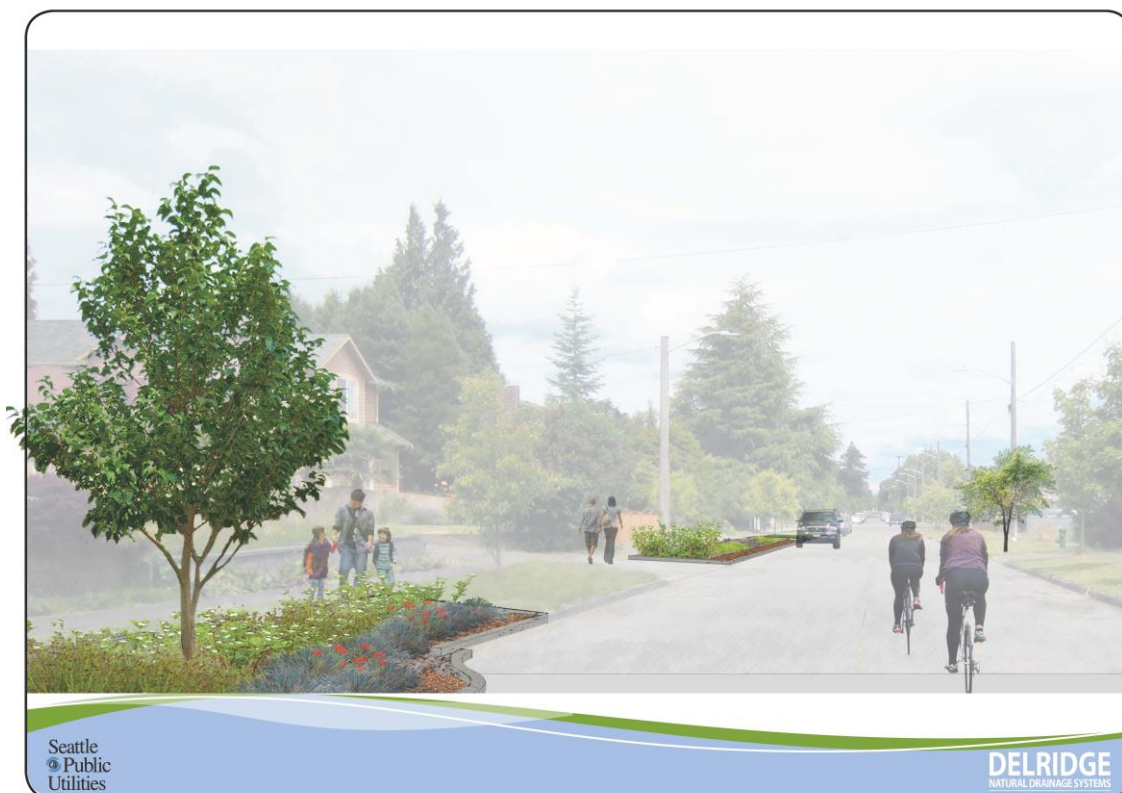
Figure 4-9. Delridge NDS 2015 Conceptual Drawing

The refined design for Delridge NDS includes raingardens connected with underdrains that convey cleaned waters to medium-depth infiltration wells (30-40' deep). These drilled drains are similar to underground injection control (UIC) wells, and provide infiltration to the advance outwash layer below glacial till. The current design coordinates siting of individual raingarden cells within existing landscape strips to minimize conflicts with utilities, driveways and trees, while maximizing the possible control of surface water within these catchment areas. Design will be completed in the second quarter of 2015, and construction is slated to begin in 2015 and extend into 2016.

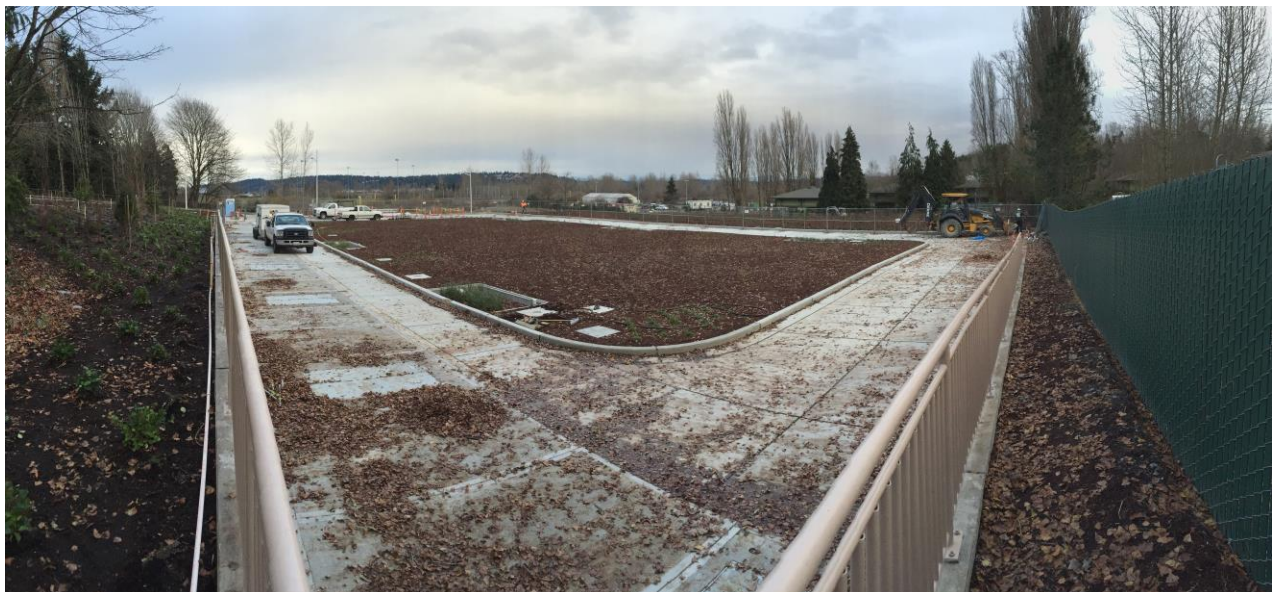
Figure 4-10. Windermere CSO Reduction Project Construction, February 2015

In 2013, SPU constructed the floor slab, walls and columns for the new storage tank and installed 1,400 feet of conveyance pipe in Sand Point Way. In 2014, SPU constructed the roof and then backfilled the storage tank; installed the remaining 700 feet of conveyance pipe in NE 65th St; installed the mechanical, electrical, and instrumentation equipment in the tank and the facility vault; and completed system and operational testing. Final commissioning of the Windermere system (including Windermere CSO 22 and 22A) is scheduled to be complete in Spring 2015.

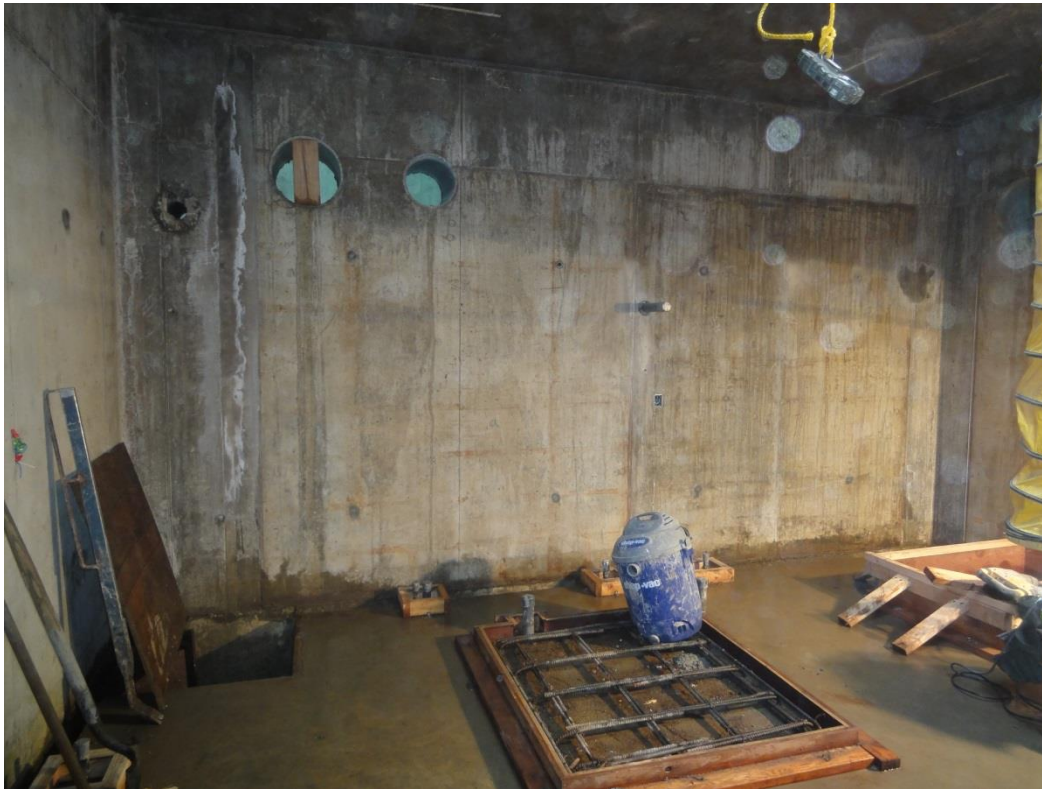
Figure 4-11. Genesee (CSO 11A) CSO Reduction Project Construction, July 2014

Construction began in April 2013 using the General Contractor / Construction Manager delivery method. In 2013, SPU installed shoring, carried out excavation, and began constructing the underground storage tanks, facility vaults, and site utilities. In 2014, SPU completed the buried concrete storage tank and facility vault structures, most of the mechanical and electrical components, and part of the piping modifications to connect the local sewer system to the new tanks. In 2015, SPU will complete construction of the local sewer system modifications, surface restoration, and testing and commissioning of the new facilities. Construction of the project is scheduled to be completed in the second quarter of 2015, well ahead of the regulatory requirement.

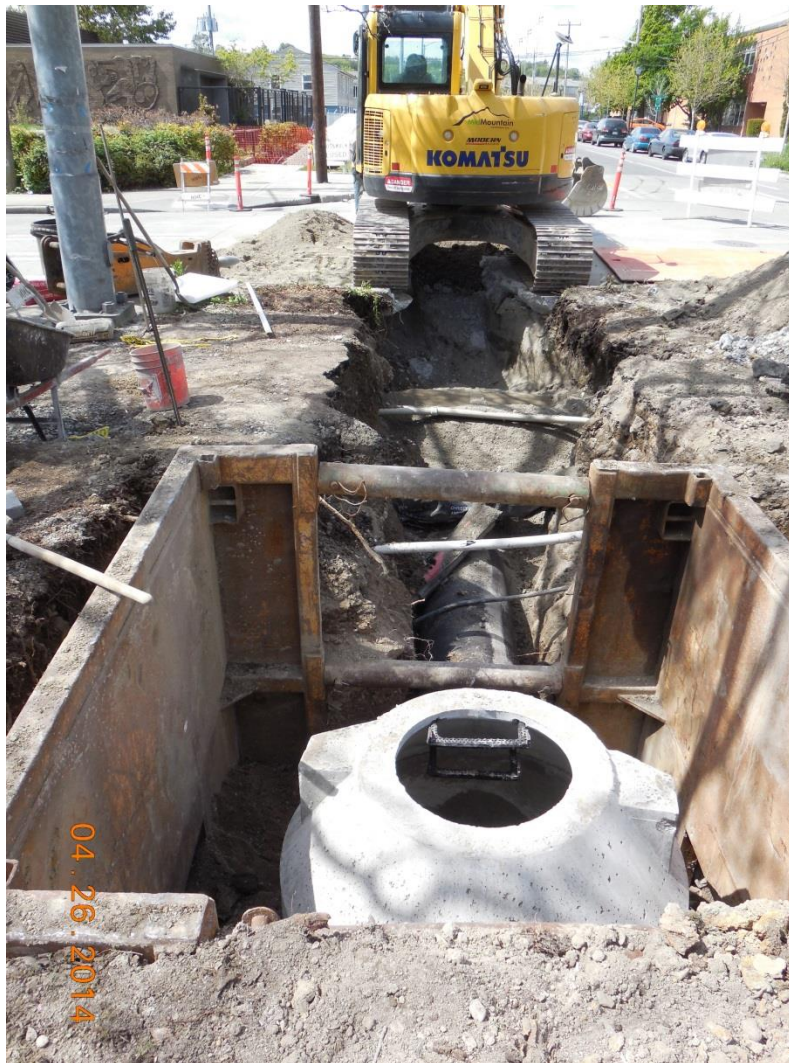
Figure 4-13. 52nd Ave S Conveyance Project Construction, April 2014

In 2014, SPU awarded the construction contract, installed the new piping and structures, restored disturbed surfaces, and put the new pipeline into service. Final construction completion will occur in 2015 as the contractor completes work with the associated Mapes Creek Restoration project. In addition, SPU will create record of construction drawings and begin post construction monitoring

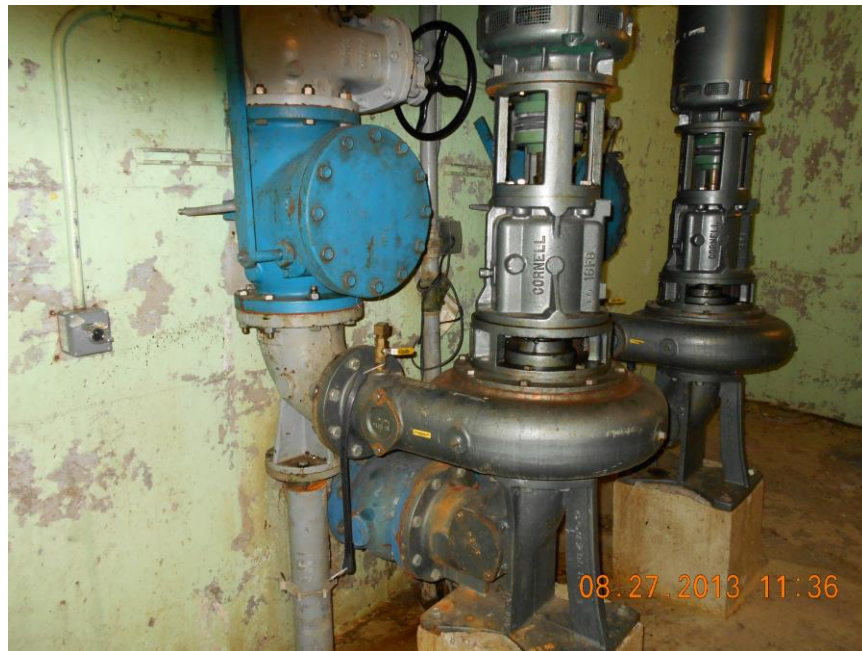
Figure 4-14. Pump Station 9 Rehabilitation Project

The Pump Station 9 Rehabilitation Project will reduce the number and volume of combined sewage overflows from Outfall 46 in the South Henderson area. SPU is replacing the existing pumps with two higher capacity pumps. SPU submitted the final design drawings and the construction quality assurance plan to Ecology for review in 2014. All required construction permits have been obtained and the contract has been awarded. SPU expects to complete construction in the third quarter of 2015.

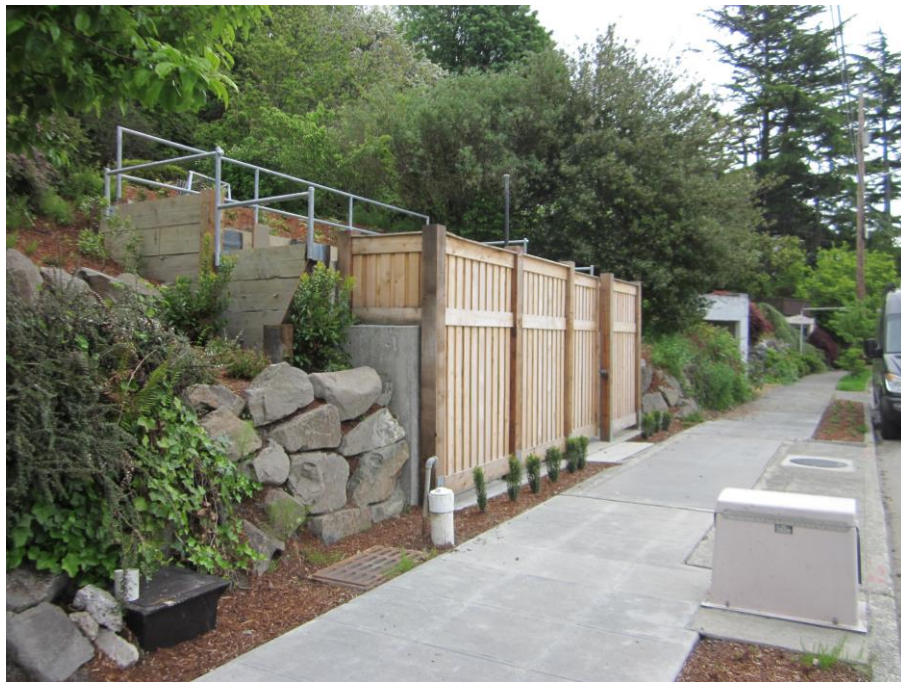
Figure 4-15. Pump Station 39 Backup Generator

In 2010, SPU installed emergency plugs at all wastewater pump stations without permanent generators. From 2011 through 2013, SPU installed permanent generators at nine additional pump stations having peak daily flows over 1 MGD, short wet well storage times (less than 1 hour during peak flow), and a history of crews needing to respond to power outages. Permanent generators were installed at five locations in 2011 (Pump Stations 7, 25, 43, 49, and 59), an additional three locations in 2012 (Pump Stations 62, 63, and 77), and one final location in 2013 (Pump Station 39). SPU completed the landscaping work at Pump Station 39 in April 2014.

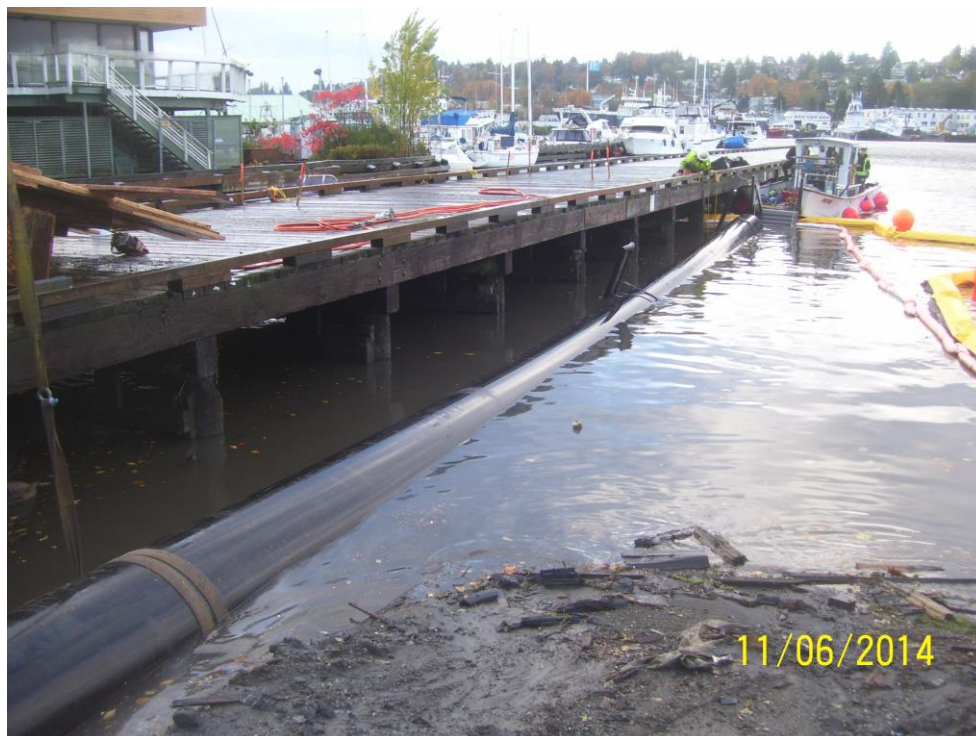
Figure 4-16. Outfall 150 Rehabilitation Project

Outfall 150 had deteriorated under an existing pedestrian pier. The Outfall 150 rehabilitation project replaced the existing maintenance hole just upstream of the shoreline and installed a replacement outfall comprised of approximately 50 feet of 30-inch diameter epoxy-coated ductile iron pipe and approximately 110 feet of 30-inch diameter high-density polyethylene (HDPE) outfall pipe. The work was completed in December 2014. As mitigation, SPU is required to install flap gates on two nearby storm drainage outfalls: Outfalls 181 and 183. The mitigation work is expected to be completed by Fall 2015.

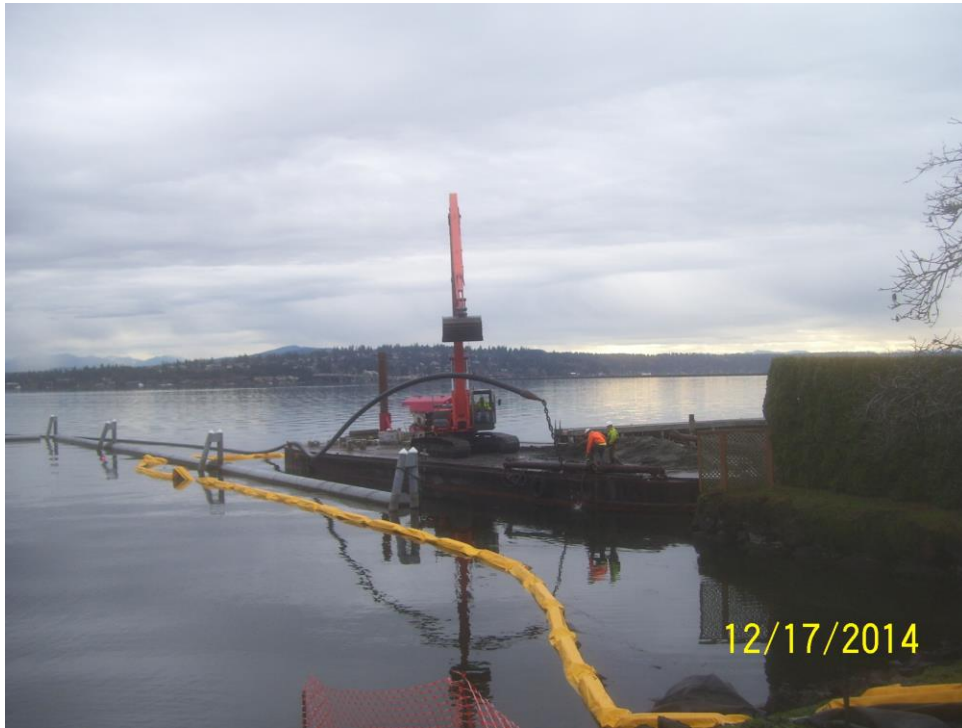
Figure 4-17. Outfall 31 Rehabilitation Project

Outfall 31 had issues with tree root intrusion and damage caused during the installation of the breakwater for Leschi Marina. The Outfall 31 rehabilitation project replaced the existing outfall with an 8-inch diameter high density polyethylene (HDPE) pipe. The land-based portion of the new HDPE pipeline was installed in the same horizontal and vertical alignments as the existing outfall pipe using trenchless pipe-bursting technology. The construction was completed in February 2015.
