CANOPY STRUCTURE REMODEL OPTIONS 1, 2, & 3

16044 33RD AVE NE LAKE FOREST PARK, WA 208.691.6148 **ROAM BAR**

5105 BALLARD AVE NW SEATTLE, WA 98107 **DON COTA RETROACTIVE APPLICATION**

AS BUILT CONDITIONS MODIFIED, PER 01/02/25 LANDMARK REVIEW

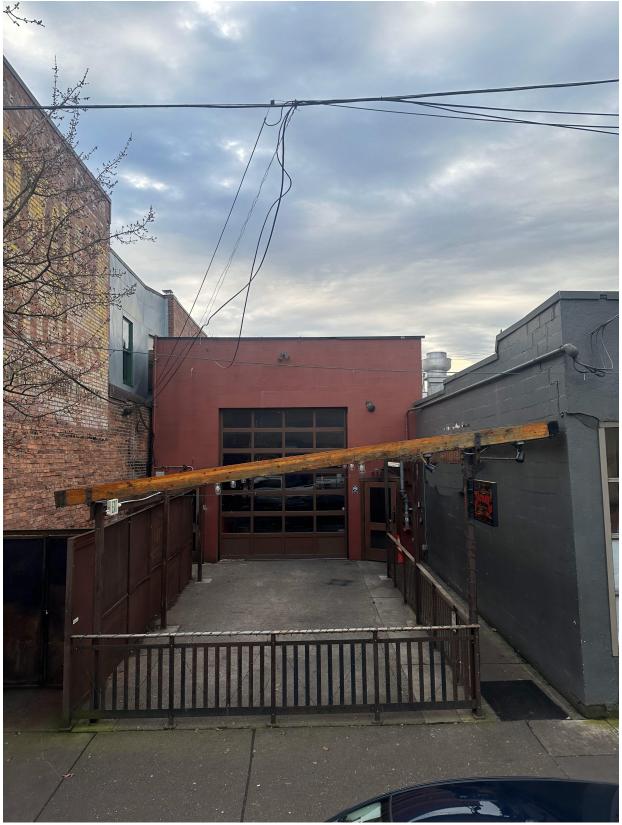
CURRENT PATIO STRUCTURE HEAD ON VIEW SHOWING WHAT IT WOULD LOOK LIKE IF CLOTH CANOPY, TELEVISIONS, SPEAKERS, AND ALL OR A PORTION OF CURRENT BEAM STRUCTURE REMAINS

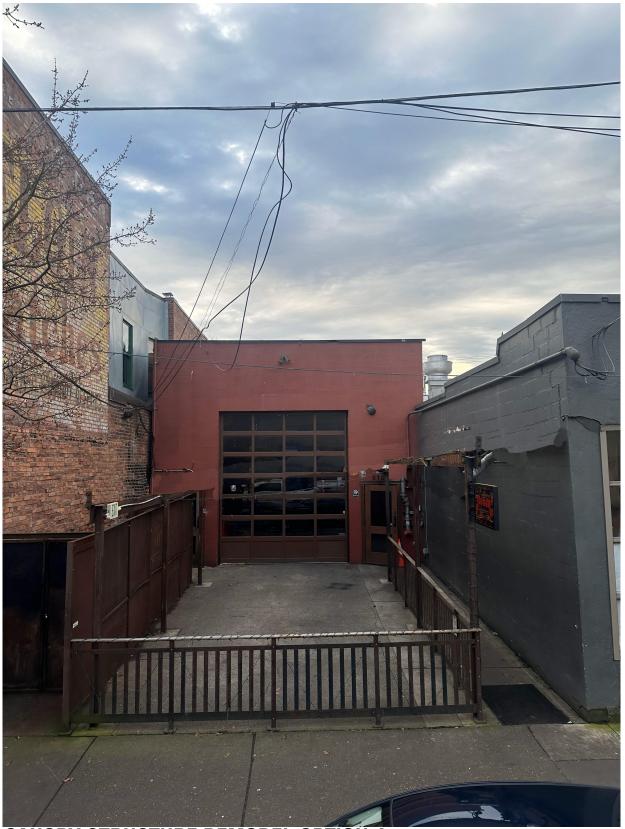
CURRENT PATIO STRUCTURE HEAD ON VIEW SHOWING WHAT IT WOULD LOOK LIKE IF TELEVISIONS, SPEAKERS, CLOTH CANOPY, AND ALL BEAMS ARE REMOVED

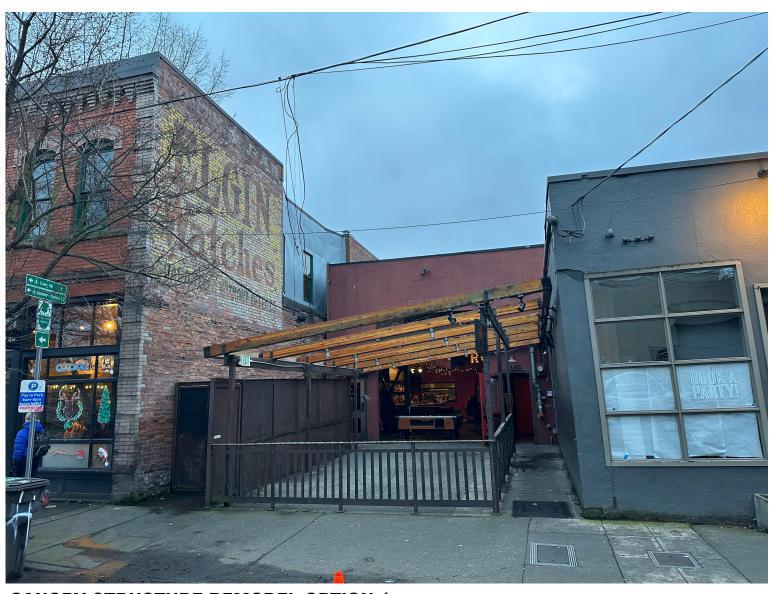
CURRENT PATIO CURBSIDE VIEW SHOWING WHAT IT WOULD LOOK LIKE IF CLOTH CANOPY, TELEVISIONS, AND SPEAKERS ARE REMOVED

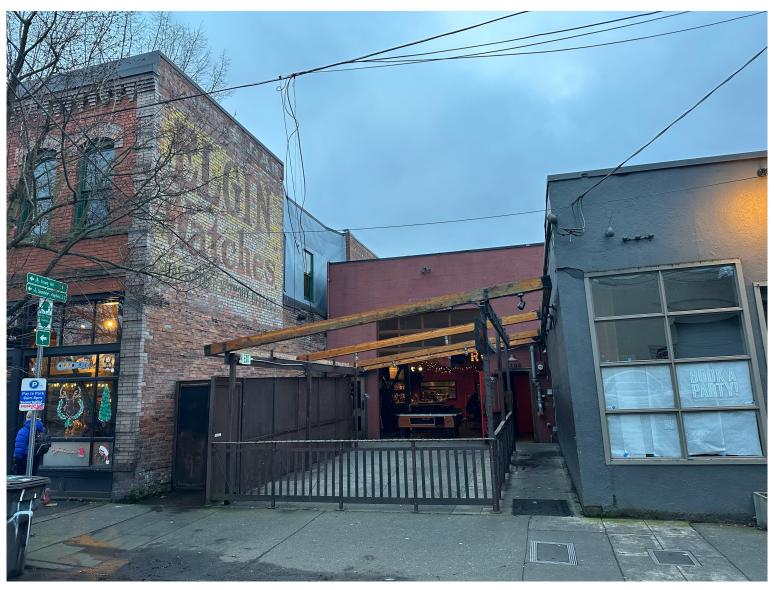
CURRENT PATIO CURBSIDE VIEW SHOWING WHAT IT WOULD LOOK LIKE IF CLOTH CANOPY, TELEVISIONS, SPEAKERS, AND TWO BEAMS ARE REMOVED

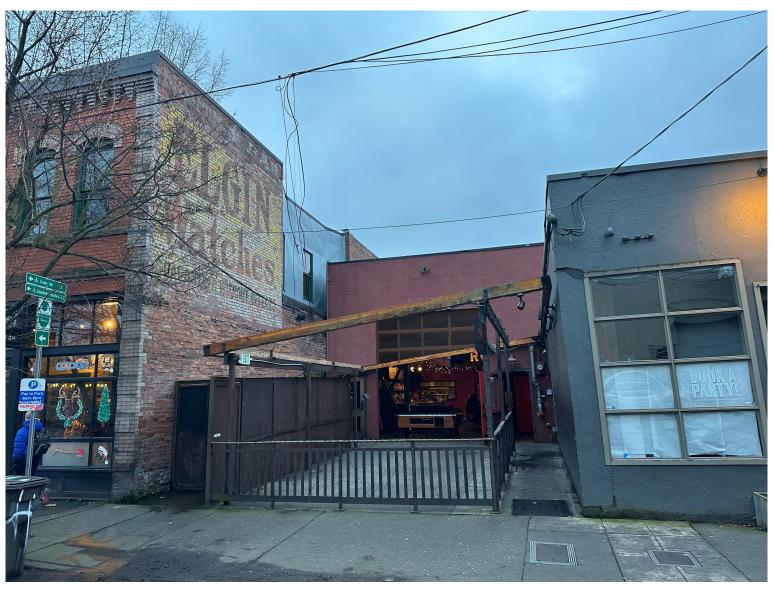
CURRENT PATIO CURBSIDE VIEW SHOWING WHAT IT WOULD LOOK LIKE IF CLOTH CANOPY, TELEVISIONS, SPEAKERS, AND INTERIOR BEAMS ARE REMOVED

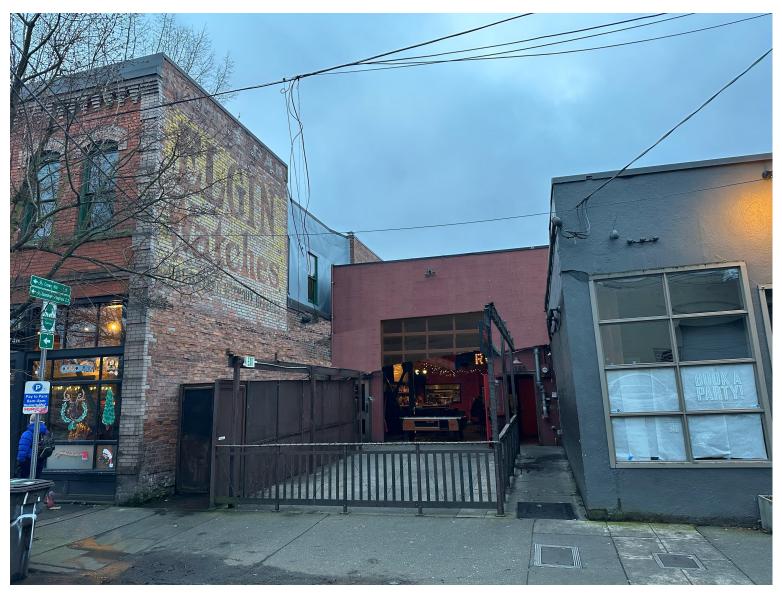
CURRENT PATIO CURBSIDE VIEW SHOWING WHAT IT WOULD LOOK LIKE IF CLOTH CANOPY, TELEVISIONS, SPEAKERS, AND ALL BEAMS ARE REMOVED

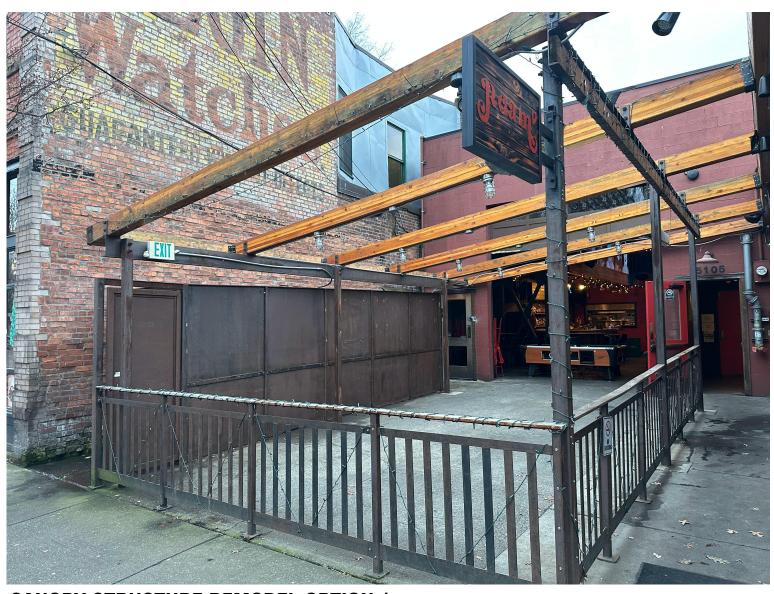
CURRENT PATIO SIDEWALK VIEW SHOWING WHAT IT WOULD LOOK LIKE IF CLOTH CANOPY, TELEVISIONS, AND SPEAKERS ARE REMOVED

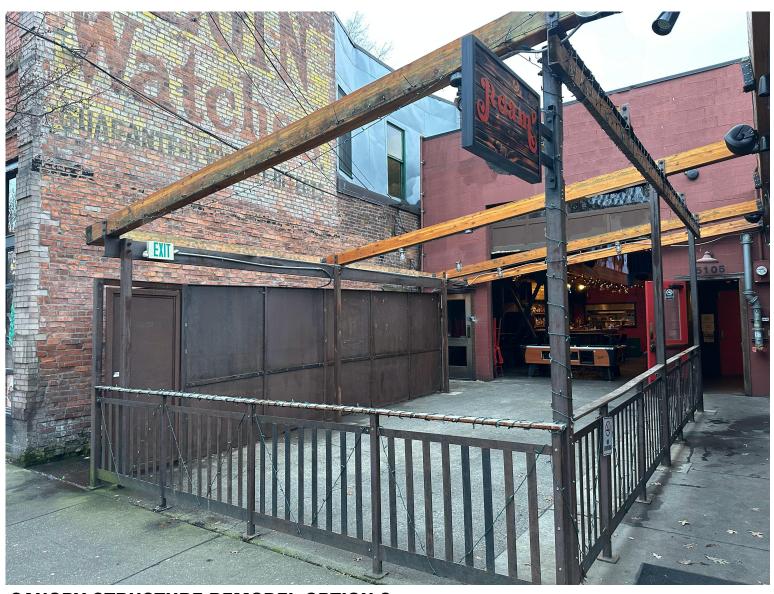
CURRENT PATIO SIDEWALK VIEW SHOWING WHAT IT WOULD LOOK LIKE IF CLOTH CANOPY, TELEVISIONS, SPEAKERS, AND TWO BEAMS ARE REMOVED

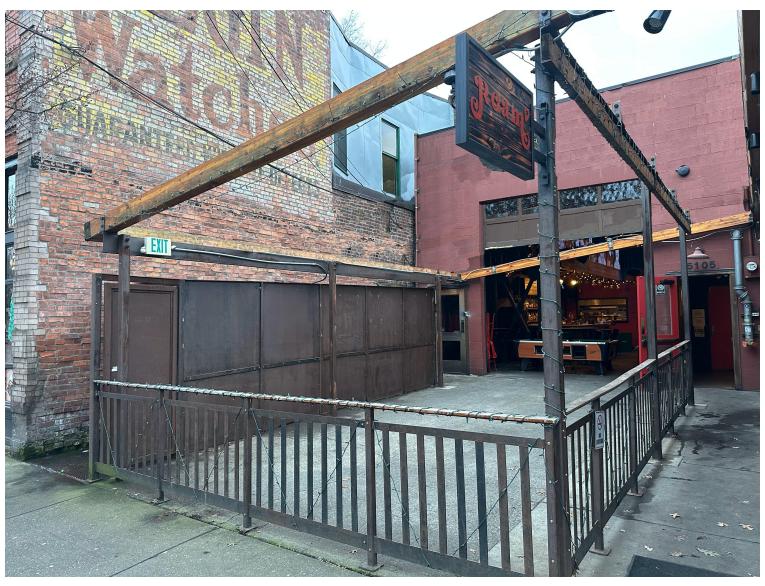
CURRENT PATIO SIDEWALK VIEW SHOWING WHAT IT WOULD LOOK LIKE IF CLOTH CANOPY, TELEVISIONS, SPEAKERS, AND INTERIOR BEAMS ARE REMOVED

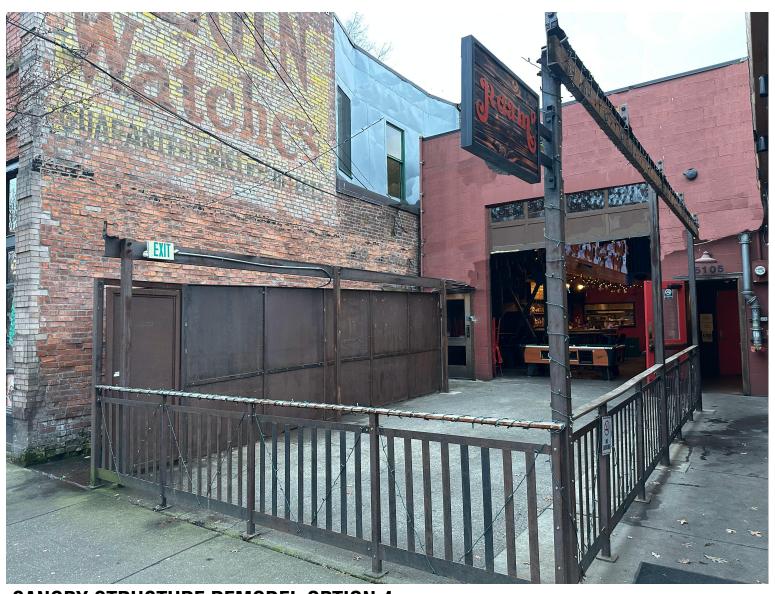
CANOPY STRUCTURE REMODEL OPTION 4

CURRENT PATIO SIDEWALK VIEW SHOWING WHAT IT WOULD LOOK LIKE IF CLOTH CANOPY, TELEVISIONS, SPEAKERS, AND ALL BEAMS ARE REMOVED

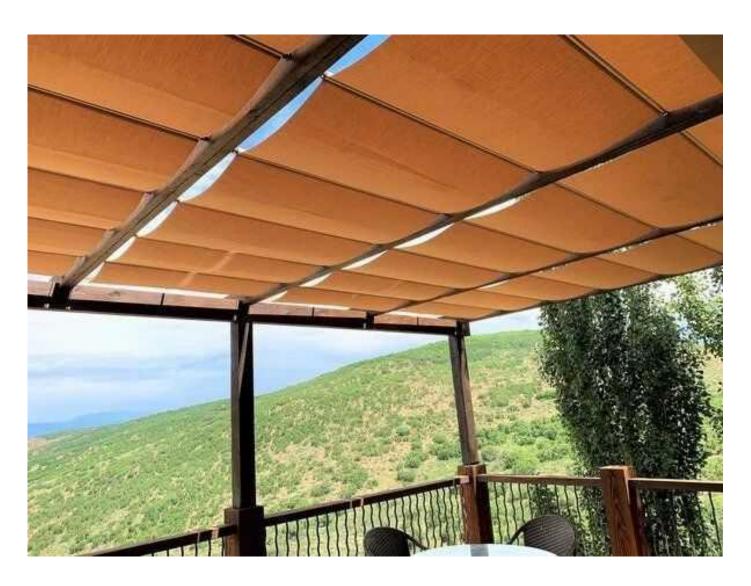
IMAGERY SHOWING FABRIC CANOPY THAT COULD MOUNT TO INTERIOR FACE OF BEAMS (BEAMS ARE \sim 6' APART, ON CENTER)

*CANOPY FABRIC COVER COLOR WHITE OR LIGHT BEIGE, COMPOSITE FABRIC (HIGH DENSITY POLYETHYLENE OR EQUIVALENT)

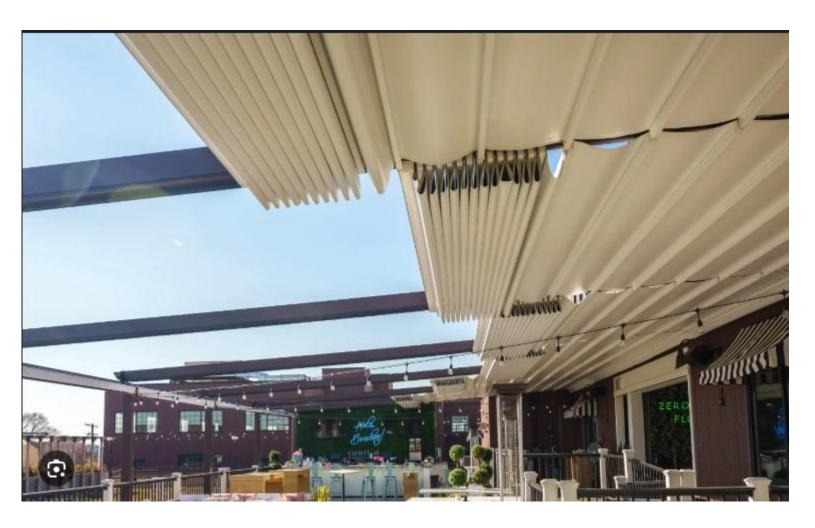
IMAGERY SHOWING FABRIC CANOPY THAT COULD MOUNT TO INTERIOR FACE OF BEAMS (BEAMS ARE \sim 6' APART, ON CENTER)

*CANOPY FABRIC COVER COLOR WHITE OR LIGHT BEIGE, COMPOSITE FABRIC (HIGH DENSITY POLYETHYLENE OR EQUIVALENT)

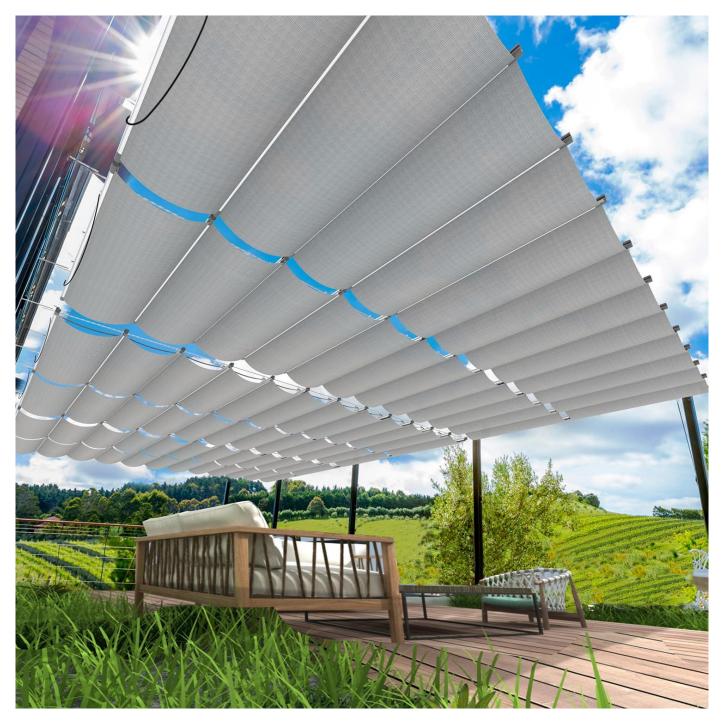
IMAGERY SHOWING FABRIC CANOPY THAT COULD SUSPEND FROM CABLES STRUNG TO STEEL STRUCTURE IF BEAMS ARE REMOVED

*CANOPY FABRIC COVER COLOR WHITE OR LIGHT BEIGE, COMPOSITE FABRIC (HIGH DENSITY POLYETHYLENE OR EQUIVALENT)

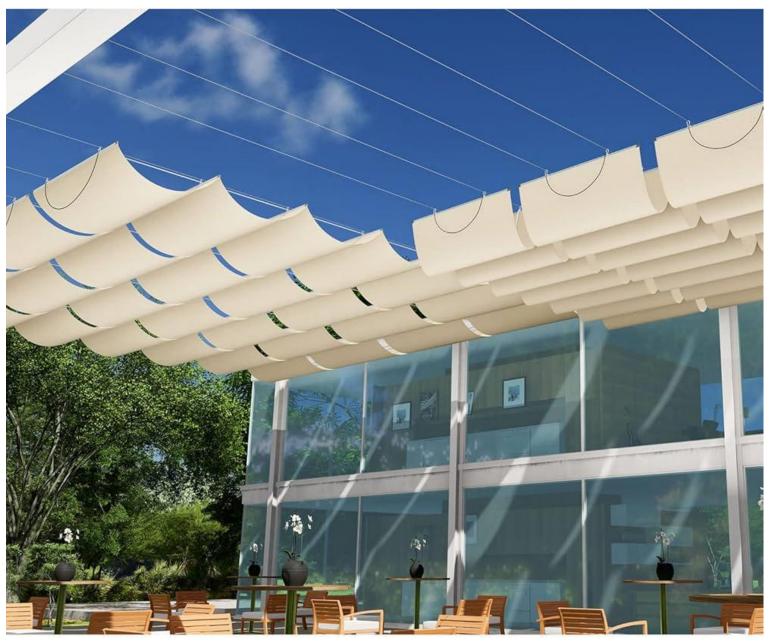
IMAGERY SHOWING FABRIC CANOPY THAT COULD SUSPEND FROM CABLES STRUNG TO STEEL STRUCTURE IF BEAMS ARE REMOVED

*CANOPY FABRIC COVER COLOR WHITE OR LIGHT BEIGE, COMPOSITE FABRIC (HIGH DENSITY POLYETHYLENE OR EQUIVALENT)
