Landmark NOMINATION Application

Name: Wilde Streatfield Residence

Street and Number: 2409 11th Avenue West, Seattle Washington 98119

**Wilde Streatfield
Residence**

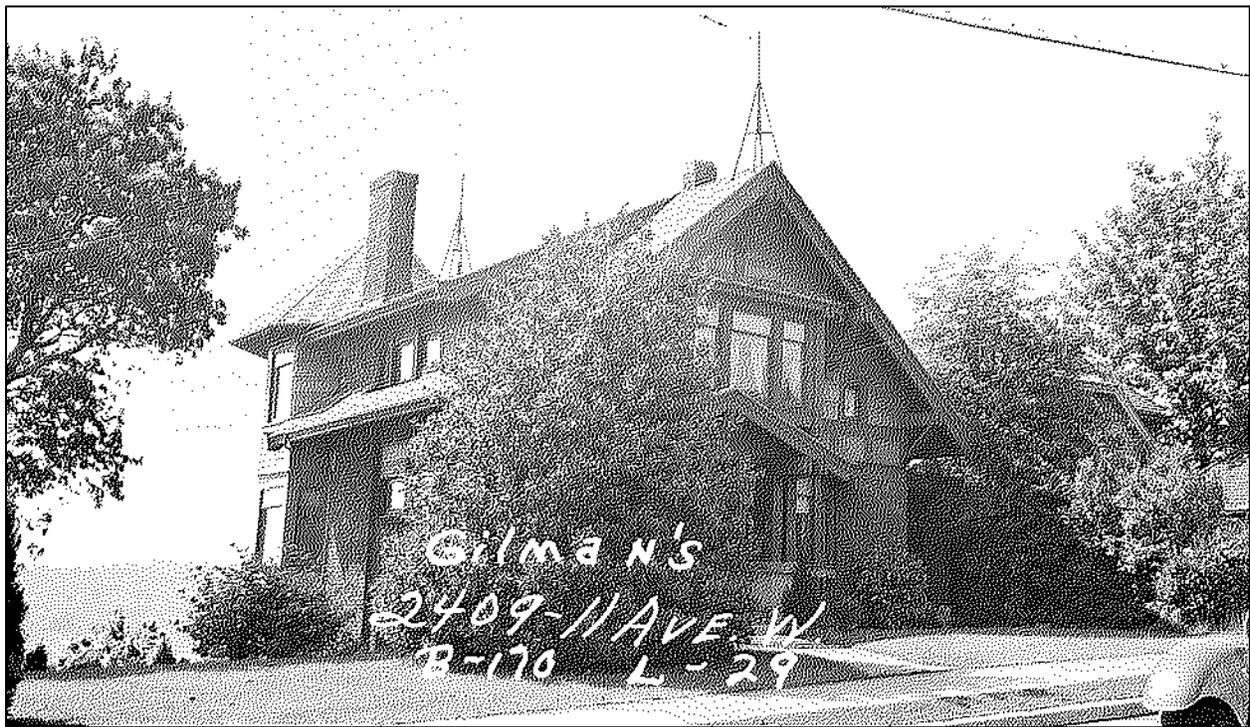
Fig. 20 – 1937 King County Assessor photo of the house.

The original house may be best understood by noting the conditions shown in the record photo and cited in the assessor's form, which notes the house as having two stories and containing twelve rooms – four in basement, five on the first floor and three on the second floor. (In the assessor reports, "rooms" exclude pantries, halls, and bathrooms; stories are cited based on full-height spaces without sloped walls.) All rooms were finished with plaster, one painted and the others with wallpaper. Hardwood flooring was provided in four rooms: those on the first floor – and fir floors in the others, along with fir trim, and tilework in the bathrooms and the kitchen drainboard (counters). Also noted were three fireplaces, two with brick and one with a tile face, nine plumbing fixtures, a hot water oil burner, and a recreation room in the basement with a drain.

"Extra Features" cited in the record include "1 Beam Ceiling, 2-20' Dormers, 1-8' Box Window, 2 Bay W(window)" along with "Usual" built ins. The exterior cladding was cedar siding or brick veneer along with "30% Part Builtex" (cement-based stucco) and composition shingle roofing. The assessor's record lists a two-story and one-story porch, both roofed, "1 Con. 1 Glass." The wood frame structure appears to have been substantial as it included deeper than usual 2x10 floor joists at 18" bridged centers, along with 6x6 posts, a concrete foundation and porch, and "brick and mitered corner joints."

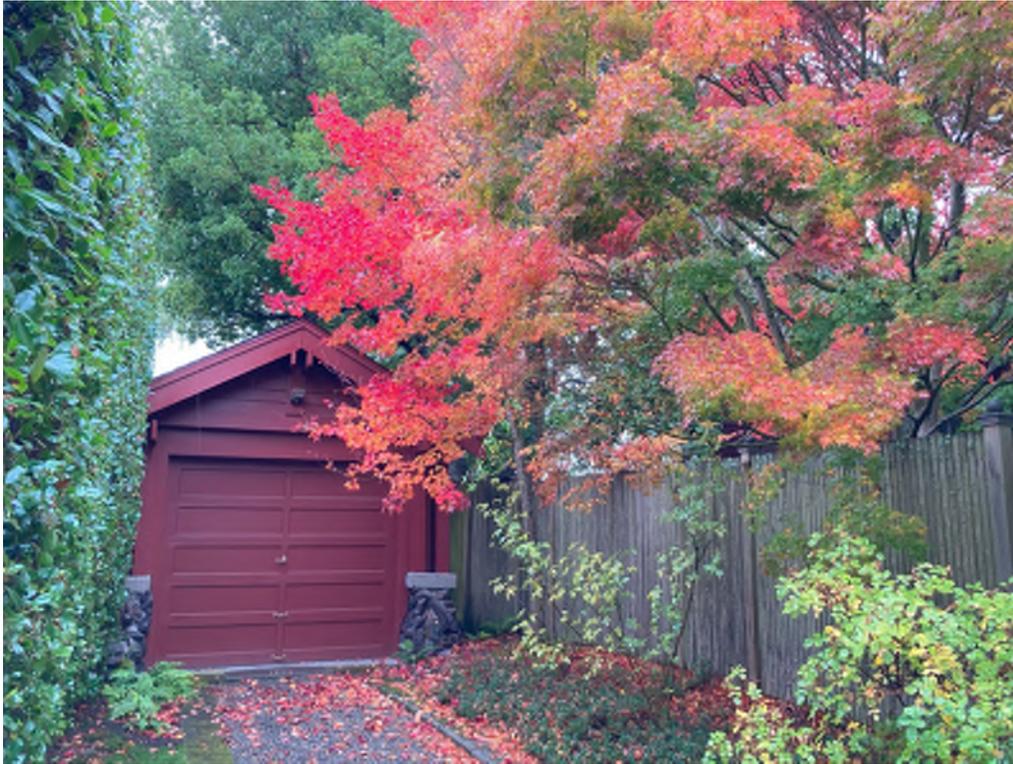
Fig. 36 – Garage, east facade, in the autumn.

The property contains a narrow concrete driveway, approximately 15 feet-deep and 8-feet-wide, from the southeast corner, which leads to a single car garage, 10 by 18 feet. The garage, built in 1926, is a small, free-standing wood frame structure supported by a tall reinforced concrete foundation. It contains a storage space in a full basement, which is inaccessible from the west garden level due to the steep slope and dense landscape. **[See Figs. 36-37 for current photos of the garage]**

dark red color of the house with wood clapboards, which are applied in a step fashion over foundation wall on the north facade. North and west facades each contain a small, fixed window. No historic photos or drawings of the garage have been discovered. With exception of the vehicle door, a painted wood panel overhead type, it is consistent in size and appearance with an early 20th century garage.

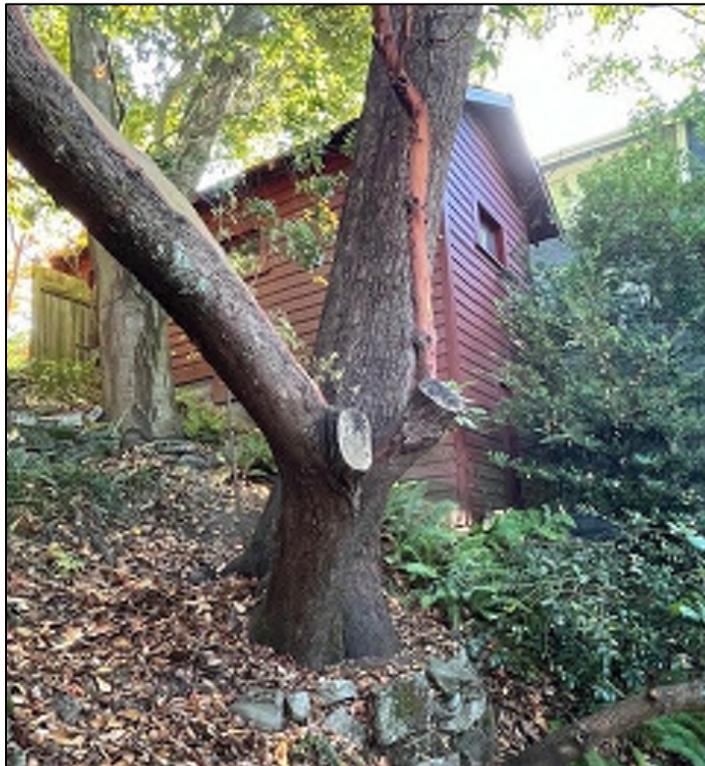
Fig. 37 – Garage, north and west facades.

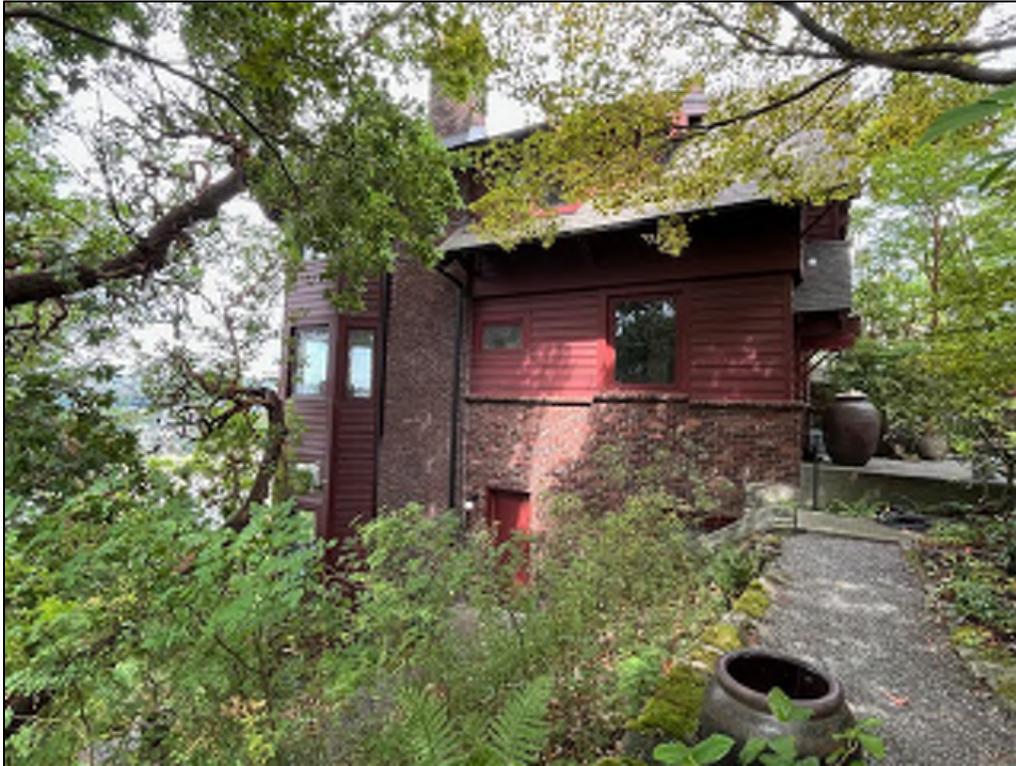
Fig. 38 – South facade.

The tall brick chimney on the south façade serves the three fireplaces located in the living room, second floor primary bedroom and basement apartment. On the exterior, the current owners cleaned and repointed the brick masonry over most of the south wall to the east of the chimney as part of their restoration efforts in ca. 1990. At the recommendation of their structural engineer, they also removed some of the masonry on the front (east façade), lowering the brick veneer to a height below the first-floor window and terminating it at a continuous brick sill.⁹

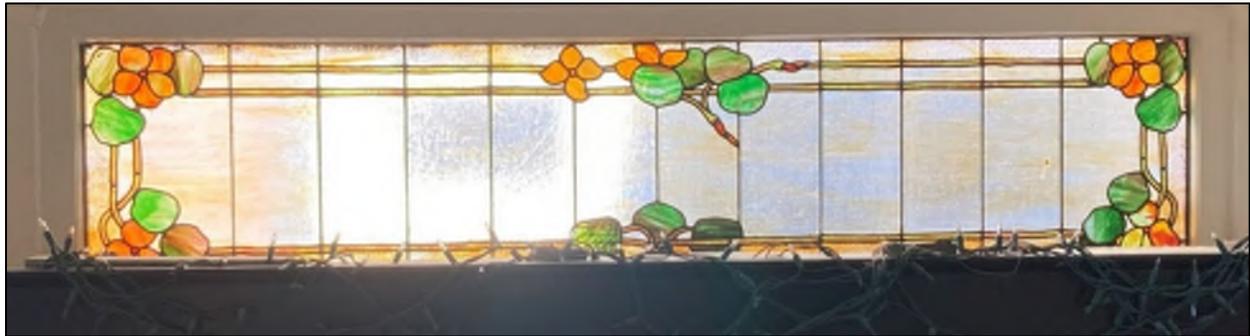
Fig. 55 – Above, an original stained glass window in the dining room.

Both rooms have views through windows on the west walls and a partially glazed door to the deck. While ample daylight comes into the living room through large, non-original wood windows in the semi-octagonal bay, the light in the dining room is filtered light through an original horizontal stained-glass window on the upper north wall.

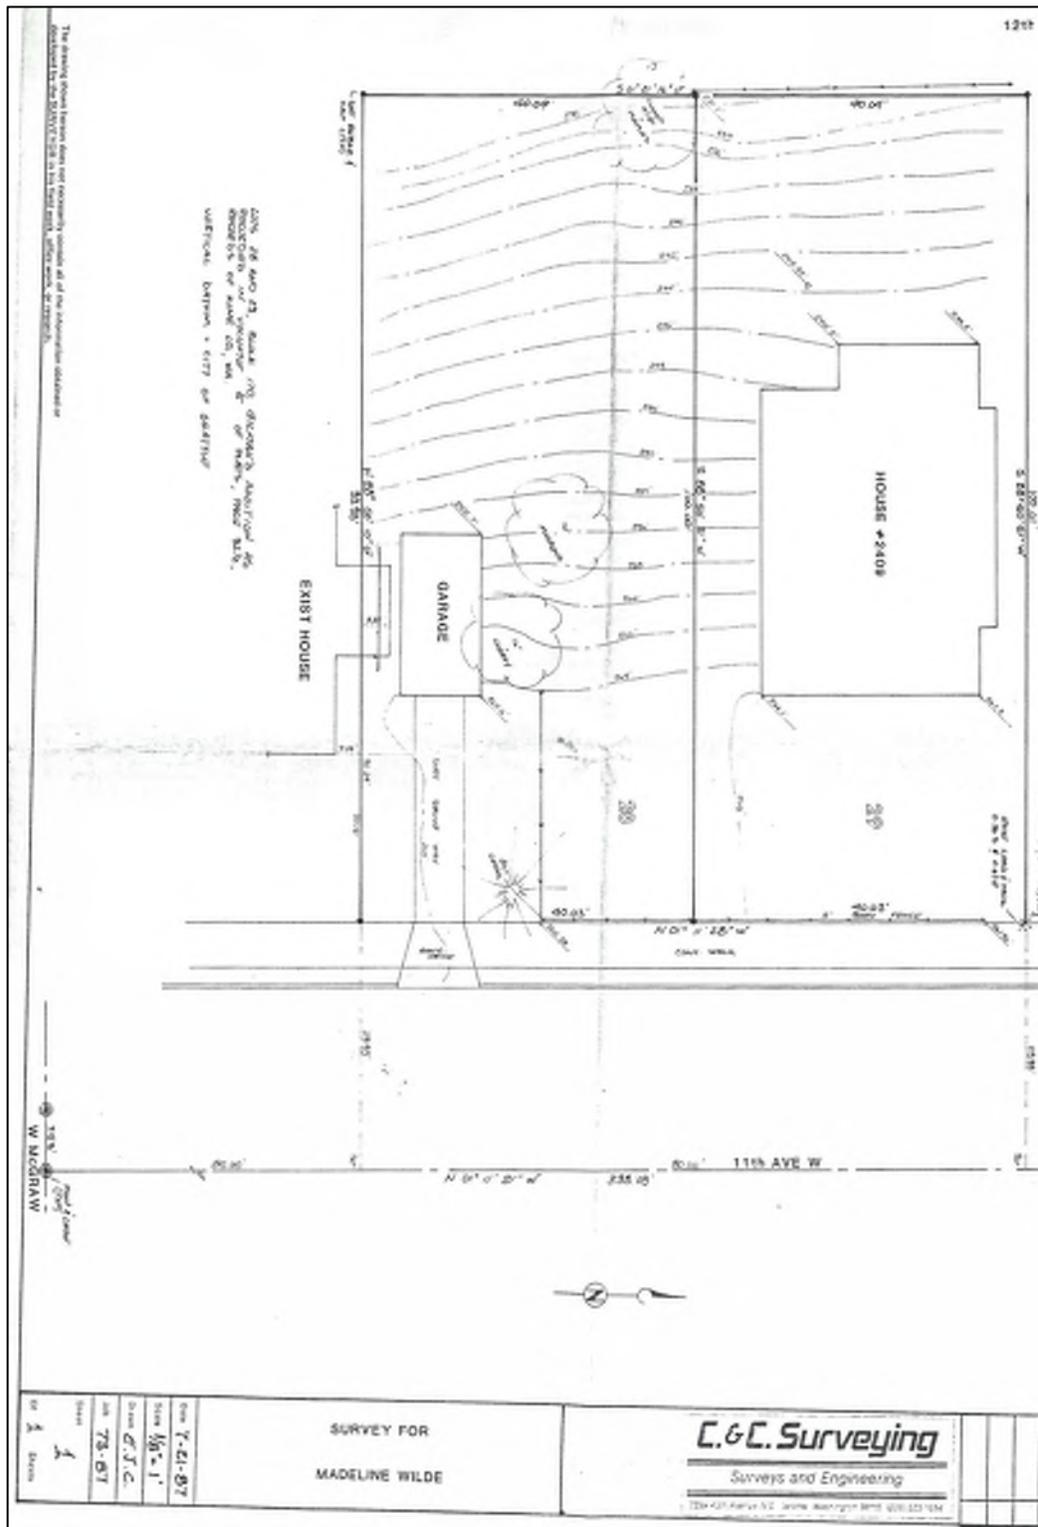
Fig. 86 – Site Plan of 2409 11TH Avenue W, Seattle WA

The grade change on the site is dramatic, rising approximately 32 feet from the southwest corner to the northwest corner. The slope is accommodated by on-grade entries at three of the four levels of the house, with concrete steps along the south side and a wood framed stair and reinforced concrete retaining wall on the north side. The deep reinforced concrete foundations include four exposed buttresses around the outer octagonal turret tower, and a heavy concrete deadman footing. Retaining walls that line the upper sides of the garden terraces consist of recycled dry-stacked concrete rip rap, 4 to 8 inches-thick. A series of concrete and stone treads and angled paths crisscross the southern side of the site (lot 28), and the back yard to access the multiple garden terraces. Some paths are lined with rough basalt stones and rustic pieces of dark red clinker brick.

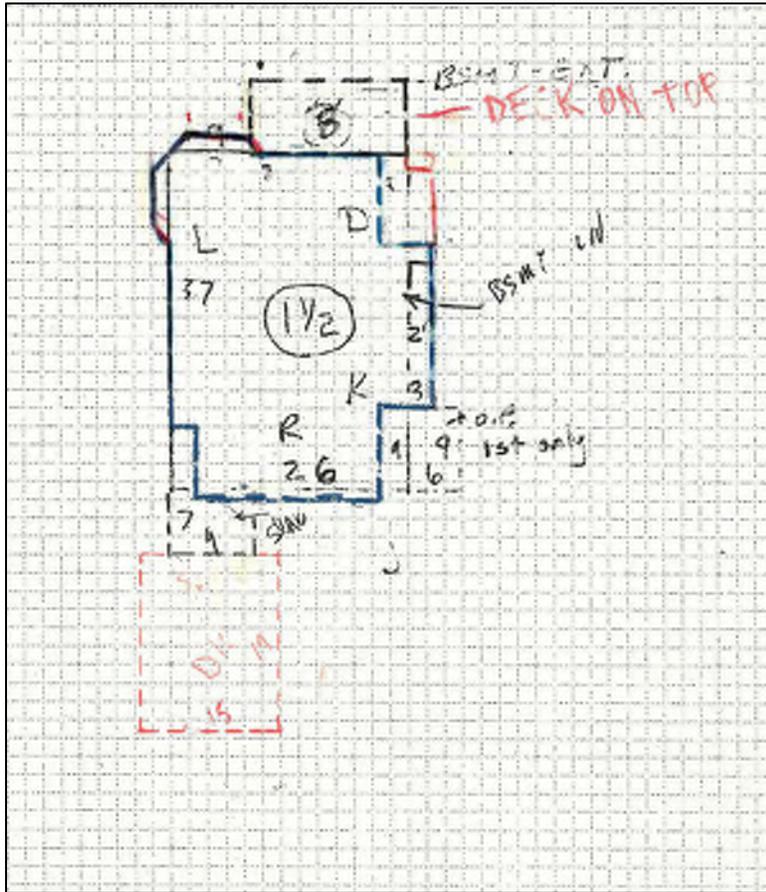
Fig. 88 – Detail of house floor plan in King County Assessor’s historic post-1972 Property Record Card (Puget Sound Regional Archives)

A simple sketch in the 1937 assessor's archival record shows a rectangular plan 26 by 37 feet, with a 6 by 11-foot porch near the south end of the primary east facade and a 7 by 17-foot sunroom on the opposite corner at the back. Additional projections of 2 by 20 feet and 4 by 17 feet are listed. (The turret-like projection at the southwest corner is visible in the accompanying 1937 photograph, but it is not listed as a feature or indicated in the sketched plan; the "sunroom" noted in the plan appears to refer to a room at the basement level.) A similar plan sketch in the current assessor's records shows the same overall dimensions of the house, 26 feet-wide by 37 feet-deep, along with the partial octagonal mass at the southwest corner, and an open deck off the northwest side of the first floor in the place of the former sunroom.
