Anderson Hall Renovation

University of Washington | DON Certificate of Approval Application | Forest Club Room Mezzanine Removal

CA 4-A PROJECT VISION & GOALS

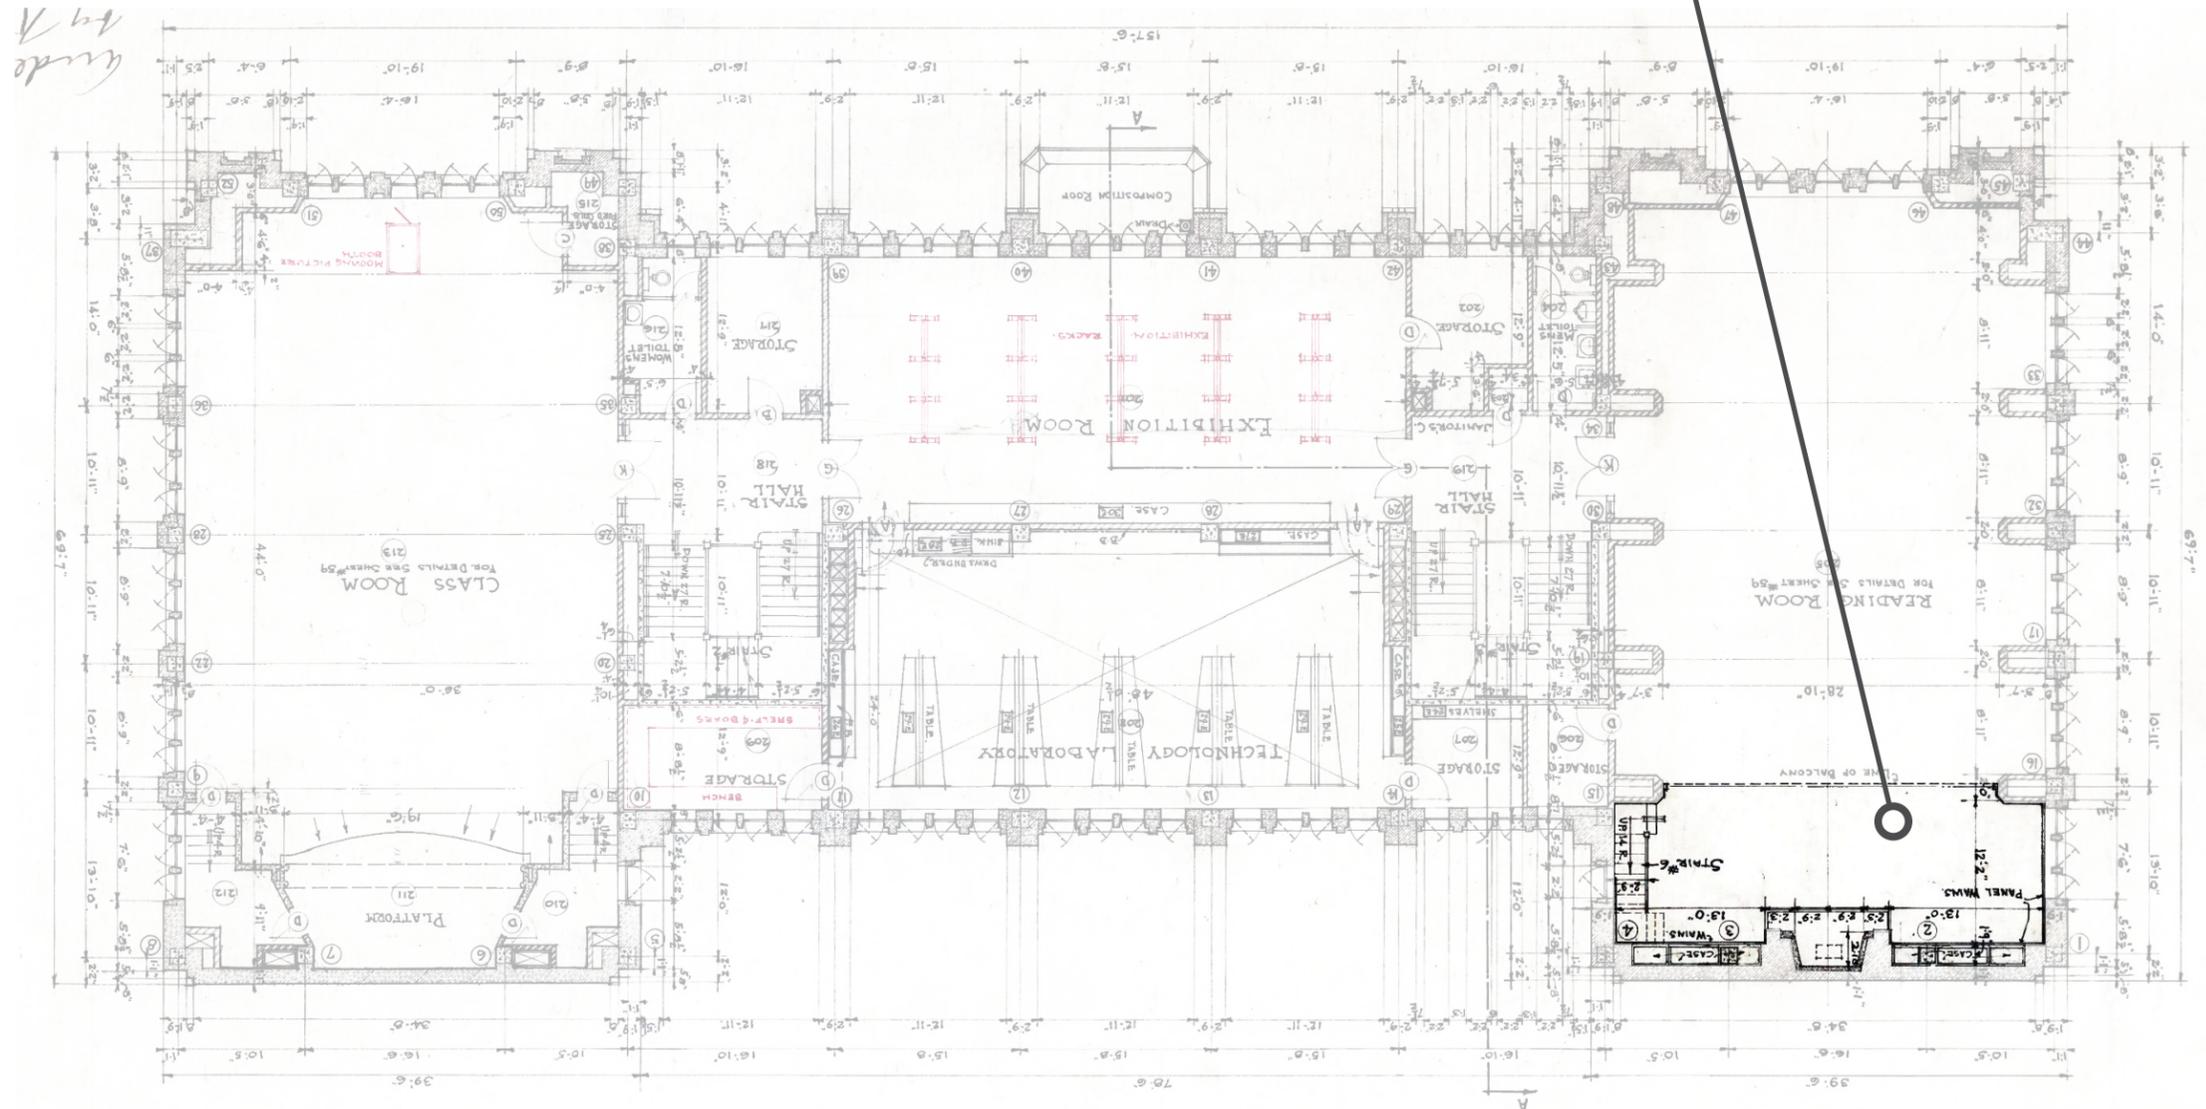
2ND FLOOR PLAN ①

MEZZANINE ABOVE (NO ORIGINAL FLOOR PLANS FOR THE MEZZANINE EXIST)

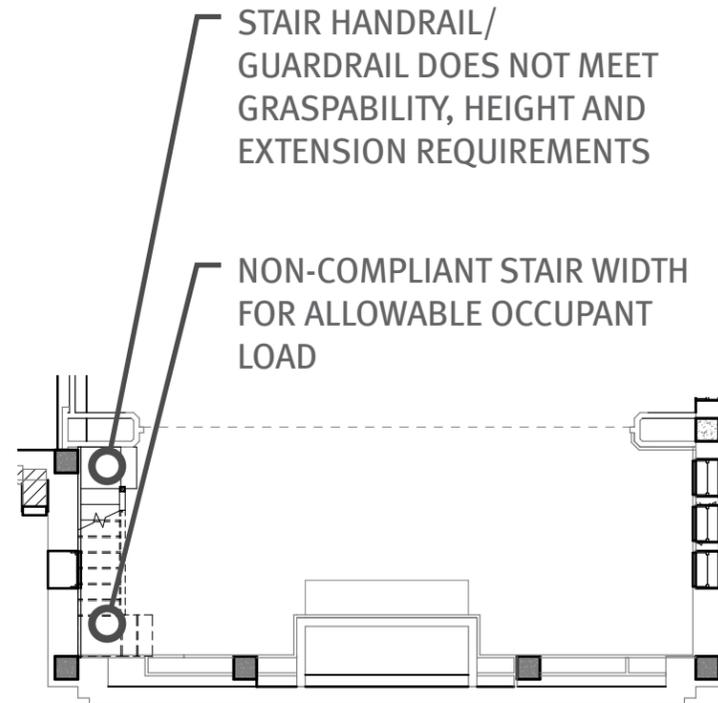
PLAN BELOW MEZZANINE

Currently, the mezzanine in the Forest Club Room is not used and the University has restricted access to the space due to public safety concerns with non-compliant conditions. Additionally, access is currently restricted with a chain and signage but the University has found this solution to be insufficient. As an area that is inherently sequestered and removed from sightlines, the mezzanine is an area of concealment, isolation and security risk.

- The mezzanine does not comply with means of egress for the allowable occupant load
- The structural capacity of the mezzanine is insufficient for the allowable occupant load
- The mezzanine does not comply with stair and elevated surface guardrail heights

As a result, SDCI requires restricting use of the mezzanine with a more robust barrier than the existing chain and signage unless the mezzanine is made to be compliant or removed.

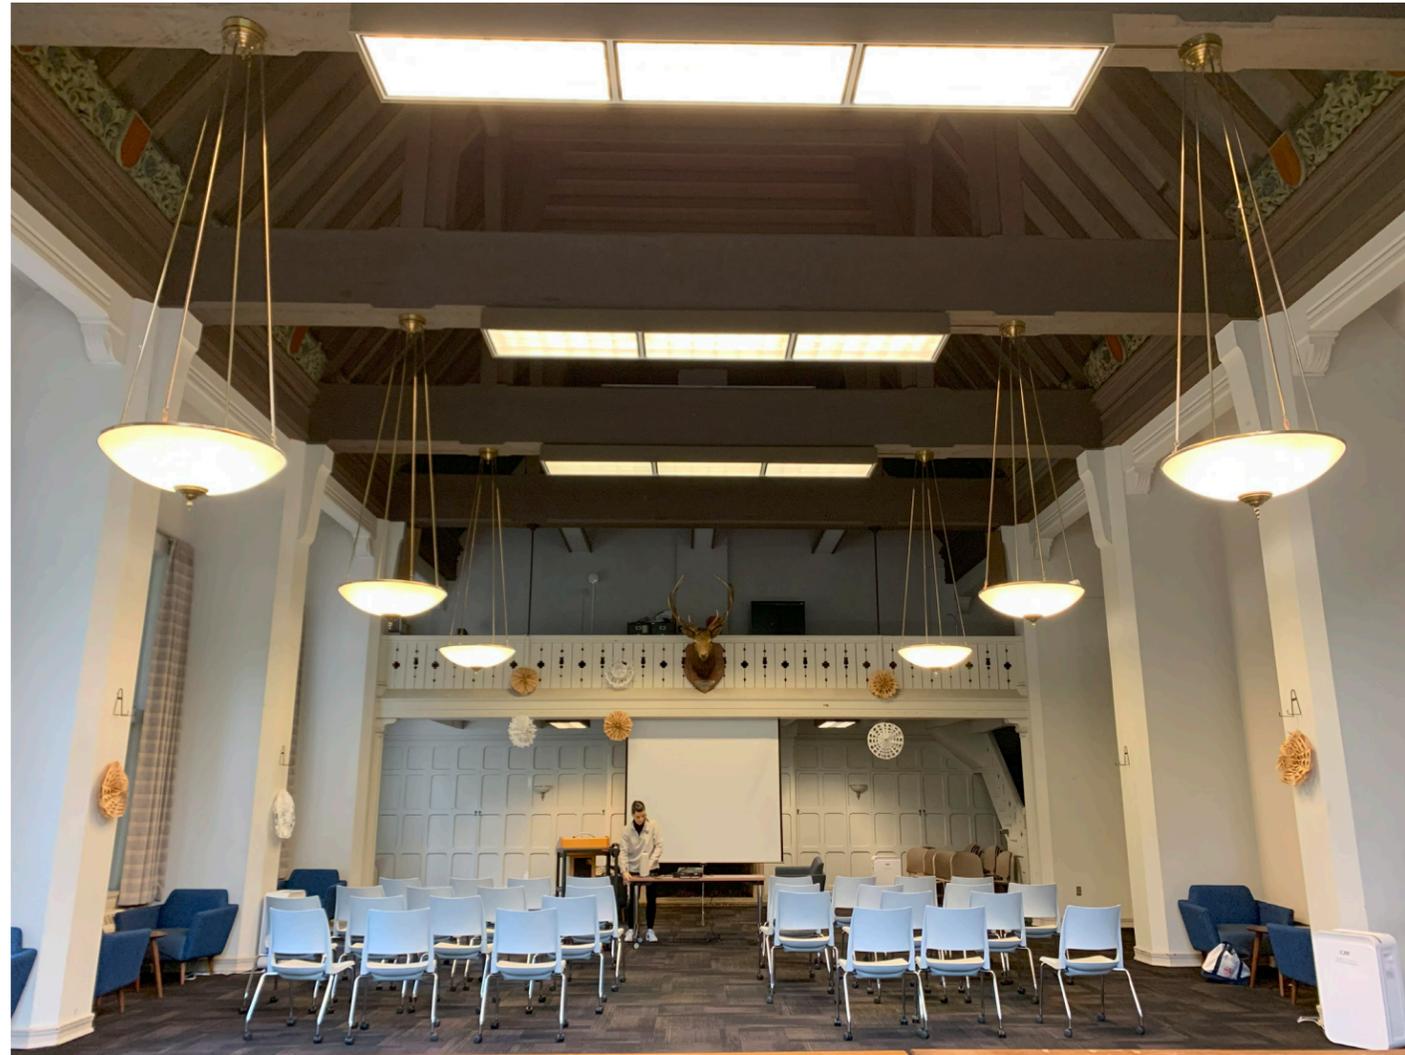
Forest Club Room, looking south at the mezzanine

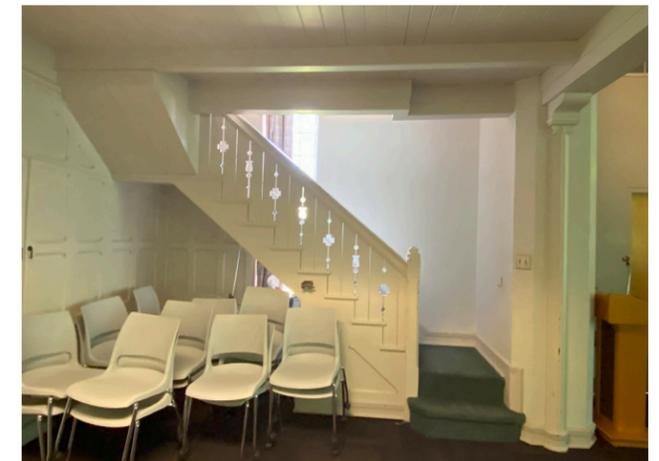
Stair to mezzanine

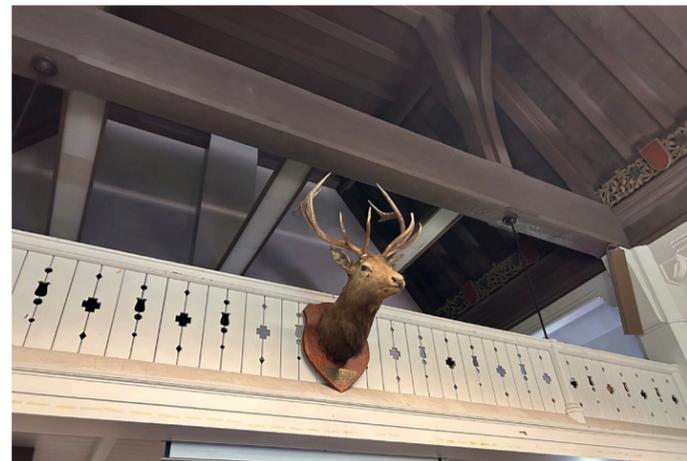
Mezzanine railing

- Install salvaged historic railing
- Provide new wood trim mantel with roll-down projection screen
- Install salvaged wood panelling
- Repair plaster on west wall as required

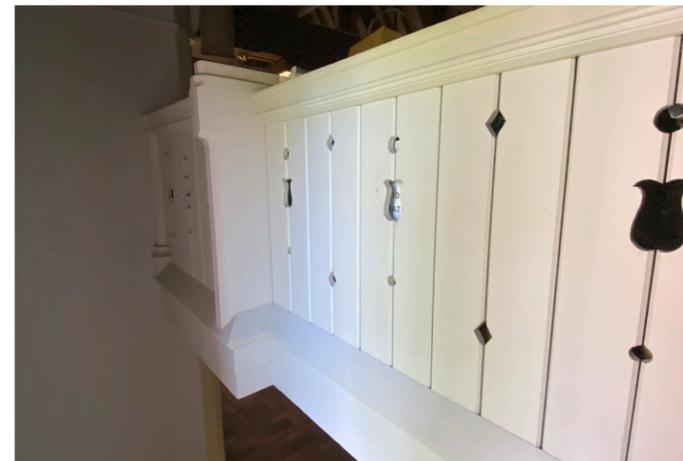
Mezzanine railing details

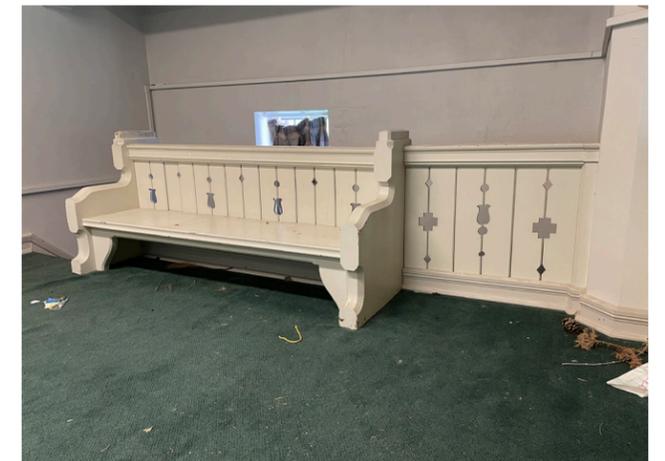
Mezzanine railing and bench above stair opening

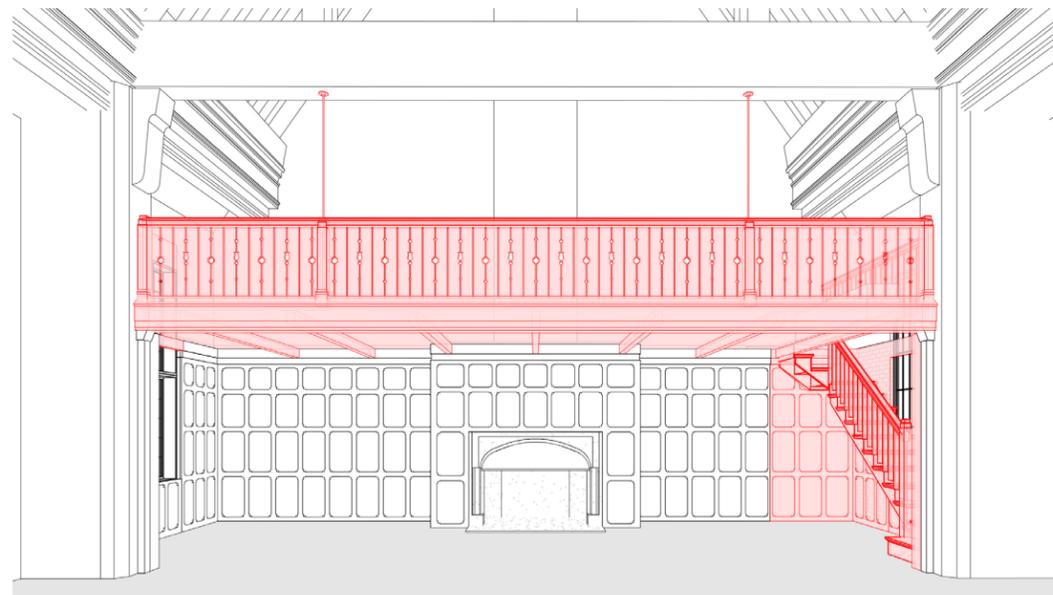
OPTION 2 - SELECTIVE DEMOLITION & SALVAGE DIAGRAM

- Remove non-compliant mezzanine
- Remove non-compliant and non-accessible mezzanine stair

- 1 Code compliance**
The existing non-compliant mezzanine and stair would be removed.
- 2 University's security concerns**
Removal of the mezzanine and stair would eliminate the current security concern.
- 3 Impact to historic fabric**
Historic elements are not proposed to be salvaged and little to no evidence of the mezzanine and stair would remain.
- 4 Universal Access**
Removing the mezzanine eliminates the condition of universal access inequity.

Although this option addresses the code compliance, safety concerns and eliminates the current condition of universal access inequity, because it removes all elements of the mezzanine leaving no evidence of the original mezzanine, this option is not recommended.

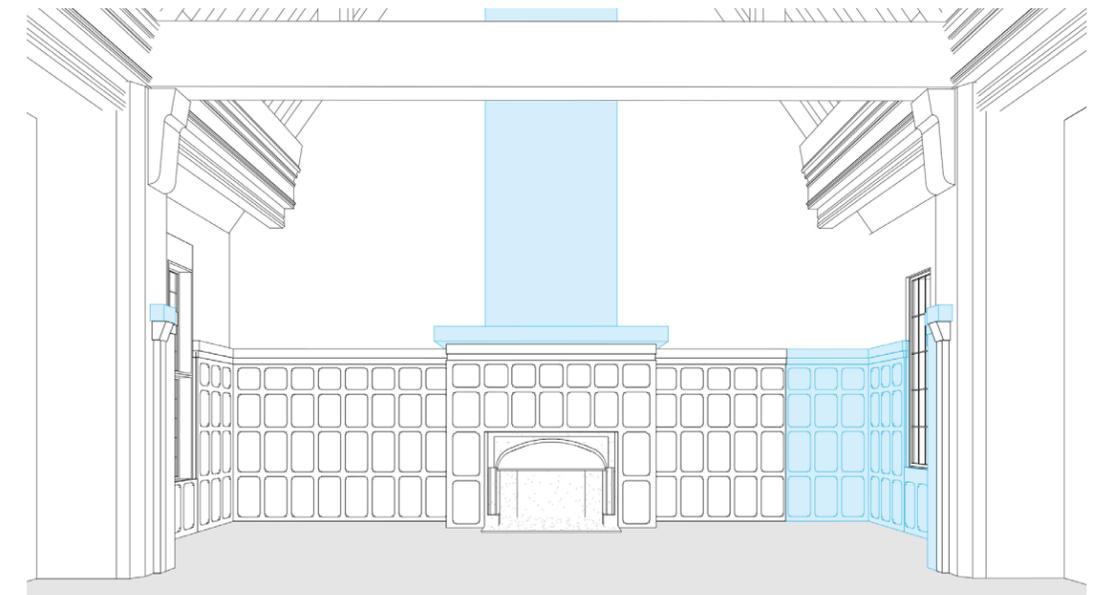
OPTION 2 - DESIGN DIAGRAM

- Provide new painted wood paneling to match existing historic wood paneling
- Provide new wood trim to match existing historic wood trim
- Provide new wood trim mantel and integrate projector screen

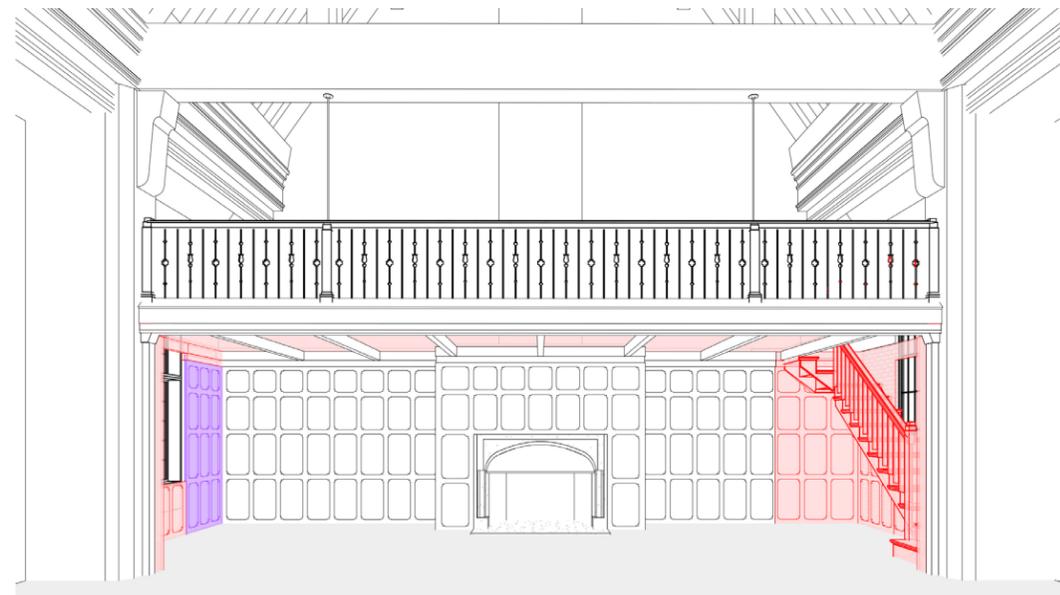
OPTION 3 - DEMOLITION & SALVAGE DIAGRAM

- Remove mezzanine floor
- Remove non-compliant and non-accessible mezzanine stair

Although this option addresses code compliance issues and the University's security concern, eliminates conditions of universal access inequity, as well a maintains clear evidence of the original mezzanine, because it introduces new risk to the University, this option is not recommended.

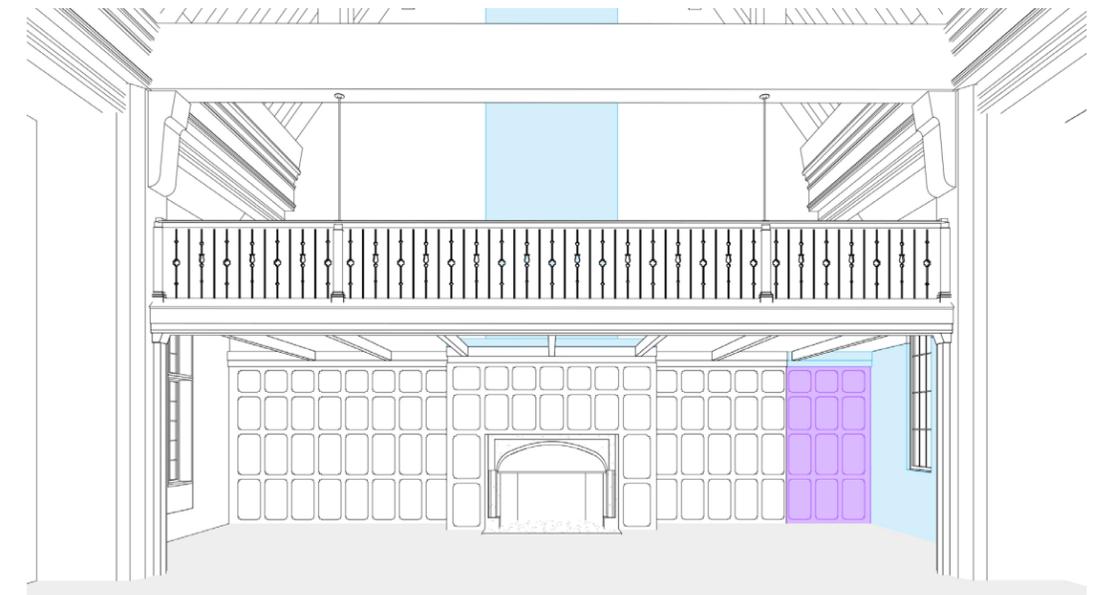
OPTION 3 - DESIGN DIAGRAM

- Provide new painted wood paneling to match existing historic wood paneling
- Provide new wood trim to match existing historic wood trim
- Provide new wood trim mantel and integrate projector screen

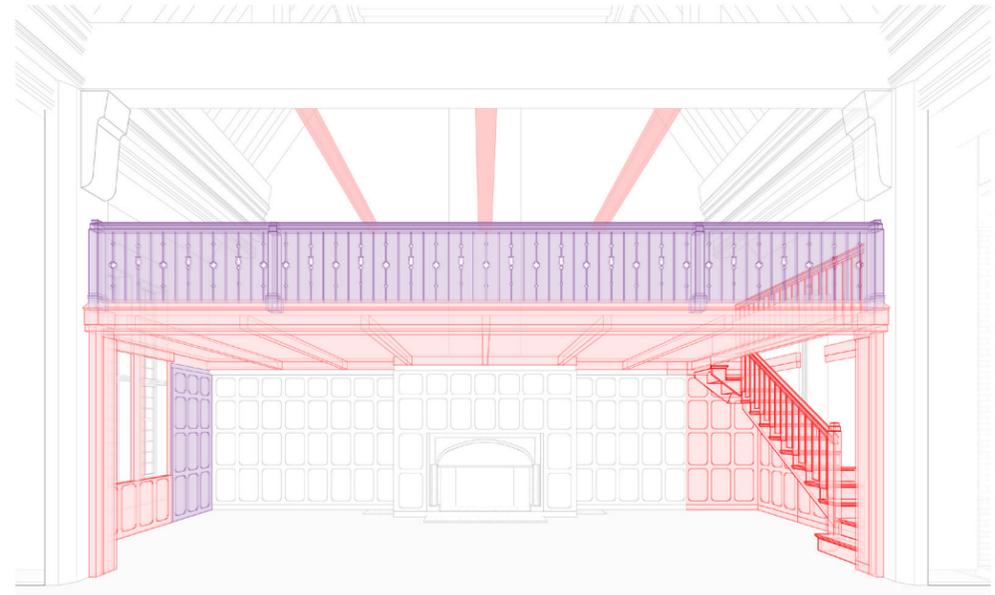
PROPOSED SELECTIVE DEMOLITION & SALVAGE DIAGRAM

- Remove non-compliant mezzanine
- Remove non-compliant and non-accessible mezzanine stair
- Salvage historic railing
- Salvage wood panelling
- Remove non-historic mezzanine lights

- 1 Code compliance**
 The existing non-compliant mezzanine and stair would be removed.
- 2 University's security concerns**
 Removal of the mezzanine and stair would eliminate the current security concern.
- 3 Impact to historic fabric**
 Salvages and reuses the historic railing and paneling to provide context and evidence of original mezzanine.
- 4 Universal Access**
 Removing the mezzanine eliminates the condition of universal access inequity.

This option is recommended and proposed as it addresses code compliance issues and the University's safety concerns, retains historic fabric to provide evidence of the original mezzanine, and eliminates the current condition of universal access inequity.

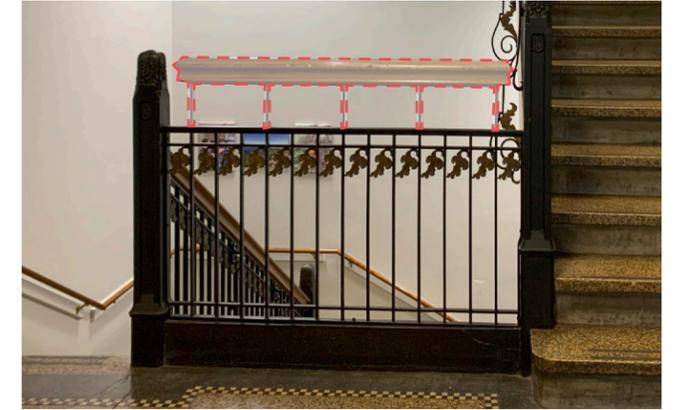
View of existing stair landing with non-historic railing and proposed recreation of historic condition

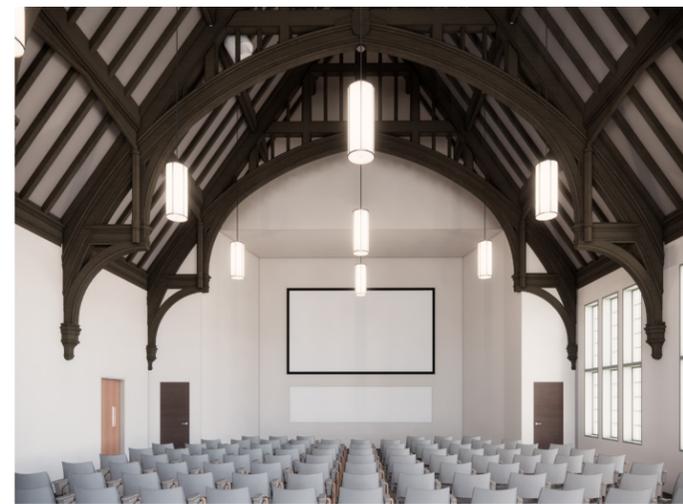
Rendering of proposed light fixture in Auditorium

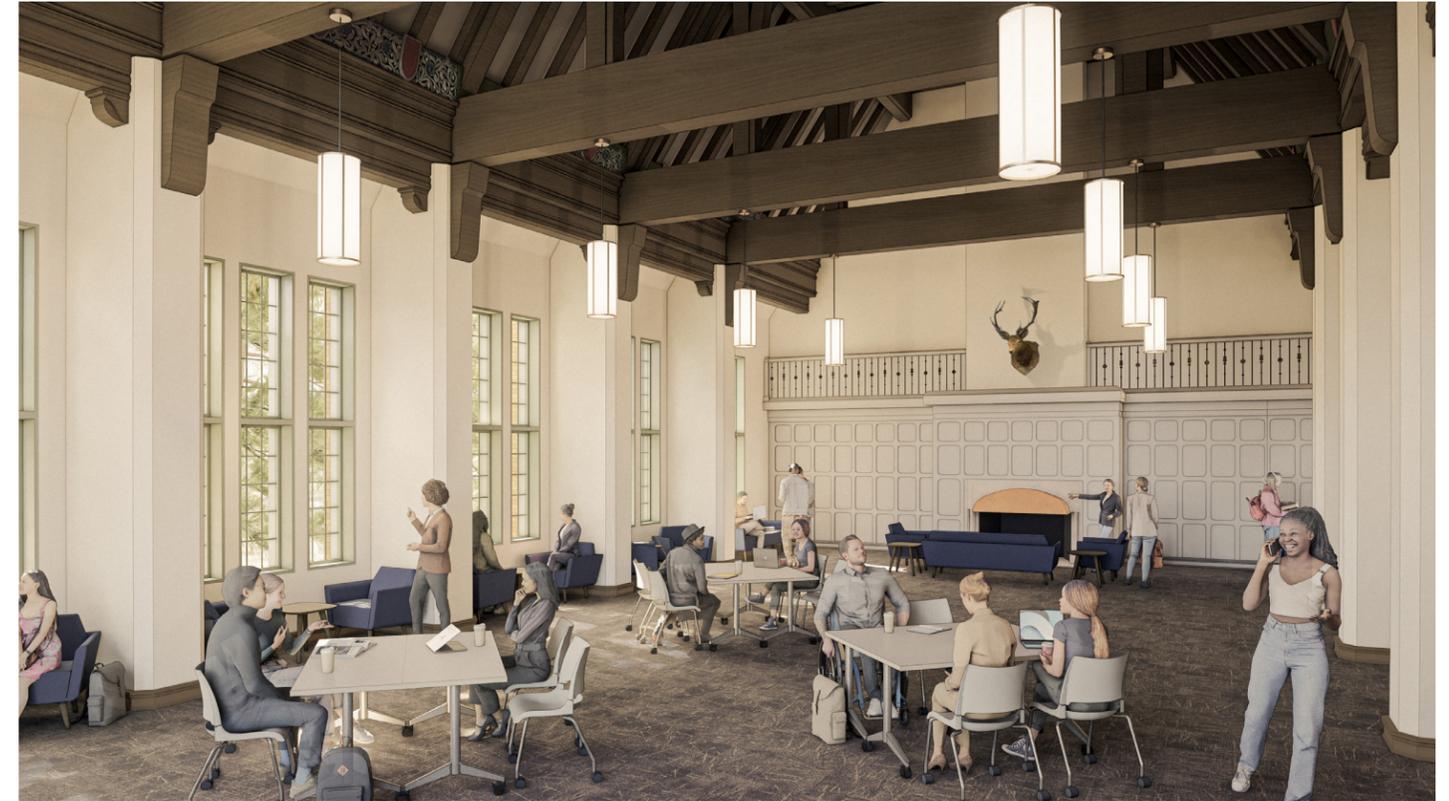
Proposed design looking southeast

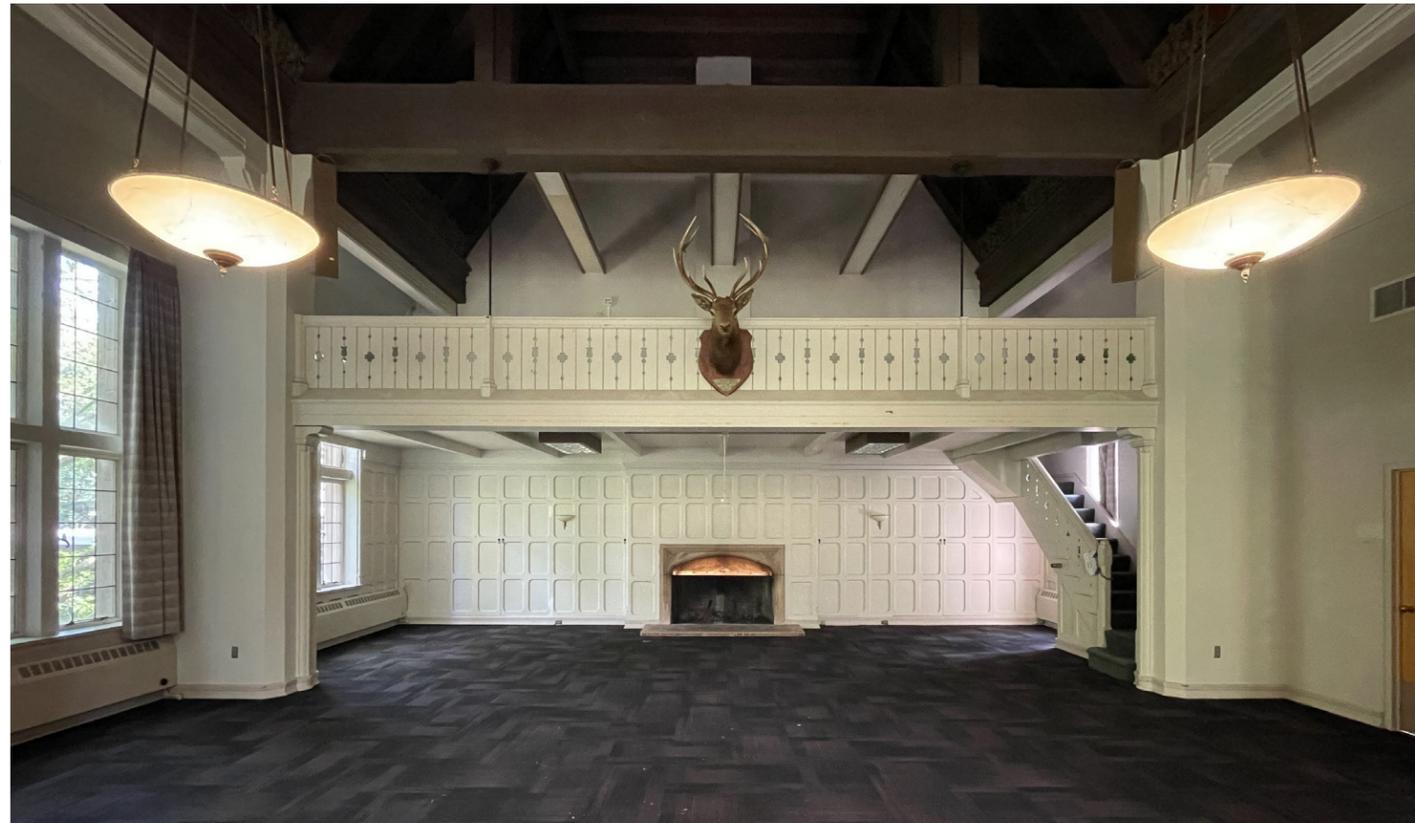
Current condition looking south

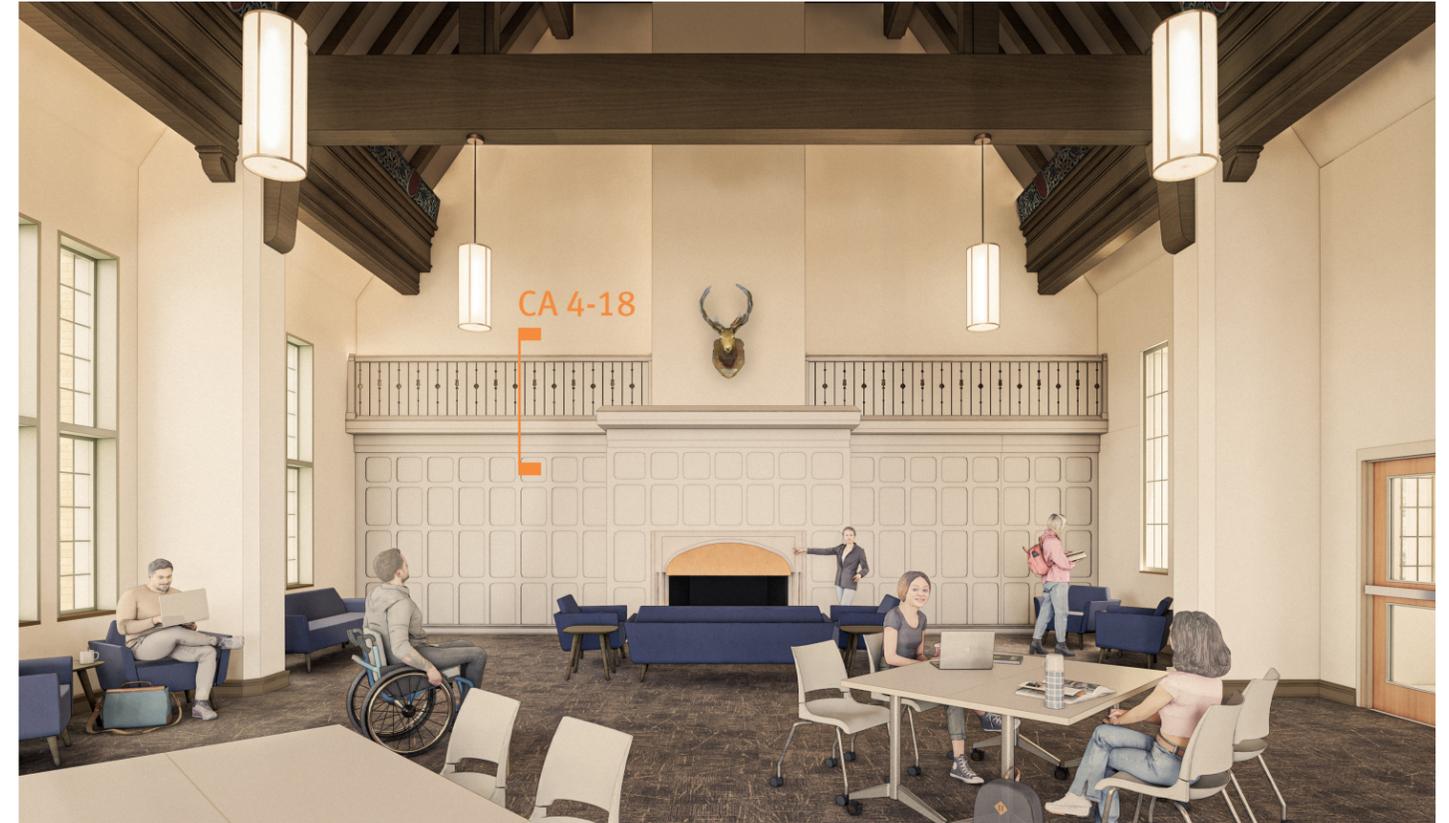
Proposed design looking south

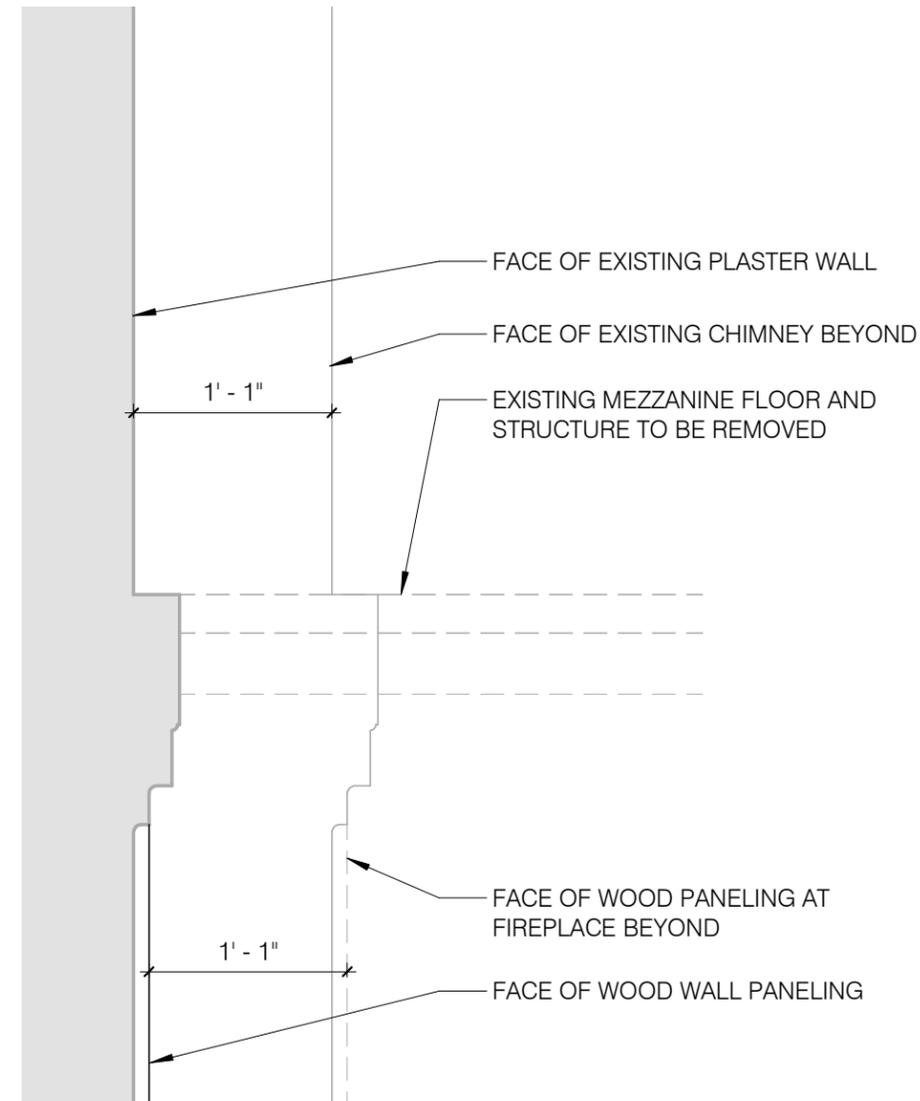
DETAIL SECTION AT FUTURE RAILING:
EXISTING CONDITIONS DIAGRAM

The diagram at right shows the existing relationships between the typical wood paneled wall and the fireplace and chimney at the Forest Club Room. A historic drawing of this condition does not exist. The diagram reflects as-built conditions, measured by a laser array point cloud scan. Notable aspects of the existing condition include:

- 1 Offset between wood panels at wall and fireplace**
The project team seeks to maintain the dimensional relationship between these elements.
- 2 Offset between plaster wall and chimney**
The project team seeks to maintain the dimensional relationship between these elements.
- 3 Decorative trim atop wood panels at underside of mezzanine**
The project team will preserve decorative trim at the underside of the mezzanine.

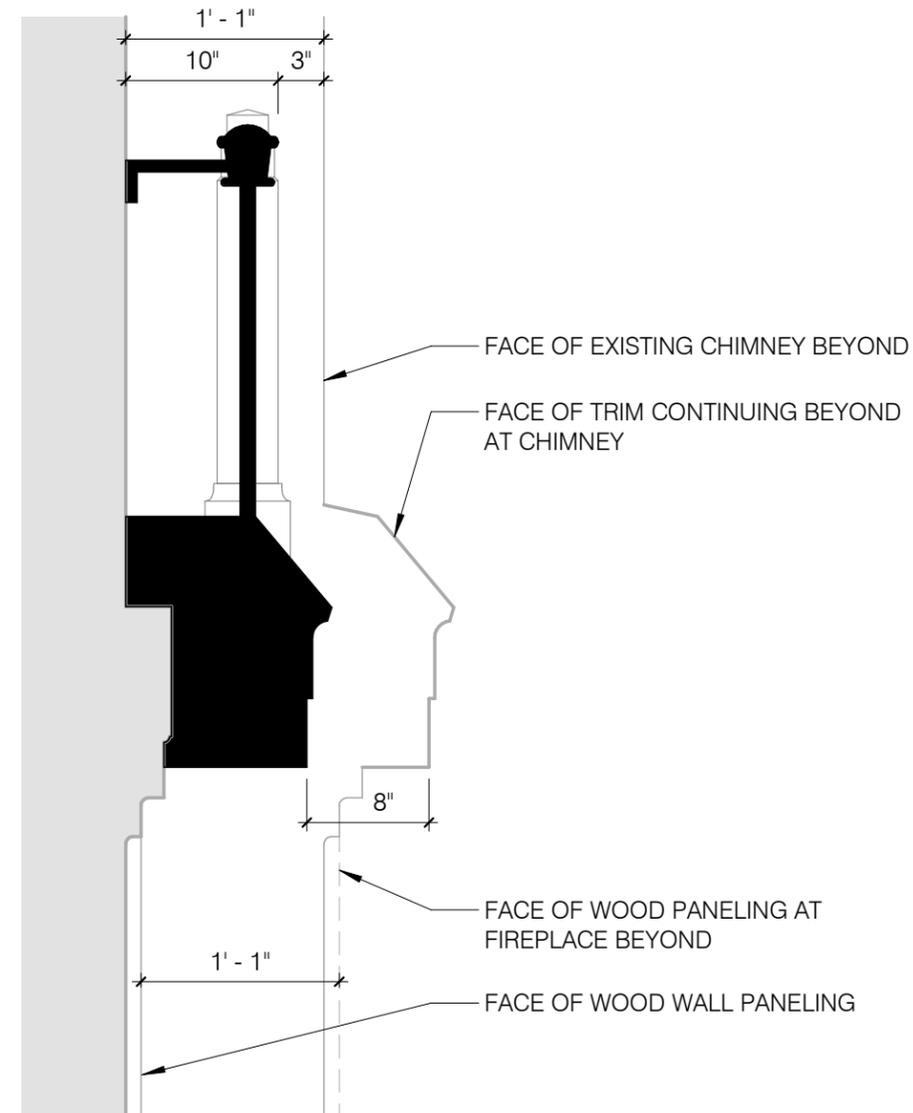
PROPOSED DETAIL SECTION AT RAILING

The void space behind the railing is enclosed for ease of cleaning and maintenance, and to avoid debris and dirt from accumulating behind the rail.

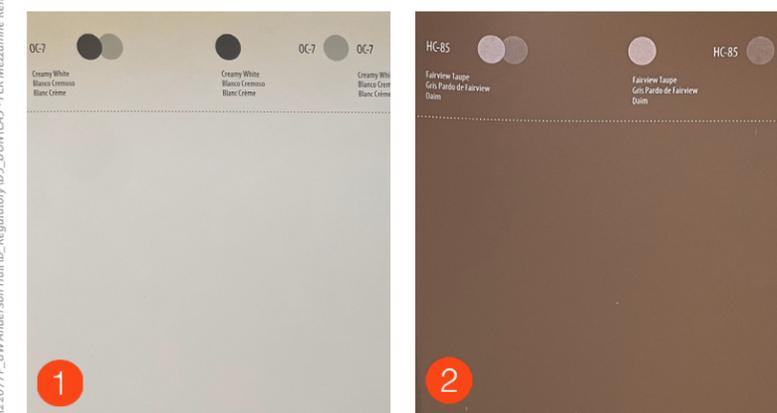
PROPOSED PAINT PALETTE: PHOTOS OF PHYSICAL SAMPLES*

*Photographing physical samples presents challenges for color rendering accuracy due to camera limitations and lighting conditions. The photos shown were taken in an environment with both natural daylight and artificial lighting. Manufacturer's digital samples have also been provided.

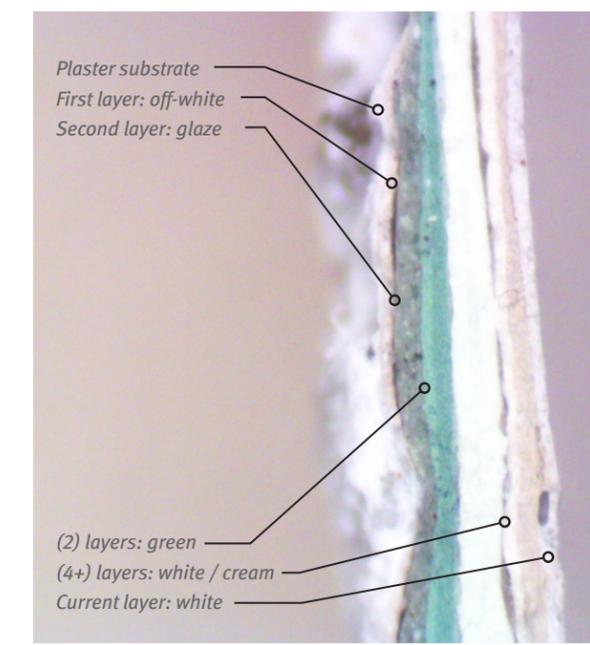
1 Microscopic paint sample from Forest Club Room plaster wall

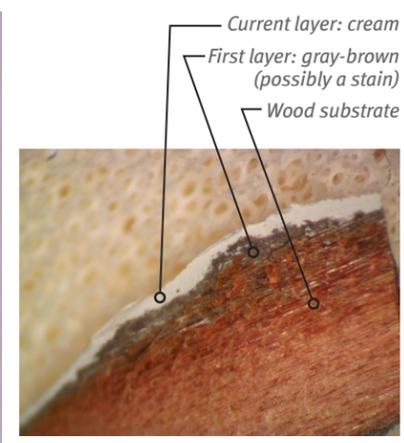
1 Microscopic paint sample from Forest Club Room wall woodwork

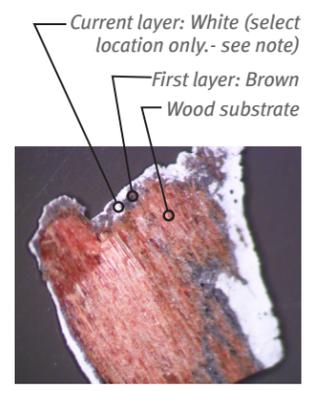
2 Microscopic paint sample from Forest Club Room wood ceiling. Note: sample was taken from lower north-south running beam along east elevation that has been painted white, but originally matched the rest of the ceiling

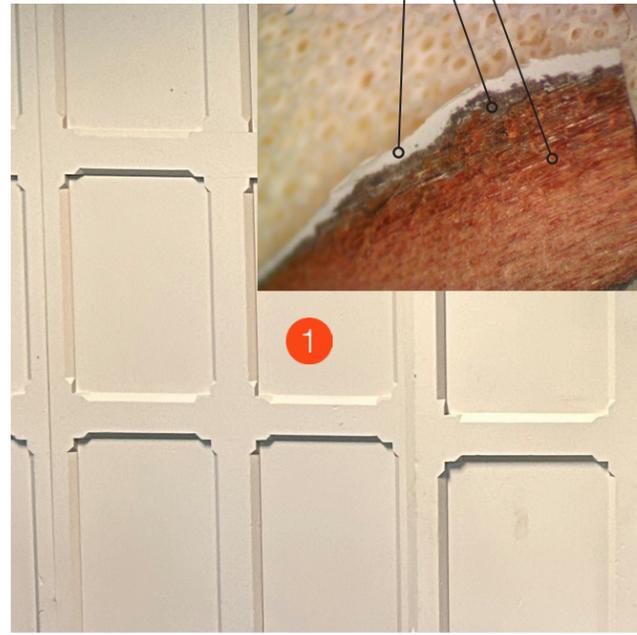
Current layer: cream
First layer: gray-brown
(possibly a stain)
Wood substrate

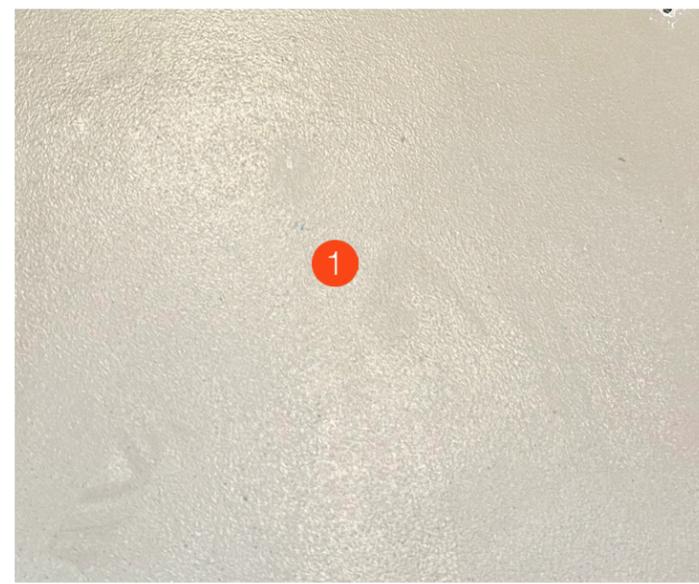
Proposed paint for Forest Club Room wood features at walls and mezzanine

Proposed paint for Forest Club Room plaster walls.

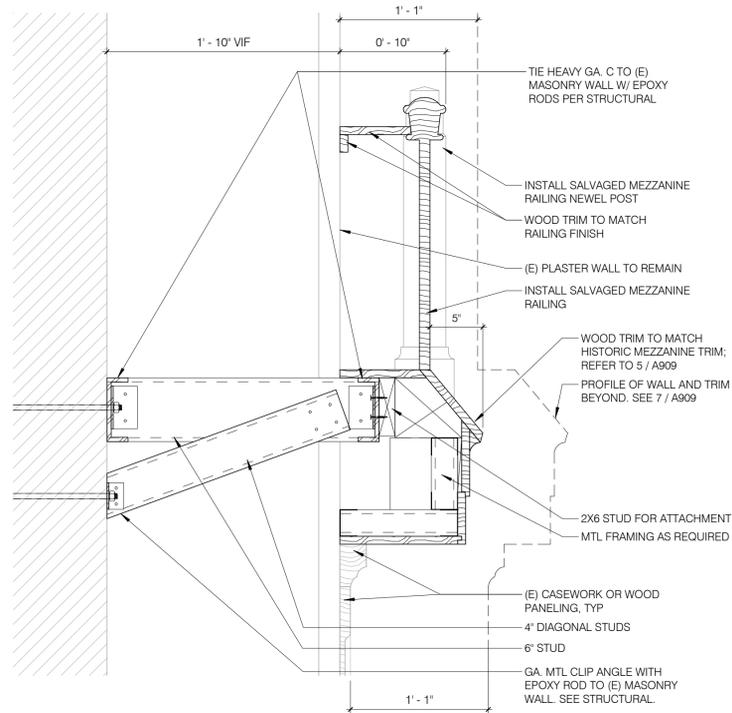
5 SECTION DETAIL - HISTORIC FCR FOR MEZZANINE
A909 1 1/2" = 1'-0"

ALL MEASUREMENTS TO BE VERIFIED IN FIELD BEFORE MEZZANINE TRIM AND BEAM REMOVAL. DIMENSIONS TO BE RECORDED FOR REFERENCE.

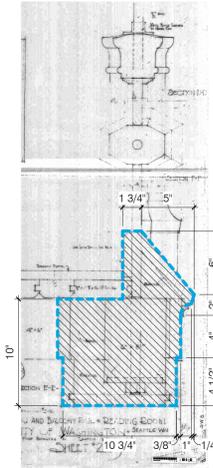
7 SECTION DETAIL - CHIMNEY ENCLOSURE @ WALL PANELS
A909 1 1/2" = 1'-0"

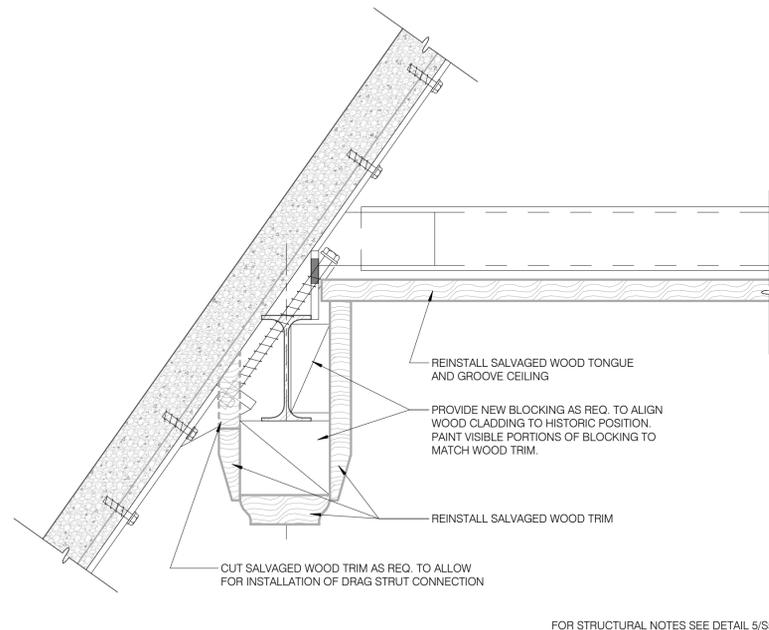
3 DETAIL - DRAG STRUT AT FCR
A909 1 1/2" = 1'-0"

ALL MEASUREMENTS TO BE VERIFIED IN FIELD BEFORE PILASTER REMOVAL TO MAINTAIN HISTORIC CONFIGURATION.

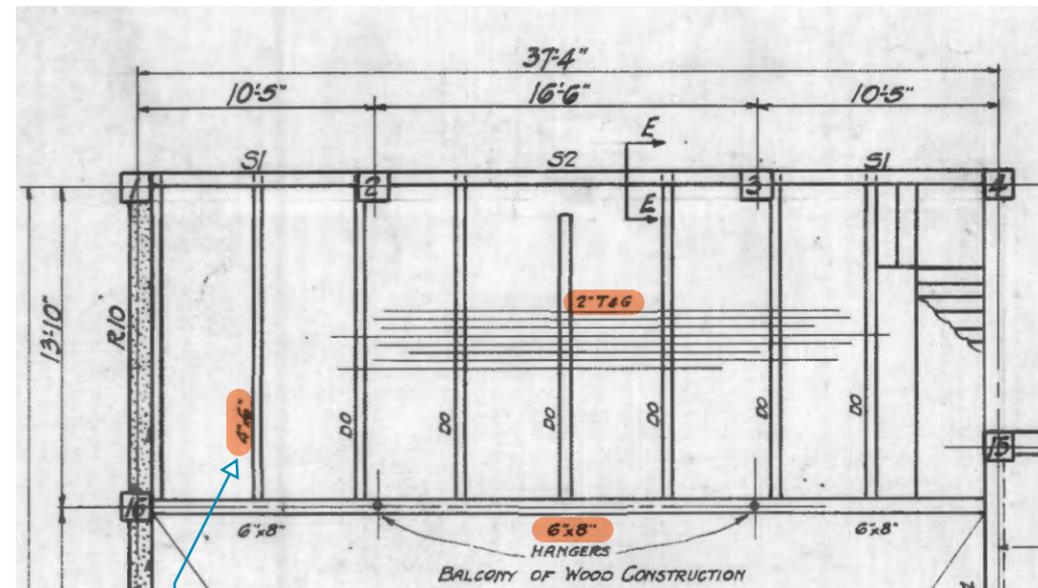
The 4x6 joists are the controlling members. Max allowable live load for the L3 mezzanine is 13 psf

see following pages for capacity checks of each member

Span	16.5 ft
DL	9.0 psf
S	51.6 in ³
Mmax	86650.3 lb-in
	7220.9 lb-ft
Trib width	7.0 ft
Max Allowable LL	21.3 psf

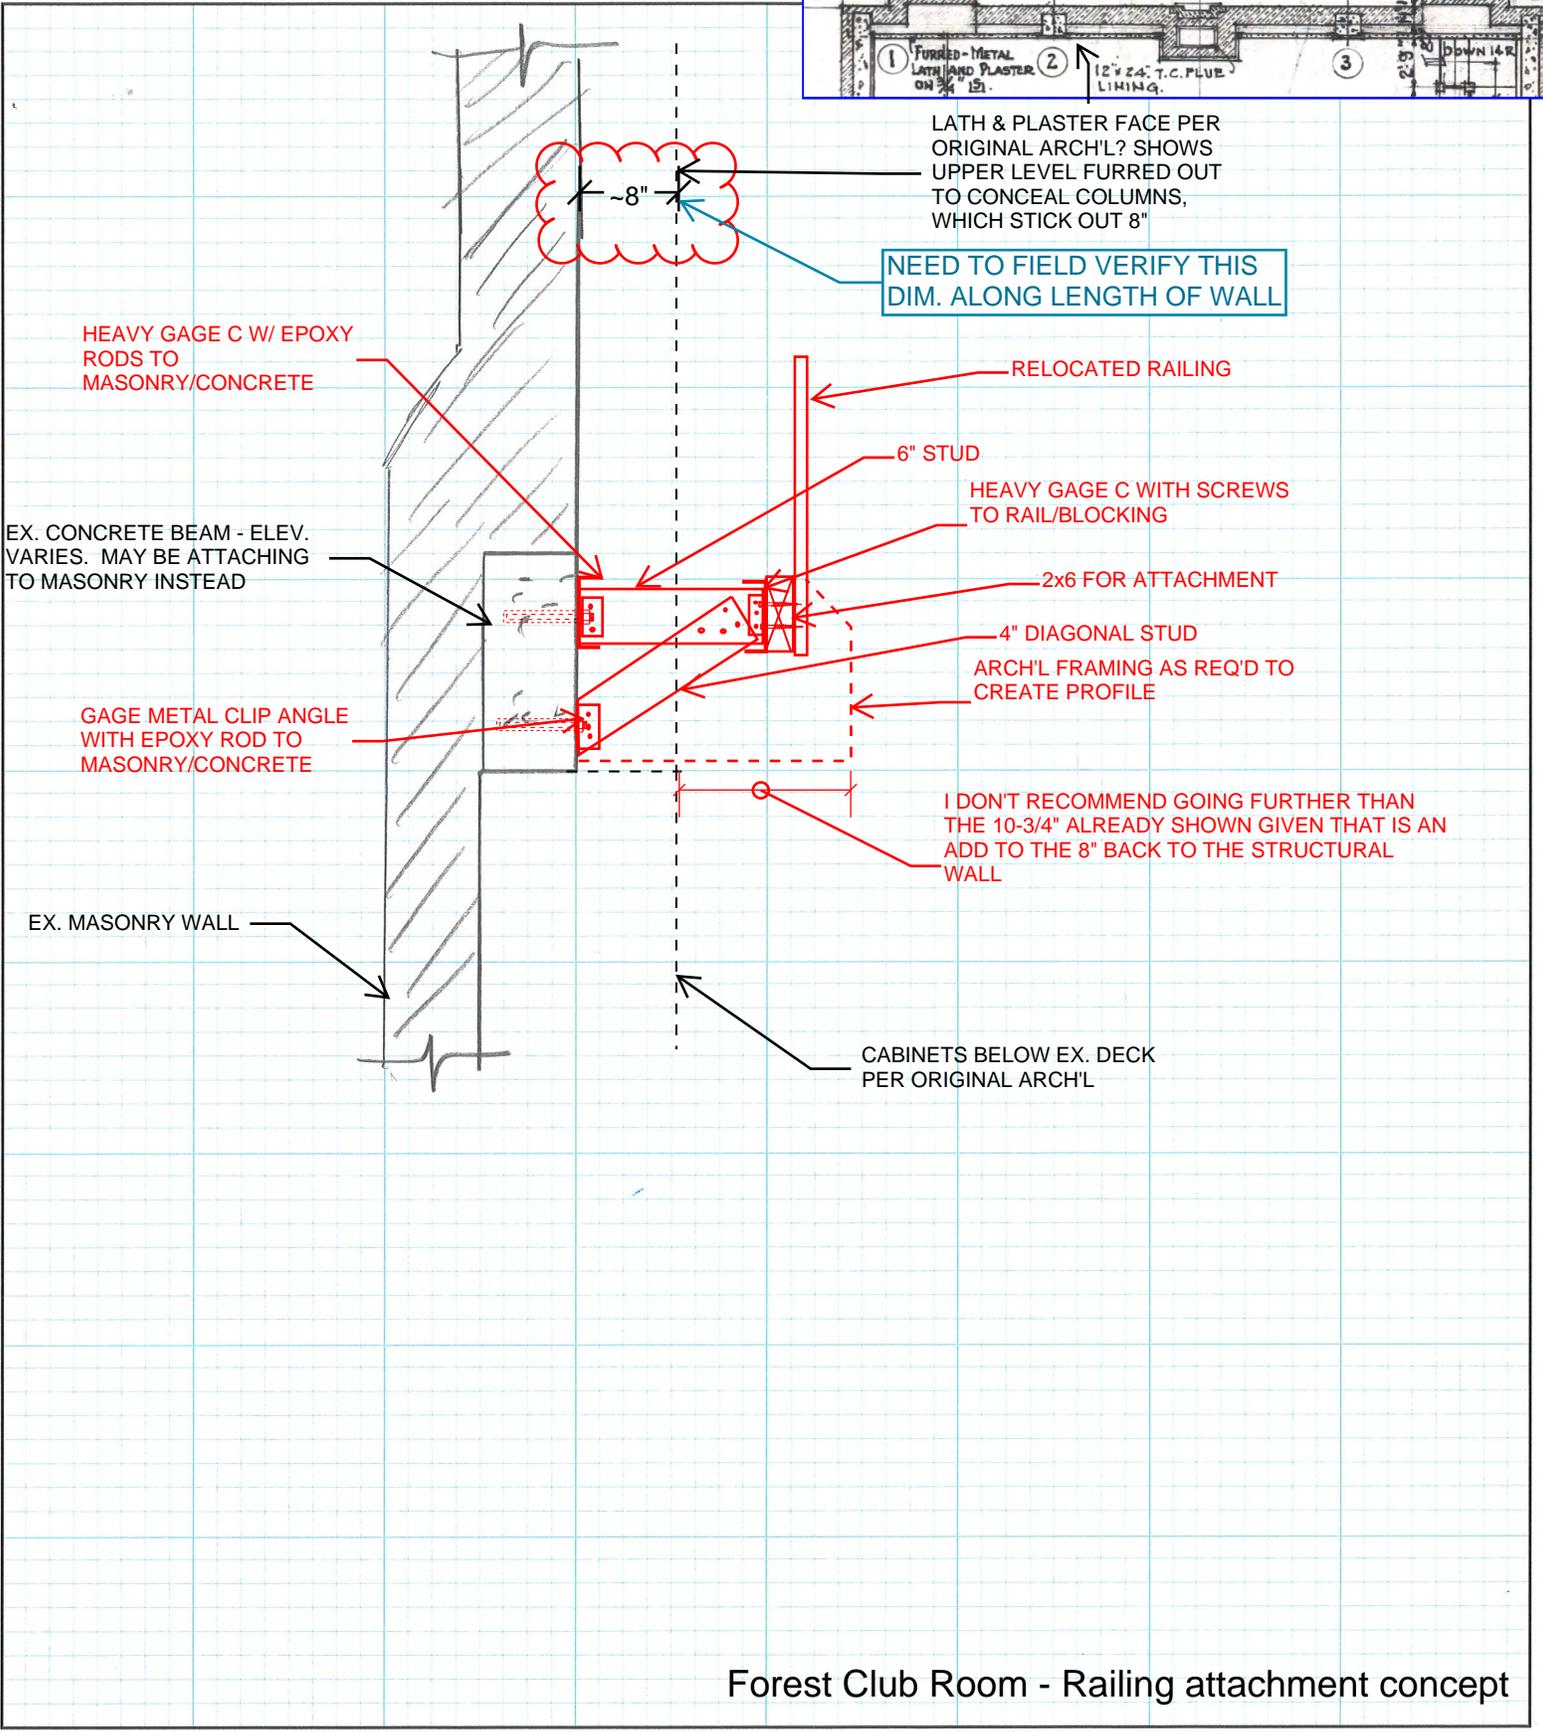
LATH & PLASTER FACE PER ORIGINAL ARCH'L? SHOWS UPPER LEVEL FURRED OUT TO CONCEAL COLUMNS, WHICH STICK OUT 8"

NEED TO FIELD VERIFY THIS DIM. ALONG LENGTH OF WALL
