PSPB BRIEFING - SEPTEMBER 3, 2025
GRAND CENTRAL RENOVATION/ADDITION
WELLNESS HOTEL & SPA

GRAND CENTRAL BLOCK

200 S 1ST ST, Seattle, WA 98104

PROJECT OVERVIEW

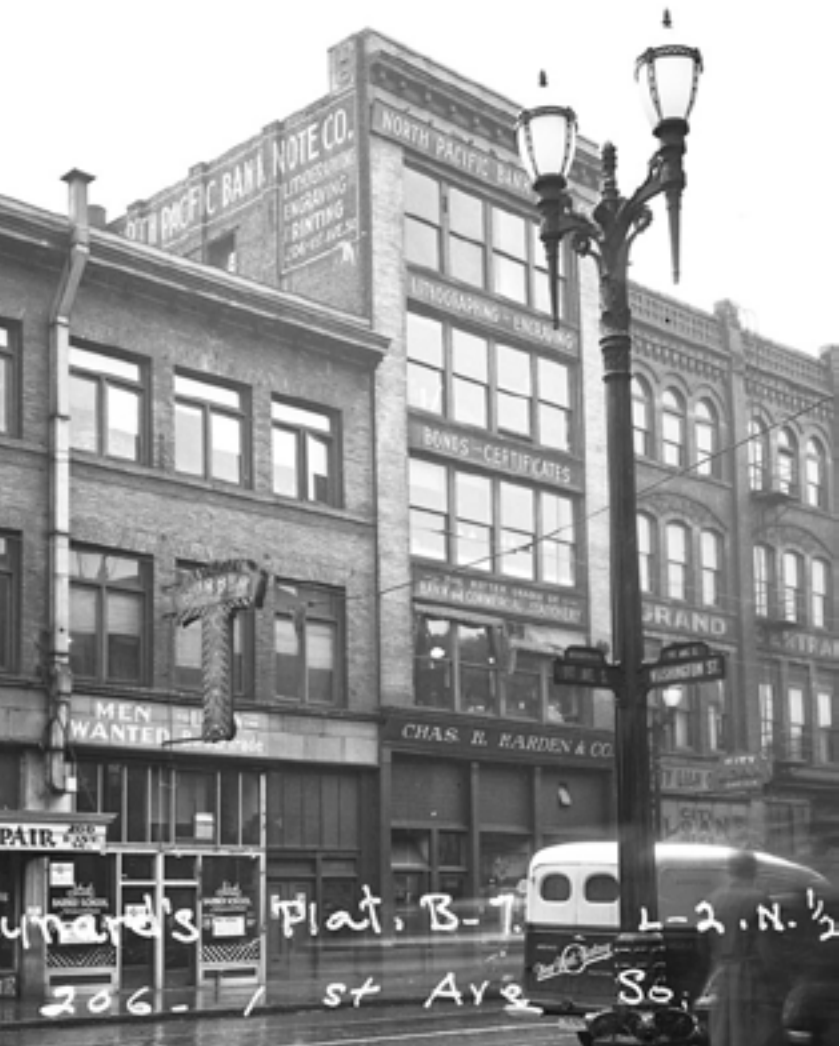
WEST ELEVATION OF CITY LOAN - 1937

- Exterior load bearing URM walls with sandstone and light gray brick on the West facade and red brick on the remaining facades
- Storefront with cast iron header and wood support columns
- Large window bays with cast iron lintels and sandstone sills on the west facade of floors 2-5
- Small double hung windows on the east facade of floors 2-5
- Exterior metal fire escape at alley elevation

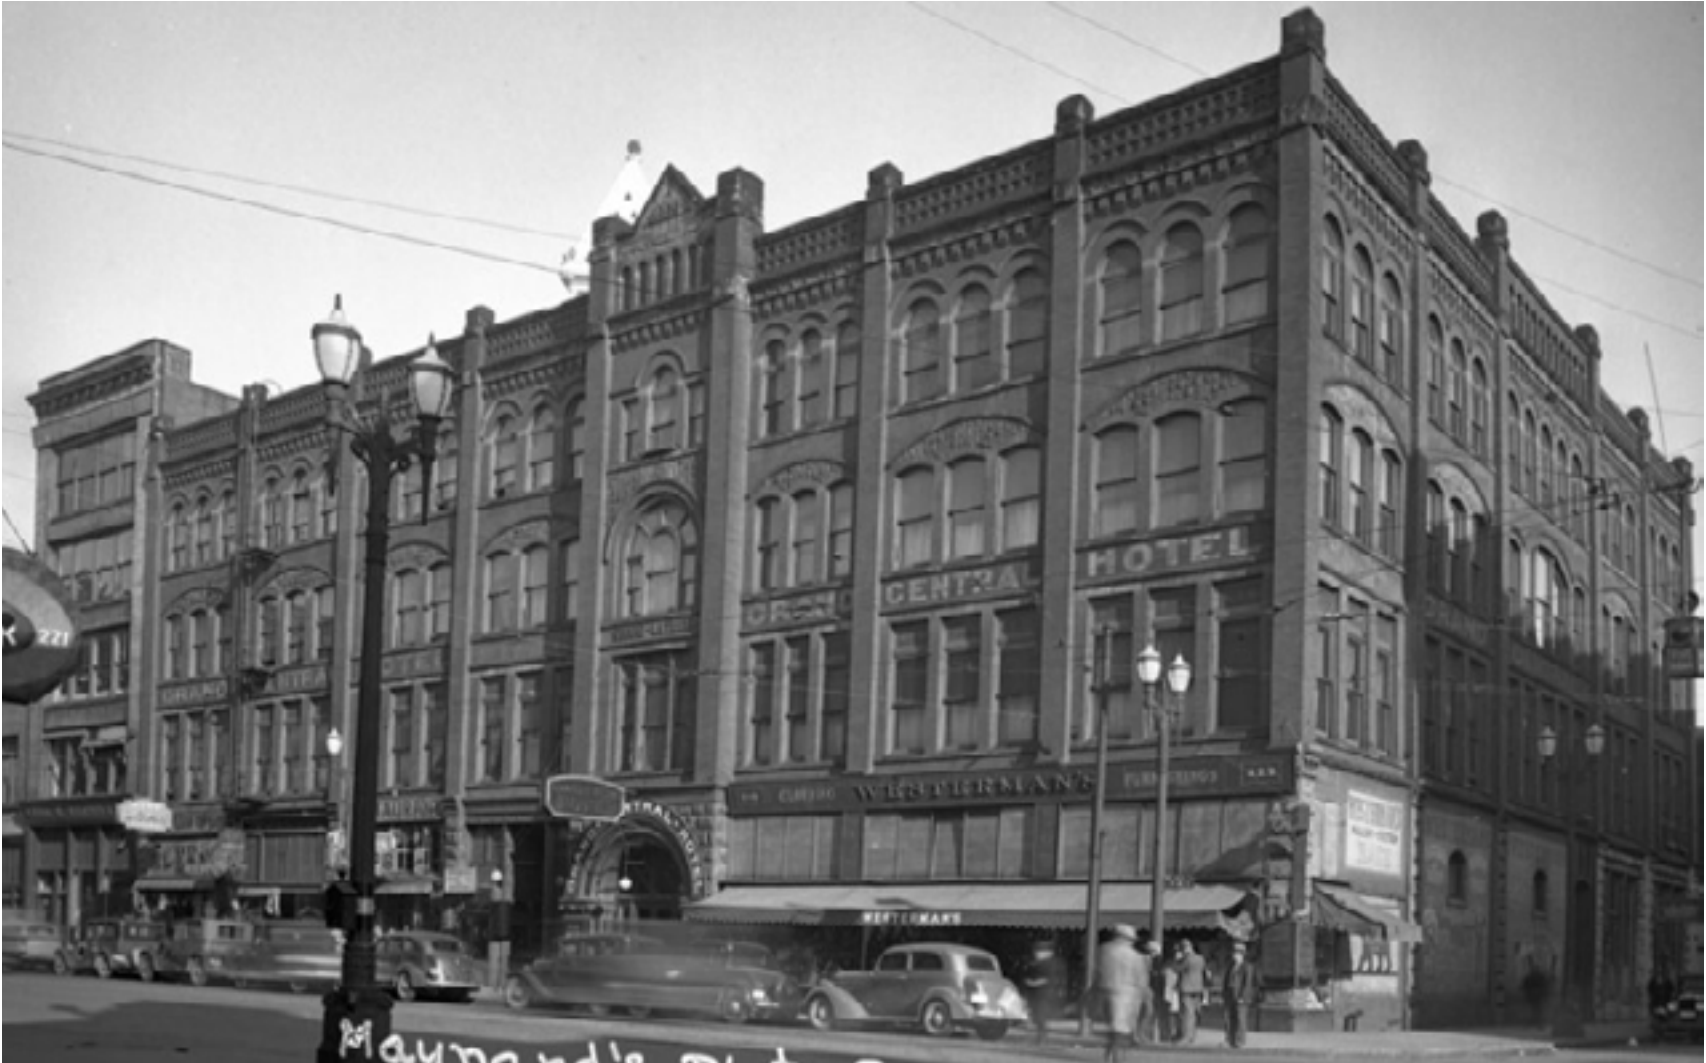
SOUTHWEST CORNER OF GRAND CENTRAL -1937

- Exterior load bearing URM walls
- Slightly asymmetrical primary facades
- Main arched stone entry w/ deeply recessed doorway and stone detailing
- Pilasters (rusticated stone at ground level and brick above)
- Storefronts with cast iron columns and lintels
- Window shape and rhythm: rectangular w/ stained glass at 2nd floor, low arch at 3rd floor, rounded arch at 4th floor; Unique windows at the West entry bay and South center bay
- Sandstone sills, string courses, and other detailing
- Entry lobby with wood staircase around an elevator shaft
- Interior light wells from 2nd to 4th floor

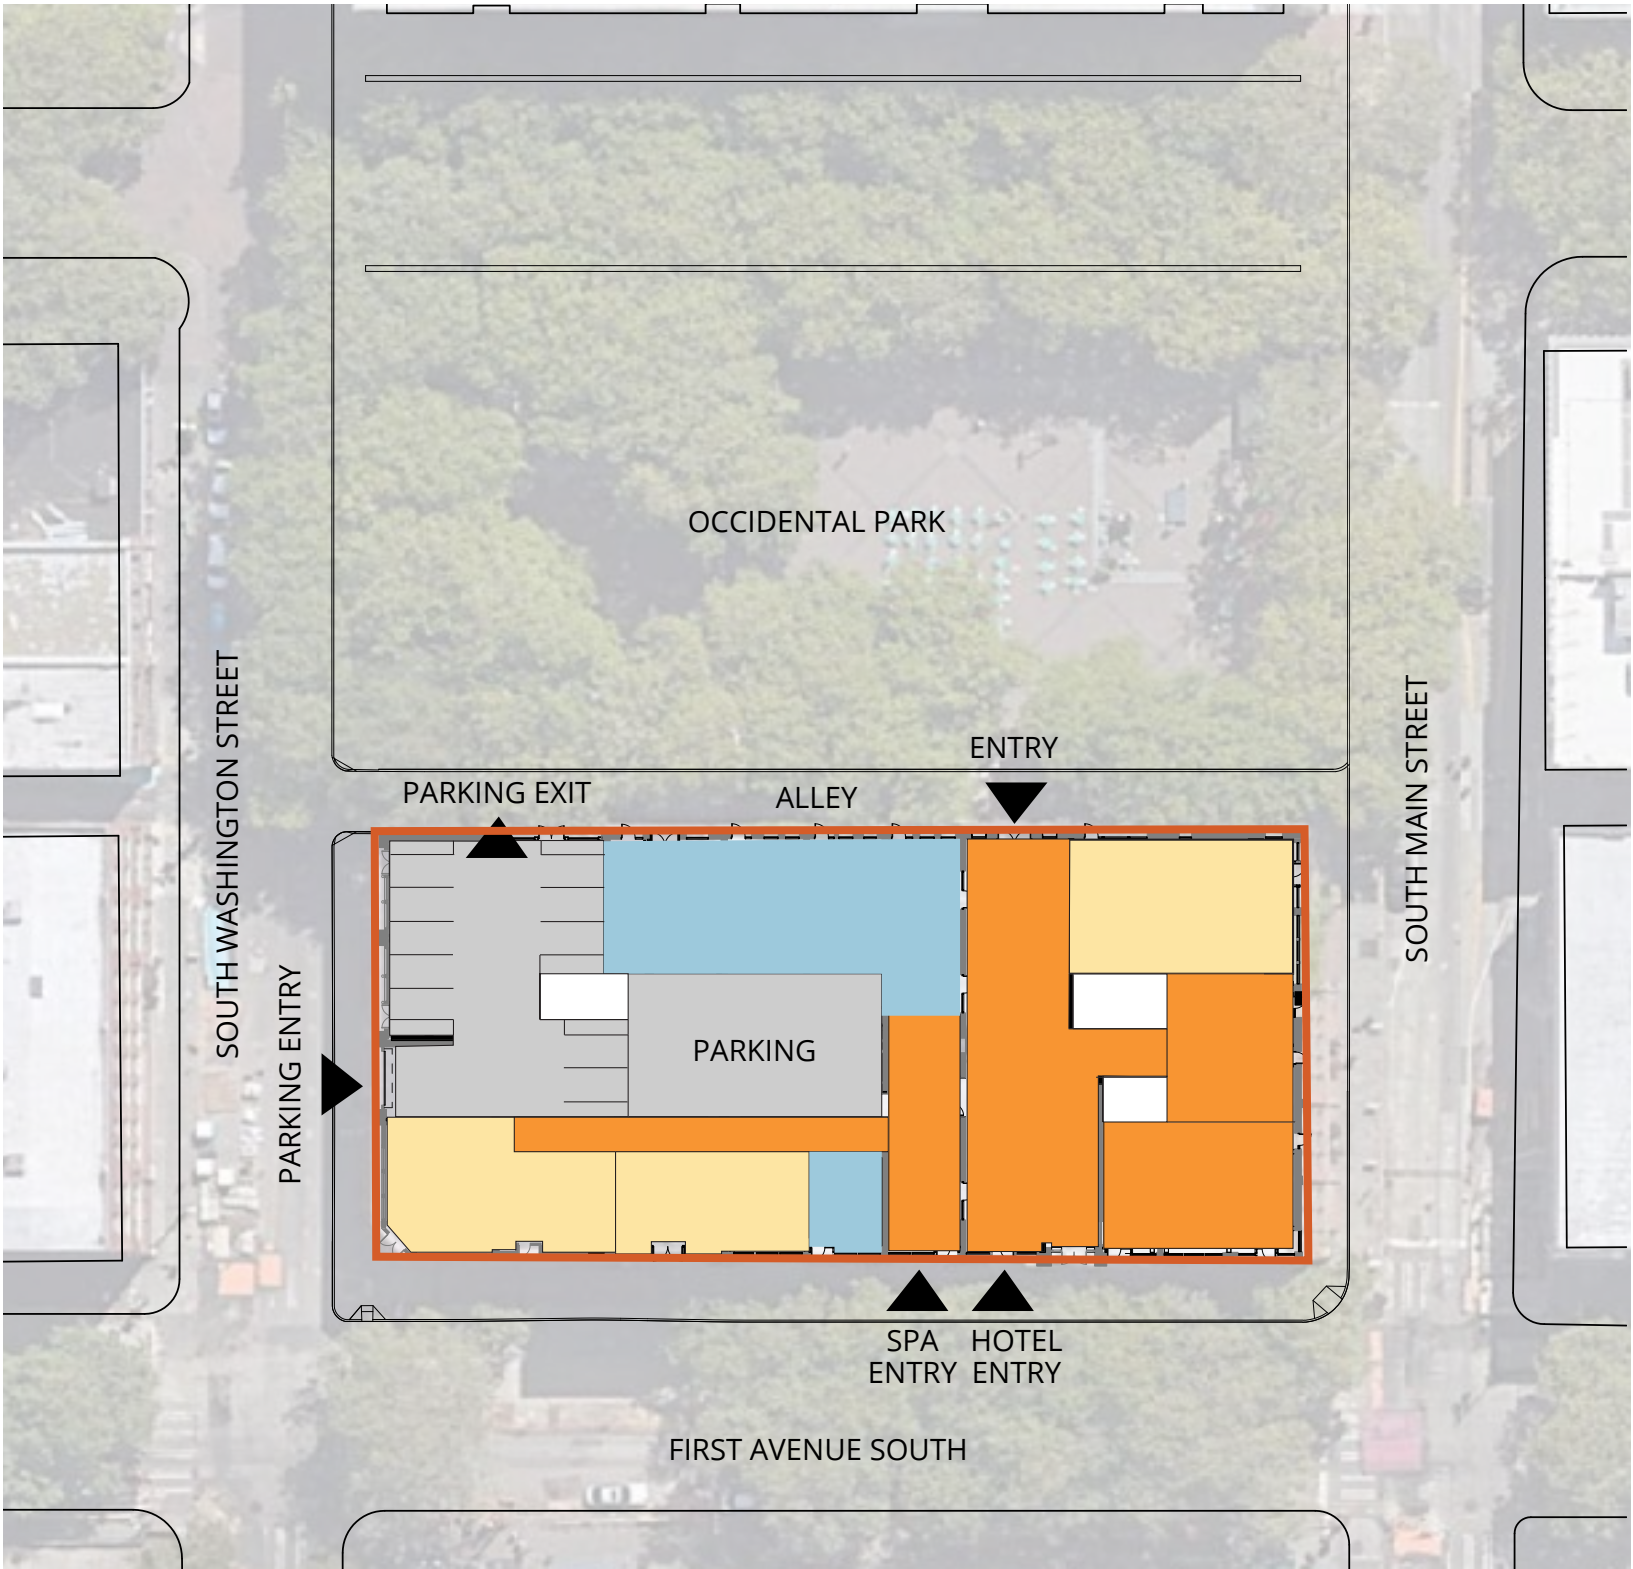
SITE PLAN

- Site Boundary
- Wellness Hotel & Spa
- Parking
- Retail/Event Space
- Restaurant/Coffee Shop

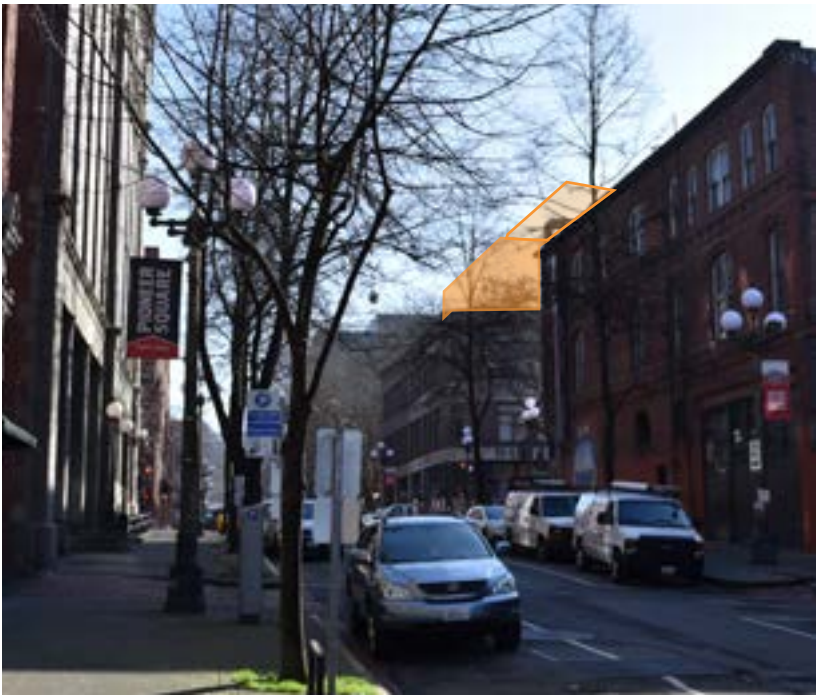
1 S WASHINGTON ST - ADDITION VISIBLE 300 FEET

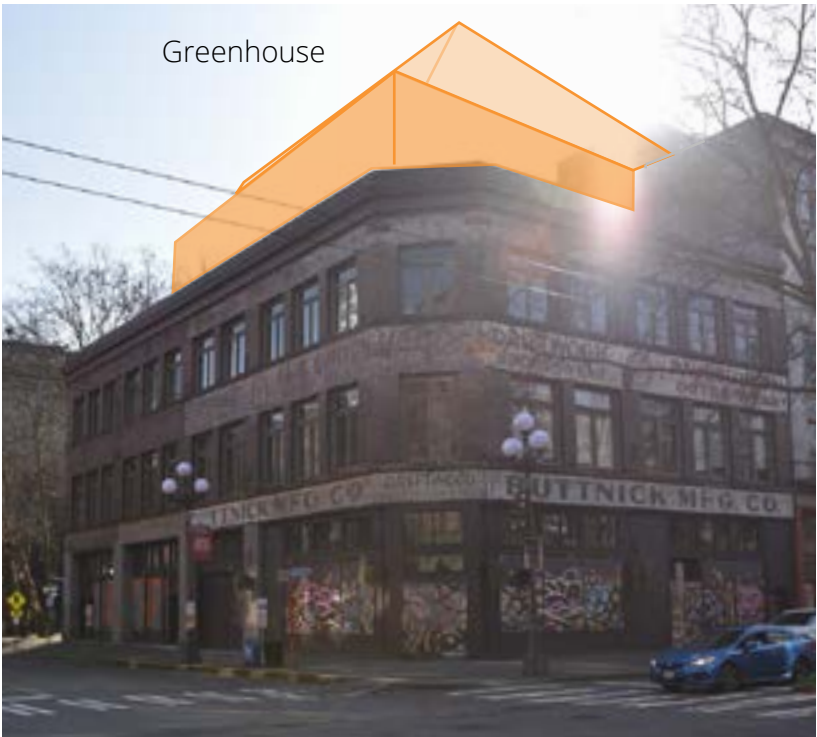
2 CROSS CORNER OF 1ST AVE S + S WASHINGTON ST - ADDITION VISIBLE

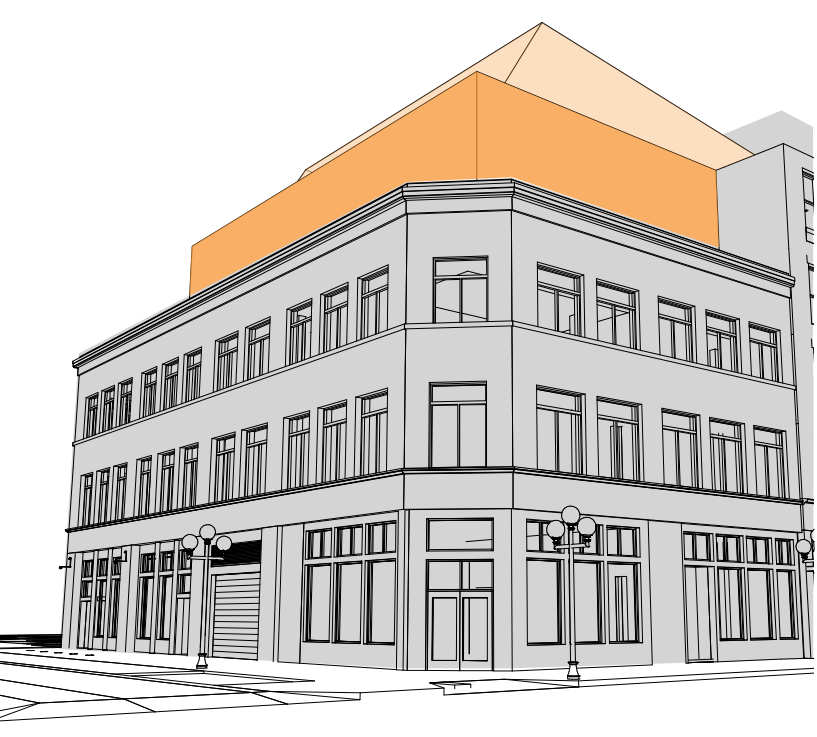
2 CROSS CORNER OF 1ST AVE S + S WASHINGTON ST - RENDERING
