APPLICATION AND CERTIFICATION OF SPECIAL VALUATION ON IMPROVEMENTS TO HISTORIC PROPERTY RCW Chapter 84.26

**Bon Marche Adaptive Reuse (FKA Macy's)
300 Pine Street Unit 1 (Floors SB, Metro, 1 & 2)
Seattle, Washington 98104**

2020 Special Tax Valuation Project Summary

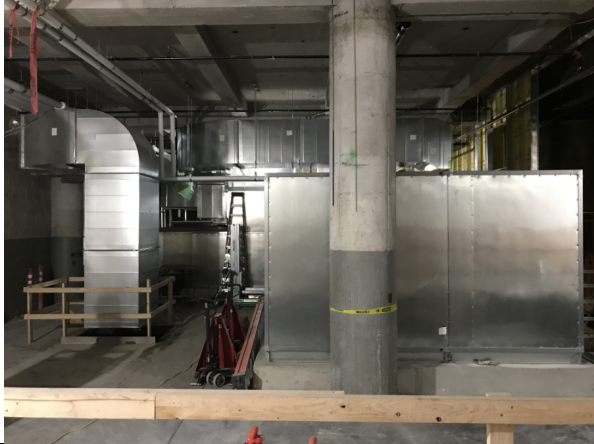
SB Mechanical Room

HVAC System (Complete): The HVAC system is connected to the building Central Chilled Water Plant for cooling and has the potential to be connected to Building Steam by the tenant. Each floor is served by two (2) newly installed dedicated Chilled-Water VAV Air Handling Units with future/unconnected Steam Heating coils, 100% air-side economizers, MERV 8 pre-filters and MERV 13 final filters. Supply air ducts are extended to the floor served for connection by tenant. Each floor is served by Variable Speed Relief Fans that are interlocked with the AHU serving that floor. Sound Traps are provided at the Mechanical Room Supply Air openings and provisions have been made for Tenant to install sound traps at Return/Relief Air openings. Pathways to atmosphere are provided for tenant odor control ventilation (i.e. restrooms and breakrooms).

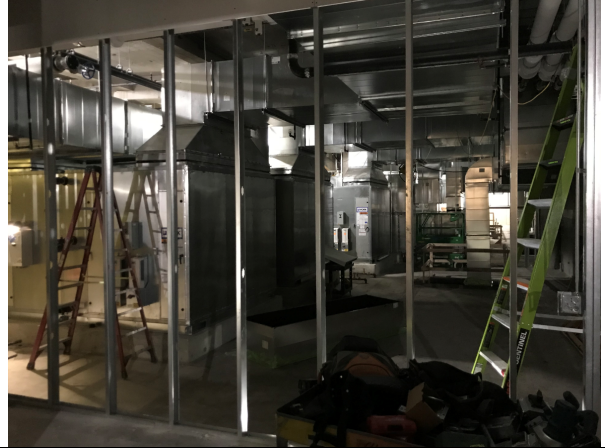
SB Mechanical Room

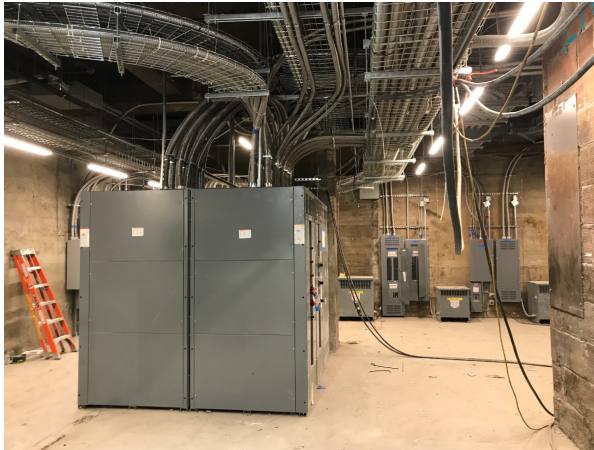
SB Electrical Room

Electrical (Complete): New separately metered electrical service is being installed from the main service in the basement area. Code required lighting and signage for vacant shell space condition is being provided.

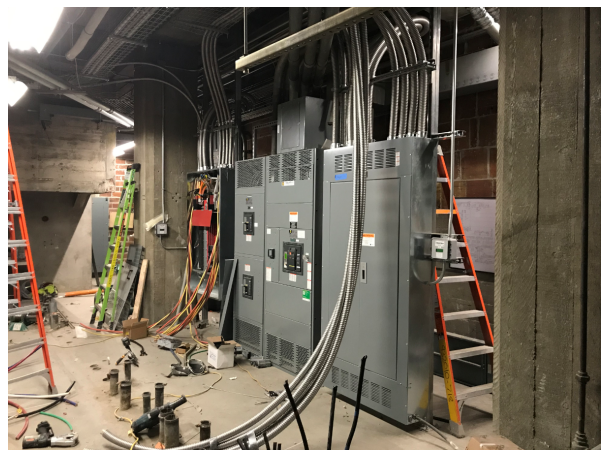
SB Electrical

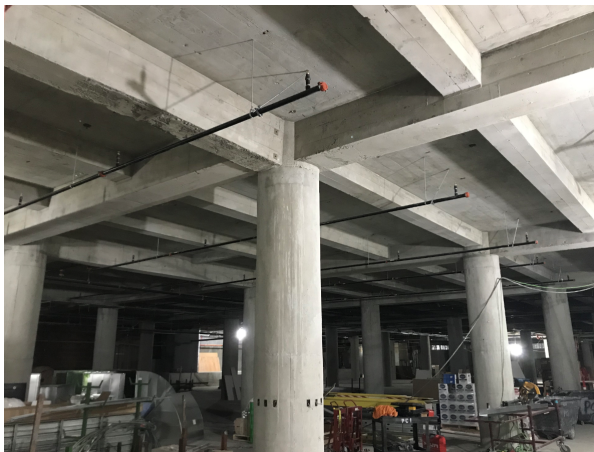
SB Fire Suppression

Fire Alarm/Sprinklers (Complete): Shell protection fire suppression will be installed. Fire Risers are available for tenant connection along with connection points to base building fire alarm systems for future tenant improvements. Shell protection fire sprinkler work has been completed and signed off by the building department for shell occupancy. As part of the Substantial Alteration, significant upgrades were needed on the shell and core system to meet code.

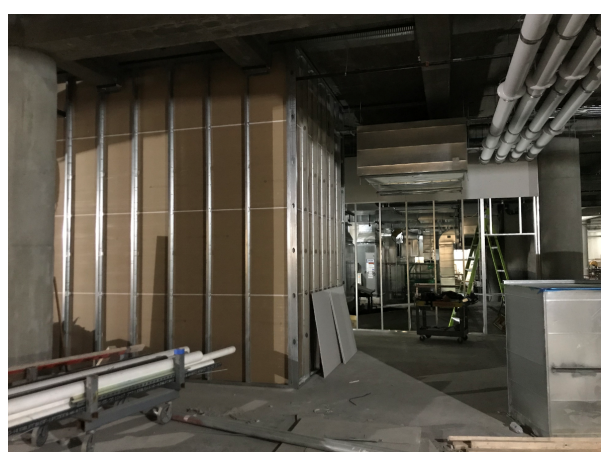
SB Framing

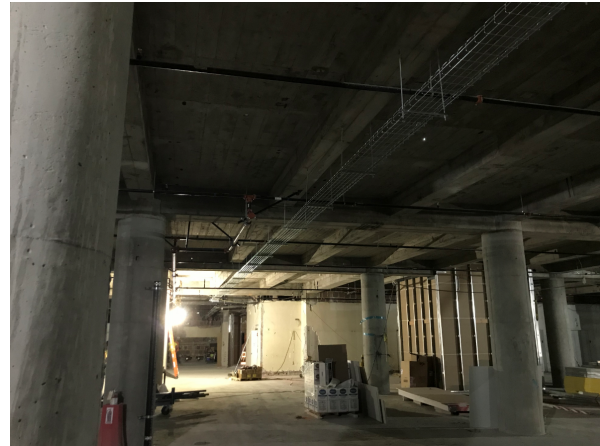
Metro Cable Tray/Fire Suppression

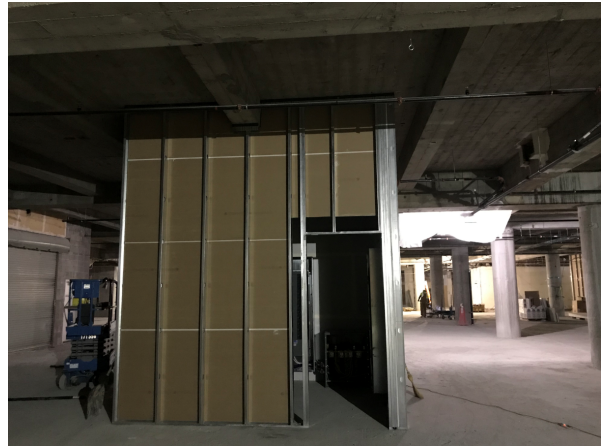
Metro Electrical Room Typ.

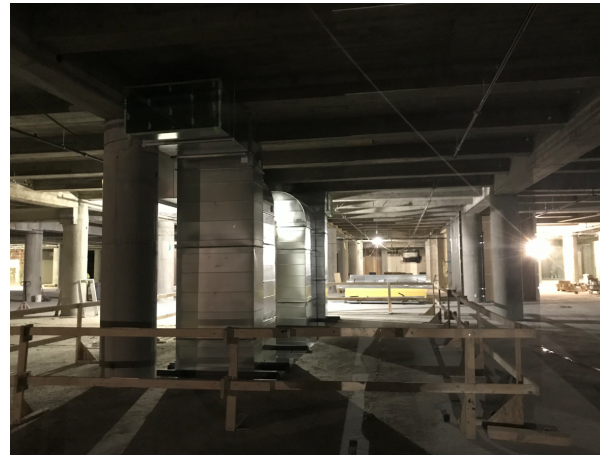
Metro Mechanical/Plumbing Rough In

Plumbing (Completed): Domestic Water is provided at each tenant floor. Waste and Vent riser(s) are provided for connection of tenant fixtures.

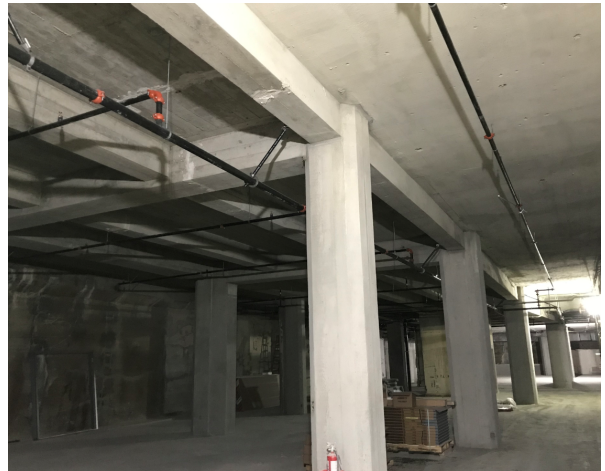
Metro Fire Suppression

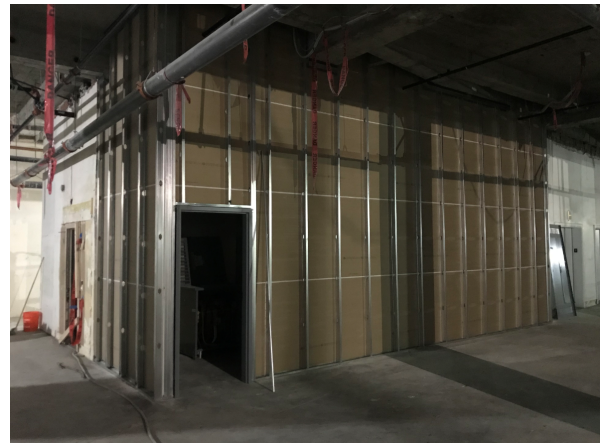
L2 Electrical Room

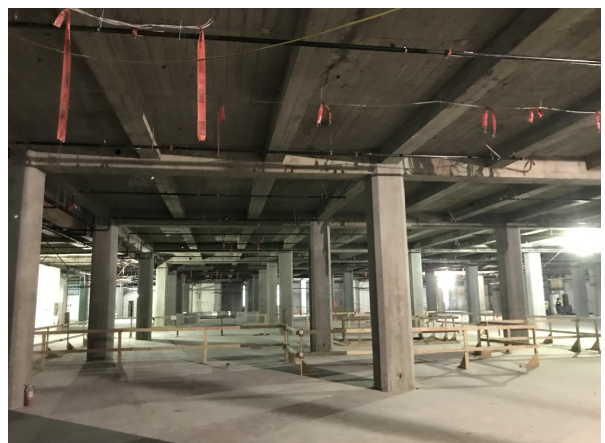
L2 Fire Suppression

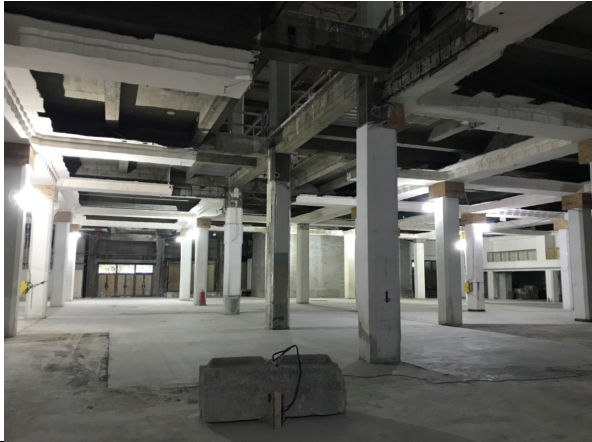
L1 Escalator Infill

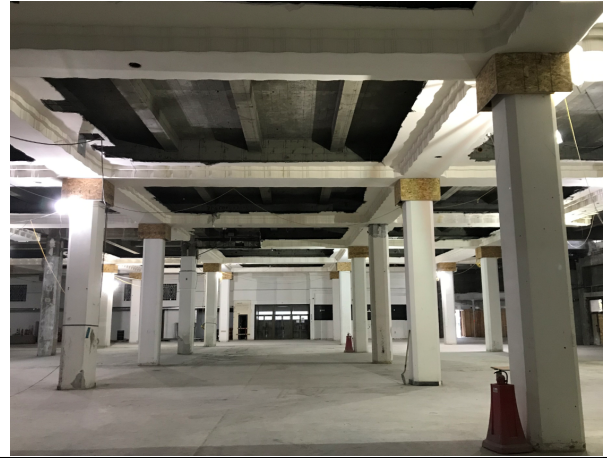
L1 Ceiling Demo Typ.

Demolition (Complete): Demolition of existing interior partitions and non-functioning infrastructure to allow for future adaptive reuse to smaller format retail. All hazardous materials have been removed. Demolition of the interior partitions and finishes is complete. Asbestos containing materials have been abated and any remaining lead based paints will be encapsulated.

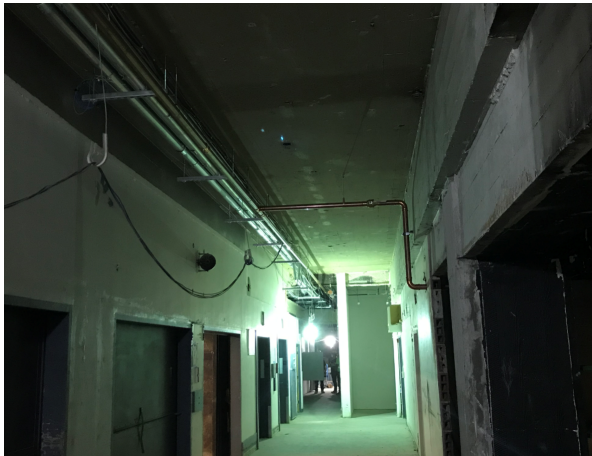
L1 Plumbing

Plumbing (Complete): Domestic Water is provided at each proposed tenant space. Waste and Vent riser(s) are provided for connection of tenant fixtures.

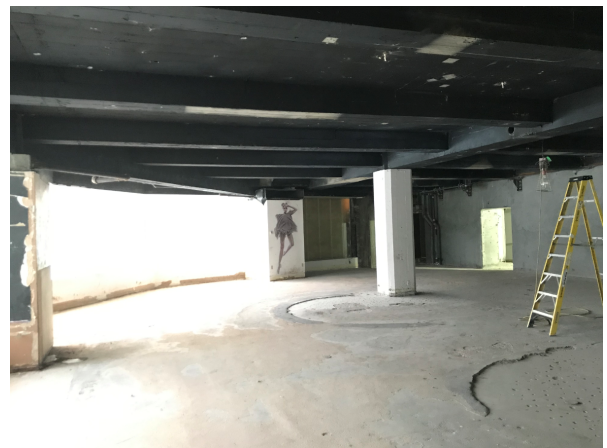
Mezzanine Demo

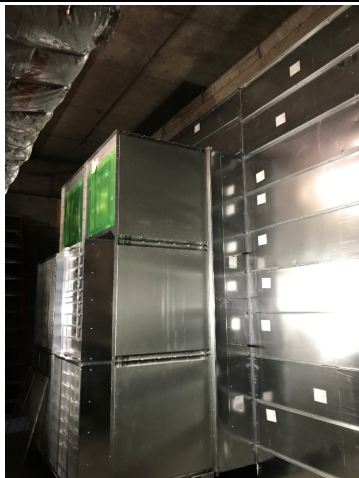
Level 9 Relief Fan 909

Relief Fan Changes (Complete): The Office tenant has requested HVAC changes that increase the relief fan capacity. This work has been completed.

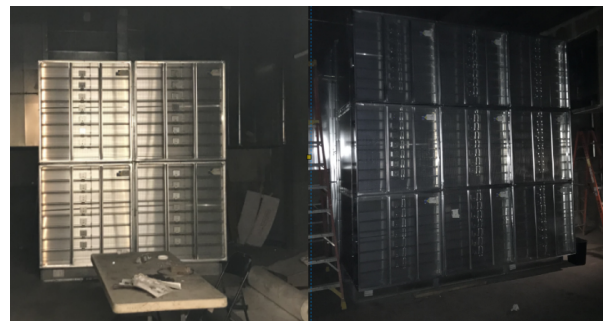
Level 9 Relief Fans 910/911
