APPLICATION AND CERTIFICATION OF SPECIAL VALUATION ON IMPROVEMENTS TO HISTORIC PROPERTY RCW Chapter 84.26

**Bon Marche Adaptive Reuse (FKA Macy's)
300 Pine Street Unit 1 (Floors SB, Metro, 1 & 2)
Seattle, Washington 98104**

2020 Special Tax Valuation Project Summary

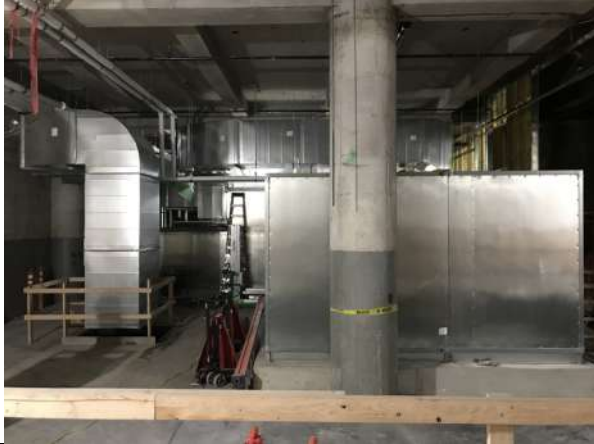
SB Mechanical Room

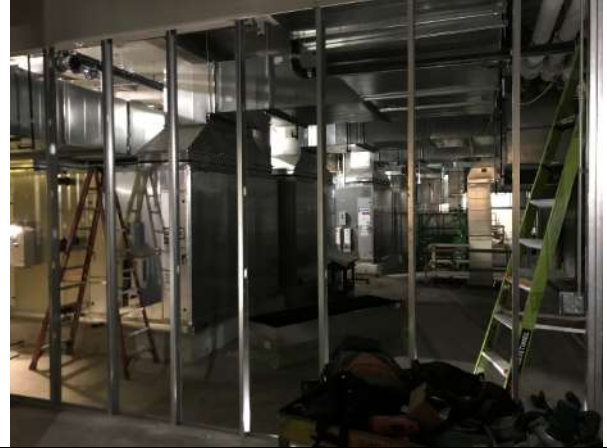
SB Mechanical Room

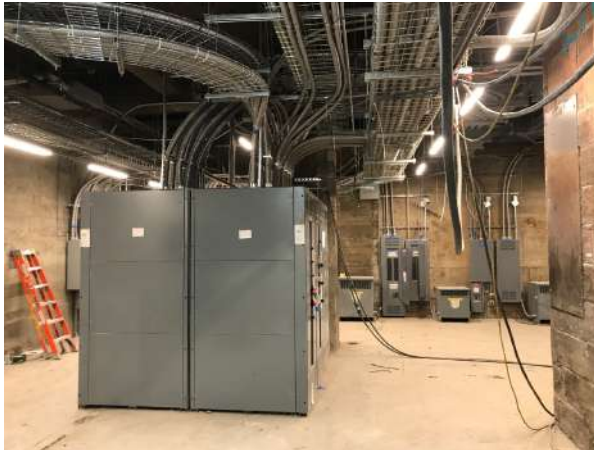
SB Electrical Room

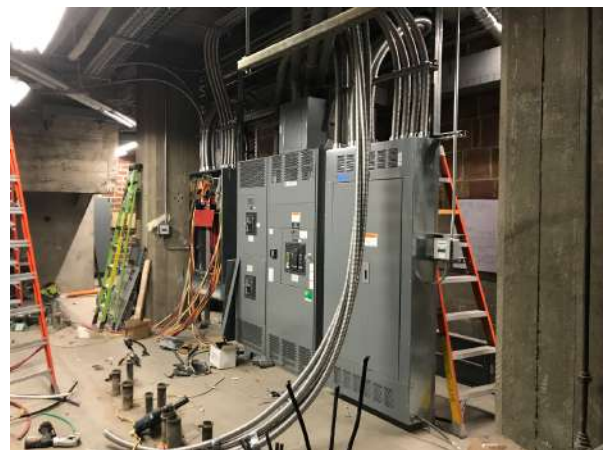
SB Electrical

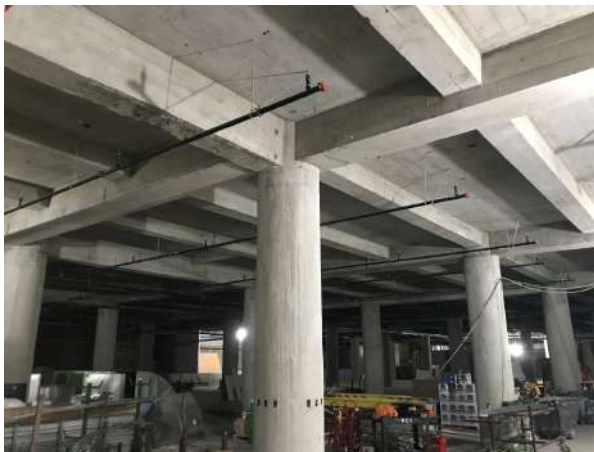
SB Fire Suppression

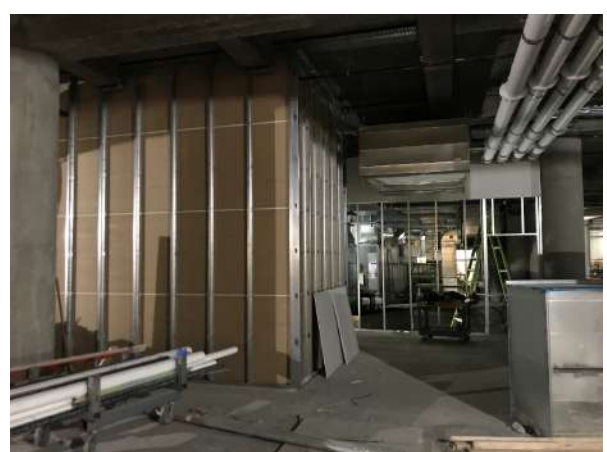
SB Framing

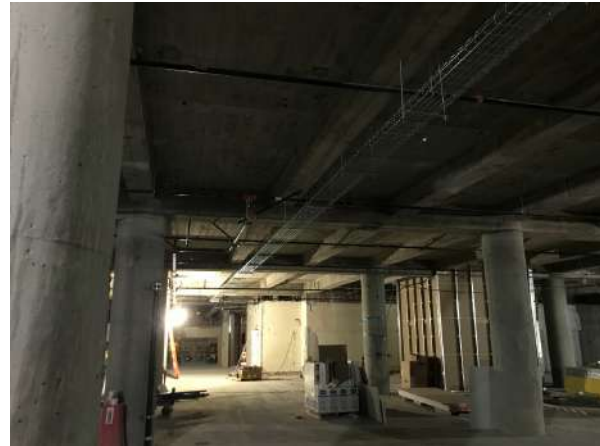
Metro Cable Tray/Fire Suppression

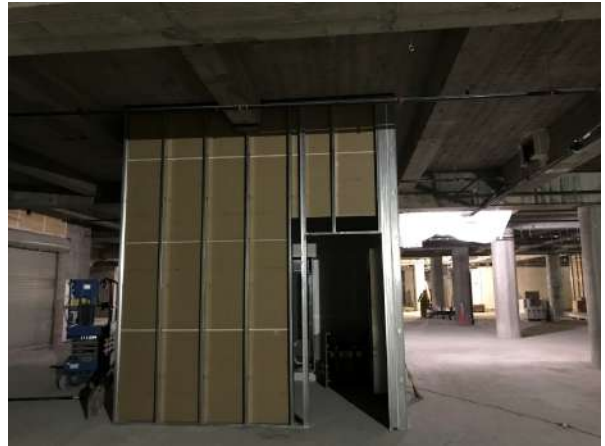
Metro Electrical Room Typ.

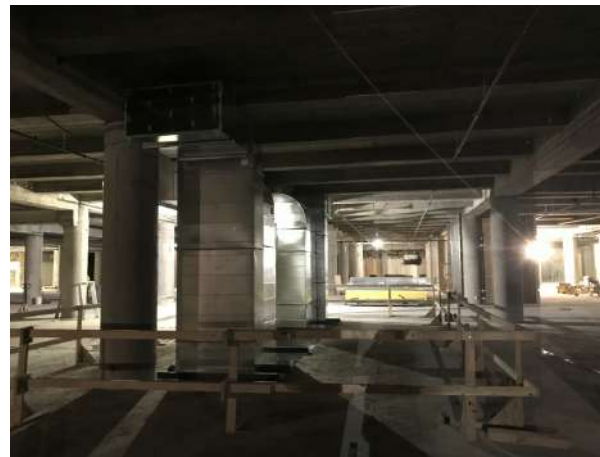
Metro Mechanical/Plumbing Rough In

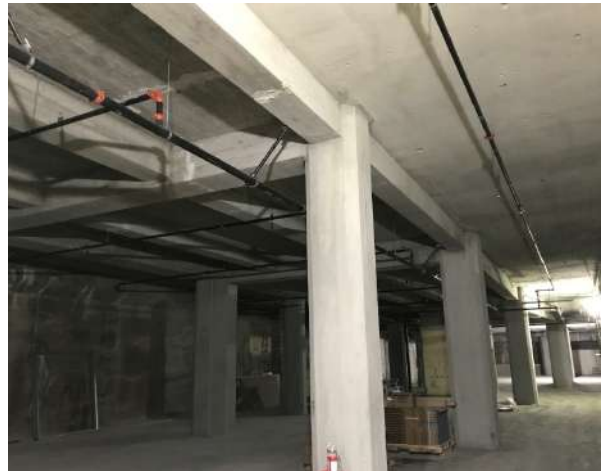
Metro Fire Suppression

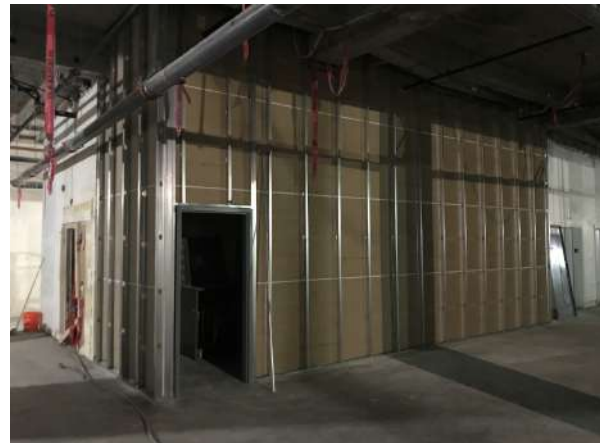
L2 Electrical Room

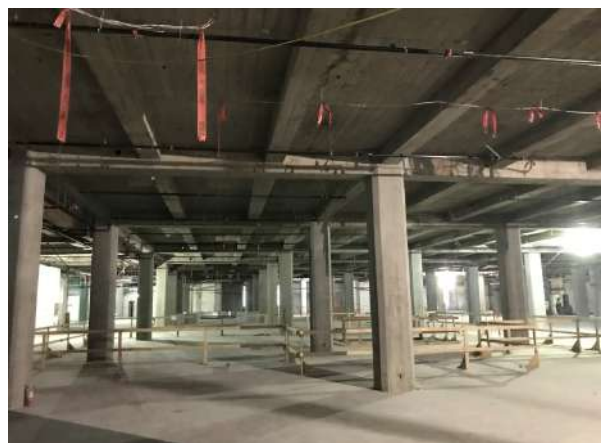
L2 Fire Suppression

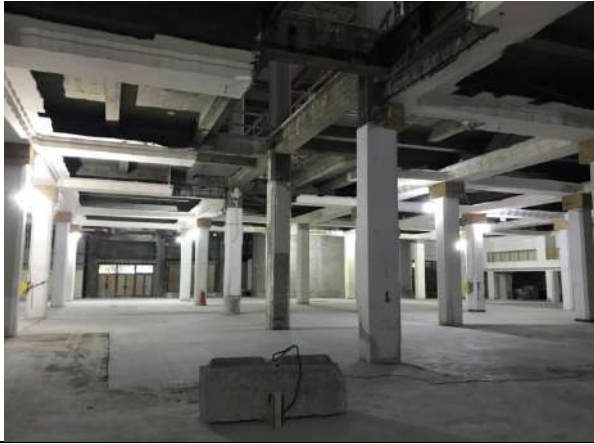
L1 Escalator Infill

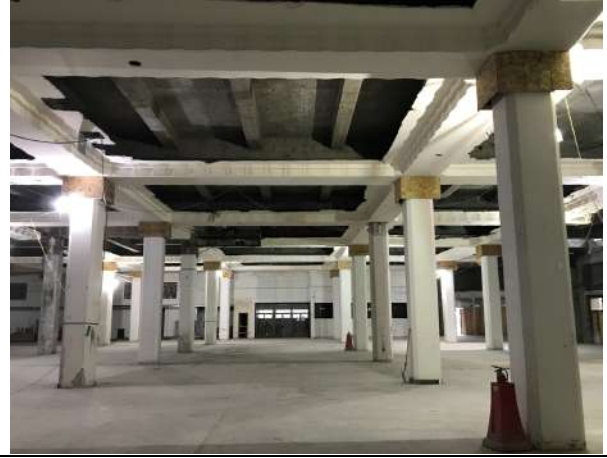
L1 Ceiling Demo Typ.

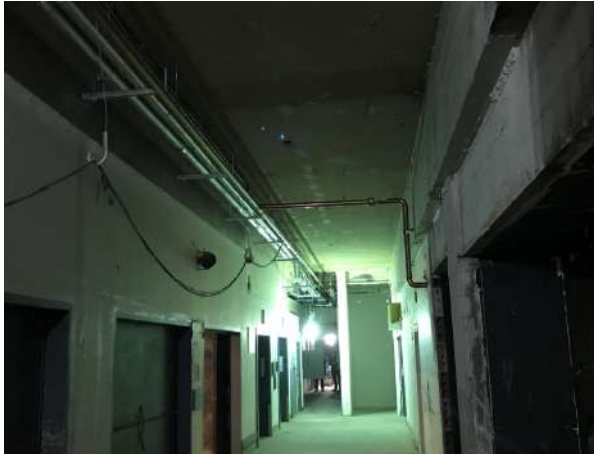
L1 Plumbing

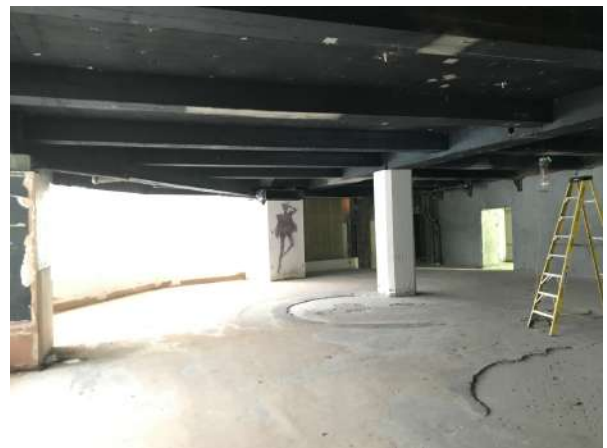
Mezzanine Demo

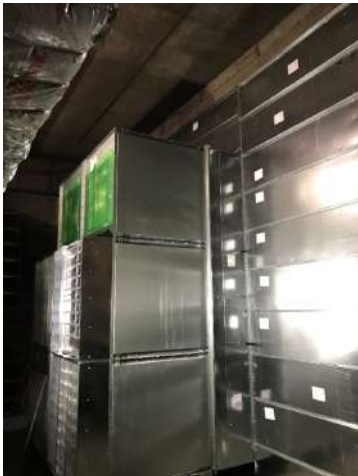
Level 9 Relief Fan 909

Relief Fan Changes (Complete): The Office tenant has requested HVAC changes that increase the relief fan capacity. This work has been completed.
