LOWMAN BEACH PARK

Feasibility Study Report

Prepared for
Seattle Parks & Recreation Department

LOWMAN BEACH PARK SEAWALL CONDITION ASSESSMENT

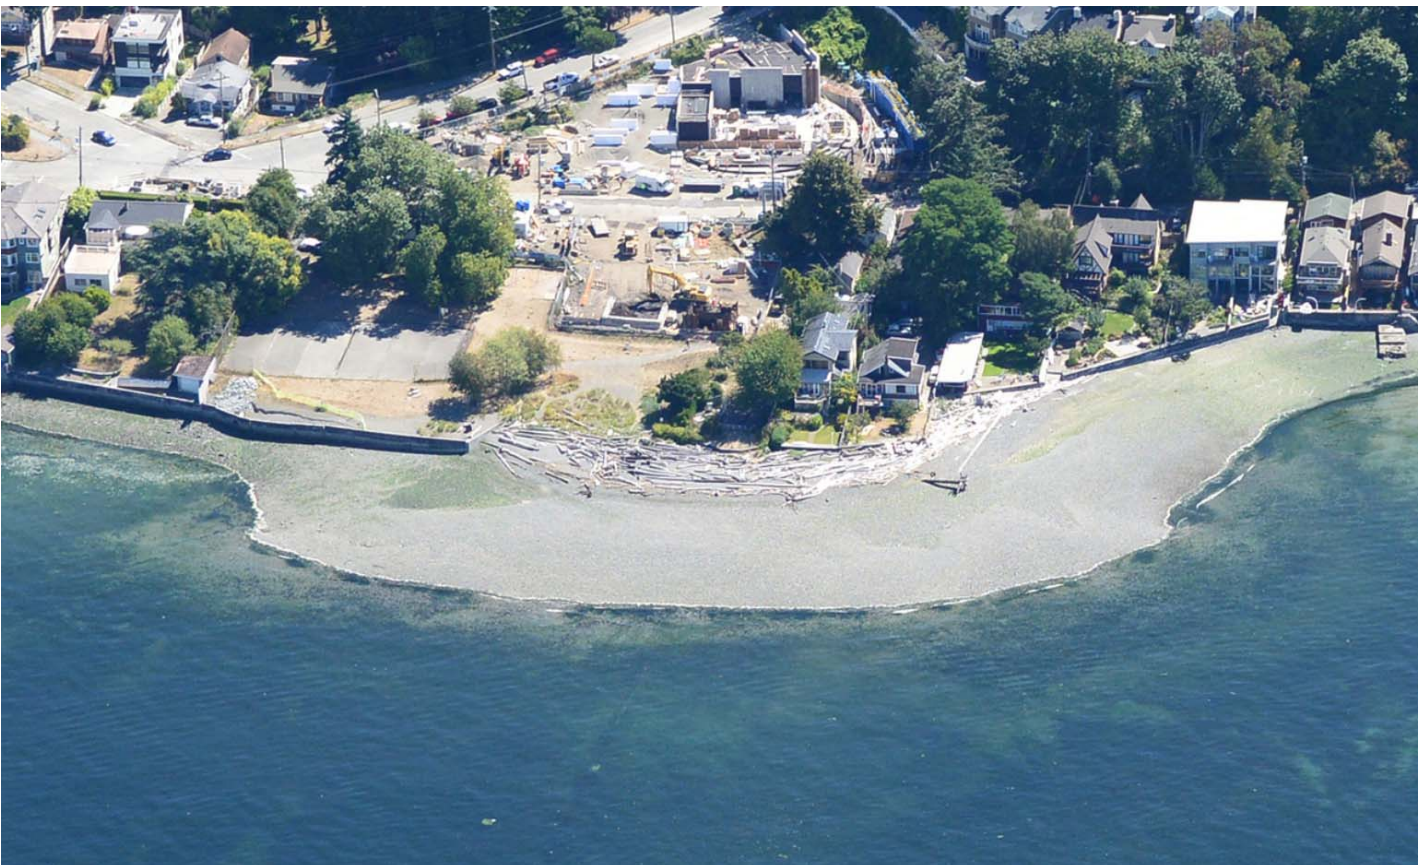
Photograph by Dept. of Ecology on 7/29/2016

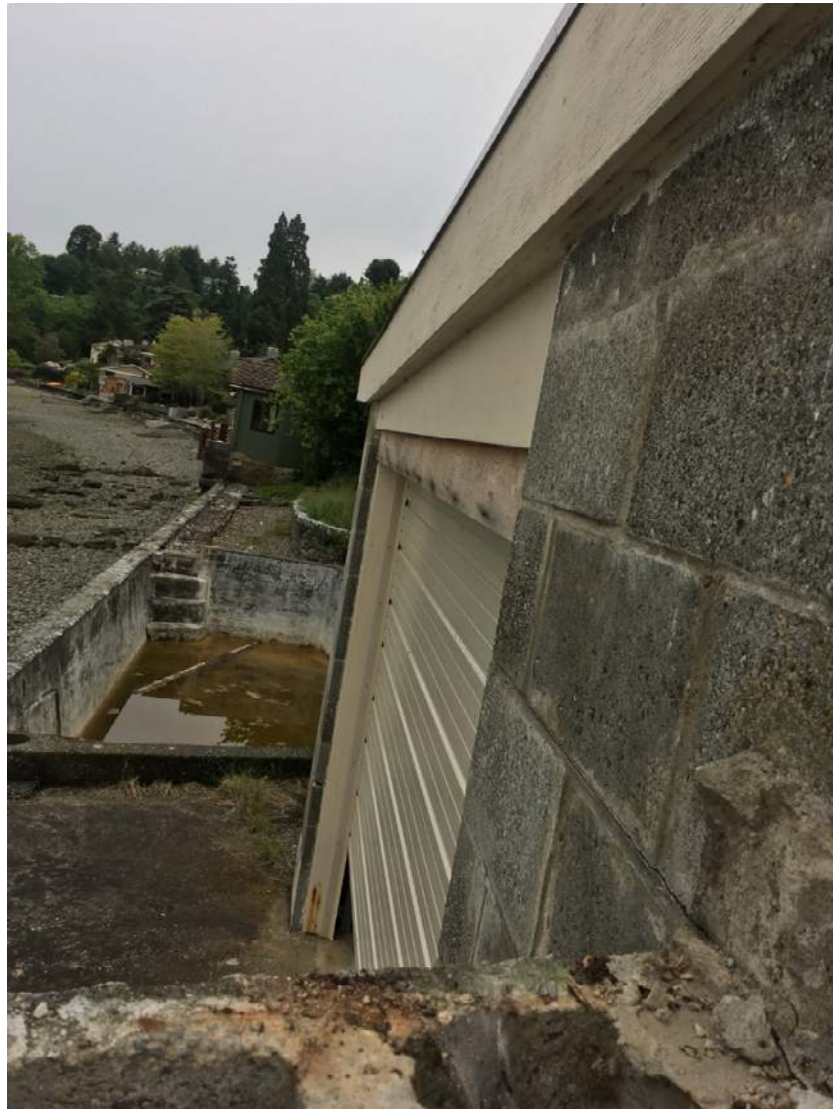
Photo 4. Adjacent Property to the North.
Source: Reid Middleton Site Visit 10/18/2016

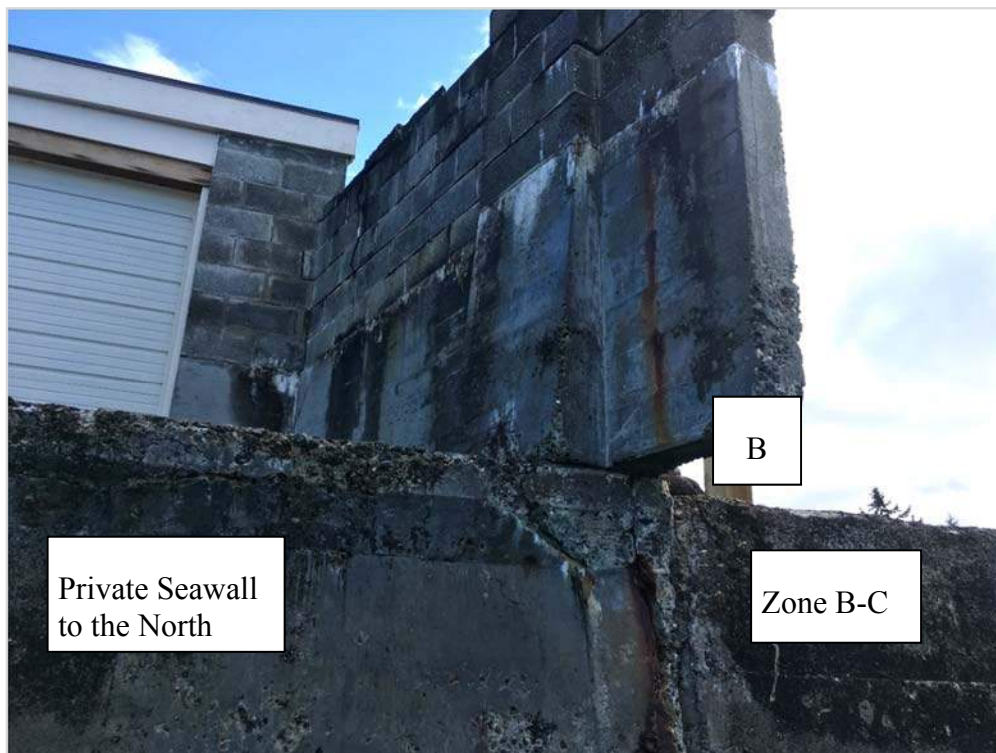
Photo 8. Zone B-C, Adjacent Property.
 Source: Reid Middleton Site Visit 10/18/2016

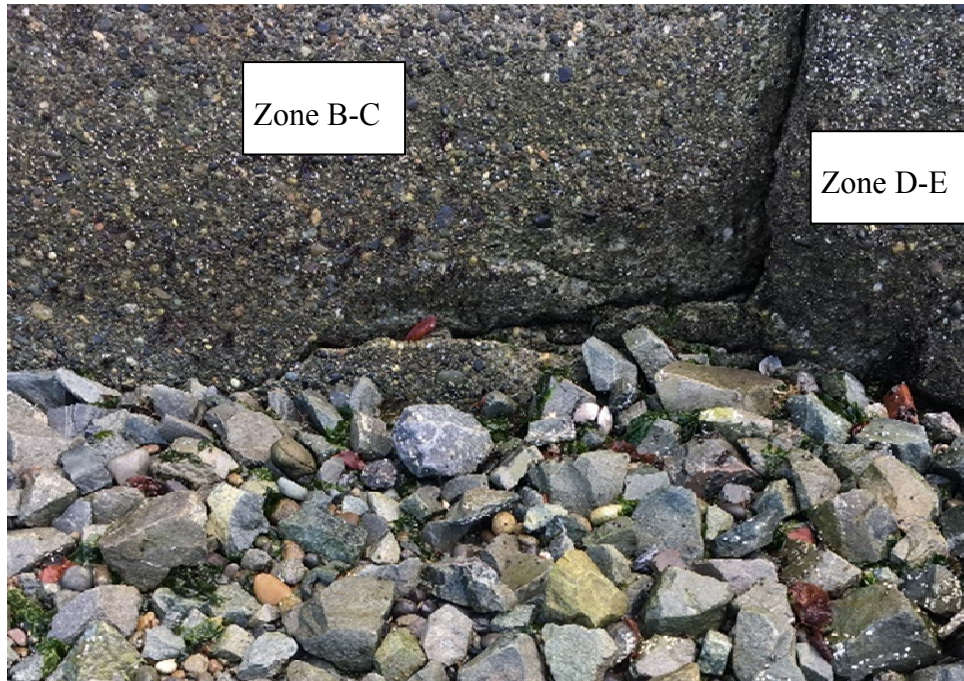
Photo 13. Zones B-C & D-E, Beach Material.
 Source: Reid Middleton Site Visit 10/18/2016

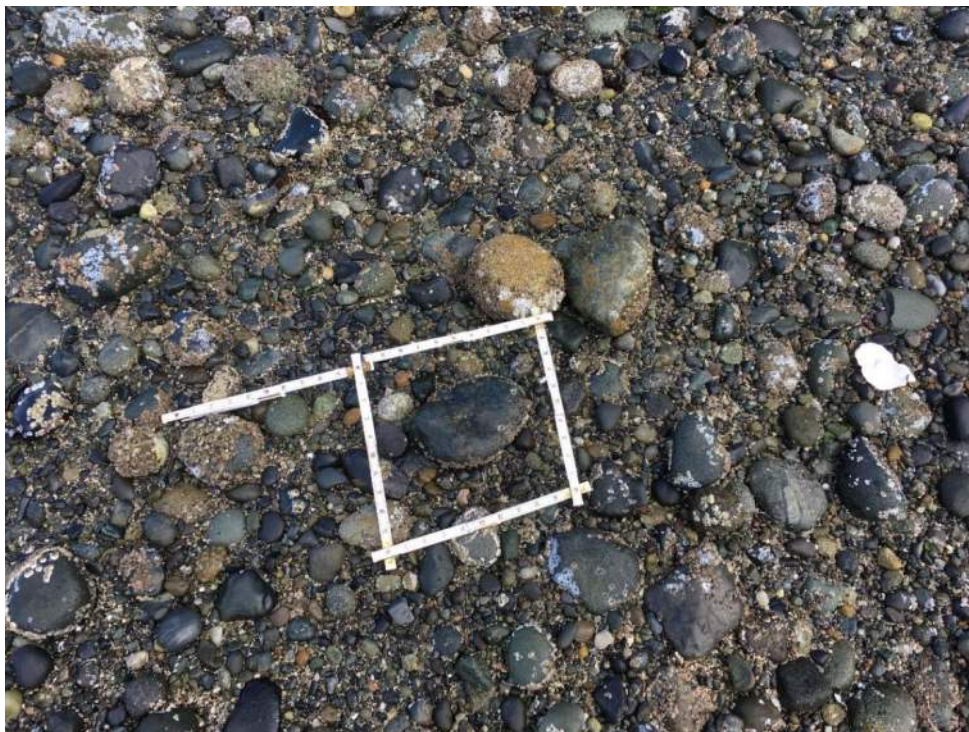
Photo 20. Beach Material at Zone J-K.
 Source: Reid Middleton Site Visit 10/18/2016

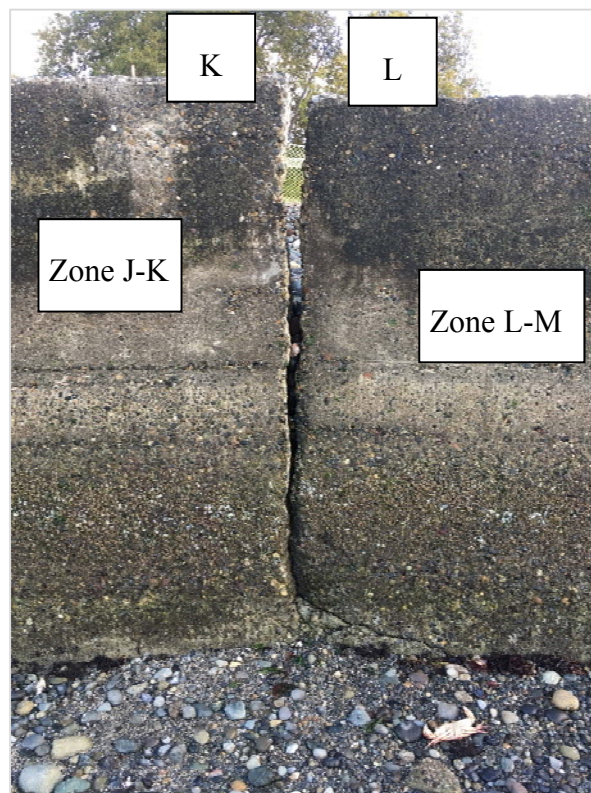
Photo 22. Zone J-K & L-M.
 Source: Reid Middleton Site Visit 10/18/2016

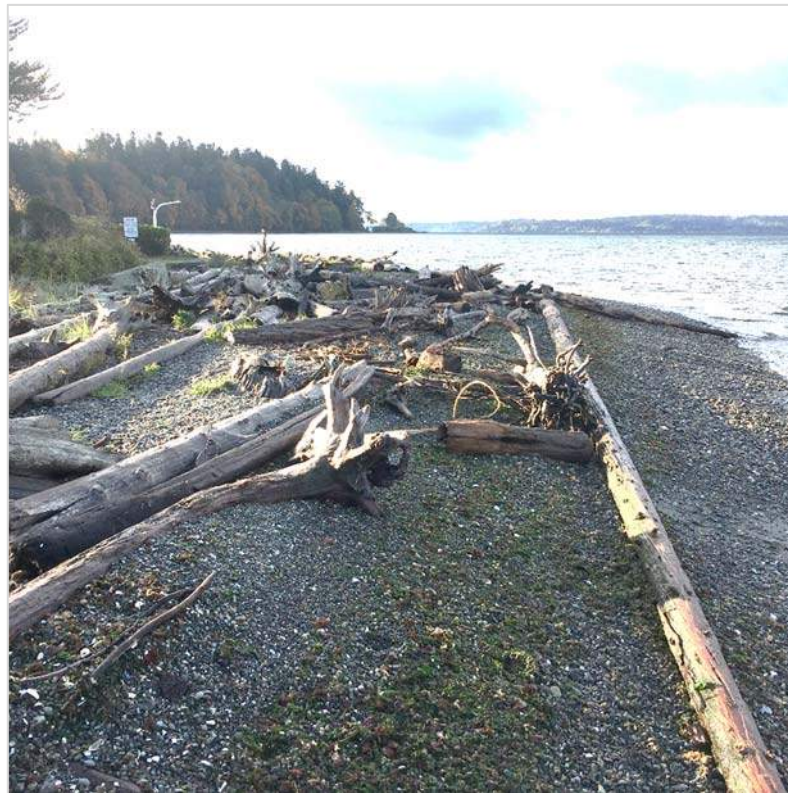
Photo 32. View to the South from Zone R-S.
Source: Reid Middleton Site Visit 10/18/2016
