Kanti C. Ramamurti, Application and Certification of Special Valuation on Improvements to Historic Property. Stewart House, 10455 Maplewood PL SW, Seattle, WA 98146

Detailed Description of Rehabilitation Work.

BEFORE
REHABILITATION
PHOTOGRAPHS

AFTER REHABILITATION
PHOTOGRAPHS ALONG WITH
HISTORIC PHOTOGRAPHS TO
SHOW ORIGINAL DESIGN.

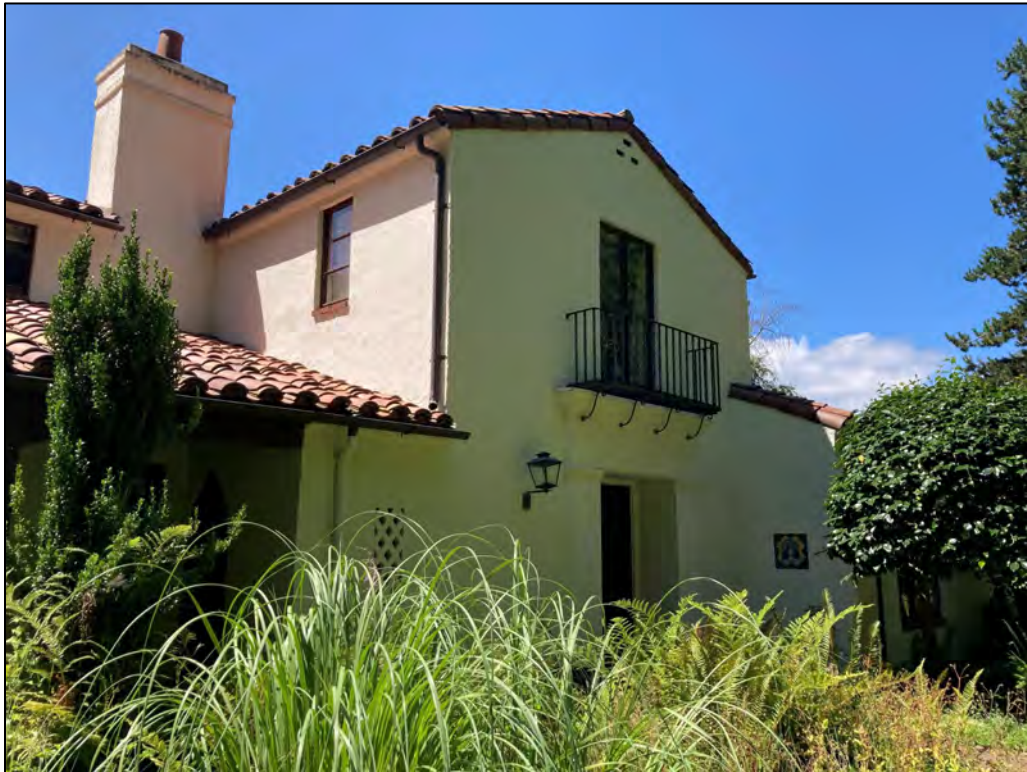
Fig. 1 – East facade, center part, view northwest showing main entry.

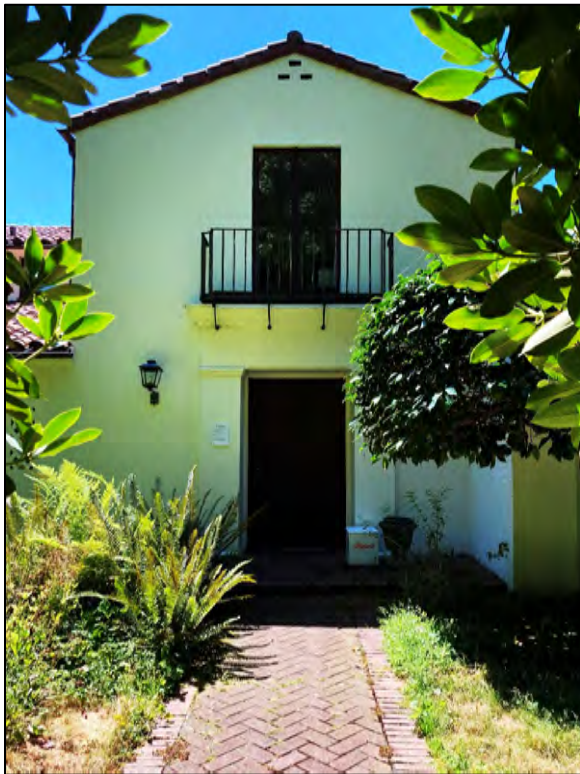
Fig. 2 – East facade, center part, view west showing main entry.

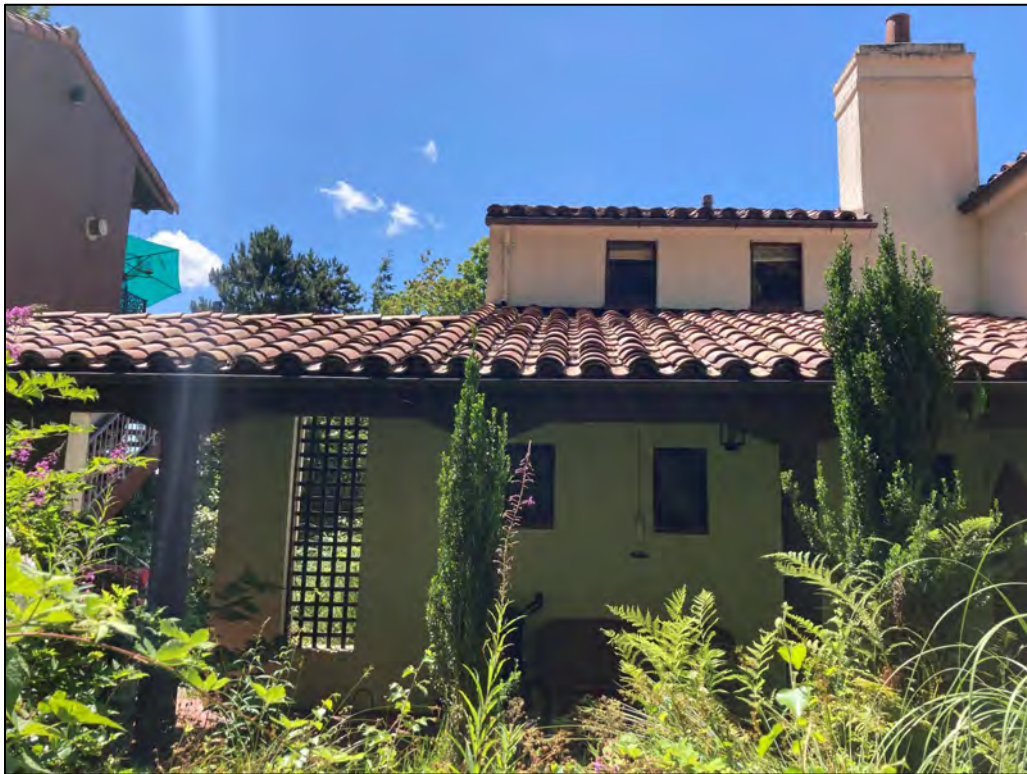
Fig. 3 - East facade, south, part showing porch between house and garage.

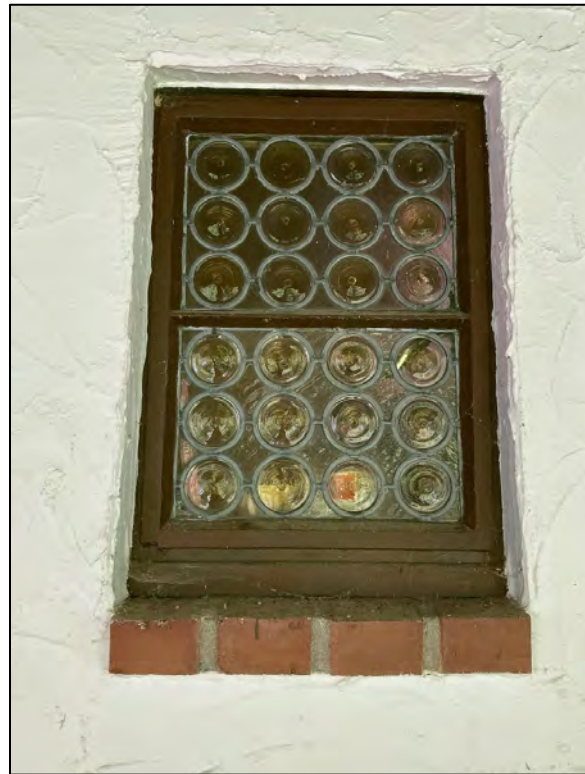
Fig. 5 – East facade, detail of window under porch (left)

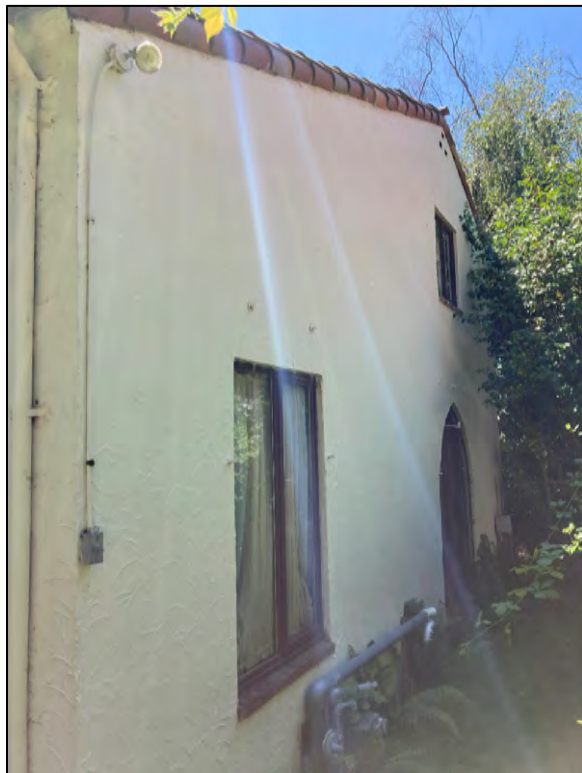
Fig. 6 – North facade, view southwest.

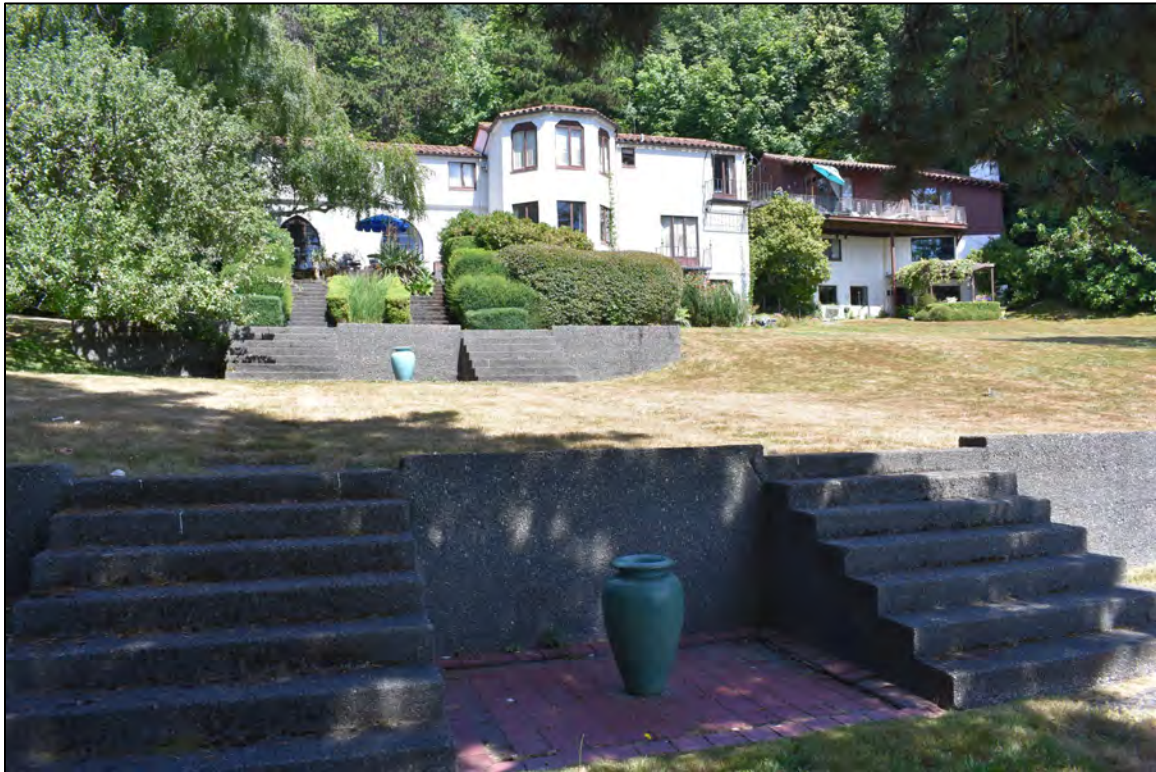
Fig. 7 – West facade, view east, from lower back yard. Garage apartments visible at right.

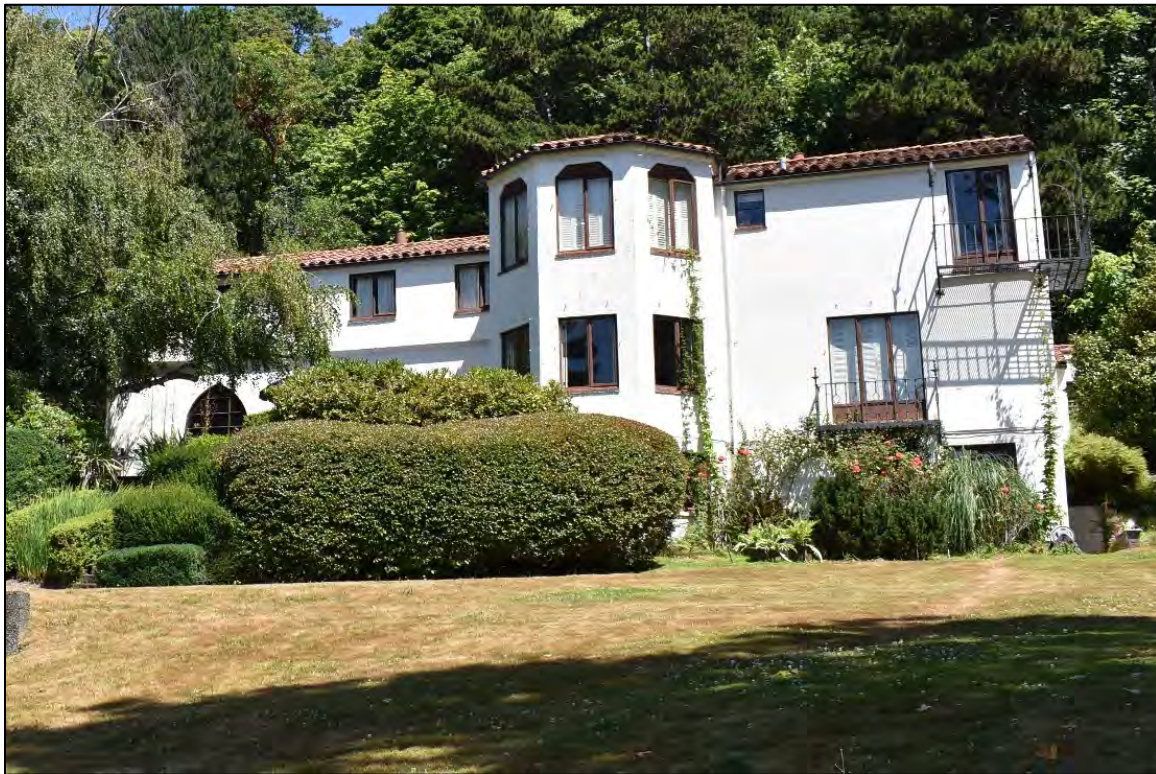
Fig. 8 – West facade, view east.

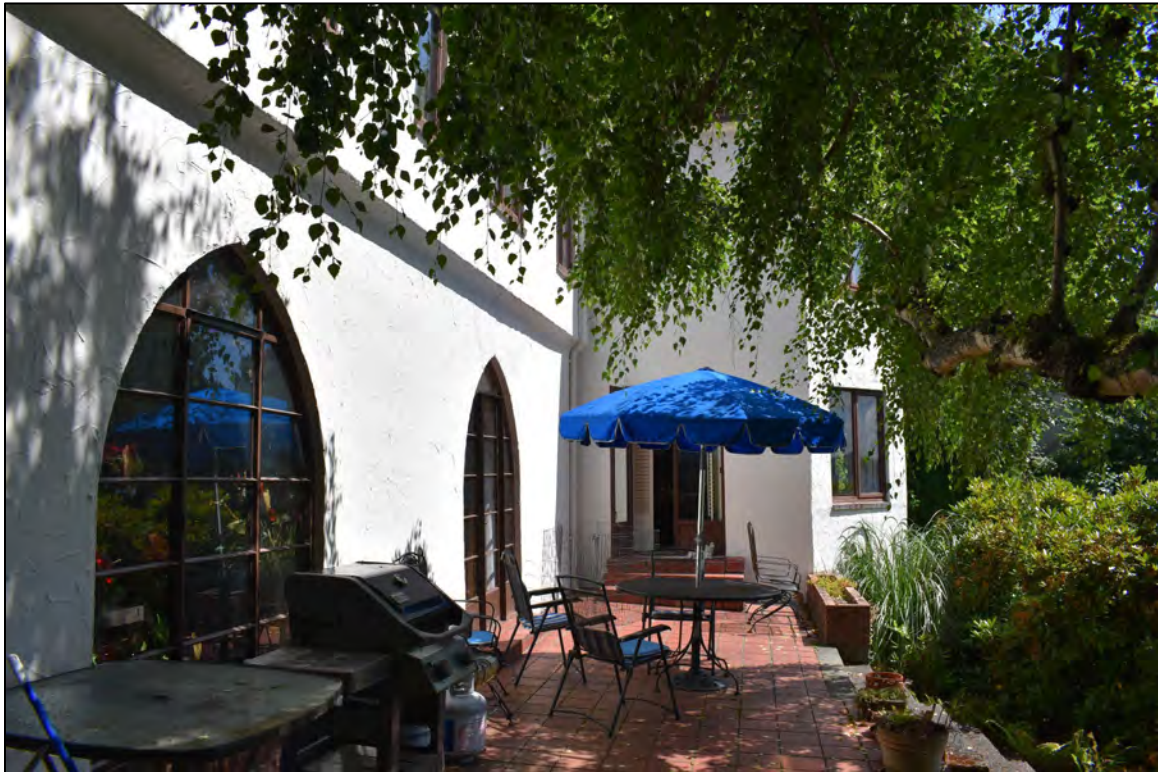
Fig. 9 – West facade, view south across rear patio.

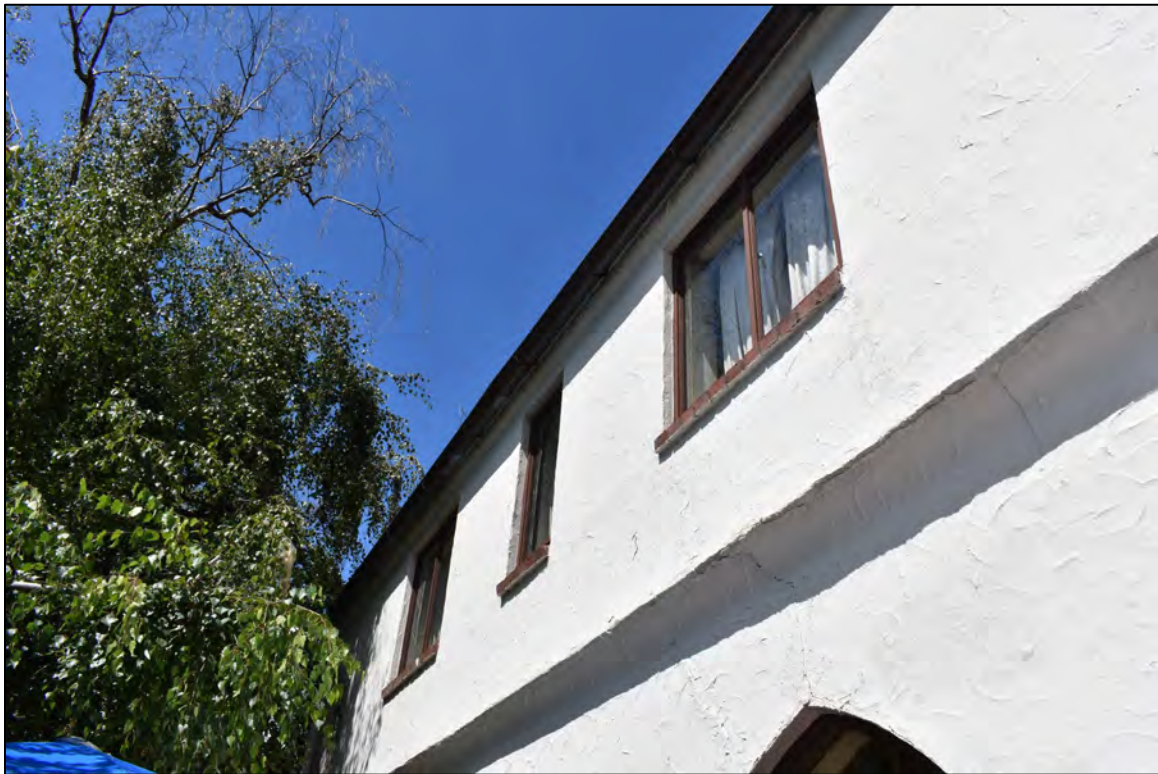
Fig. 10 – West facade, upper part, view northeast from rear patio.

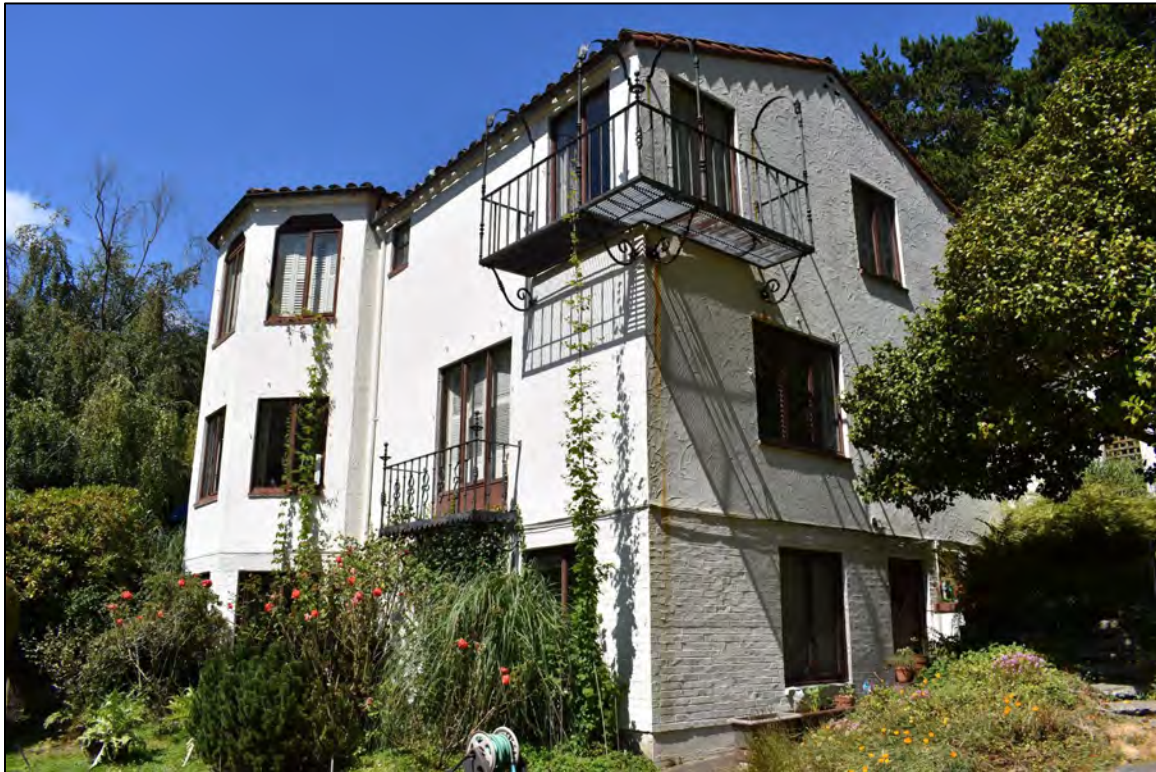
Fig. 11 – West and south facades, view northeast.

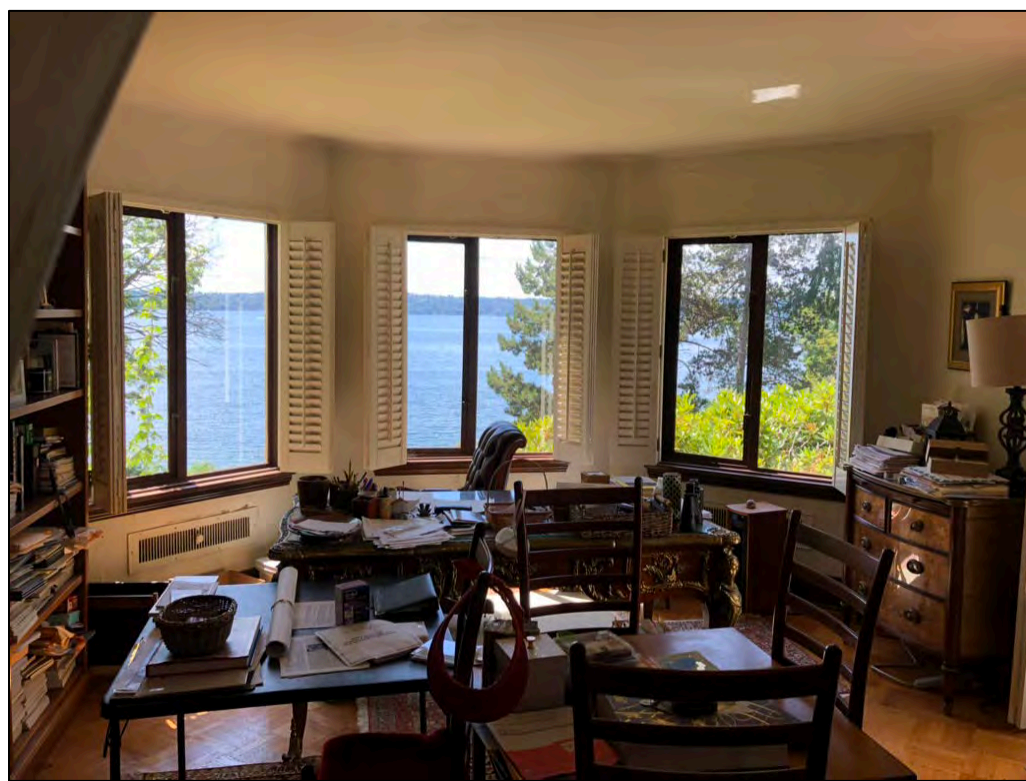
Fig. 14 – Interior, sun room, view west.

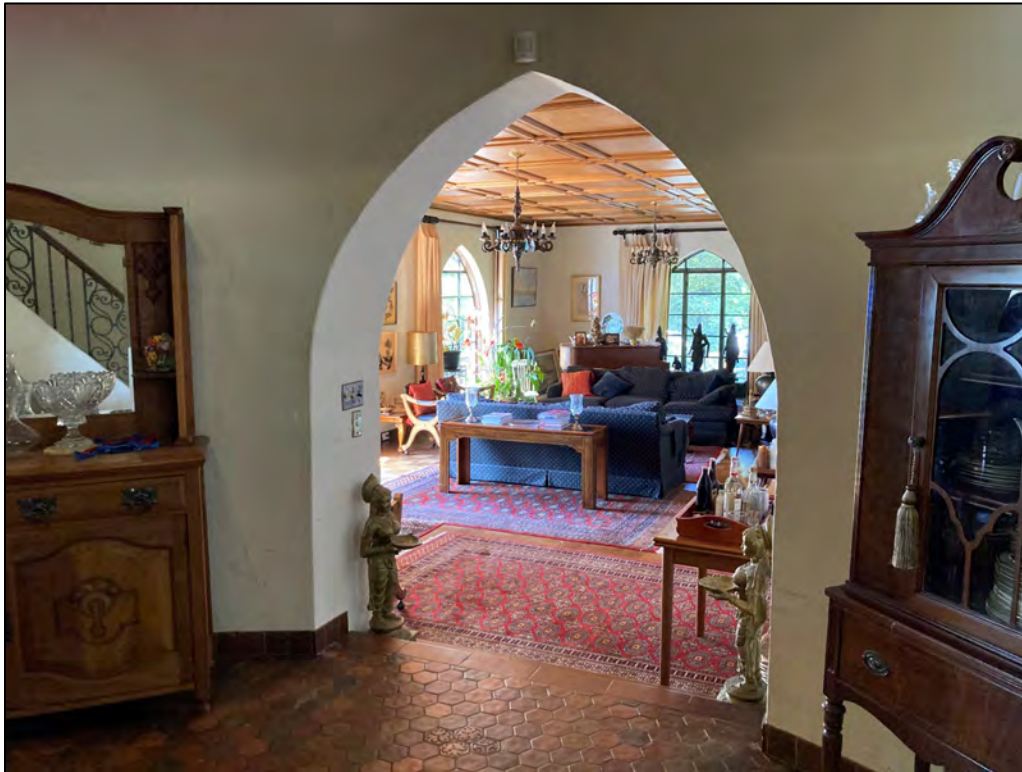
Fig. 15 – Interior, stair hall, view northwest to living room.

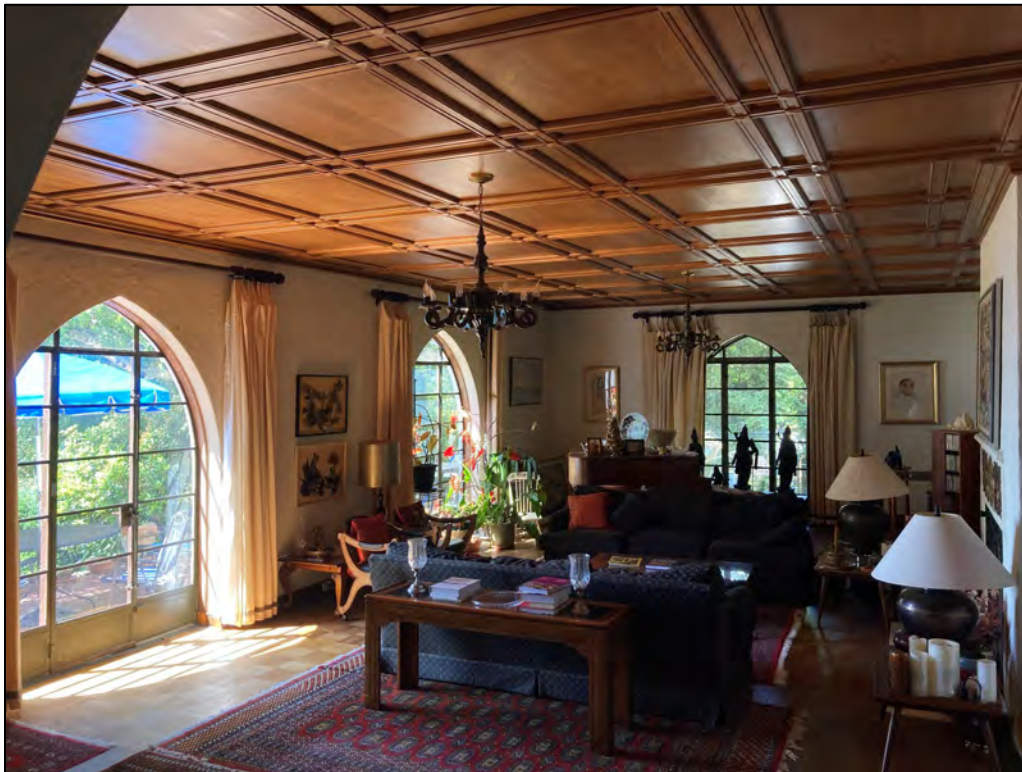
Fig. 16 – Interior, living room, view northwest. Patio visible outside windows on left.

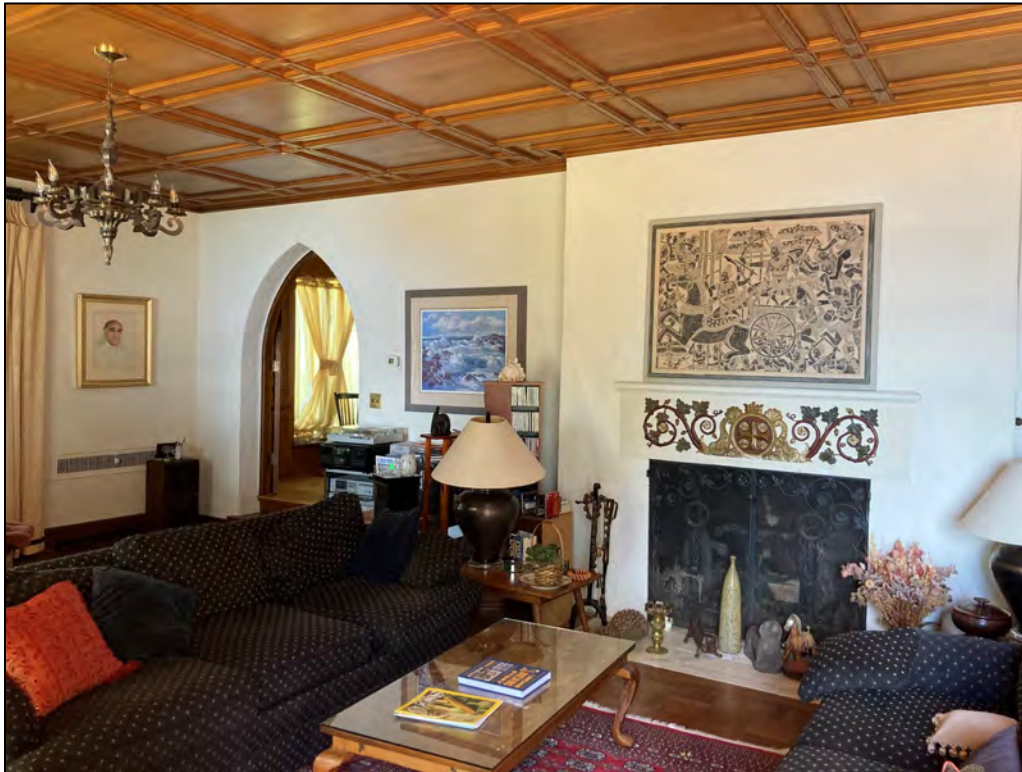
Fig. 17 – Interior, living room, view northeast. Breakfast room visible through arched doorway.

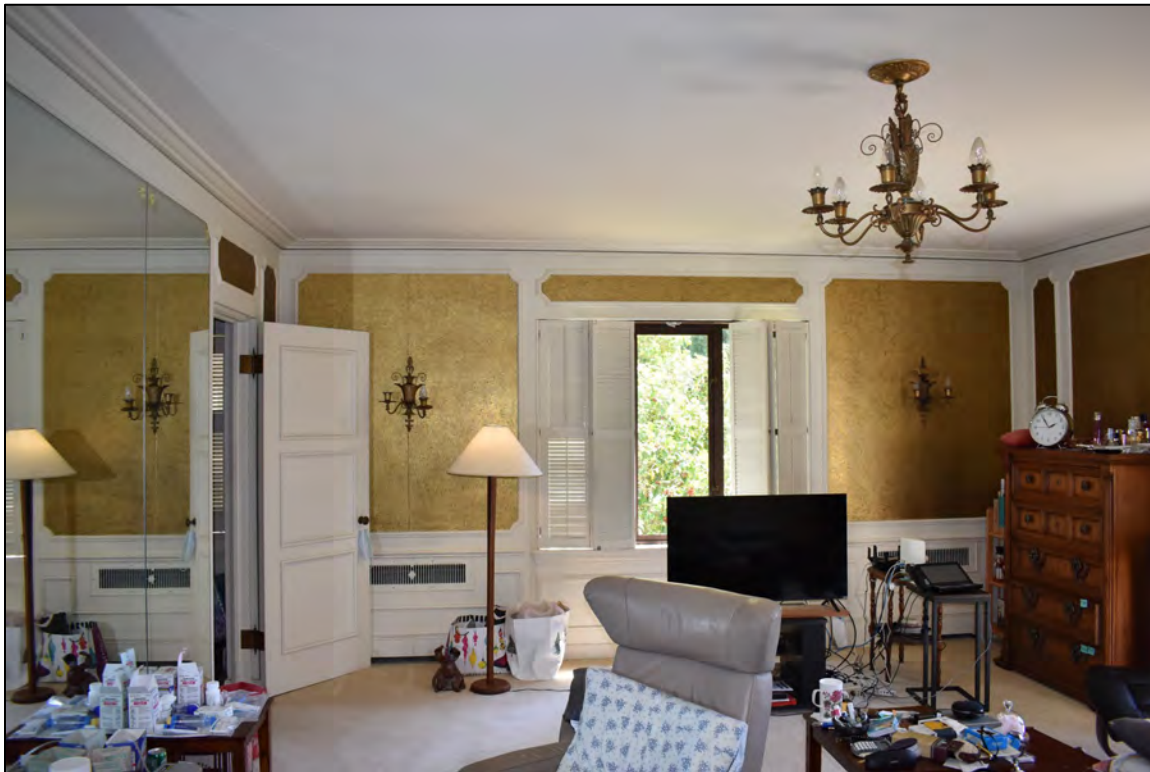
Fig. 18 – Interior, primary bedroom, view south.

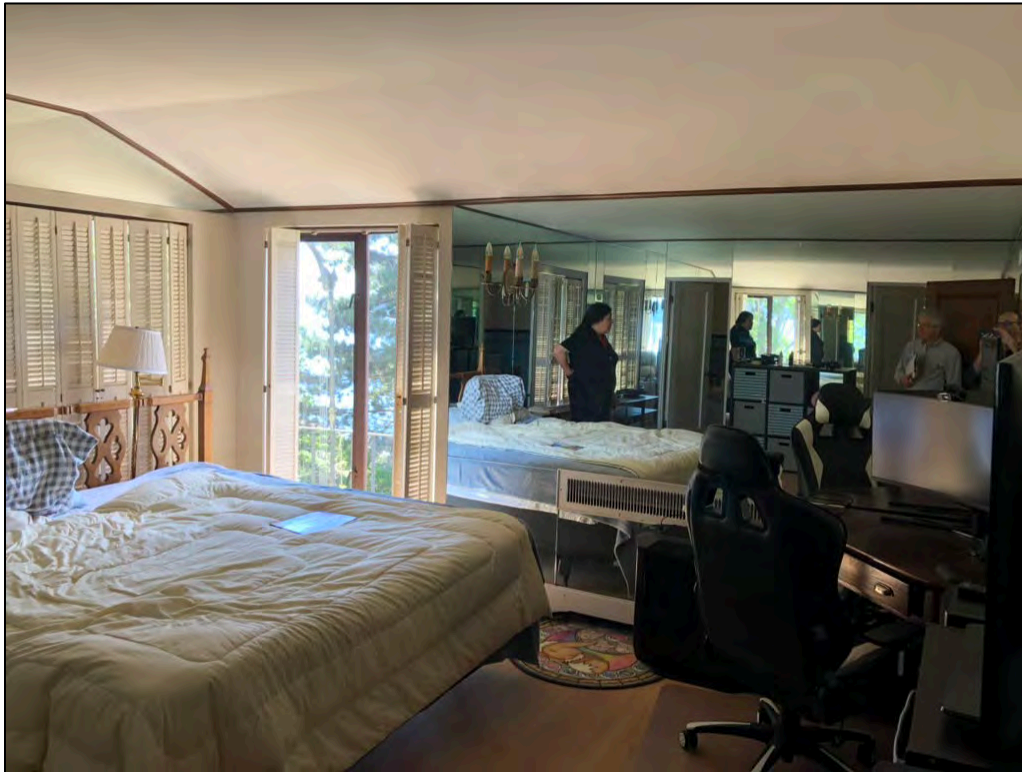
Fig. 19 – Interior, second floor, south bedroom, view southwest.

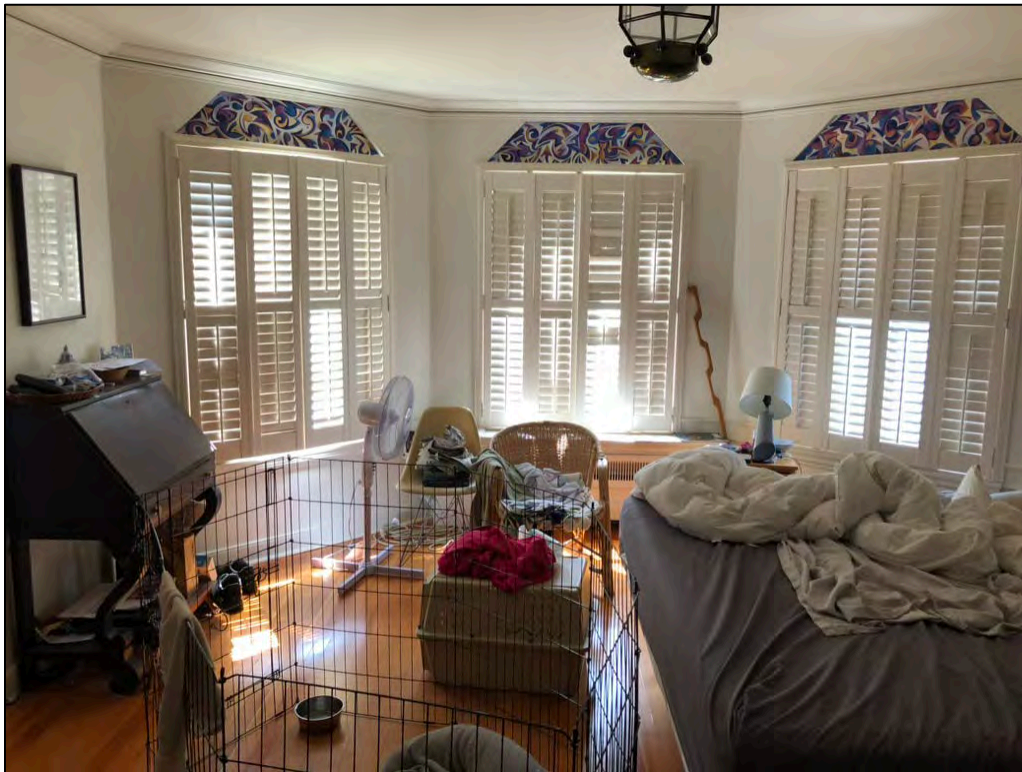
Fig. 20 – Interior, second floor, west bedroom, view west.

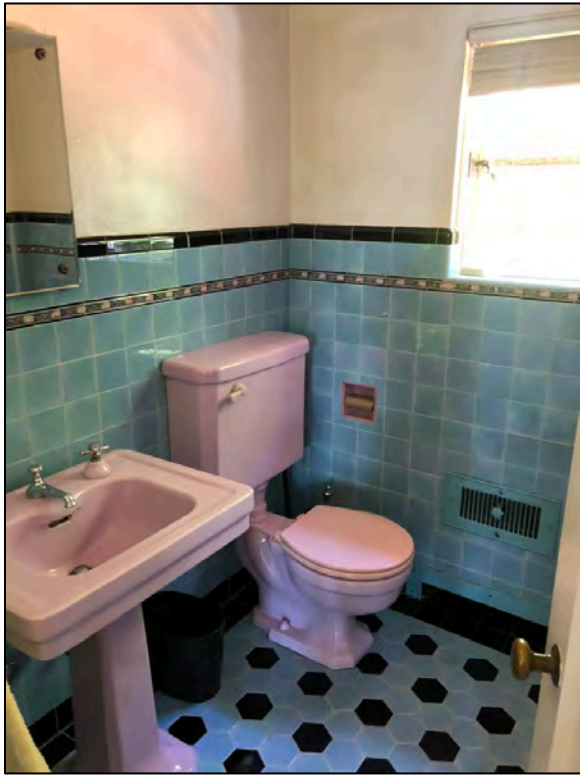
Fig. 21 – Interior, second floor, west bedroom bathroom, view southwest.

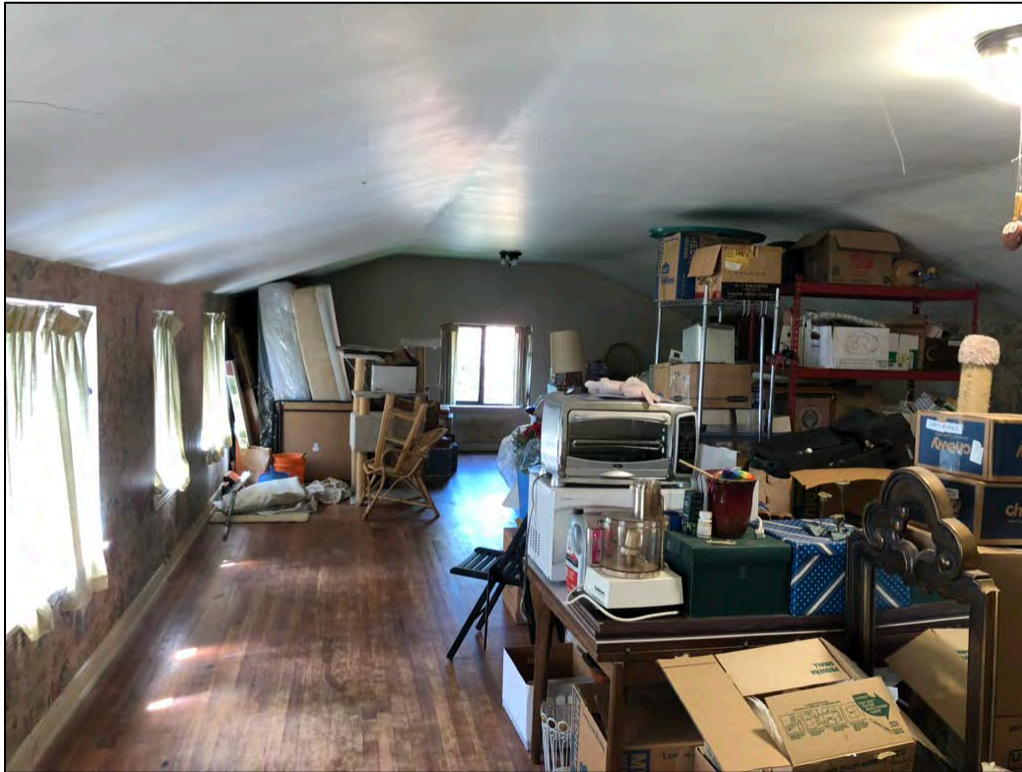
Fig. 22 – Interior, second floor, multipurpose room, view north.
