PHOTOGRAPHS
BEFORE REHABILITATION

RAINIER BREWERY
BOTTLING PLANT
(SEATTLE BREWING & MALTING CO)

5710 Airport Way S, Seattle, WA 98108

PHOTOGRAPHS
AFTER REHABILITATION

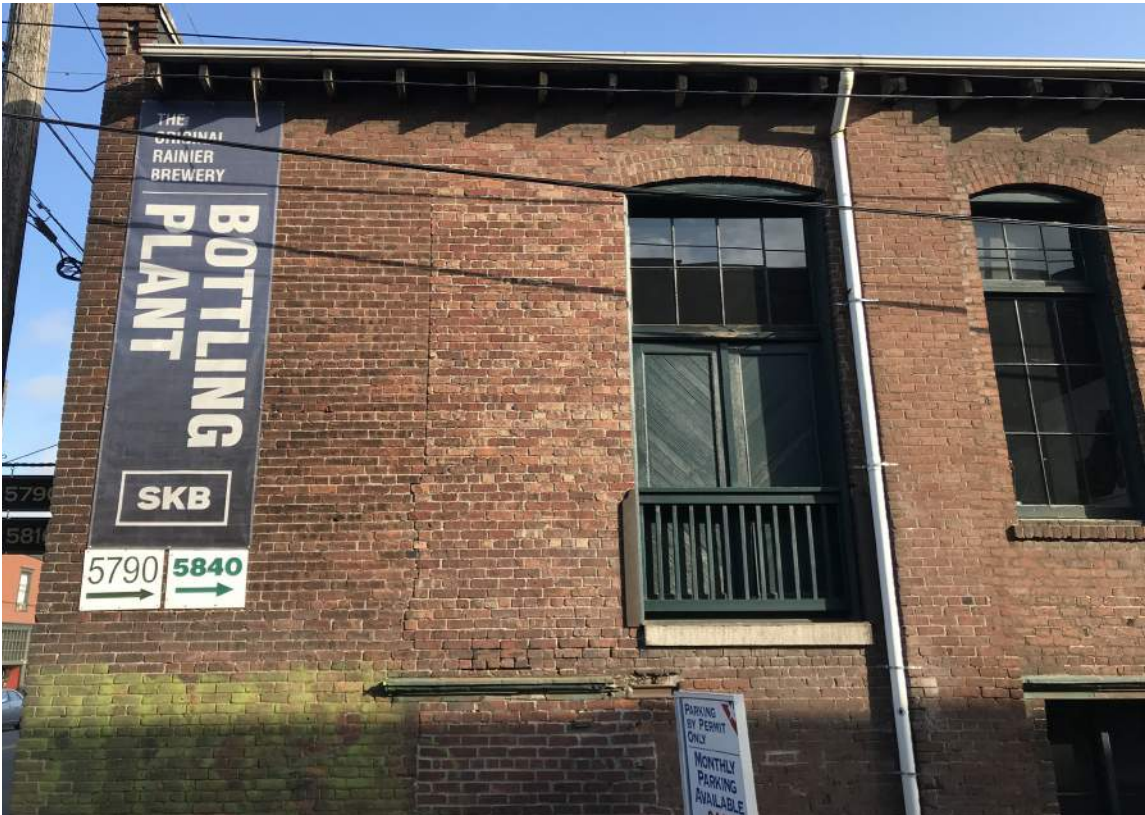
01

Brick wall; previous infill opening; painted wood windows and doors

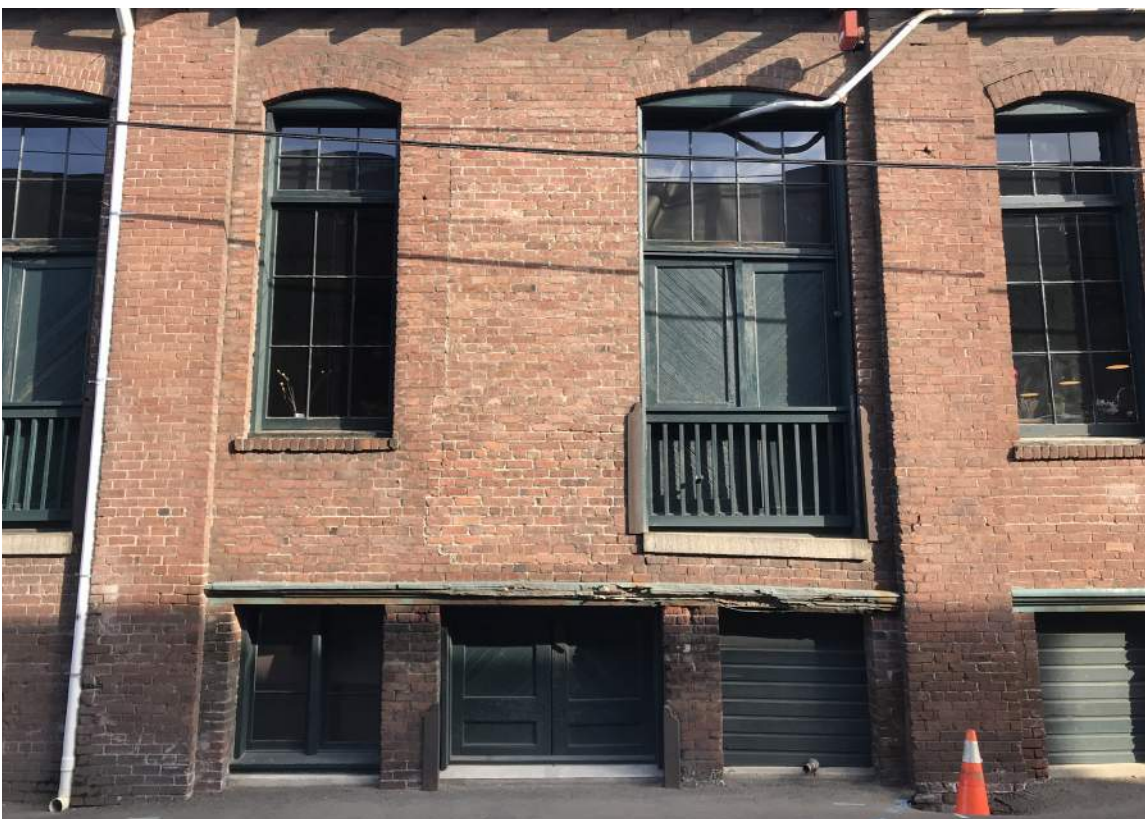
02

Brick wall; painted wood windows and doors

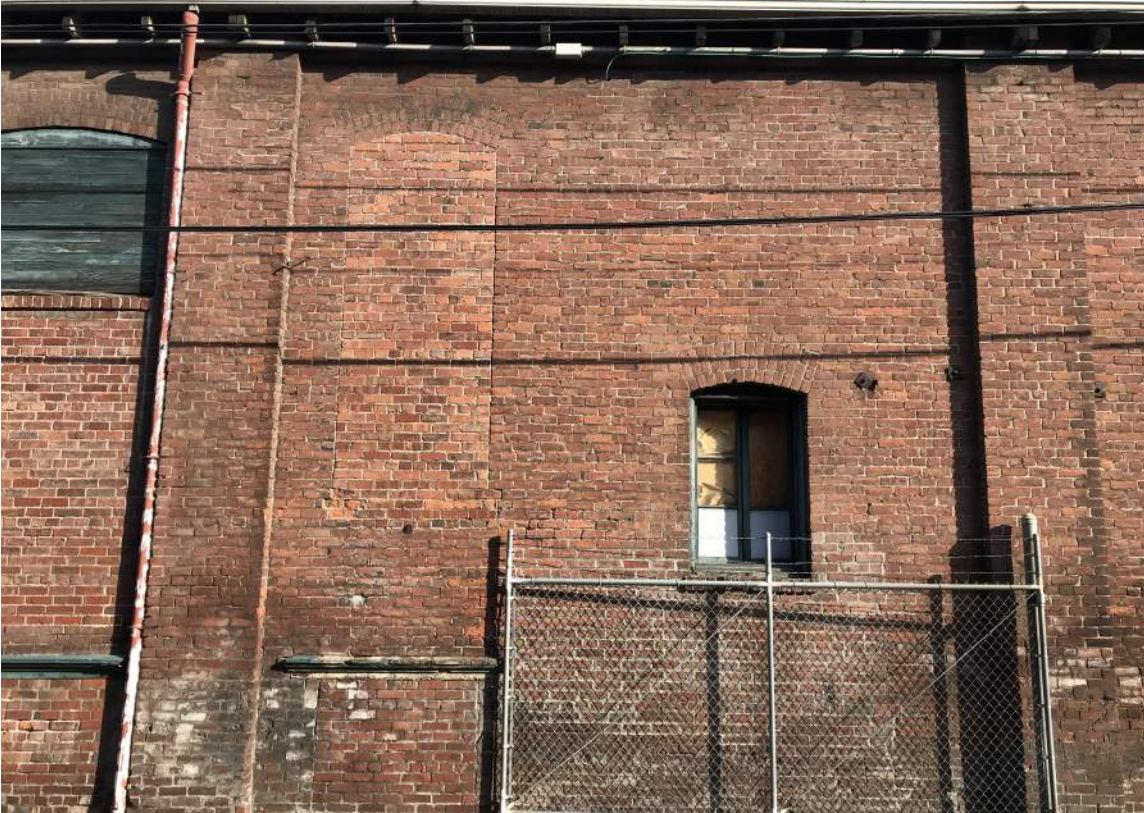
03

Brick wall; previous infill openings; painted wood window and opening infill

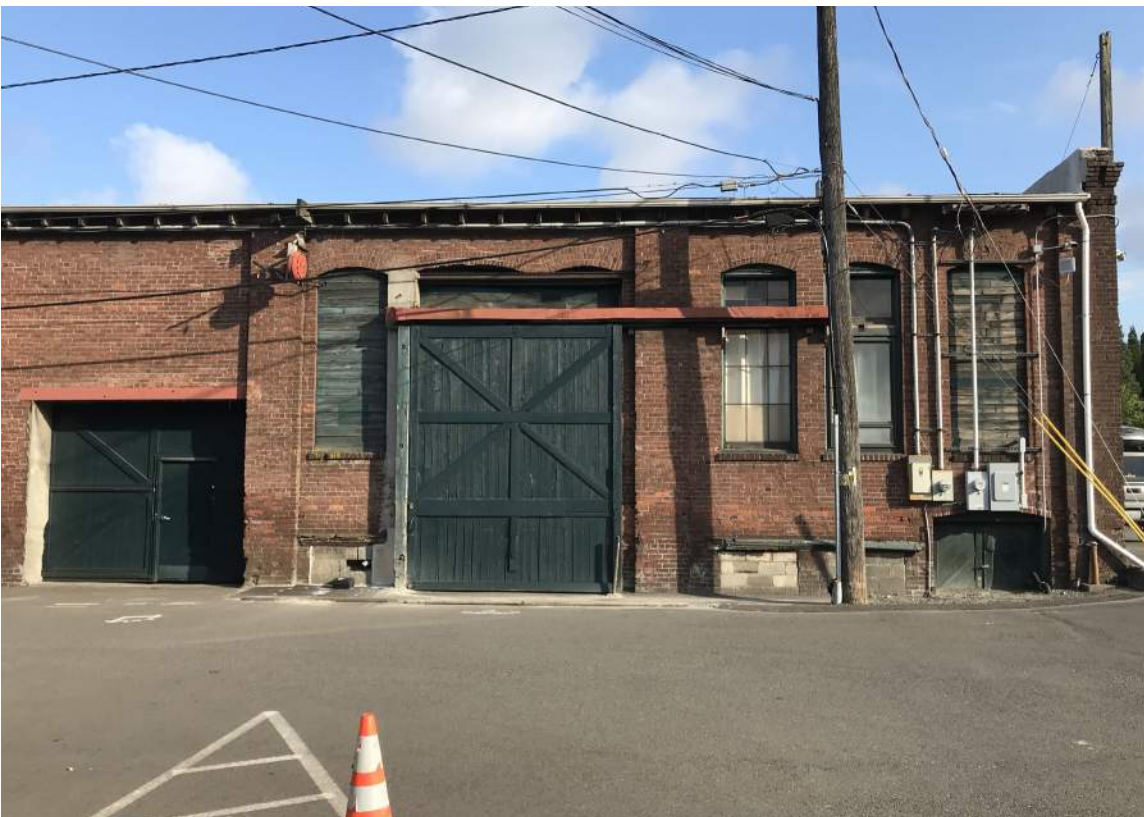
04

Brick wall; previous infill openings; painted wood windows and doors

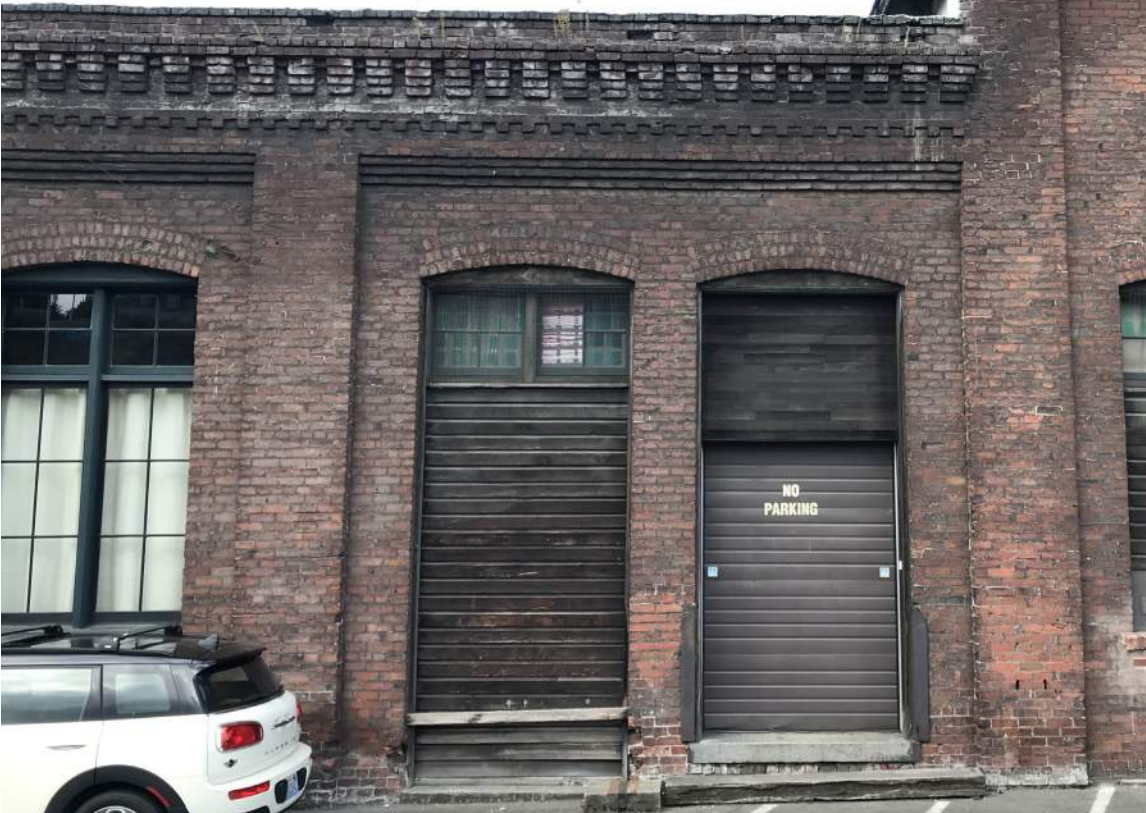
05

Brick wall; previous infill opening; painted wood windows and roll-up door

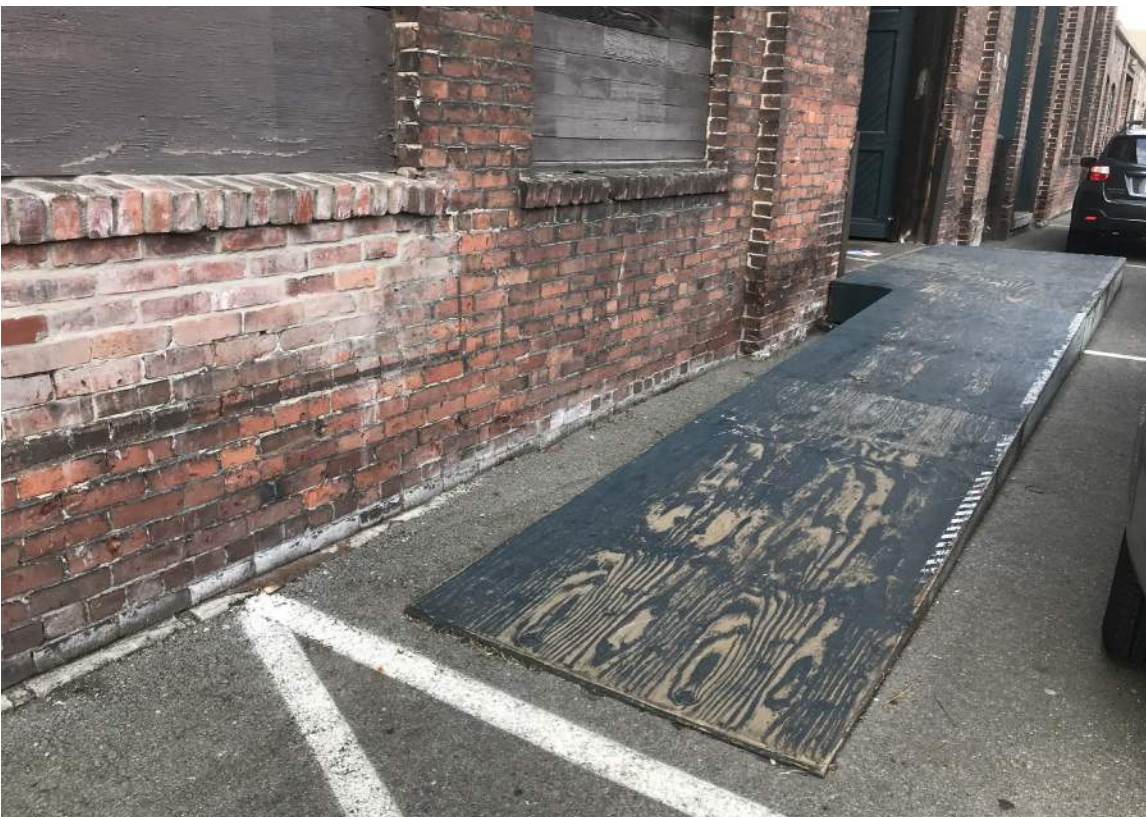
06

Brick wall; previous infill openings; painted wood ramp

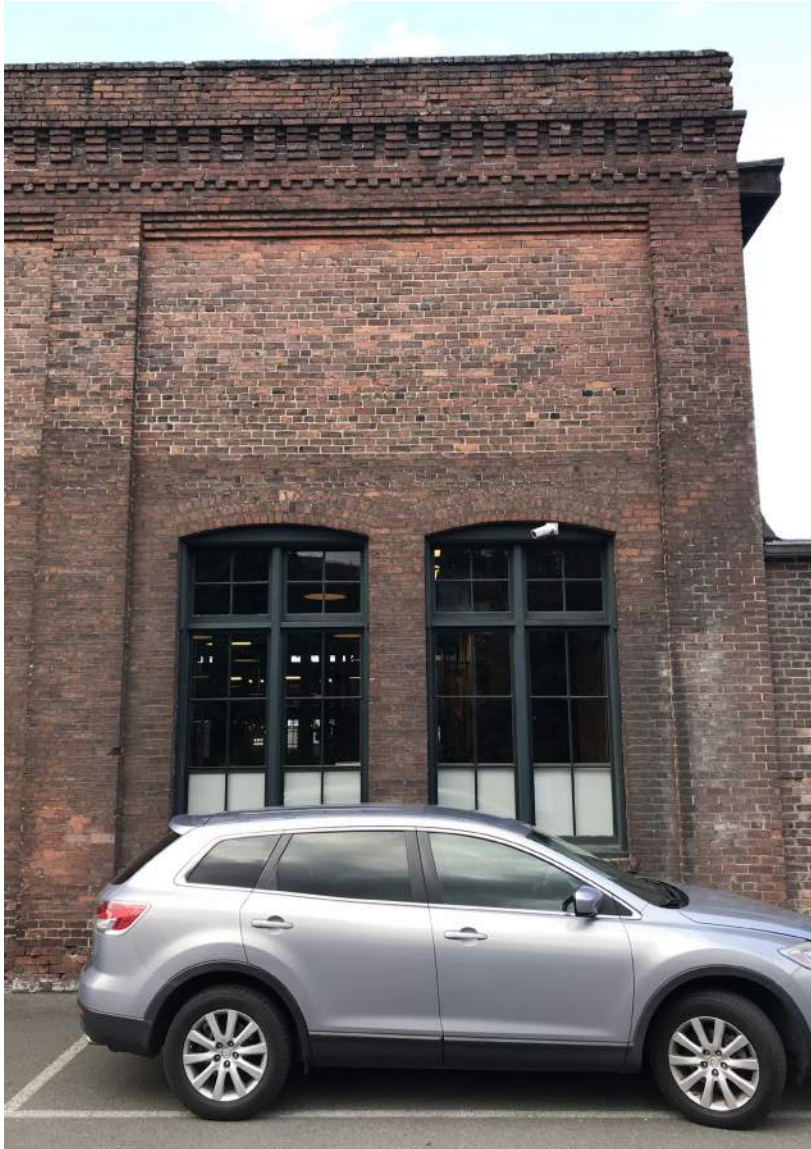
07

Brick wall; painted wood
windows

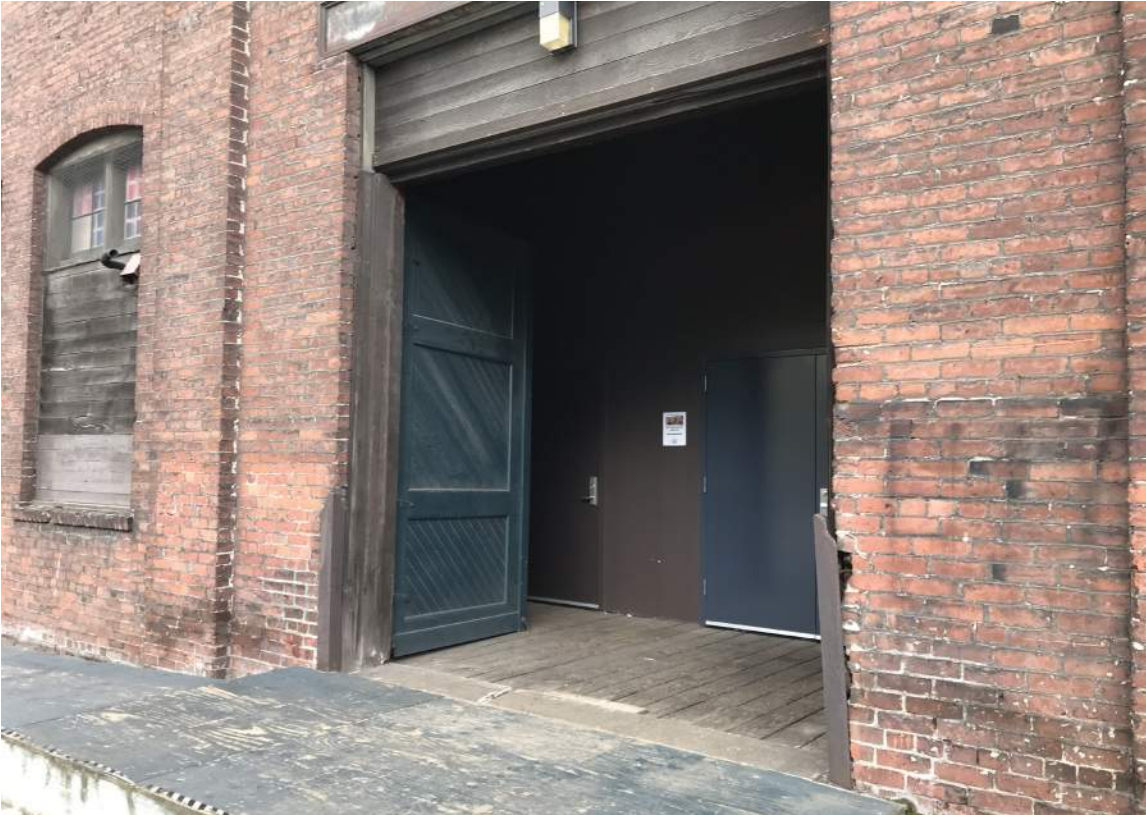
08

Brick wall; previous infill opening; painted wood doors and ramp

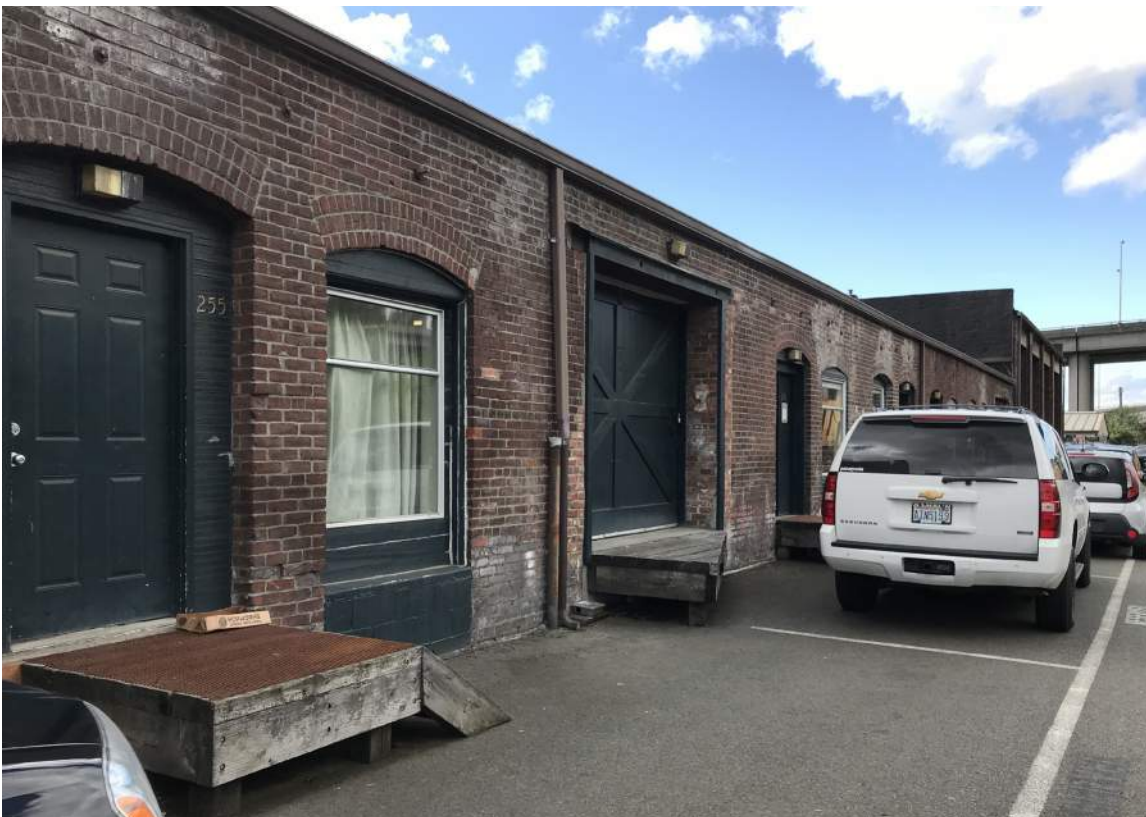
09

Brick wall; painted wood windows and doors; previous painted CMU infill below window; wood door landings

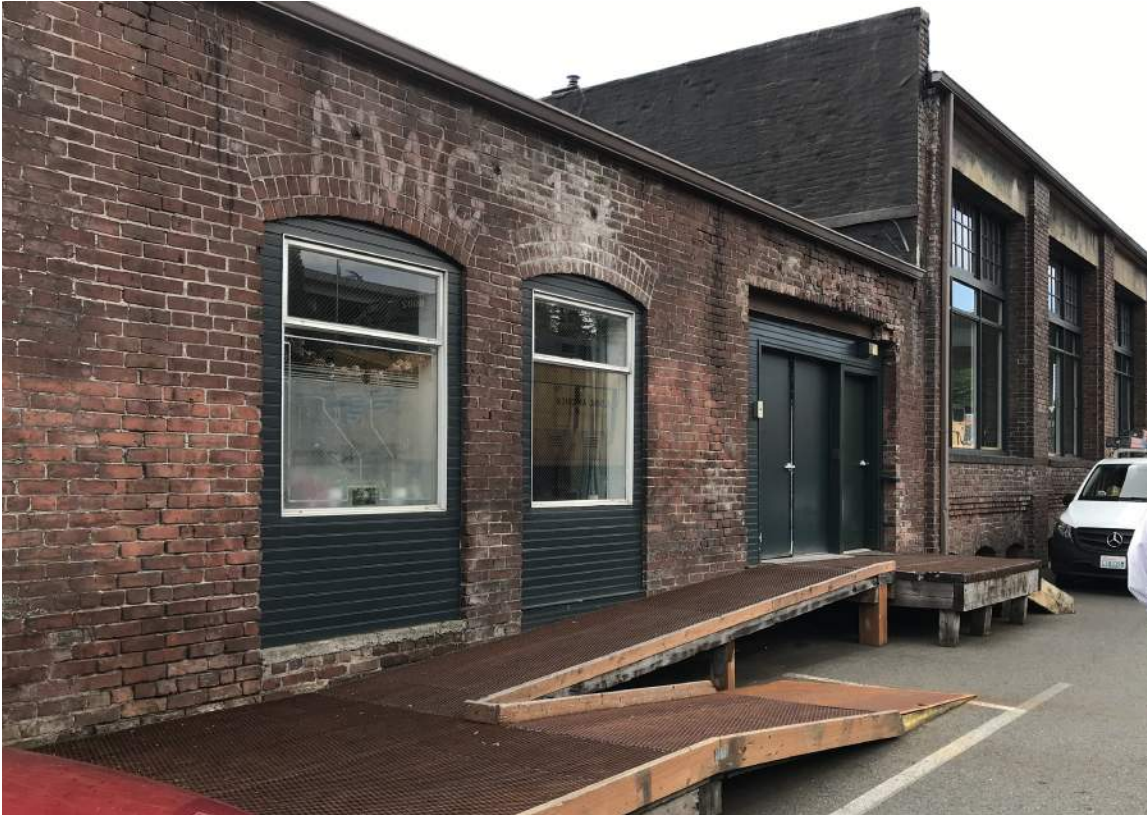
10

Brick wall; painted wood windows and doors (right); unpainted aluminum windows (left); wood door landing and ramp

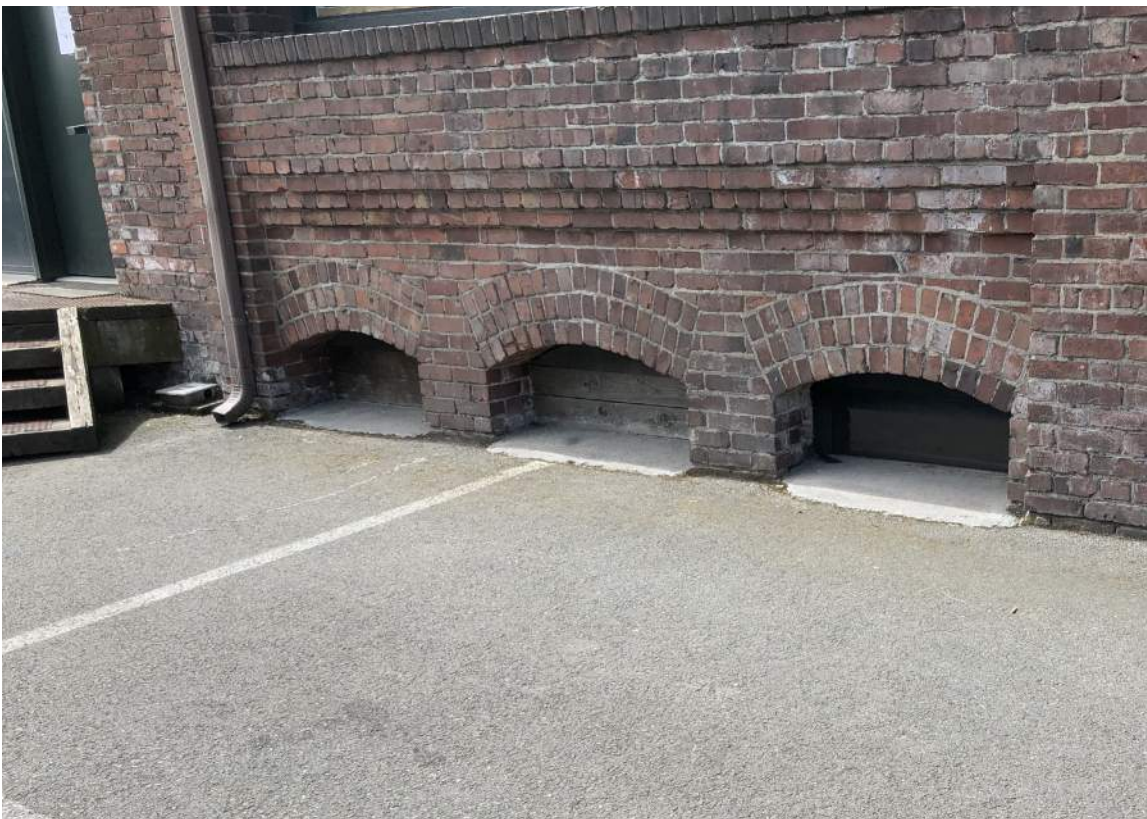
11

Brick wall; previous infill openings

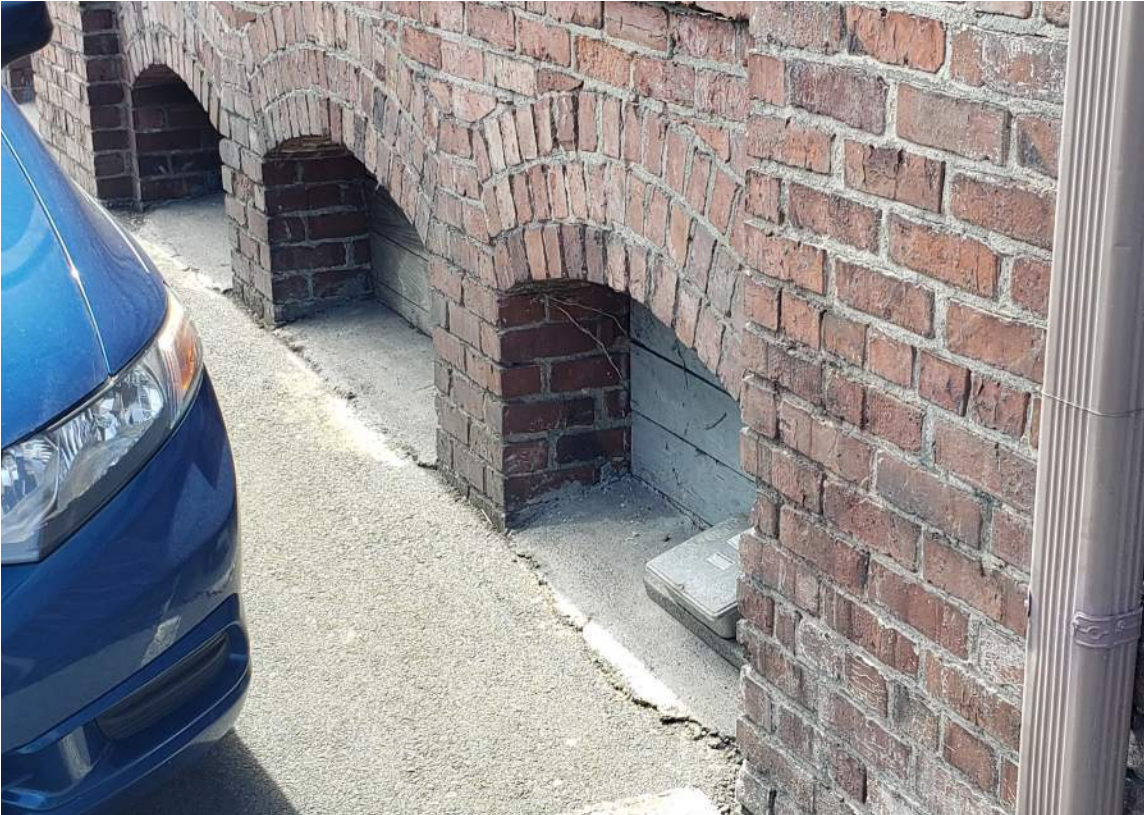
12

Brick wall; previous infill openings

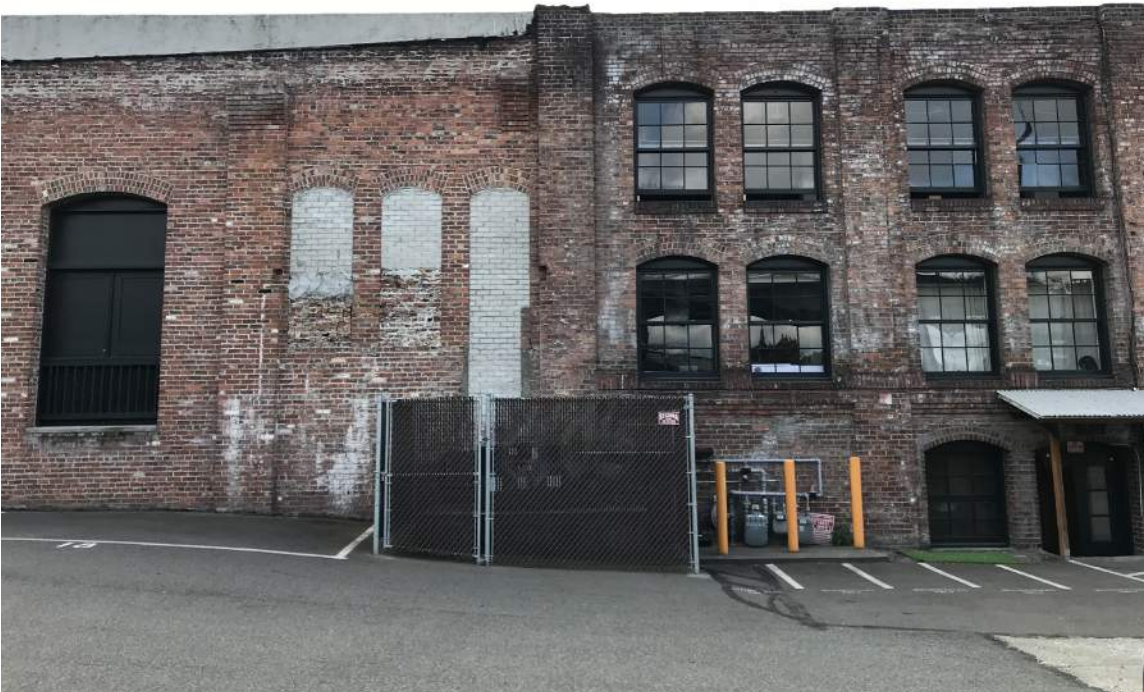
13

Brick wall; previous infill openings; painted wood windows and doors; metal trash enclosure

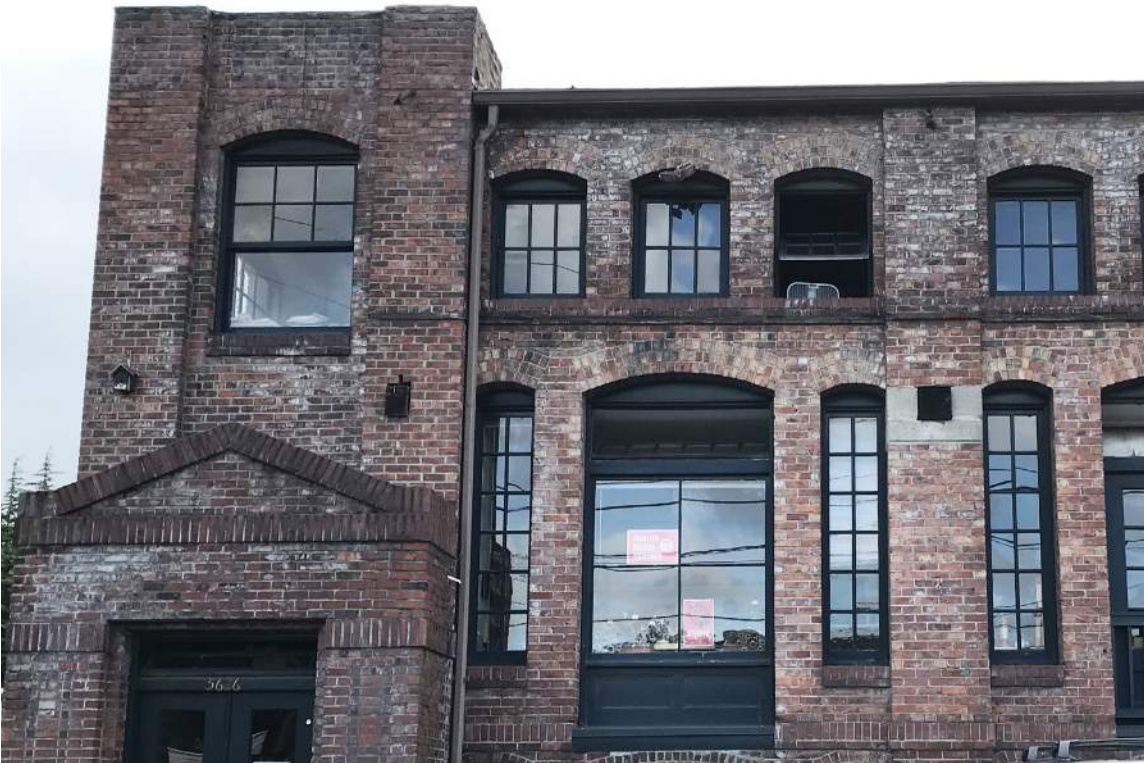
14

Brick wall; painted wood windows and doors

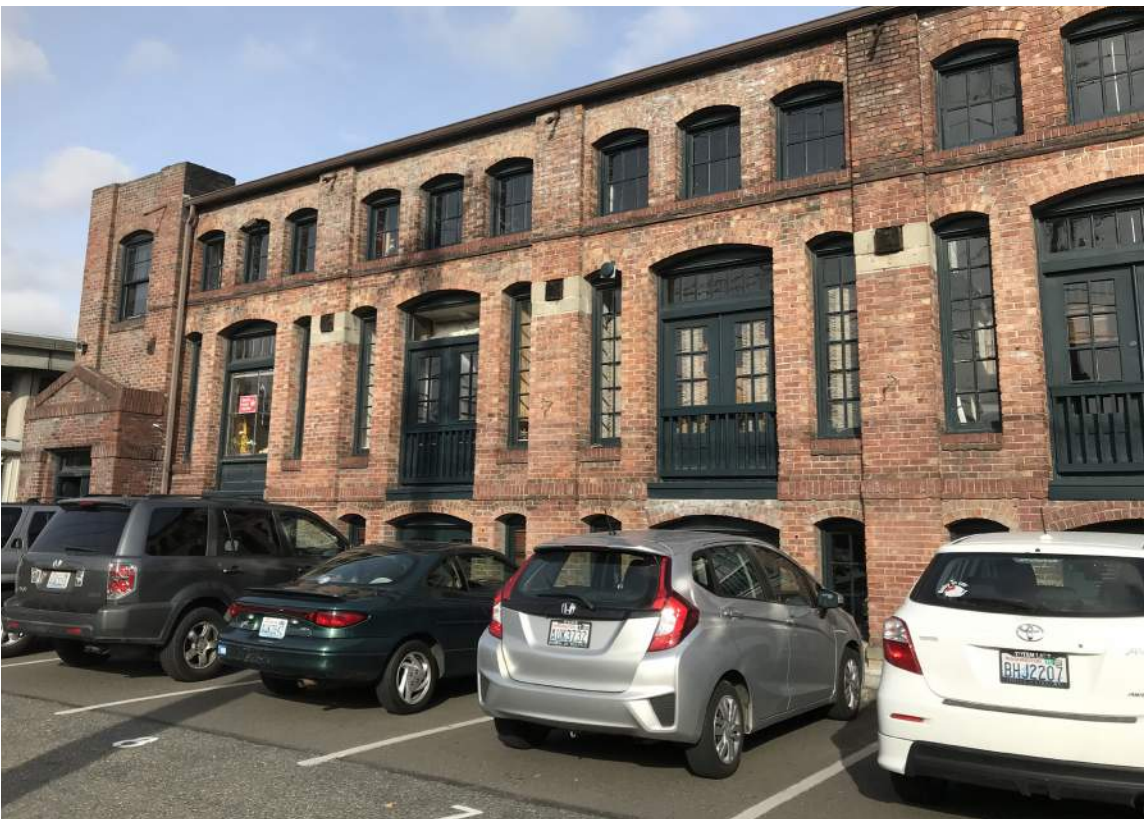
15

Brick wall; painted wood windows and doors

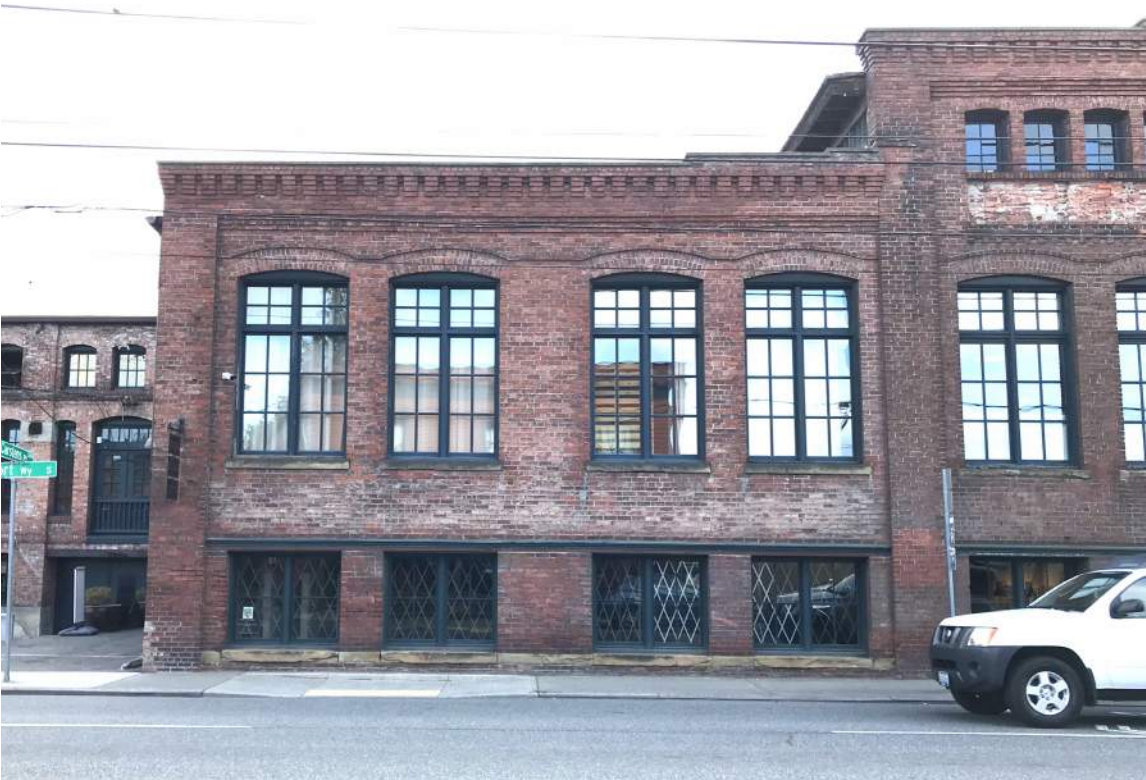
16

Brick wall; painted wood
windows

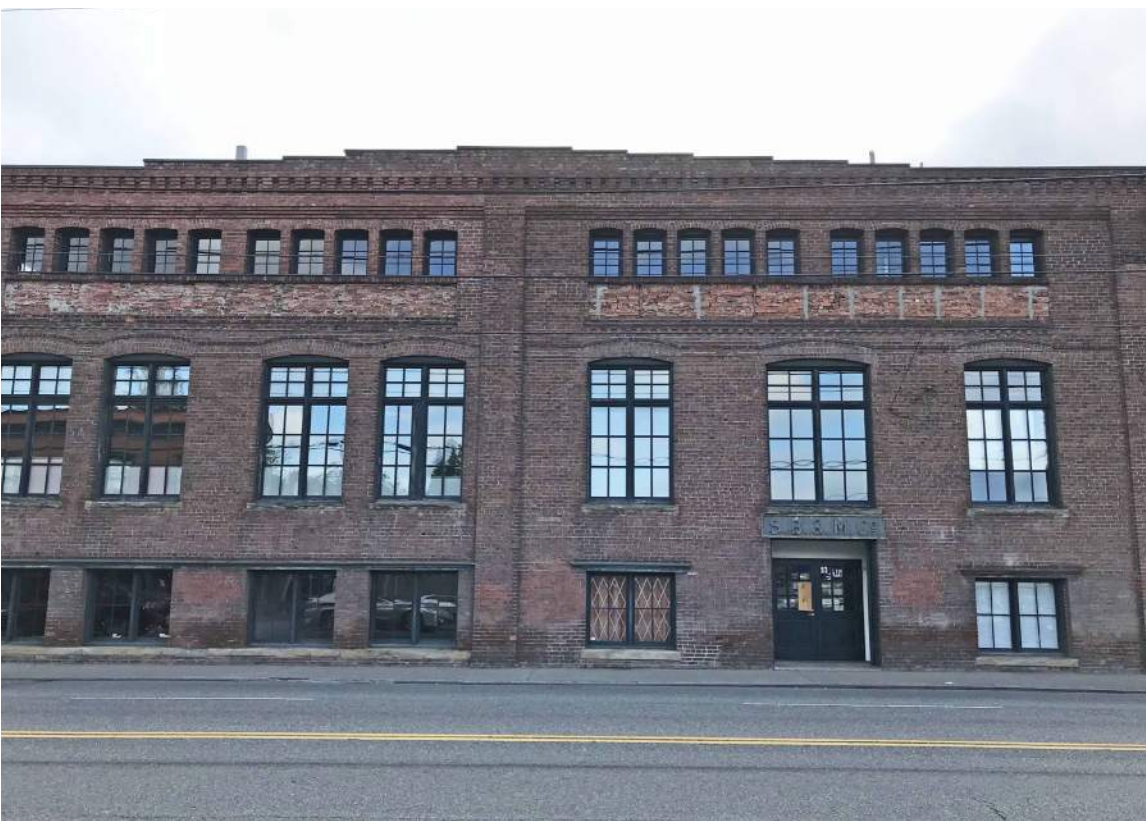
17

Brick wall; painted wood
windows and doors

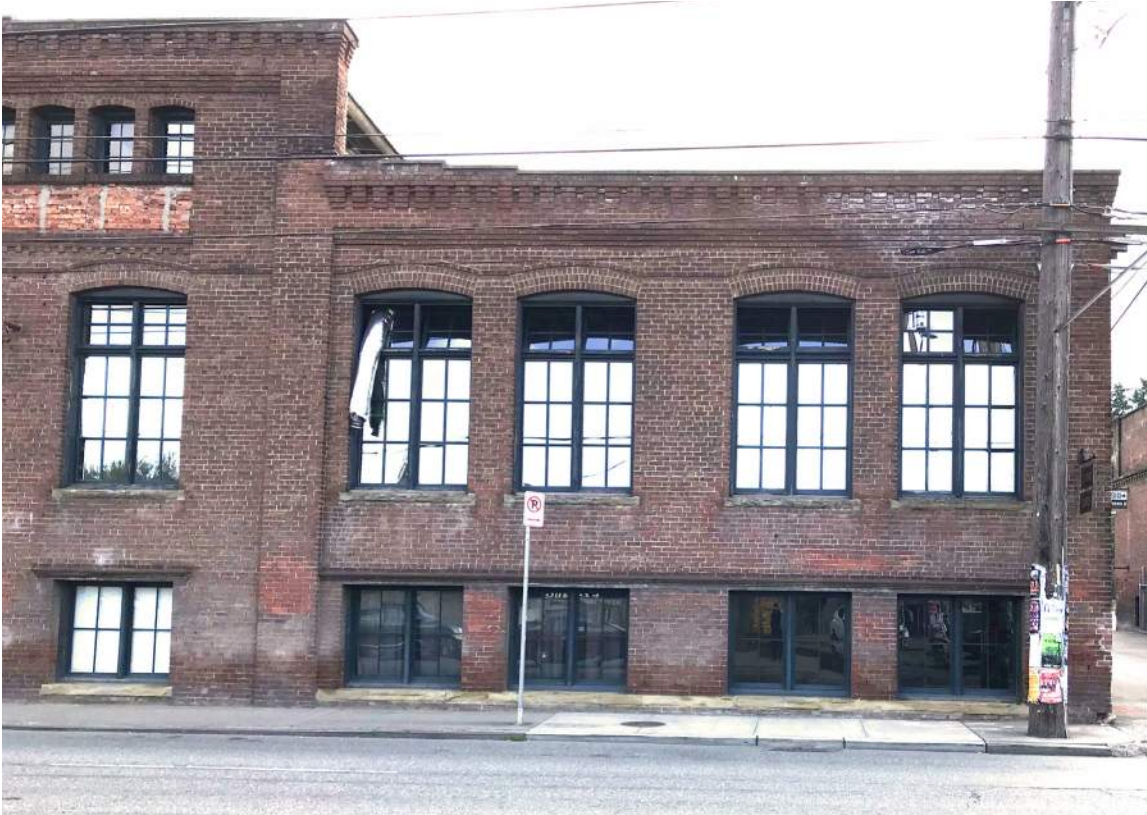
18

Brick wall; painted wood
windows

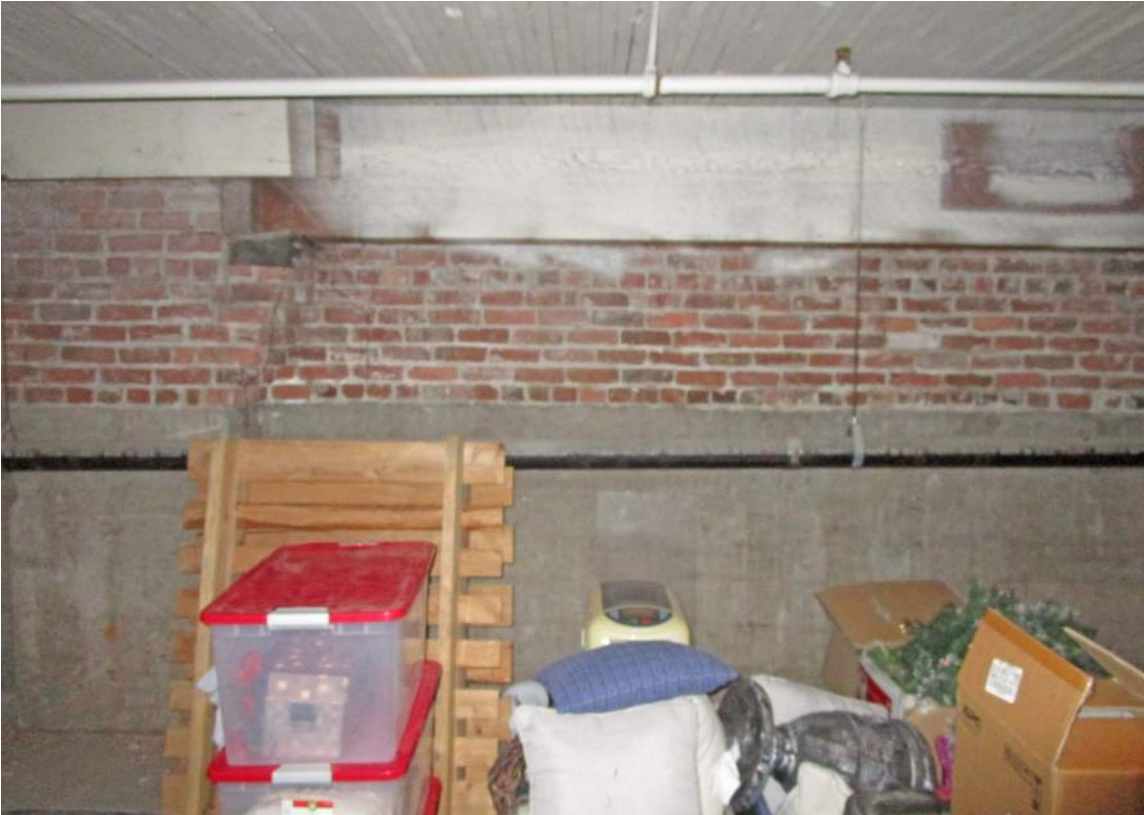
19

Brick wall; concrete pony wall; painted wood ceiling

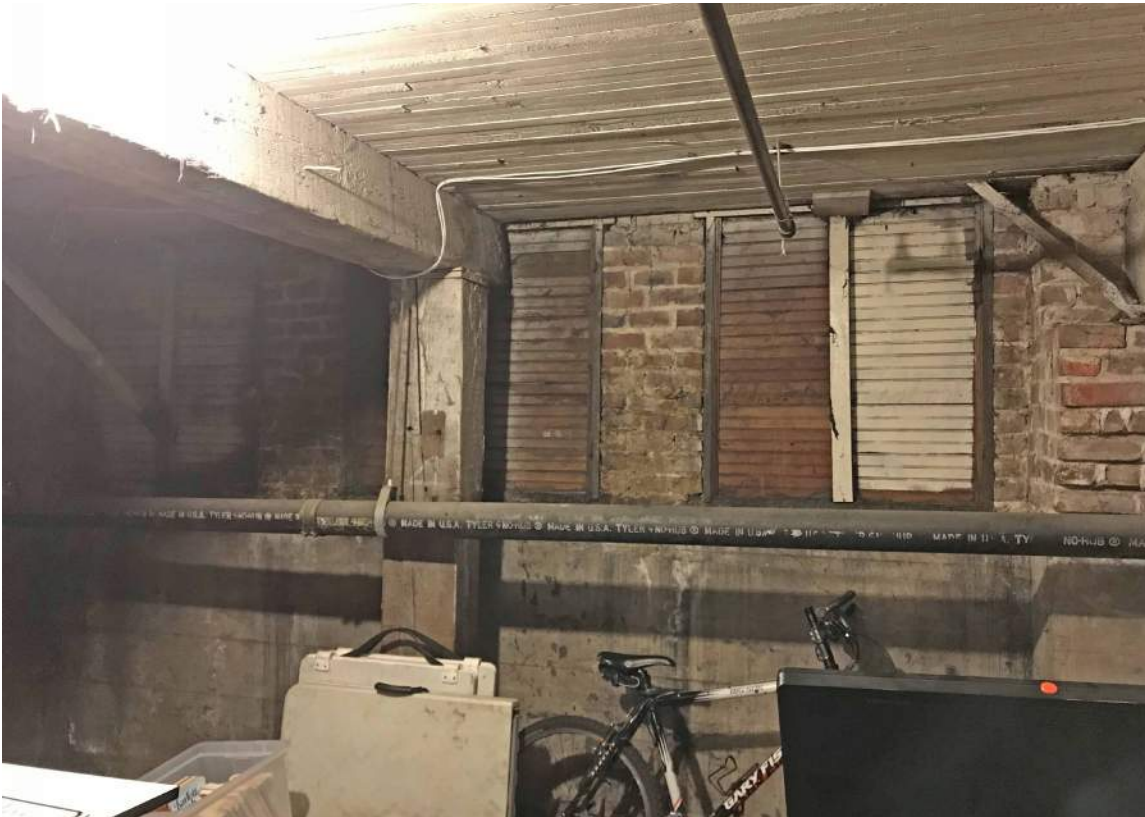
21

Brick wall; concrete pony wall; painted wood ceiling; beam and column; previous infill openings

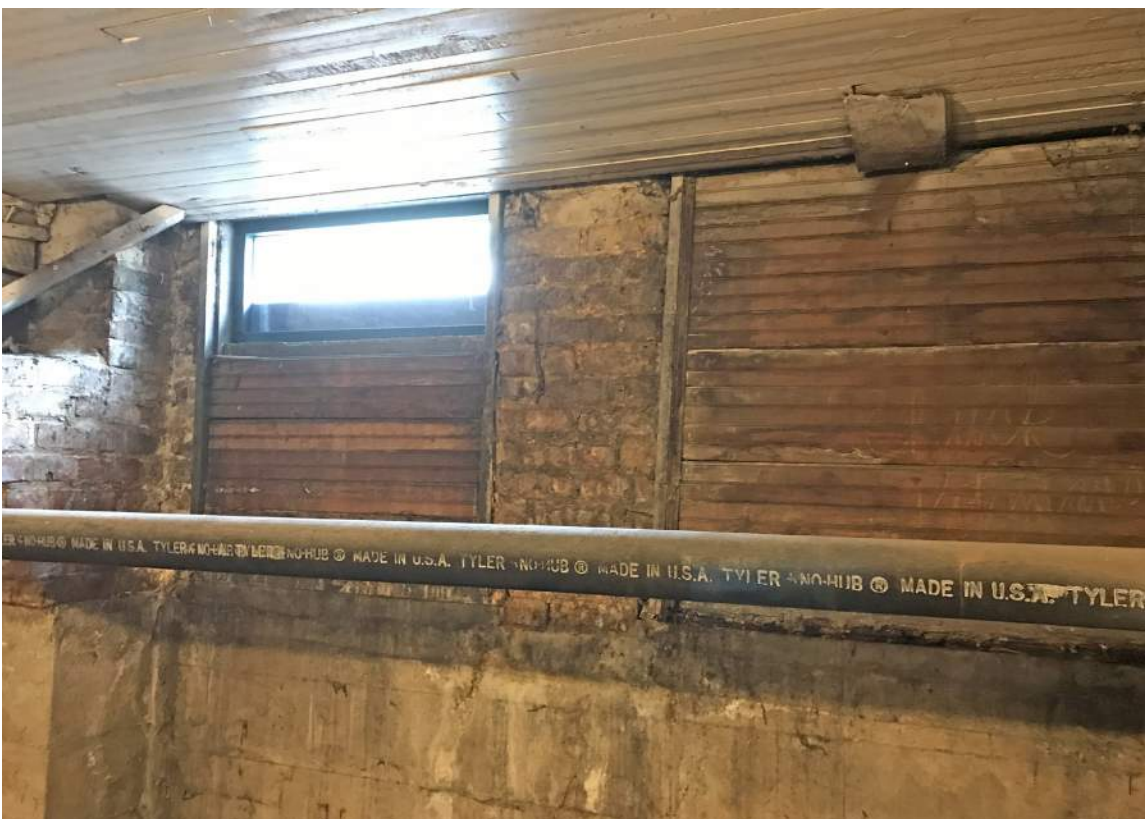
22

Brick wall; concrete pony wall; painted wood ceiling; previous infill openings; painted window

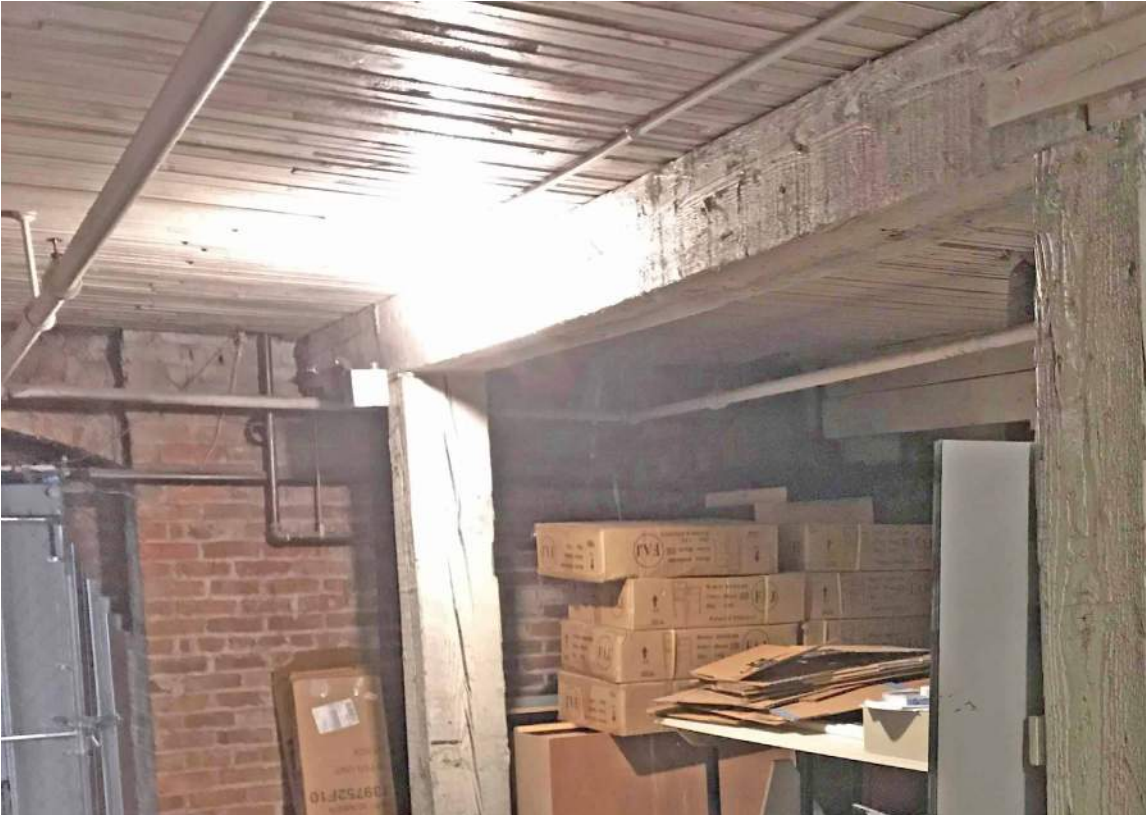
24

Brick wall; painted wood ceiling, beams and columns

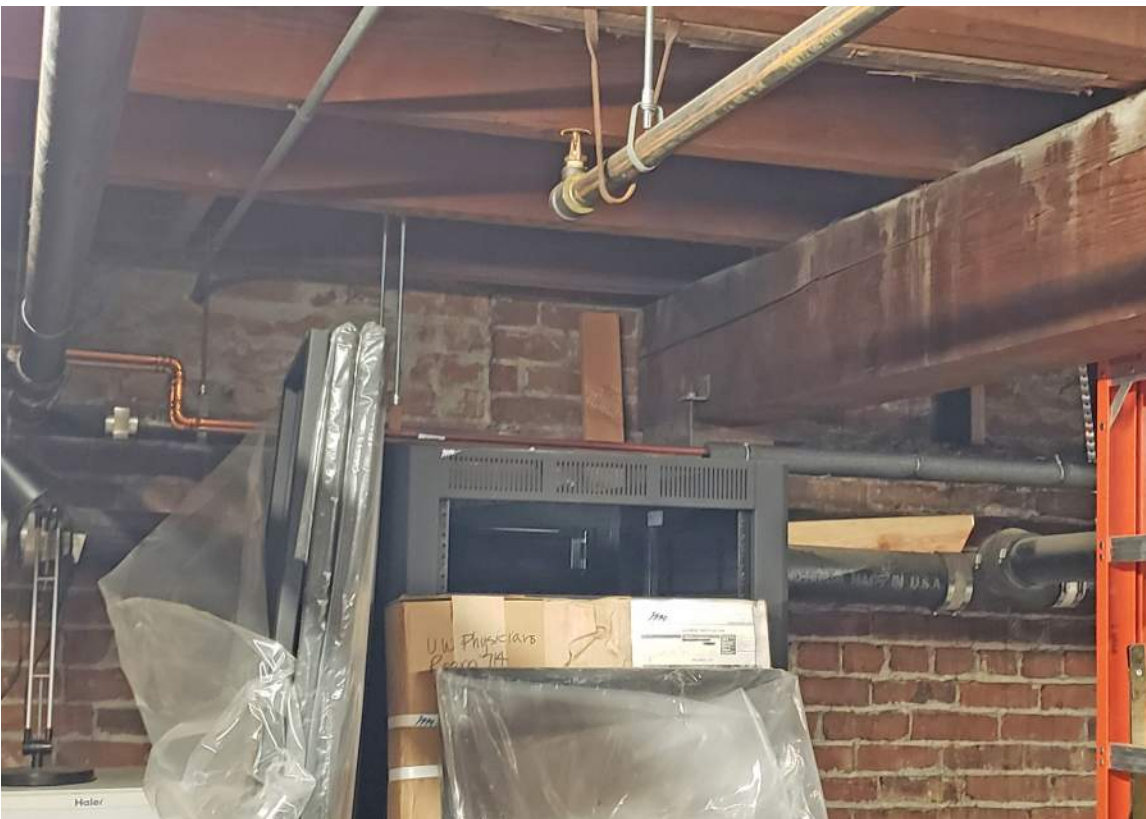
25

Brick wall; wood ceiling and beam

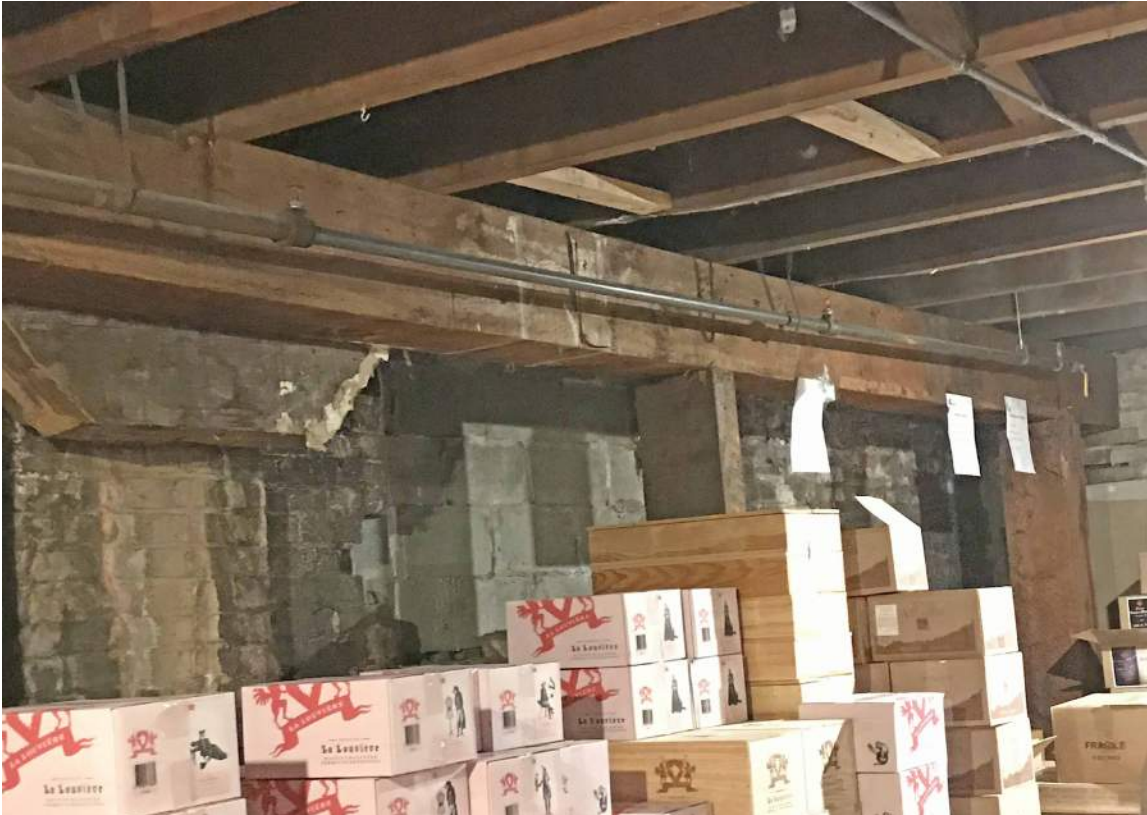
26

Brick wall; wood ceiling, beams and columns; previous CMU infill
