PHOTOGRAPHS
BEFORE REHABILITATION

RAINIER BREWERY
BOTTLING PLANT
(SEATTLE BREWING & MALTING CO)

5710 Airport Way S, Seattle, WA 98108

PHOTOGRAPHS
AFTER REHABILITATION

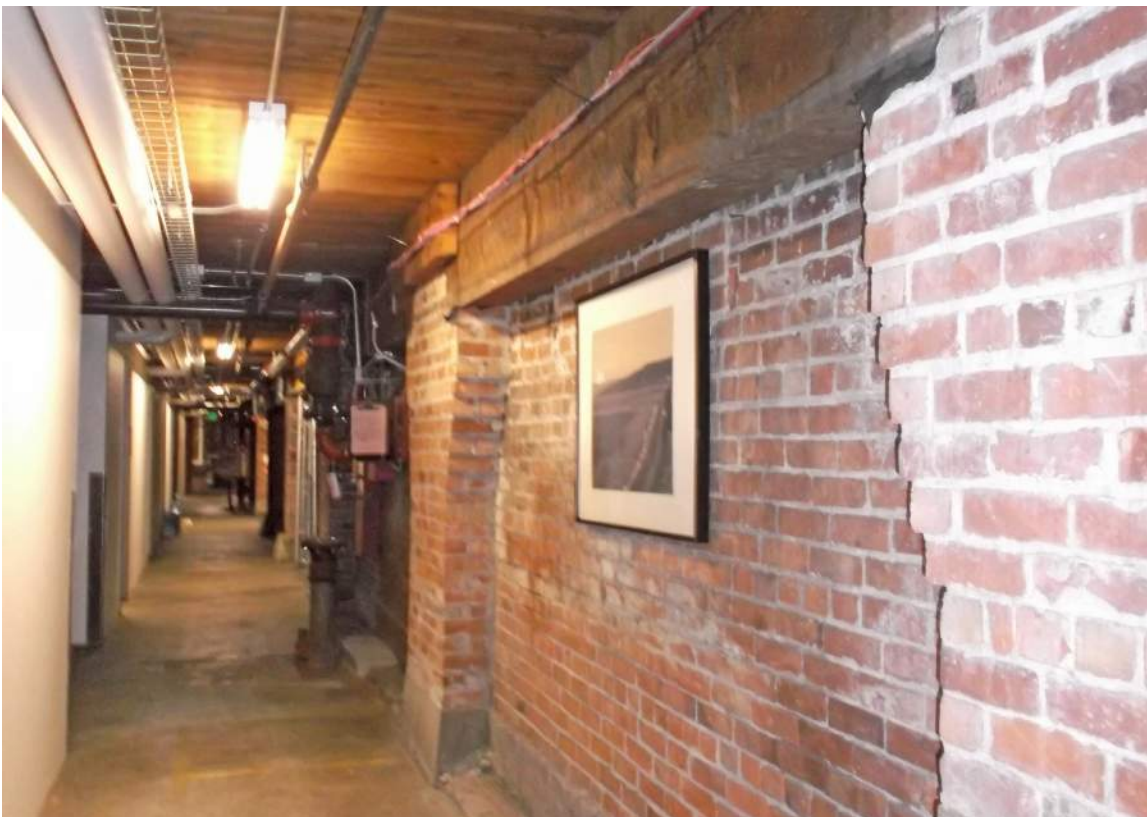
27

Brick and gypsum board walls; wood ceiling and beams; concrete floor

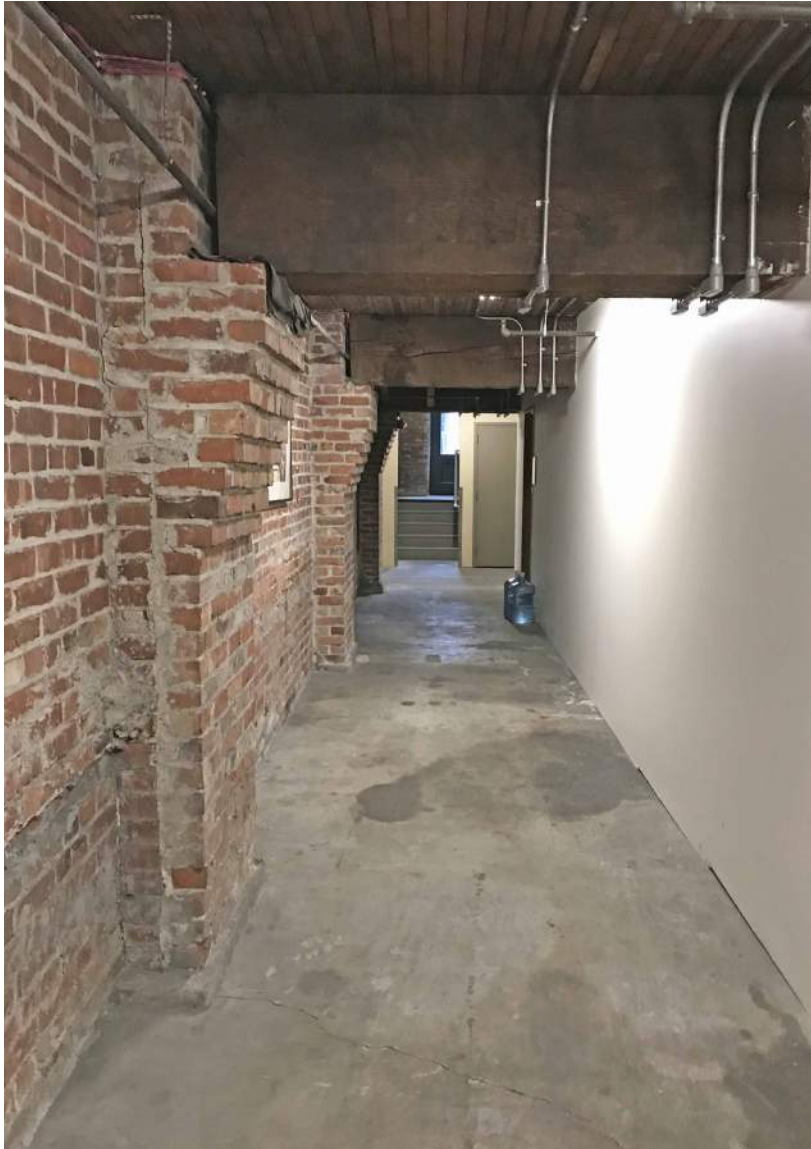
28

Brick and gypsum board walls; wood ceiling and beams; concrete floor; painted wood stair (beyond)

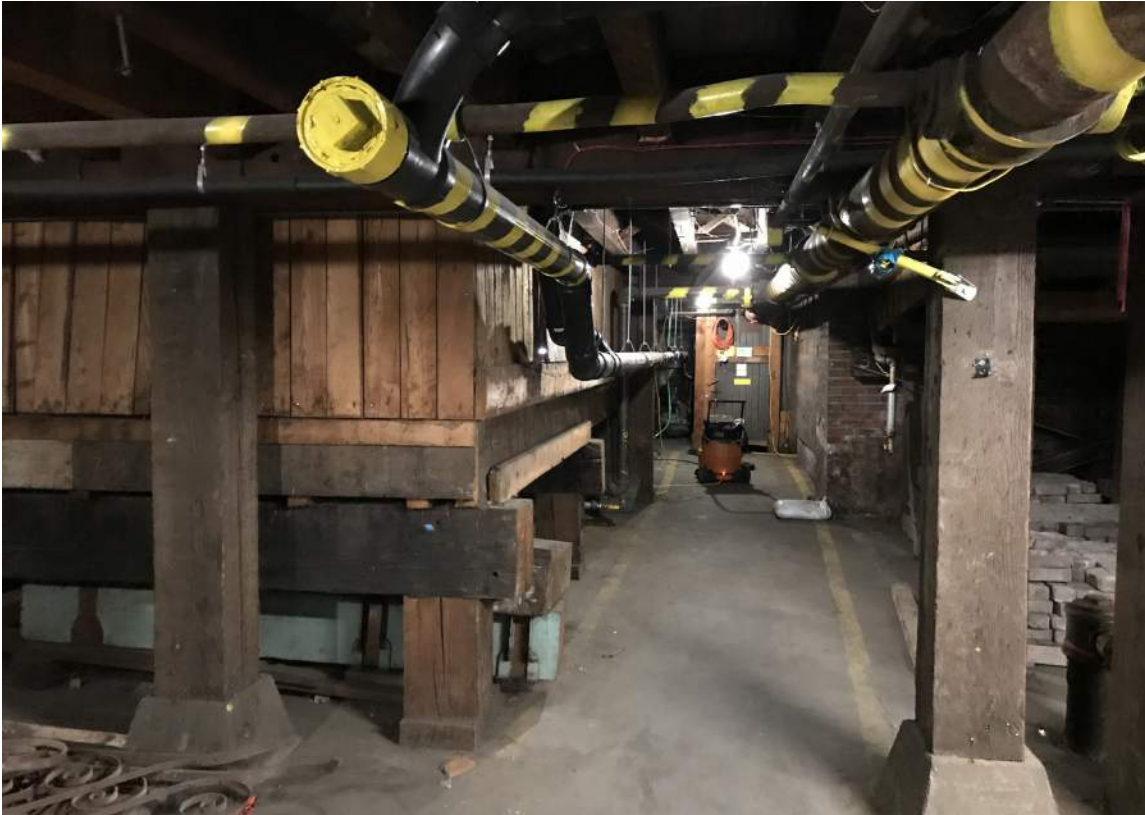
29

Brick walls (beyond);
wood ceiling, beams and
columns; wood loading
dock build-out for level 2
(left); concrete floor

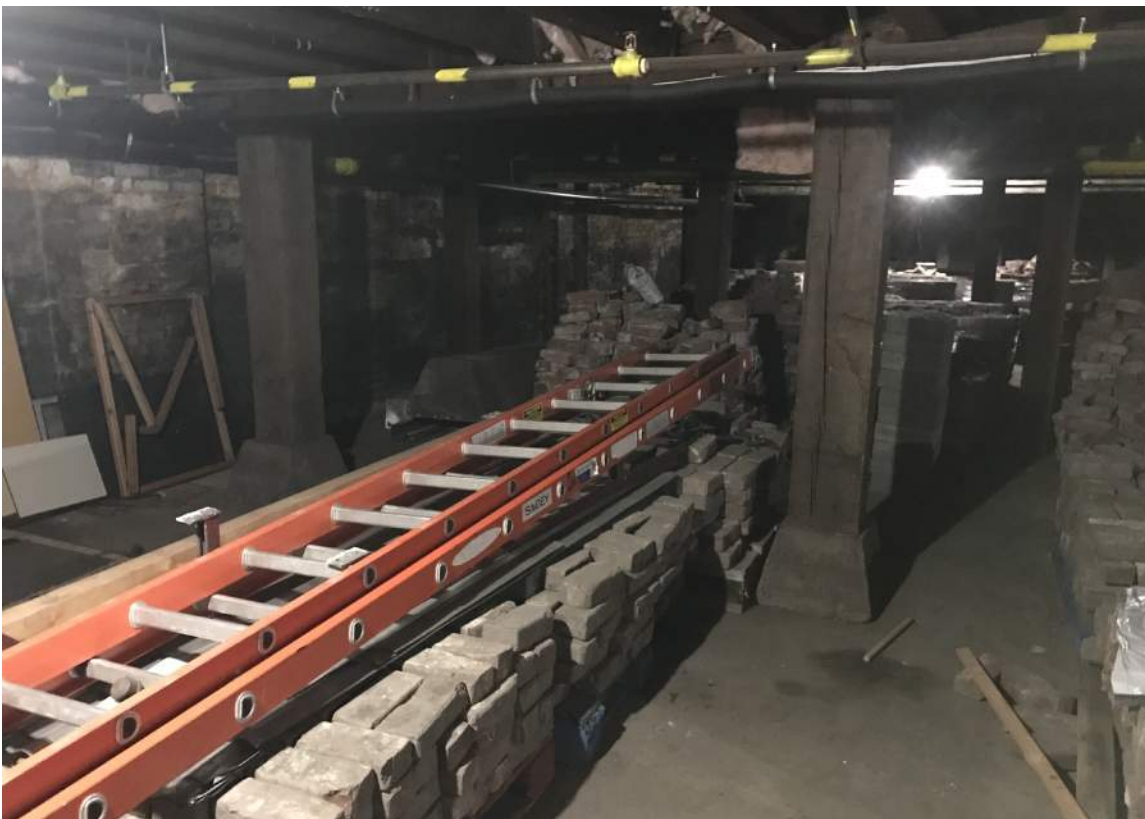
30

Brick walls; wood ceiling,
beams and columns;
pallets of salvaged brick;
concrete floor

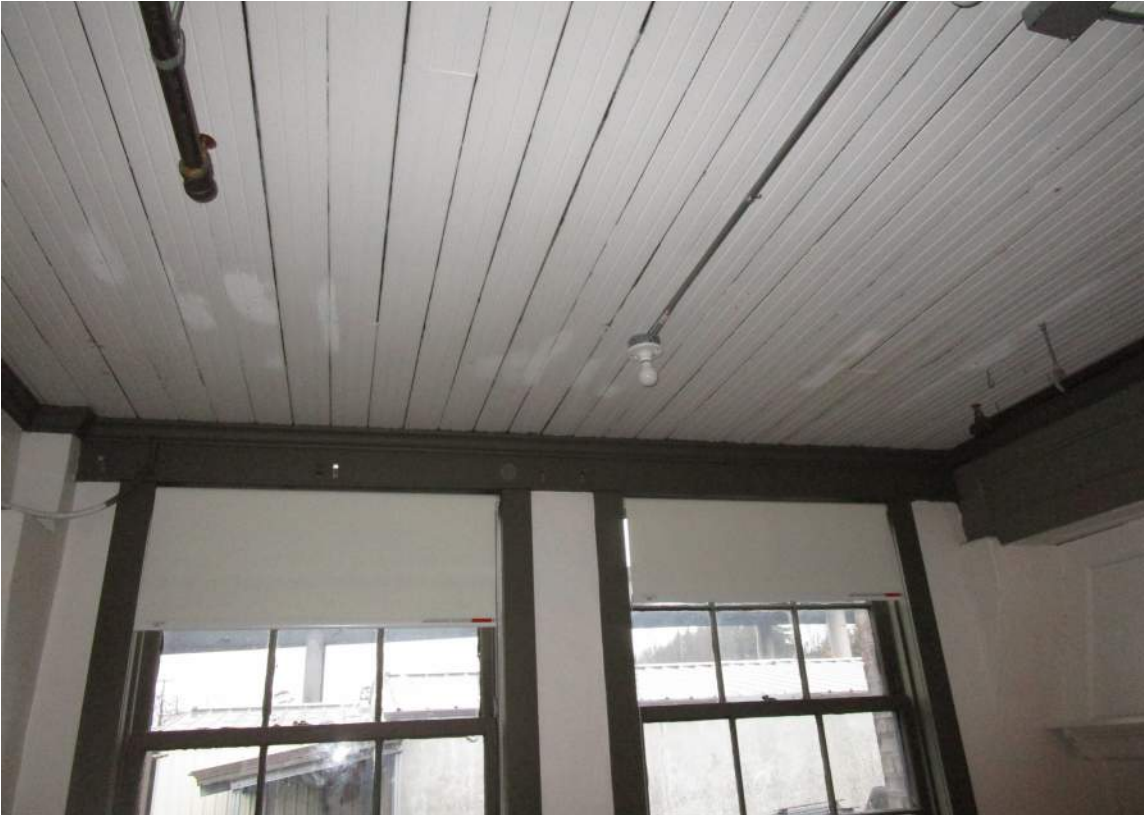
31

Gypsum board walls;
painted wood ceiling;
painted wood windows
and trim

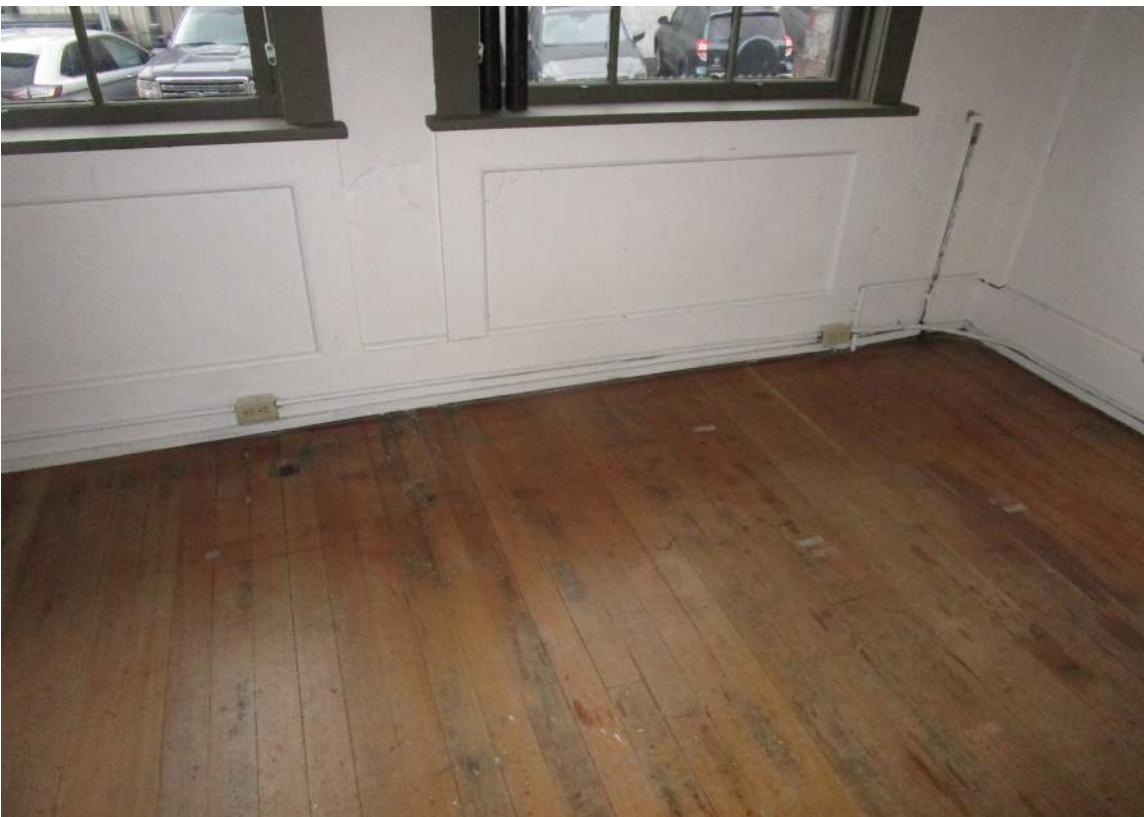
32

Gypsum board walls;
wood floor; painted wood
windows and trim

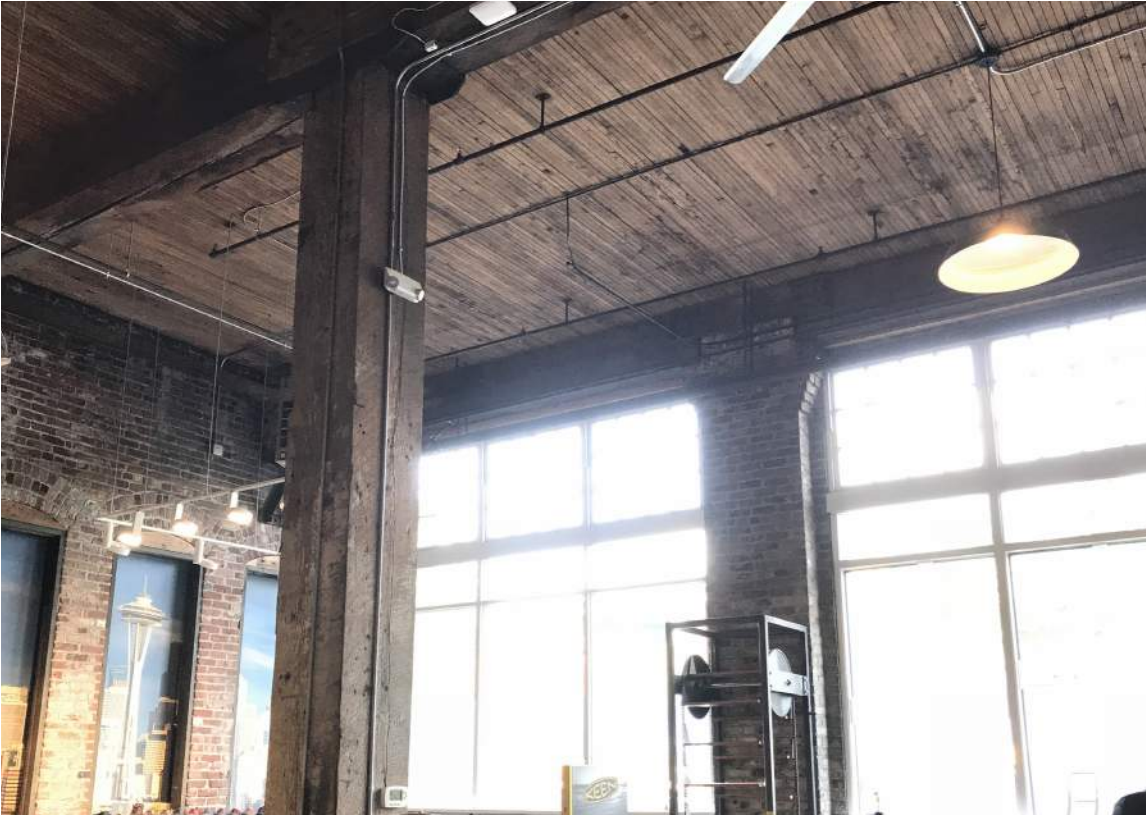
33

Brick walls; wood ceiling, beams and columns; painted wood windows and trim; previous infill openings (left)

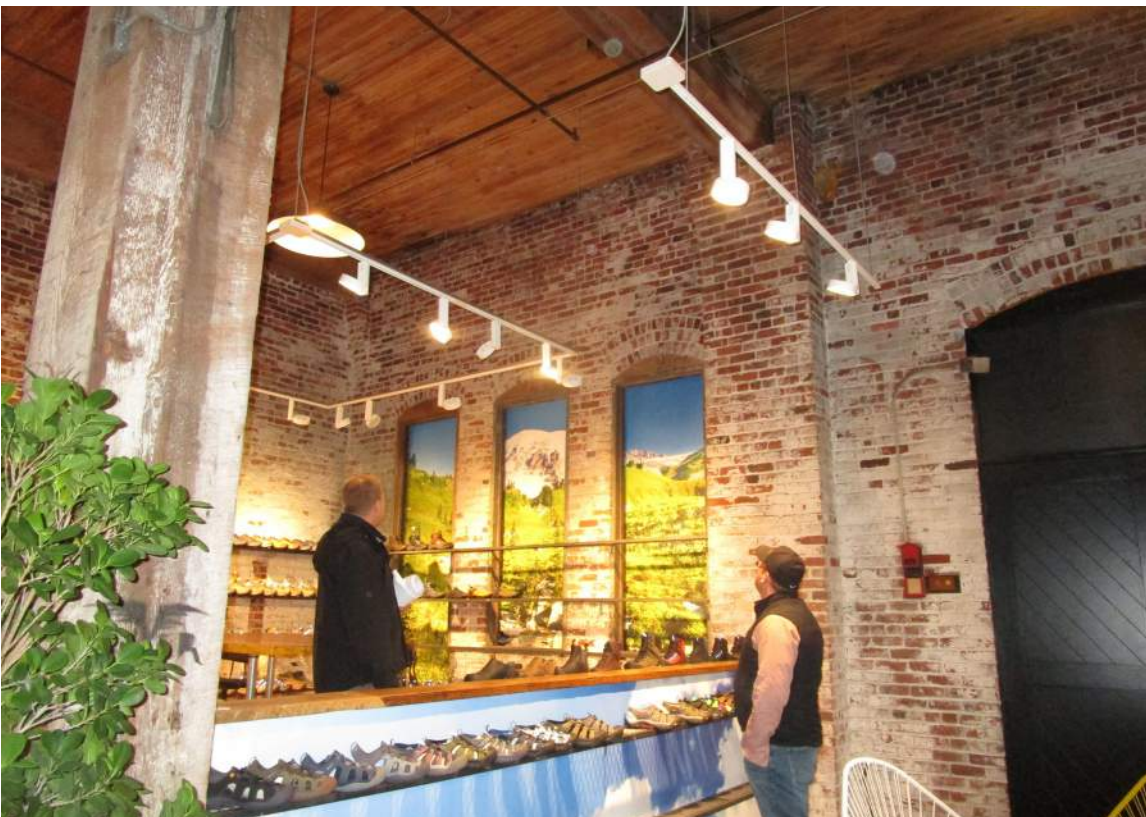
34

Brick walls; painted gypsum board partial-height wall; wood ceiling, beams and columns; painted wood door; previous infill openings (center)

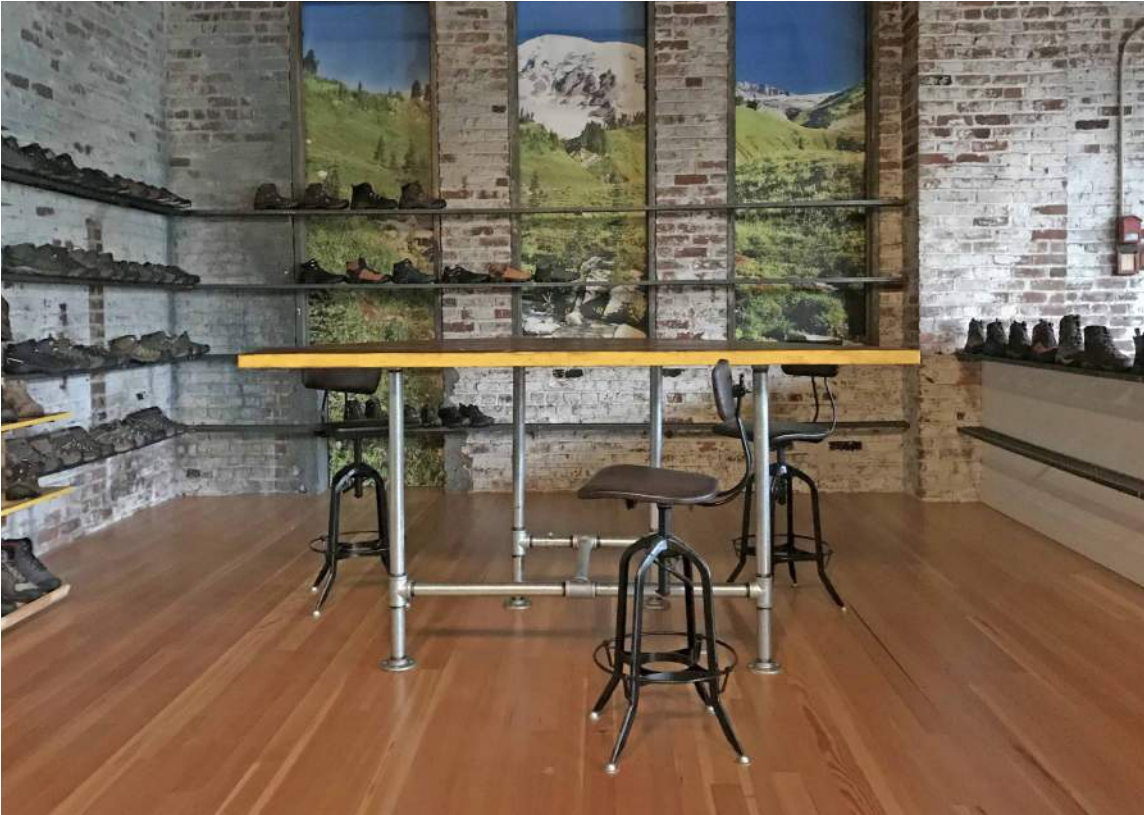
35

Brick walls; painted gypsum board partial-height wall (right); wood floor; previous infill openings (center)

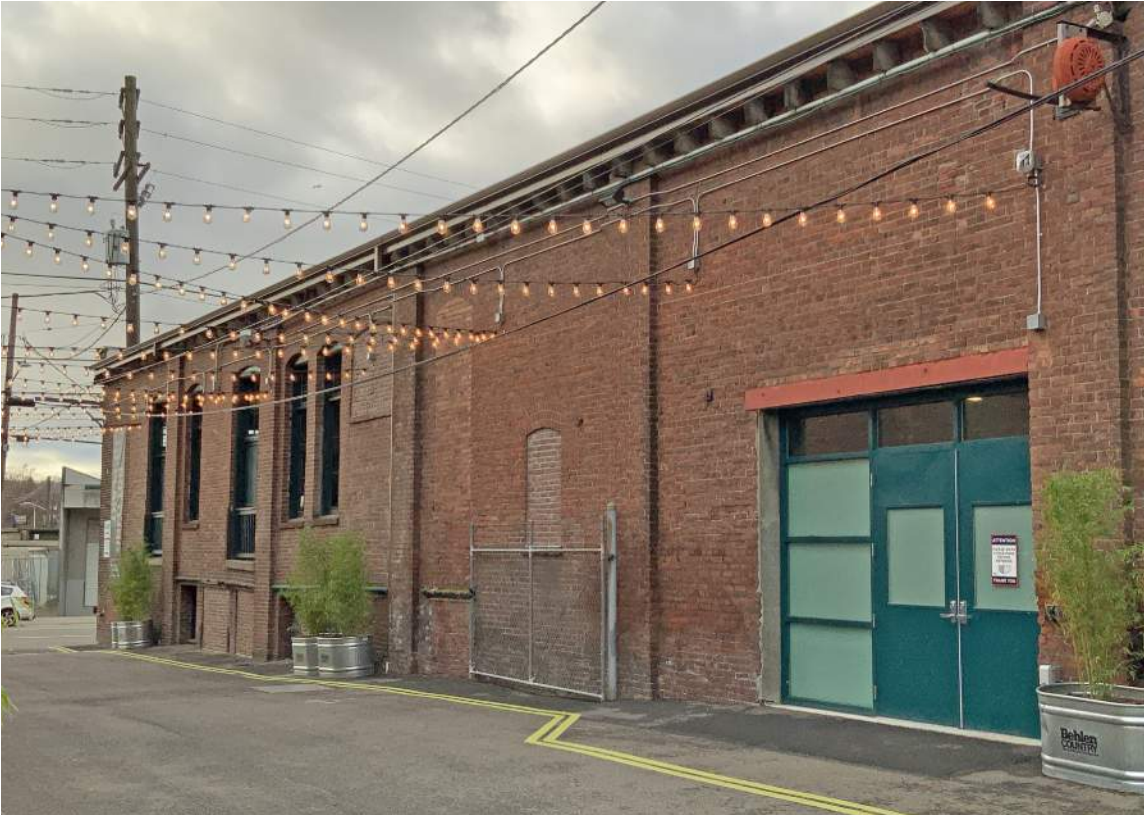
03

Brick wall; wood windows; previous infill openings; new brick infill at existing openings; new light fixtures and conduit; new storefront in existing opening; repointed brick at West end; new roof trim and gutter; new conduit and string lighting.

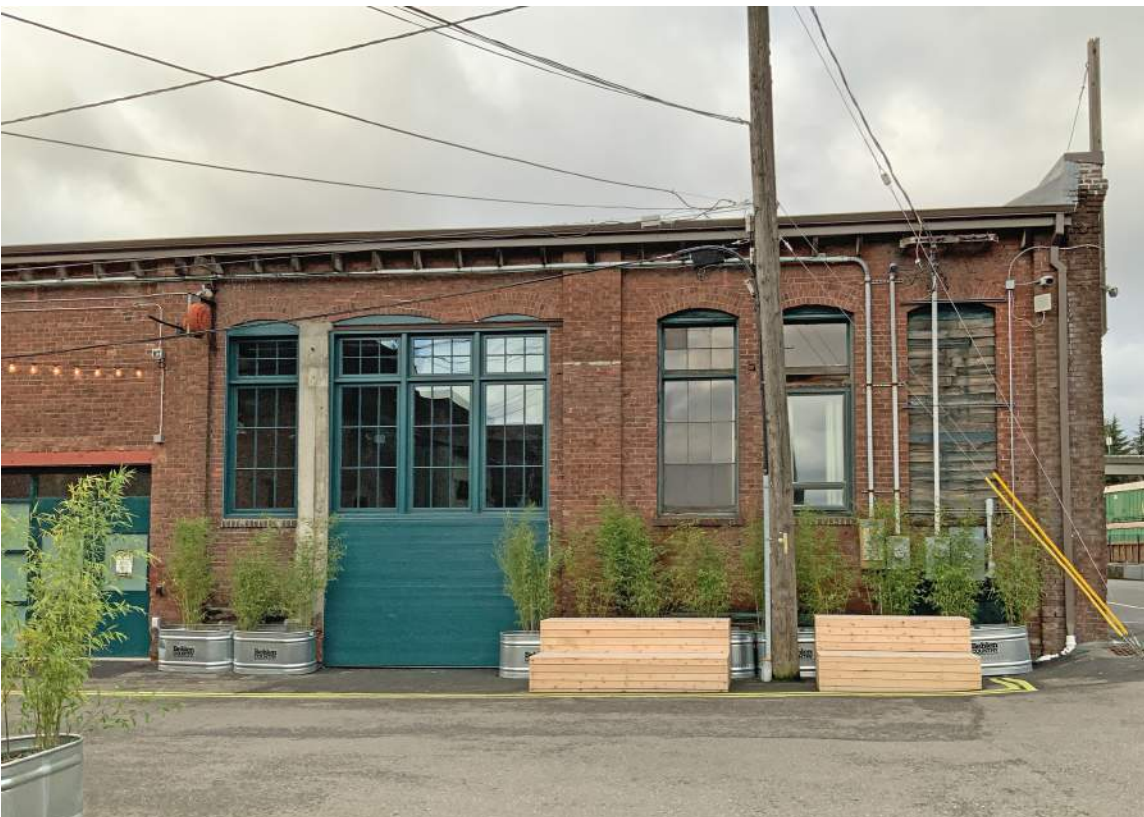
04

Brick wall; wood windows; previous infill openings; new light fixtures and conduit; new storefront in existing opening; new windows and infill at existing opening; new roof trim, parapet cap, and gutter; new downspouts; new conduit and string lighting.

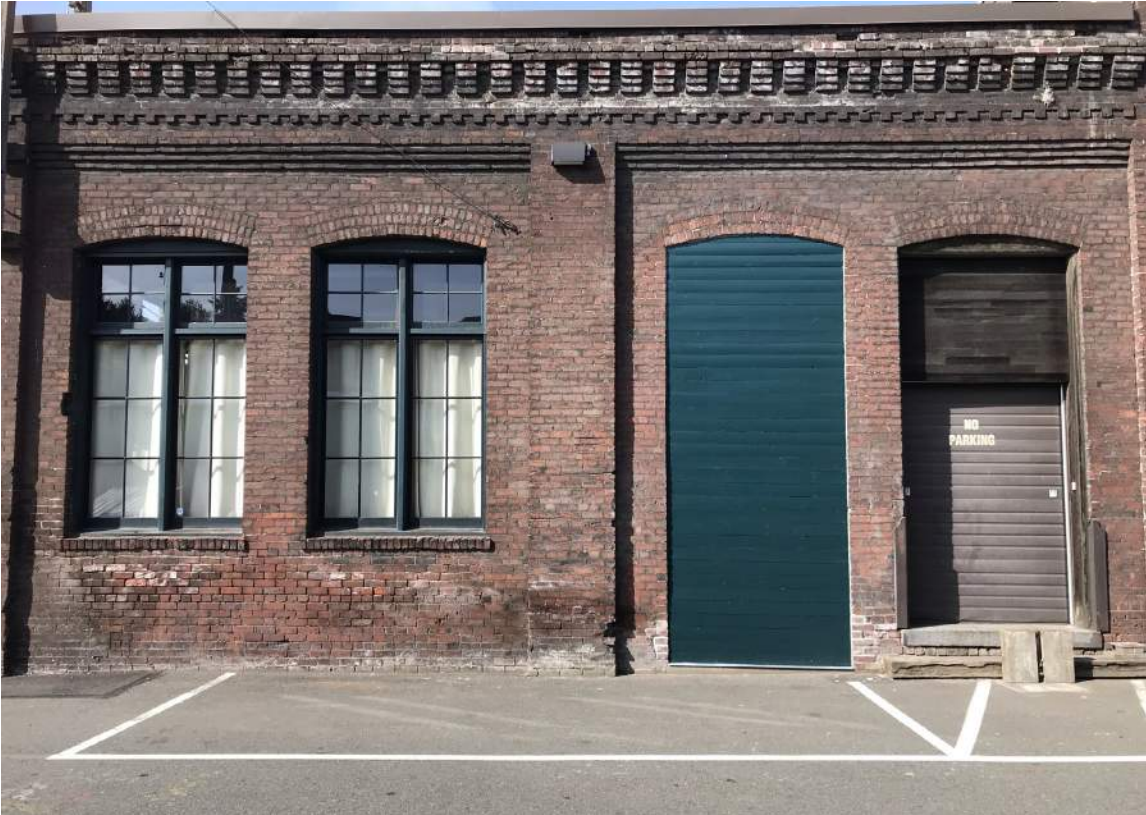
05

Brick wall; wood windows;
new wood infill at existing
opening; new light
fixtures; new roof trim
and parapet cap.

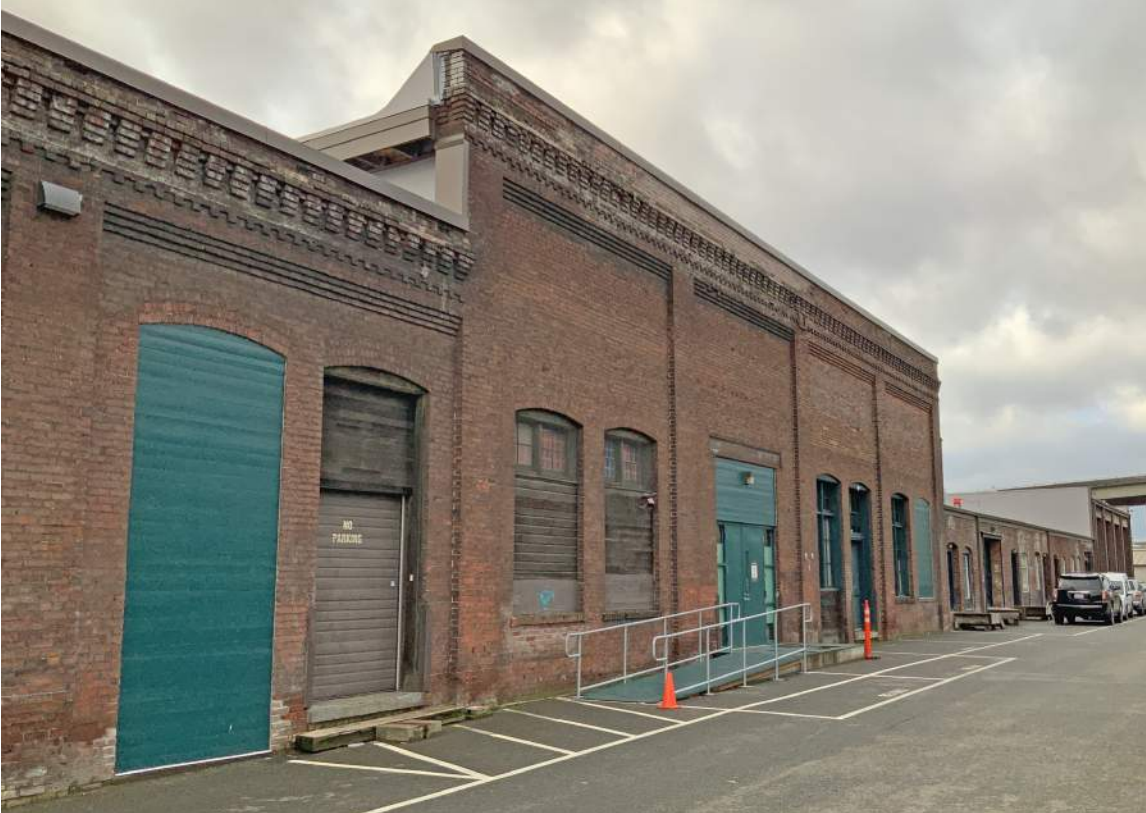
06

Brick wall; wood windows;
previous infill openings;
new storefront in existing
opening; new wood infill
at existing opening; new
light fixtures; new ramp
and railings; new roof
trim, parapet cap, and
gutter.

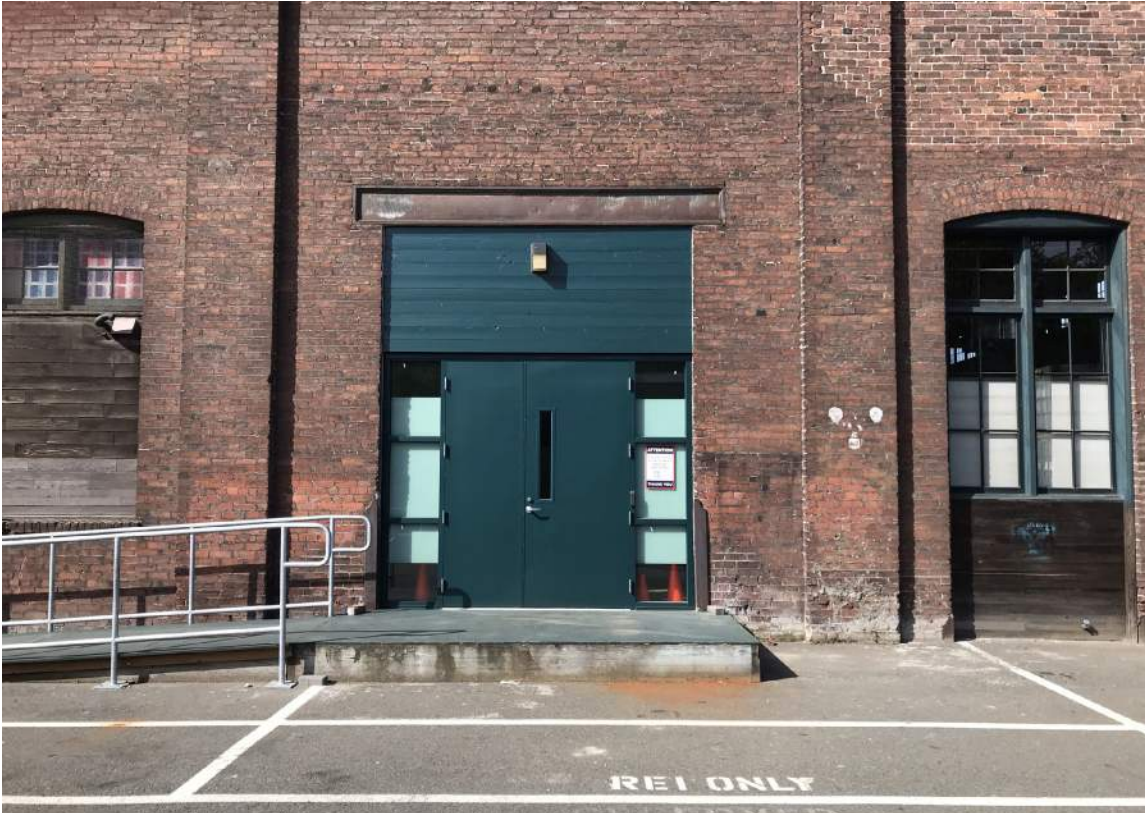
07

Brick wall; wood windows;
previous infill openings;
new storefront in existing
opening; new light fixture;
new ramp and railings.

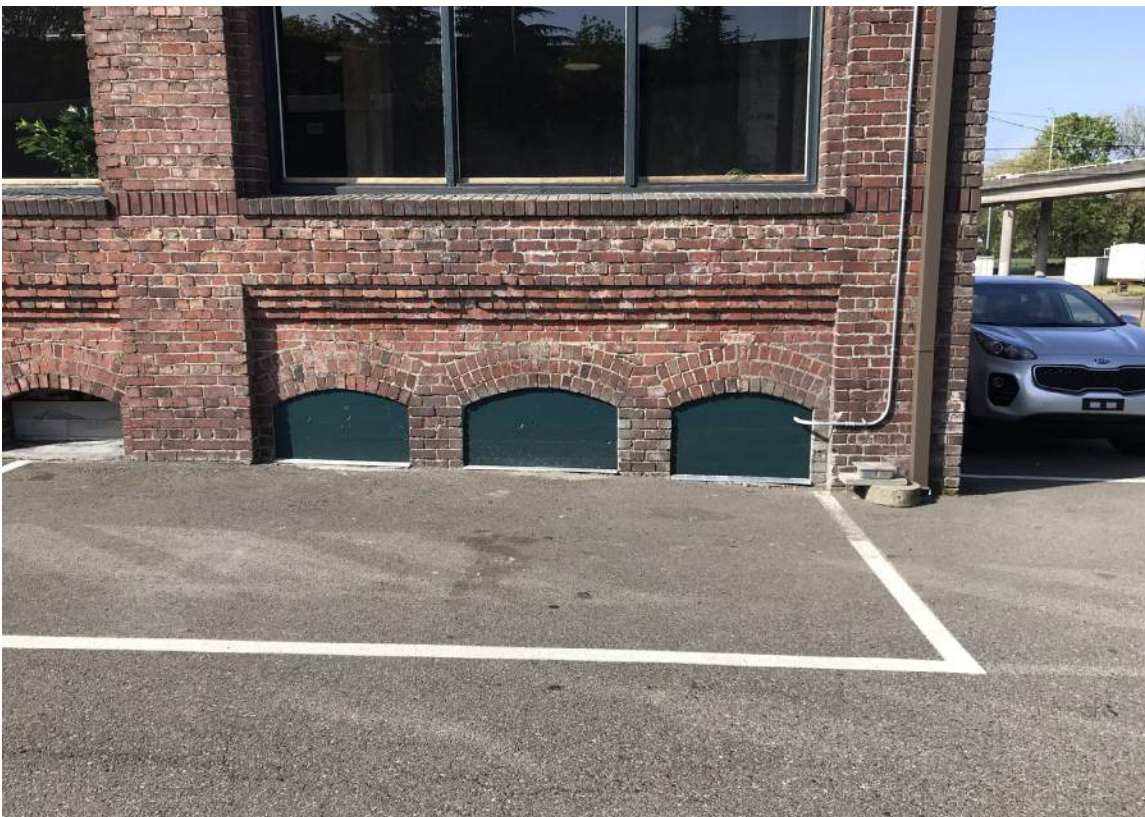
12

Brick wall; wood windows;
previous infill openings;
new wood infill at
existing opening; new
downspouts.

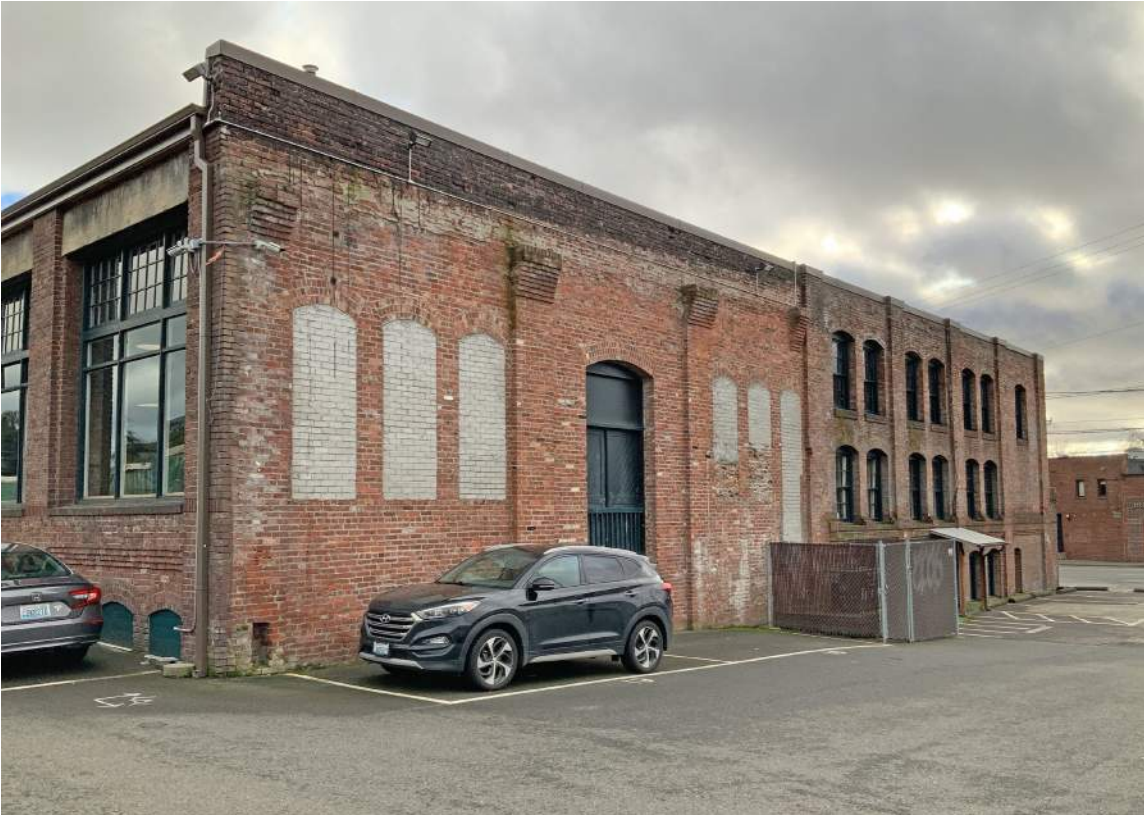
13

Brick wall; wood windows; previous infill openings; new light fixtures and conduit; new roof trim and parapet cap.

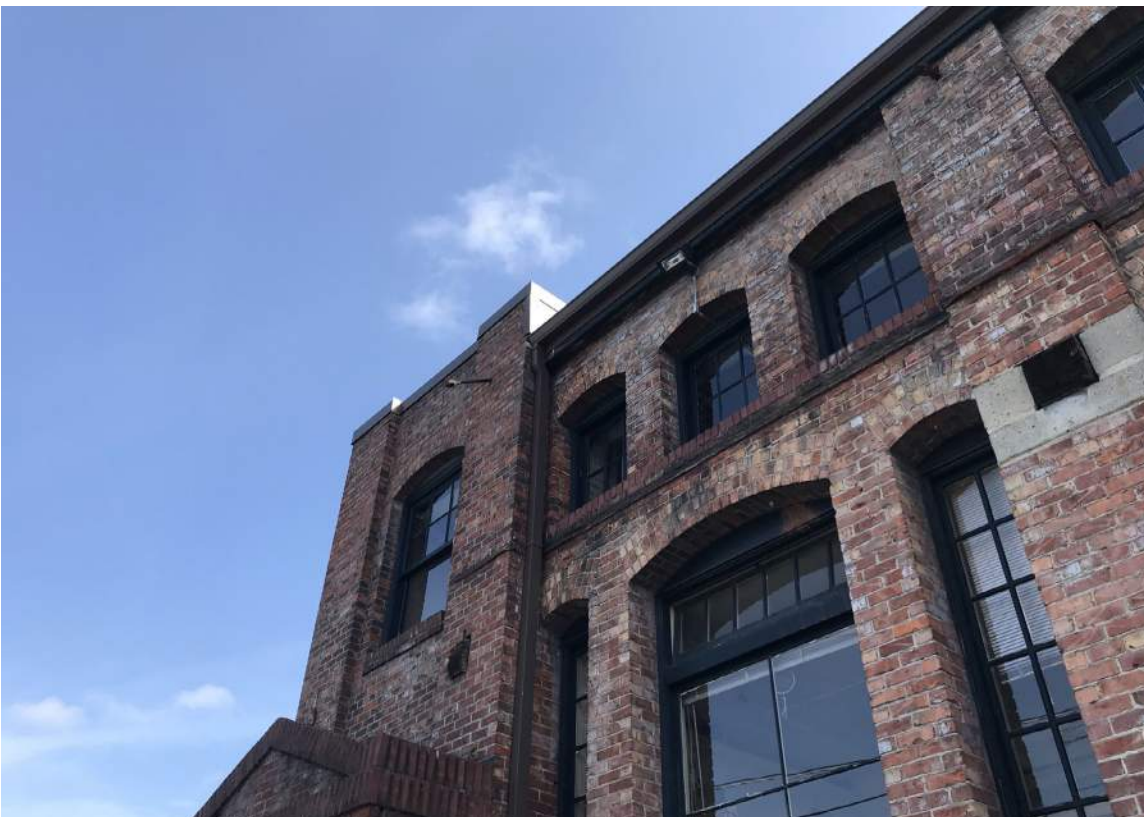
14

Brick wall; wood windows; new light fixtures and conduit; new roof trim, parapet cap, and gutter; new downspouts.

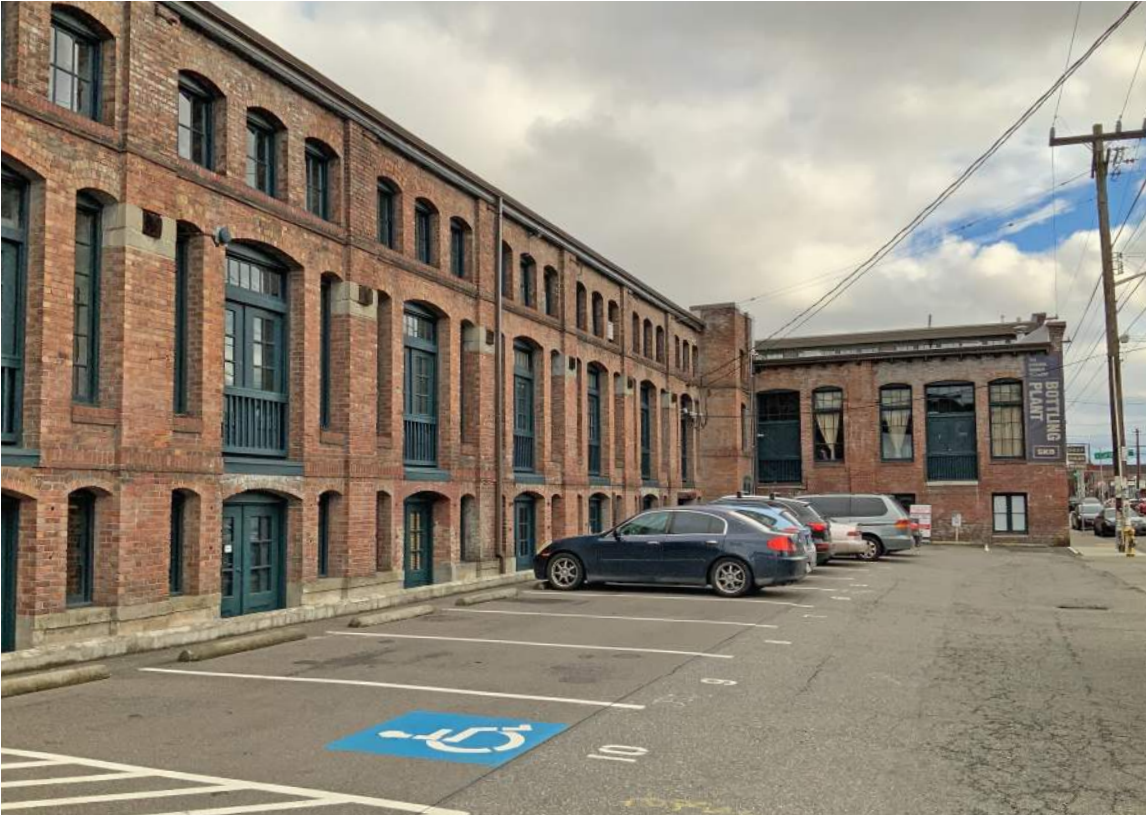
15

Brick wall; wood windows; new light fixtures and conduit; new roofing; new roof trim, parapet cap, and gutter; new downspouts.

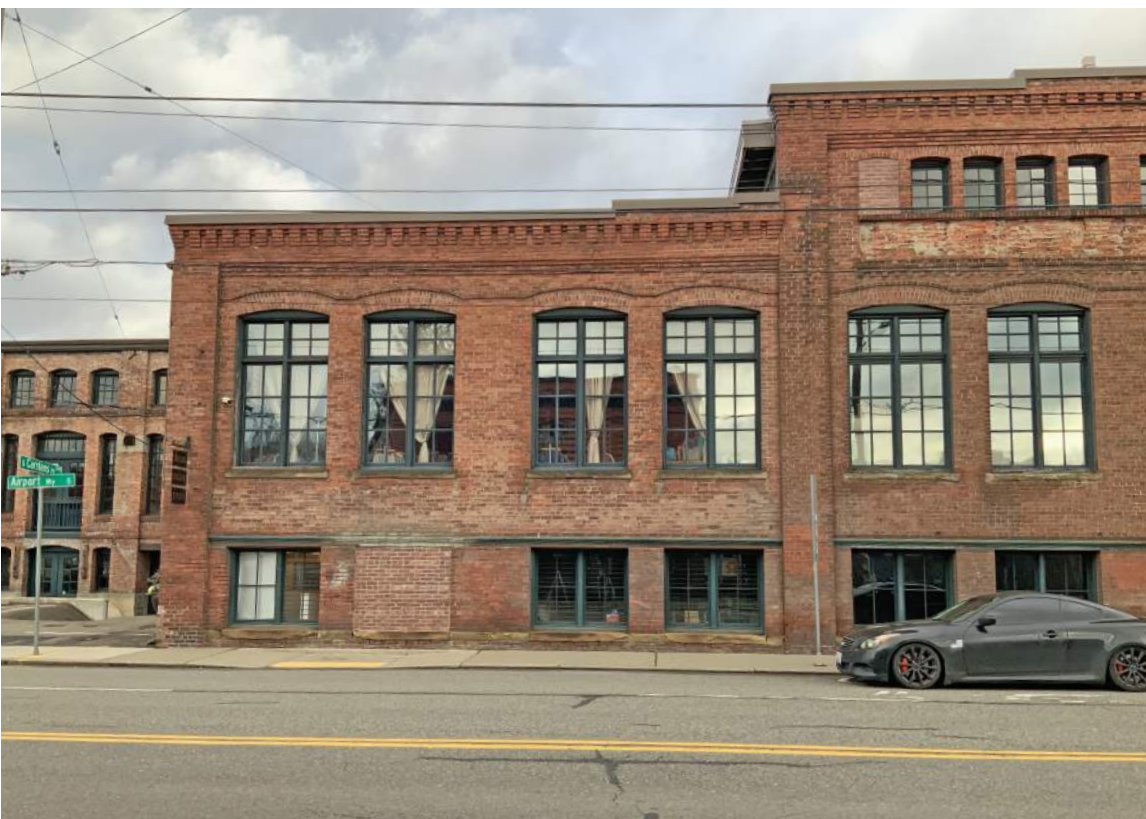
16

Brick wall; wood windows; new brick infill at existing openings; new roof trim, parapet cap, and gutter; new downspouts.

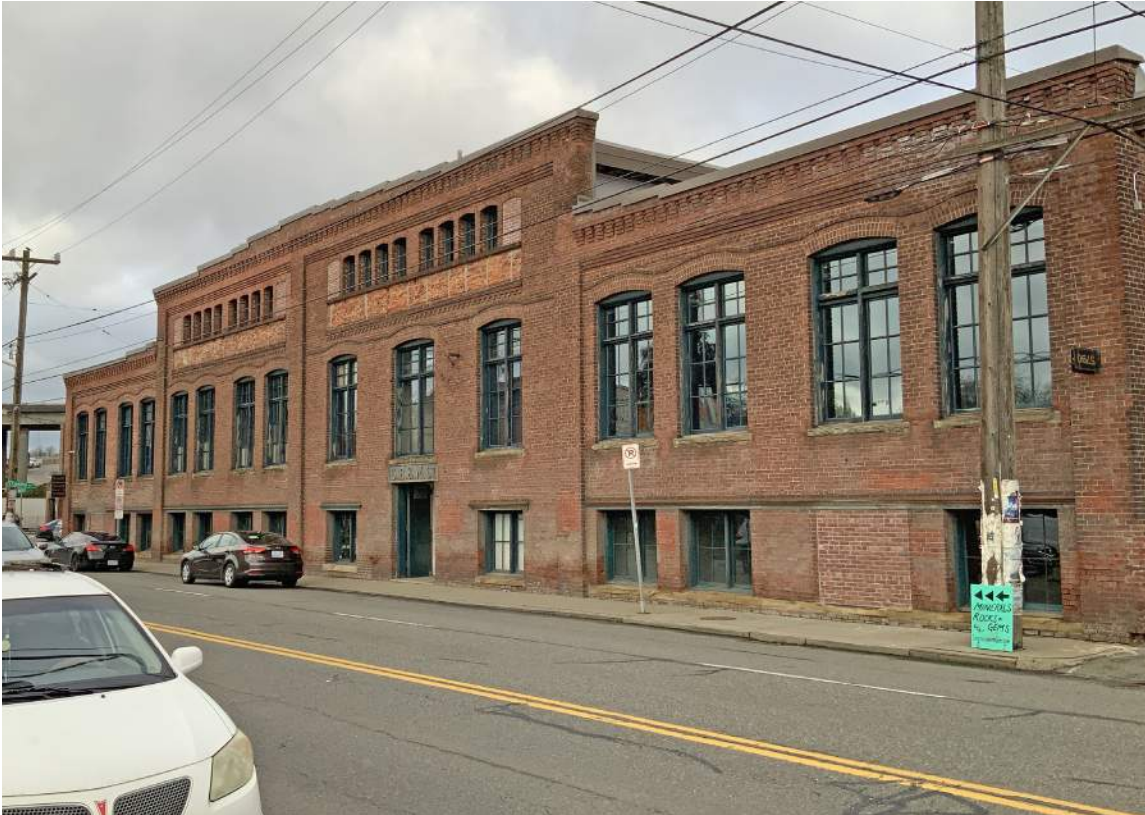
Brick wall; wood windows; new brick infill at existing openings; new roof trim, parapet cap, and gutter; new downspouts.

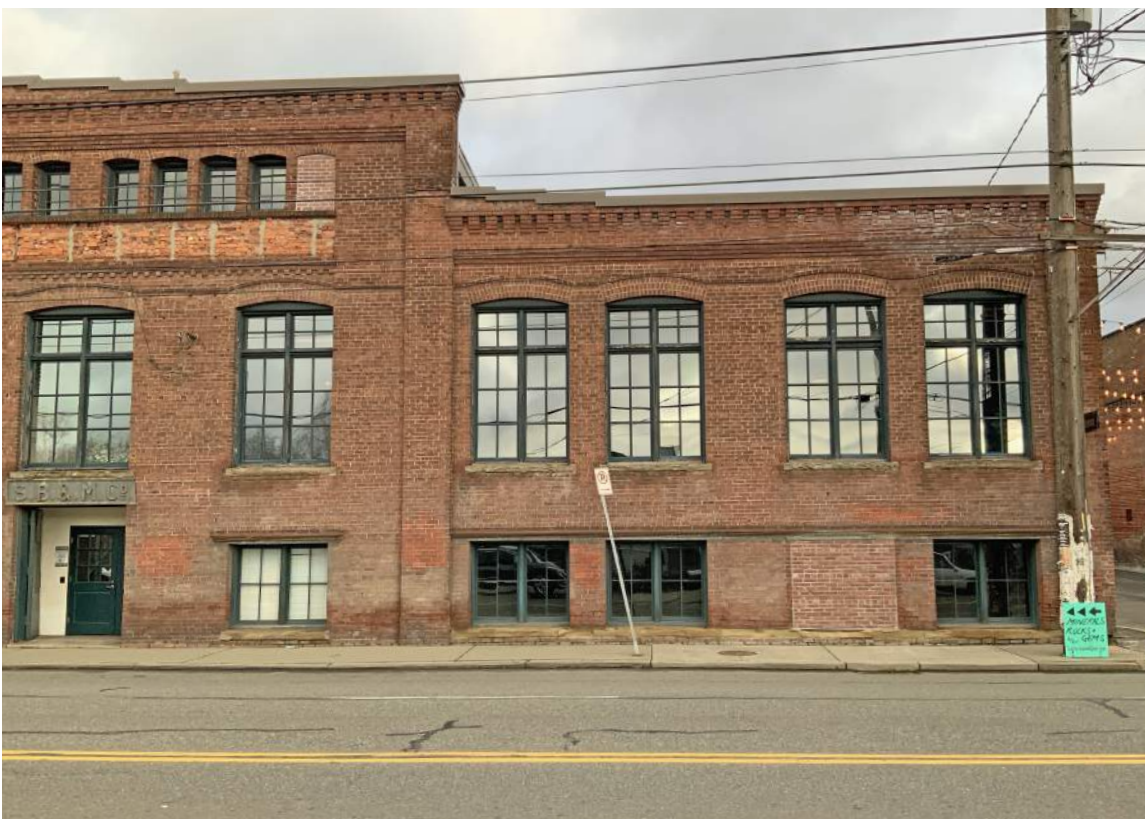
18

Brick wall; wood windows; new brick infill at existing openings; new roof trim, parapet cap, and gutter; new downspouts.

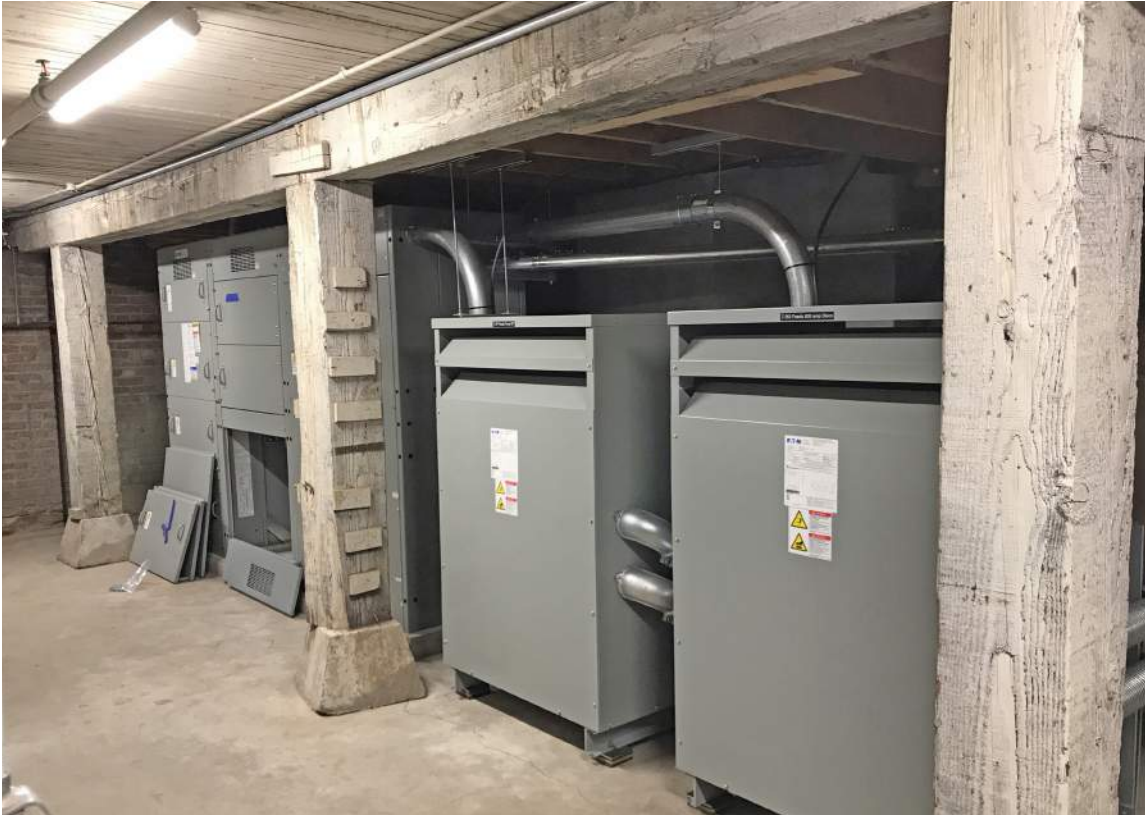
19

Painted wood ceiling;
wood beam & column;
brick walls; concrete floor;
new concrete shear wall
(beyond); new wood floor
framing; new electrical
conduit and equipment.

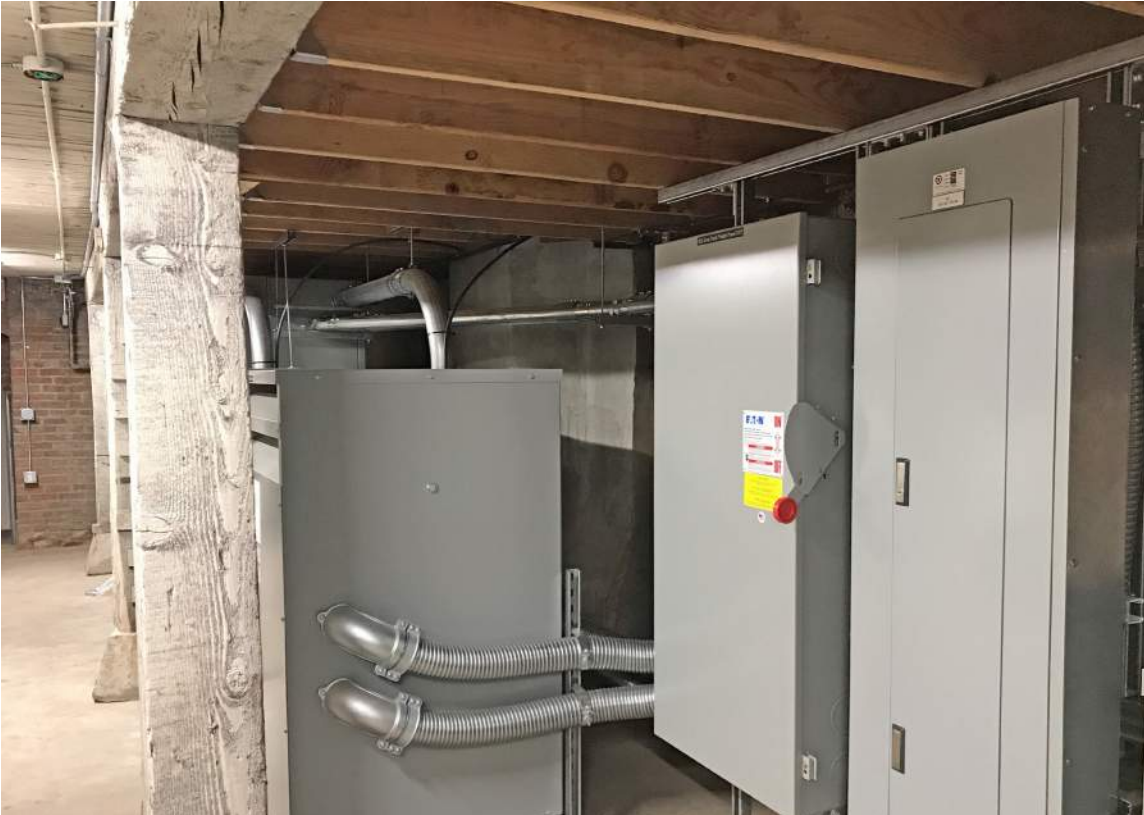
21

Brick walls; new wood floor framing and decking; new electrical conduit and equipment.

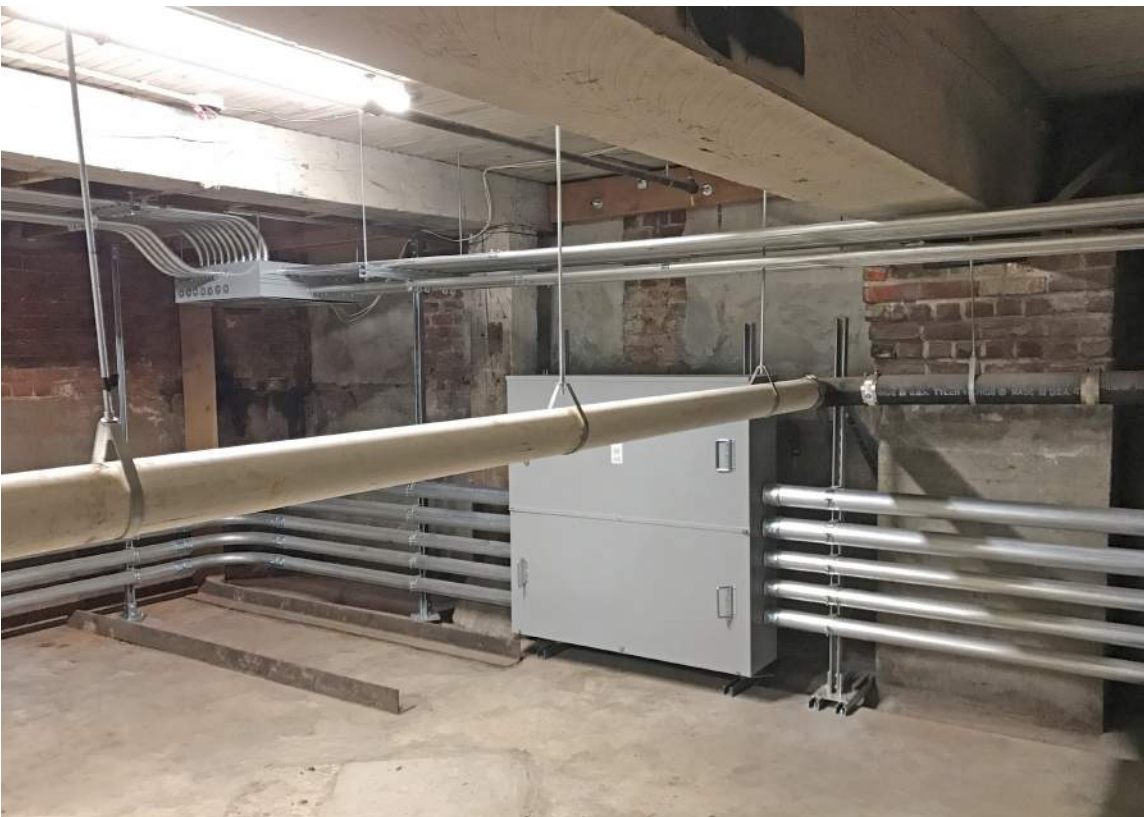
22

Painted wood ceiling; brick walls; concrete pony walls; wood beams & columns; concrete floor; new anchor bolts and wood blocking; new concrete infill at existing opening; new electrical conduit and equipment.
