PHOTOGRAPHS
BEFORE REHABILITATION

RAINIER BREWERY
BOTTLING PLANT
(SEATTLE BREWING & MALTING CO)

5710 Airport Way S, Seattle, WA 98108

PHOTOGRAPHS
AFTER REHABILITATION

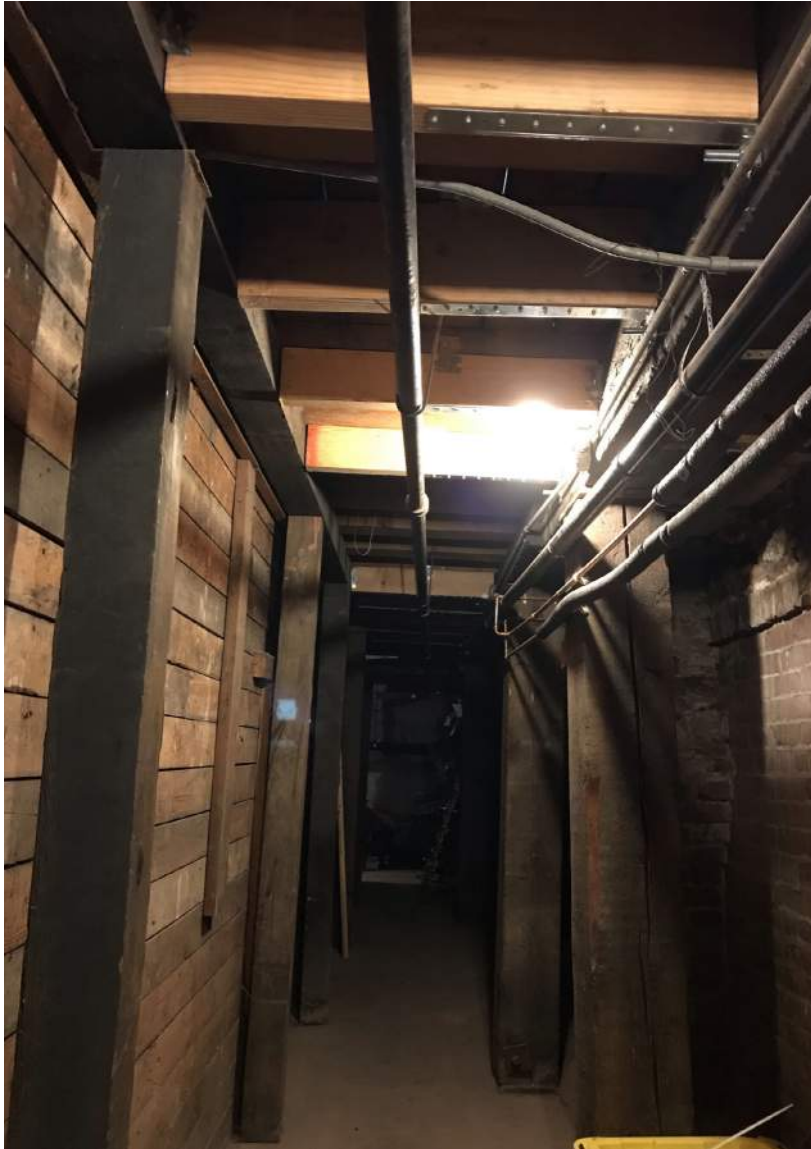
25

Wood ceiling; wood wall;
brick walls; concrete floor;
wood beams & columns;
new anchor bolts,
strapping, and wood
blocking.

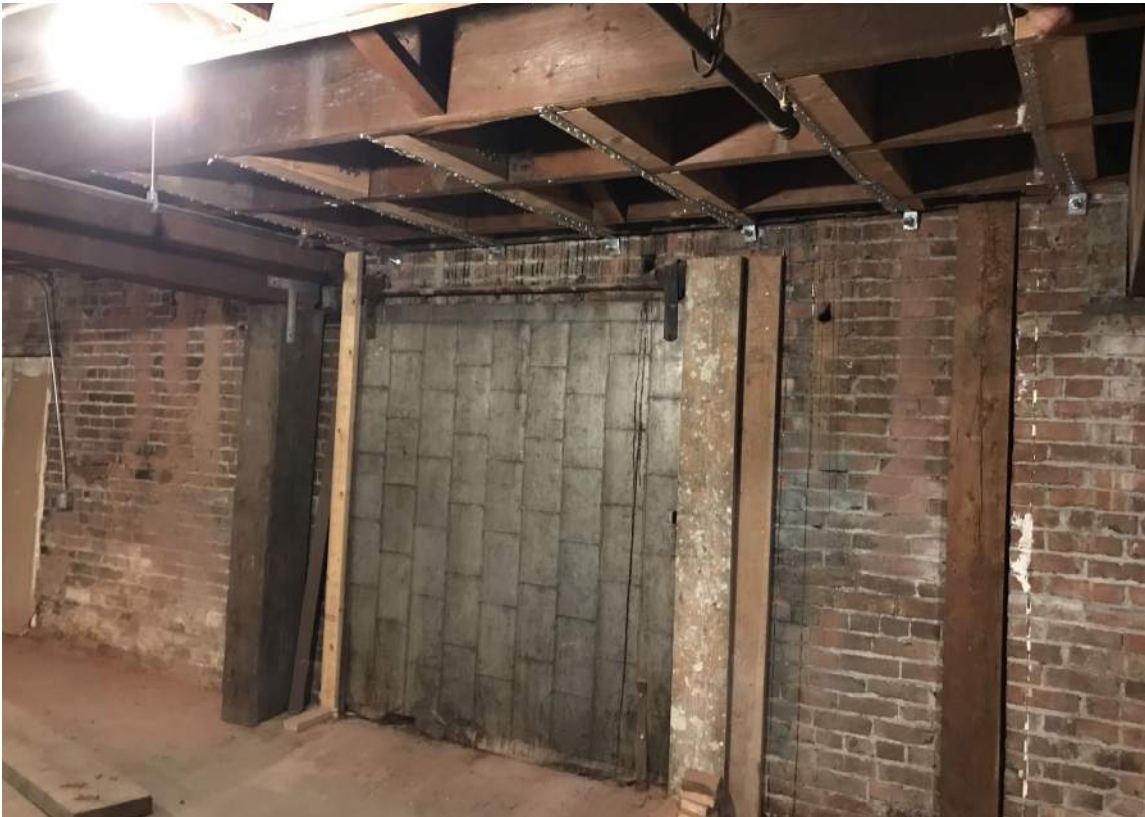
28

Wood ceiling; brick walls; concrete floor; wood beams, joists, and columns; metal fire door; new anchor bolts, strapping, and wood blocking.

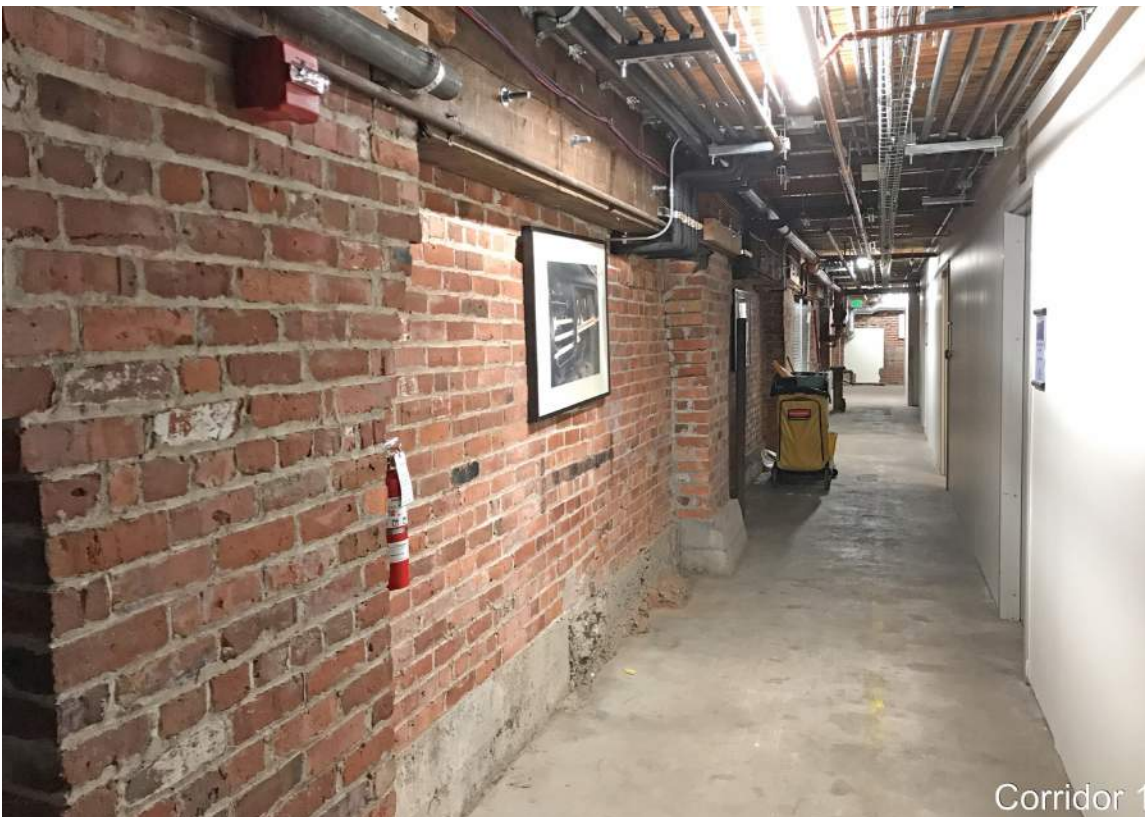
29

Wood ceiling; brick and gypsum board walls; concrete floor; wood beams; new anchor bolts, strapping, and wood blocking; conduit; new conduit.

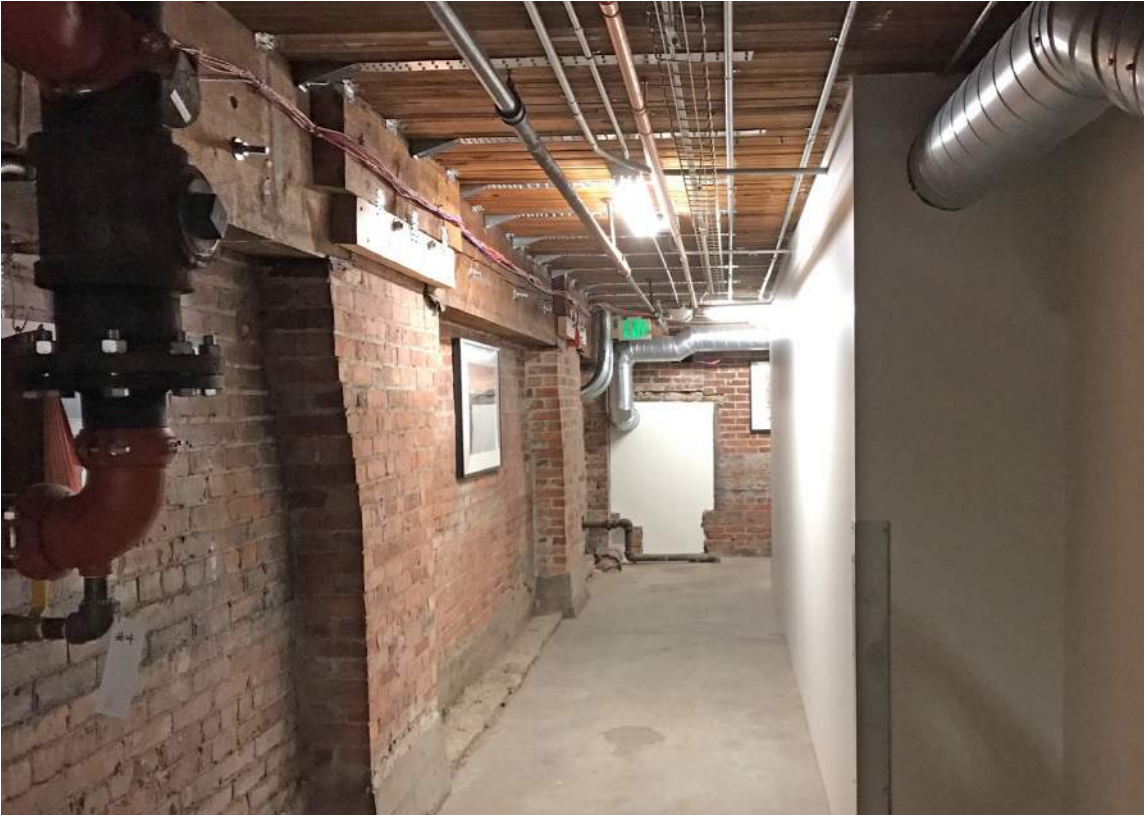
30

Wood ceiling; brick and gypsum board walls; wood beams; new anchor bolts, strapping, and wood blocking; new conduit; new ductwork.

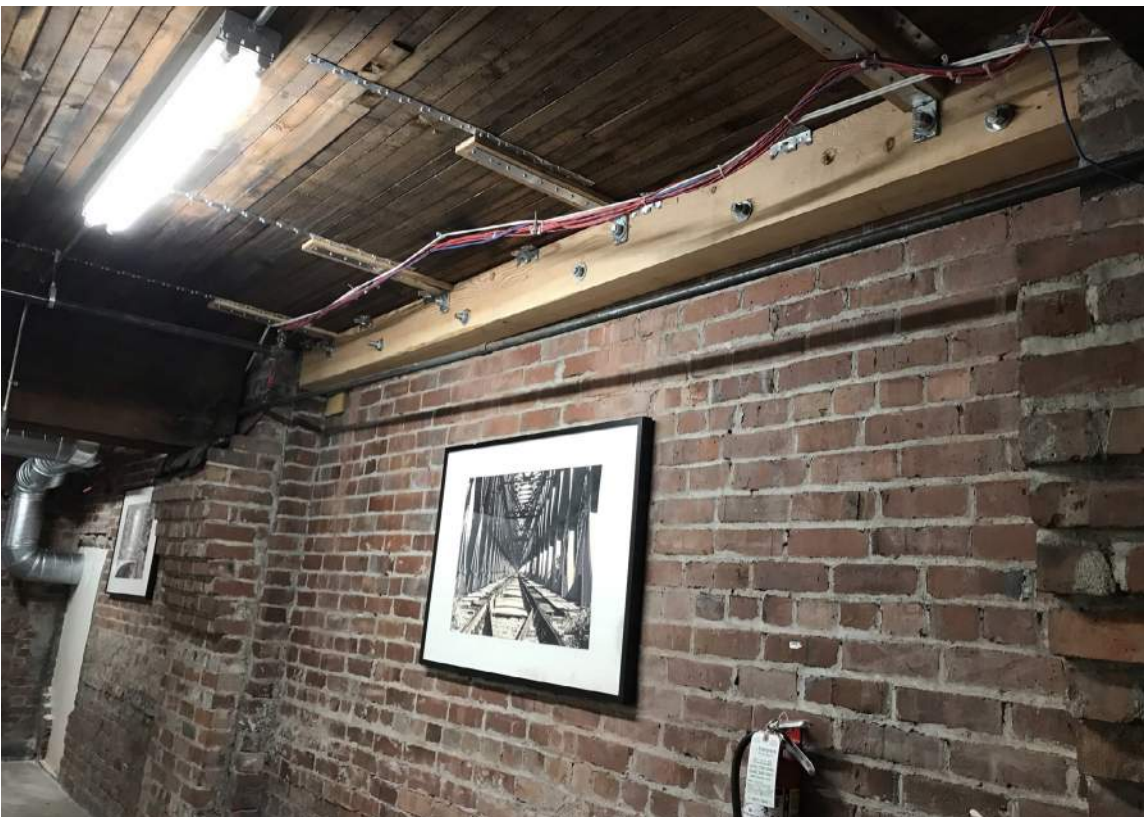
31

Wood ceiling; brick and gypsum board walls; concrete floor; wood beams; new anchor bolts, strapping, and wood blocking; new ductwork.

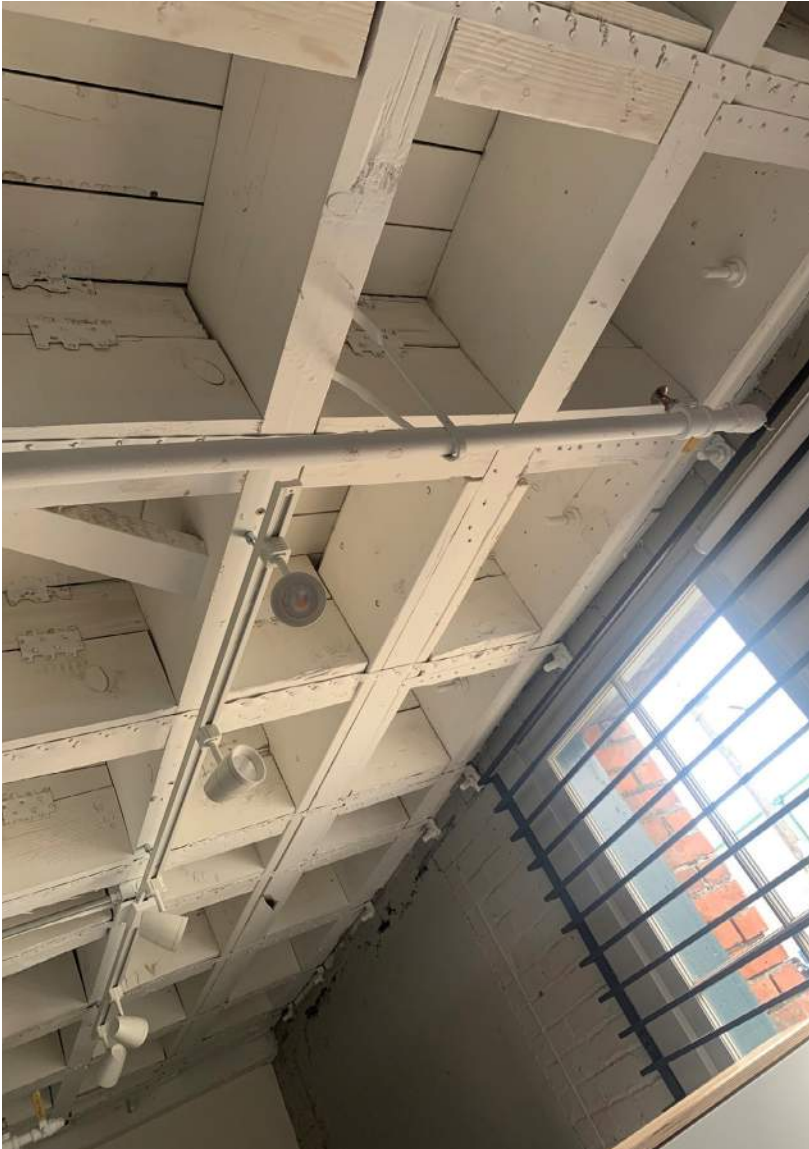
32

Painted wood ceiling;
painted brick walls;
gypsum board walls;
wood windows; new
anchor bolts, strapping,
and wood blocking; new
concrete infill at existing
opening.

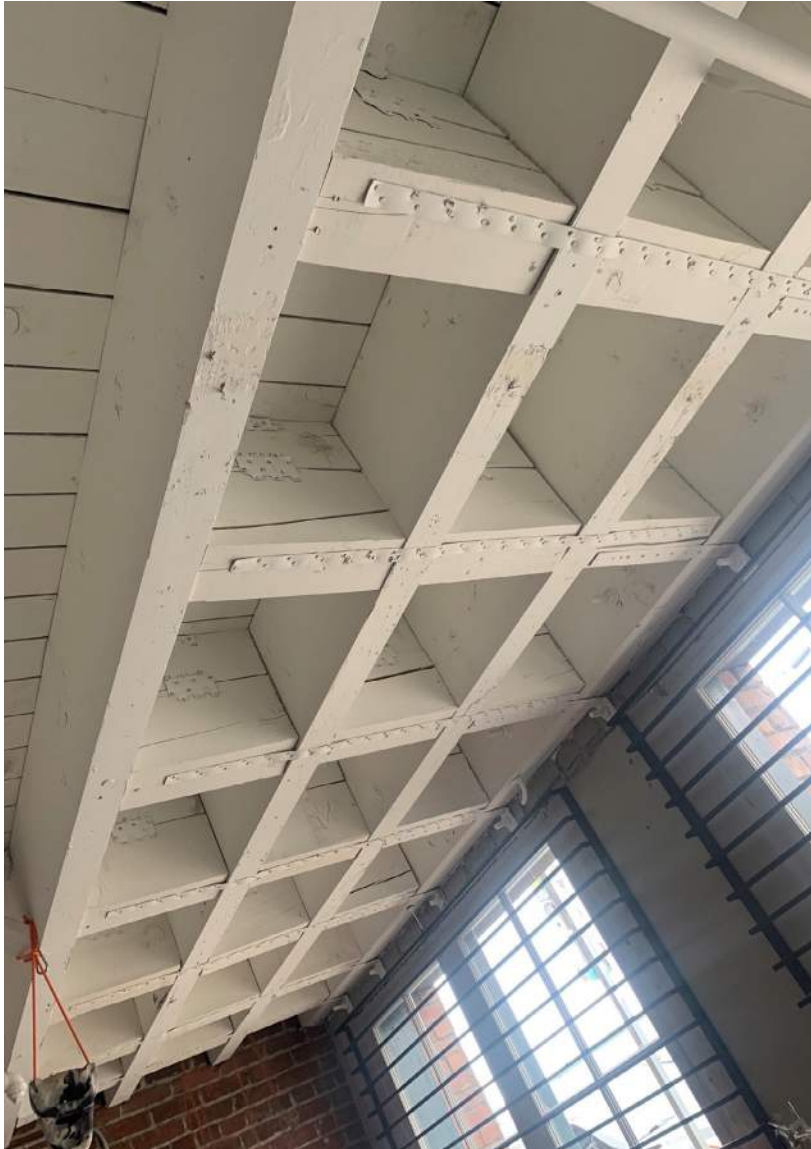
33

Painted wood ceiling;
brick walls; painted brick
walls; wood windows; new
anchor bolts, strapping,
and wood blocking.

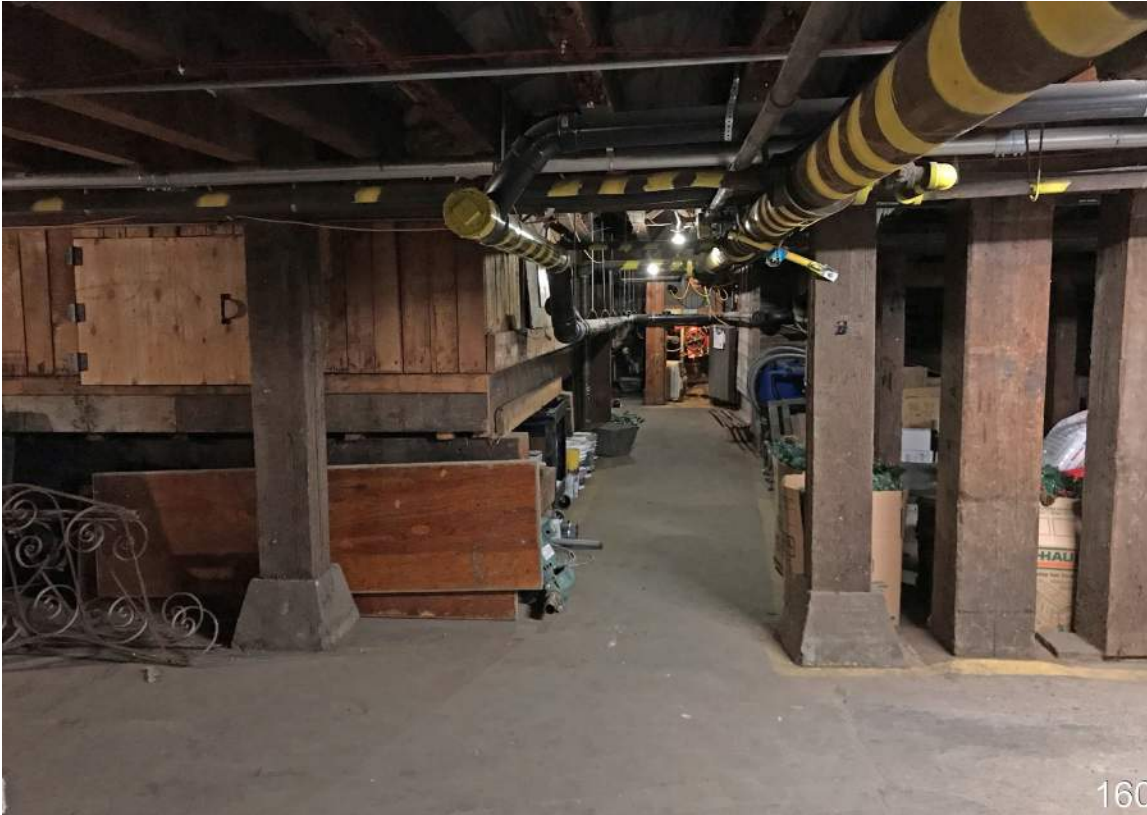
34

Wood ceiling; wood wall; concrete floor; wood beams, joists, and columns; new wood door to crawlspace below amenity area; new conduit.

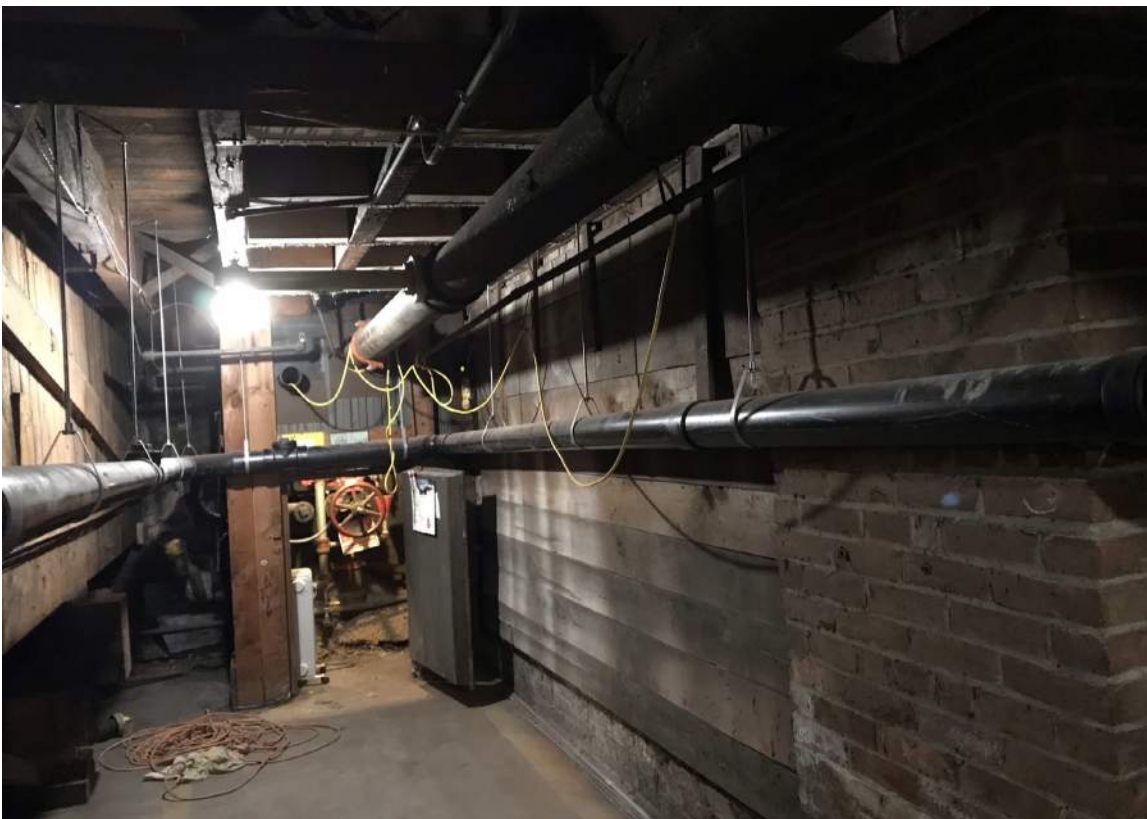
35

Wood ceiling; wood wall; brick walls; concrete floor; wood beams, joists, and columns; new wood wall on right.

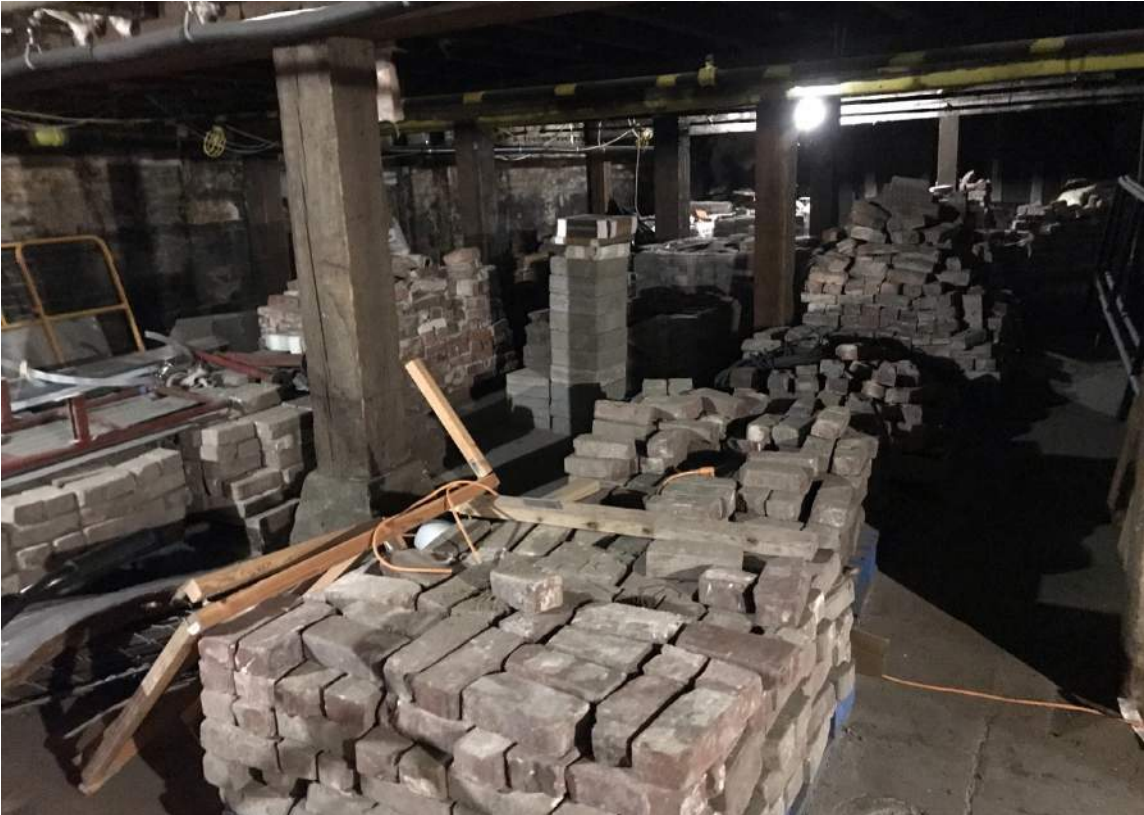
36

Brick walls; concrete floor;
wood beams, joists, and
columns; concrete pony
walls; pallets of salvaged
brick from complex.

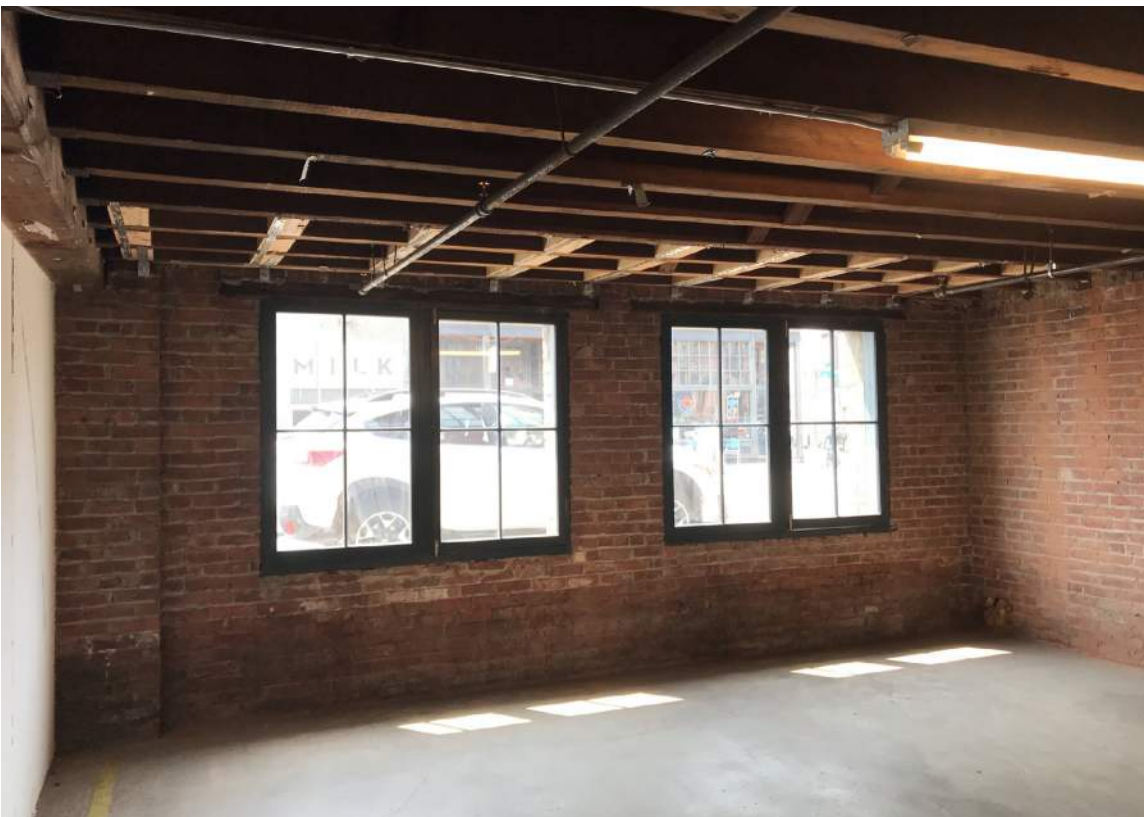
37

Wood ceiling; brick and
gypsum board walls;
wood windows; concrete
floor; wood beams and
joists; new anchor bolts,
strapping, and wood
blocking.

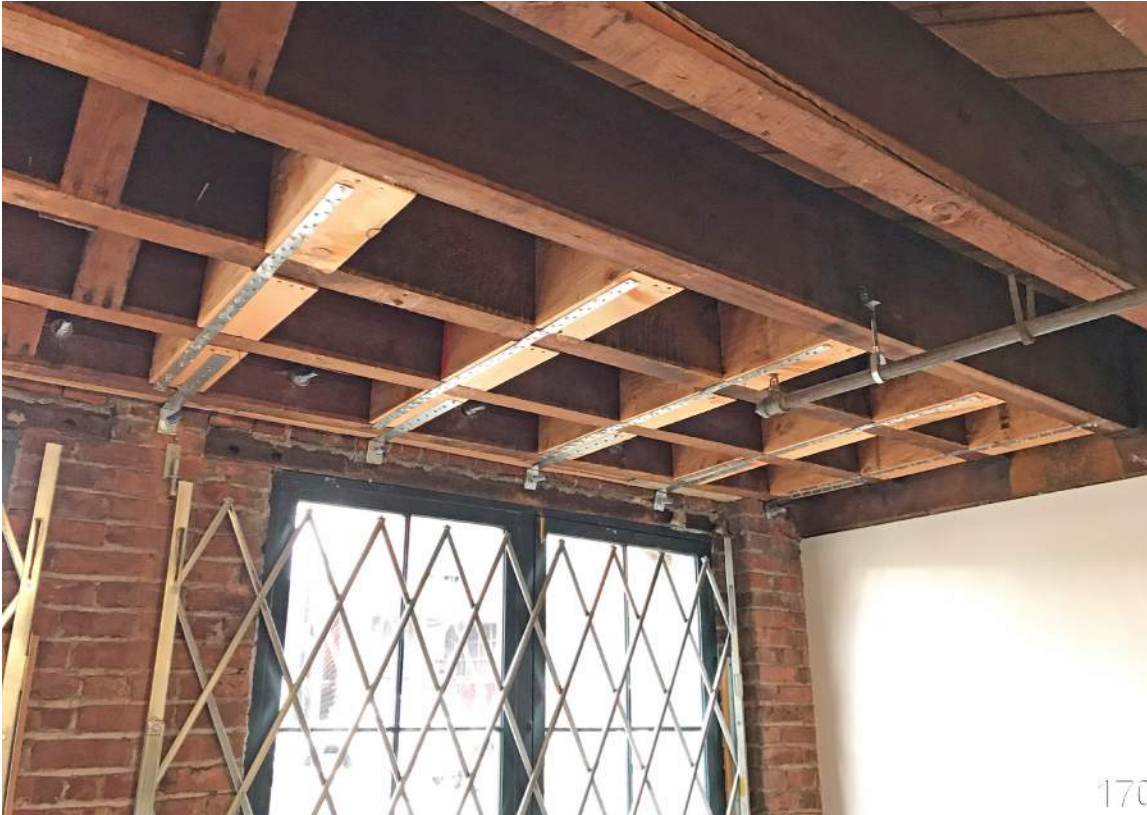
38

Wood ceiling; brick and gypsum board walls; wood windows; wood joists; new anchor bolts, strapping, and wood blocking.

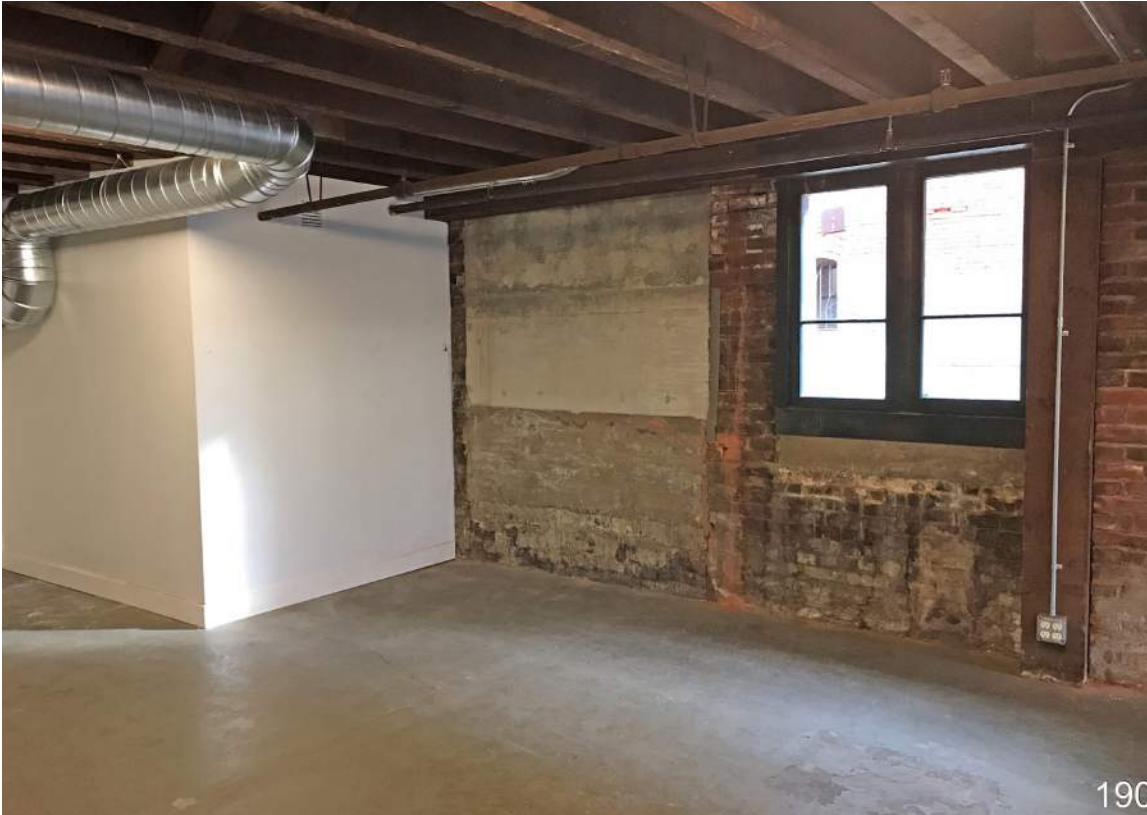
40

Wood ceiling; brick and gypsum board walls; wood windows; concrete floor; wood beams, joists, and columns; new concrete infill at existing opening; new ductwork.

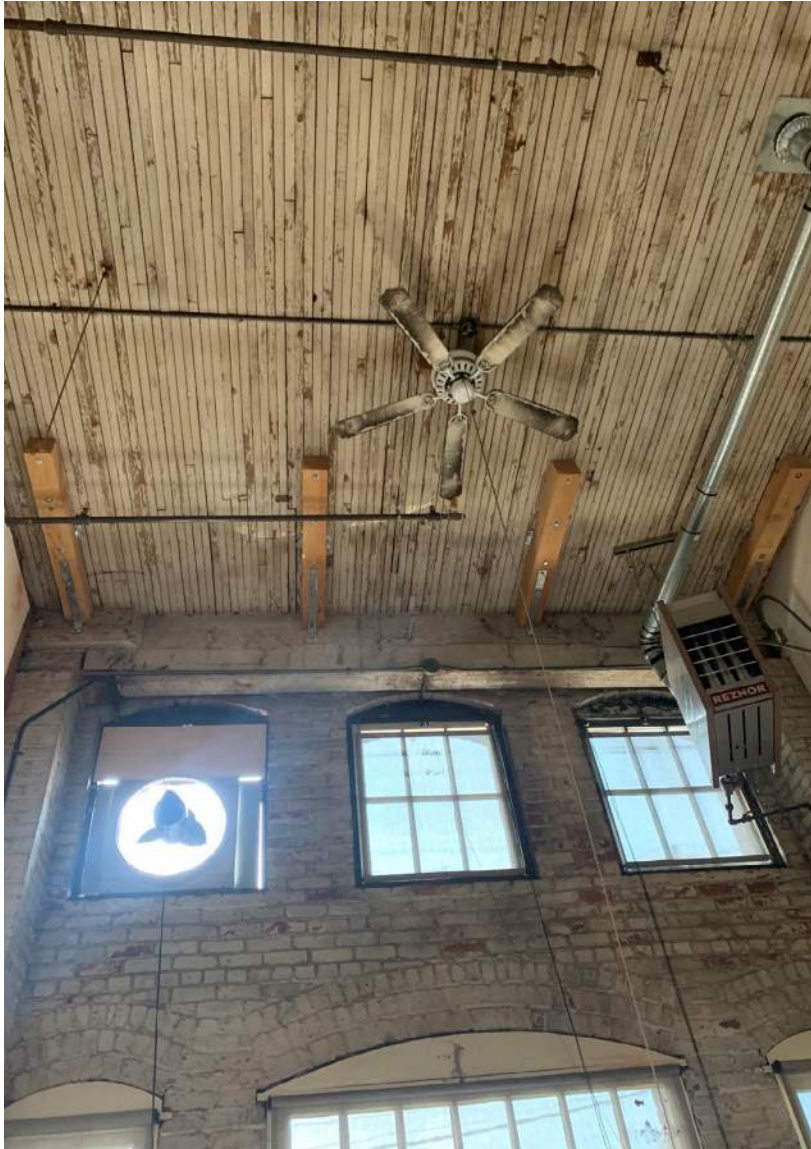
43

Painted wood ceiling;
painted brick walls;
wood windows; wood
beams; new anchor bolts,
strapping, and wood
blocking.

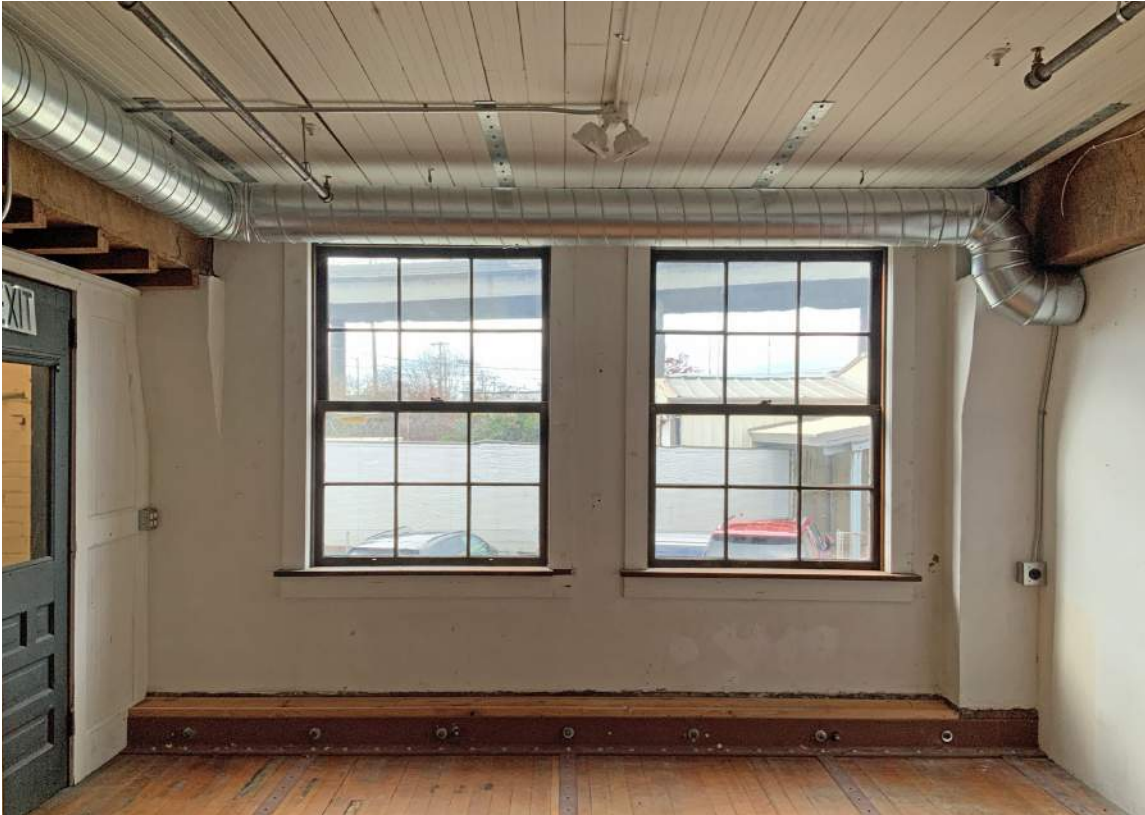
44

Painted wood ceiling;
painted brick walls;
gypsum board walls;
wood floor; wood
windows; wood beams;
new metal strut; new
anchor bolts, strapping,
and wood blocking; new
floor strapping; new
ductwork.

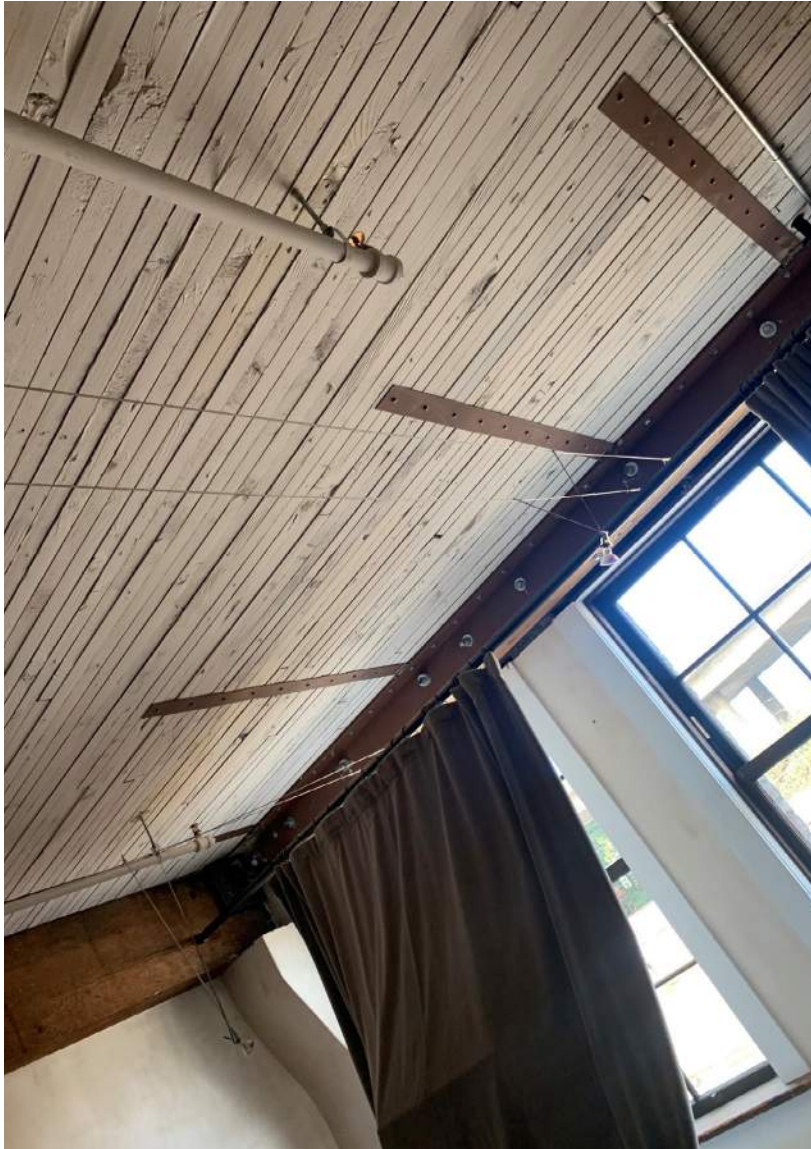
46

Painted wood ceiling;
gypsum board walls;
wood windows; wood
beams; new metal
strut; new anchor bolts,
strapping, and wood
blocking.

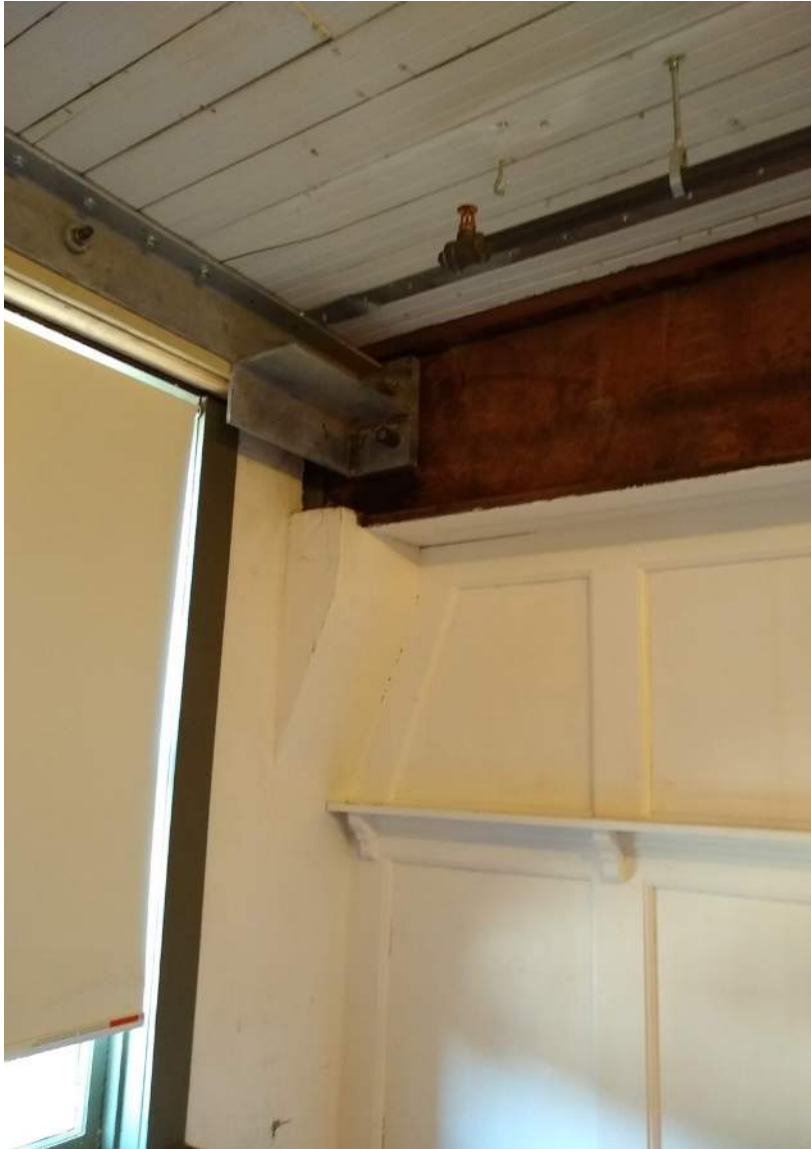
48

Painted wood ceiling;
gypsum board walls;
wood windows; wood
beams; new metal strut;
new anchor bolts and
wood blocking.

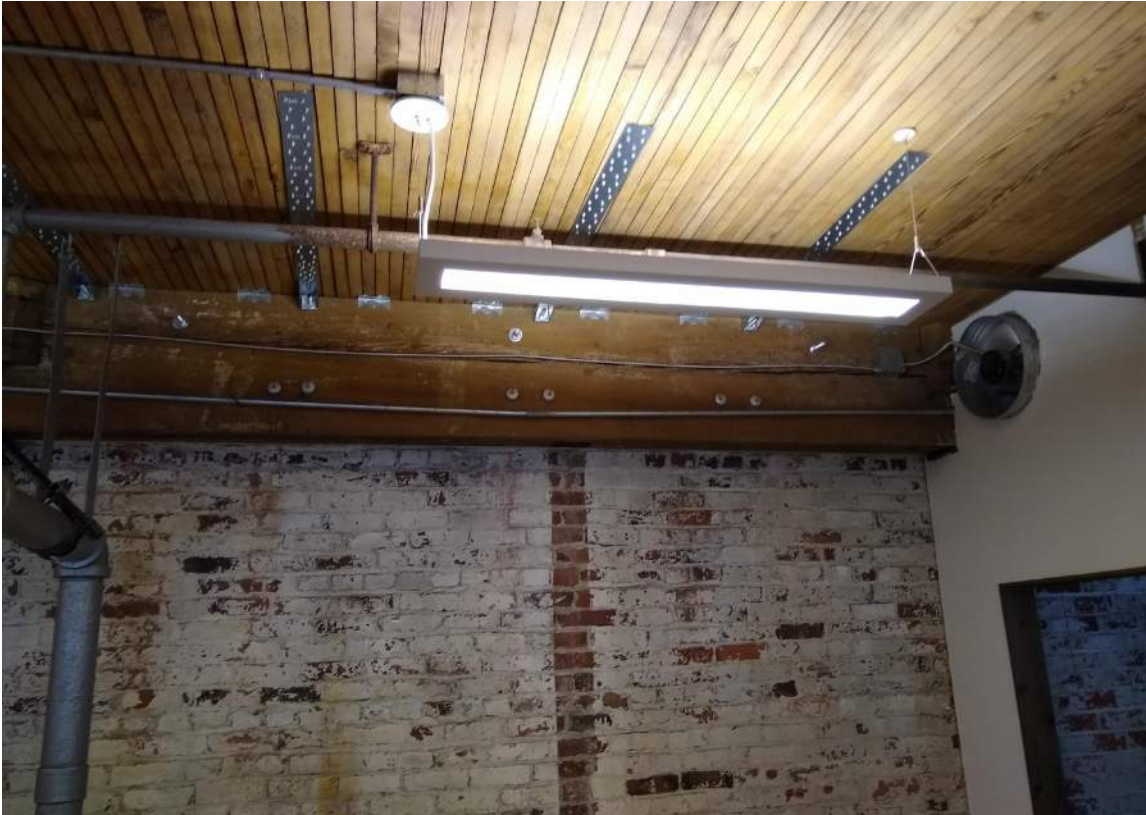
49

Wood ceiling; painted brick walls; gypsum board walls; wood beams; new anchor bolts, strapping, and wood blocking.

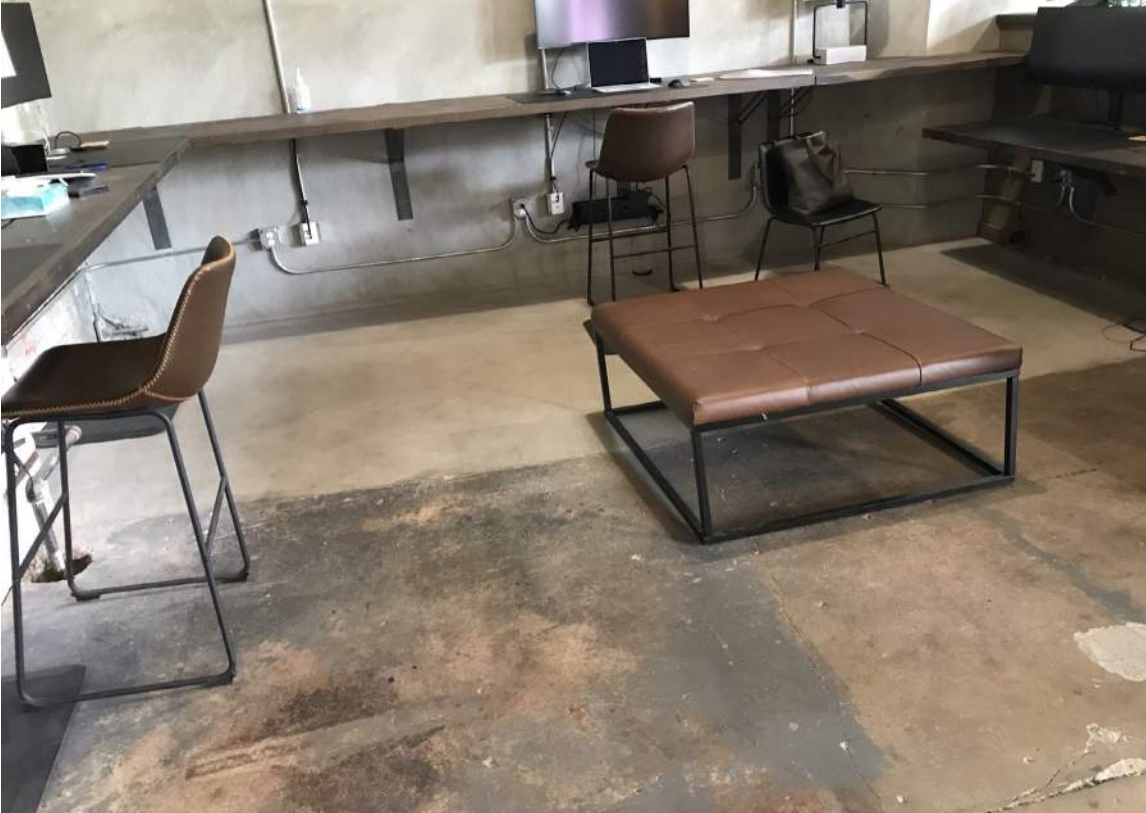
52

Brick walls; concrete floor; new concrete shear wall; new concrete floor topping.

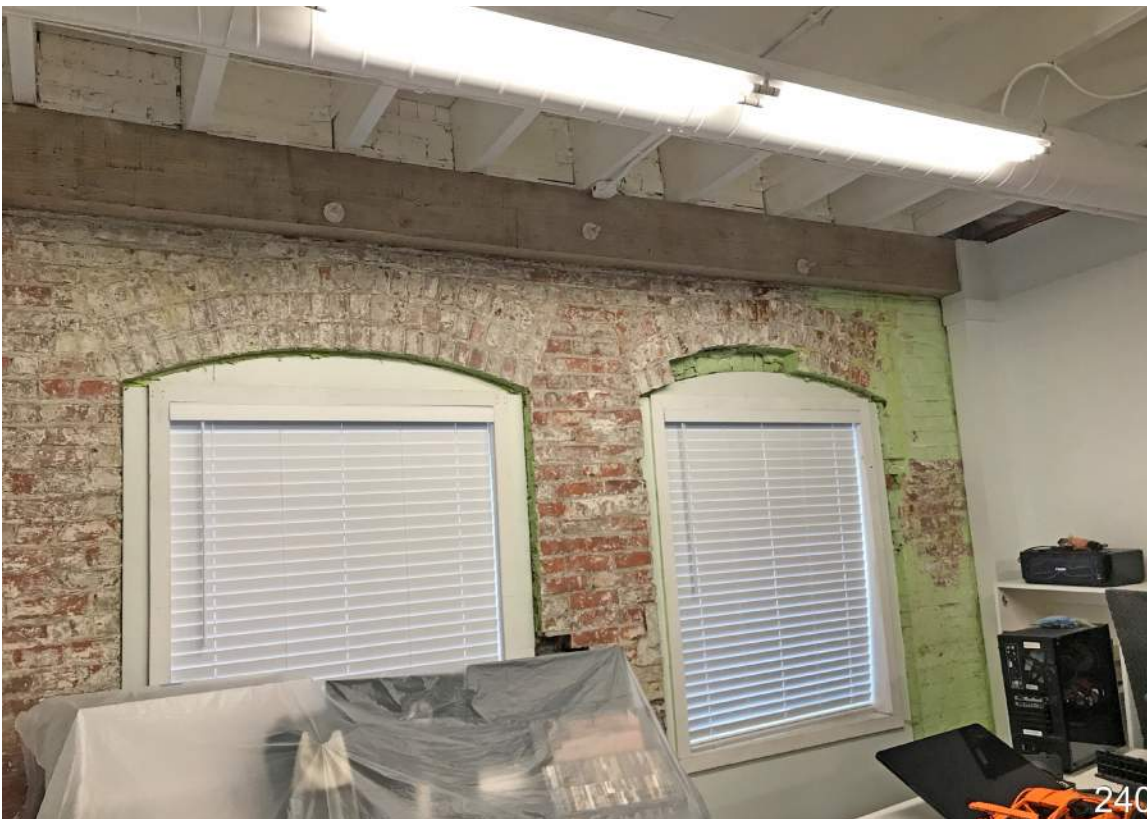
54

Painted wood ceiling; painted brick walls; gypsum board walls; wood beams and joists; previous opening infill and replacement windows; new anchor bolts, strapping, and wood blocking; new ductwork.

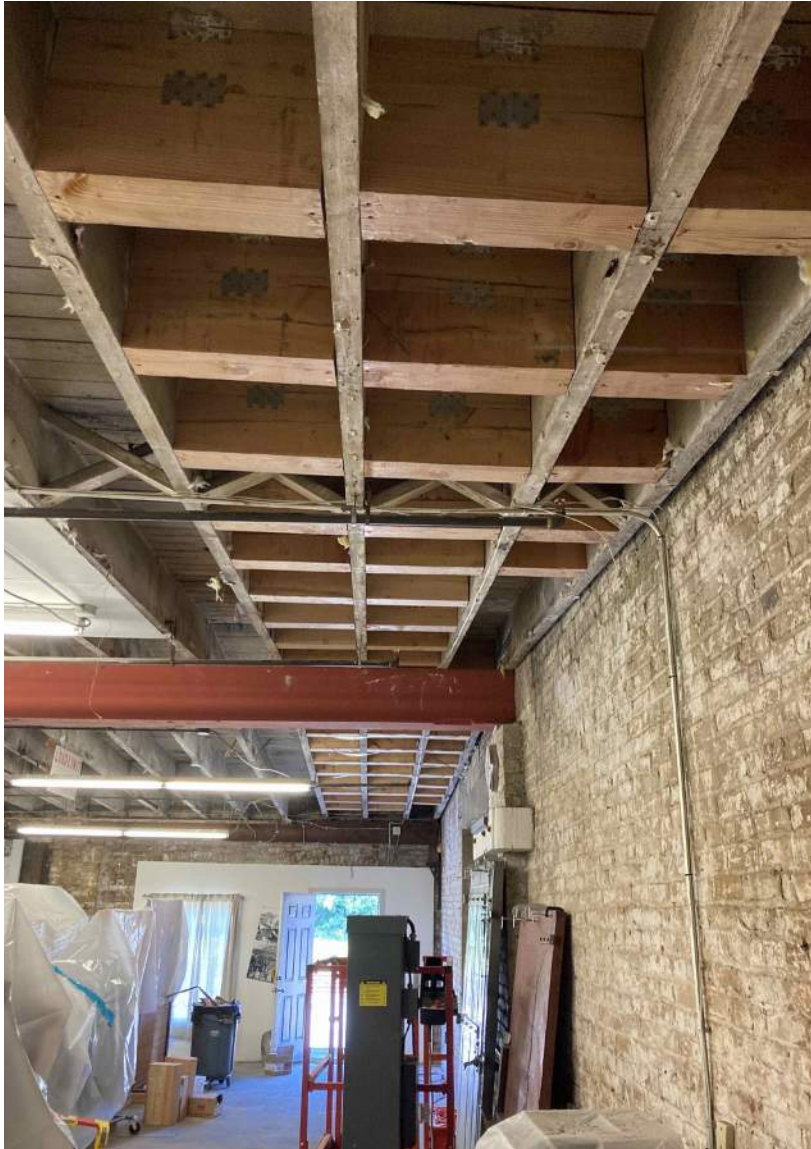
55

Wood ceiling; brick and gypsum board walls; wood exterior doors; concrete floor; wood beams and joists; steel beam; previous opening infill and replacement windows; new anchor bolts, strapping, and wood blocking.

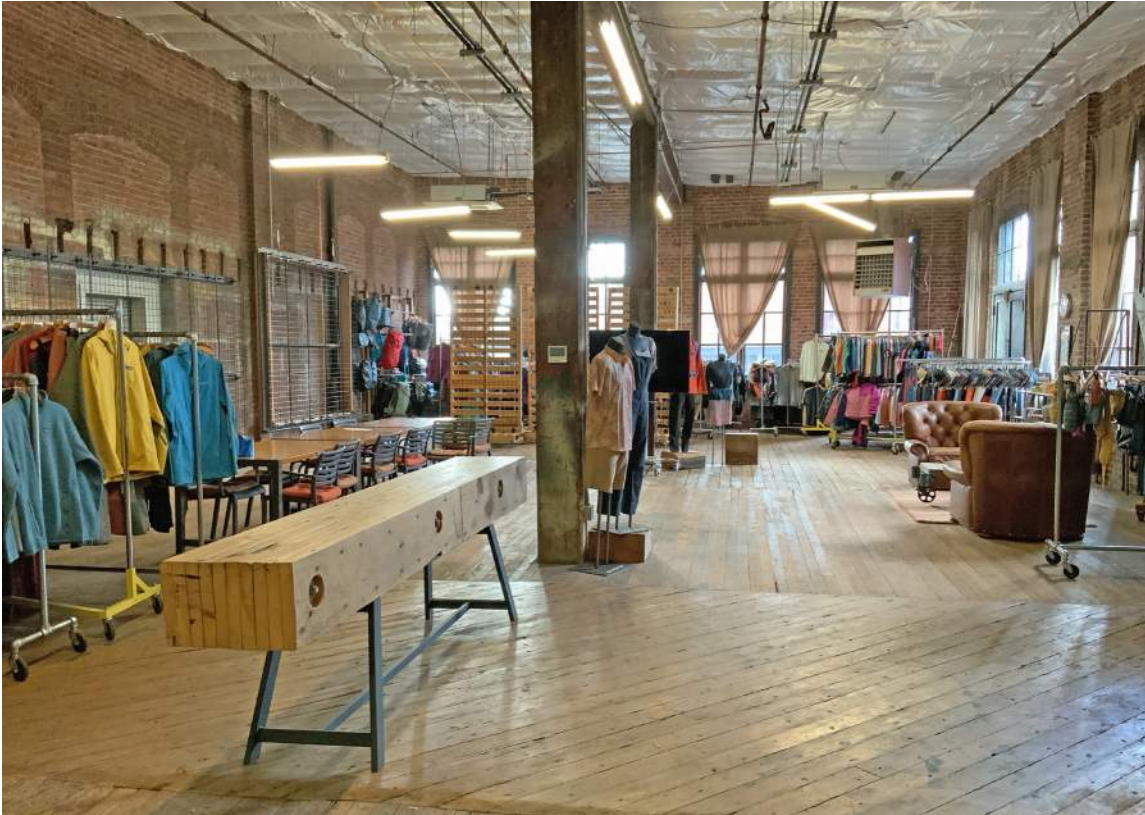
56

Brick walls; wood windows; wood exterior doors; wood floor; wood beams, joists, and columns; new ceiling insulation with cover; new conduit; new mechanical equipment.

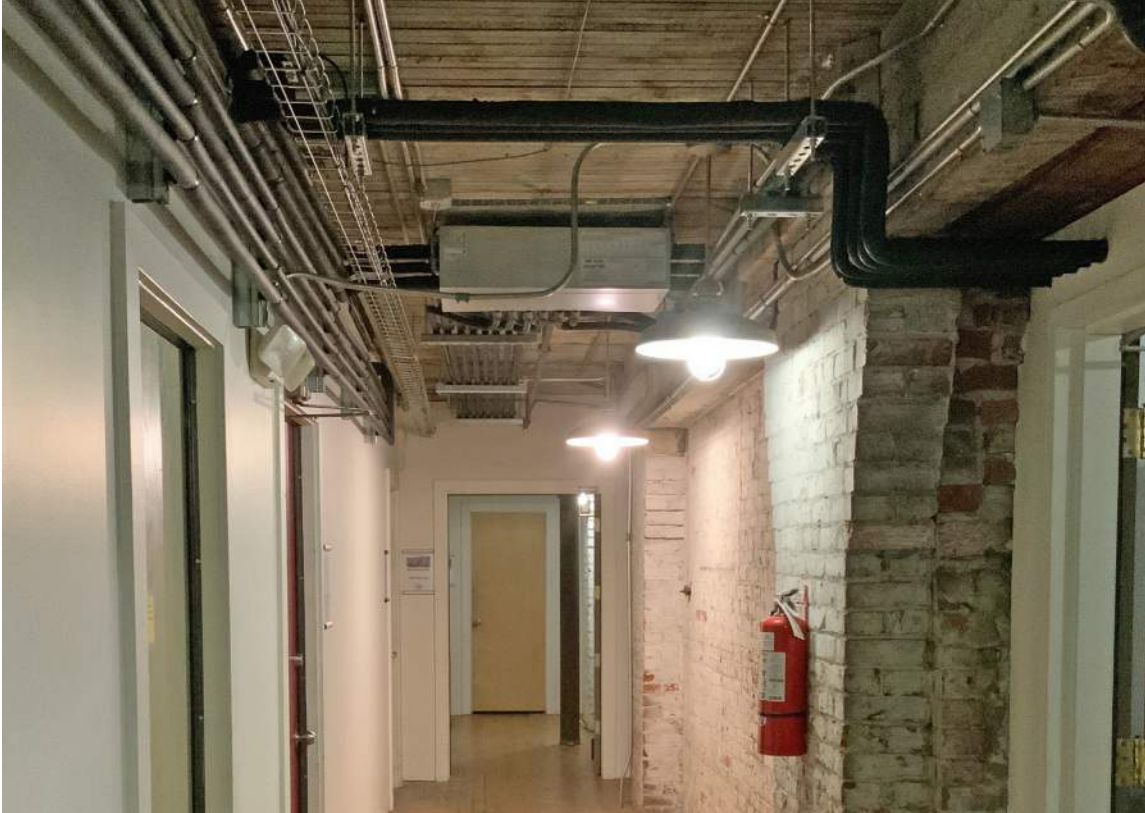
57

Wood ceiling; painted brick walls; gypsum board walls; wood beams; new anchor bolts, strapping, and wood blocking; new conduit; new mechanical equipment and ductwork.
